Building and Timber Pest Inspection Report

Inspection Date: Wed, 01 Apr 2026

Property Address: 24 Flinders St, Matraville NSW 2036,
Australia

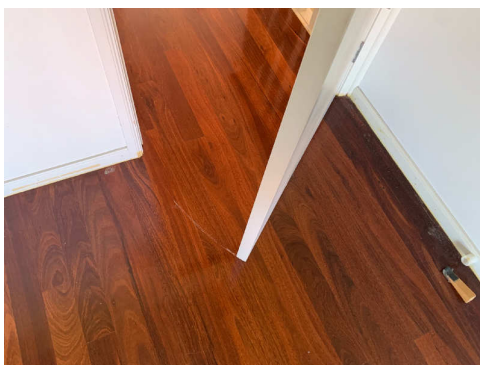
Finding 3.06

Information: Binding and/or jamming of this door is evident during standard operation. This defect inhibits the functionality of the affected door as well as creating potential for secondary defects to associated building elements, such as damage to the floor covering.

A door that binds to flooring or to the associated door frame may have several causes, ranging from minor defects, such as poor installation of the door or deteriorated hinges, through to major structural issues, such as damage to subfloor structures.

For minor causes, a qualified carpenter or general handyperson should be appointed to perform minor rectification works at client discretion.

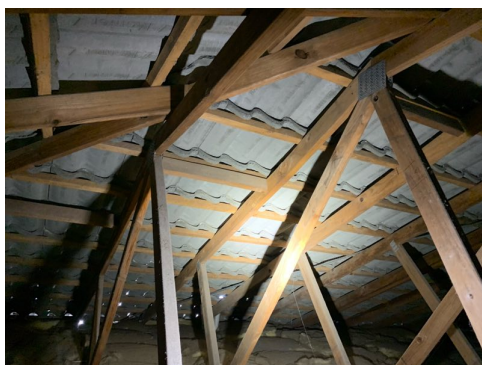
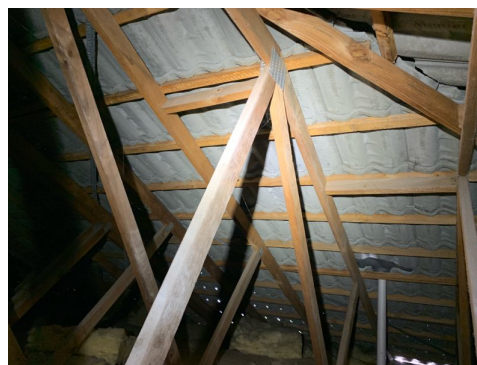
Finding 3.09

Finding: Sarking - Missing

Information: Sarking is missing under the roof sheeting. Sarking acts as an insulator that helps with noise reduction and protects against water penetration. Sarking plays a key role in the operation and function of the overall roofing structure and its performance.

Although not a requirement at the time of construction, replacement of any missing building element is advisable (although this can be quite expensive to do after the time of construction).

Where sarking is missing, regular inspections of the roof tiles for cracking and potential moisture penetration is required.

Sarking may be retrospectively fitted by a registered builder at the discretion of the client.

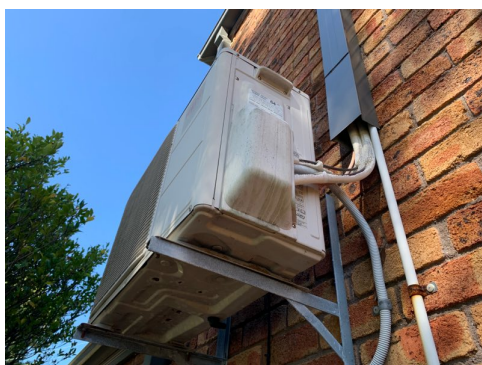
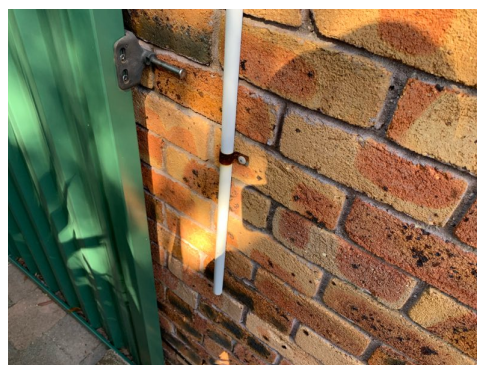
Such leaking creates an environment which is conducive to an array of defects, including water damage to associated building elements and the attraction of termite or timber pest infestation.

It is highly recommended that a licensed plumber be appointed to connect the A/C overflow in order to prevent such an environment from being created. These minor works should be carried out as soon as possible.
