Building and Timber Pest Inspection Report VR

Inspection Date: Mon, 12 Jan 2026

Property Address: 78 Bingara Cres, Bella Vista NSW 2153, Australia

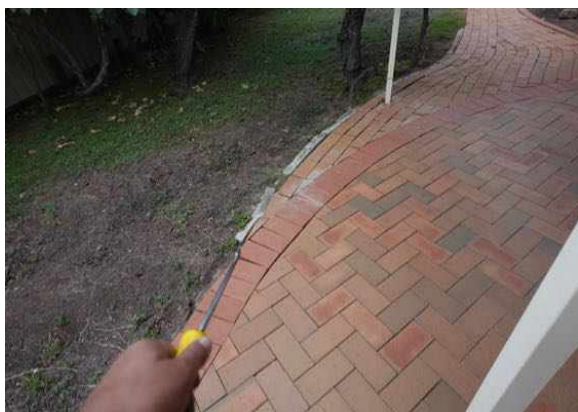
Finding 3.07

Building: Main Building
 Location: Building surrounding
 Finding: Site drainage - Inadequate
 Information: The site drainage in this area was found to be inadequate at the time of inspection, creating potential for subsequent water damage to associated building elements.

buried DPC.

Where site drainage is inadequate, installation of an Agricultural (Aggie) Drain may be required. A licensed plumber should be appointed to further inspect the property and perform any remedial works as necessary. Water damage and secondary defects are likely to occur if left unmanaged.

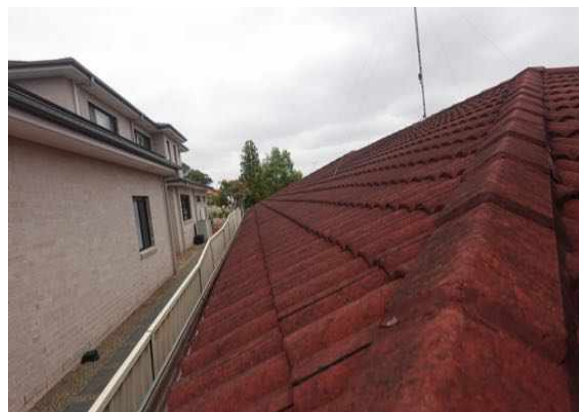
Finding 3.08

Building: Main Building
 Location: Roof Exterior
 Finding: Gutters - Blocked
 Information: Roof plumbing structures, such as guttering and downpipes, should be free of all debris to prevent blockages. Blockages of the guttering and downpipes will lead to pooling and accumulated water overflows, which is likely to subsequently flood eaves and exterior walls.

Blocked gutters are likely to lead to high levels of moisture in the affected areas. Such moisture will not only cause rust and decay of the associated building materials, but can also provide conditions that are conducive to termite and timber pest activity. Blockages in gutters should therefore be removed immediately to ensure dry conditions are maintained.

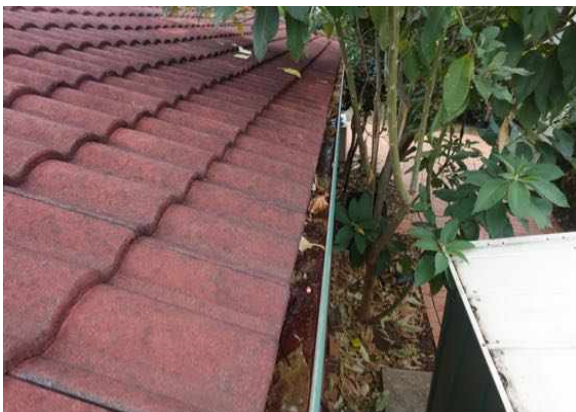
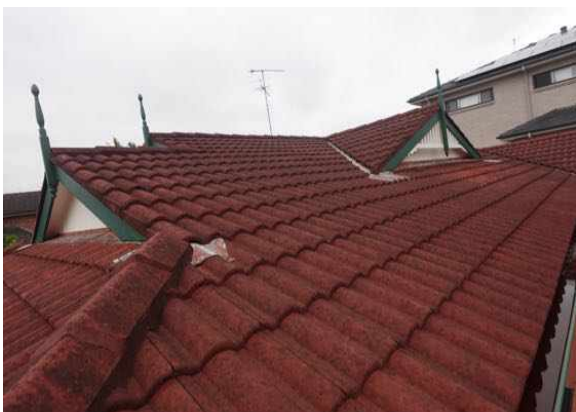
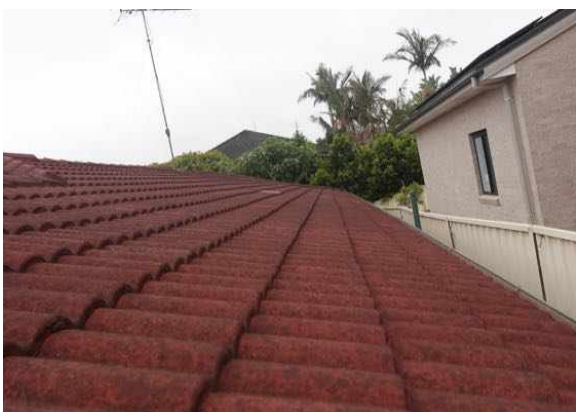
Building:	Main Building
Location:	Roof Exterior
Finding:	Roof tiles - Weathered
Information:	Upon inspection of the exterior roofing, the majority of roof tiles were considered to be in a fair condition. While weathering of the tiles is consistent with the age of the property, maintenance works are required.

Isolated areas of mortar have come loose in the valleys and minor cracking is also present. Re-pointing and re-sealing the may be considered as an interim solution by the client to help preserve and extend the life span of the tiles.

Where left unmanaged, deteriorating roof tiles are likely to lead to a number of secondary defects, including minor water leaks and weather exposure to internal roofing structures.

Consultation with a licensed roofing contractor is highly advised to gain advice on cost of remedial works that may be required in the short to medium term. Remedial works are likely to increase the longevity of the exterior roofing structure.

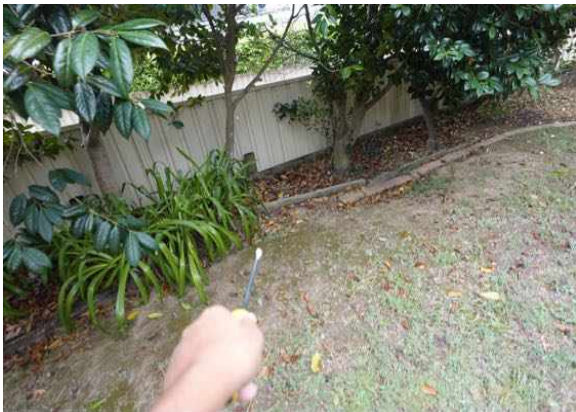
Building:	Main Building
Location:	Several external areas
Finding:	In ground contact
Information:	Any timbers in direct ground contact provide opportunity for concealed termite entry and are likely to be subject to premature rot and decay as the soil retains moisture or damp conditions against the timbers.

Remove untreated timber that is in direct contact with external grounds. Consider replacement with more durable materials i.e. treated timber or non timber elements. Frequent pest inspections are advised to readily identify any termite activity in these areas.

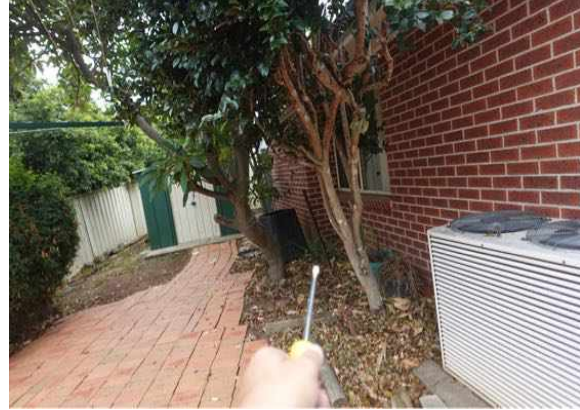
Finding 6.02

Building: Main Building
 Location: Several external areas
 Finding: Bridging - Vegetation
 Information: Where vegetation obstructs inspection of building elements, also known as bridging as it provides a bridging point for the access of termites, full inspection can not be achieved. Consequently moisture or dampness may be present and the areas becomes conducive to termite activity. Plants against or very close to buildings provide cover, shade and can provide an environment that is attractive to termite infestation.

existing vegetation will assist greatly in preventing Bridging from occurring.

The removal of any such materials that may be conducive to termite activity should be carried out as soon as possible and arrange re inspection to minimize the risk of termite attack.

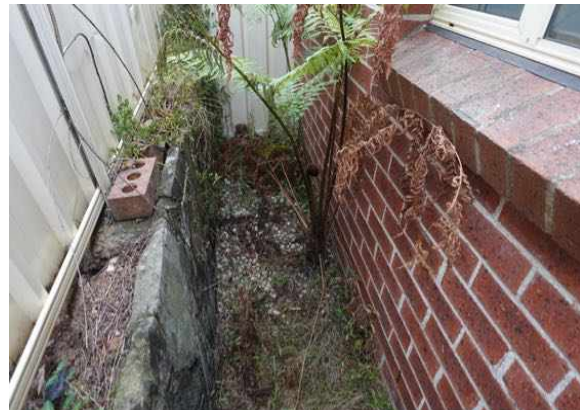
Finding 6.03

Building:	Main Building
Location:	Several external areas
Finding:	Garden Beds - Conditions Conducive to Termites
Information:	Garden beds were found to be evident in the garden area. These garden beds can include untreated timber, and with a combination of moisture from watering hosing can make conditions conducive to termite activity and termite ingress.

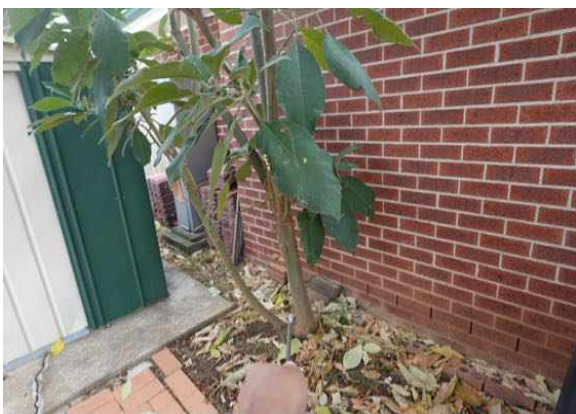
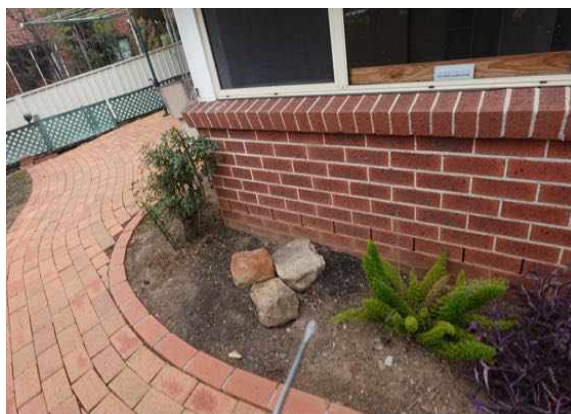
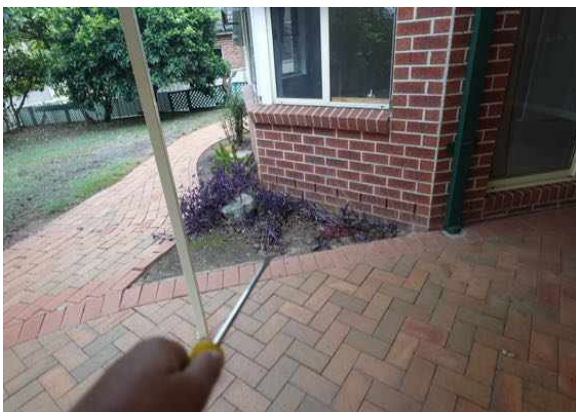
Finding 6.04

Building:	Main Building
Location:	Several external areas
Finding:	Slab Edge - Exposure
Information:	An inspection zone of at least 75mm in relation to the exposed slab edge, between the bottom brick and the perimeter pavement, is required. This inspection zone should be maintained in order to force termites into the open where they can be detected more readily during regular inspections. The slab edge should not be concealed by anything that may prevent inspection of the area, including render, landscaping, soil, turf, paving, concrete cladding or other structures.

If the slab edge is not properly exposed there is a high risk of termite attack. Sometimes, in order to determine the type of slab, a suitably qualified person such as an architect or builder may be required to consult the construction plans.

Where the slab edge cannot be properly inspected, it is highly recommended that termite or timber pest inspections be carried out every 6-12 months to aid protection of the property against infestation.
