Building and Timber Pest Inspection Report

Inspection Date: Fri, 6 Feb 2026

Property Address: 14 Varna St, Mount Colah NSW 2079,
Australia

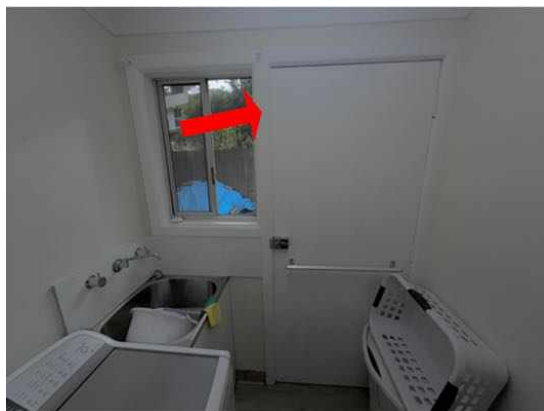
Finding 3.01

Building:	Main Building
Location:	Laundry
Finding:	Door - Binding/jamming
Information:	Binding and/or jamming of this door is evident during standard operation. This defect inhibits the functionality of the affected door as well as creating potential for secondary defects to associated building elements, such as damage to the door and jamb.

A door that binds to flooring or to the associated door frame may have several causes, ranging from minor defects, such as poor installation of the door or

deteriorated hinges, through to minor building movement.

For minor causes, a qualified carpenter or general handyperson should be appointed to perform minor rectification works at client discretion.

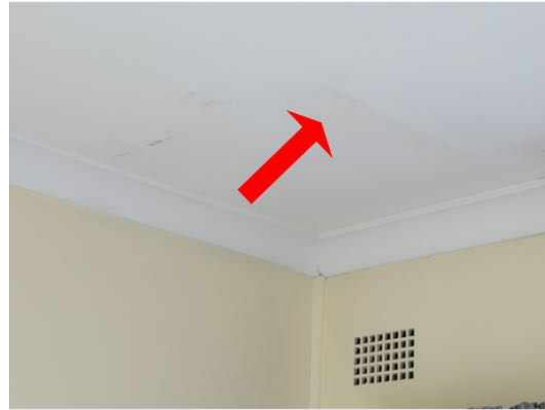
Finding 3.04

Building:	Main Building
Location:	Bedroom
Finding:	Ceiling – Staining from Previous Water Leak
Information:	Staining is present to the ceiling consistent with a past water leak. Moisture readings were taken at the time of inspection and no elevated moisture levels were recorded, the roof void in that area was inspected also and no signs of an ongoing issues were noted, indicating the leak is not currently active. While no ongoing moisture issues were identified, the staining remains visible. The affected area requires preparation and repainting to restore an acceptable finish and appearance.

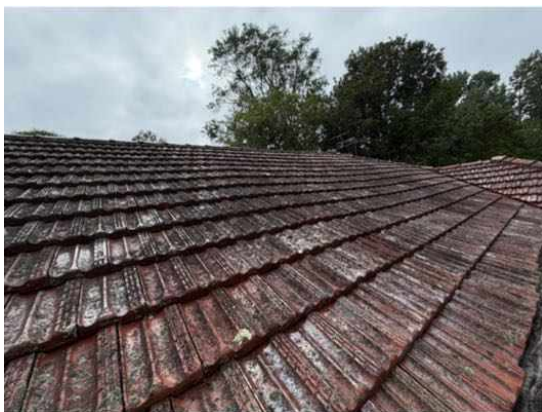
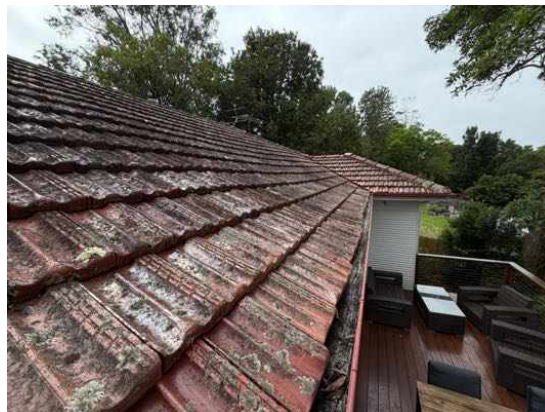
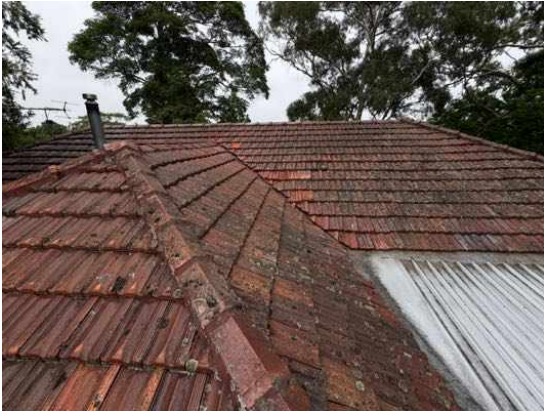
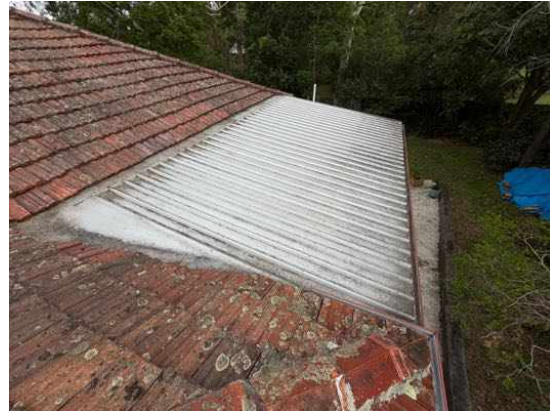
Finding 3.05

Information: Upon inspection of the exterior roofing, the majority of roof tiles were considered to be in a fair condition. While weathering of the tiles is consistent with the age of the property, maintenance works are required. Concrete roof tiles are typically cleaned to have the visible moss and lichen removed. Moss and lichen is attracted to the roof tiles surface, and if left will continue to grow and most likely restrict the flow of rain water over the tiles surface, into the roofs gutters. An application of an environmentally friendly anti-fungal solution should be applied to all moss and lichen, prior to undertaking the roof cleaning process.

A roof restoration company can be contacted for further advice.

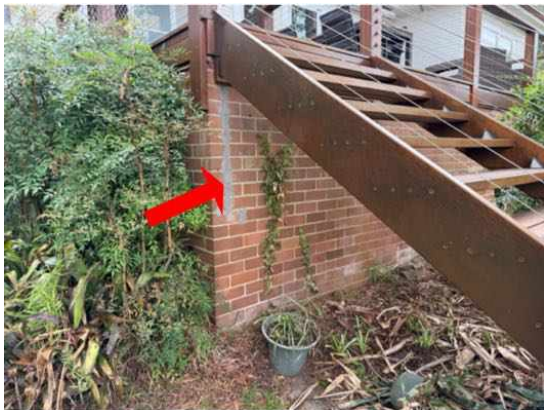
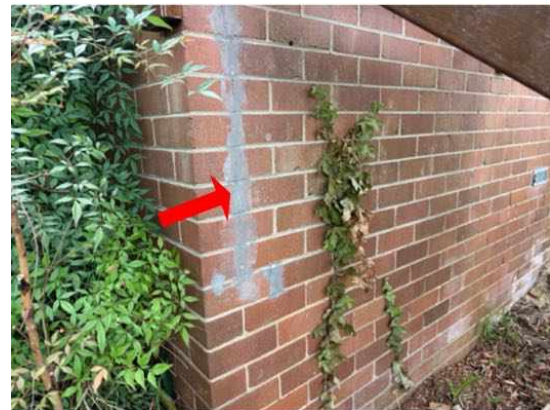
Finding 3.06

Building: Main Building
 Location: Front Left Decking
 Finding: Brickwork - Cracking [Fine]
 Information: Although fine cracks are quite noticeable, they are often only considered to be an appearance defect and usually do not indicate any structural damage. Generally, the cause of a fine crack is indicative of a separation between brickwork and mortar throughout the structure, but single bricks may also show cracks of this nature.

Cracking of this nature can generally be repaired with minor filling and should be conducted by a qualified bricklayer.

Always contact a building inspector should cracks widen lengthen or become more numerous.

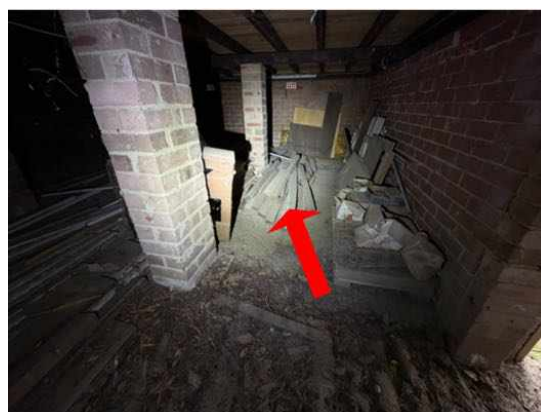
Finding 6.03

Building:	Main Building
Location:	All Areas
Finding:	Stored timbers - subfloor space or external area
Information:	The storing of timbers in the subfloor space or around the external property (including bark mulch) increases the risk of termite activity being present. As they are likely to come into contact with weather conditions or excessive moisture wood rot is likely to develop on timbers that are not treated.

It is highly recommended that any stored timbers be immediately removed from areas in which they may attract any termite / timber pest attack. Minimisation of risk / prevention of termite attack is far more adequate than dealing with the presence of termite activity.

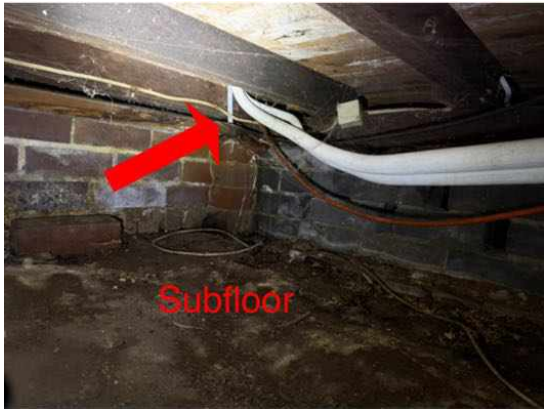
Finding 6.04

Building:	Main Building
Location:	Hot Water/AC units
Finding:	Overflows not plumbed to drainage
Information:	The overflow is not plumbed or connected to suitable drainage, which has resulted in the surrounding area becoming excessively damp.

These damp conditions can lead to secondary defects such as rot, rust or corrosion of associated building elements, the formation of fungal decay, or even the creation of potential slip hazards. When coupled with poor site drainage, pooling of water may also attract termite activity to this area.

It is highly recommended that a qualified plumber be appointed to install adequate drainage to the overflow. These works will ensure that the area remains dry and free of any secondary defects.

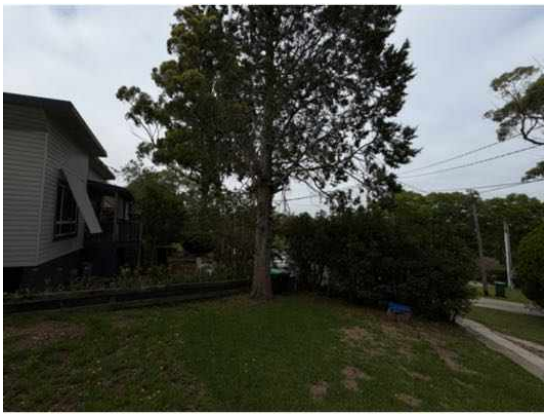
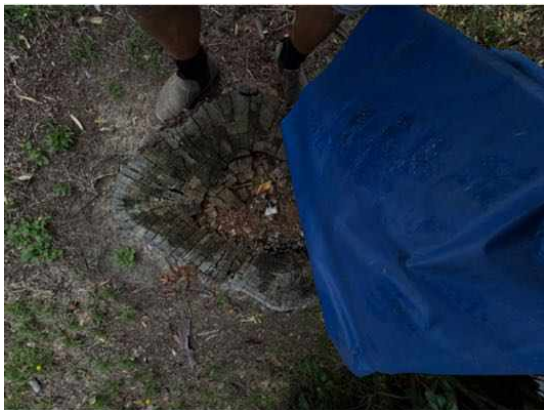
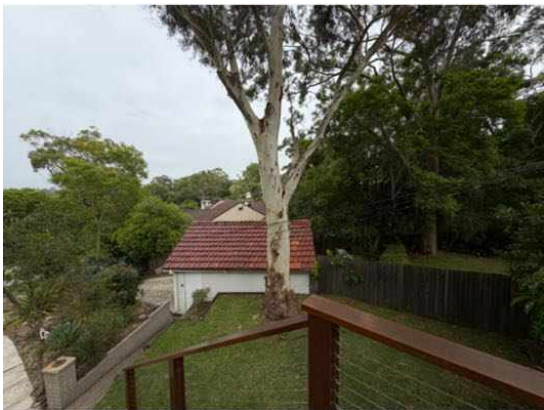
Finding 6.05

Building: Main Building
Location: Yard
Finding: Large trees/stumps within 30m of house
Information: There are a number of large trees/stumps within 30m of the house which may contain natural termite activity. It is important to monitor these areas to ensure no natural activity is allowed to progress into the main house.

Regular inspections are recommended. Consider test drilling any large trees.

A pest controller can be contacted to carry out such testing at the owners discretion.

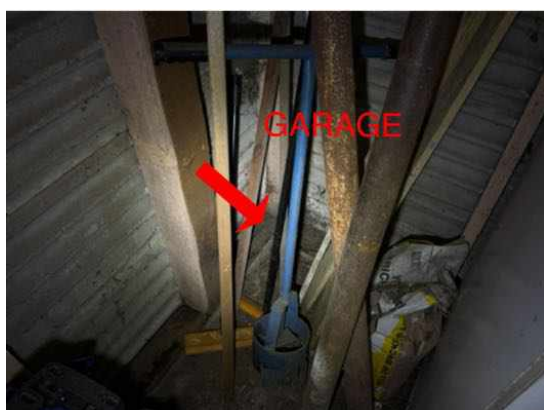
Finding 7.01

Building:	Main Building
Location:	Rear steps/detached Garage
Finding:	Fungal decay - present at the time of inspection
Information:	Fungal decay also known as wood decay or wood rot occurs when timbers and other

cellulose building materials are exposed to damp conditions on an ongoing basis. This could be the result of exposure to weathering in the long term or the pooling of water or absorbed moisture from other abutting building materials or a shower leak. It is advisable to remove these affected timbers to prevent any chance of attack in the future.

Wood decay is more susceptible to termite attack and these timbers should be replaced to limit termite attack.
