## Building Inspection Report

Inspection Date: Fri, 6 Mar 2026

Property Address: 47 Grafton St, Goulburn NSW 2580,  
Australia

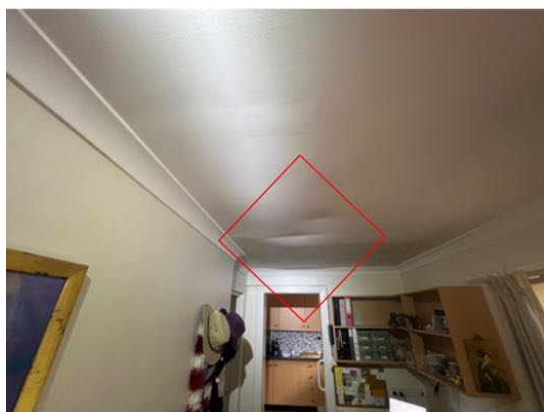
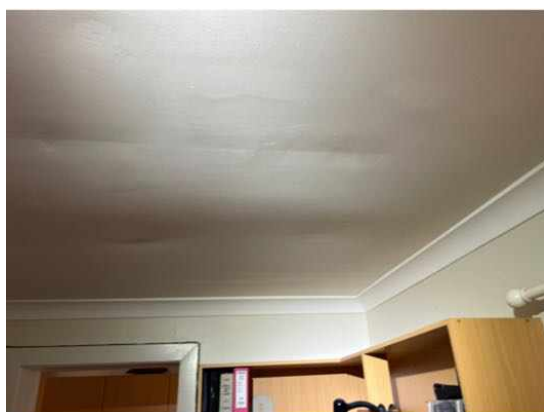
## Defects 1.02

Building:	Main Building
Location:	Lounge Room
Finding:	Ceiling - Sagging
Information:	Sections of the ceiling were found to be sagging at the time of inspection. Sagging to the fixed ceiling structure generally indicates that the building materials have swollen, due to contact with water, or that fixings (e.g. nails or glue) have become loose and require reattachment.

In some cases, sagging ceiling linings may also indicate that there are structural issues, causing surfaces to warp, twist or sag. Where sagging appears to be major, appointment of a structural engineer is advised to further inspect the property and identify the source and rectification works required.

Where minor sagging is evident, comparatively minor works, such as re-gluing of ceiling sheets, may be required. Such works may be performed by relevant tradespeople, such as plasterers and painters. Where excessive moisture has caused the roofing structure to swell and sag, the source of the water leak should primarily be identified prior to any remedial works being performed.

The appropriate action should be taken by the client as soon as possible to ensure that any potential further damage is limited.

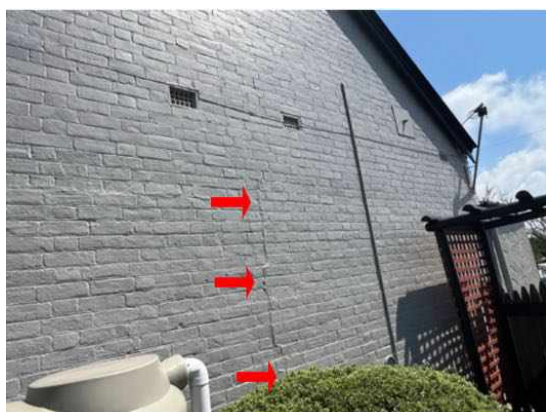
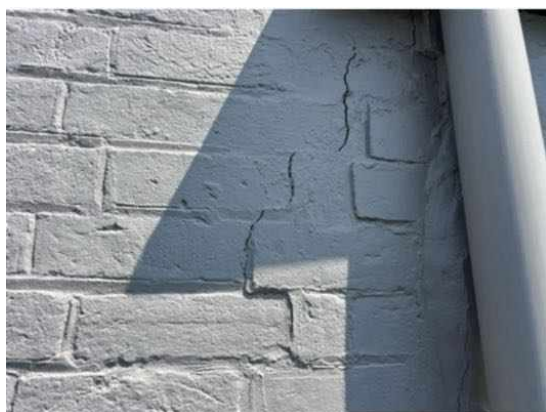
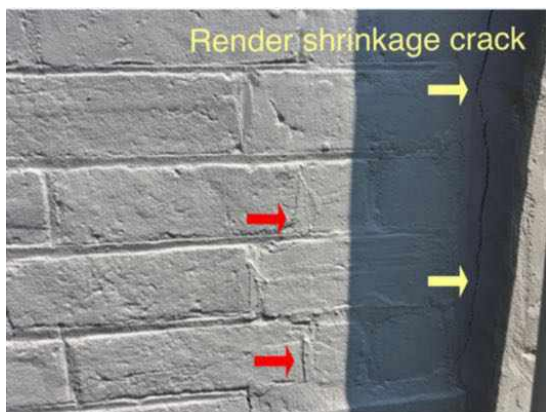
### Defects 3.01

Building: Main Building  
 Location: Exterior walls - left side  
 Finding: Brickwork - Step cracking  
 Information: Step cracking was identified to the brickwork in this area at the time of inspection. Step cracking, which is similar to other forms of cracking, has a variety of possible causes. However, the most common is the subsidence of adjacent footings.

Step cracking is a relatively common defect, and is most likely to occur adjacent to windows, doors and other openings. Mortar failure in the gaps between affected bricks indicates the stresses and tensions affecting the wall.

Where step cracking is extensive or severe, the client is advised to consult a structural engineer. Minor step cracking can be used as a warning sign to address factors causing stress to the wall, which can include the effect of surrounding trees, water

leaks, soil erosion, or even the presence of reactive soils in the surrounding area.

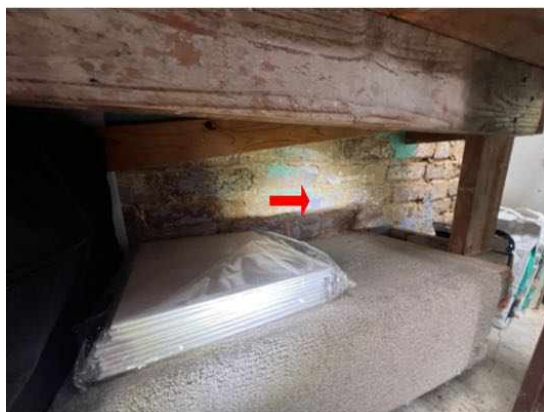
### Defects 3.03

Rising damp is generally managed by the installation of a damp proof course during construction. A Damp Proof Course (DPC) is an impermeable barrier at the base of the wall above ground level. However, many 19th Century buildings have no damp course installed, or the materials have failed. The DPC may have been omitted as a consequence of poor workmanship, or it may have been bridged where materials built up against the side of the house allow moisture ingress above the DPC level.

The first step in addressing rising damp is to diagnose the cause. The identified cause should be addressed first before addressing the appearance and other defects which have resulted from the rising damp. If the original cause is not resolved, further cases of damp are likely to ensue, resulting in secondary defects.

Consultation with a qualified plumber is advised immediately to identify the cause of

the damp and perform remedial works as required.

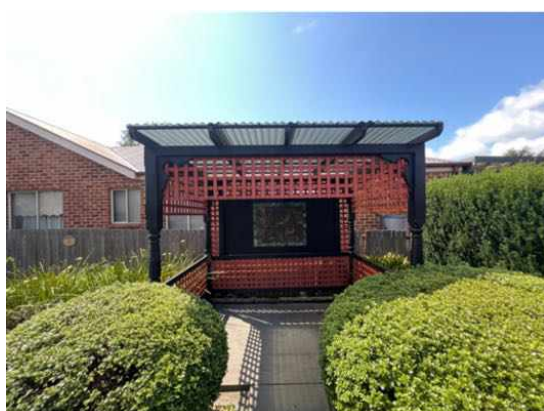
### Defects 3.04

Building:	Out Building
Location:	Pergola 2
Finding:	Pergola - Unstable
Information:	A freestanding pergola structure was observed to move and sway when moderate pressure was applied. Structures of this type should generally remain stable and resist noticeable movement under light manual force.

Movement within the posts or framing members may indicate inadequate footing support, loose or deteriorated fixings, or insufficient structural bracing. Continued movement can lead to progressive loosening of connections and may result in further instability over time.

It is recommended that a licensed builder be appointed to inspect the pergola and assess its stability. Further assessment may be required to determine whether remedial works are necessary to ensure the structure remains adequately supported and secure.

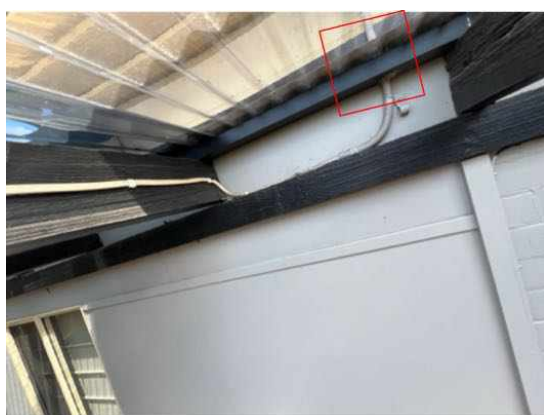
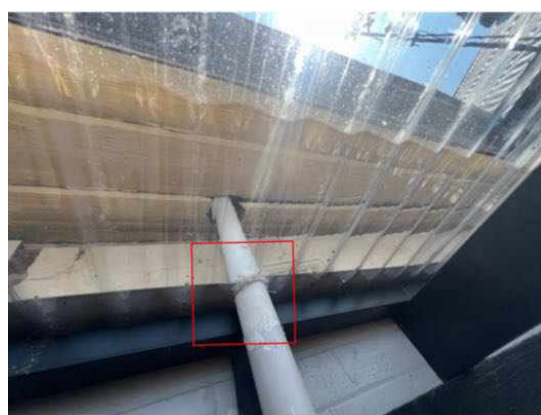
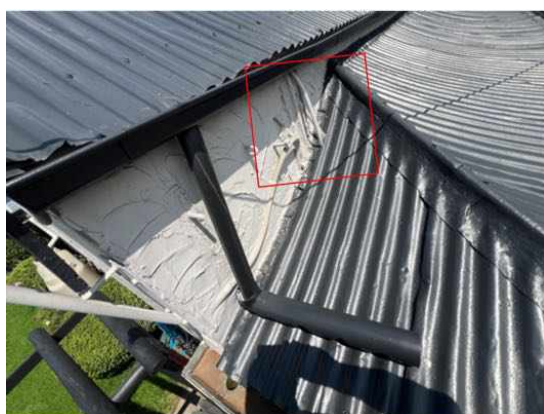
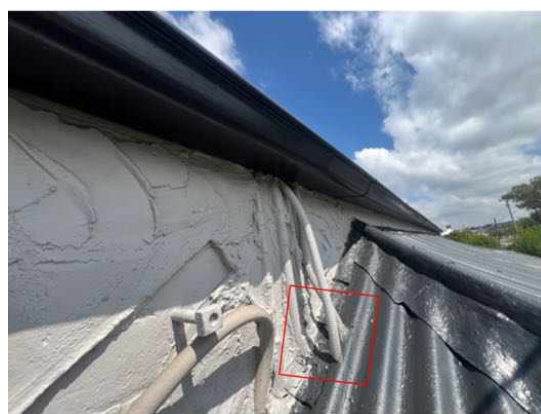
### Defects 3.05

Building:	Main Building
Location:	Verandah, Pergola

Finding: Roof Penetrations - Substandard Installation  
 Information: Various service penetrations through the roof covering, including pipework and electrical conduits, were observed to be substandard in installation. Inadequate flashing, sealing, or general detailing was noted to these penetrations.

Poorly executed roof penetrations may compromise the weatherproofing of the roof system and increase the potential for water ingress around the affected areas. If left unmanaged, moisture may enter the roof space and contribute to deterioration of surrounding building elements.

It is recommended that a licensed roofing contractor be appointed to assess the penetrations and carry out necessary works to ensure the roof covering remains adequately sealed and protected against moisture ingress.

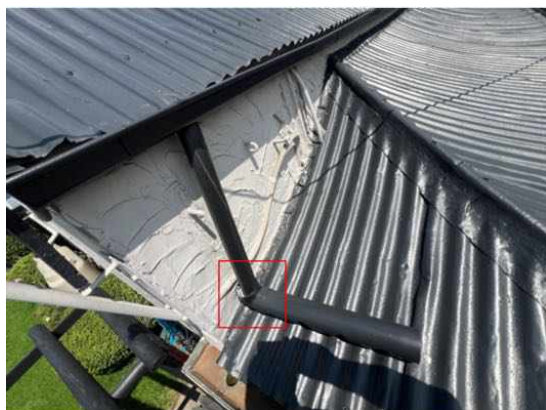
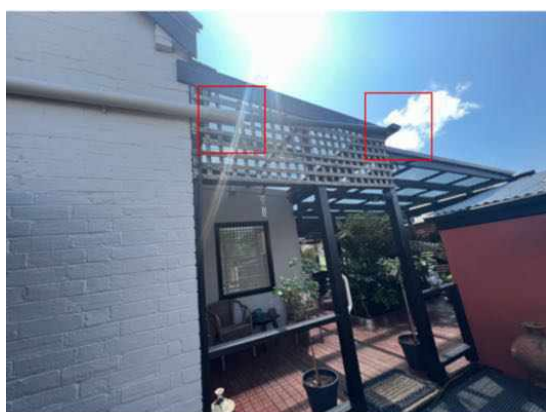
### Defects 3.06

Building: Main Building  
 Location: Exterior walls - front, rear  
 Finding: Roof plumbing - Insufficient capacity  
 Information: It is suspected that the roof plumbing to the exterior roof is insufficient in capacity and is not adequately managing the volume of rainwater that it is required to drain. The result is generally that the plumbing overflows during periods of heavy rainfall, creating damp conditions against external surfaces and the base of the building perimeter.

If left unmanaged, the excess moisture in this areas may allow the formation and development of an environment that is conducive to rust, corrosion and rot, creating potential for secondary defects to all associated building elements. Damp conditions are also conducive to termite and pest activity, further exacerbating the risk of the environment.

Appointment of a roofing plumber is recommended to replace any inadequate drainage systems to ensure proper drainage to this area. In the interim, it is important to ensure that all roof plumbing is free of any debris or blockages.

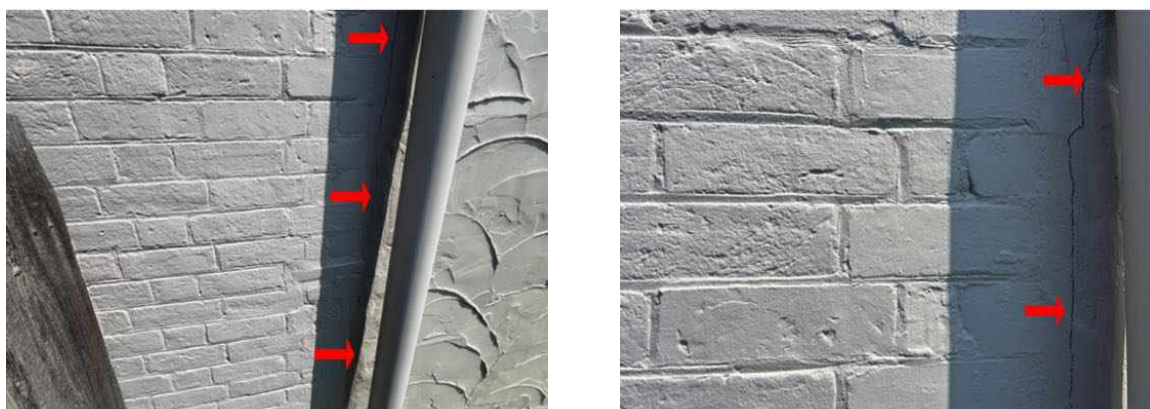
### Defects 3.07

Building:	Main Building
Location:	Exterior walls - left side
Finding:	Render - Shrinkage Crack at Junction
Information:	A straight shrinkage crack was observed to the rendered wall surface along a junction line. This type of cracking commonly occurs where an expansion or control joint has not been provided within the render system, resulting in stress cracking as the material cures or undergoes minor building movement.

If left unmanaged, cracks within rendered surfaces may allow moisture penetration behind the render coating and may lead to further deterioration of the finish over time.

A rendering contractor should be appointed to assess the affected area and undertake repairs as required, including the installation of an appropriate control or expansion joint to accommodate movement.

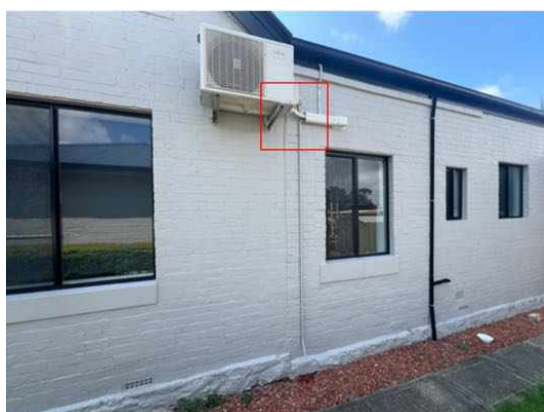
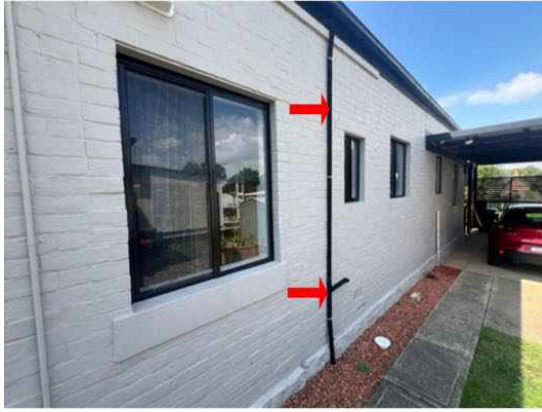
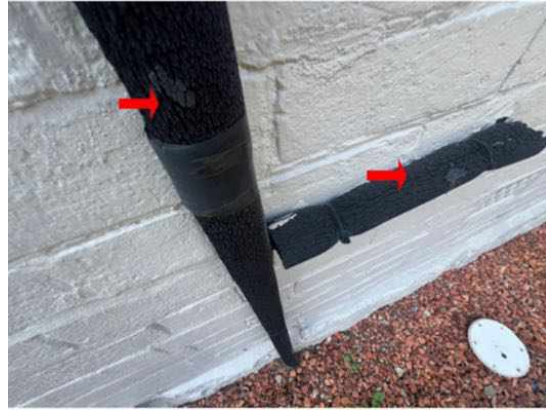
### Defects 3.08

Building:	Main Building
Location:	Exterior walls - right side
Finding:	Pipework - Insulation deteriorated
Information:	Sections of the pipe insulation show evidence of damage and deterioration. It is suspected that this deterioration has developed as a result of excessive exposure to weather, including UV exposure in daylight. Deteriorated insulation reduces the effectiveness of the material in helping to maintain the desired temperature and work most efficiently.

If left in an exposed position, it is likely that the deterioration will continue and worsen over time, potentially resulting in secondary building defects as well as a further loss in insulating properties.

Some areas of replacement of pipe insulation is likely to be required. Further preventative measures to remove or protect the material from future exposure are also advisable. Consultation with a licensed plumber is advised to gain quotes for the repair and/or replacement of deteriorated insulation.

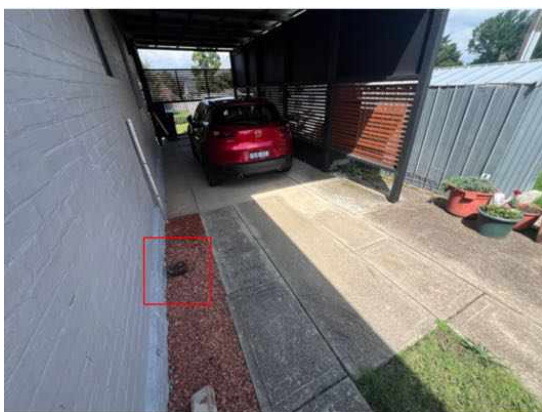
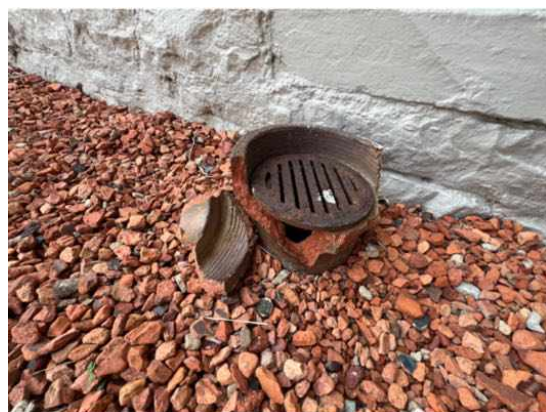
### Defects 3.09

Building:	Main Building
Location:	Exterior walls - right side
Finding:	Terracotta Pipe - Damaged
Information:	A section of terracotta pipe was observed to be cracked and broken at ground level adjacent to the building. The extent and function of the pipe could not be confirmed during the inspection; however, damage of this nature may allow uncontrolled discharge of water into the surrounding soil.

If left unaddressed, damaged pipework may contribute to localised moisture accumulation adjacent to the structure and deterioration of surrounding ground conditions.

A licensed plumber or suitably qualified contractor should be appointed to assess the pipework and carry out any necessary repairs to restore the installation to a serviceable condition.

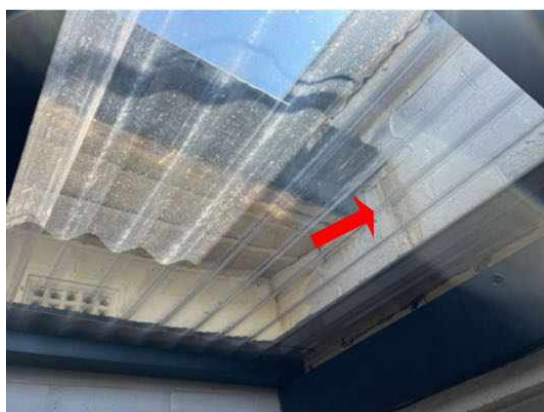
### Defects 3.10

Building:	Main Building
Location:	Exterior walls - rear
Finding:	Walls - Water stained

**Information:** Water staining to sections of the walls in this area was evident at the time of inspection. Water staining indicates that surfaces have been exposed to excessive moisture over time. The minerals and other elements in the water lead to staining, which may graduate to corrosion and deterioration if left unmanaged.

While mostly an appearance defect, water staining can be indicative of more serious defects, which may be currently concealed by wall linings.

Where water staining is active, a licensed plumber must be consulted to identify the cause of the staining and to provide advice on any reparation works that may be required. Replacement of any broken or damaged structures is advised.

Conversely, where water staining is old and inactive, affected building materials may be repaired or replaced at client discretion.

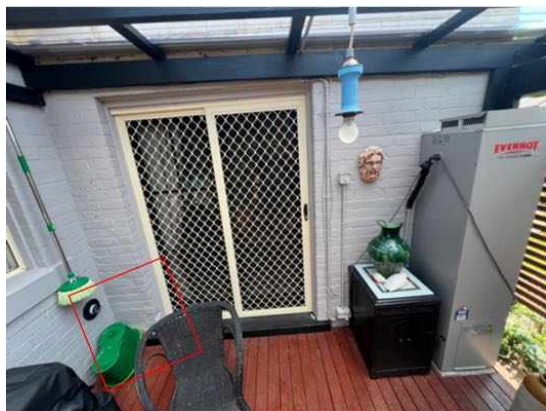
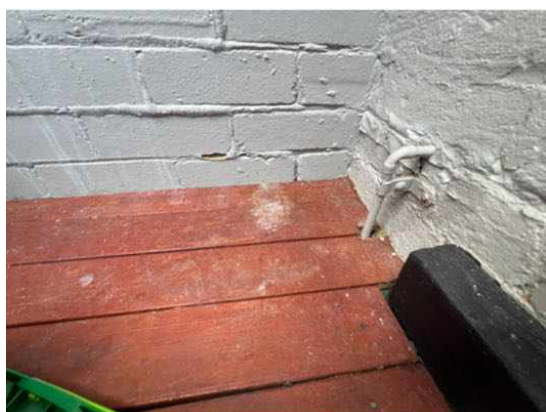
### Defects 3.11

**Building:** Main Building  
**Location:** Exterior walls - rear  
**Finding:** Brickwork - Paint Deterioration to Mortar Joints  
**Information:** The painted masonry in this area was observed to exhibit bubbling and deterioration primarily along the mortar joints. Paint failure of this nature is commonly associated with moisture movement through masonry joints, which can cause loss of adhesion and blistering of the paint coating.

Older masonry construction can allow moisture to migrate through mortar joints from sources such as ground moisture, external moisture exposure, or trapped moisture within previously painted masonry surfaces. Where moisture is present within the wall structure, painted finishes may deteriorate prematurely.

The condition appears localised to this section of wall. However, continued moisture migration through the masonry may contribute to further deterioration of finishes if left unmanaged.

It is recommended that a licensed builder be appointed to inspect the affected area

and determine the underlying source of moisture. If moisture migration through the masonry is confirmed or the condition is found to be more widespread, further assessment by a specialist in rising damp or masonry moisture remediation may be required.

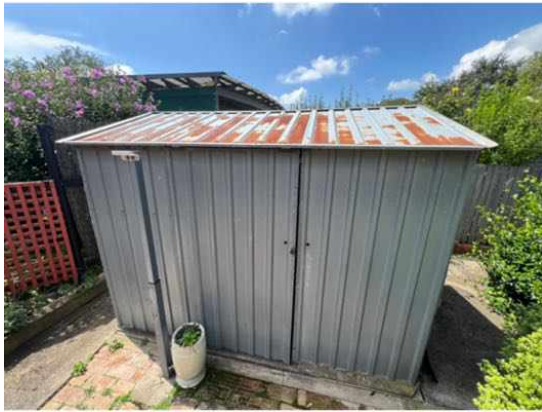
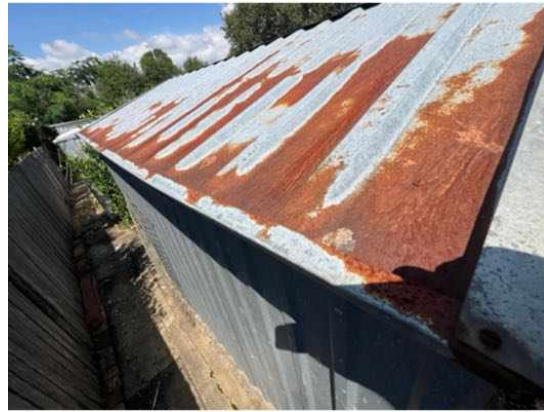
### Defects 3.12

Building:	Out Building
Location:	Shed
Finding:	Shed - Rusted or corroded
Information:	This shed shows evidence of rusting and corrosion, which is likely to have developed as a result of excessive exposure to moisture and or inadequate coatings.

As surface rust provides no protection to the underlying iron, the deteriorating condition is likely to worsen if not addressed in the short-term future.

Where possible, the use of galvanized (treated) metals or aluminium coated metals aid in rust prevention, as does regular general maintenance. Rust formation can be controlled with coatings, such as paint, that isolate the iron from the environment.

Rusting and corrosion should be managed by ideally removing or limiting the affected surface from exposure to moisture. A registered builder may be appointed to replace any building elements that have been severely affected by rust or water damage.

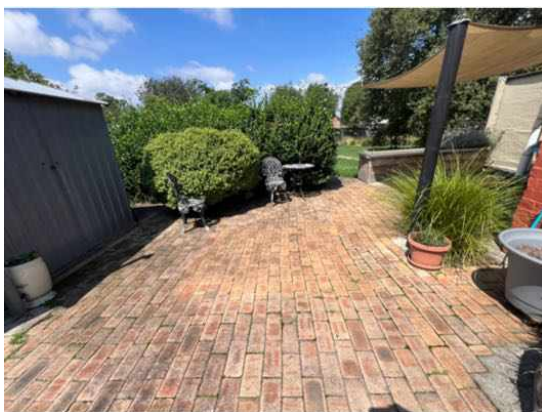
### Defects 3.16

Building:	Yard
Location:	Yard - Back
Finding:	Paving - Uneven
Information:	Sections of the external paved area are uneven, creating a potential trip hazard. It appears as though the area has been subject to rough installation, or that paving sections have lifted due to movements in the foundation of the property.

Re-paving of the area is required as soon as possible to remedy this situation. Further consultation with a specialist concreter is advised.

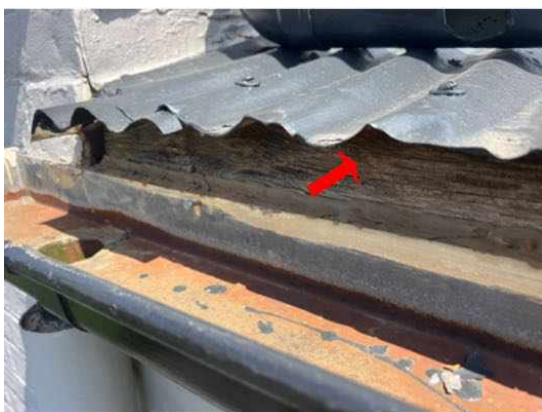
### Defects 3.17

Building:	Main Building
Location:	Roof Exterior - Verandah
Finding:	Timber - exposed to weather
Information:	External timbers that are frequently exposed to harsh weather conditions require adequate protection in order to maintain their condition. Where timbers have not been painted or treated adequately, general deterioration is likely to occur at an accelerated rate.

If left unattended, replacement of these timbers is likely to be necessary in the short-term future. Adequate treatment of these timbers is required as soon as possible by a painting contractor or general handyman.

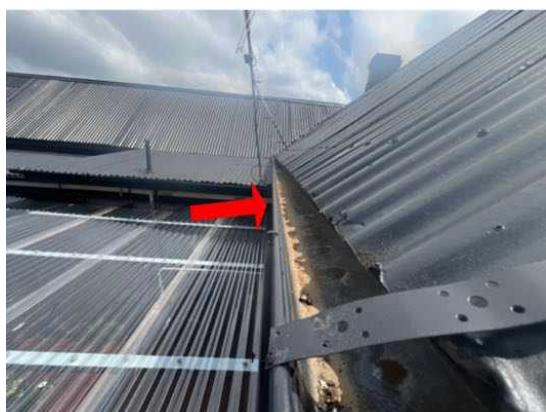
### Defects 3.18

Building:	Main Building
Location:	Roof Exterior - Verandah
Finding:	Exterior roof - Inadequate repairs
Information:	It appears that interim roof repairs have previously been undertaken, which have included application of silicone to address roof leakage.

Further consultation with a roof restoration company is highly advised. Inadequate roofing repairs are not likely to prevent roof leakage in the long-term future.

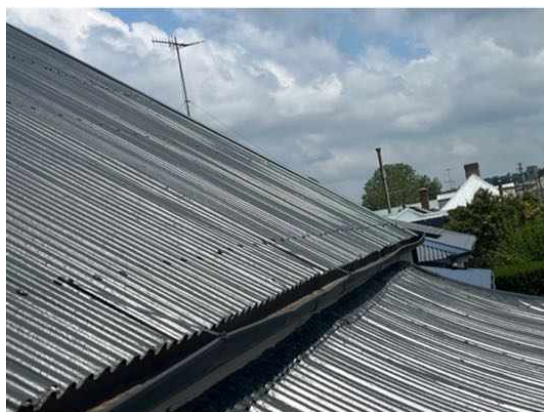
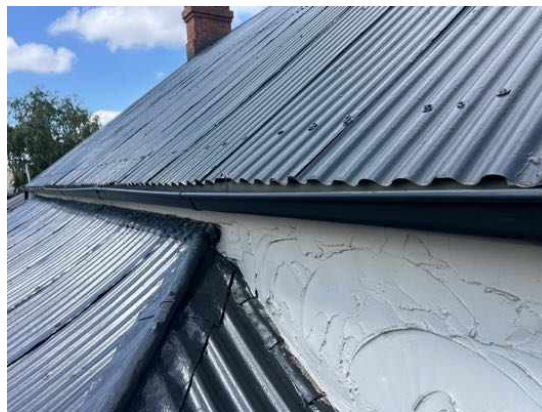
### Defects 3.19

Building:	Main Building
Location:	Roof Exterior
Finding:	Gutter - Sagging
Information:	The guttering in this area was observed to be sagging at the time of inspection. This is often caused by inadequate fixing, blocked gutters, or excessive water weight from poor drainage.

It is recommended that a roofing plumber or general handyman be engaged to assess and secure the guttering to restore proper alignment and functionality.

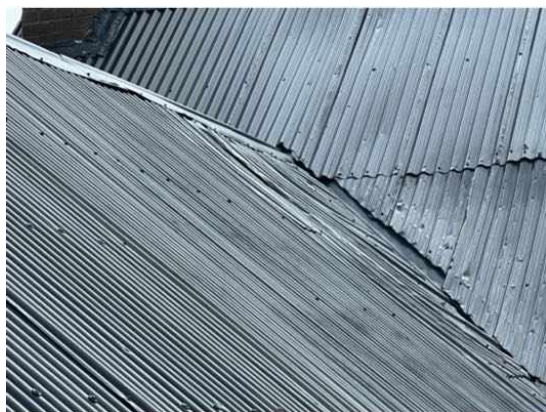
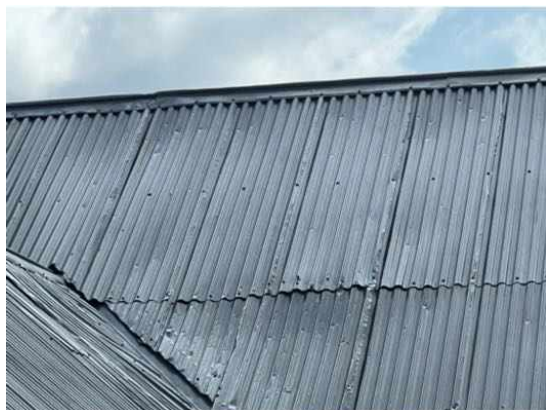
### Defects 3.20

Building:	Main Building
Location:	Roof Exterior
Finding:	Roof plumbing - Rusted or corroded
Information:	The roof plumbing has areas of rust and corrosion. It is suspected that this has been caused by blockages, resulting in pooling or standing water, that have prematurely rusted elements of the roof plumbing.

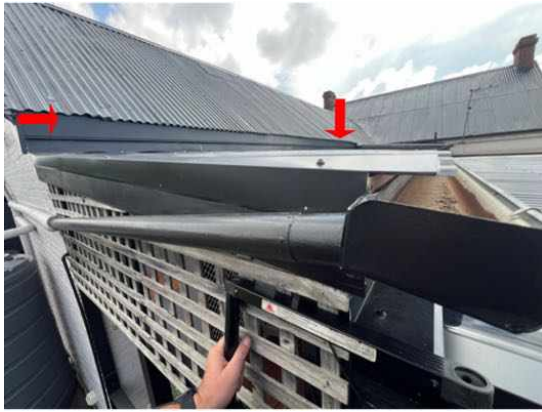
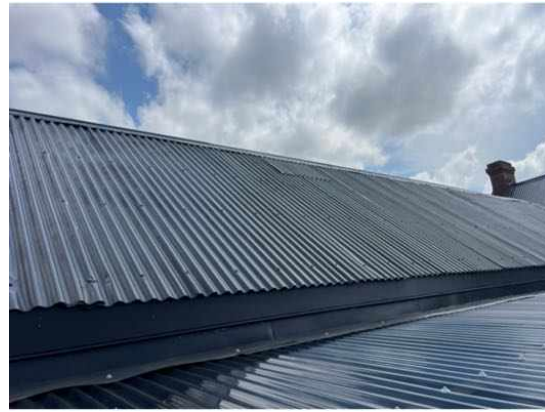
### Defects 3.22

Building:	Main Building
Location:	Roof Exterior
Finding:	Roof Plumbing - Missing Gutter
Information:	A section of guttering was observed to be missing to the upper roof area at the time of inspection. As a result, rainwater from the upper roof discharges directly onto the flashing and roof surface below.

It is recommended that a licensed roofing contractor be appointed to assess the affected area and install appropriate guttering to ensure rainwater is effectively captured and directed to the stormwater drainage system.

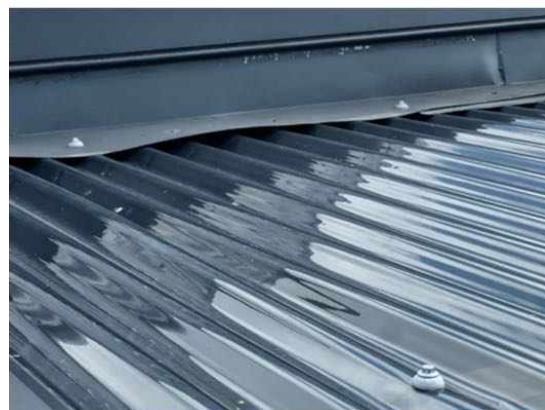
### Defects 3.23

Building:	Main Building
Location:	Roof Exterior
Finding:	Roof plumbing - Flashing inadequate
Information:	Some sections of the roof are missing or have inadequate roof flashings. Flashings are metal and other materials which are applied to seals and intersections between roof coverings and building elements. They are designed to aid in weatherproofing of roof joins.

A roofing plumber should be appointed as soon as possible to install relevant roof plumbing materials, ensuring that no further damage is sustained.

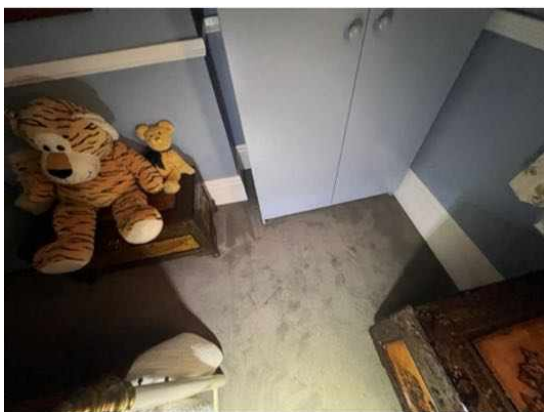
### Defects 3.25

Building:	Main Building
Location:	All Internal Areas
Finding:	Flooring - Uneven
Information:	The internal flooring in this area is out of level and uneven. Uneven flooring is likely to indicate minor defects such as expected movement of the foundations of the property, but may also indicate subsidence of the associated subfloor stumps.

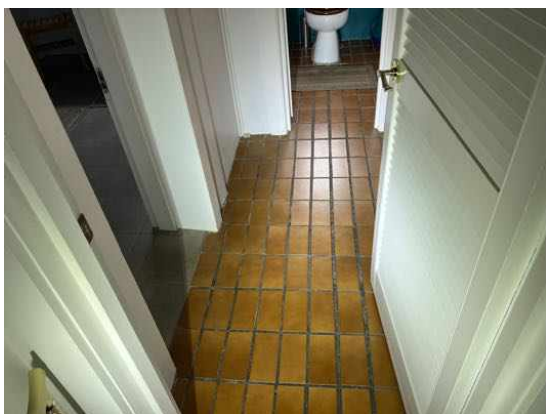
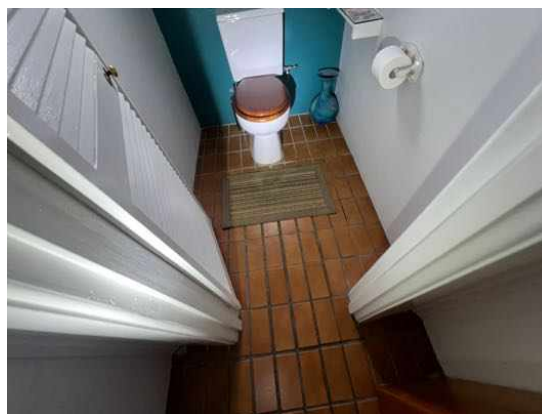
### Defects 3.29

Building:	Main Building
Location:	Laundry, Toilet (WC)
Finding:	Floor tiles - Uneven
Information:	The tiled flooring area appears to be uneven in this area. While this may indicate a failure of the subfloor structure, it is suspected, in this case, that the area has been subjected to poor tiling workmanship at the time of installation.

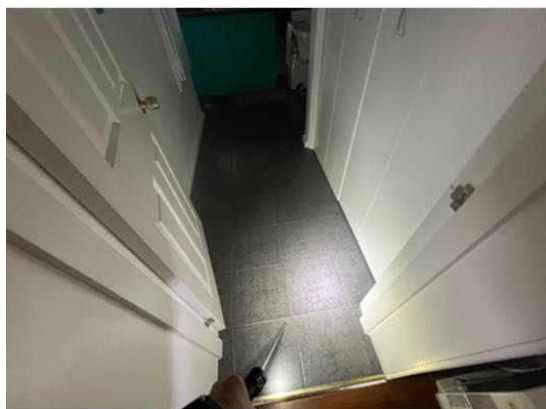
### Defects 3.30

Building:	Main Building
Location:	Laundry, Toilet (WC)
Finding:	Tiles - Drummy
Information:	Drummy tiled areas were identified at the time of inspection. The term 'drummy' refers to tiles that have become detached from their fixing, despite otherwise being in relatively good condition. Such defects are generally caused by physical or moisture damage to the area. Drummy tiled areas may also be a direct result of poor workmanship during the construction process.

Specialist trades are available for these types of services. A registered builder may be required to undertake works if damage is extensive or if secondary building defects have resulted. Otherwise, it is advised that a tiling contractor be appointed to perform works as necessary. Immediate action is recommended to ensure that no further damage is sustained in the affected area.

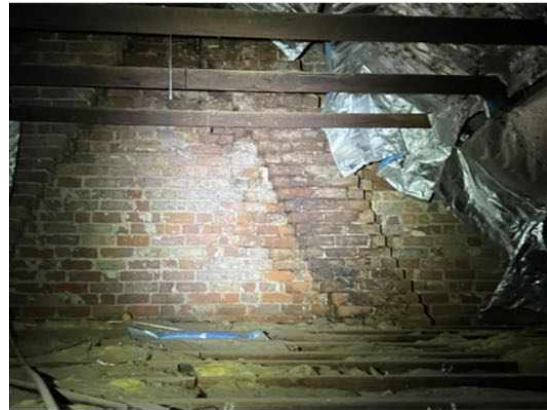
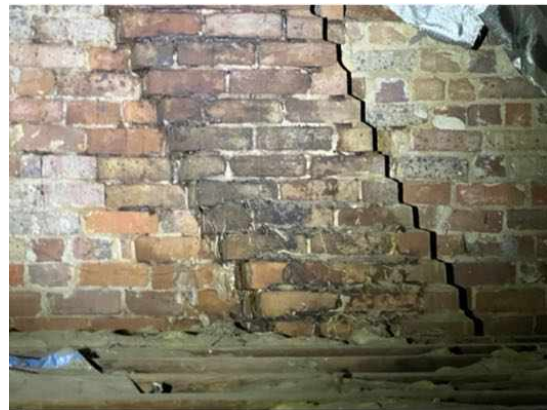
### Noted Item

Building: Main Building  
 Location: Roof Void

While the staining appears historic in nature, the area should be monitored for any future signs of moisture ingress. If staining progresses or moisture becomes evident, further assessment by a licensed roofing contractor may be required to identify the source.
