BEFORE YOU BUY
BEFORE YOU BUILD

Building and Timber Pest Inspection Report

Inspection Date: Tue, 10 Feb 2026

Property Address: 358 Great Western Hwy Service Rd,
Warrimoo NSW 2774, Australia

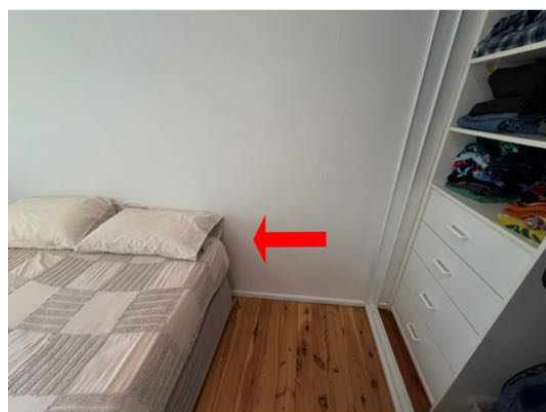
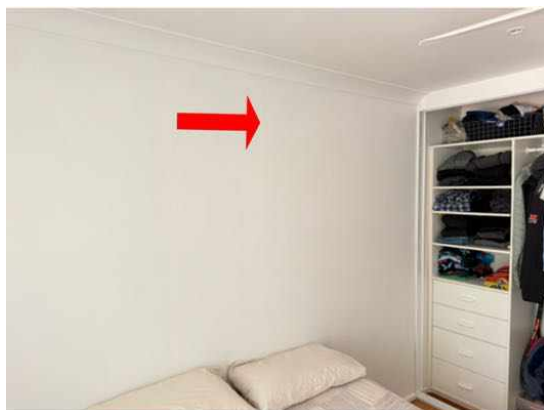
Finding: Cracking - Damage Category 1 - Fine (up to 1mm)

Information: Although fine cracks are quite noticeable, they are often only considered to be an appearance defect, and usually do not indicate any structural damage. Generally, the cause of a fine crack is indicative of a separation between building materials and finishes (e.g. paint, plaster, etc.) along joins.

Cracking of this nature can generally be repaired with minor sanding, filling and/or repainting. Such works should be performed by a qualified painter or a general handyman.

Monitoring of all cracking should be conducted frequently. Always contact a building inspector should cracks widen, lengthen, or become more numerous.

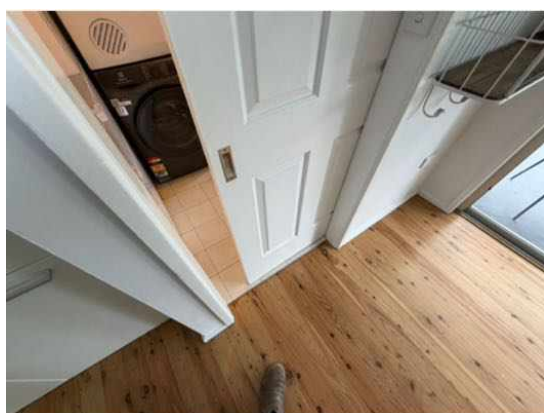
Finding 3.02

Building:	Main Building
Location:	Laundry
Finding:	Sliding door - Guide missing
Information:	The sliding door is missing the bottom door guide. As a result, the base of the door is free to move laterally when operated, causing instability and misalignment during opening and closing.

It is recommended that a suitable door guide be supplied and installed to properly secure the base of the door and ensure smooth, stable operation.

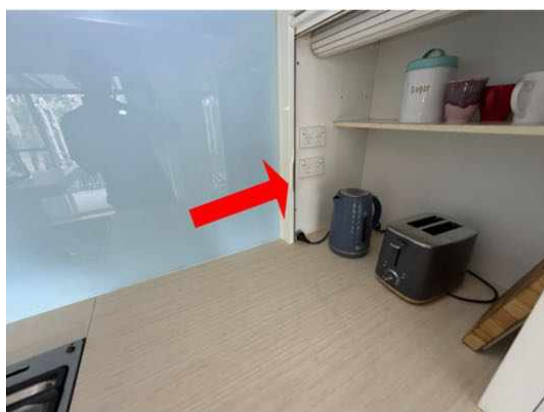
Finding 3.03

Building:	Main Building
Location:	Kitchen
Finding:	Kitchen-Panel damaged
Information:	The kitchen panel surrounding the appliance cabinet shows signs of heat-related damage. The vinyl finish has is peeling away from the underlying substrate, likely due to exposure to heat generated by the adjacent appliance.

The delamination has affected the appearance and integrity of the panel and may worsen over time if not addressed. It is recommended that the affected panel be

repaired or replaced as necessary at the owners discretion.

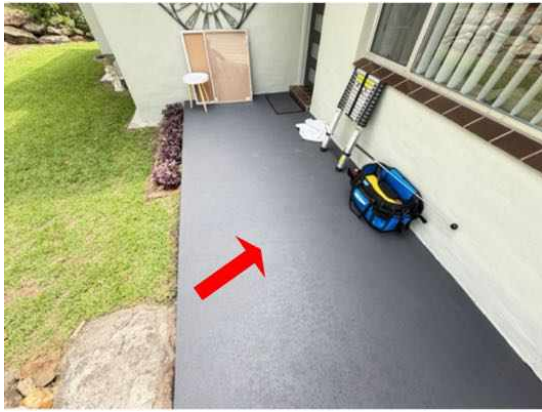
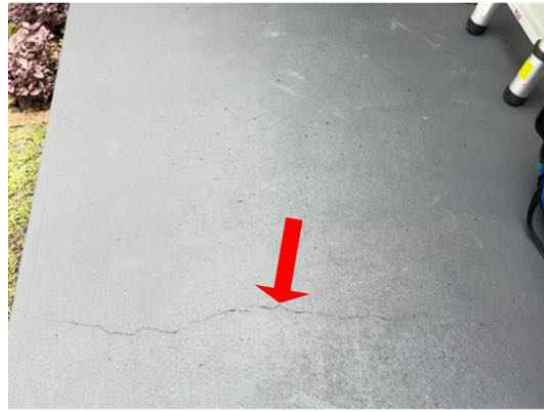
Finding 3.04

Building:	Main Building
Location:	Porch
Finding:	Cracking - External Concrete Paving Damage Category 0 - Hairline (less than 1mm)
Information:	Hairline cracks were identified in external concrete paving. Hairline cracks are very minor in nature and generally are only ever an appearance defect. To be classified as a Category 0 or hairline crack, the crack width would be less than 0.3mm. While such cracking may be noticeable in some cases, it is common and does not indicate any structural damage.

Generally the cause of a hairline crack in existing concrete paving such as driveways and pathways is indicative of the expansion and contraction of the concrete. Such causes are generally due to environmental factors, such as moisture levels, weather conditions, root systems of nearby trees or the soil types on which they are laid.

Hairline cracks may also be due to poor original installation of the concrete. Factors such as poor compaction of the sub surface and/or inadequate reinforcing of the slab may create cracking and other secondary defects.

Monitoring of all cracking should be conducted frequently. Always contact a building inspector should cracks widen, lengthen, or become more numerous.

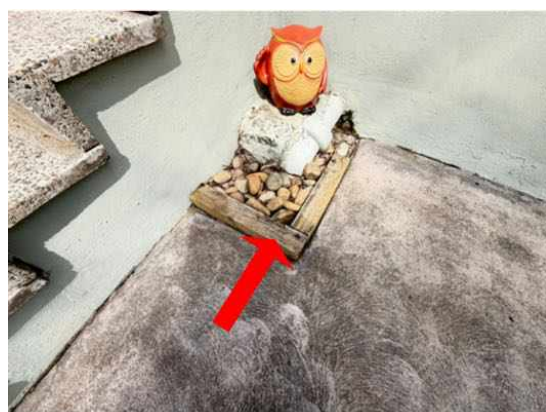
Building:	Yard
Location:	Yard
Finding:	In ground contact
Information:	Any timbers in direct ground contact provide opportunity for concealed termite entry and are likely to be subject to premature rot and decay as the soil retains moisture or damp conditions against the timbers.

Treated Timbers can decay or be poorly treated at manufacturing and as they degrade overtime can allow for termite attack.

Remove any timber that is in direct contact with external grounds. Consider replacement with more durable materials i.e. non timber elements. Frequent pest inspections are advised to readily identify any termite activity in these areas.

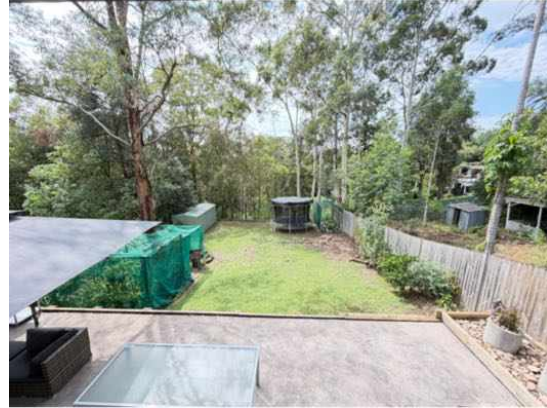
Finding 6.02

Building:	Main Building
Location:	Yard
Finding:	Large trees/stumps within 30m of house
Information:	There are a number of large trees/stumps within 30m of the house which may contain natural termite activity. It is important to monitor these areas to ensure no natural activity is allowed to progress into the main house.

Regular inspections are recommended. Consider test drilling any large trees.

A pest controller can be contacted to carry out such testing at the owners discretion.

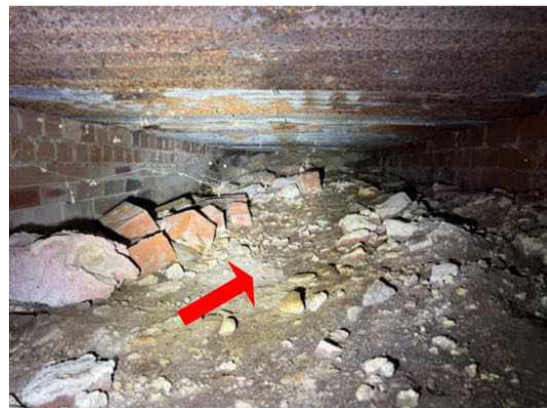
Finding 6.03

Building:	Main Building
Location:	Subfloor
Finding:	Excessive subfloor moisture
Information:	Excessive moisture can attract termites and produce conditions that promote termite attack fungal growth and wood decay.

Excessive moisture is generally caused by inadequate subfloor ventilation and poor site drainage.

There appear to be inadequate vents installed to the perimeter of the building and I would suggest that further solar powered fans or the like be installed to improve cross flow ventilation and aid in keeping the subfloor area relatively dry.

The installation of additional surface drainage to the rear of the property would also be beneficial to keeping the subfloor dry.

It is highly recommended that both subfloor ventilation and site drainage be improved and maintained regularly in order to prevent excessive moisture being present in the external / internal property.

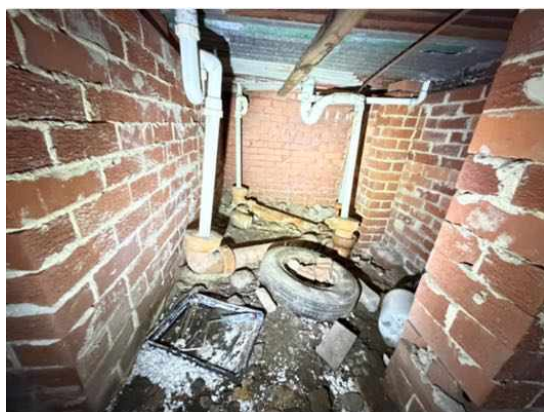
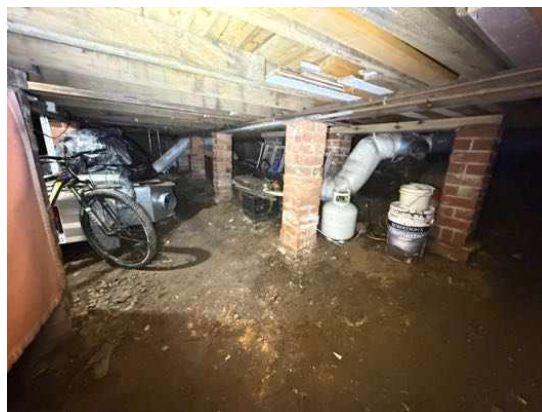
Finding 6.04

Building:	Main Building
Location:	Subfloor
Finding:	Subfloor - Lack of ventilation
Information:	It was noted at the time of inspection that the subfloor area lacks adequate ventilation. Ventilation can be restricted by a variety of minor defects, including obstructions in the subfloor space, a lack of vents or a low clearance.

A well ventilated subfloor aids in maintaining dry conditions, preventing secondary damage such as wood rot and pest activity, as well as preventing the development of mould and mildew (which can lead to respiratory safety hazards for occupants).

The initial step in improving ventilation is to ensure that the subfloor area is free of any debris or stored items. Where ventilation is still inadequate, it is advised to ensure that all vents are clear of blockages, and additional vents may be installed.

The client may also consider mechanical ventilation (powered fans) to improve subfloor airflow. Remedial works should be conducted as a matter of urgency to protect against the development of potentially harmful subfloor conditions.

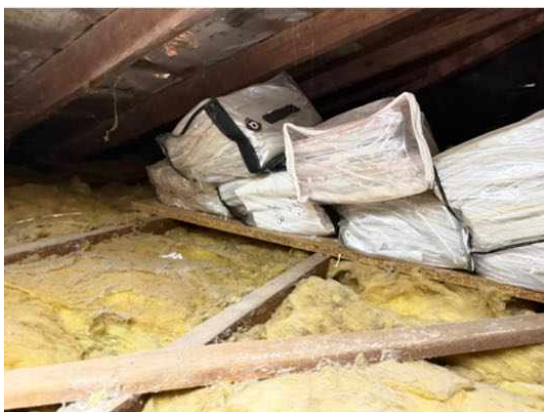
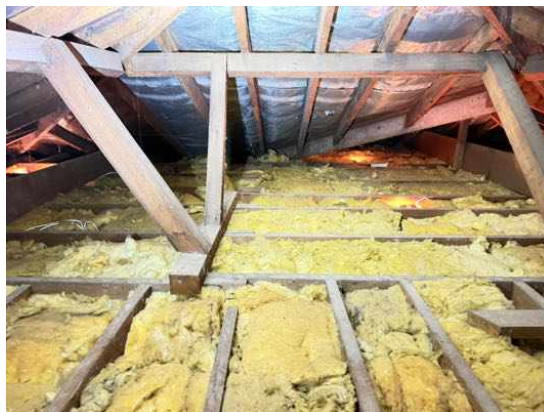
Building:	Main Building
Location:	Roof Void
Finding:	Obstructions and Limitations-Roof Void
Information:	<p>These photographs are an indication of the obstructions and limitations that impeded the full inspection of the roof cavity at the time of inspection. Note that the insulation covered nearly all the ceiling joists, which are a major structural element of the ceiling; the inspection was also limited to areas with an allowable crawl space of 600mm x 600mm, in particular towards the external walls where the roof line diminishes, it was not accessible. These obstructions and limitations can hide an array of defects and should be removed to allow a full inspection to be carried out. A re-inspection is recommended once areas are made accessible.</p>

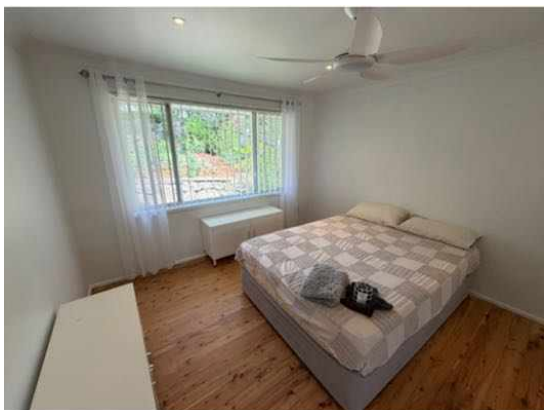
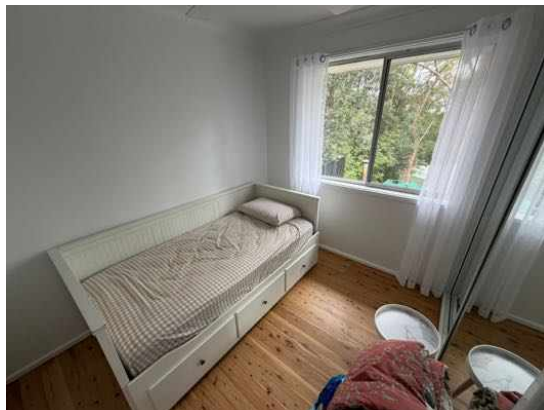
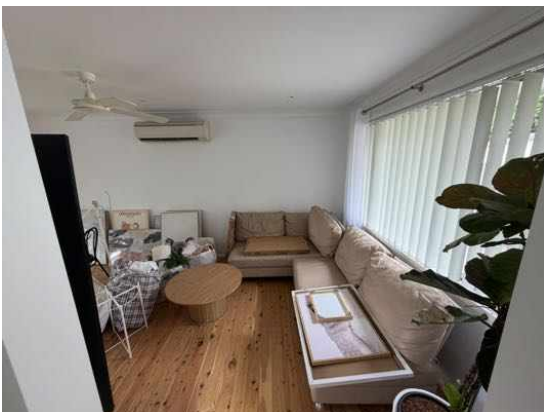
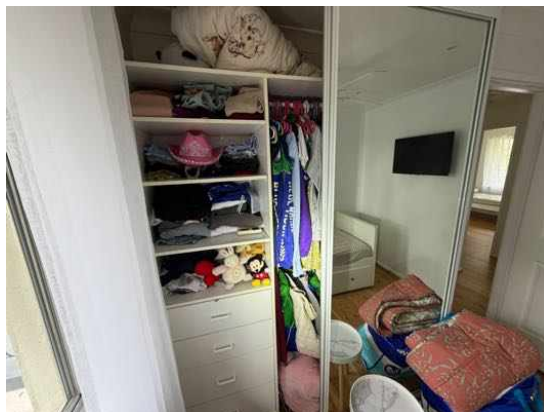
Building: Main Building
 Location: Internal Areas
 Finding: Obstructions and Limitations-Internal areas
 Information: These photographs are an indication of the obstructions and limitations which impeded full inspection of the internal areas at the time of inspection. These obstructions can hide an array of defects and should be removed to allow a full inspection to be carried out. A re-inspection is recommended once the areas are made accessible.

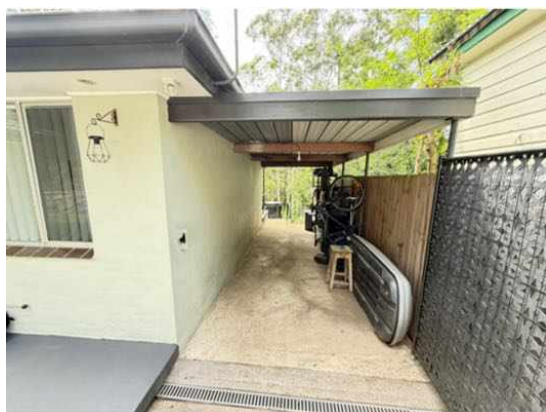
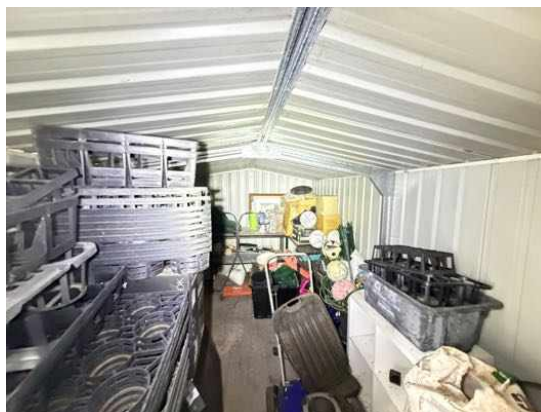
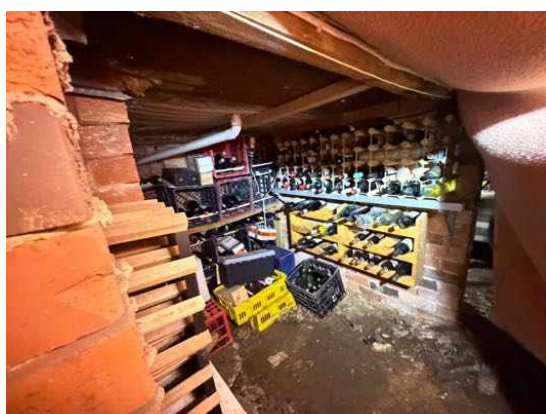
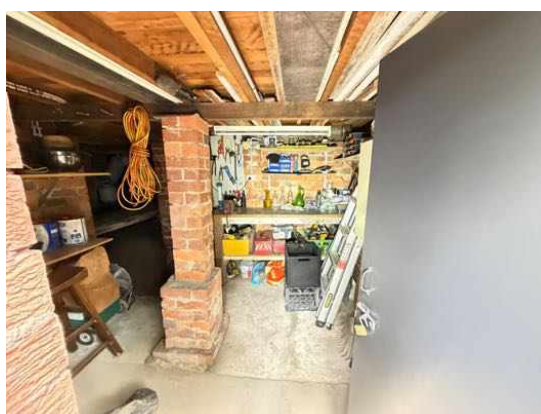
Building: Main Building
 Location: External Areas/Sub-Floor
 Finding: Obstructions and Limitations-External Areas/Sub-Floor
 Information: These photographs are an indication of the obstructions and limitations which impeded full inspection of the external areas at the time of inspection. These obstructions can hide an array of defects and should be removed to allow full inspection to be carried out. A re-inspection is recommended once the areas are made accessible.

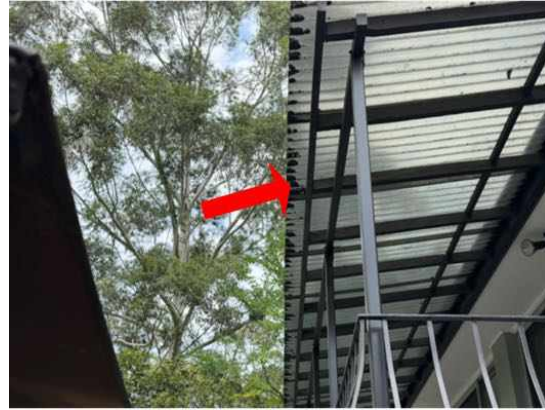
Building: Main Building
 Location: Rear Patio roof
 Finding: Gutters-Missing
 Information: The rear patio roof is not fitted with a guttering system. As a result, rainwater discharges directly from the roof edge to the ground below.

While this may be a design choice, the absence of gutters can lead to uncontrolled water runoff, which may cause surface ponding, staining to adjacent walls, increased splash-back onto external cladding, and potential moisture ingress over time. Concentrated water discharge may also contribute to movement or deterioration of paving and footings in the immediate area.

It is recommended that the area below the roof edge be monitored for signs of erosion or moisture-related issues. Consideration may be given to the installation of an appropriate guttering and stormwater disposal system to better control roof water runoff and minimise potential long-term impacts.

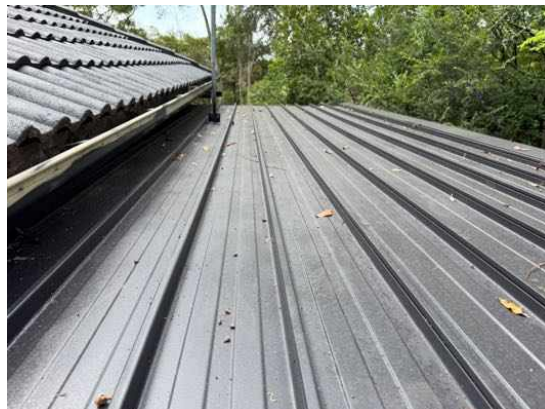
Finding: Roof Condition

Information: At the time of inspection, the roofing appeared to be in generally good condition. The roof coverings appear to have undergone a restoration, with no significant defects noted during the inspection.

Minor amounts of debris were observed within the guttering system. While this is not uncommon, gutters should be kept clean and free of debris to ensure proper stormwater flow and to prevent blockages, overflow, and potential moisture-related issues to the building fabric.

Regular maintenance and periodic cleaning of the gutters is recommended to maintain effective roof drainage and prolong the lifespan of the roofing components.

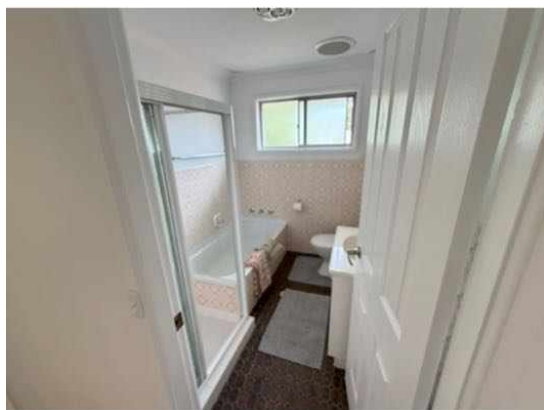
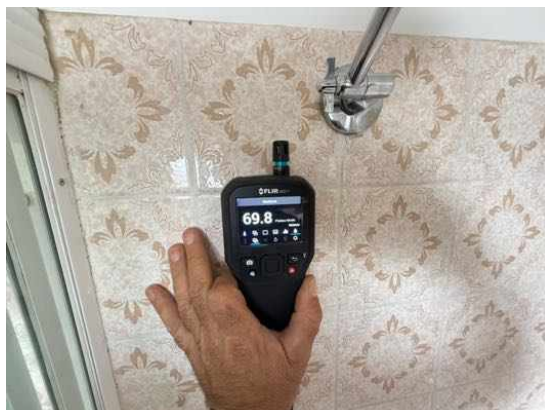
Building:	Main Building
Location:	Showers
Finding:	Shower seals recommended
Information:	The waterproofing to the shower recess was assessed by checking the walls in and around the shower recess for varying moisture content. Although a higher than normal reading was observed, there were no significant variations across the tested areas.

No sign of recent water damage was evident upon a visual inspection of the surrounding walls, where the visual nature of the inspection was possible. Consequently, there is no conclusive evidence of any current shower recess leakage and it is reasonable to assume the shower waterproofing is sound.

The purchaser may wish to re-seal the shower with a new professional epoxy seal to ensure a watertight seal into the future. Warranties of up to (10) years are on offer.
