# Building and Timber Pest Inspection Report VR

Inspection Date: Fri, 13 Mar 2026

Property Address: 11 Sayers St, Lawson NSW 2783, Australia

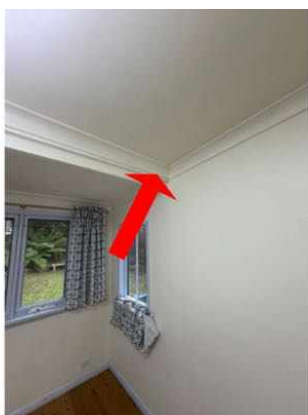
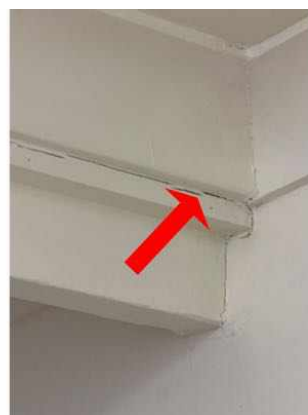
Finding: Fine Cracking to Skirtings, Architraves, Cornice

Fine cracking was observed to corner junctions of skirting boards, architraves and cornices throughout the dwelling.

The cracking appears minor in nature and is commonly associated with normal building movement, settlement, material shrinkage, or minor seasonal expansion and contraction of finishes.

At the time of inspection, no significant distortion or major structural concern was evident; however, the cracking affects the cosmetic finish of the internal linings.

I recommend to Seal, patch and repaint affected areas as part of routine maintenance. Monitor for any progression or widening of cracking which may warrant further assessment if changes are observed.

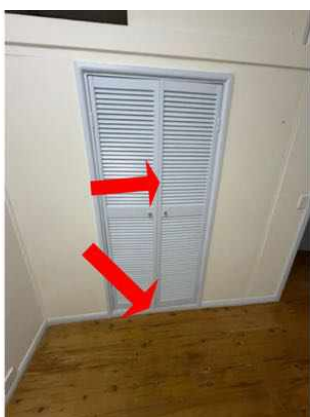
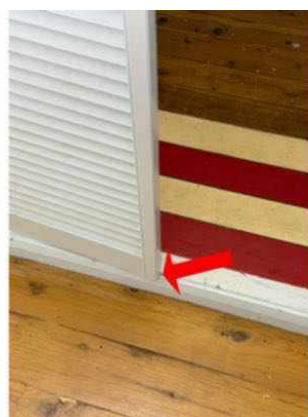
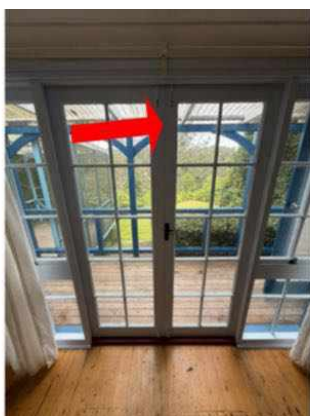
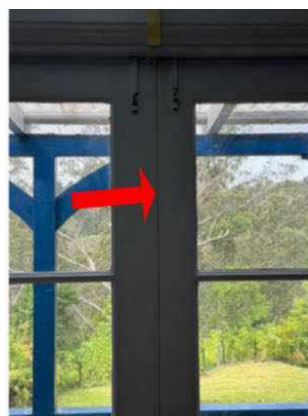
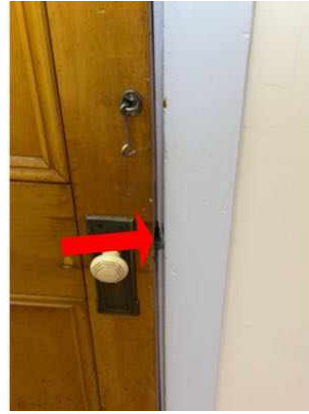
#### Finding 3.02

Information: Binding and/or jamming of several doors throughout the property were evident during standard operation. This defect inhibits the functionality of affected doors as well as creating potential for secondary defects to associated building elements, such as damage to the floor covering.

A door that binds to flooring or to the associated door frame may have several causes, ranging from minor defects, such as poor installation of the door or deteriorated hinges, through to major structural issues, such as damage to subfloor structures.

Where door binding/jamming appears to indicate major structural issues, a registered builder specialising in re-stumping should be appointed to provide an estimate on the cost of rectification.

For minor causes, a qualified carpenter or general handyperson should be appointed to perform minor rectification works at client discretion.

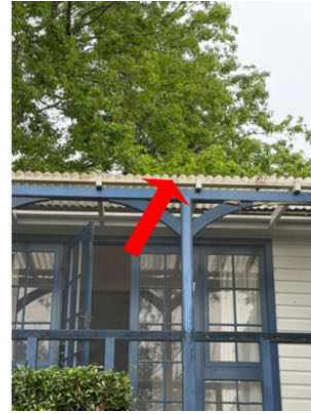
### Finding 3.03

Finding: Gutters-Missing

Information: A section of roof at the rear of the dwelling was observed to have no guttering installed. As a result, rainwater is currently discharging directly from the roof onto the ground adjacent to the building. This can lead to excessive moisture around the footings, potential soil erosion, and an increased risk of water ingress or damage to the building over time.

It is recommended that suitable guttering and downpipe connections be installed to this section of roof to ensure effective collection and discharge of roof water away from the dwelling. Installation should be carried out by a suitably qualified contractor.

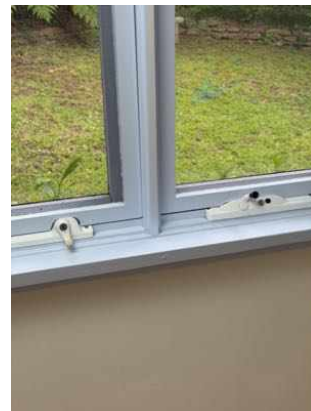
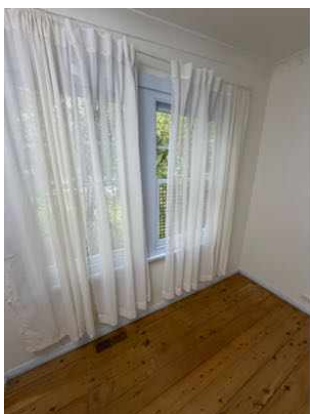
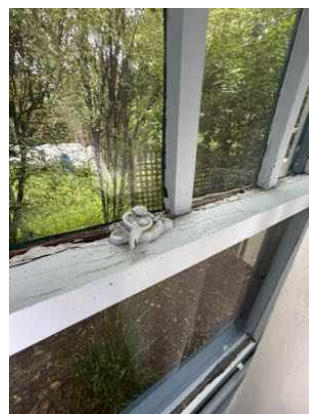
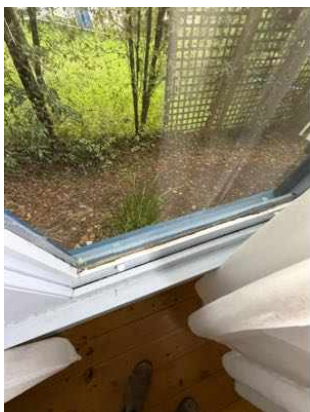
### Finding 3.04

Information: The window in the bedroom was difficult to operate at the time of the inspection. Windows provide ventilation to the adjoining area and should be at a fully operational level to ensure user comfort. Restricted function of the window may also pose as a potential safety hazard if required for emergency egress from the building.

Generally, factors such as general age of the building element and a lack of maintenance are the usual causes for this type of defect.

Replacement of window hardware or frame may be required, as well as minor repairs and cleaning. A registered builder or general handy person will be required to repair the window at the owners discretion.

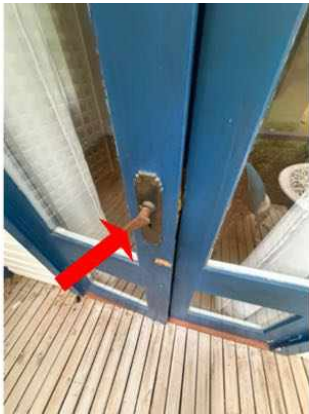
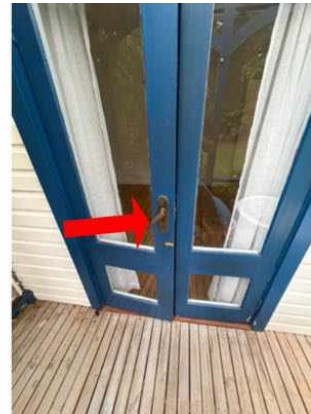
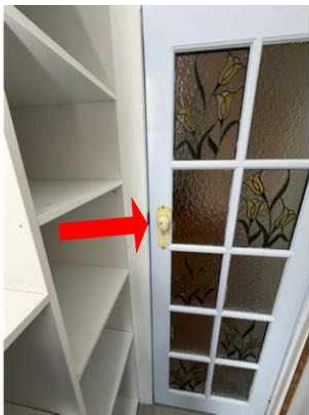
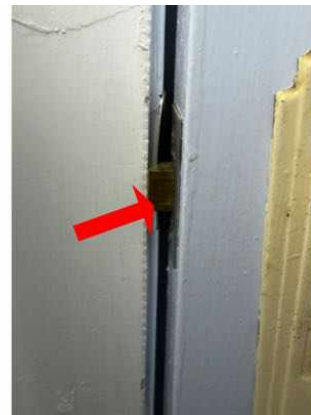
### Finding 3.05

Building: Main Building  
 Location: Front Porch/Laundry  
 Finding: Handles-Repair Required

Information: Two doors within the dwelling were observed to have defective door hardware. The door handle to the outdoor sunroom was not functioning correctly and was hanging down, indicating a likely failure of the internal mechanism or loose fittings. In addition, the door handle to the laundry was not latching properly, preventing the door from securing as intended.

Faulty door hardware can affect the proper operation and security of doors and may worsen with continued use. It is recommended that the affected door handles be

repaired or replaced to ensure the doors operate and latch correctly. Work should be carried out by a suitably qualified person.

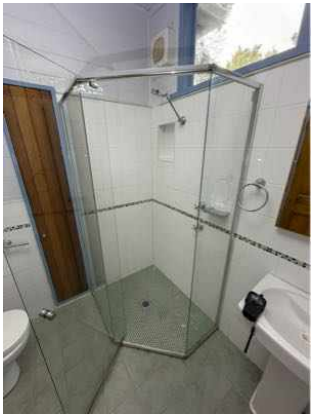
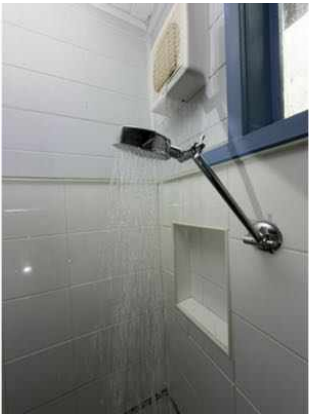
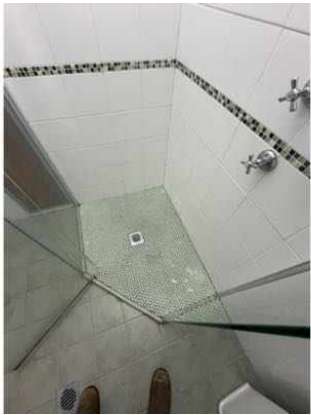
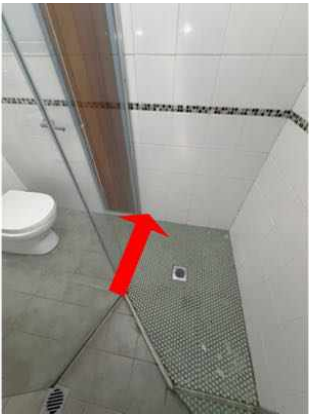
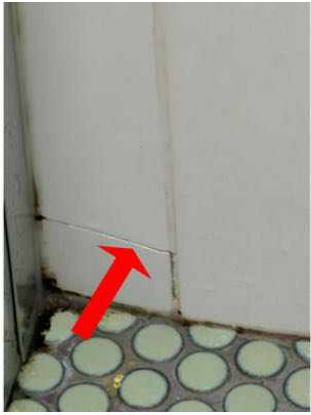
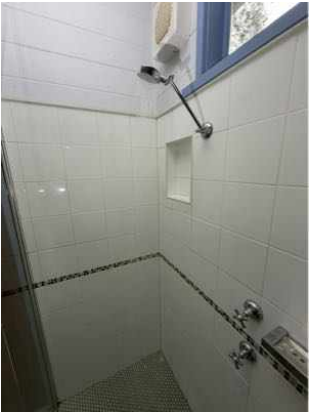
### Finding 3.06

Finding: Bathroom-Cracked tile

Information: One cracked tile was observed in the lower corner of the shower recess. Cracked tiles can allow moisture to penetrate behind the tiled surface over time, which may lead to deterioration of the underlying materials if left unaddressed.

The shower was flood tested at the time of inspection and no leaks were identified. Moisture readings were also taken from the walls and were found to be within acceptable parameters, indicating that no significant moisture issues were present at the time of inspection.

No sign of recent water damage was evident upon a visual inspection of the surrounding walls, where the visual nature of the inspection was possible. Consequently, there is no conclusive evidence of any current shower recess leakage and it is reasonable to assume the shower waterproofing is sound.

Apart from the cracked tile noted, the shower and bathroom were generally found to be in acceptable condition.

It is recommended that the cracked tile be repaired or replaced and the area appropriately sealed to help prevent potential water ingress in the future. Work should be carried out by a suitably qualified person.

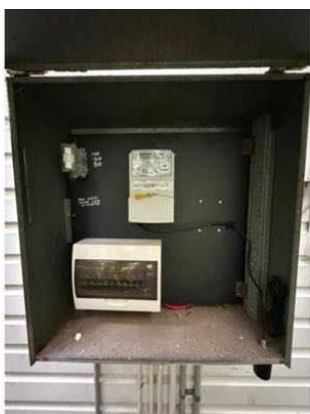
Building:	Main Building
Location:	Electrical Meter-box
Finding:	Termite Management System - no evidence of installation
Information:	The application of a post-construction chemical termite barrier is highly recommended for all properties, particularly if live termite activity has been found on the site previously. Such barriers are highly effective in preventing termite attack on any timber building elements throughout the property.

A durable notice should be placed in the switchboard unit to indicate current termite barriers. At the time of inspection, it appeared as though no termite management system has been installed, with no evidence to suggest preventative works taking place.

The client may consider gaining further advice from a pest controller as to the costs and procedures involved with this application. It is recommended that obtaining such advice be a short-term priority.

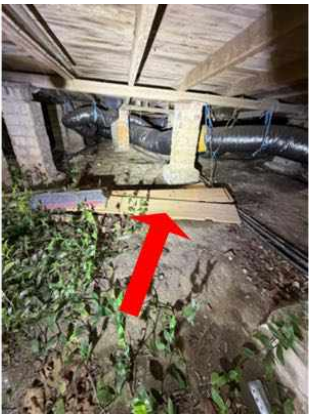
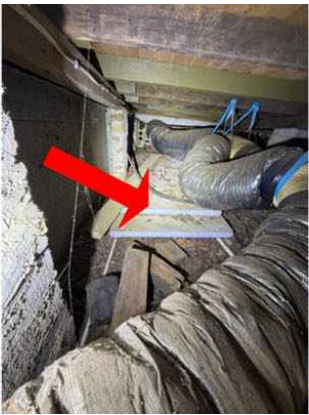
Building:	Main Building
Location:	All Areas
Finding:	Stored timbers - subfloor space or external area
Information:	The storing of timbers in the subfloor space or around the external property (including bark mulch) increases the risk of termite activity being present. As they are likely to come into contact with weather conditions or excessive moisture wood rot is likely to develop on timbers that are not treated.

It is highly recommended that any stored timbers be immediately removed from areas in which they may attract any termite / timber pest attack. Minimisation of risk / prevention of termite attack is far more adequate than dealing with the presence of termite activity.

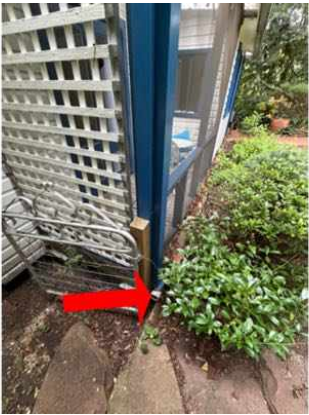
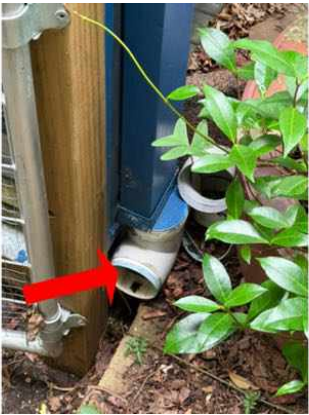
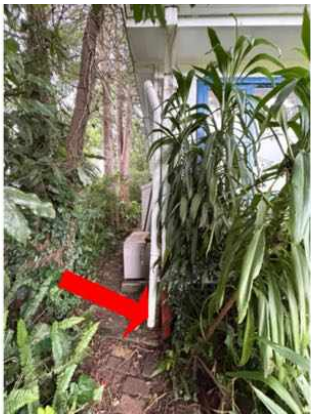
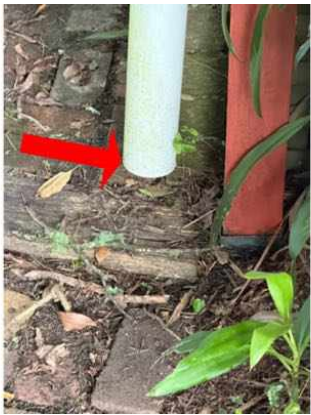
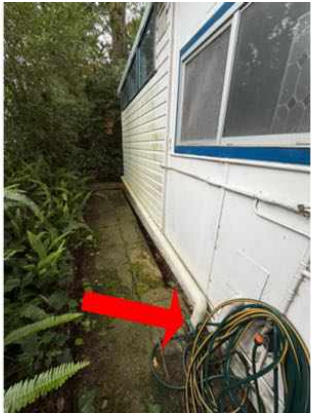
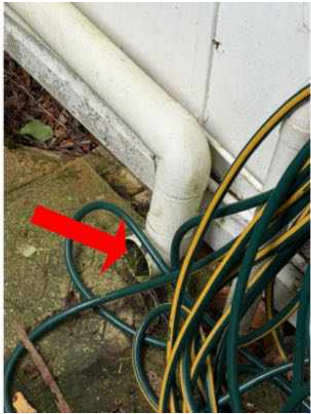
**Finding 6.04**

Building: Main Building  
 Location: Downpipes  
 Finding: Downpipe(s)-not connected  
 Information: The roof plumbing is not adequately connected to stormwater drainage on the site. This disconnection negatively impacts the functional capacity of the roof plumbing.

Where roof plumbing doesn't drain adequately, the area at the base perimeter can become excessively damp, potentially creating an environment that is susceptible to rust and corrosion of surrounding building elements, as well as attracting termites and other pests.

It is highly recommended that a plumber be appointed to further inspect the area and to connect all downpipes adequately as soon as possible.

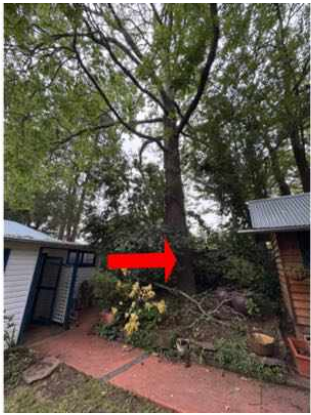
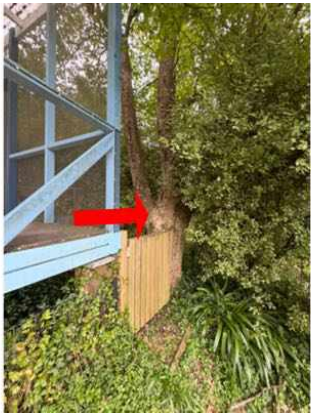
**Finding 6.05**

Building: Main Building  
 Location: Yard  
 Finding: Large trees/stumps within 30m of house  
 Information: There are a number of large trees/stumps within 30m of the house which may contain natural termite activity. It is important to monitor these areas to ensure no natural activity is allowed to progress into the main house.

Regular inspections are recommended. Consider test drilling any large trees.

A pest controller can be contacted to carry out such testing at the owners discretion.

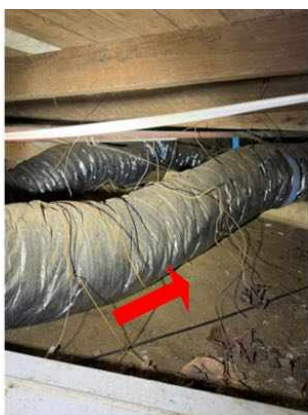
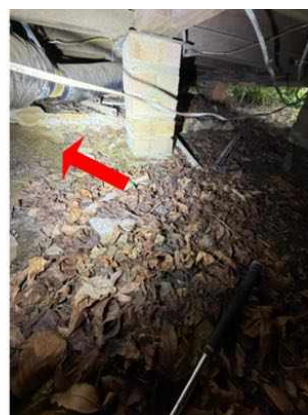
## Finding 6.06

Building:	Main Building
Location:	Subfloor
Finding:	Excessive subfloor moisture
Information:	Excessive moisture can attract termites and produce conditions that promote termite attack fungal growth and wood decay.

Excessive moisture is generally caused by inadequate subfloor ventilation and poor site drainage.

There appear to be inadequate vents installed to the perimeter of the building and I would suggest that further solar powered fans or the like be installed to improve cross flow ventilation and aid in keeping the subfloor area relatively dry.

The installation of additional surface drainage to the property would also be beneficial to keeping the subfloor dry.

It is highly recommended that both subfloor ventilation and site drainage be improved and maintained regularly in order to prevent excessive moisture being present in the external / internal property.

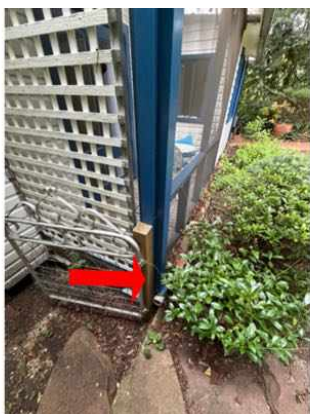
## Finding 6.07

Building:	Main Building
Location:	All Areas
Finding:	Bridging of termite barriers - Fences abutting building
Information:	Bridging is the spanning of a termite barrier or inspection zone so that subterranean termites are provided with passage over or around that barrier.

At the time of inspection it was noted that fences abutting the building on both left and right hand sides created a point for concealed access of termites into the building.

Where any part of an attachment to a building is not isolated and is not provided with a clear gap of at least 25mm from the building, bridging occurs.

The client should consider obtaining further advise from a timber pest technician regarding treatments required in this area. It is recommended that obtaining such advice be a short-term priority.

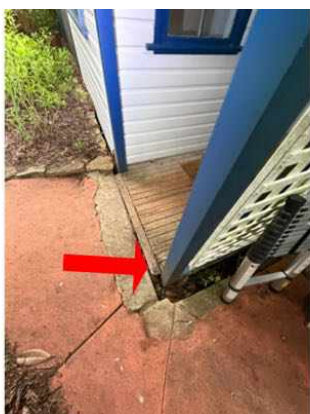
### Finding 7.01

Building: Main Building  
Location: All Areas  
Finding: Fungal decay - present at the time of inspection  
Information: Fungal decay also known as wood decay or wood rot occurs when timbers and other cellulose building materials are exposed to damp conditions on an ongoing basis. This could be the result of exposure to weathering in the long term or the pooling of water or absorbed moisture from other abutting building materials or a shower leak. It is advisable to remove these affected timbers to prevent any chance of termite attack in the future.

Wood decay is more susceptible to termite attack and these timbers should be replaced to limit termite attack.

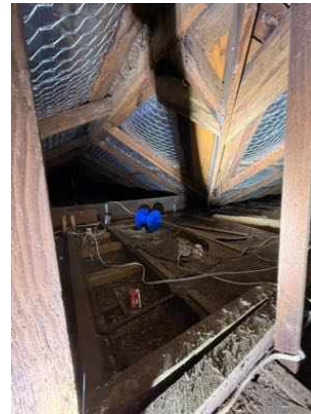
Building:	Main Building
Location:	Roof Void
Finding:	Obstructions and Limitations-Roof Void
Information:	These photographs are an indication of the obstructions and limitations that impeded the full inspection of the roof cavity at the time of inspection. Note that the insulation covered nearly all the ceiling joists, which are a major structural element of the ceiling; the inspection was also limited to areas with an allowable crawl space of 600mm x 600mm, in particular towards the external walls where the roof line diminishes, it was not accessible. These obstructions and limitations can hide an array of defects and should be removed to allow a full inspection to be carried out. A re-inspection is

recommended once areas are made accessible.

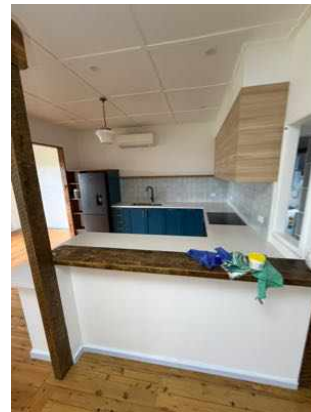
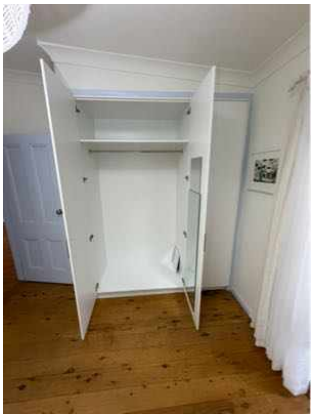
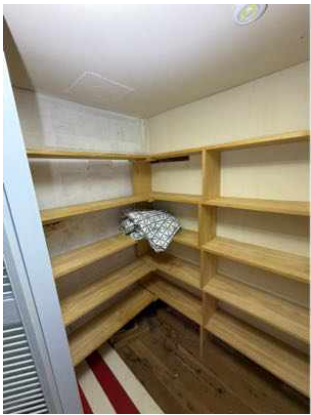
Building: Main Building  
Location: Internal Areas  
Finding: Obstructions and Limitations-Internal areas  
Information: These photographs are an indication of the obstructions and limitations which impeded full inspection of the internal areas at the time of inspection. These obstructions can hide an array of defects and should be removed to allow a full inspection to be carried out. A re-inspection is recommended once the areas are made accessible.

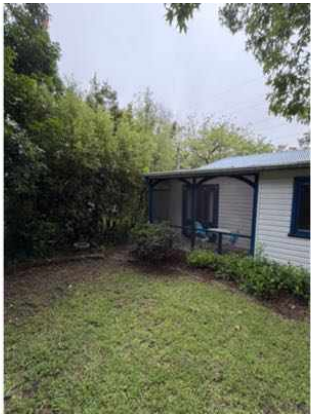
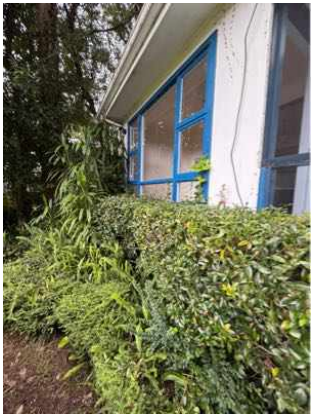
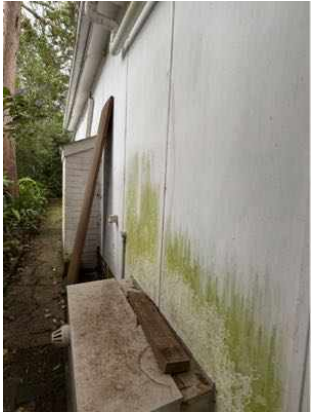
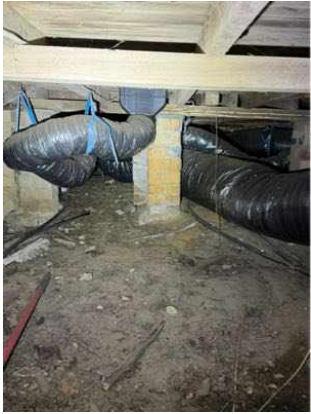
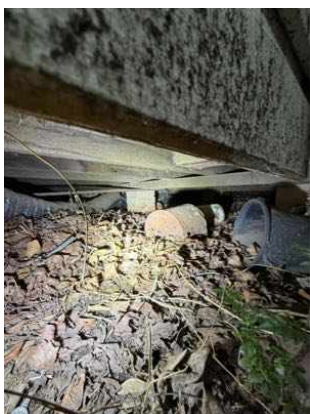
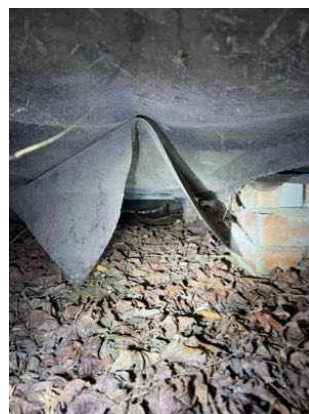
Building: Main Building  
Location: External Areas/Sub-Floor  
Finding: Obstructions and Limitations-External Areas/Sub-Floor  
Information: These photographs are an indication of the obstructions and limitations which impeded full inspection of the external areas/subfloor at the time of inspection. These obstructions can hide an array of defects and should be removed to allow full inspection to be carried out. A re-inspection is recommended once the areas are made accessible.

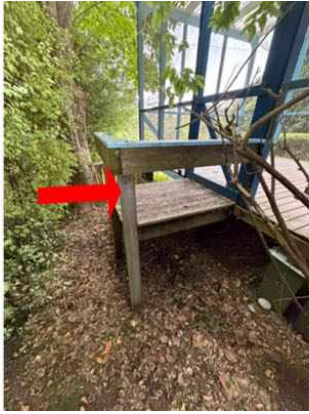
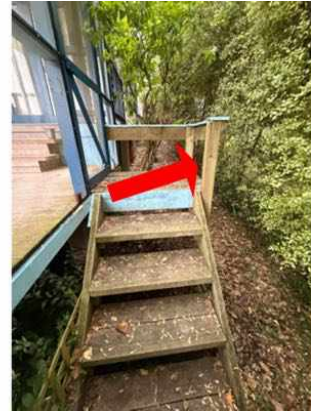
Building:	Main Building
Location:	Sunroom Exit
Finding:	FYI Balustrade-Inadequate
Information:	The balustrade to the landing outside the sunroom was observed to be lower than what would be considered an acceptable or safe height. Balustrades are intended to provide a protective barrier to reduce the risk of people accidentally falling from elevated areas. Where the height is inadequate, the effectiveness of the barrier is reduced and there is an increased risk of a person, particularly children, losing balance and falling over the edge.

Although this is provided for your information only, it would be prudent to have the balustrade height assessed and upgraded if necessary to meet current safety expectations. This work should be carried out by a suitably qualified contractor.

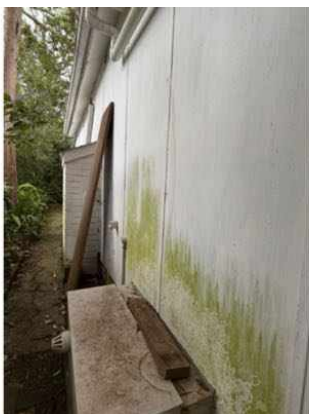
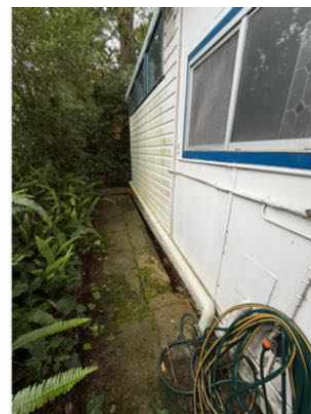
Building:	Main Building
Location:	All External Areas
Finding:	External painting deteriorated
Information:	Some of the external paintwork including but not limited to windows, fascias, guttering, veranda and other external fitments have been neglected and require attention to prepare and re-paint.

Degraded paint finishes should be sanded back, filled, leveled and painted, as applicable. Where inadequate or missing paint protection has led to the deterioration of the associated building element, repair and/or replacement of this building element may be required.

A painting contractor should be appointed as soon as possible to perform necessary works to aid the appearance of the affected area and to ensure the area is protected against further deterioration. Alternatively, the homeowner following manufacturer instructions may perform these works.

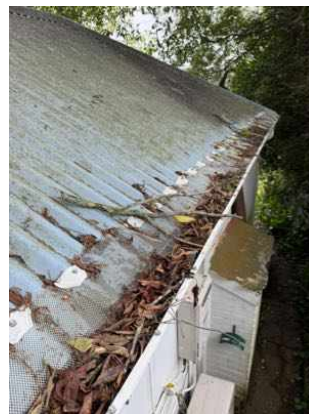
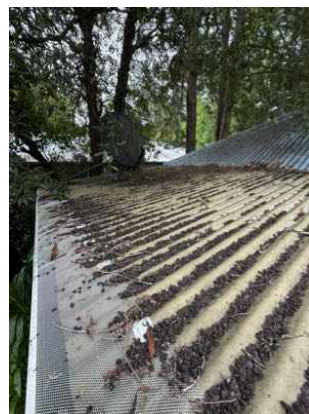
Building: Main Building  
Location: Roof Exterior  
Finding: FYI-Roof Maintenance Required  
Information: The corrugated metal roofing to the dwelling was observed to be quite weathered and had a build-up of leaves and organic debris across several areas at the time of inspection. Accumulated debris on roof surfaces can trap moisture and accelerate the deterioration of roofing materials. It can also contribute to blocked gutters and downpipes, which may lead to water overflow and potential water ingress issues.

Regular cleaning and maintenance of the roof surface and associated drainage systems is recommended to remove debris and help prolong the service life of the roofing materials. Ongoing maintenance should be carried out as required to keep the roof in good working condition.

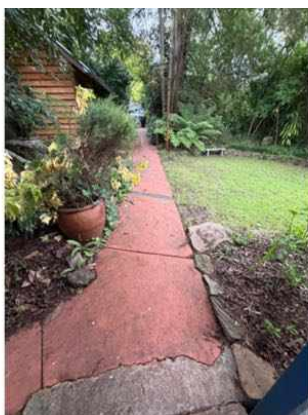
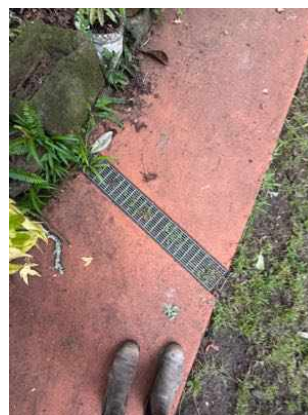
Building: Main Building  
 Location: Site Drainage  
 Finding: FYI-Site Drainage  
 Information: The site drainage appears to be inadequate. The general slope of the land directs surface water towards the dwelling, and no effective drainage provisions were observed at the front of the building to divert this runoff. As a result, a significant portion of rainwater is likely flowing beneath the house and through the subfloor area.

Any comments made in this section are relevant only in light of the conditions present at the time of inspection. It is recommended that a smoke test be obtained to determine any illegal connections, blocked or broken drains.

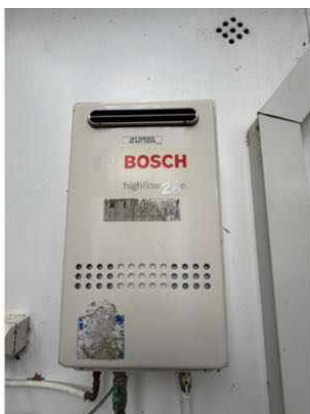
Building: Main Building  
 Location: Hot Water System  
 Finding: FYI-Hot Water Unit  
 Information: The HWS appeared to be in good condition at the time of inspection. For the date of manufacture - (see attached photo)

Water pressure appears to be normal, however, this is not an opinion of a licensed plumber. No water hammer was noted when taps are turned off fast.

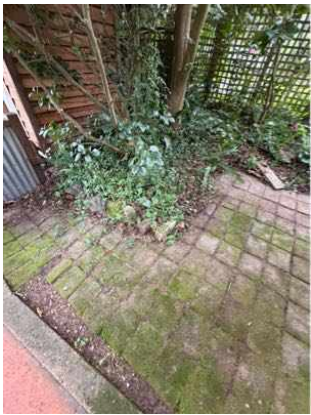
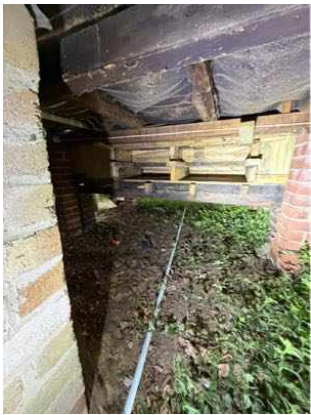
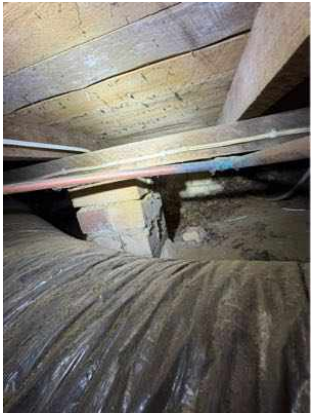
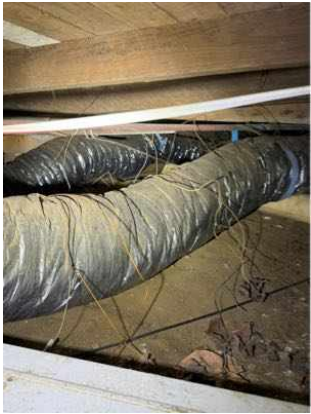
Building: Main Building  
 Location: Suspected ACM  
 Finding: FYI-Asbestos - Suspected ACM Identified on Site  
 Information: Reporting on Asbestos is outside the Scope of this Report. This suspected defect is highlighted as a caution only. We suspect, based on our experience in the building industry, that there is a higher risk of the identified building element containing asbestos.
