Building and Timber Pest Inspection Report

Inspection Date: Fri, 6 Feb 2026

Property Address: 14 Varna St, Mount Colah NSW 2079,
Australia

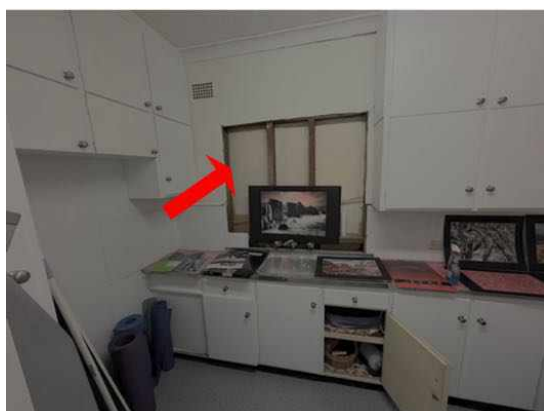
Finding 2.01

Building:	Main Building
Location:	Studio
Finding:	Plasterboard - incomplete
Information:	A section of plasterboard is missing from the wall, likely resulting from previous plumbing or remedial works. The wall lining has not been reinstated, leaving the timber framework exposed. This is considered incomplete workmanship. The plasterboard is required to be reinstated, properly fixed, set and finished, and the affected area painted to match the surrounding wall surfaces to achieve an acceptable standard of finish.

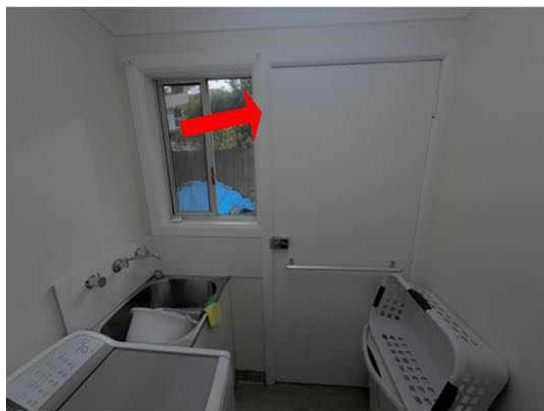
Finding 3.01

Building:	Main Building
Location:	Laundry
Finding:	Door - Binding/jamming
Information:	Binding and/or jamming of this door is evident during standard operation. This defect inhibits the functionality of the affected door as well as creating potential for secondary defects to associated building elements, such as damage to the door and jamb.

A door that binds to flooring or to the associated door frame may have several causes, ranging from minor defects, such as poor installation of the door or

deteriorated hinges, through to minor building movement.

For minor causes, a qualified carpenter or general handyperson should be appointed to perform minor rectification works at client discretion.

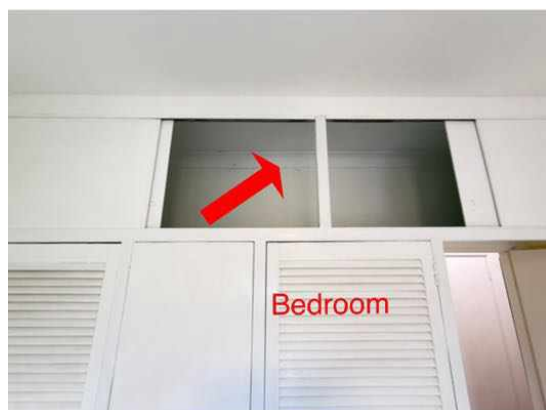
Finding 3.02

Building:	Main Building
Location:	Study/bedroom
Finding:	Cracking - Damage Category 1 - Fine (up to 1mm)
Information:	Although fine cracks are quite noticeable, they are often only considered to be an appearance defect, and usually do not indicate any structural damage. Generally, the cause of a fine crack is indicative of a separation between building materials and finishes (e.g. paint, plaster, etc.) along joins.

Cracking of this nature can generally be repaired with minor sanding, filling and/or repainting. Such works should be performed by a qualified painter or a general handyman.

Monitoring of all cracking should be conducted frequently. Always contact a building inspector should cracks widen, lengthen, or become more numerous.

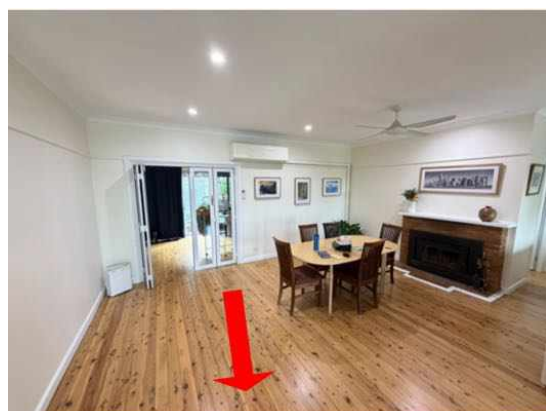
Finding 3.03

Building:	Main Building
Location:	Lounge Room
Finding:	Floors - Squeaking
Information:	Minor squeaking is evident to the timber flooring when walked across in the affected area. This indicates movement within the flooring system, potentially due to inadequate fixing, substrate movement, or installation tolerances. While not considered a major defect, remedial works are recommended to investigate the cause and rectify the issue to minimise noise, improve performance, and ensure the flooring is fixed and performing in accordance with acceptable building standards.

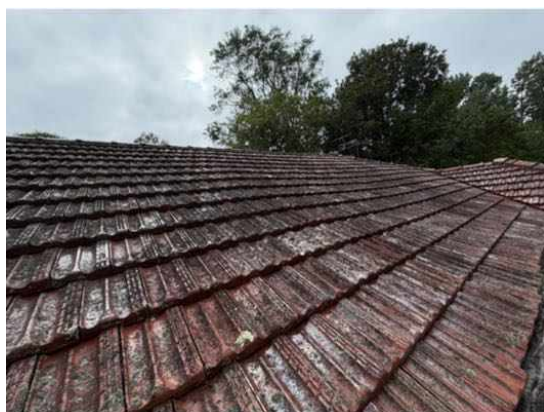
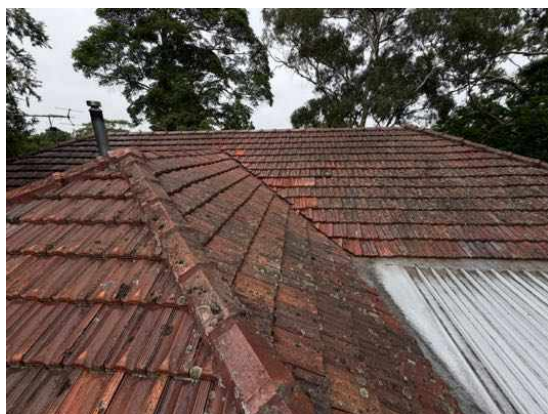
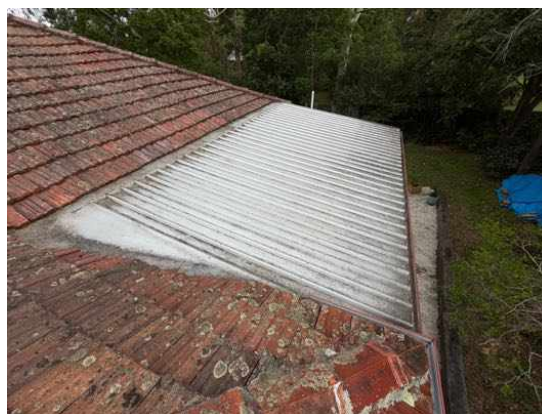
Finding 3.05

Building:	Main Building
Location:	Roof Exterior
Finding:	Lichen present on roof tiles
Information:	<p>Upon inspection of the exterior roofing, the majority of roof tiles were considered to be in a fair condition. While weathering of the tiles is consistent with the age of the property, maintenance works are required. Concrete roof tiles are typically cleaned to have the visible moss and lichen removed. Moss and lichen is attracted to the roof tiles surface, and if left will continue to grow and most likely restrict the flow of rain water over the tiles surface, into the roofs gutters. An application of an environmentally friendly anti-fungal solution should be applied to all moss and lichen, prior to undertaking the roof cleaning process.</p> <p>A roof restoration company can be contacted for further advice.</p>

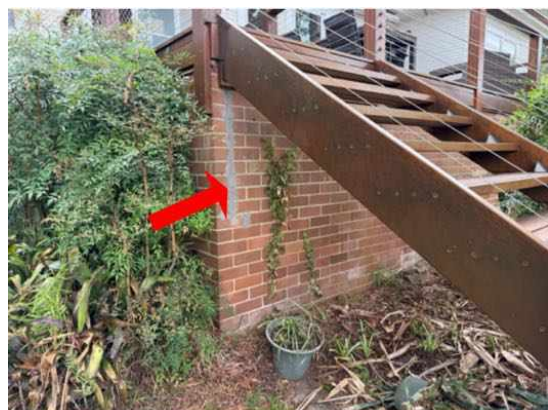
Finding 3.06

Building:	Main Building
Location:	Front Left Decking
Finding:	Brickwork - Cracking [Fine]
Information:	Although fine cracks are quite noticeable, they are often only considered to be an appearance defect and usually do not indicate any structural damage. Generally, the cause of a fine crack is indicative of a separation between brickwork and mortar throughout the structure, but single bricks may also show cracks of this nature.

Cracking of this nature can generally be repaired with minor filling and should be conducted by a qualified bricklayer.

Always contact a building inspector should cracks widen lengthen or become more numerous.

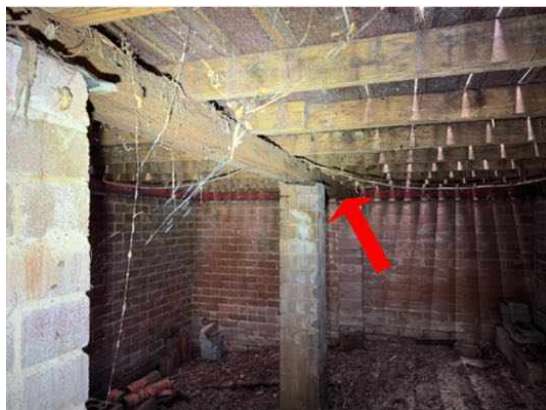
Finding 3.07

Building:	Main Building
Location:	Front Deck lhs
Finding:	Wood Rot - Decking bearers
Information:	One area of structural timber bearers located beneath the front timber decking shows visible signs of wood rot and deterioration. This condition indicates prolonged

exposure to moisture and may compromise the long-term structural integrity of the decking if it continues to deteriorate. While immediate replacement may not be required at this stage, the affected bearers should be regularly monitored, and allowance made for repair or replacement in due course to prevent further degradation and potential structural issues.

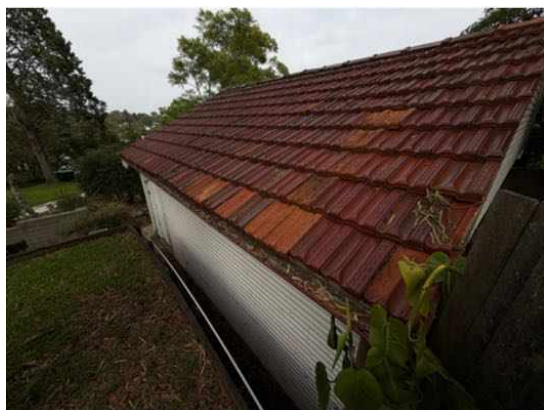
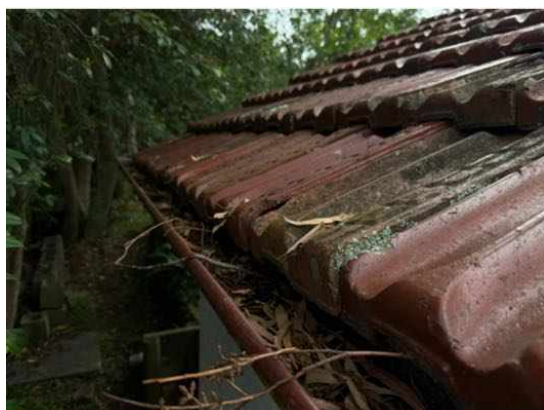
Finding 3.08

Information: At the time of inspection it was found that this gutter was completely blocked with debris, leaves and silt.

The area was checked for high readings of moisture in the area and no high levels were recorded.

Blocked gutters are likely to lead to high levels of moisture in the affected areas. Such moisture will not only cause rust and decay of the associated building materials, but can also provide conditions that are conducive to termite and timber pest activity.

Blockages in gutters should therefore be removed immediately to ensure dry conditions are maintained.

Consult a Licensed Plumber for further specific advice on remedial works that may be required. In the interim, it is highly advised that blocked gutters be removed by the homeowner or a general handyperson as a matter of urgency.

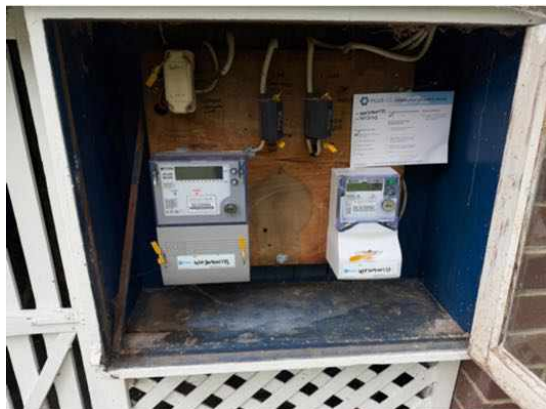
Building:	Main Building
Location:	Electrical Meter-box
Finding:	Termite Management System - no evidence of installation
Information:	The application of a post-construction chemical termite barrier is highly recommended for all properties, particularly if live termite activity has been found on the site previously. Such barriers are highly effective in preventing termite attack on any timber building elements throughout the property.

system has been installed, with no evidence to suggest preventative works taking place.

The client may consider gaining further advice from a pest controller as to the costs and procedures involved with this application. It is recommended that obtaining such advice be a short-term priority.

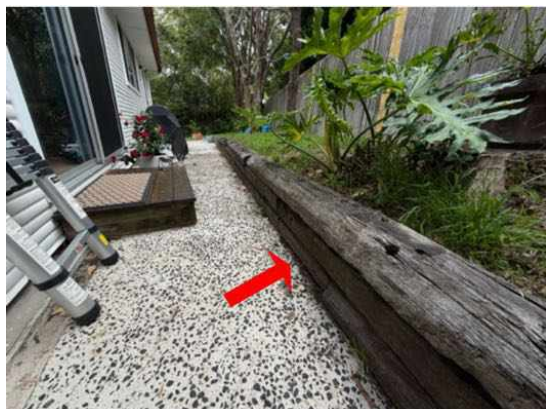
Finding 6.02

Building:	Yard
Location:	Yard
Finding:	In ground contact
Information:	Any timbers in direct ground contact provide opportunity for concealed termite entry and are likely to be subject to premature rot and decay as the soil retains moisture or damp conditions against the timbers.

Treated Timbers can decay or be poorly treated at manufacturing and as they degrade overtime can allow for termite attack.

Remove any timber that is in direct contact with external grounds. Consider replacement with more durable materials i.e. non timber elements. Frequent pest inspections are advised to readily identify any termite activity in these areas.

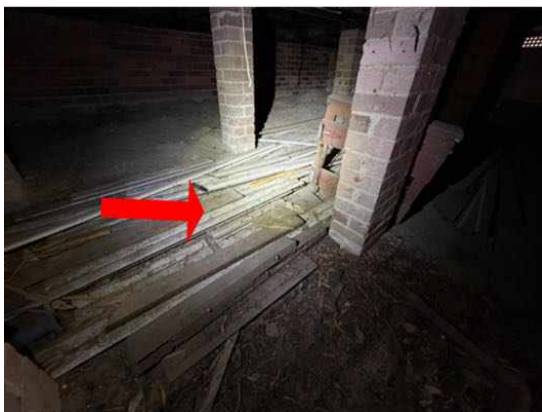
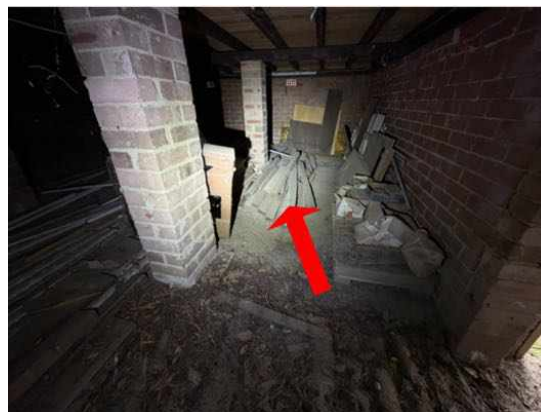
Finding 6.03

Building:	Main Building
Location:	All Areas
Finding:	Stored timbers - subfloor space or external area
Information:	The storing of timbers in the subfloor space or around the external property (including bark mulch) increases the risk of termite activity being present. As they are likely to come into contact with weather conditions or excessive moisture wood rot is likely to develop on timbers that are not treated.

It is highly recommended that any stored timbers be immediately removed from areas in which they may attract any termite / timber pest attack. Minimisation of risk / prevention of termite attack is far more adequate than dealing with the presence of termite activity.

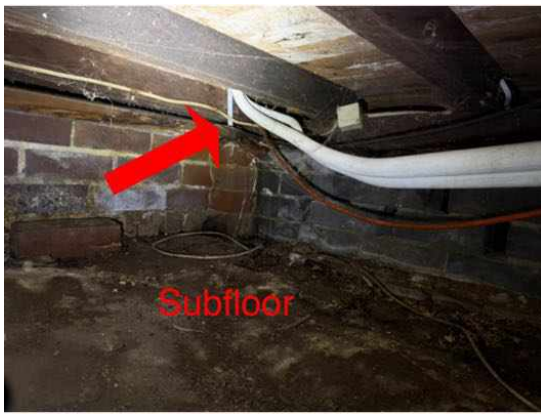
Finding 6.04

Building:	Main Building
Location:	Hot Water/AC units
Finding:	Overflows not plumbed to drainage
Information:	The overflow is not plumbed or connected to suitable drainage, which has resulted in the surrounding area becoming excessively damp.

These damp conditions can lead to secondary defects such as rot, rust or corrosion of associated building elements, the formation of fungal decay, or even the creation of potential slip hazards. When coupled with poor site drainage, pooling of water may also attract termite activity to this area.

It is highly recommended that a qualified plumber be appointed to install adequate drainage to the overflow. These works will ensure that the area remains dry and free of any secondary defects.

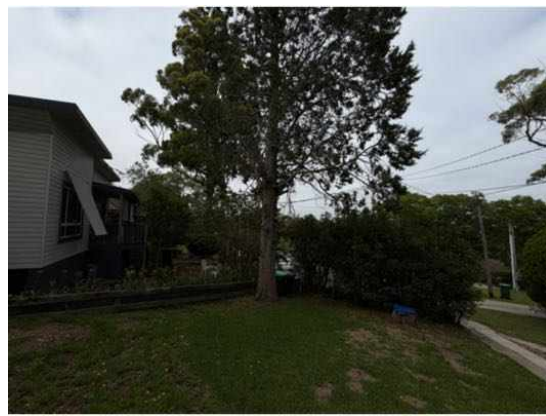
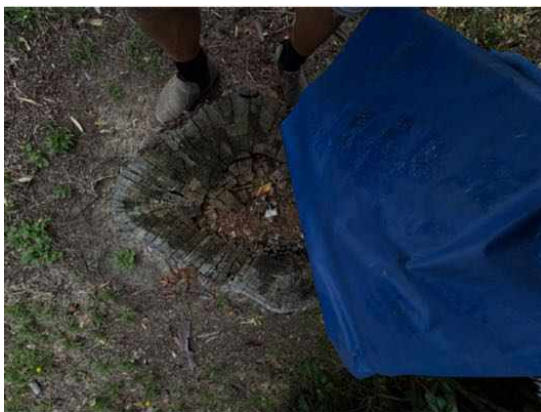
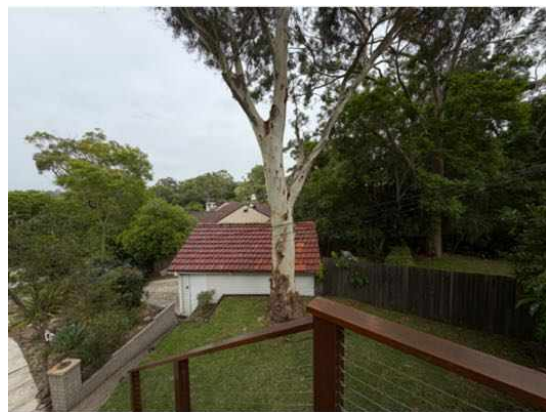
Finding 6.05

Building: Main Building
 Location: Yard
 Finding: Large trees/stumps within 30m of house
 Information: There are a number of large trees/stumps within 30m of the house which may contain natural termite activity. It is important to monitor these areas to ensure no natural activity is allowed to progress into the main house.

Regular inspections are recommended. Consider test drilling any large trees.

A pest controller can be contacted to carry out such testing at the owners discretion.

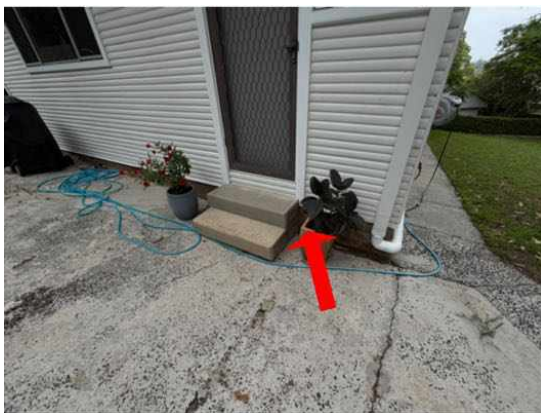
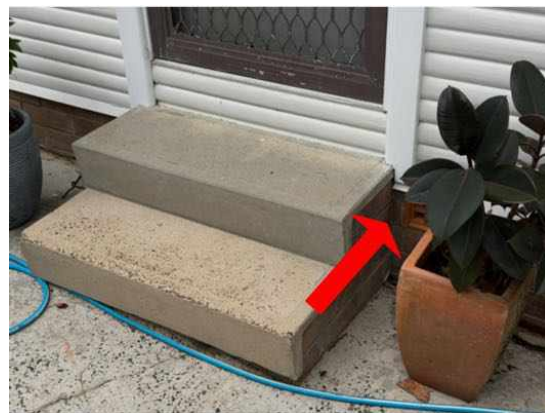
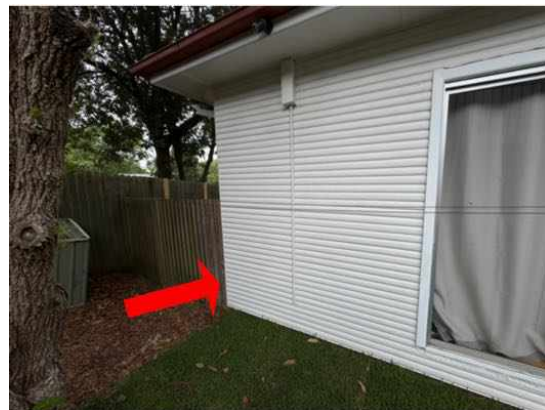
Finding 6.06

Building:	Main Building
Location:	Subfloor
Finding:	Excessive subfloor moisture
Information:	Excessive moisture can attract termites and produce conditions that promote termite attack fungal growth and wood decay.

Excessive moisture is generally caused by inadequate subfloor ventilation and poor site drainage.

There appear to be inadequate vents installed to the perimeter of the building and I would suggest that further solar powered fans or the like be installed to improve cross flow ventilation and aid in keeping the subfloor area relatively dry.

Additionally build-up of moisture is likely to occur if weep holes are covered further attracting termite activity to these areas.

It is highly recommended that both subfloor ventilation and site drainage be improved and maintained regularly in order to prevent excessive moisture being present in the external / internal property.

It is highly recommended that weep holes are left exposed in all areas throughout the external property. Therefore if any termite activity leading into weep holes becomes easily detectable during frequent pest inspections.

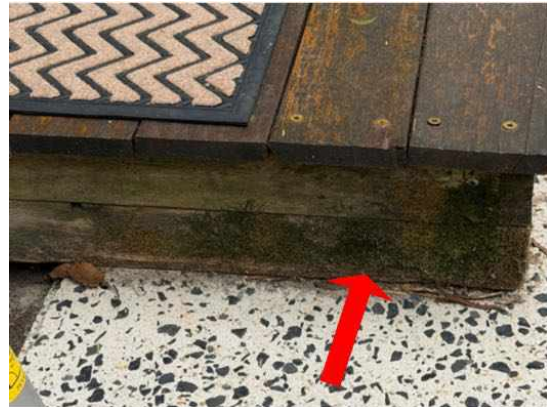
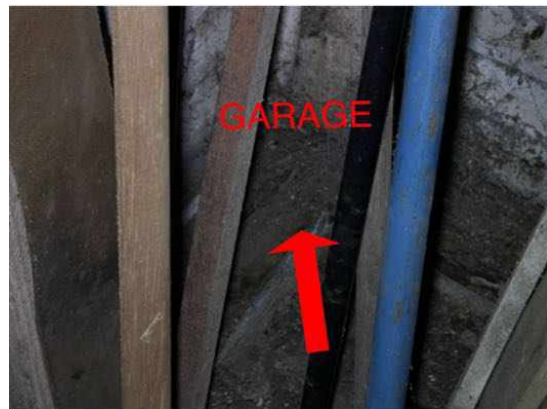
Finding 7.01

Building:	Main Building
Location:	Rear steps/detached Garage
Finding:	Fungal decay - present at the time of inspection
Information:	Fungal decay also known as wood decay or wood rot occurs when timbers and other

cellulose building materials are exposed to damp conditions on an ongoing basis. This could be the result of exposure to weathering in the long term or the pooling of water or absorbed moisture from other abutting building materials or a shower leak. It is advisable to remove these affected timbers to prevent any chance of attack in the future.

Wood decay is more susceptible to termite attack and these timbers should be replaced to limit termite attack.
