Building and Timber Pest Inspection Report VR

Inspection Date: Thu, 12 Feb 2026

Property Address: 50 Ardoyne Rd, Corinda QLD 4075,
Australia

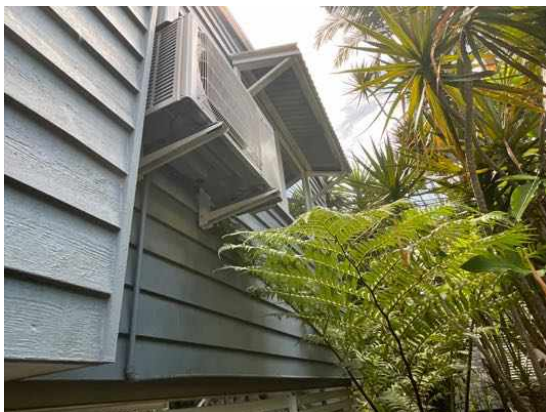
Finding 6.02

Finding: Dense vegetation around a property can increase the risk of termite infestation.

Information: The presence of dense vegetation around a property can increase the risk of termite infestation, as it provides a conducive environment for them.

To address this, consider maintaining a clear space between the vegetation and your home.

If you suspect a termite issue, it's advisable to consult with a licensed pest control professional for inspection and treatment.

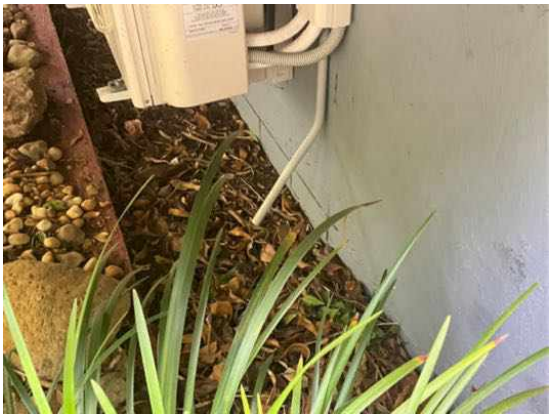
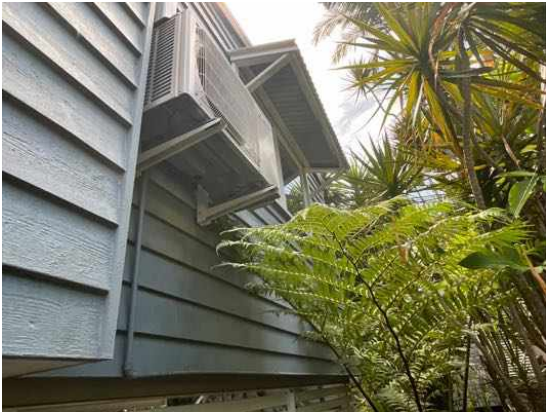
Finding 6.05

Building:	Main Building
Location:	All Areas
Finding:	Air conditioner - Disconnected overflow
Information:	The Air Conditioner (A/C) overflow was found to be disconnected from storm water drainage and is creating excessive moisture in the surrounding area.

Such leaking creates an environment which is conducive to an array of defects, including water damage to associated building elements and the attraction of termite or timber pest infestation.

It is highly recommended that a licensed plumber be appointed to connect the A/C overflow in order to prevent such an environment from being created. These minor works should be carried out as soon as possible.

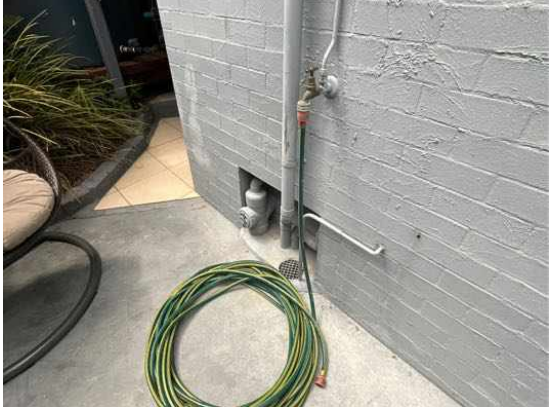
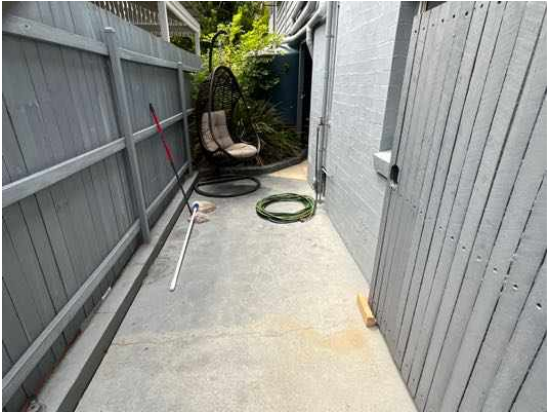
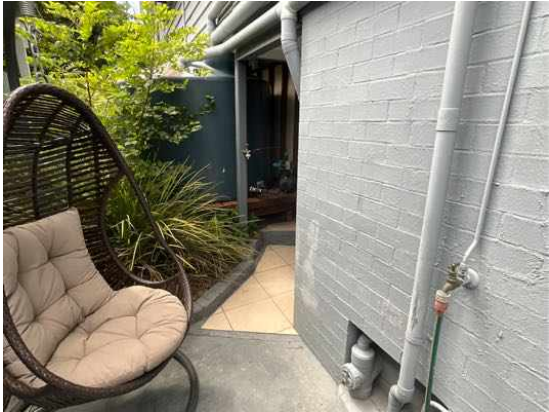
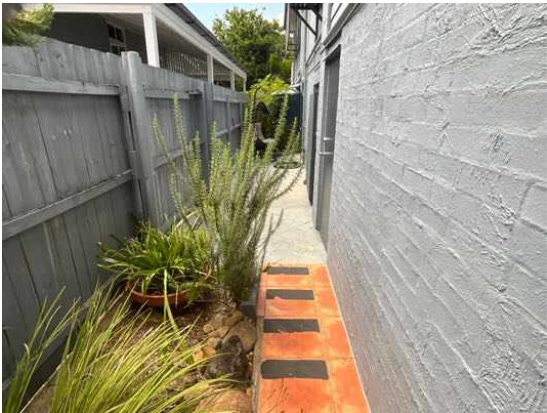
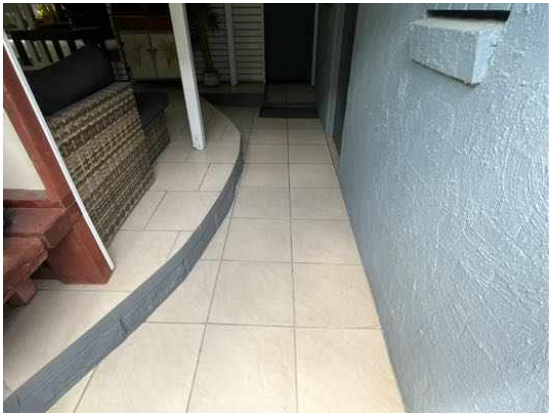
Noted Item

If the slab edge is not properly exposed there is a high risk of termite attack. Sometimes, in order to determine the type of slab, a suitably qualified person such as an architect or builder may be required to consult the construction plans.

Where the slab edge cannot be properly inspected, it is highly recommended that termite or timber pest inspections be carried out every 6-12 months to aid protection of the property against infestation.

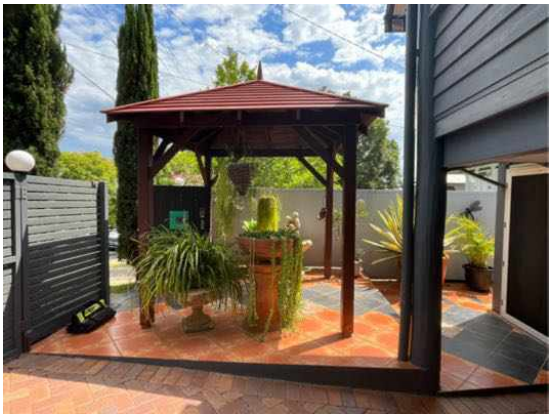
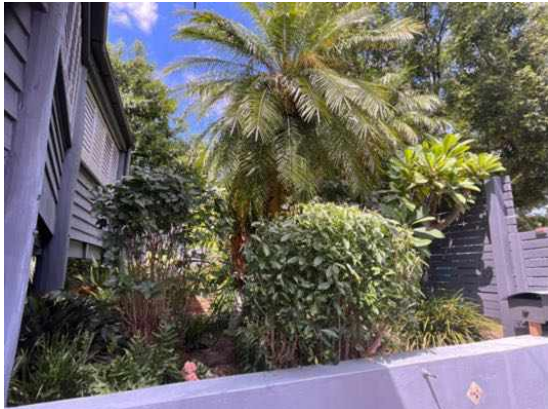
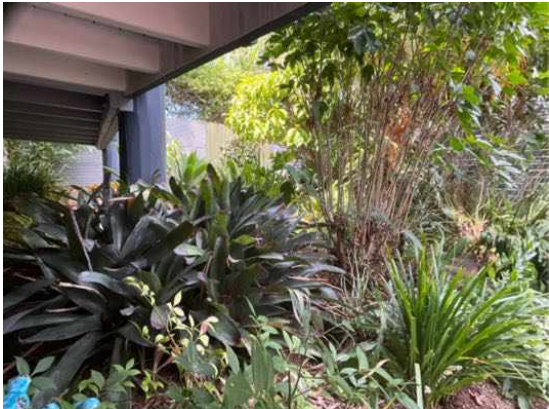
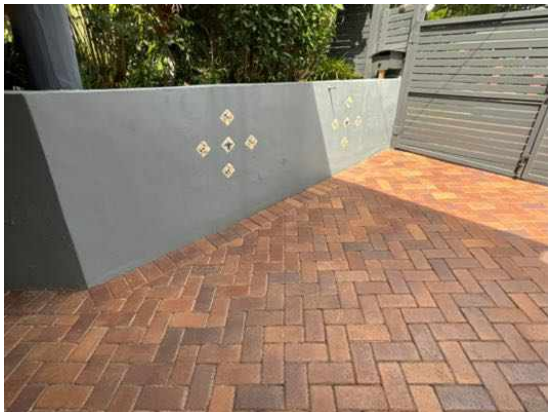
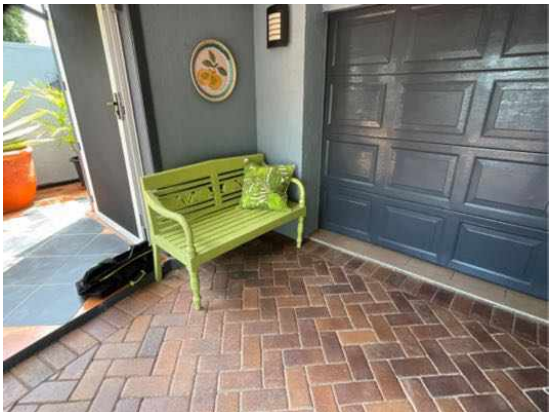
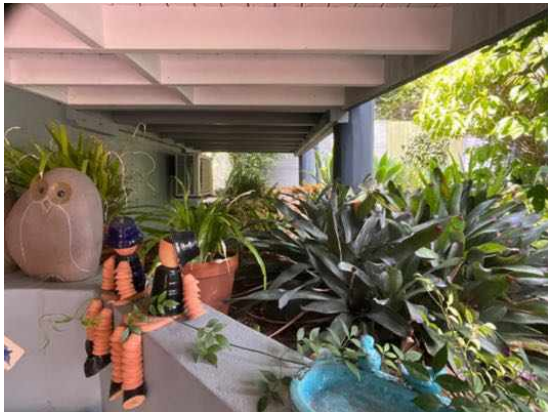
Noted Item

Building: Main Building
 Location: All Areas
 Finding: Additional Photos - Obstructions and Limitations
 Information: These photographs are an indication of the obstructions and limitations which impeded full inspection of the property at the time of inspection. These obstructions can hide an array of defects and should be removed to allow full inspection to be carried out. A re-inspection is recommended once the areas are made accessible.

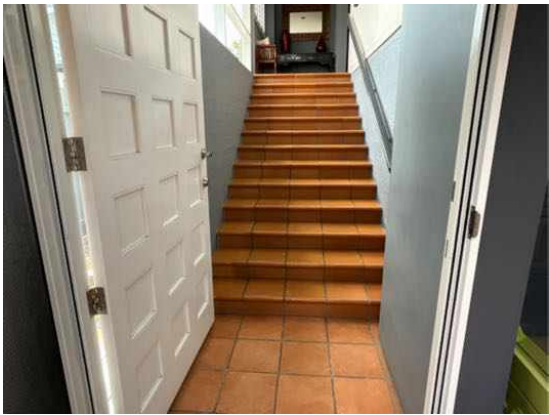
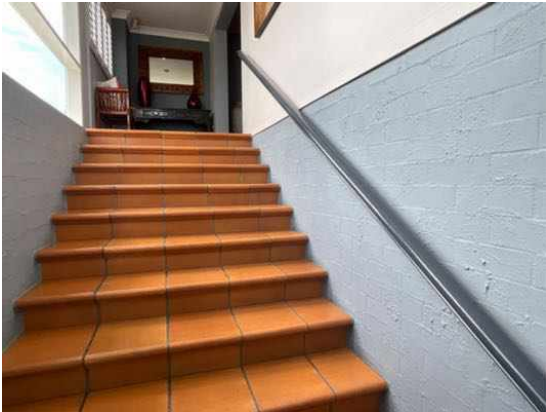
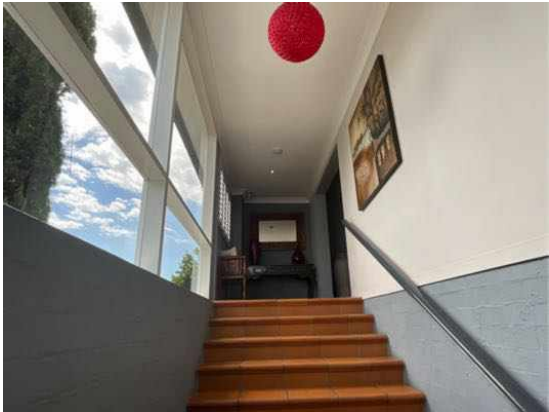
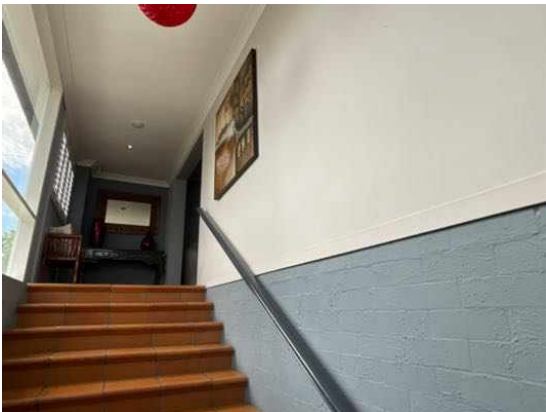
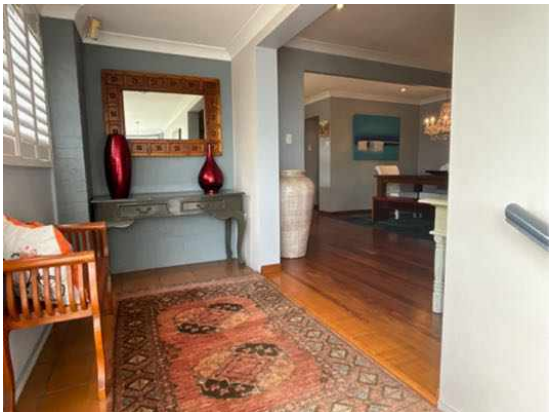
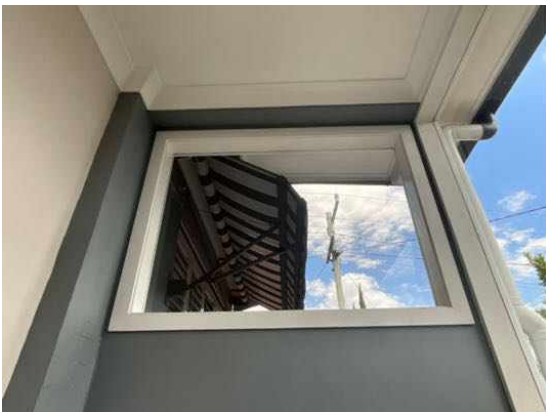
Noted Item

Building:	Main Building
Location:	All Areas
Finding:	Additional Photos - Obstructions and Limitations
Information:	These photographs are an indication of the obstructions and limitations which impeded full inspection of the property at the time of inspection. These obstructions can hide an array of defects and should be removed to allow full inspection to be carried out. A re-inspection is recommended once the areas are made accessible.
