Building and Timber Pest Inspection Report

Inspection Date: Wed, 4 Mar 2026

Property Address: 20 Ravenswood Rise, Bella Vista NSW 2153, Australia

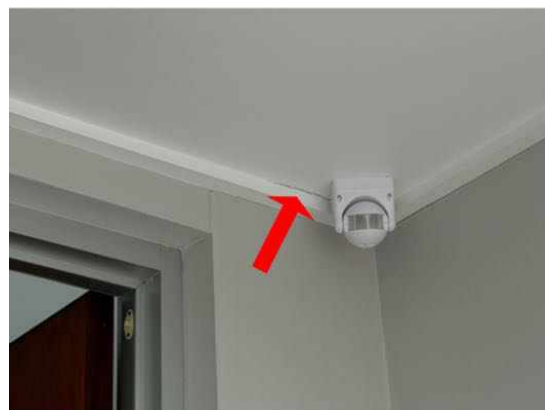
Building:	Main Building
Location:	All Internal Areas
Finding:	Fine Cracking to Skirtings, Architraves, Cornice, Ceilings
Information:	Fine cracking was observed to corner junctions of skirting boards, architraves, cornices and some ceilings throughout the dwelling.

The cracking appears minor in nature and is commonly associated with normal building movement, settlement, material shrinkage, or minor seasonal expansion and contraction of finishes.

At the time of inspection, no significant distortion or major structural concern was evident; however, the cracking affects the cosmetic finish of the internal linings.

I recommend to Seal, patch and repaint affected areas as part of routine maintenance. Monitor for any progression or widening of cracking which may warrant further assessment if changes are observed.

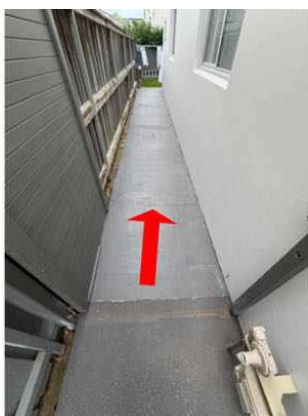
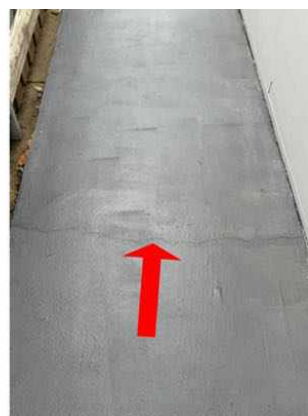
Finding 3.02

Building:	Main Building
Location:	Path LHS
Finding:	Cracking - External Concrete Paving Damage Category 0 - Hairline (less than 1mm)
Information:	Hairline cracks were identified in external concrete paving. Hairline cracks are very minor in nature and generally are only ever an appearance defect. To be classified as a Category 0 or hairline crack, the crack width would be less than 0.3mm. While such cracking may be noticeable in some cases, it is common and does not indicate any structural damage.

Generally the cause of a hairline crack in existing concrete paving such as driveways and pathways is indicative of the expansion and contraction of the concrete. Such causes are generally due to environmental factors, such as moisture levels, weather conditions, root systems of nearby trees or the soil types on which they are laid.

Hairline cracks may also be due to poor original installation of the concrete. Factors such as poor compaction of the sub surface and/or inadequate reinforcing of the slab may create cracking and other secondary defects.

Monitoring of all cracking should be conducted frequently. Always contact a building inspector should cracks widen, lengthen, or become more numerous.

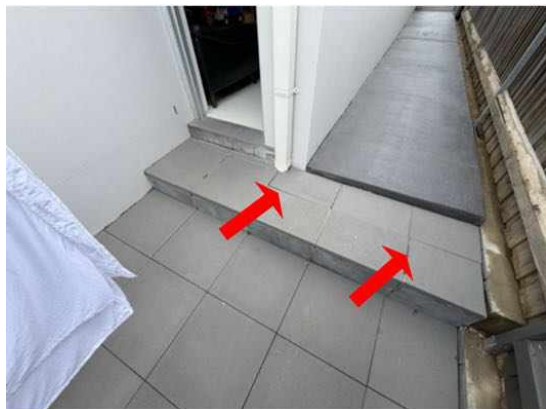
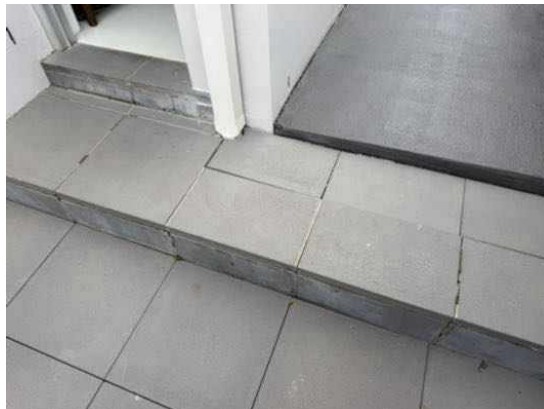
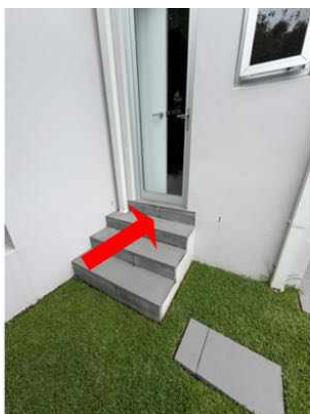
Finding 3.03

Building:	Main Building
Location:	Path LHS
Finding:	Paving - Uneven/Grout Missing
Information:	At the time of inspection, some external concrete pavers were found to be loose underfoot, and cracking was observed within the grout joints between adjacent pavers. Loose paving and deteriorated grout can allow movement of the pavers, increase the likelihood of further cracking, and may create a potential trip hazard. In addition, open or cracked joints can allow water to penetrate beneath the paving, which may lead to further movement or deterioration of the base material over time.

It is recommended that the affected pavers be lifted where necessary, the base

preparation checked and reinstated as required, and the pavers reset and re-grouted to restore stability and prevent further deterioration. Repairs should be carried out by a suitably qualified contractor.

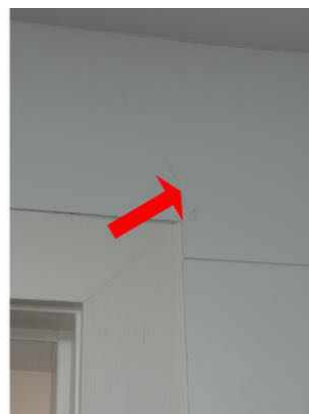
Finding 3.04

Finding: Tiles - Cracked

Information: At the time of inspection, one wall tile located at the upper corner of the bathroom doorway, and one tile to the side of the vanity unit were found to be cracked. This type of cracking is typically minor and is commonly caused by slight building movement over time. While it is not considered a major defect, the damaged tile should be replaced to maintain the condition and appearance of the tiled surface.

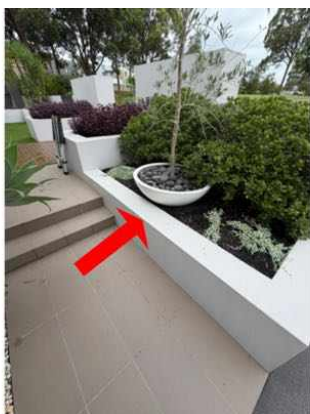
Finding 3.05

Finding: Retaining Wall–Minor Crack

Information: At the time of inspection, a minor crack was observed to the top section of the cement-rendered brick retaining wall forming the garden bed. This type of cracking is commonly associated with minor movement or normal shrinkage in rendered surfaces over time.

While the defect appears minor at present, it is recommended that the crack be sealed and the render repaired to prevent moisture ingress and to maintain the overall condition and appearance of the wall. Repairs should be carried out by a suitably qualified tradesperson if required.

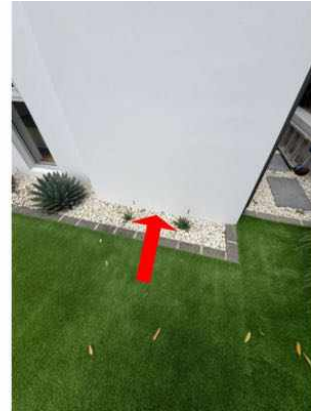
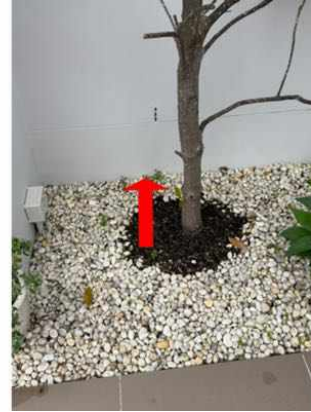
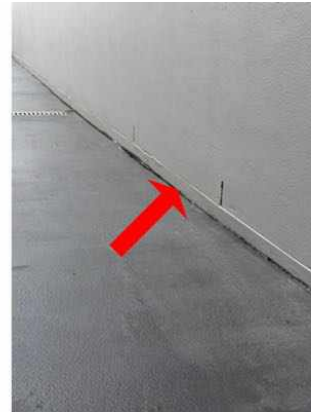
If the slab edge is not properly exposed there is a high risk of termite attack. Sometimes, in order to determine the type of slab, a suitably qualified person such as an architect or builder may be required to consult the construction plans.

Where the slab edge cannot be properly inspected, it is highly recommended that termite or timber pest inspections be carried out every 6-12 months to aid protection of the property against infestation.

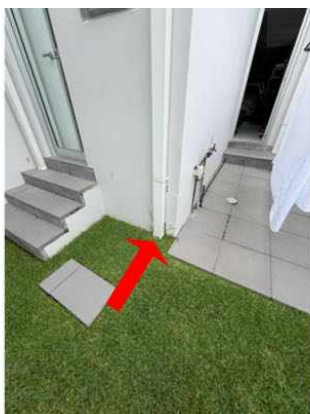
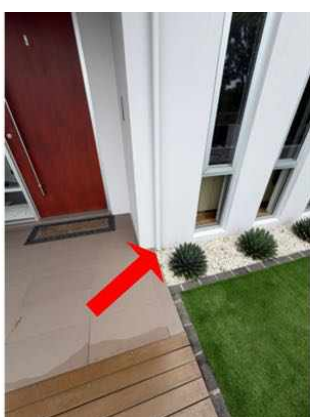
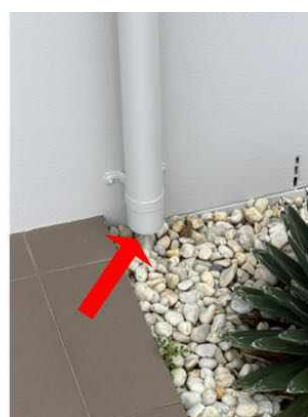
Finding 6.02

Building:	Main Building
Location:	Downpipes
Finding:	Downpipe(s)-not connected
Information:	The roof plumbing is not adequately connected to stormwater drainage on the site. This disconnection negatively impacts the functional capacity of the roof plumbing.

Where roof plumbing doesn't drain adequately, the area at the base perimeter can become excessively damp, potentially creating an environment that is susceptible to rust and corrosion of surrounding building elements, as well as attracting termites and other pests.

It is highly recommended that a plumber be appointed to further inspect the area and to connect all downpipes adequately as soon as possible.

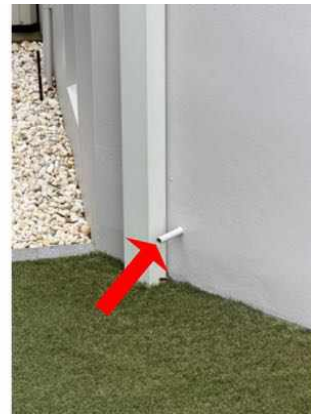
Finding 6.03

Building:	Main Building
Location:	Hot Water/AC units
Finding:	Overflows not plumbed to drainage
Information:	The overflow is not plumbed or connected to suitable drainage, which has resulted in the surrounding area becoming excessively damp.

These damp conditions can lead to secondary defects such as rot, rust or corrosion of associated building elements, the formation of fungal decay, or even the creation of potential slip hazards. When coupled with poor site drainage, pooling of water may also attract termite activity to this area.

It is highly recommended that a qualified plumber be appointed to install adequate drainage to the overflow. These works will ensure that the area remains dry and free of any secondary defects.

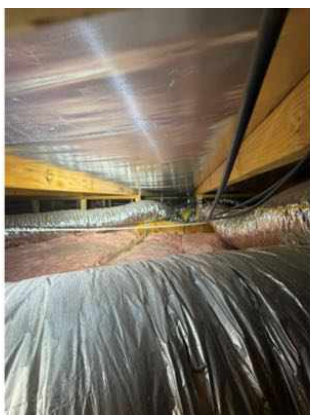
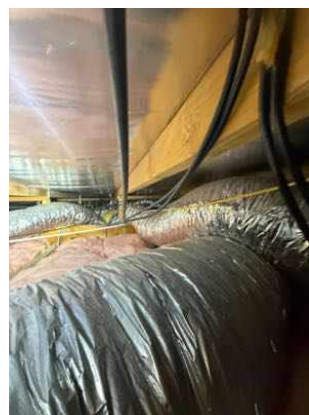
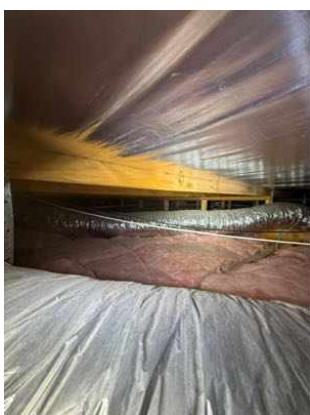
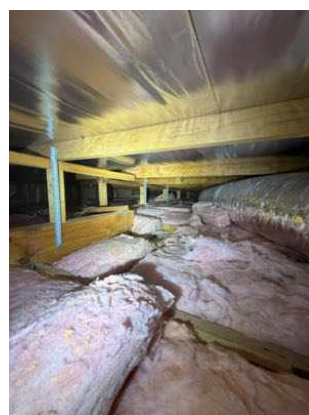
Building:	Main Building
Location:	Roof Void
Finding:	Obstructions and Limitations-Roof Void
Information:	These photographs are an indication of the obstructions and limitations that impeded the full inspection of the roof cavity at the time of inspection. Note that the insulation covered nearly all the ceiling joists, which are a major structural element of the ceiling; the inspection was also limited to areas with an allowable crawl space of 600mm x 600mm, in particular towards the external walls where the roof line diminishes, it was not accessible. These obstructions and limitations can hide an array of defects and should be removed to allow a full inspection to be carried out. A re-inspection is

recommended once areas are made accessible.

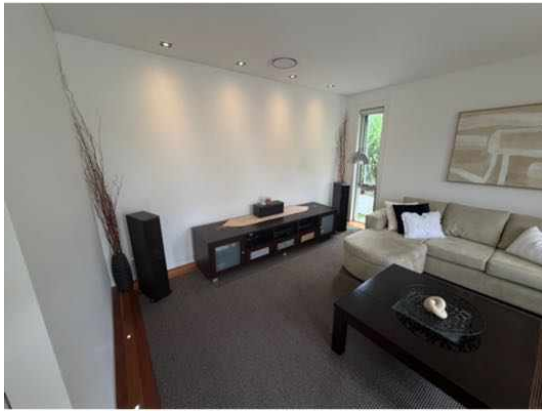
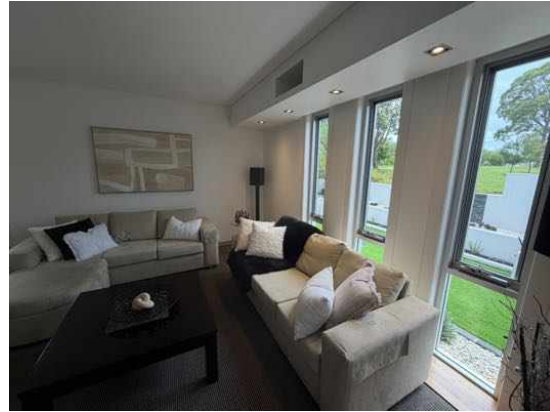
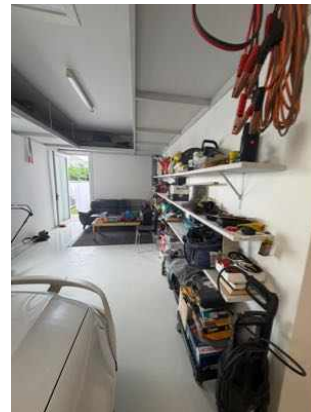
Building:	Main Building
Location:	Internal Areas
Finding:	Obstructions and Limitations-Internal areas
Information:	These photographs are an indication of the obstructions and limitations which impeded full inspection of the internal areas at the time of inspection. These obstructions can hide an array of defects and should be removed to allow a full inspection to be carried out. A re-inspection is recommended once the areas are made accessible.

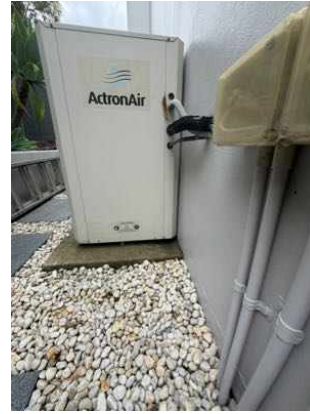
Building:	Main Building
Location:	External Areas/Sub-Floor
Finding:	Obstructions and Limitations-External Areas/Sub-Floor
Information:	These photographs are an indication of the obstructions and limitations which impeded full inspection of the external areas/subfloor at the time of inspection. These obstructions can hide an array of defects and should be removed to allow full inspection to be carried out. A re-inspection is recommended once the areas are made accessible.

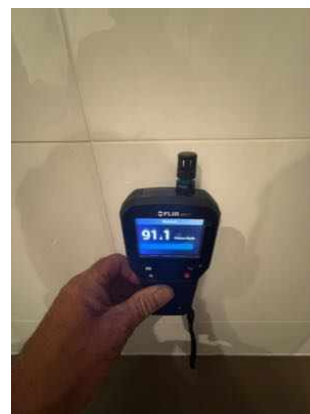
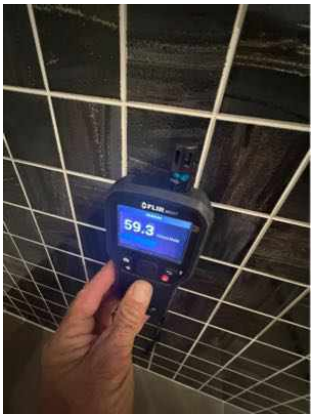
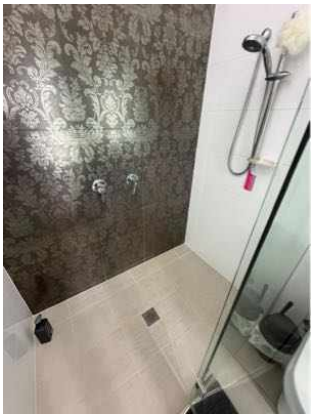
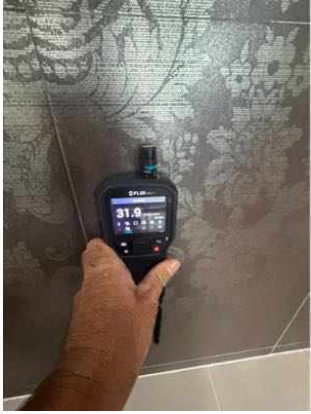
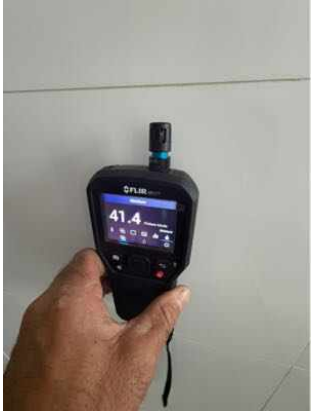
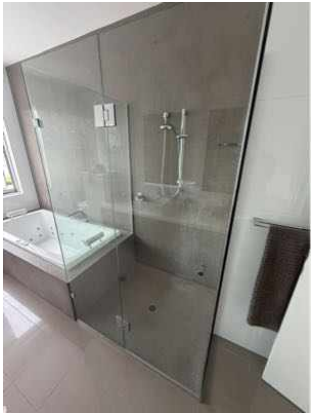
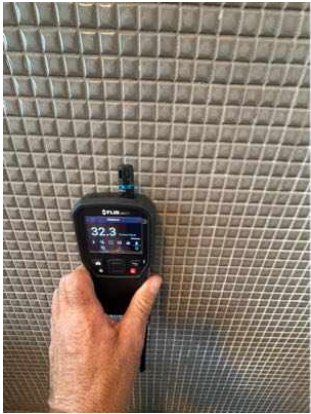
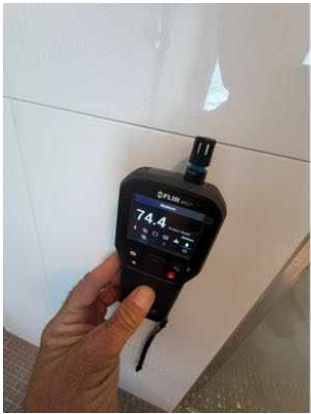
Finding: Shower/s Condition

Information: At the time of inspection, the showers within the dwelling flood tested, checked for signs of leakage and tested for elevated moisture readings in the surrounding wall and floor areas. No visible leaks, moisture intrusion, or abnormal moisture readings were detected during the inspection, and the shower areas appeared to be performing satisfactorily at that time.

Based on the observations made at the time of inspection, no defects were evident and the showers appeared to be functioning as intended. Ongoing monitoring and regular maintenance of seals and grout are recommended to help prevent future water ingress.

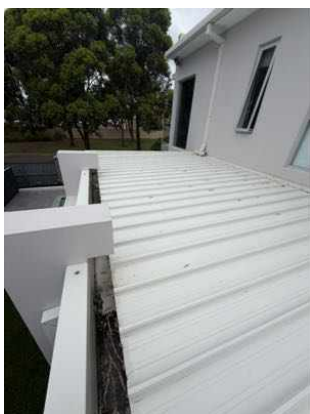
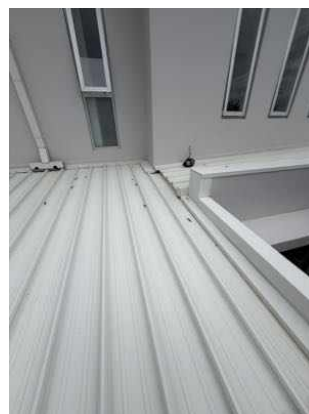
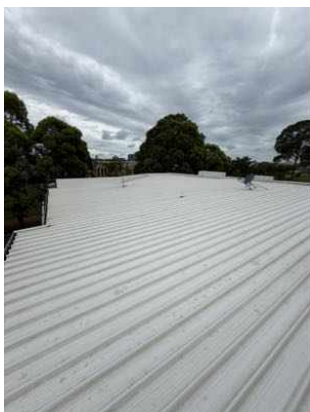
Building: Main Building
Location: Roof Exterior
Finding: FYI-Roofing Condition
Information:

At the time of inspection, the roofing visible from accessible areas were visually assessed and appeared to be in generally good condition. No significant damage, displacement, or defects were noted to the roof sheeting or flashings that were observable during the inspection.

Based on the observations made during the inspection, the roofing appeared to be serviceable and performing as intended at the time of assessment. Regular maintenance and periodic roof inspections are recommended to help ensure the roof covering continues to perform effectively over time.

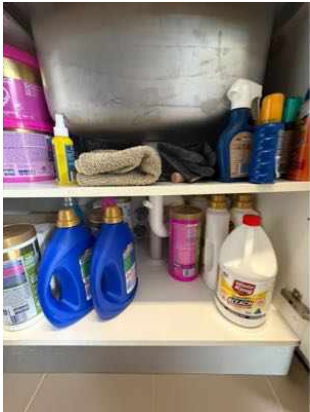
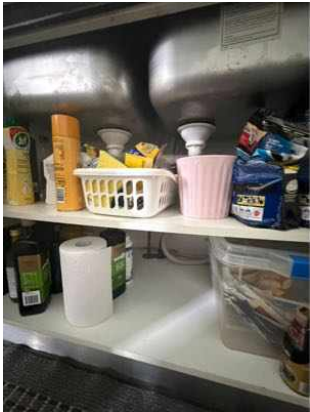
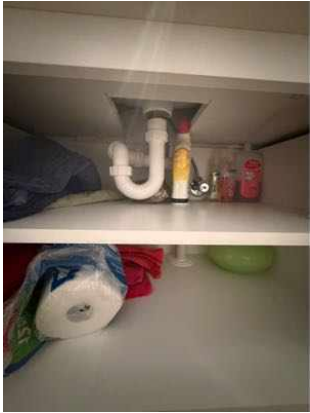
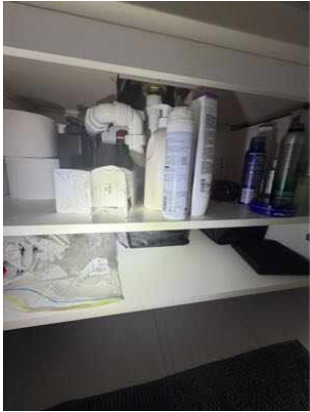
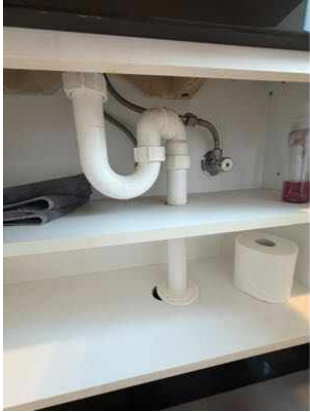
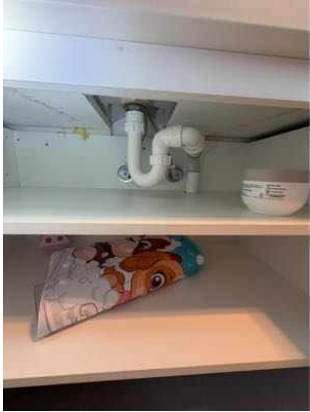
Building: Main Building
 Location: Cabinetry Plumbing
 Finding: FYI-Cabinetry Plumbing
 Information: All cupboards where sinks and basins with drainage plumbing were inspected no evidence of leaks were present at the time of inspection.

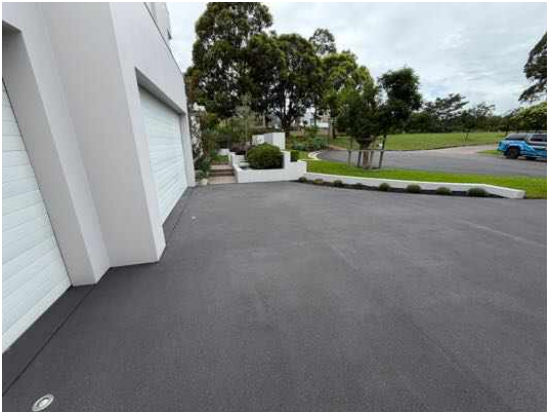
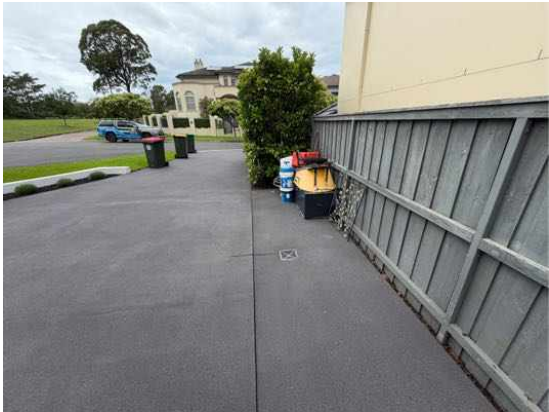
Building: Main Building
Location: Site Drainage
Finding: FYI-Site Drainage
Information: Site drainage appears to be acceptable at the time of inspection, however the site/yard should be monitored during heavy rain to determine whether the existing drains can cope. If it appears that they cannot cope, then additional drains may be required.

Any comments made in this section are relevant only in light of the conditions present at the time of inspection. It is recommended that a smoke test be obtained to determine any illegal connections, blocked or broken drains.

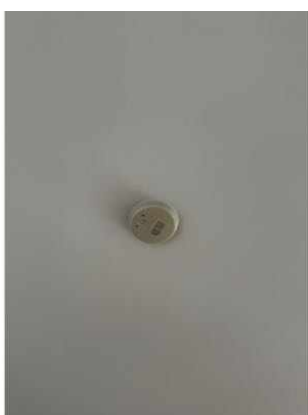
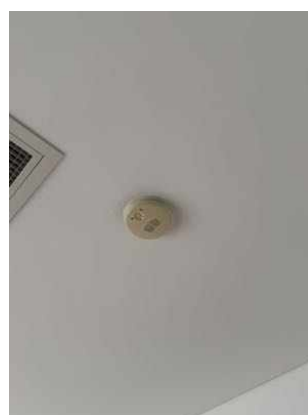
Please note that this defect is highlighted as a caution only. We suspect, based on our experience in the building industry, that the absence of smoke detectors, or their poor condition, should be addressed as a matter of urgency to improve occupant safety.

Always ensure sufficient working and suitable smoke detectors are installed prior to occupying any building. Additionally, it is advised that all smoke detectors be tested by the homeowner on a monthly basis.

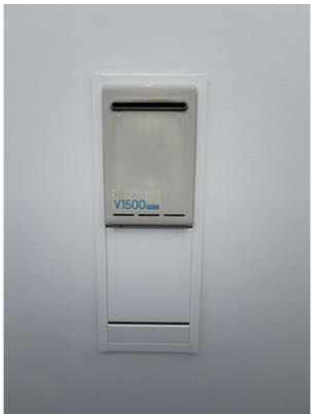
Building: Main Building
 Location: Hot Water System
 Finding: FYI-Hot Water Unit
 Information: The HWS appeared to be in good condition at the time of inspection. For the date of manufacture - (see attached photo)
