Building and Timber Pest Inspection Report

Inspection Date: Tue, 10 Feb 2026

Property Address: 358 Great Western Hwy Service Rd,
Warrimoo NSW 2774, Australia

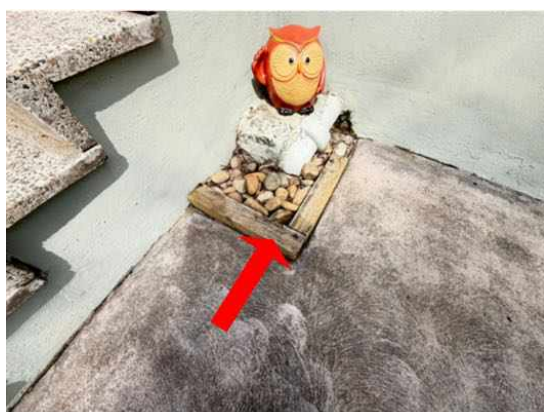
Building:	Yard
Location:	Yard
Finding:	In ground contact
Information:	Any timbers in direct ground contact provide opportunity for concealed termite entry and are likely to be subject to premature rot and decay as the soil retains moisture or damp conditions against the timbers.

Treated Timbers can decay or be poorly treated at manufacturing and as they degrade overtime can allow for termite attack.

Remove any timber that is in direct contact with external grounds. Consider replacement with more durable materials i.e. non timber elements. Frequent pest inspections are advised to readily identify any termite activity in these areas.

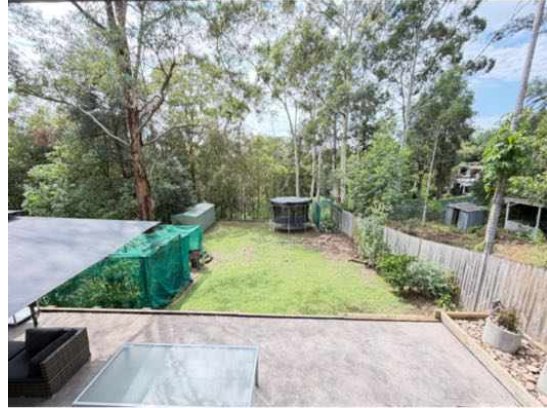
Finding 6.02

Building:	Main Building
Location:	Yard
Finding:	Large trees/stumps within 30m of house
Information:	There are a number of large trees/stumps within 30m of the house which may contain natural termite activity. It is important to monitor these areas to ensure no natural activity is allowed to progress into the main house.

Regular inspections are recommended. Consider test drilling any large trees.

A pest controller can be contacted to carry out such testing at the owners discretion.

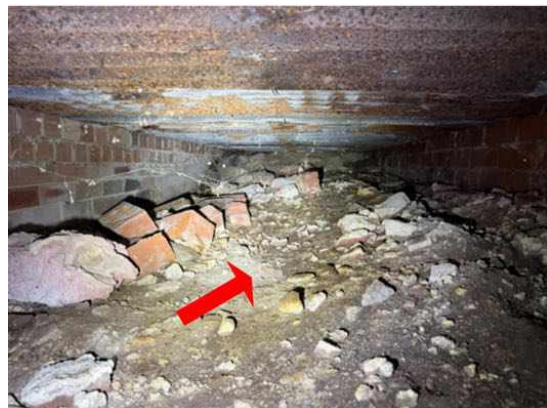
Finding 6.03

Building:	Main Building
Location:	Subfloor
Finding:	Excessive subfloor moisture
Information:	Excessive moisture can attract termites and produce conditions that promote termite attack fungal growth and wood decay.

Excessive moisture is generally caused by inadequate subfloor ventilation and poor site drainage.

There appear to be inadequate vents installed to the perimeter of the building and I would suggest that further solar powered fans or the like be installed to improve cross flow ventilation and aid in keeping the subfloor area relatively dry.

The installation of additional surface drainage to the rear of the property would also be beneficial to keeping the subfloor dry.

It is highly recommended that both subfloor ventilation and site drainage be improved and maintained regularly in order to prevent excessive moisture being present in the external / internal property.
