Building and Timber Pest Inspection Report VR

Inspection Date: Mon, 16 Feb 2026

Property Address: 90/316 Long St E, Graceville QLD 4075, Australia

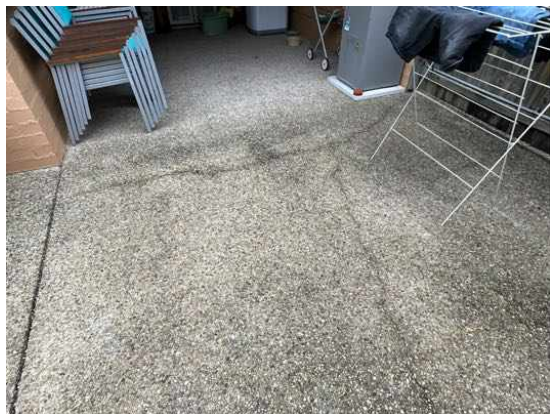
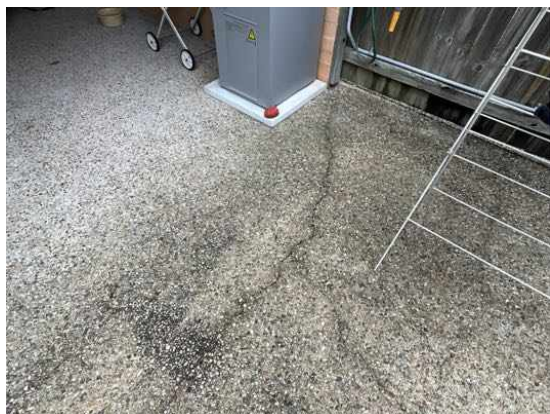
Building: Main Building
Location: Yard - Back
Finding: Crack in concrete slab - Category 1
Information: A crack coded as Category 1 was identified in the slab. A Category 1 crack is described as a fine but noticeable crack, with the slab at an otherwise reasonable level.

To be considered Category 1, the approximate width of the crack is less than 1.0mm, or a less than 10mm change in offset when a 3m straight edge is placed over the defect.

Category 1 cracks should be monitored for a period of 12 months. At the end of the monitoring period, identified cracks that are rated greater than Category 2 are considered defects, and require rectification.

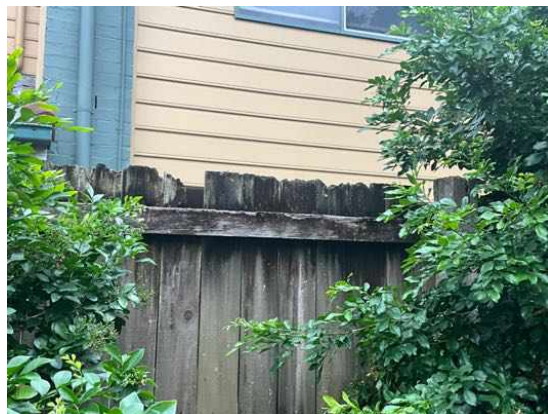
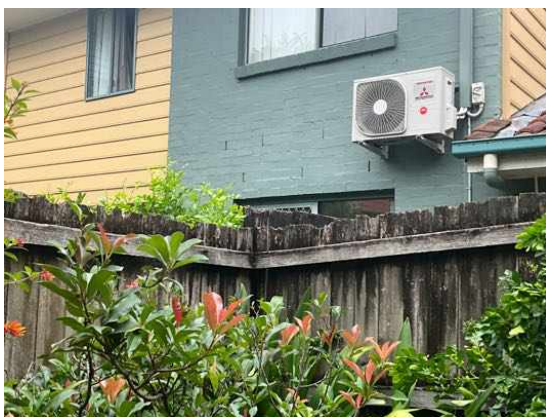
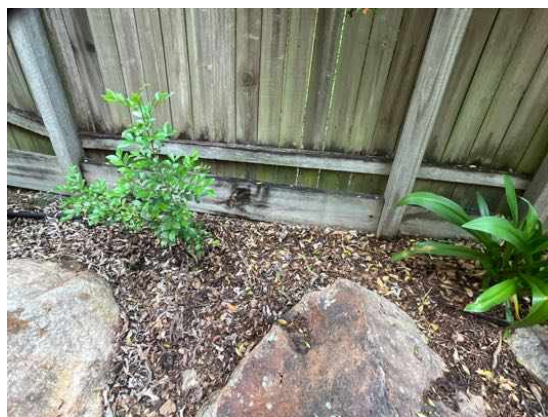
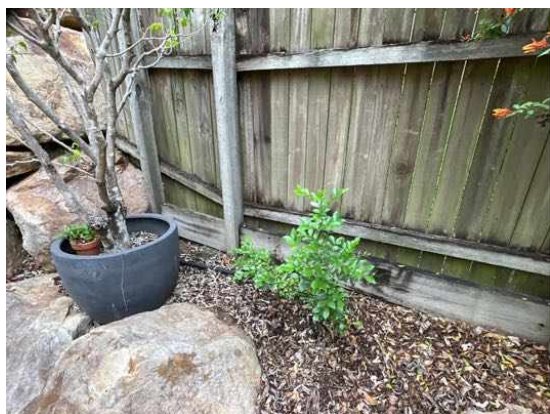
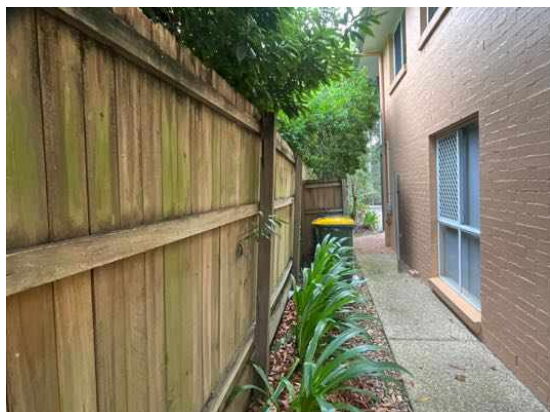
Finding 3.02

Building:	Main Building
Location:	Yard - Back & Side
Finding:	Timber Boundary Fence – General Deterioration and Weathering (Rear and Side Boundaries)
Information:	Timber Boundary Fence – General Deterioration and Weathering (Rear and Side Boundaries)

The timber boundary fence exhibits advanced weathering and deterioration, including aged and discoloured palings, surface decay, biological growth (algae/mould staining), uneven alignment, and localized timber degradation to rails and posts. Several palings appear warped or weakened, and overall structural condition is considered poor to fair. These conditions are consistent with prolonged exposure to moisture and lack of ongoing maintenance.

Continued deterioration may result in loss of structural integrity, reduced privacy and security, and potential fence failure during high winds. Degraded timber also increases

the likelihood of pest activity and further decay if left unaddressed.

Engage a licensed fencing contractor or qualified carpenter to assess the fence integrity. Repairs may include replacement of damaged palings, rails, and posts, or full fence replacement depending on extent of deterioration. Consider pressure cleaning and protective coating only if structural condition allows.

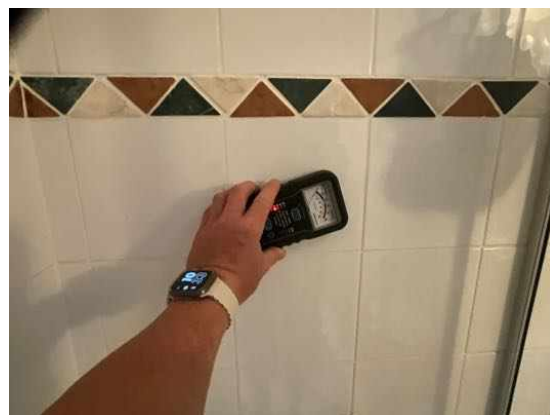
Building:	Main Building
Location:	Bathroom
Finding:	Shower damp - Monitor - high moisture readings
Information:	Damp is evident to the lower 400mm of wall to the shower alcove. There is high reading around the taps, but not high readings transferring to the other side of the wall.

This defect is quite common, and is suspected to have been caused by moisture permeating or leaching through the grouting and perhaps gaps in the sealant prior to repair.

Highly recommend a leak detection test is done on shower to determine if there is a tap or shower head leaking.

Monitoring the area is advised and if any visual signs of excessive moisture appear (peeling paint, mould) then consultation with a qualified plumber or bathroom specialist would be advised to identify the cause of damp and to perform remedial works as required.

Always ensure that sealant and grout is in good condition to prevent any moisture issues occurring in the future.

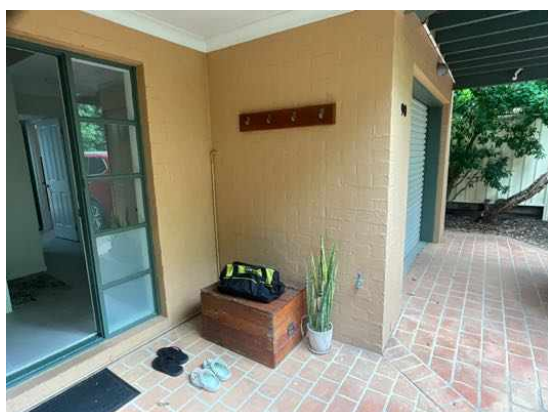
Building:	Main Building
Location:	All Areas
Finding:	No Drain under tap.
Information:	There is no drain installed under the tap, leading to water accumulation and creating conducive conditions for timber pests.

This defect needs immediate attention to prevent potential damage and pest infestation.

A licensed plumber or a qualified building contractor can address this defect by:

1. Assessment: Evaluating the area to determine the best approach for installing a proper drainage system under the tap.
2. Installation: Installing a drain that effectively channels water away from the base of the tap, preventing water accumulation and dampness.
3. Repair and Prevention: Inspecting and repairing any existing water damage and implementing measures to prevent future water accumulation and pest infestations.

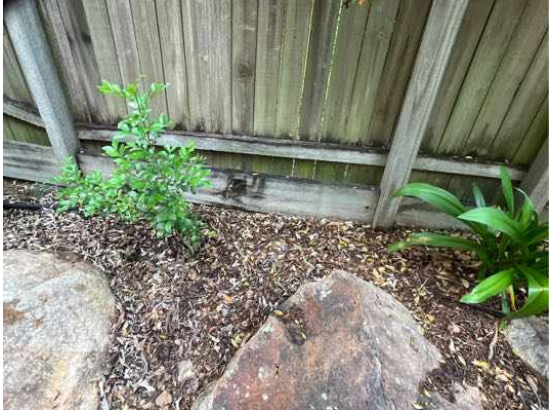
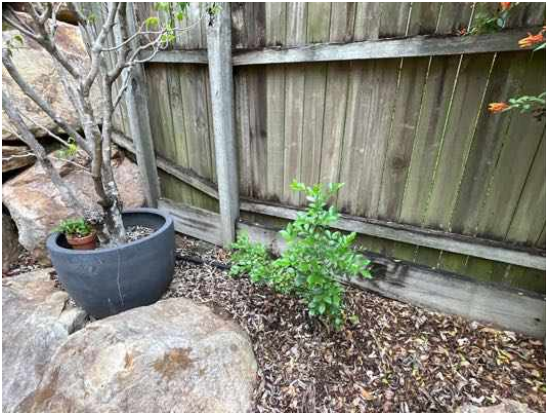
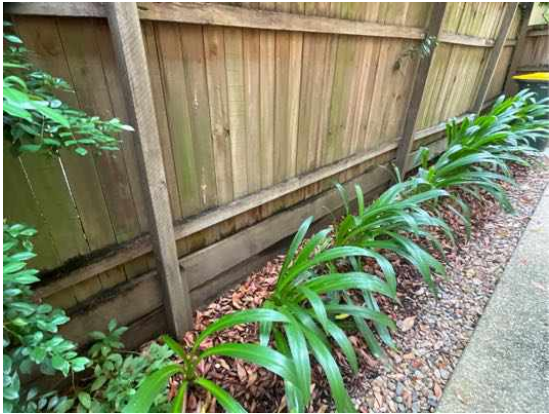
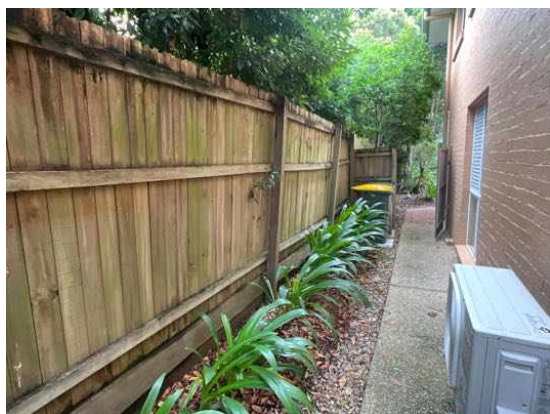
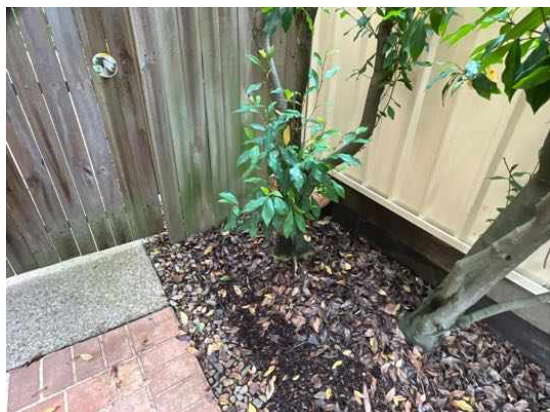
Finding 6.03

Building: Main Building
Location: All Areas
Finding: Timber on ground / conducive conditions to termite damage.
Information: Timber on the ground is indeed conducive to termite damage.

Termites are known to thrive in moist environments, and wood in contact with soil or moisture is more susceptible to infestation.

To prevent this, it's important to keep timber elevated and away from direct ground contact.

Regular inspections and proper termite control measures are also essential to protect your wooden structures from termite damage.

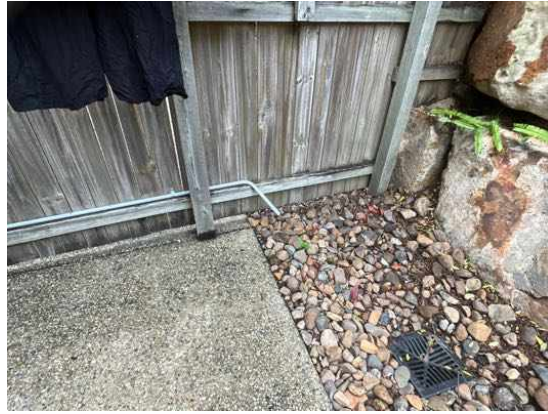
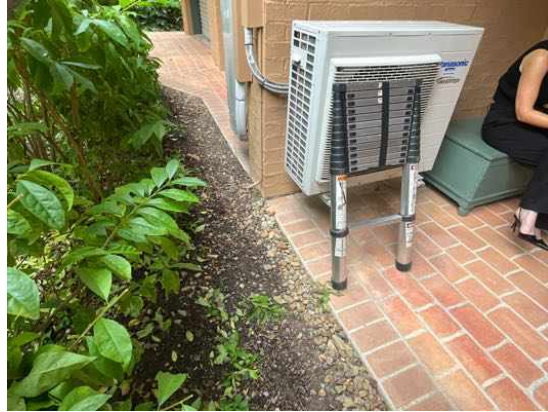
Finding 6.04

Building:	Main Building
Location:	All Areas
Finding:	Air conditioner - Disconnected overflow
Information:	The Air Conditioner (A/C) overflow was found to be disconnected from storm water drainage and is creating excessive moisture in the surrounding area.

Such leaking creates an environment which is conducive to an array of defects, including water damage to associated building elements and the attraction of termite or timber pest infestation.

It is highly recommended that a licensed plumber be appointed to connect the A/C overflow in order to prevent such an environment from being created. These minor works should be carried out as soon as possible.
