Building and Timber Pest Inspection Report VR

Inspection Date: Mon, 9 Feb 2026

Property Address: 34 Barclay St, Bundamba QLD 4304,
Australia

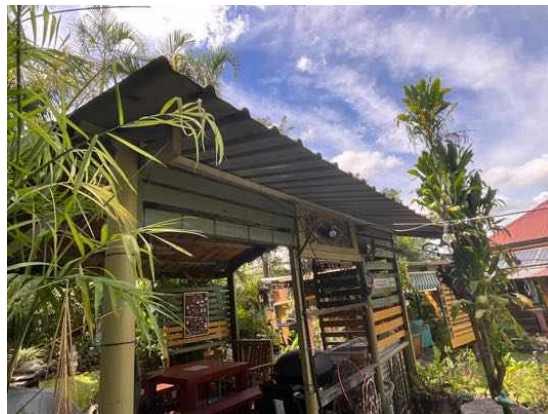
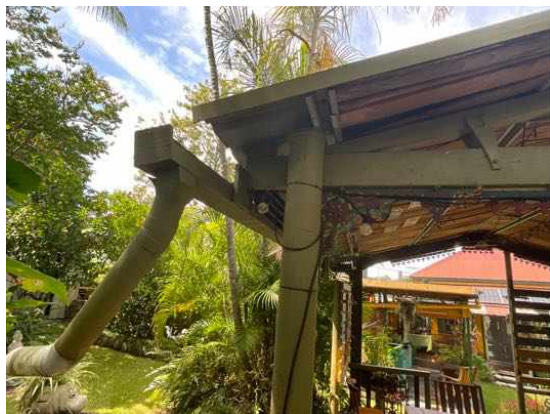
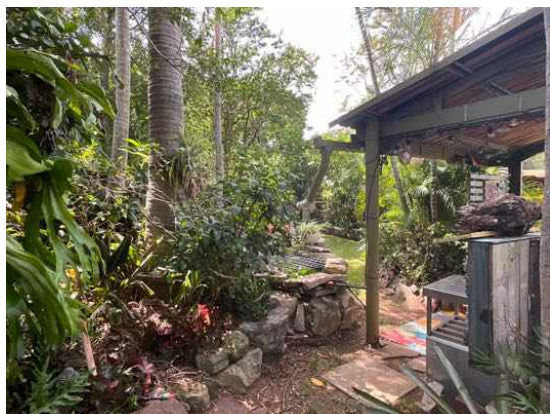
The outdoor awning/pergola structure shows signs of general deterioration and age-related wear. Roof sheeting appears weathered and uneven, with sections showing misalignment and inadequate support. Timber framing members exhibit visible movement and deflection, and fixings appear inconsistent in places. The structure is supported by painted posts with evidence of previous patch repairs and surface degradation. Drainage components (downpipe and gutter connection) appear non-standard and poorly aligned, which may compromise effective stormwater discharge. Overall presentation indicates non-engineered construction with ad-hoc modifications over time.

The current condition increases the risk of water ingress, further structural movement, and potential failure during high winds or heavy rain events. Poor roof alignment and drainage may accelerate timber decay and corrosion of fixings. If left unrectified, this may lead to progressive deterioration and possible safety hazards to occupants using the entertaining area.

Engage a licensed builder or qualified carpenter to carry out a structural assessment of the awning/pergola, including roof sheeting, framing members, posts, and drainage connections. Rectification works may include realignment or replacement of roof sheets, upgrading fixings, improving stormwater discharge, and repairing or replacing deteriorated structural elements. Where required, works should comply with current NCC requirements and relevant Australian Standards.

Repairs are recommended within 3–6 months, or sooner if further movement, leaks, or instability are observed.

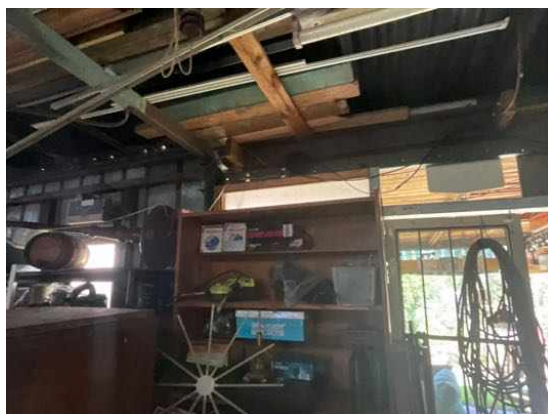
Finding 2.02

Building:	Main Building
Location:	Yard - Back
Finding:	Tool Shed – General Condition and Structural Integrity (Rear Yard)
Information:	Tool Shed – General Condition and Structural Integrity (Rear Yard)

The tool shed is constructed using a combination of aged timber framing, mixed cladding materials, recycled windows, and corrugated metal roofing. Based on visual inspection, the structure presents as non-standard and makeshift in nature. The following conditions were observed:

- Visible timber deterioration, weathering, and uneven framing.
- Roofing materials appear inconsistently installed, with gaps and patchwork sections increasing risk of water ingress.
- Internal framing and ceiling linings show staining and signs consistent with historic moisture exposure.
- Stored materials and equipment obstructed full inspection of wall linings, floor areas,

- Electrical cabling and lighting appear ad-hoc and not installed to a clearly compliant standard.
- External access paths are narrow and uneven, creating trip hazards and restricting safe maintenance access.
- Overall presentation indicates the shed is approaching the end of its serviceable life.

- Increased risk of structural instability over time.
- Potential for water ingress leading to further timber decay and internal deterioration.
- Possible safety hazards associated with improvised electrical installations and stored materials.
- Elevated pest entry risk due to gaps, organic debris, and concealed areas.
- If asbestos-containing materials are present, disturbance could pose a health risk.

- Engage a licensed builder or carpenter to assess structural integrity and advise on repair versus replacement.
- Consider full removal and replacement of the shed due to overall condition and non-compliant construction.
- Arrange a licensed asbestos assessor or laboratory testing of suspect materials prior to any demolition or disturbance.
- Any asbestos identified must be removed by a licensed asbestos removal contractor in accordance with WHS regulations.
- Electrical components should be inspected by a licensed electrician.
- Clear stored items to allow a complete inspection and reduce pest harborage.

Short term (0–3 months) – Further deterioration and safety risks are likely if not addressed.

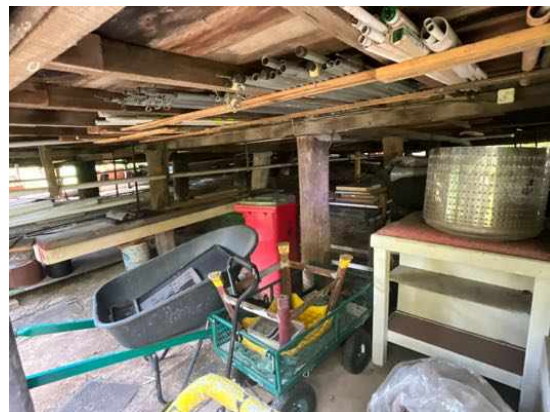
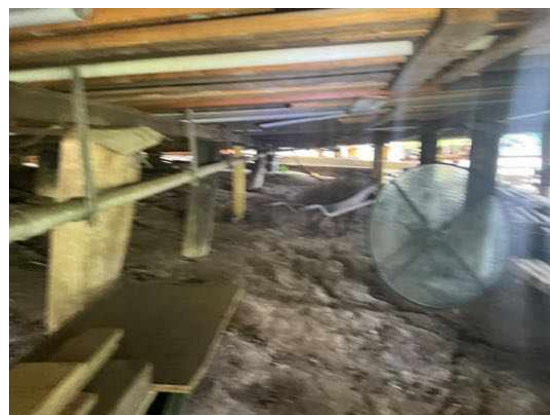
Finding 2.03

Building:	Main Building
Location:	Subfloor
Finding:	Subfloor & Timber Stumps – General Condition and Support (Subfloor Area)
Information:	Subfloor & Timber Stumps – General Condition and Support (Subfloor Area)

Inspection of the subfloor area identified ageing timber stumps supporting the dwelling, with visible weathering, soil contact and signs of deterioration to several stump bases. Some stumps appear unevenly loaded and/or out of plumb. General subfloor conditions also show exposed soil, inconsistent ground levels and limited clearance in areas. Stored materials and services restrict full inspection to all structural members.

Timber bearers and joists are original/aged and show surface weathering. No active collapse was observed at the time of inspection; however, the condition indicates an older support system that may not comply with current construction tolerances. Localised timber degradation was observed to at least one stump/bearer interface.

Continued deterioration of timber stumps may lead to structural movement, uneven floors, cracking to walls and ceilings, and potential long-term footing instability. Timber in ground contact is susceptible to moisture damage and termite activity. Restricted ventilation and exposed soil increase the risk of moisture accumulation and concealed timber decay.

alignment and load distribution. Replacement or underpinning with compliant supports (e.g., concrete or steel stumps) should be considered where deterioration or movement is confirmed. Improve subfloor ventilation and ground clearance where practicable. A licensed pest inspector is also recommended to assess for termite activity given timber-to-ground proximity.

Further assessment recommended within 30 days, with rectification works completed as required following professional advice.

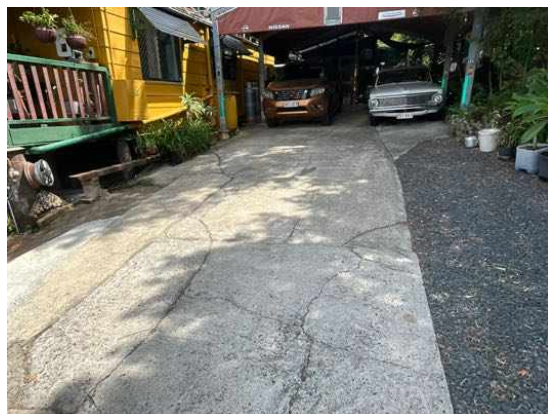
Building: Main Building
 Location: Driveway
 Finding: Crack in concrete slab - Category 3
 Information: A crack coded as Category 3 was identified in the slab. A Category 3 crack is described as a wide crack with obvious curvature or change in level, affecting the slab.

The approximate width of the crack to be considered Category 3 is greater than 2.0mm, or a change in offset of 15-25mm when a 3m straight edge is placed over the defect.

Category 3 cracks to slabs exceed allowable Standards and Tolerances, and are considered defects requiring rectification.

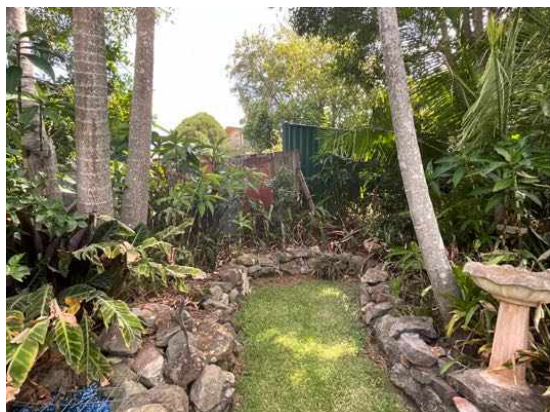
Finding 3.02

Building: Main Building
 Location: Yard - Back
 Finding: Deteriorated & Non-Compliant Boundary Fence – Rear Yard
 Information: Defect: Deteriorated & Non-Compliant Boundary Fence – Rear Yard

The rear boundary fence is constructed from mixed aged timber palings and corrugated metal sheeting and is in poor overall condition. Visible deterioration includes weathered and decaying timber, rusted metal sheeting, inconsistent fence heights, and vegetation growth hard up against the fence line. Several sections appear unstable and poorly supported, with evidence of prior patch repairs. Dense vegetation is contributing to moisture retention and accelerating deterioration of fence components.

The fence no longer provides adequate structural integrity, privacy, or security. Continued deterioration may result in fence failure or collapse. The current condition also presents a potential injury risk and may allow pest/vermin access. Vegetation contact increases moisture exposure and raises the likelihood of timber decay and termite activity.

Engage a licensed fencing contractor or carpenter to assess the full fence line and carry out repairs or replacement as required. It is recommended the fence be rebuilt using compliant materials and correct footing/post installation. Clear vegetation away from the fence to improve airflow and reduce moisture exposure. A pest inspection is also recommended due to prolonged timber-to-soil and vegetation contact.

Repairs or replacement recommended within 1–3 months to prevent further deterioration and potential failure.

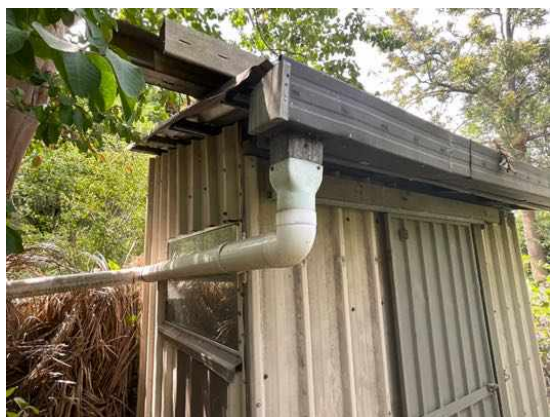
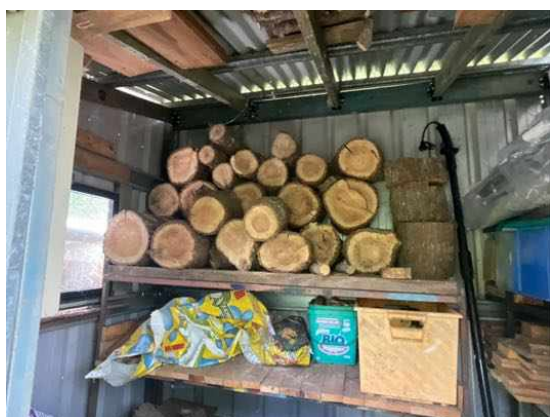
Finding 3.03

Building:	Main Building
Location:	Yard - Back
Finding:	Shed – External Walls, Roof & Overall Condition (Rear Yard)
Information:	Shed – External Walls, Roof & Overall Condition (Rear Yard)

The external shed structure is in poor overall condition. Corrugated wall cladding shows age-related deterioration, weathering and uneven alignment. The roof sheeting appears dated with visible edge distortion and inconsistent fixings. Evidence of vegetation encroachment is present around the perimeter, including organic debris buildup at the base of walls, increasing moisture retention and pest harbourage risk.

The shed is constructed on uneven footings/pavers with signs of settlement and inadequate support. Door alignment appears compromised, and general wear suggests the structure is nearing the end of its serviceable life.

- Increased risk of moisture ingress and further material deterioration
- Potential pest harbourage (including termites and rodents) due to vegetation contact and debris accumulation
- Reduced structural stability due to uneven base support
- Possible health risk if materials are disturbed and later confirmed to contain asbestos
- Reduced usability and security of the shed

Engage a licensed builder or shed installer to assess the structure and provide advice on repair versus full replacement. Vegetation should be cleared away from all shed walls to improve ventilation and reduce moisture/pest risk. If renovation, cutting, or demolition is proposed, asbestos sampling by a NATA-accredited laboratory is strongly recommended prior to any works.

Repairs or replacement should be considered within 3–6 months, or sooner if the shed is actively used or storing valuable items.

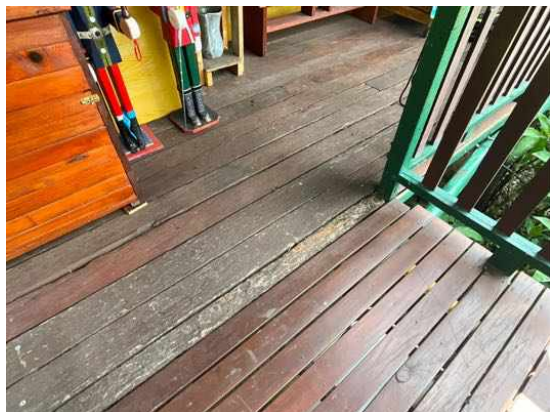
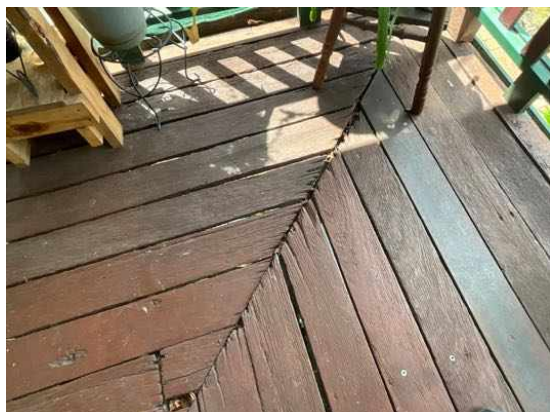
Finding 3.04

Building:	Main Building
Location:	Verandah
Finding:	Deck / Verandah – General Deterioration and Localised Timber Damage
Information:	Deck / Verandah – General Deterioration and Localised Timber Damage

The timber deck and verandah flooring shows widespread age-related deterioration, including uneven and misaligned boards, open gaps at junctions, poorly finished mitred board joints, and areas of surface weathering. Several boards show signs consistent with timber degradation, including splitting, edge breakdown, and loss of section, particularly at corners and high-traffic locations. Fixings appear inconsistent in places, and some boards may not be adequately supported beneath, contributing to movement and unevenness underfoot.

- Increased trip and fall hazard, particularly at uneven board junctions and raised or deteriorated edges
- Progressive timber deterioration if moisture ingress continues
- Potential reduction in the structural serviceability of the deck over time
- Localised timber damage may worsen if not addressed, leading to more extensive repairs

A licensed builder or experienced carpenter should carry out a detailed assessment of the deck structure and flooring. Works may include re-fixing or replacing damaged or deteriorated boards, correcting uneven junctions, improving fixings, and assessing sub-floor support and ventilation. Any replacement timbers should be suitable for external exposure and installed in accordance with relevant standards.

Repairs are recommended in the short to medium term. Trip hazards should be addressed as a priority to reduce safety risks.

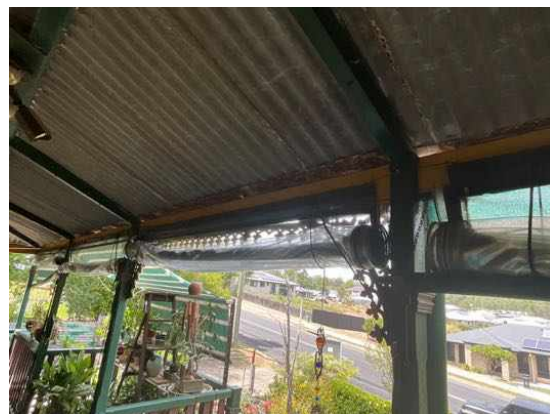
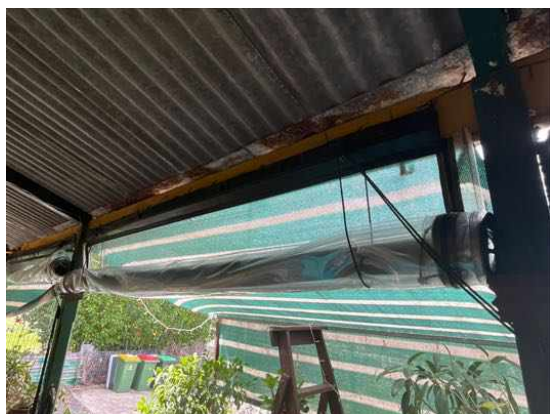
Finding 3.05

Building: Main Building
 Location: Verandah
 Finding: Veranda Roof Sheeting
 Information: Condition Summary – Veranda Roof Sheeting

The veranda roof is clad with older-style corrugated sheeting showing signs of age-related wear, including surface weathering, staining, and general deterioration consistent with prolonged exposure to the elements. Localised corrosion is evident to associated metal framing and fixings. No active leaks were observed at the time of inspection; however, the overall condition indicates the roof covering is aged and approaching the later stage of its serviceable life.

- Continued exposure to weather may result in progressive deterioration.
- Ongoing ageing may increase the likelihood of future leaks or material failure.

- Corrosion to supporting elements may reduce long-term durability if left unaddressed.

Monitor the condition of the veranda roof and associated structural components. Allow for maintenance, repairs, or future replacement as part of ongoing property upkeep. Any works should be carried out by a suitably qualified and licensed contractor.

Medium term, or sooner should signs of active leakage, further corrosion, or deterioration become evident.

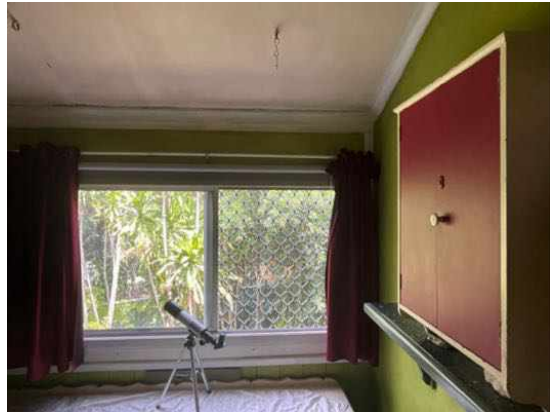
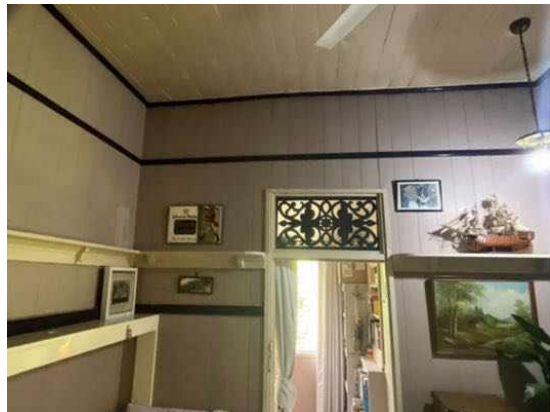
Finding 3.06

Building:	Main Building
Location:	All Areas
Finding:	Ceiling Linings – Cracking, Joint Separation & General Wear
Information:	Ceiling Linings – Cracking, Joint Separation & General Wear

The ceiling linings exhibit visible cracking along sheet joints and cornice junctions, minor separation at trim interfaces, and general ageing-related deterioration. Hairline cracking is evident across several areas, with localized joint movement and minor surface irregularities. These conditions are consistent with building movement, age-related settlement, and historical moisture exposure.

While no immediate structural failure was observed at the time of inspection, continued movement may lead to further cracking and deterioration of finishes. Open joints may also allow moisture ingress or pest entry if left unattended. Aesthetic presentation is reduced, and ongoing degradation may increase future repair costs.

A qualified plasterer or builder should assess the affected areas and carry out appropriate repairs, including re-fixing where required, re-taping joints, patching cracks, and repainting to restore condition and prevent further deterioration.

Repairs are recommended within the short to medium term (within 3–6 months), or sooner if cracking worsens.

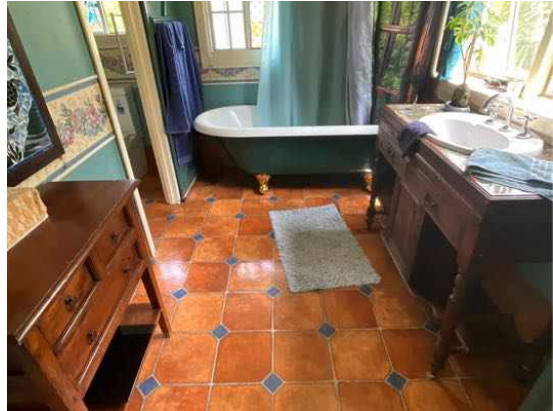
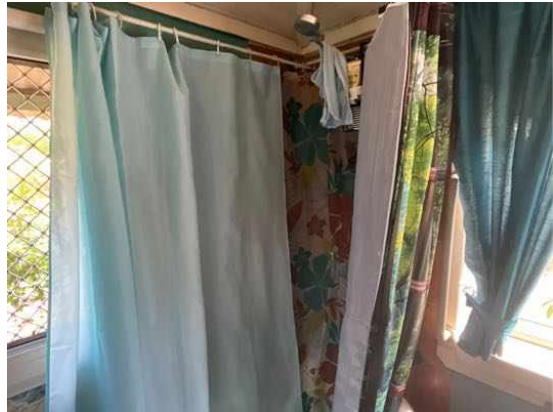
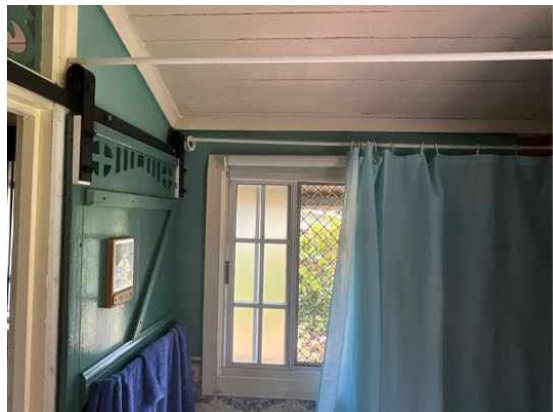
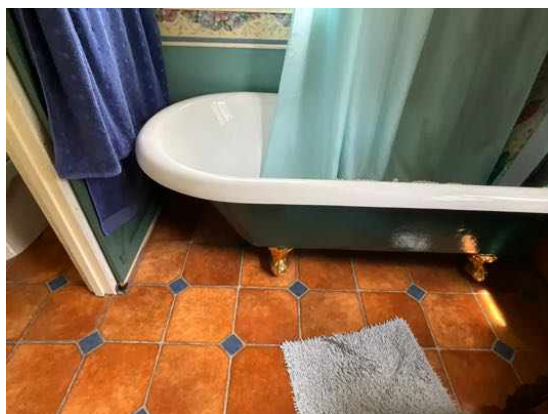
Finding 3.07

Building: Main Building
Location: Bathroom
Finding: Inadequate Wet Area Waterproofing – Shower/Bath Area
Information: Inadequate Wet Area Waterproofing – Shower/Bath Area

At the time of inspection, the shower/bath area was observed to have no fixed tiled wet-area linings or waterproof wall finishes installed. Water containment is currently reliant on a plastic shower curtain only, with painted wall surfaces directly exposed to moisture splash zones. No compliant waterproof membrane, splashback tiling, or water-resistant wall linings were evident within the shower/bath area.

This configuration does not provide adequate protection against ongoing moisture ingress and is inconsistent with typical wet-area construction standards.

- Increased risk of water penetration into wall linings and framing
- Potential for concealed moisture damage, timber decay, mould growth, and pest attraction
- Accelerated deterioration of internal finishes
- Possible non-compliance with minimum wet-area construction practices
- Reduced long-term durability and habitability of the bathroom

Repairs are recommended in the short term to reduce the risk of moisture-related damage.

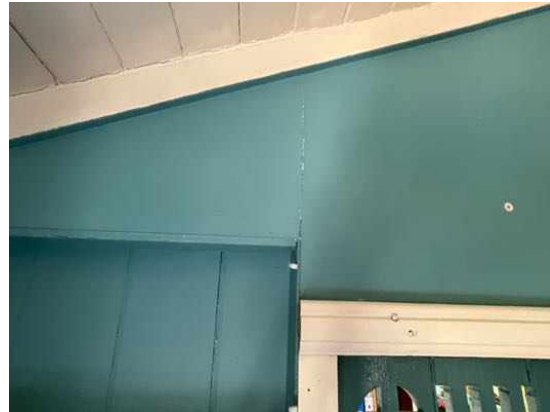
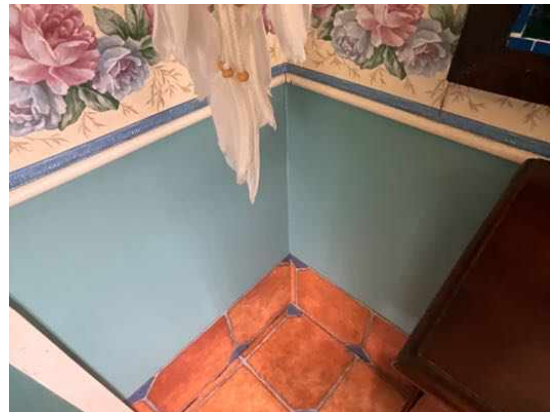
Finding 3.08

Building:	Main Building
Location:	Bathroom
Finding:	Cracking to Internal Bathroom Walls – Upper Wall Junctions and Door Opening
Information:	Cracking to Internal Bathroom Walls – Upper Wall Junctions and Door Opening

Non-urgent – monitor and repair within the next 3–6 months, or sooner if cracking worsens or moisture becomes evident.

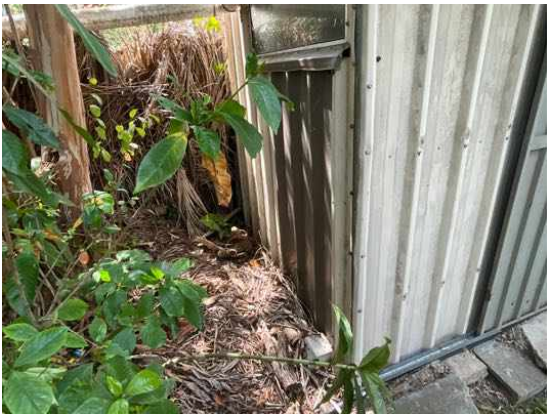
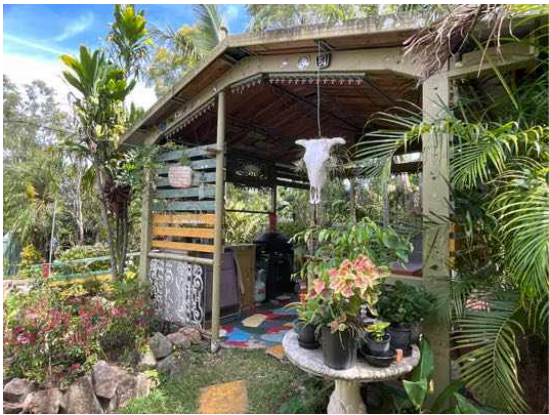
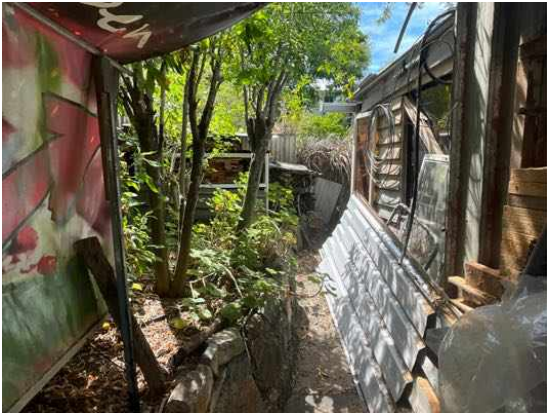
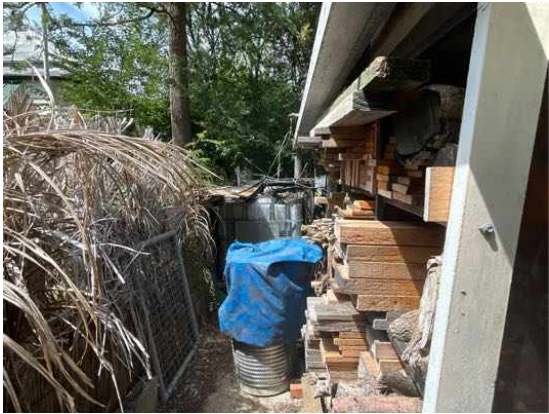
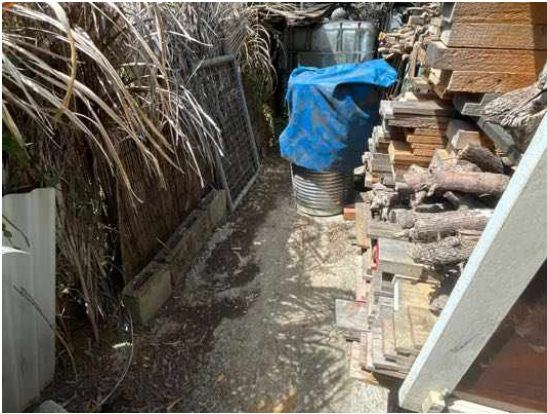
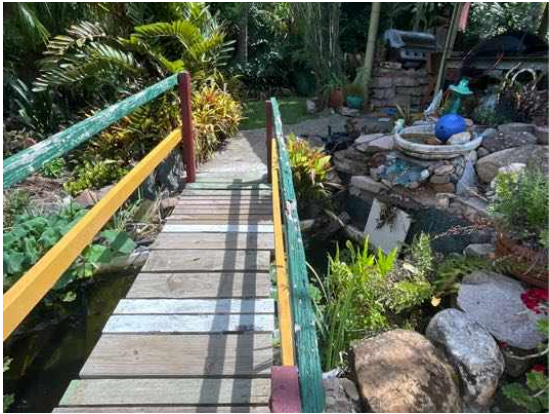
Finding 6.02

Building:	Main Building
Location:	All Areas
Finding:	Timber on ground / conducive conditions to termite damage.
Information:	Timber on the ground is indeed conducive to termite damage.

Regular inspections and proper termite control measures are also essential to protect your wooden structures from termite damage.
