# Building Inspection Report

Inspection Date: Thu, 19 Feb 2026

Property Address: 13 Lillie St, Glebe TAS 7000, Australia

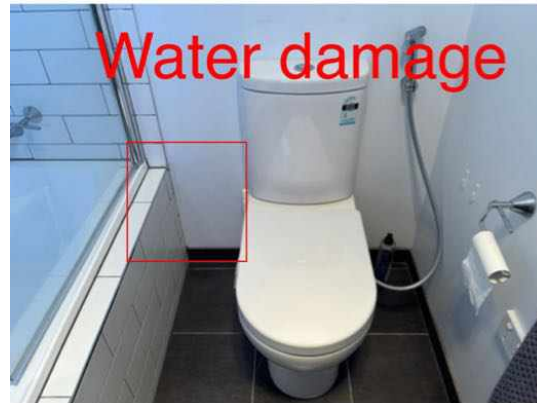
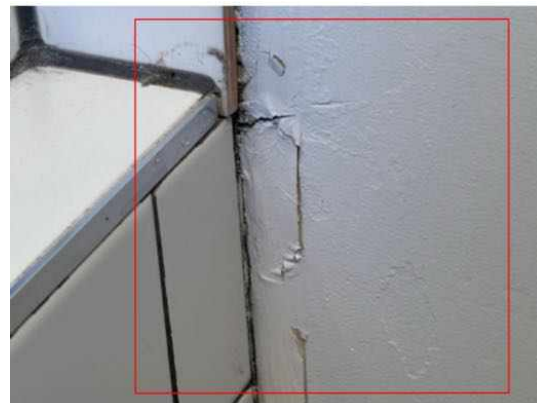
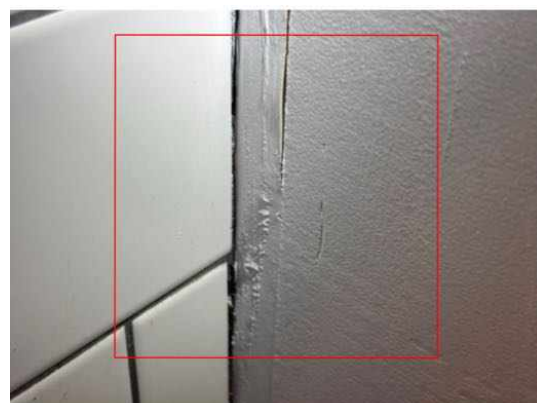
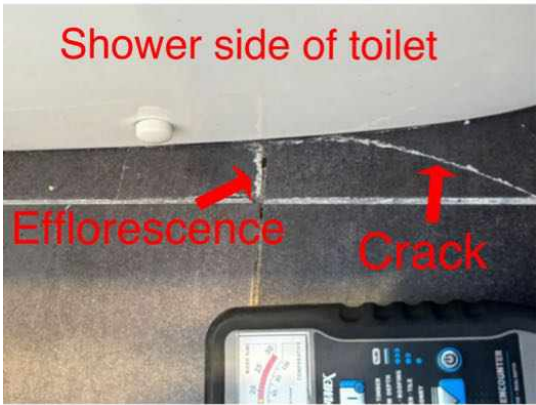
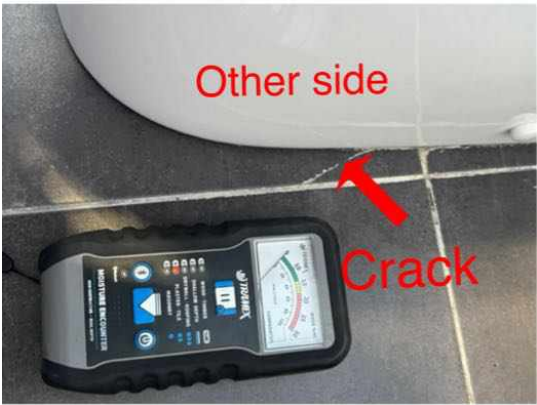
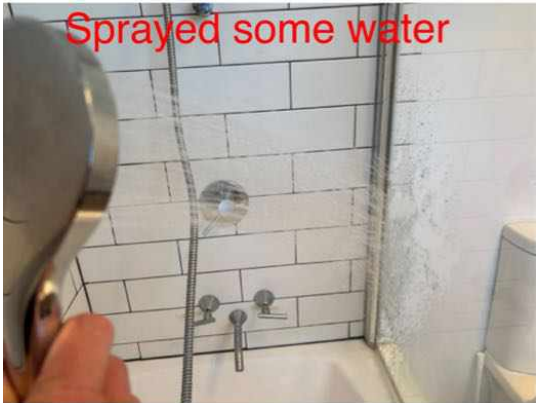
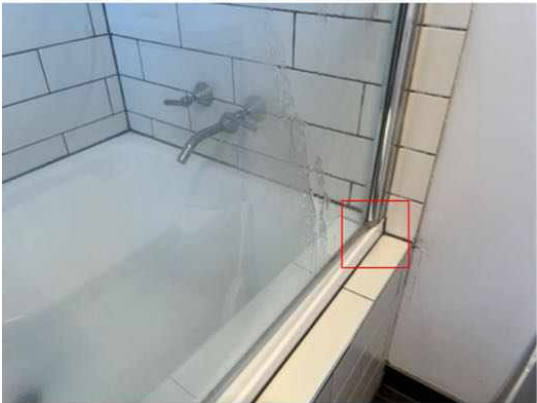
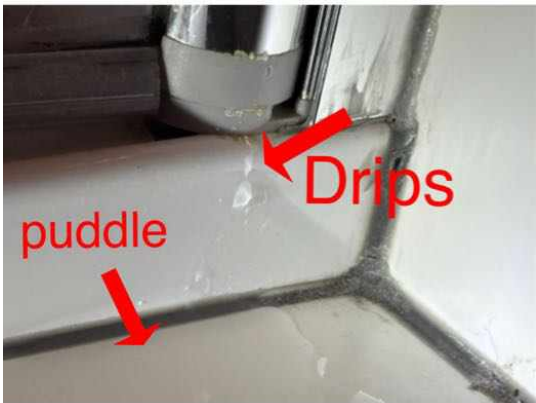
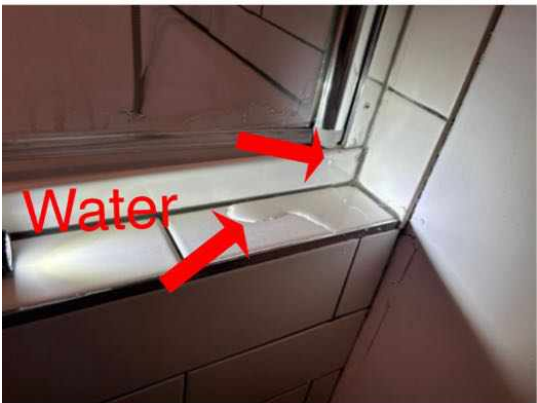
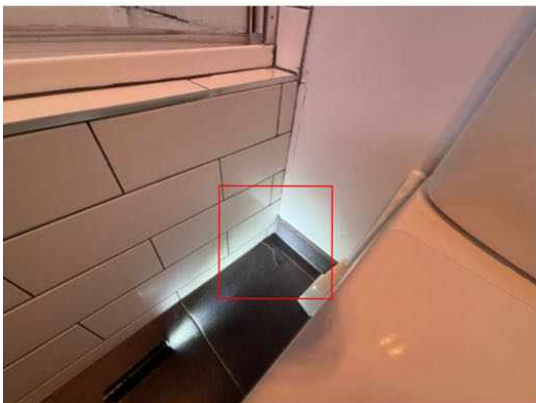
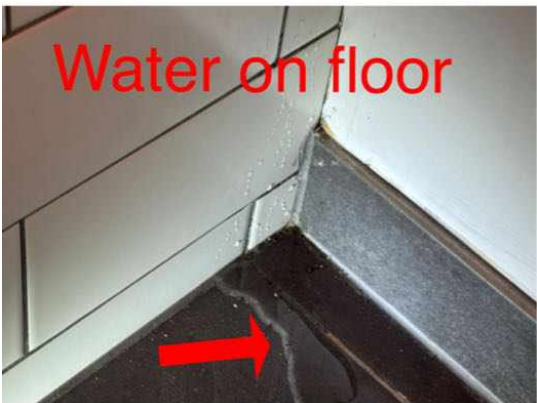
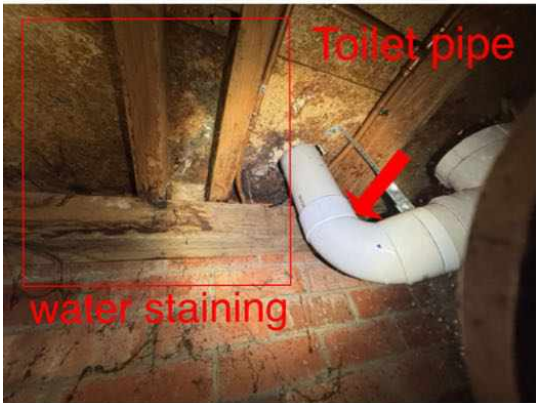
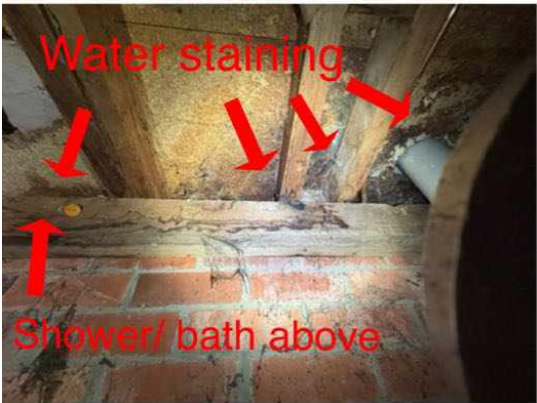
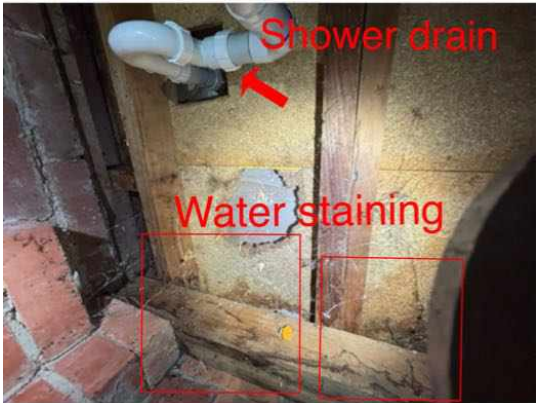
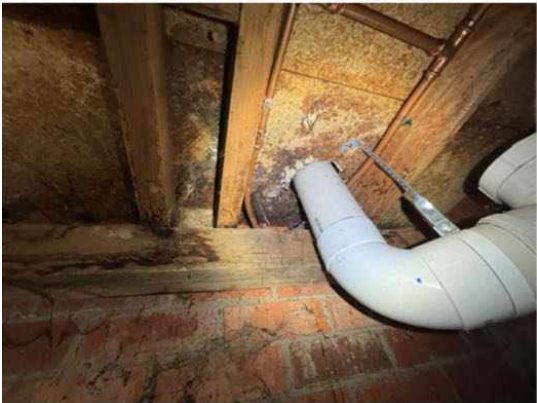
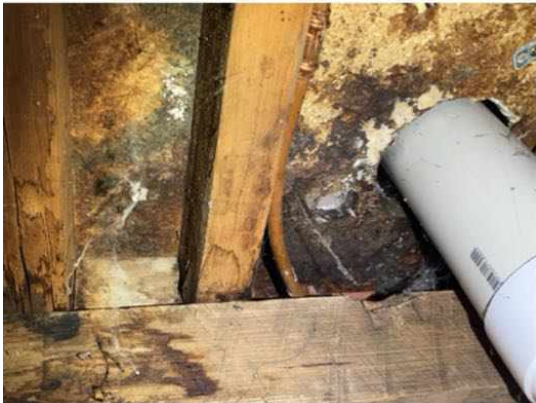
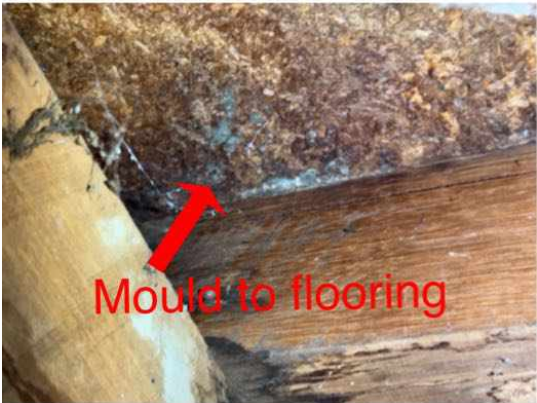
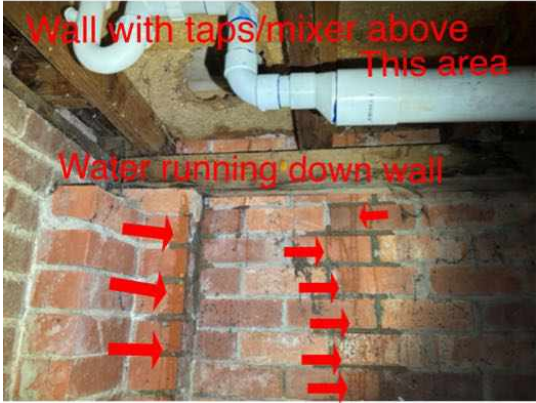
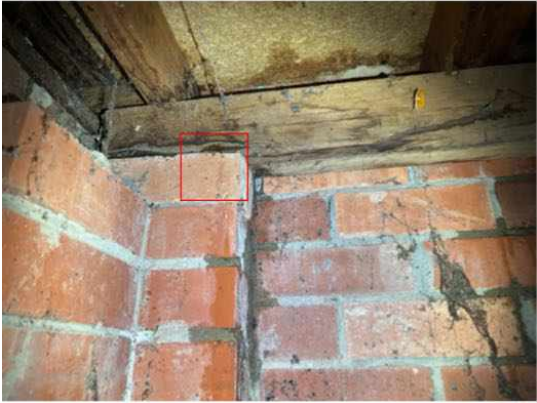
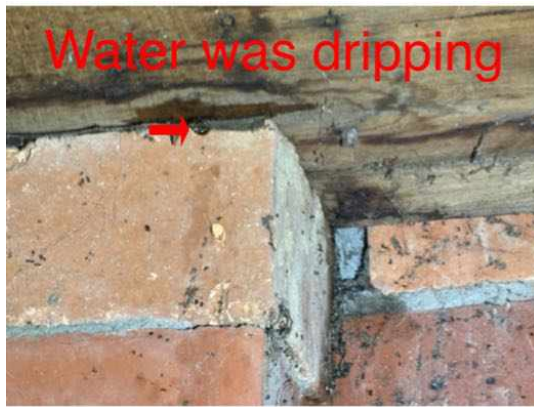
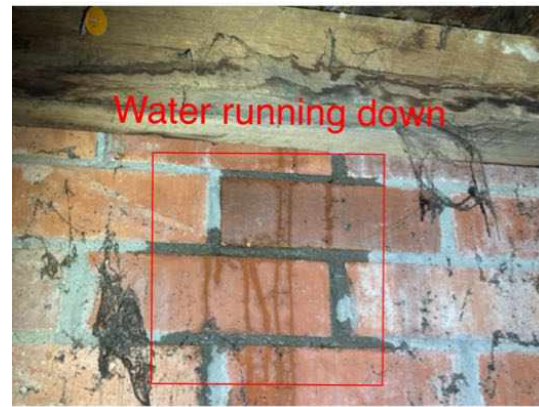
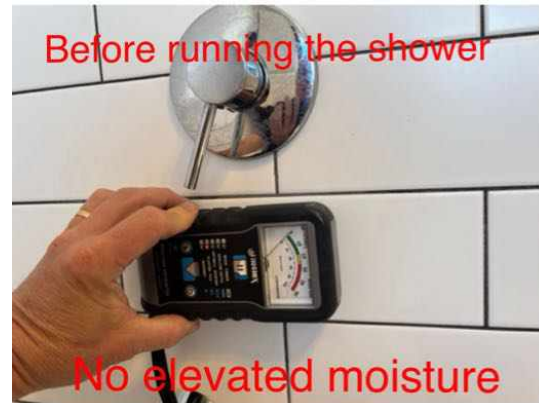
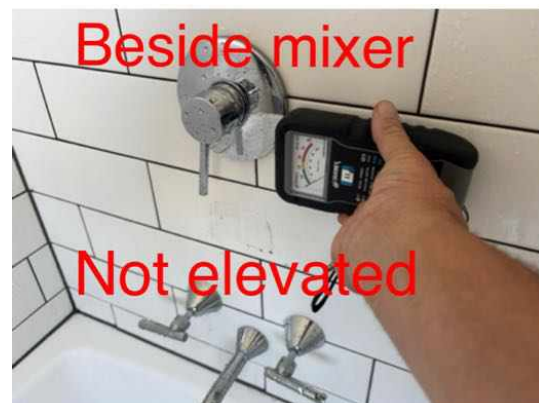
#### Defects 2.01

Building: Main Building  
Location: Bathroom  
Finding: Bathroom  
Information: In the bathroom, there appear to be at least two water leaks to the shower.

There is some damage to the plasterboard beside the shower. There is some efflorescence to the floor tiles, (which indicates moisture under the tiles).

The first leak is suspected from the gap in the shower screen where it pivots. When tested, water ran down to the floor tiles beside the toilet. Also there is damage/cracking to the floor tiles beside the toilet. In the subfloor there is mould and water damage to the flooring underneath this area. Due to the amount of damage under the floor, it does appear to have been leaking and wet for some time. I suspect the cracked tiles next to the toilet are due to the flooring getting wet and soft, and then the movement from someone sitting on the toilet caused the cracks.

The second leak appears to be on the wall where the shower taps are located. I suspect the water is getting into the tap penetrations and may be moving side ways through the tiles via capillary action. There is visible damage beside the bath. I ran the shower for approximately 10 mins directed toward the wall with the taps on it and water was dripping out in the subfloor. The structural timbers appear to be still sound, however there is damage to the chipboard flooring. There were also elevated moisture readings, which indicates water behind the tiles. There is likely to be damage to the wall lining/plasterboard behind the tiles, and possibly mould.

Water leaks can be detrimental to surrounding building elements. Rust, corrosion, decay and water damage are potential outcomes where a water leak is left unattended. In extreme cases, structural damage/subsidence may develop due to a prolonged water leak.

If not rectified, water will continue to ingress and lead to further water damage and deterioration of the surrounding building elements.

Mould can cause health issues.

There was one Major Defect. The bathroom has active water leaks and water damage is visible in the subfloor, and there are elevated moisture readings and mould. Recommend client engage a Lic Plumber to rectify leaks immediately.

Recommend client firstly engage a Lic Plumber to investigate and rectify the active water leaks immediately. The Plumber may be able to identify the source and apply a short term solution such as silicone to prevent further damage.

After the Plumber has attended, recommend client engage a Lic Builder (who specializes in bathroom renovations), to inspect as soon as possible (perhaps with a camera to view inside the wall void). Partial or full demolition and reconstruction is likely to be required. The full extent of damage is often not apparent until demolition work commences.

Then recommend client engage a Lic Builder who specializes in Bathroom Renovations. Partial or full demolition and reconstruction is likely to be required. The full extent of damage is often not apparent until demolition work commences. Recommend that this be rectified as soon as possible to prevent further damage.

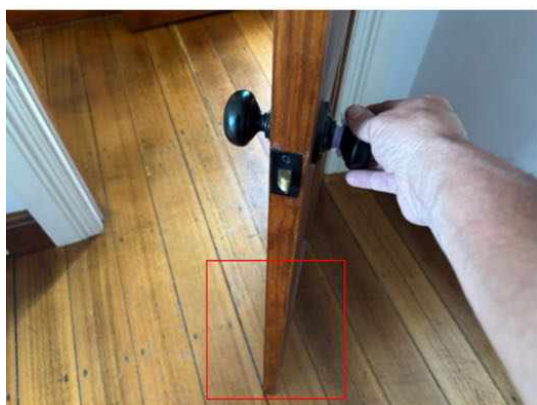
### Defects 3.01

Building: Main Building  
 Location: Master bedroom  
 Finding: Door binding  
 Information: The master bedroom door has some very minor binding on the bottom of the door. This has caused some very minor damage to the floorboards.

Failure to rectify will lead to further deterioration to the floorboards.

Recommend client engage a Handy Person to rectify at clients convenience.

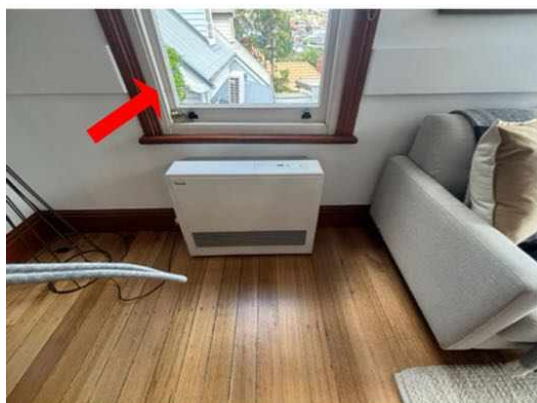
### Defects 3.02

Building: Main Building  
 Location: Living  
 Finding: Window stuck  
 Information: The window in the rear living area (behind the heat pump), was stuck and needs adjustment. The rest of the windows were operating well and they appear well maintained.

Windows provide ventilation to the adjoining area and should be at a fully operational level to ensure user comfort. Restricted function of the window may also pose as a potential safety hazard if required for emergency egress from the building.

Generally, factors such as general age of the building element and a lack of maintenance are the usual causes for this type of defect.

Recommend client engage a Handy Person to rectify at clients convenience.

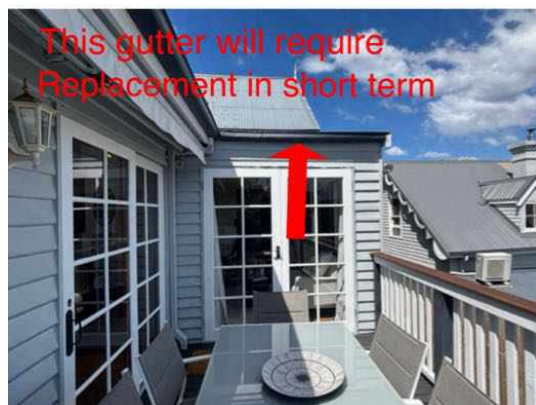
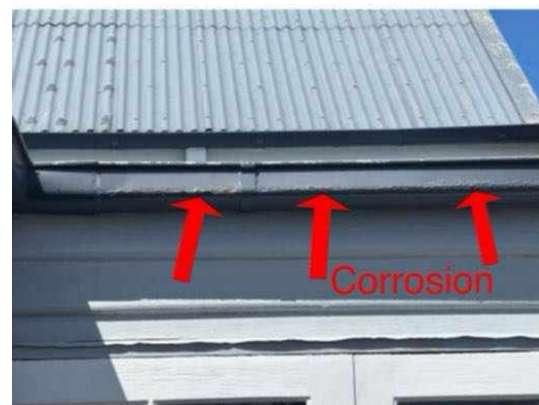
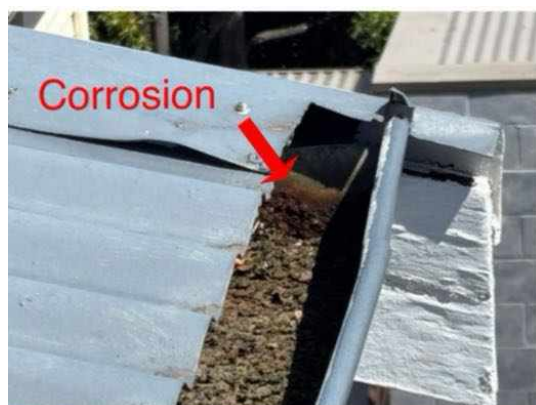
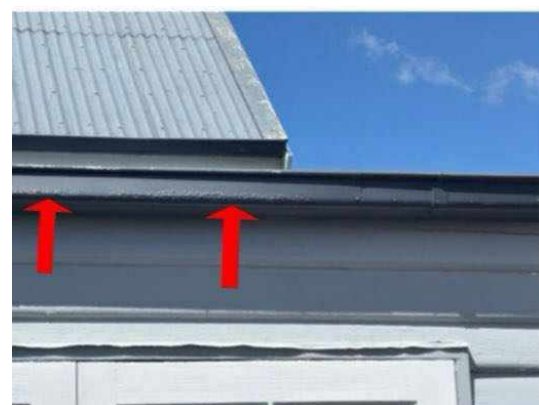
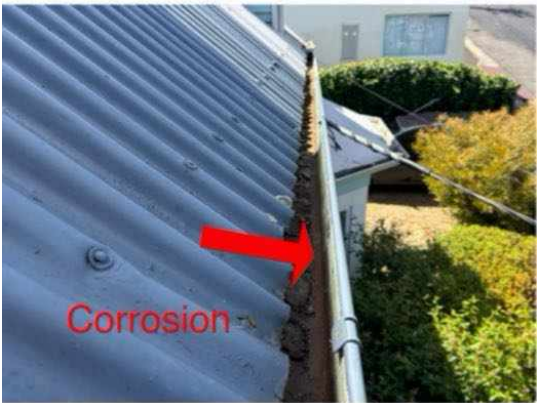
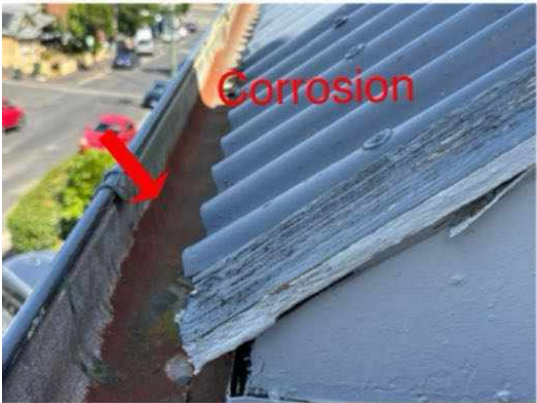
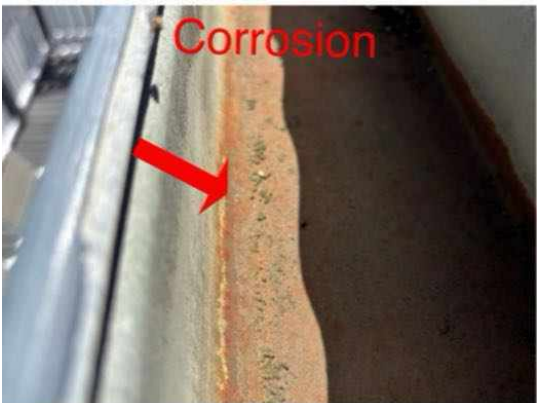
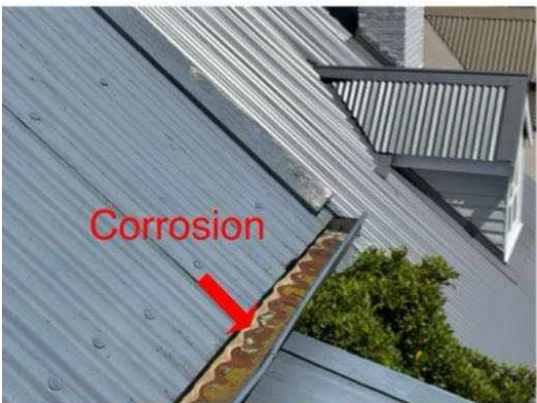
### Defects 3.03

Location: Roof  
 Finding: Corrosion to gutters  
 Information: Some of the gutters show evidence of rusting and corrosion. The gutter to the rear, above the french doors will need replacement in the very near future. The rest are in varying states and this will be part of future maintenance.

This is most likely to have developed due to a age and lack of maintenance/cleaning of debris which then causes water pooling. As surface rust provides no protection to the underlying iron, the deteriorating condition is likely to worsen if not addressed in the short-term future.

Recommend client engage a Lic Plumber to replace the gutter above the french doors, as soon as practicable.

Recommend that the client ensure the gutters be cleaned and maintained on a regular basis to prevent further corrosion.

Rust formation can be controlled with coatings, such as paint, that isolate the iron from the environment.

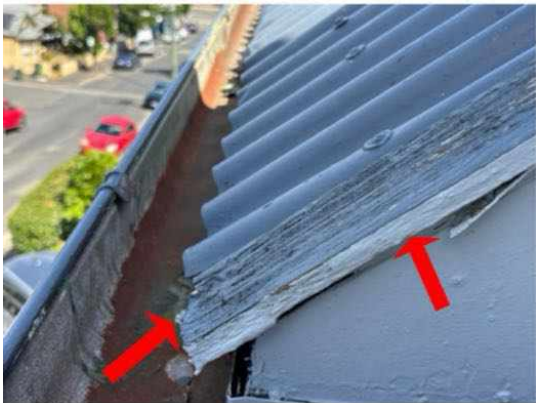
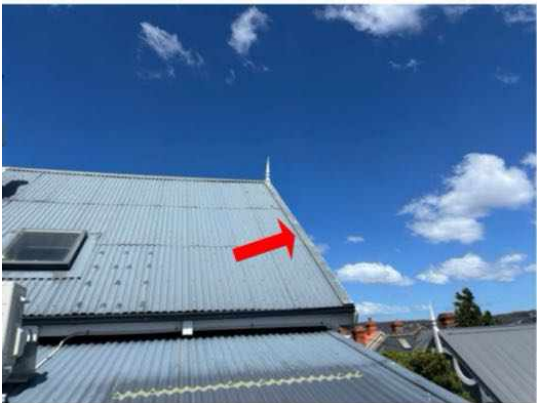
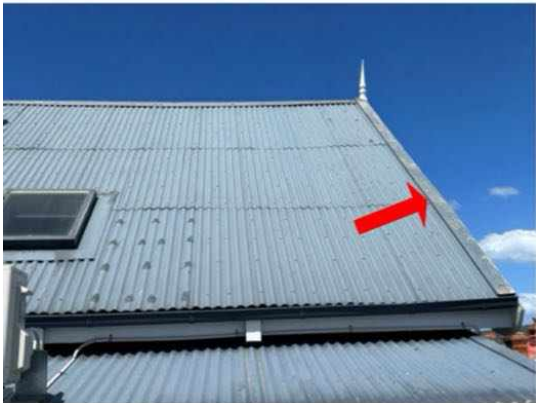
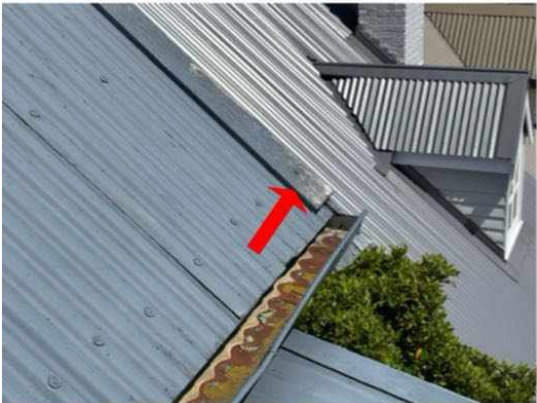
Defects 3.04

Information: On the roof, timber has been used as trims/flashings on the gable ends in various locations. The timber is in various states of repair. Some needs painting and some requires replacement. A better long term solution I would recommend, is that that client engage a Lic Roof Plumber to make and install custom flashings to go over the timbers, covering and encapsulating them. This will reduce future maintenance and prevent further deterioration to the timbers. However this would need to be checked with Heritage Controls, as they may need to approve this first.

Recommend client engage a Lic Roof Plumber to rectify as soon as possible.

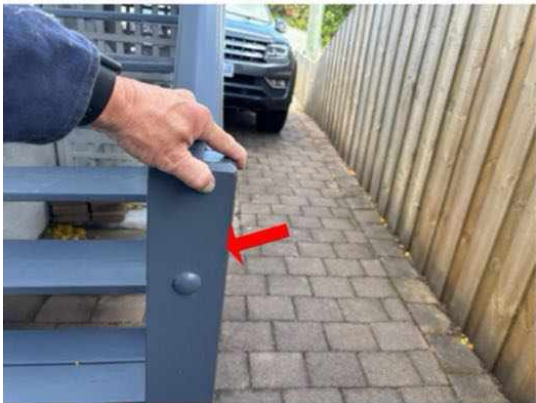
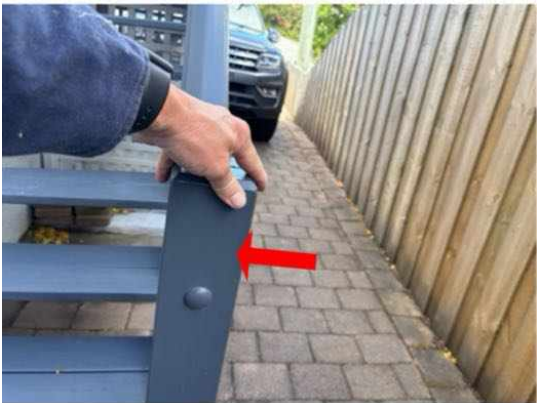
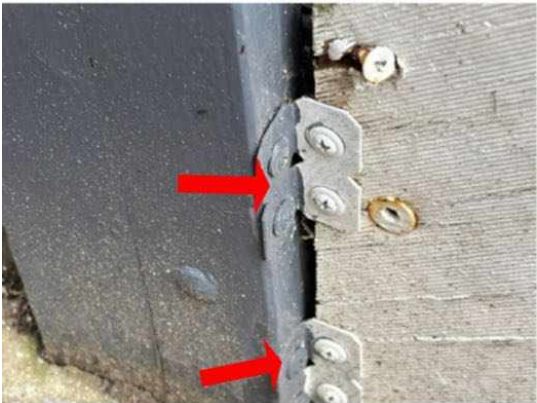
**Defects 3.05**

Building: Main Building  
 Location: Front stairs  
 Finding: Balustrade post  
 Information: The balustrade corner post to the front stairs is loose. There are some small brackets but they need to be reinforced and replaced with something sturdier.

Failure to rectify could cause further deterioration.

Recommend client engage a Handy Person to rectify as soon as possible.

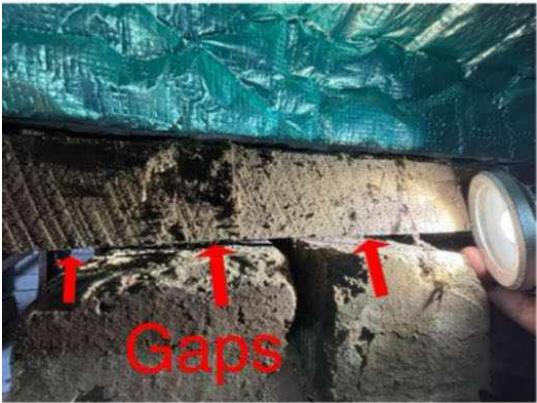
**Defects 3.06**

Building: Main Building  
 Location: Subfloor  
 Finding: Pier  
 Information: In the subfloor, there is a pier under the rear of the house that has become disengaged. The whole pier is loose.

Recommend client engage a Brick Layer to rectify as soon as possible. This pier will likely need to be demolished and rebuilt.

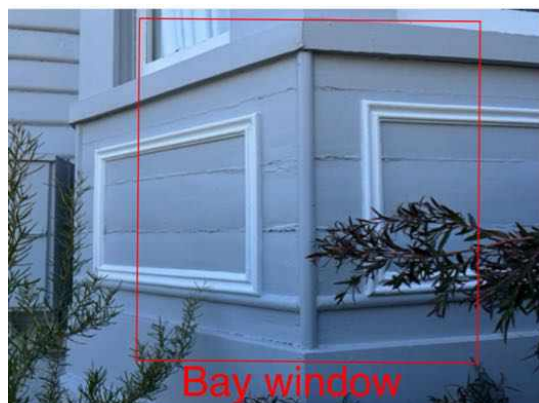
## Defects 3.07

Building:	Main Building
Location:	Roof
Finding:	Minor paint deterioration to some exterior timbers
Information:	There is some minor paint deterioration next to the upper side gable window, front upper dormer window and the front panelling of the bay window down low. Generally the paintwork is in quite good condition. If you are able to get details of the current paint colour that would be helpful.

It is likely that paint deterioration has developed as a result of frequent exposure to rain and other weather conditions. It is suspected that failure to maintain the timbers over a prolonged period has resulted in them deteriorating at an accelerated rate, increasing their susceptibility to the development of wood rot. Early intervention and regular maintenance will prolong the useful life of these building elements.

Recommend client engage a Handy Person/Painter to rectify as soon as practicable.

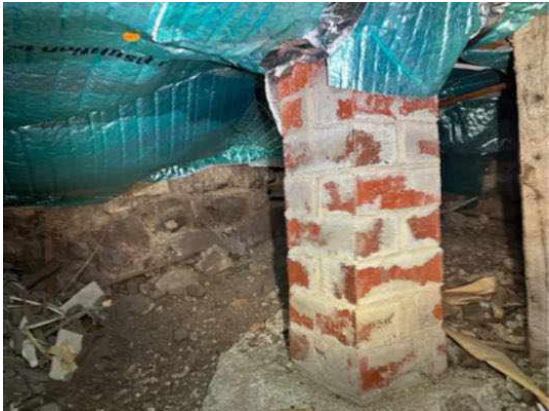
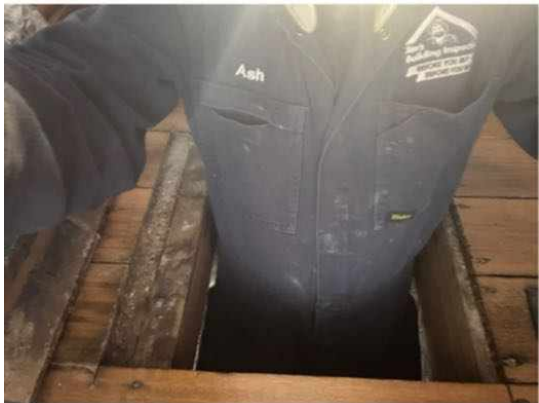
Building: Main Building  
 Location: Subfloor  
 Finding: FYI piers  
 Information: FYI some of the older piers at the front subfloor section have been replaced with brick piers. FYI access to this section is via a hatch in the hallway.

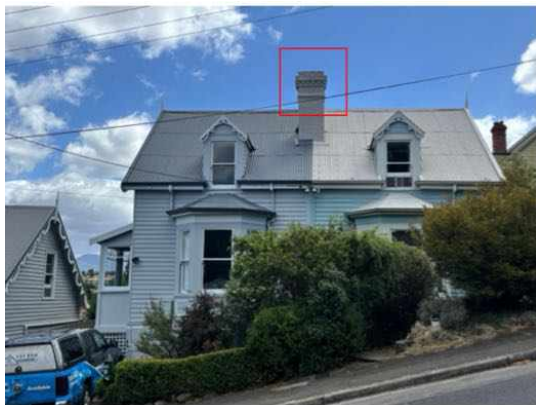
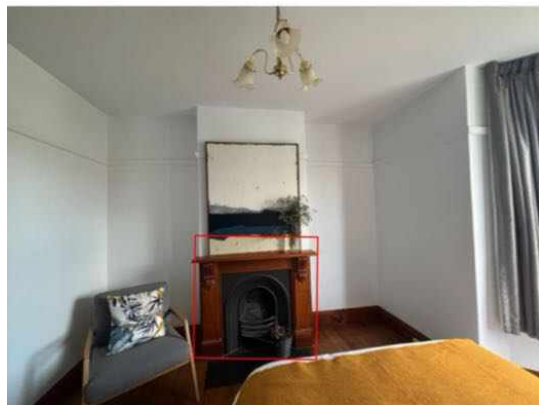
Building: Main Building  
Location: Roof  
Finding: FYI front chimney  
Information: FYI the front chimney is uncapped. This is for the fire in the front bedroom. If you are not going to use it then capping the chimney to prevent, bird, vermin, insect and water entry is recommended.
