Building and Timber Pest Inspection Report

Inspection Date: Thu, 19 Mar 2026

Property Address: 6A Turner St, Gawler East SA 5118,
Australia

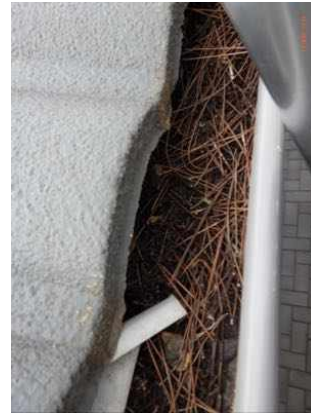
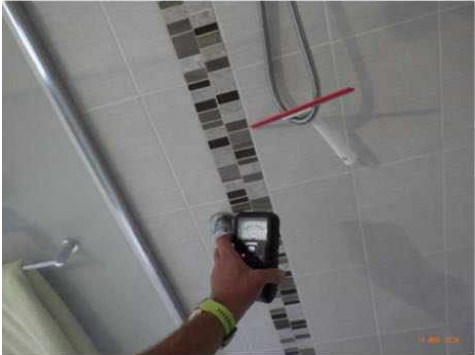
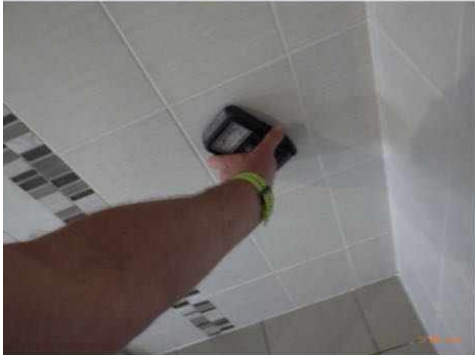
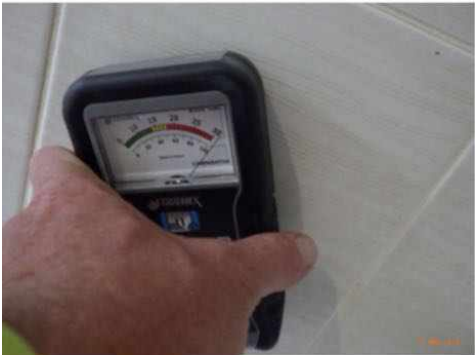
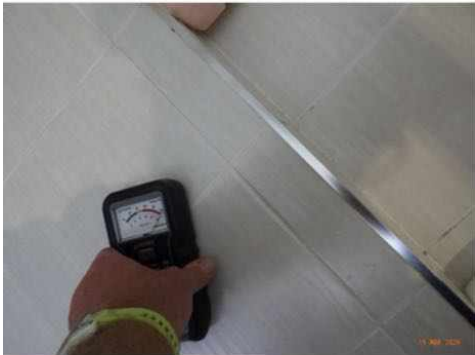
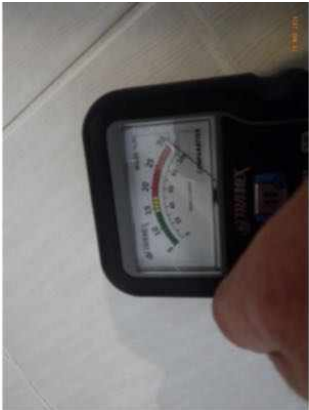
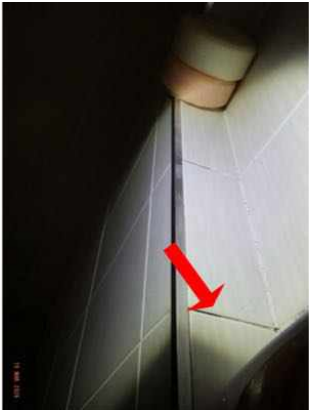
Finding 2.02

Building:	Building 1
Location:	Ensuite - Master
Finding:	Shower - Damp
Information:	Damp is evident to the walls to the shower alcove up to 1200mm high. There are small areas showing high readings transferring to the other side of the wall also.

This defect is quite common, and is suspected to have been caused by moisture permeating through the tiling, grouting and or sealant in this area, which shows evidence of deterioration. Leaking pipes within the adjoining wall is also a possible however appears unlikely as high readings were found on the non tap wall also.

Unmanaged damp in the shower recess is likely to facilitate the formation and development of mould and fungi growth, decaying associated building materials and compromising their structural integrity. High moisture around timber elements also creates an environment that is conducive to termite activity. Further investigation

Consultation with a qualified plumber is advised immediately to identify the cause of damp and to perform remedial works as required.

Always ensure that sealant and grout is in good condition to prevent any moisture issues occurring in the future.

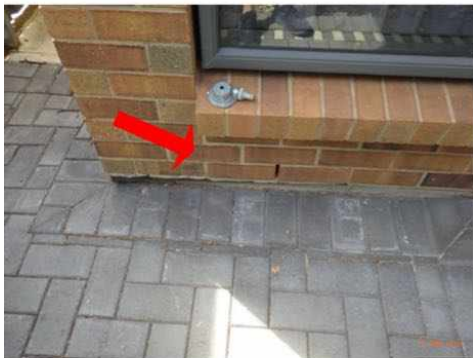
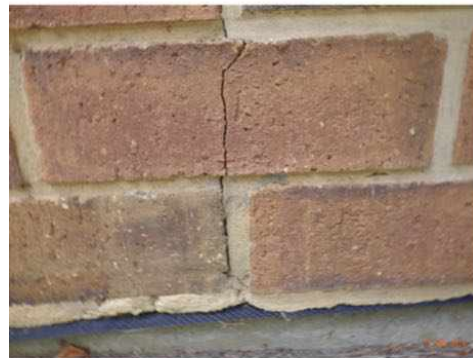
Building:	Building 1
Location:	Exterior walls
Finding:	Brickwork - Cracking [Fine]
Information:	There were fine cracks evident to the external brickwork at the time of inspection.

Although fine cracks are quite noticeable, they are often only considered to be an appearance defect and usually do not indicate any structural damage. Generally, the cause of a fine crack is indicative of a separation between brickwork and mortar throughout the structure, but single bricks may also show cracks of this nature.

Cracking of this nature can generally be repaired with minor filling and should be conducted by a qualified bricklayer.

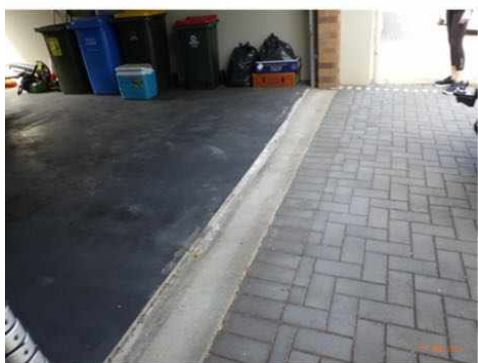
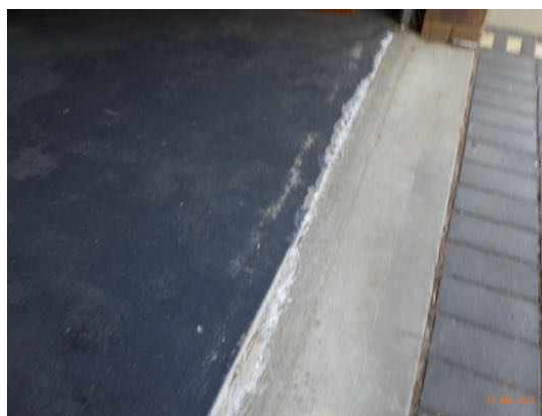
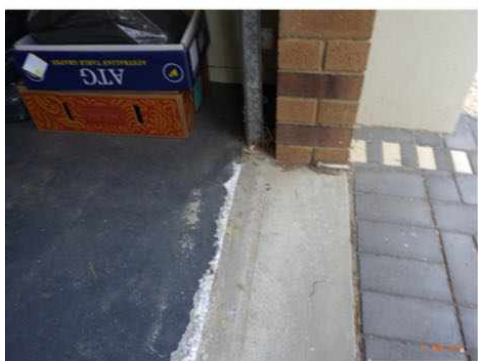
Finding 3.02

It is typically seen as white salt deposits on the surfaces of concrete pavement and spalling on the face of the concrete.

Generally, soluble salt deposits can be removed by dry brushing with a stiff-bristled brush. Repeated dry brushing is an ideal treatment for eliminating this forming of efflorescence. A cleaning contractor or general handyperson may be appointed to perform these works at the discretion of the client.

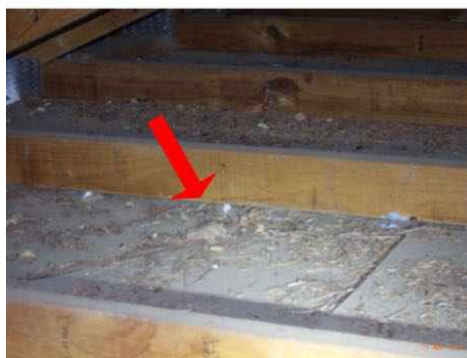
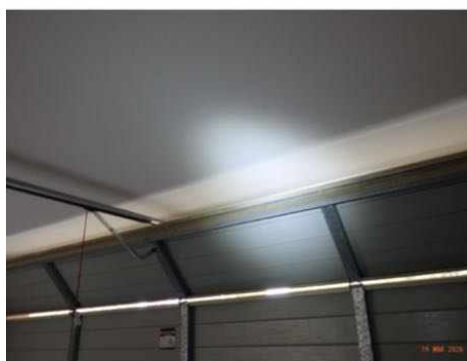
Finding 3.03

Building: Building 1
Location: Carport
Finding: Ceiling - Garage

Information: A very common defect found in garages is that the ceiling can sag over time, due to their lack of insulation and or their susceptibility to moisture. Condensation builds up

in the roof and rests on the plasterboard softening it somewhat which makes it more likely to sag and release from its fixing points. Moisture evaporating from cars can also contribute to this issue.

Therefore we recommend that you insulate your garage and also apply a good coat of washable paint to the ceiling of the garage to prevent any moisture entering the plasterboard and creating issues in the future. A licensed building insulation installer and licensed painting contractor could be appointed to carry out these works at the discretion of the client.

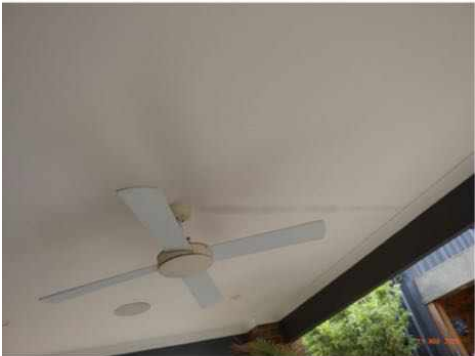
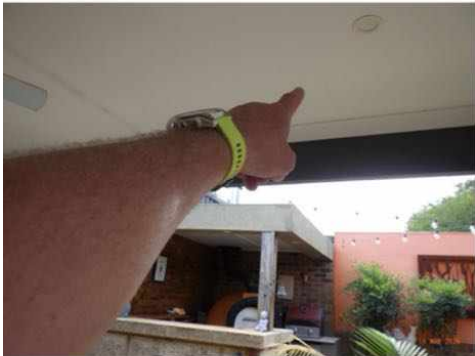
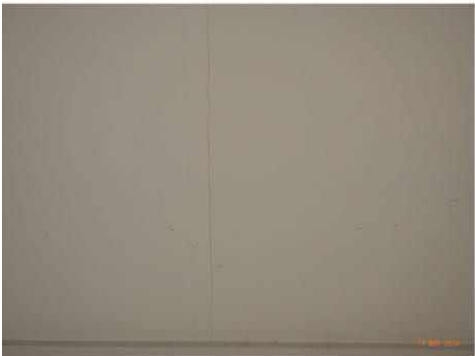
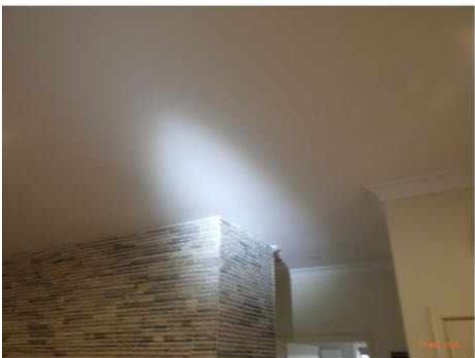
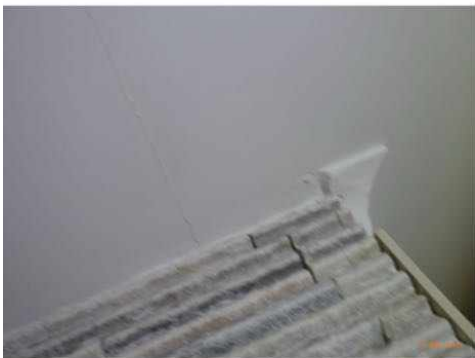
Finding 3.04

Building:	Building 1
Location:	All Internal Areas
Finding:	Cracking - Damage Category 1 - Fine (up to 1mm)
Information:	There were fine cracks evident to the walls and ceilings throughout the dwelling at the time of inspection.

Although fine cracks are quite noticeable, they are often only considered to be an appearance defect, and usually do not indicate any structural damage. Generally, the cause of a fine crack is indicative of a separation between building materials and finishes (e.g. paint, plaster, etc.) along joins.

Cracking of this nature can generally be repaired with minor sanding, filling and/or repainting. Such works should be performed by a qualified painter or a general handyman.

Monitoring of all cracking should be conducted frequently. Always contact a building inspector should cracks widen, lengthen, or become more numerous.

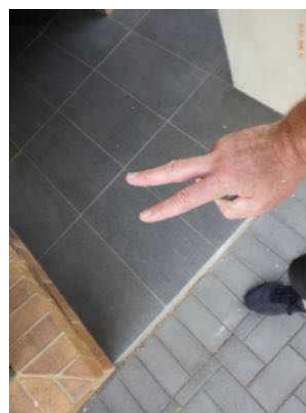
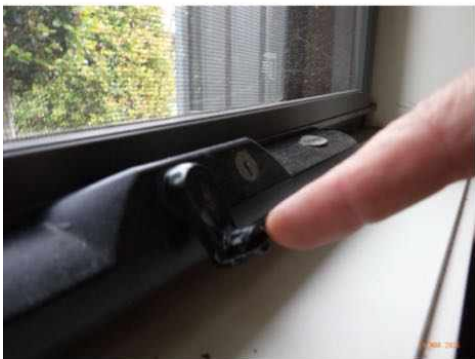
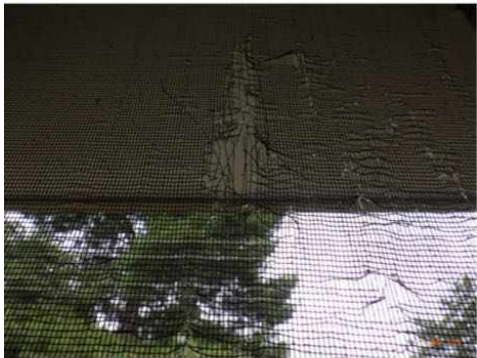
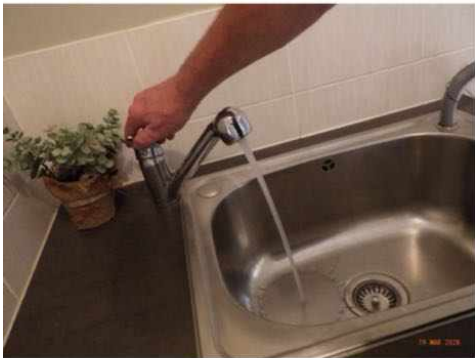
Finding 3.05

Building: Building 1
 Location: All Areas
 Finding: Minor defects present
 Information: There were several age and maintenance related defects evident to the dwelling at the time of inspection. These defects include but are not limited to

- approximately 20% of Porch tiles are drummy
- External power point missing its switch
- Roof tiles been pushed up and not returned onto place.
- Window winder is missing handle
- Several Fly screens are damaged
- Laundry tap is loose

Appropriate licensed trades people could be appointed to make repairs at the discretion of the client.

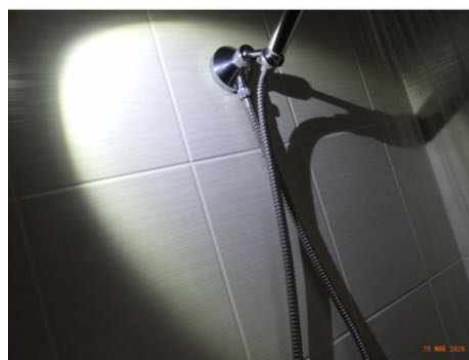
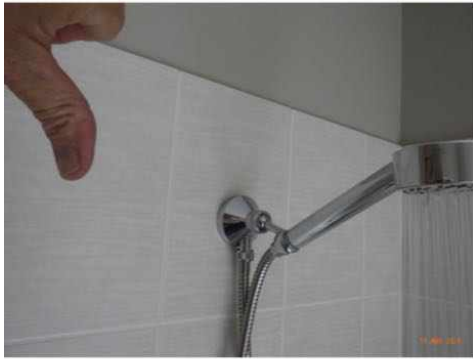
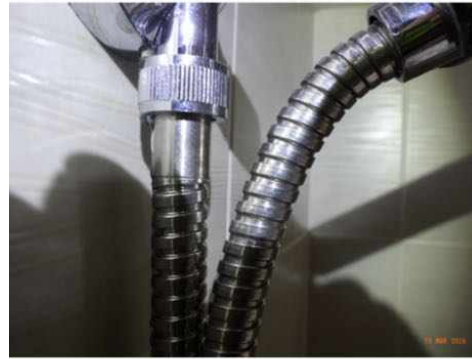
Building: Building 1
Location: Bathroom
Finding: Shower Head - Leaking
Information: The main shower head was found to be leaking at the time of inspection. There is no high moisture readings evident.

This is a common defect that is consistent with general ageing of the building element. However, it may be indicative of substandard plumbing workmanship if the tap is relatively new.

While this defect only seems minor, if left unmanaged, it is likely to result in the development of rust, water damage and/or extensive water usage.

It is advised that a licensed plumber be appointed immediately to perform remedial works on the affected fitting.

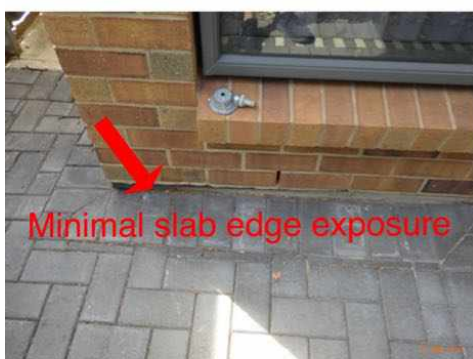
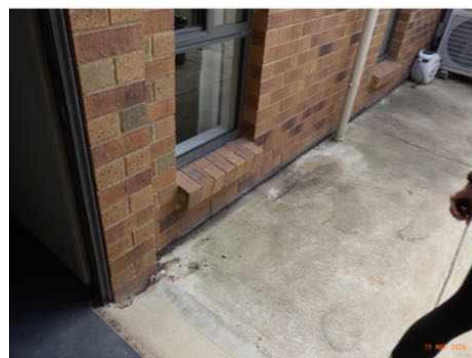
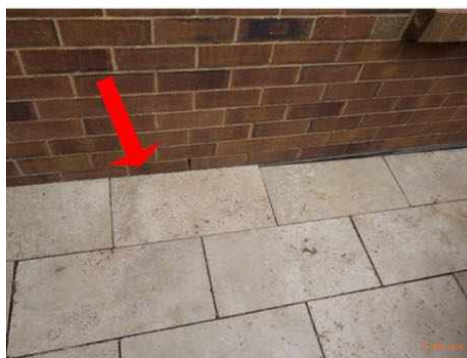
Finding 6.02

Building:	Building 1
Location:	All External Areas
Finding:	Slab Edge - Exposure
Information:	An inspection zone of at least 75mm in relation to the exposed slab edge, between the bottom brick and the perimeter pavement, is required. This inspection zone should be maintained in order to force termites into the open where they can be detected more readily during regular inspections. The slab edge should not be concealed by anything that may prevent inspection of the area, including render, landscaping, soil, turf, paving, concrete cladding or other structures.

If the slab edge is not properly exposed there is a high risk of concealed termite attack which your inspector will likely not be able to see. Sometimes, in order to determine the type of slab, a suitably qualified person such as an architect or builder may be required to consult construction plans.

Where the slab edge cannot be properly inspected, it is highly recommended that termite or timber pest inspections be carried out every 6-12 months to aid protection of the property against infestation and termite treatment advice is followed closely.

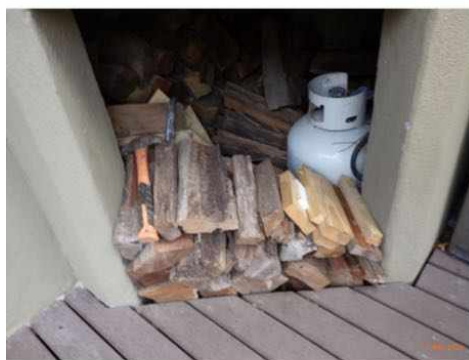
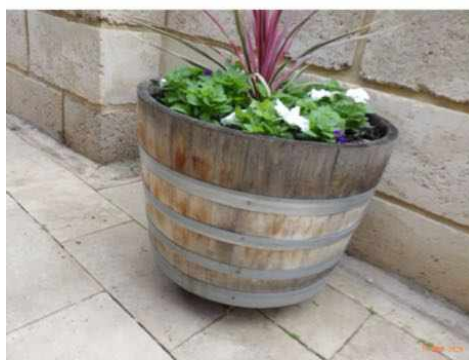
Finding 6.03

Building:	Building 1
Location:	All External Areas
Finding:	Untreated or non-durable timbers in a hazardous environment
Information:	To reduce the risk of timber pest attack it is essential that timber used in a hazardous environment (e.g. in direct contact with the ground or frequently exposed to damp conditions) is of sufficient durability and/or is adequately preservative treated. Additionally any timber lying around or timber stumps should be removed.

Untreated timbers in direct contact with the ground are likely to develop severe wood rot and/or fungal decay if left unattended creating attraction for subterranean termites to infest the timbers from surrounding areas.

If untreated or non-durable timbers are found to be in a hazardous environment it is highly advised that replacement of these building elements be performed as soon as possible to aid the protection of the property against termite / timber pest attack. Failing this close monitoring is recommended in an attempt to identify termite infestation at an early stage.

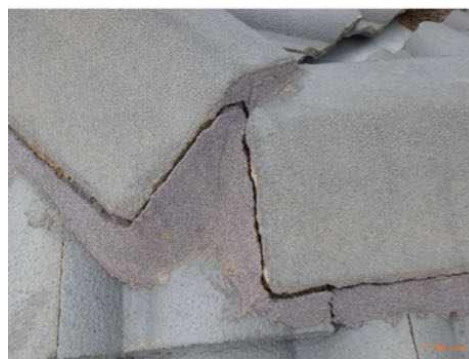
Building:	Building 1
Location:	Roof Exterior
Finding:	Mortar - Deterioration
Information:	Mortar, or 'bedding', is the material which fills joints and intersections between tiles and other building elements on the exterior roof covering, such as gable ends, hip capping and valleys. Upon inspection of the exterior roof, it was noted that sections of the mortar show varying levels of deterioration.

Mortar generally deteriorates as a result of frequent exposure to weather conditions over a prolonged period of time. Mortar that is deteriorating may allow water ingress into the roof void, putting associated building elements and roofing structures at risk of water damage.

Deteriorated mortar also detracts from the functionality of roof tiles and other roofing elements, potentially decreasing weather tightness and roof drainage.

Mortar deterioration can be attended to by a handyperson where areas of deterioration are localised and easily accessible. Otherwise, consultation with a roofing contractor is advised where greater works are required.

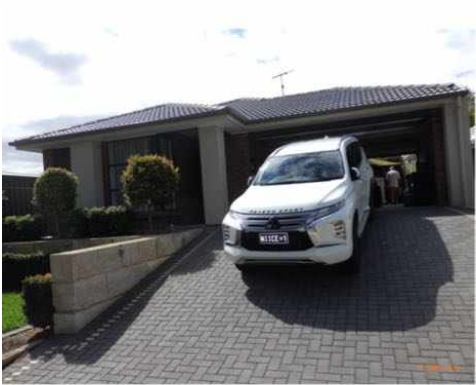
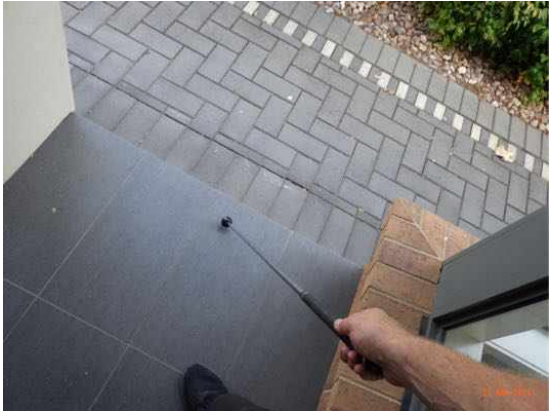
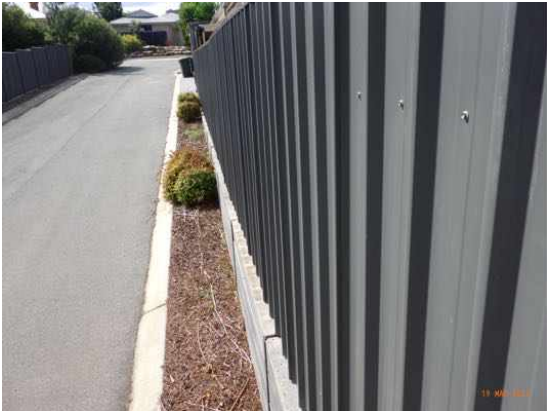
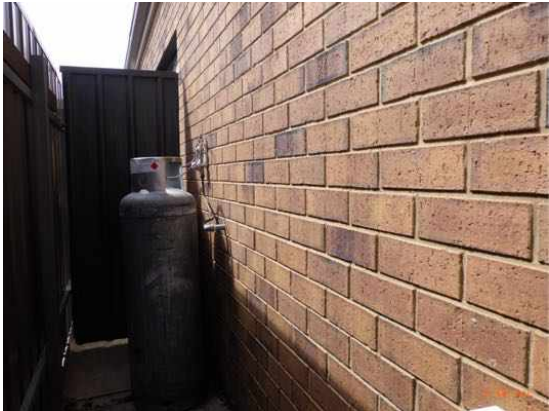
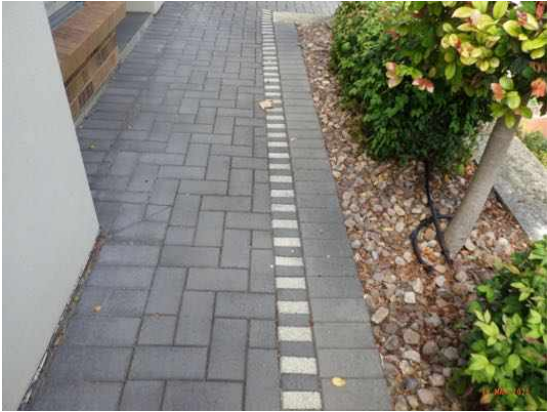
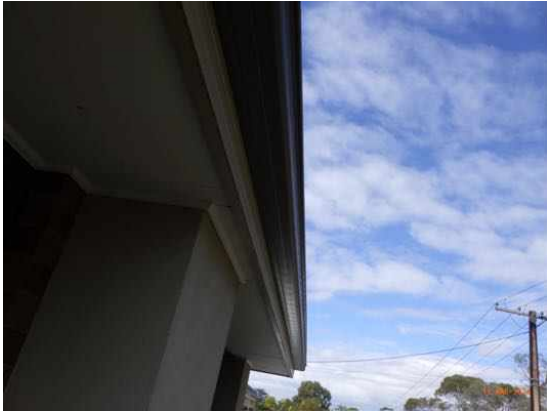
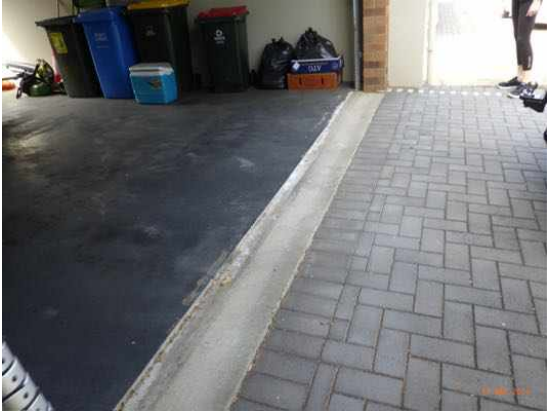
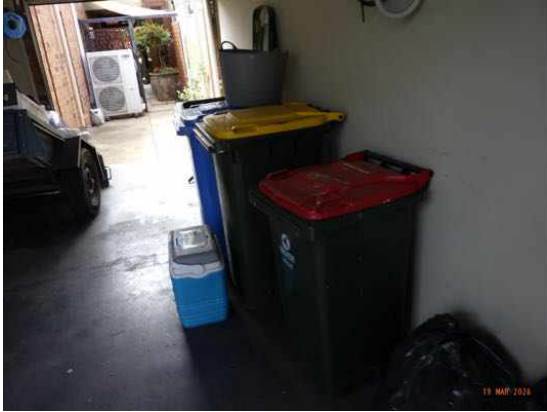
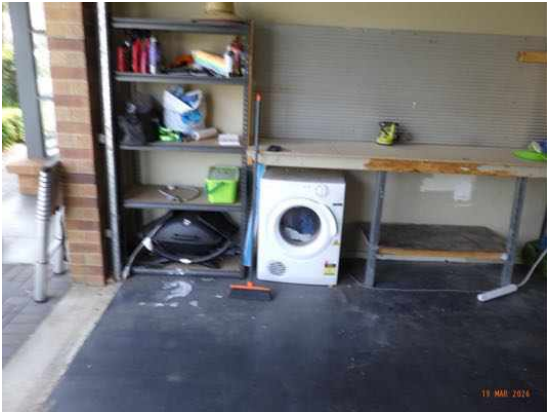
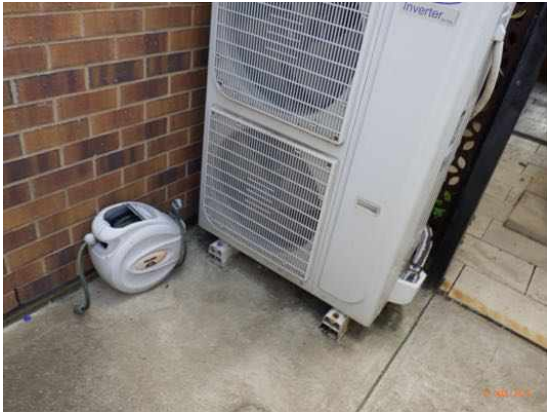
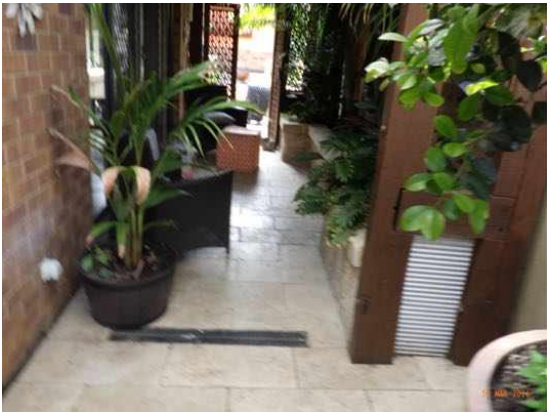
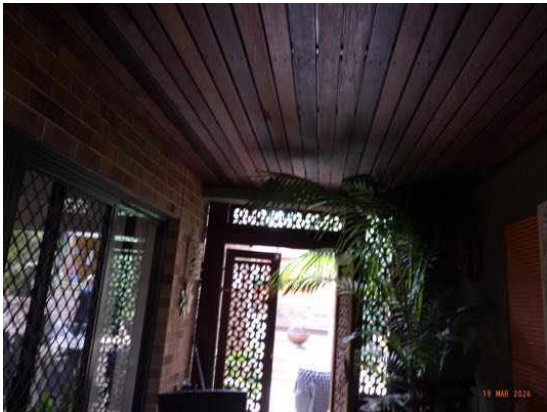
Building: Building 1
Location: All Areas
Finding: Additional Photos - Obstructions and Limitations
Information:

These photographs are an indication of the obstructions and limitations which impeded full inspection of the property at the time of inspection. These obstructions can hide an array of defects and should be removed to allow full inspection to be carried out.
