Building and Timber Pest Inspection Report

Inspection Date: Wed, 25 Mar 2026

Property Address: 18B Marara Rd, Caulfield South VIC 3162,
Australia

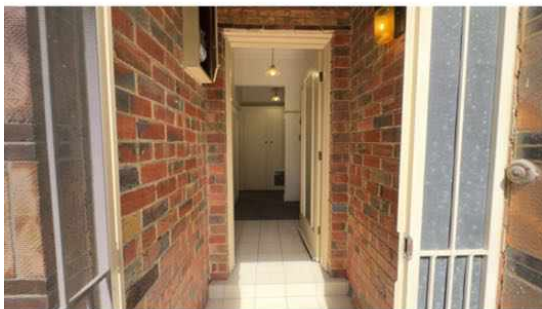
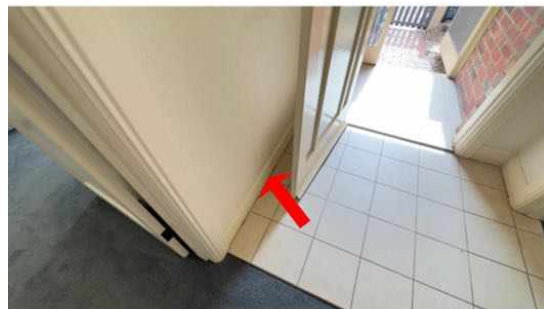
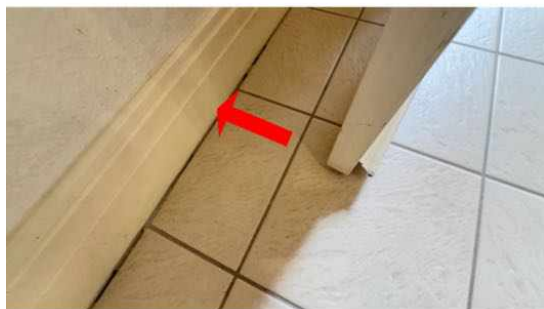
Building: Main Building
Location: All Areas
Finding: Doors - Missing Door Stops
Information: The inspection identified missing door stops in this area. Missing door stops can lead to damage to walls or doors and may impair the proper operation of the doors.

The absence of door stops may be due to them not being installed during construction or having been removed after installation.

It is recommended that a qualified carpenter or competent handyman be engaged promptly to install the missing door stops. Correct installation will protect doors and walls and ensure proper door functionality.

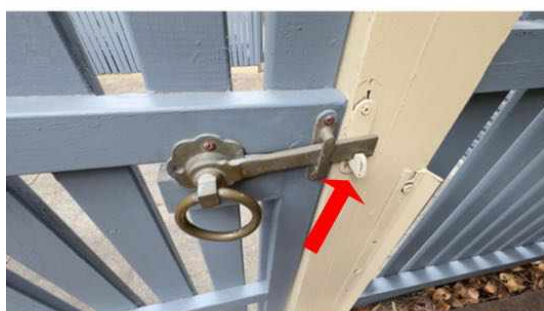
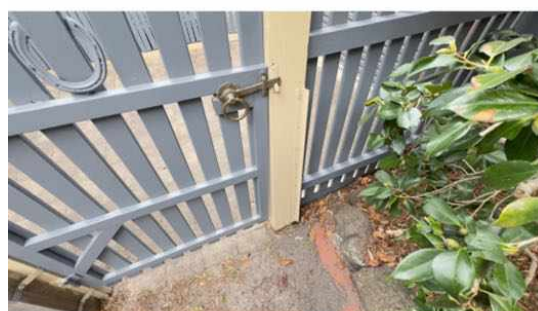
Finding 3.02

Building: Main Building
 Location: Gate >
 Finding: Doors - Loose Door Handles
 Information: The inspection identified loose door handles in this area. Loose door hardware can affect door operation, making opening and closing difficult and reducing overall functionality.

The issue appears to be caused by wear and tear, corrosion, improper installation, or impact damage.

A qualified carpenter or door specialist should be engaged immediately to repair, replace, or adjust the loose handles. Prompt rectification will ensure doors operate smoothly and maintain functionality.

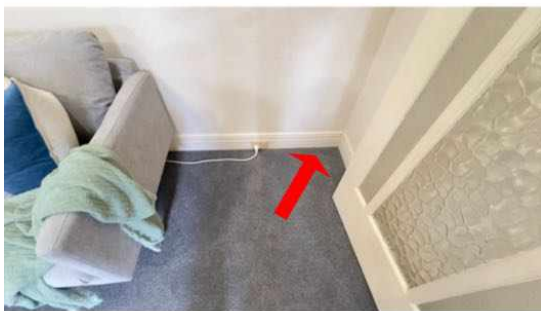
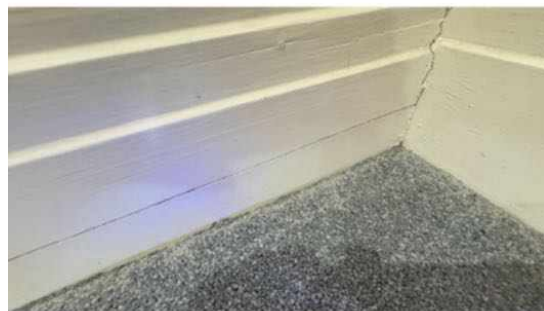
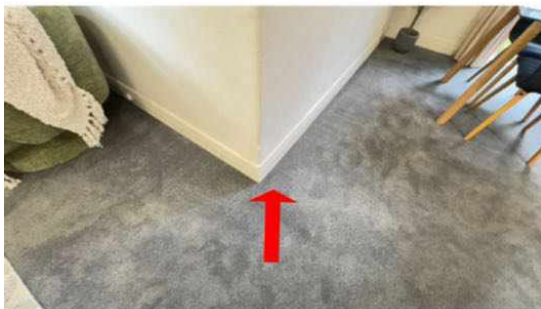
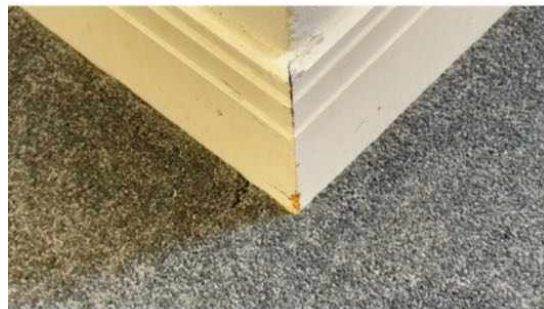
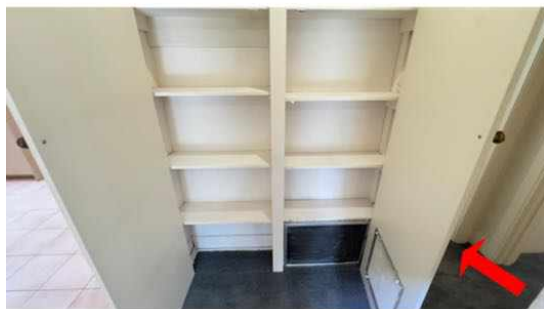
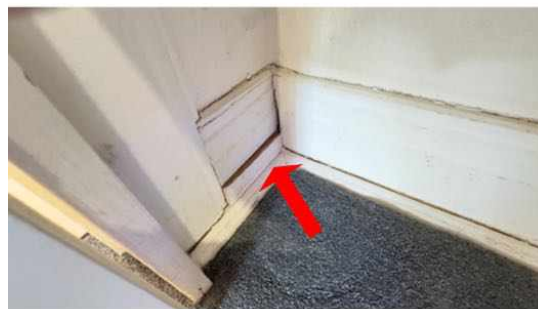
Finding 3.03

Building: Main Building
 Location: All Areas >
 Finding: Architraves & Skirting Boards - Minor Movement
 Information: Minor movement was noted in the architraves and skirting boards in this area, with small gaps at joints, slight separations from adjoining surfaces, and minor cracking in

Common causes include seasonal timber shrinkage or expansion, slight building settlement, historic moisture or thermal movement, or insufficient fixing during installation. While largely cosmetic, these gaps and cracks can affect the appearance of finishes. If left unaddressed, minor deterioration may continue over time.

When practical, a qualified painter should be engaged to fill and repaint affected areas, to restore a neat finish.

Ongoing monitoring is advised, especially after seasonal changes. If movement worsens, a structural engineer should be consulted immediately to assess and recommend any necessary repairs.

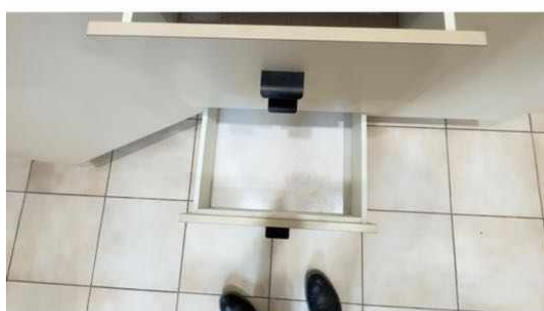
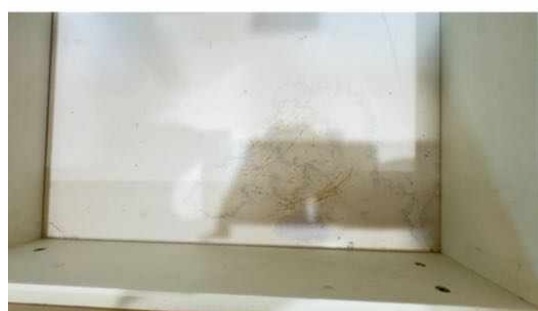
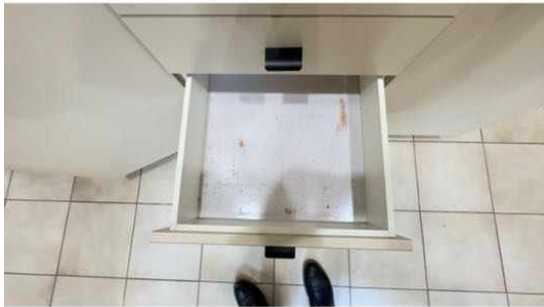
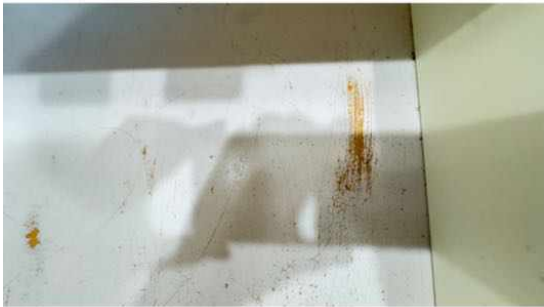
Finding 3.04

Finding: Cabinets - Damaged

Information: The inspection identified cabinets with visible damage. Defective cabinets can compromise usability, hygiene, and, over time, may deteriorate further if exposed to moisture.

The issue may be caused by age-related material deterioration, poor installation practices or impact damage from daily use.

A licensed carpenter, joiner, or kitchen specialist should be engaged immediately to assess, repair, or replace the affected cabinets. Remedial works may include re-gluing, re-sealing, replacing damaged sections, or full replacement if structural integrity is compromised. Prompt rectification will restore functionality, prevent further deterioration, and maintain hygiene and appearance.

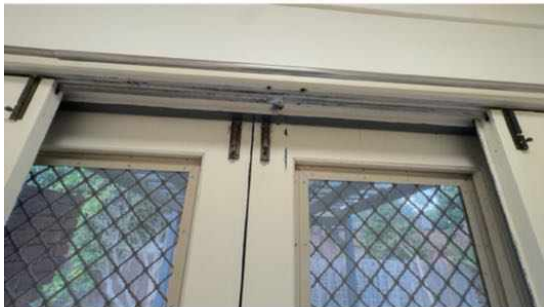
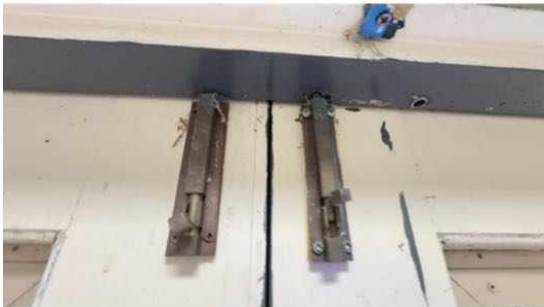
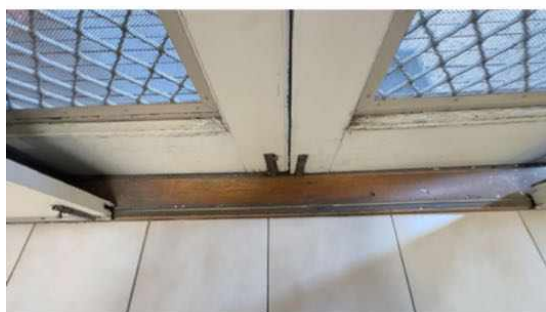
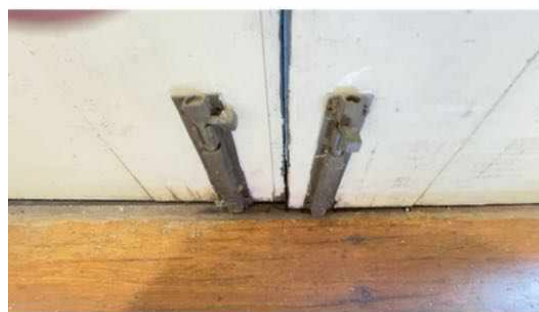
Finding 3.05

Building: Main Building
Location: All Areas >
Finding: Fittings & Hardware Deteriorated
Information: Fittings and hardware in this area were observed to be deteriorated. Deterioration of fittings and hardware can affect functionality reduce security, and, in some cases, make the windows or doors difficult to open, close, or lock properly.

Possible causes include age-related wear, corrosion from moisture or environmental exposure, mechanical stress from repeated use, and lack of maintenance over time.

It is recommended that a carpenter be engaged to assess the affected hardware and replace any deteriorated fittings and hardware to restore proper function, security, and appearance.

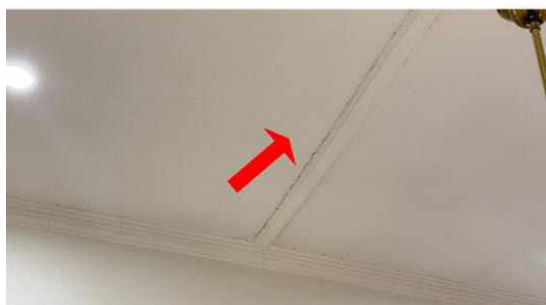
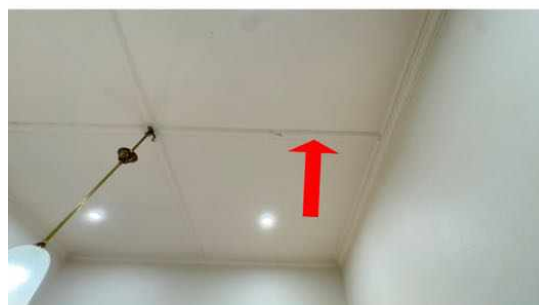
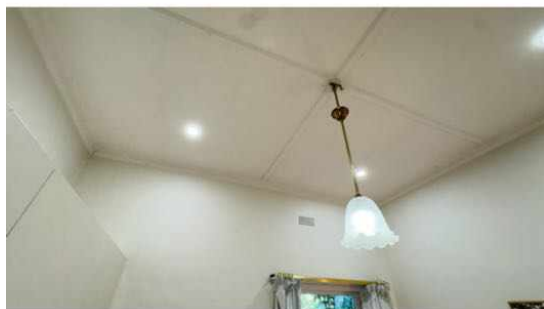
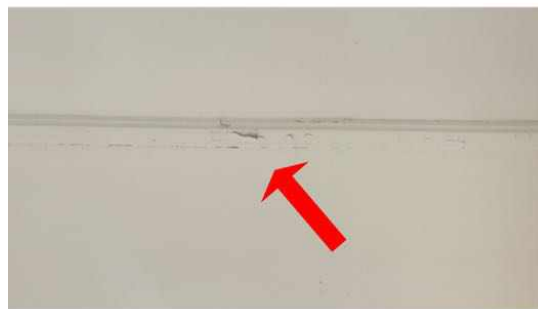
Finding 3.06

Building: Main Building
 Location: All Areas >
 Finding: Ceilings - Minor Plaster Cracking
 Information: The ceilings were inspected and cracking in the plaster was observed in this area. Cracks can affect the appearance of the ceilings and may worsen over time if left unaddressed.

When practical, a qualified plastering contractor should be engaged to assess and repair the cracked plaster. Prompt action will improve the appearance of the ceilings and help prevent further deterioration.

Cracking should be monitored over time to determine whether movement is ongoing. Where cracks are purely cosmetic, patching and repainting by a qualified plasterer may be undertaken as part of routine maintenance. If cracks widen, reappear after repairs, or are accompanied by other structural signs, further investigation by a registered builder or structural engineer is recommended immediately.

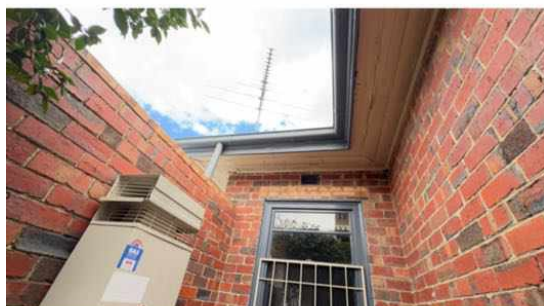
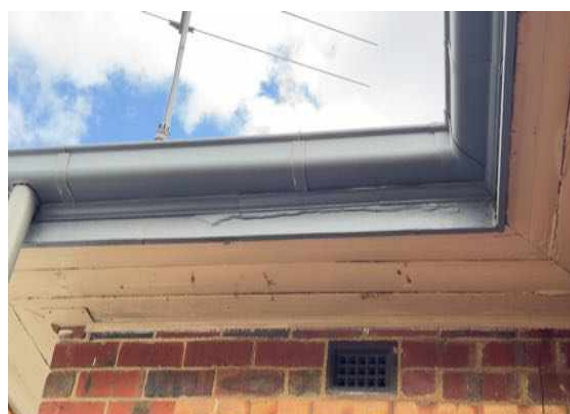
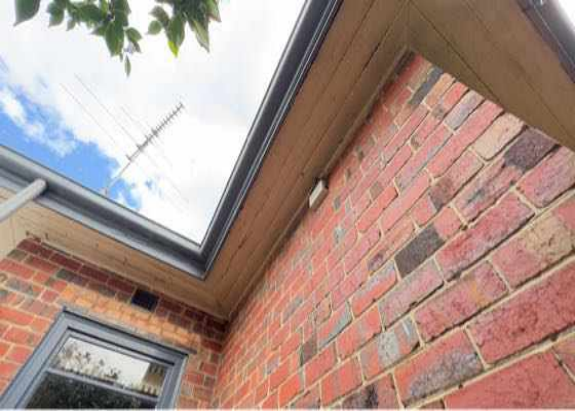
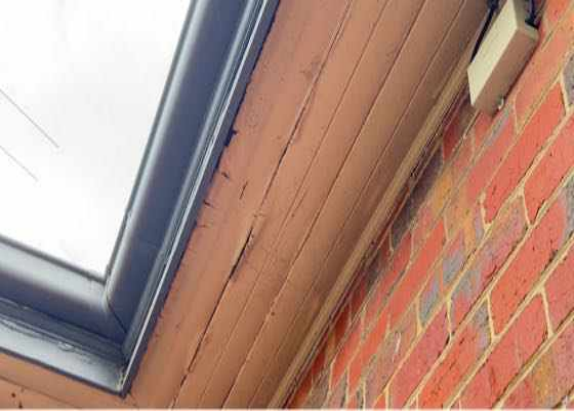
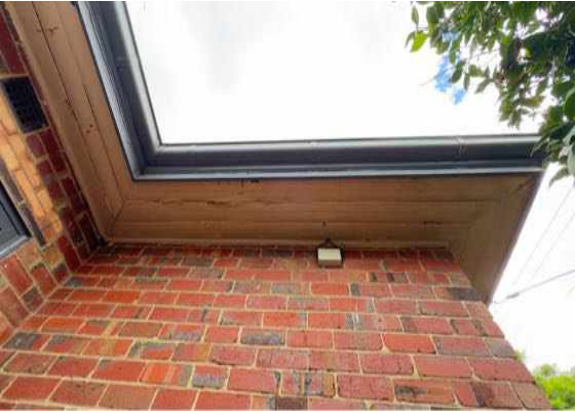
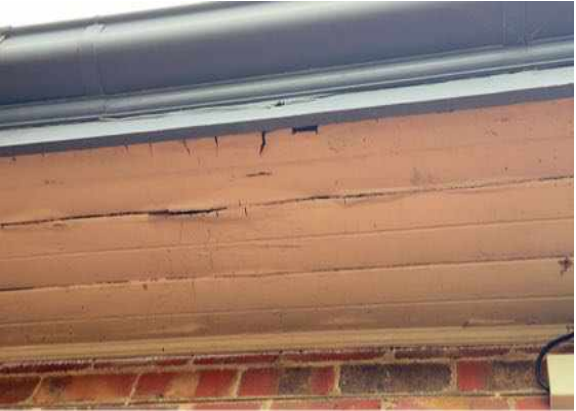
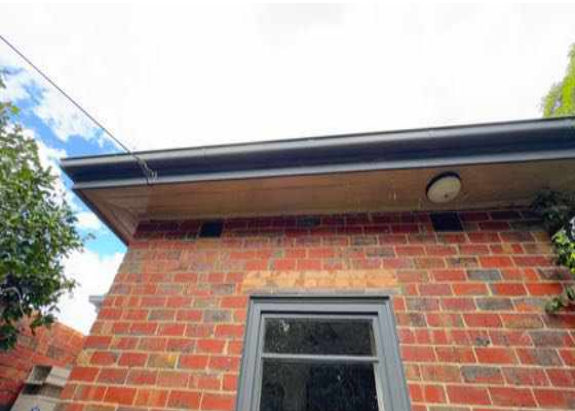
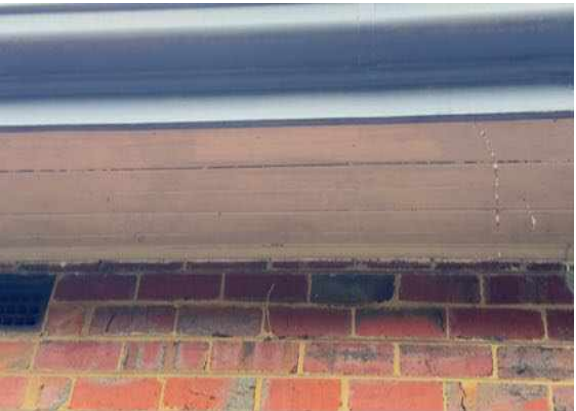
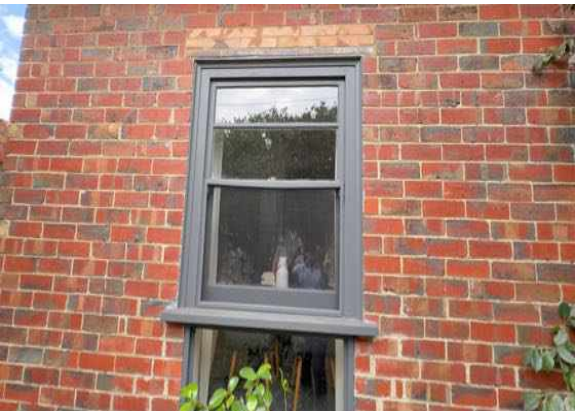
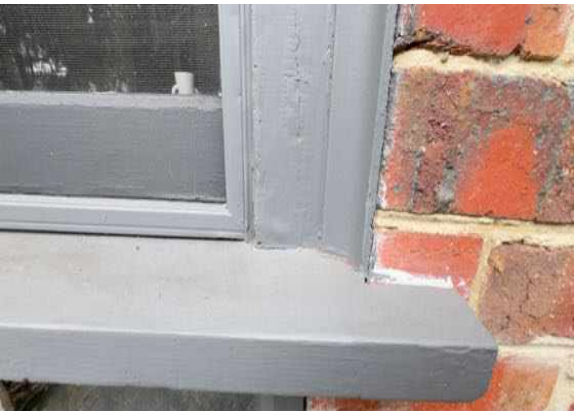
Finding 3.07

Building:	Main Building
Location:	All External Areas
Finding:	External Timber - Timber Rot
Information:	Timber elements including wall claddings, timber rails & posts, landscaping timbers, and other external timber surfaces were inspected and show signs of rot, decay and fungal attack in these areas. Softening, discoloration, splitting, and moisture penetration indicate ongoing timber degradation.

This is likely caused by prolonged moisture exposure, inadequate protective coatings or maintenance, direct contact with soil or water, or poor detailing that traps water or limits ventilation.

If left unaddressed, the affected timber may lose structural integrity, leading to progressive decay, potential collapse of walls, decks, or landscaping features, mould growth, and reduced durability and appearance of the building exterior.

A registered builder or timber specialist should inspect the affected areas immediately to determine the extent of damage. Damaged timbers should be repaired or replaced, protective treatments applied, and drainage or detailing corrected to prevent recurrence. Ongoing monitoring and urgent remedial action are required to prevent further deterioration.

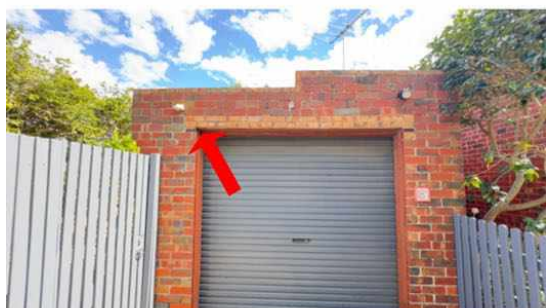
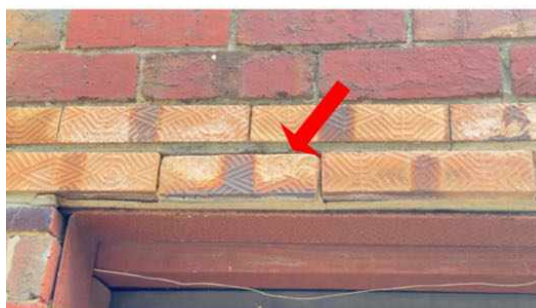
Building:	Main Building
Location:	Garage >
Finding:	Brickwork - Minor Cracking
Information:	Minor cracking was observed in the brickwork in this area. Hairline cracks are commonly cosmetic in nature; however, the presence of wider or stepped cracks, displaced bricks, or delaminated render may indicate structural movement or water ingress.

Possible contributing factors include normal thermal expansion and contraction, minor foundation settlement, structural movement, moisture penetration, impact damage, or workmanship-related issues.

*Note: No elevated moisture levels were detected at the time of inspection.

The brickwork in this area should be monitored, and if cracks widen or additional movement occurs, a structural engineer should be engaged immediately to assess the condition and advise on any required remedial works. Cosmetic hairline cracking can be repaired by a registered builder or qualified bricklayer to improve appearance and maintain weatherproofing.

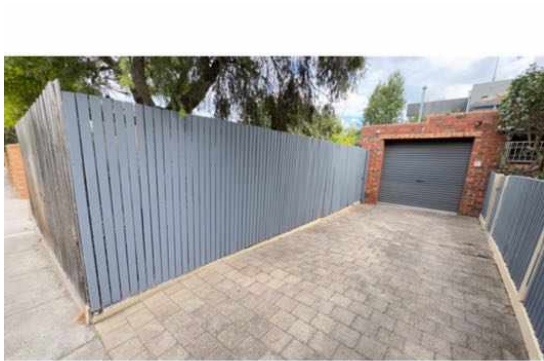
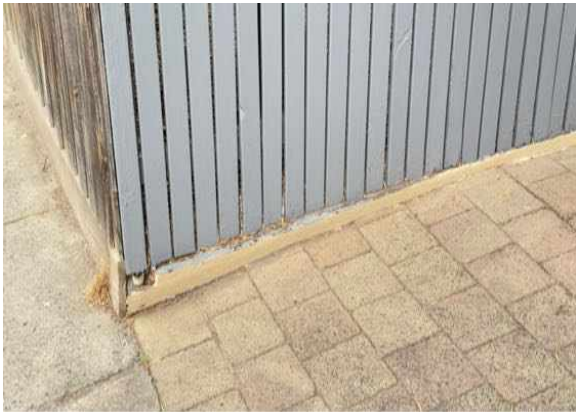
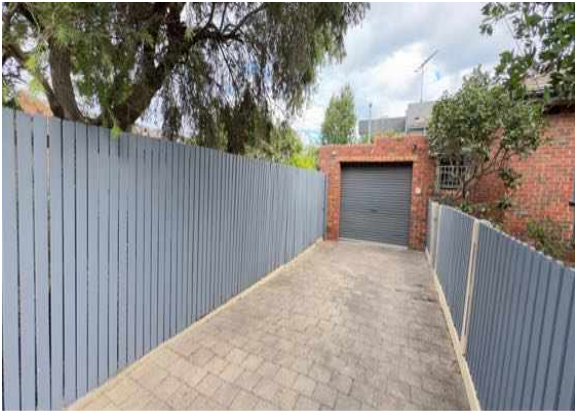
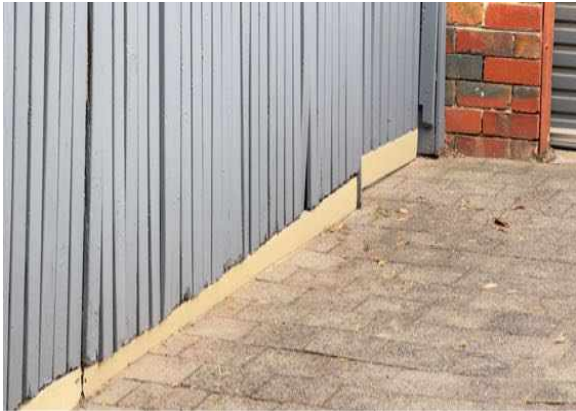
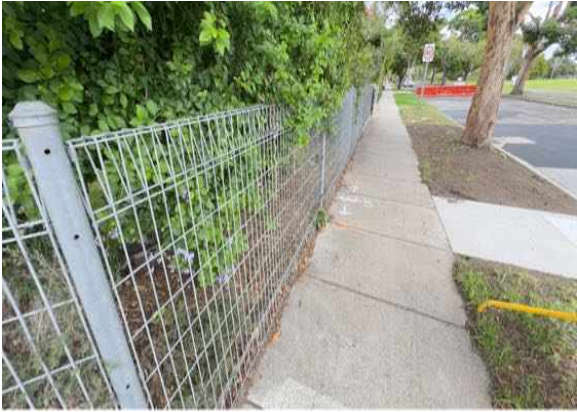
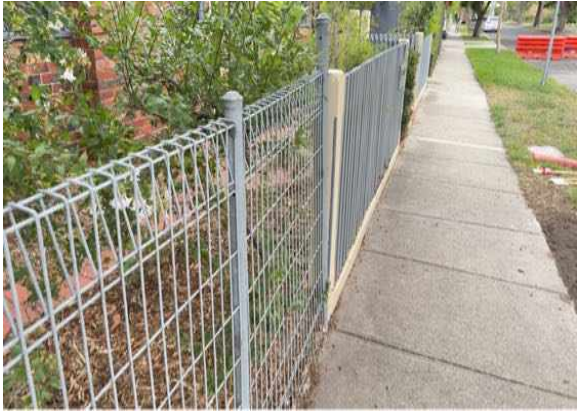
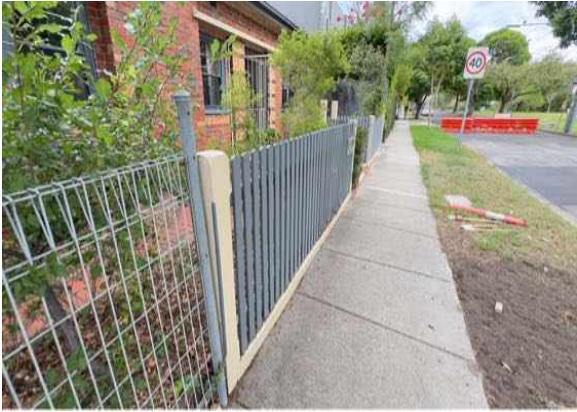
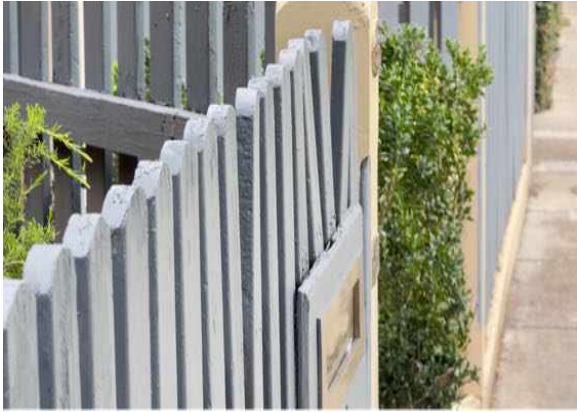
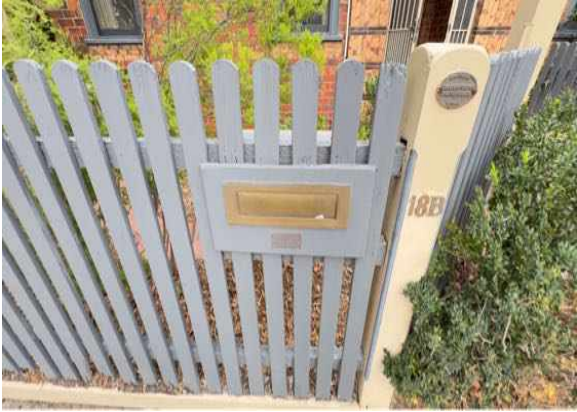
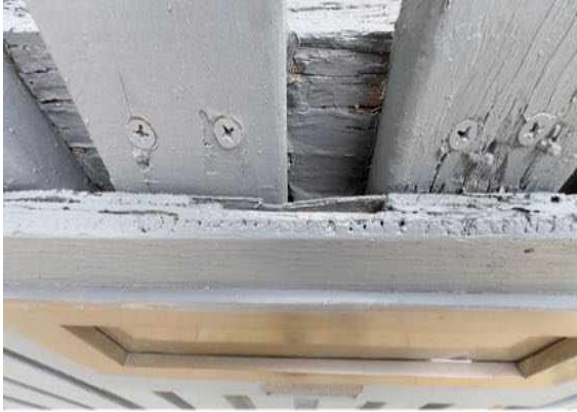
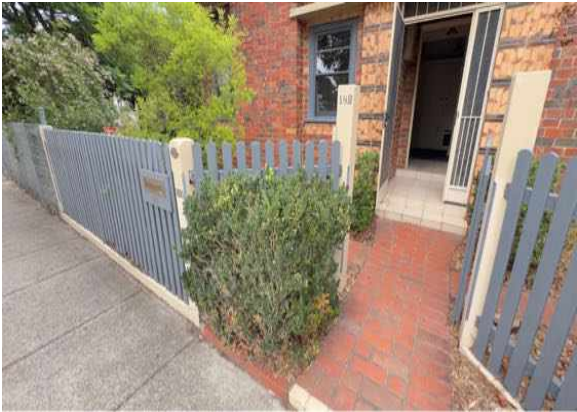
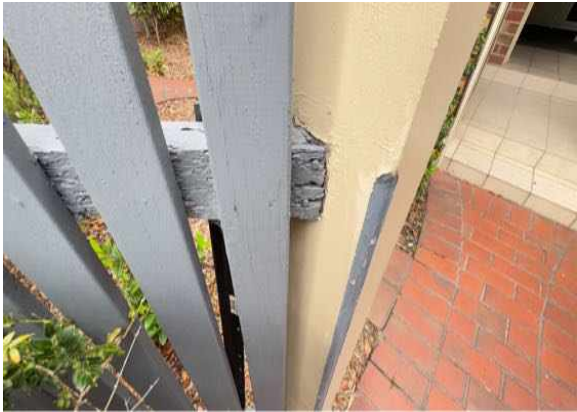
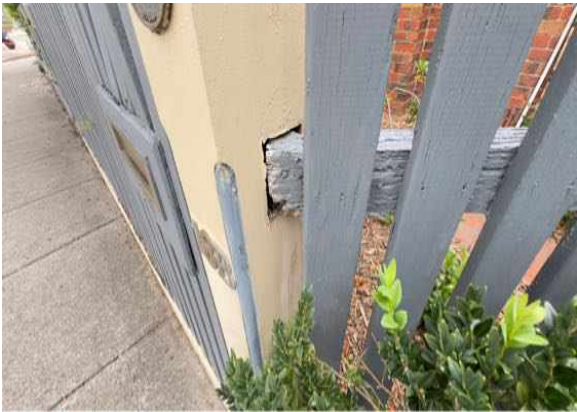
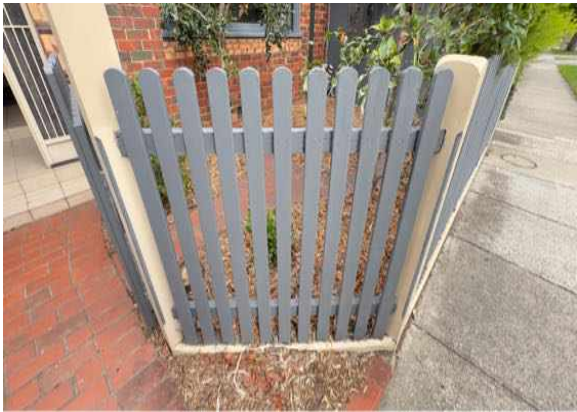
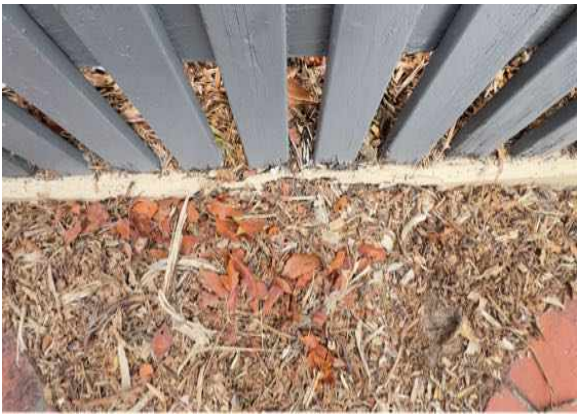
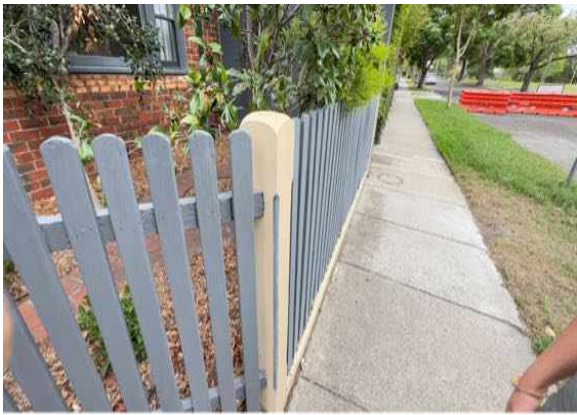
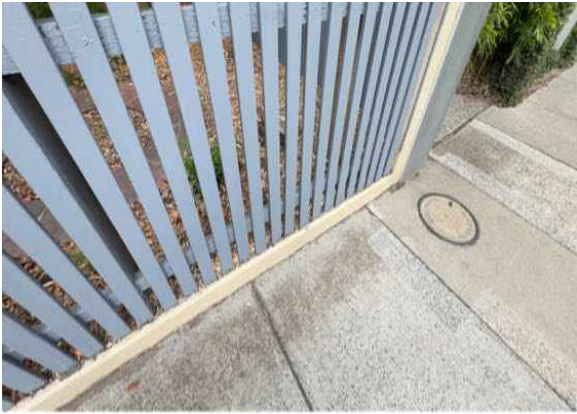
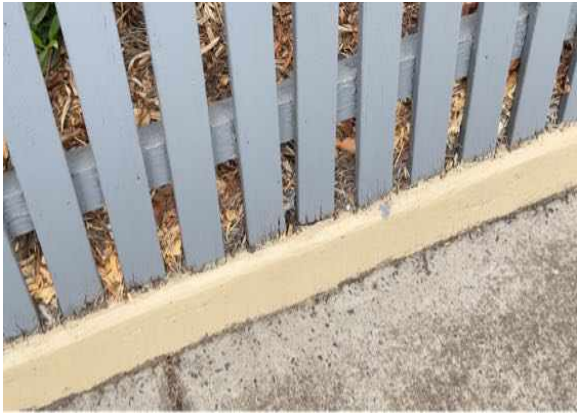
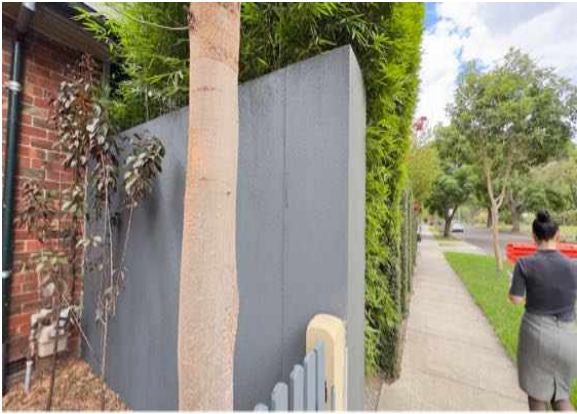
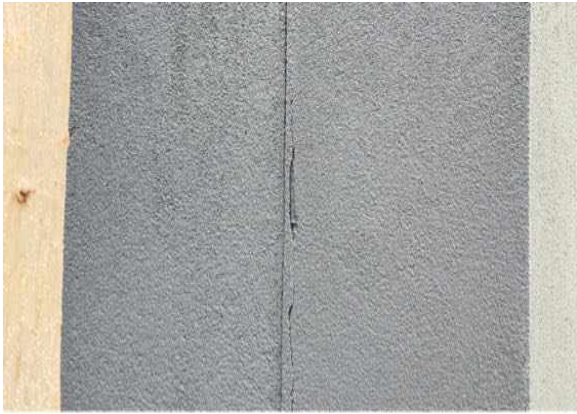
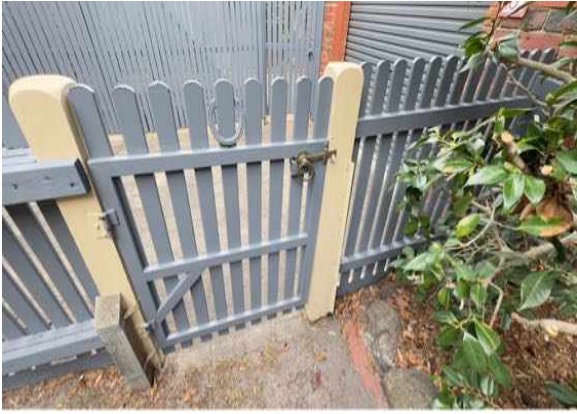
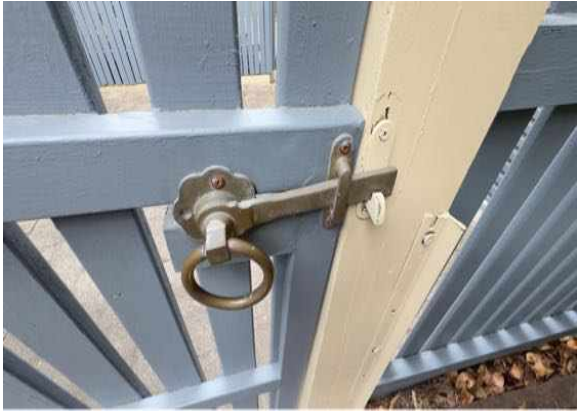
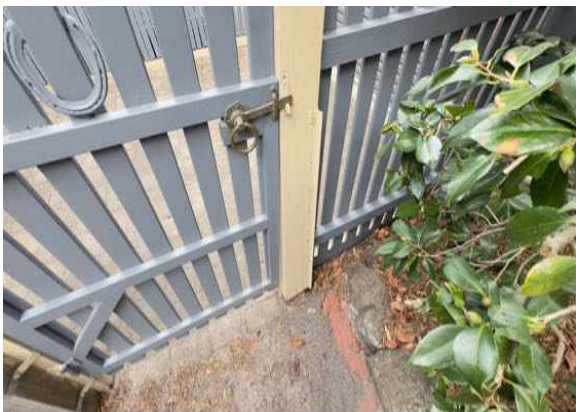
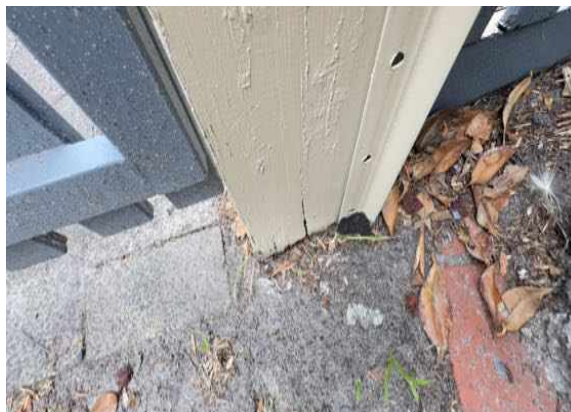
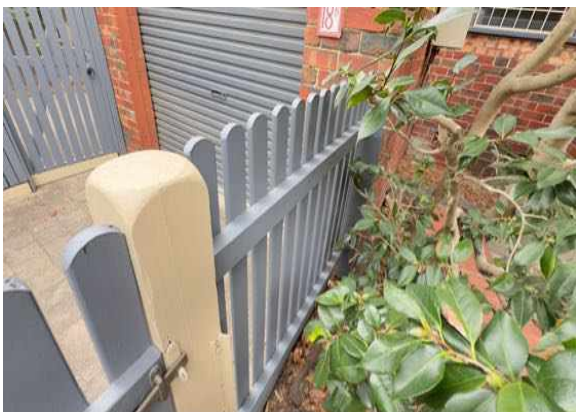
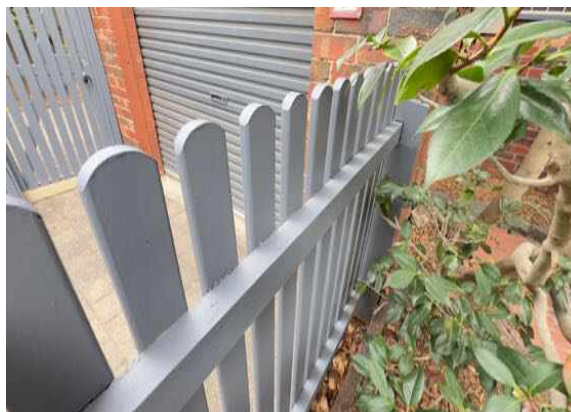
Finding 3.09

Building: Main Building
Location: Fencing All Areas
Finding: Fencing - Deteriated
Information: Timber fencing was inspected and deterioration was observed in this area. Deteriorated fencing can compromise structural stability, reduce privacy, and may allow pest ingress or accelerated decay if left unaddressed.

Possible causes include age-related timber decay, prolonged exposure to moisture or sunlight, poor maintenance, or impact damage.

When practical, a qualified carpenter or fencing specialist should be engaged to repair or replace affected sections, and a qualified painter should be engaged to restore protective finishes. Prompt rectification will maintain structural performance, improve appearance, and extend the lifespan of the fencing.

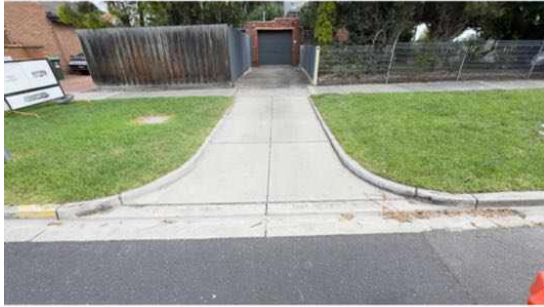
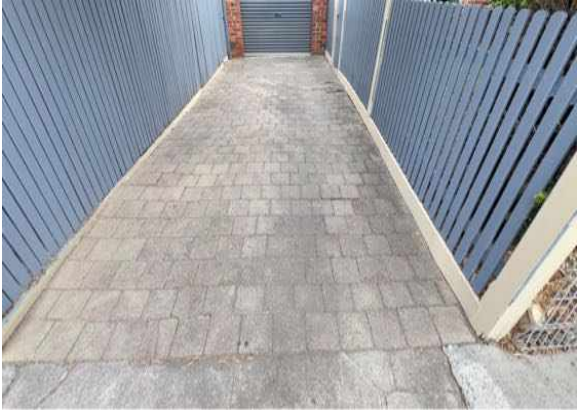
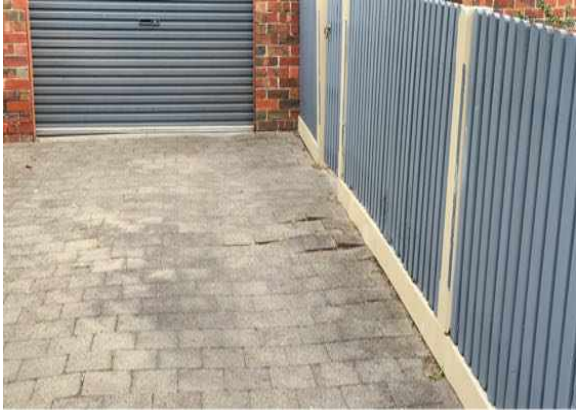
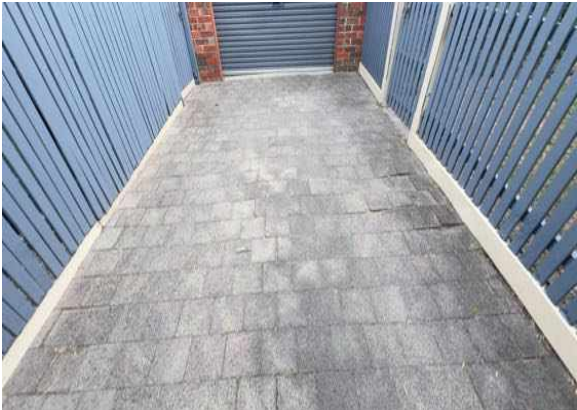
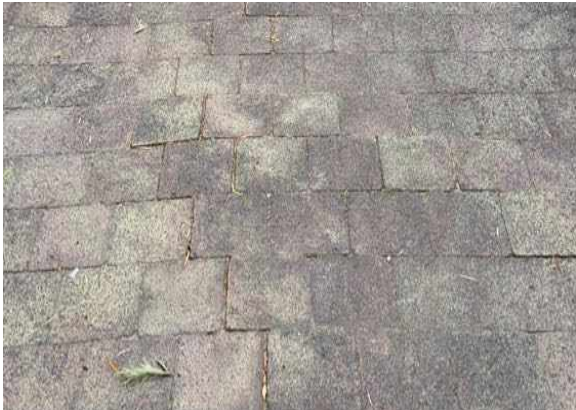
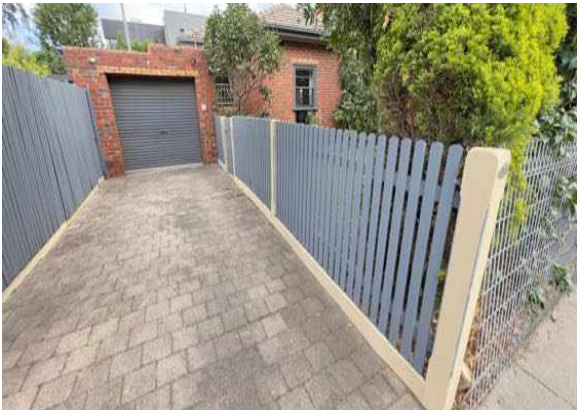
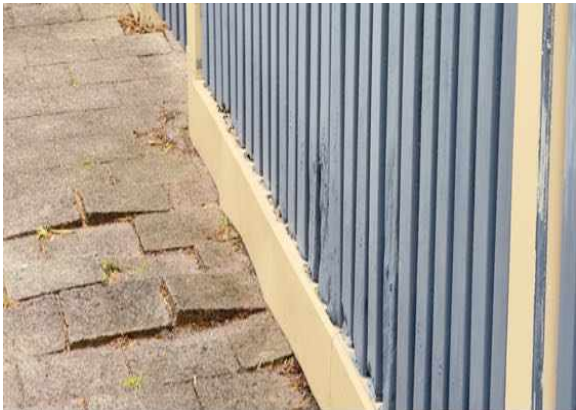
Finding 3.10

Building:	Main Building
Location:	Driveway >
Finding:	Driveway - Minor Cracking & Surface Imperfections
Information:	The external driveway was visually inspected. Minor cracking, surface settlement, and minor unevenness was observed in this area. While these defects do not currently compromise structural safety, they may affect long-term durability, appearance, and vehicle access.

These issues may be caused by age-related wear, soil movement or settlement beneath the driveway, possible tree root intrusion, or inadequate original construction or reinforcement.

A qualified concreter should be engaged when practical to repair or resurface affected areas. Prompt rectification will restore a smooth surface, improve appearance, and prevent further deterioration.

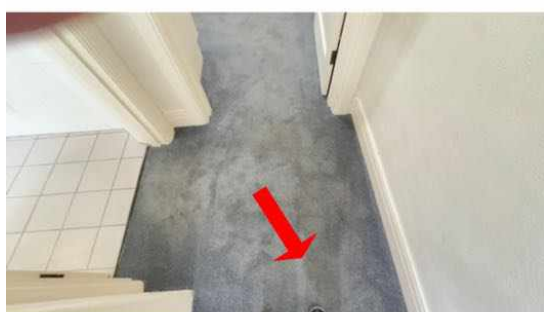
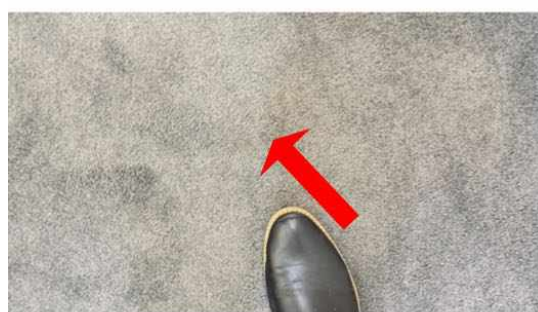
Building:	Main Building
Location:	Subfloor
Finding:	Sub Floor - Stumps Dropping
Information:	The subfloor stumps were observed to be dropping and settling unevenly. The issue is present where the floor is sagging and load is unevenly distributed.

This has likely occurred due to ground movement, soil erosion or age-related deterioration of stumps. Dropping stumps can compromise the integrity of bearers and joists, increase the risk of structural failure, and create a serious safety hazard.

A registered builder or structural engineer is required to inspect the subfloor immediately, assess the affected stumps, and undertake remedial works. This should be rectified as soon as possible to restore structural stability and ensure safety.

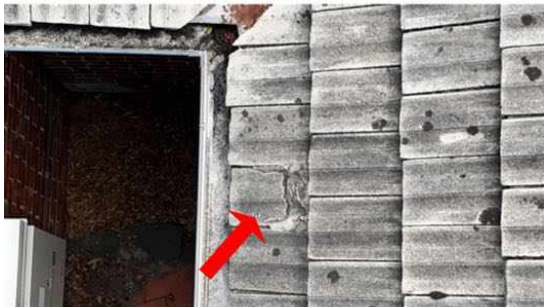
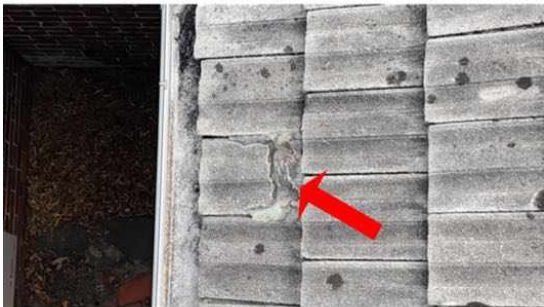
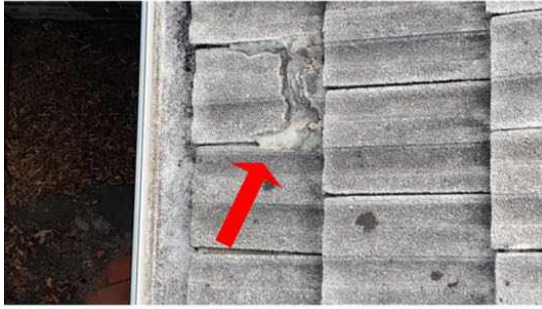
Building: Main Building
Location: Roof Exterior
Finding: Roof Plumbing - Roof Tiles Cracked
Information: Roof tiles in this area are cracked and may no longer provide full protection. The issue is observed across the roof surface where damaged tiles are present.

This has likely occurred due to impact, weathering, or poor installation. Cracked tiles may allow water to penetrate, causing leaks, water damage to internal structures, or deterioration of surrounding tiles.

A licensed roof plumber is required to inspect and repair or replace the cracked tiles in this area. This should be rectified immediately to prevent water ingress and further damage.

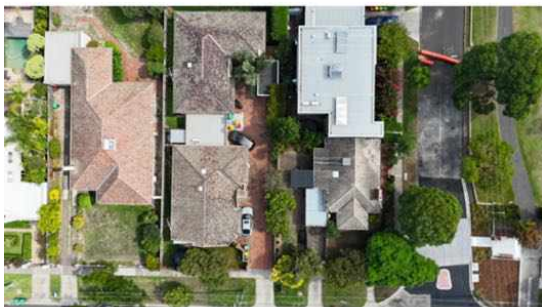
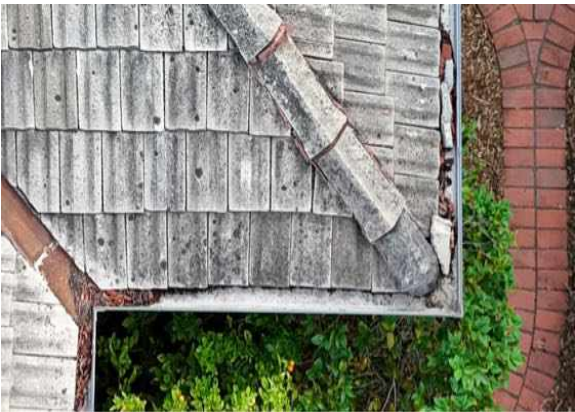
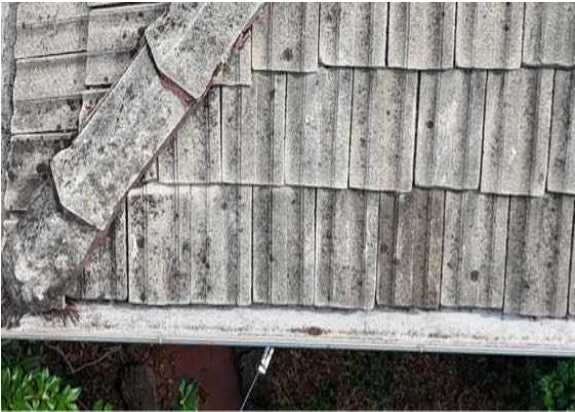
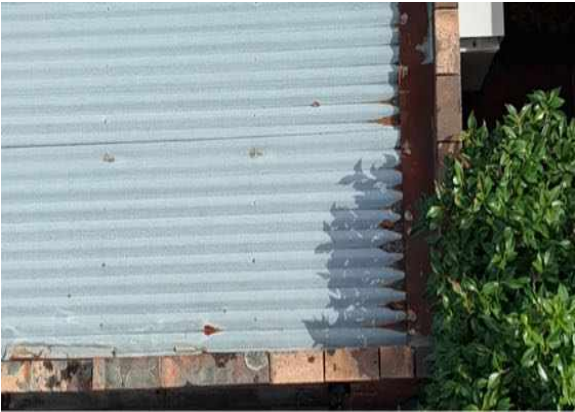
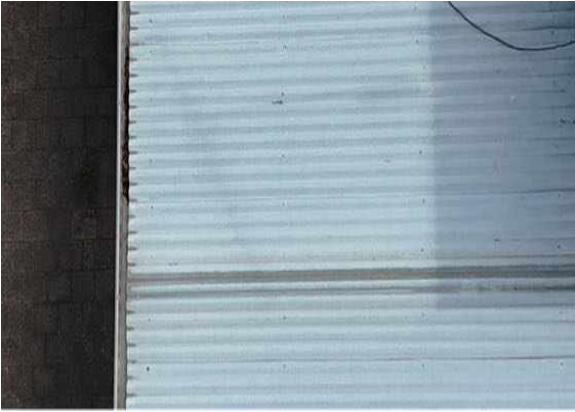
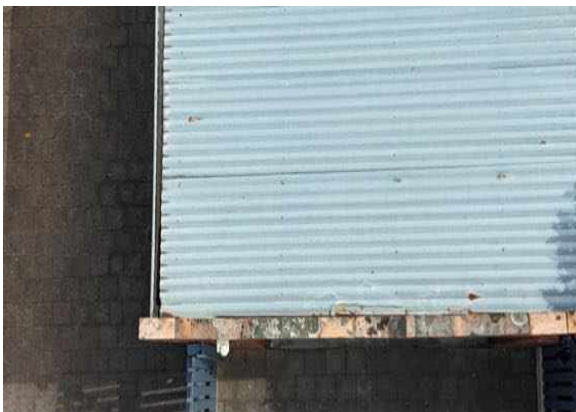
Finding 3.14

Building:	Main Building
Location:	Roof Exterior
Finding:	Roof Plumbing - Roof Tiles Deteriorated
Information:	Roof tiles are weathered, deteriorated, and show moss, algae, lichen growth, and discolouration. The edges and corners of some tiles are also eroded, and the tiles are more porous and prone to water absorption.

This has likely occurred due to long-term exposure to sunlight, rain, wind, frost, and environmental conditions. These combined issues increase the risk of water penetration, leaks, damage to the roof structure, and further deterioration of surrounding tiles.

A licensed roof plumber is required to inspect and repair or replace the affected tiles in this area. This should be rectified immediately, which may include removing moss, algae, and lichen, realigning or replacing damaged tiles, treating deteriorated tiles, and ensuring the roof covering is fully watertight to prevent further damage.

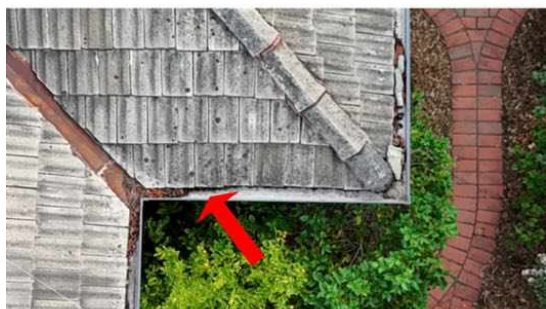
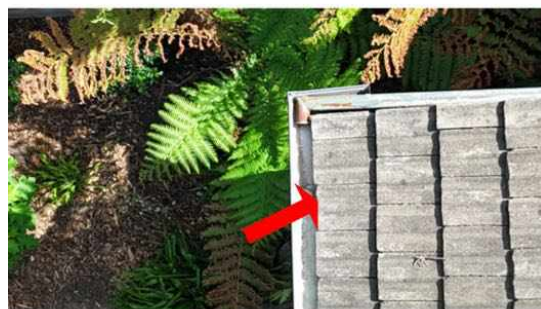
Finding 3.15

Building:	Main Building
Location:	Roof Exterior
Finding:	Roof Plumbing - Roof Tiles Misaligned
Information:	Roof tiles in this area are misaligned and not sitting correctly on the roof battens. The issue is observed across the roof surface where tiles are out of position.

This has likely occurred due to poor installation, movement from weather, or impact. Misaligned tiles may allow water to penetrate, cause leaks, and increase the risk of damage to surrounding tiles or roof structure.

A licensed roof plumber is required to inspect and realign the tiles in this area. This should be rectified immediately to prevent water ingress and further damage.

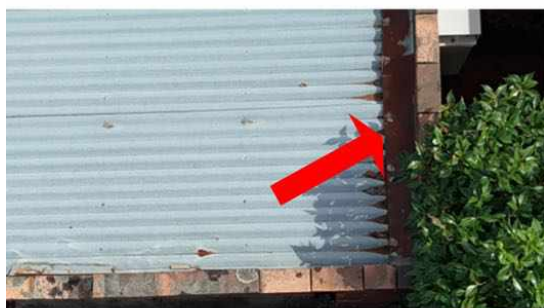
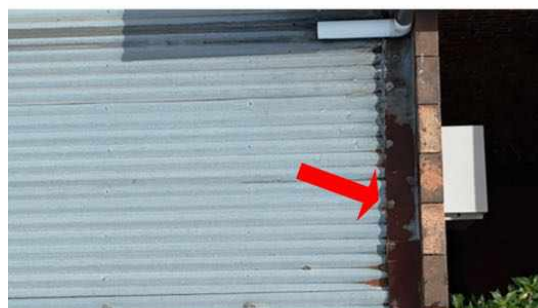
Finding 3.16

Building:	Main Building
Location:	Roof Exterior
Finding:	Roof Plumbing - Rusted & Corroded
Information:	The roof plumbing has areas of rust and corrosion. It is suspected that this has been caused by blockages, resulting in pooling or standing water, that have prematurely rusted elements of the roof plumbing.

Rusted roof plumbing will generally develop holes and leaks that can affect other building elements with poor drainage of storm water. Poorly drained roof areas will also lead to damp conditions surrounding the base perimeter of the building which, if left unmanaged, can lead to a range of secondary building defects.

Repair and/or replacement of rusted roof plumbing is highly required in order to reinstate the roof drainage system to a fully operational level. To further maintain these areas, gutters should be cleaned frequently, allowing the avoidance of any partial blockages.

A licensed plumber or specialist roof restoration company should be appointed to undertake these works. It is advised that such works be completed as soon as possible to prevent any further damage and deterioration.

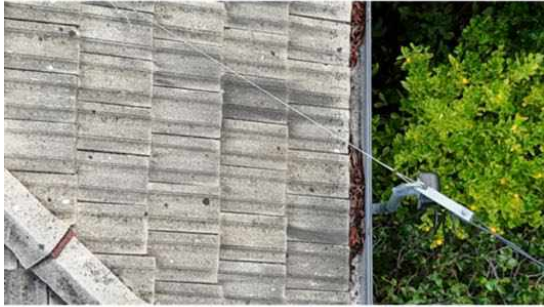
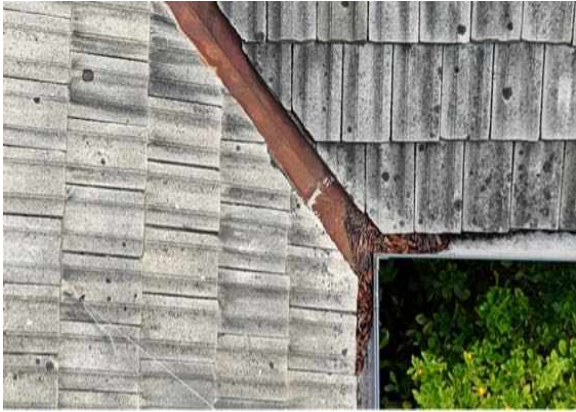
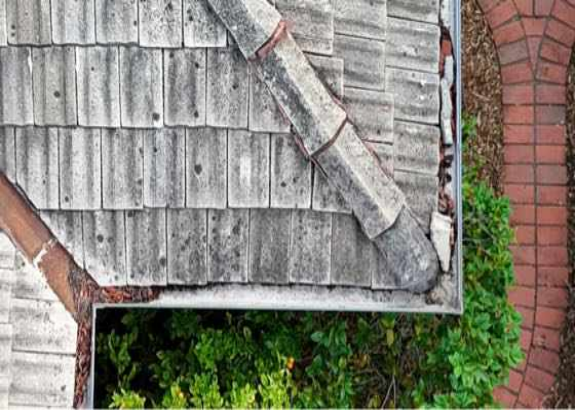
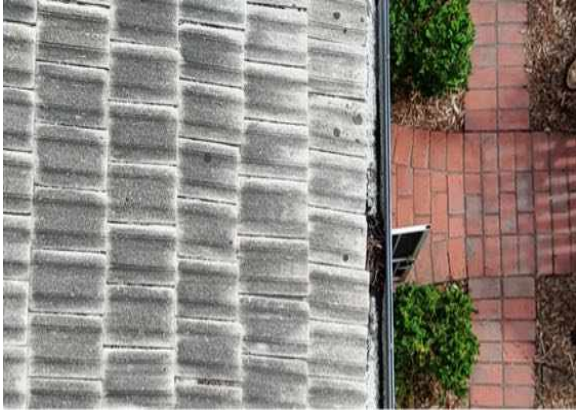
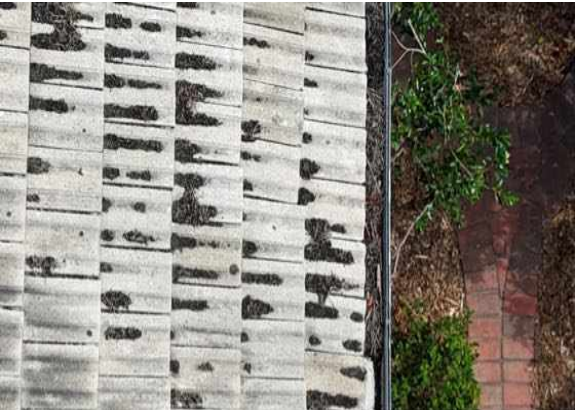
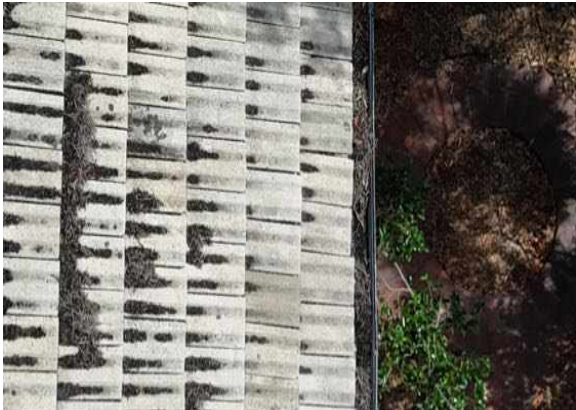
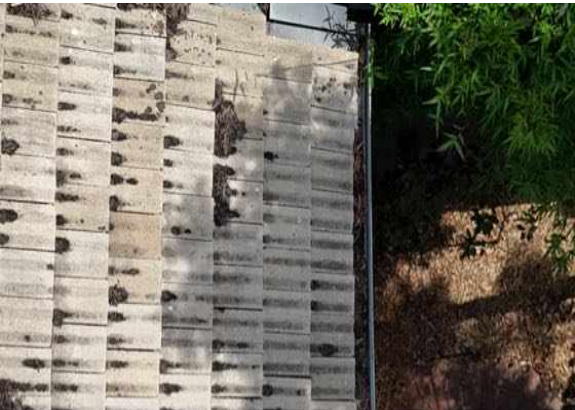
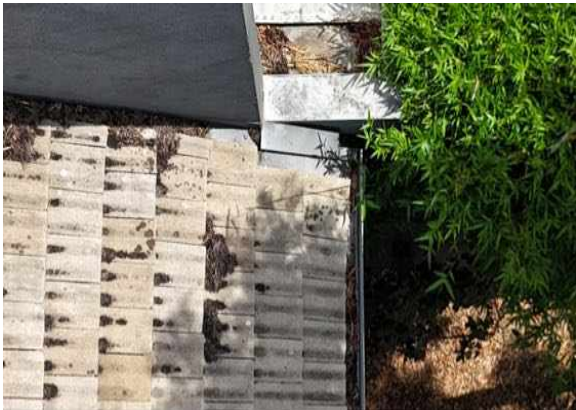
Finding 3.17

Building:	Main Building
Location:	Roof Exterior
Finding:	Roof Plumbing - Gutters Blocked
Information:	Gutters in this area are blocked and not allowing water to flow freely. The issue is observed along the gutter runs where leaves, debris, or other obstructions have accumulated.

This has likely occurred due to lack of maintenance or build-up of debris over time. Blocked gutters may cause water to overflow, damage the roof, walls, or foundations, and increase the risk of erosion or water ingress.

A licensed roof plumber or competent handy man is required to inspect and clear the blocked gutters in this area. This should be rectified immediately to ensure water drains correctly and to prevent potential damage to the building.
