Building and Timber Pest Inspection Report

Inspection Date: Wed, 25 Mar 2026

Property Address: 18B Marara Rd, Caulfield South VIC 3162,
Australia

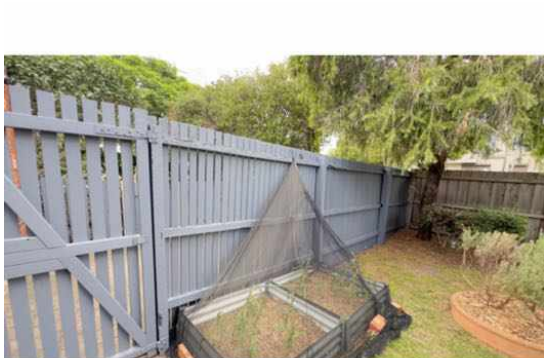
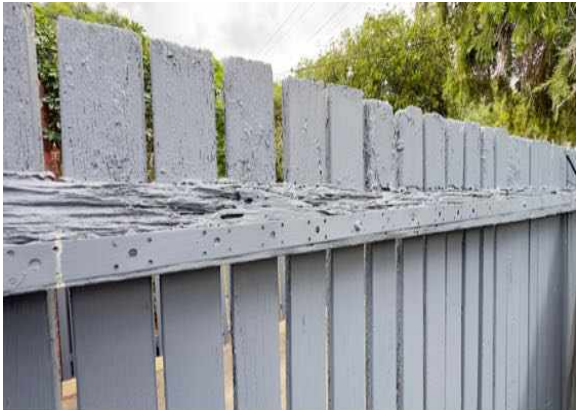
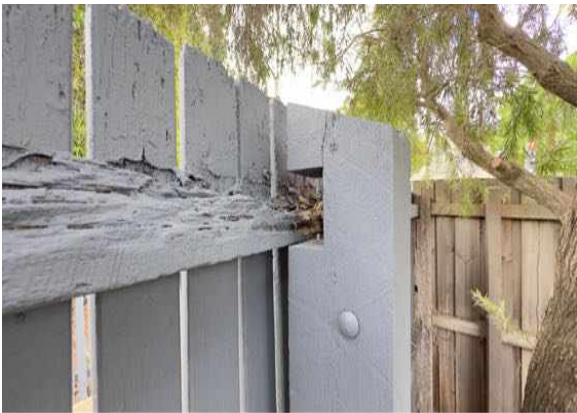
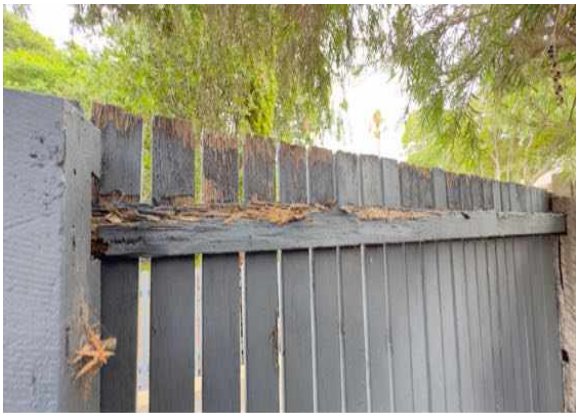
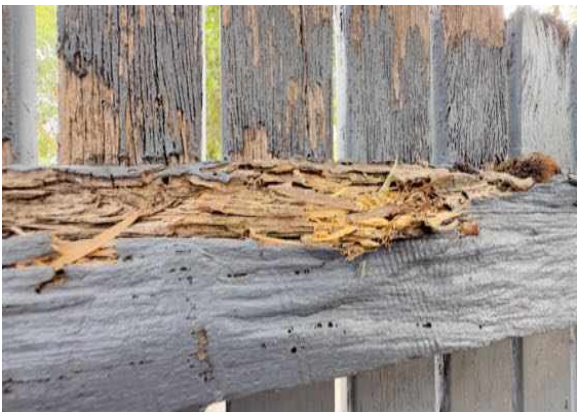
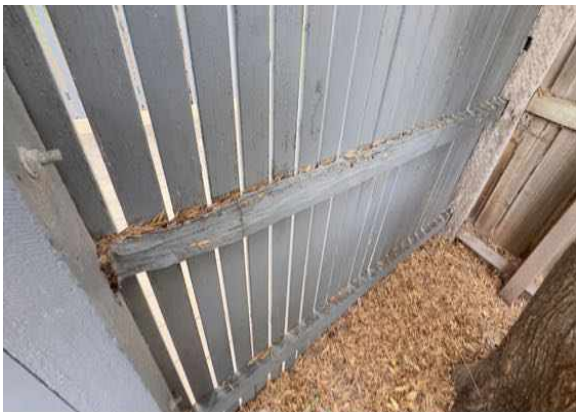
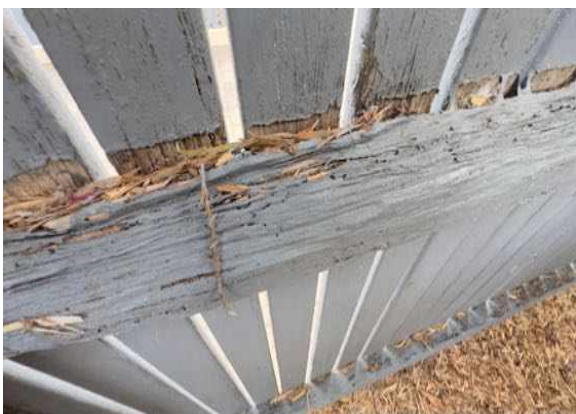
Building:	Main Building
Location:	Fencing
Finding:	Timber Pests - Historic Timber Pest Damage Identified
Information:	During the inspection, evidence of timber pest damage was identified in the property in this area. Signs such as hollow-sounding timber, visible holes, and decayed structural elements indicate that timber pests, such as termites, borers, and fungal decay, have caused damage to the timber components of the building. If left unaddressed, this damage can lead to structural instability and further deterioration of building materials.

The presence of moisture around the timber or timber-to-soil contact may have contributed to the activity, as these conditions attract timber pests. Additionally, poor drainage and leaks can create the ideal environment for these pests to thrive. The damage observed is a clear indication that the timber has been compromised, and if the infestation is still active, it may continue to spread, further weakening structural elements.

Timber pest damage can affect essential components of the building, such as flooring, wall framing, and load-bearing timbers. As the pests feed on the timber, they can significantly weaken the structure, posing a safety risk to the occupants of the building. Additionally, the damage can create entry points for other pests, such as fungi, mould, and bacteria, which may further degrade the condition of the building and increase health risks.

Immediate action is required to assess the extent of the timber pest damage and take the necessary steps to eliminate the possible infestation. It is strongly recommended to engage a licensed pest management professional who can conduct a thorough

INVASIVE inspection to identify the type of pest and develop an appropriate treatment plan. Depending on the severity of the damage, treatment options may include chemical treatments, baiting systems, or fumigation to eliminate the active pests and prevent future infestations.

Furthermore, it is essential to consult a structural engineer or registered builder immediately to assess the damage to the timber and carry out repairs or reinforcement where necessary. This will help restore the building's structural integrity, prevent further damage, and ensure the safety and stability of the property. Regular monitoring and routine inspections should also be carried out to detect any future timber pest activity early and prevent further damage.

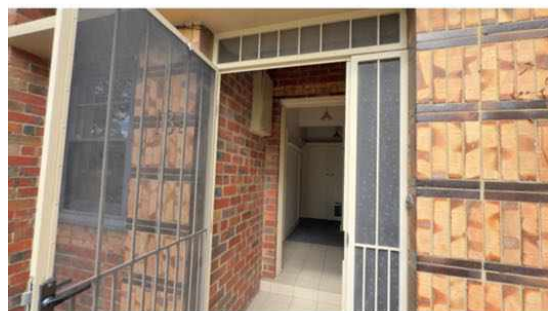
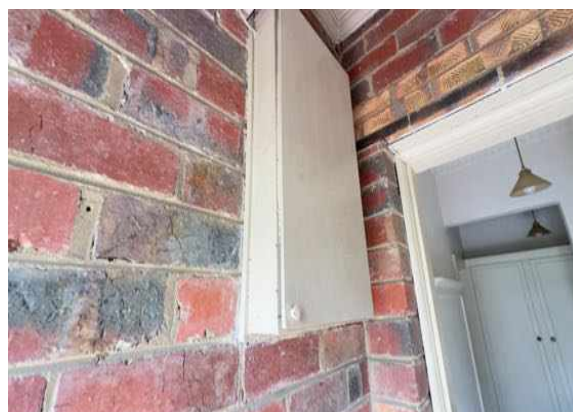
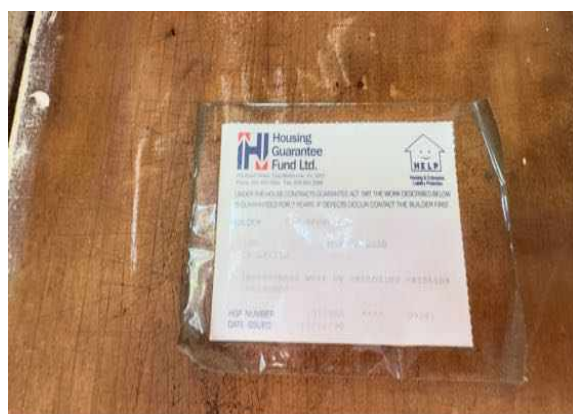
Finding 6.01

Building:	Main Building
Location:	All External Areas
Finding:	Timber Pests - Durable Notice Not Identified
Information:	During the inspection, no durable notice relating to a termite management system was observed on the property. A durable notice is required to identify the type of termite management system installed, the date of installation, and any ongoing maintenance or inspection requirements. The absence of this notice makes it difficult to confirm the presence, effectiveness, or maintenance status of any termite protection measures.

Without a durable notice, there is an increased risk that termite management systems may not be adequately maintained or may have expired, particularly in the case of chemical barriers that require periodic replenishment. This uncertainty increases the likelihood of undetected termite activity and potential damage to timber elements within the building.

The lack of a durable notice may be due to removal during renovations, age of the property, or the absence of a compliant termite management system at the time of construction. Regardless of the cause, this represents a gap in termite risk management and ongoing building protection.

It is recommended that a licensed pest management technician be engaged immediately to assess whether a termite management system is present and functioning. Where a system exists, the technician should confirm its type, condition, and maintenance requirements and install a compliant durable notice in accordance with current standards.

If no termite management system is identified, it is strongly recommended that an appropriate termite protection system be installed and documented. Regular inspections and maintenance should then be undertaken to reduce the risk of future termite infestation and associated structural damage.

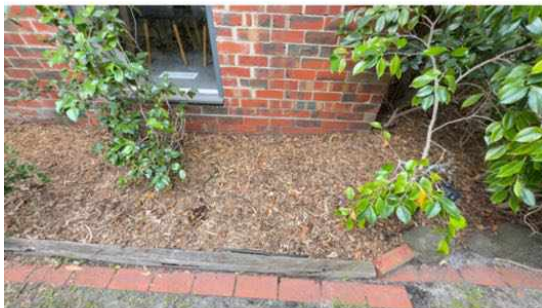
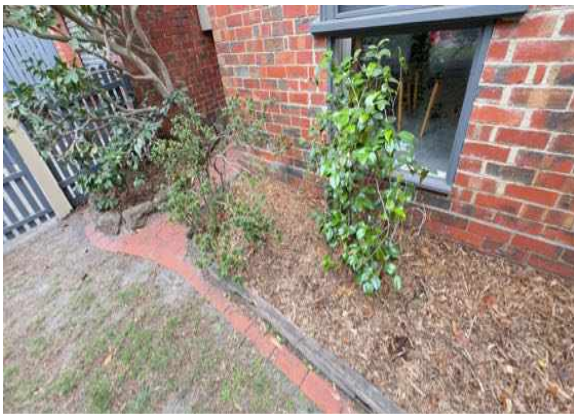
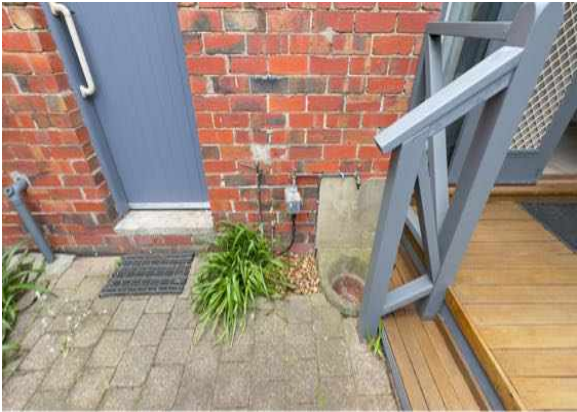
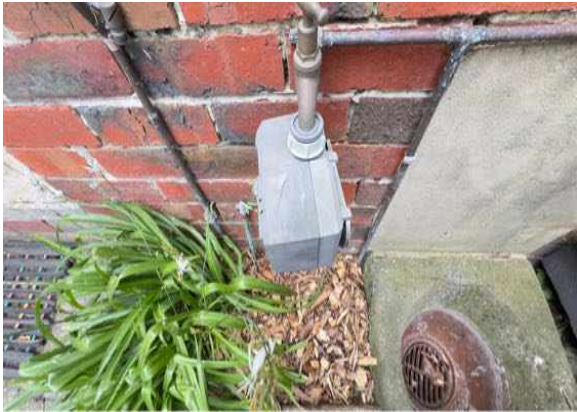
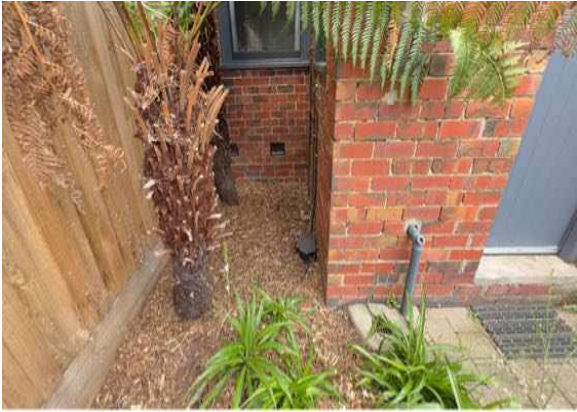
Finding 6.02

Building:	Main Building
Location:	All External Areas
Finding:	Timber Pests - Bridging Of Termite Barrier Found
Information:	During the inspection, bridging of the termite barrier was observed in certain areas. Bridging occurs when external elements, such as soil, vegetation, garden beds, or timber, make direct contact with the termite management system, effectively bypassing the barrier's protective function. This compromises the barrier's ability to prevent termites from accessing the building and can increase the risk of infestation.

The possible causes of bridging include poor landscaping practices, where soil or mulch is piled too high around the perimeter of the building, or growth of plants with roots extending into the barrier area. In some cases, structural movement or settling of the soil may also cause previously effective barriers to become bridged. The presence of bridging provides a direct path for termites to bypass the chemical or physical barrier, potentially leading to hidden infestation.

*Bridging is a significant issue as it negates the effectiveness of termite barriers, leaving the building vulnerable to termite attacks. If left unaddressed, termites can find entry points through the bridged areas, leading to structural damage and potential long-term problems for the property. Since termites can go undetected for extended

periods, the damage caused by such infestations can be costly to repair.

It is strongly recommended that a licensed pest management specialist or termite professional be engaged immediately to assess the termite barrier and address the bridging issue. This may involve removal of bridging materials, adjustment or repair of the barrier, and ensuring that the area around the barrier is clear of any materials that could facilitate termite entry.

In addition to addressing the bridging issue, it is also crucial to inspect the property for signs of termite activity immediately and consider replacing or reapplying the termite barrier to ensure it is still effective. Regular maintenance and monitoring of the barrier are recommended to prevent future issues and ensure long-term protection against termites.

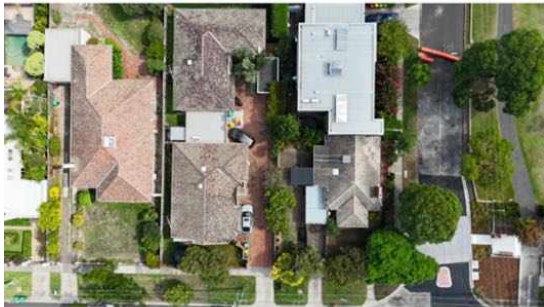
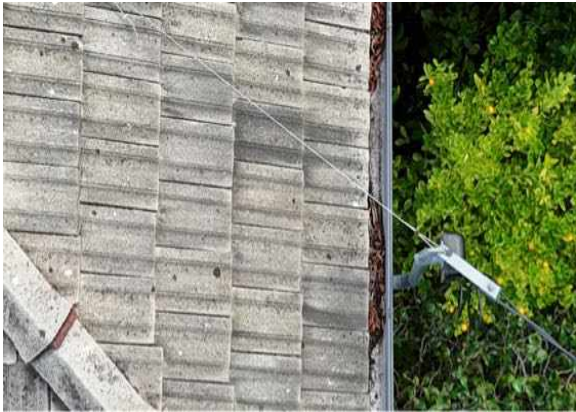
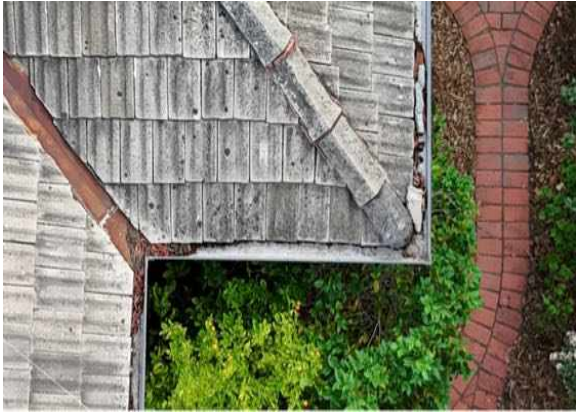
Finding 6.03

Building: Main Building
Location: All External Areas
Finding: Timber Pests - Conducive Conditions - Gutters Blocked
Information: During the inspection, gutters were observed to be blocked, resulting in water overflow and poor roof drainage. Blocked gutters are a significant concern as they can cause moisture to accumulate around roof edges, fascia boards, wall cavities, and subfloor areas. Persistent moisture in these locations creates conditions highly conducive to timber pest activity, including termites, borers, and fungal decay.

The blockage is likely due to the accumulation of debris such as leaves, dirt, and organic matter. When gutters are unable to discharge water effectively, overflow can lead to concealed moisture penetration into building elements, reducing timber durability and increasing vulnerability to pest attack.

Moisture-related conditions of this nature substantially increase the risk of timber pest infestation and can accelerate deterioration of structural timbers if left unaddressed, potentially leading to progressive damage and higher repair costs.

It is recommended that a qualified roofing contractor or competent handyman be engaged promptly to clear and service all gutters and downpipes and ensure effective drainage away from the building. Ongoing gutter maintenance, in conjunction with regular timber pest inspections, is essential to reduce moisture-related risks and protect the long-term integrity of the structure.

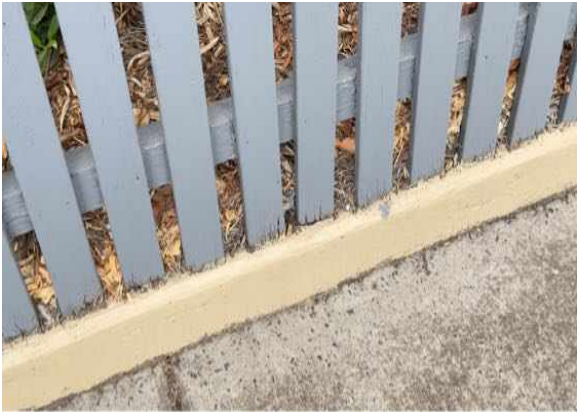
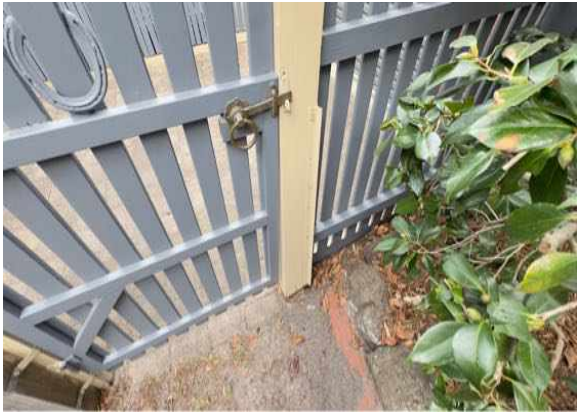
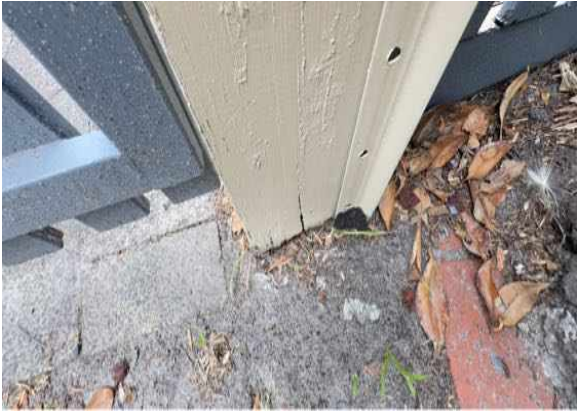
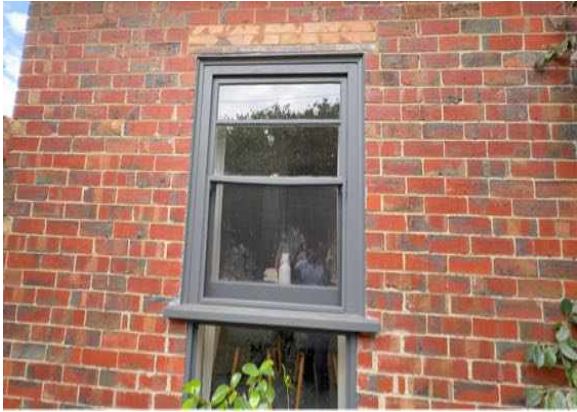
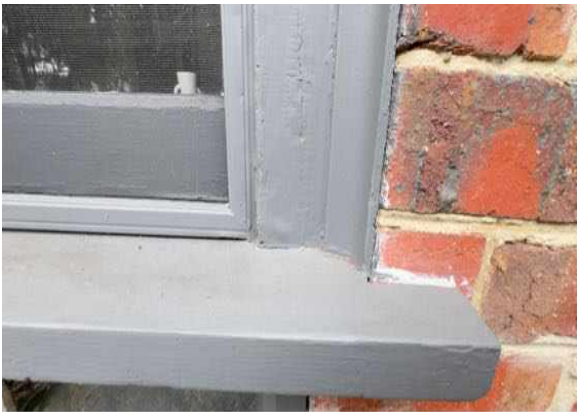
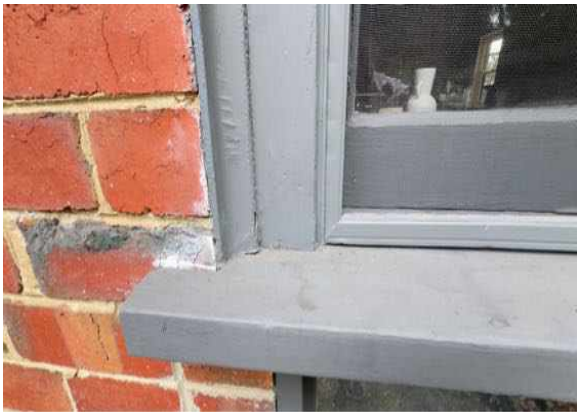
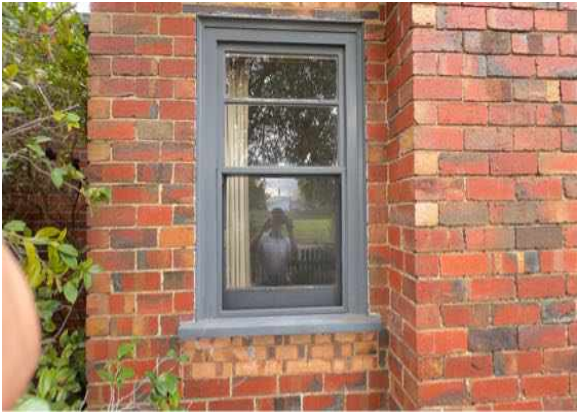
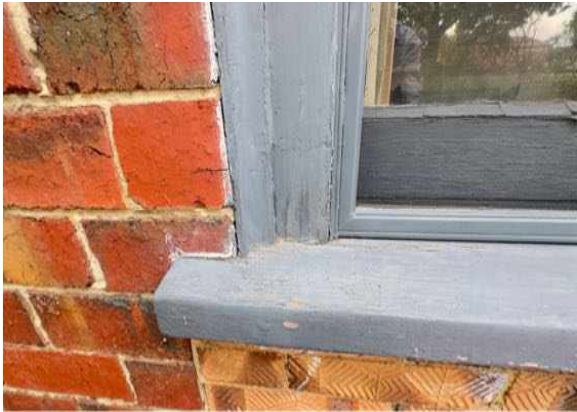
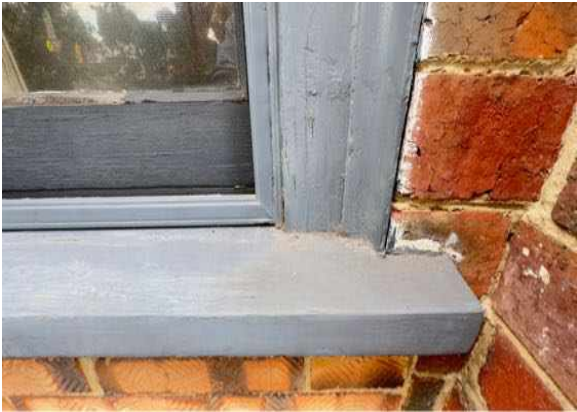
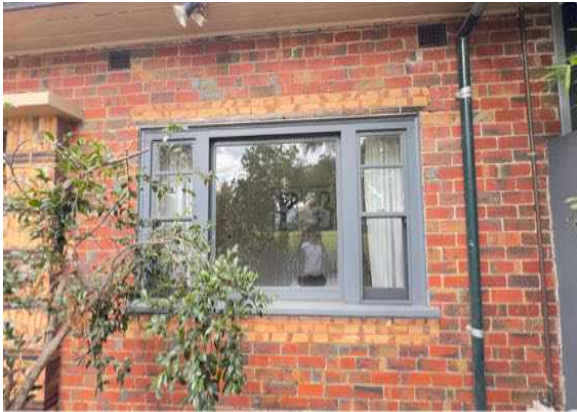
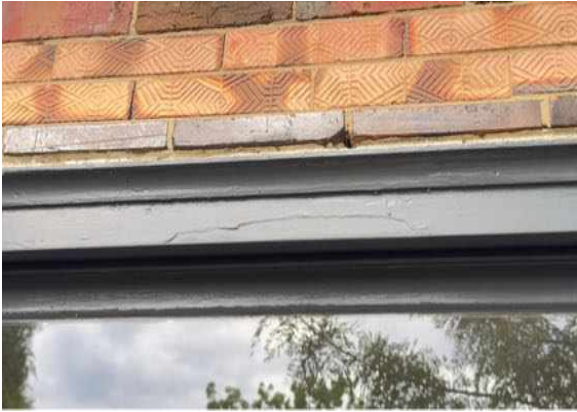
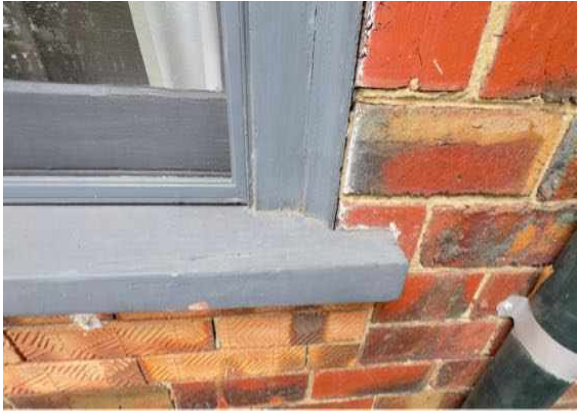
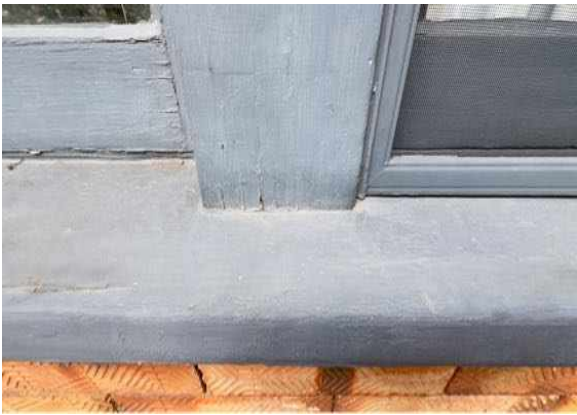
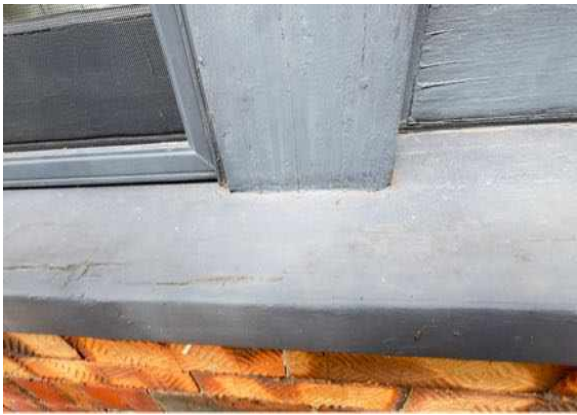
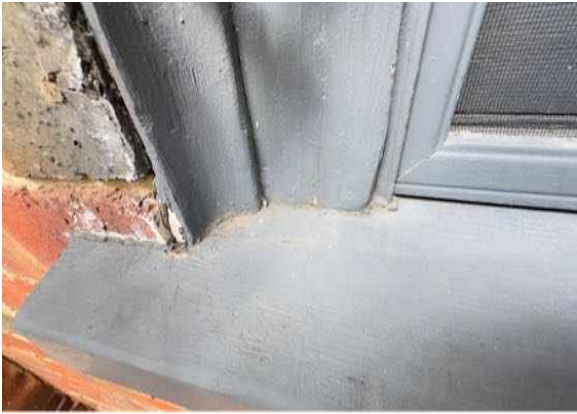
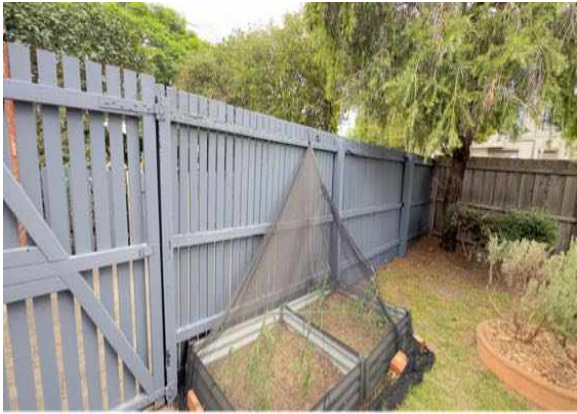
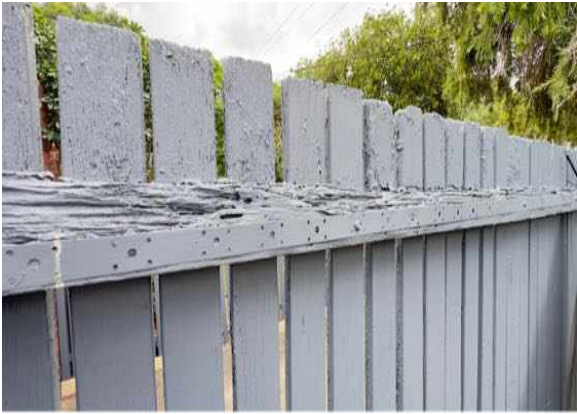
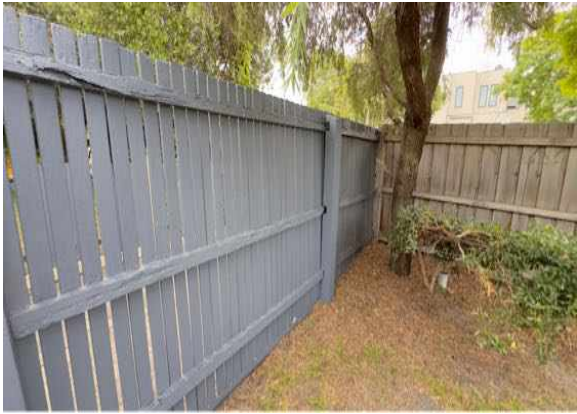
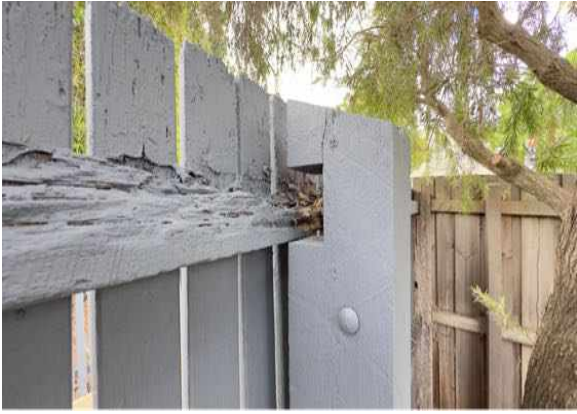
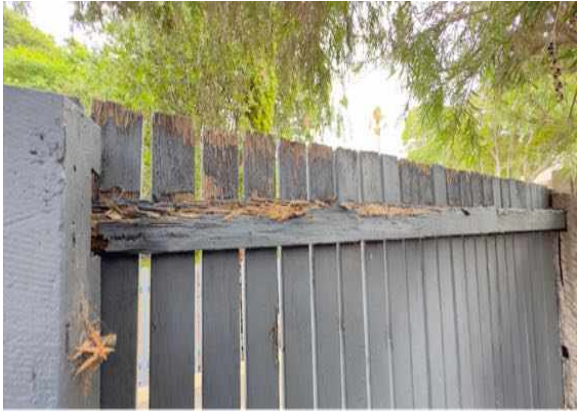
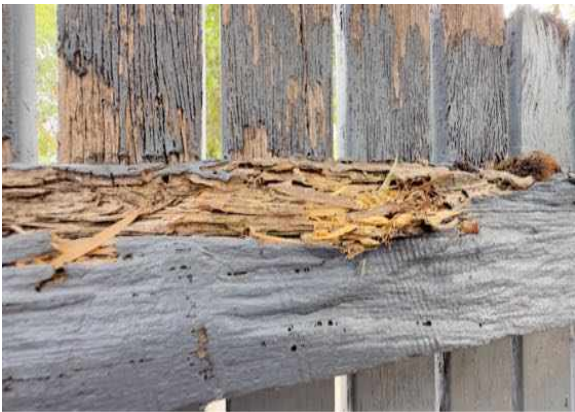
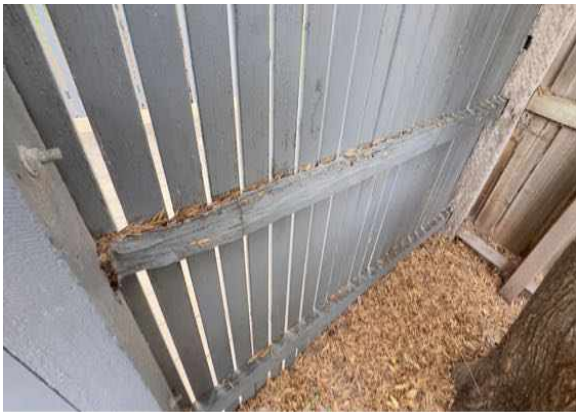
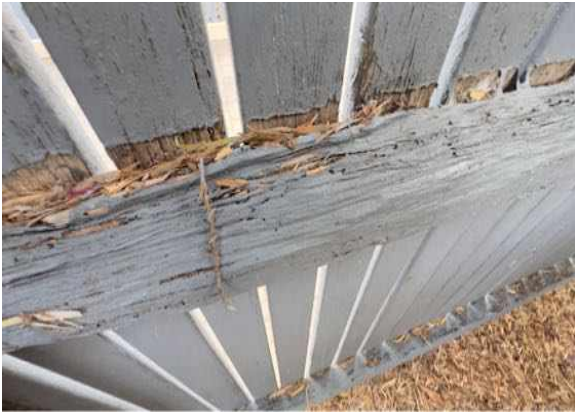
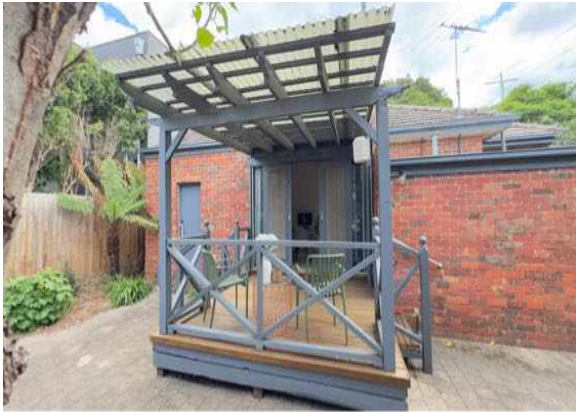
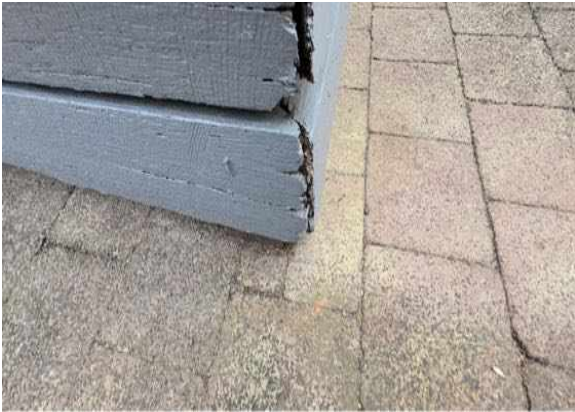
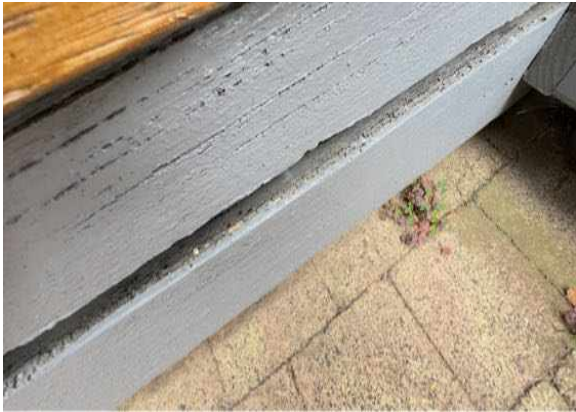
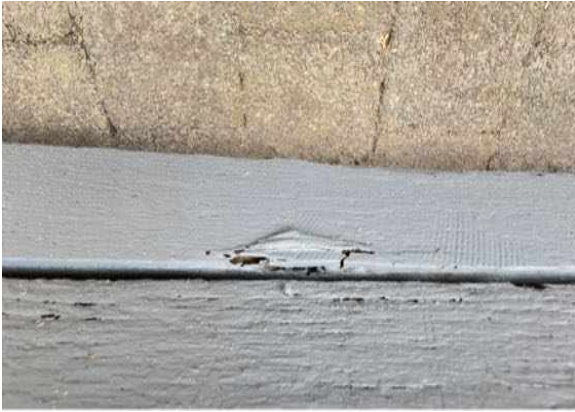
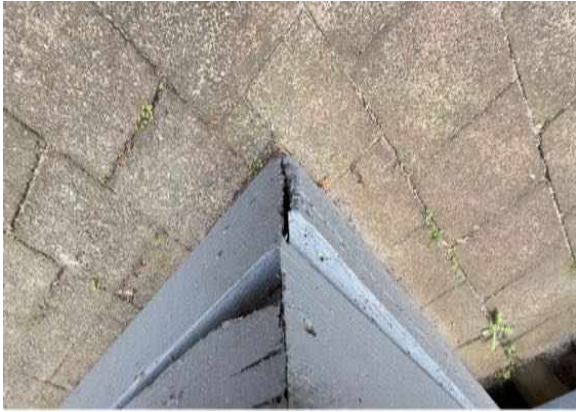
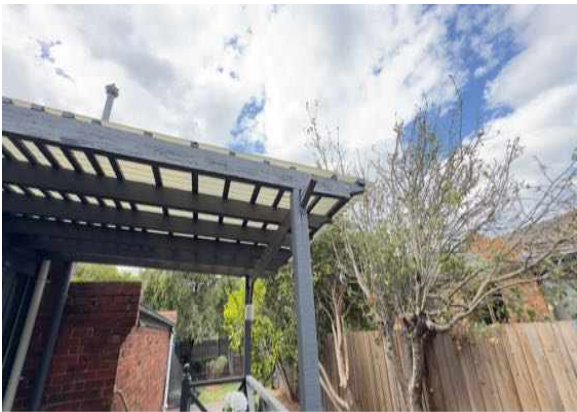
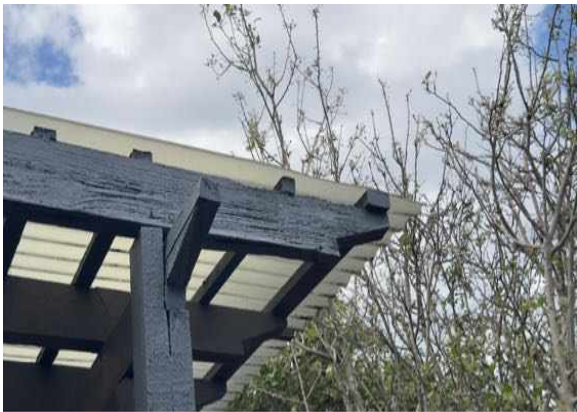
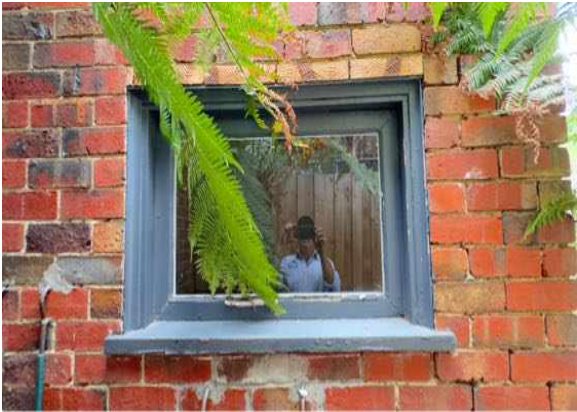
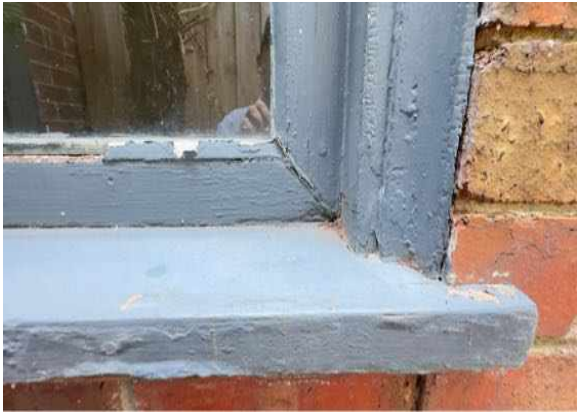
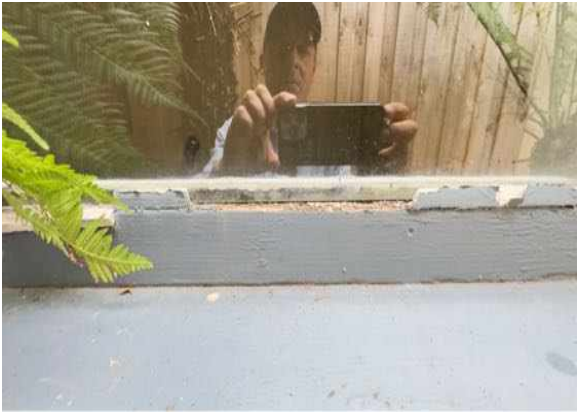
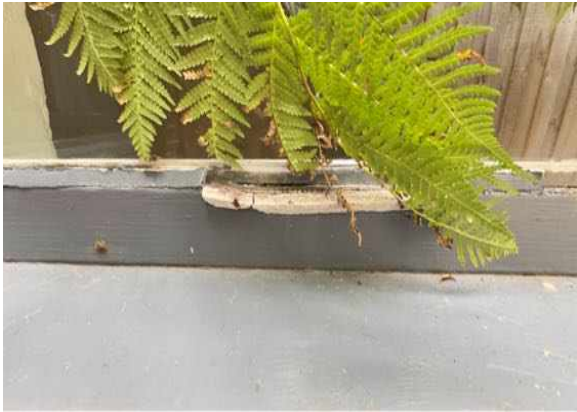
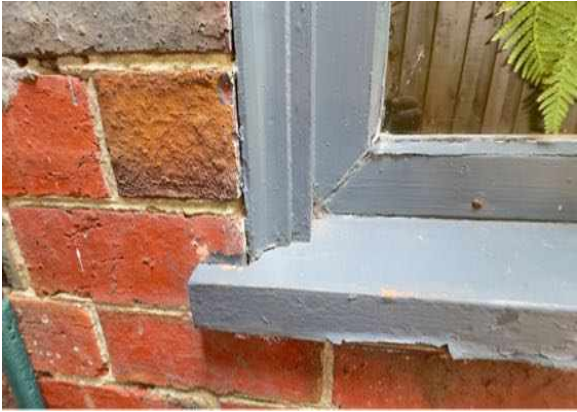
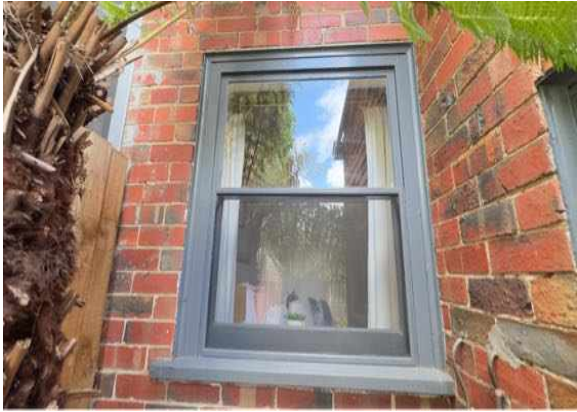
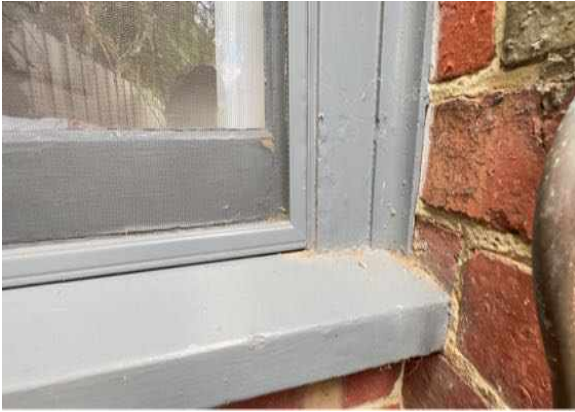
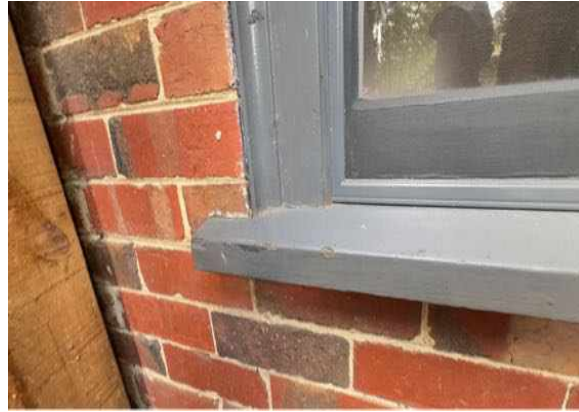
Building:	Main Building
Location:	All Areas
Finding:	Timber Pests - Conducive Conditions - Timber Rot
Information:	Timber elements on the exterior, including wall cladding, landscaping timbers, and other surfaces were inspected and show signs of rot, decay and fungal attack. Softening, discoloration, splitting, and moisture penetration indicate ongoing timber degradation.

This is likely caused by prolonged moisture exposure, inadequate protective coatings or maintenance, direct contact with soil or water, or poor detailing that traps water or limits ventilation.

If left unaddressed, the affected timber may lose structural integrity, leading to progressive decay, potential collapse of walls, decks, or landscaping features, mould growth, and reduced durability and appearance of the building exterior.

A registered builder or timber specialist should inspect the affected areas immediately to determine the extent of damage. Damaged timbers should be repaired or replaced, protective treatments applied, and drainage or detailing corrected to prevent recurrence. Ongoing monitoring and urgent remedial action are required to prevent further deterioration.
