Building and Timber Pest Inspection Report

Inspection Date: Wed, 25 Mar 2026

Property Address: 18B Marara Rd, Caulfield South VIC 3162,
Australia

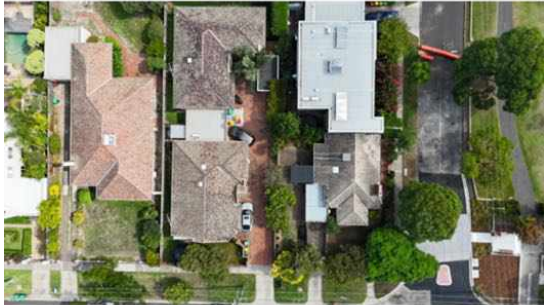
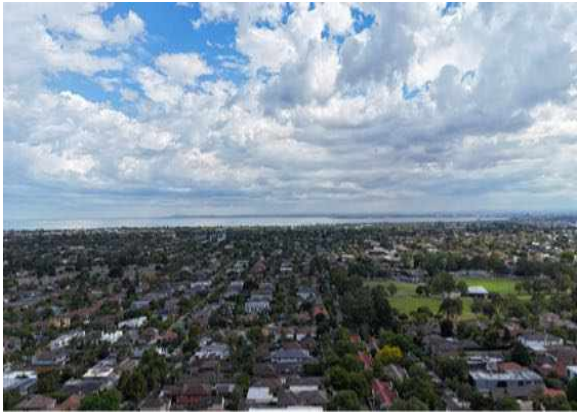
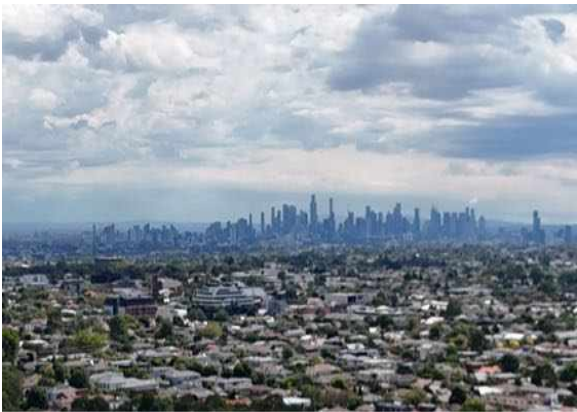
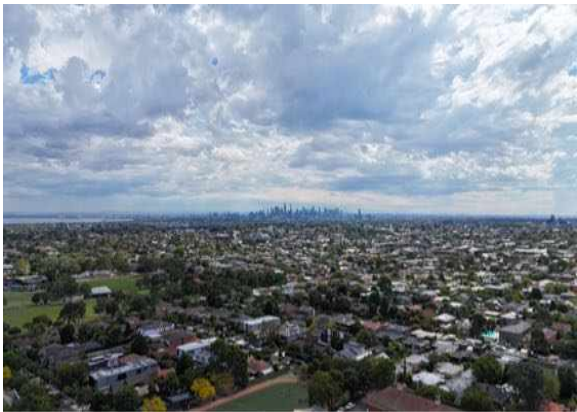
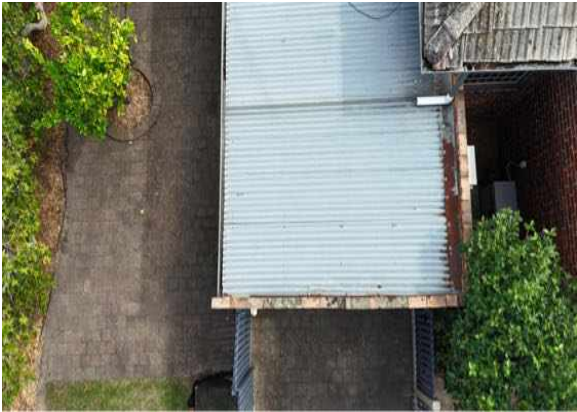
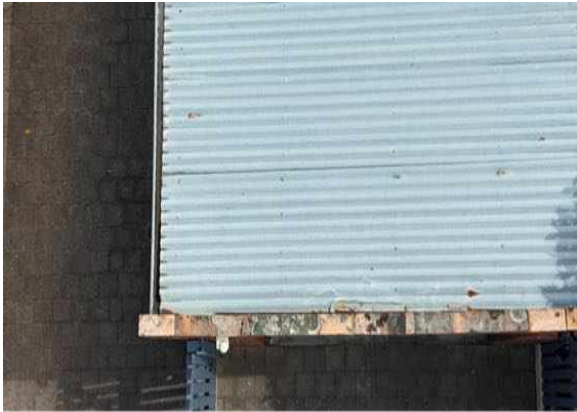
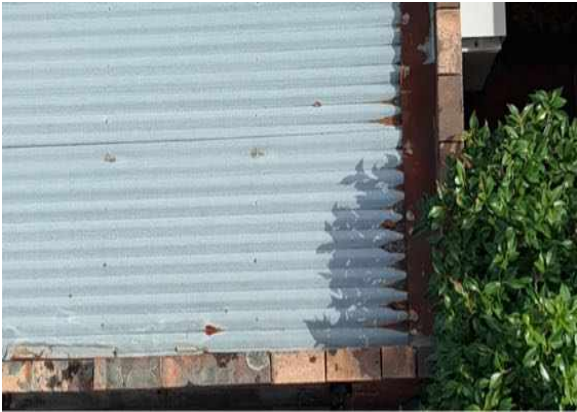
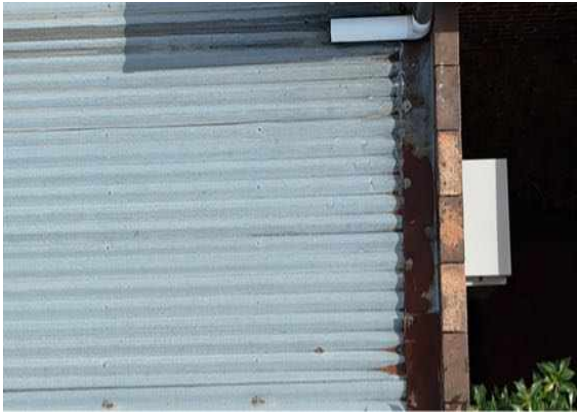
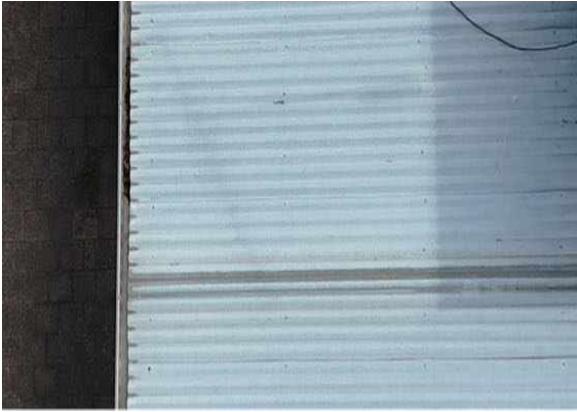
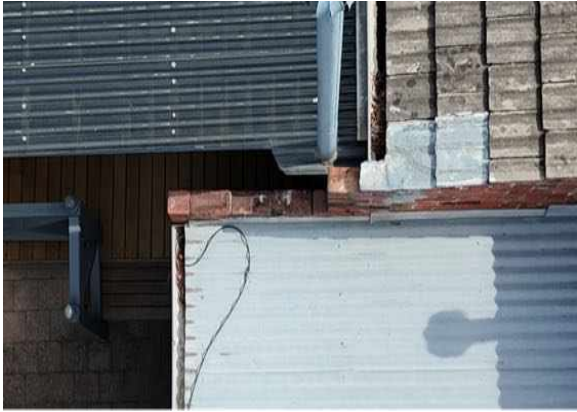
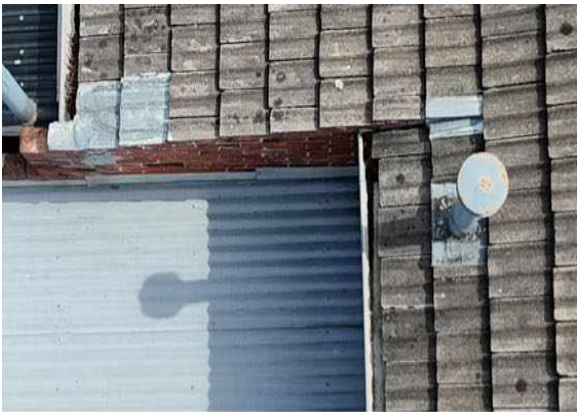
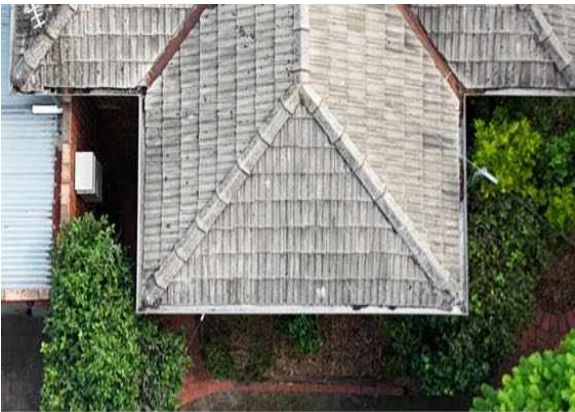
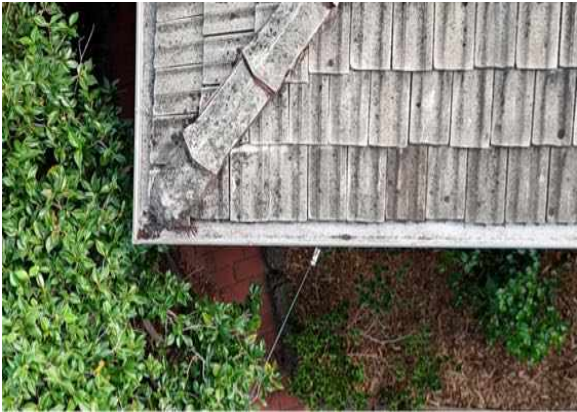
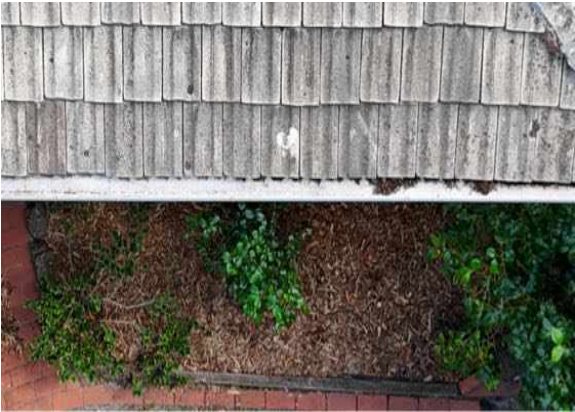
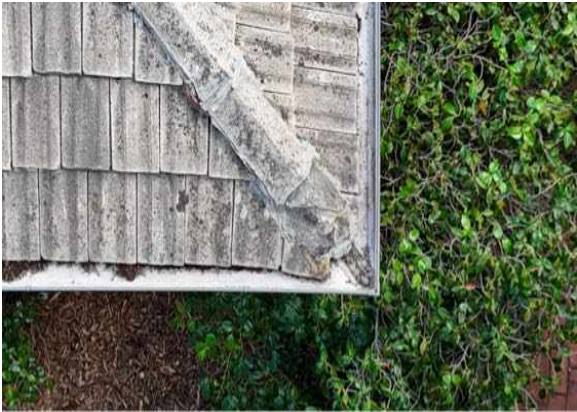
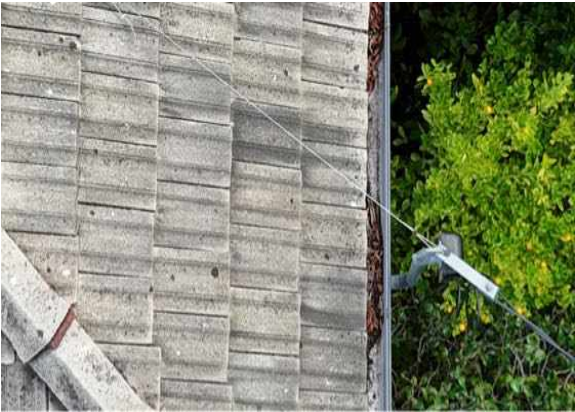
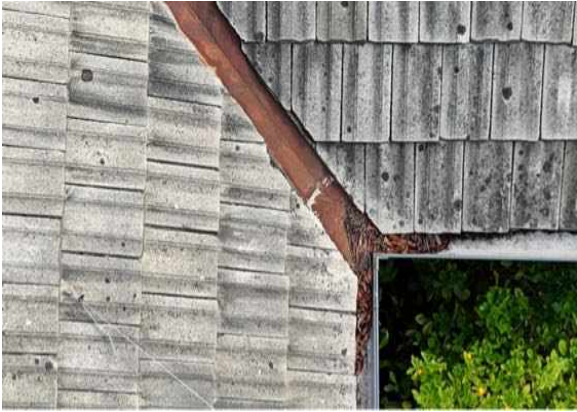
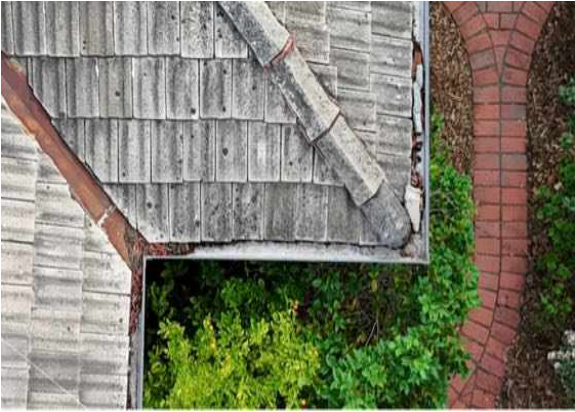
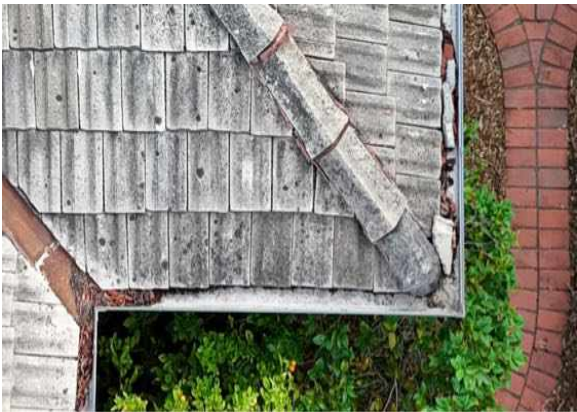
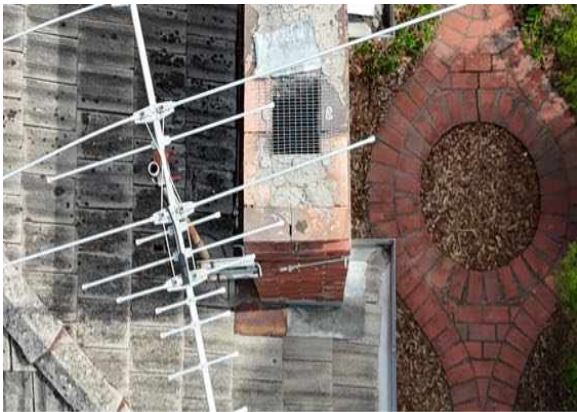
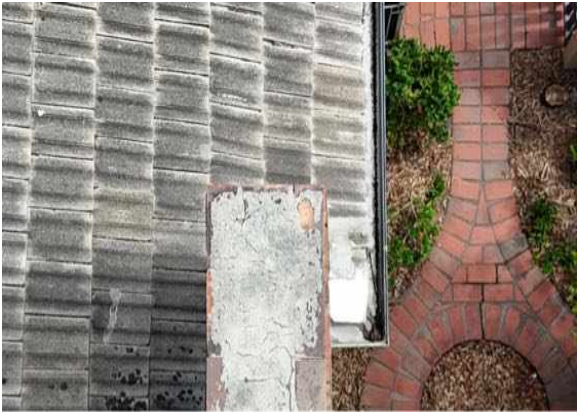
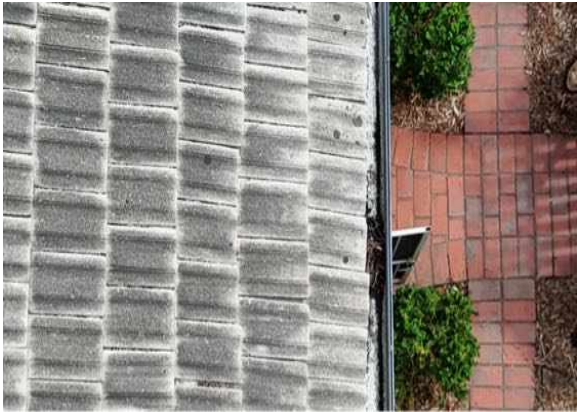
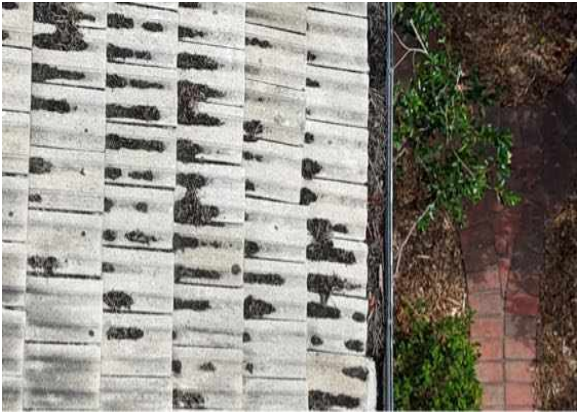
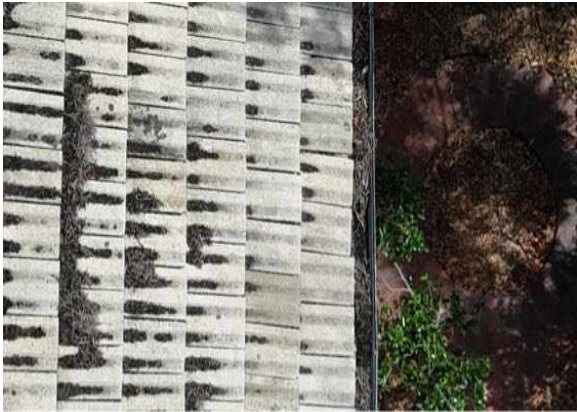
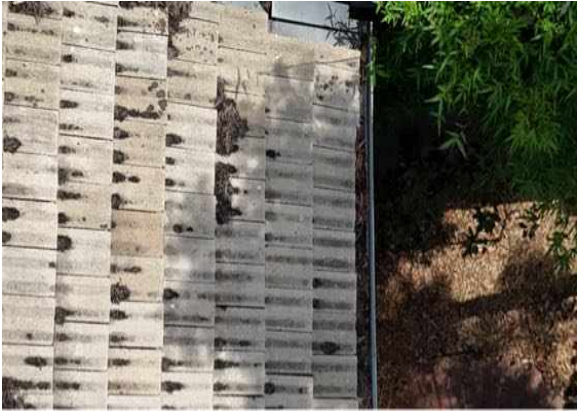
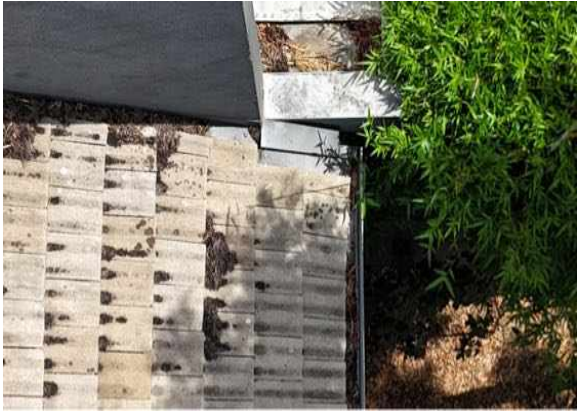
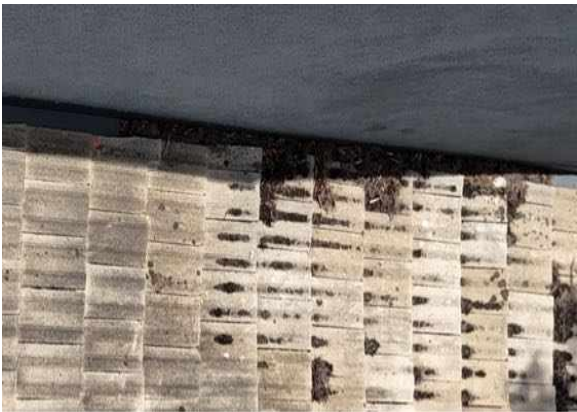
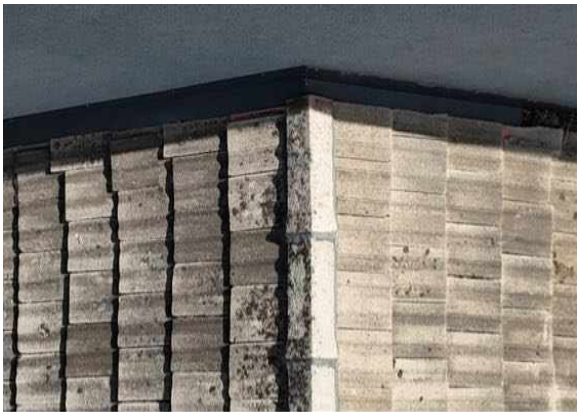
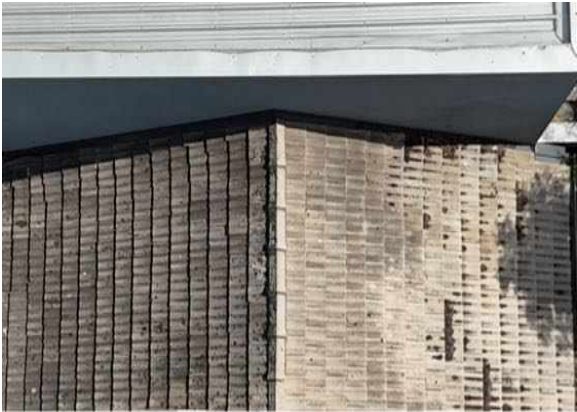
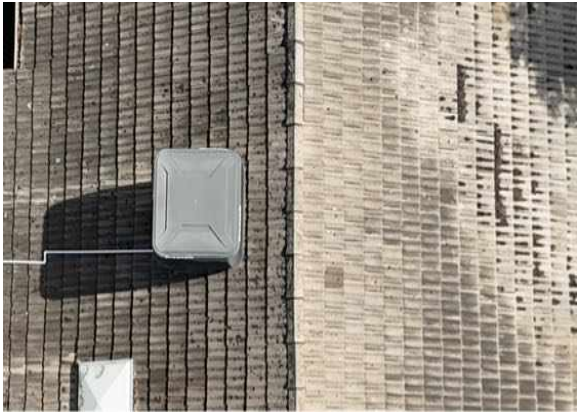
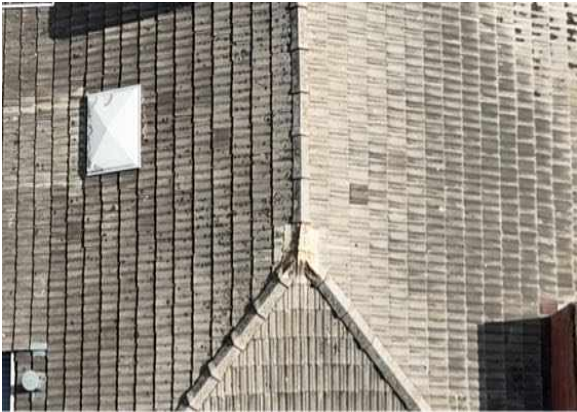
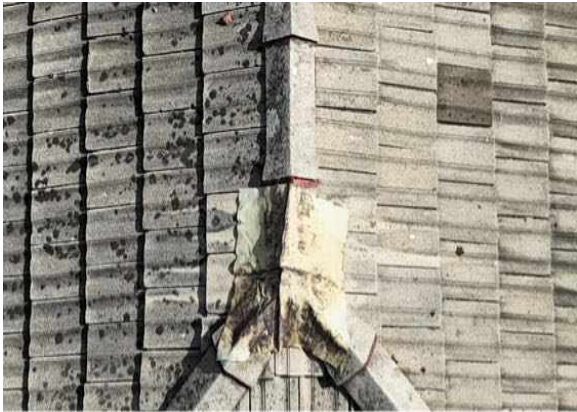
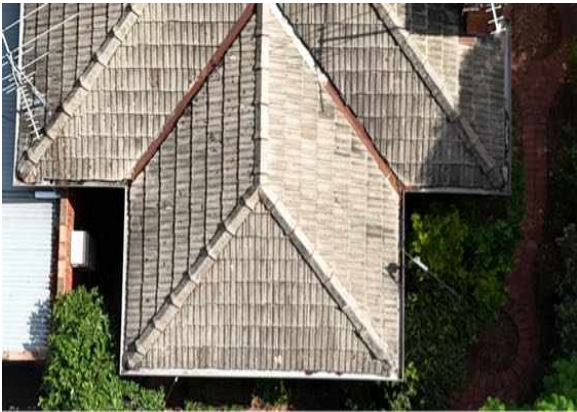
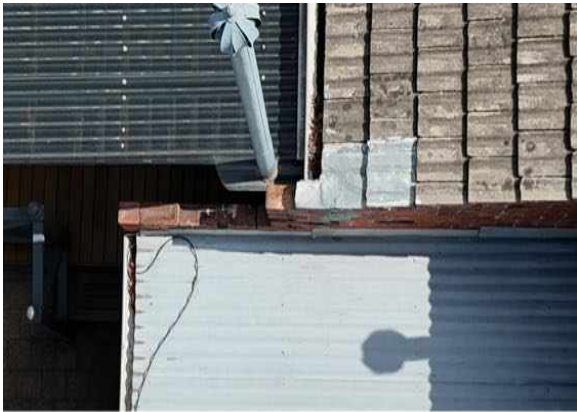
Please note that photographic images may not capture the full extent of site conditions, levels of deterioration, or concealed defects. Roof coverings and components can only be properly assessed through physical inspection, and some areas may be inaccessible due to height, pitch, safety constraints, or limited access at the time of inspection.

If there are any concerns regarding the roof structure, coverings, flashings, drainage, or associated elements, further assessment by a licensed roofing contractor is recommended immediately.

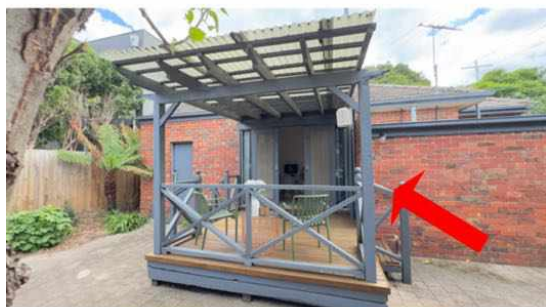
Building:	Main Building
Location:	All Areas
Finding:	Building Approvals – Prior Renovations Advisory
Information:	For your information, the dwelling has undergone several renovations over the past years. Evidence of multiple alterations and upgrades was observed at the time of inspection. The inspection did not include verification of council approvals, permits, or compliance documentation for these works.

Unapproved or undocumented renovations may present compliance, safety, insurance, or resale risks if not properly approved or certified.

It is strongly recommended to make enquiries with the relevant local council immediately and engage appropriately qualified professionals, where necessary, to confirm that all historic renovations were carried out with the required permits, approvals, and certifications.

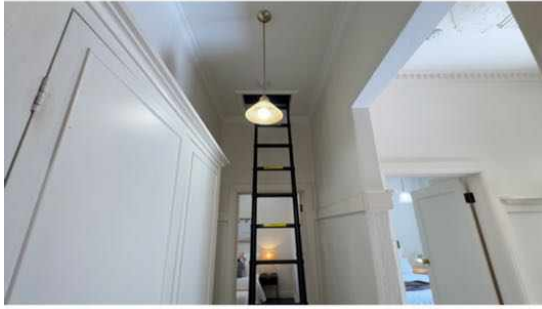
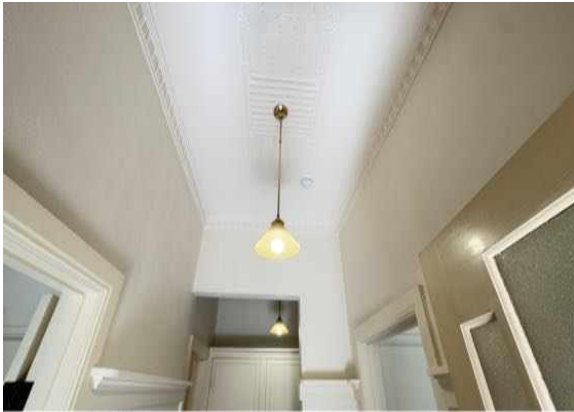
Building:	Main Building
Location:	All Internal Areas
Finding:	Smoke Detectors - Advisory
Information:	During the inspection, smoke detectors were noted for advisory purposes only. The operation, age, type, and compliance of smoke detectors could not be fully verified as part of this inspection.

Smoke detectors are critical life-safety devices, and non-compliant, outdated, or non-operational units may not provide adequate warning in the event of a fire.

It is recommended that a licensed electrician be engaged immediately to test, service, and upgrade smoke detectors as required to ensure correct operation and compliance with current safety requirements.

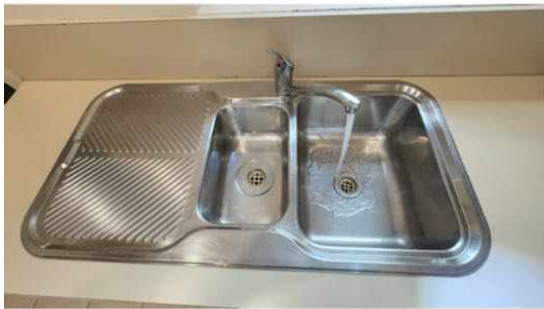
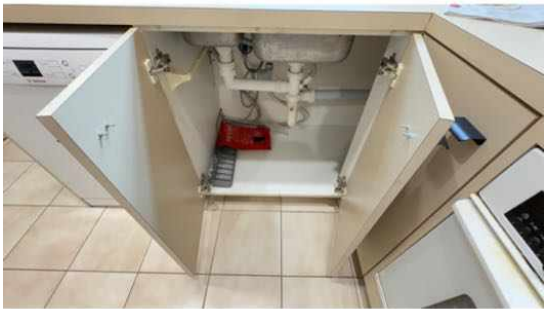
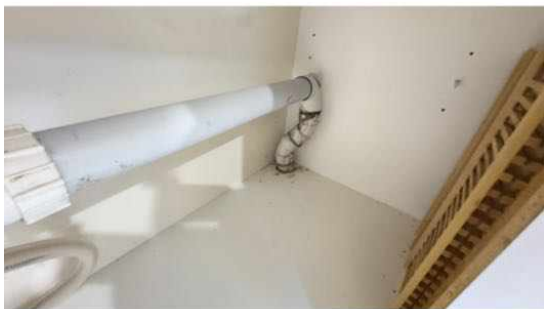
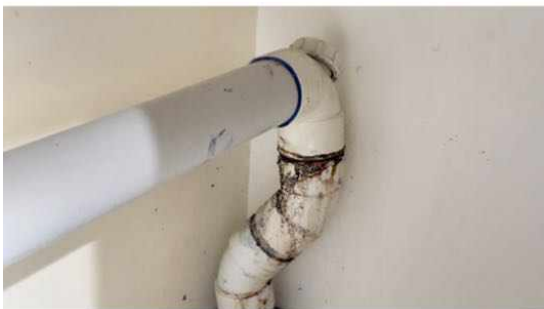
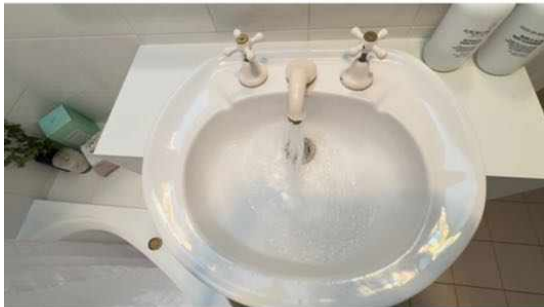
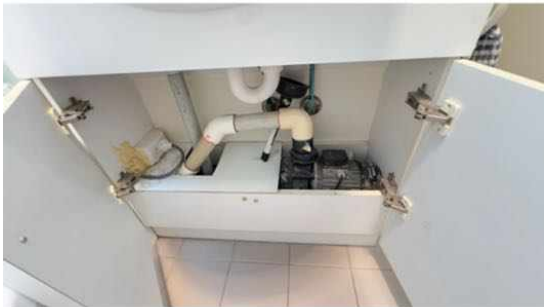
Building: Main Building
Location: All Internal Areas
Finding: Water Supply & Drainage - Shower, Basins, Toilets, & Plumbing Fixtures
Information: The shower recess was tested, and no visible water penetration to surrounding areas was observed at the time of inspection, except where noted as a separate defect elsewhere in this report. Water appeared to flow freely toward the floor waste. Moisture detected to the shower walls is documented separately in the report. The shower floor waste appeared clear during inspection.

Flushing the toilet revealed no visible leaks, and the fixture appeared to operate normally unless otherwise noted as a separate defect. No water damage was observed to the vanity unit unless specifically stated elsewhere in the report. Basins, bathtubs, laundry tubs, vanities, and sinks were tested and inspected with no evidence of leaks, blockages, or drainage issues at the time of inspection unless otherwise noted. All internal taps and shower heads were tested with no leaks observed, unless documented as a separate defect.

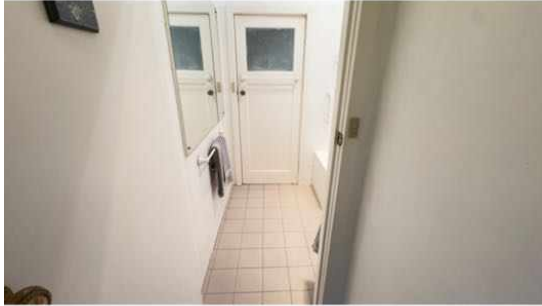
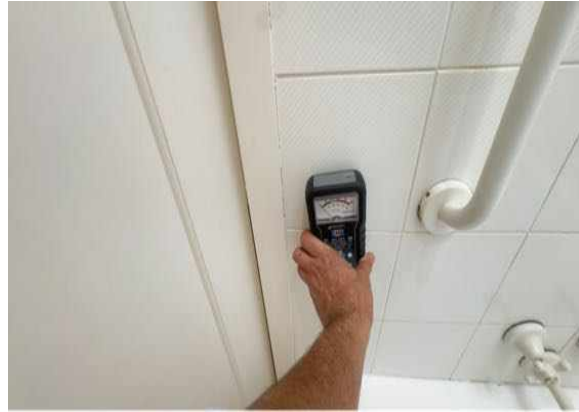
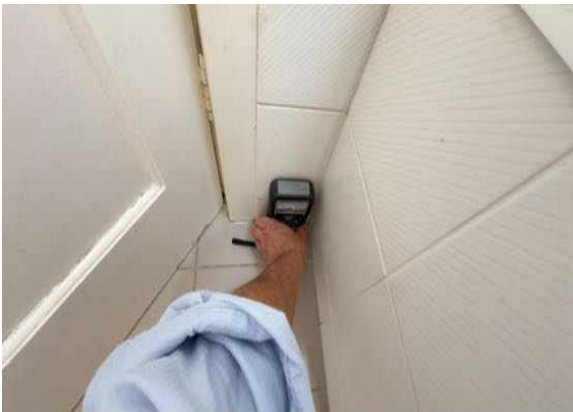
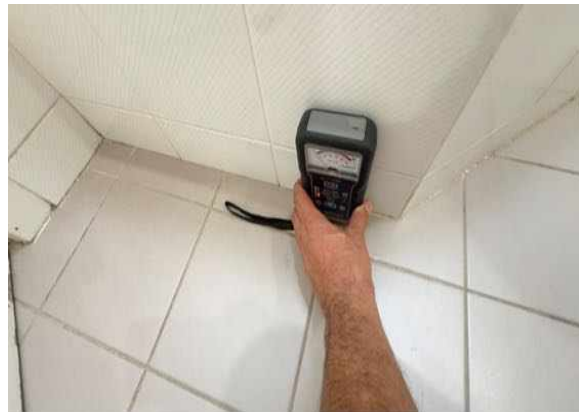
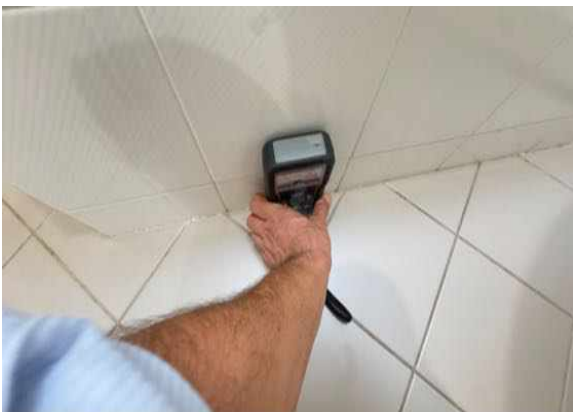
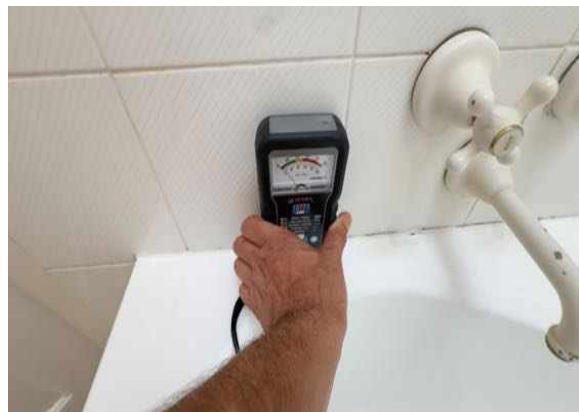
Building: Main Building
 Location: All Areas Interior & Exterior
 Finding: Moisture Levels - Advisory - No Elevated Moisture Levels Present
 Information: At the time of inspection, no elevated moisture levels were detected in these areas. Moisture readings were taken (using a Tramex Moisture Meter) and non-invasive testing methods and reflect conditions present at the time of inspection only. This item is noted for advisory purposes and should not be relied upon as a guarantee that moisture issues are not present elsewhere or may not occur in the future.

It is important to note that moisture levels can fluctuate due to weather conditions, plumbing usage, seasonal changes, or intermittent leaks. Concealed moisture within

wall cavities, subfloor areas, or other inaccessible locations may not be detected during a visual or limited moisture assessment.

Ongoing monitoring of the property is recommended, and further investigation by a qualified tradesperson should be considered if signs of water ingress, dampness, staining, mould growth, or material deterioration become apparent.

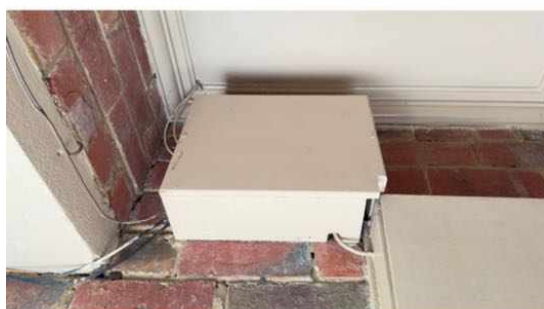
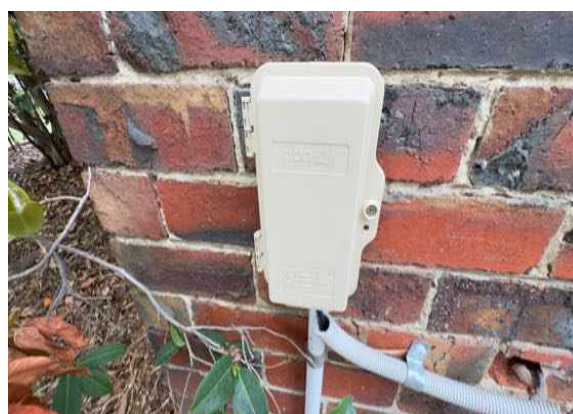
Building: Main Building
 Location: All Areas, Interior & Exterior
 Finding: Appliances, Heating & Cooling Systems, Mechanical Systems, Plumbing, Electrical, Fireplaces - Advisory
 Information: The inspection did not include testing, operation, safety, or assessment of any installed or portable appliances or mechanical systems. This includes, but is not limited to, ovens, cooktops, microwaves, rangehoods, dishwashers, ducted vacuum systems, air-conditioning units, heating systems, hot water services, ceiling fans, exhaust fans, intercoms, security systems, fireplaces, and solid fuel heaters.

Where appliances are beyond their warranty period, the owner should be prepared for potential costs of repair or replacement at any time. The operation of these appliances cannot be guaranteed, and further inspection by a licensed tradesperson may be required. Many appliances are only covered by limited manufacturer or installer warranties. Confirming warranty status is strongly recommended prior to purchase, as out-of-warranty items may require servicing, replacement, or certification by a qualified technician.

Appliances may be worn, damaged, or malfunctioning. Electrical or gas appliances can pose serious safety hazards if incorrectly installed or maintained.

Service, repair, or replace equipment as necessary, particularly where service history or warranty coverage is unknown.

Inspect any water, gas, or electrical connections associated with appliances to ensure safety and compliance.

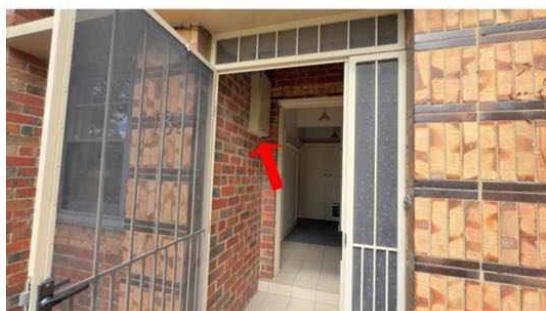
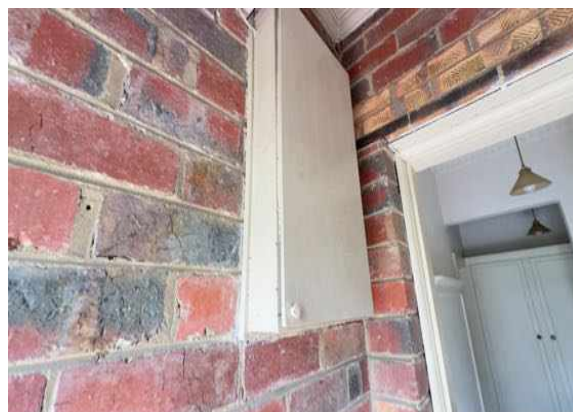
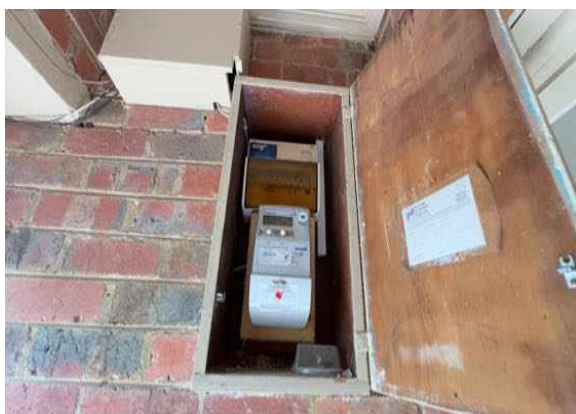
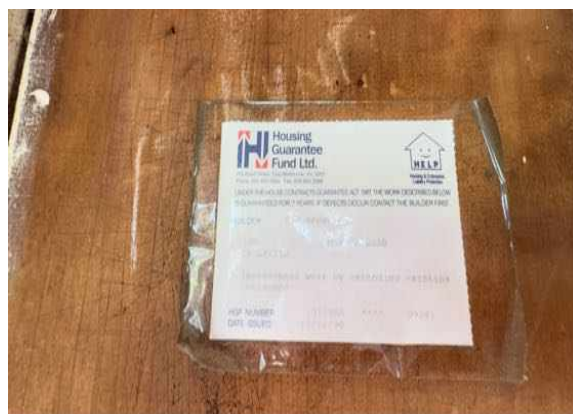
Building: Main Building
 Location: All External Areas
 Finding: Electrical Switch Board - Location
 Information: For your information, the main electrical switchboard was visually inspected. No intrusive testing or detailed electrical assessment was performed as part of this inspection.

For full compliance and safety verification, a licensed electrician should be engaged to inspect the switchboard, test all circuits, and ensure all components are functioning correctly. This will help maintain electrical safety and prevent potential hazards.

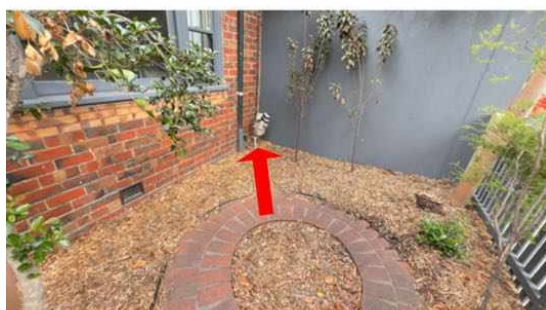
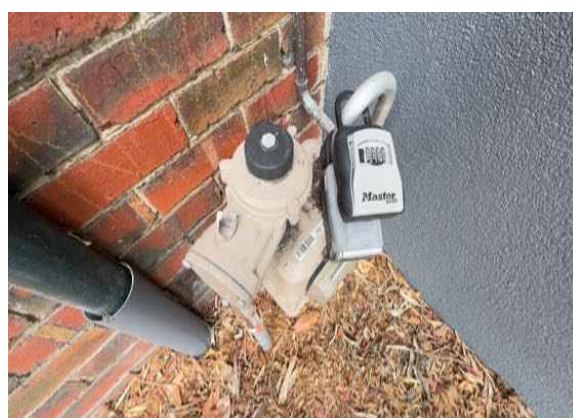
Building: Main Building
 Location: All External Areas
 Finding: Gas Meter - Location For Your Information
 Information: The gas meter was inspected and photographed for reference and location purposes only.

Gas meters can be affected over time by age, environmental exposure, or accidental impact, which may lead to corrosion, physical damage, leakage, or non-compliance with current regulations. Regular checks are recommended to ensure ongoing safe operation.

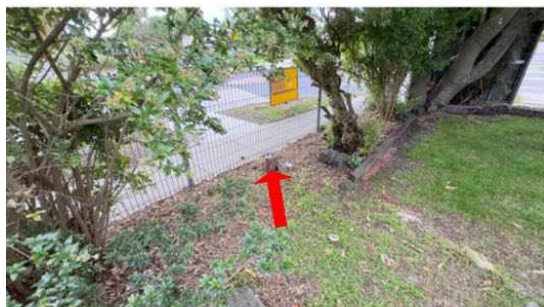
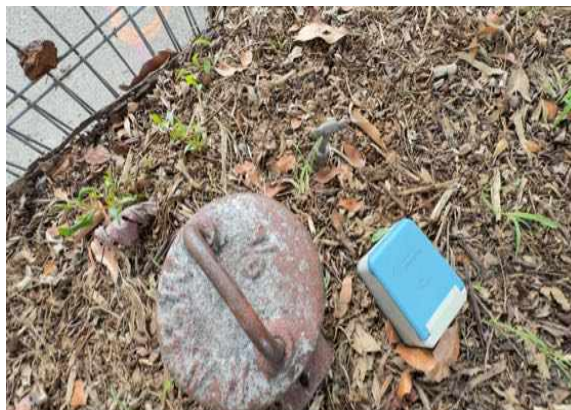
Building:	Main Building
Location:	All External Areas
Finding:	Water Meter - Location For Your Information Only
Information:	The water meter was photographed at the time of the inspection. The meter is included for reference & location purposes only.

Water meters can be affected over time by age, environmental exposure, accidental impact, or poor maintenance. Potential issues could include leaks, corrosion, or malfunction that may impact water supply or cause water damage.

It is recommended that a licensed plumber carry out routine inspections and maintenance to ensure continued safe and compliant operation. Observations are for informational purposes only and do not form part of a full safety or compliance inspection.

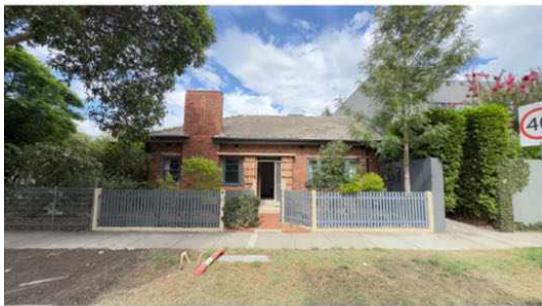
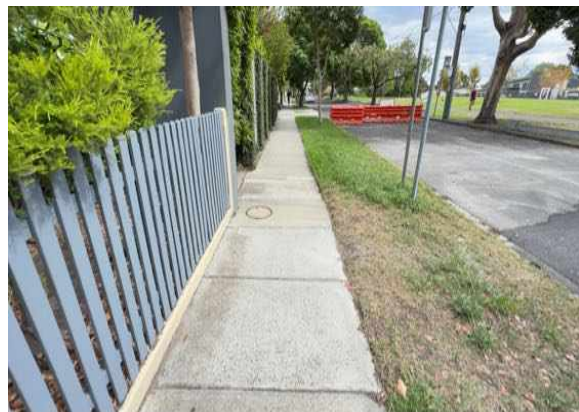
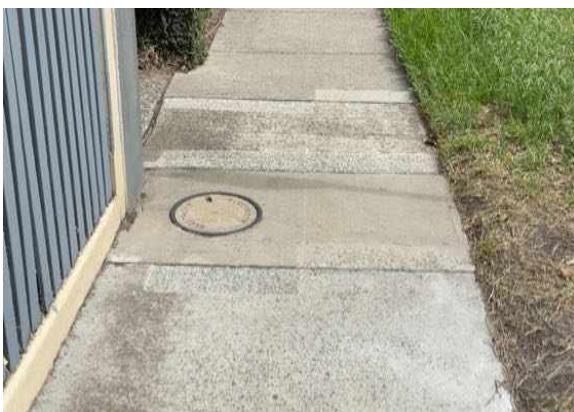
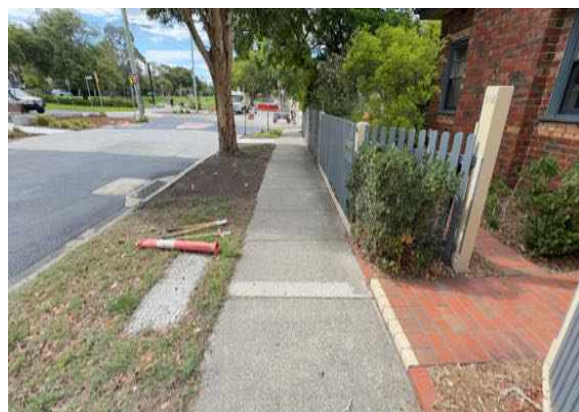
During the inspection, minor cracking, surface wear, or uneven sections were observed on footpaths or crossovers. Some accessible metal components, such as street signage or grates, showed signs of rust or deterioration. Debris accumulation and vegetation encroachment were also noted around council infrastructure. Access or visibility was limited to certain council-owned assets.

These areas should be monitored, and for detailed assessment, maintenance, or compliance verification, the relevant local council authority should be contacted immediately. Regular monitoring of adjacent council assets is recommended to ensure ongoing safety and proper maintenance.

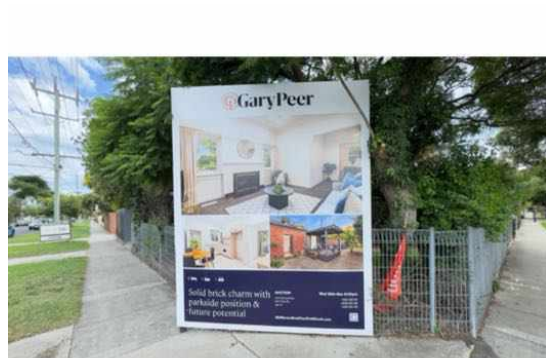
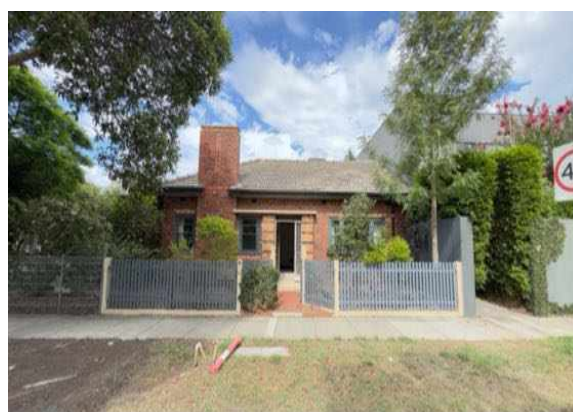
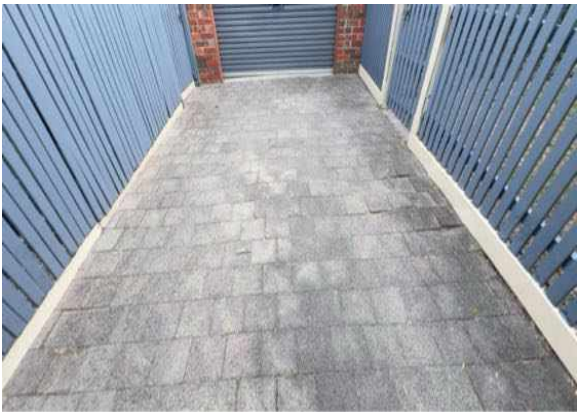
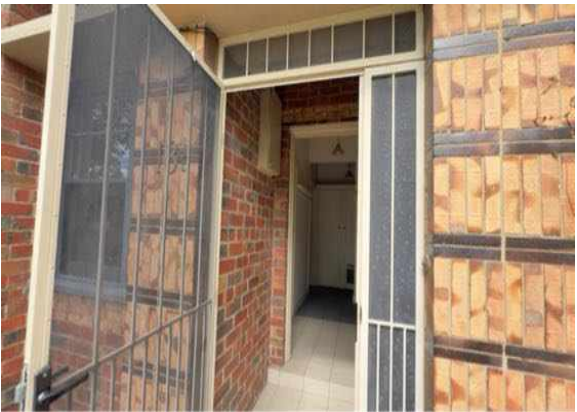
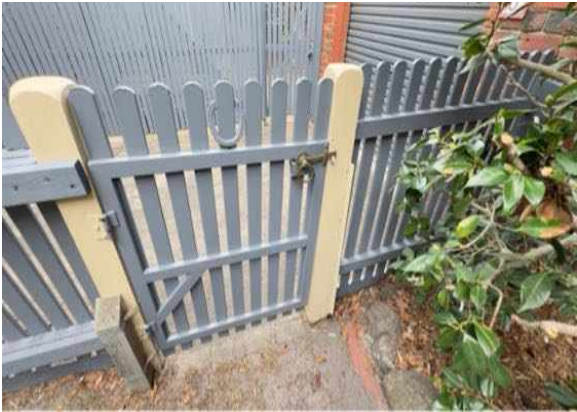
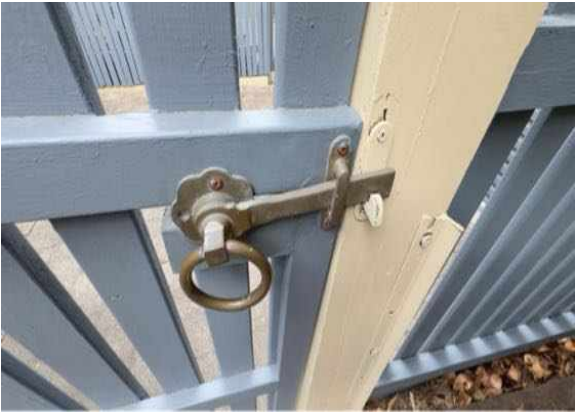
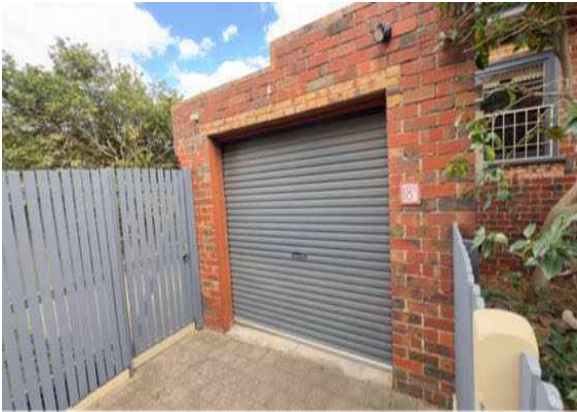
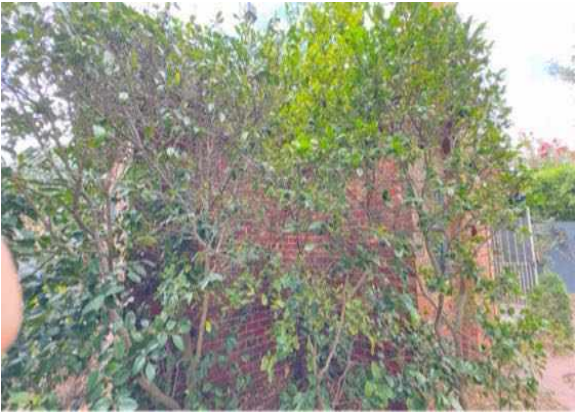
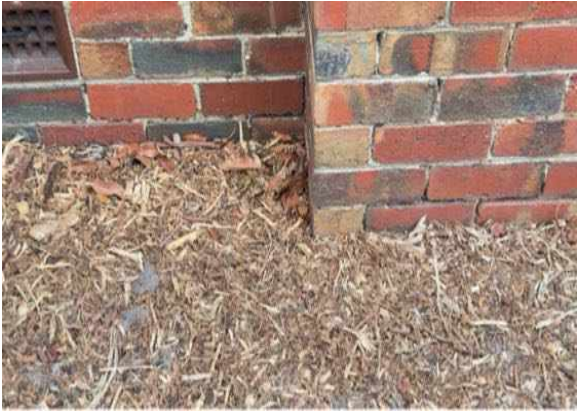
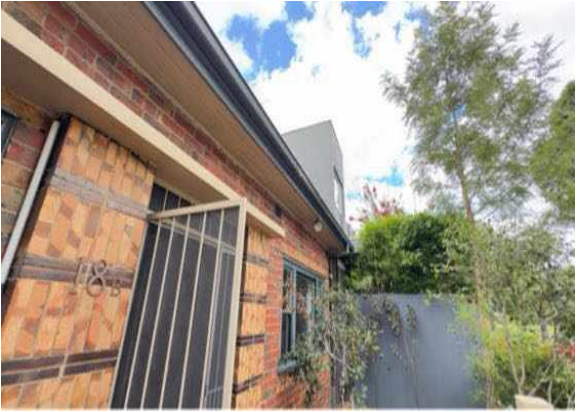
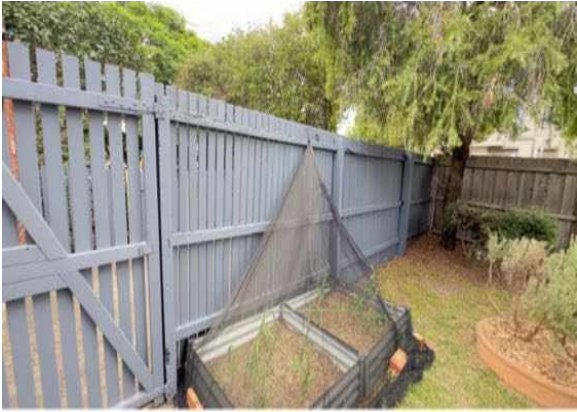
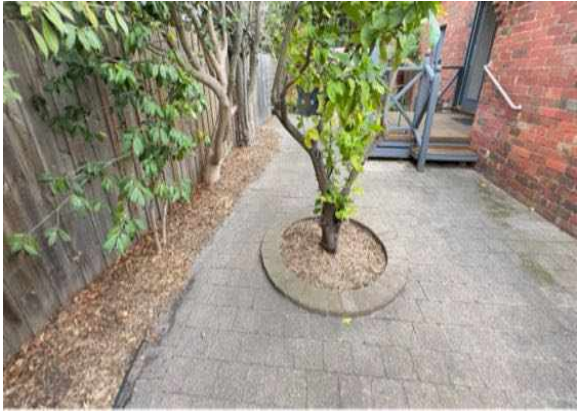
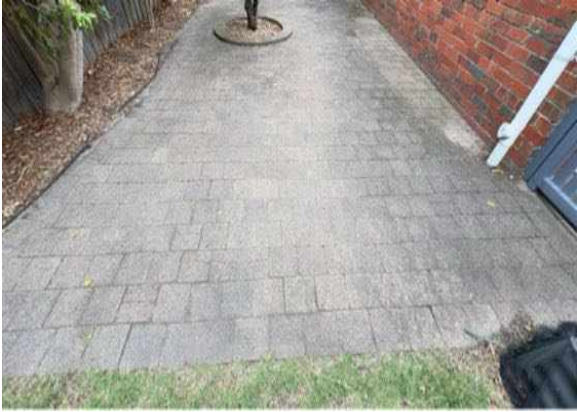
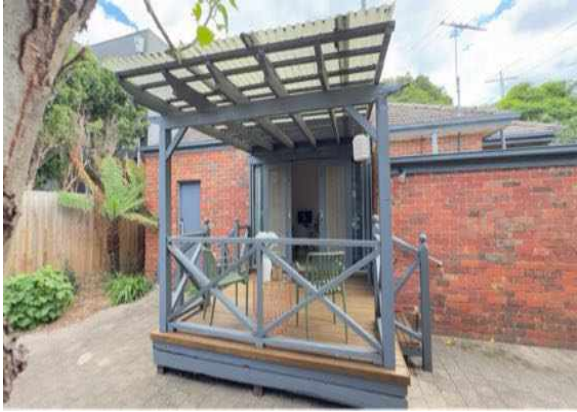
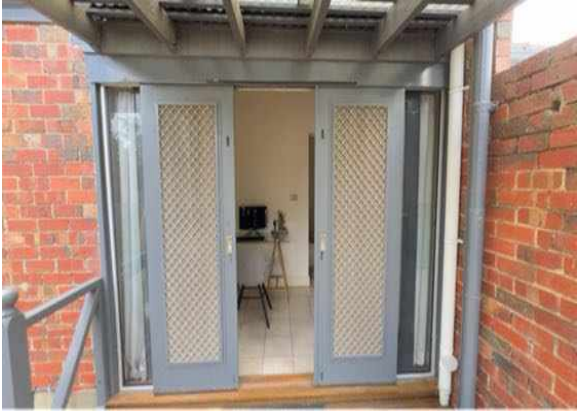
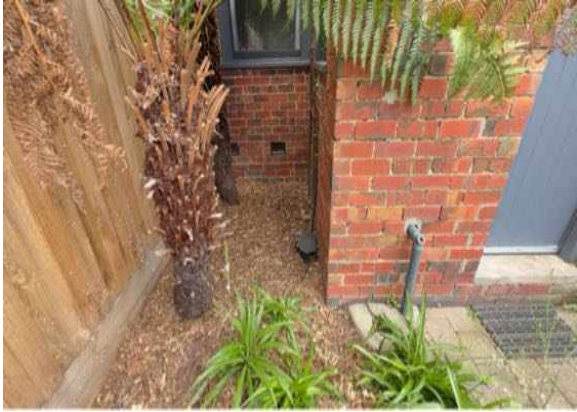
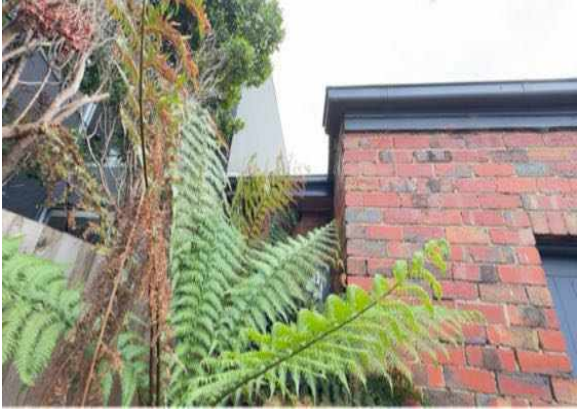
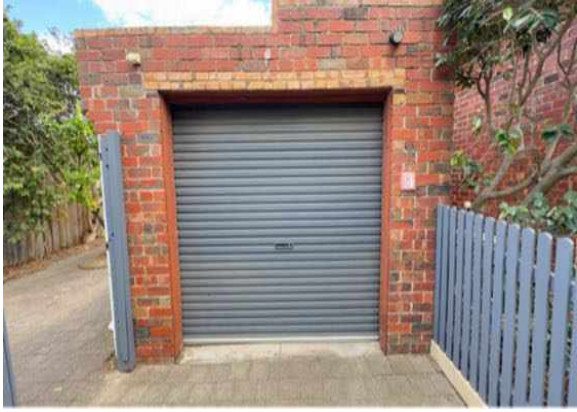
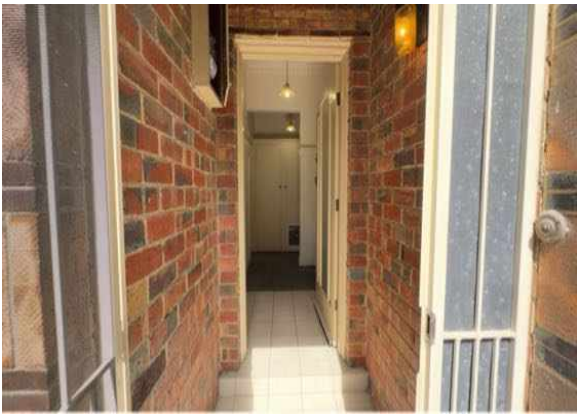
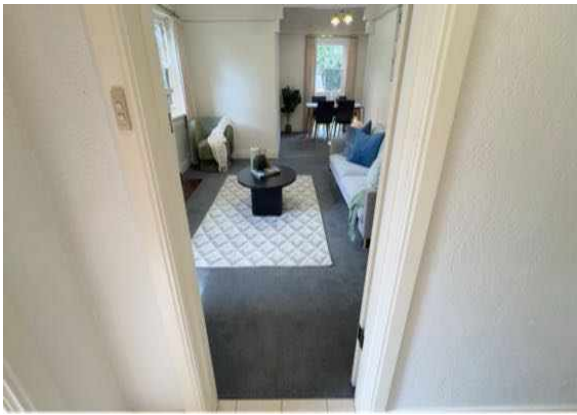
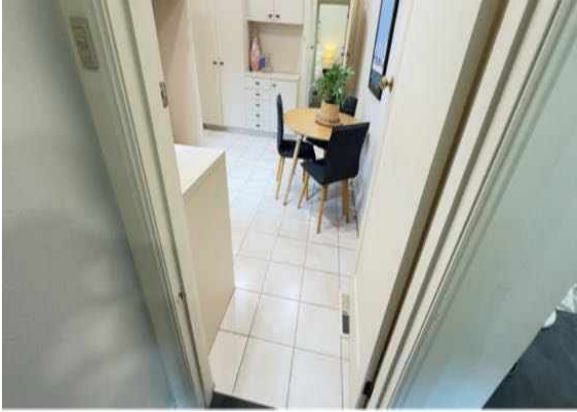
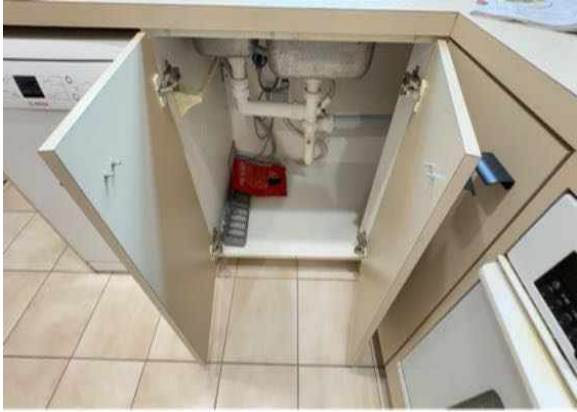
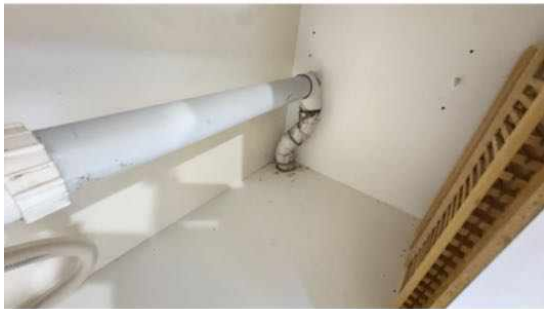
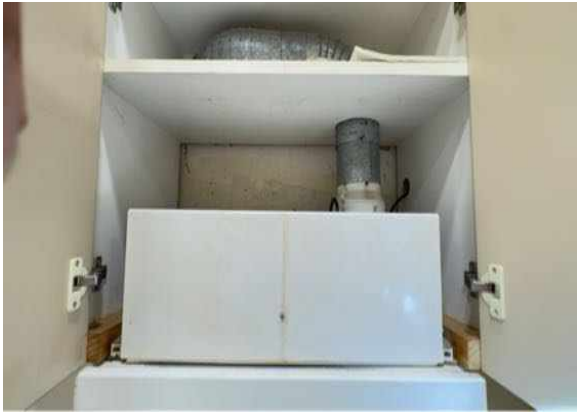
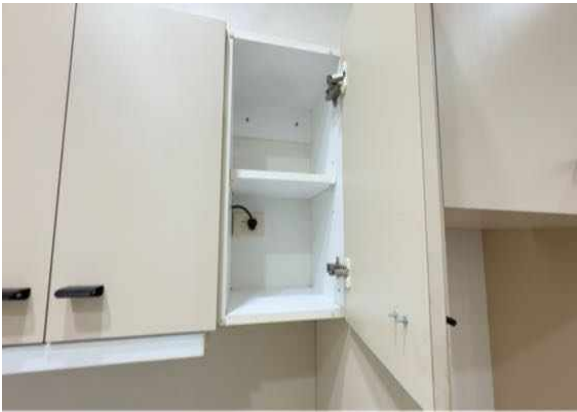
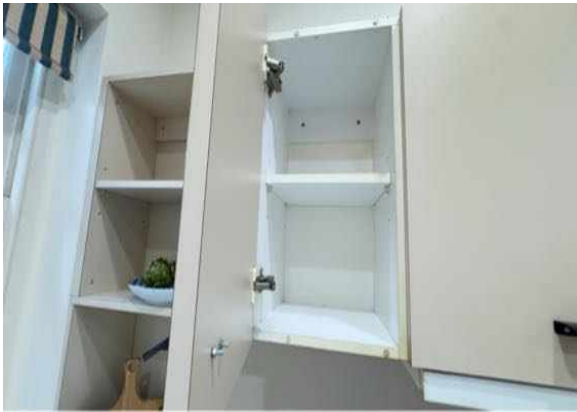
Noted Item

It is important to note that these restrictions can conceal a wide range of building defects, including but not limited to:

Structural damage such as cracking or movement in walls, floors, or ceilings.

Pest activity such as termites or timber decay.

Electrical, plumbing, or safety hazards.

Because these areas could not be visually assessed, no comment can be made on their condition within this report.

It is strongly recommended that obstructions be removed and concealed areas made fully accessible immediately. A re-inspection should then be carried out to allow a complete assessment of the property's condition. This is particularly important prior to purchase, as defects in concealed areas can carry significant rectification costs.
