Building and Timber Pest Inspection Report

Inspection Date: Sat, 7 Mar 2026

Property Address: 102/19 Eve St, Erskineville NSW 2043,
Australia

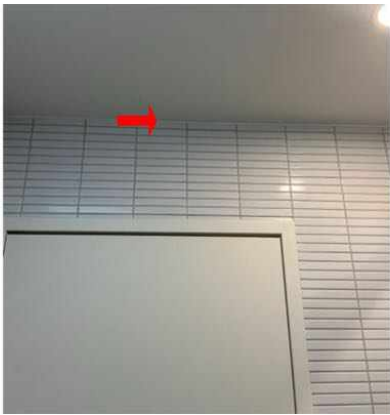
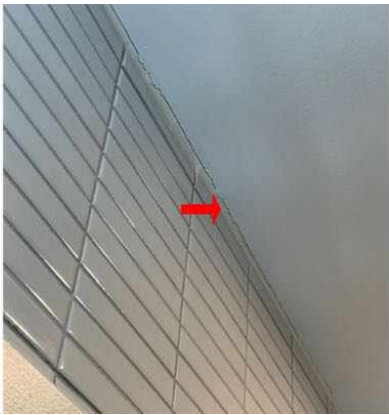
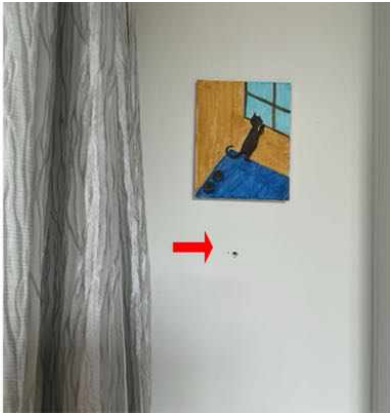
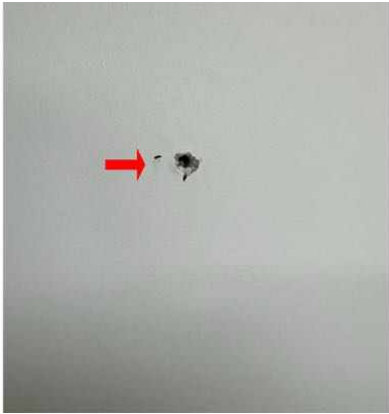
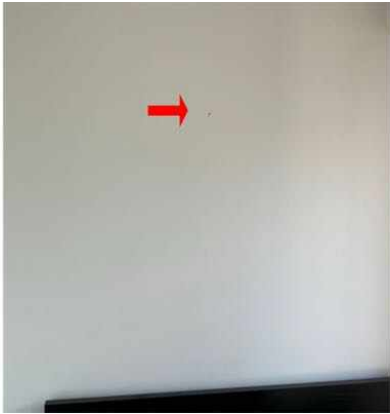
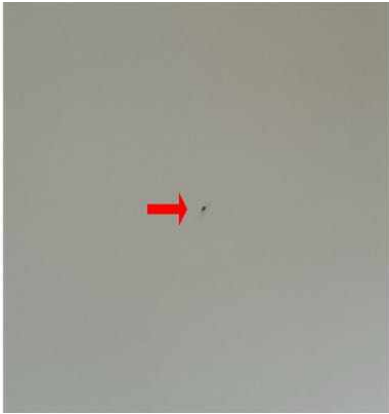
Finding 3.08

Building: Main Building
Location: All Internal Areas - Bath, Laundry , Balcony
Finding: Sealant and grouting - Missing or degraded
Information: It was noted on inspection that sealant or grout is degraded. There is also evidence of poor workmanship and excessive use of sealant. Silicone should never be used as a first line of defence against waterproofing.

A sealant specialist or tiling contractor should be appointed to complete these works as soon as possible

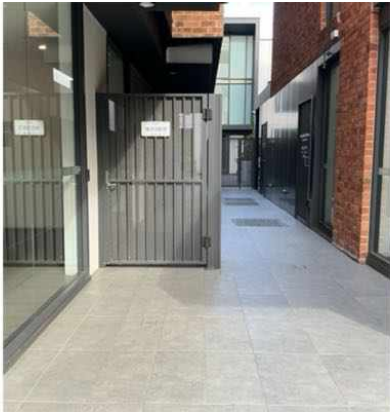
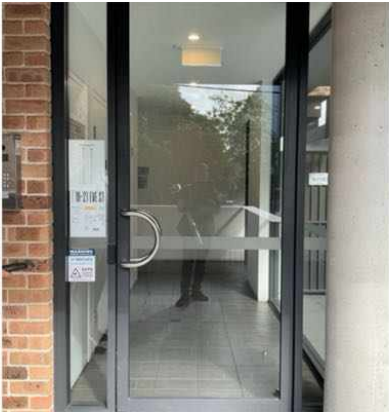
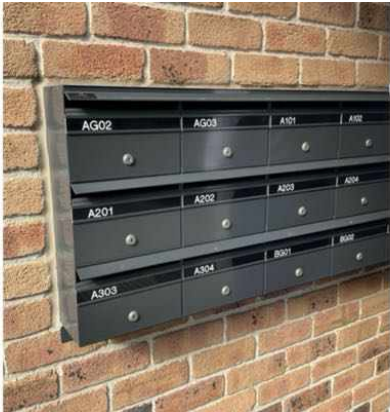
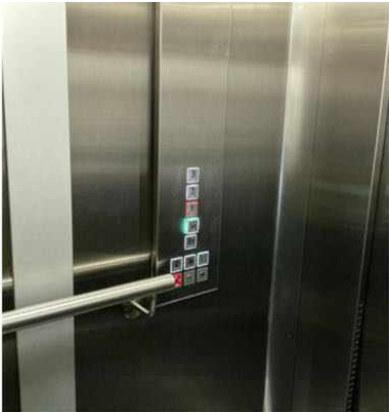
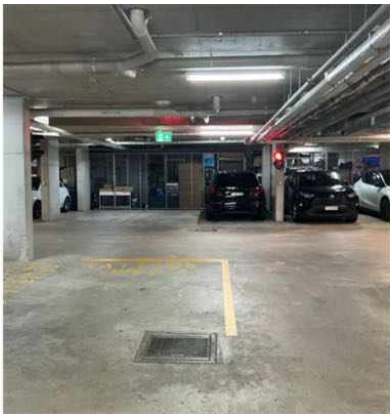
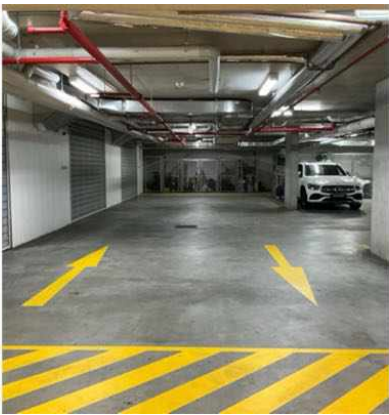
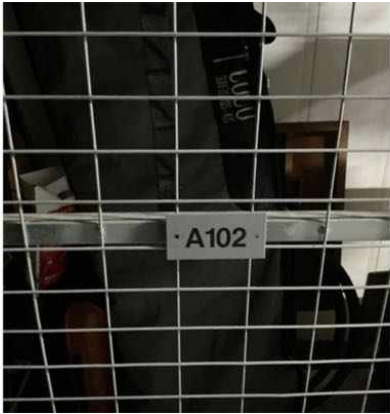
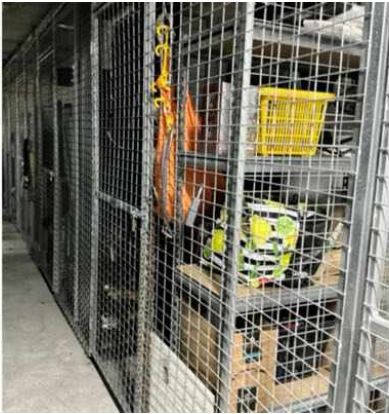
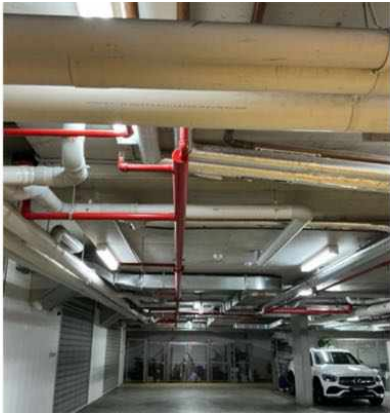
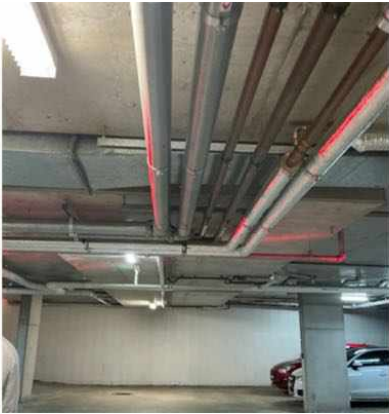
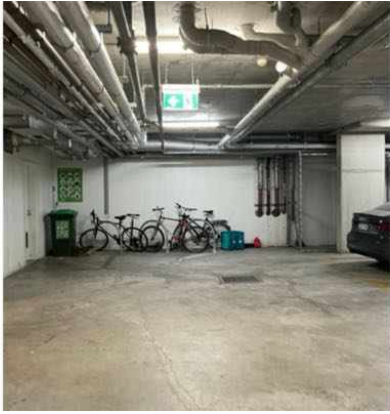
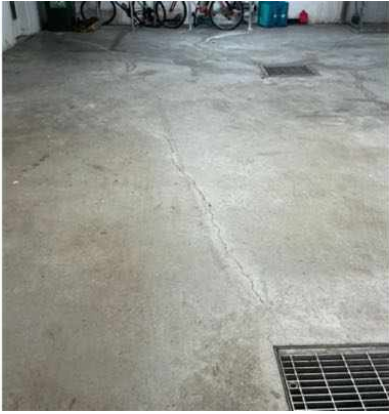
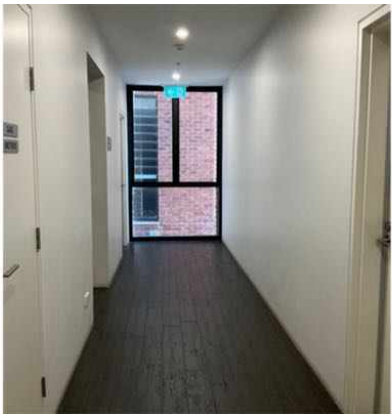
Building: Main Building
Location: All External Areas
Finding: Additional Photos - Obstructions and Limitations
Information: These photographs are an indication of the obstructions and limitations which impeded full inspection of the property at the time of inspection. These obstructions can hide an array of defects and should be removed to allow full inspection to be carried out. A re-inspection is recommended once the areas are made accessible.

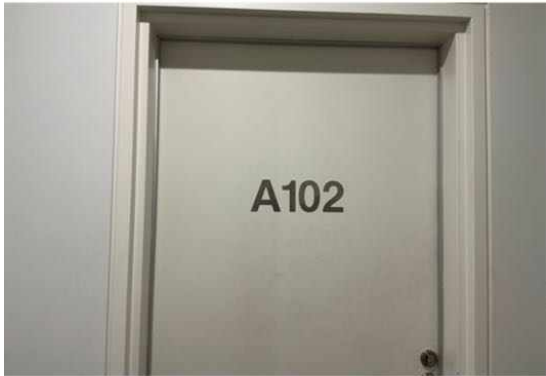
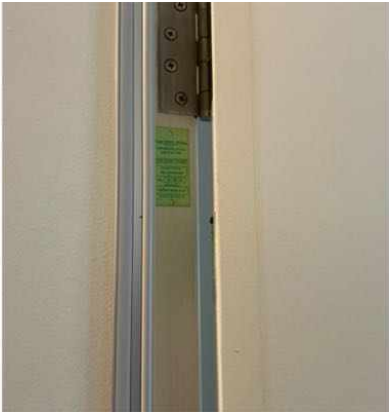
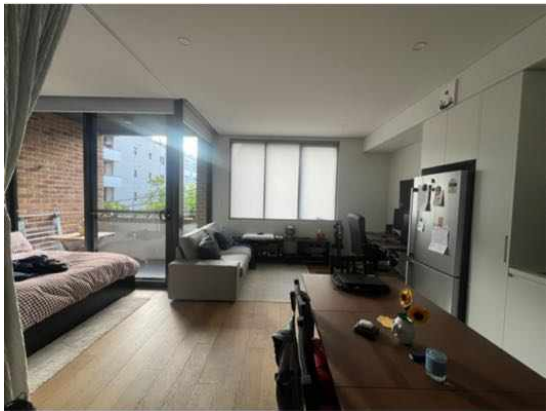
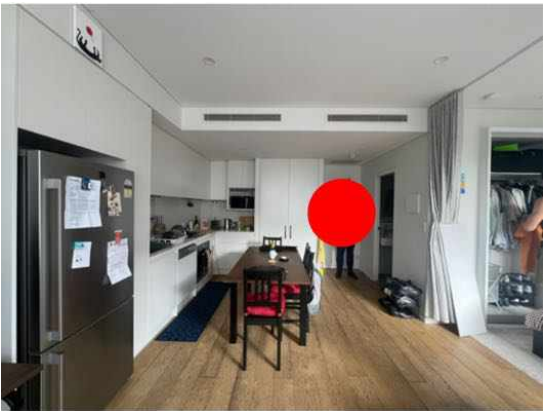
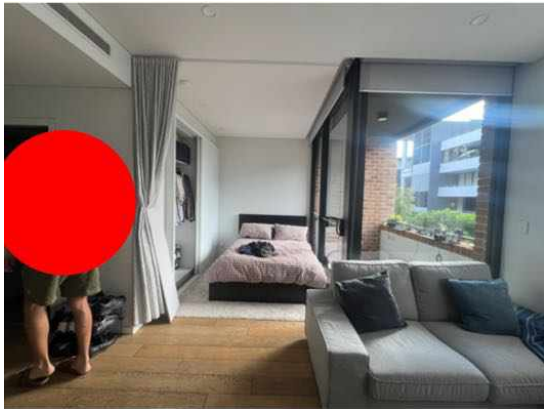
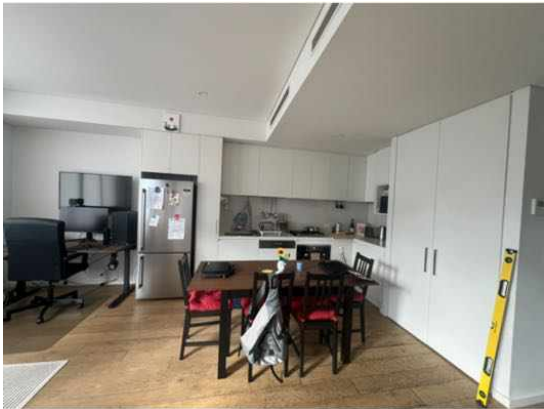
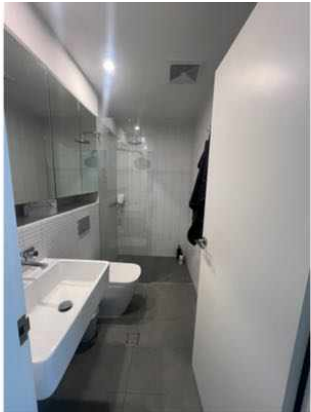
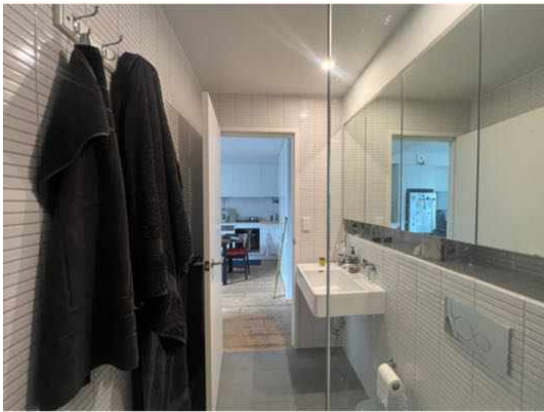
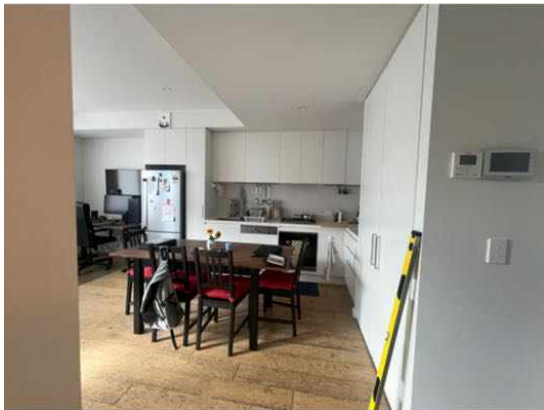
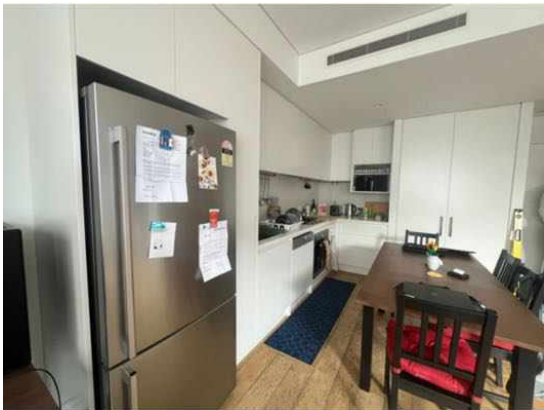
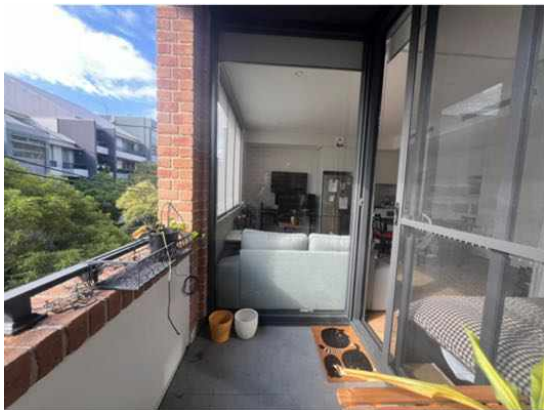
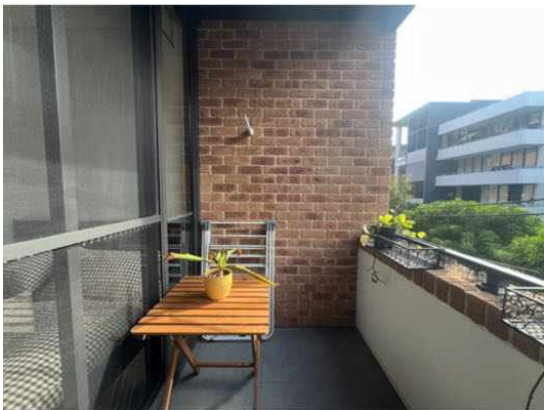
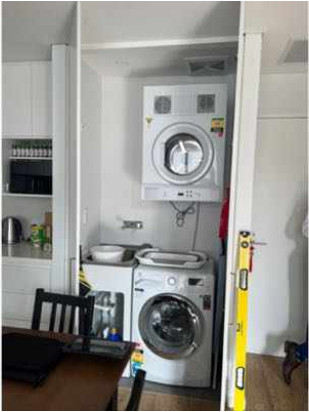
Building: Main Building
Location: All Internal Areas
Finding: Additional Photos - Obstructions and Limitations
Information: These photographs are an indication of the obstructions and limitations which impeded full inspection of the property at the time of inspection. These obstructions can hide an array of defects and should be removed to allow full inspection to be carried out. A re-inspection is recommended once the areas are made accessible.
