## Building Inspection Report VR

Inspection Date: Tue, 20 Jan 2026

Property Address: 13 Yorkshire St, Pascoe Vale VIC 3044,  
Australia

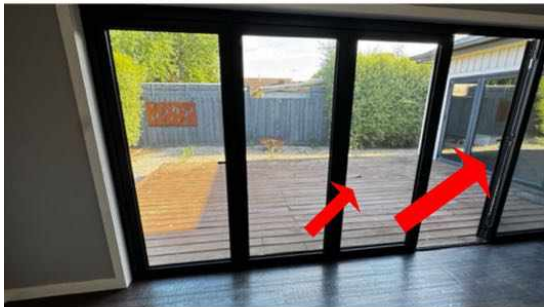
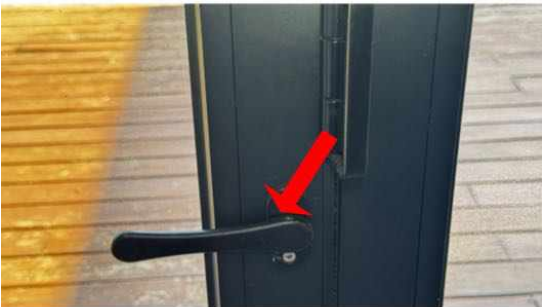
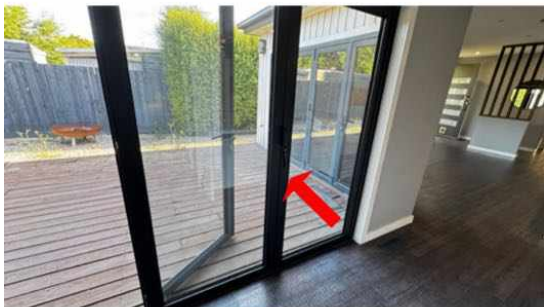
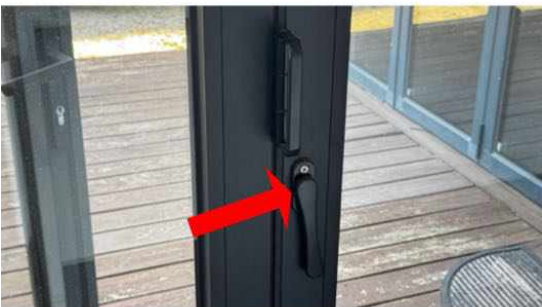
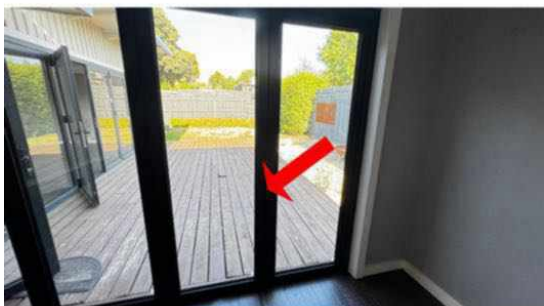
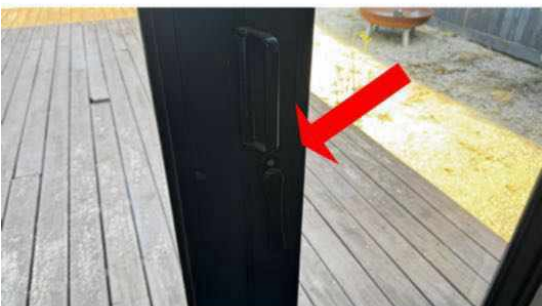
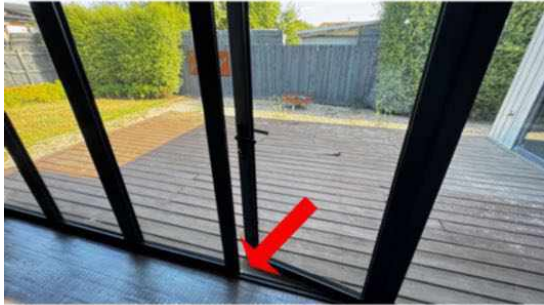
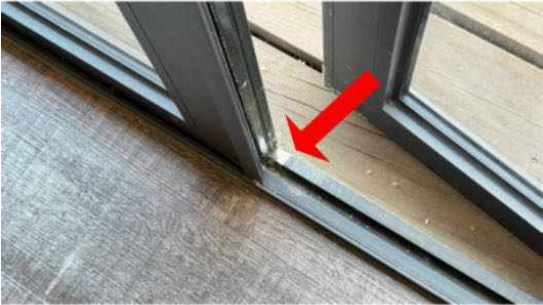
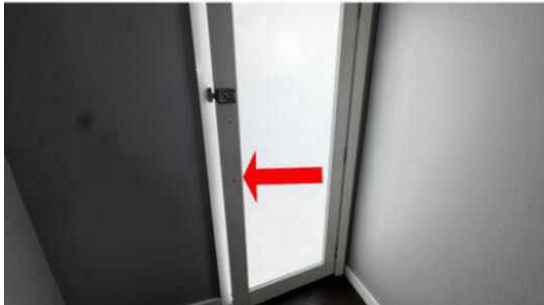
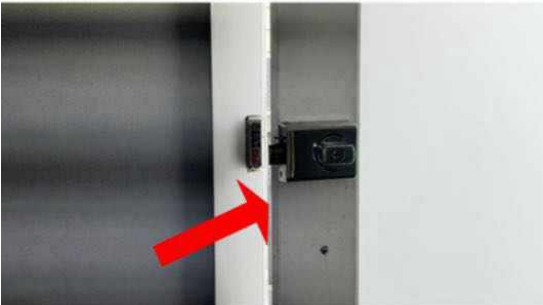
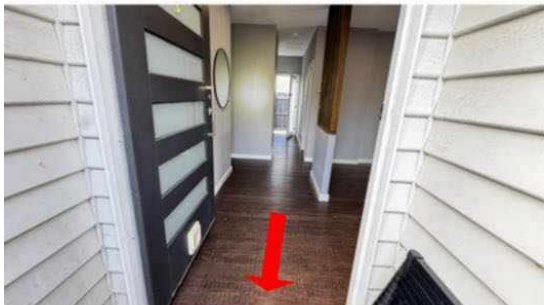
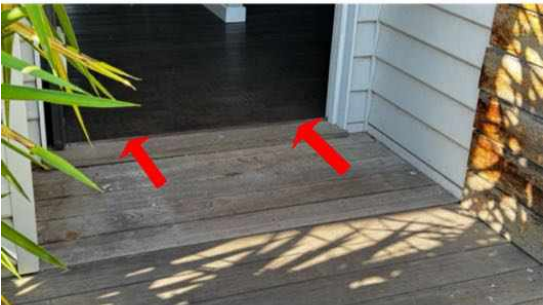
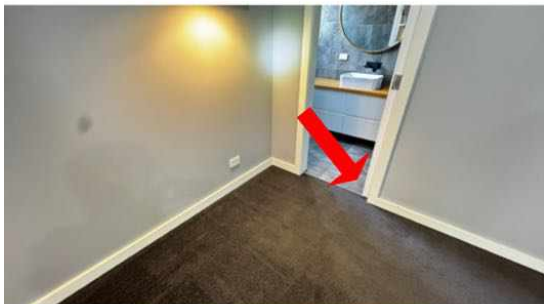
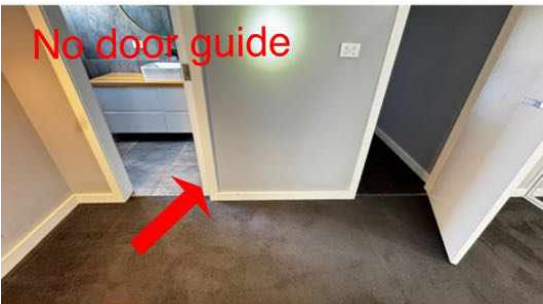
#### Defects 3.01

Building:	Main Building
Location:	All Areas
Finding:	Doors - Doors Binding
Information:	Binding or jamming of the door was observed in this area. This affects door functionality and may cause secondary damage to surrounding building elements,

Binding can result from minor issues, including poor installation, worn hinges, or misalignment, or from more significant structural problems, such as subfloor movement or damage.

When practical, a qualified carpenter should be engaged to inspect and carry out necessary repairs. If the door continues to bind after repair, or if further movement is observed, a registered builder or structural engineer should be engaged immediately to inspect for underlying structural issues.

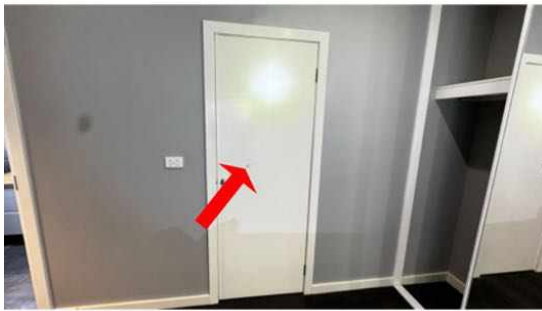
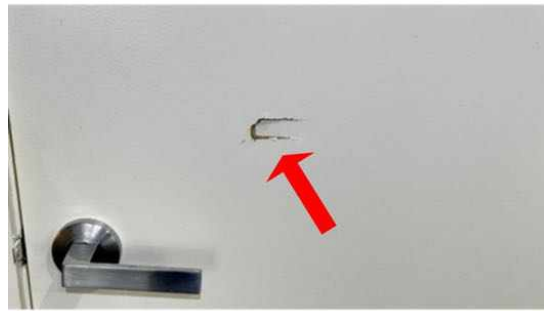
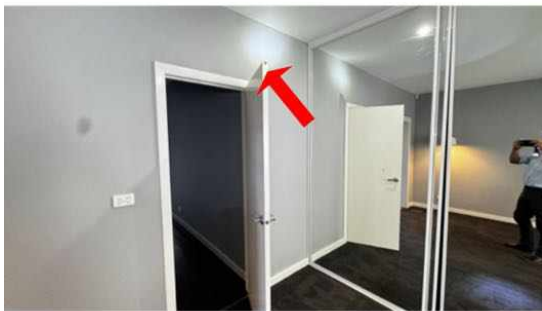
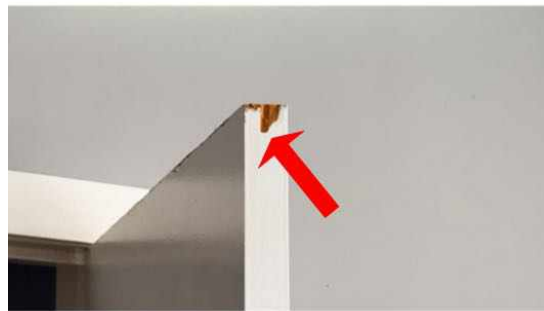
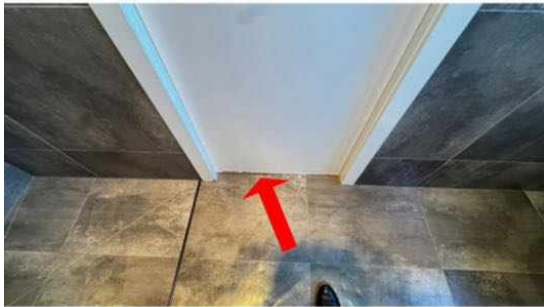
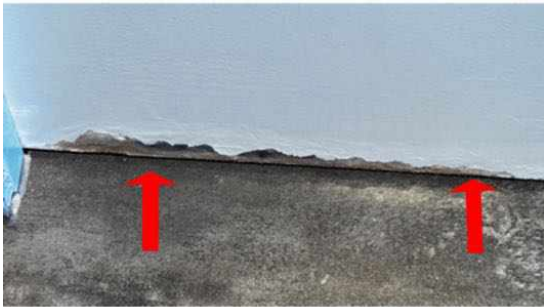
Defects 3.02

Building: Main Building  
Location: All Areas >  
Finding: Doors - Damaged Doors  
Information: The inspection identified doors with visible damage, including cracks, dents and splits. The damaged doors may affect operation, convenience, security, weatherproofing, and appearance.

The damage appears to be caused by age-related wear, poor maintenance such as inadequate painting or sealing, and minor structural movement affecting door alignment.

When practical, a qualified carpenter or door specialist should be engaged to repair, replace, or refinish the damaged doors. Prompt rectification will ensure safe operation, maintain security, and protect weatherproofing.

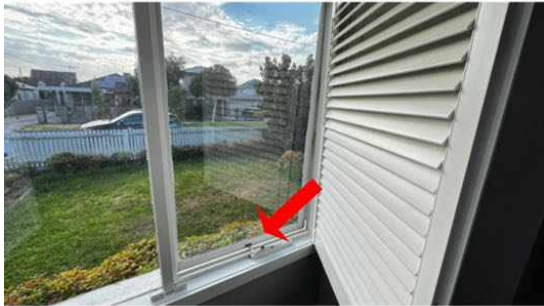
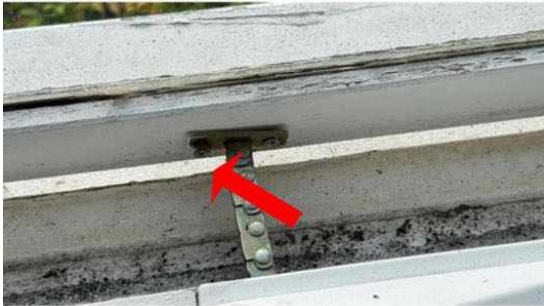
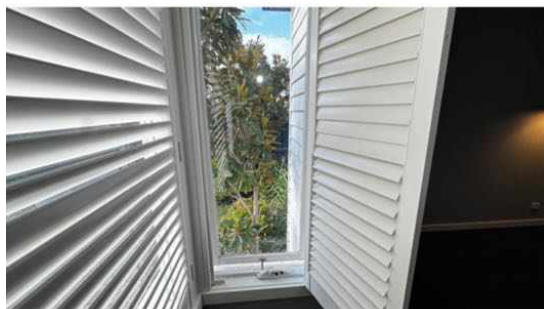
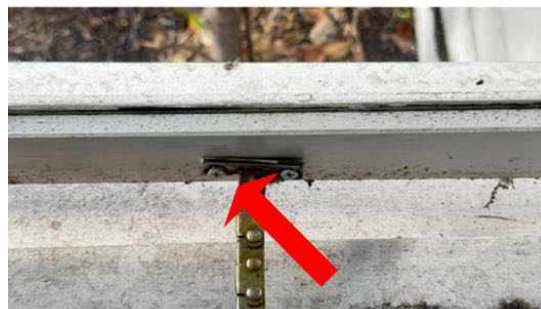
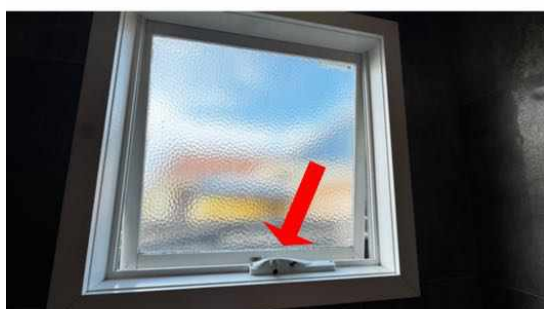
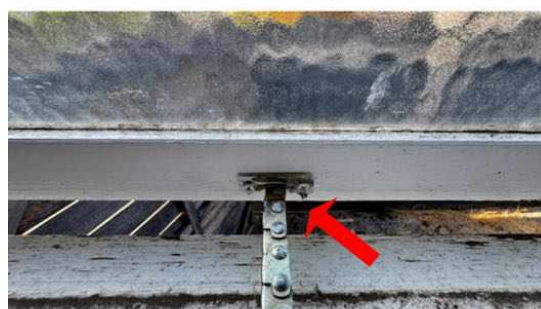
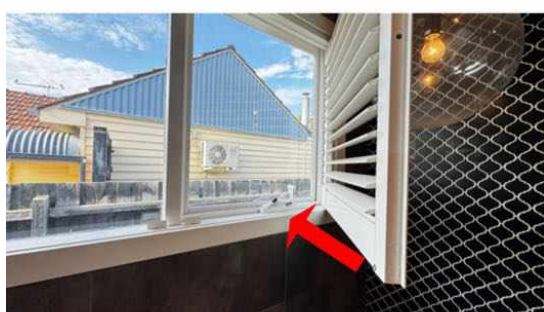
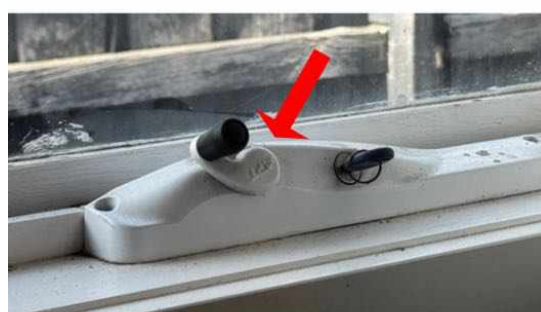
**Defects 3.03**

Building: Main Building  
Location: All Areas >  
Finding: Windows - Fittings & Hardware Deteriorated  
Information: Window fittings and hardware in this area were observed to be deteriorated. Deterioration of fittings and hardware can affect the functionality of the windows, reduce security, and, in some cases, make the windows difficult to open, close, or lock properly.

Possible causes include age-related wear, corrosion from moisture or environmental exposure, mechanical stress from repeated use, and lack of maintenance over time.

It is recommended that a window specialist or registered builder be engaged to assess the affected windows and replace any deteriorated fittings and hardware to restore proper function, security, and appearance.

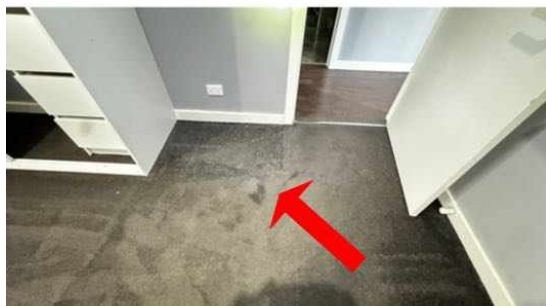
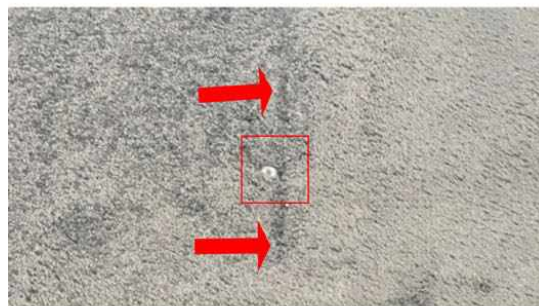
### Defects 3.04

Finding: Floors - Carpet Damaged

Information: The carpet was inspected and found to be damaged in this area, with signs of wear and staining. Damaged carpet can reduce comfort, detract from the appearance of the space, and, over time, expose the subfloor to additional wear or moisture.

This condition may result from everyday use, accidental impact, or age-related deterioration.

A qualified flooring installer should be engaged when practical to clean, repair and or

replace the affected carpet. Timely attention will restore visual appeal, comfort, and the longevity of the flooring.

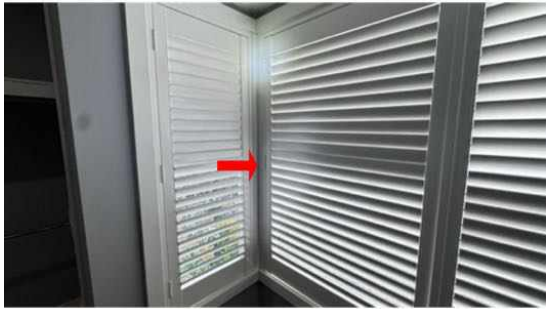
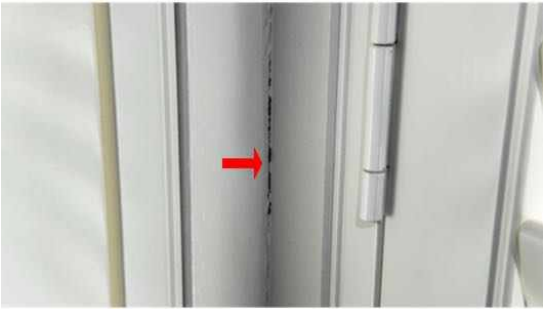
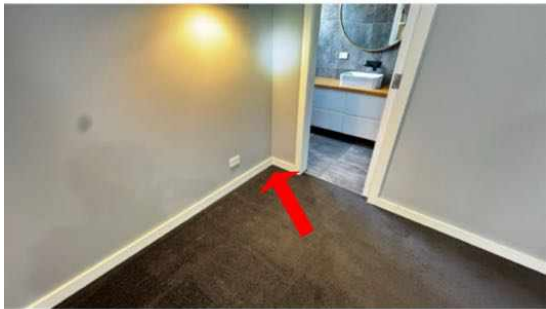
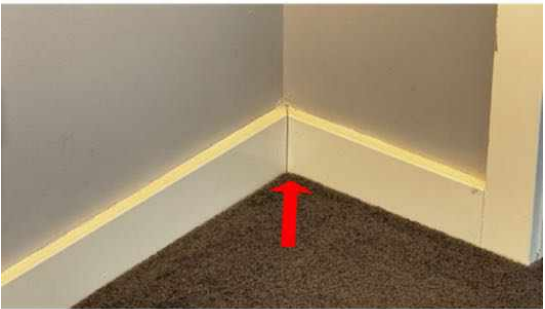
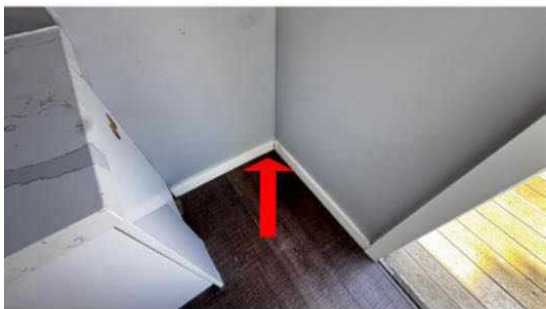
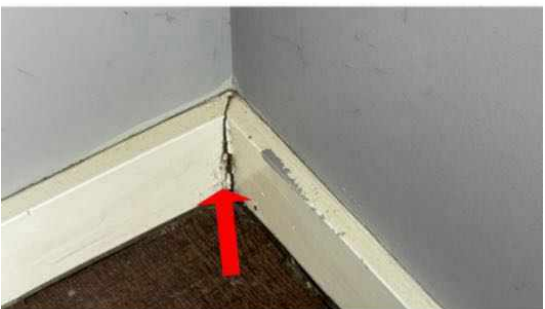
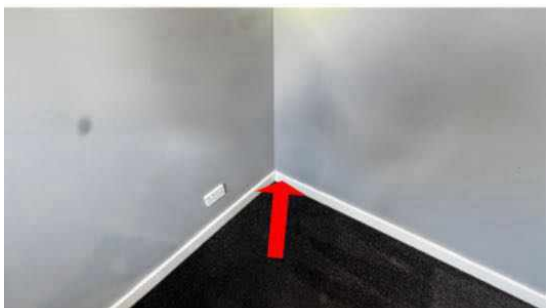
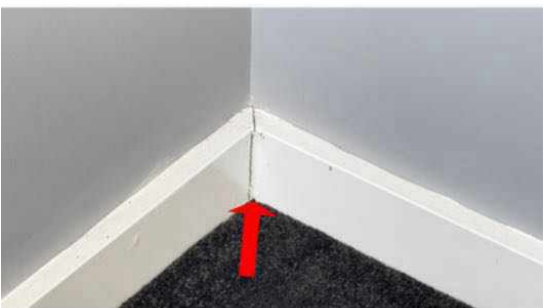
### Defects 3.05

Building:	Main Building
Location:	All Areas
Finding:	Architraves & Skirting Boards - Minor Movement
Information:	Minor movement was noted in the architraves and skirting boards in this area, with small gaps at joints, slight separations from adjoining surfaces, and minor cracking in paint and sealant. This movement appears superficial and is generally related to normal timber behaviour or minor building settlement.

Common causes include seasonal timber shrinkage or expansion, slight building settlement, historic moisture or thermal movement, or insufficient fixing during installation. While largely cosmetic, these gaps and cracks can affect the appearance of finishes. If left unaddressed, minor deterioration may continue over time.

When practical, a qualified painter should be engaged to fill and repaint affected areas, to restore a neat finish.

Ongoing monitoring is advised, especially after seasonal changes. If movement worsens, a structural engineer should be consulted immediately to assess and recommend any necessary repairs.

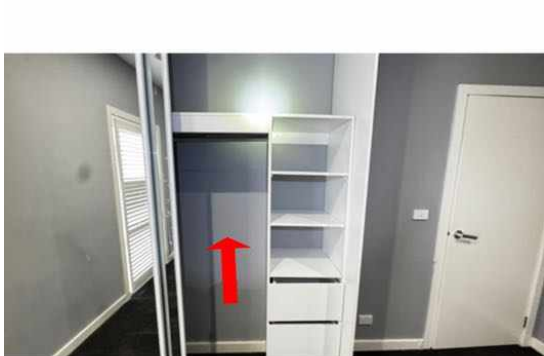
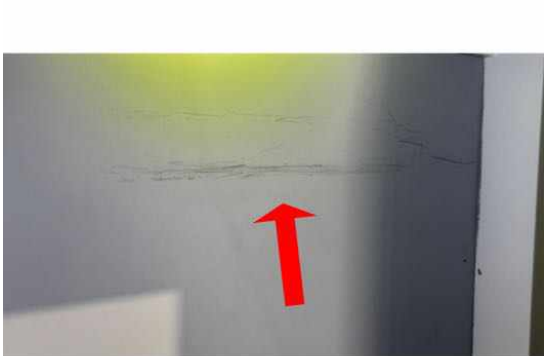
**Defects 3.06**

Information: The walls were inspected for paint condition, and discolouration was observed. While primarily a cosmetic issue, deteriorated paint may indicate poor surface preparation, or age-related wear.

Possible causes include age-related wear and impact damage.

A qualified painter should be engaged when practical to prepare and repaint affected areas. Addressing paint deterioration improves aesthetics and protects wall materials from further wear.

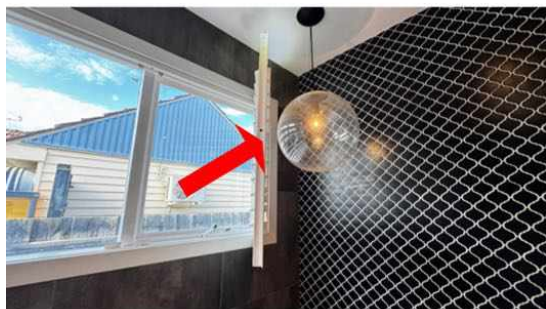
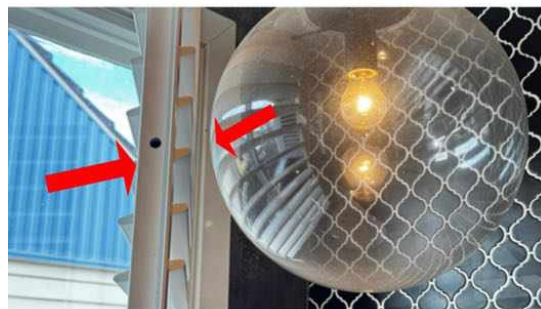
### Defects 3.12

Building:	Main Building
Location:	Kitchen >
Finding:	Floors - Timber Floor Damaged
Information:	Timber flooring was observed to be damaged in this area. The damage included scratches, dents, cracks, minor warping, and surface wear, which may affect the aesthetics, durability, and safe use of the floor.

Possible causes include impact or heavy foot traffic, water or moisture exposure, age-related wear, or poor maintenance.

When practical, a qualified carpenter or flooring specialist should be engaged to repair or replace the affected timber flooring. Prompt attention will restore appearance, durability, and safe use of the flooring.

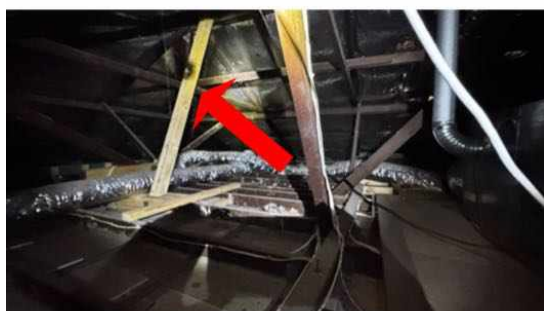
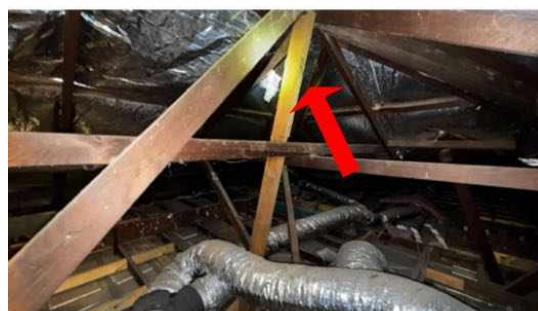
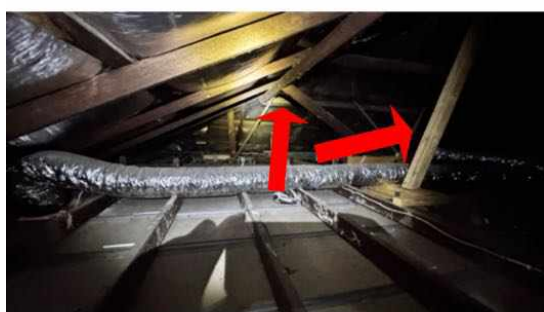
### Defects 3.17

Building: Main Building  
 Location: Roof Void >  
 Finding: Roof Void - Structural Roof Framing Altered

**Information:** During inspection of the roof space, structural members such as rafters, trusses, or joists were observed to have been cut or notched. The issue is present where these members have been altered, reducing their original size and strength.

This has likely occurred due to unauthorized modifications, installation of services without proper reinforcement, or poor original construction. Cutting or notching structural members can significantly reduce load-bearing capacity, compromise roof stability, and pose a serious safety hazard to occupants.

A structural engineer or registered builder is now required to inspect the roof space, assess the impact of the cut members, and undertake necessary remedial works. This may include reinforcement, replacement, or modification of affected members. Rectification should be completed immediately to ensure roof stability and occupant safety.

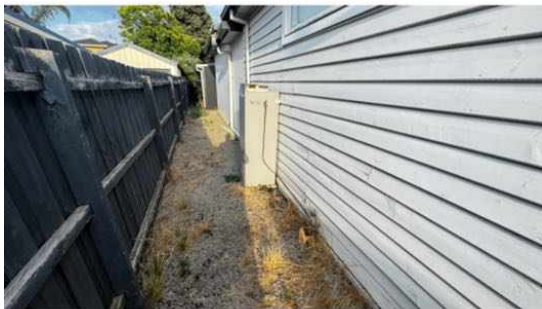
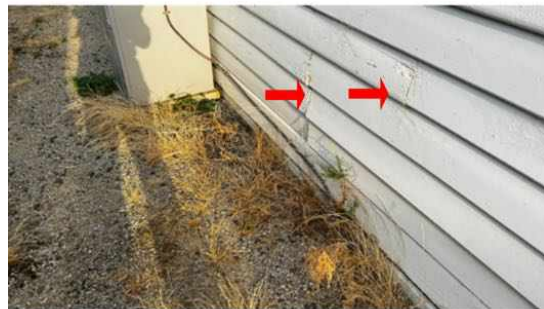
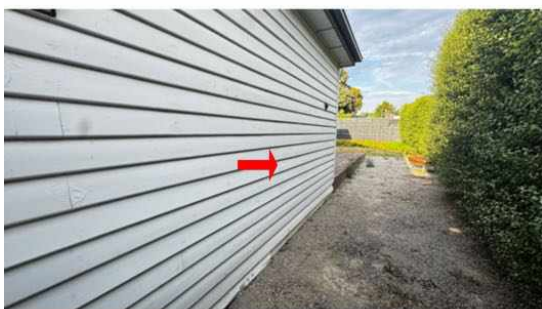
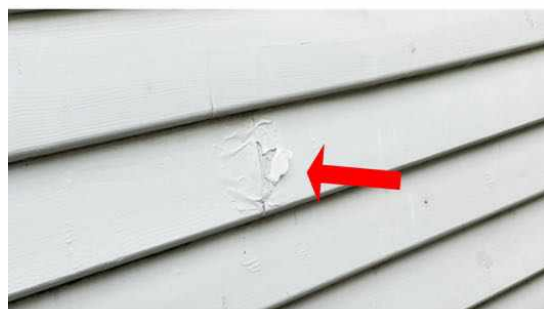
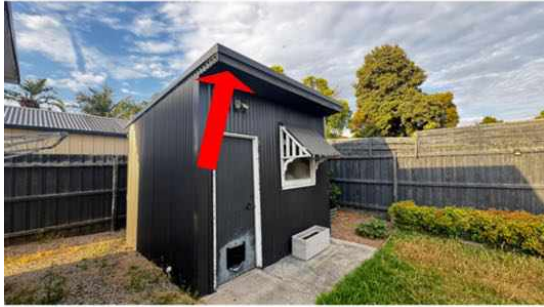
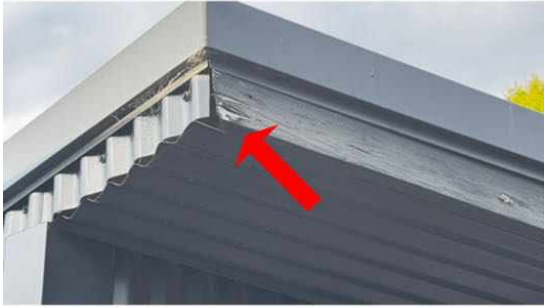
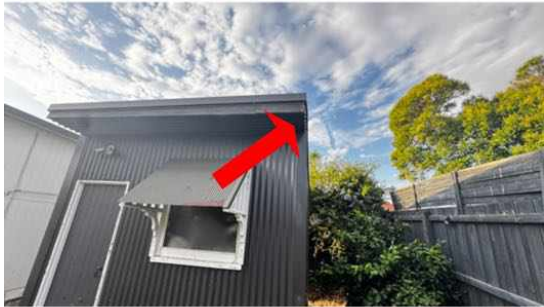
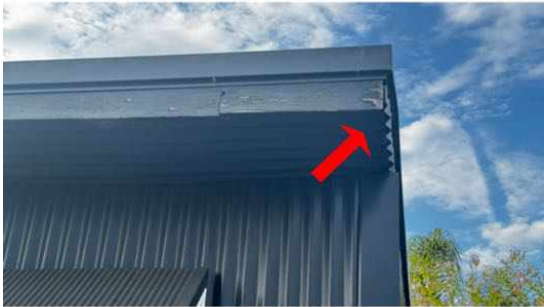
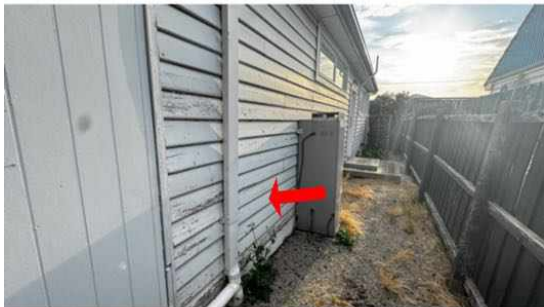
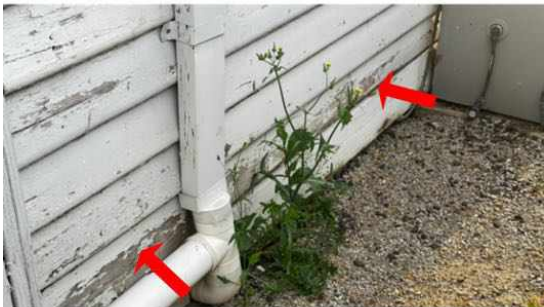
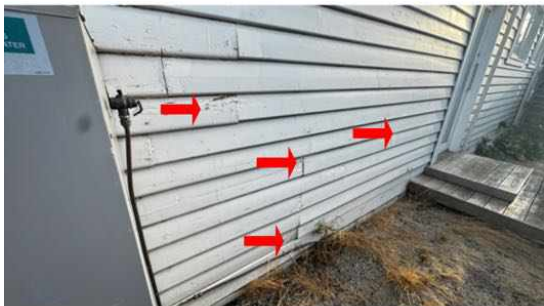
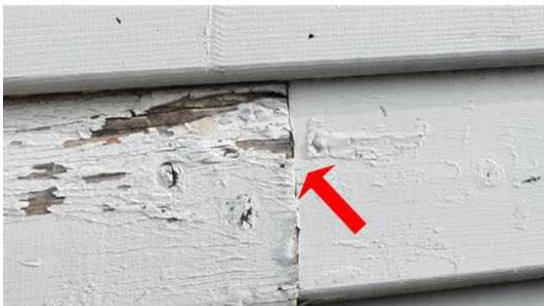
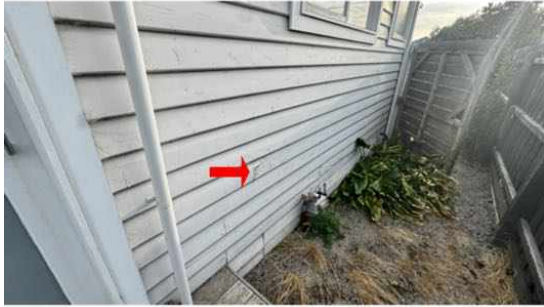
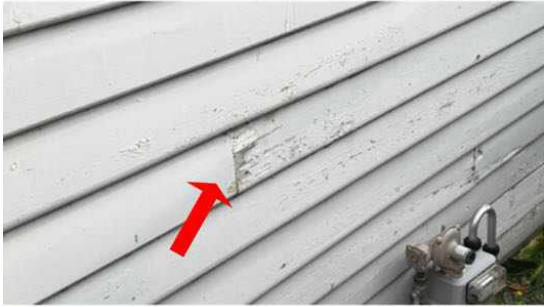
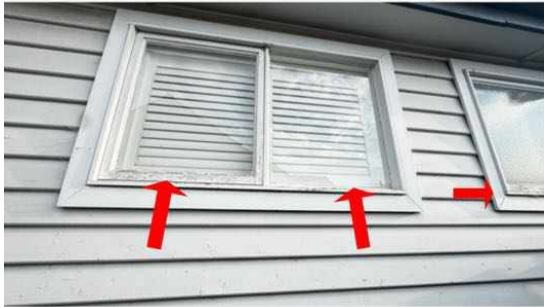
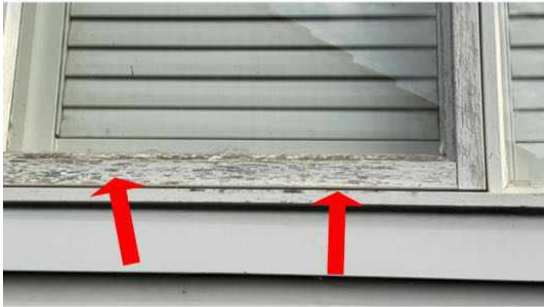
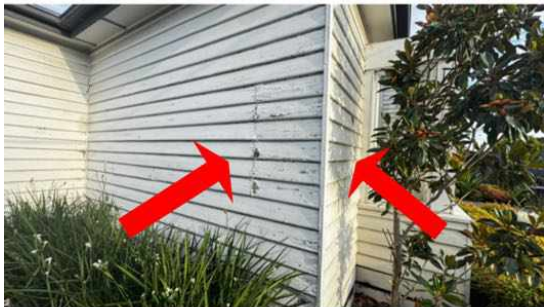
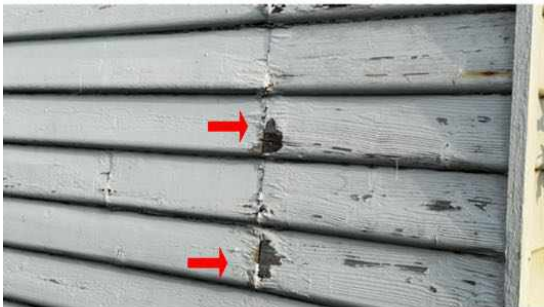
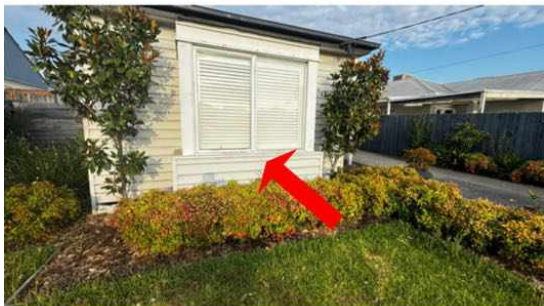
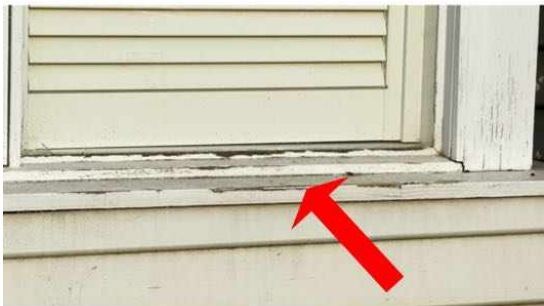
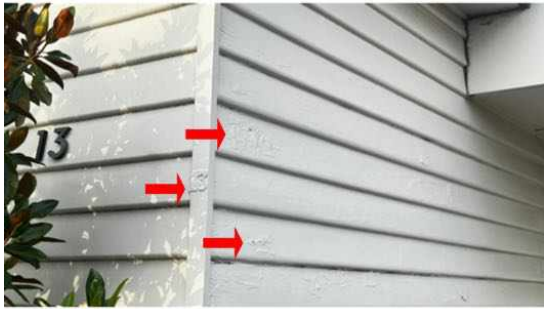
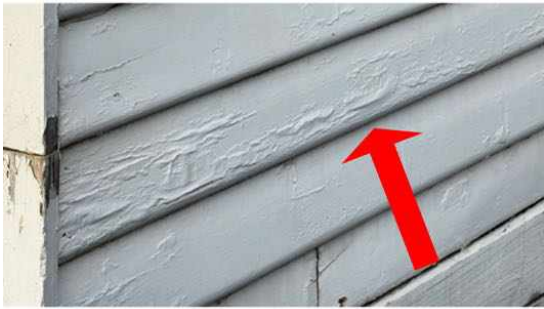
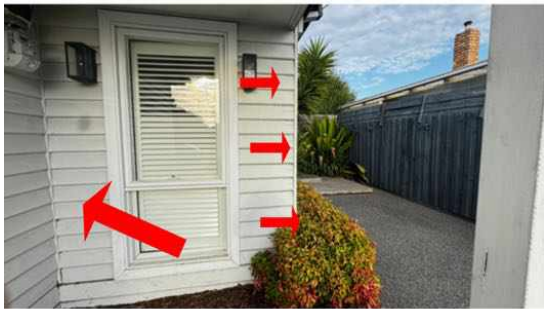
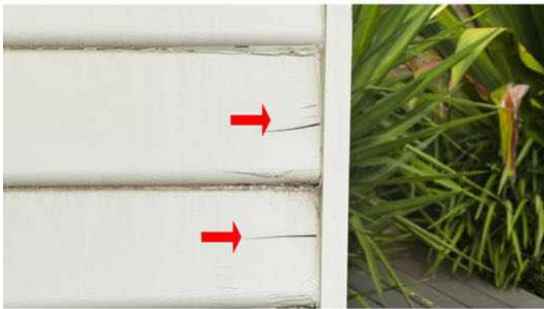
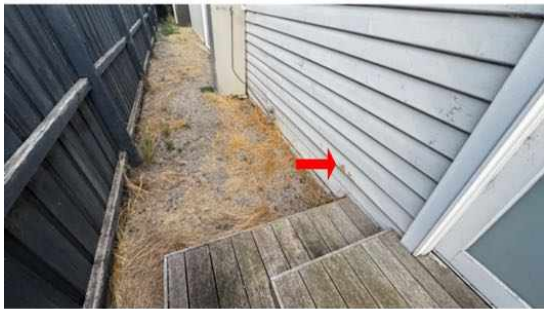
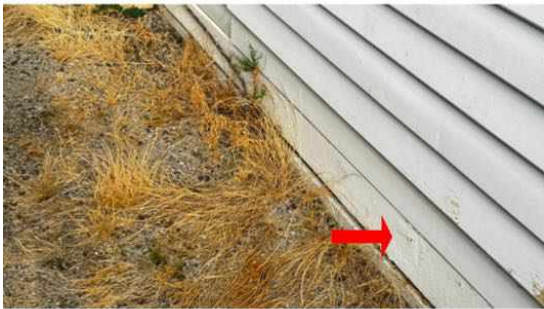
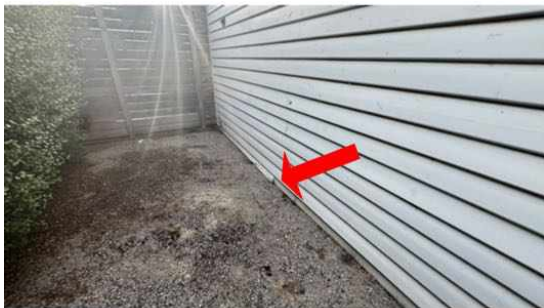
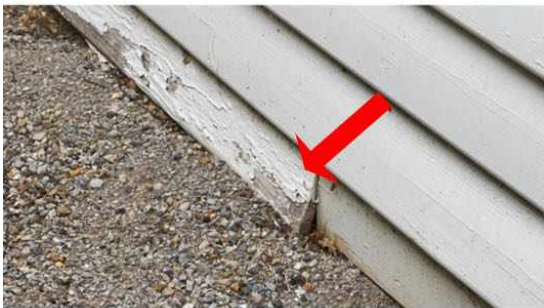
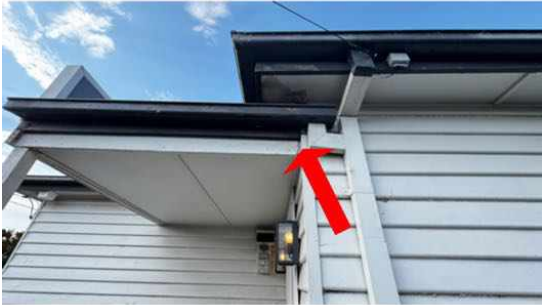
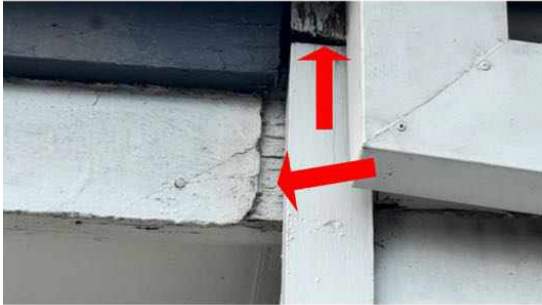
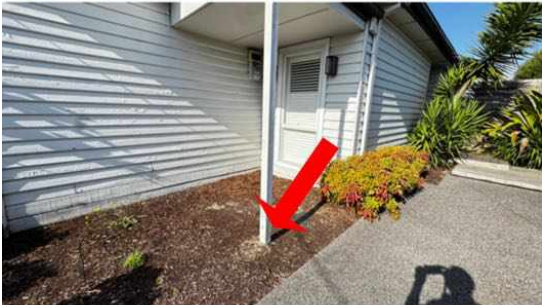
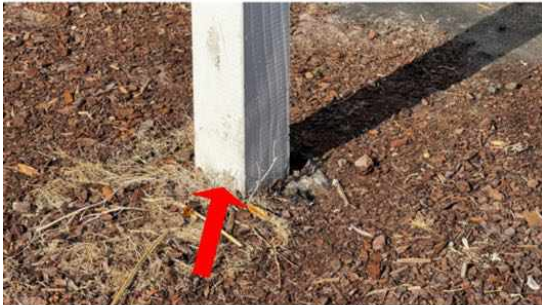
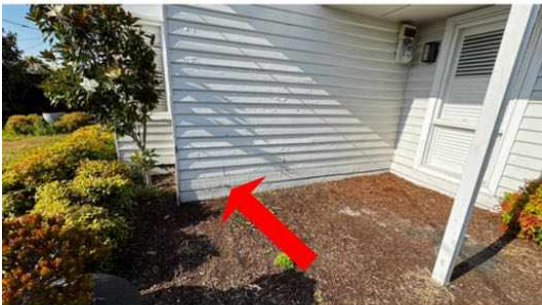
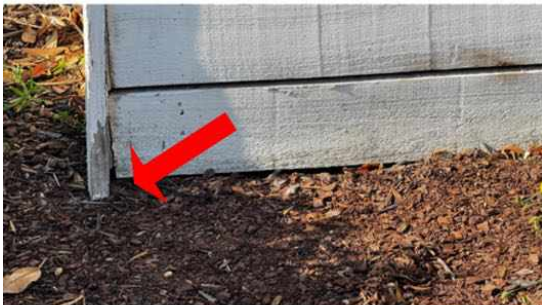
### Defects 3.18

**Building:** Main Building  
**Location:** All External Areas  
**Finding:** External Timber - Timber Rot  
**Information:** Timber elements including wall claddings, timber rails & posts, landscaping timbers, and other external timber surfaces were inspected and show signs of rot, decay and fungal attack in these areas. Softening, discoloration, splitting, and moisture

penetration indicate ongoing timber degradation.

This is likely caused by prolonged moisture exposure, inadequate protective coatings or maintenance, direct contact with soil or water, or poor detailing that traps water or limits ventilation.

If left unaddressed, the affected timber may lose structural integrity, leading to progressive decay, potential collapse of walls, decks, or landscaping features, mould growth, and reduced durability and appearance of the building exterior.

A registered builder or timber specialist should inspect the affected areas immediately to determine the extent of damage. Damaged timbers should be repaired or replaced, protective treatments applied, and drainage or detailing corrected to prevent recurrence. Ongoing monitoring and urgent remedial action are required to prevent further deterioration.

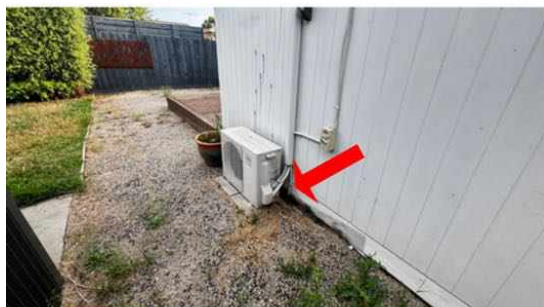
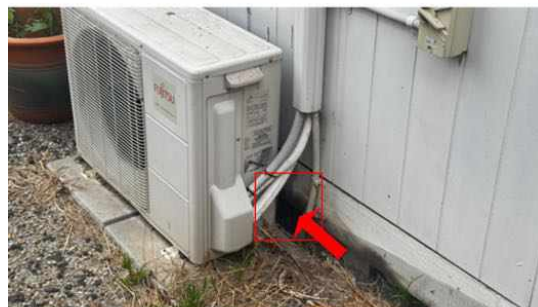
**Defects 3.19**

Building: Main Building  
Location: All External Areas >  
Finding: AC Condensate Drain - Not Connected To Storm Water  
Information: The air conditioning condensate drain in this area was observed to be disconnected from stormwater drainage.

When condensate is not properly directed to a stormwater outlet, water can accumulate around the building or air conditioning unit, creating damp conditions that may lead to secondary defects such as timber rot, corrosion of nearby metal components, mould growth, or slippery surfaces. Prolonged pooling of water may also attract termites and contribute to long-term deterioration of surrounding building

elements.

A qualified HVAC technician or licensed plumber should be engaged immediately to connect the condensate drain to a suitable stormwater outlet. Prompt rectification will ensure proper drainage, protect the building fabric, and reduce potential health and safety risks.

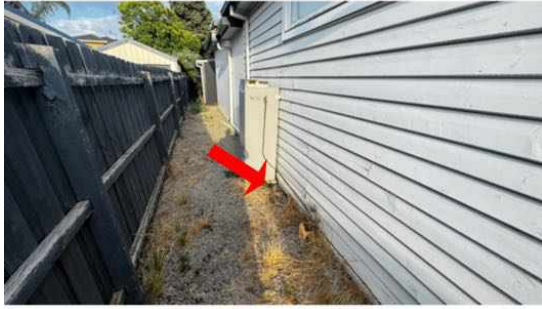
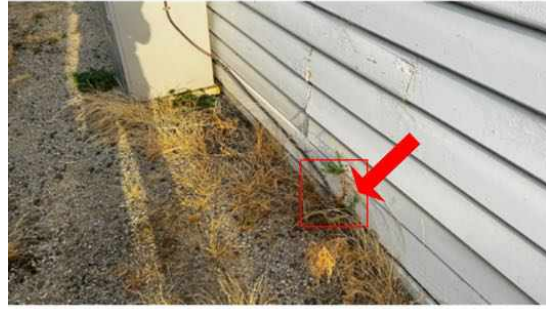
### Defects 3.20

Building:	Main Building
Location:	All External Areas >
Finding:	HWS - (T&P) Valve Not Connected To Storm Water
Information:	The Hot Water System (HWS) Temperature & Pressure Relief (T&P) valve discharge pipe was observed to be disconnected from stormwater drainage.

When not properly connected, discharged water can create damp conditions around the HWS, potentially leading to secondary defects such as timber rot, corrosion of nearby metal components, mould growth, or slip hazards. Prolonged exposure to moisture in this area may also attract termite activity and contribute to long-term deterioration of surrounding building elements.

A licensed plumber should be engaged immediately to connect the T&P discharge pipe to a suitable stormwater outlet or floor waste. Prompt rectification will ensure safe operation of the HWS, protect surrounding structures, and reduce potential health and safety risks.

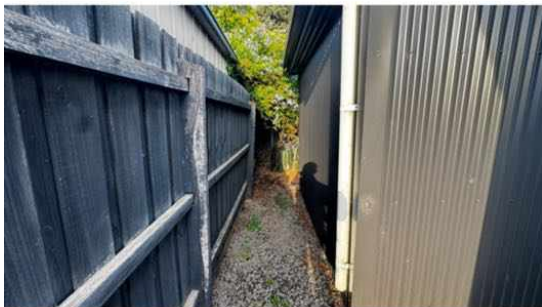
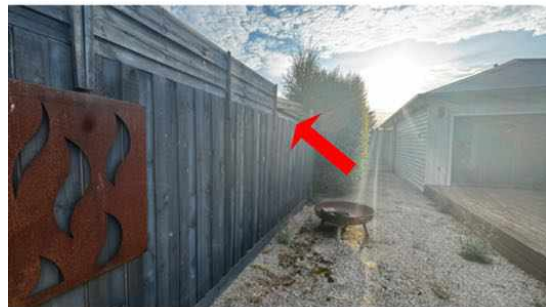
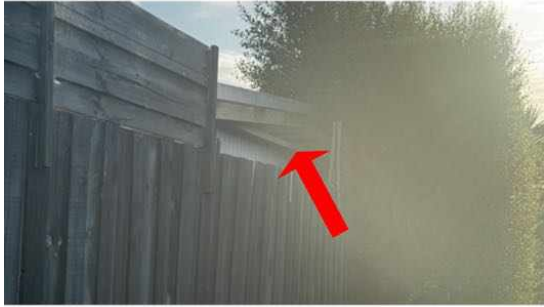
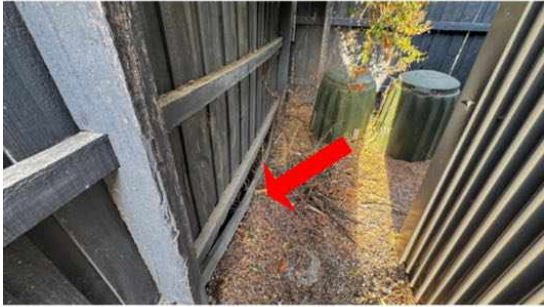
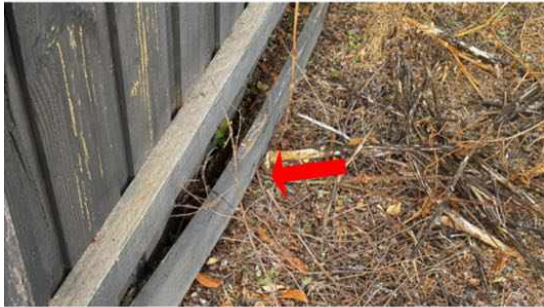
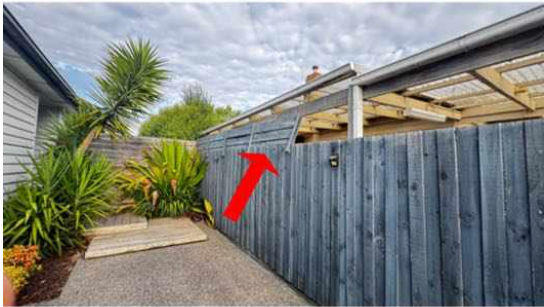
### Defects 3.21

Building: Main Building  
 Location: Fencing All Areas  
 Finding: Fencing - Deteriated  
 Information: Timber fencing was inspected and deterioration was observed in this area. Deteriorated fencing can compromise structural stability, reduce privacy, and may allow pest ingress or accelerated decay if left unaddressed.

Possible causes include age-related timber decay, prolonged exposure to moisture or sunlight, poor maintenance, or impact damage.

When practical, a qualified carpenter or fencing specialist should be engaged to repair or replace affected sections, and a qualified painter should be engaged to restore protective finishes. Prompt rectification will maintain structural performance, improve appearance, and extend the lifespan of the fencing.

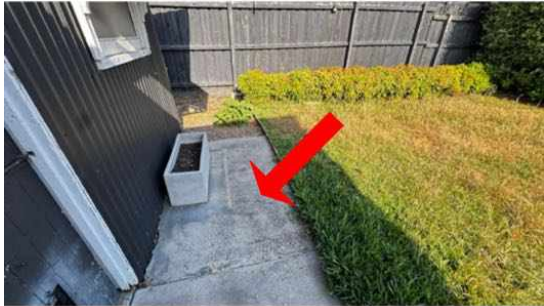
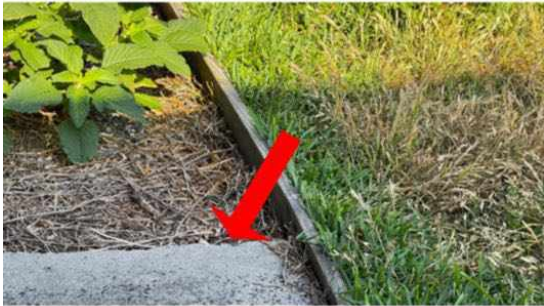
**Defects 3.22**

Building: Main Building  
Location: All External Areas >  
Finding: Paving - Minor Cracking  
Information:

The external paved areas were visually inspected. Minor cracking, uneven surfaces, and general wear were observed in this area. These defects do not currently affect structural safety but may reduce durability, appearance, and safe pedestrian access.

This may be caused by age-related deterioration of concrete, pavers, or other materials, soil movement or settlement beneath paved surfaces, tree root intrusion or erosion, or inadequate original installation or sub-base compaction.

A qualified landscaper should be engaged as soon as possible to repair or resurface sections as required. Rectification will restore even surfaces, reduce trip hazards, and improve the serviceability and appearance of the paved areas.

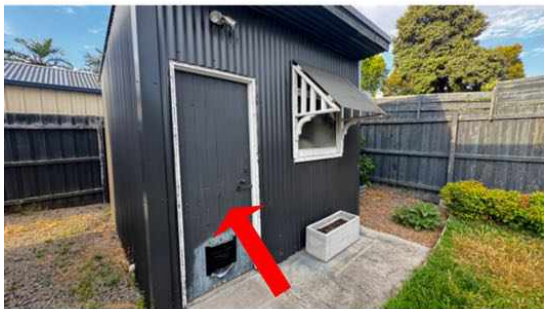
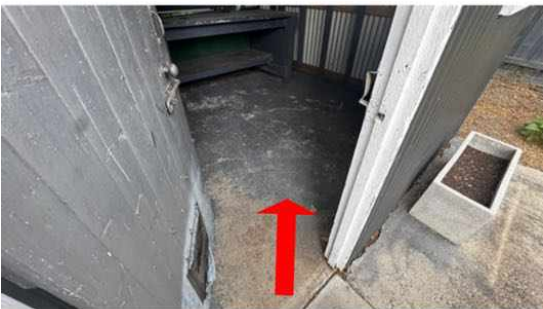
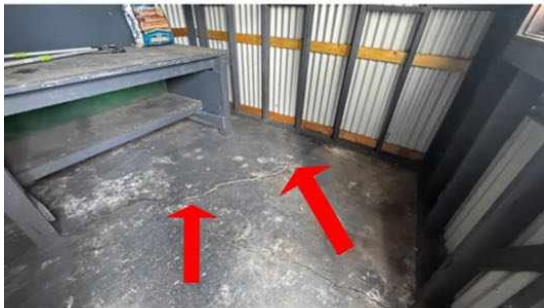
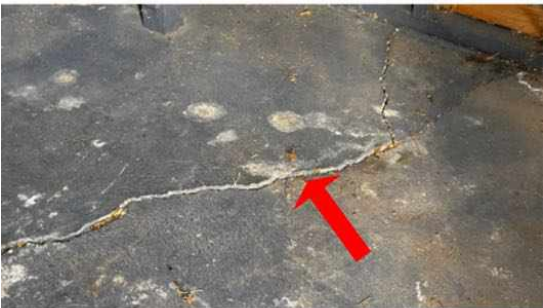
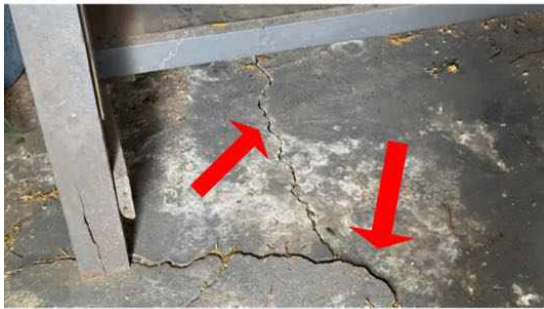
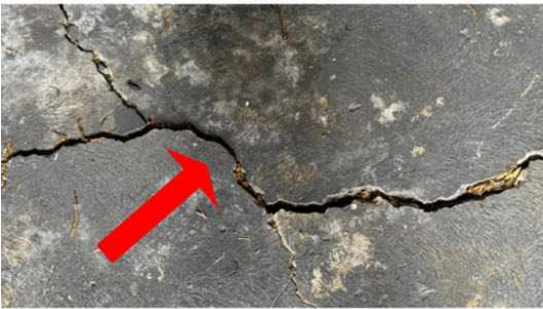
**Defects 3.23**

Building: Out Building  
Location: Shed >  
Finding: Concrete - Minor Cracking To Concrete Surface  
Information:

Concrete surfaces were inspected and minor cracking was observed in this area.

While minor cracks are generally cosmetic, they may indicate normal shrinkage, settlement, or minor movement and should be monitored over time to ensure they do not worsen.

The cracks may be caused by shrinkage of concrete as it cures, minor settlement of footings, thermal expansion or contraction, or age-related wear.

The affected area should be monitored, and if cracks widen, additional movement occurs, or other signs of structural concern are observed, a registered builder or structural engineer should be engaged immediately to assess and provide advice on remedial works. Prompt attention will help maintain the integrity and safety of the concrete surface.

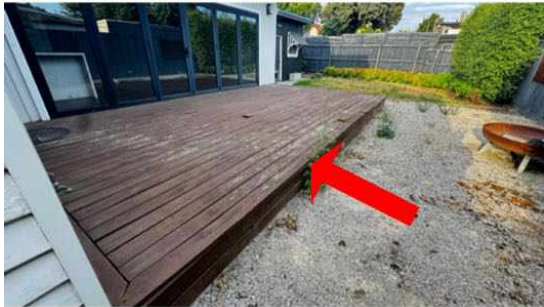
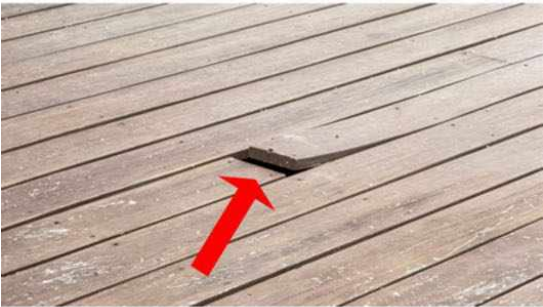
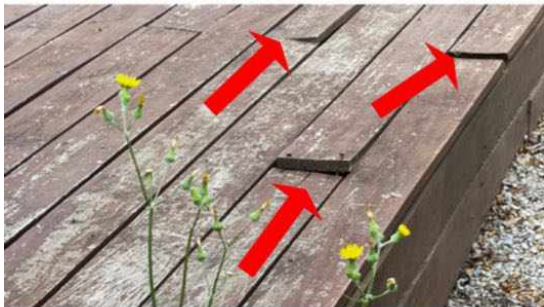
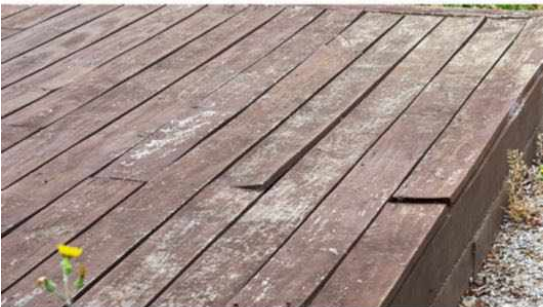
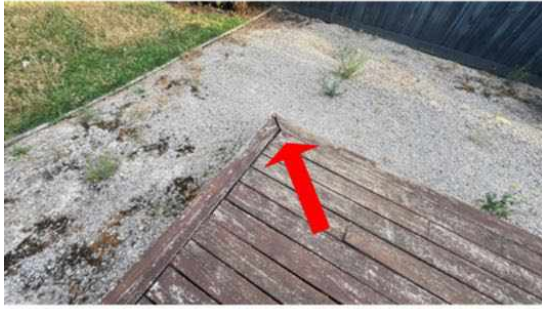
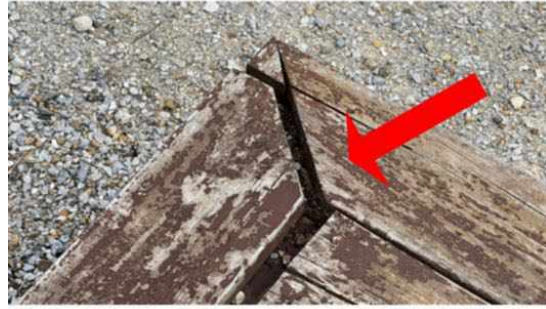
**Defects 3.24**

Building: Main Building  
Location: Deck  
Finding: Decking - Poor Condition  
Information: The external decking was inspected, and evidence of timber deterioration, loose and corroded fixings, warping, cracking, and uneven boards was observed.

The deterioration appears to be caused by age-related timber decay, weathering from sun, rain, and moisture and inadequate maintenance.

When practical, a registered builder or qualified carpenter should be engaged to inspect, repair, or replace affected decking components. Remedial works may include reinforcing or replacing damaged timber, securing loose fixings, and applying protective coatings to maintain safety and prolong the lifespan of the decking.

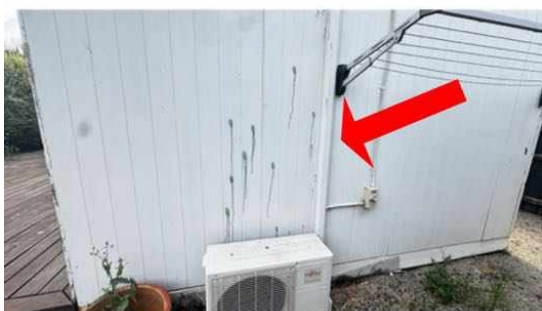
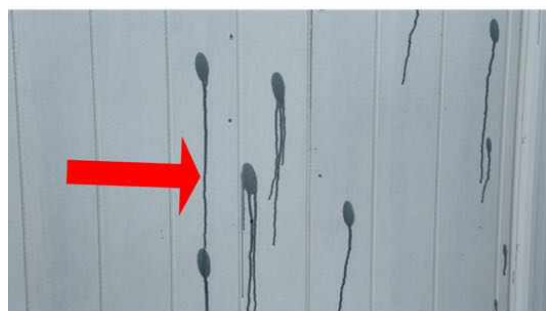
### Defects 3.25

Building:	Main Building
Location:	Exterior walls - rear
Finding:	Paint - Poor Paint Finish External
Information:	Poor paint finishes were observed in this area. The defects include uneven coverage, brush and roller marks, drips, and areas of peeling and flaking, which affect the visual appearance of the surfaces.

Poor paint finish can result from inadequate surface preparation, application over damp or unprimed surfaces, use of low-quality paint, or environmental conditions during painting. While primarily cosmetic, these issues may reduce the durability of the painted surfaces if left unaddressed.

It is recommended that a qualified painter be engaged immediately to prepare and repaint the affected areas. Rectification will restore an even, visually appealing finish and help protect the underlying surfaces from premature deterioration.

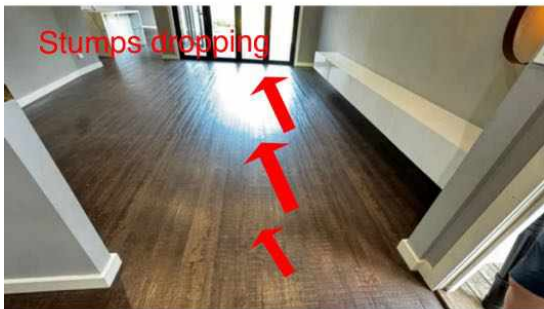
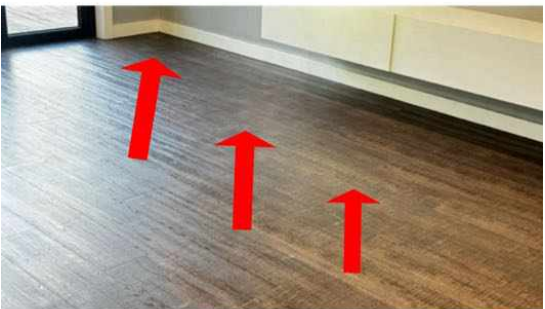
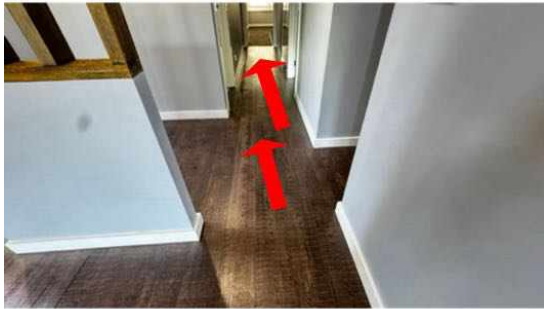
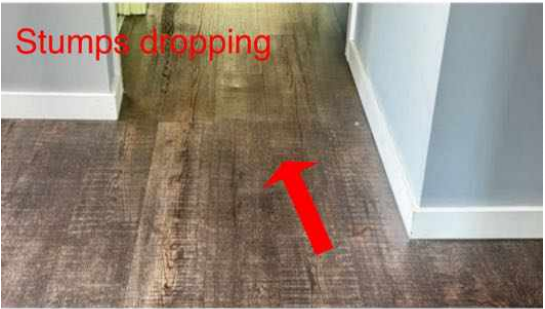
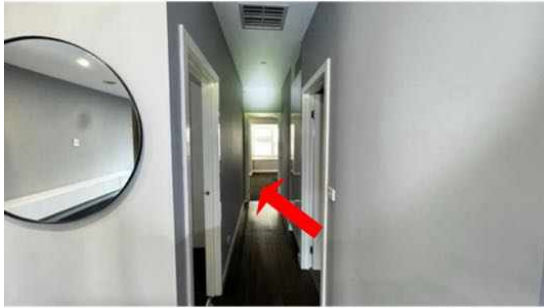
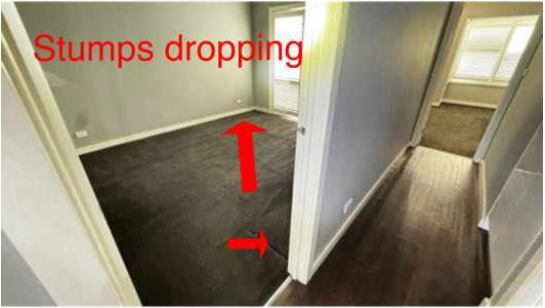
### Defects 3.26

Building:	Main Building
Location:	Subfloor
Finding:	Sub Floor - Stumps Dropping

The subfloor stumps were observed to be dropping and settling unevenly. The issue is present where the floor is sagging and load is unevenly distributed.

This has likely occurred due to ground movement, soil erosion or age-related deterioration of stumps. Dropping stumps can compromise the integrity of bearers and joists, increase the risk of structural failure, and create a serious safety hazard.

A registered builder or structural engineer is required to inspect the subfloor immediately, assess the affected stumps, and undertake remedial works. This should be rectified as soon as possible to restore structural stability and ensure safety.
