## Building Inspection Report VR

Inspection Date: Tue, 20 Jan 2026

Property Address: 13 Yorkshire St, Pascoe Vale VIC 3044,  
Australia

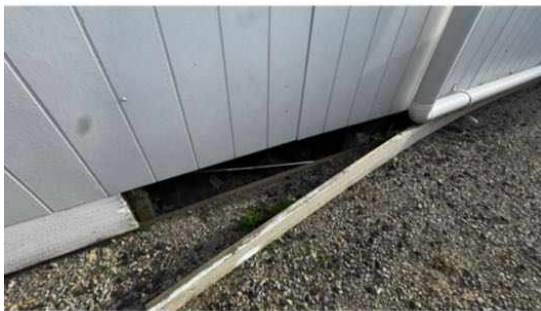
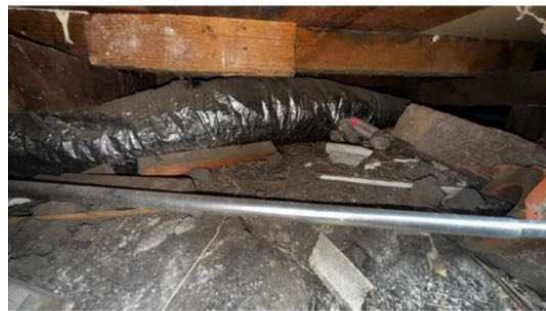
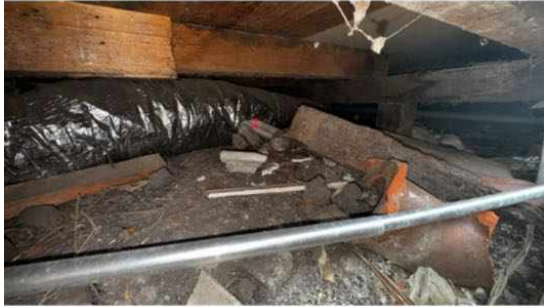
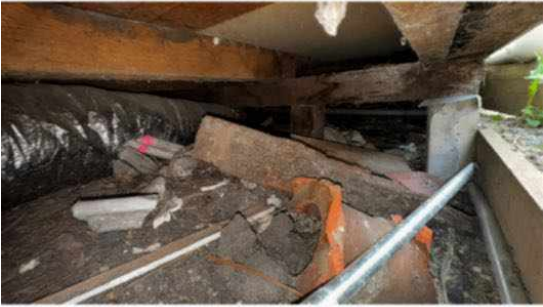
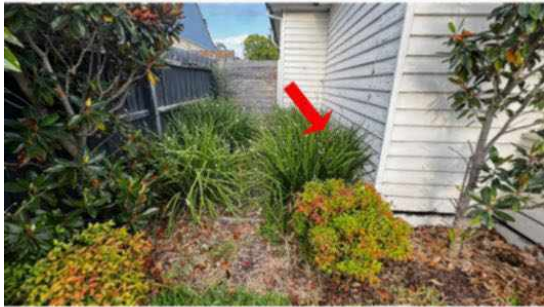
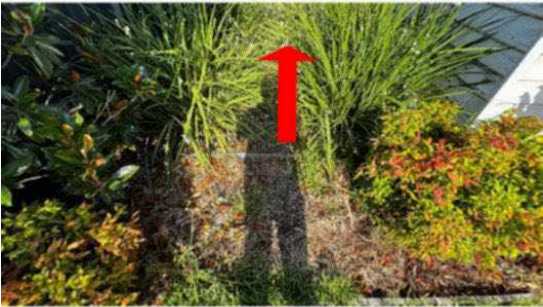
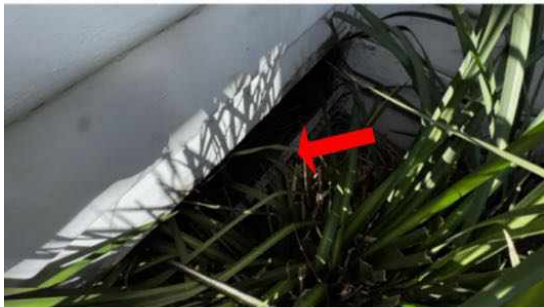
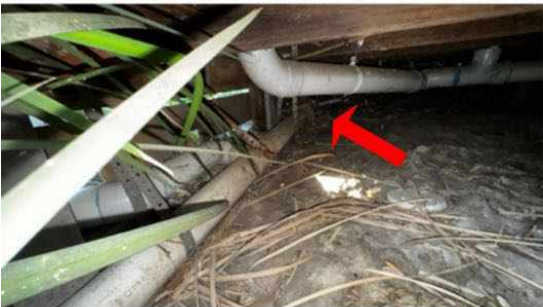
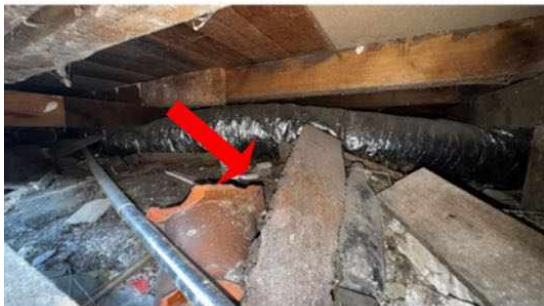
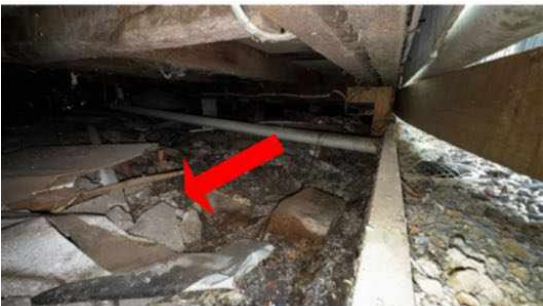
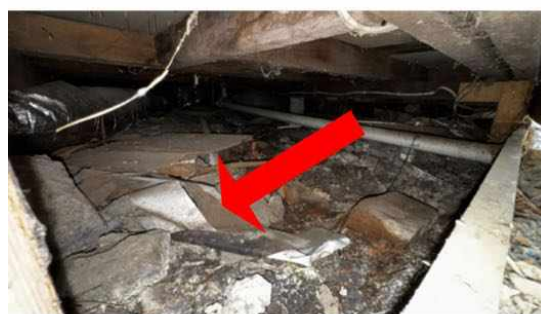
### Defects 3.27

Information: The subfloor was observed to contain stored items, rubbish, and debris. The issue is present where clutter restricts access and covers surfaces beneath the building.

This has likely occurred due to accumulation of materials over time or inadequate cleaning. Excess items can conceal defects, restrict inspections and maintenance, increase pest activity, and create fire or safety hazards.

This observation is provided for information only. When practical, a competent handyman should be engaged to remove all rubbish and clear access to ensure safe inspection, maintenance, and ongoing monitoring of the subfloor.

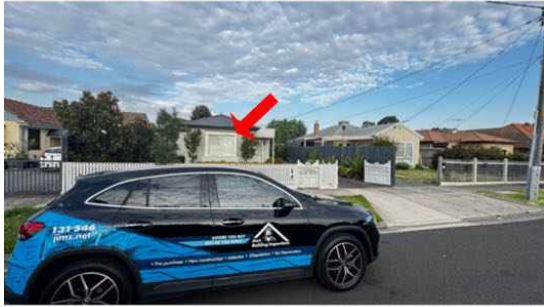
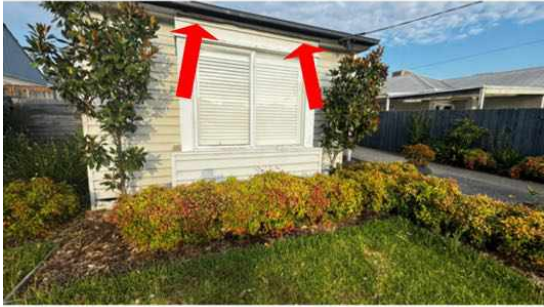
### Defects 3.28

Building:	Main Building
Location:	Roof Exterior
Finding:	Roof Plumbing - Roof Flashings Missing
Information:	The inspection identified missing roof flashings in some areas. Flashings are essential for directing water away from joints and penetrations in the roof. Missing flashings can lead to water ingress, leaks, corrosion, and damage to the underlying roof structure.

The absence of flashings may be due to poor installation, previous damage, or maintenance issues.

It is recommended that a licensed plumber or roofing specialist be engaged immediately to install the missing flashings. Prompt action will help maintain the roof's water-tightness, prevent structural damage, and prolong the service life of the roofing system.

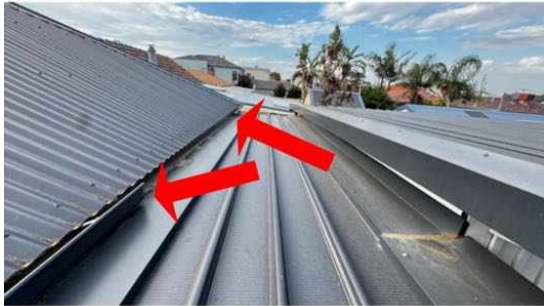
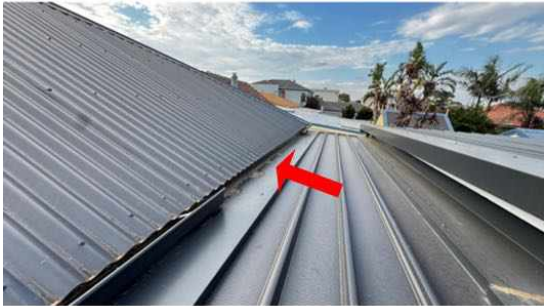
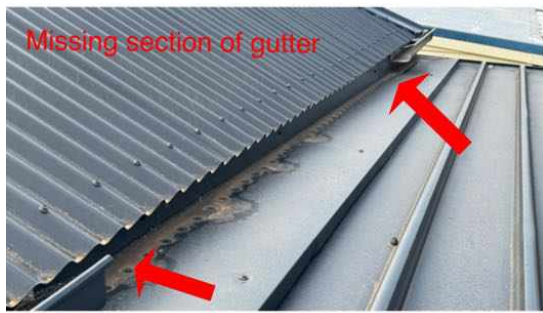
**Defects 3.29**

Building: Main Building  
Location: Roof Exterior  
Finding: Roof Plumbing - Gutters Leaking  
Information: Gutters in this area are leaking and not containing water effectively. The issue is observed along the gutter runs where joints, seams, and the gutter surface show signs of leakage.

This has likely occurred due to poor installation. Leaking gutters may cause water to overflow onto walls, windows, foundations, or landscaping, potentially leading to water damage or erosion.

A licensed roof plumber is required to inspect and repair or replace the leaking gutters in this area. This should be rectified immediately to ensure water is directed safely to the stormwater system and to prevent further damage to the building.

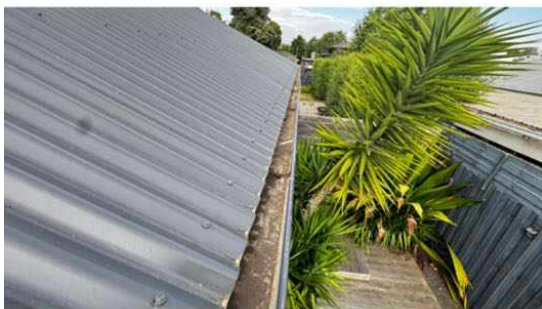
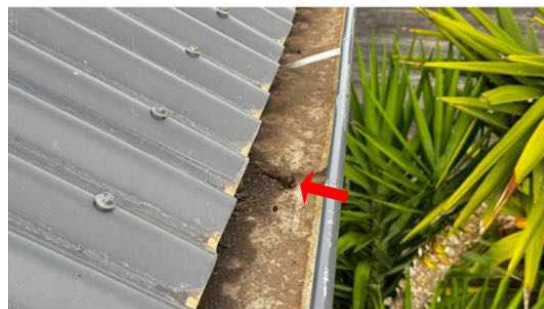
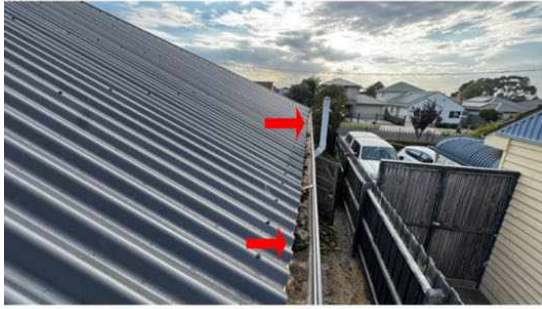
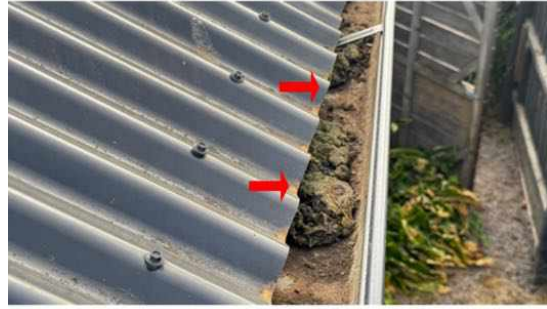
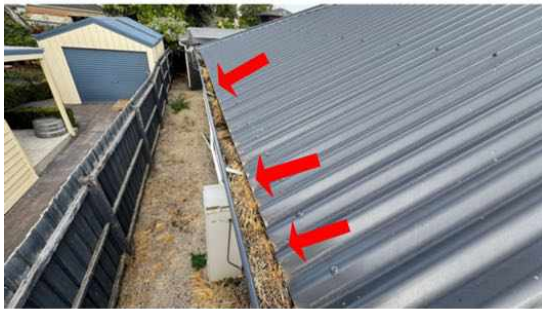
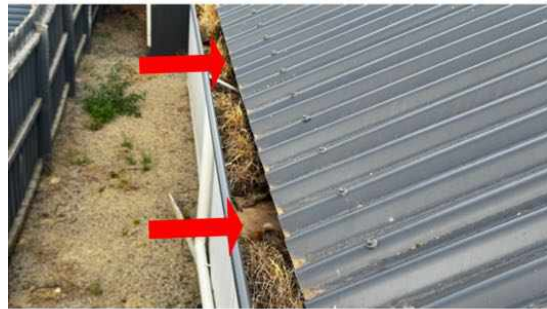
### Defects 3.30

Building:	Main Building
Location:	Roof Exterior
Finding:	Roof Plumbing - Gutters Blocked
Information:	Gutters in this area are blocked and not allowing water to flow freely. The issue is observed along the gutter runs where leaves, debris, or other obstructions have accumulated.

This has likely occurred due to lack of maintenance or build-up of debris over time. Blocked gutters may cause water to overflow, damage the roof, walls, or foundations, and increase the risk of erosion or water ingress.

A licensed roof plumber or competent handy man is required to inspect and clear the blocked gutters in this area. This should be rectified immediately to ensure water drains correctly and to prevent potential damage to the building.

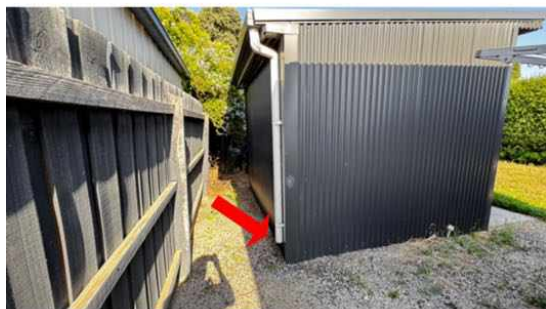
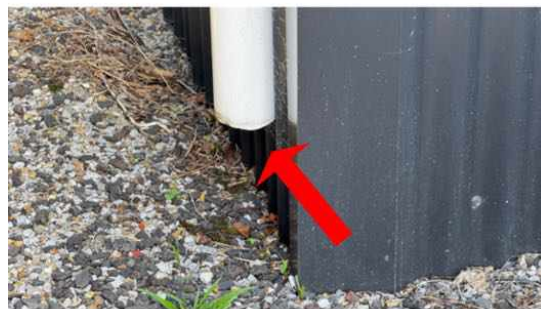
### Defects 3.31

Building:	Main Building
Location:	Roof Exterior >
Finding:	Roof Plumbing - Downpipes Not Connected To Storm Water
Information:	Downpipes in this area are not connected to the stormwater drainage system, allowing water to discharge directly onto surrounding ground.

This has likely occurred due to missing connections, poor installation, or design oversight. Uncontrolled water discharge may cause erosion, pooling, water ingress near the building, and potential damage to landscaping, paving, or foundations.

A licensed roof plumber is required to inspect and connect the downpipes to the stormwater system in this area. This should be rectified immediately to ensure proper drainage and prevent potential water damage.

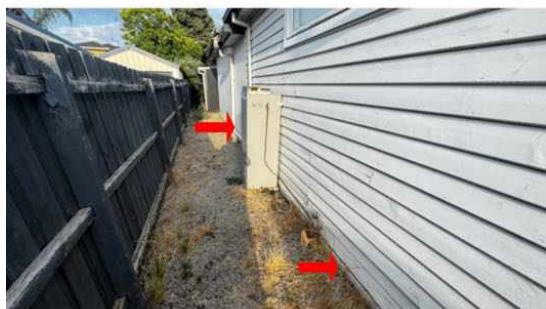
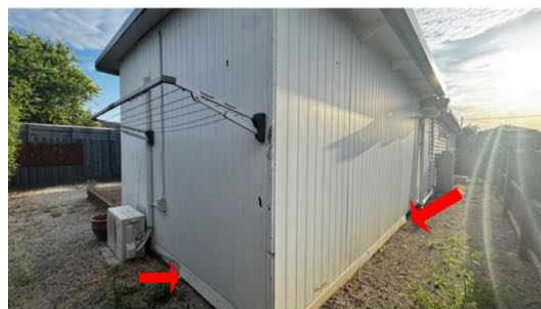
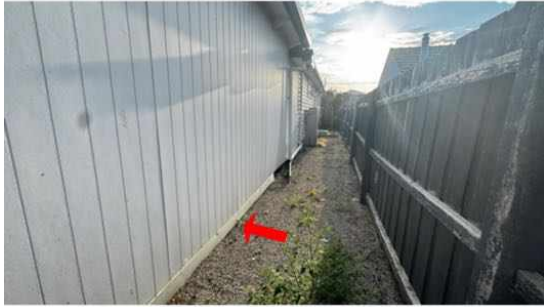
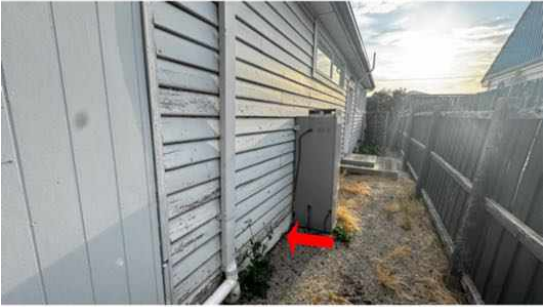
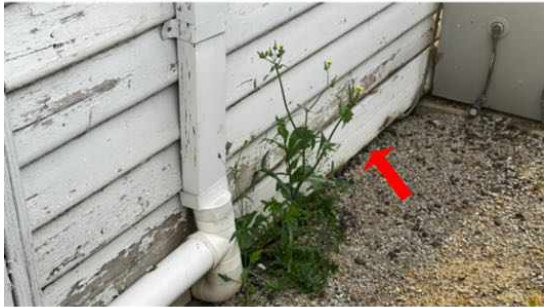
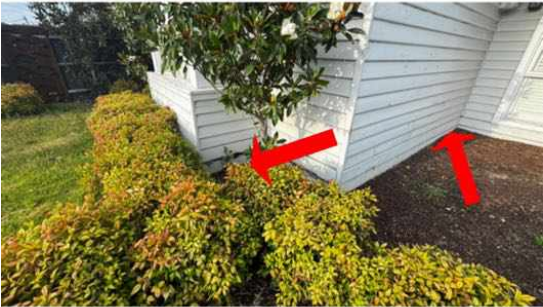
### Defects 3.32

Finding: Site Drainage - Inadequate

Information: The overall site drainage was observed to be inadequate at the time of inspection. Poor drainage can cause water to pond near external walls, increasing the risk of rising damp, foundation movement, timber decay, and deterioration of associated building elements.

Ground levels should slope away from the dwelling to direct water from walls and footings. Downpipes must be properly connected to the stormwater system and should not discharge directly onto walls, paving, or plinths. Stormwater should be directed away from the property through adequately sized and maintained drains. Where ground levels are too high and cover the damp-proof course (DPC), lowering the levels may be necessary to expose the DPC and allow effective drainage.

A licensed plumber should be engaged promptly to investigate and recommend suitable remedial works, which may include the installation of an agricultural (aggie) drain or other site drainage improvements. Immediate action is strongly recommended, as inadequate drainage can lead to progressive water damage and secondary building defects over time.

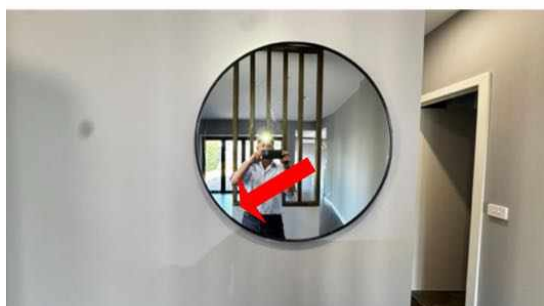
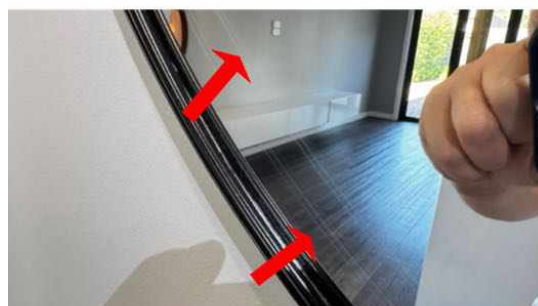
Building: Main Building  
 Location: Entry  
 Finding: Mirrors - Scratched  
 Information: Minor surface scratching was observed to the mirrors at the time of inspection. While the damage appears cosmetic in nature, scratching detracts from the overall appearance and finish of the mirrors and may become more noticeable under certain lighting conditions.

The condition is likely due to handling, installation, or contact with abrasive materials during construction or subsequent use.

It is recommended that a qualified glazier or building contractor be engaged to assess the extent of the scratching and determine whether polishing, repair, or replacement of the affected mirrors is required to achieve an acceptable finish.

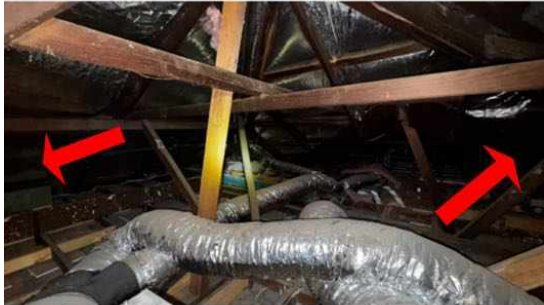
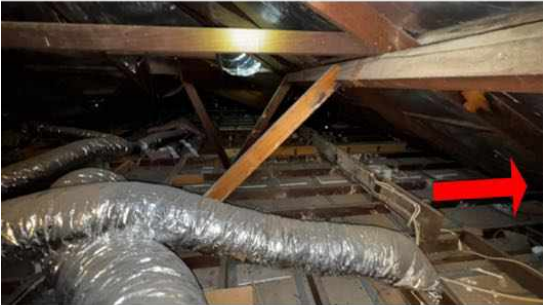
Building: Main Building  
 Location: Roof Void  
 Finding: Roof Void - Limited Access  
 Information: Limited access to the roof void was present due to facts including but not limited to, limited access, insulation, Air condition Unit & ducting, obstructions or placement of insulation and or sarking, for this reason complete access to the roof void was not possible.

A visual inspection was carried out from accessible areas only, recommend installing another access hatch in a more accessible area for a re-inspection.

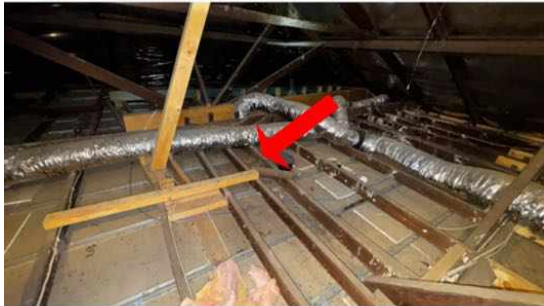
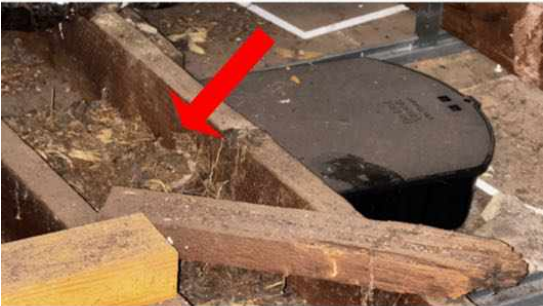
Building: Main Building  
Location: Roof Void >  
Finding: Roof Void - Debris & Rubbish  
Information: Debris and rubbish were observed within the roof void.

The accumulation of foreign material can create an unhygienic environment, attract pests, and compromise the overall condition of the roof space.

It is recommended that a competent handy man be engaged to safely remove the debris. Prompt removal will maintain proper ventilation, improve hygiene, and allow safe and effective inspection and maintenance of the roof void.

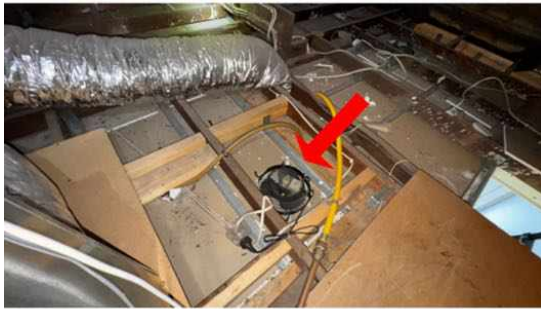
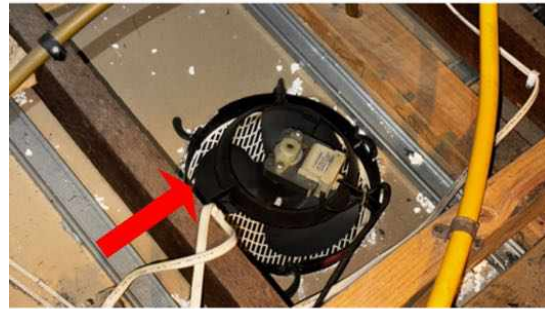
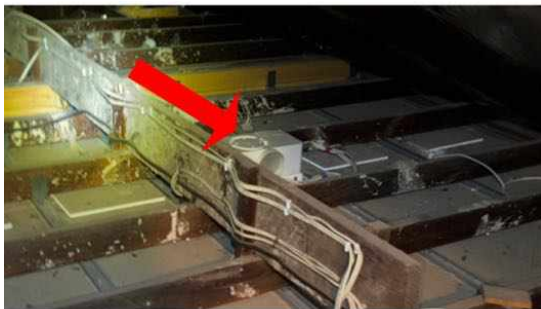
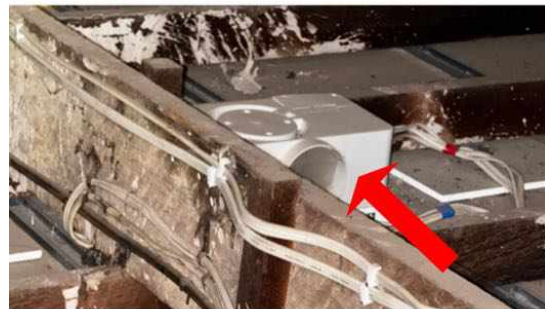
**Finding:** Roof Void - Exhaust Fans Not Ducted To Atmosphere  
**Information:** The exhaust fans in the roof void are not ducted to the atmosphere. The issue is observed where fan outlets discharge directly into the roof space instead of venting outside.

This has likely occurred due to incomplete installation or missing ducting. Unducted fans may cause moisture buildup, condensation, and potential damage to insulation, ceiling linings, or timber, increasing the risk of mould growth and structural deterioration.

A licensed HVAC technician or licensed roof plumber is required to install proper ducting to vent the exhaust fans to the atmosphere. This should be rectified immediately to prevent moisture-related damage and maintain the performance of the ventilation system.

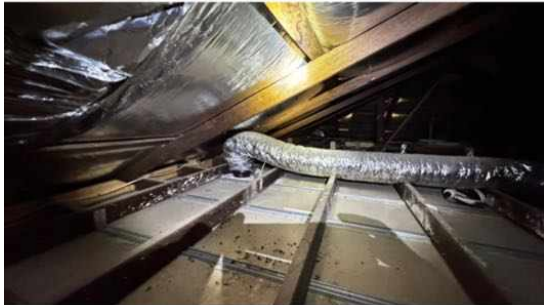
**Building:** Main Building  
**Location:** Roof Void >  
**Finding:** Roof Void - No Insulation  
**Information:** Insulation in the roof void was found to not be installed. This reduces its effectiveness in maintaining thermal efficiency.

The issue may result from poor workmanship during installation or movement of insulation after installation. If not corrected, no insulation can increase heating and cooling costs and may create cold spots that lead to localized condensation or moisture issues.

A qualified insulation installer should be engaged promptly to assess the roof void and add insulation as needed to ensure full, even coverage without compression. Regular monitoring is recommended to maintain thermal performance.

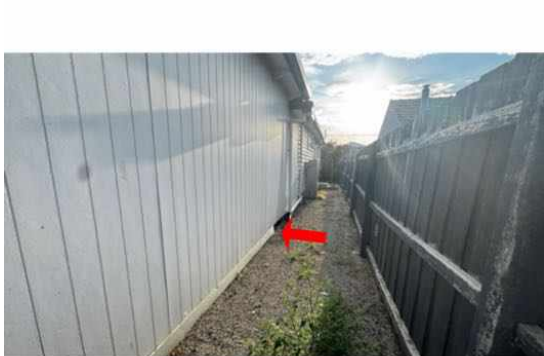
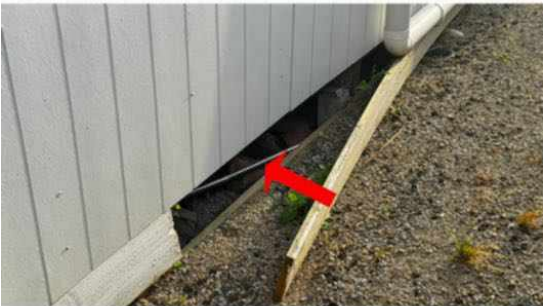
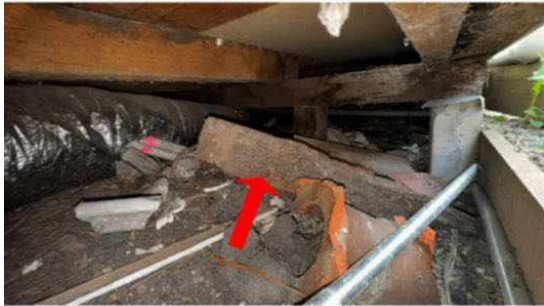
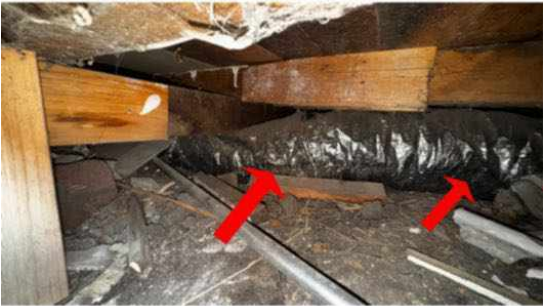
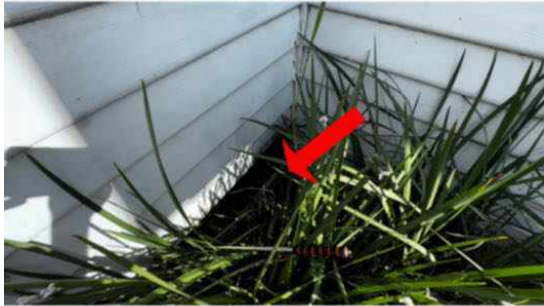
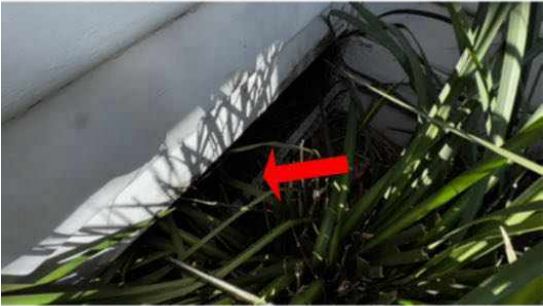
Building: Main Building  
Location: Subfloor  
Finding: Sub Floor - Limited Access  
Information: The subfloor area was observed to have restricted, limited and difficult access. The issue is present where limited space and obstacles prevent safe entry and movement beneath the building.

This has likely occurred due to inadequate access points. Poor access can impede inspections, maintenance, and timely identification of structural, pest, or service issues, increasing long-term repair costs and safety risks.

A registered builder is required to assess and improve subfloor access. This should be addressed as soon as possible to ensure safe entry, proper inspection, and maintenance of the subfloor.

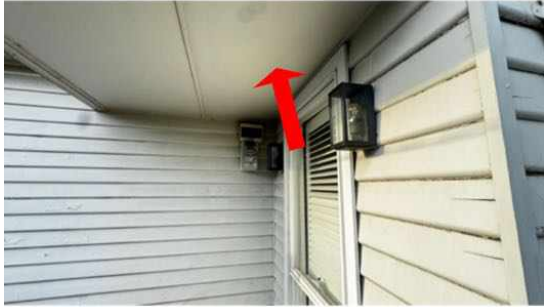
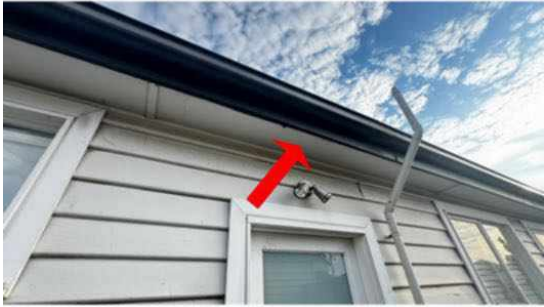
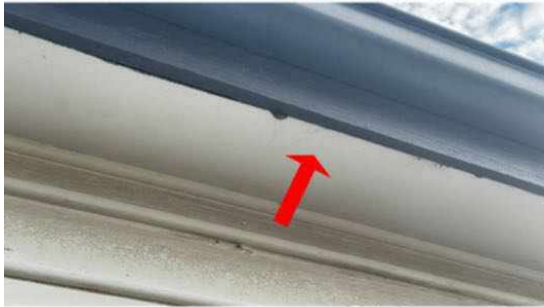
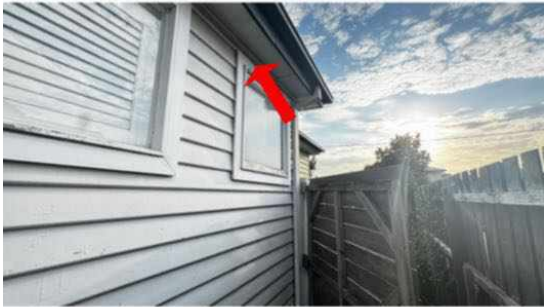
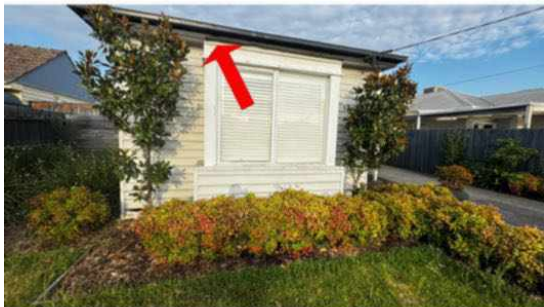
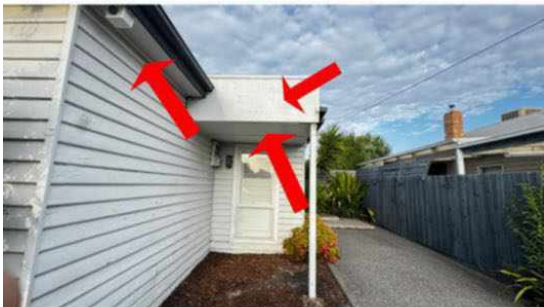
Building:	Main Building
Location:	All Areas
Finding:	Asbestos - Suspected ACM Identified On Site
Information:	Reporting on Asbestos is outside the Scope of this Report. This suspected defect is highlighted as a caution only. We suspect, based on our experience in the building industry, that there is a higher risk of the identified building element containing asbestos to areas inside and outside the property.

As Asbestos Reporting is outside the scope of this report, we **STRONGLY** advise that you consider a separate Asbestos Inspection and Condition Audit, which can include the taking of samples for definitive confirmation of the presence of Asbestos.

In the interim, the client is advised to act with caution not only to the areas within the report but all areas within the property, especially when considering any damage to building materials general wear and tear renovations extensions demolition and general maintenance activities due to the suspected presence of Asbestos

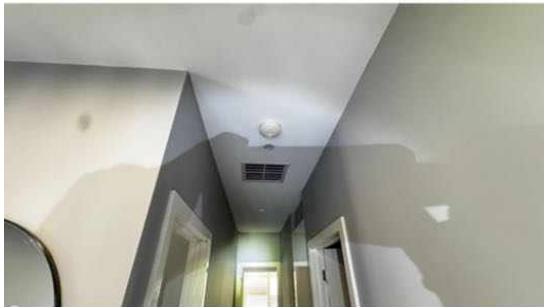
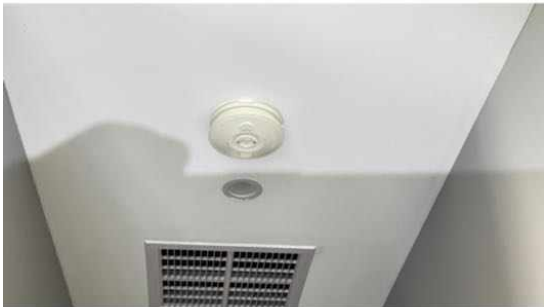
During the inspection, smoke detectors were noted for advisory purposes only. The operation, age, type, and compliance of smoke detectors could not be fully verified as part of this inspection.

It is recommended that a licensed electrician be engaged immediately to test, service,

and upgrade smoke detectors as required to ensure correct operation and compliance with current safety requirements.

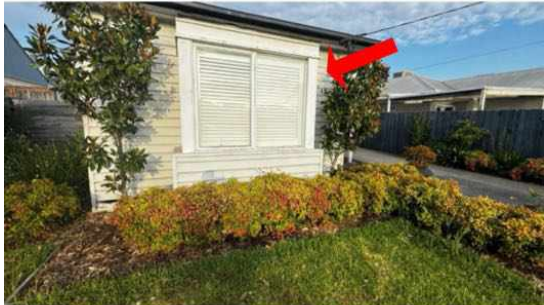
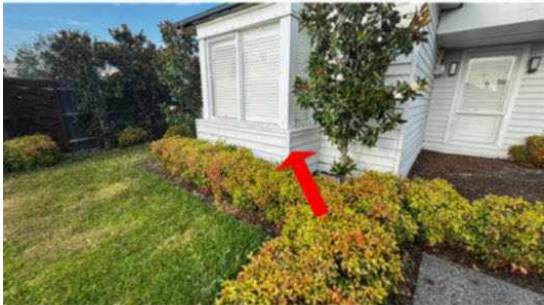
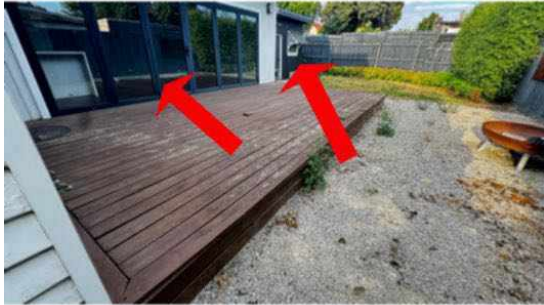
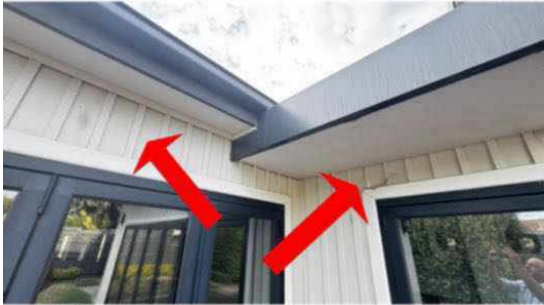
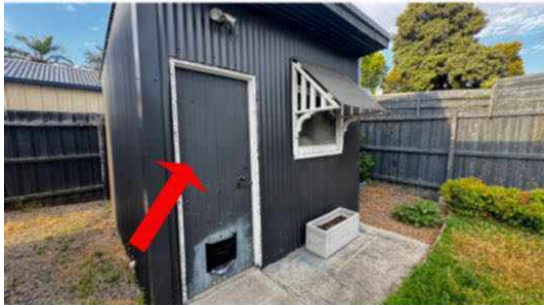
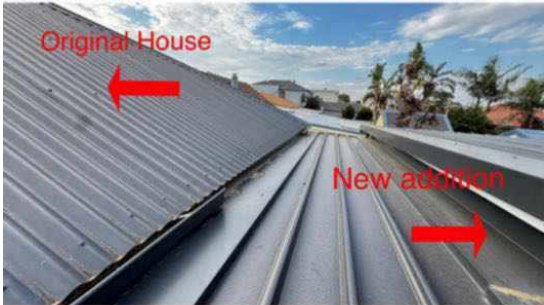
Building: Main Building  
Location: All Areas  
Finding: Building Approvals – Prior Renovations Advisory  
Information: For your information, the dwelling has undergone several renovations over the past years. Evidence of multiple alterations and upgrades was observed at the time of inspection. The inspection did not include verification of council approvals, permits, or compliance documentation for these works.

Unapproved or undocumented renovations may present compliance, safety, insurance, or resale risks if not properly approved or certified.

It is strongly recommended to make enquiries with the relevant local council immediately and engage appropriately qualified professionals, where necessary, to confirm that all historic renovations were carried out with the required permits, approvals, and certifications.

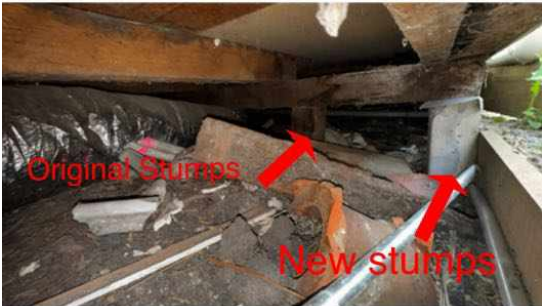
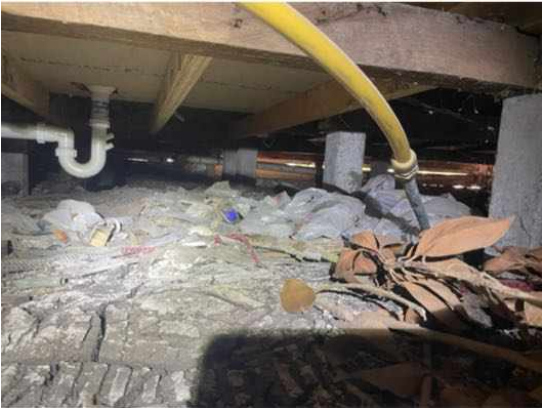
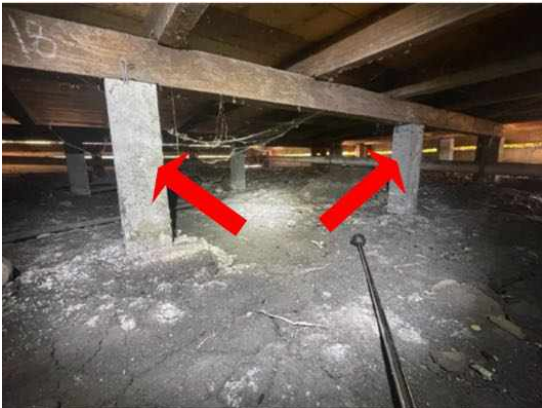
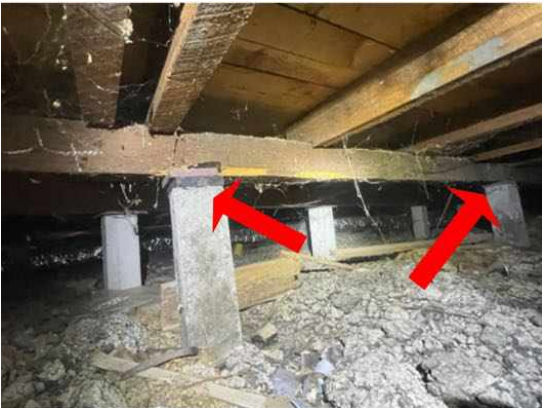
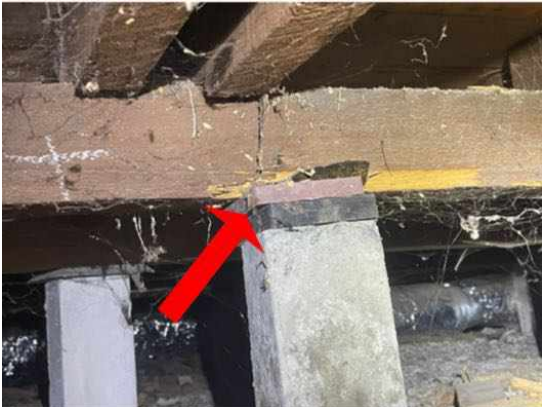
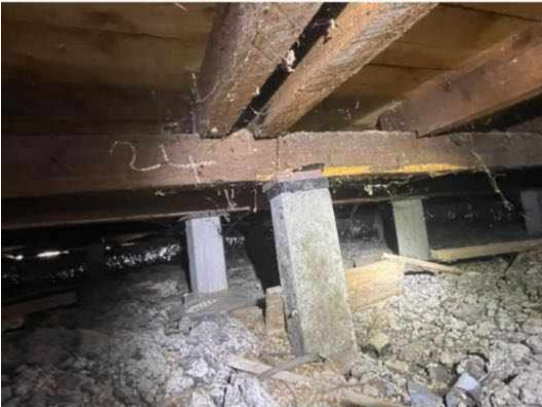
Building: Main Building  
 Location: Subfloor >  
 Finding: Sub Floor - Evidence of Historic Re-Stumping and Floor Level Deviations  
 Information: Evidence of historic re-stumping works was observed within the subfloor area at the time of inspection. Variations and deviations in floor levels were also noted, which may indicate movement, settlement, or uneven performance of the existing stumps.

The condition may be due to age, soil movement, differential settlement, or the adequacy of previous re-stumping works.

Continued movement could result in further floor level variations, cracking to finishes,

or operational issues with doors and windows if left unaddressed.

It is recommended that a qualified and licensed re-stumping contractor be engaged immediately to assess the subfloor structure, verify the condition and adequacy of the existing stumps, and advise on any remedial works required to stabilise floor levels and prevent further movement.

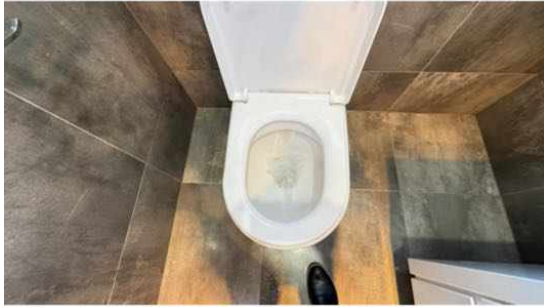
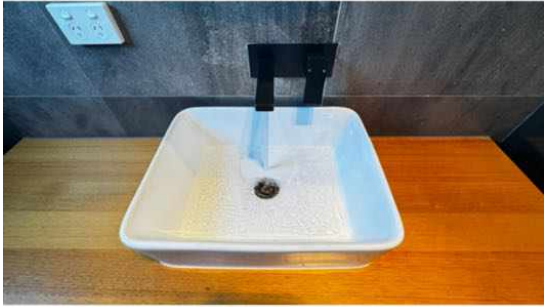
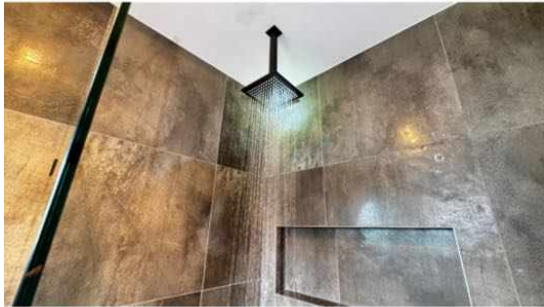
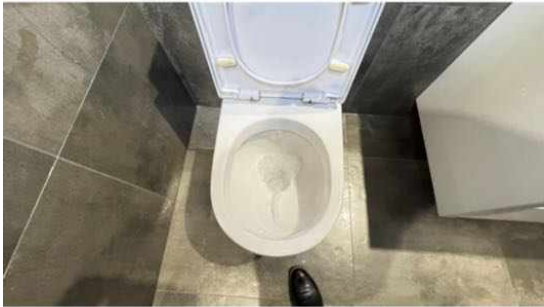
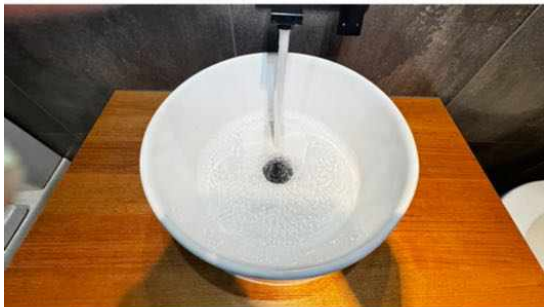
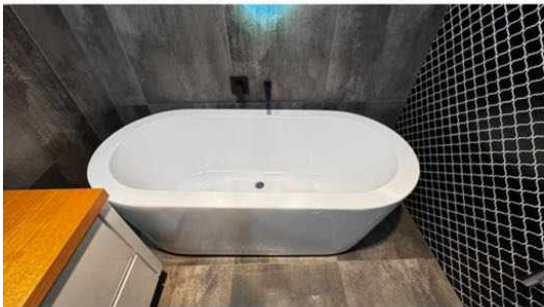
Building: Main Building  
 Location: All Internal Areas  
 Finding: Water Supply & Drainage - Shower, Basins, Toilets, & Plumbing Fixtures  
 Information: The shower recess was tested, and no visible water penetration to surrounding areas was observed at the time of inspection, except where noted as a separate defect elsewhere in this report. Water appeared to flow freely toward the floor waste. Moisture detected to the shower walls is documented separately in the report. The shower floor waste appeared clear during inspection.

Flushing the toilet revealed no visible leaks, and the fixture appeared to operate normally unless otherwise noted as a separate defect. No water damage was observed to the vanity unit unless specifically stated elsewhere in the report. Basins, bathtubs, laundry tubs, vanities, and sinks were tested and inspected with no evidence of leaks, blockages, or drainage issues at the time of inspection unless otherwise noted. All internal taps and shower heads were tested with no leaks observed, unless documented as a separate defect.

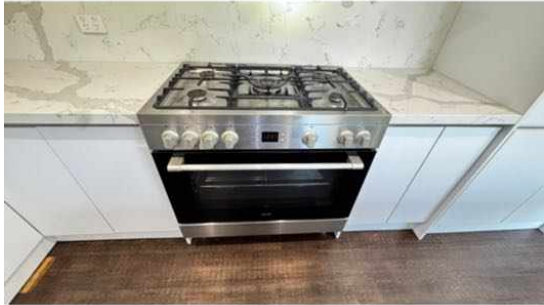
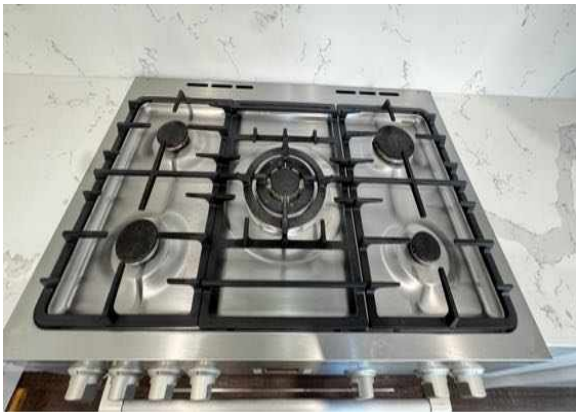
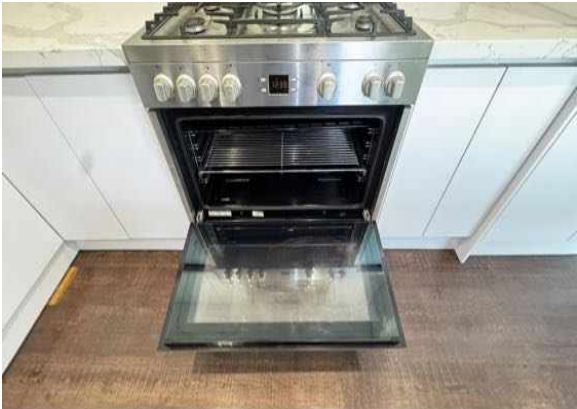
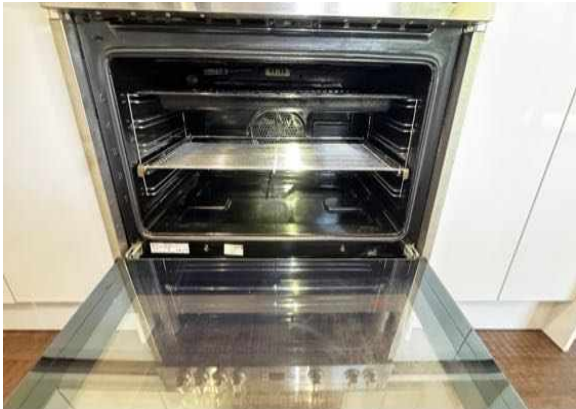
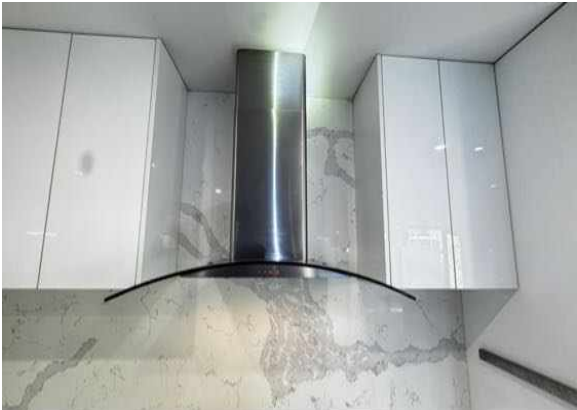
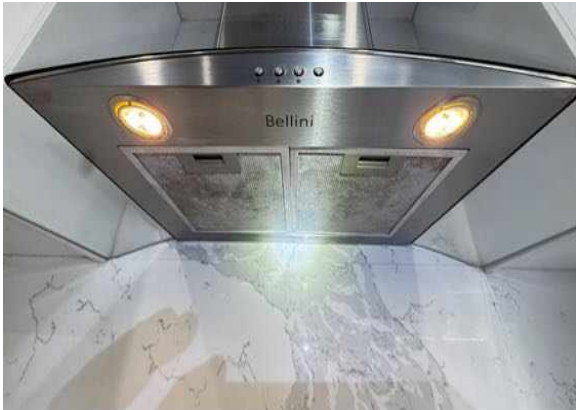
The inspection did not include testing, operation, safety, or assessment of any installed or portable appliances or mechanical systems. This includes, but is not limited to, ovens, cooktops, microwaves, rangehoods, dishwashers, ducted vacuum systems, air-conditioning units, heating systems, hot water services, ceiling fans, exhaust fans, intercoms, security systems, fireplaces, and solid fuel heaters.

Appliances may be worn, damaged, or malfunctioning. Electrical or gas appliances can pose serious safety hazards if incorrectly installed or maintained.

Observations and images of appliances are for informational purposes only and do not form part of the formal building inspection.

Service, repair, or replace equipment as necessary, particularly where service history or warranty coverage is unknown.

Inspect any water, gas, or electrical connections associated with appliances to ensure safety and compliance.

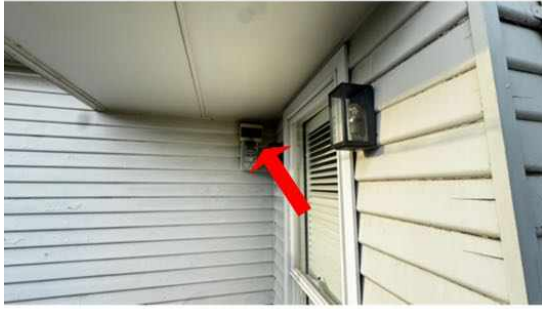
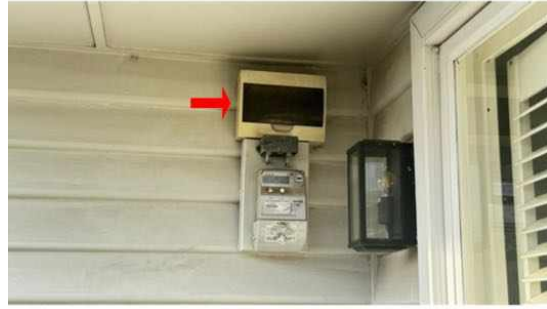
(AS 4349.1-2007: Electrical Switchboard & meter inspections are for your information only, as functional testing is outside the scope of a standard pre-purchase building inspection.)

For full compliance and safety verification, a licensed electrician should be engaged to inspect the switchboard, test all circuits, and ensure all components are functioning correctly. This will help maintain electrical safety and prevent potential hazards.

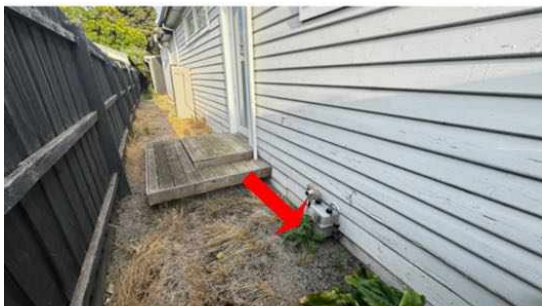
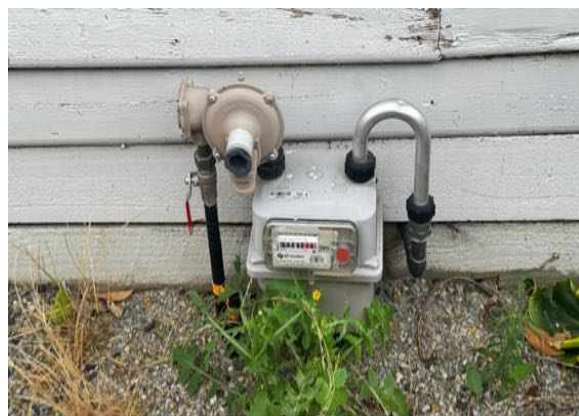
Building: Main Building  
 Location: All External Areas  
 Finding: Gas Meter - Location For Your Information  
 Information: The gas meter was inspected and photographed for reference and location purposes only.

Gas meters can be affected over time by age, environmental exposure, or accidental impact, which may lead to corrosion, physical damage, leakage, or non-compliance with current regulations. Regular checks are recommended to ensure ongoing safe operation.

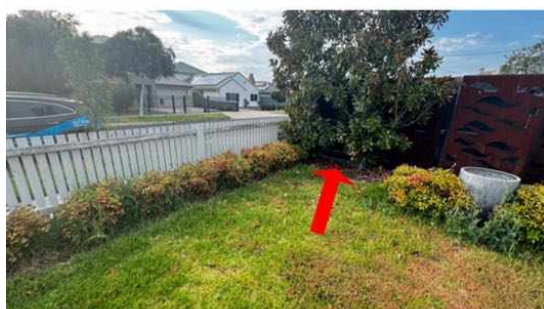
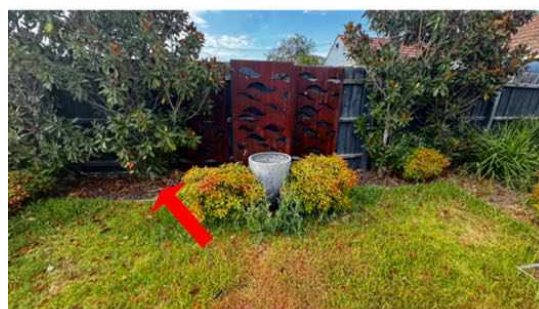
Building: Main Building  
 Location: All External Areas  
 Finding: Water Meter - Location For Your Information Only  
 Information: The water meter was photographed at the time of the inspection. The meter is included for reference & location purposes only.

Water meters can be affected over time by age, environmental exposure, accidental impact, or poor maintenance. Potential issues could include leaks, corrosion, or malfunction that may impact water supply or cause water damage.

It is recommended that a licensed plumber carry out routine inspections and maintenance to ensure continued safe and compliant operation. Observations are for informational purposes only and do not form part of a full safety or compliance inspection.

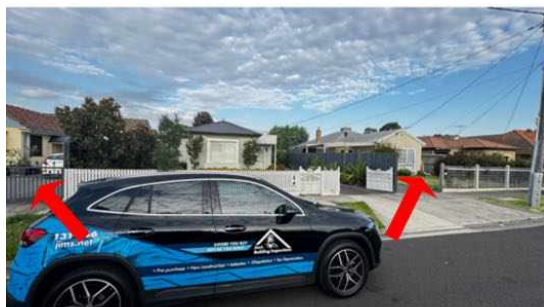
Building:  
 Location:  
 Finding: Neighbouring Properties - For Your Information  
 Information: Neighbouring properties were visually inspected from publicly accessible areas. No detailed structural, noise, or compliance testing was performed as part of this inspection.

Recommendation: For concerns regarding noise, encroachments, or structural issues affecting neighbouring properties, it is recommended to engage relevant specialists (e.g., acoustic consultant, building surveyor, or a registered builder) and/or contact the local council.

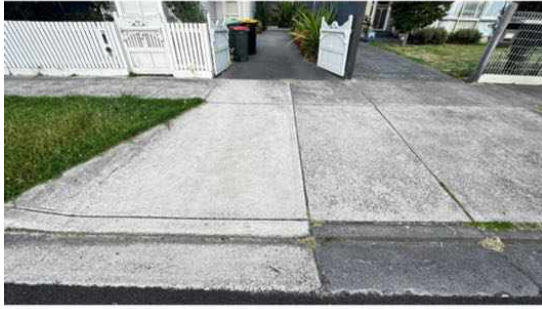
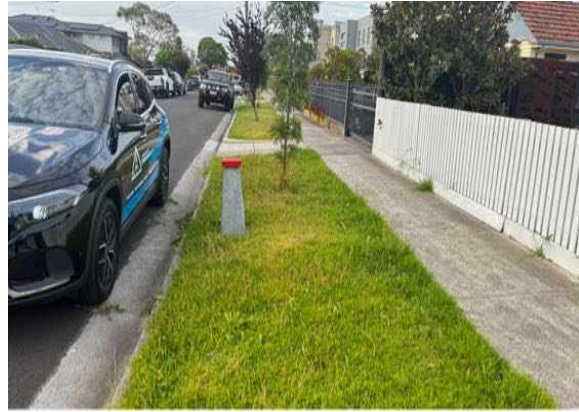
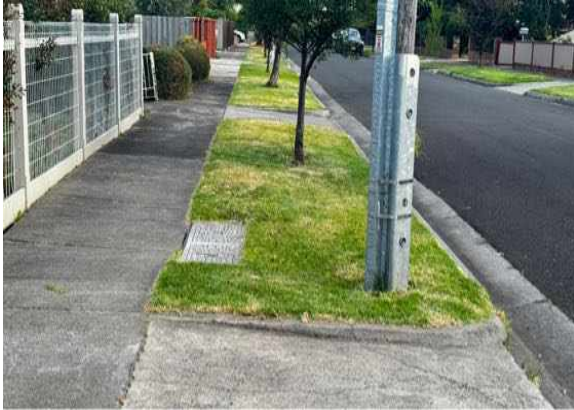
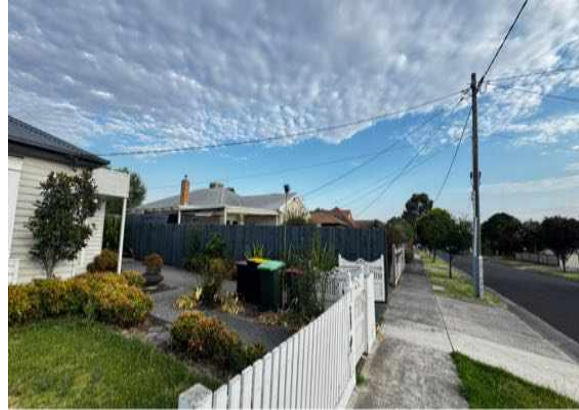
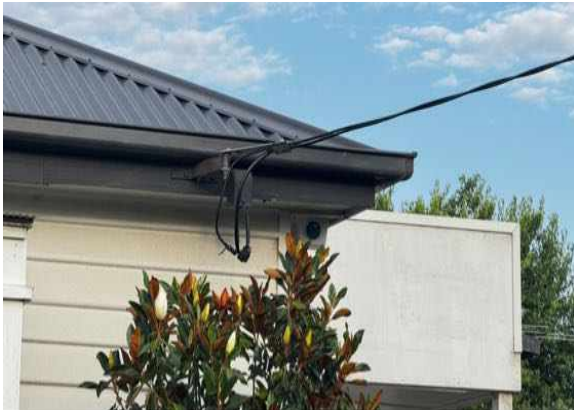
During the inspection, minor cracking, surface wear, or uneven sections were observed on footpaths or crossovers. Some accessible metal components, such as street signage or grates, showed signs of rust or deterioration. Debris accumulation and vegetation encroachment were also noted around council infrastructure. Access or visibility was limited to certain council-owned assets.

These areas should be monitored, and for detailed assessment, maintenance, or compliance verification, the relevant local council authority should be contacted immediately. Regular monitoring of adjacent council assets is recommended to ensure ongoing safety and proper maintenance.

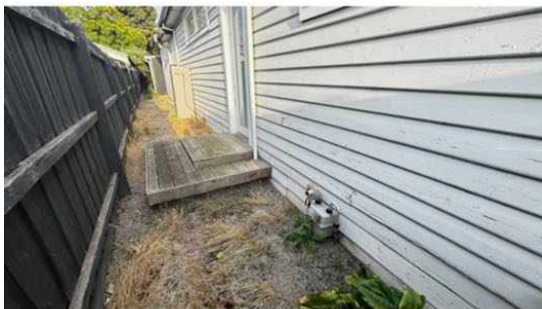
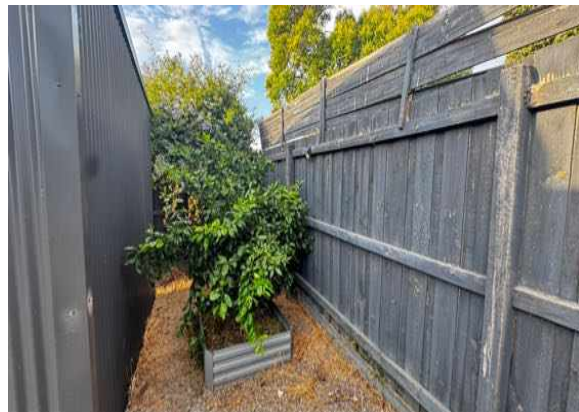
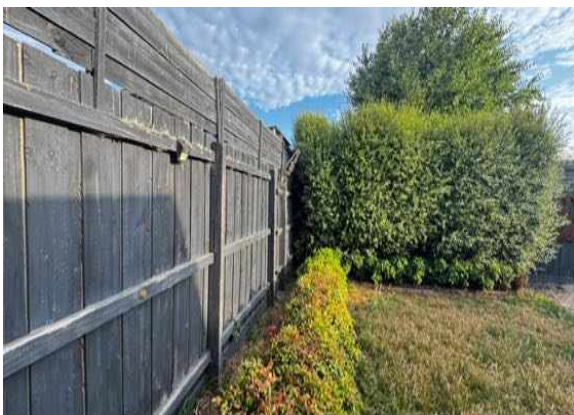
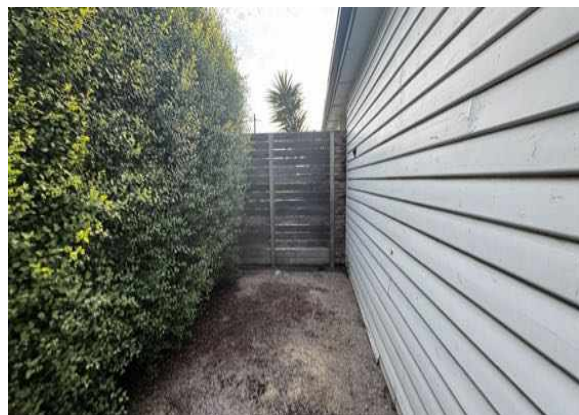
It is important to note that these restrictions can conceal a wide range of building defects, including but not limited to:

Because these areas could not be visually assessed, no comment can be made on their condition within this report.

It is strongly recommended that obstructions be removed and concealed areas made fully accessible immediately. A re-inspection should then be carried out to allow a complete assessment of the property's condition. This is particularly important prior to purchase, as defects in concealed areas can carry significant rectification costs.
