Building and Timber Pest Inspection Report

Inspection Date: Wed, 7 Jan 2026

Property Address: 91 Prince Edward Ave, Culburra Beach NSW
2540, Australia

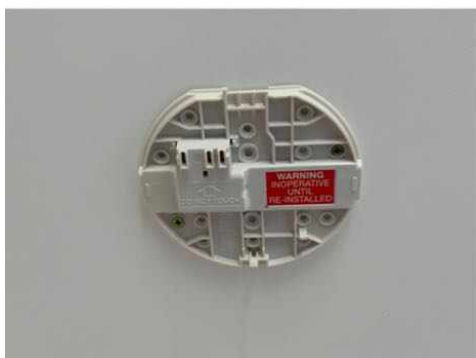
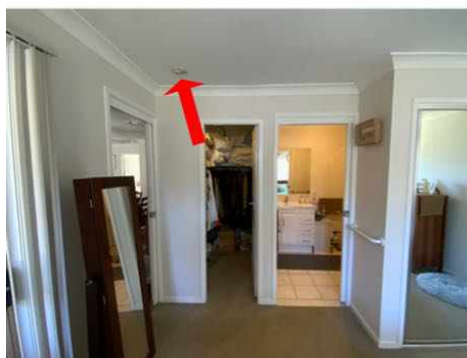
Building:	Main Building
Location:	Bedroom - Master
Finding:	Smoke Detectors and Alarms (missing)
Information:	Reporting on Smoke Detectors or Alarms, including hard wired smoke detection systems and their legislative requirements, is outside the Scope of this Report.

Please note that this defect is highlighted as a caution only. We suspect, based on our experience in the building industry, that the absence of smoke detectors, or their poor condition, should be addressed as a matter of urgency to improve occupant safety.

Always ensure sufficient working and suitable smoke detectors are installed prior to occupying any building. Additionally, it is advised that all smoke detectors be tested by the homeowner on a monthly basis.

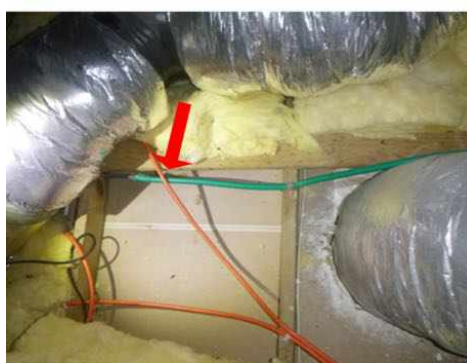
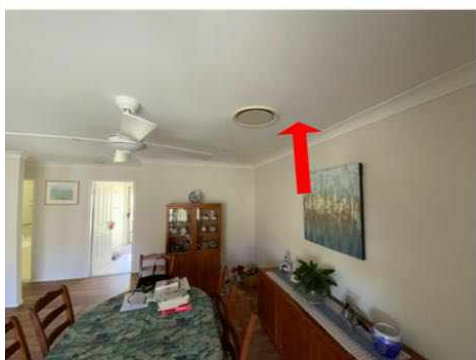
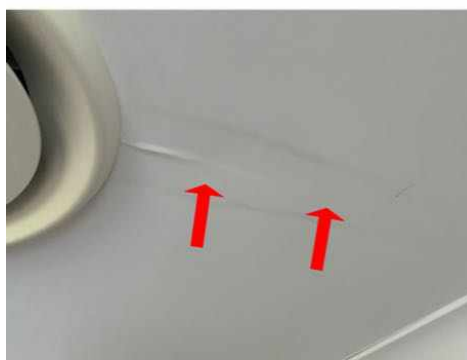
Finding 2.01

Finding: Water leak - Internal (This appears to be from a leaking water pipe join)

Information: A water leak was found in this area at the time of inspection. Internal water leaks can be detrimental to surrounding building elements; their potential causes include damage to plumbing fittings and fixtures, through to water damage and deterioration of associated building elements.

Rust, corrosion, decay and water damage are potential outcomes where a minor water leak is left unattended. More serious defects may also result, such as electrical hazards, or water damage to structural building elements.

In extreme cases, structural damage may develop due to a prolonged water leak. It is highly advised that internal water leaks be addressed by a licensed plumber as a matter of relative urgency.

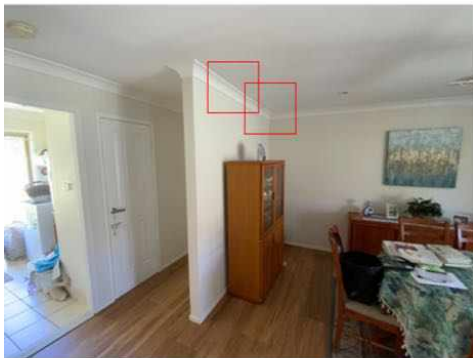
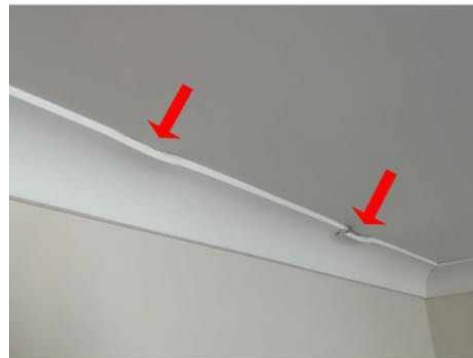
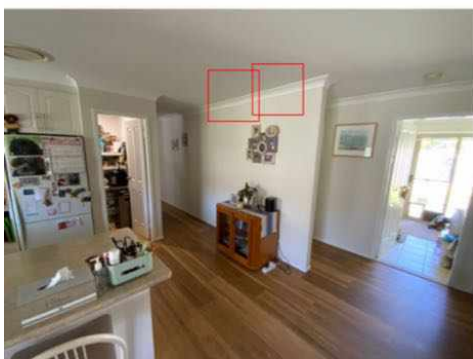
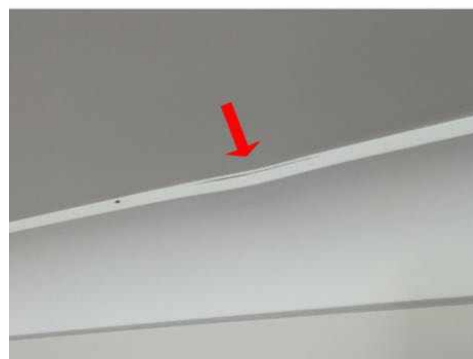
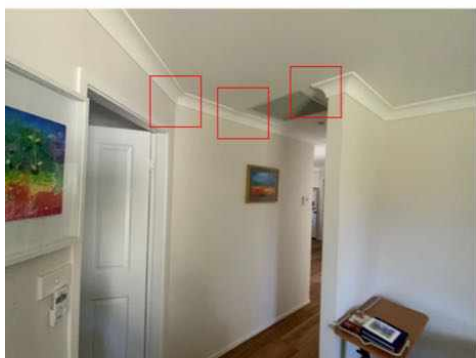
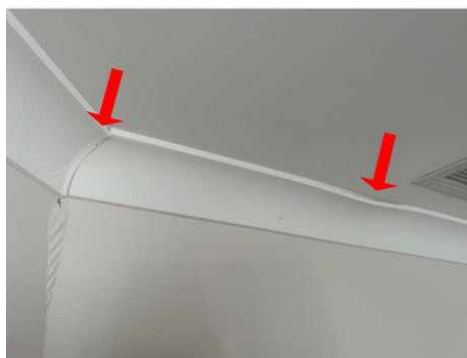
Finding 2.02

Information: Sections of the ceiling were found to be sagging at the time of inspection. Sagging to the fixed ceiling structure below the roof trusses generally indicates that the roof trusses have settled (or sagged) over time due to the weight or load put on the roof trusses. Excessive moisture can also play a role in sagging of timbers, the installation

In some cases, sagging roof trusses may also indicate that there are structural issues (inadequate design of the roof trusses), causing sagging of the roof trusses and ceilings. Monitoring of these areas is recommended (after patching and painting is completed) to identify any further movement or sagging. If further movement and sagging continues, the appointment of a structural engineer is advised to further inspect the property and identify the source and rectification works required.

of a “whirly bird” or similar type of external air extraction device is recommended to be installed to the roof void to extract moist or hot air from the wet area exhaust fans and in hot or wet weather conditions.

The appropriate action should be taken by the client as soon as possible to ensure that any potential further damage is limited.

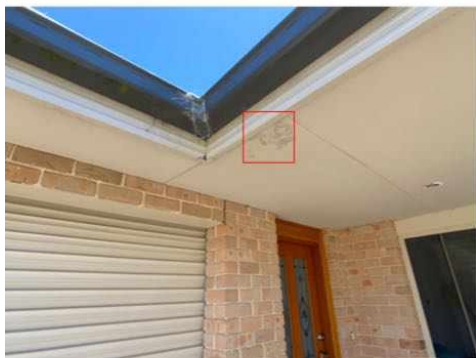
Finding 2.03

Building:	Main Building
Location:	Roof Exterior
Finding:	Eaves - Water stained (from blocked and overflowing guttering)
Information:	Water staining to eaves/ceiling linings in this area was evident at the time of inspection. Water staining indicates that surfaces have been exposed to excessive moisture over time. The minerals and other elements in the water lead to staining, which may graduate to corrosion and deterioration if left unmanaged.

While mostly an appearance defect, water staining can be indicative of more serious defects, which may be currently concealed by ceiling linings. Cleaning out of the guttering and roof valleys is highly recommended as priority to avoid water overflows into the eaves and potentially into the external walls of the house also.

It is highly advised that blocked gutters be cleaned out by a professional gutter cleaner, the homeowner or a general handyperson as a matter of urgency. The installation of a quality suitable gutter guard is also highly recommended to reduce blockages, however regular flushing out of the guttering is still recommended to avoid debris build up below the gutter guard.

Replacement of any damaged structures is advised.

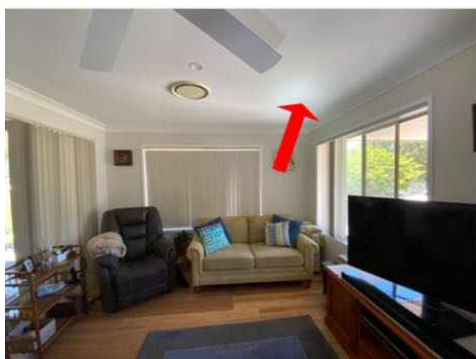
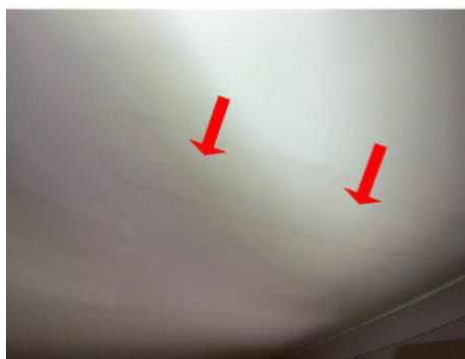
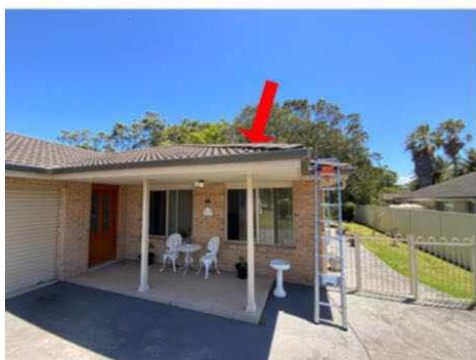
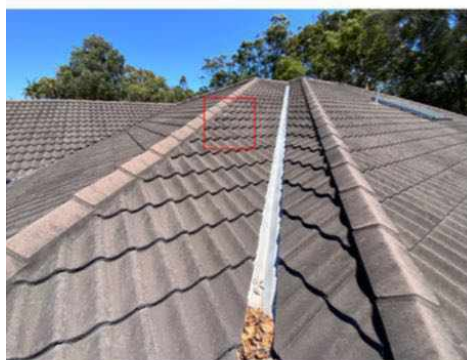
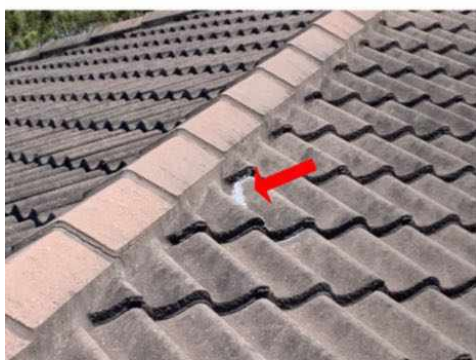
Finding 2.04

Building:	Main Building
Location:	Lounge Room
Finding:	Ceiling - Water stained from a broken roof tile above
Information:	Water staining to ceiling linings in this area was evident at the time of inspection. Water staining indicates that surfaces have been exposed to excessive moisture over time. The minerals and other elements in the water lead to staining, which may graduate to corrosion and deterioration if left unmanaged.

While mostly an appearance defect, water staining can be indicative of more serious defects, which may be currently concealed by interior ceilings.

Where water staining is active, a licensed plumber must be consulted to identify the cause of the staining and to provide advice on any reparation works that may be required. Replacement of any damaged structures is advised.

Conversely, where water staining is old and inactive, affected building materials may be repaired or replaced at client discretion.

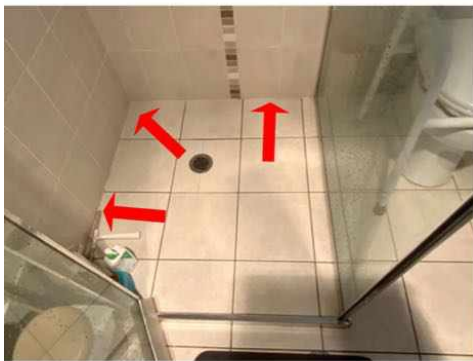
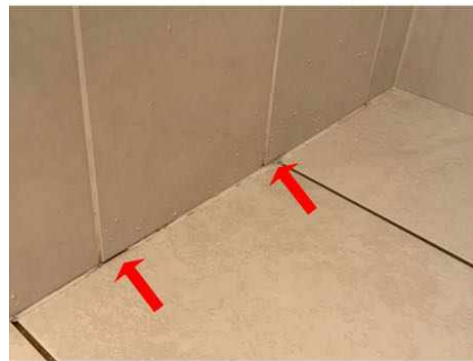
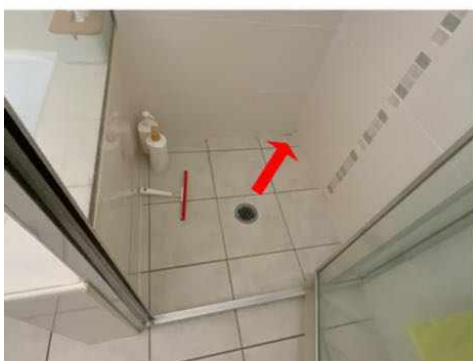
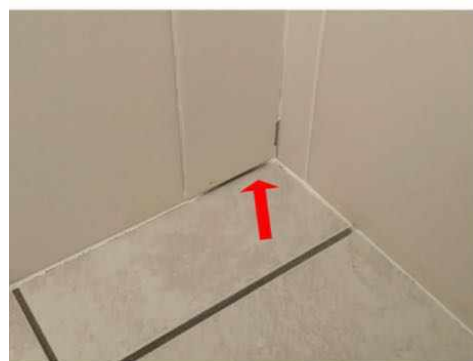
Finding 3.01

Building:	Main Building
Location:	All Wet Areas
Finding:	Sealant or Grout - Deteriorated, Missing or substandard installation
Information:	Sealant appears to be inadequate to these tiled areas. The different materials and floor areas move at different rates therefore cracking the grout at this point. A flexible sealant is required to allow for this expansion & contraction while keeping the joint water tight and without holes for long term care of all building materials.

Cut sealant nozzle end to approximately 5mm hole diameter and Squeeze in. Push in and wipe off excess silicone with your finger (lightly first to even out sealant and to push into gaps then push in harder the 2nd time), carefully peel off the masking tape, spray area with spray & wipe (or similar to avoid sealant smearing up the wall) then finally run your finger over the sealant to give a smooth final finish.

Regular maintenance &/or replacement of damage or missing sealant is highly recommended for the long term care of your property.

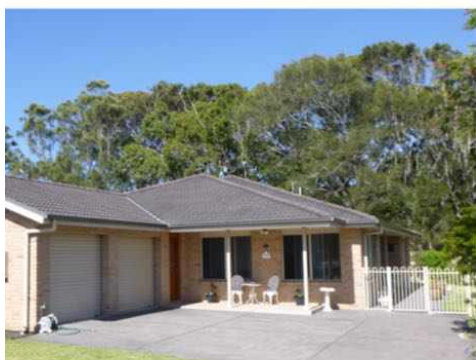
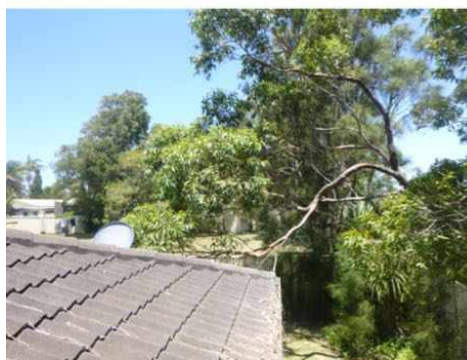
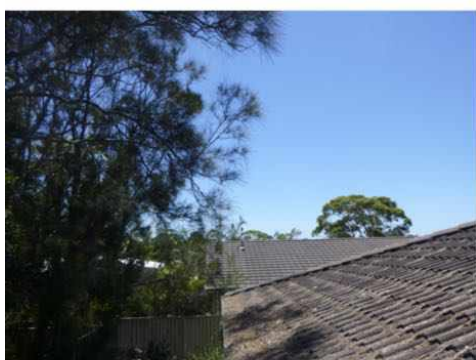
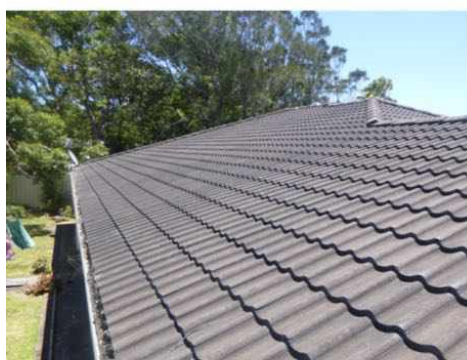
Finding 3.02

Building:	Main Building
Location:	Roof Exterior
Finding:	Trees - Overhanging and filling gutters

It is highly advised that all overhanging tree branches be removed as soon as possible to prevent any further damage. Repair and/or replacement of sections of damaged guttering may also be required where the extent of the damage necessitates.

Such works should be performed by the homeowner; however, appointment of a landscape contractor or an arborist may be required. Consultation with a licensed roof plumber is required where guttering has been damaged.

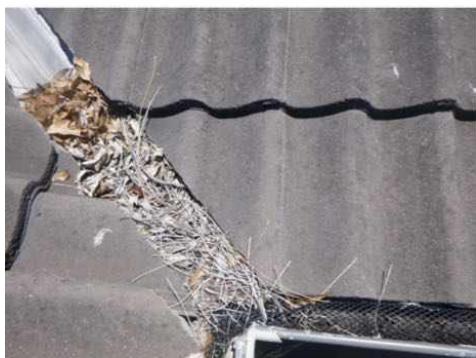
Finding 3.03

Building: Main Building
 Location: Roof Exterior
 Finding: Gutters - Blocked
 Information: Roof plumbing structures, such as guttering and downpipes, should be free of all

Blocked gutters are likely to lead to high levels of moisture in the affected areas. Such moisture will not only cause rust and decay of the associated building materials, but can also provide conditions that are conducive to termite and timber pest activity. Blockages in gutters should therefore be removed immediately to ensure dry conditions are maintained.

Consult a Licensed Plumber for further specific advice on remedial works that may be required. In the interim, it is highly advised that blocked gutters be removed by a professional gutter cleaner, the homeowner or a general handyperson as a matter of urgency. The installation of a suitable gutter guard is also highly recommended to reduce blockages, however regular flushing out of the guttering is still recommended to avoid debris build up below the gutter guard.

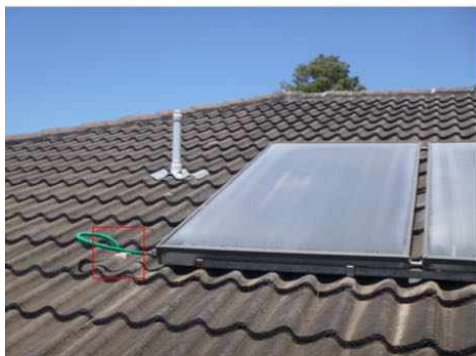
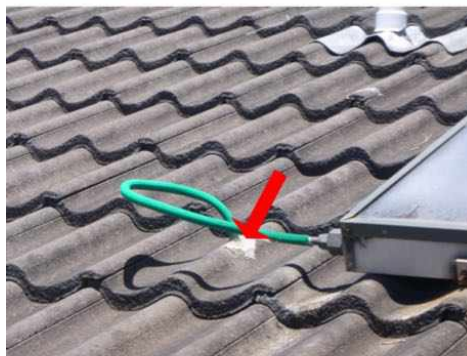
Finding 3.04

Building:	Main Building
Location:	Roof Exterior
Finding:	Roof plumbing - Flashing missing to pipe penetration
Information:	Some sections of the roof are missing or have inadequate roof flashings. It appears that silicone only has been used to seal the hole to the roof which will break down over time and cause a leak. Flashings are metal and other materials which are applied to seals and intersections between roof coverings and building elements. They are designed to aid in weatherproofing of roof joins.

Premature ageing and secondary building defects are imminent where roof plumbing is missing or inadequately installed. Additionally, water pooling also creates an environment that is susceptible to termite and pest infestation.

A roofing plumber should be appointed as soon as possible to install relevant roof plumbing materials, ensuring that no further damage is sustained.

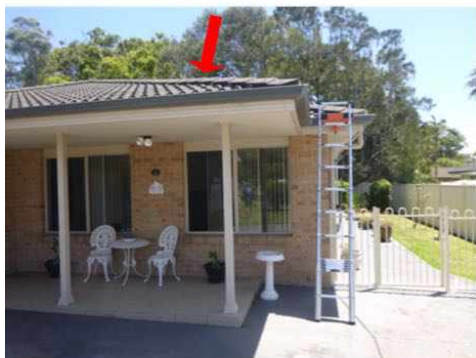
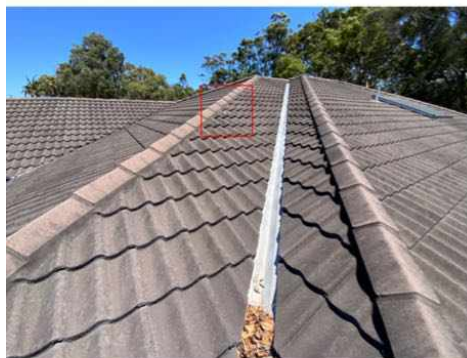
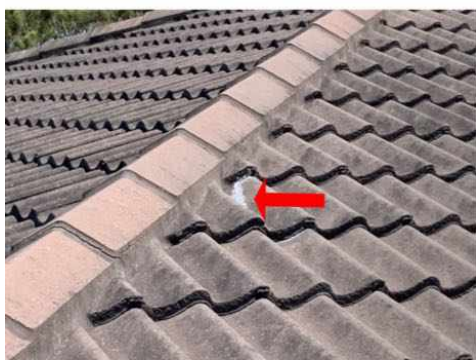
Finding 3.05

Building:	Main Building
Location:	Roof Exterior
Finding:	Roof tiles - Broken (sealed with silicone - regular monitoring and replacement of sealant or tile is required)
Information:	Upon inspection of the exterior roof covering, broken roofing tiles were identified. Broken and friable roof tiles are generally the result of damage from falling tree branches or ageing and weathering of what is essentially a porous material. It appears that silicone has been used to repair the broken tile. Silicone will break down over time, so needs replacing regularly to avoid water leaks. Monitoring of the sealant is recommended and replace when required, however replacement of broken roof tiles is the best long term solution.

If left to further deteriorate, broken and brittle roof tiles are likely to lead to water penetration via the roof into the ceiling space, causing secondary damage to ceiling linings, insulation and roof structures. Broken roof tiles are also likely to detract from the effectiveness of the roof drainage system, creating potential for secondary damage to the exterior roof covering and roof plumbing.

Replacement of broken tiles is recommended and should be performed by a roofing contractor as soon as possible.

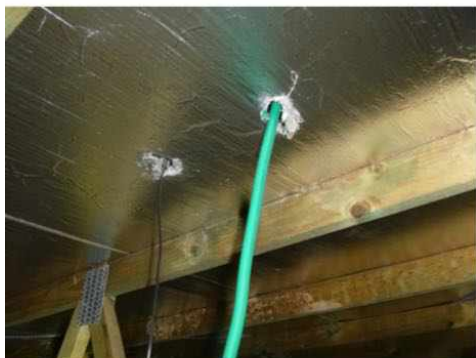
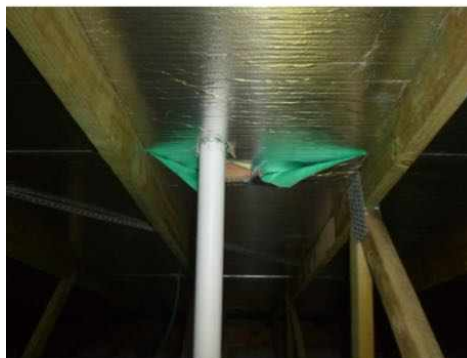
Finding 3.06

Building:	Main Building
Location:	Roof Void
Finding:	Sarking - Damaged or Loose
Information:	Sarking to under the roofing material is damaged, loose or has holes and gaps. Sarking acts as an insulator, helps with noise reduction & is a second barrier against water penetration from broken or slipped tile leaks & condensation.

A Builder, Carpenter or handyman will be able to repair the holes with pieces of sarking and AS4254 tape specific foil tape for this product.

Consult a builder or insulation specialist for further advice.

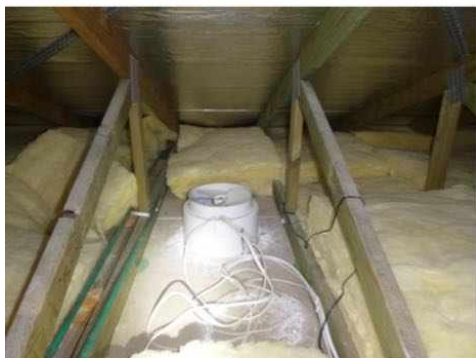
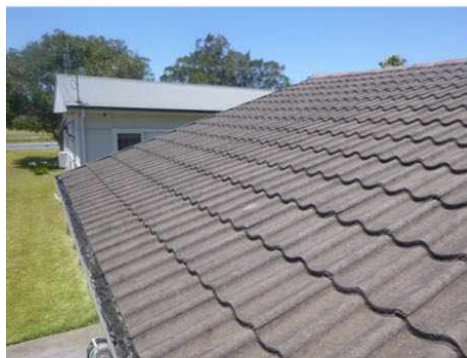
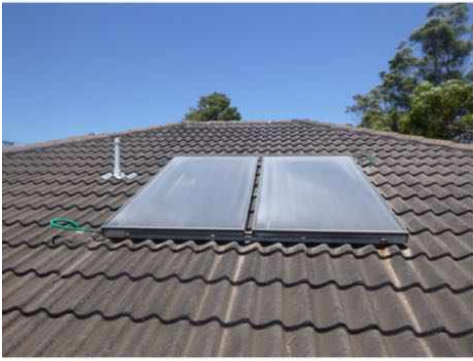
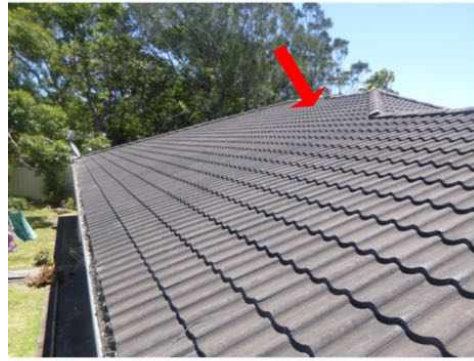
Finding 3.07

Building:	Main Building
Location:	Roof Void
Finding:	Exhaust fans - Sarking on roof (Ducting, Roof Vent or Eave Vents are required)
Information:	On inspection of the roof void, it was observed that the exhaust fans to the bathrooms do not exhaust directly to the outside of the building, which is required by the NCC if sarking has been fitted, as it has in this home.

NCC 3.8.5.1 states: An exhaust fan or other means of mechanical ventilation may be used to ventilate a sanitary compartment, kitchen, laundry or bathroom, or where mechanical ventilation is provided in accordance with 3.8.5.3(b), provided contaminated air exhausts:

- (i) directly to outside the building by way of ducts or
- (ii) into a roof space that;
 - (A) is adequately ventilated by open eaves, and/or roof vents or
 - (B) is covered by roof tiles WITHOUT SARKING or similar materials which would prevent venting through gaps between the tiles.

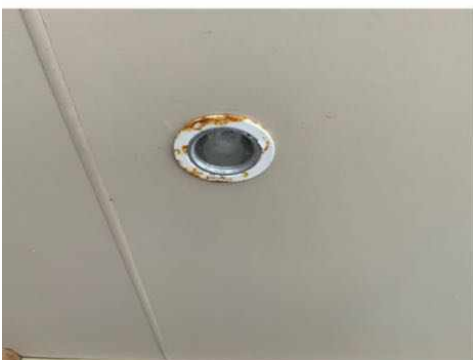
Finding 3.08

Building:	Main Building
Location:	All Areas
Finding:	Building elements - Rusted or corroded (external fittings & fixtures)
Information:	This building element shows evidence of rusting and corrosion, which is likely to have developed as a result of excessive exposure to moisture and or inadequate coatings.

As surface rust provides no protection to the underlying iron, the deteriorating condition is likely to worsen if not addressed in the short-term future.

Where possible, the use of galvanized (treated) metals or aluminium coated metals aid in rust prevention, as does regular general maintenance. Rust formation can be controlled with coatings, such as paint, that isolate the iron from the environment.

Rusting and corrosion should be managed by ideally removing or limiting the affected surface from exposure to moisture. A registered builder may be appointed to replace any building elements that have been severely affected by rust or water damage.

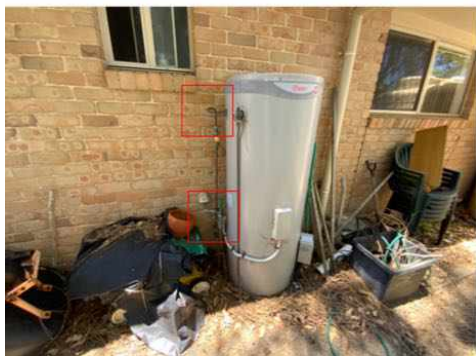
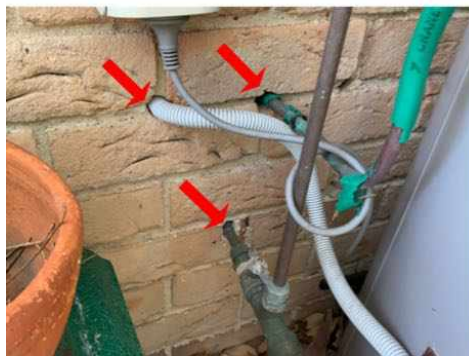
Gaps and holes around pipework makes the area susceptible to insect and vermin ingress, as well as allowing water penetration to the cavity wall. As such, associated building elements are likely to deteriorate at an accelerated rate, and major implications are expected if holes around the pipework are left unmanaged.

All excessive holes, gaps or cracks should be adequately filled by a suitable sealant or trimmings as soon as possible to prevent any further damage. Such works may be conducted by a general handyperson or licensed plumber.

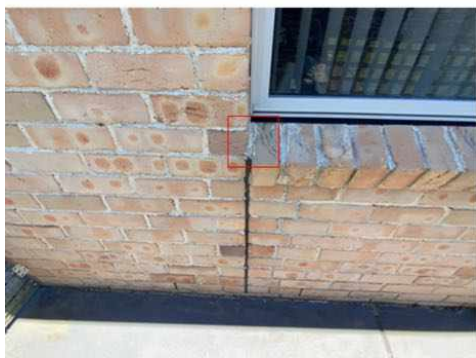
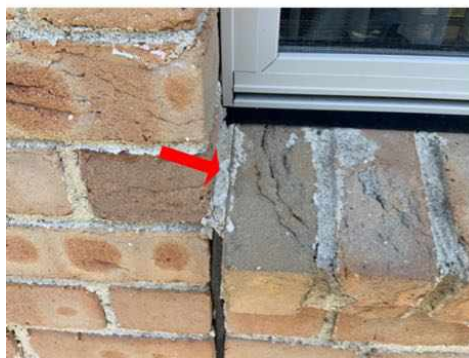
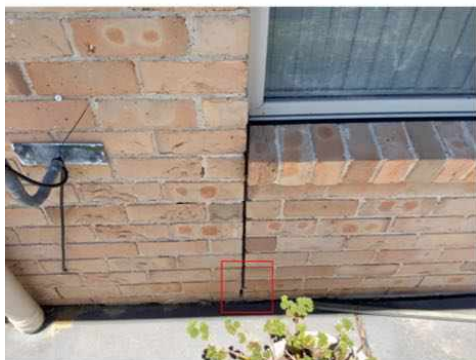
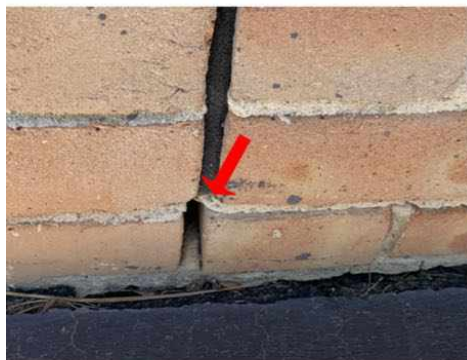
Finding 3.12

Building: Main Building
 Location: Exterior walls
 Finding: Articulation joints - Inadequate to some areas
 Information: The articulation or control joints throughout the exterior brickwork were deemed as insufficient at the time of inspection. Mortar, a non-compressive material, is still evident in some of the joints, not allowing the joints to do their job and allow the brick walls to expand and contract as required during different weather conditions.

Articulation joints must be cleaned of all non-compressive material and then sealed with an appropriate flexible sealant. Failure to perform these necessary works is likely to lead to excessive moisture ingress into these joints, or cracking to the brick walls during extreme weather conditions, which may carry major implications for associated building elements if left unmanaged.

These preventative works are important in ensuring the structural integrity of the associated brickwork. Appointment of a qualified builder or bricklayer is advised to perform remedial works as necessary.

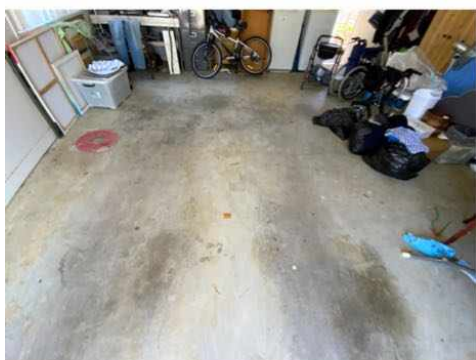
Finding 3.13

Finding: Cracks in concrete slab - Category 1

Information: Several cracks coded as Category 1 were identified in the slab. A Category 1 crack is described as a fine but noticeable crack, with the slab at an otherwise reasonable level.

To be considered Category 1, the approximate width of the crack is less than 1.0mm, or a less than 10mm change in offset when a 3m straight edge is placed over the defect.

Category 1 cracks should be monitored for a period of 12 months. At the end of the monitoring period, identified cracks that are rated greater than Category 2 are considered defects, and require rectification.

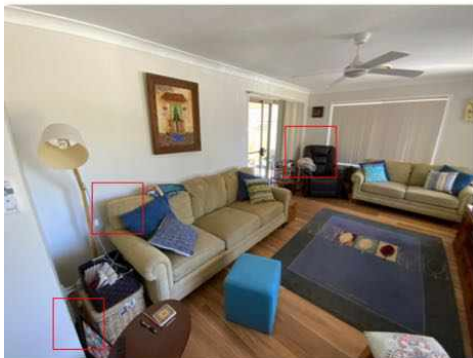
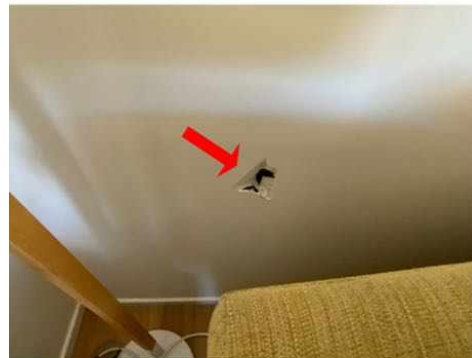
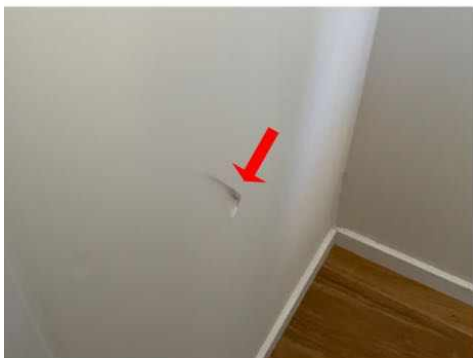
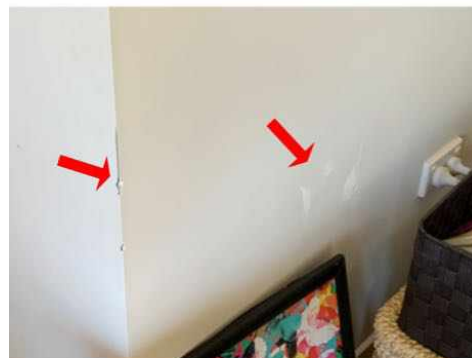
Finding 3.14

Finding: Walls - Damaged

Information: Breakage occurs generally when the building materials have either aged and decayed, or as a result of damage (accidental or deliberate).

Repair and/or replacement of broken elements is advised to ensure that additional secondary defects do not arise as a consequence. Such works are necessary, as all building elements play a key role in the operation and function of the overall structure and its performance.

A relevant tradesperson should be appointed to repair or replace the affected building element prior to any subsequent damage being caused.

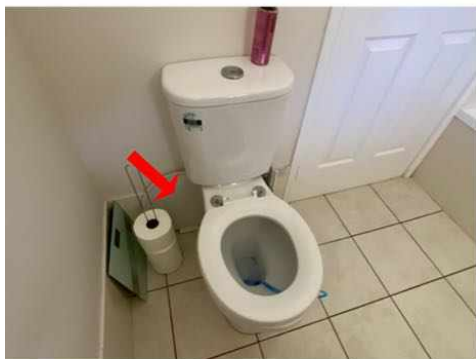
Finding 3.15

Finding: Building element - Broken (toilet seat lid not connected)

Information: Breakage occurs generally when the building materials have either aged and decayed, or as a result of damage (accidental or deliberate).

Repair and/or replacement of broken elements is advised to ensure that additional secondary defects do not arise as a consequence. Such works are necessary, as all building elements play a key role in the operation and function of the overall structure and its performance.

A relevant tradesperson should be appointed to repair or replace the affected building element prior to any subsequent damage being caused.

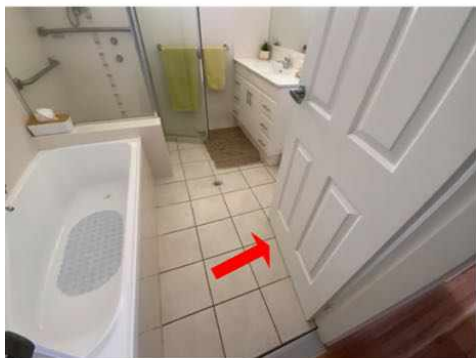
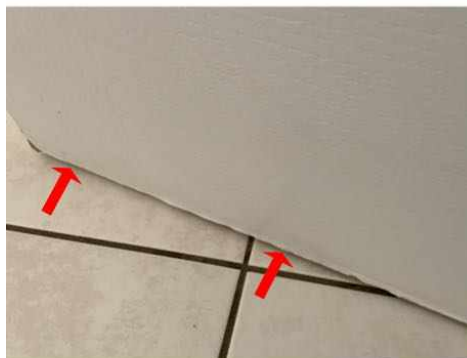
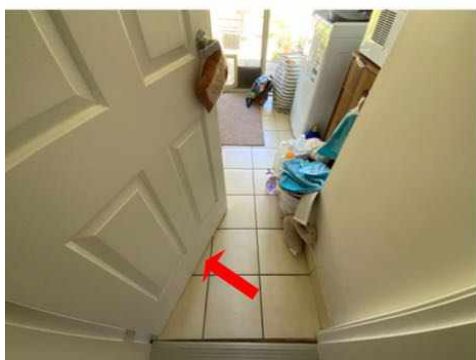
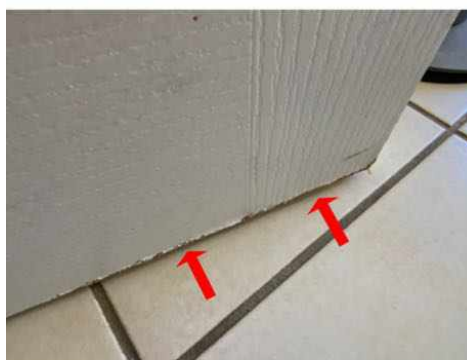
Finding 3.16

Building:	Main Building
Location:	Bathroom & Laundry
Finding:	Building element - Swollen (Bottom of doors from lack of paint)
Information:	Swollen building elements generally indicate that the building materials have been affected by excessive moisture over a prolonged period of time, and have swollen as a result. The formation and development of mould/fungi or mildew is also a likely consequence of excessive moisture, which may pose major respiratory issues for occupants, particularly the elderly, the very young and those with existing illnesses and could be potential health safety hazards. In these cases an appropriately qualified inspector/tester should also be contacted for advice and/or technical assistance.

The structural integrity of swollen building elements can not be guaranteed, and further damage is likely to develop if left unmanaged. Excessive moisture is likely to lead to the development of secondary damage to any associated building elements, which may necessitate major reparation works if prolonged.

Rectification of the cause of the water leak should be addressed prior to any remedial works to the swollen building elements. A licensed plumber should be appointed immediately to identify the cause of the leak and provide advice on remedial works as necessary. Repair and/or replacement of swollen building elements should be conducted as a matter of urgency by a registered builder or qualified carpenter.

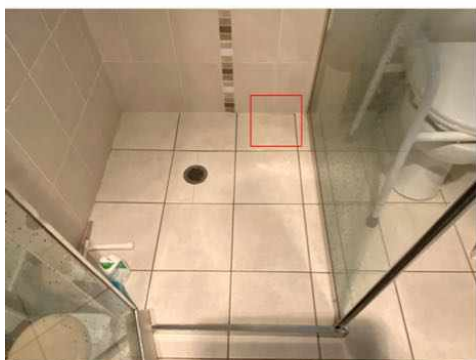
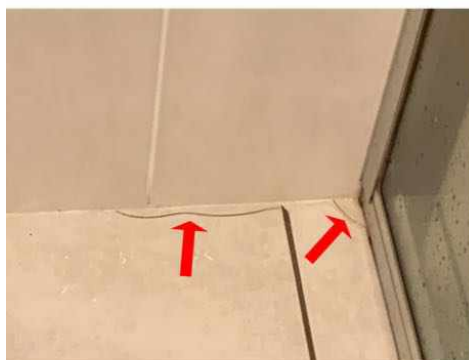
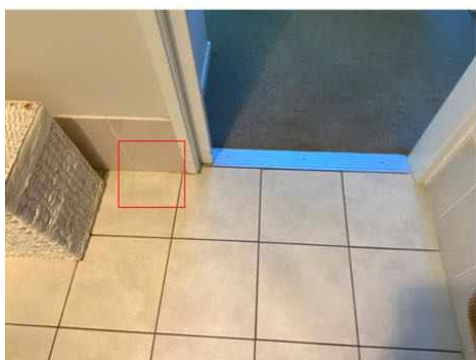
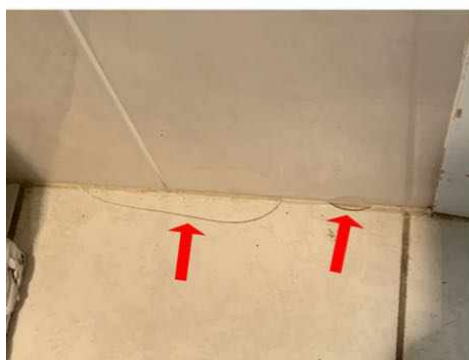
Finding 3.17

Building:	Main Building
Location:	Ensuite - Master
Finding:	Tiles - Cracked or damaged
Information:	Cracking was evident to the tiling in this area at the time of inspection. While the cracking appears to be minor, this area is frequently exposed to water, allowing potential for water penetration into adjoining sections of walls or flooring.

If left unmanaged, water penetration to these areas may lead to subsequent water damage, which is likely necessitate repair work to affected building elements.

A tiling contractor should be appointed to ensure that no further water damage occurs. The re-application of silicone and grouting throughout remaining tile work is also advised, to further protect the area against water penetration.

Where water penetration has led to water damage, appointment of a relevant tradesperson may be required to repair damaged building elements.

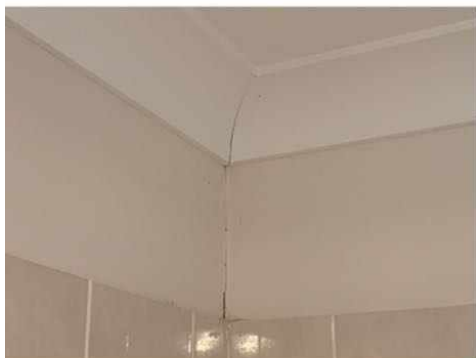
Finding 3.18

Building:	Main Building
Location:	All Areas
Finding:	Cracking - Damage Category 2 - Noticeable (up to 5mm)
Information:	Noticeable cracks are a common occurrence as a result of many primary defects. Such causes may include age, general wear and tear, expected building movement, general expansion/contraction of building materials in different weather conditions, and/or minor failings in the installation or application of building materials.

Noticeable cracks may result in minor sticking or jamming of associated doors and windows, which require easement. However, noticeable cracks are easily filled and repaired. A plasterer can be consulted to install an expansion joint at this point to allow for this movement during different weather conditions.

Monitoring of all cracking should be conducted frequently. Always contact a building inspector should cracks widen, lengthen, or become more numerous. Additionally, your building inspector should also be contacted if associated building elements such as doors and windows become more difficult to operate over time.

Relevant tradespeople, such as carpenters, painters and plasterers, should be appointed to perform remedial works, as deemed necessary.

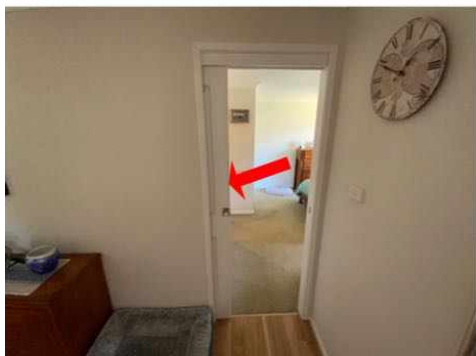
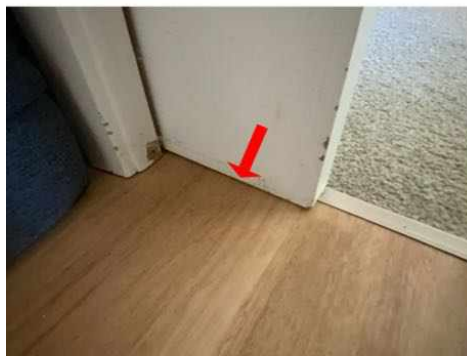
Finding 3.19

Building:	Main Building
Location:	Bedroom - Master
Finding:	Building element - Not operating (Sliding door requires adjustment)
Information:	Non-operational items should be addressed to ensure that the full function of the building structure is available. Where some building elements are not operating as intended, it is possible that secondary building defects could arise due to their non-operation.

Repair and/or replacement of the faulty building element is recommended. It is highly recommended that the relevant tradesperson be engaged to perform any necessary works.

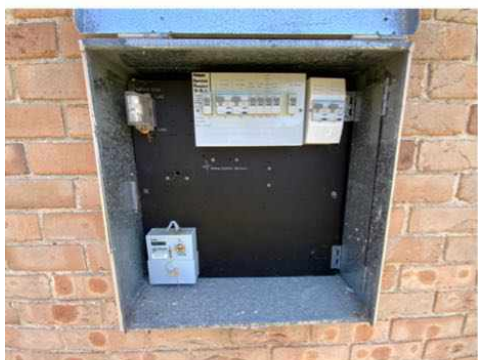
Building:	Main Building
Location:	All Areas
Finding:	Termite Management System - no evidence of a chemical installation
Information:	The application of a post-construction chemical termite barrier is highly recommended for all properties, particularly if live termite activity has been found on the site previously. Such barriers are highly effective in preventing termite attack on any timber building elements throughout the property.

A durable notice should be placed in the switchboard unit to indicate current termite barriers. At the time of inspection, it appeared as though no termite management system has been installed, with no evidence to suggest preventative works taking place.

The client may consider gaining further advice from a pest controller as to the costs and procedures involved with this application. It is recommended that obtaining such advice be a short-term priority.

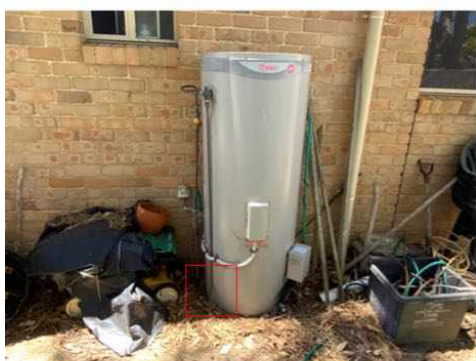
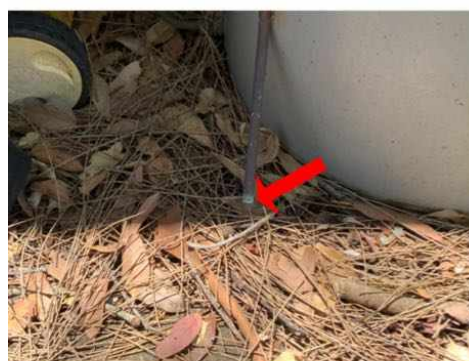
Building:	Main Building
Location:	All Areas
Finding:	HWS Overflow - Not Connected
Information:	The Hot Water System (HWS) overflow was found to be disconnected from storm water drainage and is creating excessive moisture in the surrounding area.

These damp conditions can lead to secondary defects such as rot, rust or corrosion of associated building elements, the formation of fungal decay, or even the creation of potential slip hazards. When coupled with poor site drainage, pooling of water may also attract termite activity to this area.

It is highly recommended that a licensed plumber be appointed to connect the HWS overflow in order to prevent such an environment from being created. These minor works should be carried out as soon as possible.

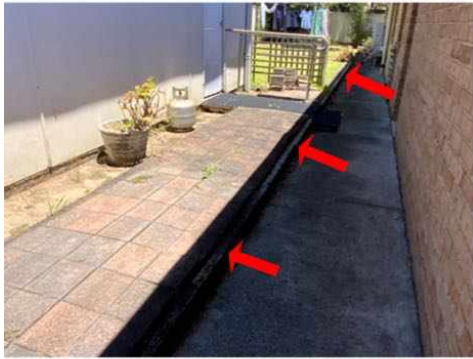
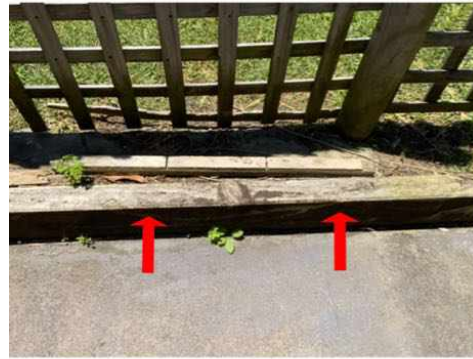
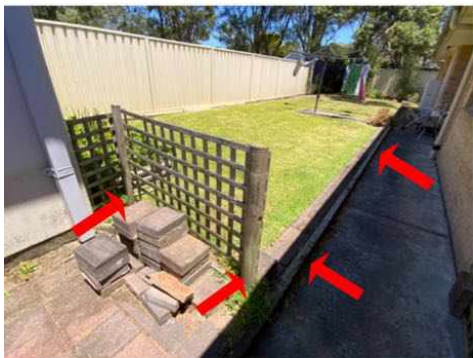
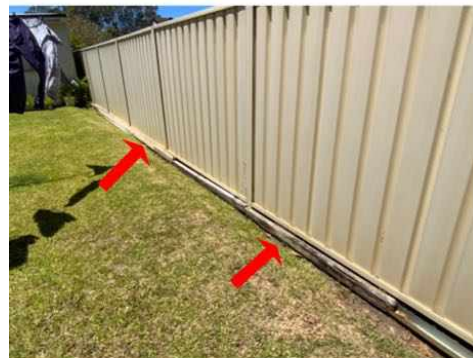
Finding 6.04

Building:	Main Building
Location:	All Areas
Finding:	Timber in ground contact
Information:	To reduce the risk of timber pest attack it is essential that timber used in a hazardous environment (e.g. in direct contact with the ground or frequently exposed to damp conditions) is of sufficient durability and/or is adequately preservative treated.

Untreated timbers in direct contact with the ground are likely to develop severe wood rot and/or fungal decay if left unattended creating attraction for subterranean termites to infest the timbers from surrounding areas.

If untreated or non-durable timbers are found to be in a hazardous environment it is highly advised that replacement of these building elements be performed as soon as possible to aid the protection of the property against termite / timber pest attack.

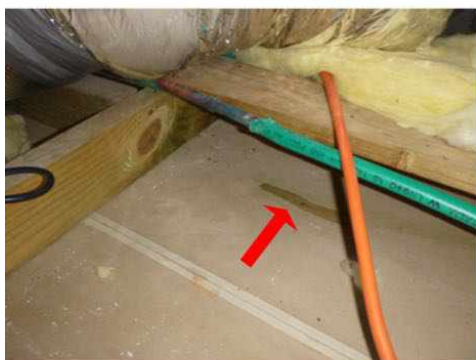
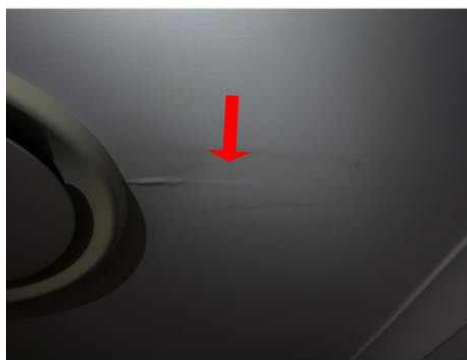
Finding 6.05

Building:	Main Building
Location:	All Areas
Finding:	Evidence of excessive moisture was present at the time of inspection (water leak to roof void)
Information:	Excessive moisture can attract termites and produce conditions that promote termite attack fungal growth and wood decay.

Excessive moisture is generally caused by deteriorated inadequate or missing roof drainage, leaking plumbing pipes or fixtures, poorly plumbed HWS overflows or condenser units and poor site drainage.

It is highly recommended that all plumbing and drainage fixtures and fittings be maintained regularly in order to prevent excessive moisture being present in the external / internal property.

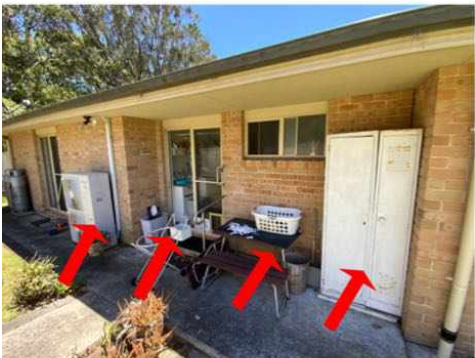
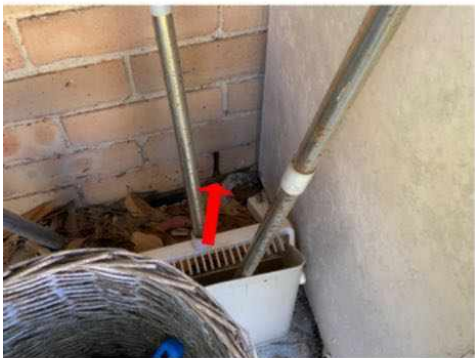
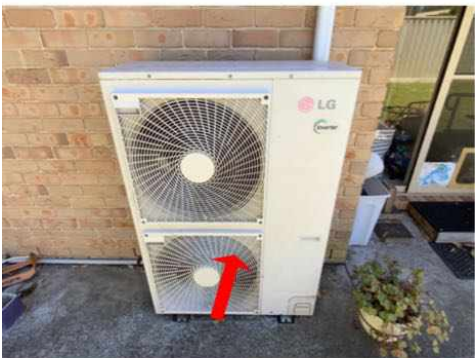
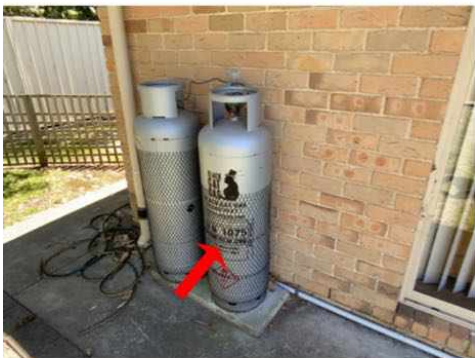
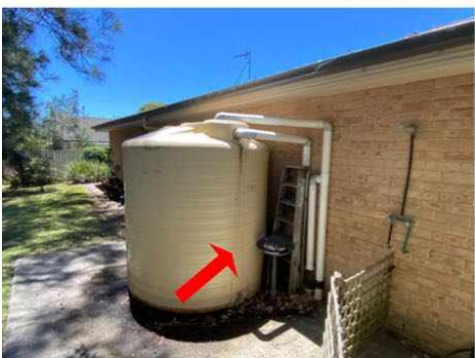
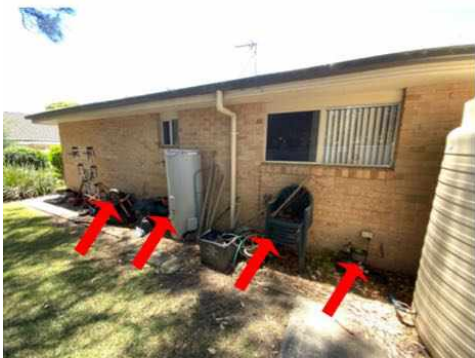
Finding 6.06

Building:	Main Building
Location:	Exterior walls
Finding:	Bridging or breaching of termite barriers - weep holes
Information:	Bridging is the spanning of a termite barrier or inspection zone so that subterranean termites are provided with passage over or around that barrier.

Weep holes in the exterior brickwork of the property are designed to allow condensation that may build up between the brickwork and subsequent timber framework to drain from within the wall hence preventing any deterioration of the timber building elements.

Additionally build-up of moisture is likely to occur if weep holes are covered further attracting termite activity to these areas.

It is highly recommended that weep holes are left exposed in all areas throughout the external property. Therefore if any termite activity leading into weep holes becomes easily detectable during frequent pest inspections.

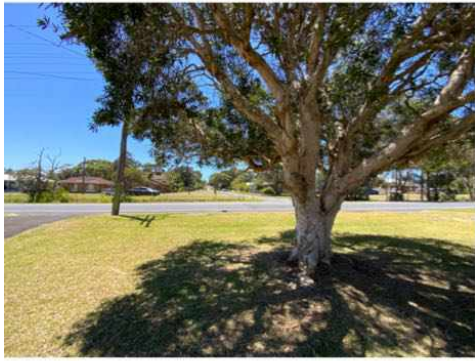
Finding 6.07

Building: Main Building
 Location: All Areas
 Finding: Trees within 50m of the property
 Information: Trees within 50m of the property can be conducive to termite activity. It is recommended an invasive inspection of all trees with 50m to the property be carried out by a qualified pest control expert.

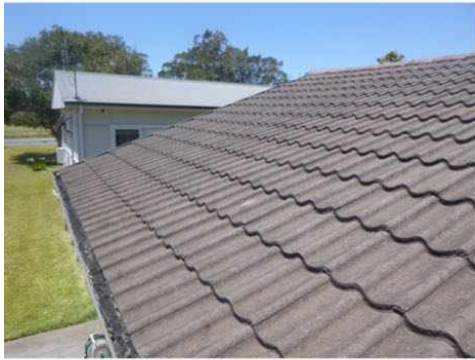
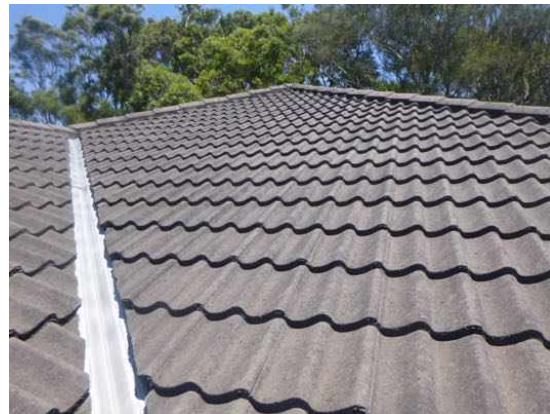
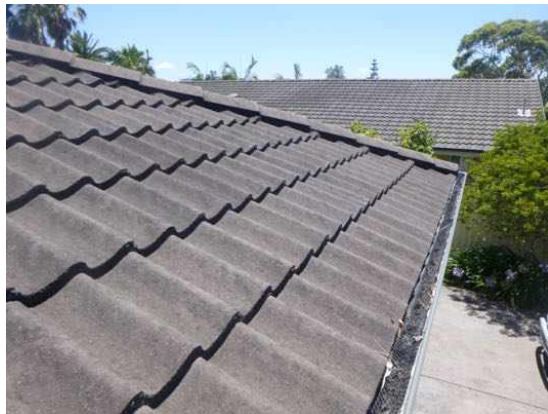
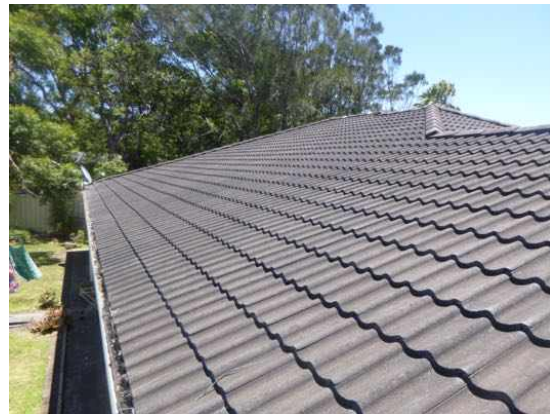
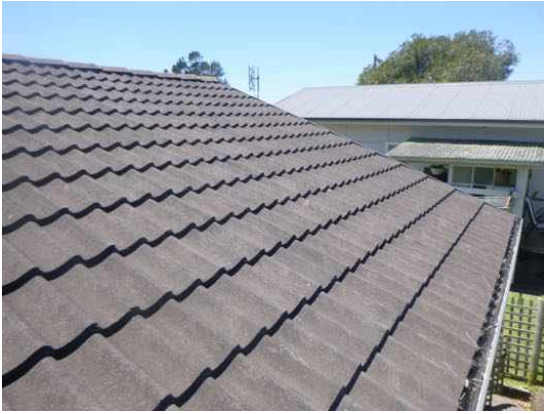
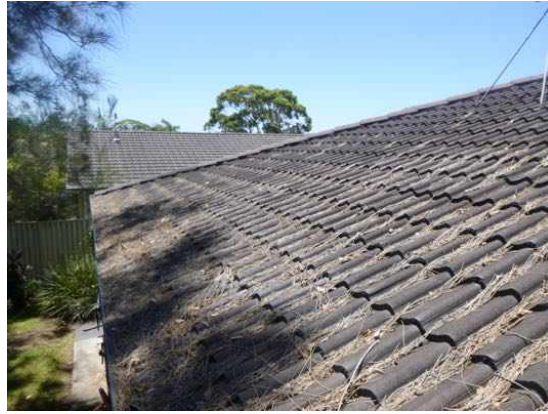
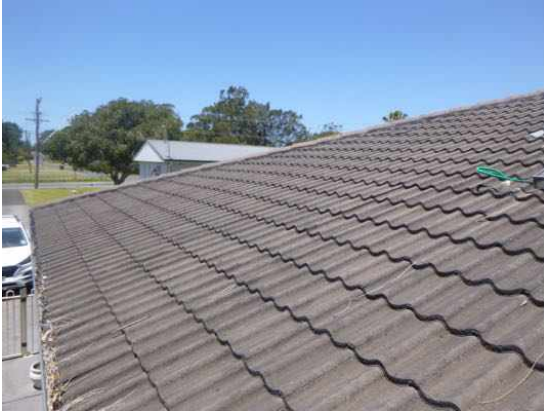
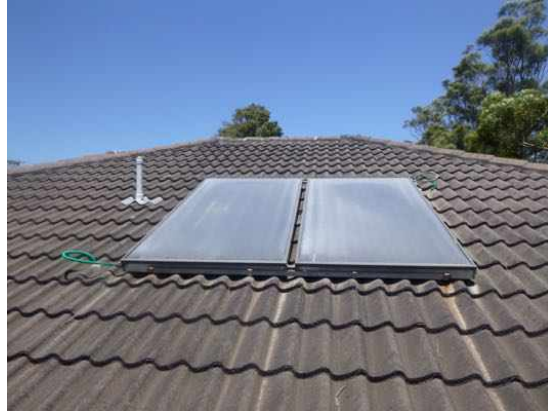
Building: Main Building
Location: Roof Exterior
Finding: Additional Photos - Obstructions and Limitations
Information: These photographs are an indication of the obstructions and limitations which impeded full inspection of the property at the time of inspection. These obstructions can hide an array of defects and should be removed to allow full inspection to be carried out. A re-inspection is recommended once the areas are made accessible.
