Building and Timber Pest Inspection Report

Inspection Date: Wed, 7 Jan 2026

Property Address: 91 Prince Edward Ave, Culburra Beach NSW
2540, Australia

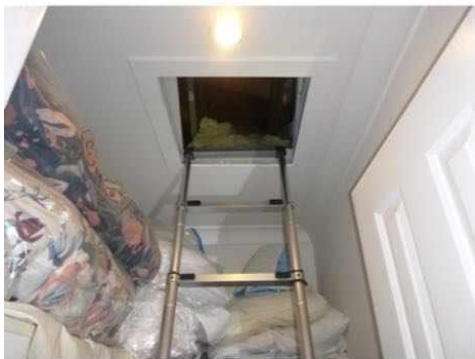
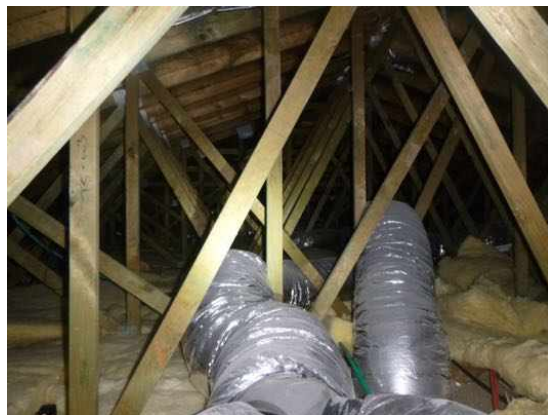
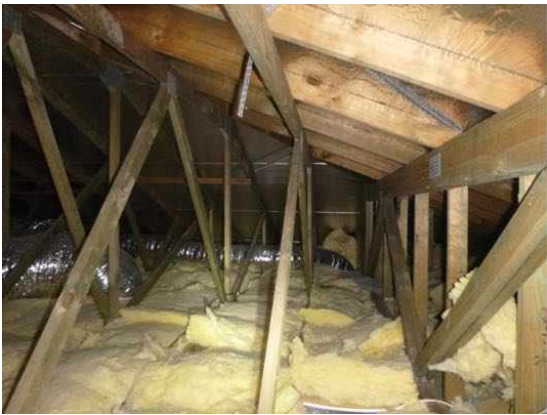
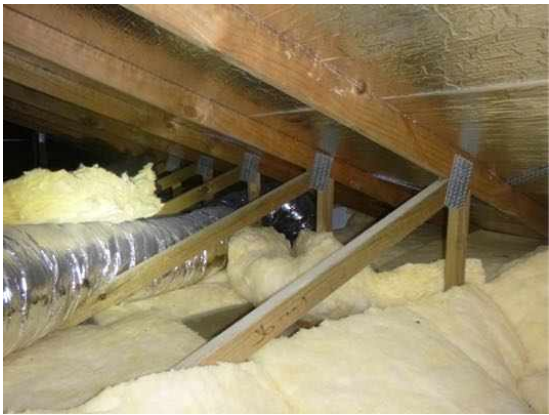
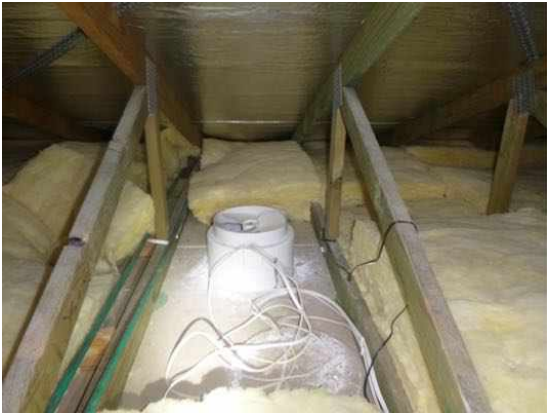
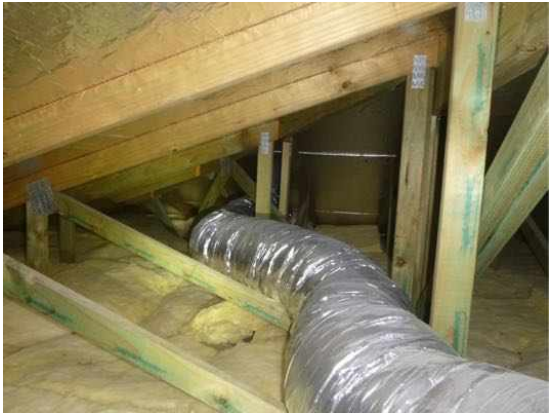
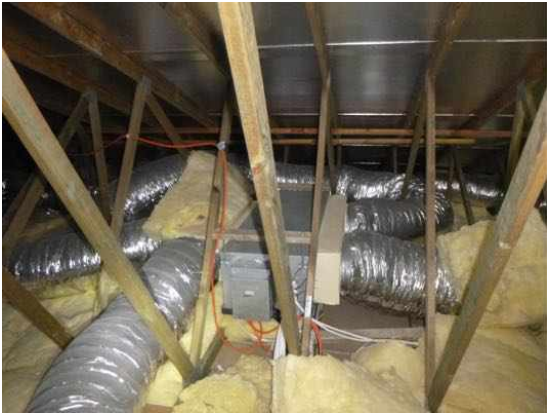
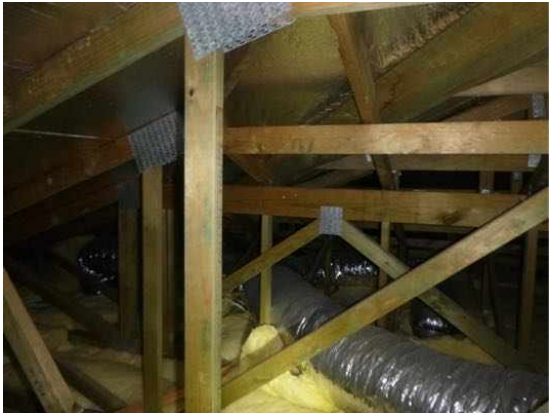
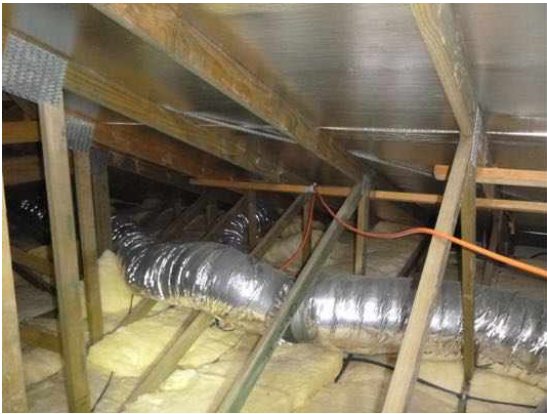
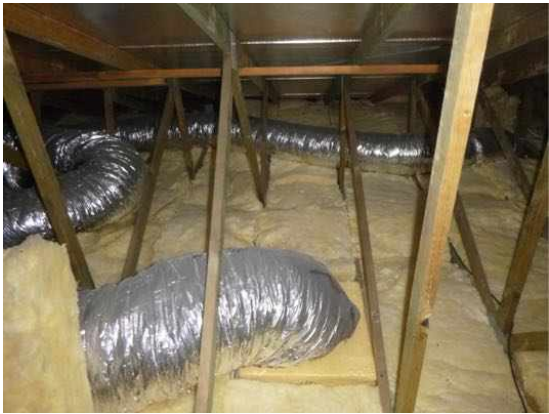
Building:	Main Building
Location:	Roof Void
Finding:	Additional Photos - Obstructions and Limitations
Information:	These photographs are an indication of the obstructions and limitations which impeded full inspection of the property at the time of inspection. These obstructions can hide an array of defects and should be removed to allow full inspection to be carried out. A re-inspection is recommended once the areas are made accessible.

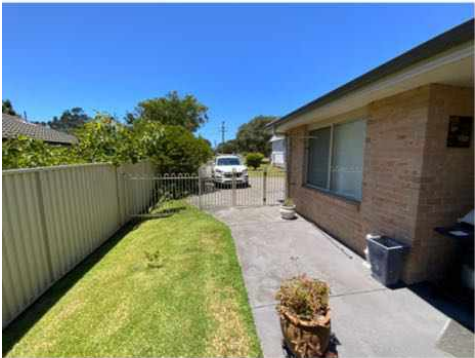
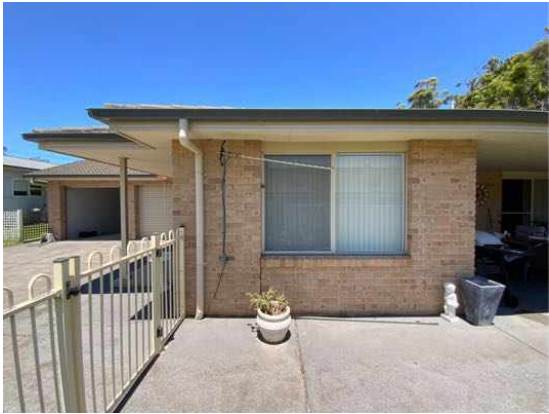
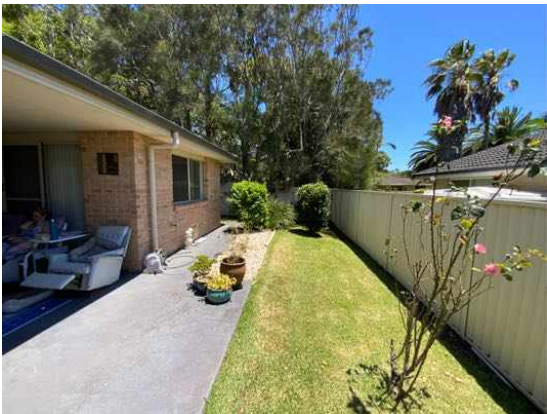
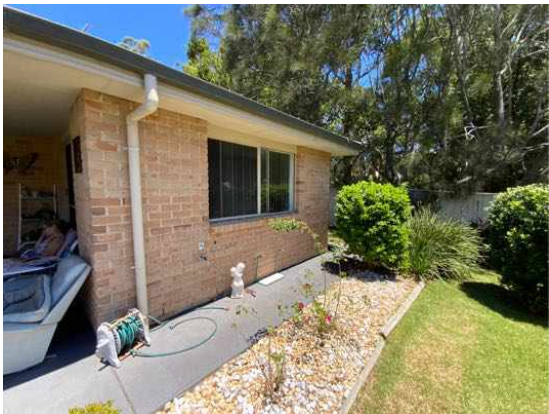
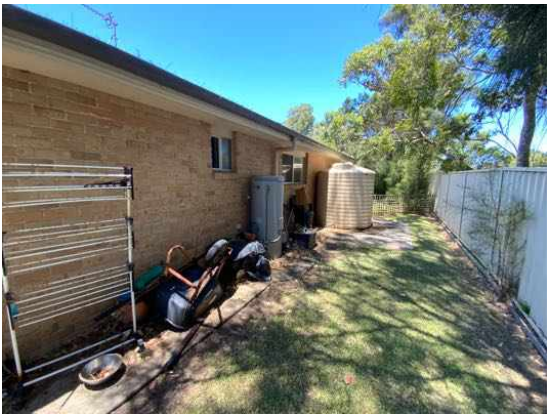
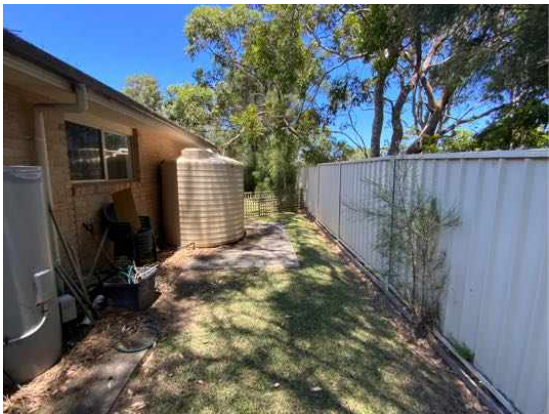
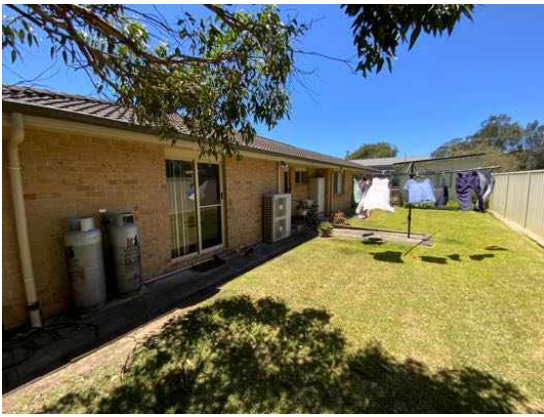
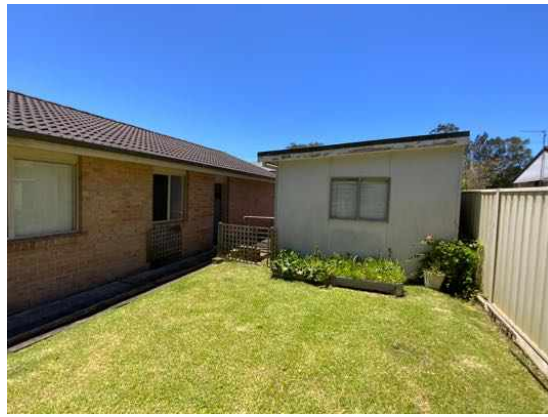
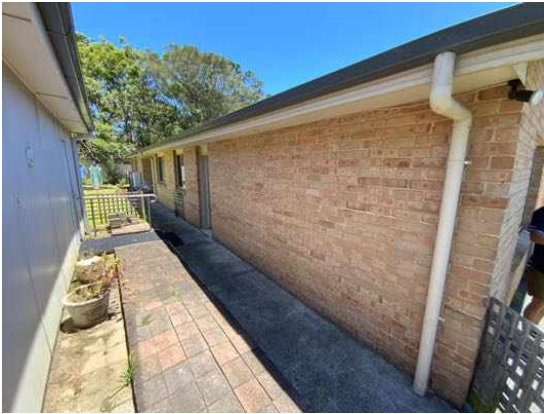
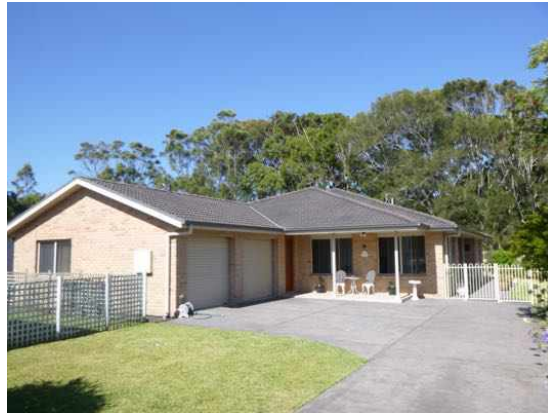
Building: Main Building
Location: All Areas
Finding: Additional Photos - Obstructions and Limitations
Information: These photographs are an indication of the obstructions and limitations which impeded full inspection of the property at the time of inspection. These obstructions can hide an array of defects and should be removed to allow full inspection to be carried out. A re-inspection is recommended once the areas are made accessible.

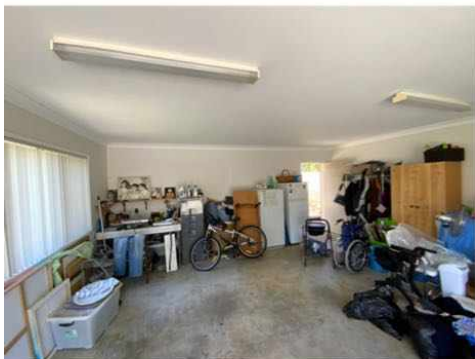
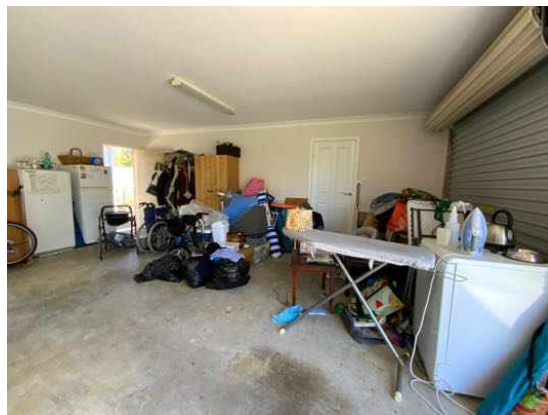
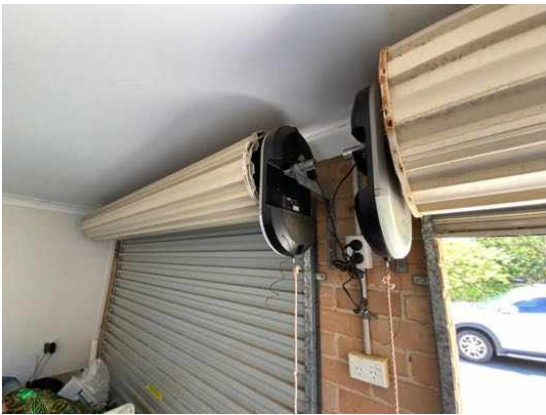
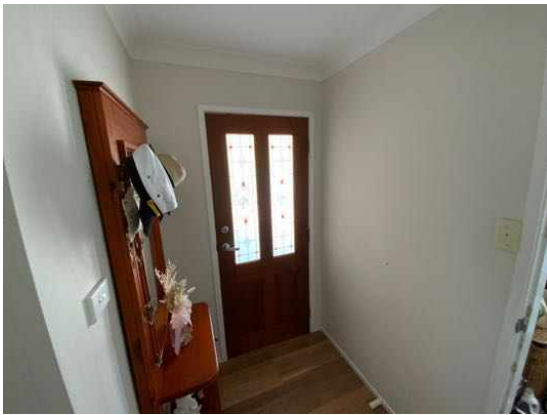
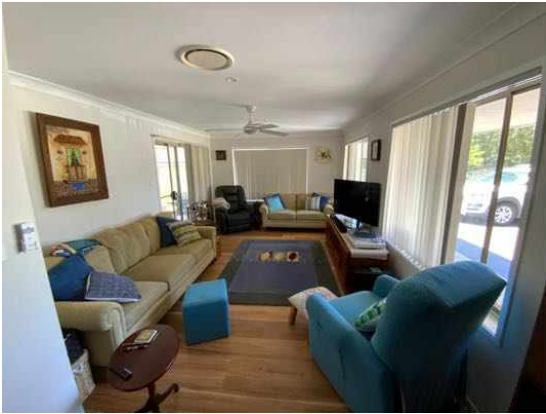
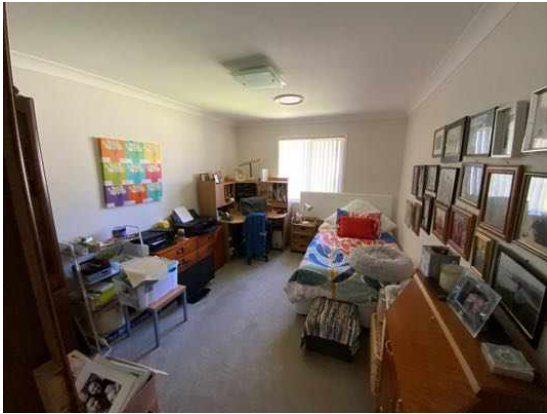
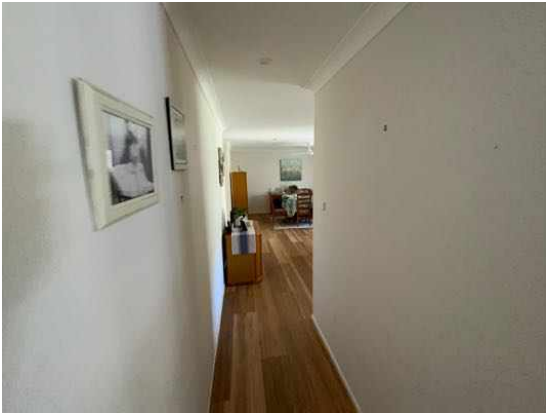
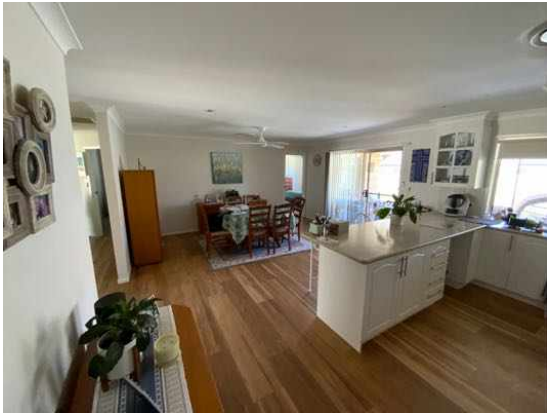
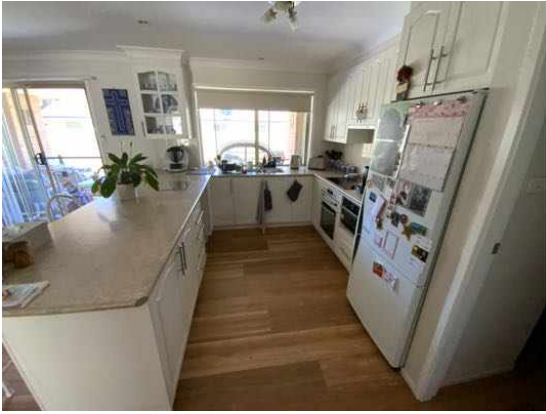
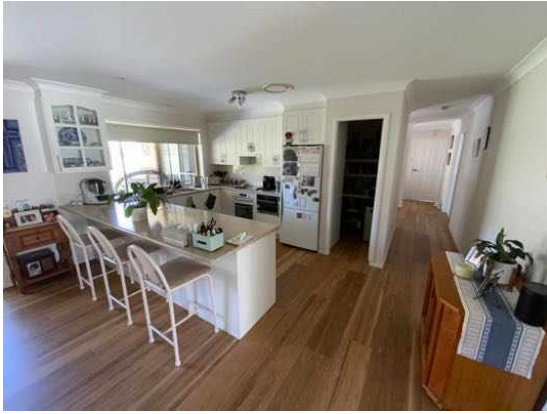
Finding: Additional Photos - Obstructions and Limitations

Information: These photographs are an indication of the obstructions and limitations which impeded full inspection of the property at the time of inspection. These obstructions can hide an array of defects and should be removed to allow full inspection to be carried out. A re-inspection is recommended once the areas are made accessible.

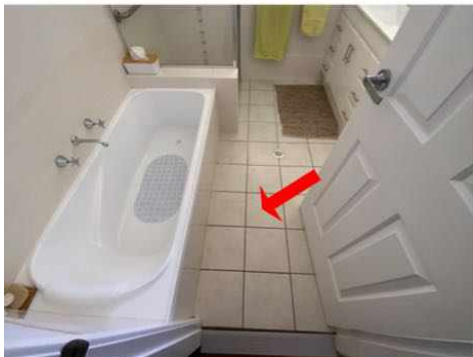
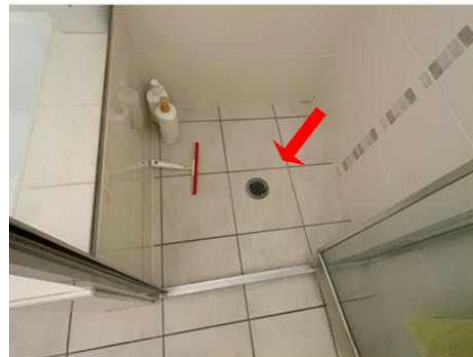
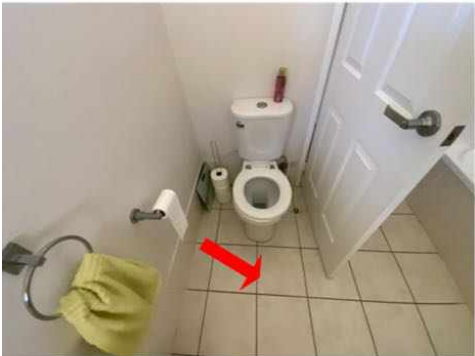
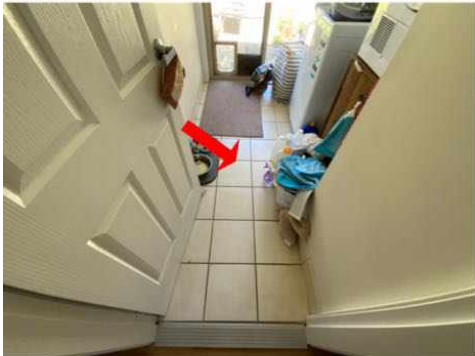
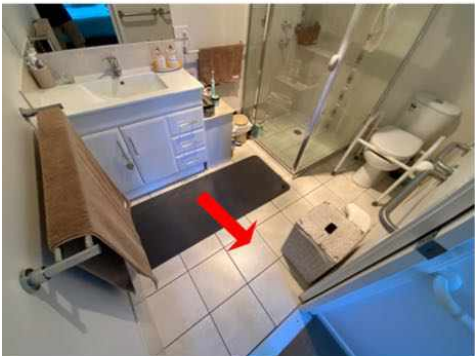
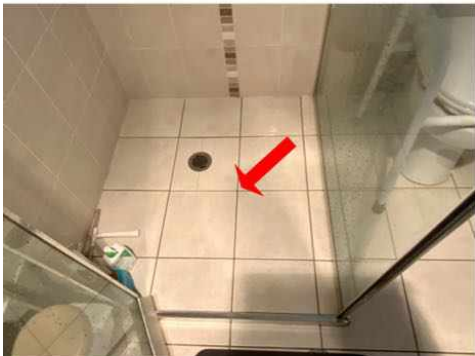
Building:	Main Building
Location:	All Wet Areas
Finding:	Water Proofing Membranes - Information Only
Information:	Internal Water Proofing Membranes, are crucial in preventing water ingress into the property is important to know that the Membrane System used is to Australian Standards and has been installed correctly.

With older property's where this information is unavailable all wet areas should be monitored. Generally waterproofing certificates are only valid for approximately 7-8yrs. If any leaks, water staining, peeling or bubbling of the paint become evident to any adjacent walls or ceilings below a licensed builder or waterproofing specialist is recommended to investigate further.

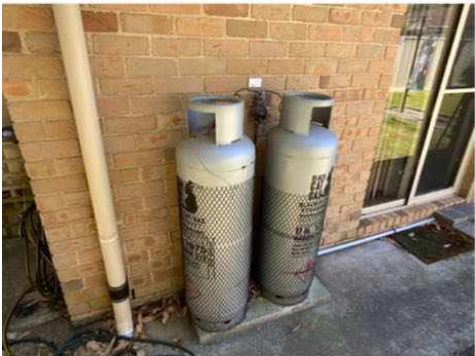
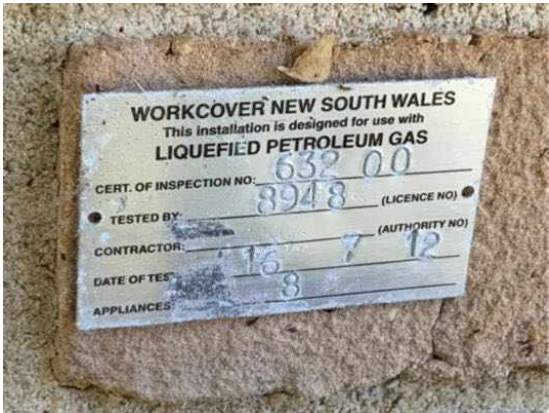
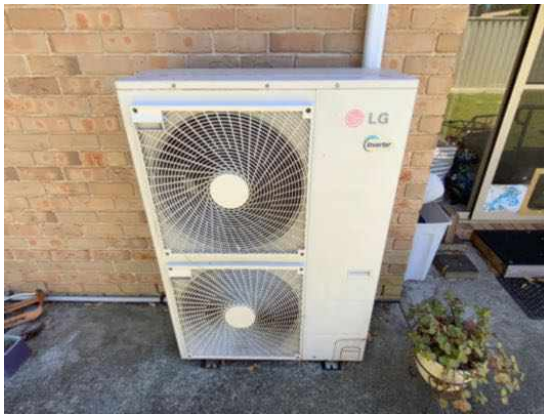
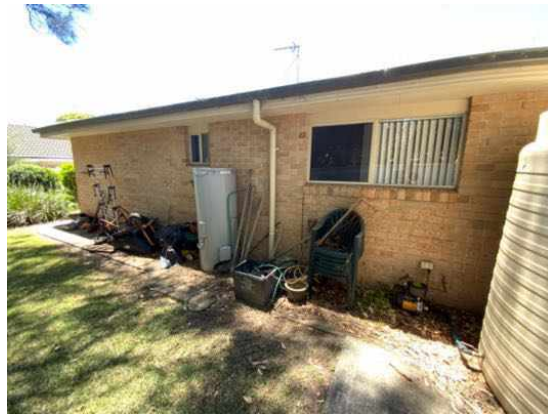
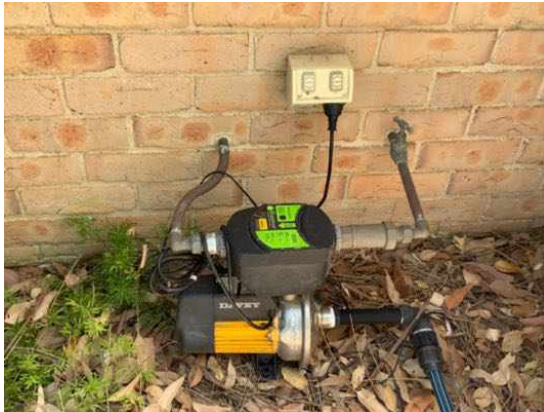
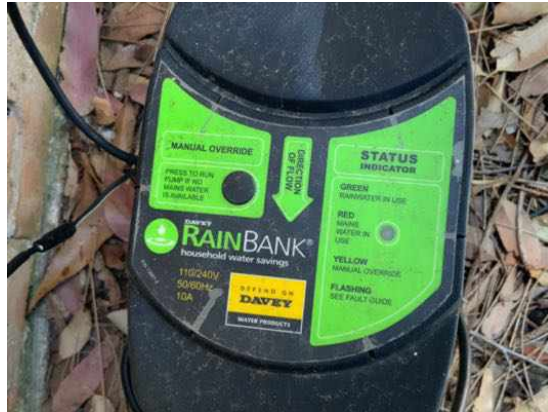
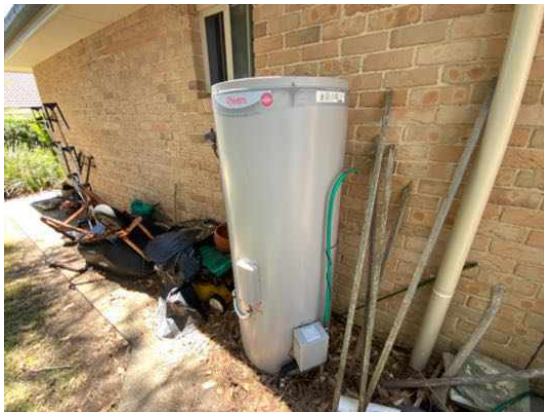
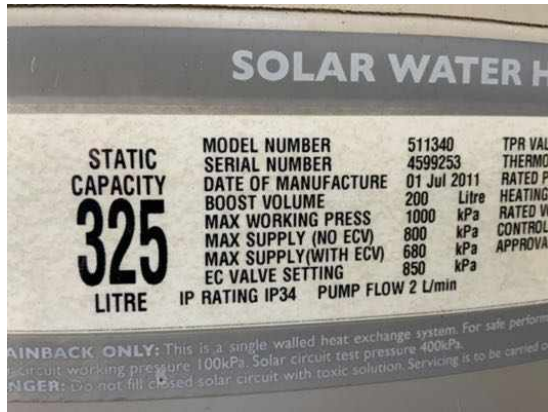
Building: Main Building
Location: All Areas
Finding: Additional Photos
Information:

Additional photos are provided for your general reference. Arrows have been included to highlight areas of importance. Please discuss these photos with your building consultant for clarification.

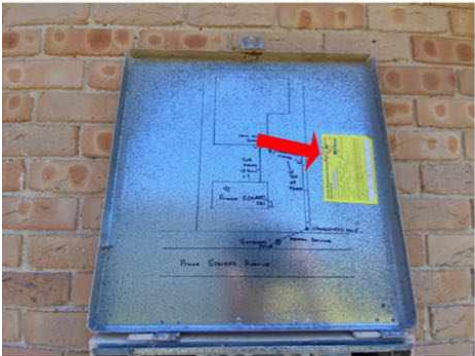
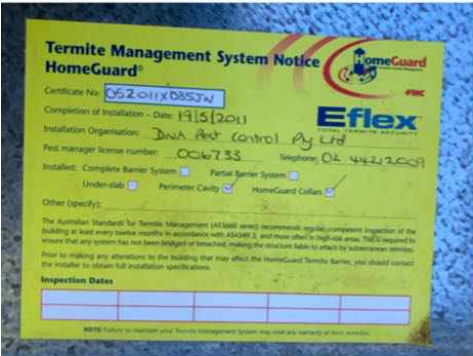
Where a Termite Management System has been identified you should refer to the type of barrier date of installation warranty conditions and any documentation provided by a builder or past owner. Consult the company who installed the barrier to confirm whether the system is still under warranty.

Most chemical termite management systems expire and require replenishment and all physical systems are primarily designed to prevent concealed entry.
