Building and Timber Pest Inspection Report

Inspection Date: Fri, 14 Nov 2025

Property Address: 8 Kitchener Ave, Earlwood NSW 2206,
Australia

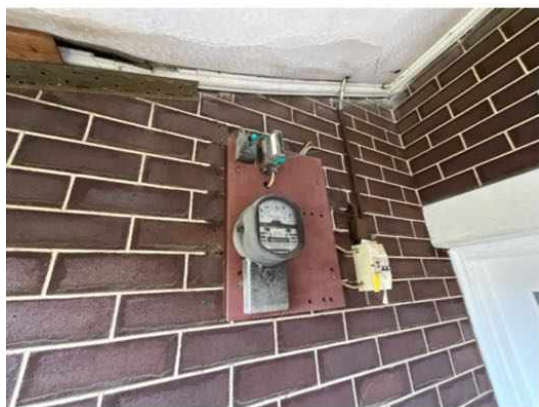
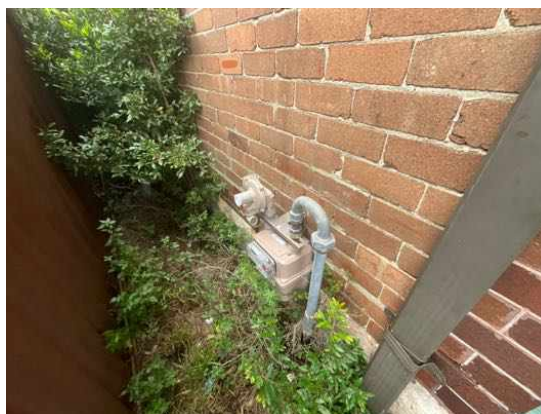
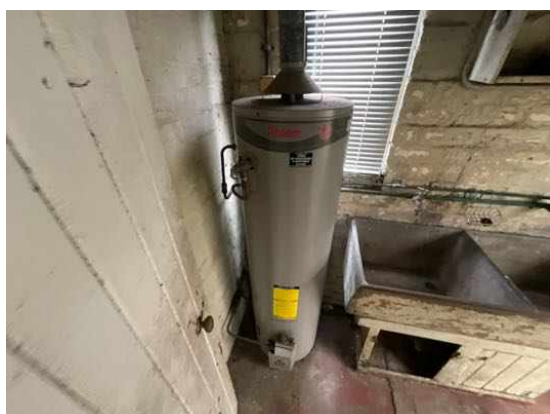
Building: Yard
 Location: Garage
 Finding: Asbestos - Suspected ACM Identified on Site
 Information: Reporting on Asbestos is outside the Scope of this Report. This suspected defect is highlighted as a caution only. We suspect, based on our experience in the building industry, that there is a higher risk of the identified building element containing asbestos.

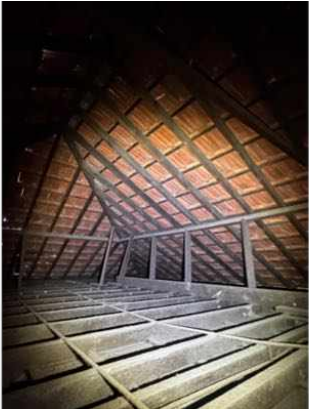
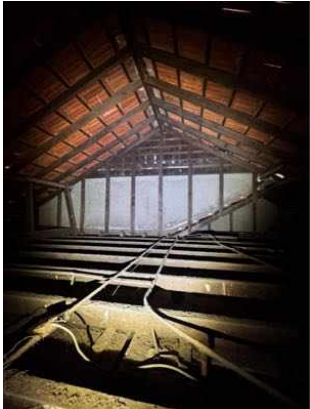
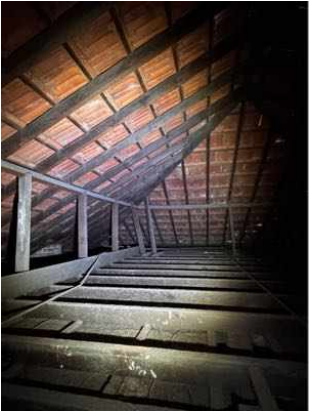
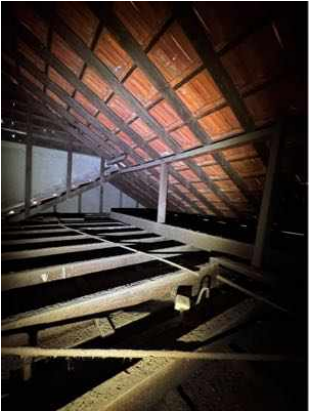
- Building: Main Building
- Location: Roof Void
- Finding: Photos Added
- Information: Additional photos are provided for your general reference.
