Building and Timber Pest Inspection Report

Inspection Date: Thu, 5 Feb 2026

Property Address: 4/23 Pye Rd, Quakers Hill NSW 2763,
Australia

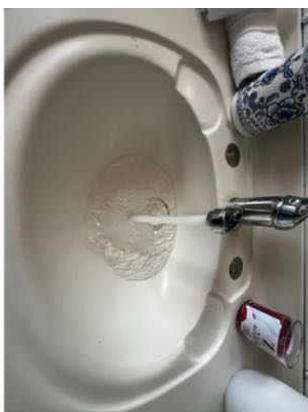
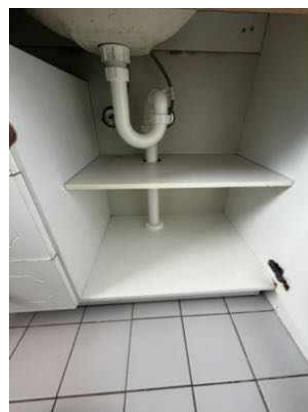
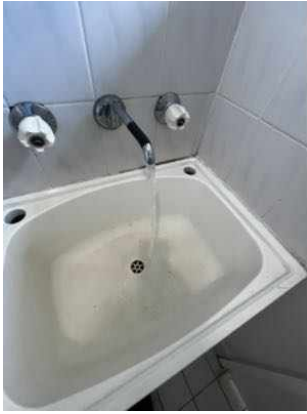
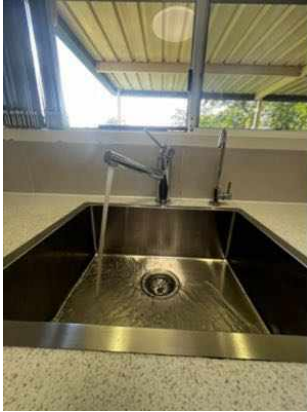
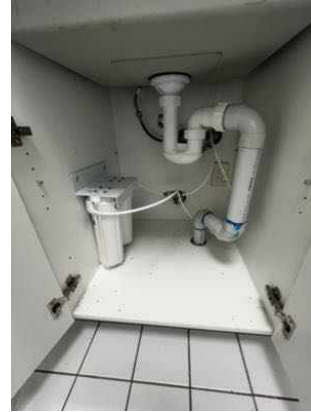
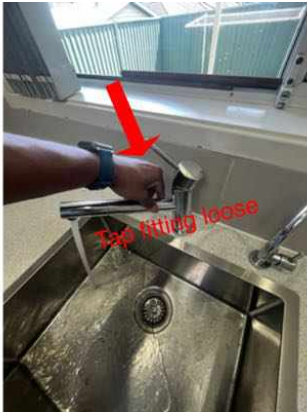
Building: Main Building
Location: Kitchen/ Laundry/ Ensuite/ Bathroom
Finding: Cabinetry Plumbing - Kitchen/ Laundry/Ensuite
Information: All cupboards where sinks and basins with drainage plumbing were inspected and no evidence of leaks were present at the time of inspection.

If damp or wet conditions do occur there are many consequences including the development of fungal decay and/or wood rot, swelling or water damage to building materials.

For your information only no remedial works are required at the time of inspection.

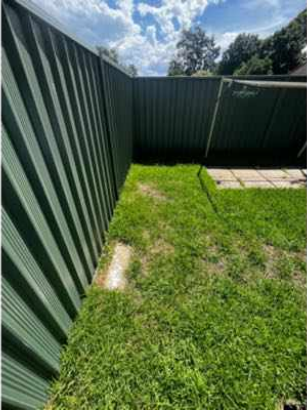
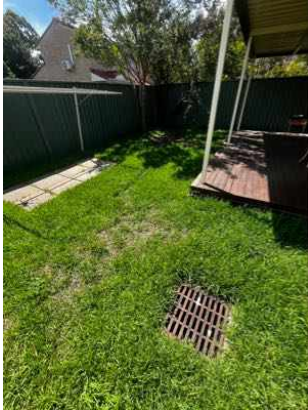
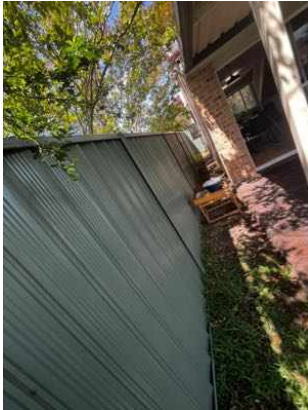
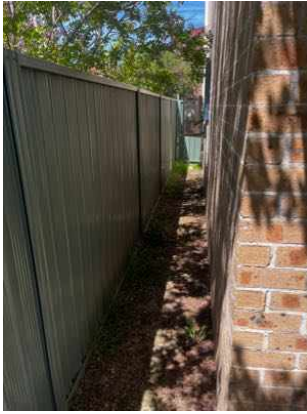
Finding 3.02

Building: Main Building
 Location: Yard
 Finding: Perimeter Fencing -
 Information: For your information photos taken at the time of inspection.

It was noted at the time of inspection that sections of the fencing throughout the property have deteriorated. Typically fencing deteriorates due to age and or wear, rot and or rust which is generally expected for a structure of this age, due to prolonged exposure to weather conditions. Sometimes inadequate installation or maintenance can be to blame.

If left unattended, it is likely that further damage will occur. It is suspected that repair of several elements of the fencing may be required however replacement may be a consideration of the client also.

A licensed fencing contractor should be appointed to provide further advice and perform rectification works as necessary.

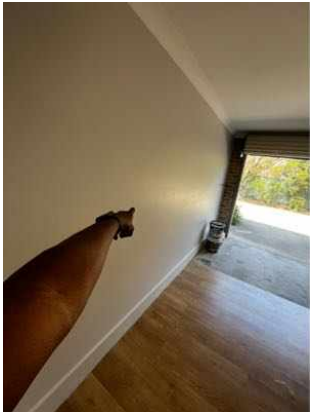
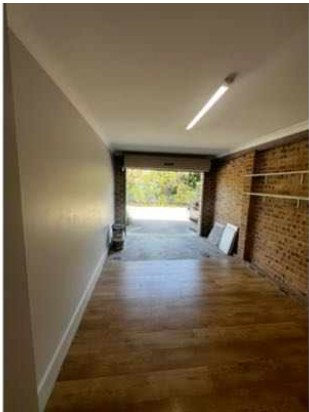
Finding 3.03

Finding: Crack in concrete slab - Category 2

Information: A crack coded as Category 2 was identified in the slab. A Category 2 crack is described as a distinct crack, with the slab being noticeably curved or changed in level.

To be considered Category 2, the approximate width of the crack is less than 2.0mm, or a change in offset of less than 15mm when a 3m straight edge is placed over the defect.

Category 2 cracks to slabs should be monitored for a period of 12 months. At the end of the monitoring period, cracks rated greater than Category 2 are considered defects that require rectification.

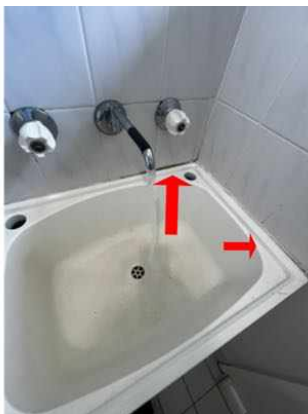
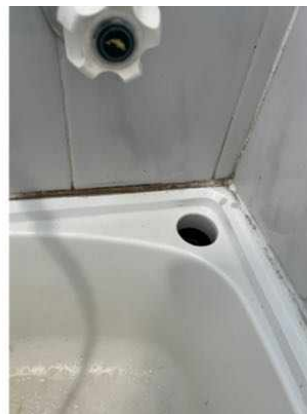
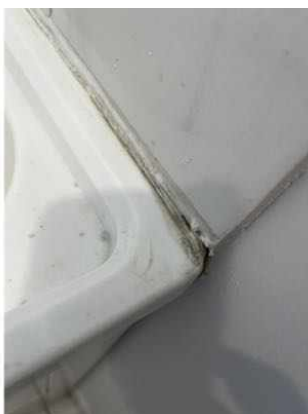
Building: Main Building
 Location: Laundry
 Finding: Sealant and grouting - Missing or damaged
 Information: It was noted on inspection that sealant or grout is degraded in the Laundry Tub area .

Different materials and floor areas move at different rates, generally causing cracking to grout or sealant at this point. A flexible sealant is required to allow for expected expansion and contraction, while keeping the joint water tight and protective of all associated building materials.

There appears to be excessive mould to the sealant and grout which will likely require scraping out and replacement.

A sealant specialist or tiling contractor should be appointed to complete these works as soon as possible to prevent any water damage.

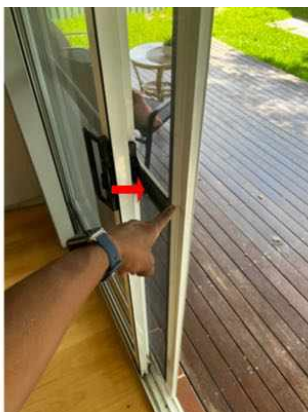
Finding 3.06

Building:	Main Building
Location:	Alfresco Mesh Door
Finding:	Door - Missing handle
Information:	The handle to the door was missing at the time of the inspection. Absence of the handle limits the operation of the sliding door and may pose as a safety risk.

Replacement of the handle should be conducted as soon as possible. A general handy person or qualified carpenter should be appointed to perform these works to improve the operational state of the affected door and improve the safety of the internal area.

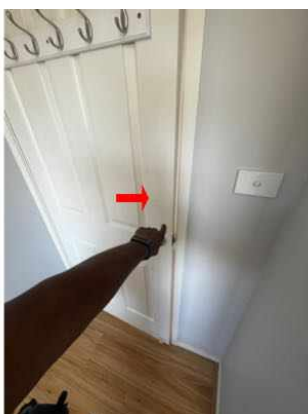
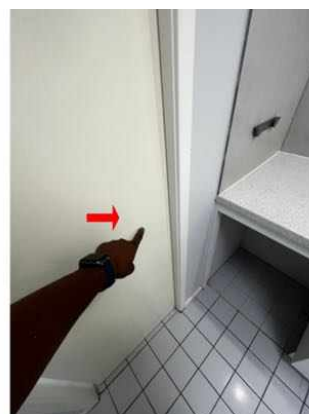
Finding 3.07

Building:	Main Building
Location:	Laundry sliding door/ Bedroom door
Finding:	Door - Binding/jamming
Information:	Binding and/or jamming of this door is evident during standard operation. This defect inhibits the functionality of the affected door as well as creating potential for secondary defects to associated building elements, such as damage to the floor covering.

A door that binds to the associated door frame may have several causes, ranging from minor defects, such as poor installation of the door or deteriorated hinges.

For minor causes, a qualified carpenter or general handyperson should be appointed to perform minor rectification works at client discretion.

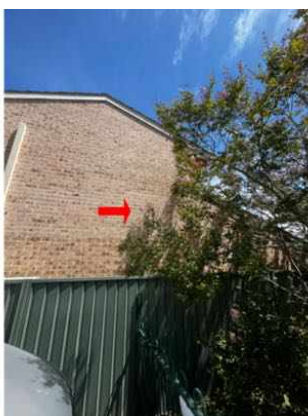
Finding 3.08

Building:	Main Building
Location:	Yard Side
Finding:	Trees - Overhanging and filling gutters
Information:	Overhanging trees often result in excessive amounts of leaf debris accumulating in gutters.

Gutters are a critical part of the building's management of storm water and rain. It is therefore important that they be kept clear to prevent secondary damage to associated building elements, including exterior and interior walls, ceiling linings and any adjoining building elements. Where gutters are blocked, pooling of rainwater is likely to occur, fast-tracking rust and corrosion of the roof plumbing elements.

It is highly advised that all overhanging tree branches be removed as soon as possible to prevent any further damage. Repair and/or replacement of sections of damaged guttering may also be required where the extent of the damage necessitates.

Such works should be performed by the homeowner; however, appointment of a landscape contractor or an arborist may be required. Consultation with a licensed roof plumber is required where guttering has been damaged.

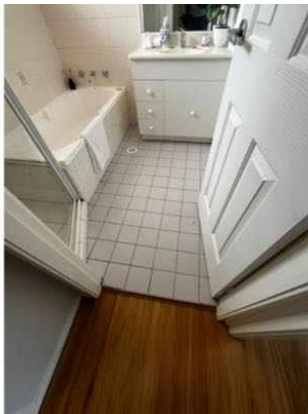
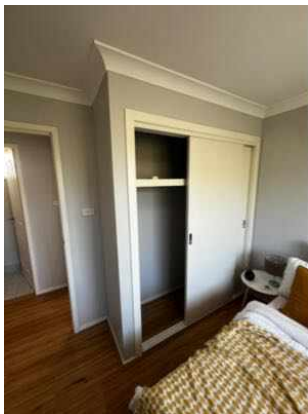
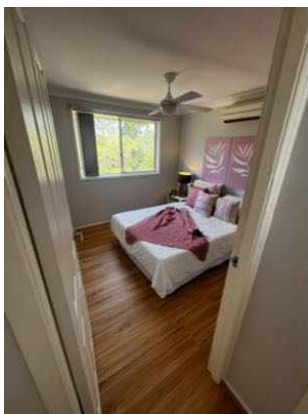
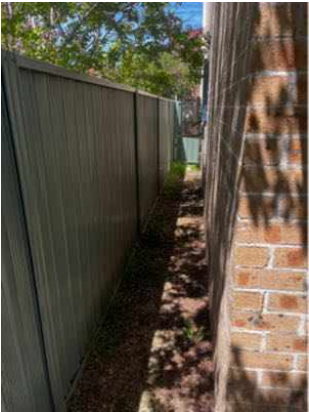
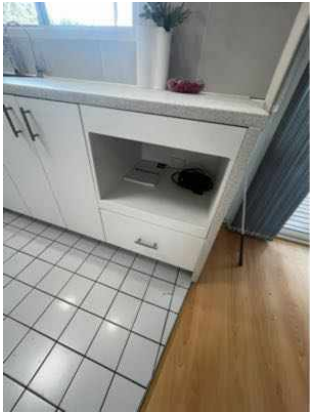
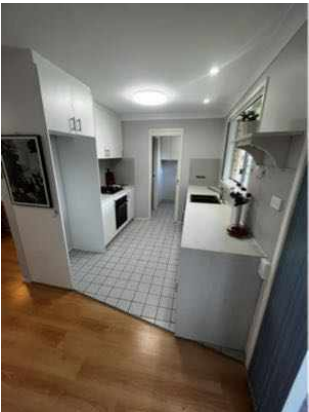
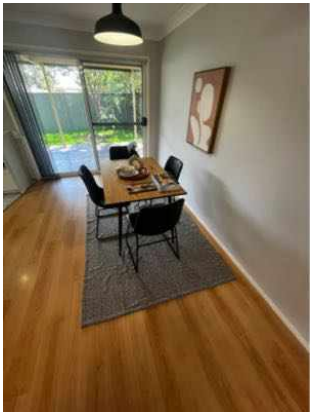
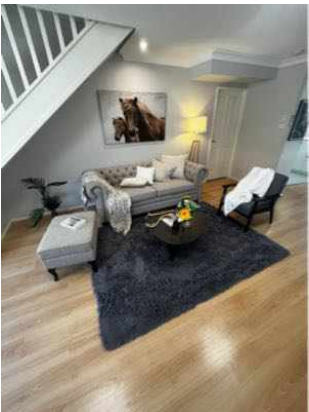
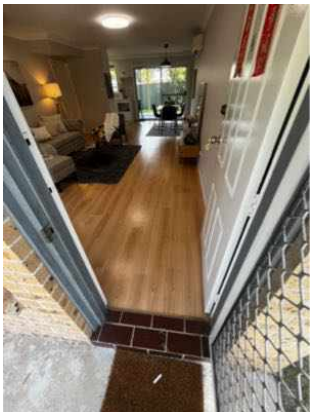
Finding: Additional Photos - Obstructions and Limitations

Information: These photographs are an indication of the obstructions and limitations which impeded full inspection of the property at the time of inspection. These obstructions can hide an array of defects and should be removed to allow full inspection to be carried out. A re-inspection is recommended once the areas are made accessible.

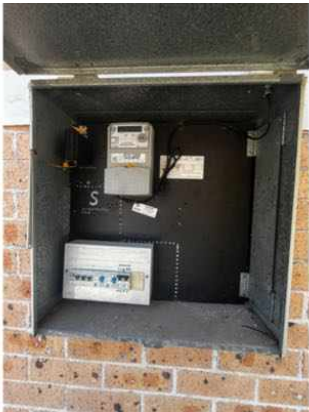
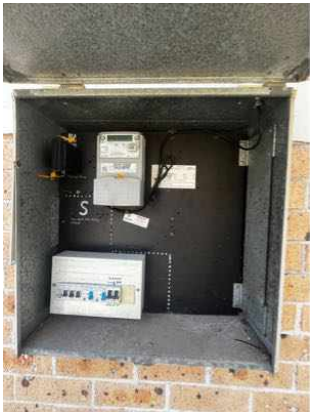
Finding 6.02

Building: Main Building
 Location: Electrical Box
 Finding: Termite Management System - no evidence of a chemical installation no Durable Notice
 Information: The application of a post-construction chemical termite barrier is highly recommended for all properties, particularly if live termite activity has been found on the site previously. Such barriers are highly effective in preventing termite attack on any timber building elements throughout the property.

A durable notice should be placed in the switchboard unit to indicate current termite barriers. At the time of inspection, it appeared as though no termite management system has been installed, with no evidence to suggest preventative works taking place.

The client may consider gaining further advice from a pest controller as to the costs and procedures involved with this application. It is recommended that obtaining such advice be a short-term priority.

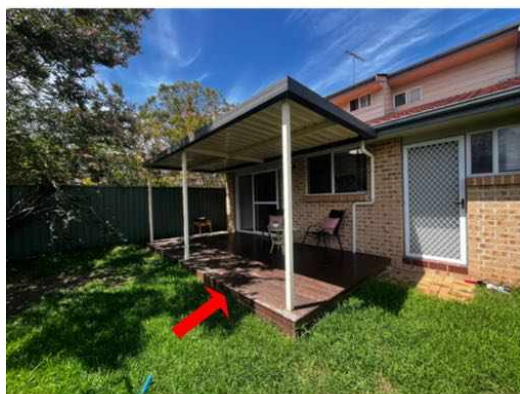
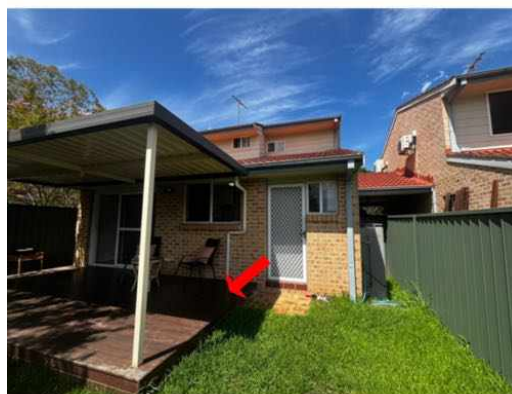
Finding 6.03

These obstructions can hide an array of defects and should be removed to allow full inspection to be carried out. A re-inspection is recommended once the areas are made accessible.

It is highly recommended that any stored timbers be immediately removed from areas in which they may attract any termite / timber pest attack. Minimisation of risk / prevention of termite attack is far more adequate than dealing with the presence of termite activity.

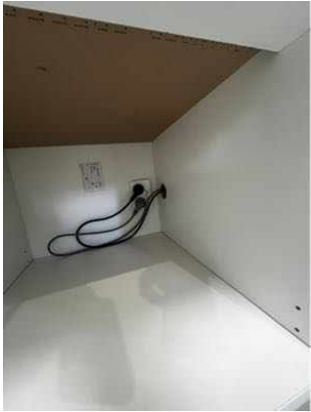
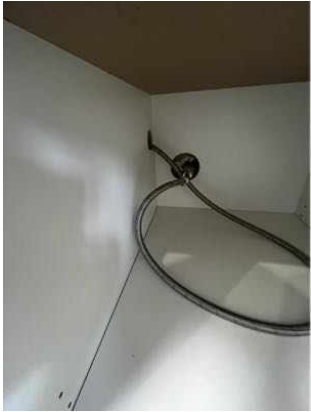
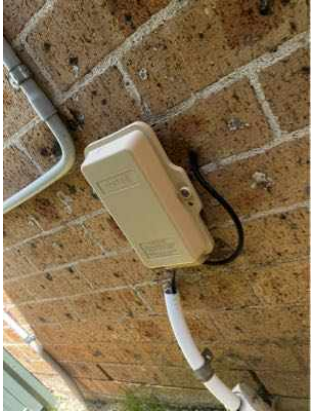
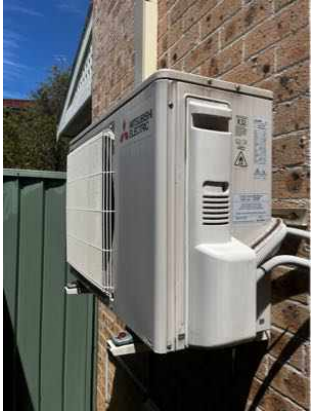
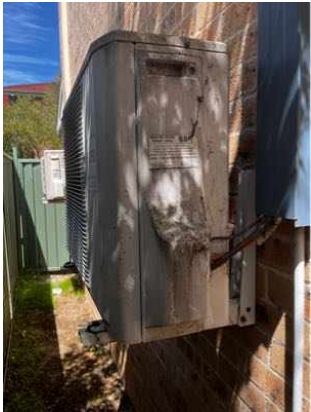
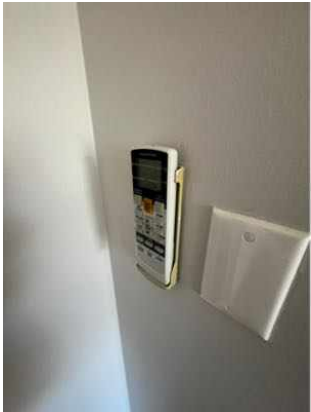
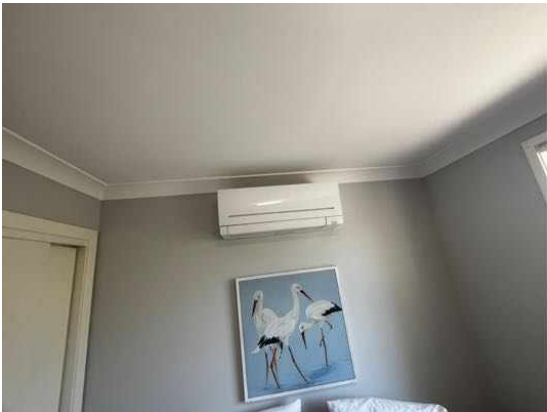
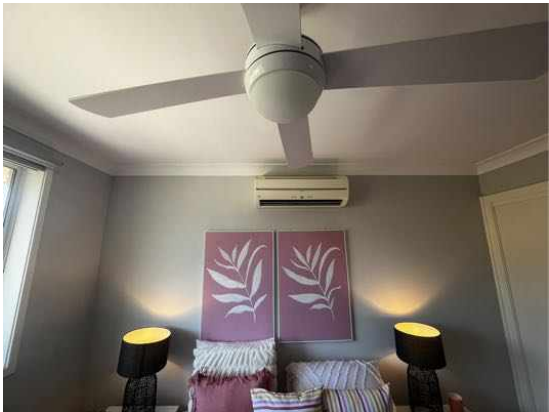
Building: Main Building
Location: Bathroom/Toilets >
Finding: For information only
Information: A Cluster of Photos taken at the time of inspection.

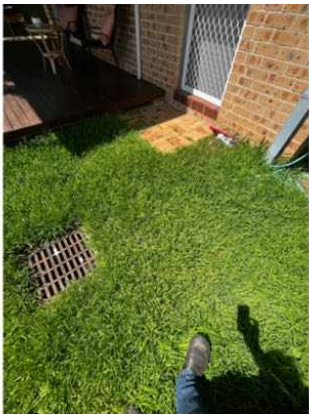
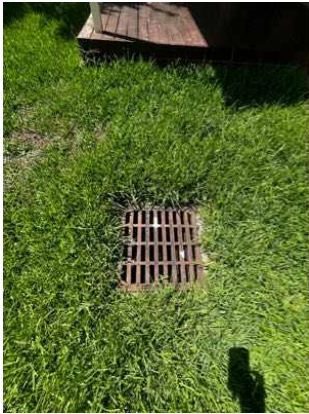
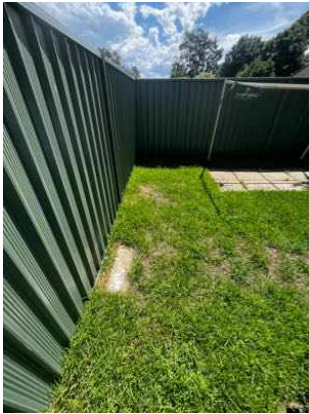
The general adequacy of site drainage is not included in the standard property inspection report. Comments on surface water drainage are limited as where there may have been either little or no rainfall for the period of time, Surface water drainage may appear to be adequate during the inspection but then during periods of heavy rain, may be found to be inadequate.

Any comments made in the section are relevant only in light of the conditions present at the time of inspection. It is recommended that a smoke test be obtained to determine any illegal connections, blocked or broken drains.

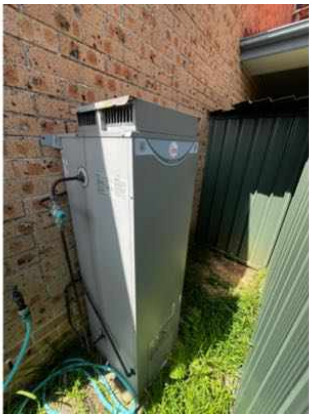
Building: Main Building
Location: Yard - Side
Finding: Hot Water Unit
Information: The HWS appeared to be in good condition at the time of inspection.

Water pressure appears to be normal, however, this is not an opinion of a licensed plumber. No water hammer was noted when taps are turned off fast.
