Building and Timber Pest Inspection Report

Inspection Date: Mon, 30 Mar 2026

Property Address: U2 102 Central Rd, Unanderra NSW 2526, Australia

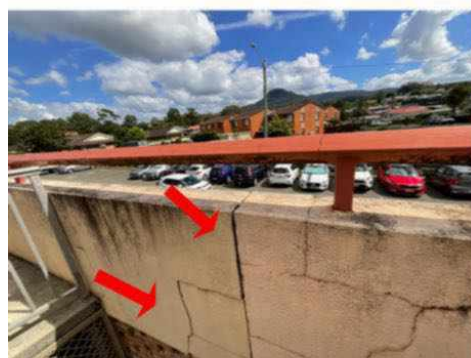
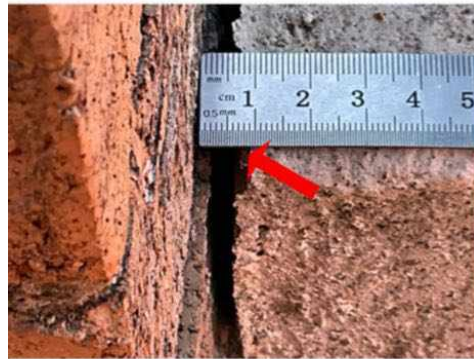
Building: Main Building
 Location: Garage stairs outside unit 1 and unit 2 north east balcony corner
 Finding: Step cracking to brickwork major
 Information: Step cracking of 7mm and 8mm respectively was identified to the brickwork in the external wall area outside unit 1 (bordering unit 2) and the unit 2 balcony corner

The NSW Standards and Tolerances 2017 states cracks over 5mm in width are a major defect requiring rectification work.

Step cracking, which is similar to other forms of cracking, has a variety of possible causes. However, the most common is the subsidence of adjacent footings.

Step cracking is a relatively common defect, and is most likely to occur adjacent to windows, doors and other openings. Mortar failure in the gaps between affected bricks indicates the stresses and tensions affecting the wall.

Where step cracking is extensive in this case, the client is advised to consult a structural engineer. Even minor step cracking can be used as a warning sign to address factors causing stress to the wall, which can include the effect of surrounding trees, water leaks, soil erosion, or even the presence of reactive soils in the surrounding area.

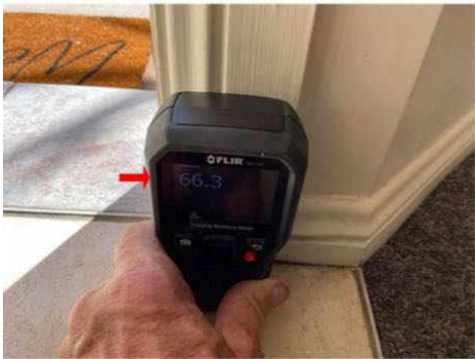
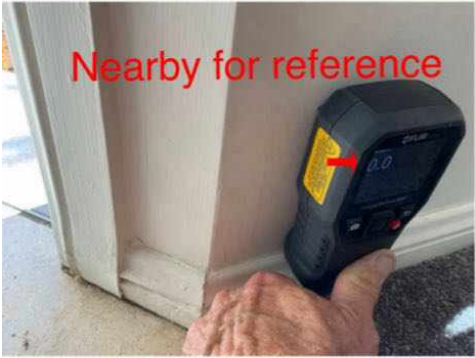
Finding 2.02

Building:	Main Building
Location:	Entry, hall behind shower and hall cupboard behind hit water system.
Finding:	Evidence of excessive moisture was present at the time of inspection
Information:	Excessive moisture was found in the unit entry door and bathroom door frames and hall wall. A high reading of 66.3 was recorded in the entry and up to 48.8 near the bathroom. All nearby areas had zero readings for reference. Old water damage was found in the hall cupboard behind the shower. Due to this current and old moisture damage, damage to internal wall framing is highly likely making the bathroom failed waterproofing membrane and wall damage a major defect and the entry moisture a minor defect. It is unclear if the damage in the hall cupboard originated from the

Excessive moisture can attract termites and produce conditions that promote termite attack and has all readily produced fungal growth and wood decay.

Excessive moisture is generally caused by deteriorated inadequate or missing roof drainage, failed waterproofing membranes, damaged sealant, leaking plumbing pipes or fixtures poorly plumbed HWS overflows or condenser units and poor site drainage.

It is highly recommended that all plumbing and drainage fixtures and fittings be maintained regularly in order to prevent excessive moisture being present in the external / internal property.

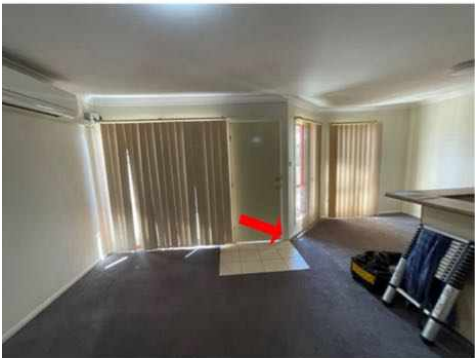
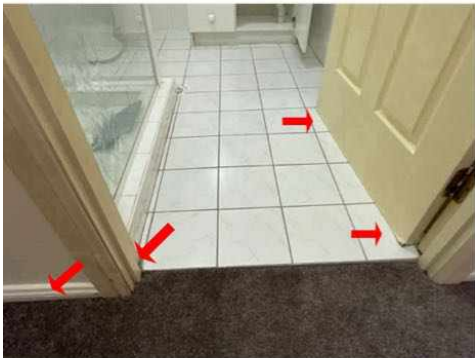
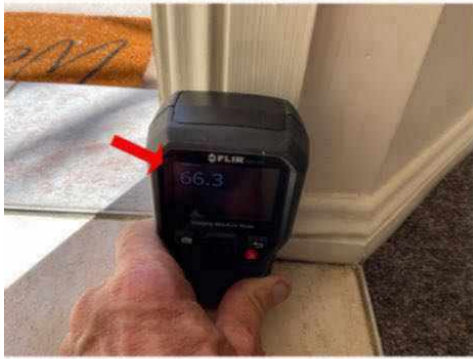
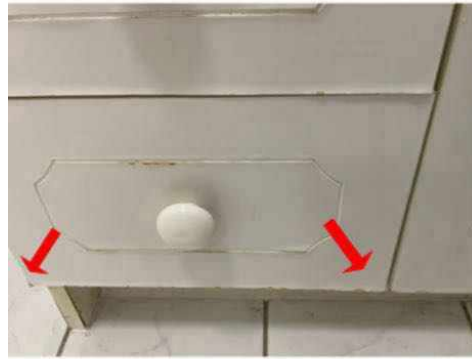
Building: Main Building
Location: Bathroom, entry,
Finding: Building elements - Swollen
Information: Swollen building elements generally indicate that the building materials have been affected by excessive moisture over a prolonged period of time, and have swollen as a result. The structural integrity of swollen building elements cannot be guaranteed, and further damage is possible if these areas are left unmanaged.

The north entry wall, hall wall and door frame all showed high moisture leading to swollen and damaged trim indicating water damage (see excessive moisture defect).

Repair or replacement of swollen building elements should be conducted by a qualified carpenter or cabinet maker after the cause if the leaks is rectified.

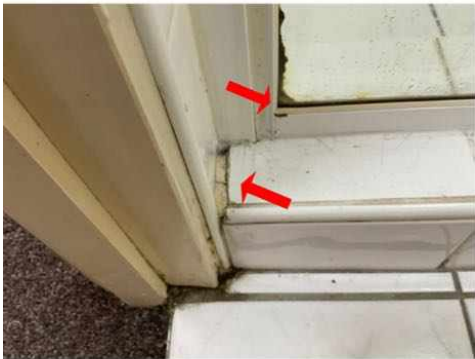
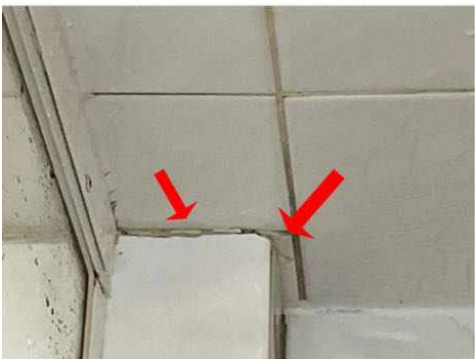
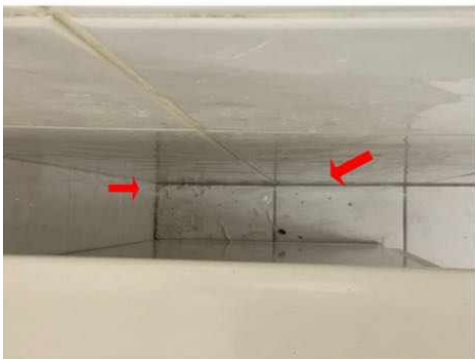
Finding 3.02

Building: Building 1
 Location: Pictured laundry and bathroom areas
 Finding: Sealant and grouting - Missing
 Information: It was noted on inspection that sealant or grout is missing to these pictured areas of the building.

Flexible and mould resistant materials should be applied to affected areas to prevent any subsequent water damage that is likely to occur.

This needs to be brought to the attention of the builder.

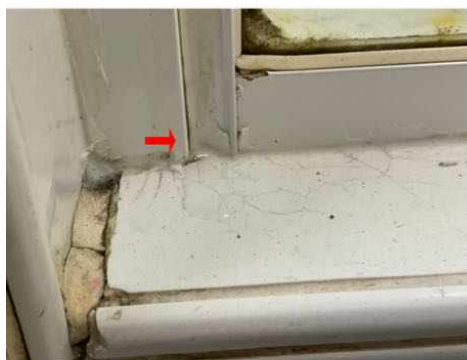
Finding 3.03

Building:	Main Building
Location:	Bathroom
Finding:	Shower screen - Leaking
Information:	<p>Leaking was evident to the shower screening at the time of inspection. It is suspected that the leaking has occurred as a result missing sealant. Leaking from the shower , where left unattended, is likely to lead to water damage to adjoining flooring and walls. Such damage can lead to water damage and necessitate extensive remedial works being required. Active water leaks may also create an environment that is susceptible to the formation and development of mould. This is not the leak found in the hall wall.</p> <p>Appointment of a sealant expert is required to repair or replace this missing sealant. Such works should be performed as soon as possible to ensure that no further damage occurs.</p>

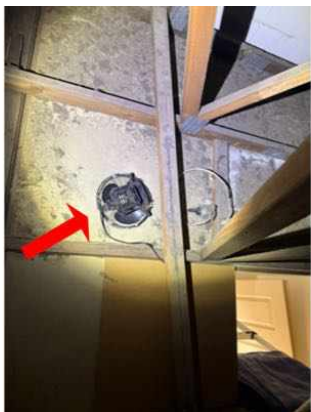
Finding 3.04

Building:	Main Building
Location:	Roof Void
Finding:	Exhaust fans not vented to the external environment
Information:	<p>On inspection of the roof void, it was observed that the exhaust fan(s) to the bathroom do not exhaust directly to the outside of the building.</p>

It is recommended to engage a carpenter or suitably qualified person to add ducting to vent the fan(s) to the eave or external wall to stop possible mould growth in the ceiling.

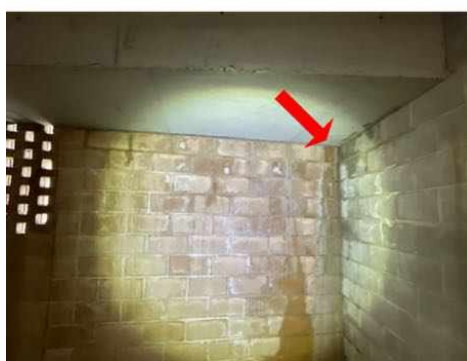
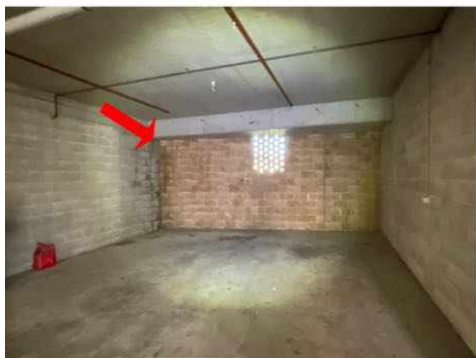
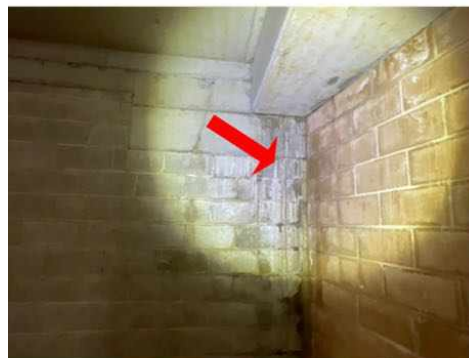
Finding 3.05

Building:	Main Building
Location:	Garage walls and above balcony areas
Finding:	Site drainage - Inadequate
Information:	The site drainage to most rear balconies was found to be inadequate at the time of inspection, creating potential for subsequent water damage to associated building elements. Garage wall water staining shows water from many balconys (some are garden beds) run down the internal garage southeast walls.

Water damage and secondary defects are likely to occur if left unmanaged.

Where site drainage is inadequate in these cases, some external waterproofing membranes need to be checked by a qualified plumber or waterproofing specialist.

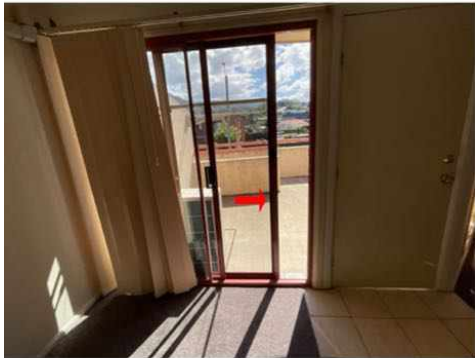
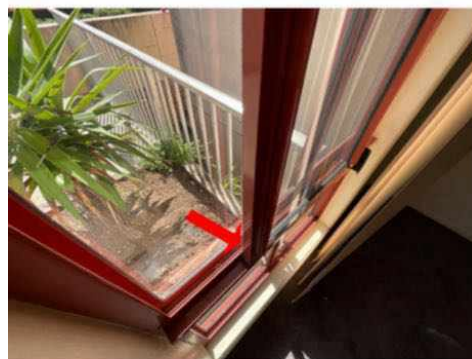
Building:	Building 1
Location:	Pictured Areas
Finding:	Building elements - Damaged
Information:	Evidence of damage was identified to the following areas -

1. The shower spout fell off when touched. Replacement is recommended.

2. The front flyscreen is binding and needs repair.

4. The front wall external push button light does not work.

A carpenter and electrician is required to repair this area and bring it back to full function.

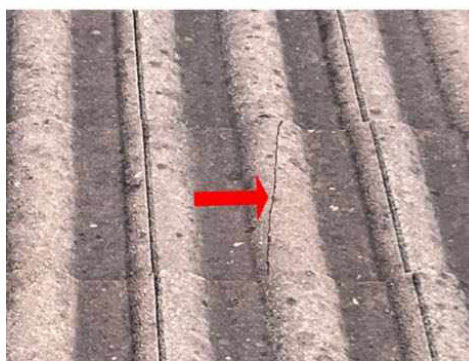
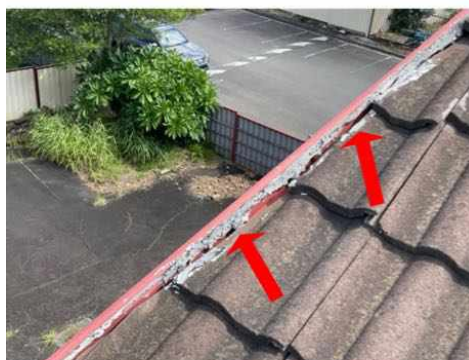
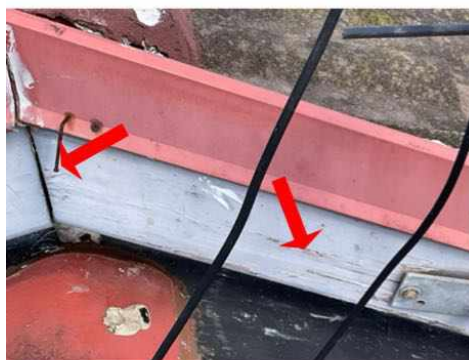
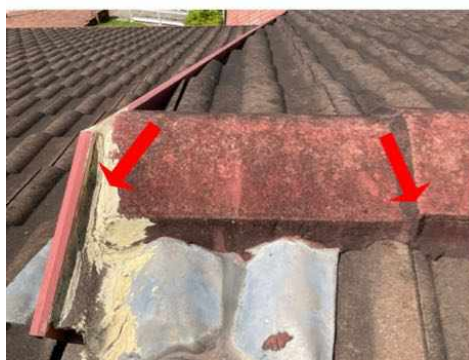
Finding 3.08

Location: Some roof areas
Finding: Roof areas (tiles, mortar, sealant)- weathered
Information: Upon inspection of the exterior roofing, the majority of roof tiles and mortar were considered to be in a good condition. The barges were in poor condition with wood rot and damaged paint. While weathering of the roofing areas is consistent with the age of the property, maintenance works are required.

Isolated areas of mortar and tiles show minor cracking is present. Re-pointing and re-sealing the may be considered as an interim solution by the client to help preserve and extend the life span of the tiles. Where left unmanaged, deteriorating roof mortar and tiles are likely to lead to a number of secondary defects, including minor water leaks and weather exposure to internal roofing structures.

Consultation with a roofing contractor is highly advised to gain advice on cost of remedial works that may be required in the short to medium term. Remedial works are likely to increase the longevity of the exterior roofing structure.

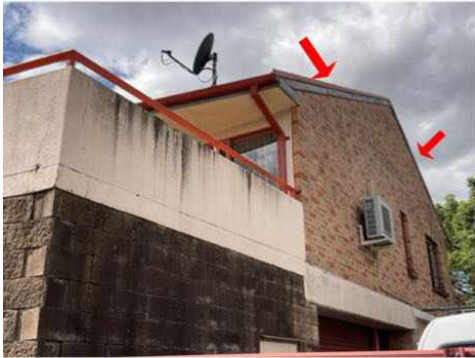
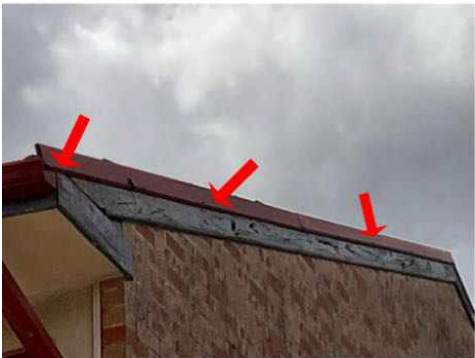
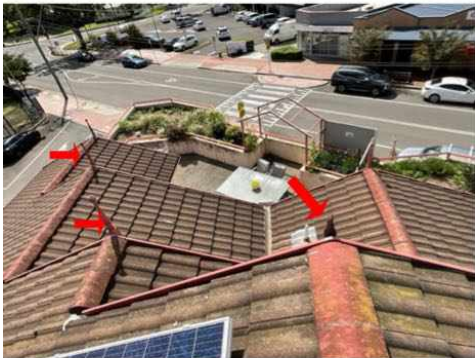
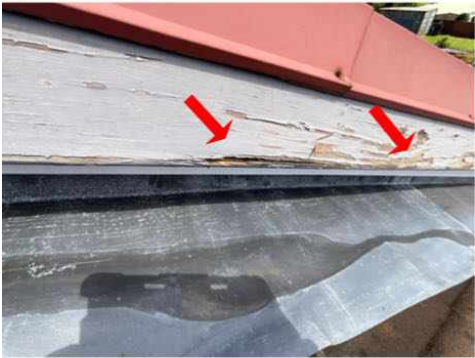
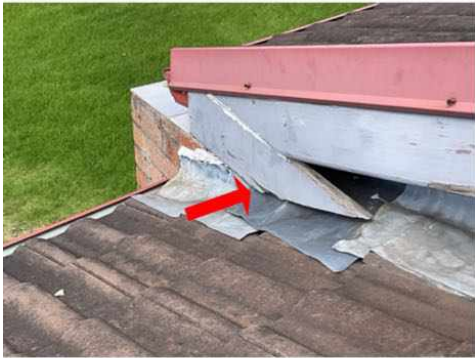
Finding 3.09

Building:	Main Building
Location:	Roof Exterior
Finding:	Fascias, barges, finials - Wood rot
Information:	Wood rot was found to be affecting fascias and barges on many roof areas. Wood rot, also known as Fungal Decay, occurs when timbers and other cellulose building materials are exposed to damp conditions on an ongoing basis.

It is likely that this wood rot has developed as a result of faults in the roof plumbing, creating excessive moisture in this areas. Frequent exposure to rain and other weather conditions also make fascias and barges susceptible to accelerated deterioration.

Early intervention and regular maintenance will prolong the useful life of these building elements. Prior to any works being performed, the cause of the moisture that has created the visible wood rot should be identified and addressed in a suitable manner.

It is advised that a roof plumber be appointed to inspect all roof plumbing and subsequently identify the cause of the wood rot. Replacement of affected fascias and bargeboards may then be a necessary step in protecting surrounding building elements from such deterioration.

A qualified carpenter or registered builder may also be required to replace affected building materials.

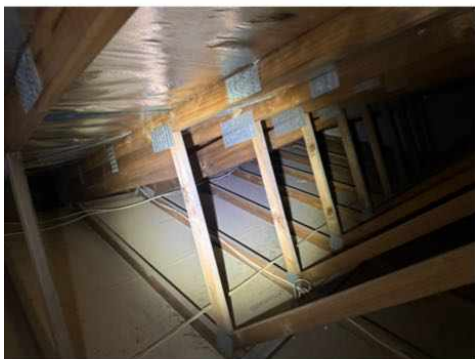
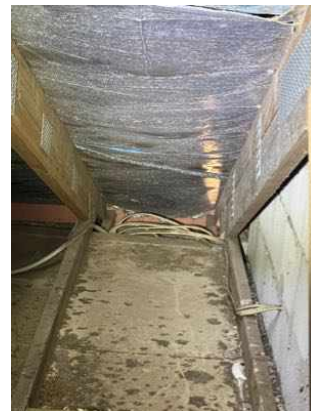
Finding 3.10

Building:	Main Building
Location:	Roof Void
Finding:	Insulation - Missing
Information:	Upon inspection of the roof void it was noted that insulation is not present.

Insufficient insulation will result in a comparatively higher cost to heat and cool a property as there is a lack of Insulation (or uneven coverage of insulation) which works as a barrier to heat transfer. This helps to keep out unwanted heat in summer and preserves warmth inside your home in winter. It can also help soundproof your home from unwanted airborne noise transfer.

Where insulation is absent, the area does not meet current Australian Standards. Installation of adequate insulation is required and should be conducted as soon as possible.

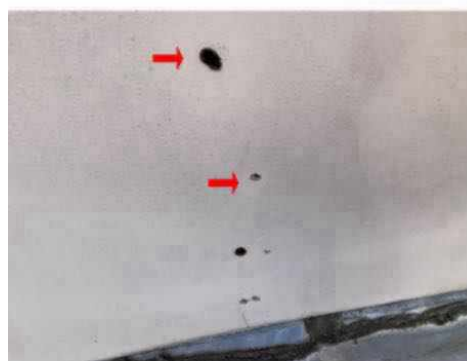
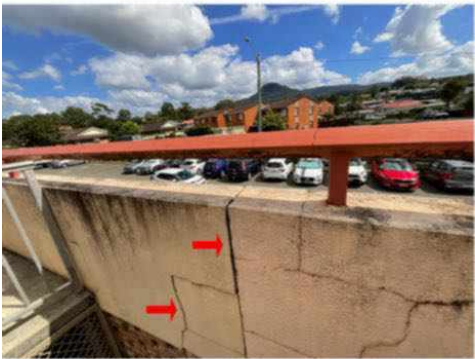
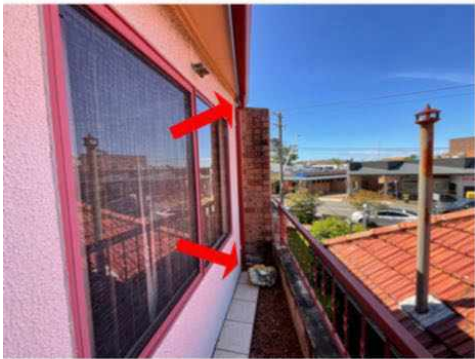
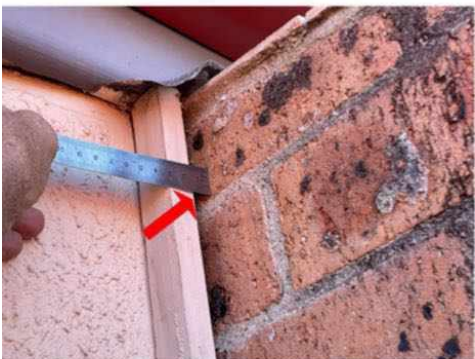
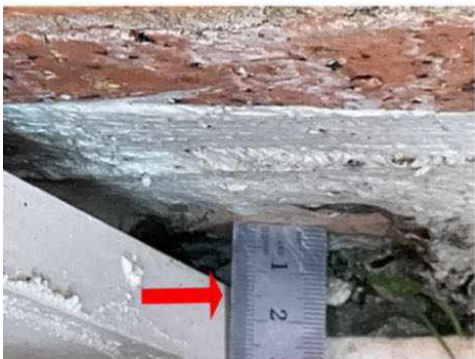
Finding 3.11

Building:	Main Building
Location:	Some External Areas
Finding:	Sealant (external) - Missing.
Information:	It was noted on inspection that areas of external sealant was missing to small areas of the external walls.

Very large gaps of 11mm and 13mm were found in the rear unit 2 balcony. See pages 7 & 8.

Flexible sealants should be applied to these affected areas to prevent any subsequent water damage that is likely to occur.

A sealant specialist or skilled handy person should be appointed to complete these works as soon as possible

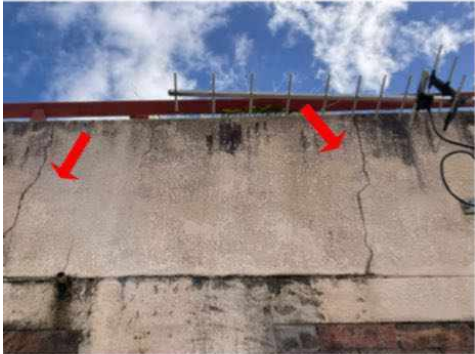
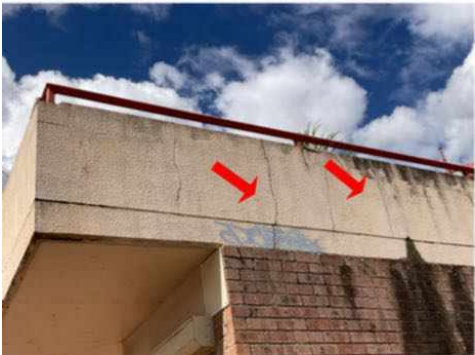
Finding 3.12

Building: Main Building
Location: Many external Areas
Finding: Render (external) cracking.
Information: It has been observed that cracking to many external rendered surfaces. The degree of most damage is described as “slight” noticeable cracks which are easily filled. Cracking of this size are generally less than 5mm in width.

Always contact your building inspector should cracks widen, lengthen, or become more numerous.

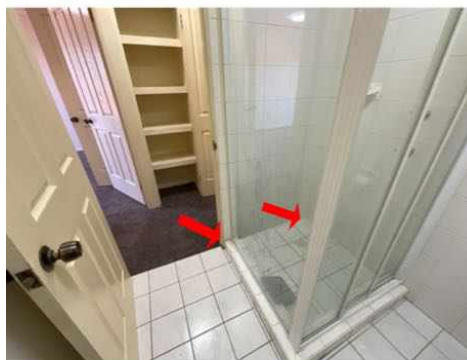
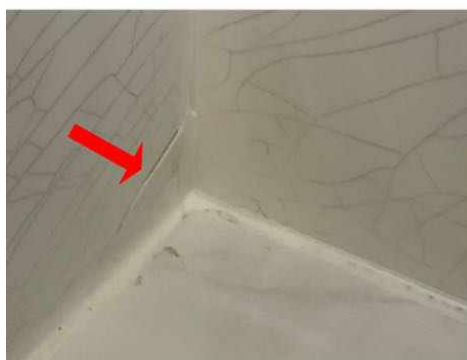
Finding 3.13

Building: Main Building
 Location: Pictured tiles
 Finding: Tiles - Cracked or damaged
 Information: Cracking was evident to the tiling in these areas at the time of inspection. While the cracking appears to be minor, this area is frequently exposed to water, allowing potential for water penetration into adjoining sections of walls or flooring.

If left unmanaged, water penetration to these areas may lead to subsequent water damage, which is likely necessitate repair work to affected building elements.

A tiling contractor should be appointed to ensure that no further water damage occurs. The re-application of silicone and grouting throughout remaining tile work is also advised, to further protect the area against water penetration.

Where water penetration has led to water damage, appointment of a relevant tradesperson may be required to repair damaged building elements.

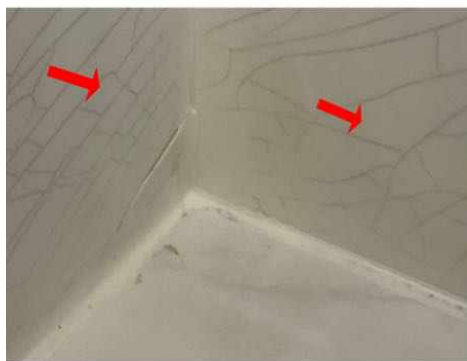
Crazing is internal fracturing without a change of the surface texture. It might be seen when light transmits through transparent or translucent material and it can also exist in opaque plastics. Crazing can be a precursor to cracking if it extends to the surface, but even if it stops short of the surface, crazing still decreases the strength of the material.

These tiles may need replacement in the future and can be undertaken by a tiling contractor.

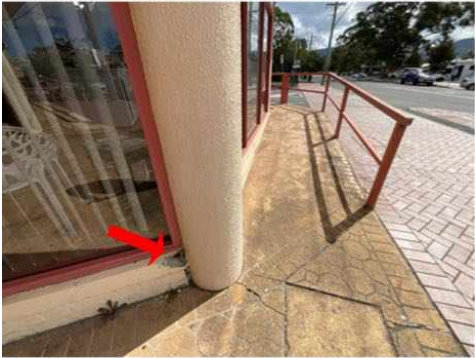
Building:	Main Building
Location:	Small areas of exterior walls and interior stairs
Finding:	Concrete spalling
Information:	These areas have suffered Concrete Spalling. This is the breakdown of concrete via natural weathering and/or chemical reaction that results in sections of cement chipping off the main body – often resulting in fractured, compromised concrete. Spalling looks like pitted acne scarring and breaks off in flecks which can expose rebar.

A concreting contractor can provide advice on repairs of this damaged concrete when convenient.

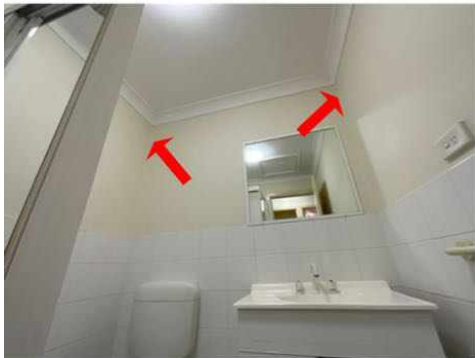
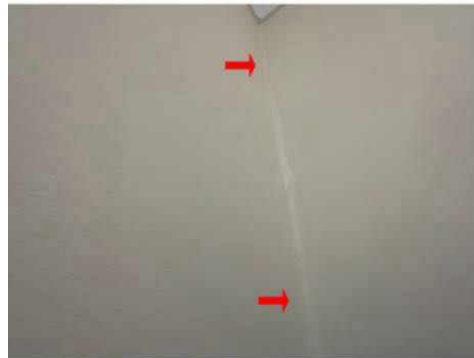
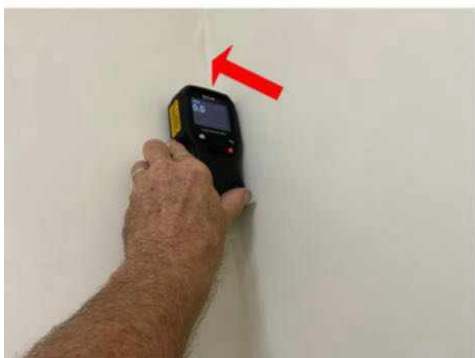
Building: Main Building
Location: Bathroom & Laundry
Finding: Building plaster damaged
Information: Evidence of minor plaster damage was identified to these areas. No moisture was evident after numerous tests.

A plasterer can repair these walls when convenient.

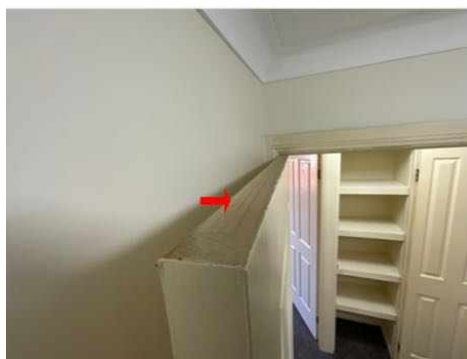
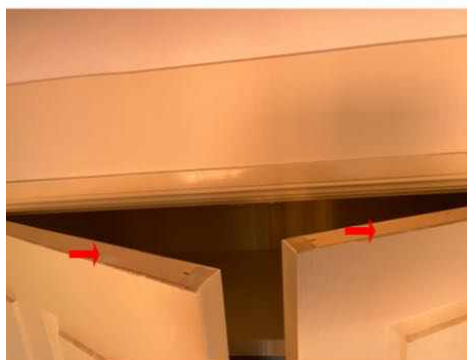
Finding 3.21

Building:	Main Building
Location:	Some doors
Finding:	Door - Binding/jamming and no paint protection
Information:	Binding and/or jamming of one bedroom door is evident during standard operation. All doors are also lacking paint top and bottom. These defects inhibits the functionality of the affected doors as well as creating potential for secondary defects to associated building elements, such as damage to the floor covering or swelling in wet areas.

A door that binds to flooring or to the associated door frame may have several causes, ranging from minor defects, such as poor installation of the door or deteriorated hinges, through to major structural issues, such as damage to subfloor structures.

Where door binding/jamming appears to indicate major structural issues, a registered builder specialising in re-stumping should be appointed to provide an estimate on the cost of rectification.

For minor causes, a qualified carpenter or general handyperson should be appointed to perform minor rectification works at client discretion.

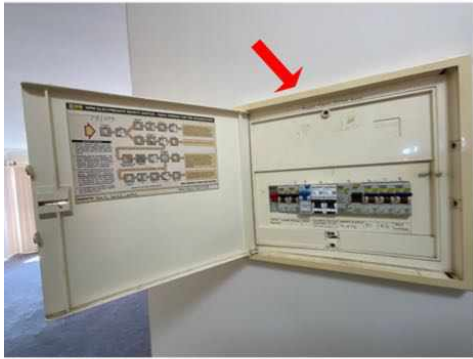
Building:	Main Building
Location:	Fuse box
Finding:	Termite Management System - no evidence of a chemical installation or durable notice
Information:	The application of a post-construction chemical termite barrier is highly recommended for all properties. Such barriers are highly effective in preventing termite attack on any timber building elements throughout the property.

A durable notice should be placed in the switchboard unit to indicate current termite barriers. At the time of inspection, the durable notice was missing and it appeared as though no chemical termite management system has been installed, with no evidence to suggest preventative works taking place since the property was built.

The client may consider gaining further advice from the body corporate and a pest controller as to the costs and procedures involved with a 'chemical' application. It is recommended that obtaining such advice be a short-term priority.

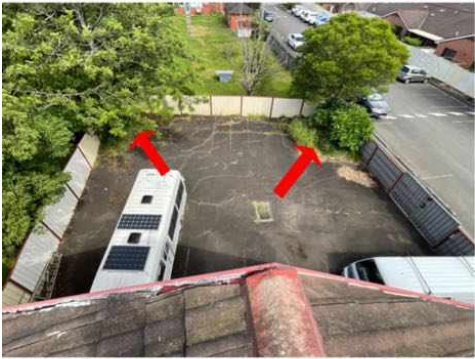
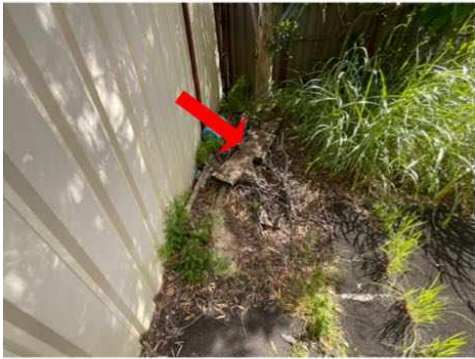
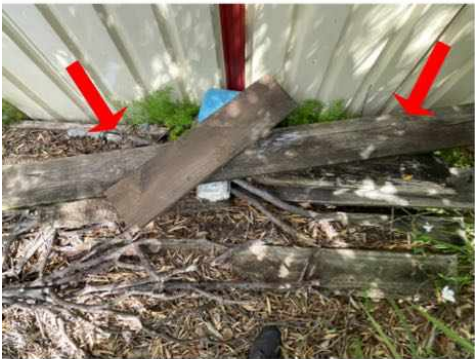
Finding 6.02

Building:	Main Building
Location:	Roof Exterior and rear yard areas
Finding:	Fungal decay - present (localised)
Information:	Fungal decay also known as wood decay or wood rot generally refers to the deterioration of timber elements when in contact with excessive levels of moisture for a prolonged period of time.

The development of fungal decay is accelerated by temperatures from 5degreeC to 40degreeC as well as the presence of oxygen. Generally fungal decay develops on timber elements that are in use in an external environment which are exposed to rain penetration.

In this case, the affected timber is decaying and attracting termites. This needs removal.

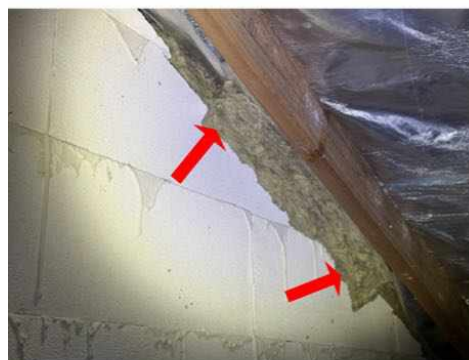
This wall has gaps at the top of the wall, appears to be crossed by timber and does not appear to be “packed with mineral fibre or other suitable fire-resisting material”.

This was not a requirement at the time of construction.
