Building and Timber Pest Inspection Report

Inspection Date: Tue, 17 Feb 2026

Property Address: 2 Grazier Cres, Werrington Downs NSW
2747, Australia

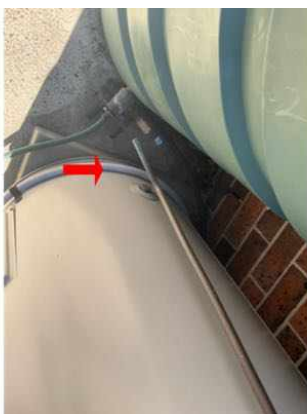
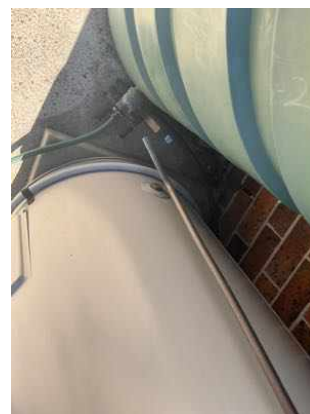
Building: Main Building
 Location: Exterior walls - left side
 Finding: HWS Overflow - Not Connected
 Information: The Hot Water System (HWS) overflow was found to be disconnected from storm water drainage and is creating excessive moisture in the surrounding area.

These damp conditions can lead to secondary defects such as rot, rust or corrosion of associated building elements, the formation of fungal decay, or even the creation of potential slip hazards. When coupled with poor site drainage, pooling of water may also attract termite activity to this area.

It is highly recommended that a licensed plumber be appointed to connect the HWS overflow in order to prevent such an environment from being created. These minor works should be carried out as soon as possible.

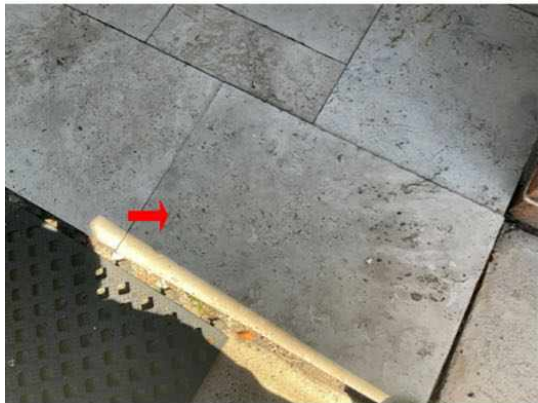
Finding 3.02

Building: Main Building
 Location: Yard - Back
 Finding: loose pavers and improper proper drainage

The side passageway of the property is obstructed by overgrown vegetation and uneven, loose pavers, which may impede proper drainage and access. The area shows signs of poor maintenance, potential water pooling, and trip hazards due to moss-covered, unstable surfaces.

Risk: Increased risk of personal injury due to slips and trips, mosquito breeding from stagnant water, and potential structural moisture damage from inadequate site drainage.

Recommended Action: A licensed landscaper or drainage specialist should be engaged to clear vegetation, regrade the area for proper water runoff, and relay or replace pavers to ensure a safe and accessible walkway.

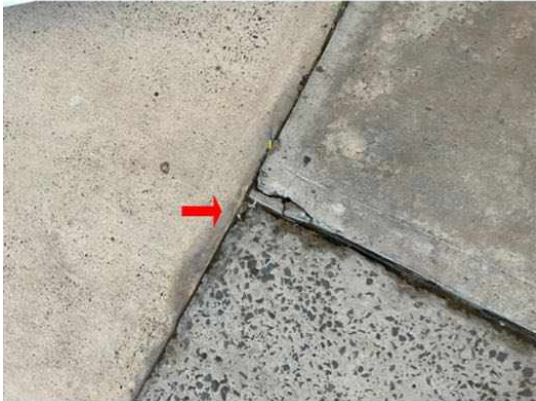
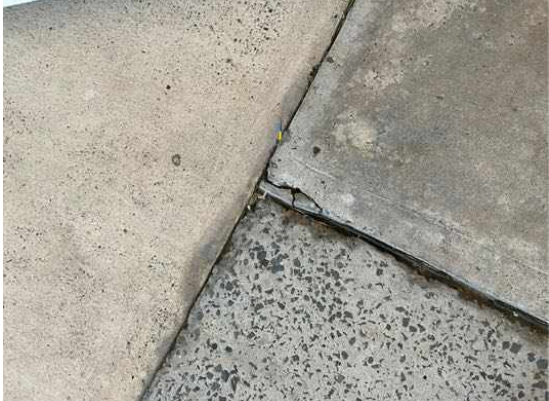
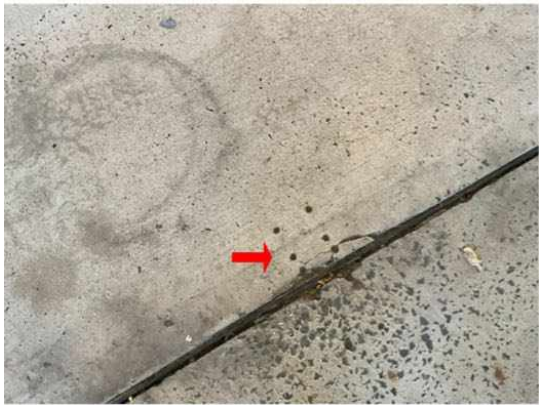
Finding 3.03

Building: Main Building
Location: Yard - Back
Finding: Concrete damaged
Information: The concrete pavement exhibits various forms of damage, including cracks, potholes, and spalling, compromising its integrity and smoothness.

Risk: Damaged concrete pavement poses several risks, including trip hazards, vehicle damage, and drainage issues. Cracks and potholes can cause pedestrians to trip and fall, leading to injuries, while vehicle damage may occur from driving over uneven surfaces. Additionally, poor drainage due to damaged pavement can result in water accumulation, leading to erosion, flooding, and further deterioration of the pavement over time.

A professional concrete contractor or pavement repair company should be engaged to assess the extent of the damage and determine the appropriate repair method. Depending on the severity of the damage, repairs may involve patching, resurfacing, or replacing sections of the concrete pavement to restore functionality and safety. Additionally, measures may be taken to address underlying issues such as poor drainage to prevent future damage.

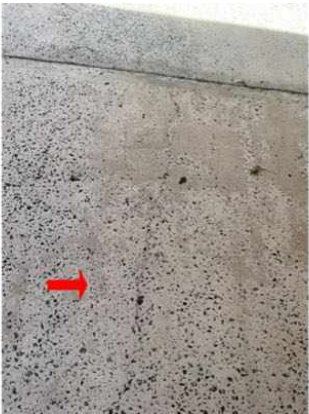
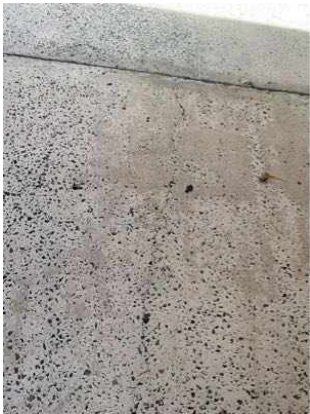
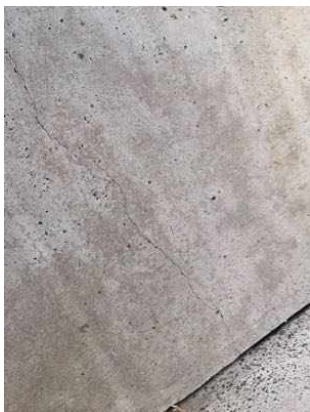
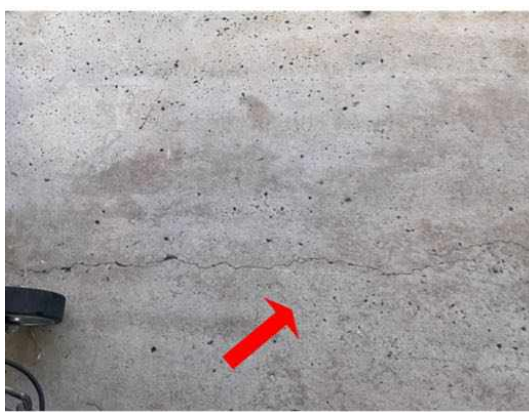
Finding 3.04

Building: Main Building
Location: All Areas
Finding: Crack in concrete slab - Category 0
Information: A crack coded as Category 0 was identified in the slab. A Category 0 crack is described as a hairline crack, representing insignificant movement of slab from level.

The approximate width of the crack to be considered Category 0 is 0.3mm, or change in offset of less than 8mm when a 3m straight edge is placed over the defect.

No rectification is required at this time. However, all cracking should be monitored over a 12 month period to identify any further damage in the area.

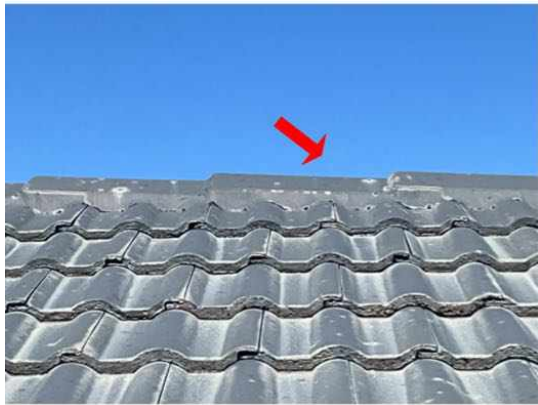
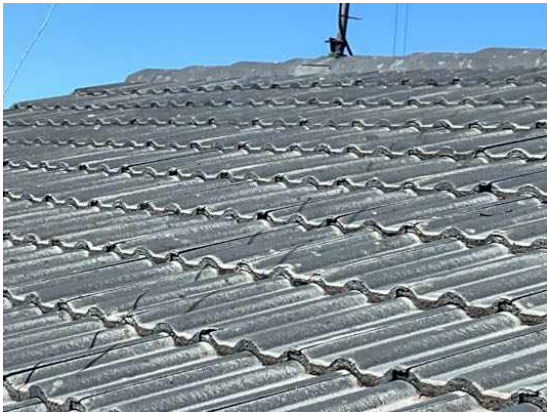
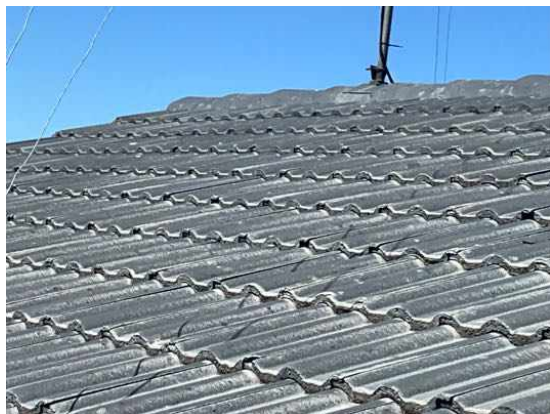
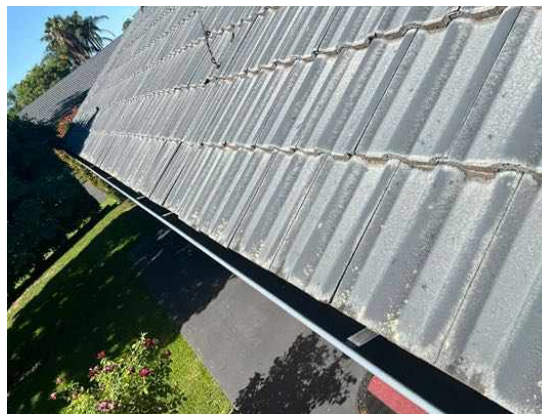
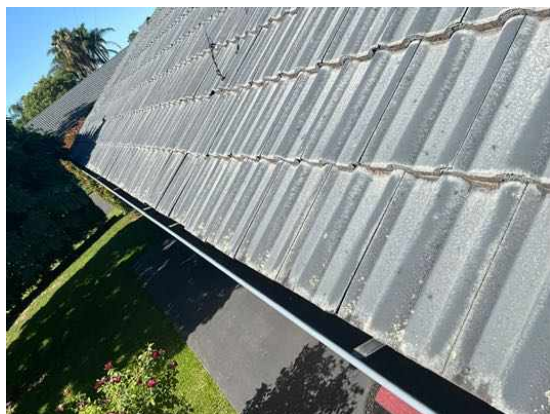
Finding 3.05

Information: Inspection of the roof revealed widespread weathering to the tiled roof surface. The tiles show loss of surface finish, colour fading, and age-related deterioration typical of older roof coverings. Although no significant cracking was noted, weathering can lead to increased porosity, reduced water-shedding capability, and a higher risk of future cracking or displacement during adverse weather conditions.

A licensed roofer should be engaged to undertake a closer inspection, carry out routine maintenance, and replace any tiles that may be compromised. Ongoing monitoring is recommended due to the age and condition of the roof covering.

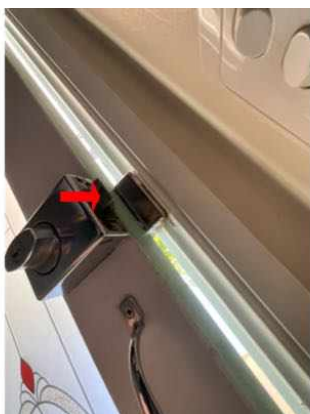
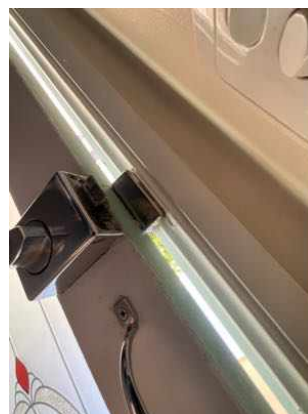
Finding 3.06

Building:	Main Building
Location:	Front door
Finding:	Door - Binding/jamming
Information:	Binding and/or jamming of this door is evident during standard operation. This defect inhibits the functionality of the affected door as well as creating potential for secondary defects to associated building elements.

A door that binds to flooring or to the associated door frame may have several causes, ranging from minor defects, such as poor installation of the door or deteriorated hinges, through to major structural issues. For minor causes, a qualified carpenter or general handyperson should be appointed to perform minor rectification works at client discretion.

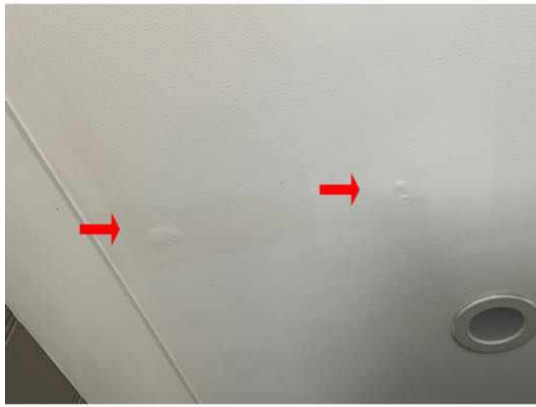
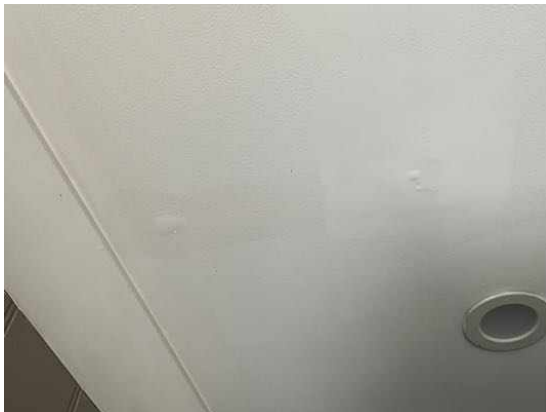
Finding 3.07

Information: A visible paint bubble (or blister) was identified on the surface. The deformation appears as a raised area in the paint film, typically resulting from adhesion failure between the paint and substrate, possibly due to moisture, poor surface preparation, or incompatible paint layers.

As per AS 4349.1-2007, this is considered a minor defect. However, if moisture is the cause, it may indicate an underlying issue such as water ingress or high humidity, which could worsen over time and lead to mould growth or plasterboard deterioration if left unattended.

Minor Defect — unless associated with active moisture ingress, in which case it may be upgraded depending on extent and cause.

A licensed painter or plasterer should assess the cause of the blister. If moisture is present, the source must be identified and rectified before repairs. Once dry, the affected area should be scraped back, sealed, patched, and repainted. Further investigation may be required if there is suspicion of plumbing or roofing leaks above the ceiling.

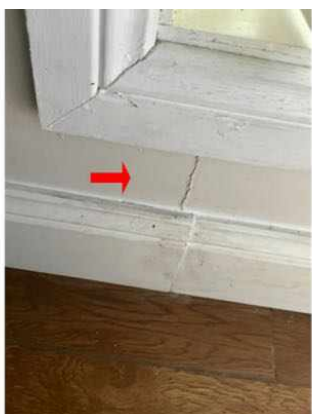
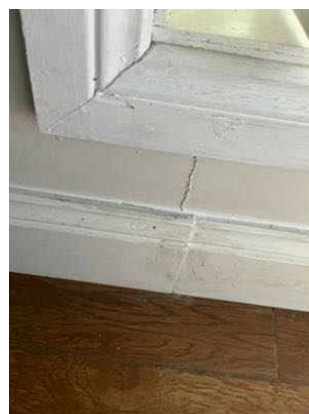
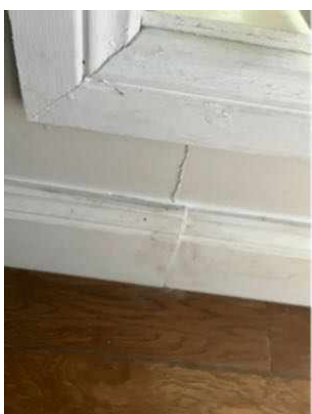
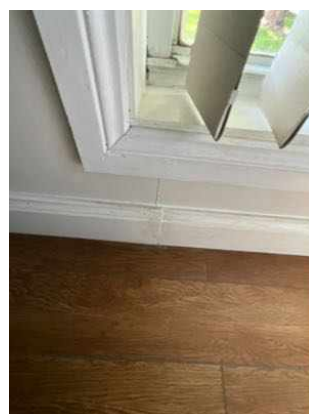
Finding 3.08

Building:	Main Building
Location:	Bedroom
Finding:	Gyprock - Crack (Fine)
Information:	Fine cracks have appeared in the gyprock of the ceiling, suggesting potential issues with settling or structural movement.

The fine cracks in the gyprock ceiling pose a risk of further widening, compromising the aesthetic appeal of the space, and potentially indicating underlying structural problems.

A skilled plasterer or a contractor specializing in drywall repairs should assess the

extent of the cracks and address them promptly. Identifying and fixing the root cause of the issue, whether related to settling or structural concerns, is essential to prevent further damage and maintain the integrity of the ceiling.

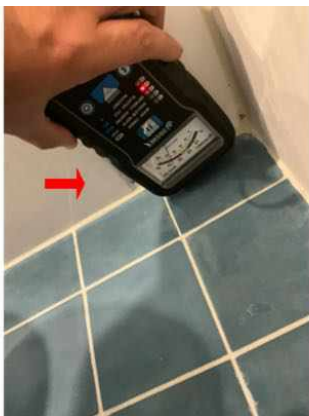
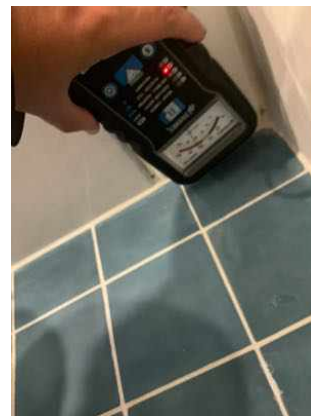
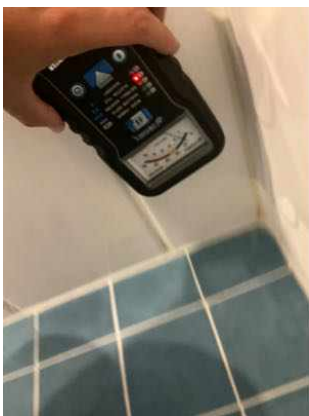
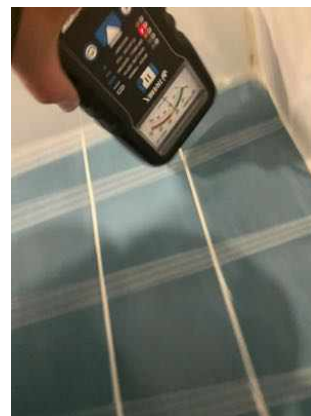
Finding 3.09

Building:	Main Building
Location:	Bathroom
Finding:	Shower - Damp
Information:	Damp is evident to the lower 300mm of wall to the shower alcove. This defect is quite common, and is suspected to have been caused by moisture permeating through the grouting in this area, which shows evidence of deterioration. Leaking pipes within the adjoining wall is also a possible cause.

Unmanaged damp in the shower recess is likely to facilitate the formation and development of mould and fungi growth, decaying associated building materials and compromising their structural integrity. It is important to address damp conditions, as the World Health Organisation notes that excess moisture leads - on almost all indoor

Consultation with a qualified plumber or bathroom specialist is advised immediately to identify the cause of damp and to perform remedial works as required. Where excessive mould growth is present, further inspection by a specialist environmental health inspector should also be considered.

Always ensure that sealant and grout is in good condition to prevent any moisture issues occurring in the future.

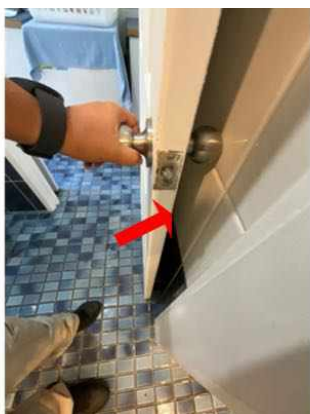
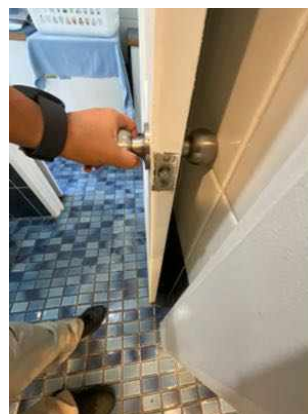
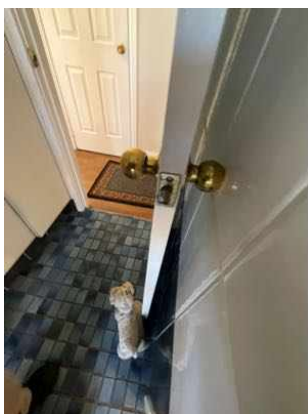
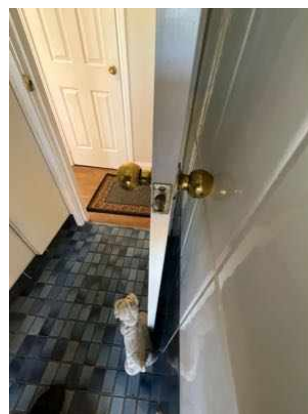
Finding 3.10

Finding: Missing Door Stopper

Information: The door lacks a stopper, which is essential to prevent the door from swinging too far and potentially damaging the wall or the door handle. The absence of a door stopper increases the likelihood of impact damage to both the door and surrounding surfaces over time.

- **Damage Risk:** Moderate risk of damage to the door handle, wall, or door itself from repeated impacts when the door is opened forcefully or by a gust of wind.
- **Wear and Tear Risk:** Increased wear on door hardware and hinges due to the potential for abrupt stops without a dedicated stopper.

- **Engage a Handyman or Carpenter:** A handyman or carpenter should install a suitable door stopper to prevent excessive door movement. This could be a floor-mounted or wall-mounted stopper depending on the space and door design.

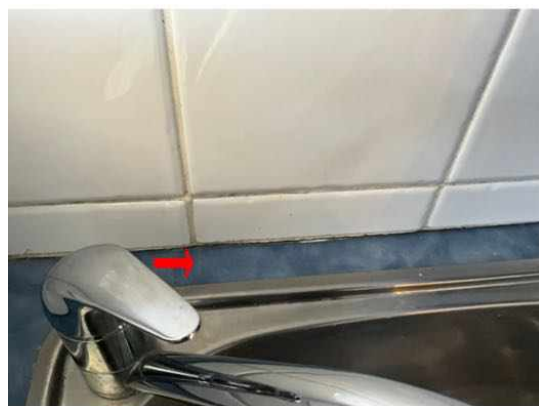
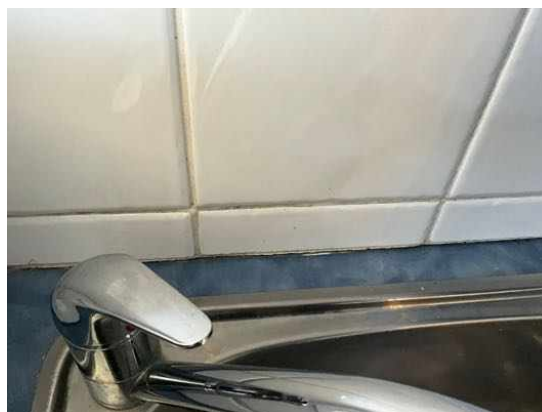
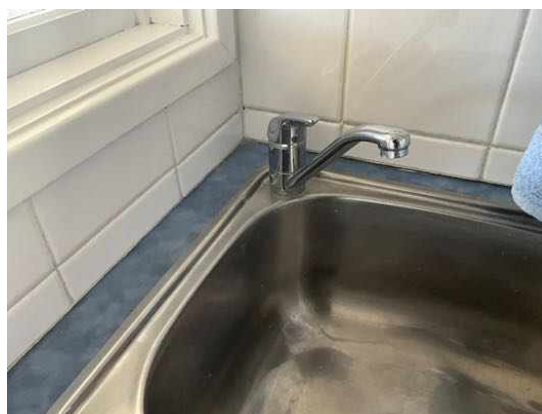
Finding 3.11

Building:	Main Building
Location:	Laundry
Finding:	Sealant and grouting - Missing or damaged
Information:	It was noted on inspection that sealant or grout is degraded to the tiled shower alcove and or other areas of the bathroom.

Different materials and floor areas move at different rates, generally causing cracking to grout or sealant at this point. A flexible sealant is required to allow for expected expansion and contraction, while keeping the joint water tight and protective of all associated building materials.

There appears to be excessive mould to the sealant and grout which will likely require scraping out and replacement.

Flexible and mould resistant materials should be applied to affected areas to prevent any subsequent water damage that is likely to occur. Regular maintenance and replacement of damage or missing or damaged sealant and grout is highly recommended to the wet areas, as this is a regular wear and tear defect. Sealant and grouting in areas that come into regular contact with water should be maintained for the long term care of your property.

A sealant specialist or tiling contractor should be appointed to complete these works as soon as possible

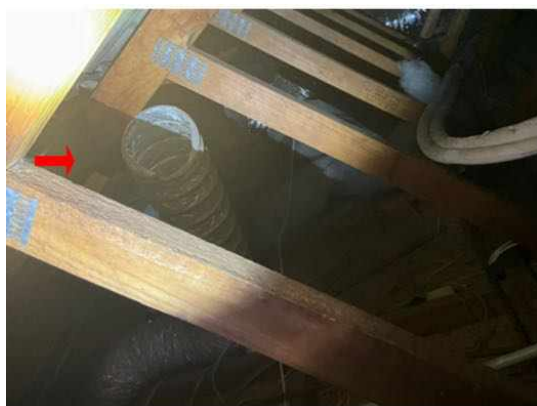
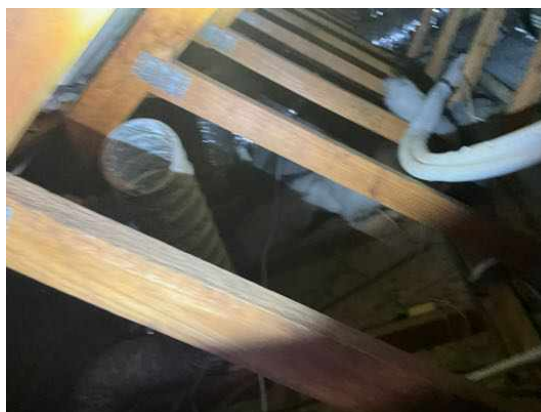
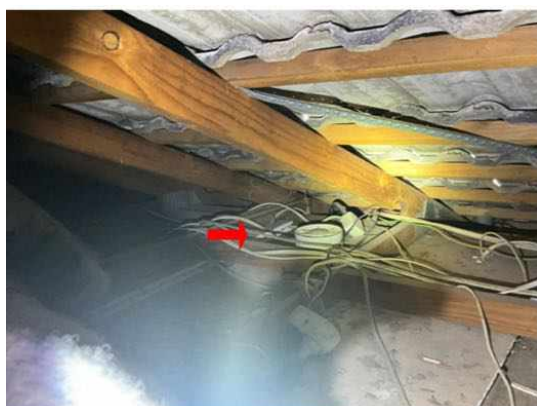
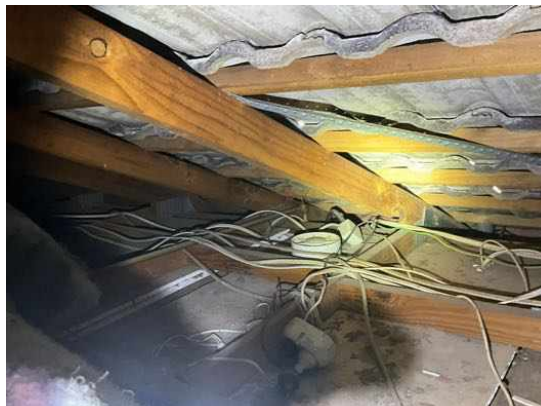
Finding 3.12

Building:	Main Building
Location:	Roof Void
Finding:	Exhaust fan not vented out
Information:	The exhaust fan located within the roof void is not appropriately ducted to the external atmosphere and is currently discharging moist air directly into the roof space. This is considered a defect under AS 4349.1, as it does not meet the minimum standard of residential building performance expected under normal residential building practices.

This condition may lead to excessive condensation within the roof void, increasing the risk of mould growth, deterioration of insulation, timber decay, and overall reduced durability of building elements. It may also result in poor indoor air quality, potentially affecting occupant health.

It is recommended that the exhaust fan be modified by a licensed HVAC contractor or qualified builder, ensuring it is properly ducted to discharge externally in accordance with manufacturer specifications, the National Construction Code (NCC), and applicable Australian Standards.

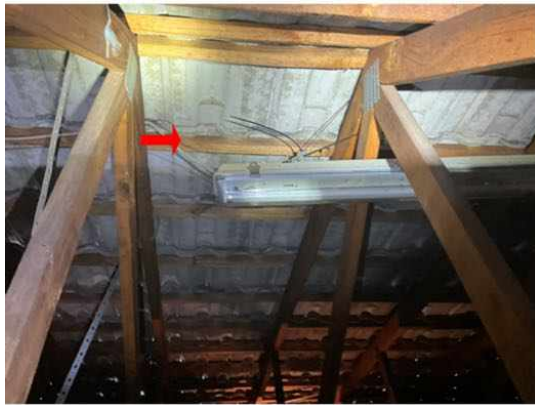
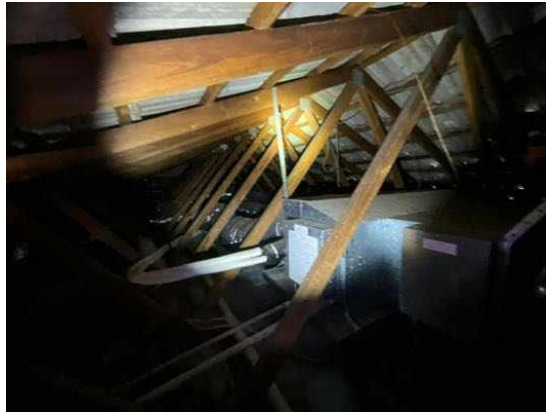
Building:	Main Building
Location:	Roof Void
Finding:	Sarking - Missing
Information:	Sarking is missing under the roof sheeting. Sarking acts as an insulator that helps with noise reduction and protects against water penetration. Sarking plays a key role in the operation and function of the overall roofing structure and its performance.

Although not a requirement at the time of construction, replacement of any missing building element is advisable (although this can be quite expensive to do after the time of construction). Where sarking is missing, regular inspections of the roof tiles for cracking and potential moisture penetration is required.

Sarking may be retrospectively fitted by a registered builder at the discretion of the client.

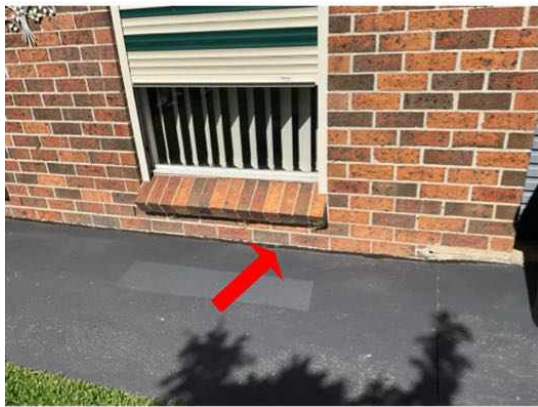
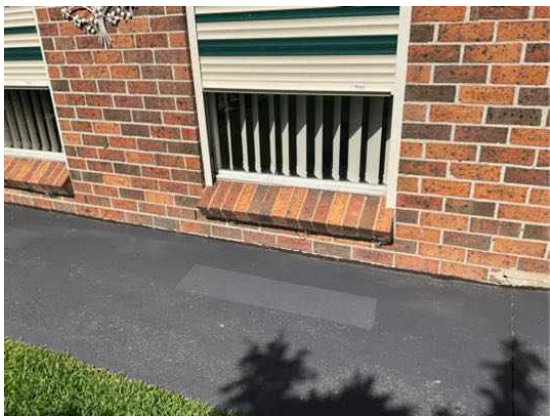
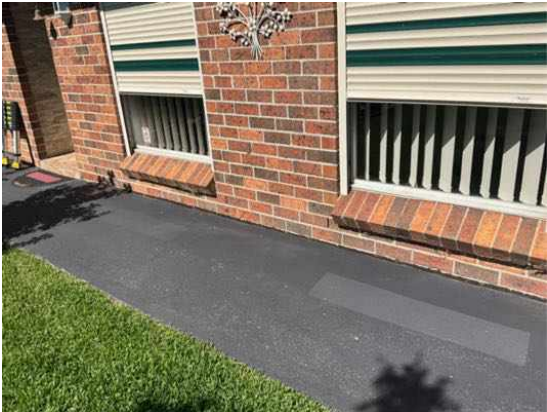
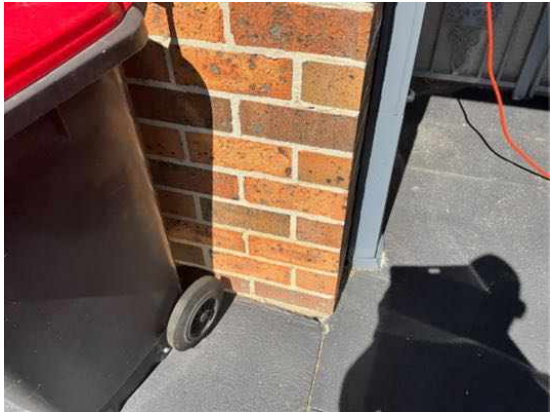
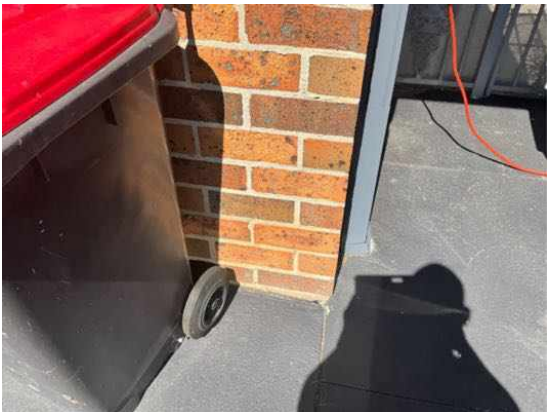
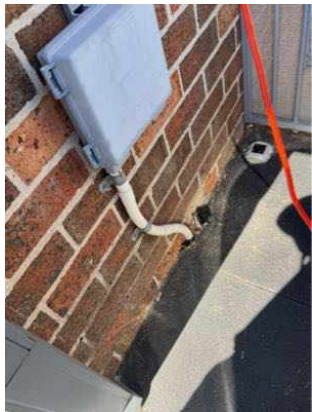
Finding 6.02

Building:	Main Building
Location:	All Areas
Finding:	Slab Edge - Exposure
Information:	An inspection zone of at least 75mm in relation to the exposed slab edge, between the bottom brick and the perimeter pavement, is required. This inspection zone should be maintained in order to force termites into the open where they can be detected more readily during regular inspections. The slab edge should not be concealed by anything that may prevent inspection of the area, including render, landscaping, soil, turf, paving, concrete cladding or other structures.

If the slab edge is not properly exposed there is a high risk of termite attack. Sometimes, in order to determine the type of slab, a suitably qualified person such as an architect or builder may be required to consult the construction plans.

Where the slab edge cannot be properly inspected, it is highly recommended that termite or timber pest inspections be carried out every 6-12 months to aid protection of the property against infestation.

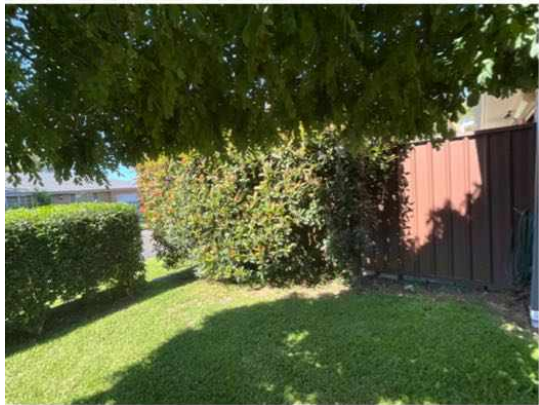
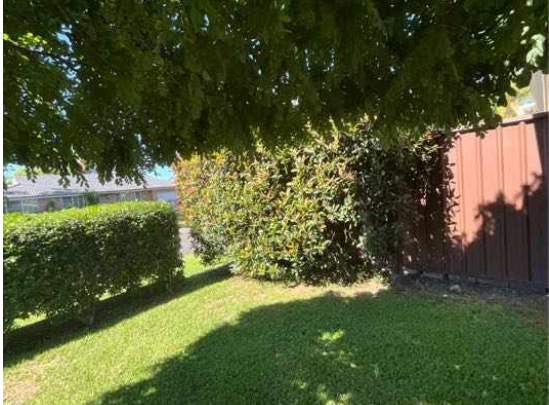
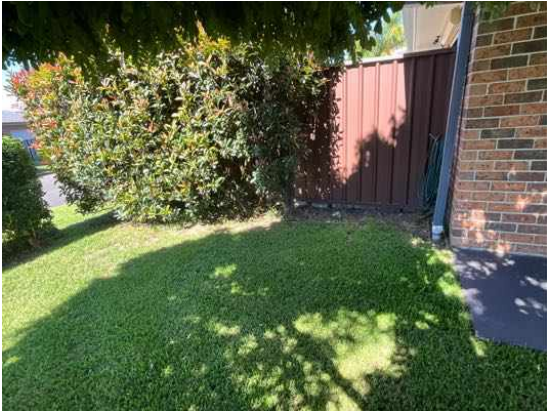
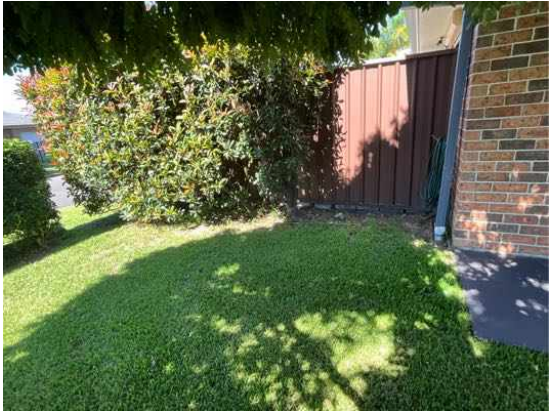
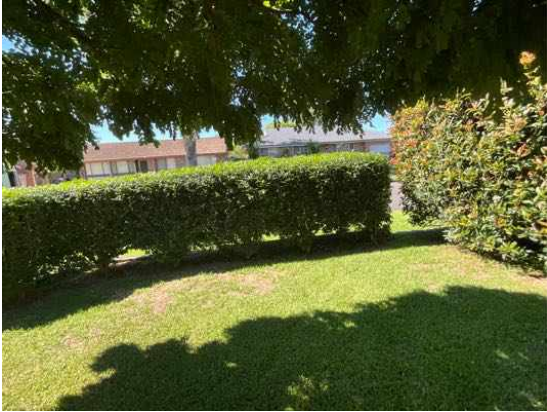
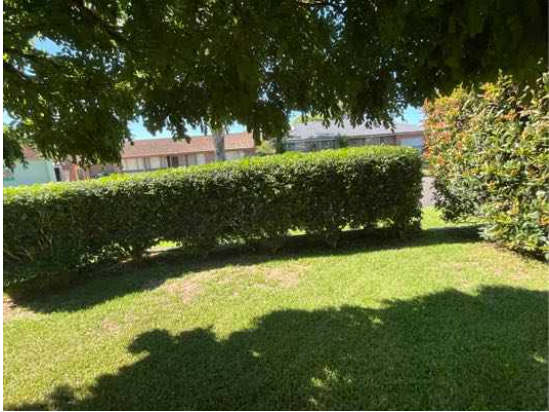
Finding 6.03

Building: Main Building
Location: All Areas
Finding: Dense vegetation around a property can increase the risk of termite infestation
Information: The presence of dense vegetation around a property can increase the risk of termite infestation, as it provides a conducive environment for them. To address this, consider maintaining a clear space between the vegetation and your home. If you suspect a termite issue, it's advisable to consult with a licensed pest control professional for inspection and treatment.

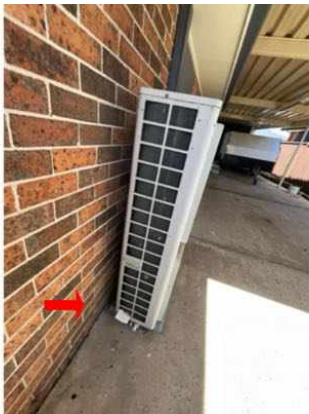
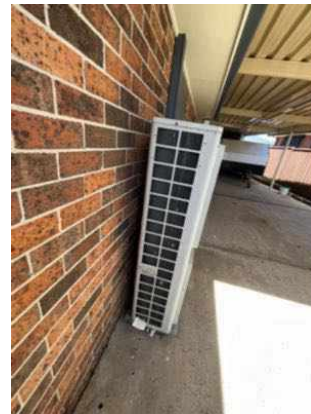
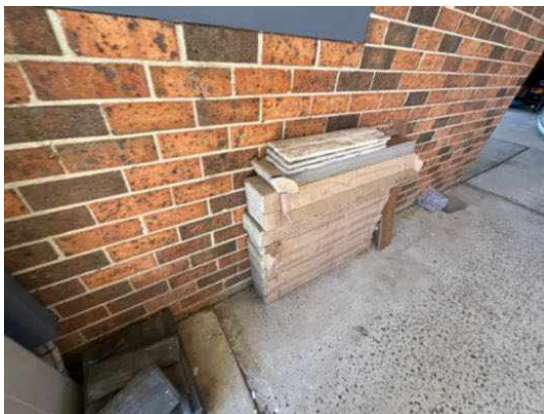
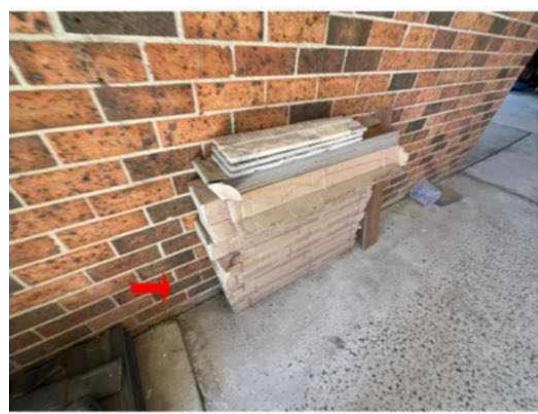
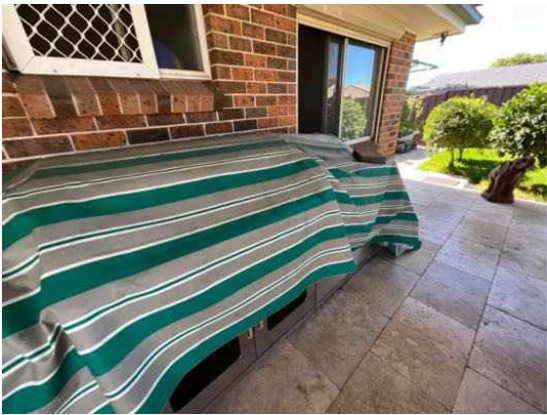
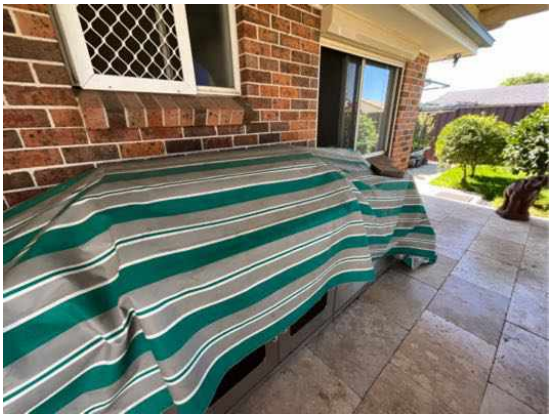
Finding 6.04

Building: Main Building
Location: All Areas
Finding: Bridging or Obstruction Conducive environment for Termites
Information: Bridging of termite barriers occurs when termites bridge (usually by building a mud tunnel) a termite barrier or inspection inspection zone or where termites have a passage, allowing them to bridge the barrier.

Where bridging has occurred full inspection is prevented and termites may enter a property in a concealed or undetected manner.

Recommended moving obstructions away from the external walls for further and future inspections.

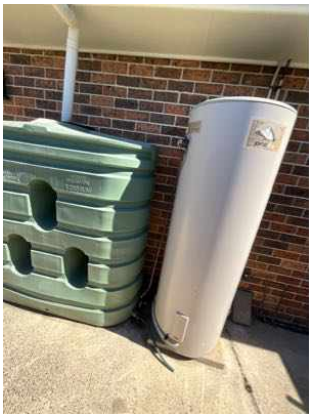
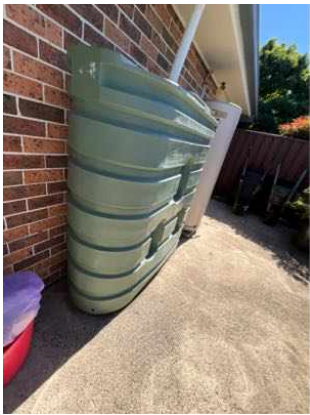
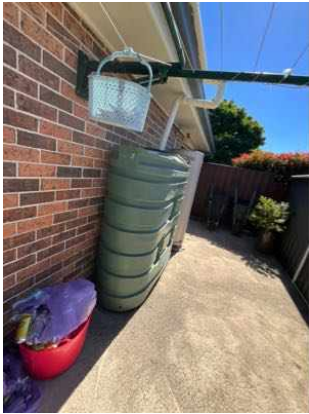
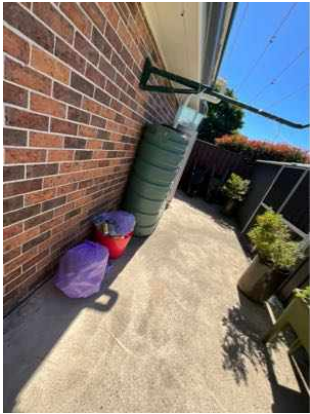
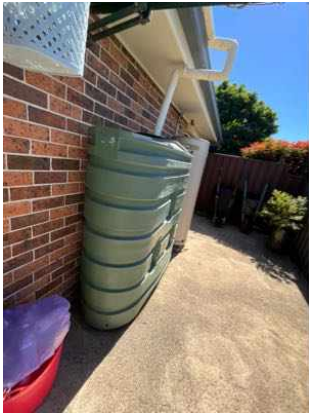
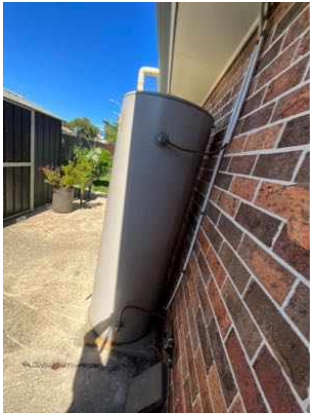
Finding 6.05

Building: Main Building
Location: Exterior walls - left side
Finding: HWS not connected - conducive conditions for timber pest attacks
Information: The hot water system (HWS) is not connected, leaving exposed pipes and creating conducive conditions for timber pest attacks.

Risk of Timber Pest Attack: The risk of timber pest attack is heightened when the hot water system is not connected. Exposed pipes provide easy access points for timber pests like termites and ants to infiltrate the building structure. These pests are attracted to moisture, and the absence of flowing water through the system can lead to moisture buildup, creating an ideal environment for pests to thrive and cause

damage to timber components within the building.

A licensed plumber or qualified plumbing technician should be engaged to reconnect the hot water system. They will assess the existing plumbing infrastructure, determine the appropriate connection points, and ensure proper installation and functionality of the HWS. Additionally, they may inspect for any signs of timber pest activity and recommend preventive measures, such as installing physical barriers or implementing moisture control measures, to deter pest infestations and protect the building from damage. Regular maintenance and inspections by homeowners or property managers are also essential to detect and address potential issues before they escalate.

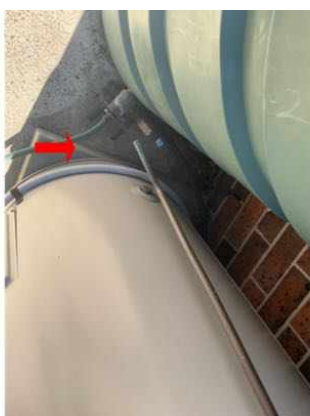
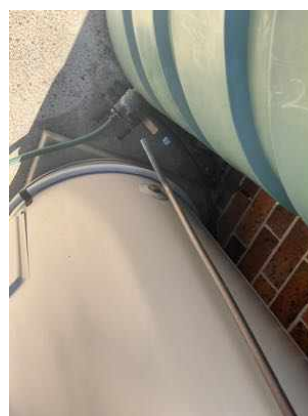
Finding 6.06

Building:	Main Building
Location:	Bathroom
Finding:	Excessive moisture - Conducive to Timber pest
Information:	Excessive moisture can attract termites and produce conditions that promote fungal growth and wood decay.

Excessive moisture is generally caused by deteriorated inadequate or missing roof drainage leaking plumbing pipes or fixtures poorly plumbed HWS overflows or condenser units and poor site drainage.

If mould growth has been found there may be environmental biological or health issues involved. In these cases an appropriately qualified inspector should also be contacted.

Prior to any remedial works being performed a qualified plumber should be appointed to further inspect the property and to identify the cause of the excessive moisture. Works to remove affected building elements may then be necessary and should be performed by an appropriate tradesperson.

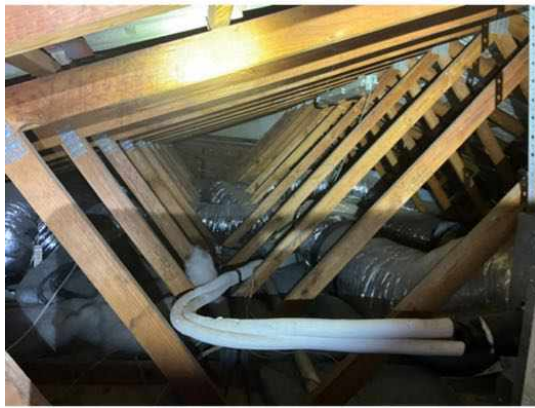
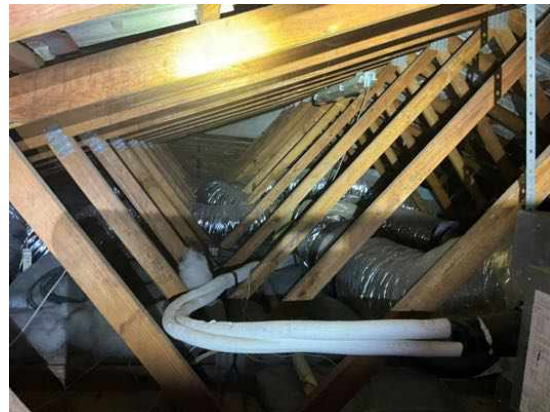
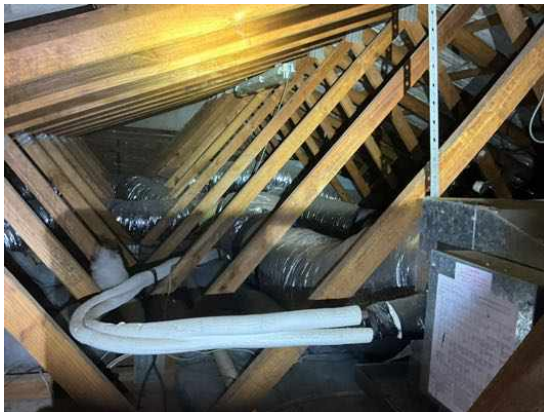
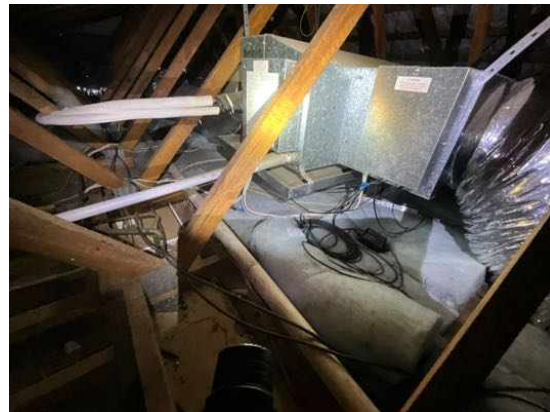
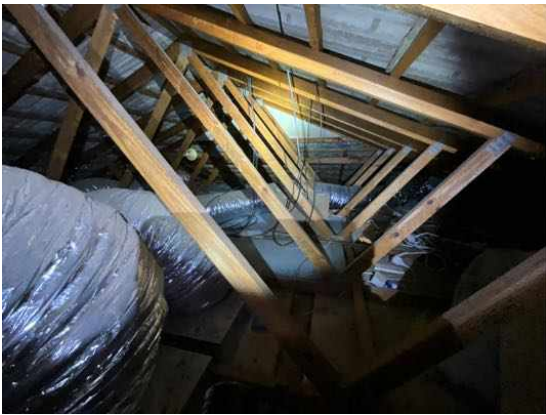
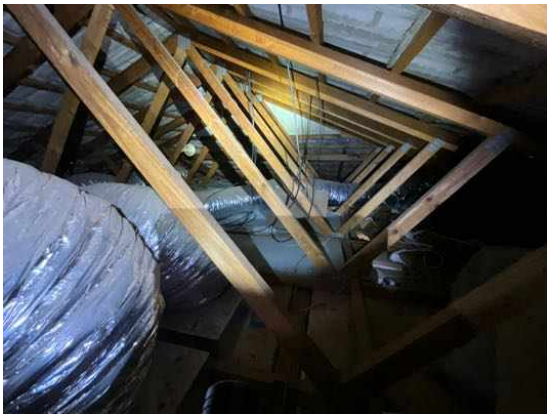
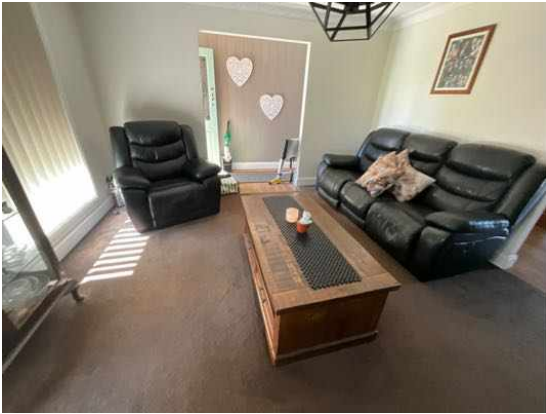
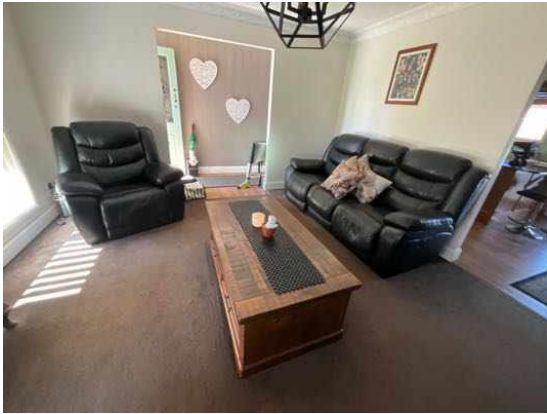
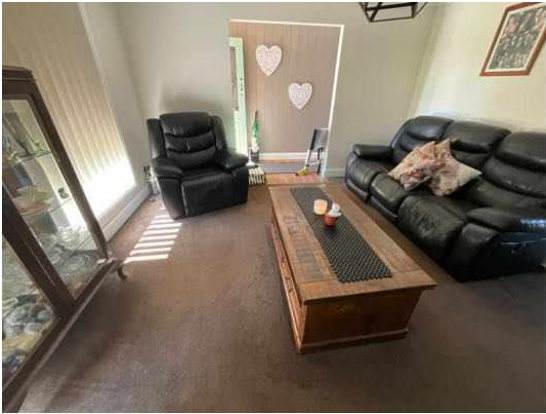
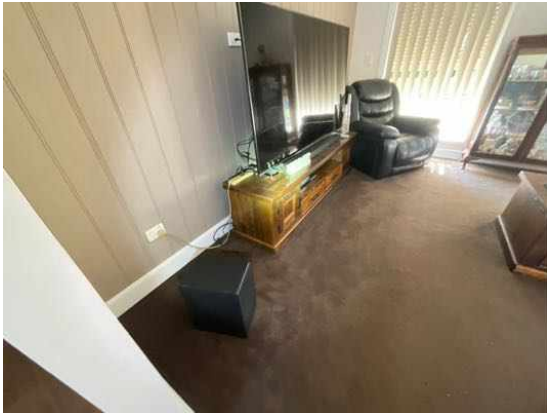
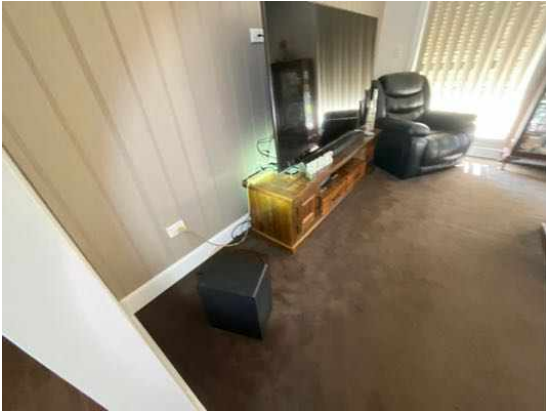
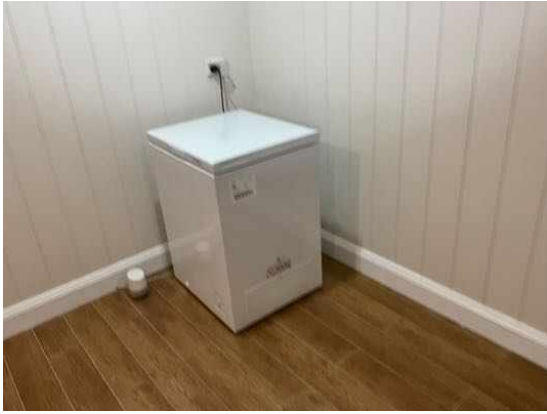
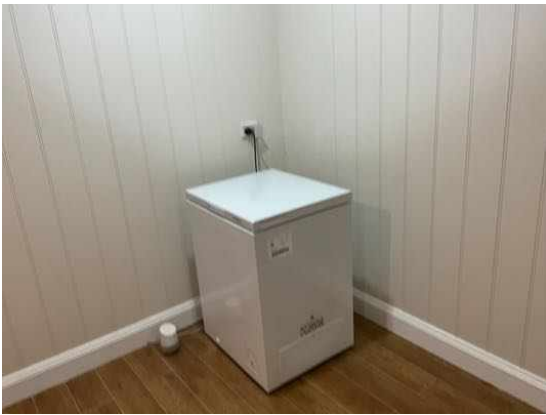
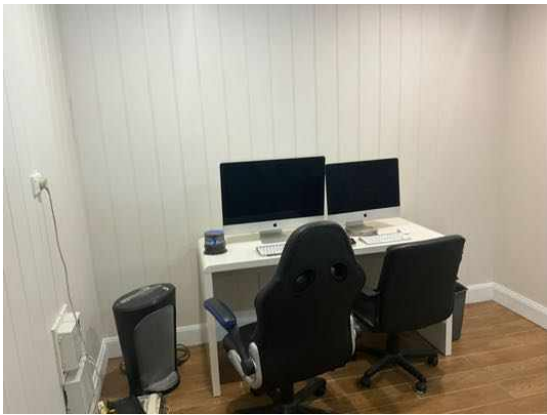
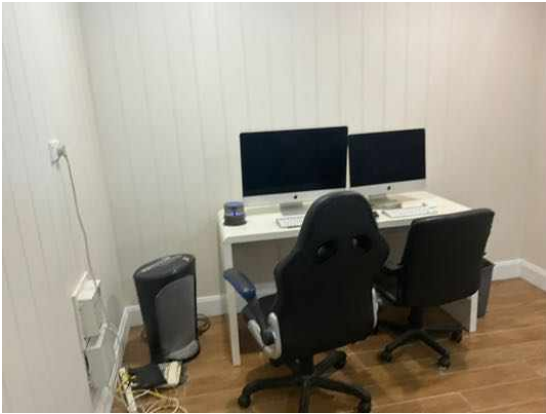
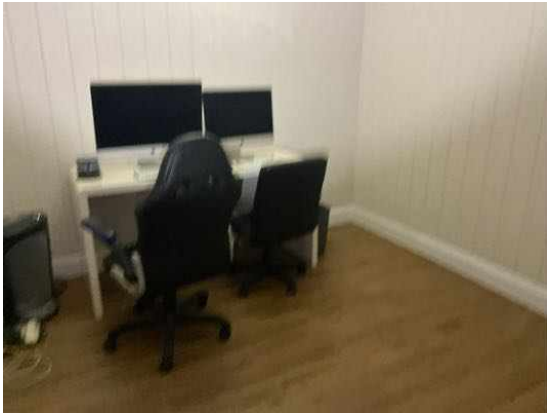
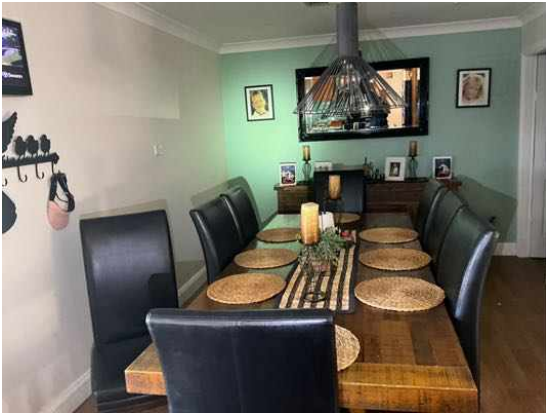
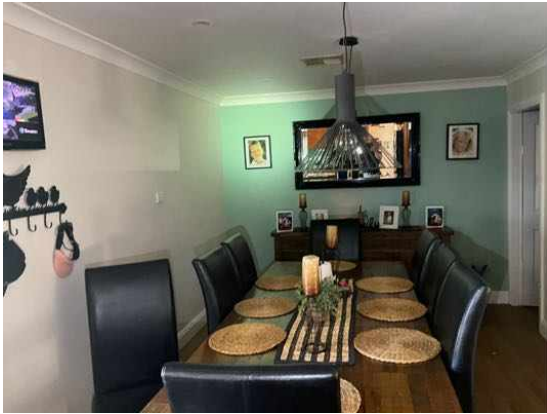
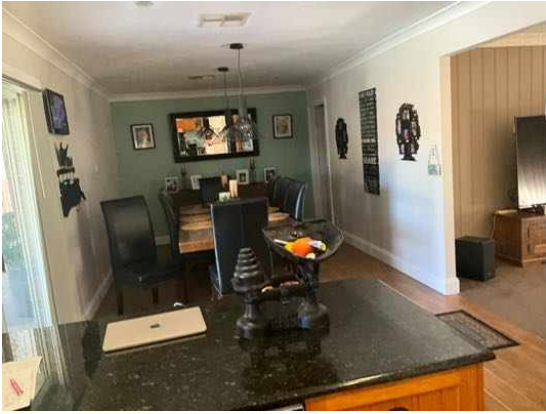
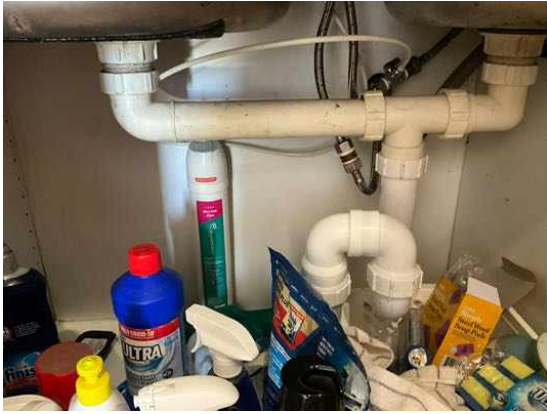
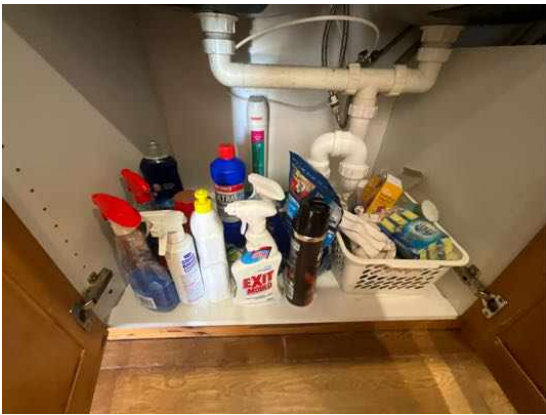
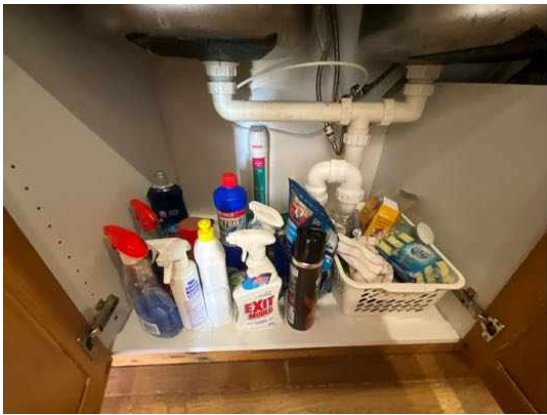
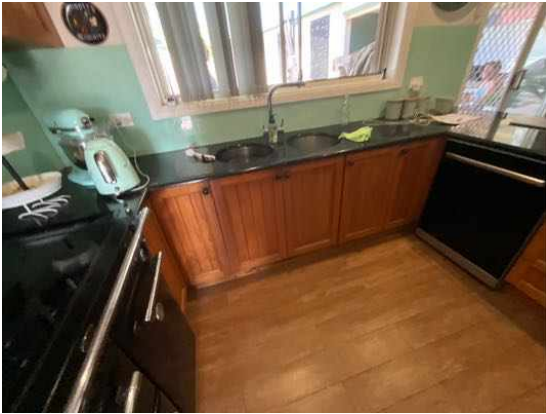
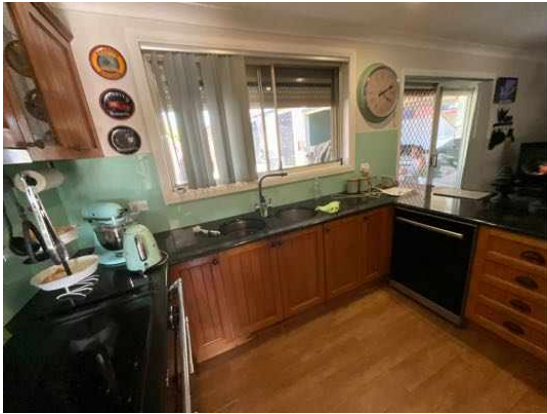
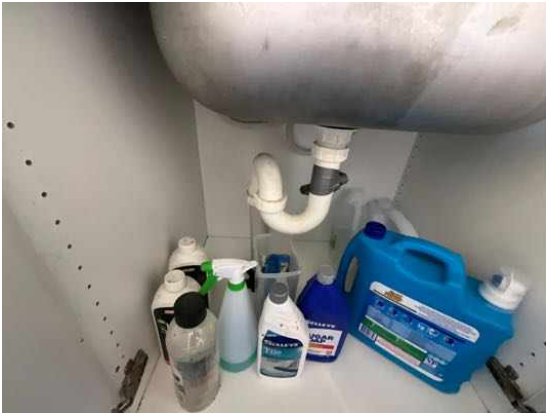
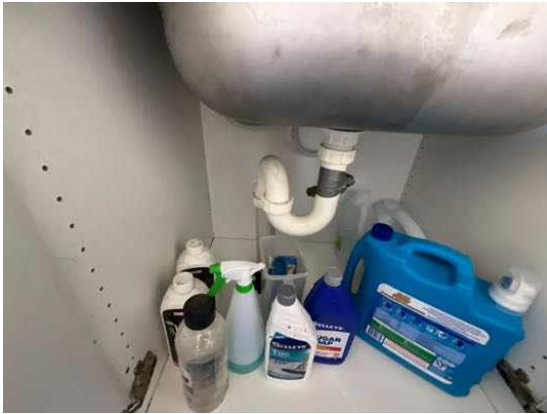
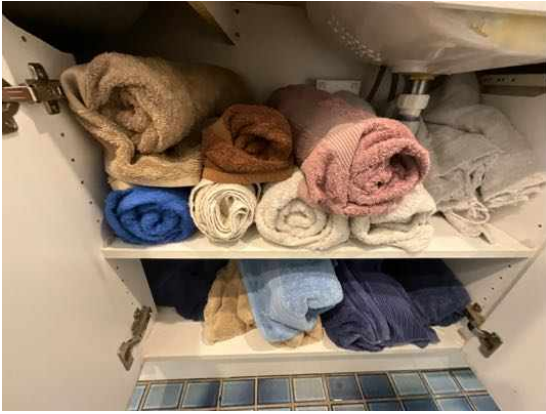
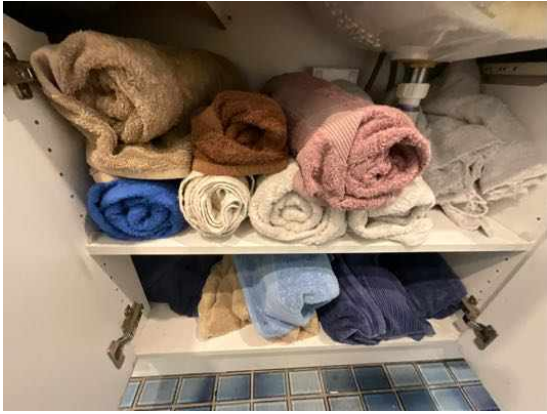
Noted Item

Building: Main Building
Location: All Areas
Finding: Additional Photos - Obstructions and Limitations
Information: These photographs are an indication of the obstructions and limitations which impeded full inspection of the property at the time of inspection. These obstructions can hide an array of defects and should be removed to allow full inspection to be carried out. A re-inspection is recommended once the areas are made accessible.
