Building and Timber Pest Inspection Report

Inspection Date: Tue, 17 Feb 2026

Property Address: 2 Grazier Cres, Werrington Downs NSW
2747, Australia

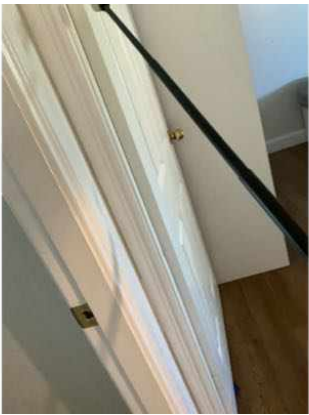
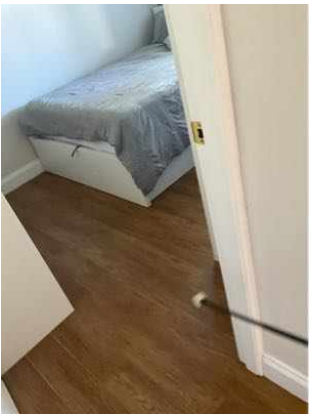
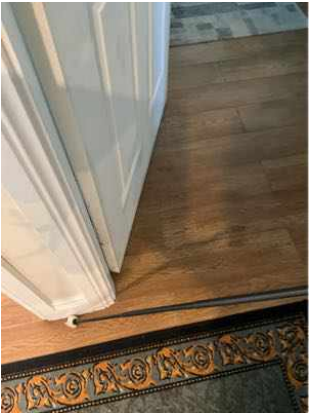
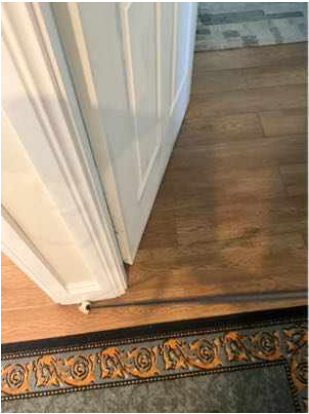
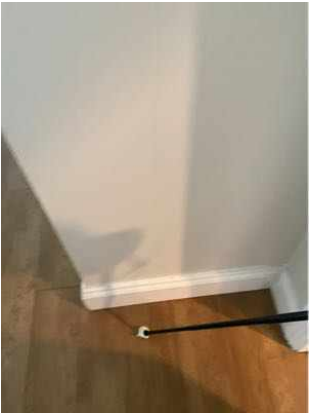
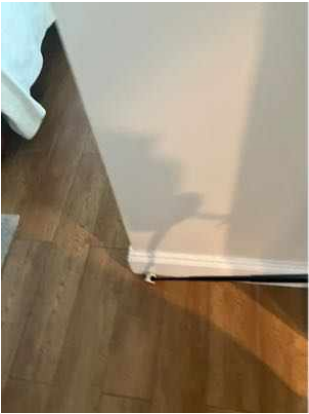
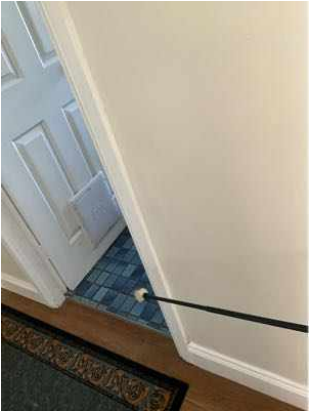
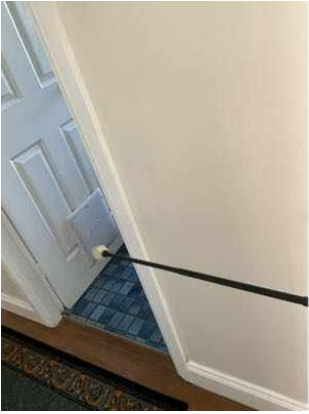
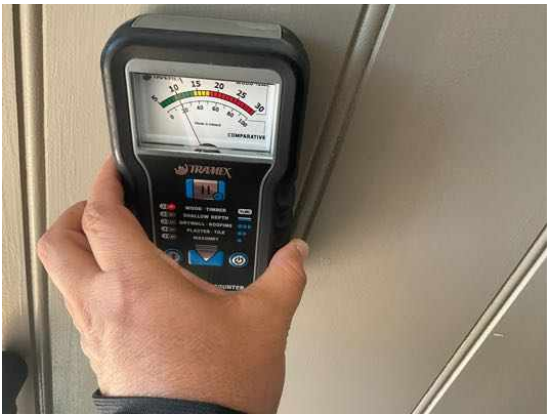
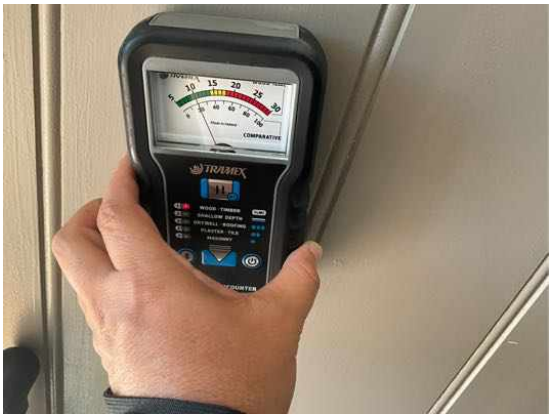
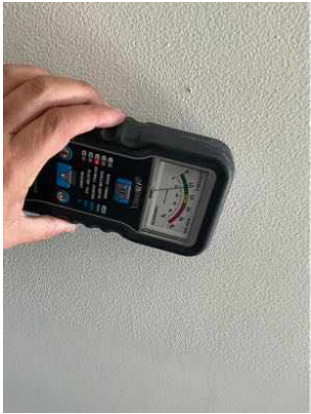
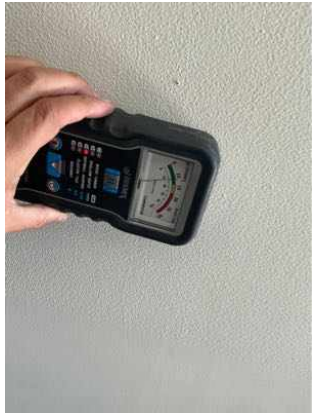
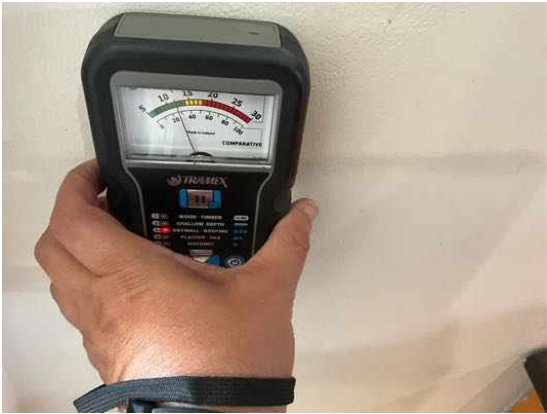
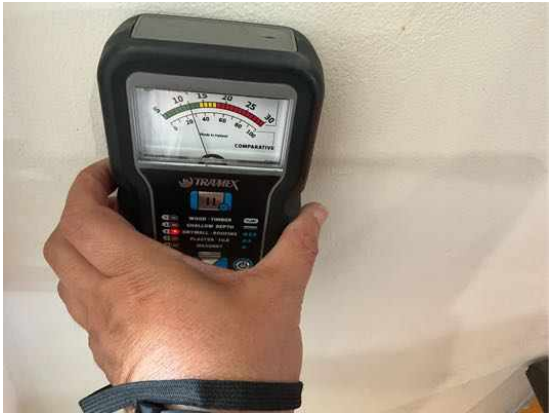
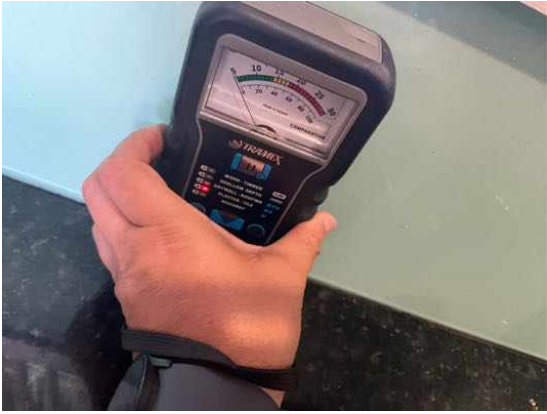
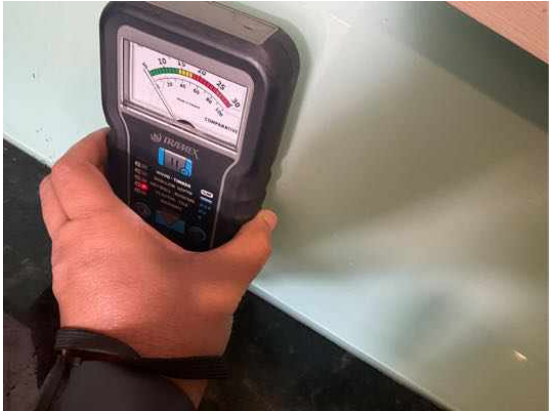
Building: Main Building
Location: All Areas
Finding: Additional Photos
Information: Additional photos are provided for your general reference
