BEFORE YOU BUY
BEFORE YOU BUILD

Building and Timber Pest Inspection Report

Inspection Date: Fri, 13 Feb 2026

Property Address: 27 John Street, Hazlebrook NSW 2779

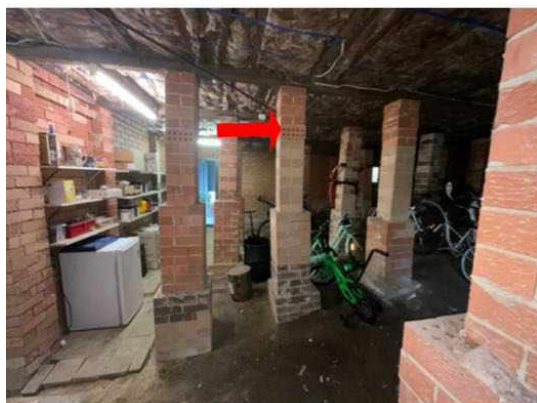
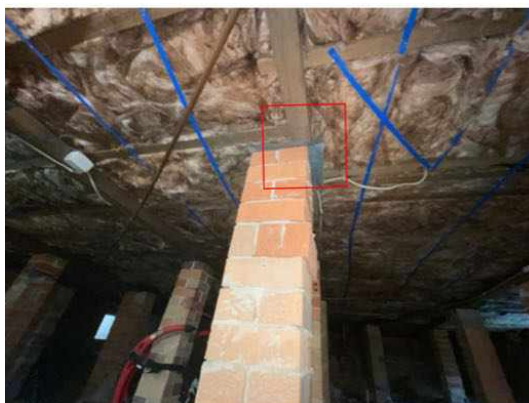
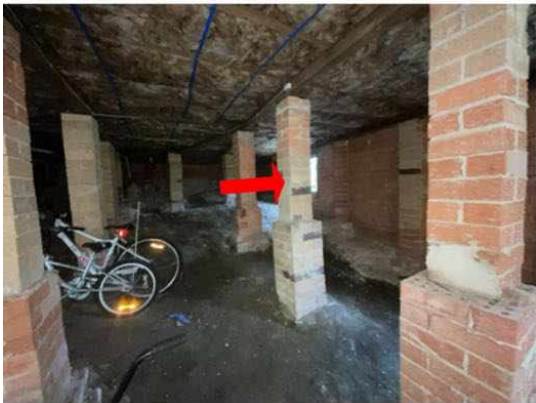
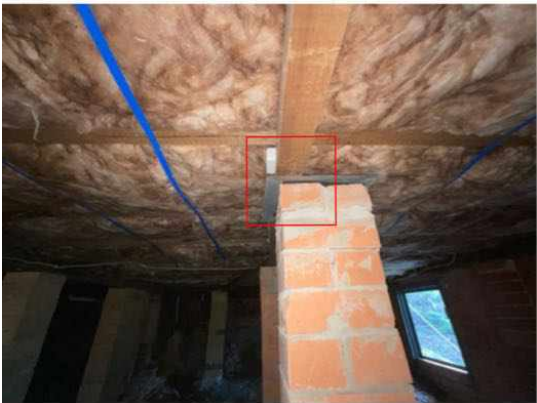
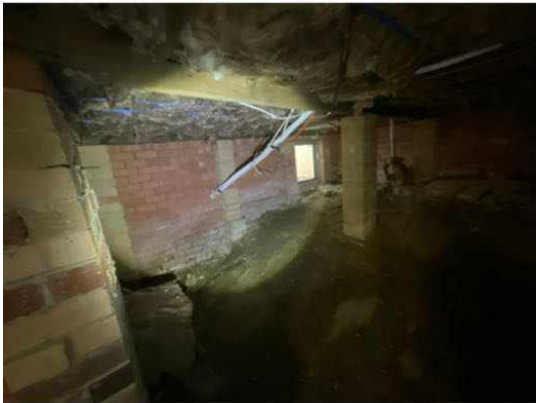
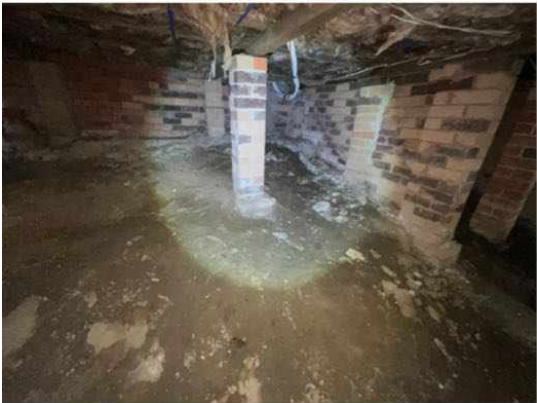
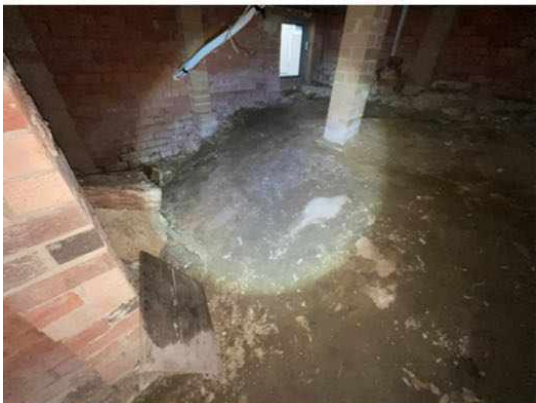
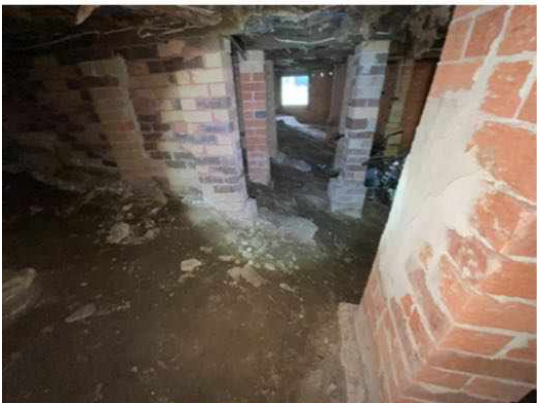
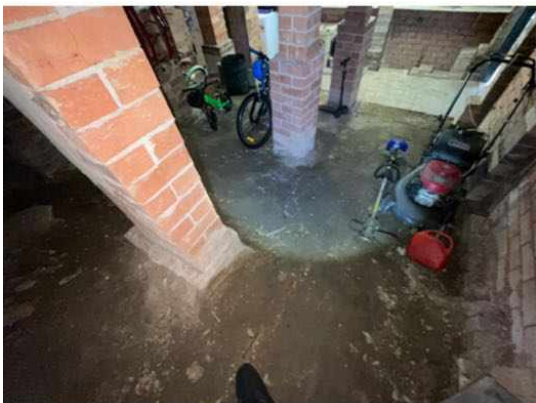
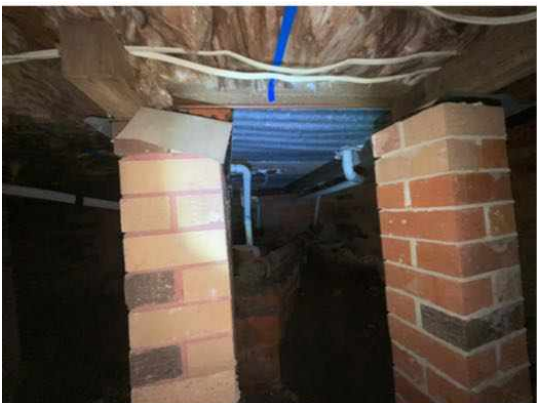
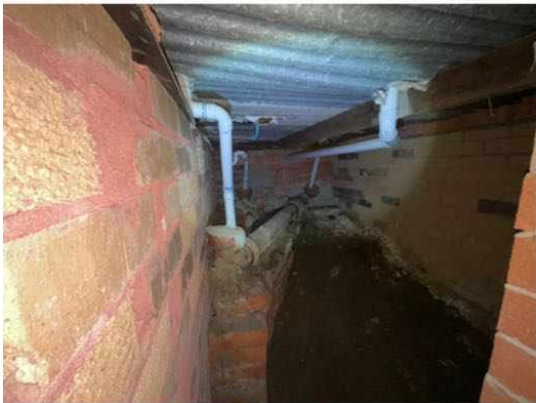
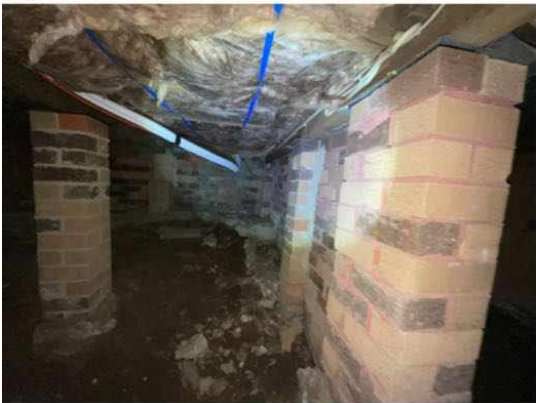
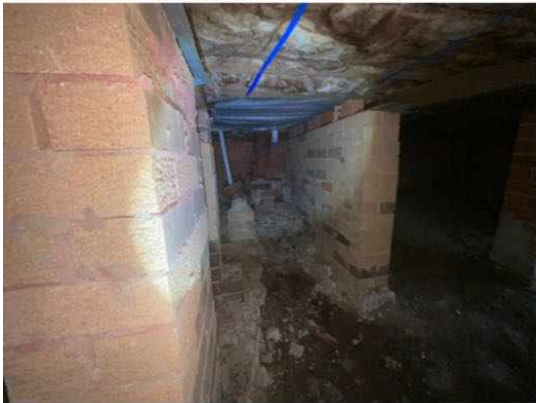
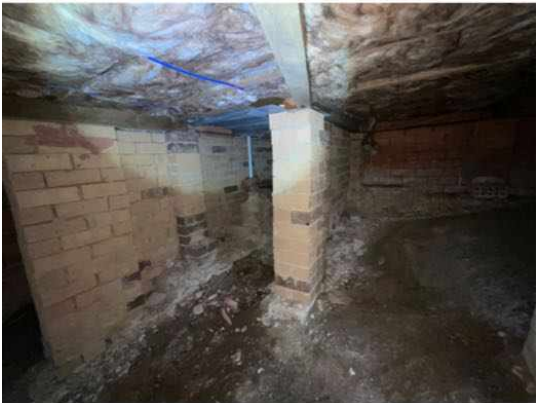
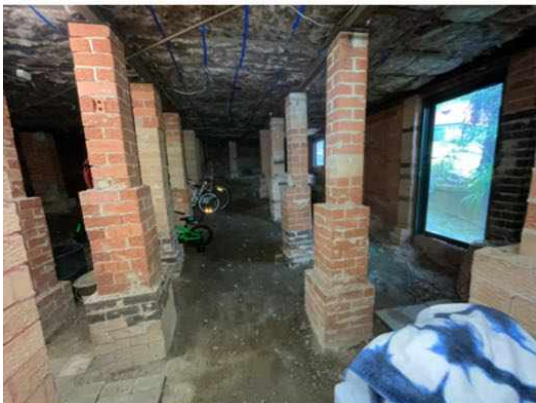
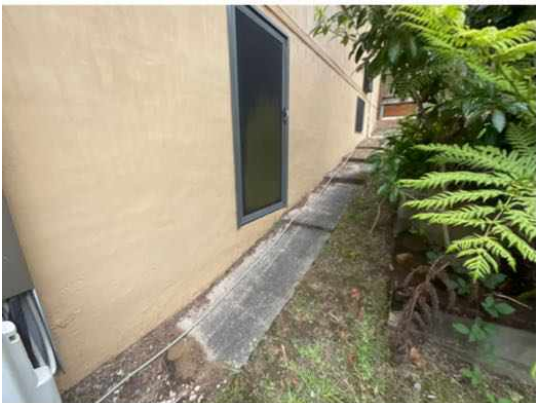
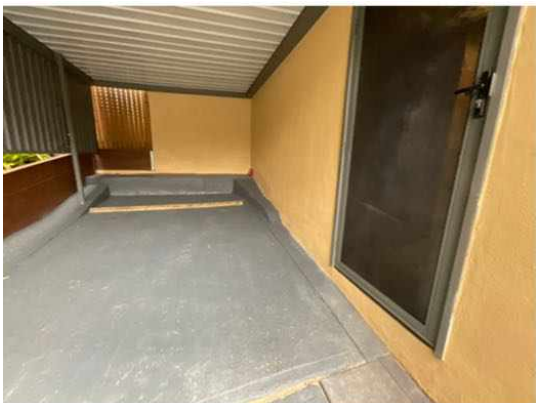
The subfloor area is in good overall condition at the time of inspection. Ventilation improvements are contributing positively to moisture management. Site drainage enhancements and continued monitoring of pier movement are recommended to maintain structural performance and minimise future risk.

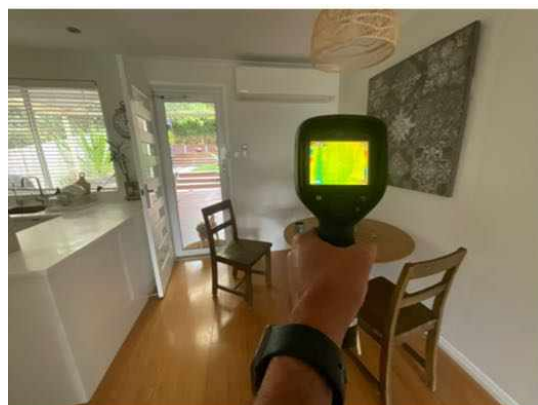
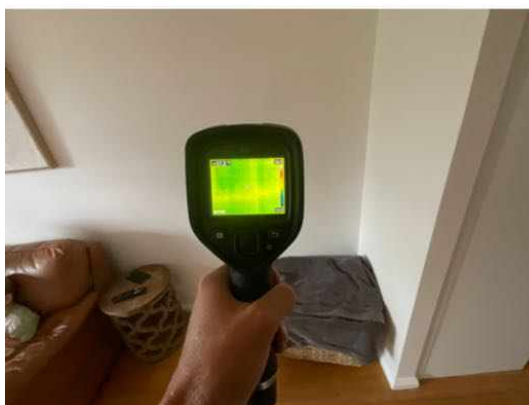
At the time of the inspection, no abnormalities indicating live termite activity were observed. However, it's important to note that various factors—such as obstructions, ambient temperature, and wall material/thickness—can impact the accuracy of thermal readings. In cases where surfaces are visually restricted or obstructed, a comprehensive thermal scan may not always be feasible.

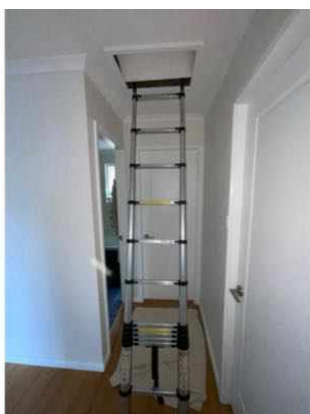
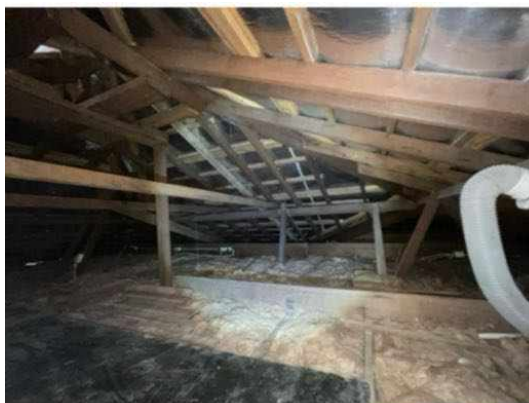
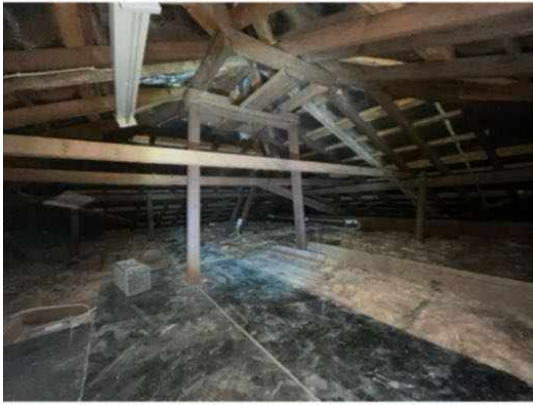
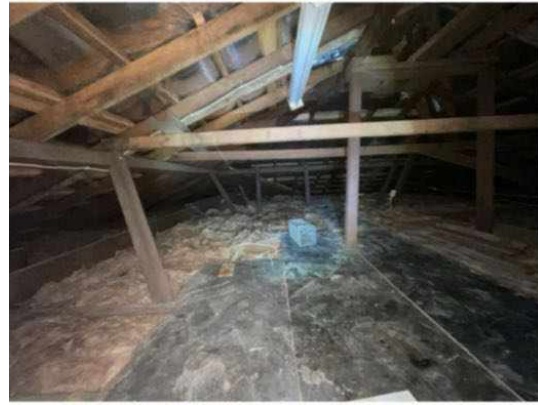
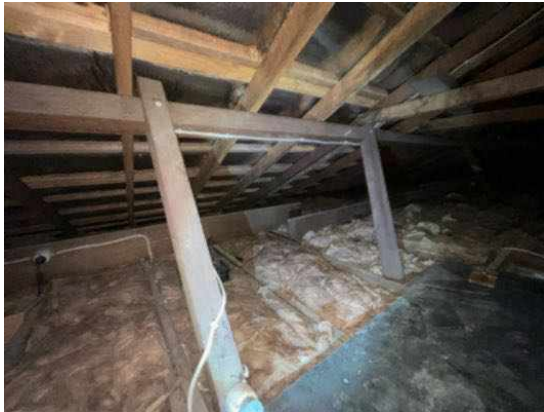
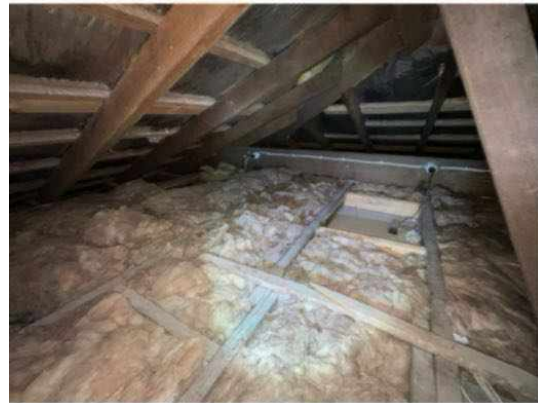
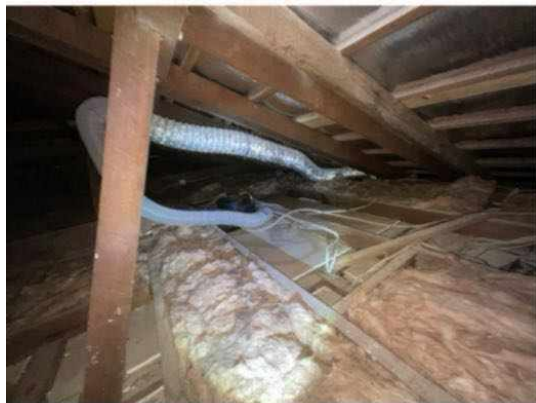
Based on accessible areas, the roof void presents in satisfactory condition at the time of inspection. Access limitations apply, and ongoing monitoring as part of routine property maintenance is advised to ensure continued performance of the roof system.

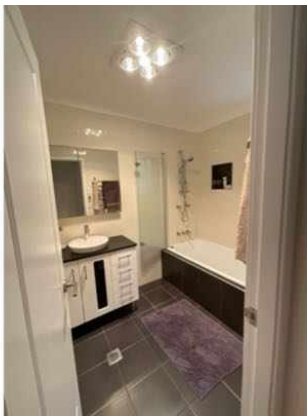
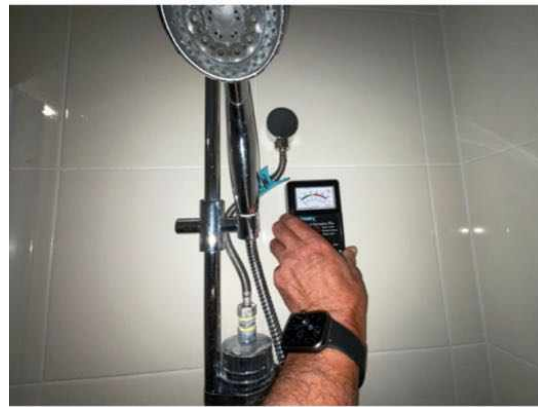
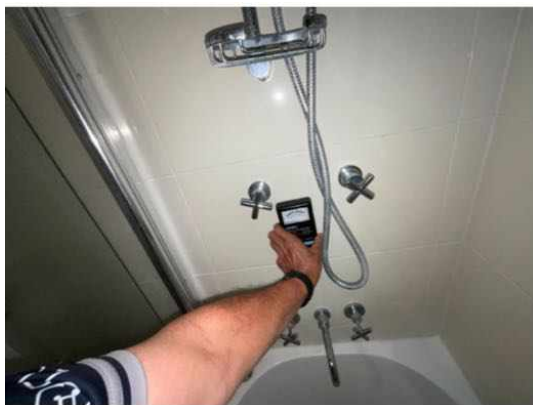
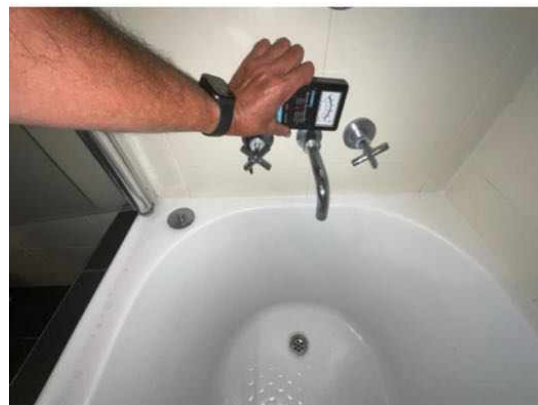
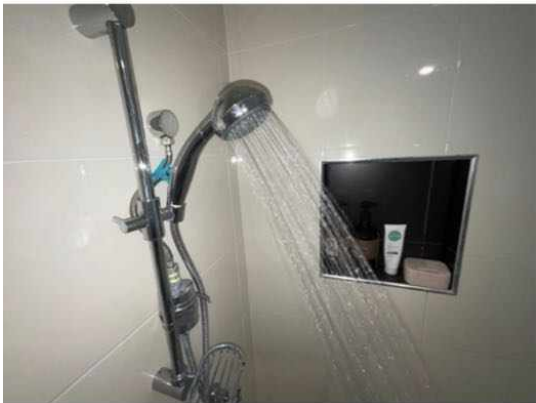
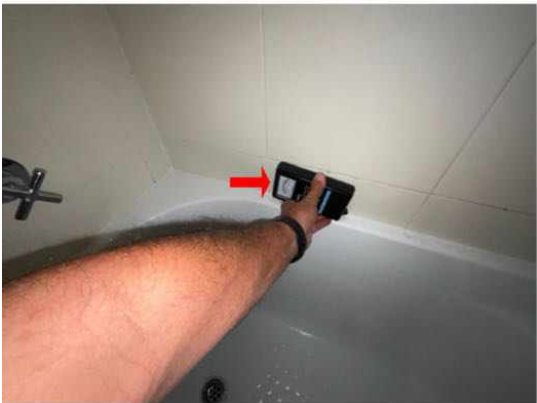
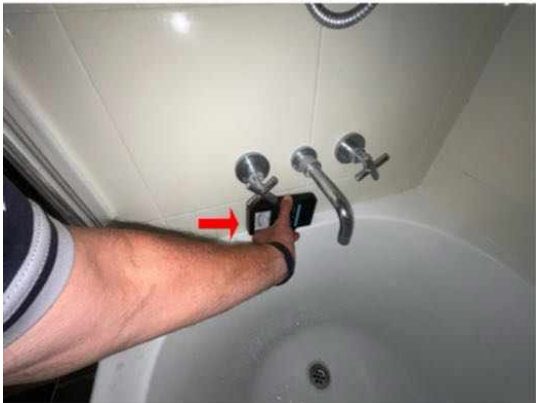
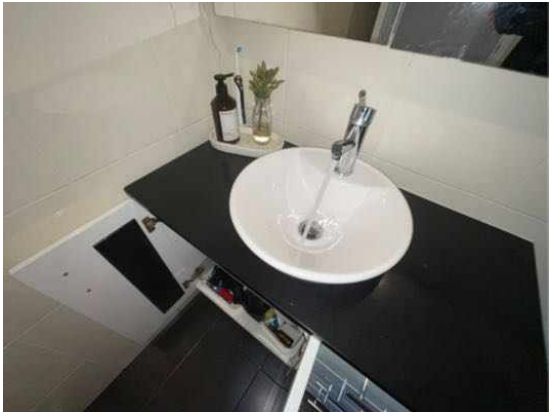
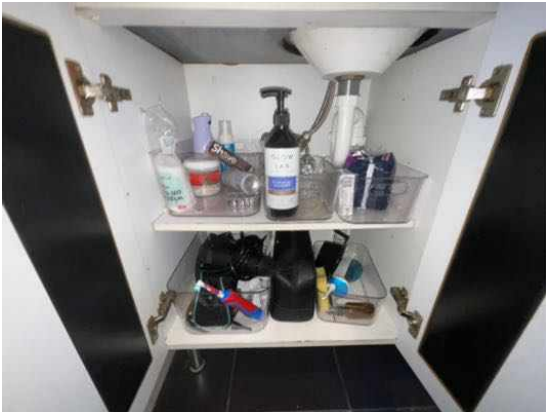
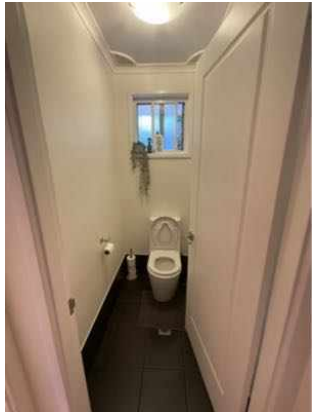
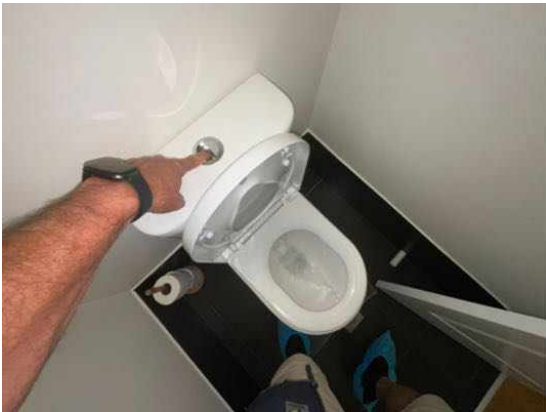
It is not possible under the visual inspection criteria of a standard pre-purchase report to categorically determine if leaks are present. If a more detailed or accurate assessment is required, a special-purpose inspection should be undertaken.

Alternatively, the assumption should be made that leakage may occur, particularly where historical or environmental conditions are conducive. The visual nature of this inspection cannot detect issues concealed behind wall/floor linings or cabinetry, and invasive investigation may be necessary to confirm the true condition of adjacent or hidden structures.

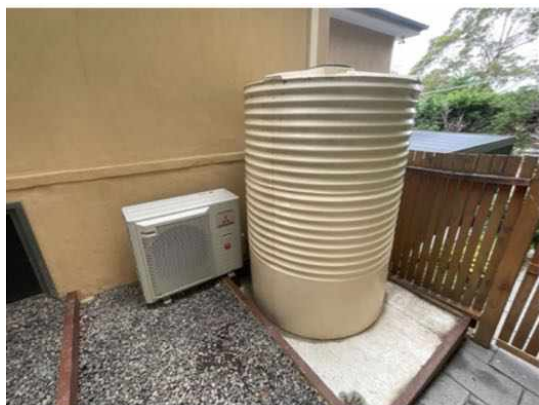
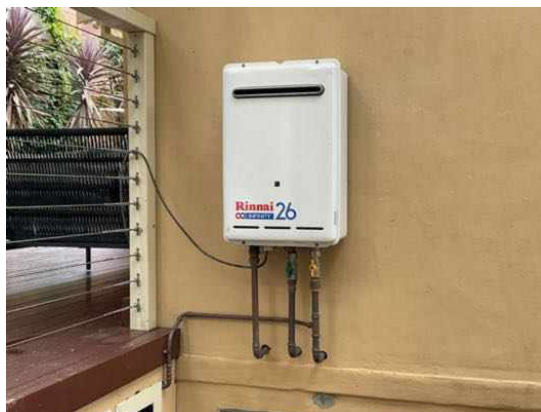
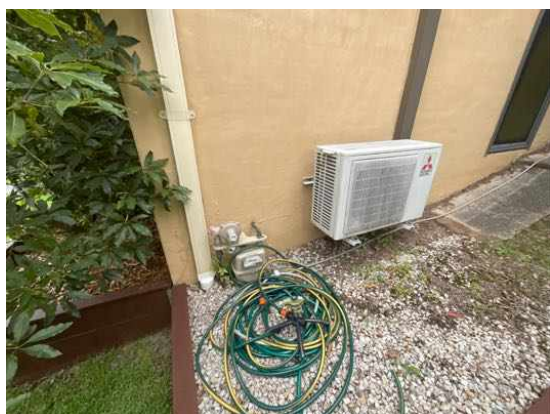
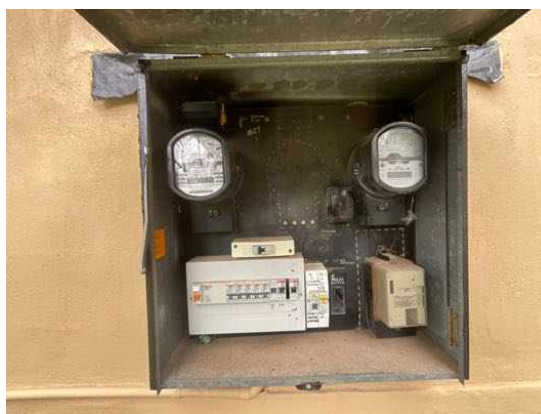
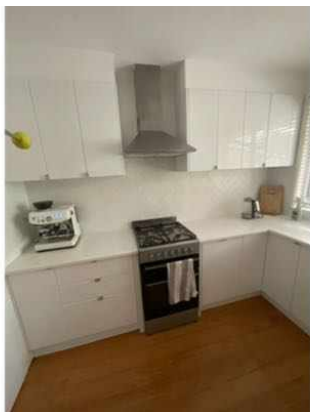
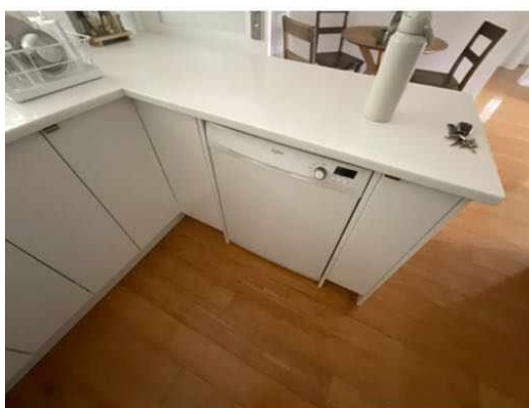
- Finding: Plumbing, Electrical & Gas Installations – Scope and Recommendations.
- Information: Plumbing and electrical inspections fall outside the scope of this building inspection and must be carried out by appropriately licensed and registered tradespersons.
- Any gas appliances (if applicable) must be inspected by a licensed gas plumber to confirm they are operating safely and efficiently.
 - We also recommend that all other plumbing and electrical installations be thoroughly checked by qualified professionals to ensure they are functioning correctly and meet current safety and compliance standards.

While this inspection includes observations of visually apparent defects relating to plumbing and electrical elements, it does not assess compliance with current regulations. Legislation requires that any such assessment be undertaken and documented by licensed electricians and plumbers.

It is strongly recommended that a Licensed Plumber be engaged to conduct a comprehensive assessment of the plumbing system to verify its functionality, check for any underlying issues, and confirm compliance with current regulations and standards.

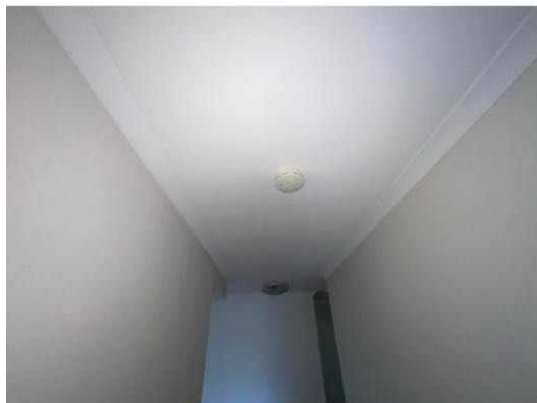
Building:	Main Building
Location:	All Areas
Finding:	Smoke Detectors / Alarms.
Information:	Reporting on the presence, type, location, or compliance of smoke detectors or alarms, including hard-wired smoke detection systems and their legislative requirements, is outside the scope of this inspection report.

To ensure compliance and safety, further inspection and/or advisory services from a qualified specialist are recommended. These services can confirm the sufficiency, type, location, and functionality of all smoke detection devices within the property.

- All smoke detectors be tested monthly by the homeowner.
- All systems comply with the requirements of AS 3786 and any applicable state-based legislation.
