# Building and Timber Pest Inspection Report

Inspection Date: Mon, 2 Mar 2026

Property Address: 11/30 Kings Rd, Ingleburn NSW 2565,  
Australia

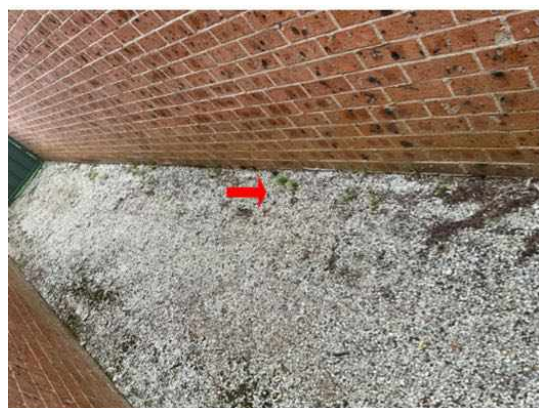
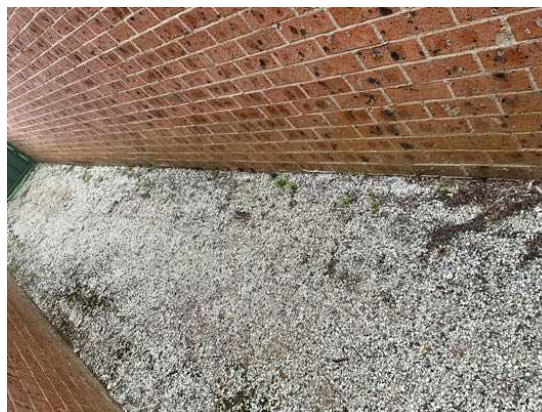
Building:	Main Building
Location:	All Areas
Finding:	Perimeter - Insufficient Fall
Information:	The perimeter ground levels were found to have an inadequate slope away from the adjoining building structure, creating potential for water pooling in this area.

Perimeter is required to fall from the building by a minimum of 25mm in the first metre and bare ground should fall away from the house by 50mm in the first meter. This standard ensures that excessive moisture does not pool around the base of building structures, which creates potential for water and structural damage, as well as making the area susceptible to termite and timber pest activity.

Where ground levels do not have adequate fall, a licensed paving contractor should be appointed to install or remove and re-level pavement.

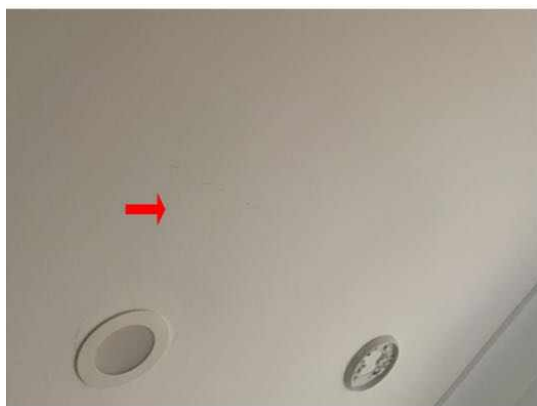
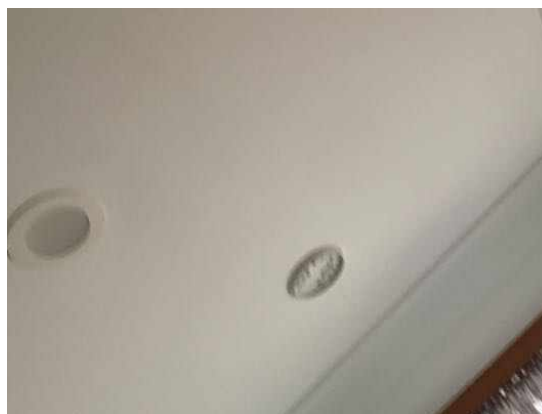
### Finding 3.12

Building:	Main Building
Location:	Above Stair Landing
Finding:	Gyprock - Crack ( Fine )
Information:	Fine cracks have appeared in the gyprock of the ceiling, suggesting potential issues with settling or structural movement.

The fine cracks in the gyprock ceiling pose a risk of further widening, compromising the aesthetic appeal of the space, and potentially indicating underlying structural problems.

A skilled plasterer or a contractor specializing in drywall repairs should assess the extent of the cracks and address them promptly. Identifying and fixing the root cause of the issue, whether related to settling or structural concerns, is essential to prevent further damage and maintain the integrity of the ceiling.

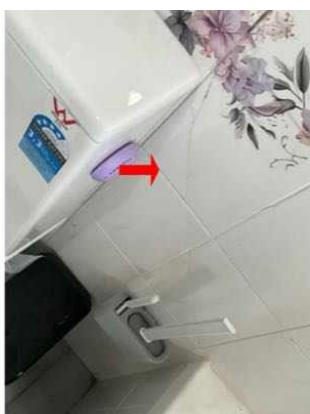
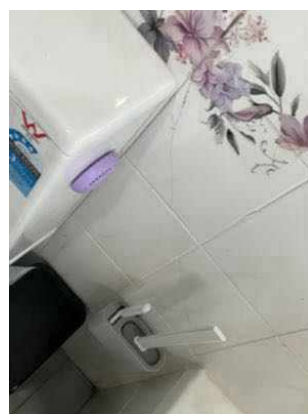
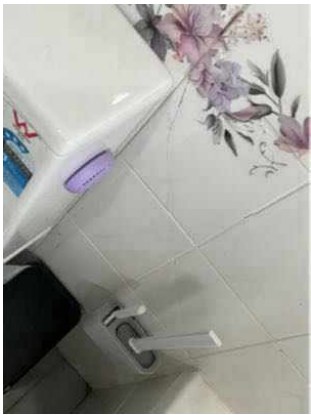
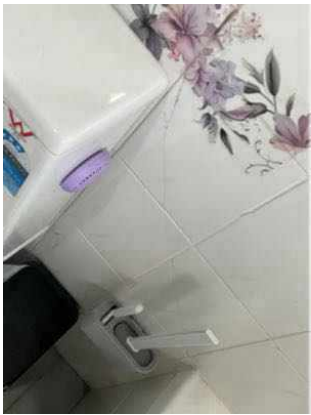
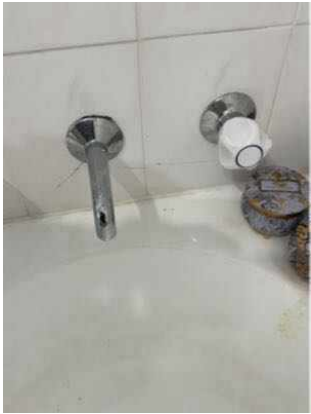
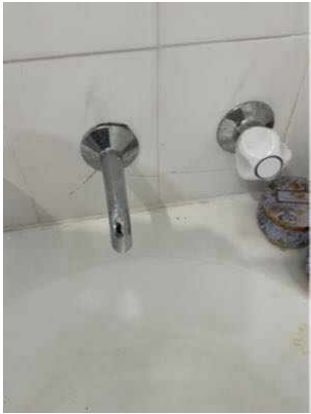
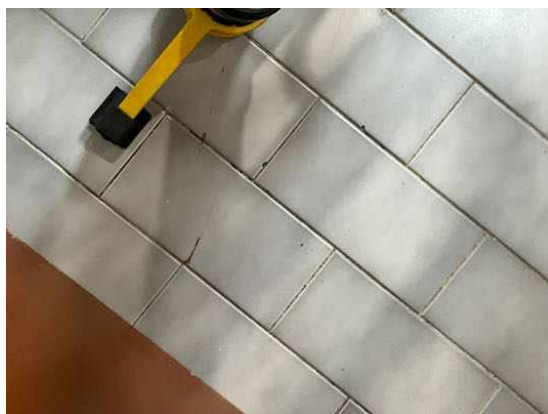
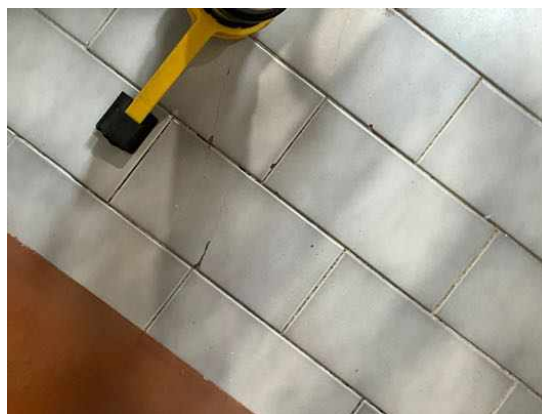
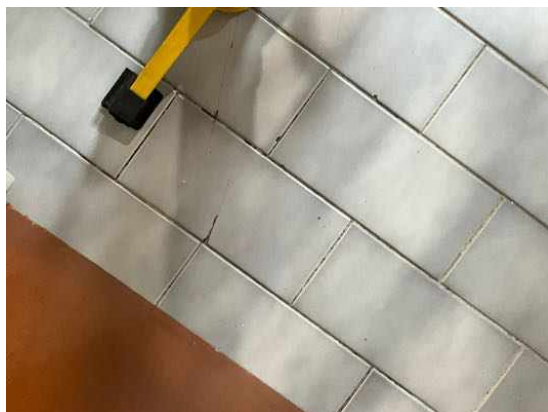
### Finding 3.13

Finding: Tiles - Cracked or damaged

Information: Cracking was evident to the tiling in this area at the time of inspection. While the cracking appears to be minor, this area is frequently exposed to water, allowing potential for water penetration into adjoining sections of walls or flooring.

If left unmanaged, water penetration to these areas may lead to subsequent water damage, which is likely necessitate repair work to affected building elements.

A tiling contractor should be appointed to ensure that no further water damage occurs. The re-application of silicone and grouting throughout remaining tile work is also advised, to further protect the area against water penetration.

Where water penetration has led to water damage, appointment of a relevant tradesperson may be required to repair damaged building elements.

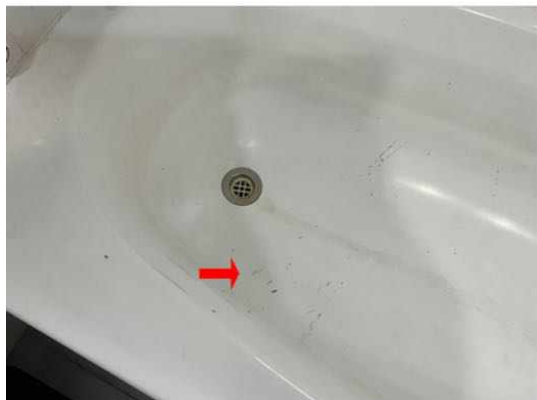
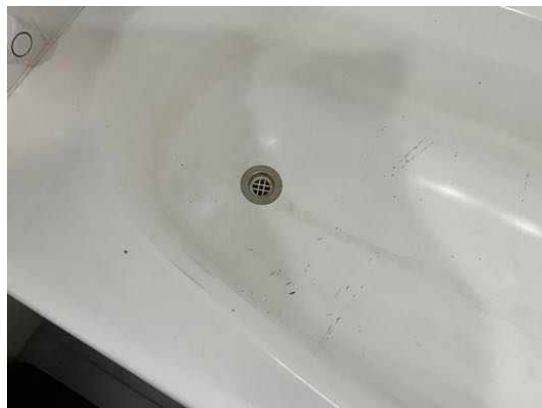
### Finding 3.14

Finding: Bathtub Stains

Information: This staining is indicative of long-term water exposure, possibly due to slow drainage, water quality issues, or the deterioration of materials in the bath.

- **Aesthetic Damage:** The stains detract from the visual appeal of the bathroom and may affect its overall cleanliness perception.
- **Material Degradation:** The source of the stains, such as rust or hard water, may eventually contribute to the deterioration of the bathtub's surface, leading to further damage if not addressed.
- **Plumbing Issues:** If the staining is caused by slow drainage or leaks, this may indicate a more significant issue with the plumbing that could worsen over time.

- **Professional Cleaner:** A professional cleaner specializing in bathroom or surface restoration can attempt to remove the stains using appropriate cleaning agents.

- Plumber: If the staining is caused by slow drainage, a plumber should inspect the drainage system for blockages or leaks.
- Bath Refinishing Specialist: If the staining is severe or has caused damage to the surface, a refinishing specialist can repair or recoat the bathtub.

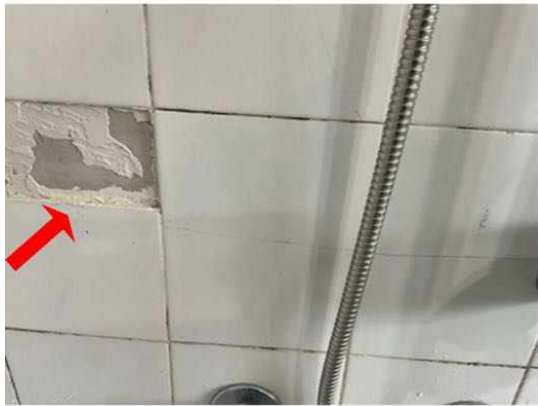
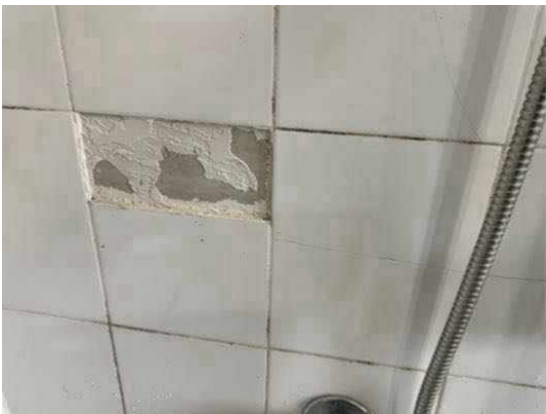
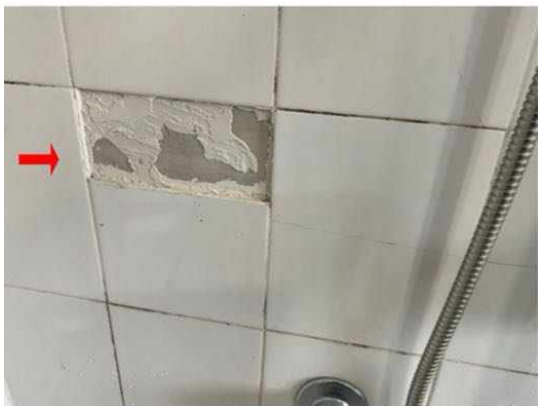
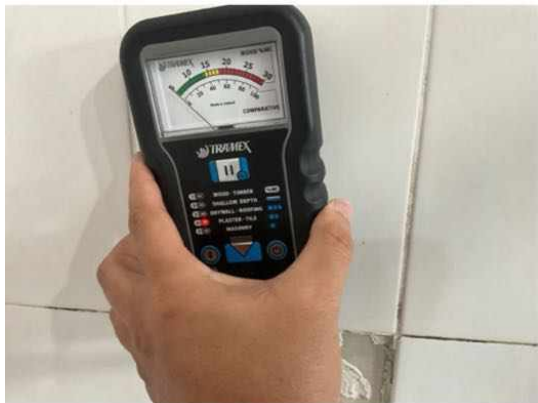
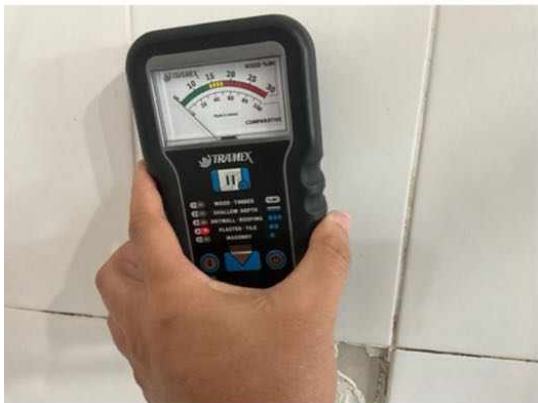
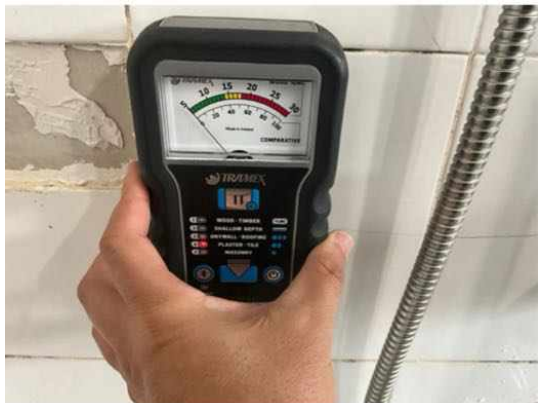
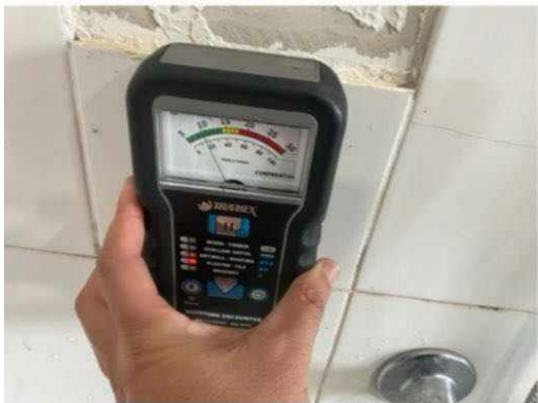
### Finding 3.15

Building:	Main Building
Location:	Bathroom
Finding:	Damaged Tile – Potential Waterproofing Risk
Information:	Damage was observed to a tile near the bath. The tile is chipped and cracked, exposing the substrate beneath. In wet areas, such damage may compromise the integrity of the waterproofing membrane underneath, which is essential for preventing water ingress.

Implication: Ongoing exposure to water in this area may result in membrane failure, water ingress, and deterioration of subfloor materials or adjoining finishes.

Recommendation: Engage a qualified tiler or waterproofing specialist to assess the extent of damage. An invasive inspection may be necessary to verify whether the waterproofing membrane has been breached and to undertake appropriate repairs to prevent future water damage.

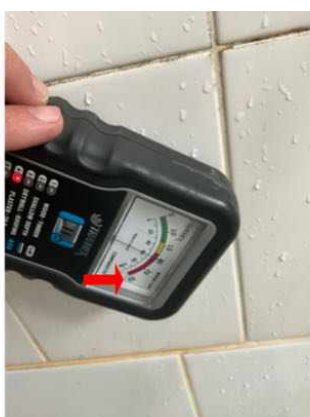
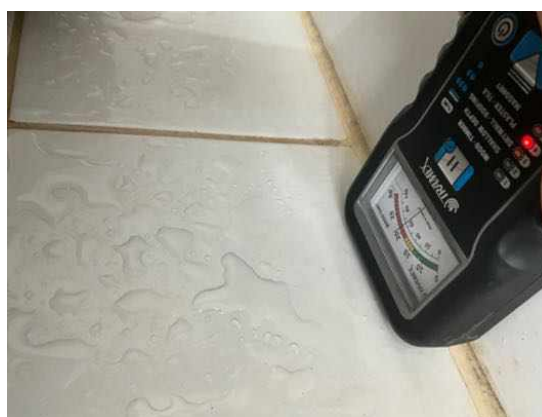
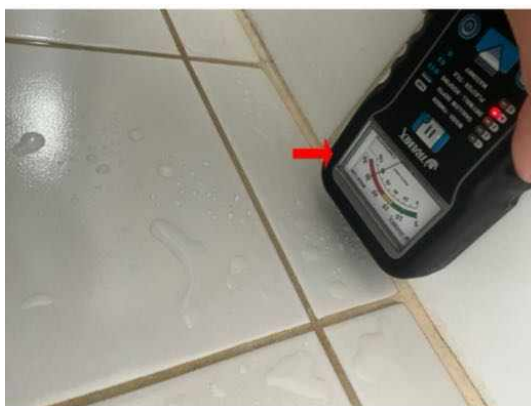
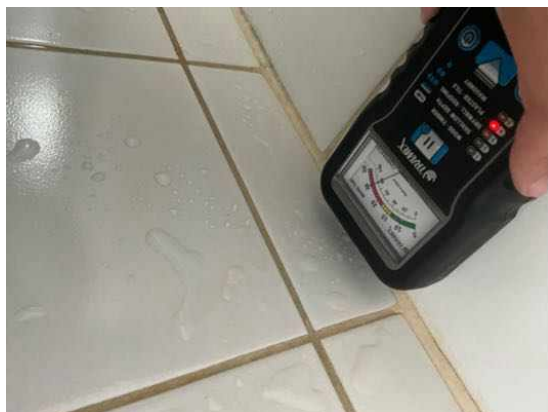
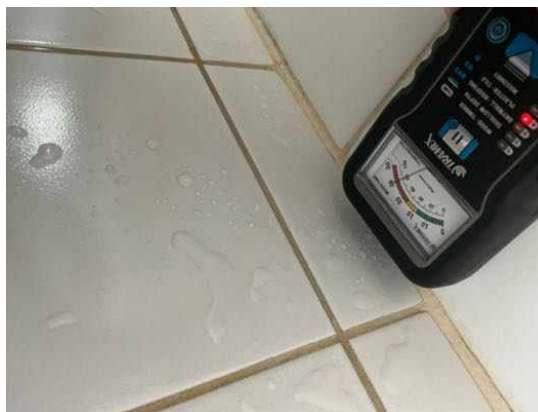
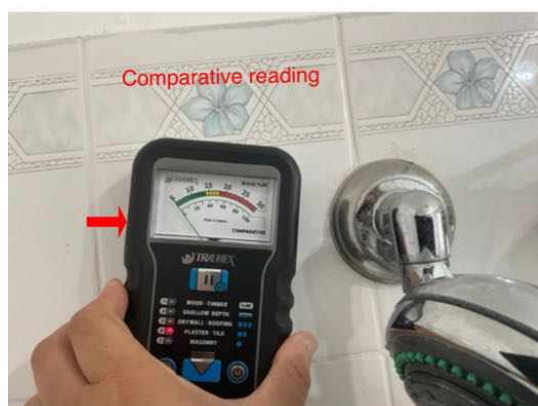
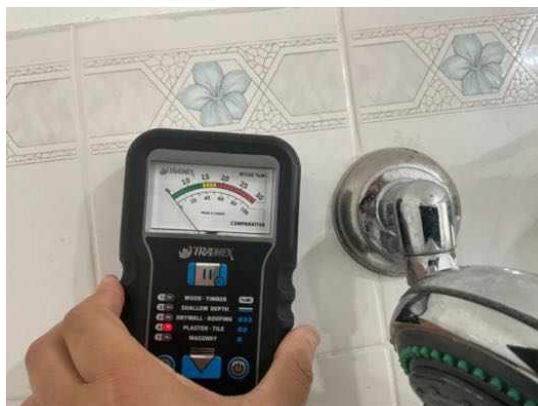
Finding 3.16

Building:	Main Building
Location:	Bathroom
Finding:	Shower - Damp
Information:	Damp is evident to the lower 300mm of wall to the shower alcove. This defect is quite common, and is suspected to have been caused by moisture permeating through the grouting in this area, which shows evidence of deterioration. Leaking pipes within the adjoining wall is also a possible cause.

Unmanaged damp in the shower recess is likely to facilitate the formation and development of mould and fungi growth, decaying associated building materials and compromising their structural integrity. It is important to address damp conditions, as the World Health Organisation notes that excess moisture leads - on almost all indoor materials - to growth of microbes such as moulds, fungi and bacteria, which subsequently emit spores and other matter into the indoor air. Exposure to these contaminants is associated with a wide range of respiratory and other health-related problems.

Consultation with a qualified plumber or bathroom specialist is advised immediately to identify the cause of damp and to perform remedial works as required. Where excessive mould growth is present, further inspection by a specialist environmental health inspector should also be considered.

Always ensure that sealant and grout is in good condition to prevent any moisture issues occurring in the future.

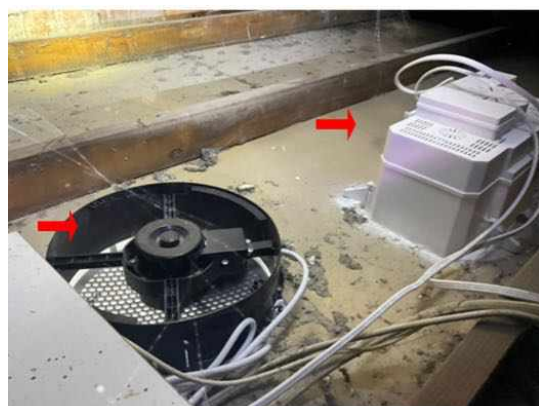
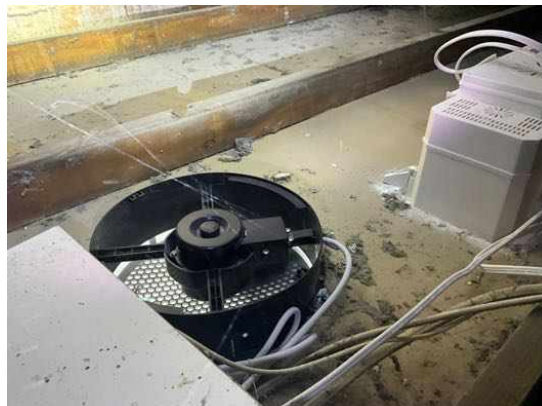
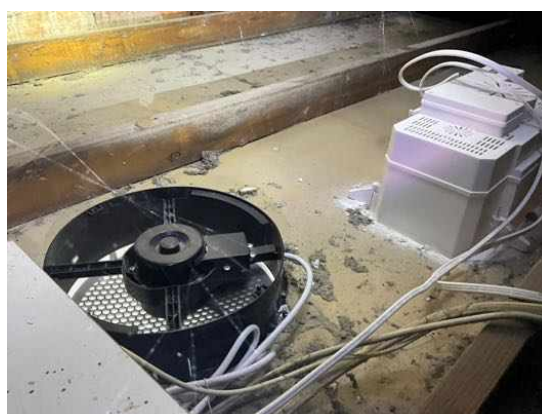
### Finding 3.17

Building: Main Building  
 Location: Roof Void  
 Finding: Exhaust fan not vented out  
 Information: The exhaust fan located within the roof void is not appropriately ducted to the external atmosphere and is currently discharging moist air directly into the roof space. This is considered a defect under AS 4349.1, as it does not meet the minimum standard of residential building performance expected under normal residential building practices.

This condition may lead to excessive condensation within the roof void, increasing the

risk of mould growth, deterioration of insulation, timber decay, and overall reduced durability of building elements. It may also result in poor indoor air quality, potentially affecting occupant health.

It is recommended that the exhaust fan be modified by a licensed HVAC contractor or qualified builder, ensuring it is properly ducted to discharge externally in accordance with manufacturer specifications, the National Construction Code (NCC), and applicable Australian Standards.

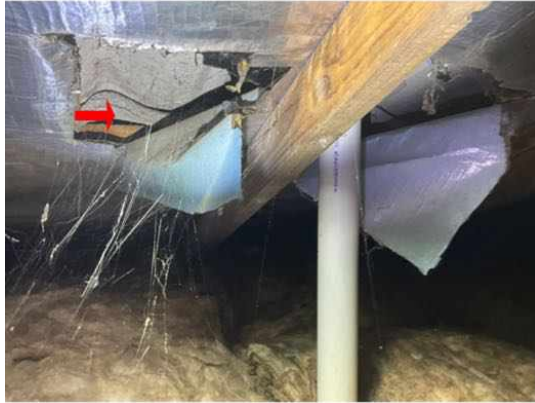
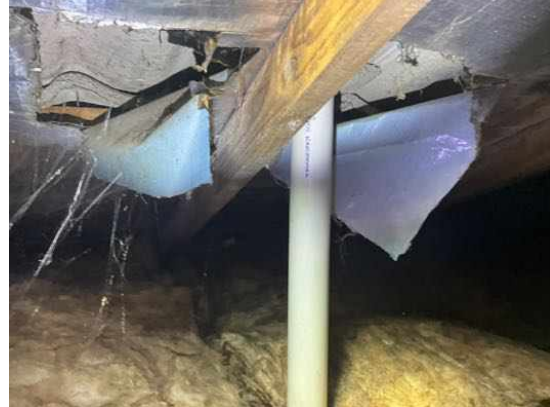
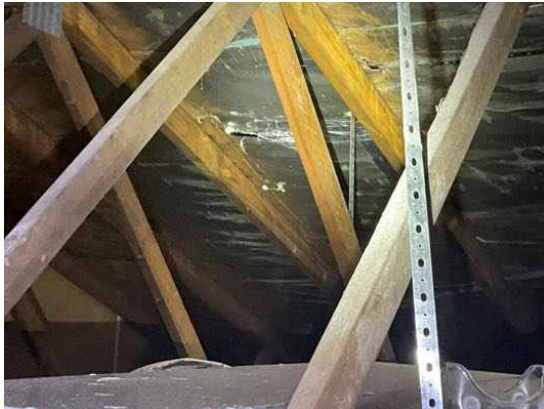
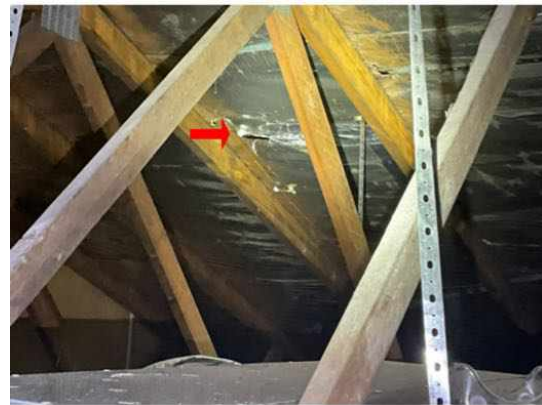
Building:	Main Building
Location:	Roof Void
Finding:	Sarking - Damaged
Information:	Sarking, a laminated aluminium foil applied to the interior of the roof covering, assists in insulating the property and acting as a vapour-barrier to the roof void and, subsequently, to the household.

Where sarking is damaged, both insulation and moisture protection of the property are inhibited. This creates a loss of energy and thus negatively impacts the energy efficiency of the property, allowing potential for moisture ingress from condensation or leaking roof tiles.

It is important to repair any holes or damaged sections of sarking to ensure that the building material is fully functional. A registered builder or qualified carpenter should be consulted to provide further advice on this defect and to perform rectification works at client discretion.

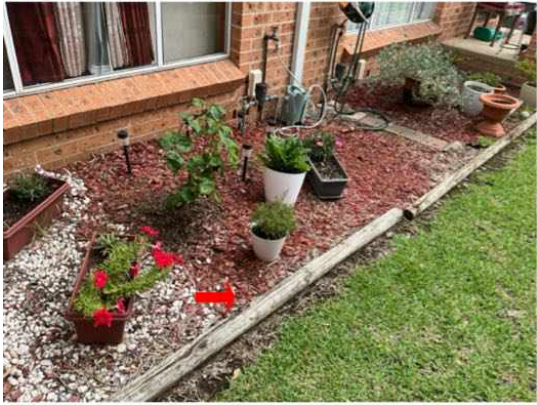
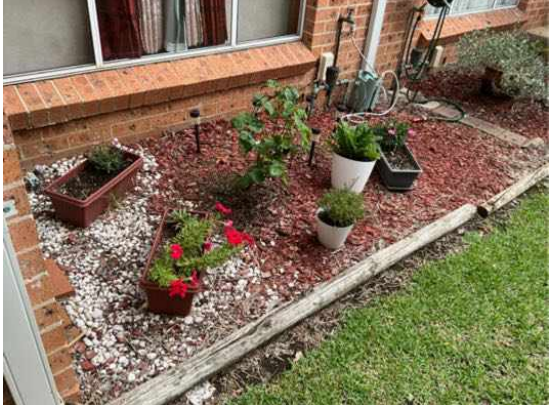
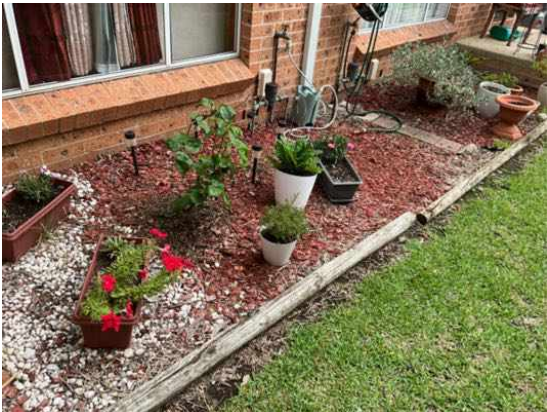
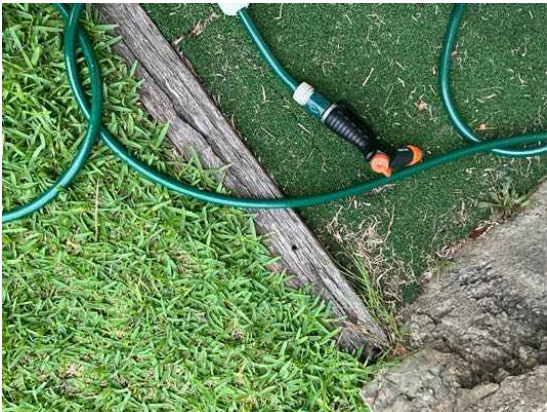
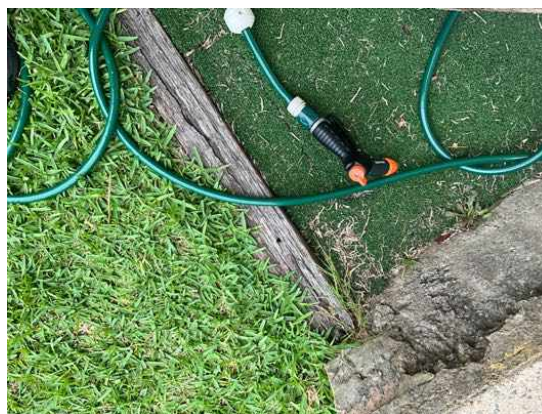
Building:	Main Building
Location:	All Areas
Finding:	Timber on ground / conducive conditions to termite damage
Information:	Timber on the ground is indeed conducive to termite damage. Termites are known to

thrive in moist environments, and wood in contact with soil or moisture is more susceptible to infestation.

To prevent this, it's important to keep timber elevated and away from direct ground contact. Regular inspections and proper termite control measures are also essential to protect your wooden structures from termite damage.

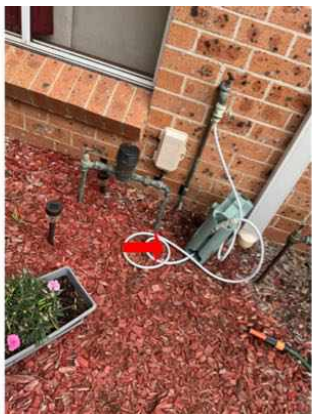
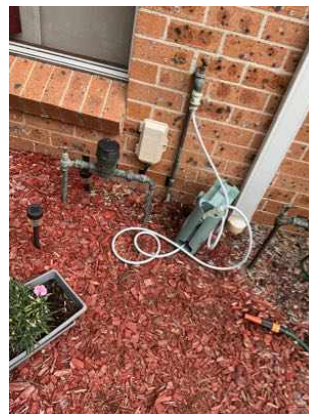
## Finding 6.02

Building:	Main Building
Location:	All Areas
Finding:	No Drain under tap
Information:	There is no drain installed under the tap, leading to water accumulation and creating conducive conditions for timber pests. This defect needs immediate attention to prevent potential damage and pest infestation.

1. Water Accumulation: Without proper drainage, water can accumulate around the base of the tap, leading to persistent dampness in the surrounding area.
2. Timber Pest Infestation: The damp environment created by standing water is highly conducive to timber pests, such as termites and wood borers, which thrive in moist conditions and can cause significant damage to wooden structures.
3. Structural Damage: Prolonged exposure to moisture can lead to wood rot and deterioration of structural timber, compromising the integrity of the building.
4. Health Hazards: Persistent dampness can also promote mold and mildew growth, posing health risks to occupants.
5. Aesthetic Damage: Water stains and damage to finishes and materials around the tap area can detract from the appearance of the building and lead to costly repairs.

A licensed plumber or a qualified building contractor can address this defect by:

3. Repair and Prevention: Inspecting and repairing any existing water damage and implementing measures to prevent future water accumulation and pest infestations.

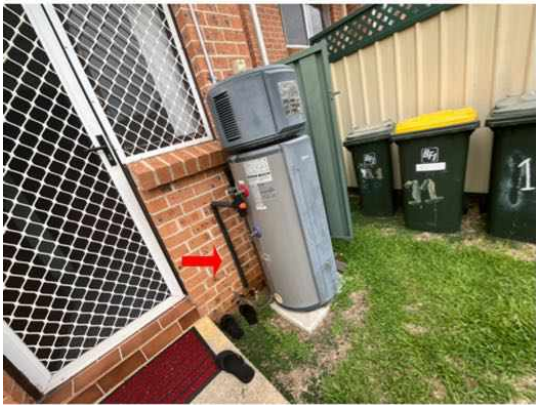
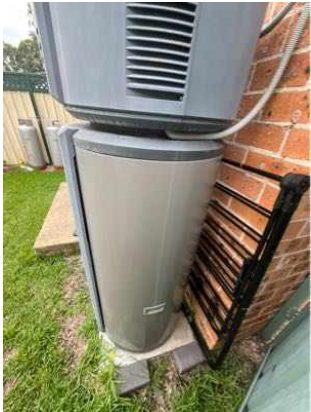
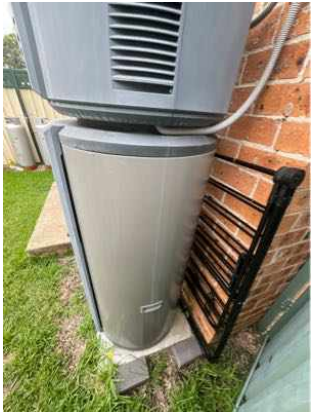
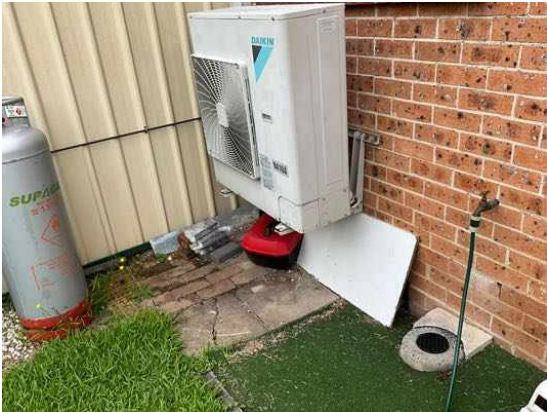
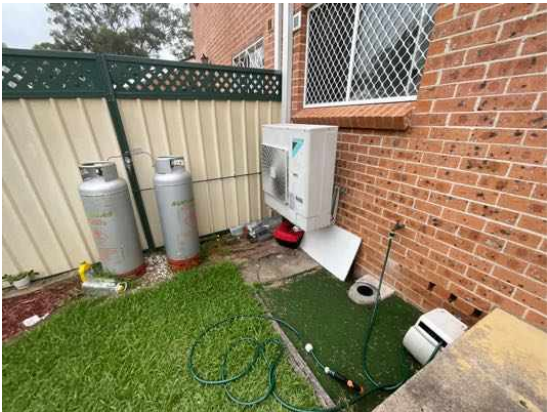
### Finding 6.03

Building:	Main Building
Location:	All Areas
Finding:	Bridging or Obstruction Conducive environment for Termites
Information:	Bridging of termite barriers occurs when termites bridge (usually by building a mud tunnel) a termite barrier or inspection inspection zone or where termites have a passage, allowing them to bridge the barrier.

Where bridging has occurred full inspection is prevented and termites may enter a property in a concealed or undetected manner.

Recommended moving obstructions away from the external walls for further and future inspections.

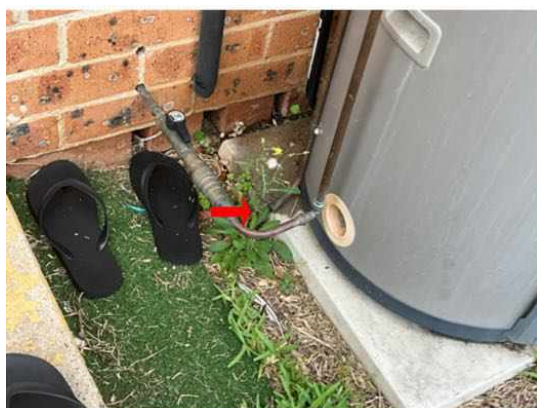
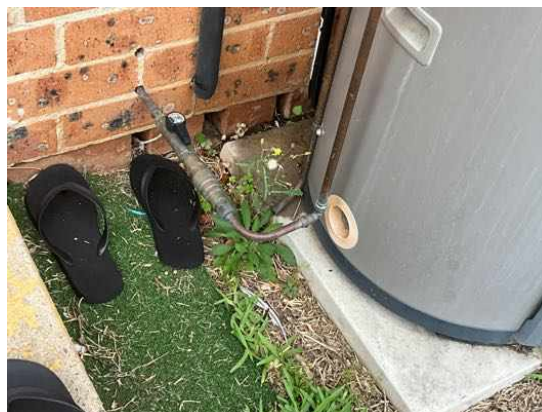
Finding 6.04

Building:	Main Building
Location:	Exterior walls - rear
Finding:	HWS not connected - conducive conditions for timber pest attacks
Information:	The hot water system (HWS) is not connected, leaving exposed pipes and creating conducive conditions for timber pest attacks.

**Risk of Timber Pest Attack:** The risk of timber pest attack is heightened when the hot water system is not connected. Exposed pipes provide easy access points for timber pests like termites and ants to infiltrate the building structure. These pests are attracted to moisture, and the absence of flowing water through the system can lead to moisture buildup, creating an ideal environment for pests to thrive and cause damage to timber components within the building.

A licensed plumber or qualified plumbing technician should be engaged to reconnect the hot water system. They will assess the existing plumbing infrastructure, determine the appropriate connection points, and ensure proper installation and functionality of the HWS. Additionally, they may inspect for any signs of timber pest activity and recommend preventive measures, such as installing physical barriers or implementing moisture control measures, to deter pest infestations and protect the building from damage. Regular maintenance and inspections by homeowners or property managers are also essential to detect and address potential issues before they escalate.

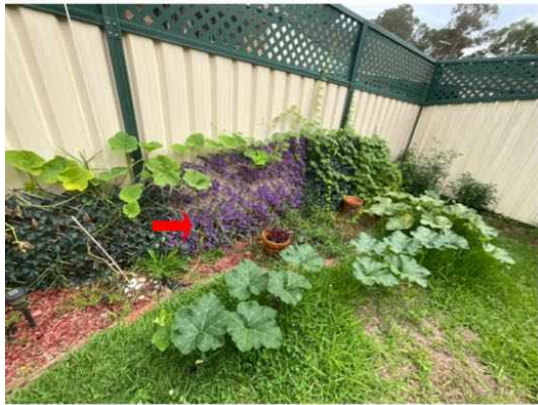
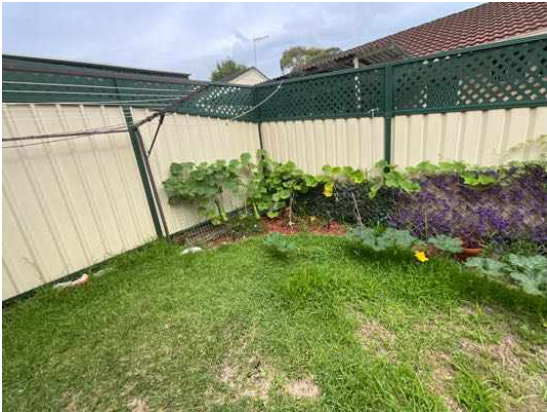
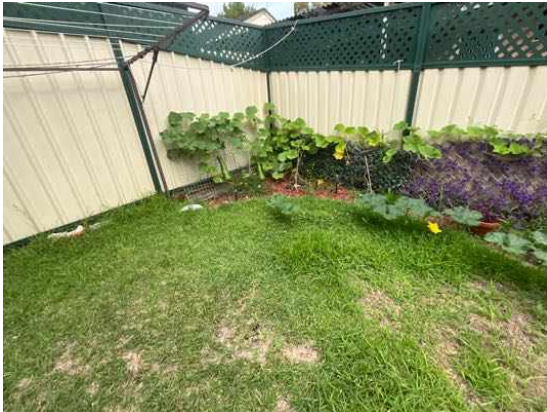
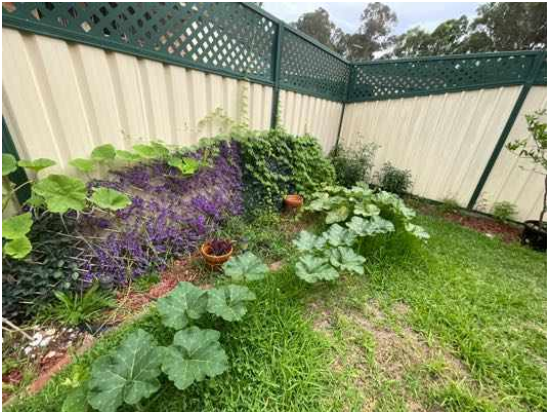
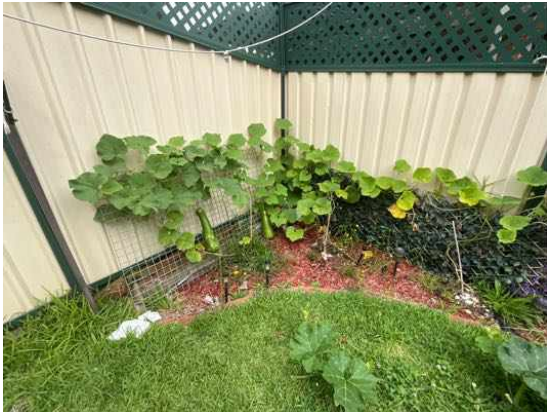
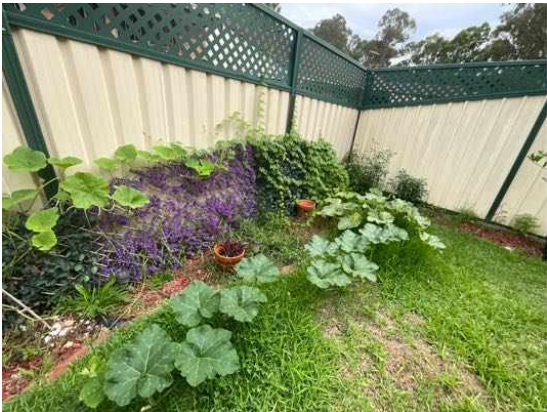
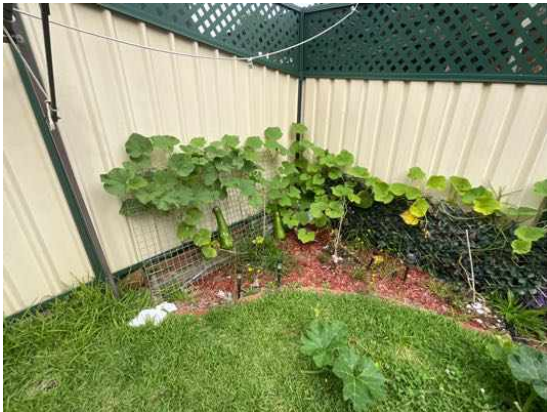
### Finding 6.05

Building:	Main Building
Location:	All Areas
Finding:	Dense vegetation around a property can increase the risk of termite infestation
Information:	The presence of dense vegetation around a property can increase the risk of termite infestation, as it provides a conducive environment for them. To address this, consider maintaining a clear space between the vegetation and your home. If you suspect a termite issue, it's advisable to consult with a licensed pest control professional for inspection and treatment.

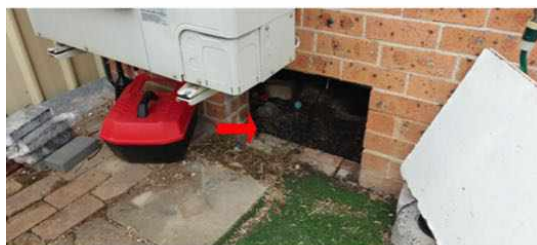
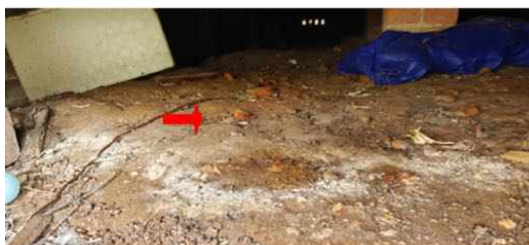
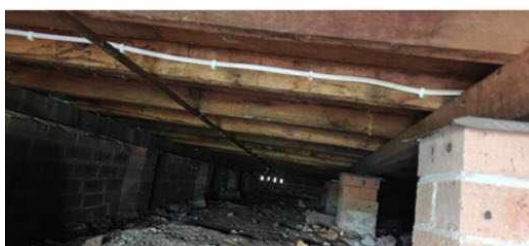
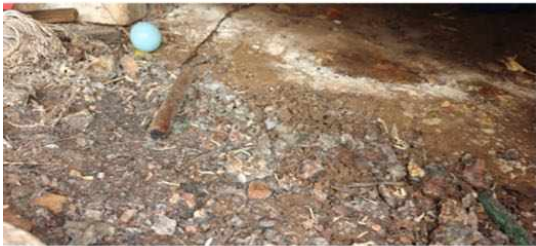
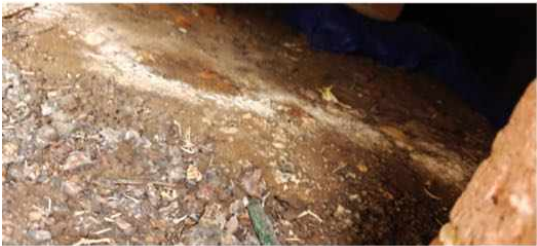
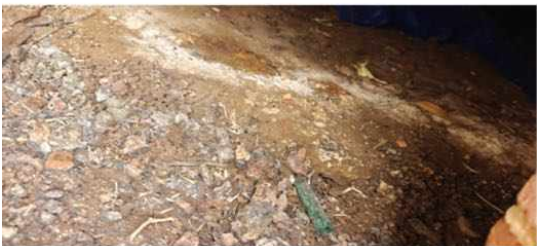
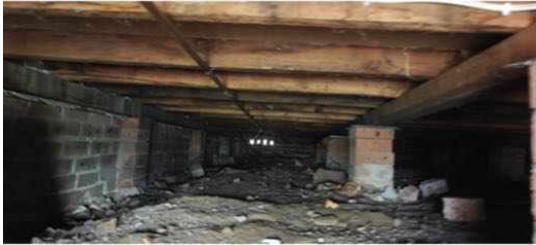
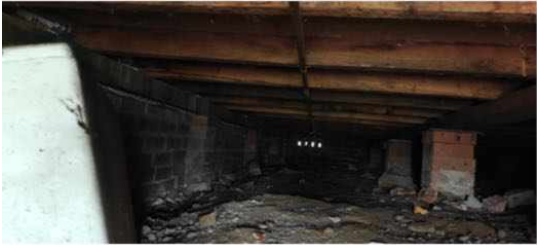
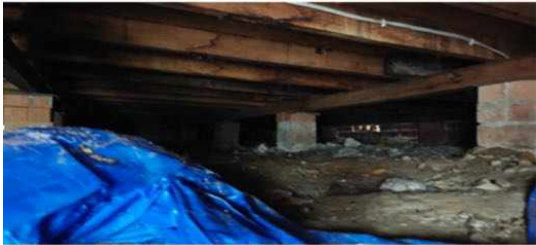
Finding 6.06

Building:	Main Building
Location:	Subfloor
Finding:	Subfloor - poor ventilation, inadequate site drainage, water stains
Information:	The subfloor lacks adequate ventilation, suffers from inadequate site drainage, exhibits water stains, creating conducive conditions for timber pests such as termites.

Risk: The combination of poor ventilation, inadequate drainage, water stains significantly increases the risk of timber pest infestations. Termites are attracted to moist environments and can thrive in subfloors with high humidity levels and water damage. The lack of proper ventilation and drainage exacerbates moisture retention, providing an ideal habitat for timber pests to establish colonies and cause extensive damage to the subfloor structure. Additionally, water stains indicate previous or ongoing moisture issues, which further attract timber pests and contribute to the deterioration of timber materials.

A licensed pest control professional specializing in timber pest management should be consulted to assess the extent of the infestation and develop a comprehensive treatment plan. They can implement strategies to eliminate existing timber pests, such as termites and prevent future infestations by addressing underlying moisture issues. Additionally, a qualified plumber or builder may be needed to improve subfloor ventilation, enhance site drainage, repair water-damaged areas. Regular inspections and maintenance are essential to ensure ongoing protection against timber pests and maintain the structural integrity of the subfloor.

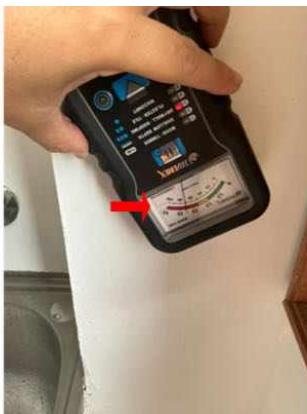
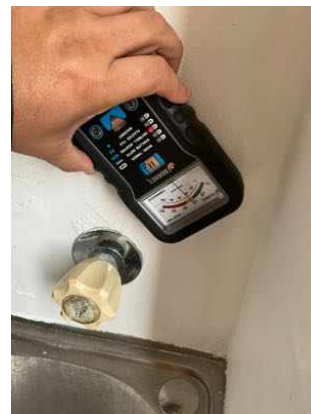
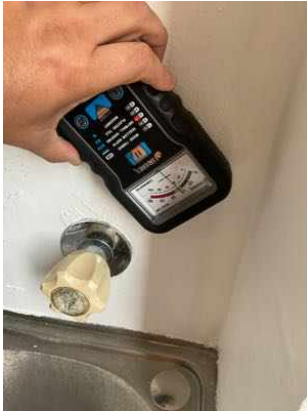
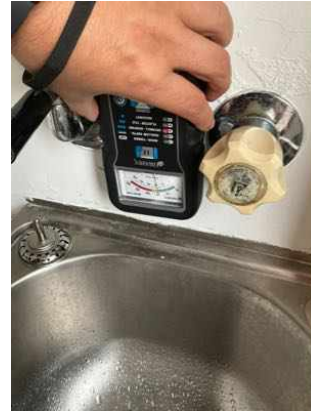
### Finding 6.07

Building:	Main Building
Location:	Laundry
Finding:	Excessive moisture - Conducive to Timber pest
Information:	Excessive moisture can attract termites and produce conditions that promote fungal growth and wood decay.

Excessive moisture is generally caused by deteriorated inadequate or missing roof drainage leaking plumbing pipes or fixtures poorly plumbed HWS overflows or condenser units and poor site drainage.

Prior to any remedial works being performed a qualified plumber should be appointed to further inspect the property and to identify the cause of the excessive moisture. Works to remove affected building elements may then be necessary and should be performed by an appropriate tradesperson.

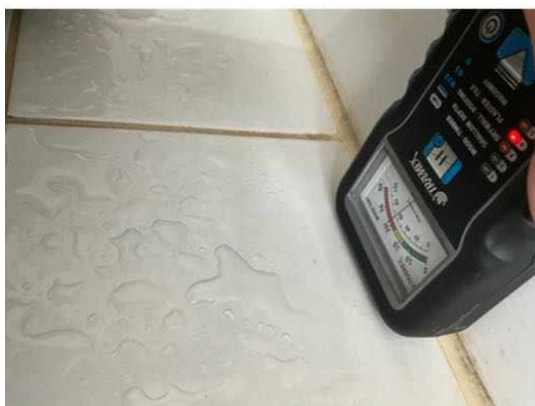
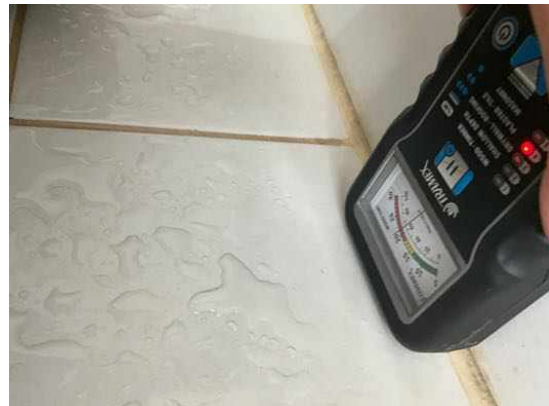
### Finding 6.08

Building:	Main Building
Location:	Bathroom
Finding:	Excessive moisture - Conducive to Timber pest
Information:	Excessive moisture can attract termites and produce conditions that promote fungal growth and wood decay.

Excessive moisture is generally caused by deteriorated inadequate or missing roof drainage leaking plumbing pipes or fixtures poorly plumbed HWS overflows or condenser units and poor site drainage.

Prior to any remedial works being performed a qualified plumber should be appointed to further inspect the property and to identify the cause of the excessive moisture. Works to remove affected building elements may then be necessary and should be performed by an appropriate tradesperson.

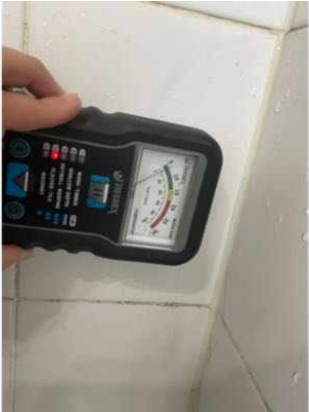
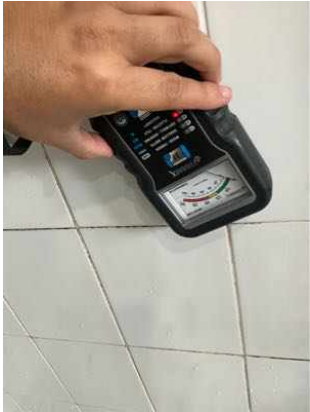
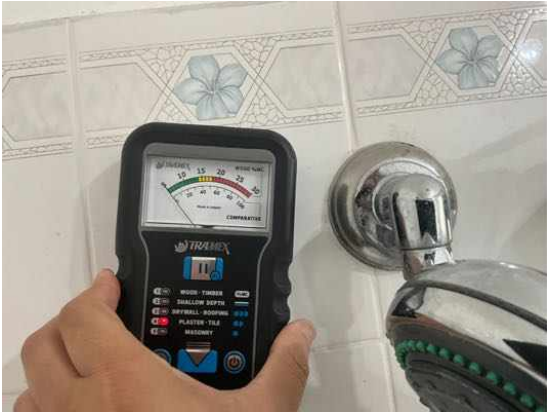
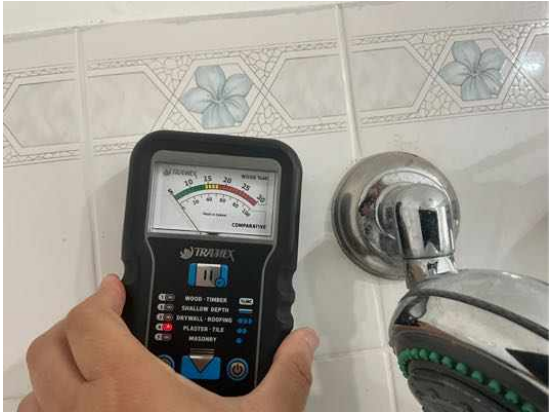
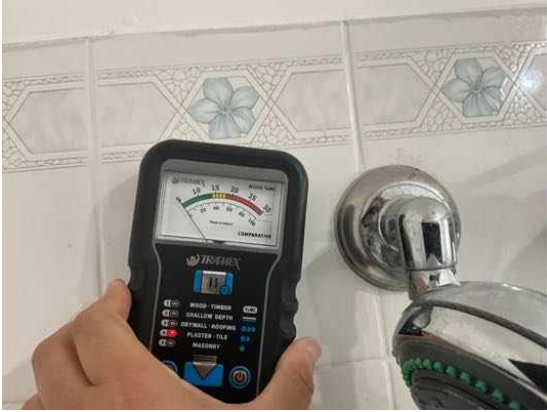
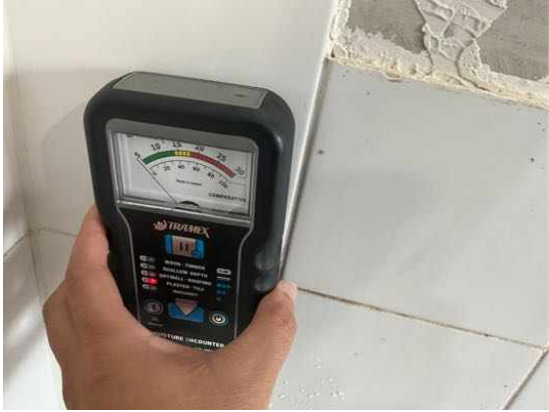
- Building: Main Building
- Location: All Areas
- Finding: Additional Photos
- Information: Additional photos are provided for your general reference
