# Building and Timber Pest Inspection Report

Inspection Date: Mon, 2 Mar 2026

Property Address: 11/30 Kings Rd, Ingleburn NSW 2565,  
Australia

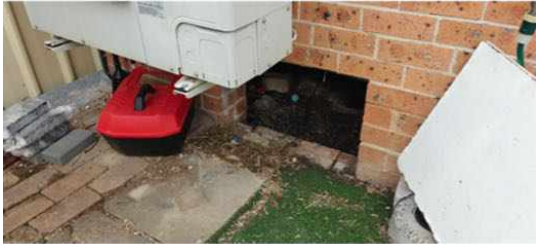
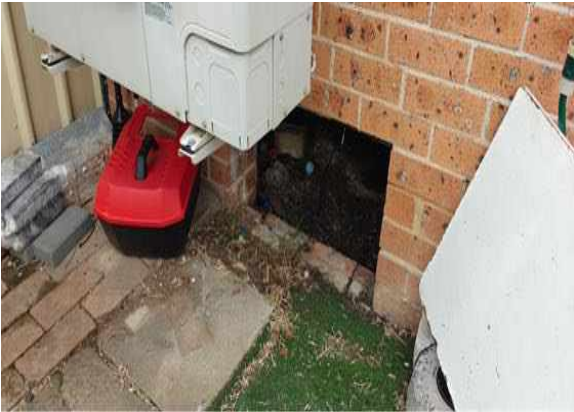
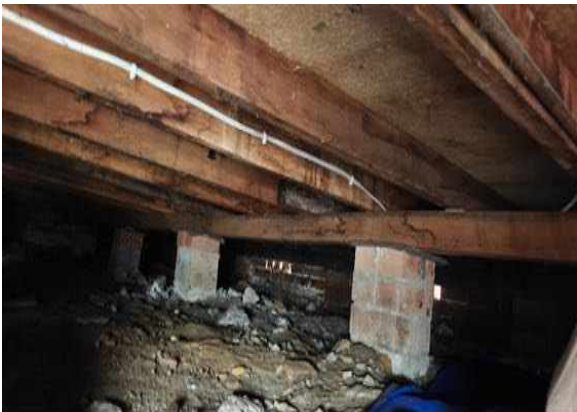
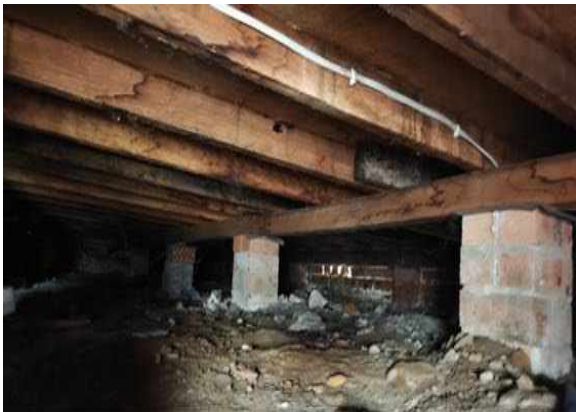
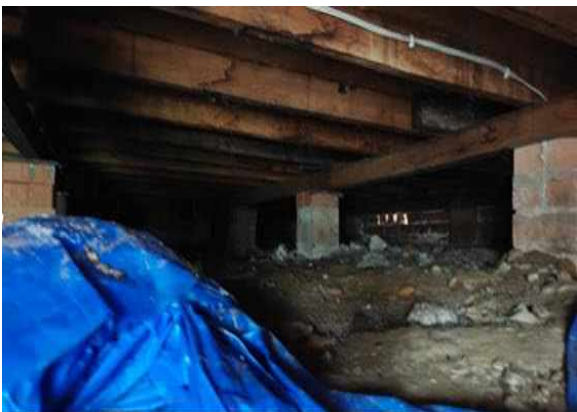
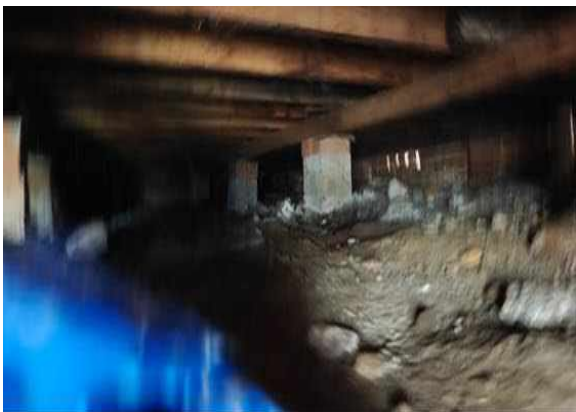
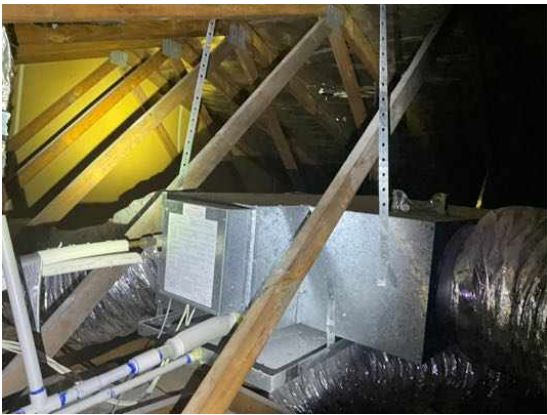
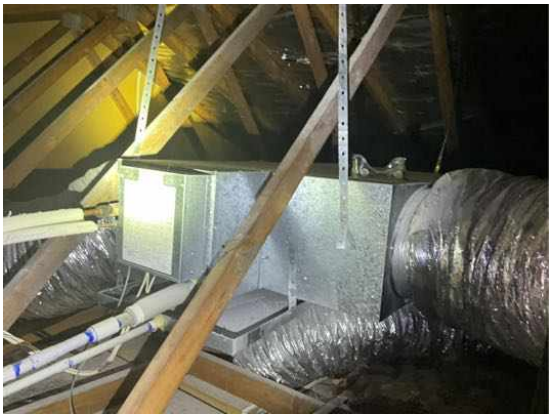
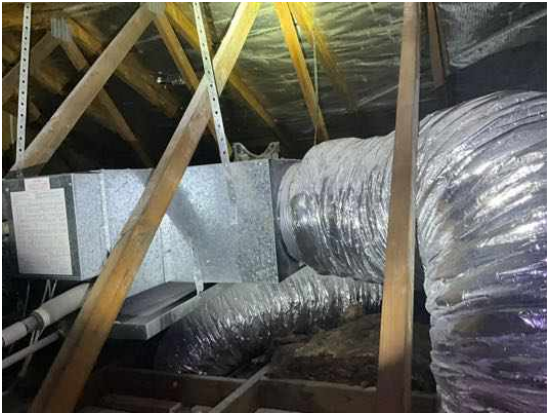
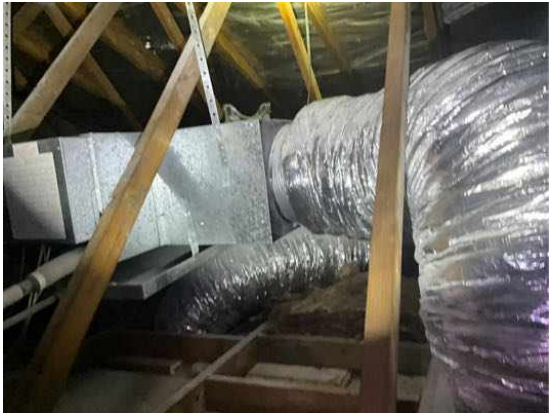
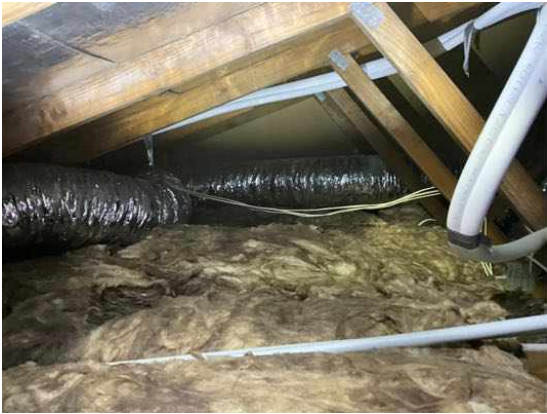
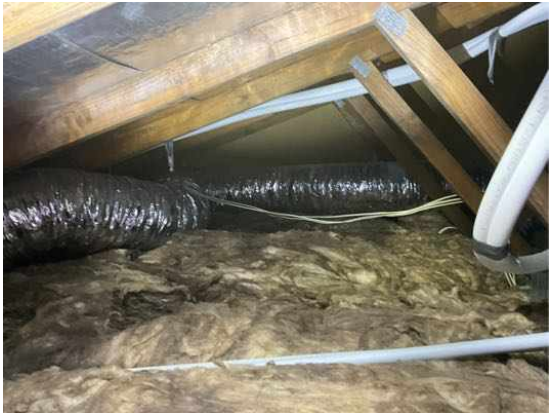
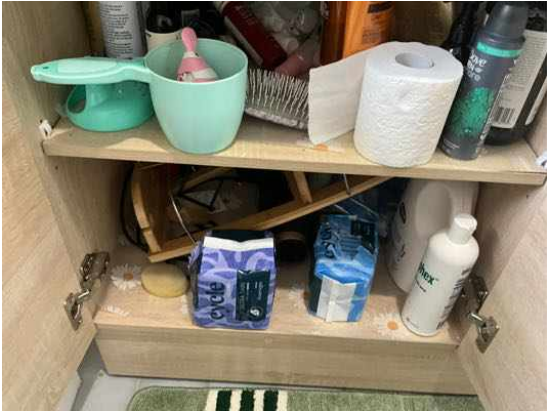
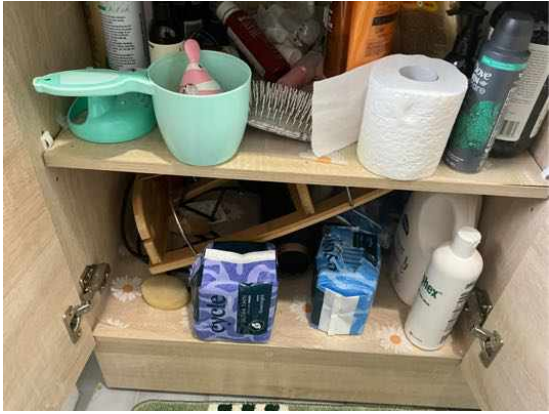
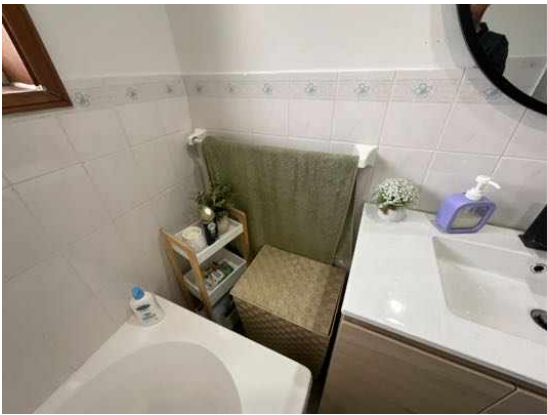
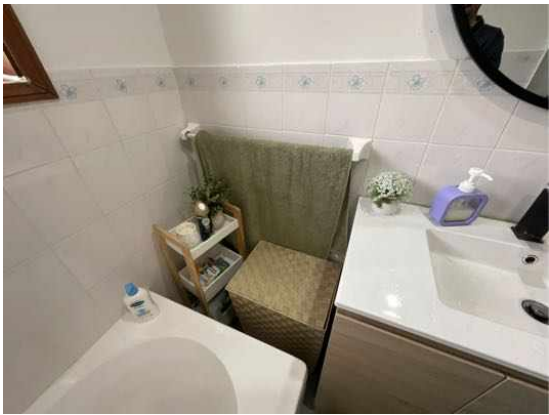
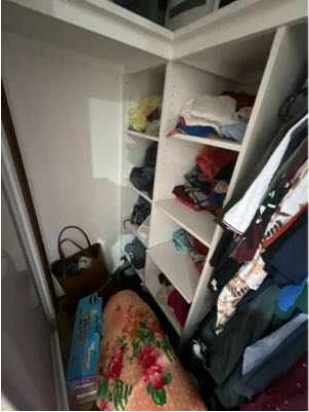
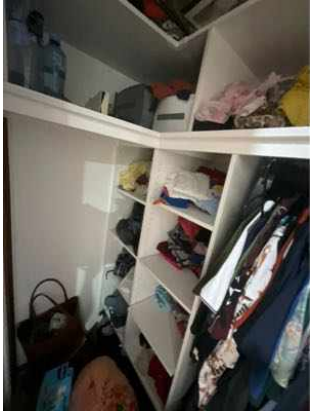
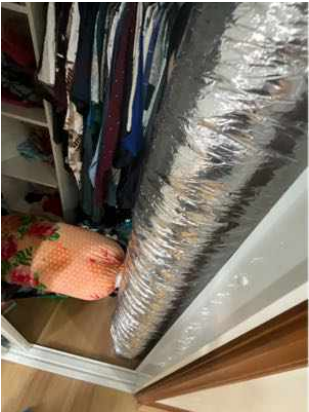
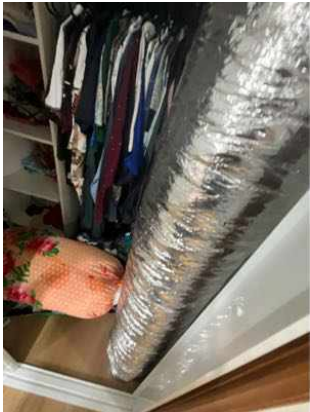
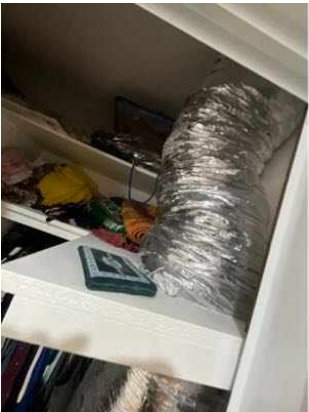
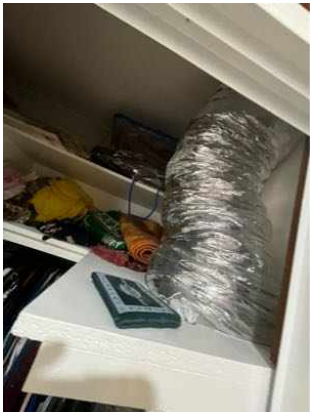
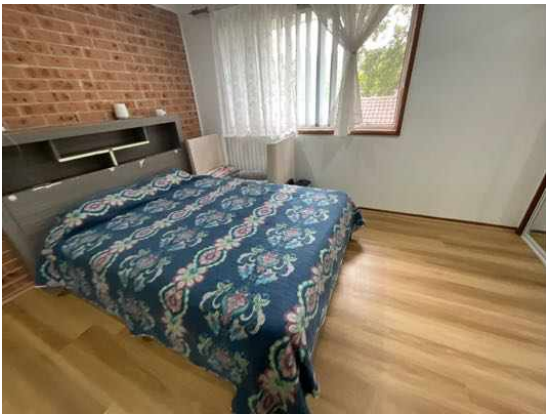
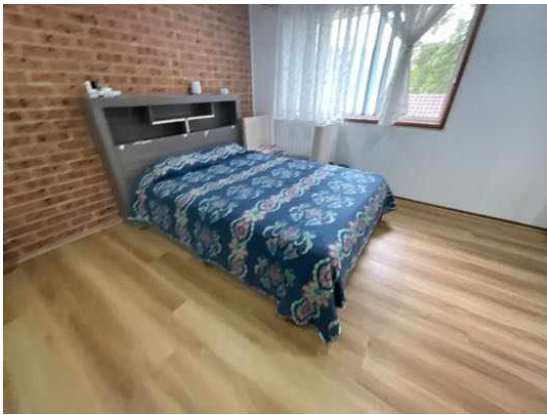
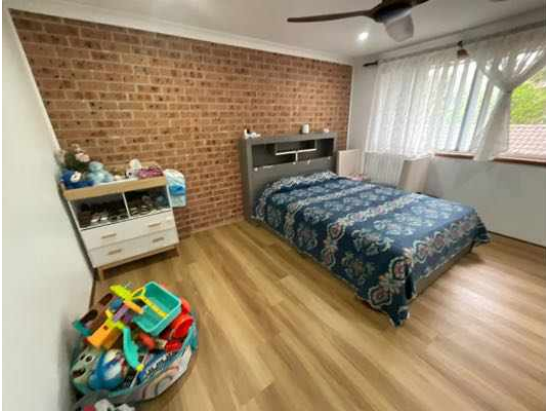
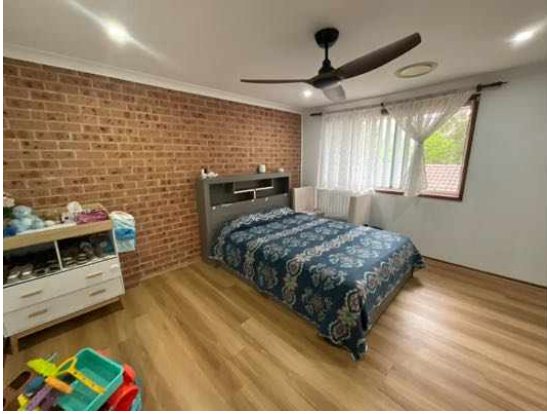
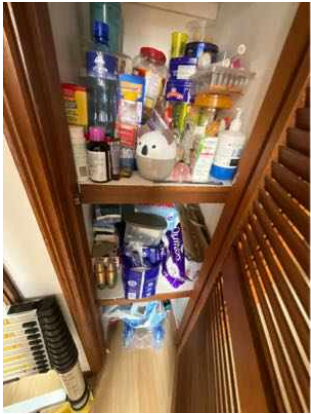
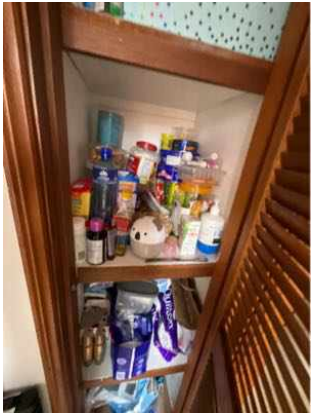
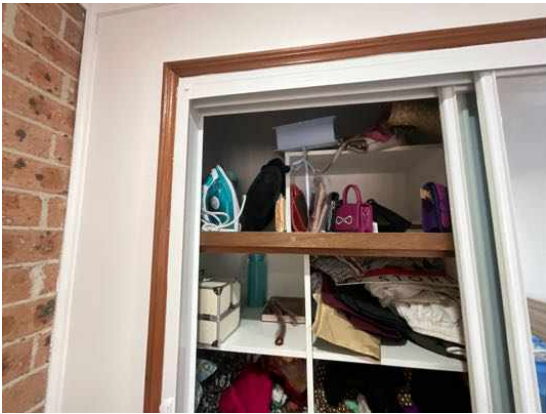
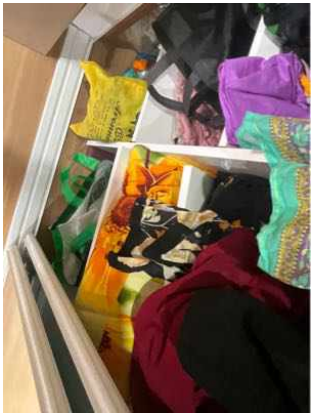
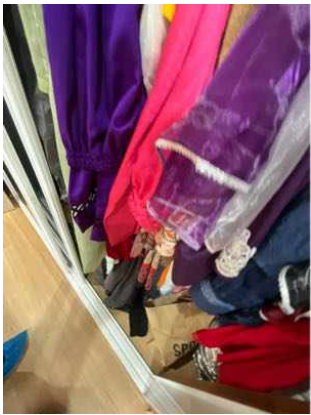
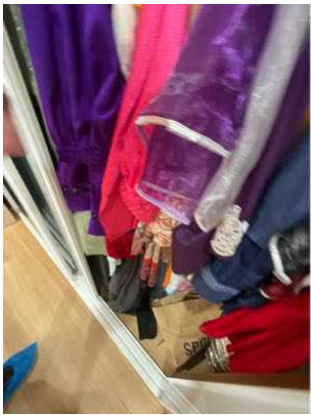
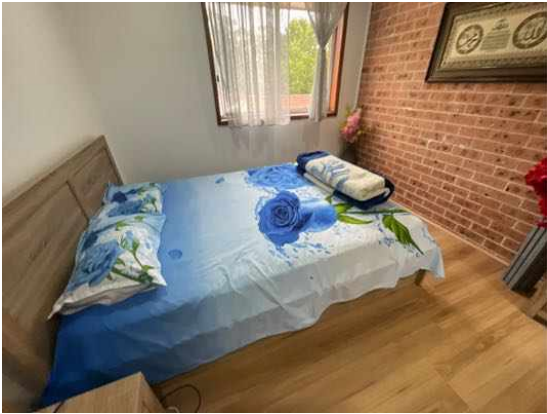
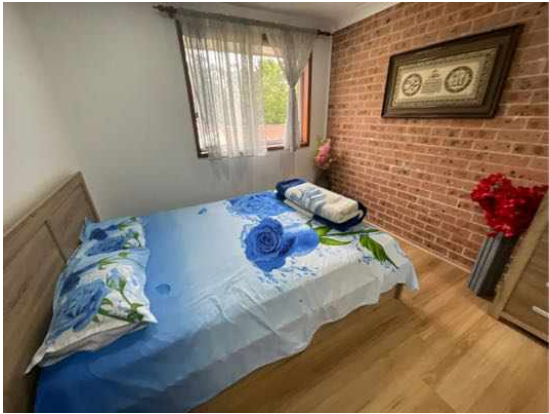
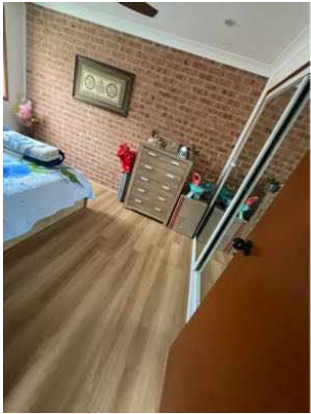
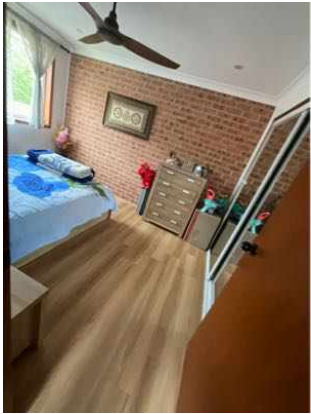
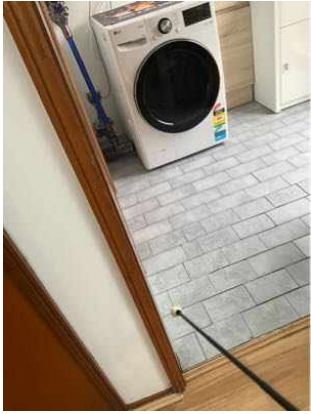
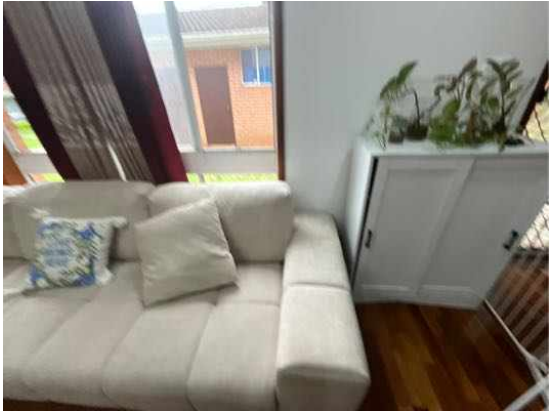
Building: Main Building  
Location: All Areas  
Finding: Additional Photos - Obstructions and Limitations  
Information: These photographs are an indication of the obstructions and limitations which impeded full inspection of the property at the time of inspection. These obstructions can hide an array of defects and should be removed to allow full inspection to be carried out. A re-inspection is recommended once the areas are made accessible.
