Building and Timber Pest Inspection Report

Inspection Date: Thu, 19 Feb 2026

Property Address: 19 Shorthorn Avenue, Glenmore Park NSW
2745

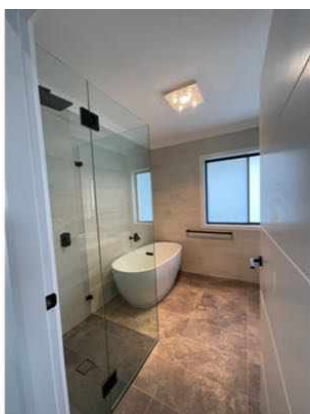
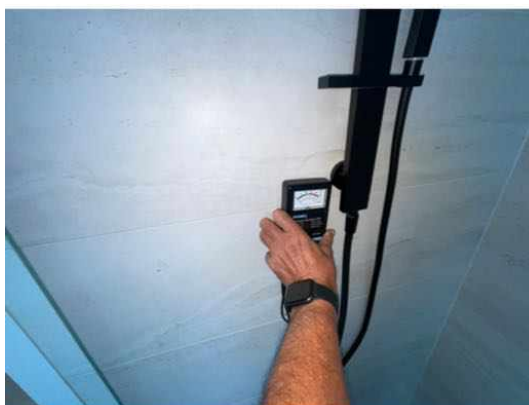
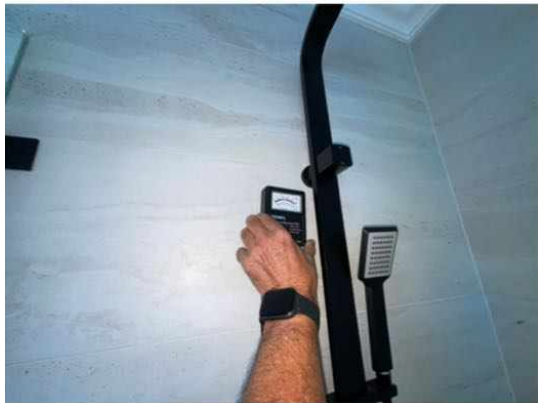
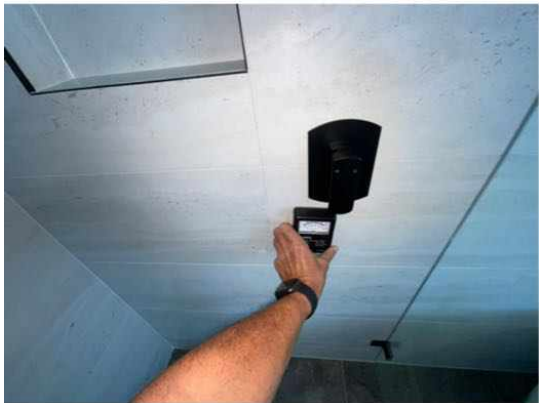
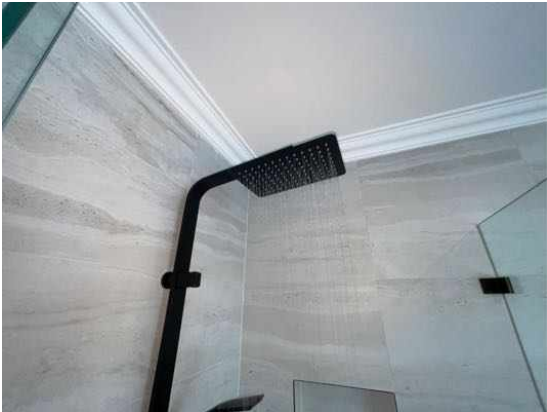
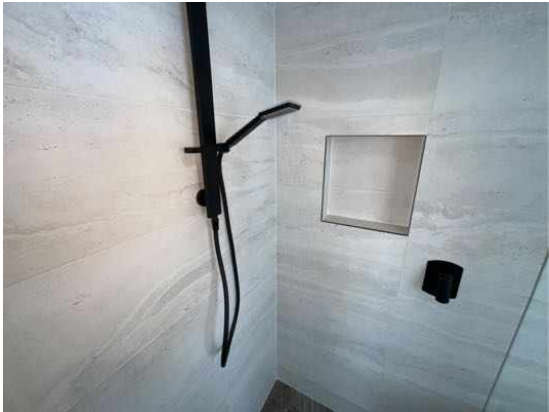
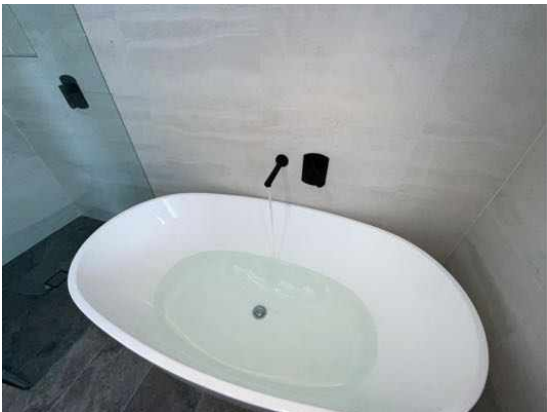
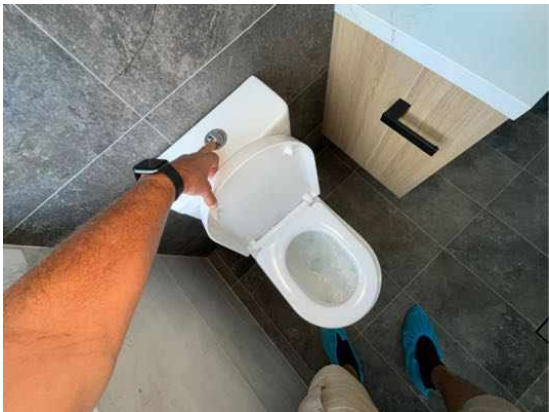
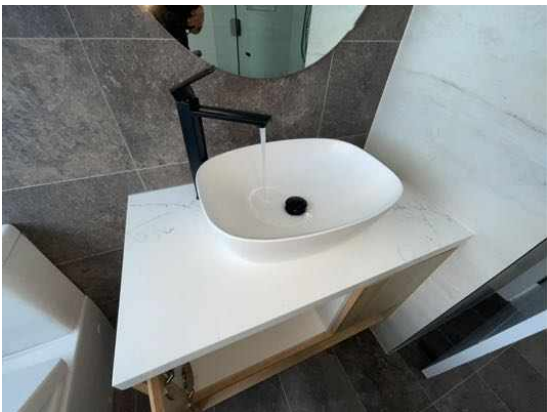
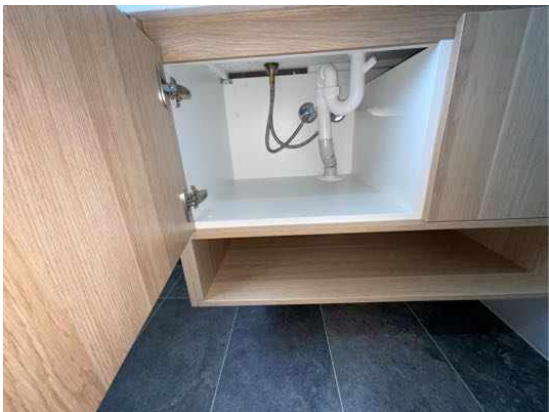
Building: Main Building
Location: Ensuite
Finding: Wet Areas - Bathroom(s) - Overall Condition & Recommendations.
Information: Overall Condition & Recommendations

It is not possible under the visual inspection criteria of a standard pre-purchase report to categorically determine if leaks are present. If a more detailed or accurate assessment is required, a special-purpose inspection should be undertaken.

Alternatively, the assumption should be made that leakage may occur, particularly where historical or environmental conditions are conducive. The visual nature of this inspection cannot detect issues concealed behind wall/floor linings or cabinetry, and invasive investigation may be necessary to confirm the true condition of adjacent or hidden structures.

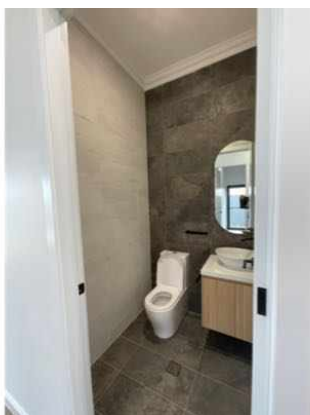
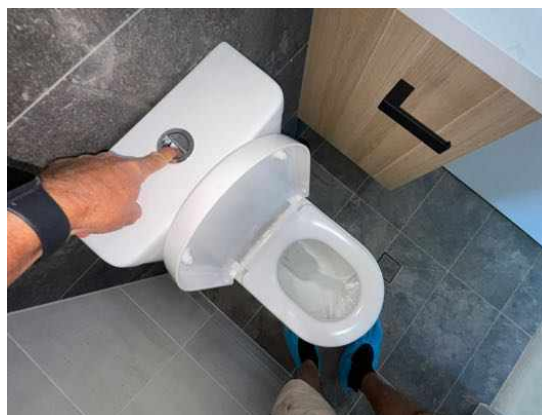
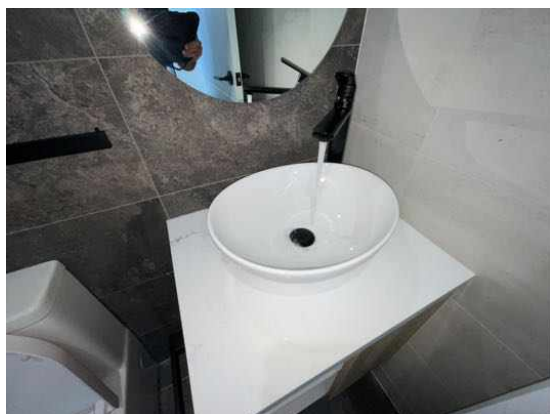
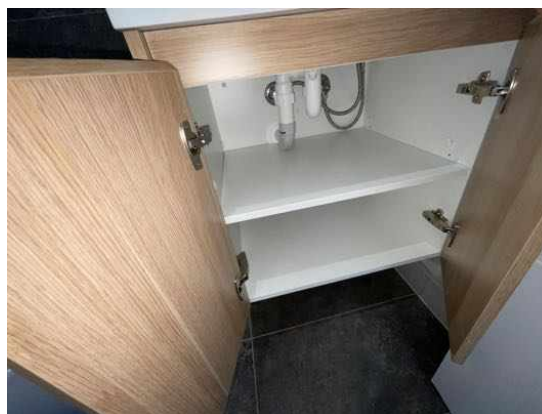
Building: Main Building
 Location: All Areas
 Finding: Water Pressure – Observation Only.
 Information: During the inspection, water pressure appeared to be within a normal operating range based on a basic functional check. However, this observation was made without the use of pressure testing equipment and does not constitute an assessment by a licensed plumber.
