Building and Timber Pest Inspection Report

Inspection Date: Wed, 11 Feb 2026

Property Address: 120 Sir John Jamison Cct Glenmore Park
NSW 2745

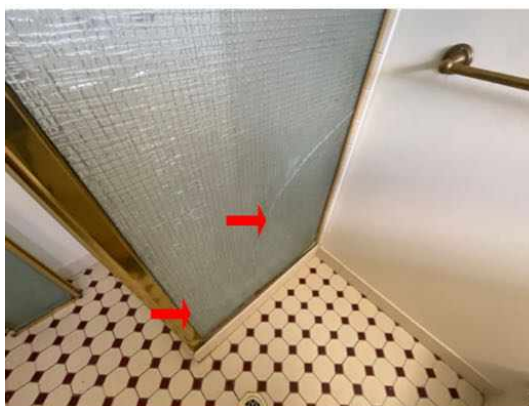
Building:	Main Building
Location:	Bathroom
Finding:	Damaged Shower Screen Glass Panel.
Information:	Major Defect – Bathroom Shower Screen (Cracked Glass Panel)

During the inspection of the bathroom, the shower screen glass panel was observed to have sustained visible and significant cracking. Also noted the two sliding doors have been removed and will need to be replaced. The cracking is clearly evident and extends through the glass panel, indicating that the integrity of the glass has been compromised. Based on the condition observed at the time of inspection, the damage is considered major. Any additional stress, vibration, or minor impact may cause the crack to propagate further or result in sudden and complete failure of the glass panel.

Cracked shower screen glass presents a serious safety hazard. Tempered or toughened glass, when compromised, can fail without warning and shatter into multiple fragments, creating a high risk of personal injury to occupants. Continued use of the shower in its current condition significantly increases the likelihood of glass failure. In addition, deterioration of the crack over time is likely, which will ultimately require full replacement of the shower screen assembly rather than minor repair.

It is strongly recommended that a qualified glazier be engaged as a matter of urgency to assess the extent of the damage. The cracked glass panel should be repaired or, more likely, fully replaced to restore the shower screen to a safe and compliant condition. Until appropriate remedial works are completed, occupants should exercise extreme caution and avoid using or coming into contact with the affected shower screen to minimise the risk of injury.

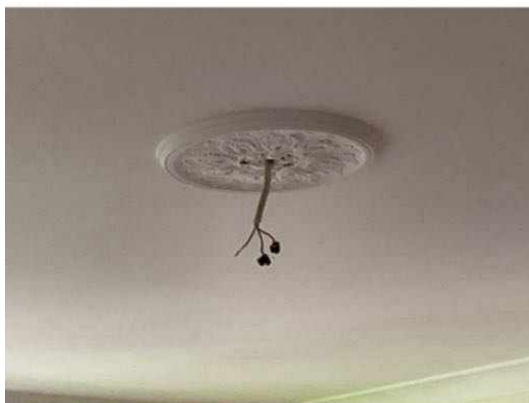
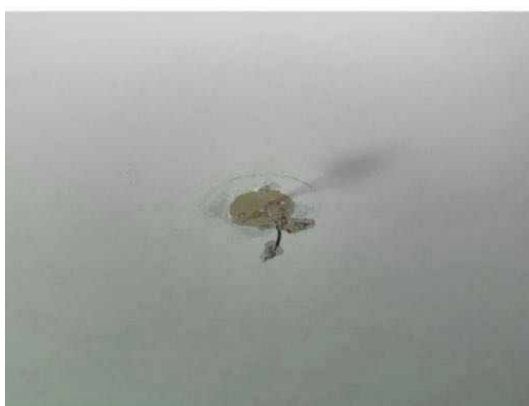
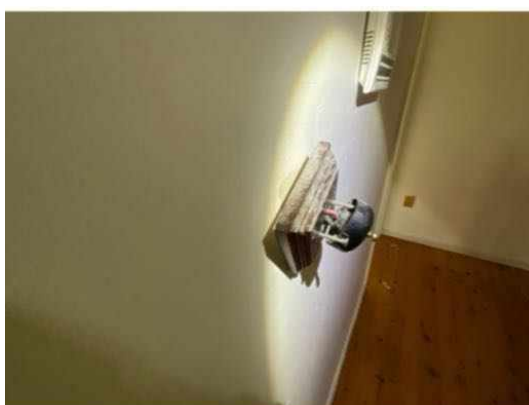
Finding 1.03

Building:	Main Building
Location:	Bedrooms
Finding:	Electrical – Exposed Wiring (Safety Hazard)
Information:	Exposed electrical wiring was identified within the bedroom ceiling areas where light fittings have been removed and not reinstated. The absence of enclosed light fixtures has left active wiring accessible at the ceiling lining interface. This condition is not considered safe and does not meet acceptable electrical safety standards.

In addition, a light switch located in the hallway was observed to be loose within its mounting. The switch plate was not securely fixed, and internal wiring was visible. Loose fittings can place strain on conductors and terminations, increasing the likelihood of short-circuiting, arcing, or overheating.

Exposed or inadequately protected electrical wiring represents a significant safety hazard. Risks include electric shock through direct contact, increased fire risk due to arcing or poor connections, and potential non-compliance with relevant electrical safety regulations.

This matter requires urgent attention. It is strongly recommended that a licensed electrician be engaged without delay to undertake a comprehensive inspection of the affected circuits, safely terminate or reinstall compliant light fittings, secure the loose switch, and ensure all wiring is properly enclosed and compliant with current electrical

standards. The area should be treated as a safety hazard until rectification has been completed.

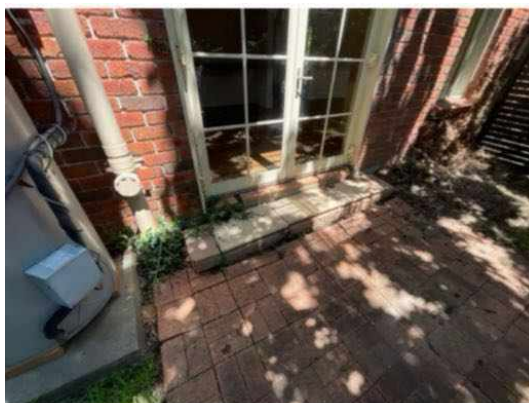
Finding 1.04

Building:	Main Building
Location:	Exterior - left side
Finding:	External Paved Area and Stair Access – Potential Safety Hazard
Information:	The paved surface leading to the side external doors was observed to be uneven and out of level at the time of inspection. Differential movement and/or subsidence of the paving has resulted in an irregular walking surface, which presents a foreseeable trip hazard to occupants and visitors. In addition, the uneven grading may allow water to

Tiles installed to the stair tread and threshold area were noted to be loose and/or not bonded. Loose tiles present a direct slip and trip hazard and may further deteriorate with continued use or exposure to weather conditions.

In its current condition, this area is not considered safe for regular foot traffic. Prompt rectification is recommended. Works should include lifting and reinstating affected paving to achieve a stable and adequately drained surface, stabilising or reconstructing the stair tread as required, and securely re-fixing or replacing loose tiles. All repairs should be carried out by a suitably qualified tradesperson to ensure safe and durable access to the external doors.

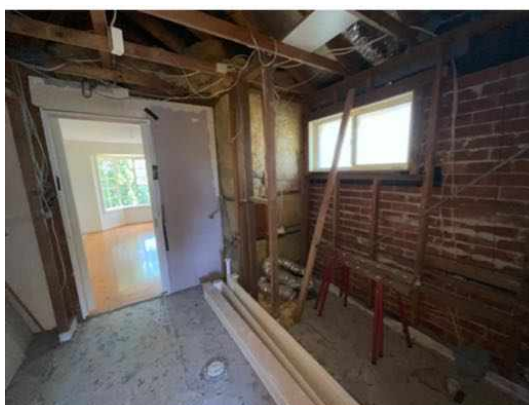
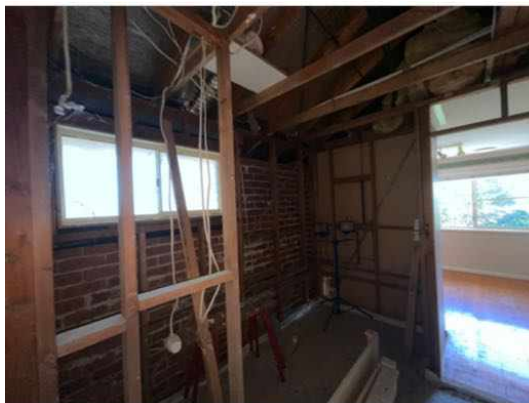
Finding 2.01

Location: Ensuite
Finding: Major Defect – Incomplete Ensuite Renovation
Information: The ensuite has been partially demolished in preparation for renovation works. Wall, floor and ceiling linings, including tiles and associated fixtures and fittings, have been removed. At the time of inspection, renovation works had ceased and the area remains incomplete.

As a result of the demolition stage, building elements are exposed, including structural framing and electrical cabling. Exposed electrical wiring presents a safety hazard and increases the risk of electric shock, mechanical damage to cables and potential fire risk if not properly protected and terminated. In addition, the removal of waterproofing, linings and floor finishes leaves surrounding building materials vulnerable to moisture ingress, deterioration and possible secondary damage if the area is inadvertently exposed to water.

An incomplete wet area renovation is considered a major defect in the context of a pre-purchase inspection. The bathroom is currently non-functional and cannot be used for its intended purpose. Furthermore, unfinished works may conceal additional defects, non-compliant work practices, or incomplete plumbing and electrical installations that cannot be fully assessed at this stage.

It is recommended that a suitably qualified and licensed bathroom renovation specialist or registered builder be appointed to assess the current condition of the works, verify compliance of any installed services, and complete the renovation in accordance with current Building Code requirements and relevant Australian Standards, including compliant waterproofing and certified electrical and plumbing installations. Any exposed electrical components should be made safe as a priority.

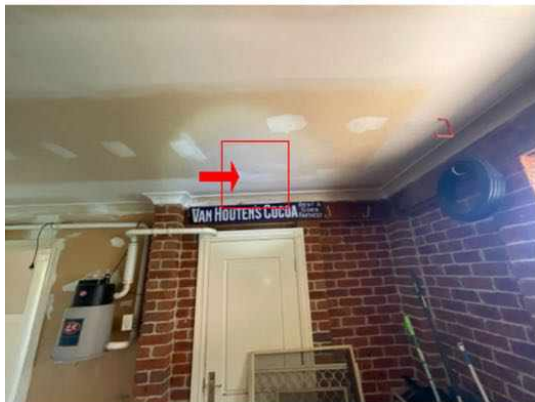
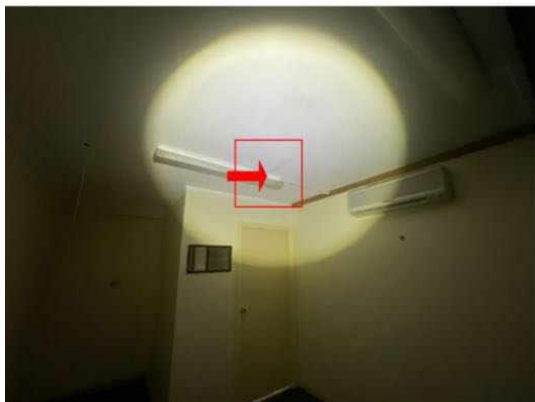
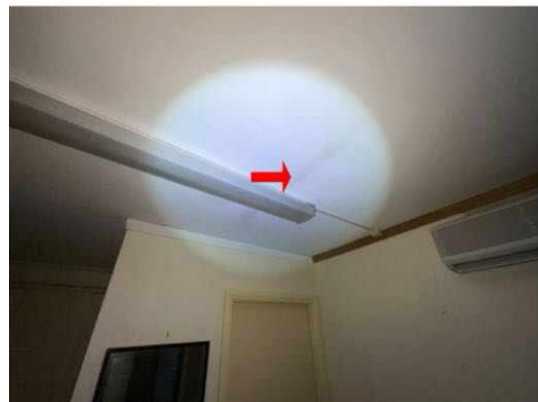
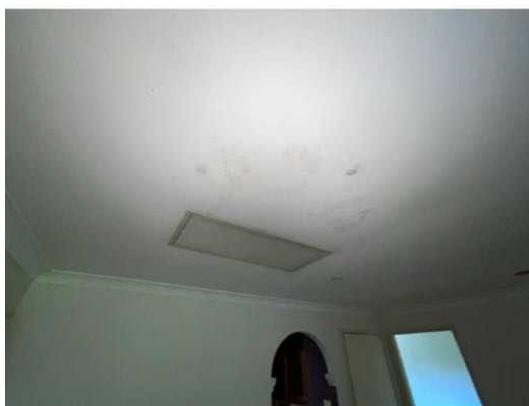
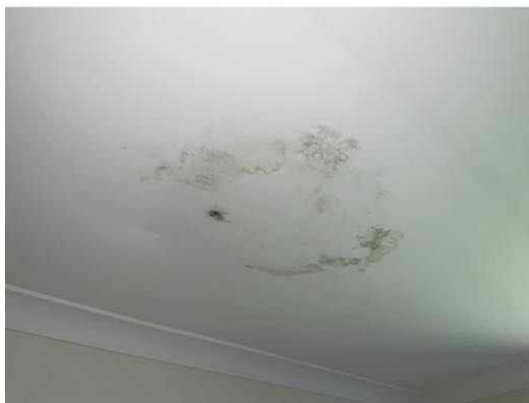
Finding 2.02

Building:	Main Building
Location:	Garage & Upstairs
Finding:	Ceiling - Water damaged
Information:	Observation:

Water staining and damage was noted to ceiling linings in the inspected area(s) at the time of the inspection. These stains present as discoloured or patchy areas and may suggest a history of moisture ingress, most commonly associated with roof leaks.

Water staining is typically the result of prolonged exposure to moisture, which allows minerals and other contaminants carried by the water to accumulate on surfaces, leaving visible marks. If ongoing or left untreated, moisture ingress can lead to more serious issues such as:

Due to the visual-only nature of this pre-purchase inspection, it is not possible to conclusively determine whether water staining is active or inactive at the time of inspection. Further assessment under a special-purpose inspection is recommended if a more detailed diagnosis is required.

Additionally, it is important to note that even minor damage to roofing materials—such as lifted flashings, cracked tiles, or poorly sealed penetrations—can allow water ingress that may lead to costly internal damage. Close-up inspection by a roofing contractor is advised to assess the condition of the roof coverings and associated fixtures more accurately.

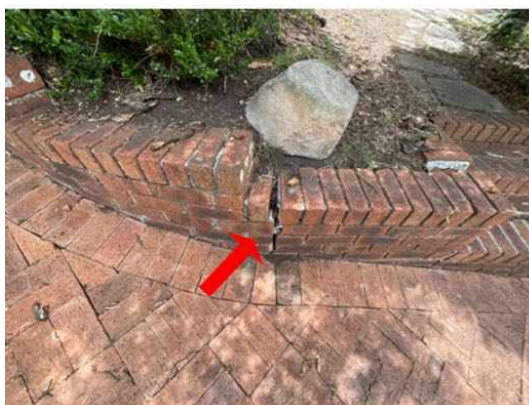
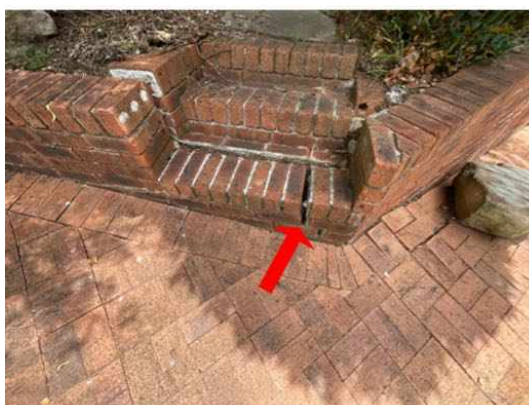
Finding 3.01

Building: Yard
 Location: Yard - Front
 Finding: Minor Defect – Masonry Retaining Wall.
 Information: Observation:

Monitoring is advised. If movement or further deterioration becomes evident, the client may consider:

- Engaging a landscaper or retaining wall contractor to carry out repairs or replacement
- Where the wall is considered structural, consulting a qualified structural engineer or building surveyor is recommended to assess and advise on appropriate remedial works.

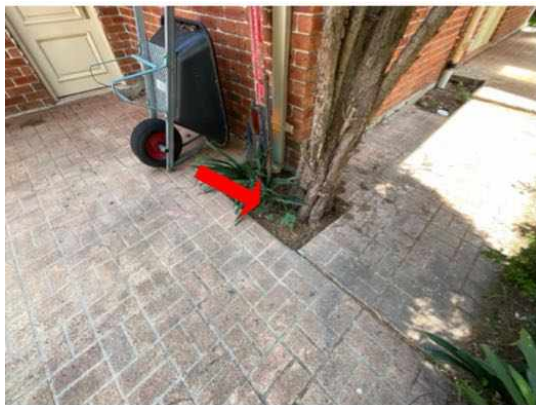
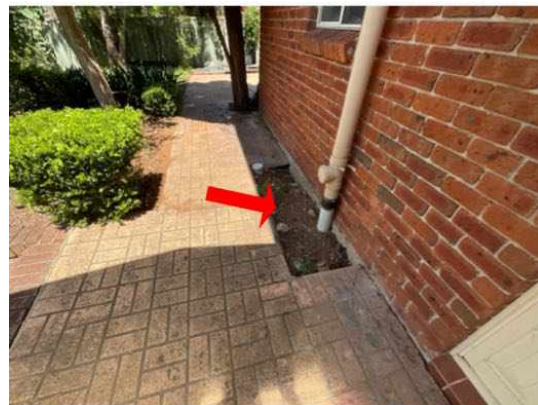
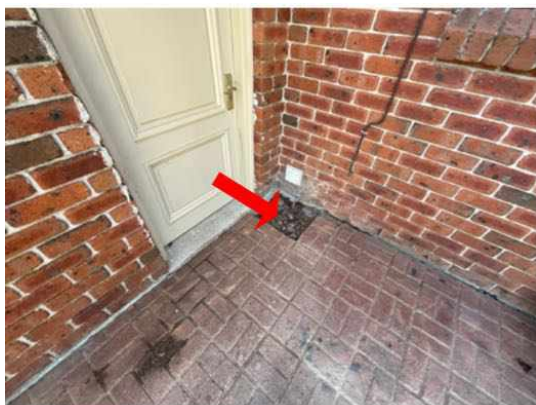
Finding 3.02

Building:	Main Building
Location:	Exterior - rear
Finding:	Inadequate Site Drainage & Surface Water Management.
Information:	Observation:

- Complete or upgrade surface as needed

Remedial action will help ensure effective water management and protect the building and site from water-related issues.

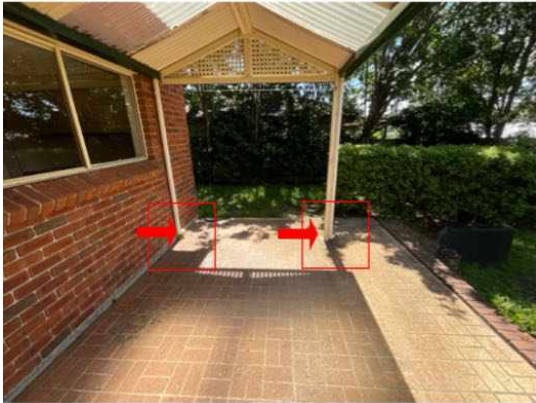
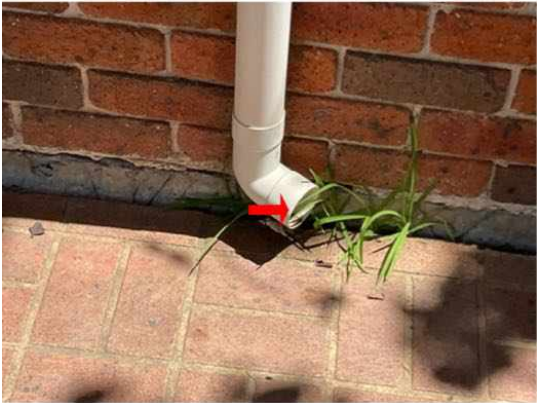
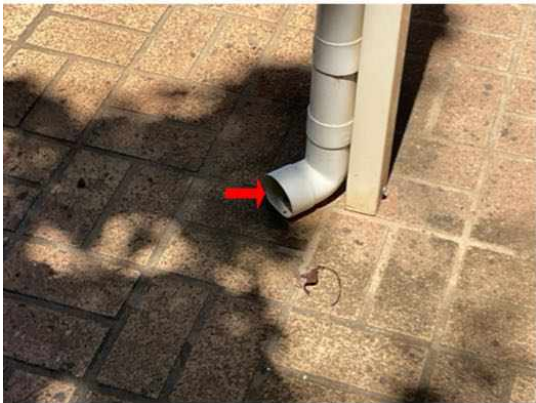
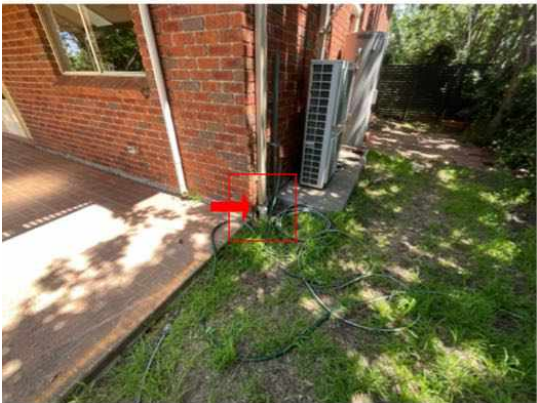
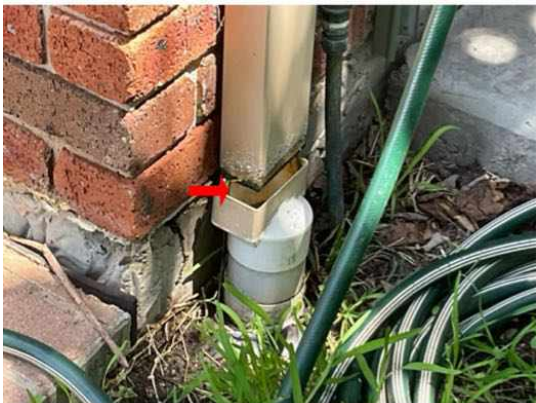
Finding 3.03

Building: Main Building
Location: Exterior - rear
Finding: Downpipe – Unconnected.

The current roof plumbing setup poses both compliance and moisture-management concerns, with the potential to contribute to structural or pest-related issues. Prompt rectification by a qualified professional is advised to ensure proper water management and protect the integrity of the building.

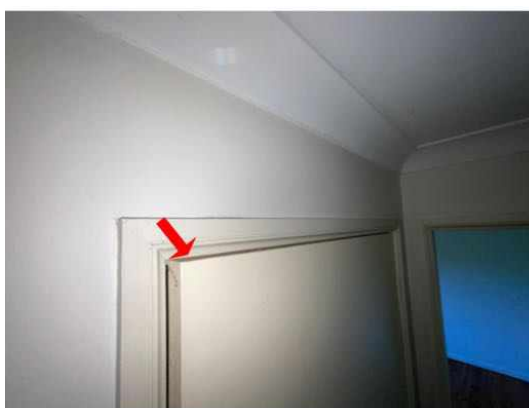
Finding 3.04

Building: Main Building
Location: Linen Cupboard
Finding: Door - Binding and/or Jamming.
Information: Functional Defect Identified

- If the issue appears to be related to major structural movement, it is recommended that a registered builder with experience in re-stumping or subfloor repairs be engaged to assess the extent of the movement and provide a quotation for necessary remedial works.
- Where the issue is minor in nature, a qualified carpenter or general handyperson may be appointed to carry out corrective works at the client's discretion.

Prompt assessment and remediation are advised to prevent further deterioration or related damage.

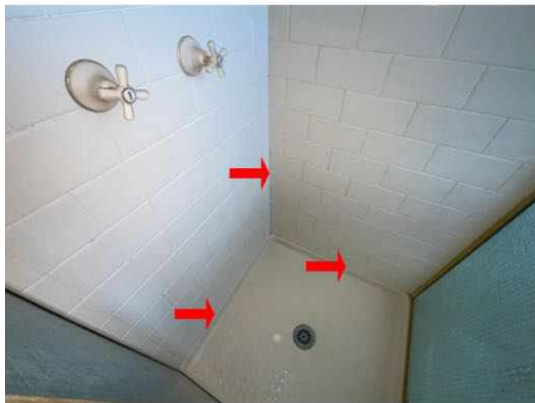
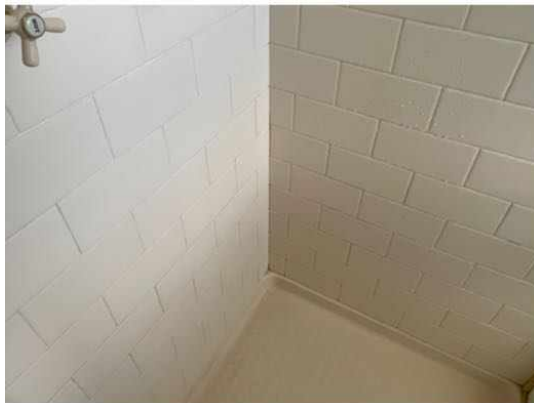
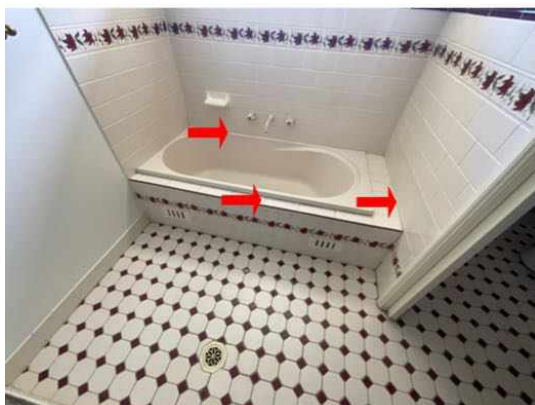
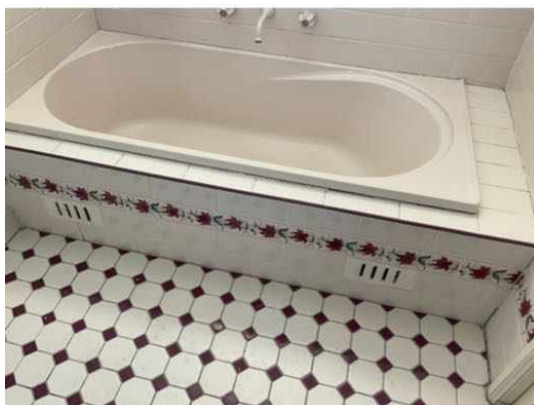
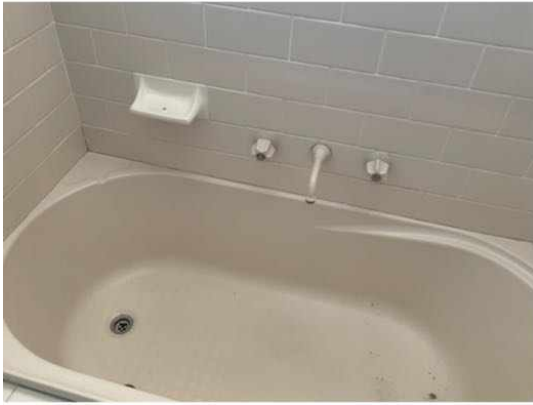
Finding 3.05

Building:	Main Building
Location:	Bathroom
Finding:	Sealant and grouting - Degraded or Missing

Sealant and grouting in areas that come into regular contact with water should be maintained for the long term care of your property.

A sealant specialist or tiling contractor should be appointed to complete these works as soon as possible.

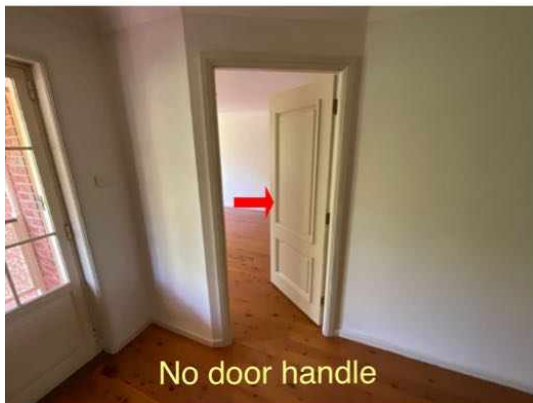
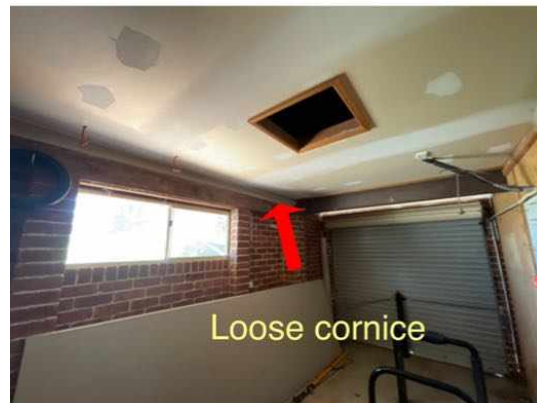
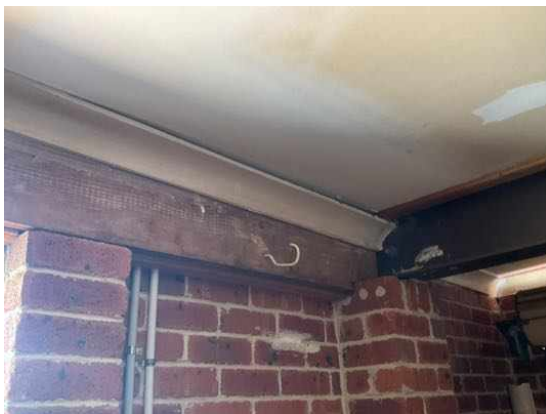
Finding 3.06

Building: Main Building
Location: All Areas
Finding: Photographic Reference Note.
Information: Additional photos have been provided for your general reference.

Arrows have been included in the images to highlight areas where minor defects or general wear and tear are present.

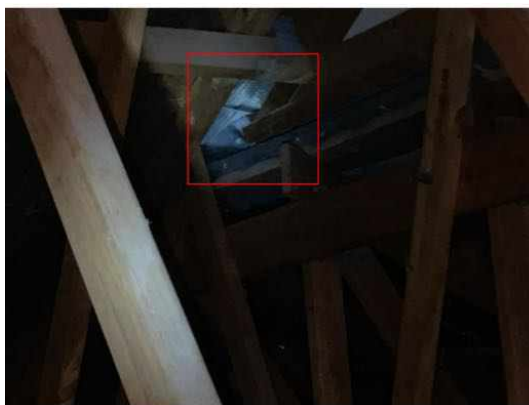
Finding 3.07

Building: Main Building
 Location: Roof Void
 Finding: Sarking was found to be damaged in this area.
 Information: Damaged Roof Sarking

It is recommended that a licensed roofing plumber or suitably qualified roofing contractor be engaged as soon as practicable to carry out a detailed assessment of the Dutch gable flashings. Any deteriorated or defective flashing materials should be repaired or replaced as necessary to restore effective weatherproofing. Prompt remedial action is advised to minimise the risk of ongoing water ingress and to prevent the development of further internal damage or consequential defects.

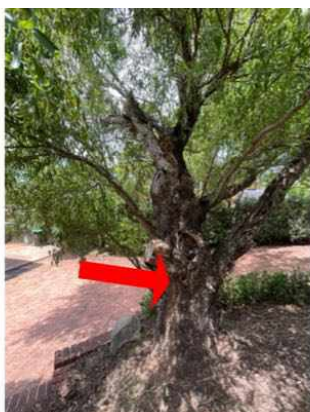
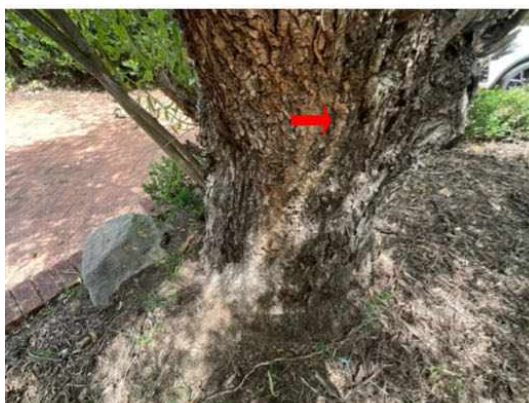
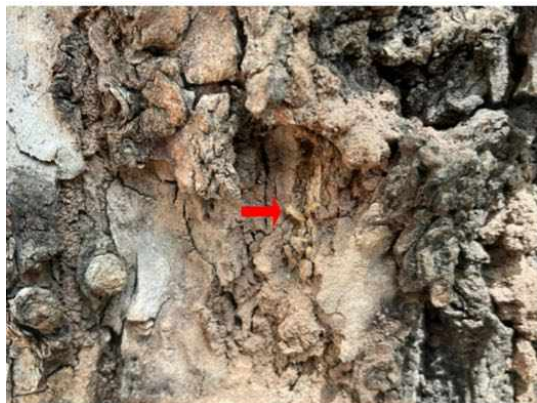
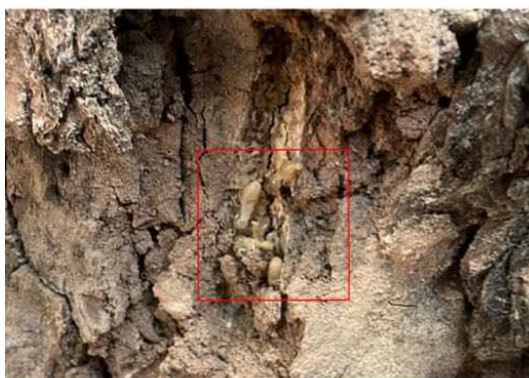
Finding 4.01

Active termite infestations will continue to cause damage while untreated. Immediate intervention is required to prevent further infestation of the affected tree and to reduce the risk of termites spreading to structural timber elements of the dwelling or other improvements on the property.

It is strongly recommended that a licensed and experienced pest management professional be engaged as a matter of urgency to identify the termite species, implement an appropriate eradication program, and assess the need for a comprehensive termite management system for the property in accordance with relevant Australian Standards. Ongoing monitoring and maintenance will be essential to mitigate future risk.

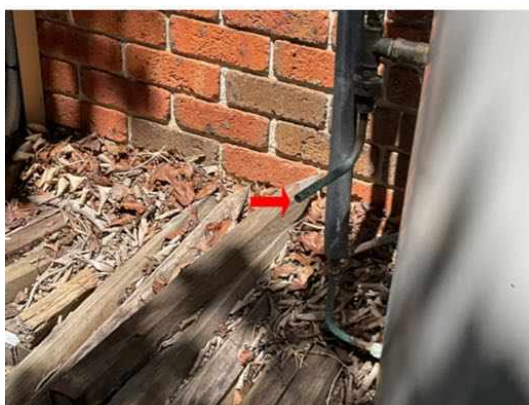
Building: Main Building
Location: Yard
Finding: Conducive Conditions – Timber and Firewood Storage Near the Structure..
Information: During the inspection, it was noted that timber and/or firewood is being stored against the house including around the external areas of the property. This practice is considered a conducive condition for timber pest activity, particularly termites.

Termites are naturally attracted to cellulose-based materials such as untreated timber and firewood, which can serve as both a food source and a potential nesting site. When these materials are stored in contact with the ground or close to the building's perimeter, they create ideal conditions for termites to establish activity and potentially gain concealed entry into the structure.

It is strongly recommended that all firewood, off-cuts, untreated timber, and similar cellulose materials be immediately removed from direct ground contact and relocated away from the building's perimeter (ideally stored on a raised, well-ventilated platform at least several metres from the structure). This significantly reduces the likelihood of attracting termites and helps maintain an environment that is less favourable for timber pest activity.

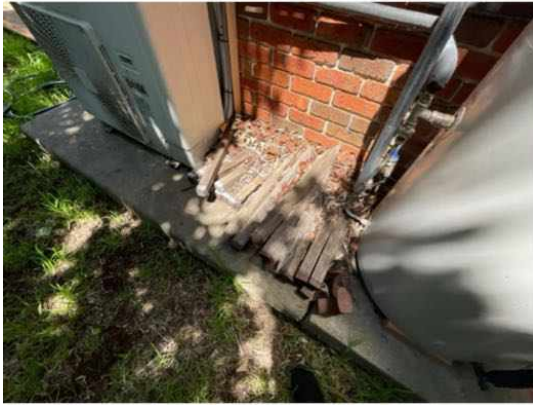
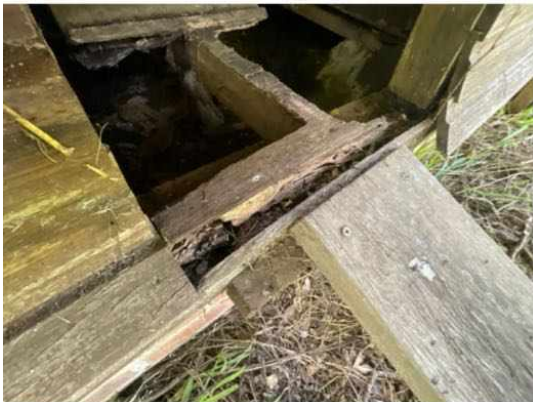
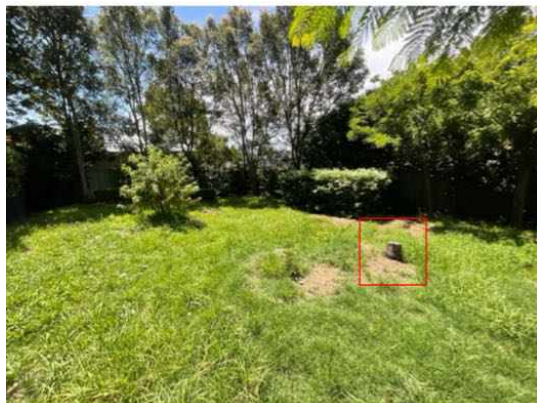
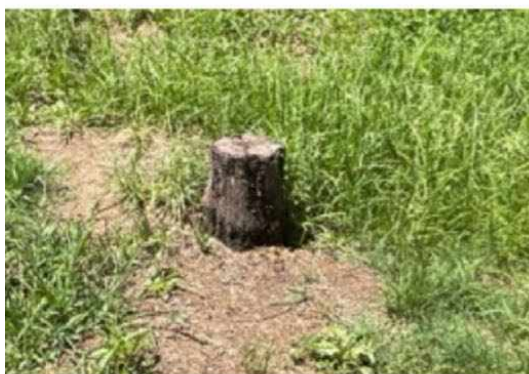
Building:	Main Building
Location:	Exterior walls - left side
Finding:	Bridging of Termite Barriers – Concealed Weep Holes..
Information:	Observation:

At the time of inspection, it was noted that the weep holes in the external brickwork of the property are concealed by adjacent concrete paving, stored timber and vegetation. This creates a bridging point for termites, allowing undetected access over or around the termite barrier system and into the structure. As a result, a full inspection of this area could not be achieved. Where external weep holes are not visible or accessible, there is a significantly increased risk of concealed termite entry. Termites can exploit these hidden access points to enter the structure undetected.

- All weep holes should remain exposed and unobstructed across the entire property to allow for effective drainage and visual termite inspections.
- It is strongly advised that any material or structure covering weep holes be removed promptly, and a re-inspection carried out to ensure termite entry is not occurring undetected.
- Where removal of obstructions is not feasible, it is recommended that the area be inspected regularly, ideally every 3 to 6 months, to monitor for signs of termite activity or moisture-related damage.

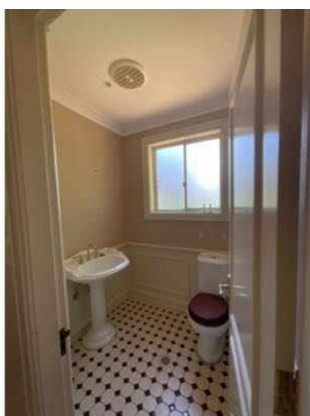
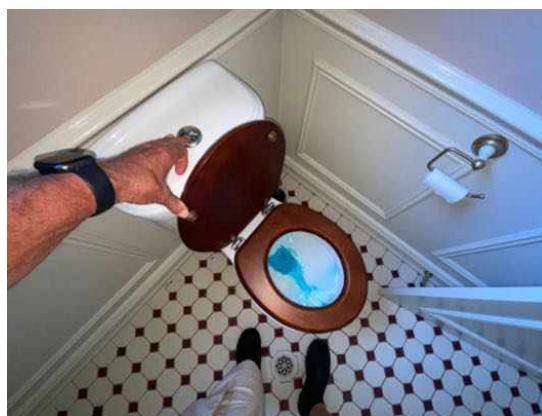
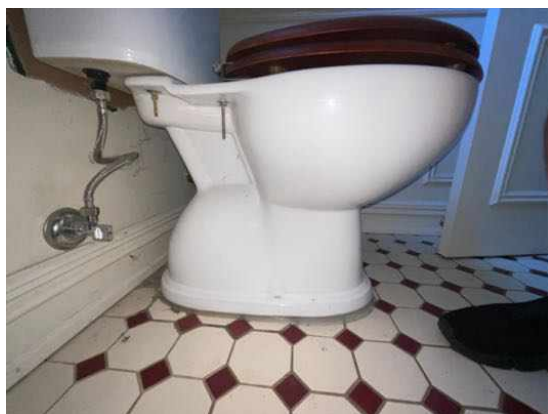
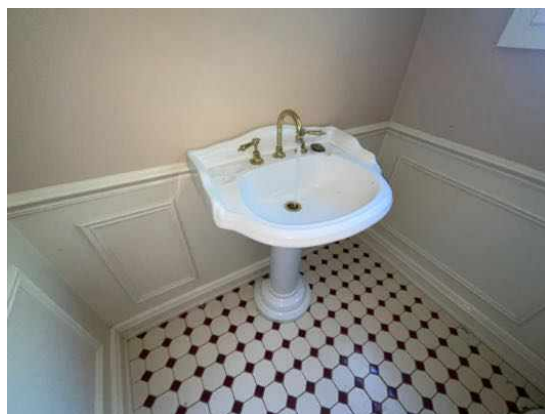
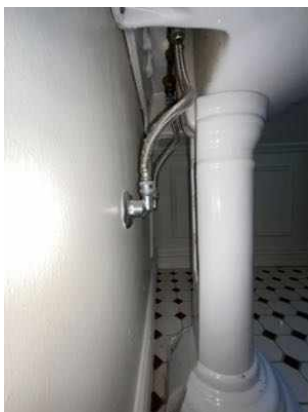
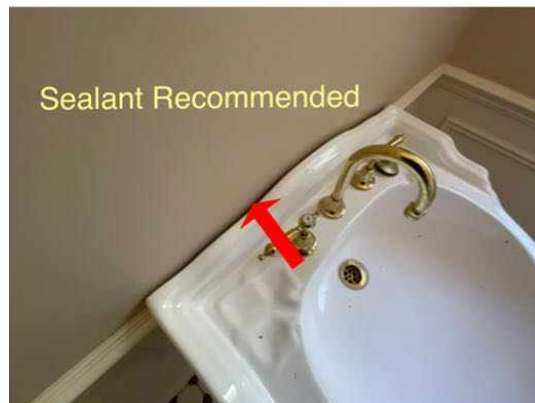
Building: Main Building
 Location: All Areas
 Finding: Water Pressure – Observation Only.
 Information: During the inspection, water pressure appeared to be within a normal operating range based on a basic functional check. However, this observation was made without the use of pressure testing equipment and does not constitute an assessment by a licensed plumber.

It is strongly recommended that a Licensed Plumber be engaged to conduct a comprehensive assessment of the plumbing system to verify its functionality, check for any underlying issues, and confirm compliance with current regulations and standards.
