Building and Timber Pest Inspection Report

Inspection Date: Tue, 3 Feb 2026

Property Address: 5/9-11 Veron St, Fairfield East NSW 2165,
Australia

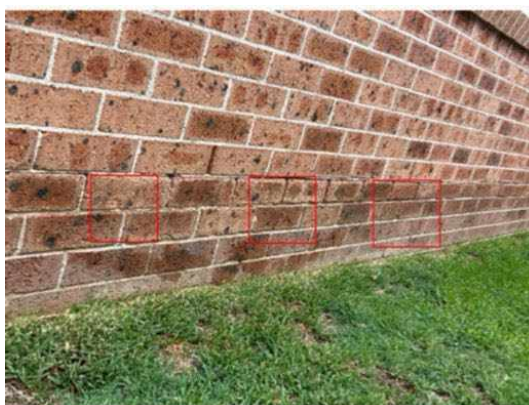
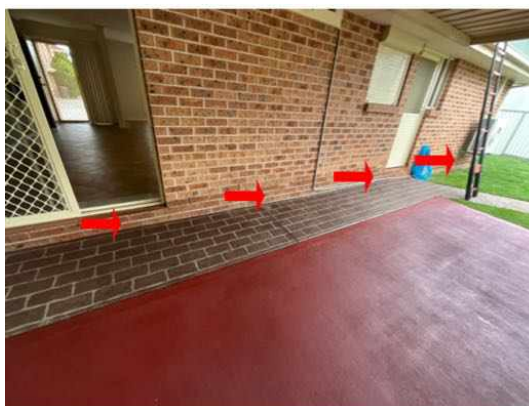
Building:	Main Building
Location:	Lower sections of external walls
Finding:	Brickwork and Mortar - Deteriorated (Erosion)
Information:	Lower sections of walls were found to be deteriorated. Mortar, or 'bedding', is the material which fills joints and intersections between bricks in masonry walls and structures.

Commonly referred to as corrosion or erosion, the bricks and mortar are aged and likely to have been affected by a variety of factors, including moisture, salt-based deterioration, and more.

Regular monitoring must be carried out as the conditions are currently not severe. A licensed plumber must be appointed urgent to ensure site drainage is addressed adequately.

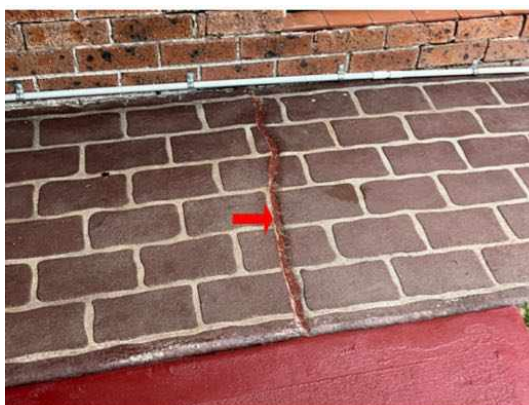
Finding 3.03

Building:	Main Building
Location:	Alfresco
Finding:	Cracking - External Concrete Paving Damage Category 3 - Wide Cracks (2mm - 4mm)
Information:	Wide cracks were identified in external concrete paving. Wide cracks are significant and are likely to lead to the development of safety hazards and secondary defects if left unmanaged.

General age and expected deterioration of the paved areas is a common cause of this type of cracking. However, expansion and contraction of the slab may also have occurred due to environmental factors. Such factors include variable moisture and weather conditions, the presence of trees and their roots having a settling or lifting affect on the soil, or the effect of load bearing, e.g. heavy vehicles over a sustained period of time.

Cracking to this degree may also be due to poor original installation of the concrete. Factors such as poor compaction of the sub surface and/or inadequate reinforcing of the slab may create cracking and other secondary defects. Wide cracks may also have a more significant structural cause, such as subsidence of soils.

Where the crack is located adjacent to structural elements of the building, the advice of a Structural Engineer is advisable before undertaking repairs.

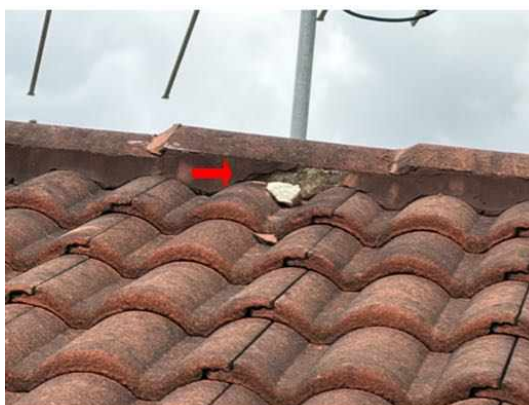
Finding 3.04

Building:	Main Building
Location:	Roof Exterior
Finding:	Roof tiles - Weathered
Information:	Upon inspection of the exterior roofing, the majority of roof tiles were considered to be in a fair condition. While weathering of the tiles is consistent with the age of the property, maintenance works are required.

Isolated areas of mortar have come loose and minor cracking is also present. Re-pointing and re-sealing the may be considered as an interim solution by the client to help preserve and extend the life span of the tiles.

Where left unmanaged, deteriorating roof tiles are likely to lead to a number of secondary defects, including minor water leaks and weather exposure to internal roofing structures.

Consultation with a licensed roofing contractor is highly advised to gain advice on cost of remedial works that may be required in the short to medium term. Remedial works are likely to increase the longevity of the exterior roofing structure.

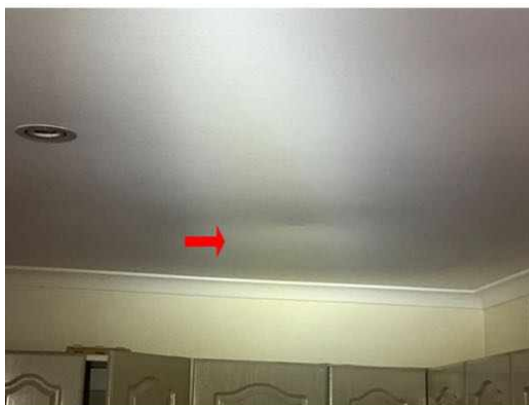
Information: Sections of the ceiling were found to be sagging at the time of inspection. Sagging to the fixed ceiling structure generally indicates that the building materials have swollen, due to contact with water, or that fixings (e.g. nails or glue) have become loose and require reattachment.

Where minor sagging is evident, comparatively minor works, such as re-gluing of ceiling sheets, may be required. Such works may be performed by relevant tradespeople, such as plasterers and painters. Where excessive moisture has caused the roofing structure to swell and sag, the source of the water leak should primarily be identified prior to any remedial works being performed.

The appropriate action should be taken by the client as soon as possible to ensure that any potential further damage is limited.

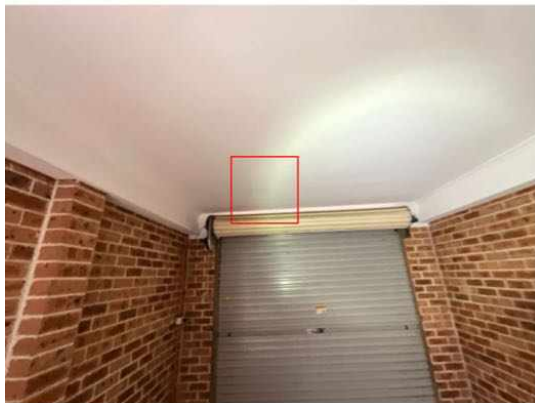
Finding 3.07

Finding: Water leak - Inactive

Information: Water leaks generally occur when a particular area of the property is not weather- or water-tight. Repair work was identified to the roof flashing above this point. While the damage in this area appears to be from an old inactive water leak, the area should be monitored frequently for the recurrence of any dampness.

Repair and / or replacement of previously affected building elements is at client discretion. Consider a further invasive inspection: removal of obstructions around the damaged area may reveal further damage which has been concealed. A more significant or major defect may be identified at this time.

Where recurrence of an active water leak is identified, a licensed roof plumber should be appointed immediately to rectify the leak and advise on any further preventative works as necessary.

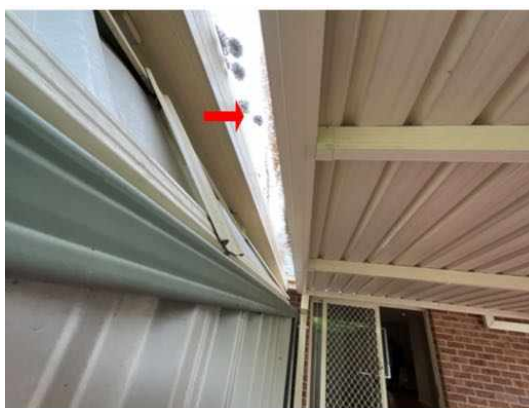
Finding 3.08

Works that have not been completed to a satisfactory level create potential for the development of building defects and may impede on the safety and integrity of the overall structure.

It is highly recommended that the relevant trades be appointed to complete these works and ensure the safety of the area and the longevity of all associated building elements.

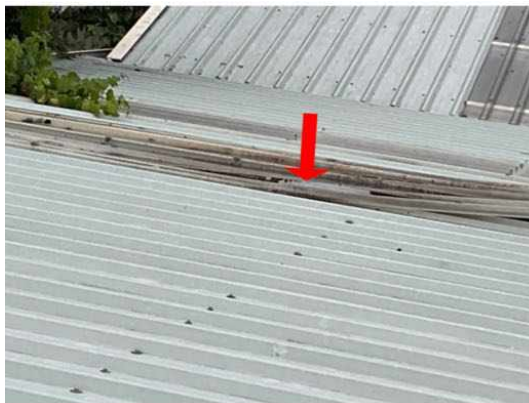
Finding 3.09

Building: Main Building
 Location: Alfresco
 Finding: Roof sheets - Water pooling
 Information: The roof drainage in sections of the exterior roof appears to be poor, evidenced by water pooling on the roof sheets. This is generally caused by either inadequate roof plumbing or roof structures not effectively draining due to the construction method.

Where water is pooling, rust and deterioration of the roof sheets is imminent if left unattended, which may necessitate major repair works.

Consultation with a roofing plumber is recommended as soon as possible to provide advice on rectification options. Additional works to rectify structural issues with the roof may also be required.

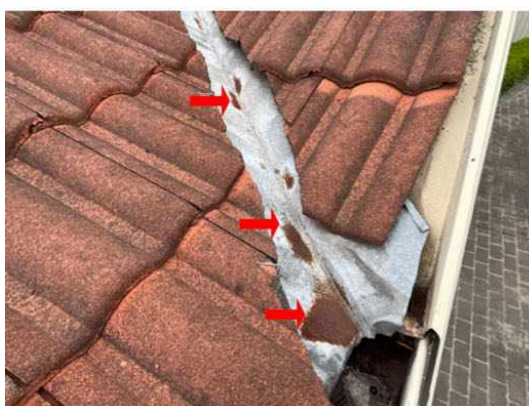
Finding 3.10

Building: Main Building
 Location: Front Elevation
 Finding: Valley - Rusted
 Information:

The valley on the roof were found with rust and corrosion. Rusted roof plumbing will generally develop holes and leaks that can affect other building elements with poor drainage of storm water. Poorly drained roof areas will also lead to damp conditions surrounding the base perimeter of the building which, if left unmanaged, can lead to a range of secondary building defects.

Repair and/or replacement of rusted roof plumbing is highly required in order to reinstate the roof drainage system to a fully operational level. To further maintain these areas, gutters should be cleaned frequently, allowing the avoidance of any partial blockages.

A licensed roofing specialist should be engaged for rectification as soon as possible.

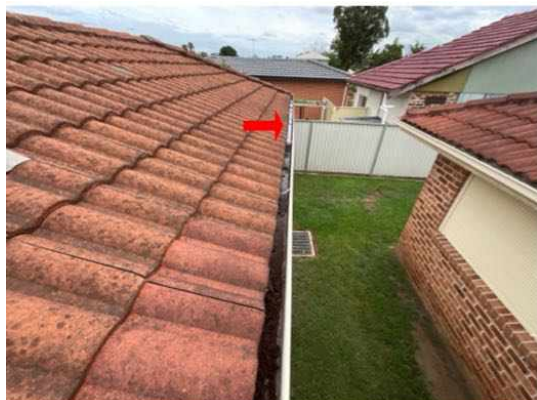
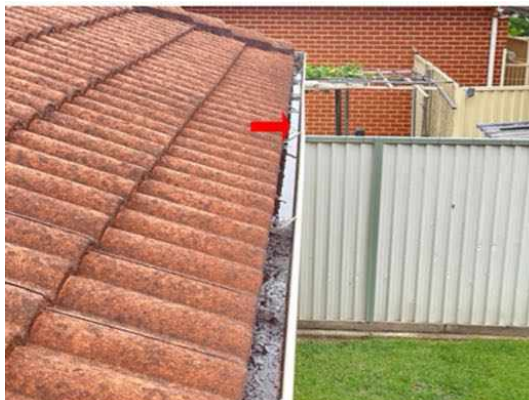
Building: Main Building
 Location: Garage
 Finding: Gutters - Water pooling
 Information: Water was found to be pooling in sections of the roof guttering. This is generally a secondary defect caused by blocked or partially blocked gutters. Furthermore inadequate fall to the adjacent downpipe could also be the underlying cause.

Water pooling is likely to lead to rust and water damage to associated structures if left unattended. This excess dampness is additionally conducive to termite activity.

Any areas of guttering that shows evidence of water pooling should be checked for partial or full blockages or otherwise appropriate fall to the downpipe must be applied accordingly. Any secondary damage that may have occurred as a result must be rectified. Depending on the extent of the damage, building elements may require repair and/or replacement to ensure adequate roof drainage and function of exterior

plumbing system.

A roofing plumber must be appointed as soon as possible if inadequate fall to downpipe is deemed to be the cause. It is highly advised that all gutters be maintained on a frequent basis to ensure the condition of roof plumbing.

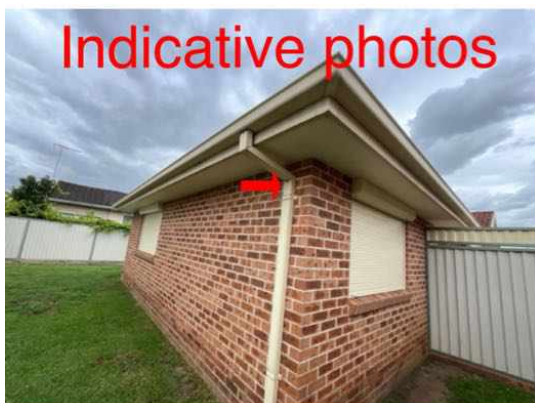
Finding 3.13

Building:	Main Building
Location:	Rear left corner
Finding:	Stormwater drain - Damaged
Information:	The roof plumbing is not adequately connected to stormwater drainage on the site. This disconnection negatively impacts the functional capacity of the roof plumbing.

Where roof plumbing doesn't drain adequately, the area at the base perimeter can become excessively damp, potentially creating an environment that is susceptible to rust and corrosion of surrounding building elements, as well as attracting termites and other pests.

It is highly recommended that a plumber be appointed to further inspect the area and to install adequate drainage equipment where necessary.

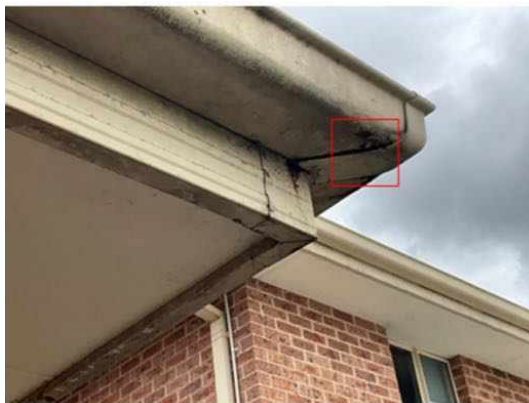
Building:	Main Building
Location:	Multiple areas
Finding:	Water leak - External
Information:	Water leaks were found to be present to exterior plumbing work. Leaks are generally caused by deterioration of the plumbing elements over time, due to exposure to weather conditions, but may have also been caused by minor impact damage.

Such leaking creates damp conditions in the affected area, causing potential for water pooling and subsequent water damage if left unattended. These conditions may also attract termite attack, particularly if the area is subject to minimal levels of sun throughout daylight hours.

It is highly advised that a licensed plumber be appointed to rectify any water leaks that may be present. Areas of repair and replacement of plumbing fittings and fixtures may be required and, as such, a quotation should be sought.

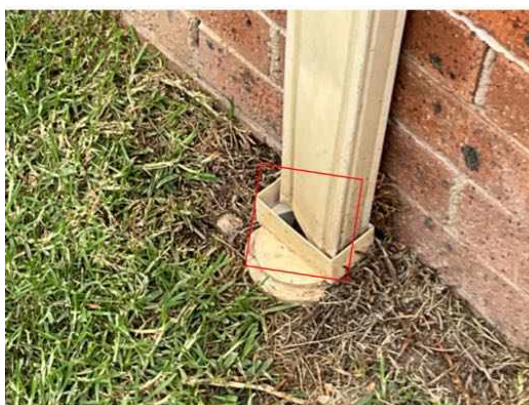
Finding 3.15

Building:	Main Building
Location:	Rear right corner
Finding:	Plumbing - Point of connection non-compliant
Information:	At the time of inspection it was noted that connections between above ground pipe work and below ground sewer/storm water systems were incomplete.

Additionally, where sewer pipes are concerned, gases can escape from unsealed connections which can pose a serious health risk.

Engagement of a certified plumber is strongly recommended to ensure all connection points are sealed in accordance with the plumbing construction guidelines.

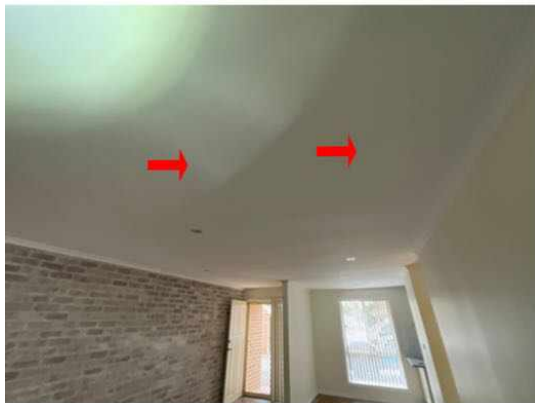
Building:	Main Building
Location:	Lounge Room
Finding:	Cracking - Damage Category 0 - Hairline (less than 1mm)
Information:	Hairline cracks are very minor in nature and generally are only ever an appearance defect. While such cracking may be noticeable in some cases, it is quite common and does not indicate any structural damage.

Cracking of this nature can generally be repaired with minor sanding, filling and/or repainting. Such works should be performed by a qualified painter or a general handyman.

Monitoring of all cracking should be conducted frequently. Always contact a building inspector should cracks widen, lengthen, or become more numerous.

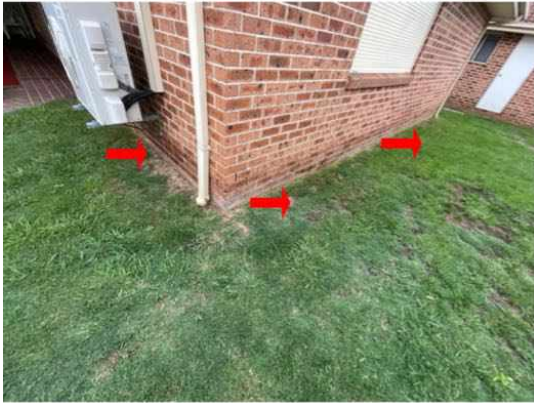
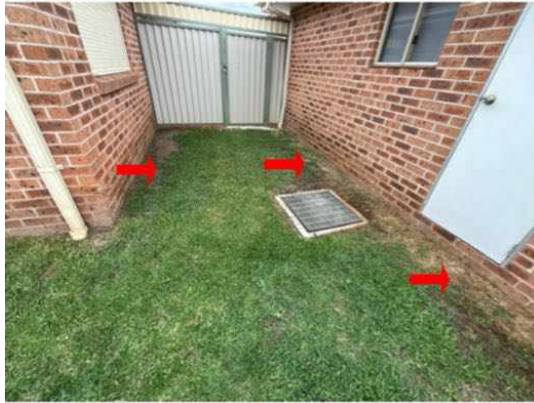
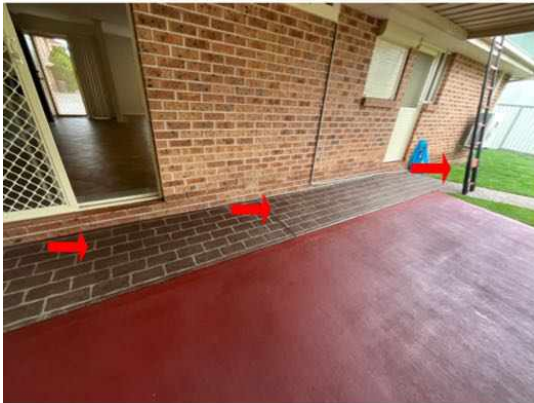
It is important that water does not lie against the base of walls; surrounding paths and ground levels should be sloped to drain water away from walls. Downpipes should not discharge stormwater onto lower walls or plinths. Stormwater should be carried away by large, regularly cleaned drains. Ground levels may need to be lowered to expose a buried DPC.

Where site drainage is inadequate, installation of an Agricultural (Aggie) Drain may be required. A licensed plumber should be appointed to further inspect the property and perform any remedial works as necessary. Water damage and secondary defects are likely to occur if left unmanaged.

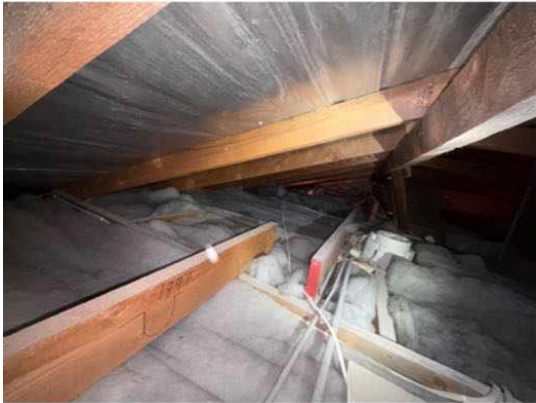
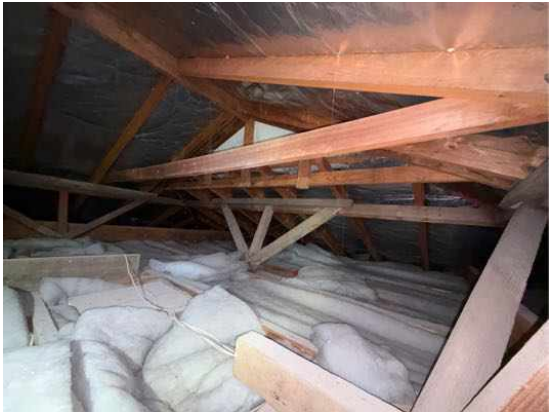
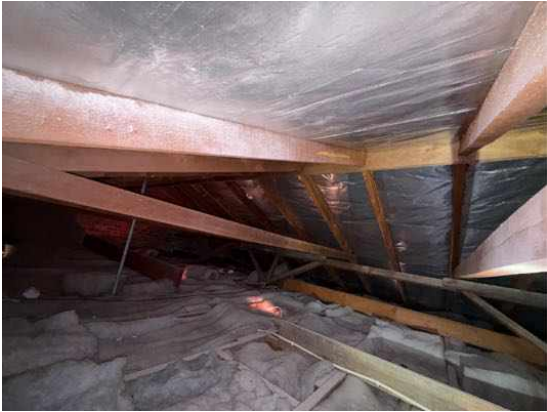
Building: Main Building
Location: Roof Void
Finding: Additional Photos
Information:

Additional photos are provided for your general reference.

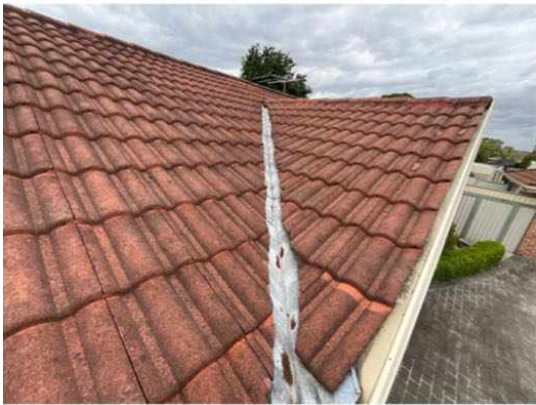
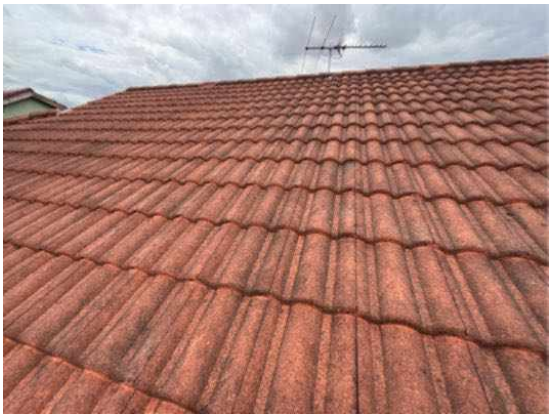
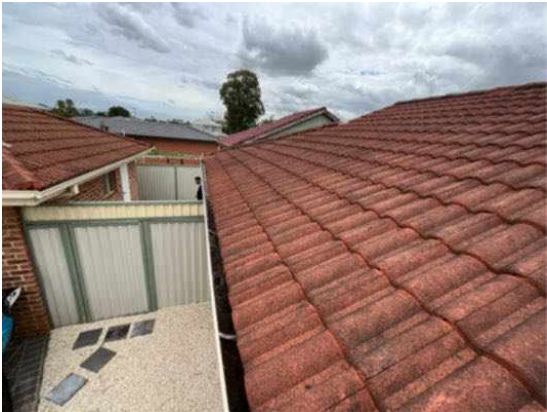
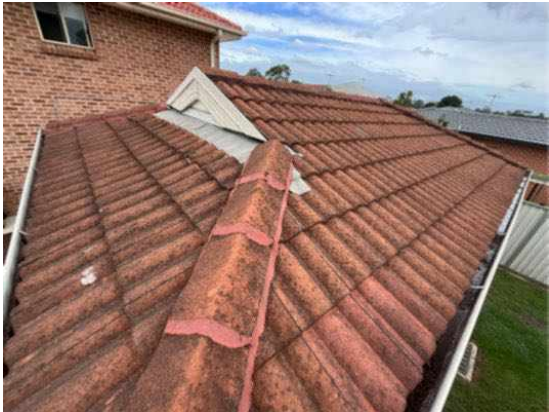
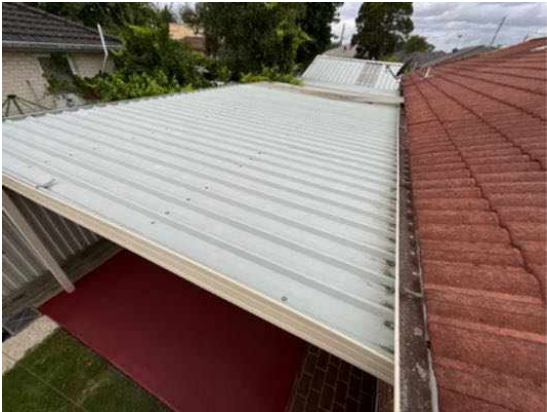
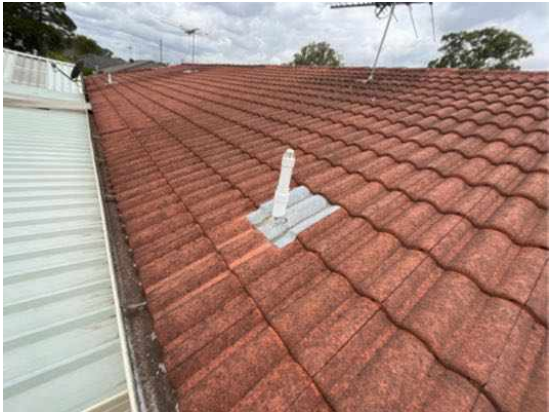
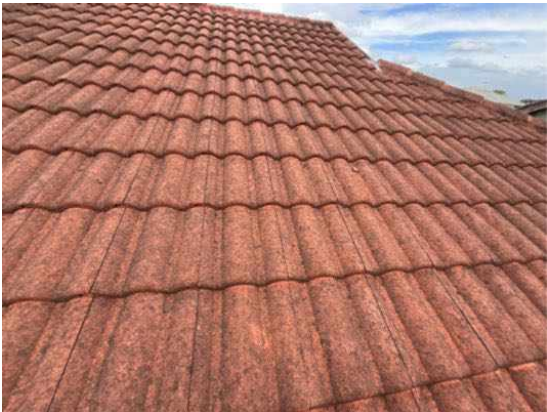
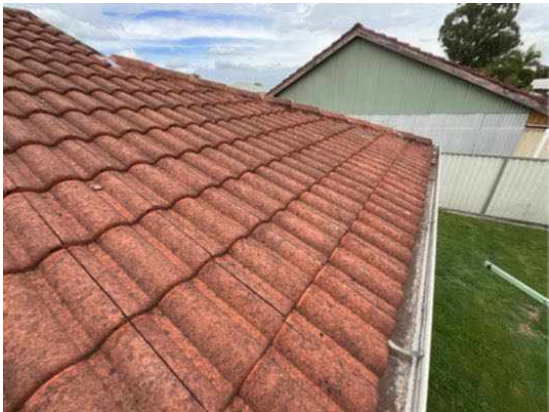
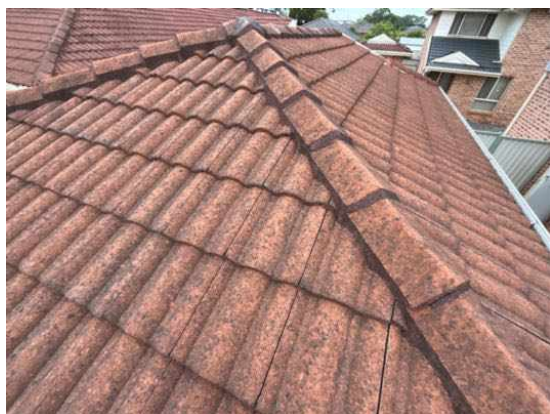
Building: Main Building
Location: Roof Exterior
Finding: Additional Photos
Information:

Additional photos are provided for your general reference.

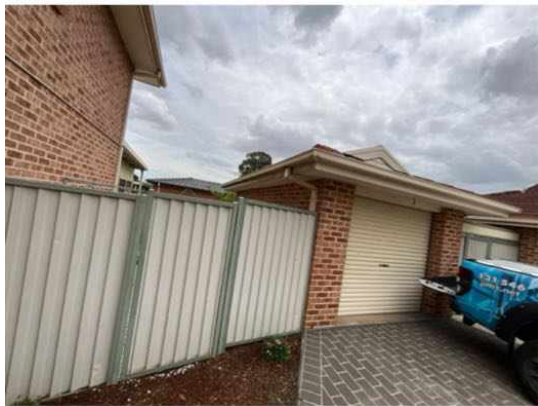
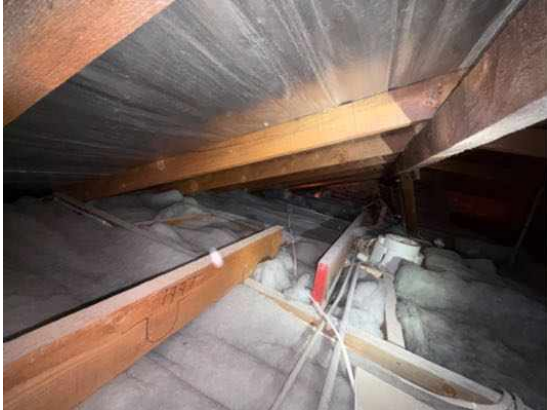
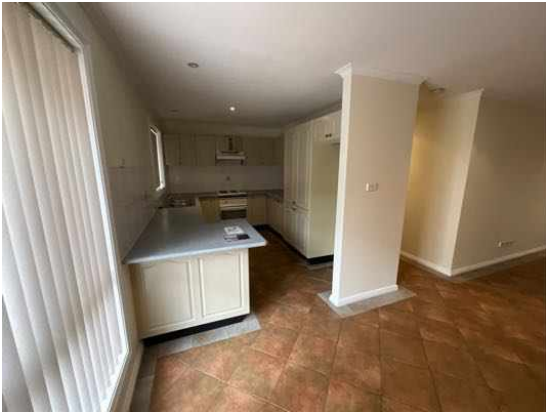
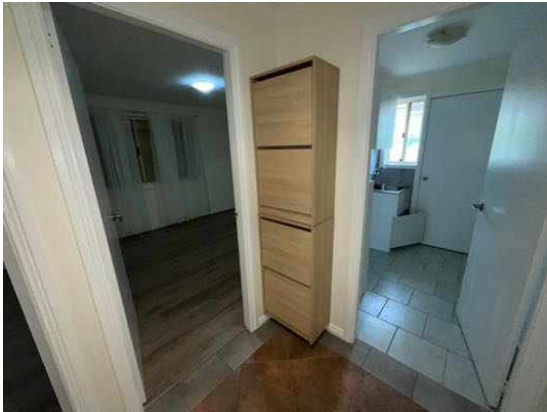
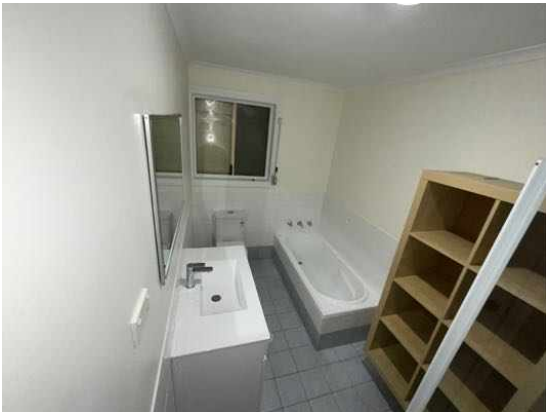
Building: Main Building
Location: All Areas
Finding: Additional Photos - Obstructions and Limitations
Information:

These photographs are an indication of the obstructions and limitations which impeded full inspection of the property at the time of inspection. These obstructions can hide an array of defects and should be removed to allow full inspection to be carried out. A re-inspection is recommended once the areas are made accessible.
