Building and Timber Pest Inspection Report

Inspection Date: Tue, 27 Jan 2026

Property Address: 20 Forman Ave, Glenwood NSW 2768,
Australia

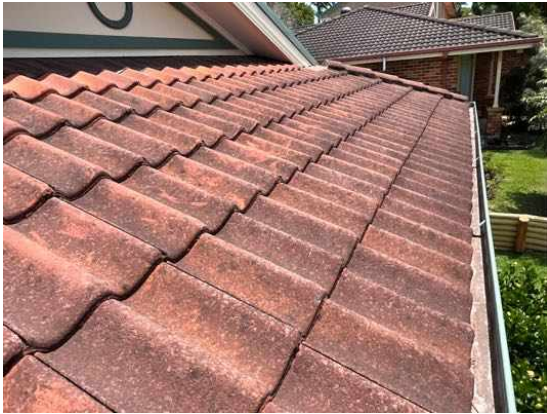
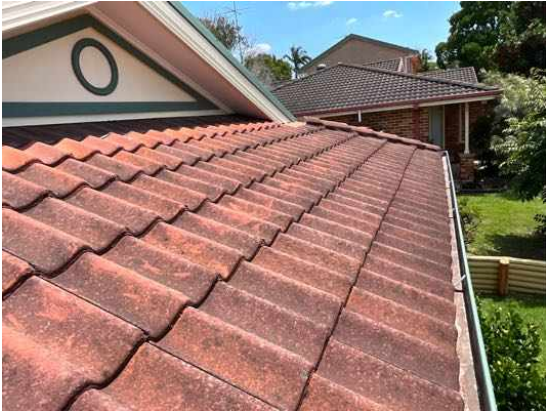
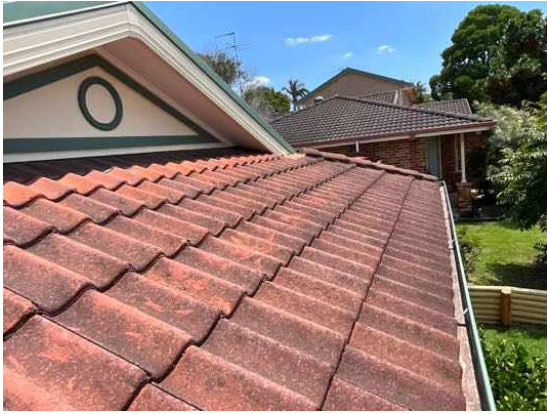
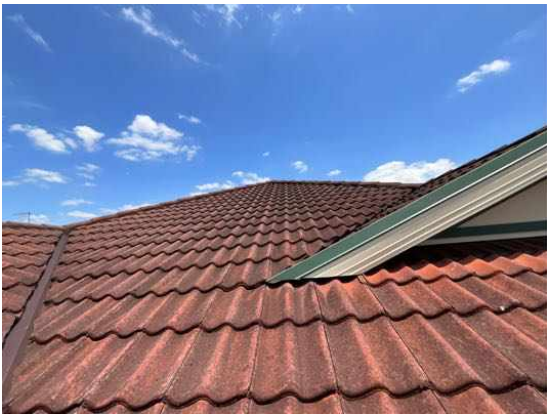
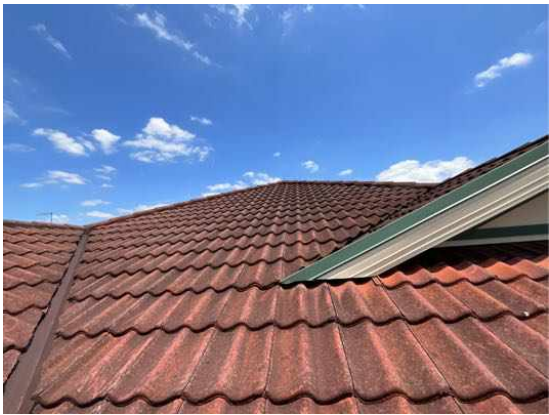
Finding 3.02

Building: Main Building
Location: All Areas
Finding: Blocked Gutters
Information: Blocked gutters , advised gutter to be cleaned.

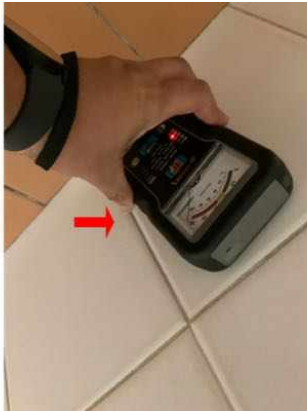
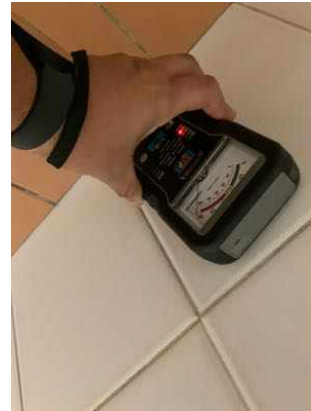
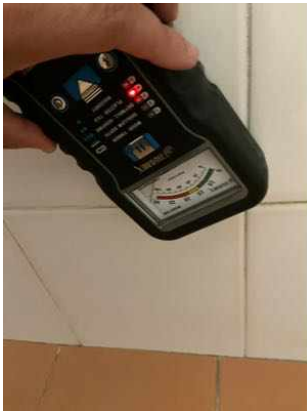
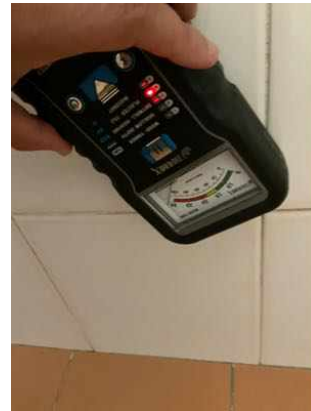
Finding 3.09

Building:	Main Building
Location:	Ensuite
Finding:	Shower base - Water pooling
Information:	Evidence of water pooling around the floor waste in the shower recess was noticed at the time of inspection. It is suspected that this excessive moisture is attributed to insufficient fall in the shower floor tiles.

This pooling is minor overall but is still considered unsatisfactory, as standard tiling practices would not permit this situation to occur. Pooling water around floor wastes can create a slip hazard in extreme cases and create conditions that are conducive to mould growth over time. Where left unmanaged, the degradation of sealant and grouting is also likely to occur, possibly necessitating further repair works.

Remedial works may involve some sections of tiling and flooring repair and replacement. A tiling contractor or bathroom specialist should be appointed to provide further advice on reparation options and to perform works as necessary.

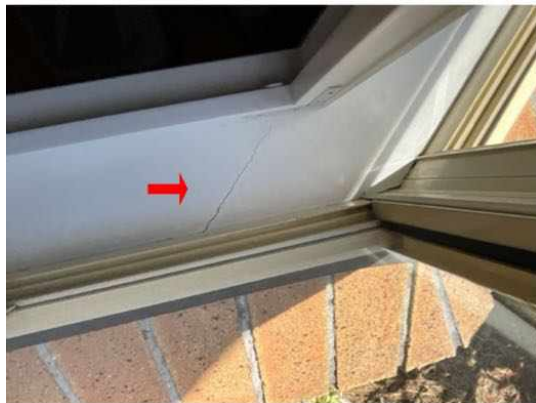
Building: Main Building
 Location: Living Room
 Finding: Window Frame Crack
 Information: A crack near a window frame,. This crack may indicate movement or settling in the structure, poor finishing work, or thermal expansion.

- Structural Movement: If the crack is caused by structural movement, it could worsen over time, leading to more significant structural issues.
- Water Ingress: Cracks around window frames can allow moisture to seep into the

wall cavity, potentially leading to water damage, mold growth, or decay.

- Aesthetic Concerns: The crack detracts from the aesthetic appearance of the wall and may worsen without proper repair.

- Builder or Structural Engineer: If there is concern about structural movement, a structural engineer should assess the crack to determine the cause and ensure the stability of the area.
- Handyman or Painter: If the crack is minor and not related to structural movement, a handyman or painter can fill and repair the crack, followed by repainting to restore the wall's appearance.
- Window Installer: If the crack is related to improper window installation, a window installer may need to inspect and adjust or replace the window.

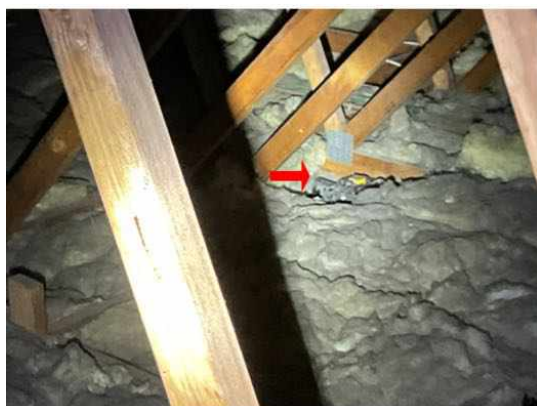
Finding 3.11

Building: Main Building
 Location: Roof Void
 Finding: Exhaust fan not vented out
 Information: The exhaust fan located within the roof void is not appropriately ducted to the external atmosphere and is currently discharging moist air directly into the roof space. This is considered a defect under AS 4349.1, as it does not meet the minimum standard of residential building performance expected under normal residential building practices.

It is recommended that the exhaust fan be modified by a licensed HVAC contractor or qualified builder, ensuring it is properly ducted to discharge externally in accordance with manufacturer specifications, the National Construction Code (NCC), and applicable Australian Standards.

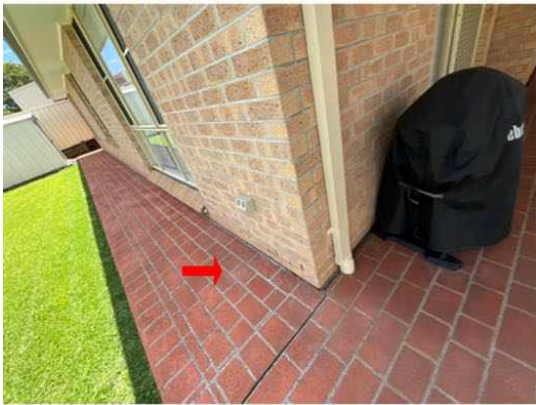
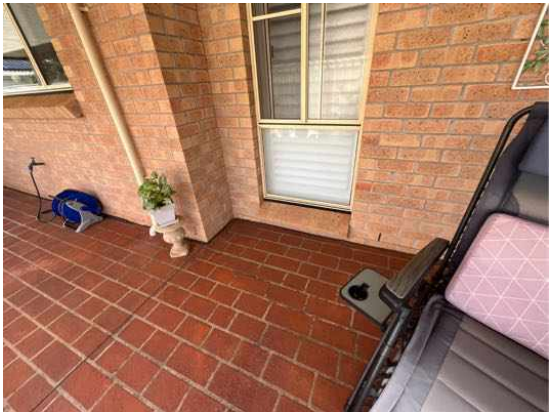
If the slab edge is not properly exposed there is a high risk of termite attack. Sometimes, in order to determine the type of slab, a suitably qualified person such as an architect or builder may be required to consult the construction plans.

Where the slab edge cannot be properly inspected, it is highly recommended that termite or timber pest inspections be carried out every 6-12 months to aid protection of the property against infestation.

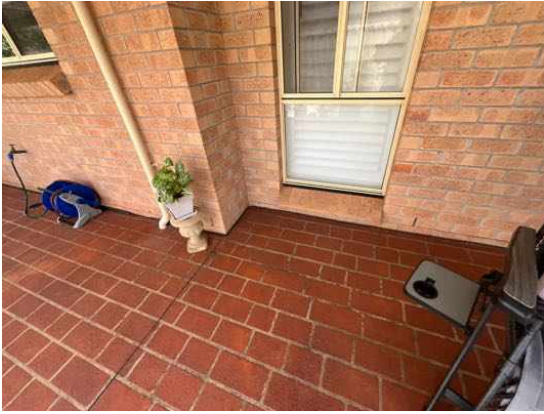
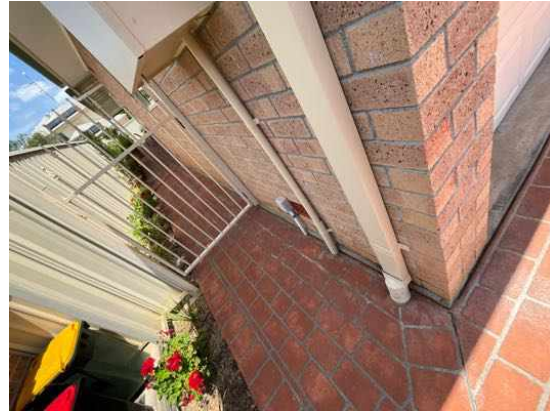
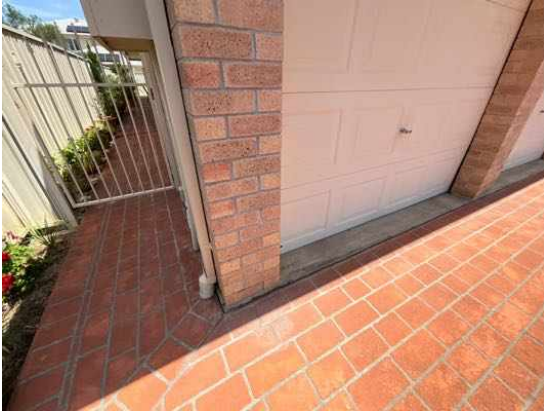
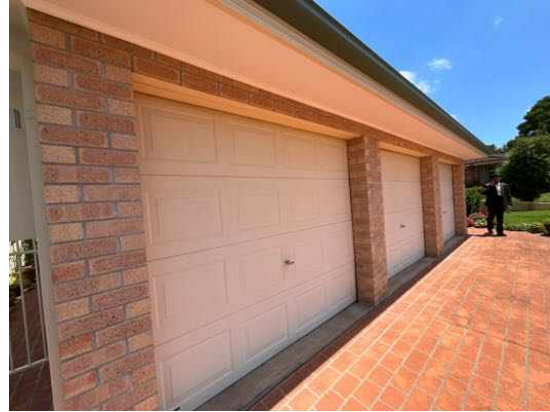
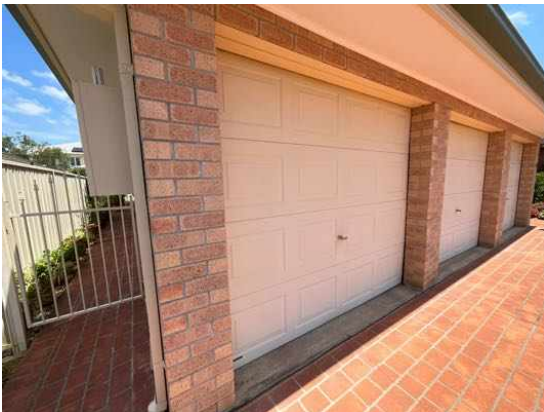
Finding 6.02

Building:	Main Building
Location:	All Areas
Finding:	Timber on ground / conducive conditions to termite damage
Information:	Timber on the ground is indeed conducive to termite damage. Termites are known to thrive in moist environments, and wood in contact with soil or moisture is more susceptible to infestation.

To prevent this, it's important to keep timber elevated and away from direct ground contact. Regular inspections and proper termite control measures are also essential to protect your wooden structures from termite damage.

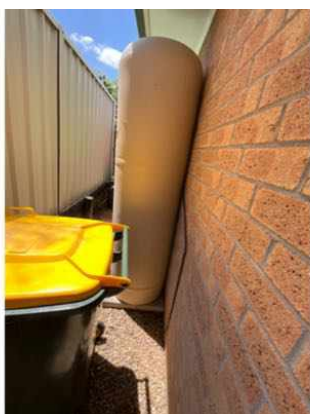
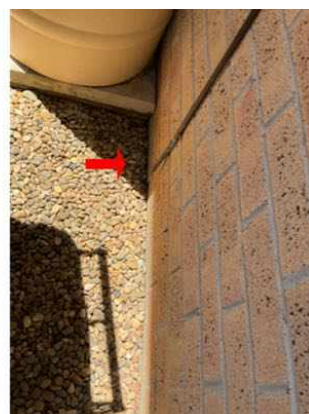
Finding 6.04

Building:	Main Building
Location:	All Areas
Finding:	Bridging or Obstruction Conducive environment for Termites
Information:	Bridging of termite barriers occurs when termites bridge (usually by building a mud tunnel) a termite barrier or inspection inspection zone or where termites have a passage, allowing them to bridge the barrier.

Where bridging has occurred full inspection is prevented and termites may enter a property in a concealed or undetected manner.

Recommended moving obstructions away from the external walls for further and future inspections.

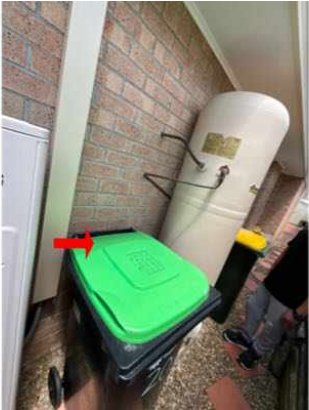
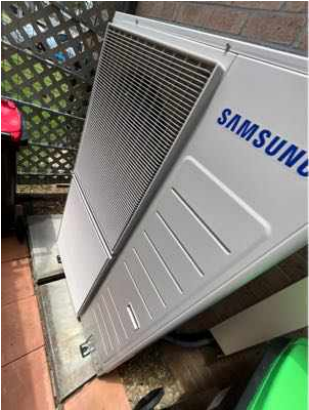
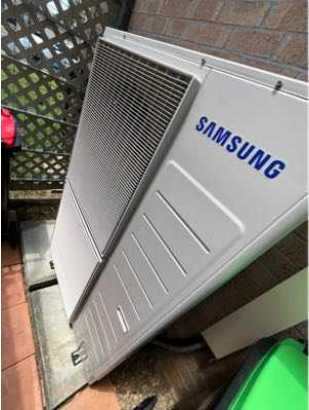
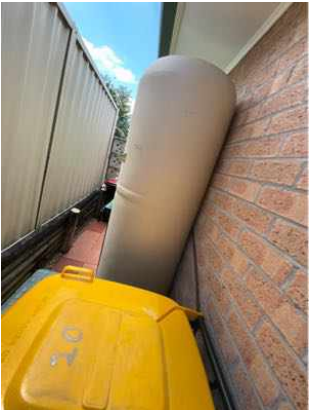
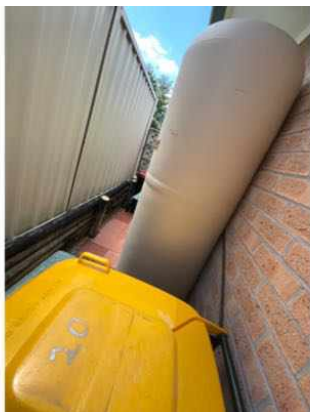
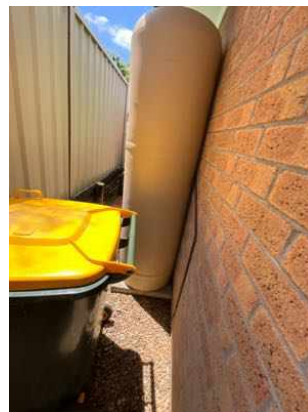
Finding 6.05

Building:	Main Building
Location:	Ensuite
Finding:	Excessive moisture - Conducive to Timber pest
Information:	Excessive moisture can attract termites and produce conditions that promote fungal growth and wood decay.

Excessive moisture is generally caused by deteriorated inadequate or missing roof drainage leaking plumbing pipes or fixtures poorly plumbed HWS overflows or condenser units and poor site drainage.

If mould growth has been found there may be environmental biological or health issues involved. In these cases an appropriately qualified inspector should also be contacted.

Prior to any remedial works being performed a qualified plumber should be appointed to further inspect the property and to identify the cause of the excessive moisture. Works to remove affected building elements may then be necessary and should be performed by an appropriate tradesperson.

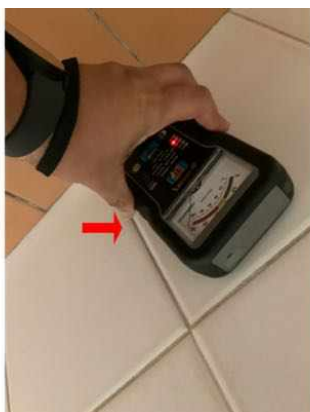
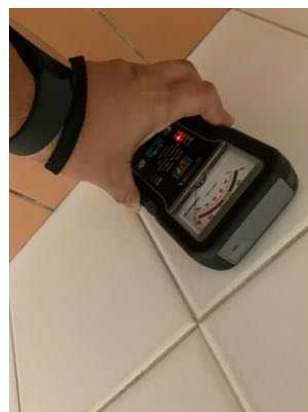
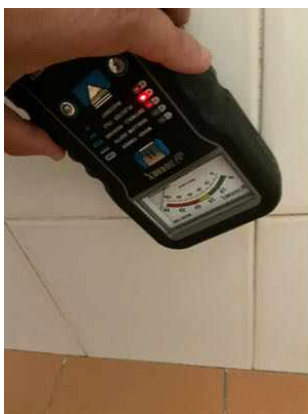
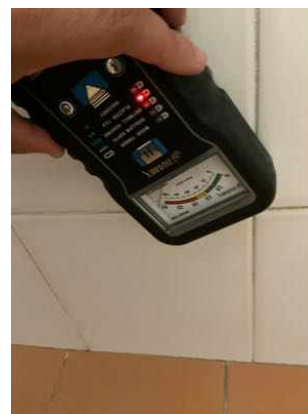
Finding 7.01

Finding: Wood rot

Information: This building element shows evidence of wood rot. Wood rot, also known as Fungal Decay, occurs when timbers and other cellulose building materials are exposed to damp conditions on an ongoing basis. This could be the result of exposure to weathering over a prolonged period of time, or the attraction of excessive moisture from other abutting building materials. Contributing factors also include poor air ventilation in the area.

Wood rot is often associated with general damp problems and is evidenced by a 'musty' smell or mould and mildew occurring on surfaces. If left unmanaged, damp conditions can lead to further health problems and the decay of timbers will continue.

Early intervention and regular maintenance, particularly of exterior timbers, will prolong the useful life of these building elements. Prior to any works being performed, the cause of the moisture that has created the visible wood rot should be identified and addressed in a suitable manner. Replacement of affected timbers may then be a necessary step in protecting surrounding building elements from such deterioration.

A qualified plumber may be appointed to assess the cause of excessive moisture and to provide advice on any remedial works as required. A qualified carpenter or registered builder may also be required to replace affected building materials.

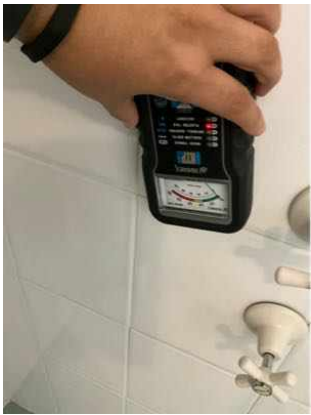
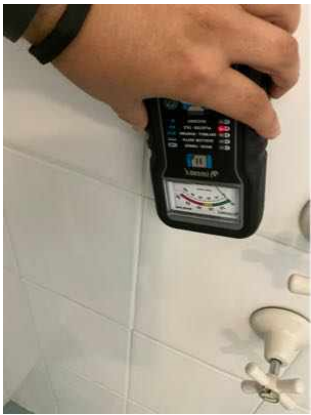
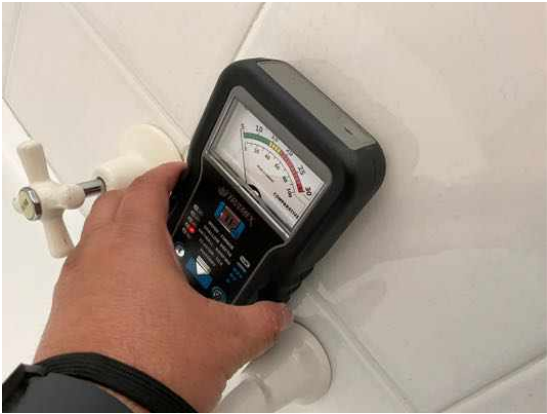
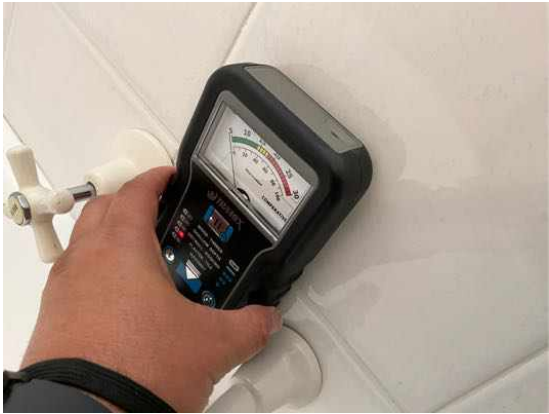
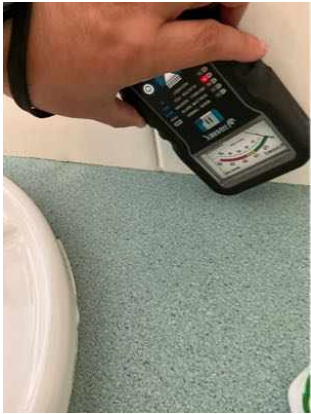
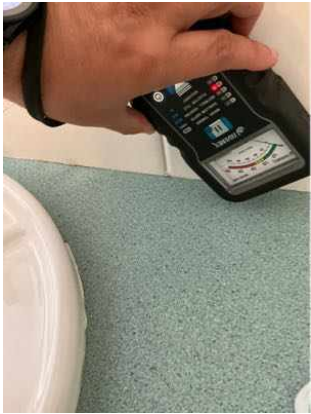
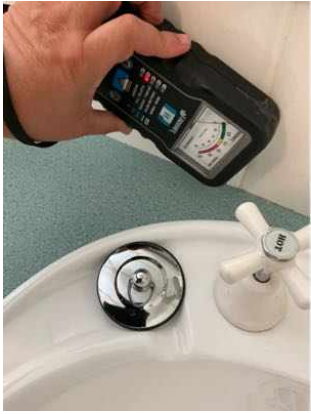
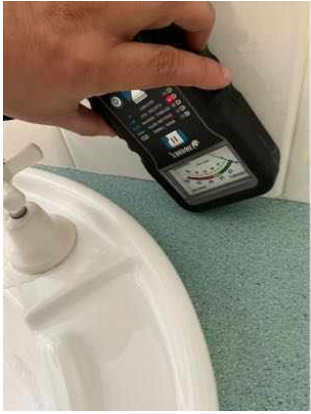
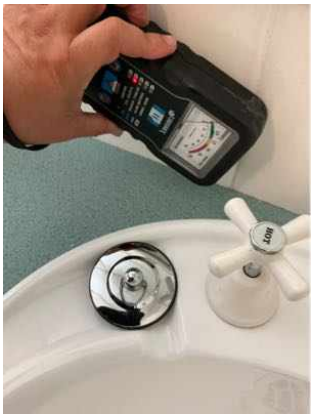
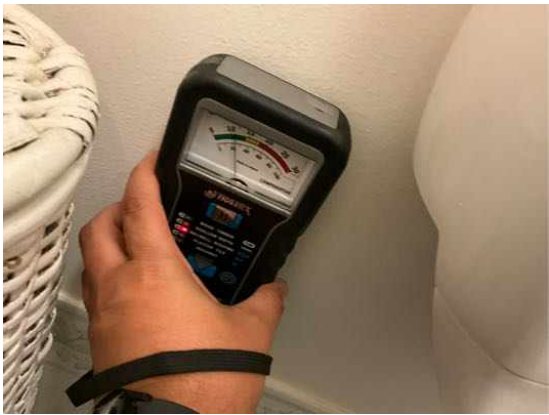
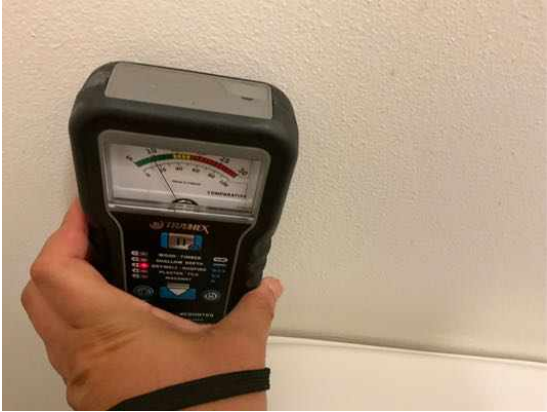
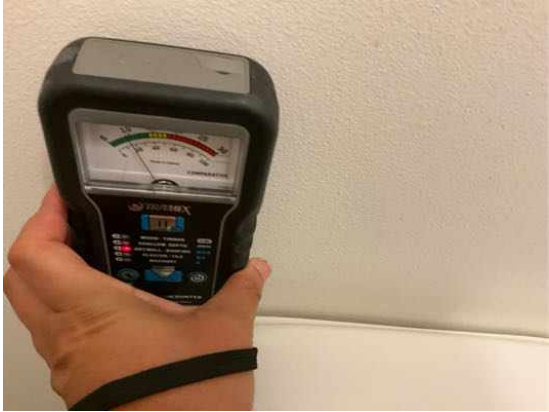
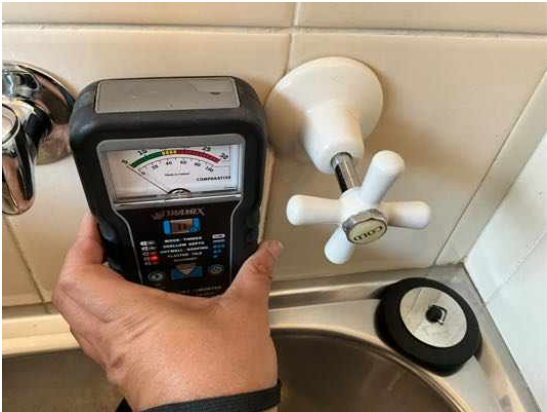
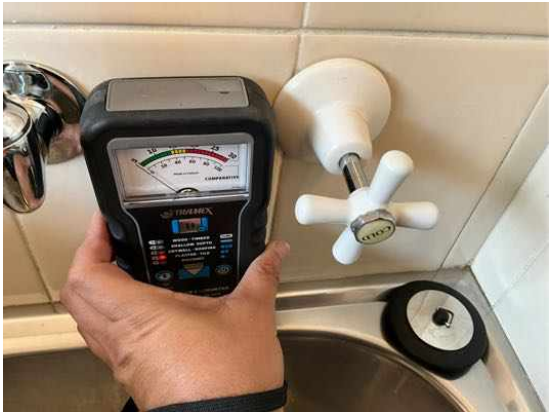
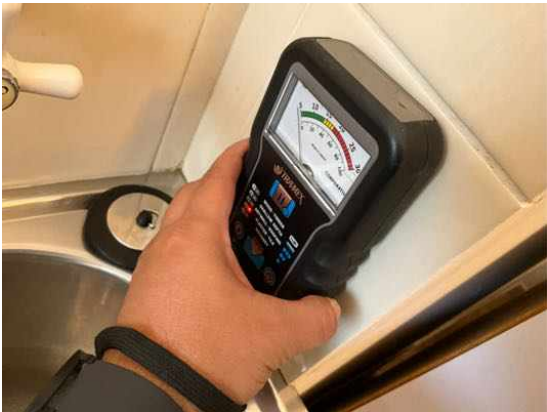
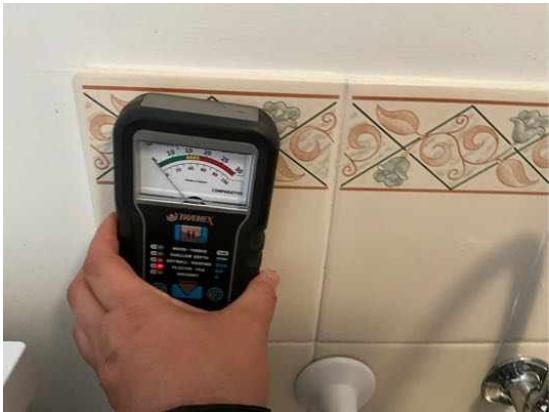
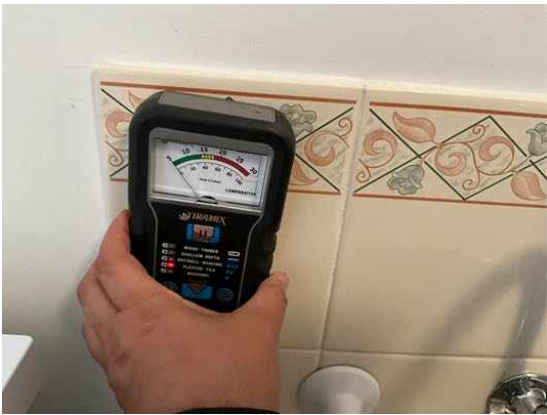
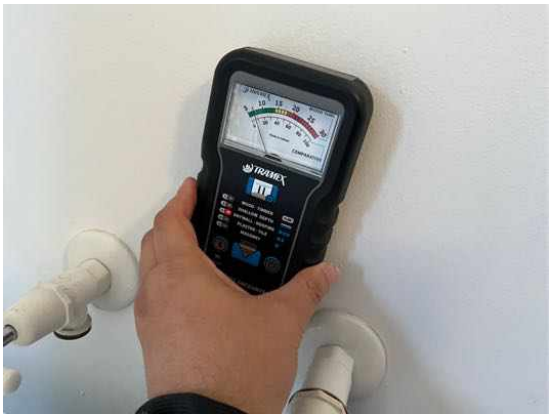
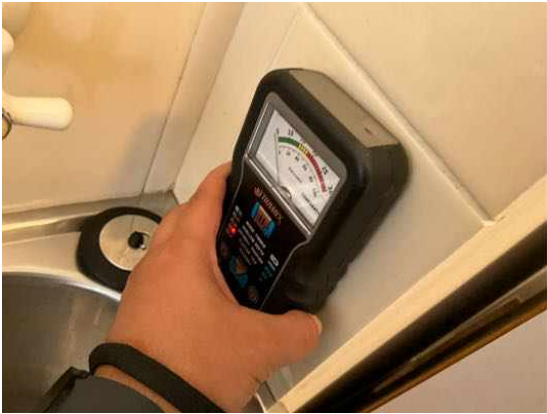
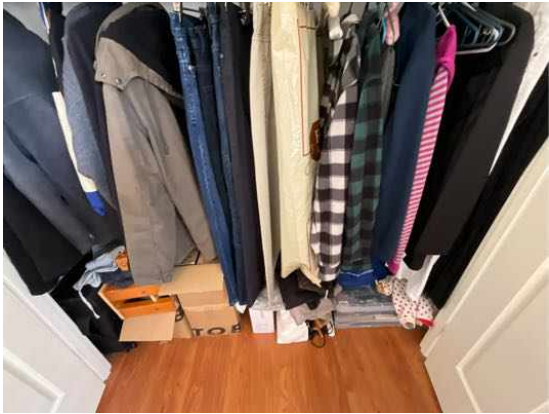
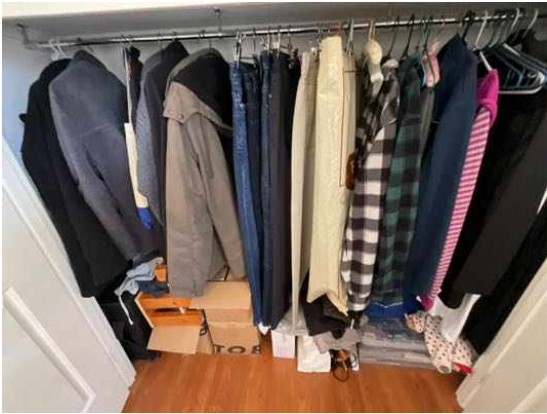
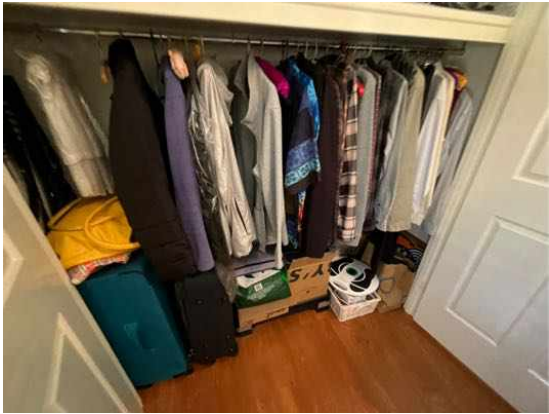
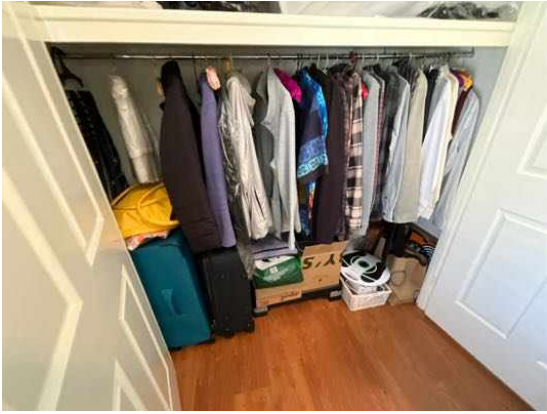
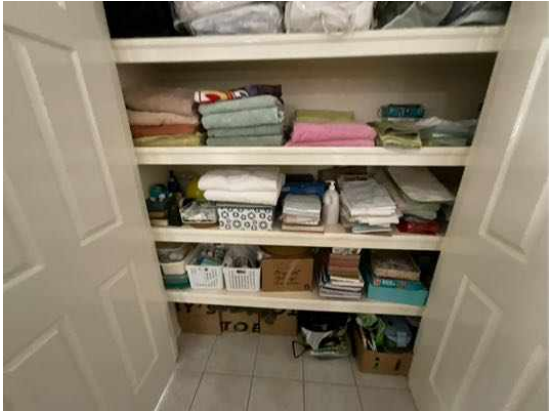
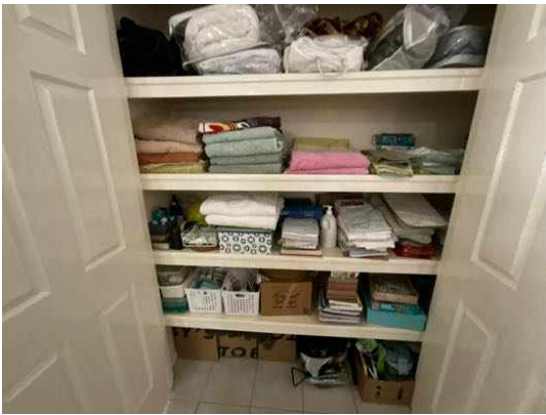
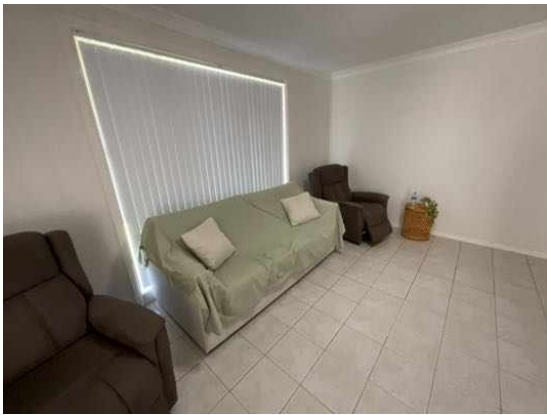
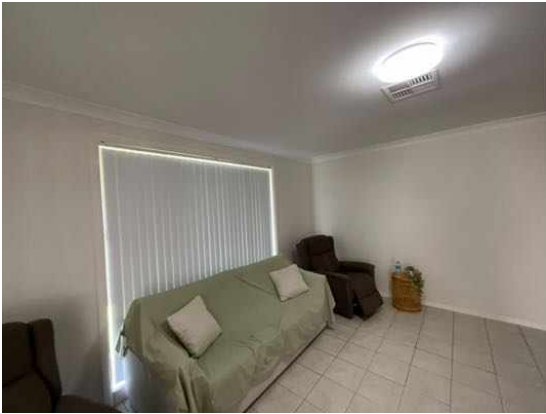
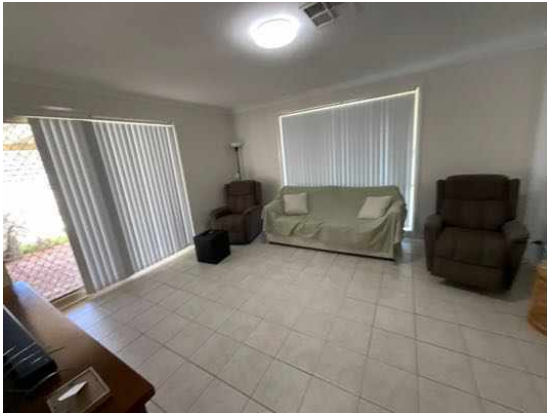
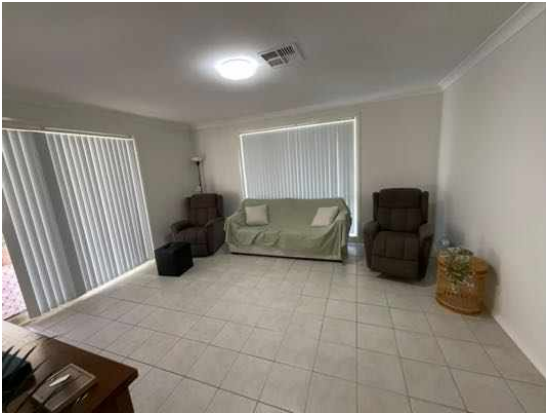
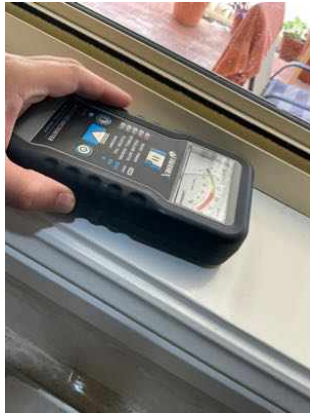
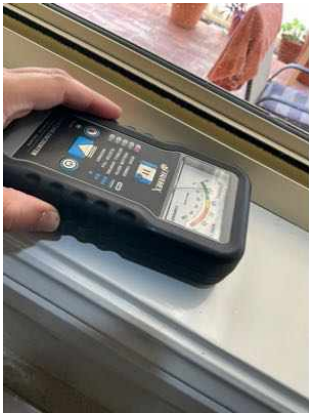
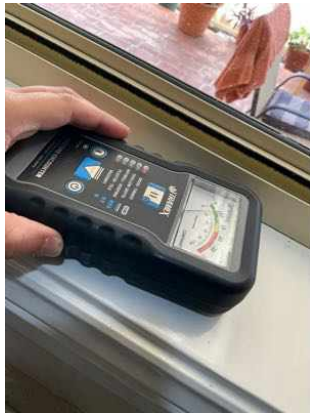
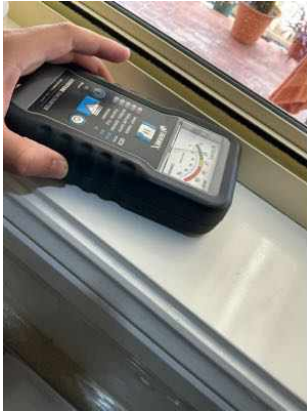
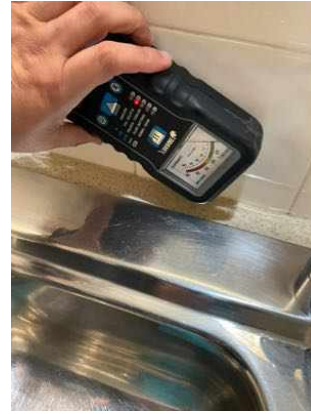
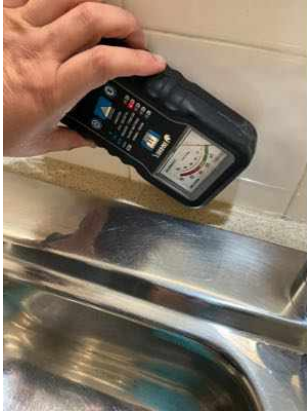
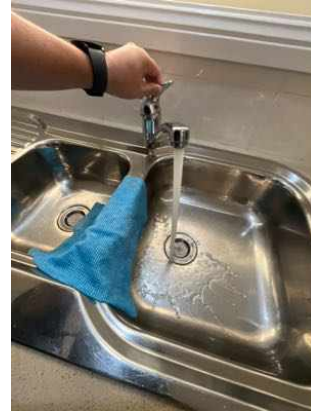
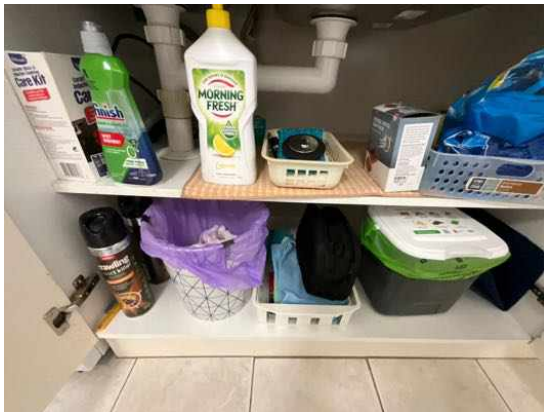
Building:	Main Building
Location:	All Areas
Finding:	Additional Photos - Obstructions and Limitations
Information:	These photographs are an indication of the obstructions and limitations which impeded full inspection of the property at the time of inspection. These obstructions can hide an array of defects and should be removed to allow full inspection to be carried out. A re-inspection is recommended once the areas are made accessible.

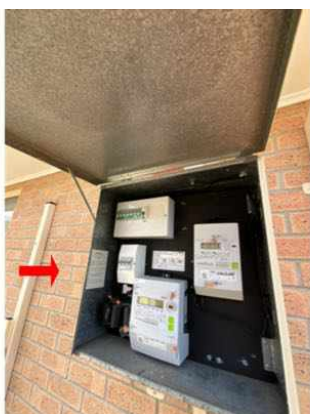
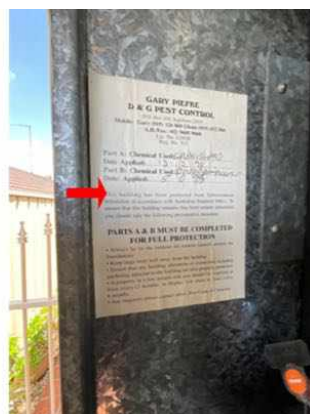
Building: Main Building
 Location: Exterior walls - left side
 Finding: Evidence of Termite Management System - Durable notice / Legible Sticker - seek further information
 Information: The application of a pre & post-construction chemical termite barrier is highly recommended for all properties. Such barriers are highly effective in preventing termite attack on any timber building elements throughout the property.

A durable notice placed in the switchboard unit to indicate termite barriers at the time of inspection.

Client must seek further information from the vendor or real estate agent if the conditions of termite management systems were maintained as per the label or seek advise from licensed pest controller.
