Building and Timber Pest Inspection Report

Inspection Date: Fri, 20 Mar 2026

Property Address: 67 Illaroo Rd, North Nowra NSW 2541,
Australia

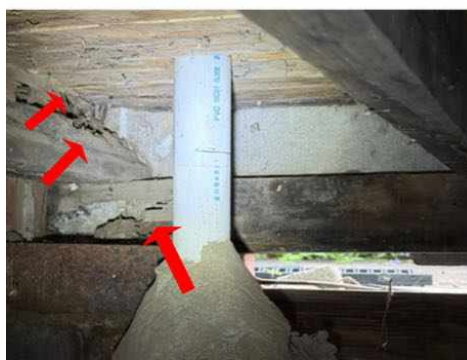
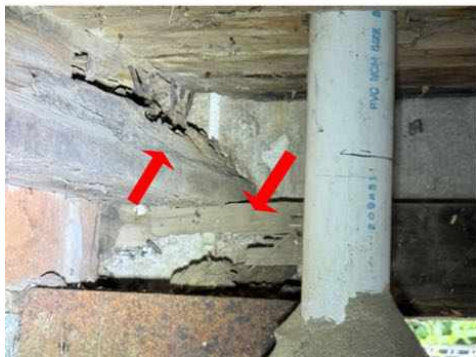
Building:	Building 1
Location:	Subfloor under kitchen/ bathroom wall
Finding:	Subfloor structure - Wood rot
Information:	The subfloor structure here is showing severe wood rot (fungal decay) of the timbers. It is suspected that this defect has developed as a result of damp conditions in the subfloor from a bathroom leak.

Damp conditions cause the timbers to fail, resulting in the subfloor structures failing to bear the load (or weight) of the building as originally intended. Without repairs and maintenance, including potential replacement of affected elements, it is likely that serious structural faults will result, as well as an array of minor defects.

The presence of wood rot to the subfloor structure is also conducive to termite infestation. As timber stumps are in direct contact with the ground, concealed termite is made possible. Such entry is made easier if the timbers become non-durable due to even slight wood rot.

Where wood rot is present to any structural timber, rectification or replacement of the affected timber building element is required. The adequate timeframe for such works are dependent on the severity of the rot. This area was inspected from 1 meter away due to tight safe access. A builder or carpenter is required to urgently restrengthen or replace these damaged timbers.

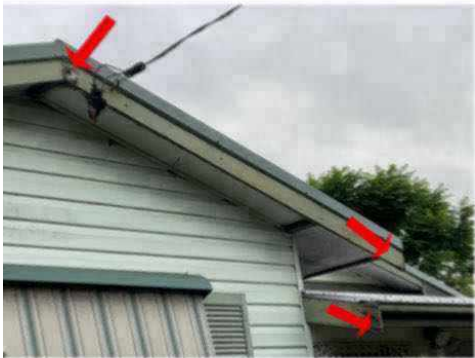
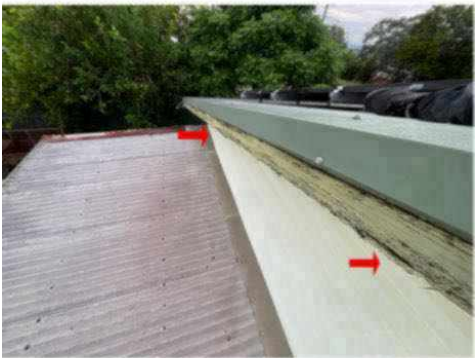
Finding 3.01

Building:	Building 1
Location:	Pictured areas
Finding:	Wood rot
Information:	The building shows evidence of wood rot. Wood rot, also known as Fungal Decay, occurs when timbers and other cellulose building materials are exposed to damp conditions on an ongoing basis. This could be the result of exposure to weathering

over a prolonged period of time, or the attraction of excessive moisture from other abutting building materials.

Early intervention and regular maintenance, particularly of exterior timbers, will prolong the useful life of these building elements. Prior to any works being performed, the cause of the moisture that has created the visible wood rot should be identified and addressed in a suitable manner. Replacement of affected timbers may then be a necessary step in protecting surrounding building elements from such deterioration.

A qualified carpenter or registered builder may also be required to replace affected building materials.

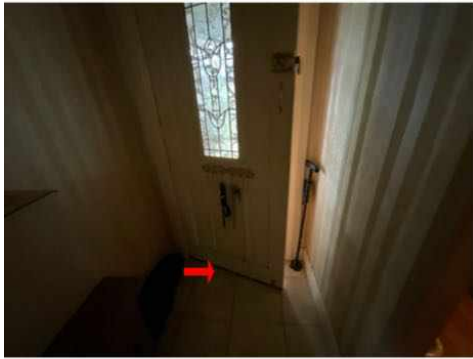
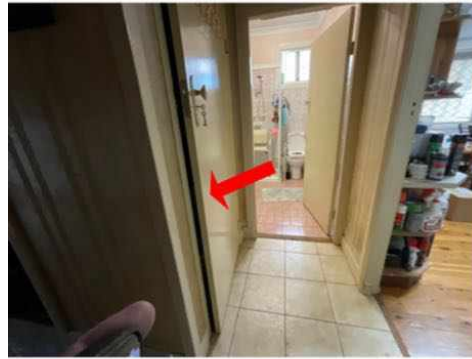
Building:	Building 1
Location:	Pictured doors
Finding:	Doors - Binding/jamming
Information:	Binding and/or jamming of these doors is evident during standard operation. This defect inhibits the functionality of the affected doors as well as creating potential for secondary defects to associated building elements, such as damage to the floor covering.

A door that binds to flooring or to the associated door frame may have several causes, ranging from minor defects, such as poor installation of the door or deteriorated hinges, through to major structural issues, such as damage to subfloor structures.

Where door binding/jamming appears to indicate major structural issues, a registered builder specialising in re-stumping should be appointed to provide an estimate on the cost of rectification.

For these minor causes, a qualified carpenter or general handyperson should be appointed to perform minor rectification works at client discretion.

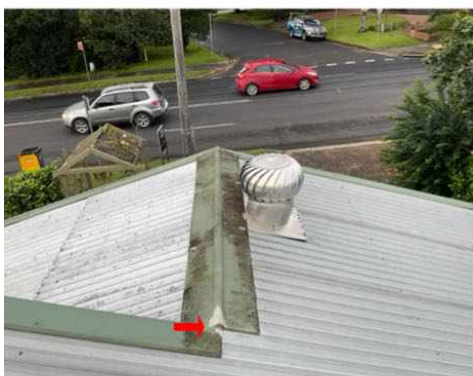
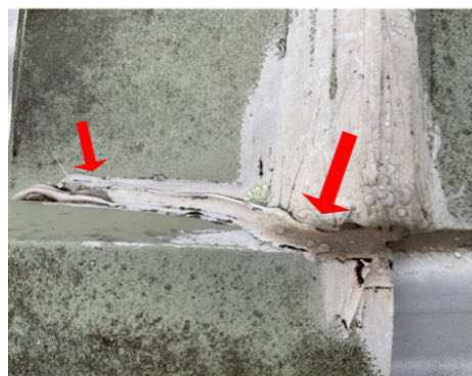
Finding 3.06

Building:	Building 1
Location:	Roof Exterior
Finding:	Roofing areas - Weathered
Information:	Upon inspection of the exterior roofing, the majority of the roof sheets areas were considered to be in a good condition. The timber areas was in fair condition.

Re-sealing old sealant and painting may be considered as an interim solution by the client to help preserve and extend the life span of these roofing areas. Some timber fascia and barges require repair/ replacement. Where left unmanaged, deteriorating roofing materials are likely to lead to a number of secondary defects, including minor water leaks and weather exposure to internal roofing structures.

Consultation with a roofing contractor is highly advised to gain advice on cost of remedial works that may be required in the short to medium term.

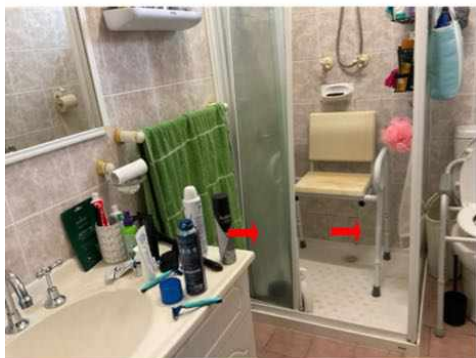
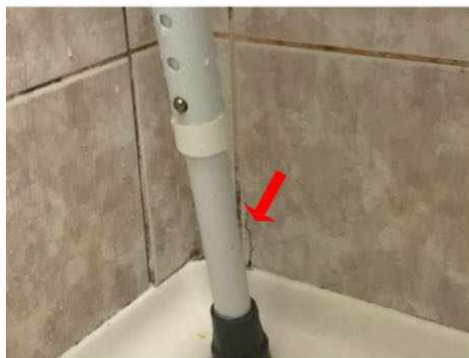
Cracked tiles throughout the household detract from the overall appearance of the affected areas. In wet areas of kitchens and bathrooms, it can lead to water damage of adjoining walls and floors.

Replacement of cracked tiles is recommended as soon as possible. A tiling contractor may be appointed to perform these works. Where cracks become more numerous, contact a licensed building inspector for further investigation.

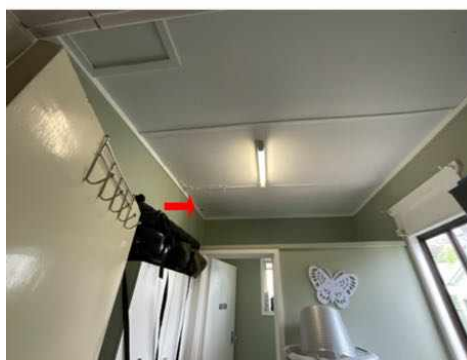
Generally, the client is advised to ensure that the general environment is free of moisture and humidity to aid in the prevention of mould formation and development. Any mould found during the inspection should be cleaned immediately by a cleaning contractor or the homeowner as applicable.

Please note that severely affected building elements may require replacement by a registered builder or qualified carpenter.

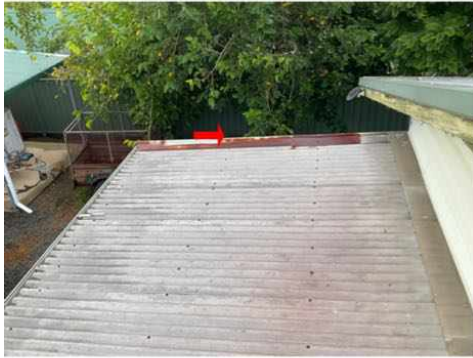
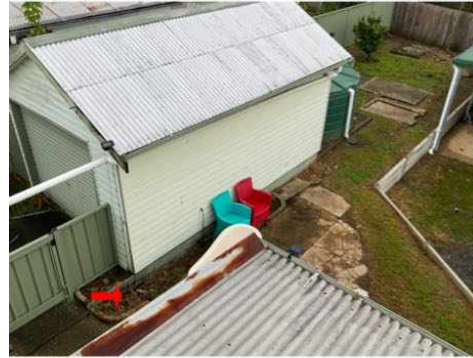
Finding 3.12

Building:	Building 1
Location:	Roof Exterior
Finding:	Building element - Rusted or corroded
Information:	This building element shows evidence of rusting and corrosion, which is likely to have developed as a result of excessive exposure to moisture and or inadequate coatings.

Rusting and corrosion should be managed by ideally removing or limiting the affected surface from exposure to moisture. A registered builder may be appointed to replace any building elements that have been severely affected by rust or water damage.

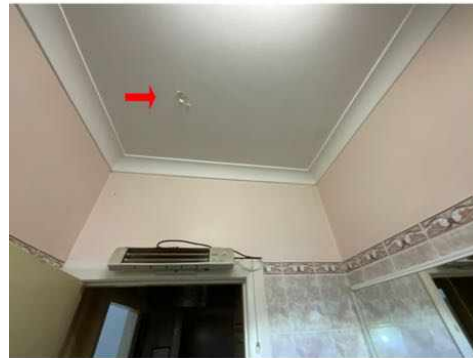
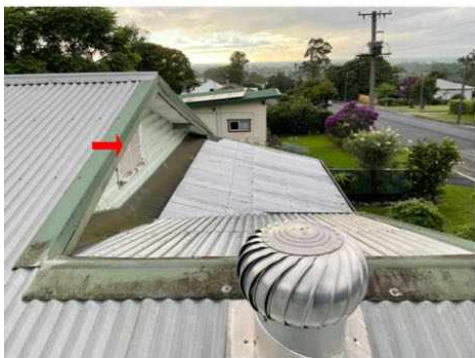
e.g. external areas or wet areas, could lead to deterioration of underlying building materials. Damaged paint finishes should be sanded back, filled, leveled and repainted, as applicable.

A painting contractor should be appointed as soon as possible to perform necessary works to aid the appearance of the affected area and to ensure that the area is protected against further deterioration. Alternatively, the homeowner following manufacturer instructions may be able to provide this service.

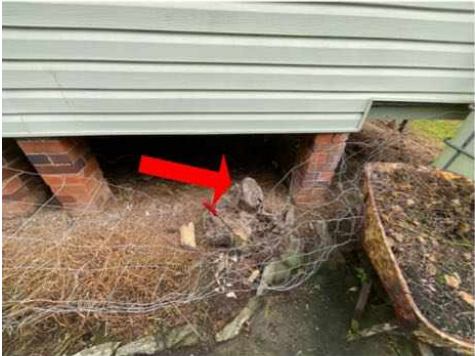
Finding 6.03

Building: Building 1
Location: Pictured yard area
Finding: Tree stumps - left in ground
Information: Tree stumps left in ground provide opportunity for termite attack as they are likely to be subject to rot and decay providing an attractive food source. Treatment and/or Removal of the stump is highly recommended. A pest controller and tree removalist should be engaged to perform such works.

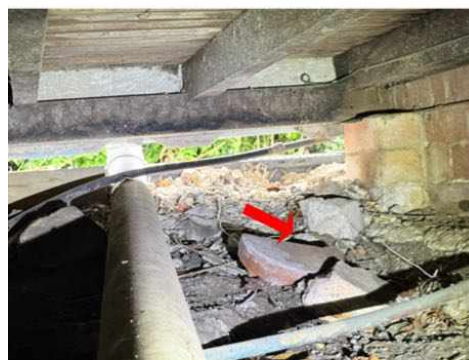
Finding 6.04

Building:	Building 1
Location:	Subfloor
Finding:	Subfloor - Debris
Information:	An array of debris was found in the subfloor area at the time of inspection. Debris in this area restricts subfloor ventilation and creates potential for concealed pest entry. Stored timbers and other materials may also make the area susceptible to termite activity and wood rot.

A clear and empty subfloor will be better ventilated and easier to maintain in a dry condition. The removal of any timber debris is vital in minimising the risk of termite or wood borer activity.

Debris in the subfloor should be removed as soon as possible. Depending on the location and amount of debris and stored items, the homeowner may elect to undertake this task. Alternatively there are a large number of rubbish removal subcontractors that could undertake these works.

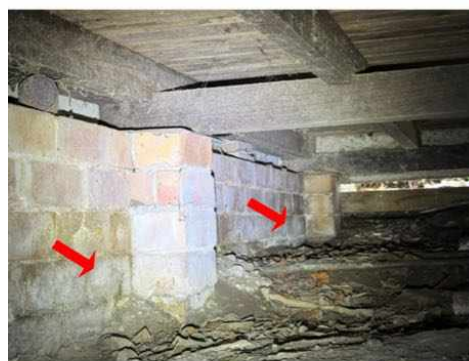
Finding 6.05

Building:	Building 1
Location:	Subfloor
Finding:	Damp - Rising
Information:	Rising damp describes the upward movement of water in low sections of building

The first step in addressing rising damp is to diagnose the cause. The identified cause should be addressed first before addressing the appearance and other defects which have resulted from the rising damp. If the original cause is not resolved, further cases of damp are likely to ensue, resulting in secondary defects.

Consultation with a qualified plumber is advised immediately to identify the cause of the damp and perform remedial works as required.

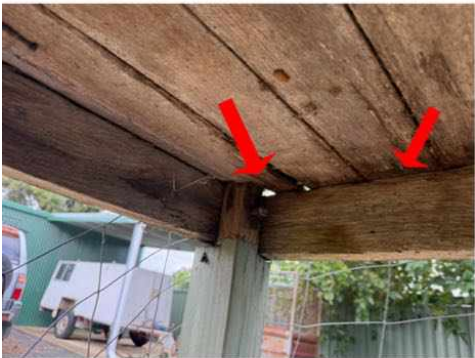
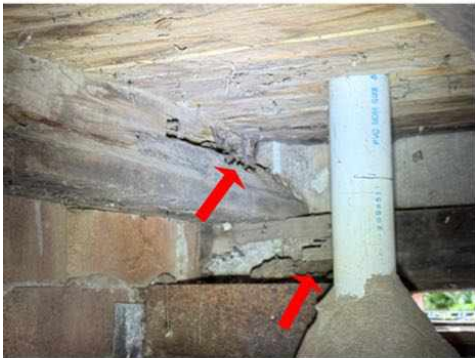
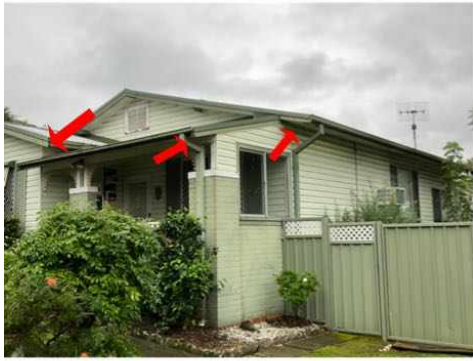
Finding 7.01

Note - See ALL wood rot photos, all these show fungal decay.

In this case, the affected timber element is in a decaying state and will need replacement by a carpenter or licensed builder.

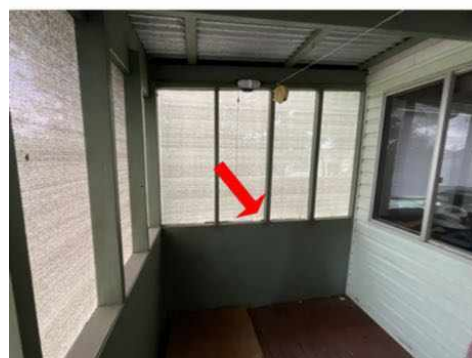
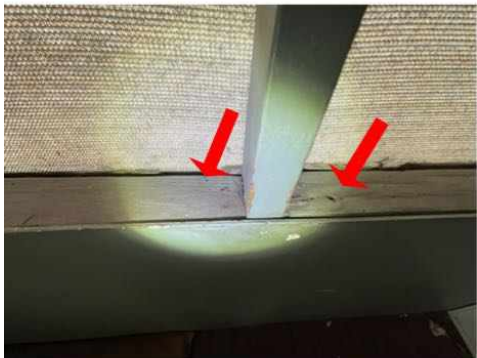
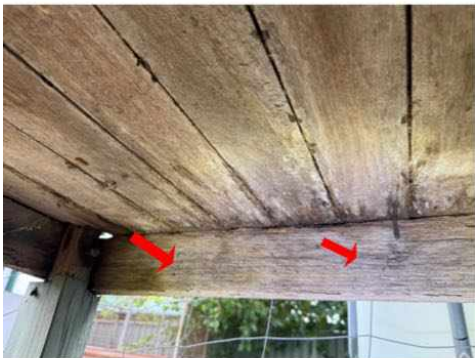
Finding 8.01

The other commonly known borer the Anobium borer is more likely to attack floorboards and may cause severe structural damage to flooring areas.

As no live wood borer activity was identified treatment is not required at this time.

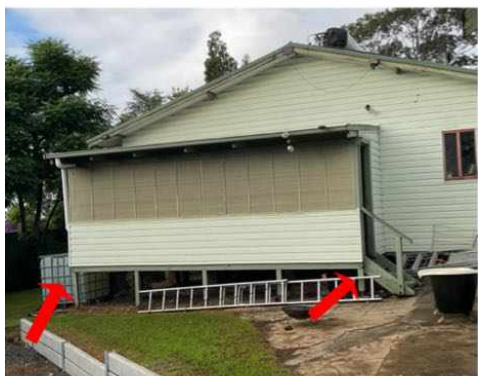
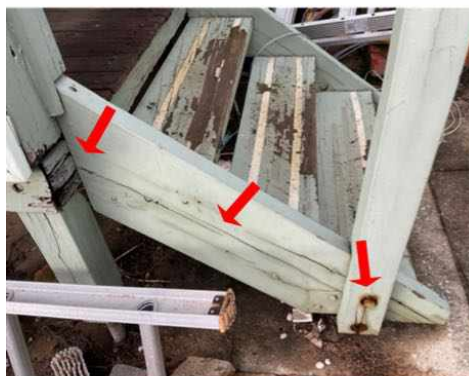
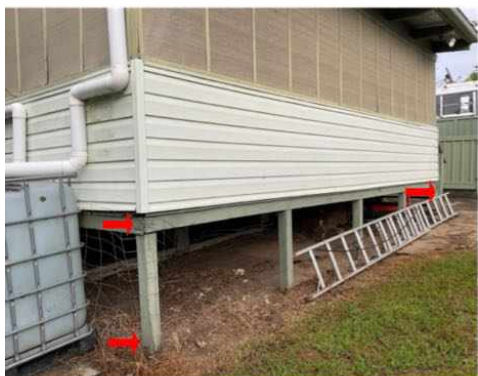
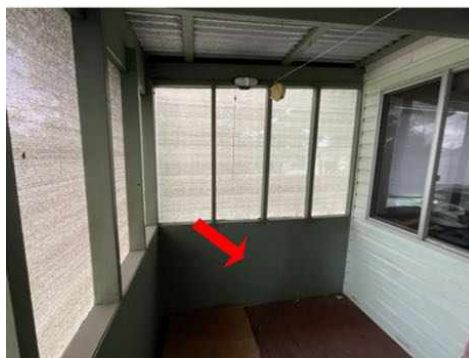
has been made, on any elevated structure, as suitable for any specific number of people or purpose. This can only be done by a qualified engineer. For the purpose of this report, the Structure includes the elevated rear verandah, handrails, stairs and walls that show rust, wood rot and bora damage and a lack of support and a loose rear wall.

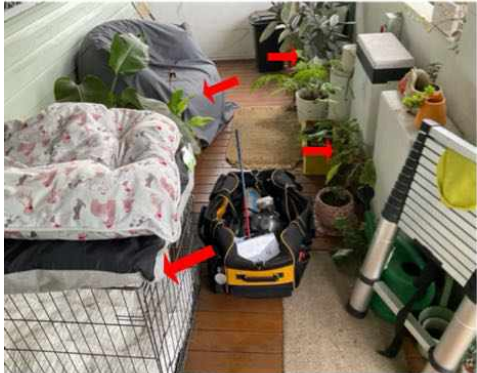
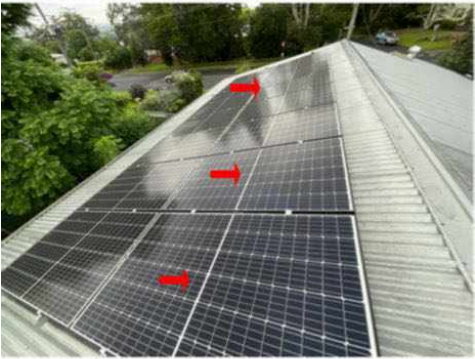
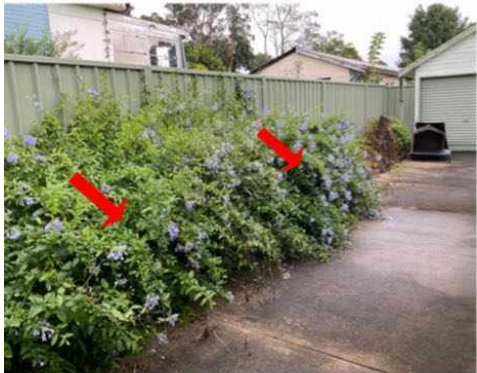
Building:	Building 1
Location:	All External Areas
Finding:	Additional Photos - Obstructions and Limitations of EXTERNAL AREAS
Information:	These photographs are an indication of the obstructions and limitations which impeded full inspection of external areas at the time of inspection. These obstructions can hide an array of defects and should be removed to allow full inspection to be carried out. A re-inspection is recommended once the areas are made accessible.

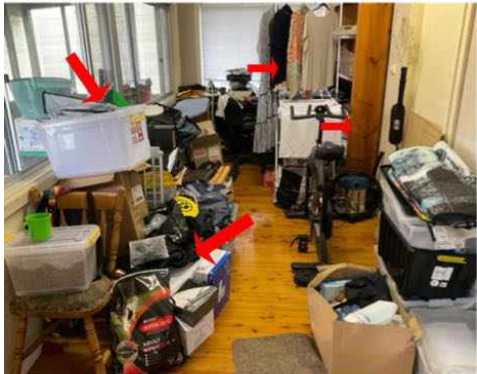
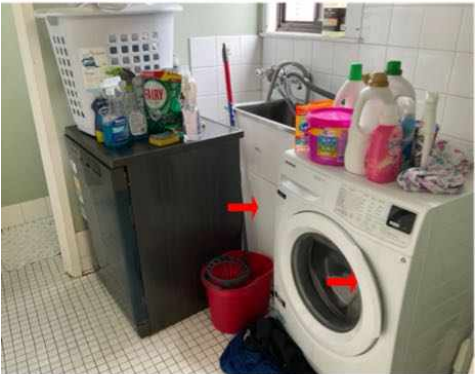
Building: Building 1
Location: All Internal Areas
Finding: Additional Photos - Obstructions and Limitations of INTERNAL AREAS
Information: These photographs are an indication of the obstructions and limitations which impeded full inspection of Internal areas at the time of inspection. These obstructions can hide an array of defects and should be removed to allow full inspection to be carried out. A re-inspection is recommended once the areas are made accessible.

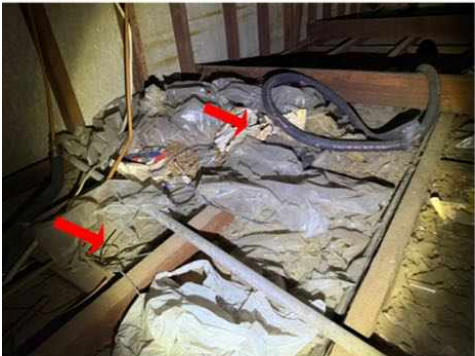
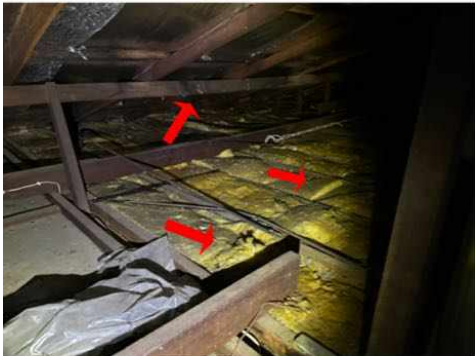
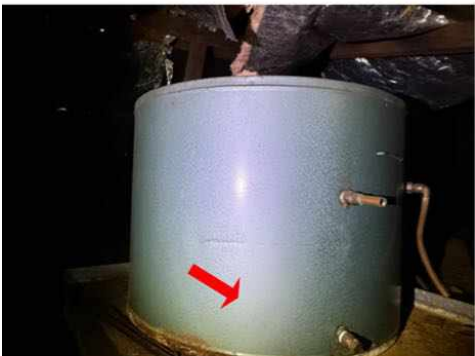
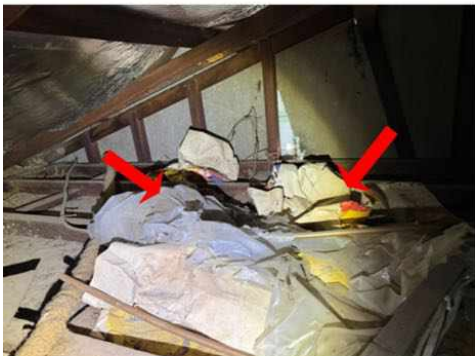
Building: Building 1
 Location: All Roof cavity areas
 Finding: Additional Photos - Obstructions and Limitations of the ROOF CAVITY
 Information: These photographs are an indication of the obstructions and limitations which impeded full inspection of roof cavity areas at the time of inspection. These obstructions can hide an array of defects and should be removed to allow full inspection to be carried out if applicable. A re-inspection is recommended once the areas are made accessible.

The inspection was also limited to areas with an allowable crawl space of 600mm x 600mm, in particular towards the external walls where the roof line diminishes, these

areas were not accessible.

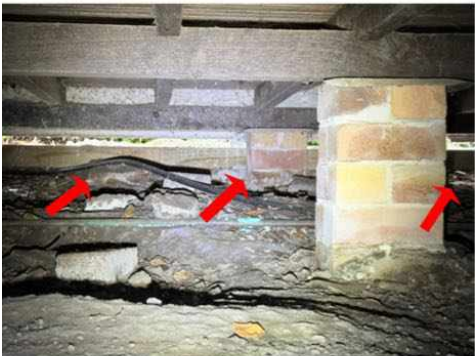
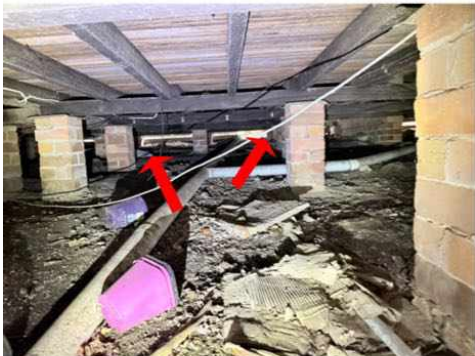
Building: Building 1
Location: All Subfloor Areas
Finding: Additional Photos - Obstructions and Limitations of SUBFLOOR AREAS
Information: These photographs are an indication of the obstructions and limitations which impeded full inspection of subfloor areas at the time of inspection. These obstructions can hide an array of defects and should be removed to allow full inspection to be carried out. A re-inspection is recommended once the areas are made accessible.

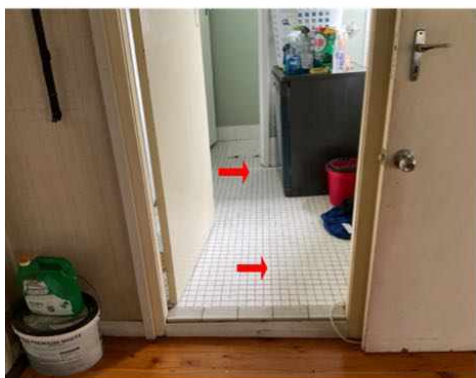
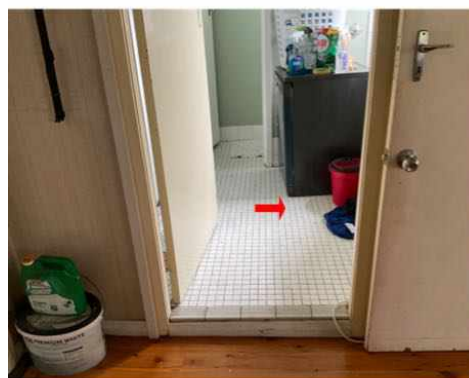
Building: Building 1
Location: Bathrooms and laundry
Finding: Waterproofing membranes - Information Only
Information: Internal Water Proofing Membranes, are crucial in preventing water ingress into the property is important to know that the Membrane System used is to Australian Standards and has been installed correctly.

With older property's where this information is unavailable all wet areas should be monitored. If any leaks, water staining, peeling or bubbling of the paint become evident to any adjacent walls or ceilings below a licensed builder or waterproofing specialist is recommended to investigate further.

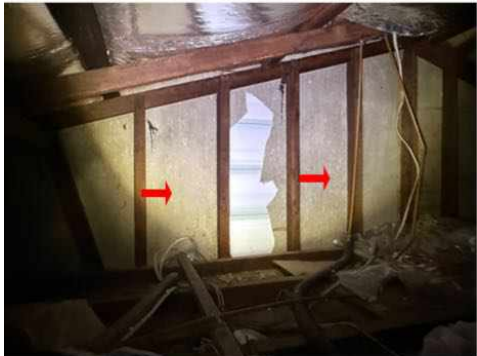
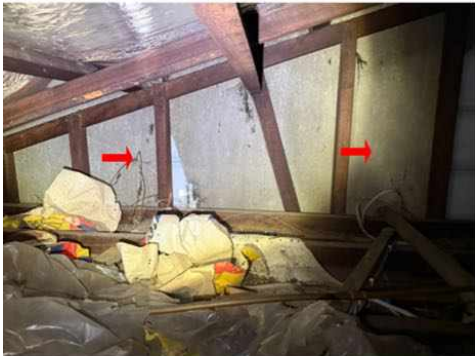
Building: Building 1
Location: Pictured wall area
Finding: Asbestos - ACM Identified on Site
Information: Reporting on Asbestos is outside the Scope of this Report. This defect is highlighted as a caution only. We suspect the house has asbestos present due to its age.

As Asbestos Reporting is outside the scope of this report, we advise that you consider a separate Asbestos Inspection and Condition Audit, which can include the taking of samples for definitive confirmation of the presence of Asbestos.

In the interim, the client is advised to act with caution, especially when considering any damage to building materials, general wear and tear, renovations, extensions, demolition and general maintenance activities due to the suspected presence of Asbestos.
