# Building and Timber Pest Inspection Report

Inspection Date: Thu, 5 Feb 2026

Property Address: 118 Vary St, Morwell VIC 3840, Australia

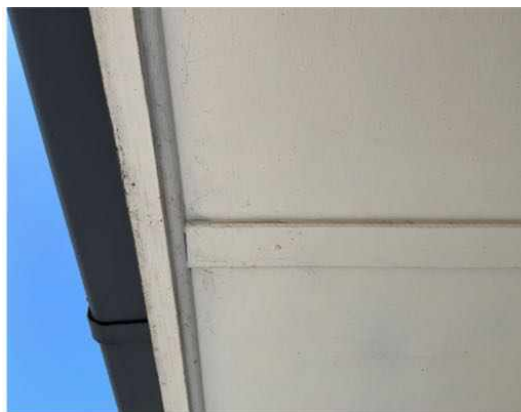
Building:	Main Building
Location:	Eaves
Finding:	Asbestos - Suspected ACM Identified on Site
Information:	Eaves were suspected to contain asbestos at the time of inspection. Reporting on Asbestos is outside the Scope of this Report. This suspected defect is highlighted as a caution only. We suspect, based on our experience in the building industry, that there is a higher risk of the identified building element containing asbestos.

As Asbestos Reporting is outside the scope of this report, we advise that you consider a separate Asbestos Inspection and Condition Audit, which can include the taking of samples for definitive confirmation of the presence of Asbestos.

In the interim, the client is advised to act with caution, especially when considering any damage to building materials general wear and tear renovations extensions demolition and general maintenance activities due to the suspected presence of Asbestos.

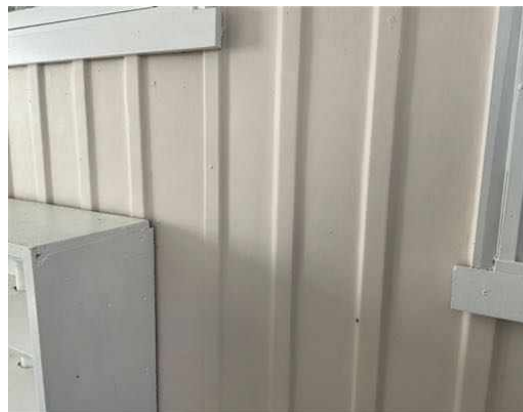
#### Finding 1.02

Building:	Main Building
Location:	Sunroom
Finding:	Asbestos - Suspected ACM Identified on Site
Information:	Internal cladding was suspected to contain asbestos at the time of inspection. Reporting on Asbestos is outside the Scope of this Report. This suspected defect is highlighted as a caution only. We suspect, based on our experience in the building industry, that there is a higher risk of the identified building element containing asbestos.

a separate Asbestos Inspection and Condition Audit, which can include the taking of samples for definitive confirmation of the presence of Asbestos.

In the interim, the client is advised to act with caution, especially when considering any damage to building materials general wear and tear renovations extensions demolition and general maintenance activities due to the suspected presence of Asbestos.

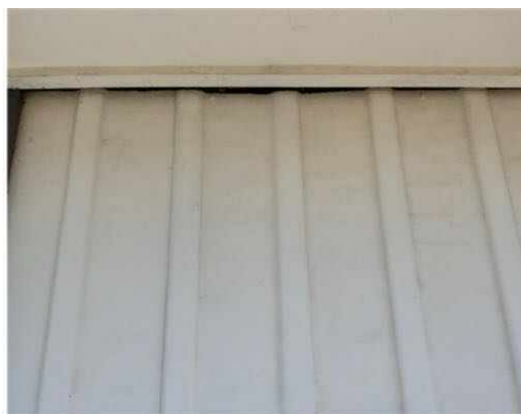
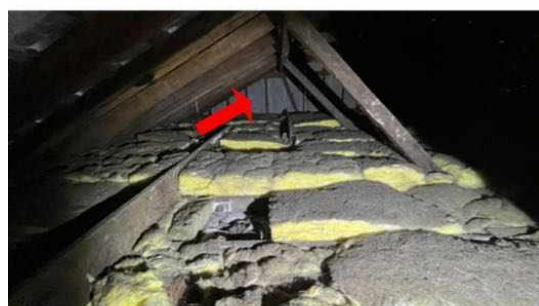
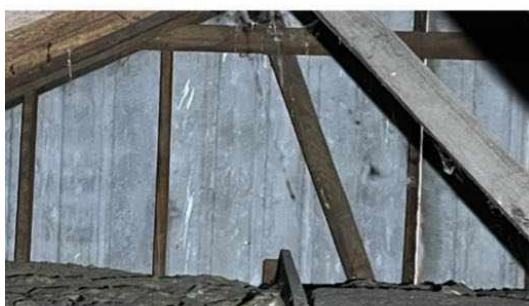
### Finding 1.03

Building:	Main Building
Location:	All Areas
Finding:	Asbestos - Suspected ACM Identified on Site
Information:	External cladding was suspected to contain asbestos at the time of inspection. Reporting on Asbestos is outside the Scope of this Report. This suspected defect is highlighted as a caution only. We suspect, based on our experience in the building industry, that there is a higher risk of the identified building element containing asbestos.

As Asbestos Reporting is outside the scope of this report, we advise that you consider a separate Asbestos Inspection and Condition Audit, which can include the taking of samples for definitive confirmation of the presence of Asbestos.

In the interim, the client is advised to act with caution, especially when considering any damage to building materials general wear and tear renovations extensions demolition and general maintenance activities due to the suspected presence of Asbestos.

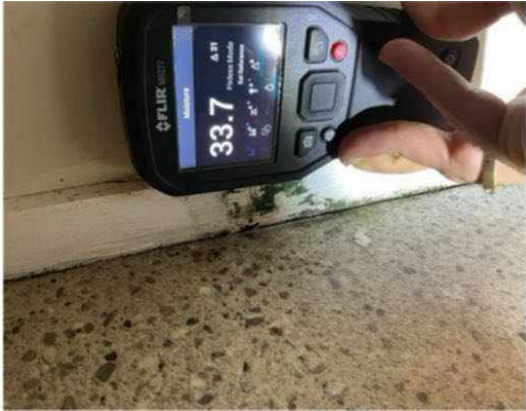
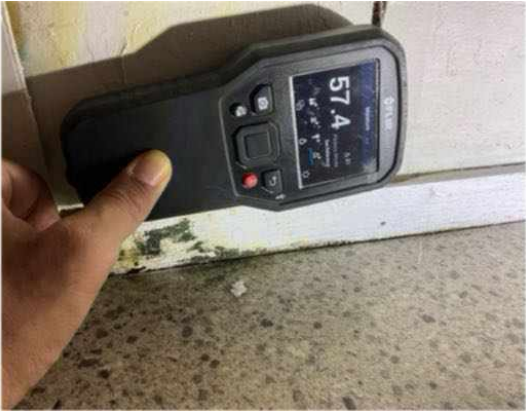
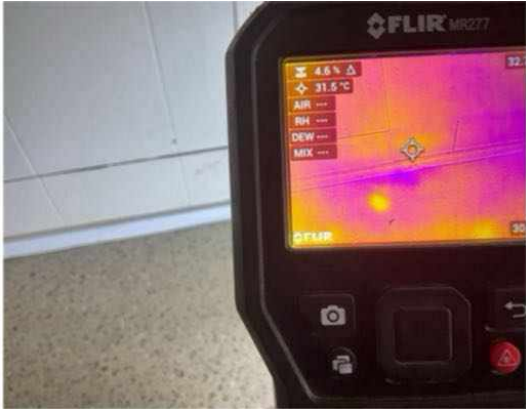
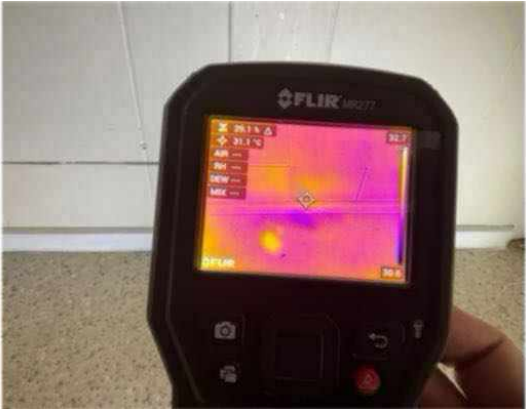
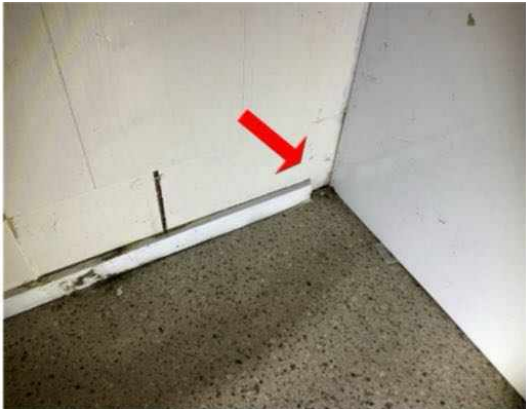
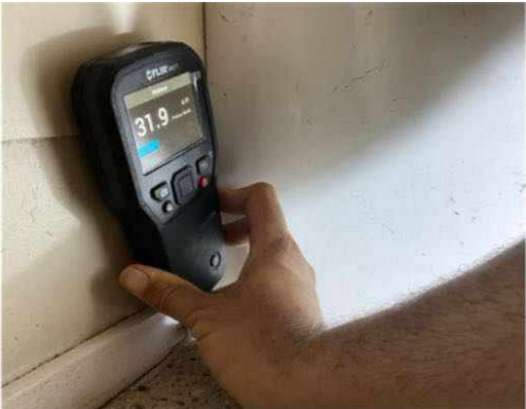
Building:	Main Building
Location:	Laundry
Finding:	Timber Skirting Decay with Elevated Moisture Levels
Information:	Timber decay was observed to the skirting board at the time of inspection. Elevated moisture levels were also recorded in this area, indicating ongoing moisture exposure. Based on the location and condition of the affected materials, an ongoing water leak within the adjoining wall is suspected.

If left unaddressed, continued moisture ingress may result in further deterioration of the skirting board and potential spread of decay to concealed timber framing, wall linings, and other adjoining building elements. Ongoing moisture may also increase the risk of mould growth and damage to internal finishes.

It is recommended that an invasive inspection be carried out to confirm the source and extent of moisture ingress. A suitably qualified plumber and/or registered builder should be engaged to investigate the suspected leak and undertake necessary repairs, including replacement of any decayed timber and remediation of affected areas.

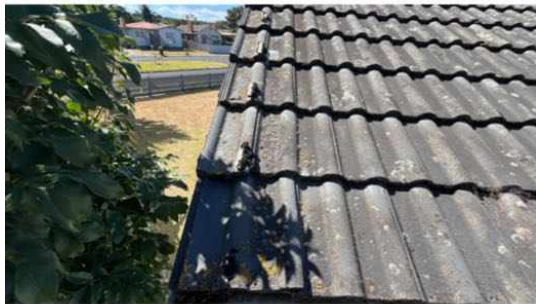
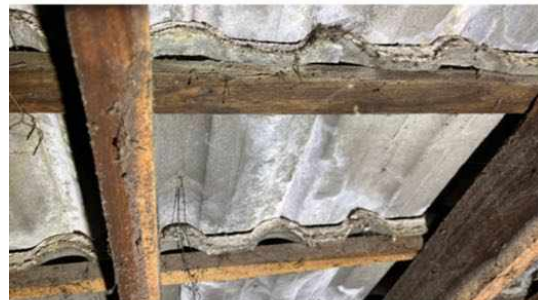
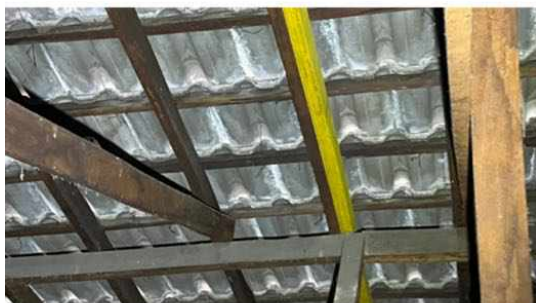
**Finding 2.02**

Building: Main Building  
 Location: Roof Exterior  
 Finding: Roof Tile and Mortar Deterioration  
 Information: Edge deterioration and surface wear were observed to the roof tiles during the inspection of the roof void. In addition, deterioration of the mortar bedding and pointing was noted along the edges of the gable roof. These defects are commonly associated with natural ageing, prolonged exposure to weather conditions, and general wear and tear over time.

If left unaddressed, the deterioration of roof tiles and mortar may compromise the

roof's ability to provide a watertight barrier, potentially leading to water ingress and damage to the roof space and interior of the dwelling. Deteriorated mortar may also reduce the stability of roof tiles, increasing the risk of tile movement or dislodgement during strong winds or storm events.

It is recommended that a licensed roof plumber or registered roofing contractor be engaged to assess the extent of tile and mortar deterioration and carry out any necessary repairs, repointing, or replacement works. Prompt rectification will help ensure the roof remains weatherproof and structurally sound.

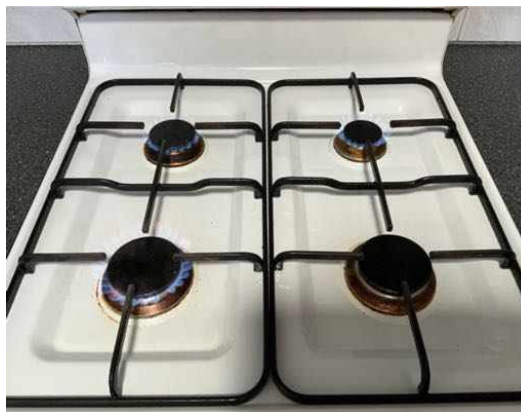
**Finding:** Non-Functioning Cooktop Burner  
**Information:** One burner was found not to be functioning at the time of inspection. This condition may be related to an appliance fault, ignition issue, or gas supply component malfunction.

If left unaddressed, a non-functioning burner may limit the safe and effective use of the appliance and could indicate an underlying issue requiring attention.

It is recommended that a licensed gas plumber or authorised appliance technician be engaged to assess the cooktop and carry out any necessary repairs or servicing.

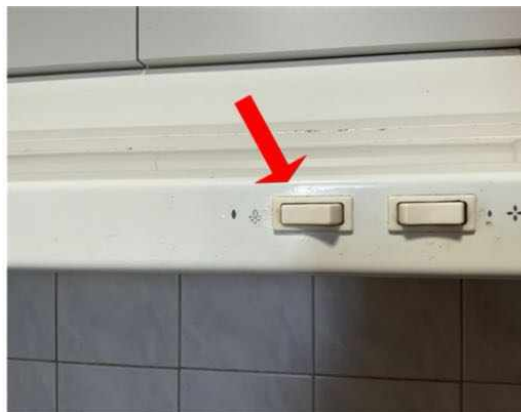
### Finding 3.03

**Building:** Main Building  
**Location:** Kitchen  
**Finding:** Non-Functioning Rangehood Light  
**Information:** The rangehood light was found not to be operating at the time of inspection. This may be due to a failed globe, wiring issue, or an internal fault within the rangehood unit.

If left unaddressed, inadequate lighting may affect the safe and effective use of the cooking area and could indicate an underlying electrical issue.

It is recommended that the rangehood light be repaired or replaced as required by a suitably qualified electrician or authorised appliance technician.

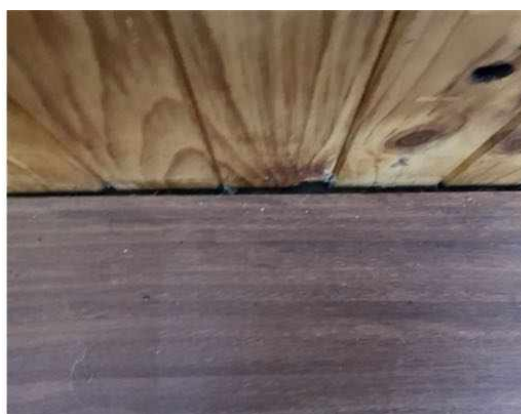
### Finding 3.04

Building:	Main Building
Location:	All Internal Areas
Finding:	Gaps to Timber Flooring Edges
Information:	Gaps were observed along the edges of the timber flooring at the time of inspection. This condition is commonly associated with natural timber movement due to changes in temperature and humidity, shrinkage, or installation tolerances.

If the gaps increase over time, they may affect the appearance of the flooring and allow debris or moisture to enter, potentially leading to further deterioration or movement of the flooring.

It is recommended that the affected areas be monitored for any changes. If the gaps widen or cause functional concerns, a suitably qualified flooring contractor should be engaged for further assessment and advice.

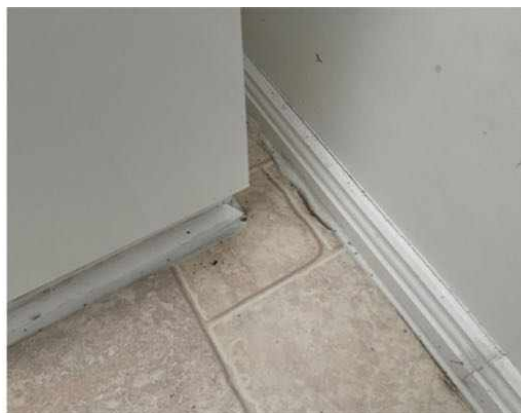
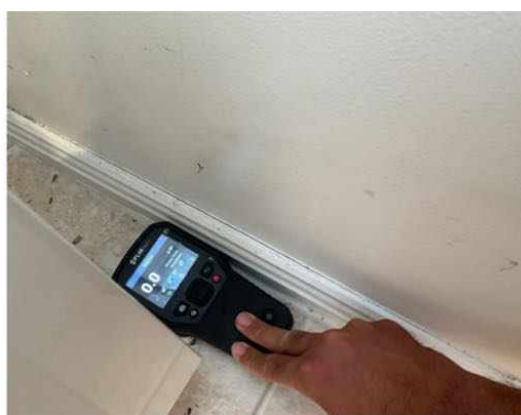
Building:	Main Building
Location:	Bathroom
Finding:	Uneven Vinyl Flooring to Bathroom
Information:	The vinyl flooring in the bathroom was found to be uneven at the time of inspection. This condition may be associated with substrate irregularities, installation issues, or general wear over time.

If left unaddressed, uneven flooring may worsen, affect the appearance and serviceability of the bathroom floor, and in some cases present a minor trip hazard.

Elevated moisture levels were not recorded in this area during the inspection. It is recommended that the flooring be monitored, and if the condition deteriorates or causes concern, a suitably qualified flooring contractor should be engaged for further assessment and advice.

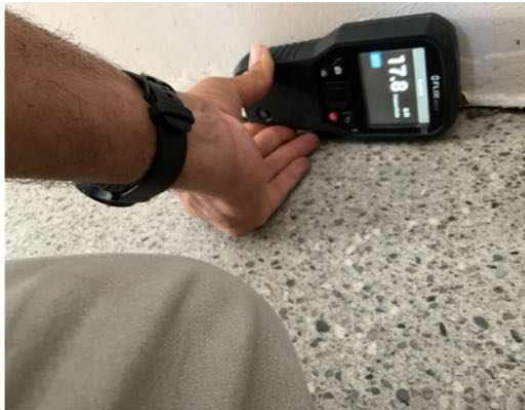
If left unaddressed, rising damp may lead to continued moisture exposure, resulting in deterioration of timber skirting, damage to adjoining wall linings, mould growth, and potential long-term impacts on internal finishes and air quality.

It is recommended that a suitably qualified contractor or damp specialist be engaged to further assess the extent and cause of the rising damp and provide appropriate remedial measures.

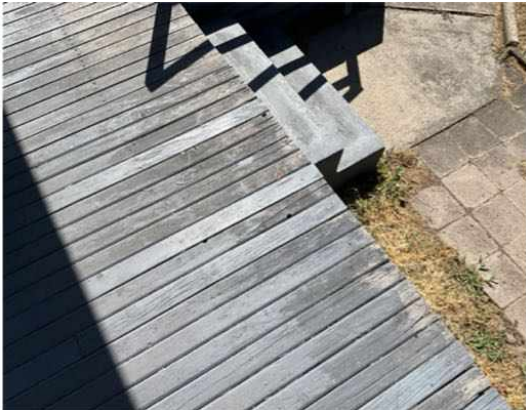
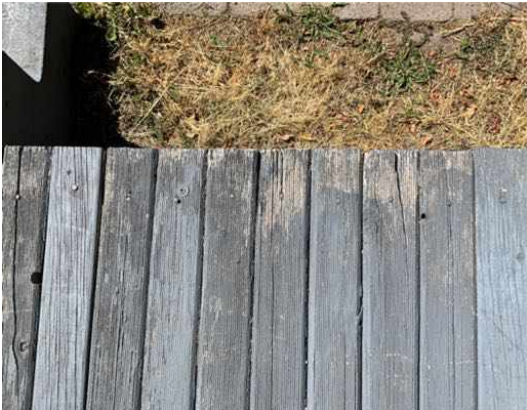
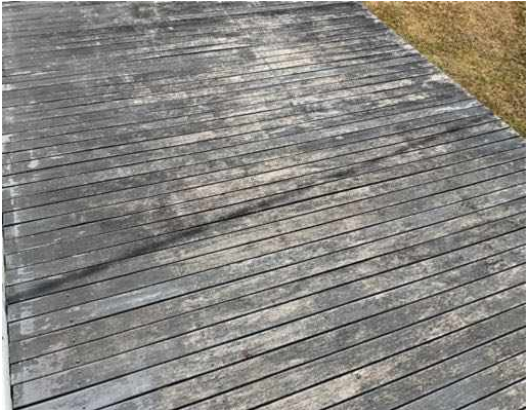
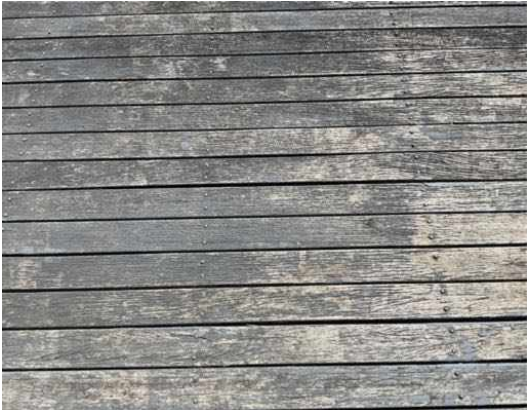
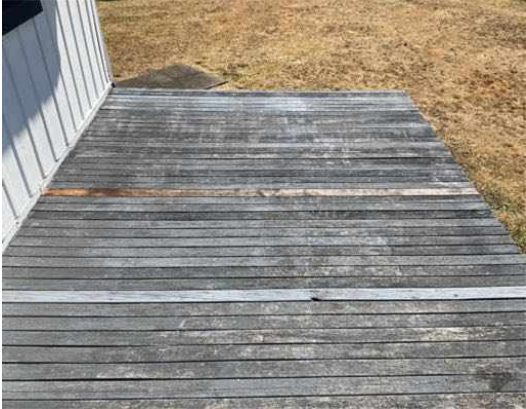
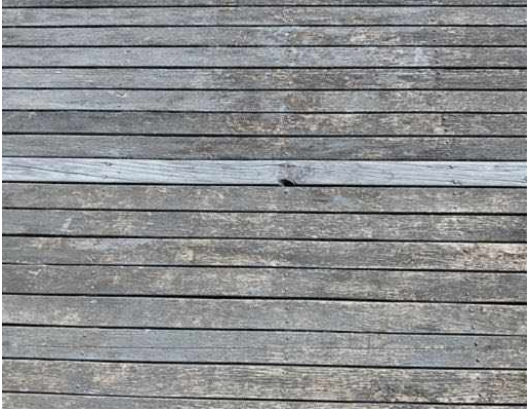
### Finding 3.11

Building: Main Building  
 Location: Deck  
 Finding: Weathered Timber Decking  
 Information: The timber decking in the deck area was observed to be weathered at the time of inspection. Surface deterioration, fading, and general wear were noted. Weathered Timber Decking, consistent with prolonged exposure to external weather conditions and a lack of recent maintenance.

Weathered timber can become more susceptible to moisture absorption, decay, and splintering. If left untreated, the deterioration may progress, potentially leading to structural weakening of the decking boards, safety hazards, and reduced overall lifespan of the deck.

It is recommended that a qualified contractor or carpenter be engaged to assess the condition of the decking and undertake appropriate maintenance. This may include cleaning, sanding, repairing any damaged sections, and applying a suitable protective coating or sealant to prolong the durability and appearance of the timber. Regular ongoing maintenance is advised.

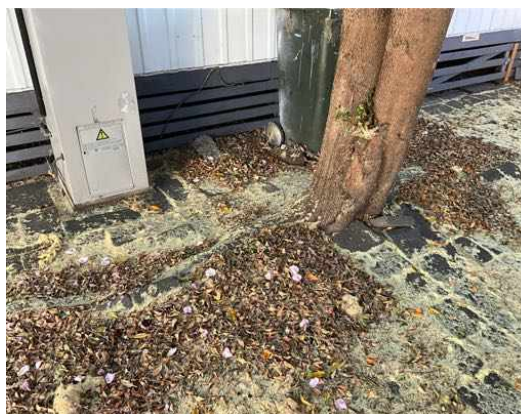
### Finding 3.13

Building:	Main Building
Location:	Exterior walls - right side
Finding:	Tree Root Growth Adjacent to Dwelling
Information:	Tree roots were observed growing close to the dwelling and were noted to be damaging sections of the surrounding paving at the time of inspection. The proximity of established tree roots to the structure increases the risk of ongoing ground movement and subsurface interference.

If left unaddressed, continued root growth may lead to further damage to paving and could potentially impact foundations, footings, underground services, or other structural elements of the dwelling. Progressive root intrusion may also contribute to uneven surfaces and ongoing maintenance issues.

It is recommended that a suitably qualified arborist or contractor be engaged to assess the extent of root growth and advise on appropriate management or removal. Ongoing monitoring is also recommended to reduce the risk of future structural damage.

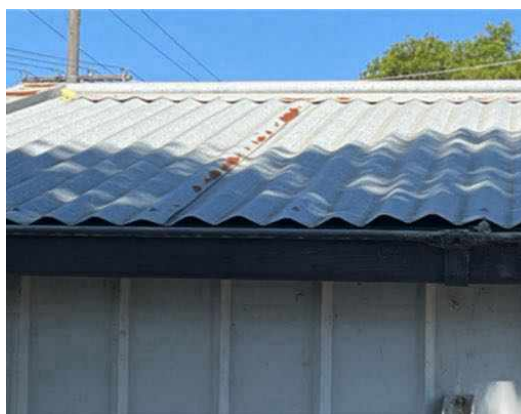
### Finding 3.14

Building:	Shed
Location:	Roof Exterior
Finding:	Corrugated Iron Roof - rusting
Information:	Rusting was observed on the corrugated iron roof in this area. The affected sections show signs of corrosion, which may be due to prolonged exposure to moisture, weathering, or inadequate drainage. Factors such as pooling water, debris accumulation, or previous damage to protective coatings could have accelerated the rusting process.

If left untreated, rust can continue to spread, weakening the metal and potentially leading to perforations or leaks. This may result in water ingress, which can cause damage to internal structures such as ceiling materials, insulation, and timber framing. In severe cases, corrosion can compromise the structural integrity of the roofing, increasing the risk of further deterioration and costly repairs.

It is recommended to engage a registered roofing contractor to assess the extent of the rust and take appropriate remedial action. Minor surface rust may be treated with rust inhibitors and protective coatings to prevent further corrosion. If rust has penetrated deeper, sections of the roofing may require repair or replacement. Regular maintenance, including clearing debris and ensuring proper water drainage, can help extend the lifespan of the roof and prevent further rust development.

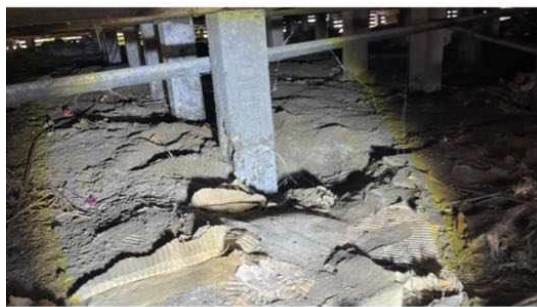
### Finding 3.16

Building: Main Building  
 Location: Subfloor  
 Finding: Backfill substandard for stumps  
 Information: Backfill was not completed around several stumps, leaving gaps and depressions in the surrounding soil. This issue is present in areas where the stumps were installed but not properly backfilled after excavation. The likely cause of this condition is inadequate soil replacement during or after the stump installation process, potentially due to time constraints, oversight, or soil compaction issues.

The lack of proper backfill creates low points around the stumps where water can accumulate, leading to persistent moisture retention. This condition increases the risk of timber decay and creates an environment conducive to termite activity, which can compromise the structural integrity of the stumps over time. Additionally, prolonged water ponding may contribute to soil movement and instability around the stumps, potentially affecting the overall foundation support.

To address this issue, it is recommended to properly backfill the affected areas with well-compacted soil to eliminate depressions and improve drainage. Ensuring adequate grading around the stumps will help direct water away from the structure, reducing the risk of moisture-related damage. If necessary, additional drainage solutions should be considered to prevent future water accumulation. Regular monitoring of moisture levels and termite activity is also advised to protect the structural components.

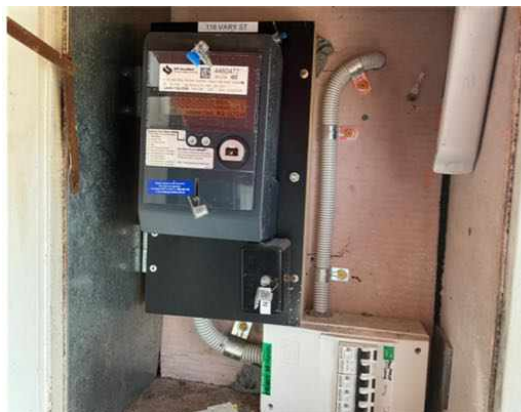
A durable notice should be placed in the switchboard unit to indicate current termite barriers. At the time of inspection, it appeared as though no termite management system has been installed, with no evidence to suggest preventative works taking place.

The client may consider gaining further advice from a pest controller as to the costs and procedures involved with this application. It is recommended that obtaining such advice be a short-term priority.

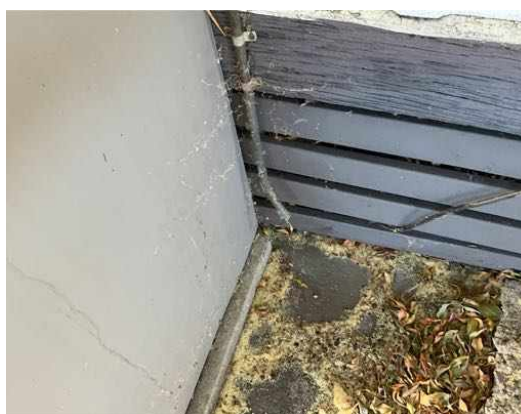
Building: Main Building  
 Location: All External Areas  
 Finding: HWS Overflow - Not Connected  
 Information: The Hot Water System (HWS) overflow was found to be disconnected from storm water drainage and is creating excessive moisture in the surrounding area.

These damp conditions can lead to secondary defects such as rot, rust or corrosion of associated building elements, the formation of fungal decay, or even the creation of potential slip hazards. When coupled with poor site drainage, pooling of water may also attract termite activity to this area.

It is highly recommended that a licensed plumber be appointed to connect the HWS overflow in order to prevent such an environment from being created. These minor works should be carried out as soon as possible.

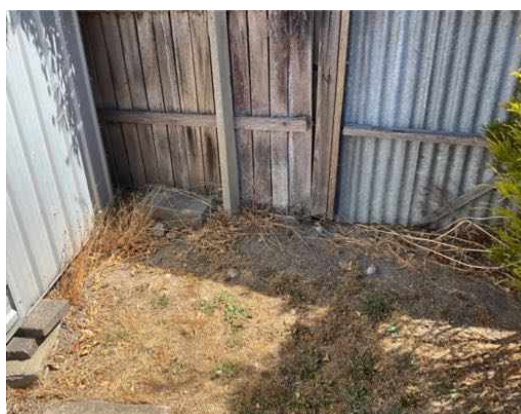
Finding: Building materials in direct ground contact - conducive to termites  
 Information: Where timber elements are in direct contact with the ground and consequently moisture or dampness they become conducive to termite activity. Whether timber is used as a building element part of a fencing structure or stored as an unused item they can provide an environment that is attractive to termite infestation.

When met with excessive moisture timber begins to decay and develop wood rot. Any timbers that are in direct contact with external grounds especially if left untreated or non-durable also provide ingress for subterranean termites into that particular element.

The removal of any such materials that may be conducive to termite activity should be removed as soon as possible to minimise the risk of termite attack.

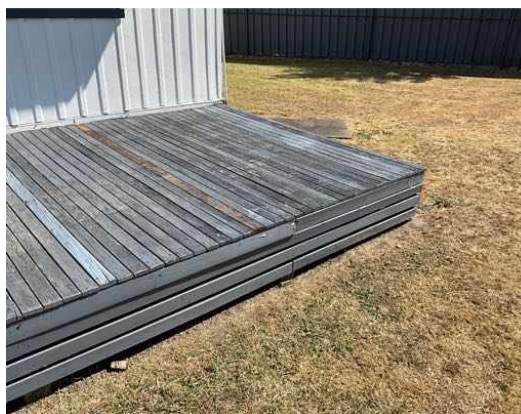
### Finding 6.06

Building: Main Building  
 Location: All External Areas  
 Finding: Ground level deck - conducive to moisture and timber decay  
 Information: The ground level deck can be conducive to timber pest infestation due to its close proximity to the soil. Without proper precautions, the moisture in the soil can create an ideal environment for timber decay and other termites to thrive. Regular inspection and treatment can help prevent infestation and protect the decks structural integrity.

An invasive inspection of the area is recommended to determine further actions.

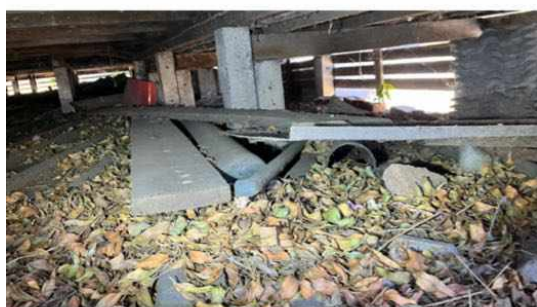
### Finding 6.07

Building:	Main Building
Location:	All External Areas
Finding:	Timber debris - exterior areas & subfloor space
Information:	Timber debris were found in the exterior areas & subfloor space at the time of inspection. The storing of timbers in the subfloor space or around the external property increases the risk of termite activity being present. As they are likely to come into contact with weather conditions or excessive moisture wood rot is likely to develop on timbers that are not treated.

It is highly recommended that any stored timbers be immediately removed from areas in which they may attract any termite / timber pest attack. Minimisation of risk / prevention of termite attack is far more adequate than dealing with the presence of termite activity.

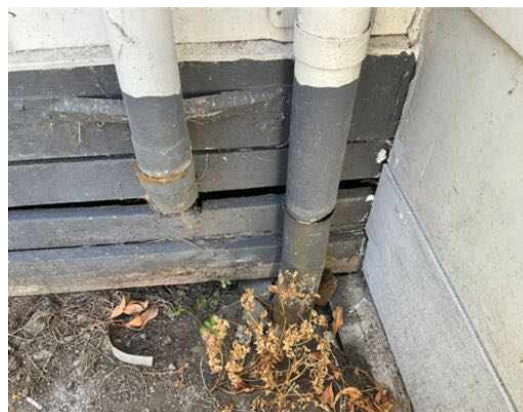
### Finding 6.08

Building:	Main Building
Location:	Exterior walls - rear
Finding:	Downpipes inadequately connected - conducive condition
Information:	The downpipe was found to be inadequately connected to the stormwater line, allowing water to discharge near the building. This creates excess moisture around the

structure, which can lead to timber decay and provides conditions conducive to termite infestation. Prolonged dampness may also contribute to foundation movement and other structural concerns.

If left unaddressed, ongoing moisture accumulation can accelerate timber deterioration and attract termites, potentially leading to costly repairs.

It is recommended to have the downpipe properly connected to the stormwater drainage system as soon as possible to prevent excessive moisture buildup and reduce the risk of termite activity.

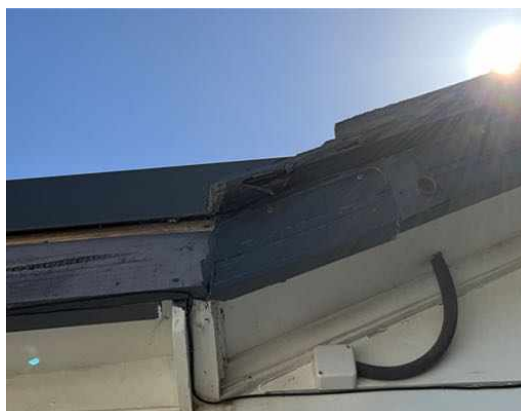
### Finding 7.01

Building:	Main Building
Location:	Roof Exterior
Finding:	Wood rot - Fascias
Information:	Fascias and barges in this area shows evidence of wood rot. Wood rot, also known as Fungal Decay, occurs when timbers and other cellulose building materials are exposed to damp conditions on an ongoing basis. This could be the result of exposure to weathering over a prolonged period of time, or the attraction of excessive moisture from other abutting building materials.

It is likely that this wood rot has developed as a result of faults in the roof plumbing, creating excessive moisture in this area. Frequent exposure to rain and other weather conditions also make fascia's and barges susceptible to accelerated deterioration.

Early intervention and regular maintenance, particularly of exterior timbers, will prolong the useful life of these building elements. Prior to any works being performed, the cause of the moisture that has created the visible wood rot should be identified and addressed in a suitable manner. Replacement of affected timbers may then be a necessary step in protecting surrounding building elements from such deterioration.

A qualified plumber may be appointed to assess the cause of excessive moisture and to provide advice on any remedial works as required. A qualified carpenter or registered builder may also be required to replace affected building materials.

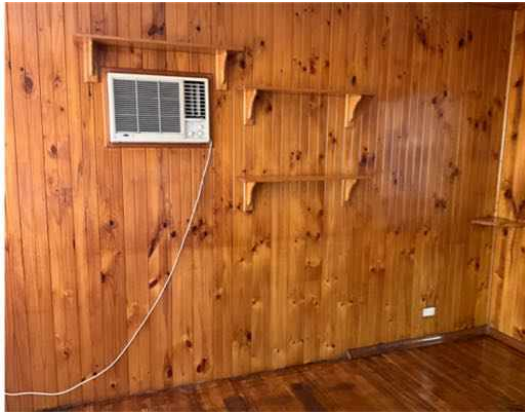
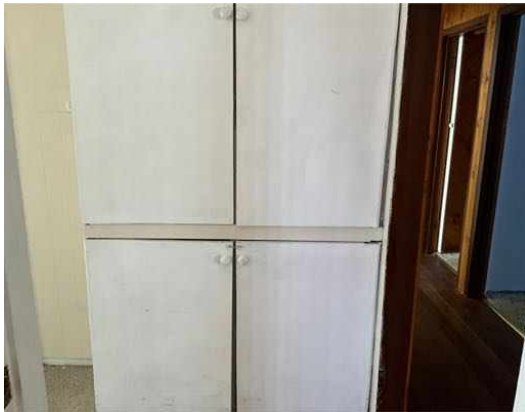
Building:	Main Building
Location:	All Internal Areas
Finding:	Obstructions and Limitations - Internal areas
Information:	These photographs are an indication of the obstructions and limitations which impeded full inspection of the internal areas of the property at the time of inspection.

These obstructions can hide an array of defects and should be removed to allow full inspection to be carried out. A re-inspection is recommended once the areas are made accessible.

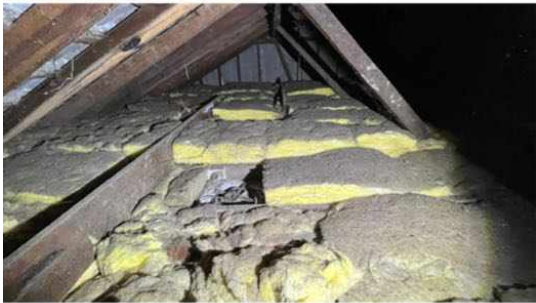
Building:	Main Building
Location:	Roof Void
Finding:	Obstructions and Limitations - Roof Cavity
Information:	These photographs are an indication of the obstructions and limitations which impeded full inspection of the roof cavity of the main building at the time of inspection. These obstructions can hide an array of defects and should be removed to allow full inspection to be carried out. A re-inspection is recommended once the areas are made accessible.

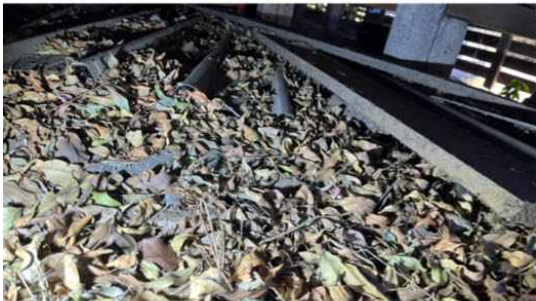
Building: Main Building  
Location: Subfloor  
Finding: Obstructions and Limitations - Subfloor  
Information: These photographs are an indication of the obstructions and limitations which impeded full inspection of the subfloor of the main building at the time of inspection. These obstructions can hide an array of defects and should be removed to allow full inspection to be carried out. A re-inspection is recommended once the areas are made accessible.
