Building and Timber Pest Inspection Report

Inspection Date: Mon, 12 Jan 2026

Property Address: 6 Frederick St, Point Frederick NSW 2250,
Australia

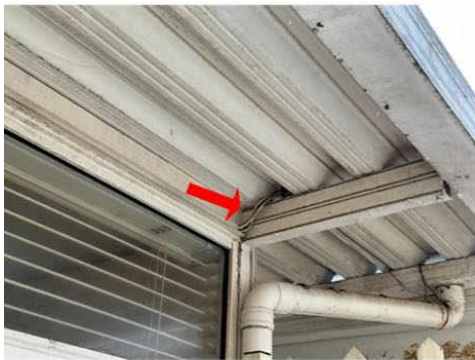
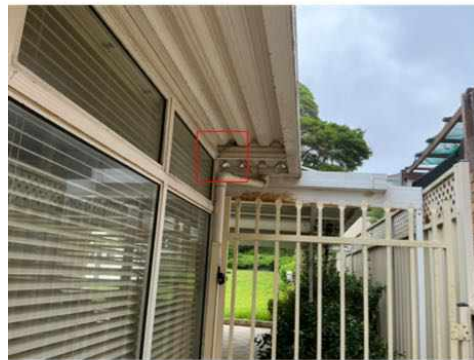
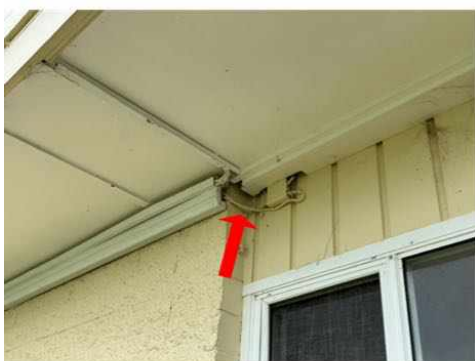
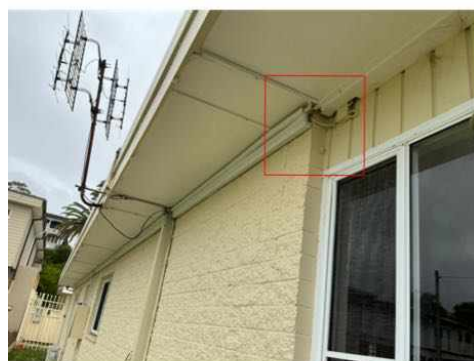
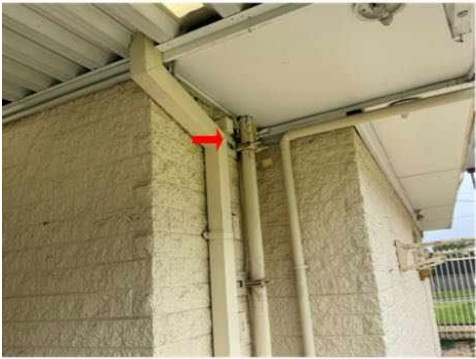
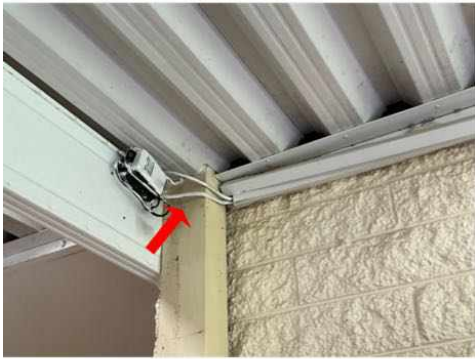
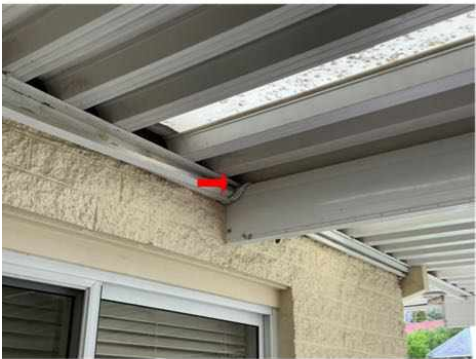
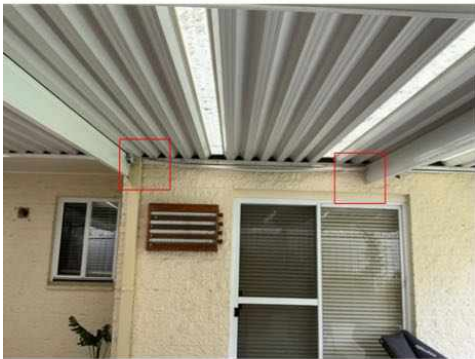
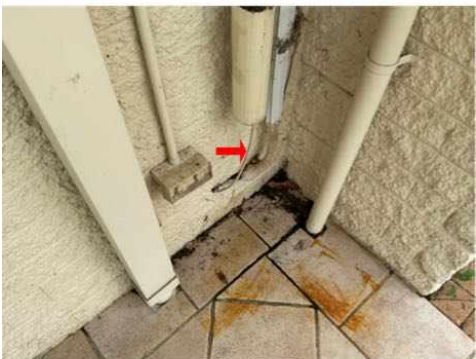
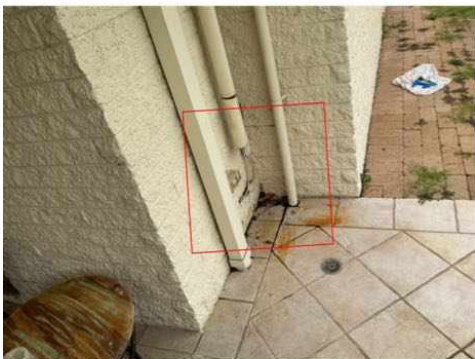
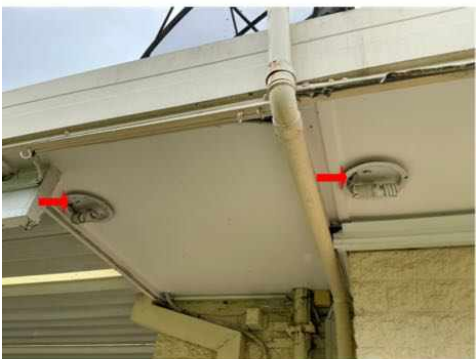
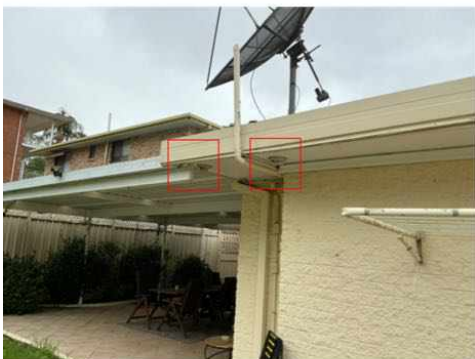
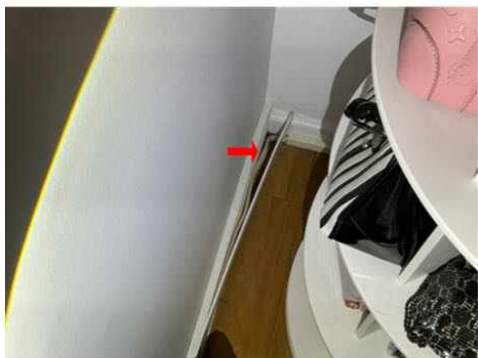
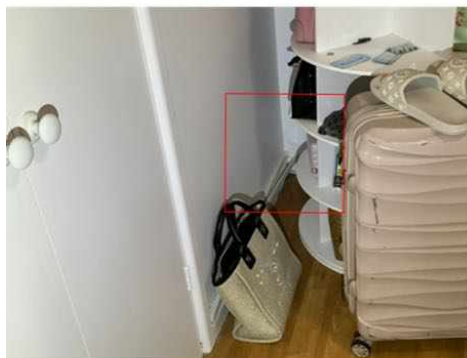
Finding 1.01

Building:	Main Building
Location:	All External Areas, Bedroom 2
Finding:	Electrical Wires - Exposed
Information:	During the inspection, exposed electrical wires were noted. This condition poses a significant safety hazard, as it increases the risk of electrical shock, short circuits, and potential fire. It is imperative that a qualified electrician addresses this issue immediately by properly insulating the exposed wires and ensuring all electrical connections comply with safety standards. Prompt action will mitigate the risks associated with exposed wiring and maintain the safety and integrity of the property's electrical system.

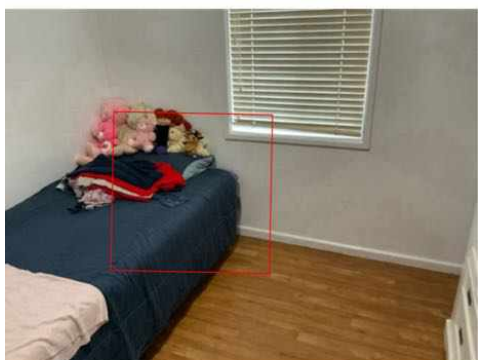
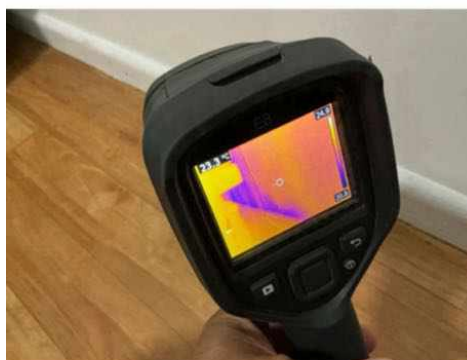
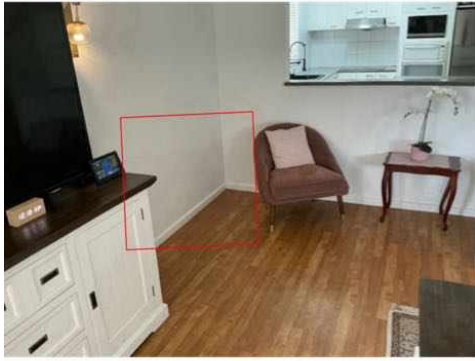
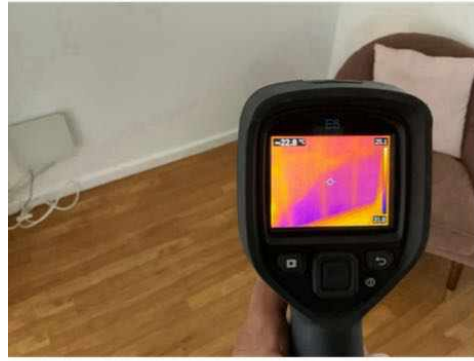
Finding 2.01

At the time of inspection, evidence of water ingress was noted to the internal walls on the left side of the house. Thermal imaging identified cooler temperature anomalies consistent with moisture presence within the wall structure. It was observed that site drainage around this section of the perimeter is inadequate, and the external ground levels are at, or close to, the same height as the internal floor levels. This condition can allow surface water to pond against the external walls and subsequently seep through the brickwork into the internal areas. If left unaddressed, ongoing moisture ingress may lead to deterioration of internal finishes, potential damage to wall structures, and an increased risk of mould growth.

It is recommended that a suitably qualified builder be engaged to further assess the cause and extent of the water ingress. Rectification works may include improving perimeter drainage, lowering external ground levels to achieve appropriate clearance below internal floor levels, and implementing suitable waterproofing measures to prevent further moisture penetration.

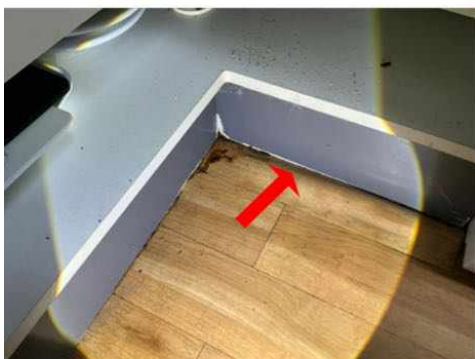
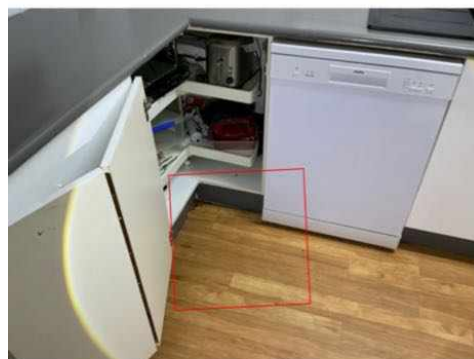
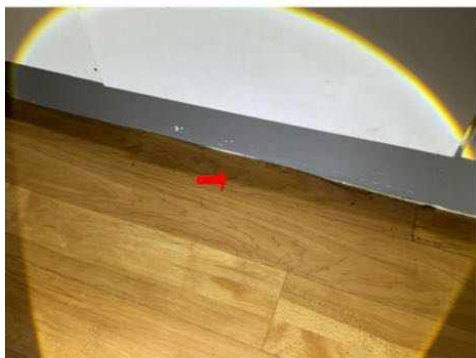
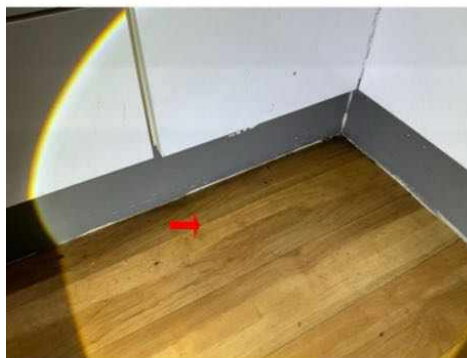
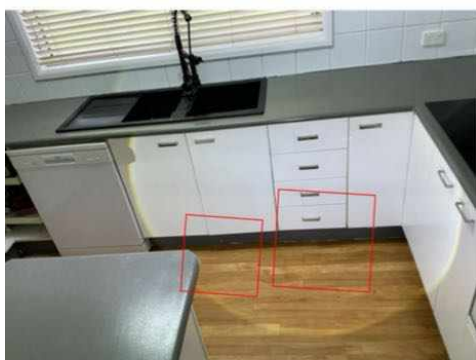
Finding 2.02

Finding: Flooring - Water Damage

Information: At the time of inspection, evidence of water ingress and water damage was noted to the flooring in the kitchen area, particularly adjacent to and beneath the kitchen cabinetry and sink.

It was further observed that external drainage around this section of the dwelling is inadequate, with external ground and paving levels set at the same level as the internal finished floor level. This configuration does not provide adequate separation or fall away from the building and significantly increases the risk of water seeping through the external walls and into the internal flooring. There could be some damaged concealed Plumbing fixture.

The affected flooring shows signs consistent with prolonged moisture exposure and deterioration. Continued moisture ingress may lead to further damage, including flooring failure, mould growth, and potential concealed structural issues.

It is recommended that a licensed Flooring Specialist be engaged to assess and replace the water-damaged flooring as required.

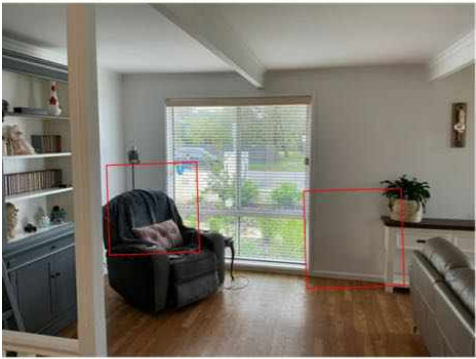
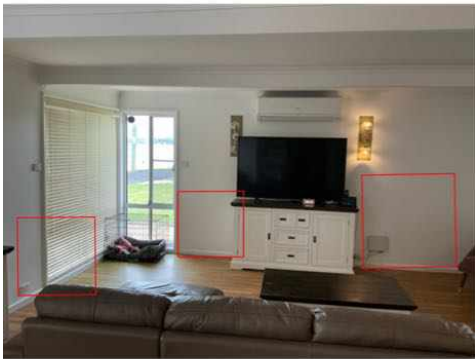
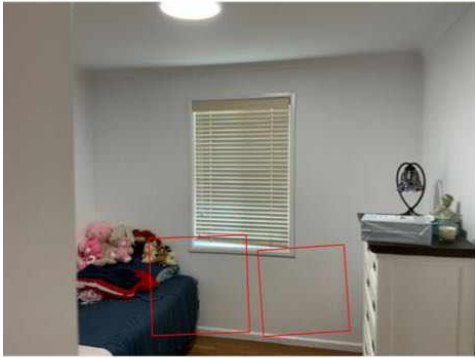
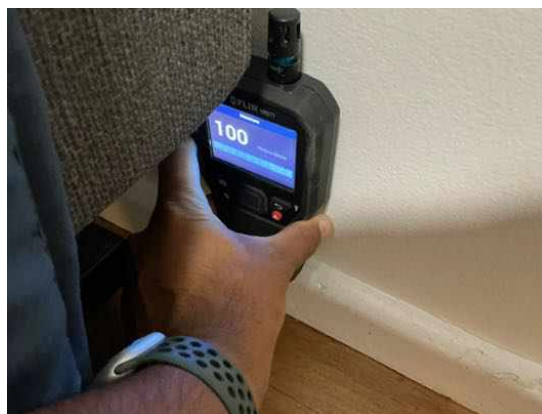
Finding 2.03

Building:	Main Building
Location:	Lounge Room, Bedroom 2
Finding:	Excessive Moisture - Walls
Information:	Excessive moisture was observed in the walls at the time of inspection, indicating potential underlying issues that could be contributing to this condition.

One possible cause is rising damp, where moisture from the ground seeps up through the brickwork due to a compromised or missing damp-proof course. Another potential factor could be water ingress from faulty or blocked gutters and downpipes, which may be allowing water to overflow and penetrate the wall. Additionally, poor drainage around the property can lead to water pooling near the base of the wall, increasing the likelihood of moisture absorption. Inadequate ventilation in the affected area could also exacerbate the problem, as it would prevent moisture from properly evaporating, leading to persistent dampness. It is essential to investigate these potential causes thoroughly to identify the source of the moisture and implement appropriate remedial actions to prevent further damage to the wall and the building's structural integrity.

The client is advised to engage services of a professional plumber to fix the issue.

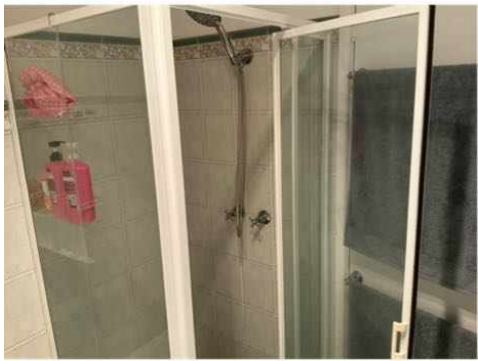
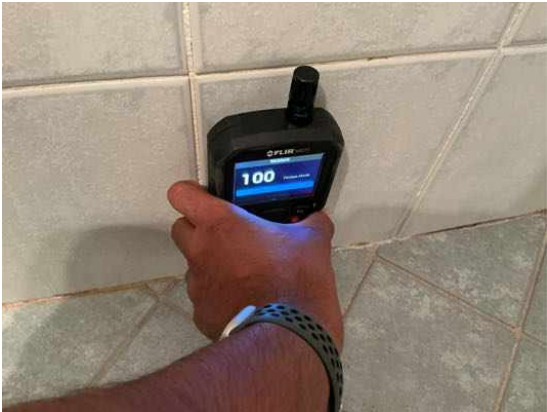
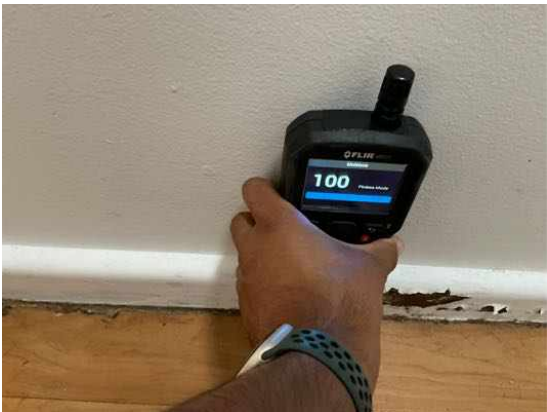
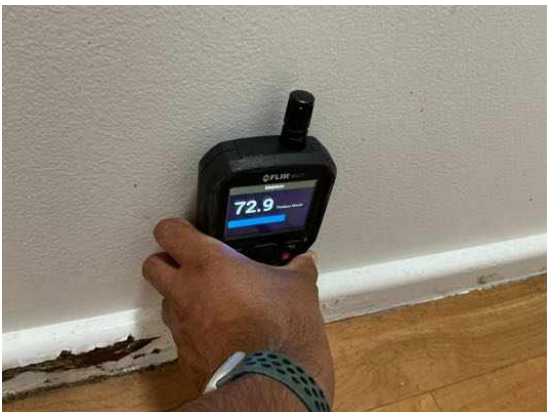
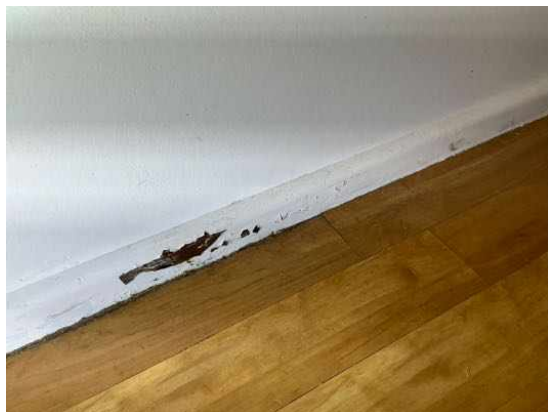
Finding 2.04

Building:	Main Building
Location:	Bathroom
Finding:	Excessive Moisture on Walls (Adjacent Bathroom) - Major Defect
Information:	A major defect was identified during the inspection, with evidence of moisture penetration noted on the walls adjoining the bathroom and shower area. These walls are shared with the bedrooms on either side of the bathroom. The presence of moisture raises serious concerns about the integrity of the waterproofing system, which is a critical component in preventing water ingress into adjoining structures.

The moisture penetration is likely due to a failure or inadequacy in the waterproofing membrane beneath the tiled surfaces in the bathroom and shower area. Waterproofing systems are designed to act as a barrier, and any breach can result in water escaping into adjacent walls. This could also be exacerbated by inadequate sealing around fixtures, joints, or tiles, which are common entry points for water. Additionally, the defect may be attributed to substandard installation practices or the natural wear and tear of waterproofing materials over time, both of which can compromise the membrane's effectiveness.

If left unaddressed, this issue could lead to significant consequences. Persistent moisture can weaken the structural integrity of the walls, resulting in costly repairs or replacement. Damp conditions also create an ideal environment for mould growth, which poses health risks and further compromises the interior condition of the property. Moreover, unresolved waterproofing issues can adversely impact the property's value and marketability.

The client is advised to use services of a professional waterproofing specialist as soon as possible.

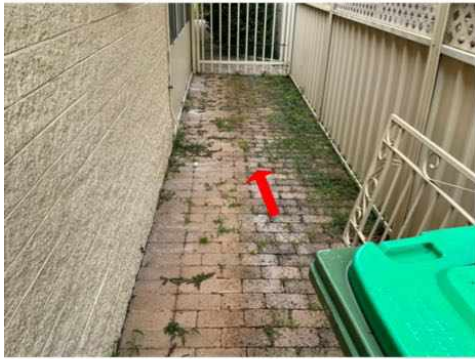
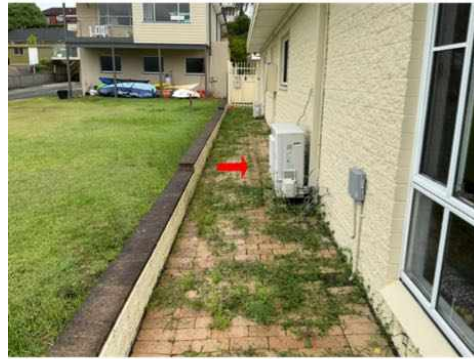
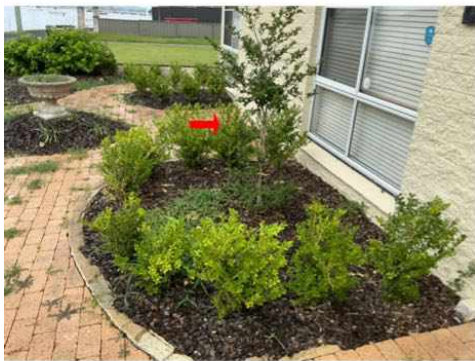
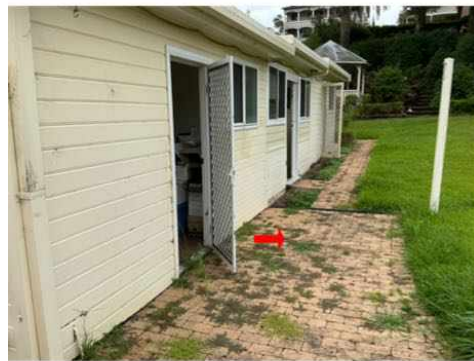
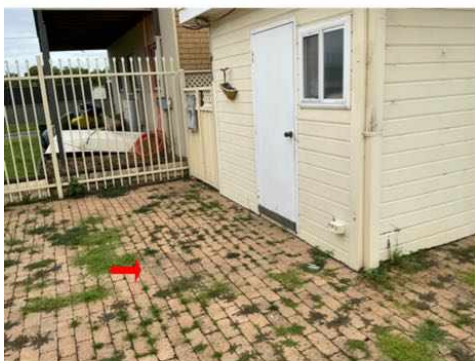
Finding 3.01

Building:	Main Building
Location:	All Areas
Finding:	Inadequate Site Drainage - Exterior Areas
Information:	At the time of inspection, inadequate site drainage was observed around the perimeter of the building, which can lead to water pooling and insufficient runoff management.

This condition may result in moisture being absorbed by the foundation or lower walls, potentially leading to rising damp, cracks in brickwork, erosion of the soil around the building, or structural issues over time. Water pooling can also create ideal conditions for mould growth, contribute to the deterioration of exterior materials, and act as conducive conditions for termite activity, as termites are attracted to areas with elevated and persistent moisture levels.

It is recommended that proper site drainage be installed, such as redirecting water flow away from the building or incorporating drainage systems, to prevent further damage and ensure the long-term stability of the structure.

To address the inadequate site drainage, a qualified landscaper or drainage specialist should be engaged to design and install appropriate drainage solutions, such as grading the ground away from the building or installing French drains, surface drains, or downspout extensions. If more complex issues are present, such as damage to the foundation or moisture entering the walls, a structural engineer may need to assess the situation, and a builder may be required for repairs.

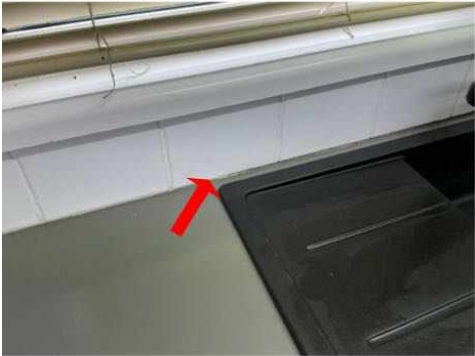
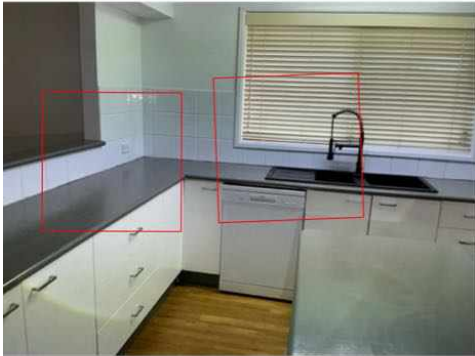
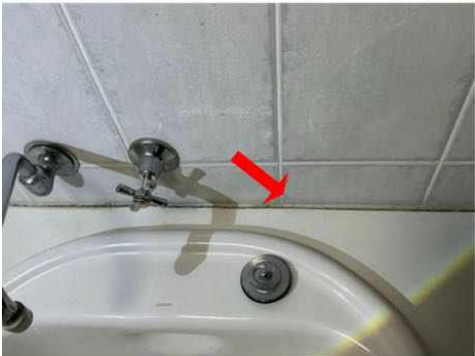
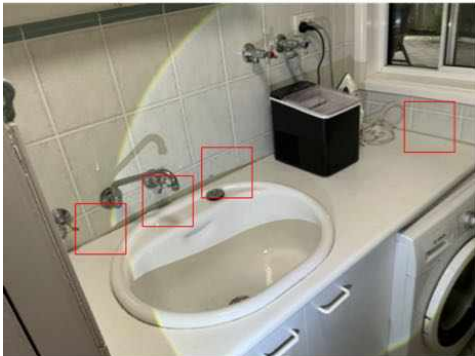
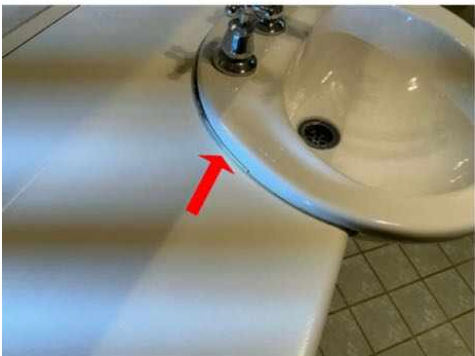
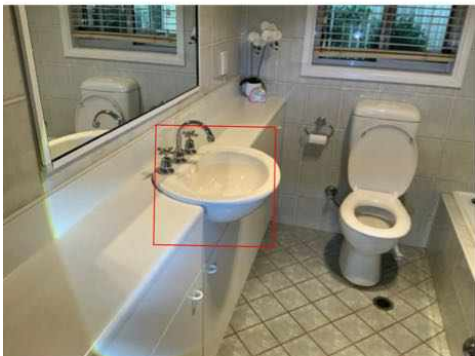
Building:	Main Building
Location:	Kitchen
Finding:	Sealant and Grouting - Missing or Damaged
Information:	It was noted on inspection that sealant or grout is degraded/missing to these areas.

Different materials and floor areas move at different rates, generally causing cracking to grout or sealant at this point. A flexible sealant is required to allow for expected expansion and contraction, while keeping the joint water tight and protective of all associated building materials.

any subsequent water damage that is likely to occur. Regular maintenance and replacement of damaged or missing or damaged sealant and grout is highly recommended to the wet areas, as this is a regular wear and tear defect. Sealant and grouting in areas that come into regular contact with water should be maintained for the long term care of your property.

A sealant specialist or tiling contractor should be appointed to complete these works as soon as possible

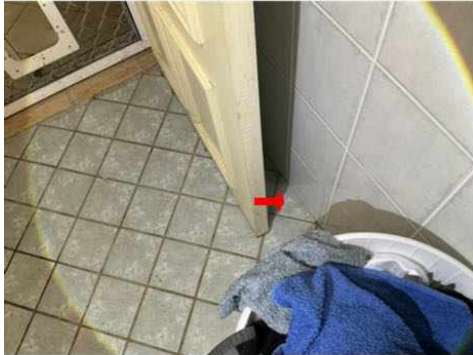
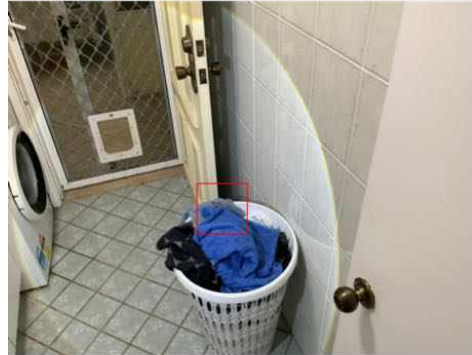
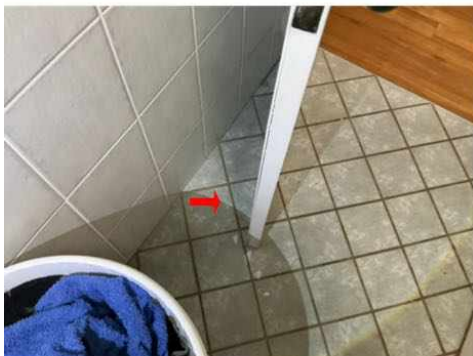
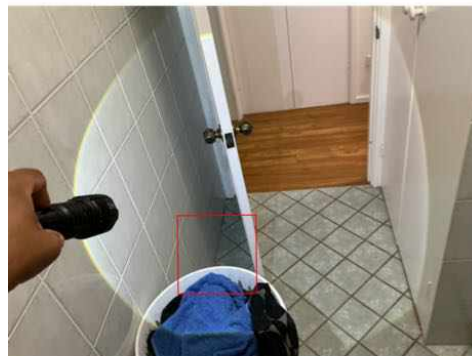
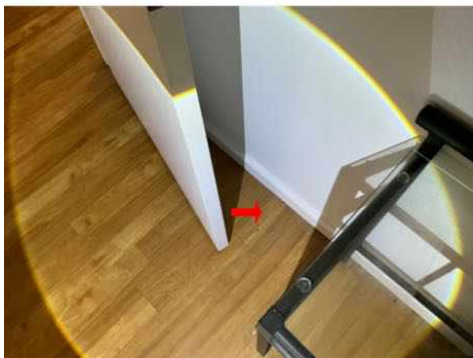
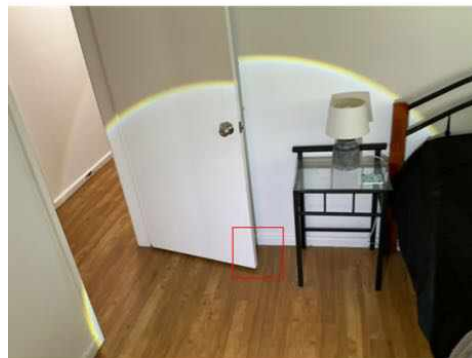
Finding 3.13

Finding: Door Stopper(s) - Missing

Information: At the time of inspection, it was noted that a door stopper was missing in this area.

The absence of a door stopper can lead to potential damage to the door, wall, or surrounding finishes, as the door may swing open too far and impact the wall or adjacent objects. Over time, this can cause dents, scuffs, or even structural damage to the wall or door. It is recommended that a door stopper be installed to prevent further damage and ensure the protection of both the door and the surrounding area.

The client is advised to engage services of a handyman to install the door stopper.

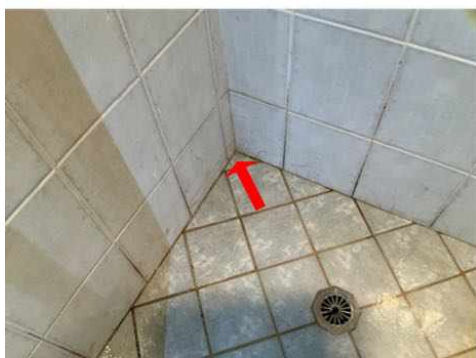
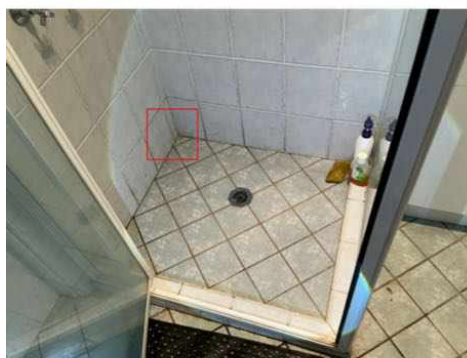
Finding 3.14

Building:	Main Building
Location:	Ensuite - Master
Finding:	Tiles - Cracked and/or Damaged
Information:	Cracking in the tiles was evident in this area at the time of inspection. It is suspected that this cracking has occurred as a result of minor settlement or shrinkage.

While the cracking appears to be minor, this area may be exposed to water, allowing potential for water penetration into adjoining sections of walls or flooring. Cracked tiles

throughout the household detracts from the overall appearance of the affected areas however it is unlikely to create or lead to any secondary defects. While not considered a matter of urgency, replacement of cracked floor tiles is recommended at the clients discretion.

A licensed tiling contractor may be appointed to perform these works. Should these cracks become more numerous, a licensed builder should be appointed to inspect and advice on rectification.

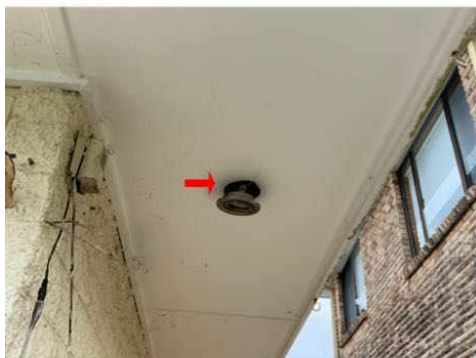
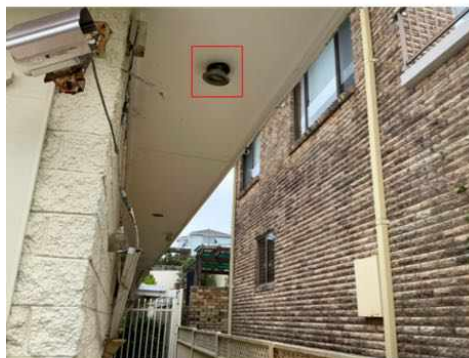
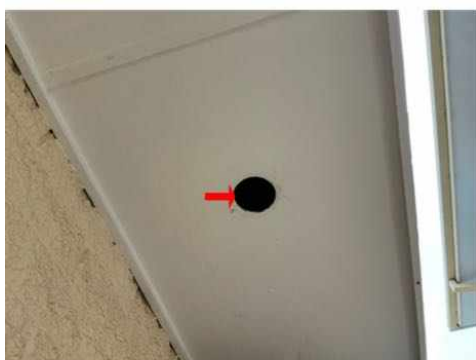
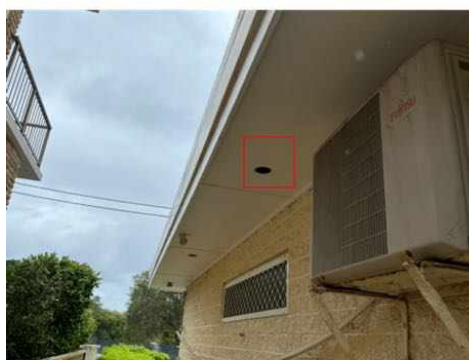
Finding 3.15

Information: It was noted at the time of inspection, there is a visible gap between the fascia board and the eaves along the edge of the roof. This condition can lead to various issues if not addressed promptly.

Changes in temperature and humidity can cause the fascia board and soffit to expand and contract, leading to gaps over time. The eaves may not have been installed correctly, resulting in an improper fit. Over time, weather conditions and environmental factors can cause the materials to deteriorate, creating gaps.

Rainwater can enter through the gap, potentially causing damage to the roof structure, walls, and interior of the building. The gap provides an entry point for insects, birds, and other pests. Gaps in the roofline can lead to increased energy loss, reducing the efficiency of heating and cooling systems.

Client is advised to hire services of a roofing contractor to rectify the issue at earliest possible.

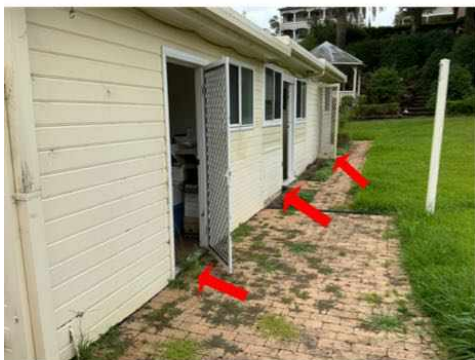
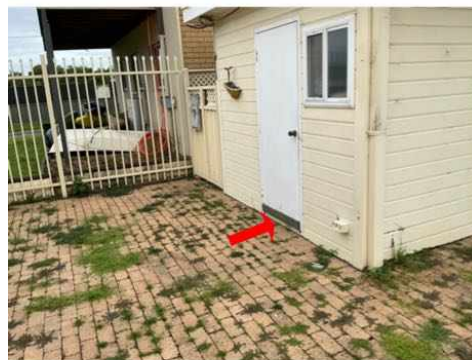
Finding 6.02

Building:	Main Building
Location:	All Areas
Finding:	Bridging or Breaching of Termite Barriers - Adjacent Internal Flooring
Information:	Bridging is the spanning of a termite barrier or inspection zone so that subterranean termites are provided with passage over or around that barrier.

It is important for internal flooring to be raised above adjacent external ground levels. Where external ground levels are above or same level as internal flooring, water pooling and subsequent internal flooding is likely to occur which may attract termite activity to the internal area.

It is highly advised that a landscaper or relevant tradesperson be appointed to lower external grounds that are raised above or same as adjacent internal flooring. Alternatively if external grounds and internal flooring is level installation of a raised door sill may be appropriate in preventing any water pooling in the area. If the client wishes not to make any changes, then a qualified pest controller is recommended for termite treatment around the perimeter of the house and subfloor (if any) as soon as possible.

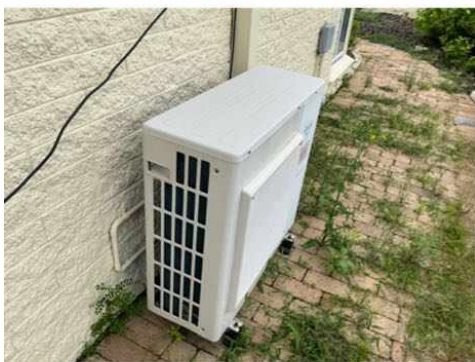
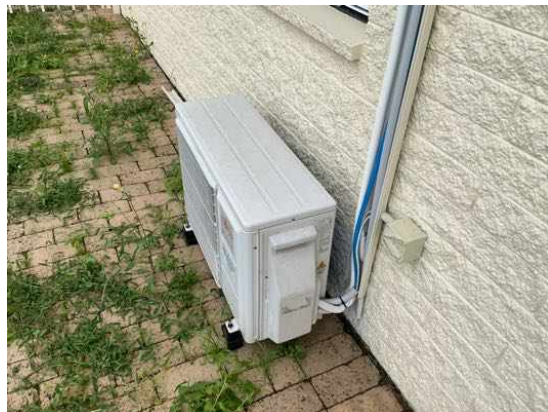
Finding 6.03

Building:	Main Building
Location:	All Areas
Finding:	Bridging Appliances - Attachment to Buildings
Information:	Bridging occurs when items against a building provide a concealed entry point for termites into the building or by passing around a termite management system.

Where any part of an attachment to a building is not isolated and is not provided with a clear gap of not less than 25mm from the building, bridging occurs. Attachments to buildings such as hot water services, downpipes, verandahs, decks, steps, fences, service conduits and the like provide the opportunity for concealed entry.

Building attachments of this nature need to be frequently inspected for termite activity by a qualified inspector.

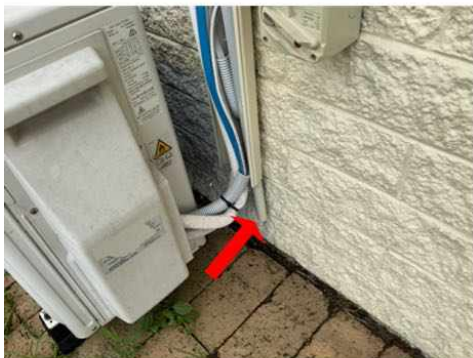
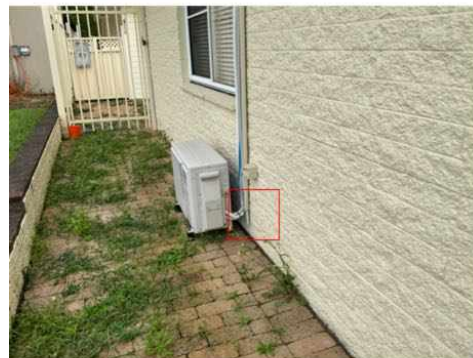
Finding 6.04

Building:	Main Building
Location:	All Areas
Finding:	Overflow Disconnected - HWS/AC/Gas - Conducive Conditions to Termites
Information:	The overflow to this service was found to be disconnected from stormwater drainage and is creating excessive moisture in the surrounding area.

Such leaking creates an environment that is conducive to an array of defects, including water damage to associated building elements and the attraction of termite or timber pest infestation. These damp conditions can lead to secondary defects such as rot, rust, or corrosion of associated building elements, the formation of fungal decay, or even the creation of potential slip hazards. When coupled with poor site drainage, pooling of water may also attract termite activity to this area.

It is highly recommended that a licensed plumber be appointed to connect the overflow in order to prevent such an environment from being created. These minor works should be carried out as soon as possible.

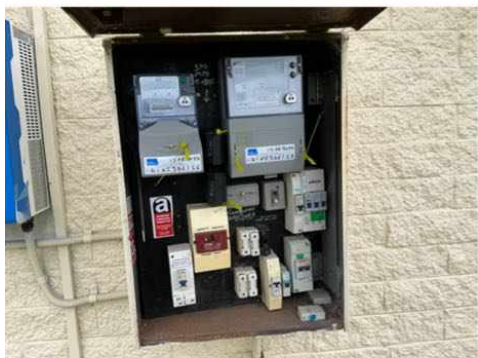
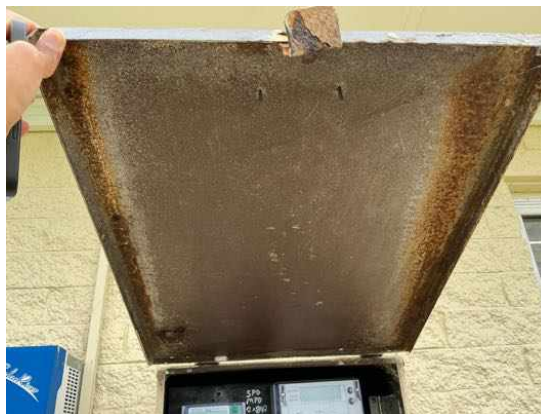
Finding 6.05

Building:	Main Building
Location:	Meter Box
Finding:	Termite Management System - No Evidence of Installation
Information:	The application of a post-construction chemical termite barrier is strongly recommended for all properties, especially if there has been any history of live termite activity on-site. These barriers are highly effective in protecting timber building elements throughout the property by preventing termite attacks. It is also advisable to install a durable notice within the switchboard unit, indicating the presence of any termite barriers for future reference.

During the inspection, there was no indication that a termite management system had been installed, nor was there any evidence to suggest that preventative measures had previously been undertaken. The client is encouraged to seek further advice from a licensed pest controller regarding the costs and procedures involved in the application of a termite barrier. Prioritizing this step in the short term is strongly advised to ensure long-term protection.

Additionally, the client may want to consult with the vendor to determine whether regular Timber Pest inspections, as per AS4349.3 or AS 3660.2, have been conducted in the past. This will provide further insights into any past termite management practices and help inform the appropriate course of action.

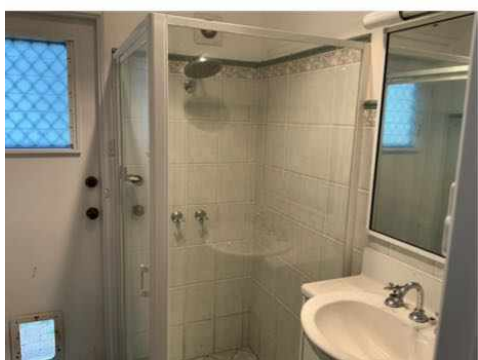
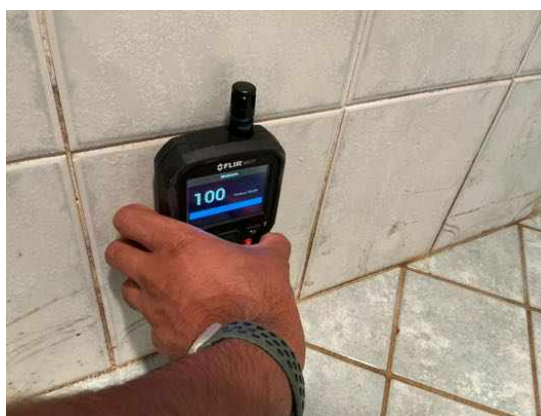
Finding 6.06

Finding: Excessive Moisture - Shower Damp

Information: At the time of inspection, excessive moisture was noted within the shower area, which is a common issue in wet areas due to the continual exposure to water. This condition is typically caused by moisture seeping through grout lines and settling behind tiles, resulting in localised high-moisture zones. Provided there is no evidence of water staining or elevated moisture readings on the opposite side of the wall, this is considered a minor defect.

However, persistently damp conditions may act as conducive conditions for termite activity, as termites are strongly attracted to moisture-rich environments. It is recommended that the client ensures regular use of the exhaust fan and maintains adequate ventilation after shower use to promote drying and reduce long-term moisture build-up, thereby also reducing the risk of attracting termites.

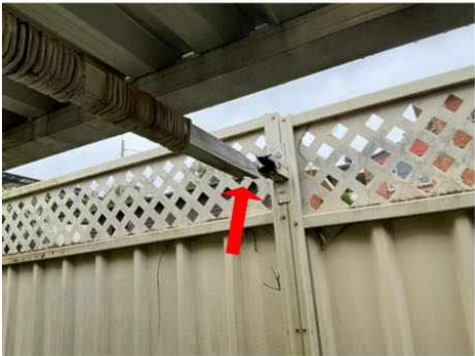
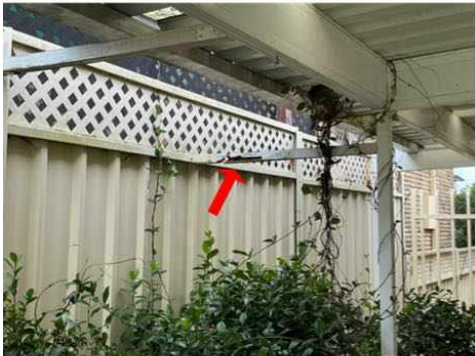
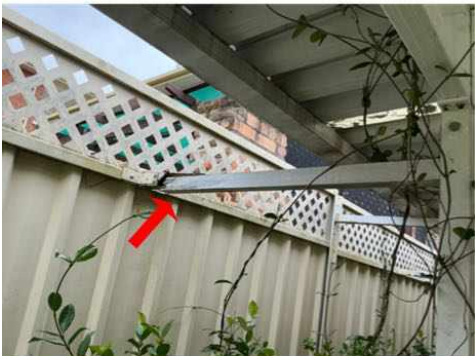
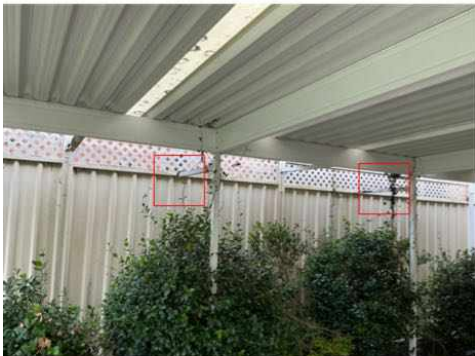
Finding 7.01

Building:	Yard
Location:	Rear Covered Area
Finding:	Fungal Decay - Present (Localised)
Information:	Fungal decay, also referred to as wood decay or wood rot, typically occurs when timber elements are exposed to excessive moisture for extended periods. This deterioration process is accelerated by temperatures ranging between 5°C and 40°C, as well as the presence of oxygen. Fungal decay is commonly found in timber components used in external environments, particularly when they are exposed to rain or moisture penetration.

In this instance, although the timber element shows signs of decay, the visible damage appears to be localized to a specific area and has not yet spread to adjoining structures or other parts of the building element. As a result, the fungal decay is likely to be relatively superficial, with minimal impact on the structural integrity or tensile strength of the timber. However, it is advisable to monitor the affected area to prevent further deterioration and address the underlying moisture issue to mitigate future risk.

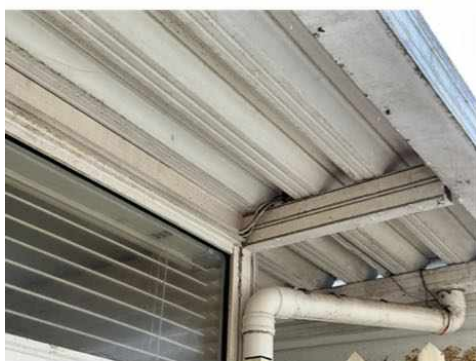
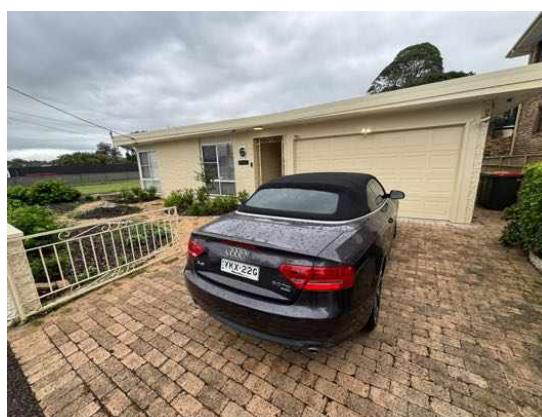
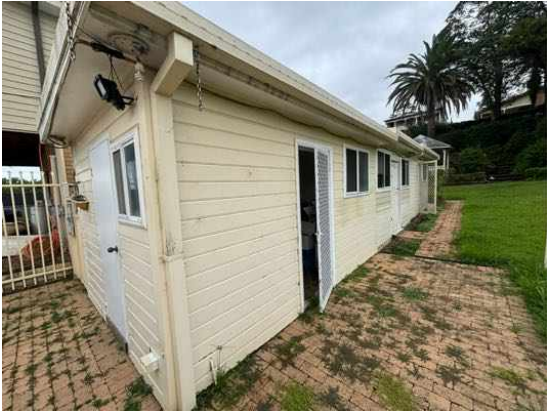
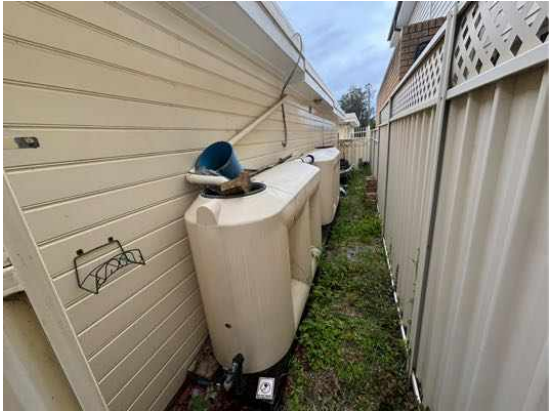
Building: Main Building
Location: All External Areas
Finding: Obstructions and Limitations - External Areas
Information: The attached photographs provide a visual representation of the obstructions and limitations that impeded a full inspection of the external areas of the property at the time of assessment. These obstructions, which may include vegetation, stored items, debris, or other physical barriers, can obscure potential defects and prevent a thorough evaluation of the property's condition. Obstructions of this nature can conceal a wide range of issues, such as structural damage, water ingress, pest infestations, or deteriorating building materials, which may not be visible during the initial inspection.

It is essential that these obstructions be cleared to allow for a comprehensive inspection of the external areas. Removing these barriers will enable a more accurate assessment of the property's condition and allow any hidden defects to be identified and addressed promptly. Failure to do so could result in undetected issues worsening over time, potentially leading to more costly repairs in the future.

Therefore, it is strongly recommended that the obstructions be removed and a re-inspection be scheduled once the affected areas are made fully accessible. This will ensure a complete evaluation of the property's exterior and provide the client with a clear understanding of any potential issues that may have been concealed during the initial inspection.

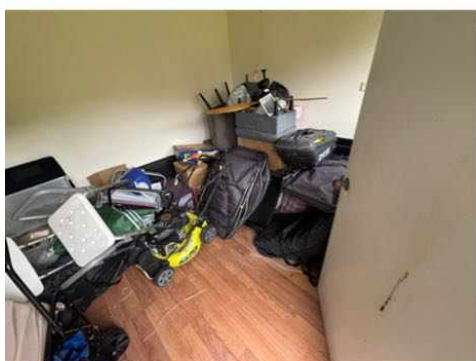
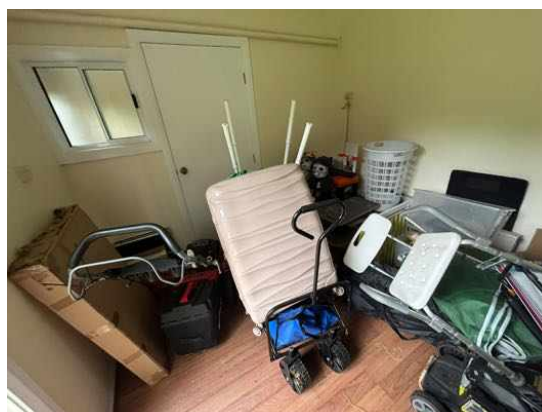
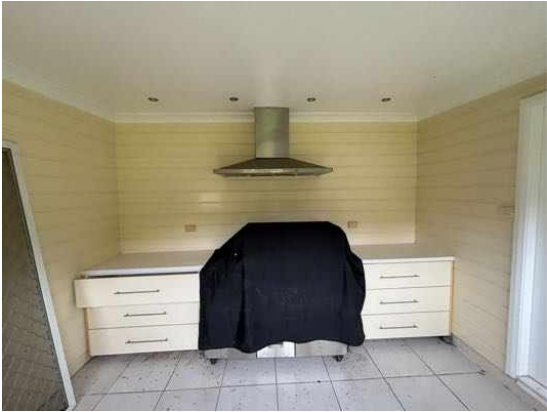
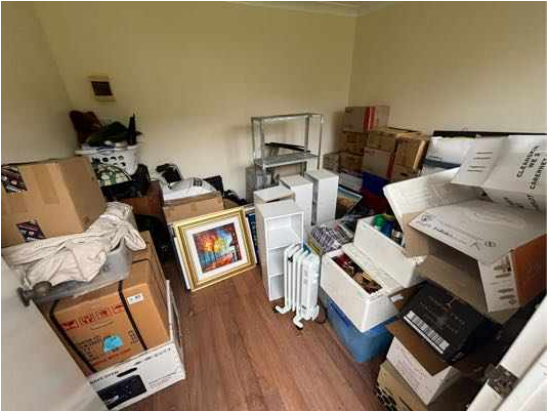
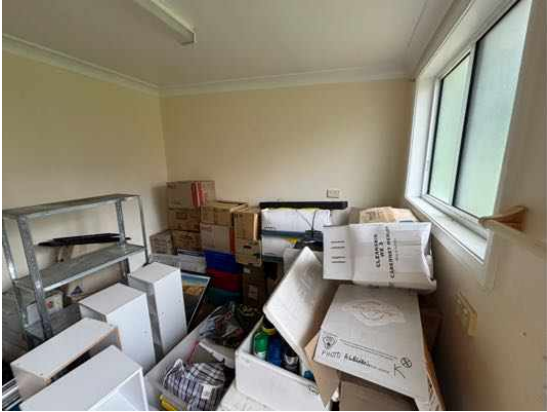
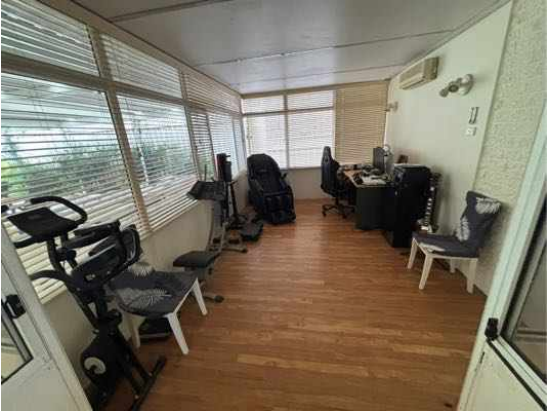
Building:	Main Building
Location:	All Internal Areas
Finding:	Obstructions and Limitations - Internal Areas
Information:	<p>The accompanying photographs provide clear evidence of the obstructions and limitations that restricted a comprehensive inspection of the internal areas of the property at the time of assessment. These obstructions, which may include furniture, personal belongings, stored items, or structural elements such as wall coverings and built-ins, significantly hindered the ability to thoroughly evaluate these areas. It is important to note that such obstructions can potentially conceal a wide array of defects, ranging from hidden structural damage, water leaks, pest infestations, or electrical issues, to deteriorating materials that may not be visible during the initial inspection.</p>

It is highly recommended that all obstructions be cleared to facilitate a complete and thorough inspection of the internal areas. Once the obstructions have been removed and full access is available, a re-inspection should be carried out to ensure that any previously concealed issues can be properly identified and rectified. This follow-up inspection will provide a more accurate assessment of the property's internal condition and help the client make informed decisions about any necessary repairs or maintenance.

In summary, the limitations encountered during the inspection highlight the importance of ensuring full access to all areas of the property to accurately assess its overall condition. A re-inspection is strongly advised once these areas are made accessible.

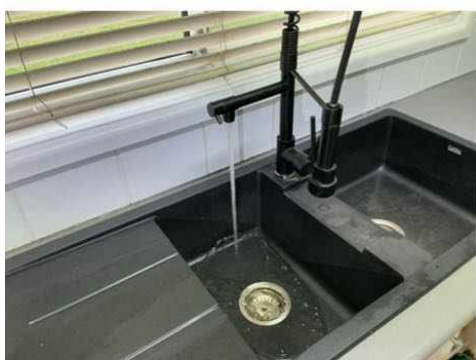
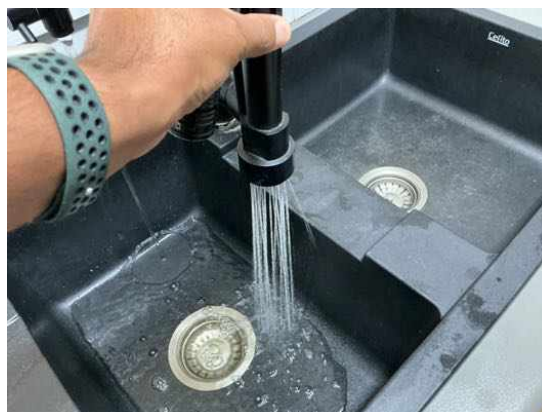
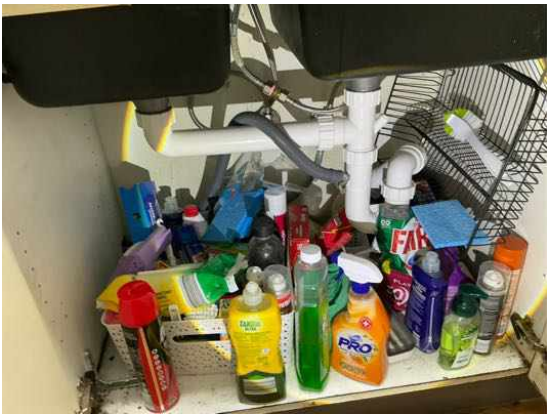
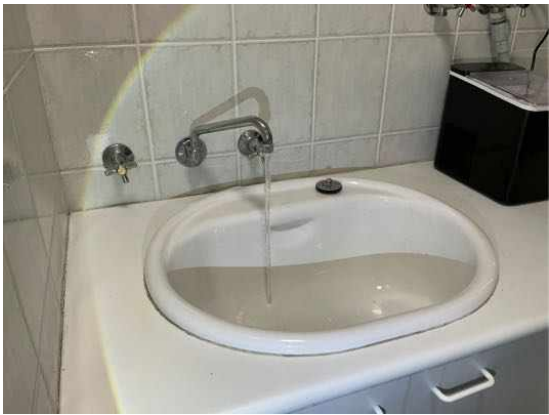
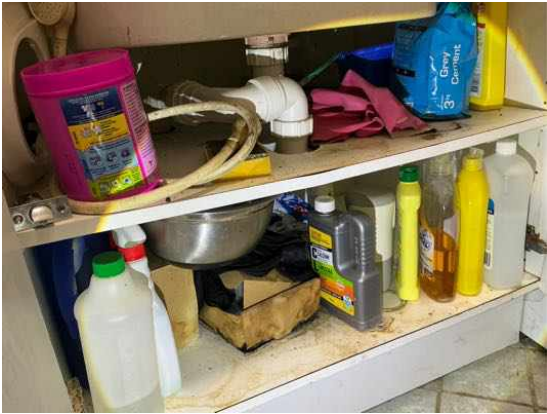
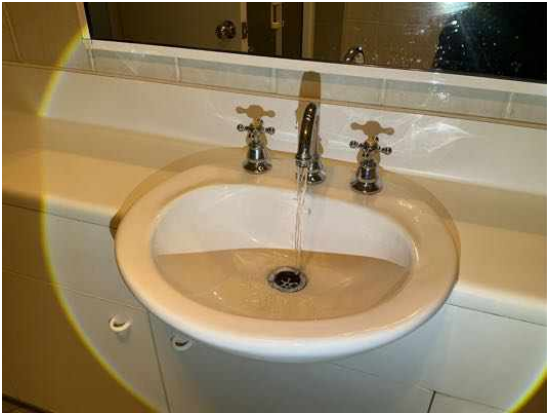
It is important to note that while a visual inspection of cupboards and cabinetry beneath sinks and vanities was undertaken, stored personal items and fixtures presented obstructions that limited full visibility of the internal areas. As per standard inspection practices, inspectors are not permitted to move or disturb personal belongings during the inspection process. Therefore, only visible and accessible sections were inspected, and concealed water damage or plumbing defects may not have been detected.

Given this, a re-inspection is recommended after all obstructions have been cleared to allow for a comprehensive assessment of these areas. Regular maintenance and monitoring of plumbing and drainage systems is also advised to ensure ongoing functionality and early detection of potential issues.

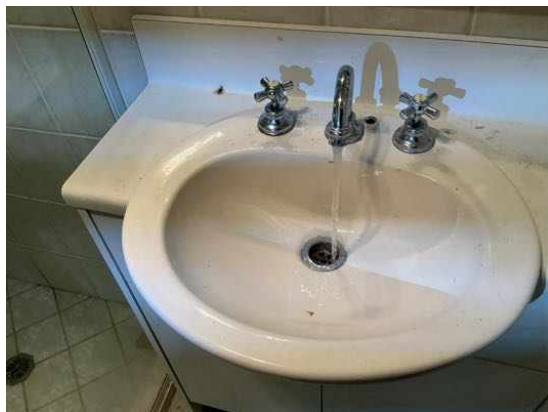
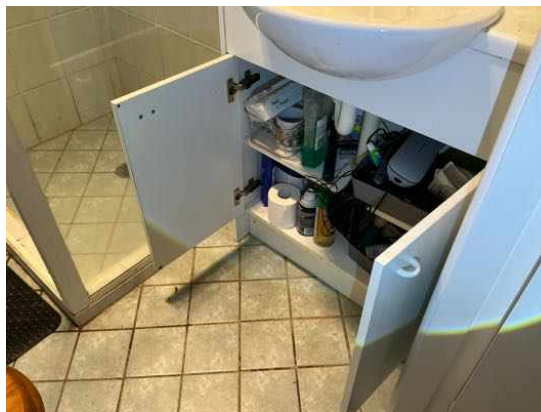
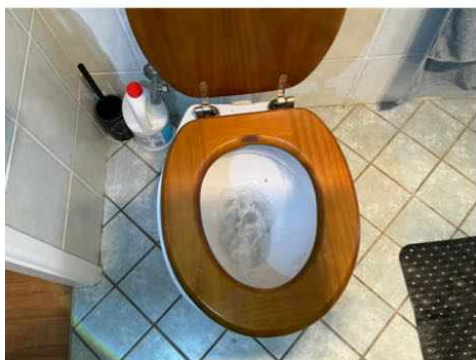
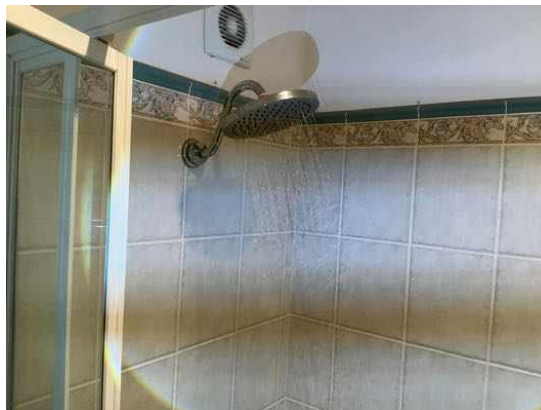
Noted Item

Building: Main Building
Location: All Areas
Finding: FYI - Taps, Drainage & Toilets Tested and Cabinetry Obstructions
Information: During the inspection, all accessible taps, drainage systems, and toilets were tested for water flow and drainage efficiency, and checked for any visible signs of leakage. At the time of the inspection, no issues were noted in these areas. Unless highlighted in a separate defect statement, no immediate remedial work appears necessary. Supporting images may be found in the additional photos section for reference.
