Building and Timber Pest Inspection Report

Inspection Date: Mon, 12 Jan 2026

Property Address: 6 Frederick St, Point Frederick NSW 2250,
Australia

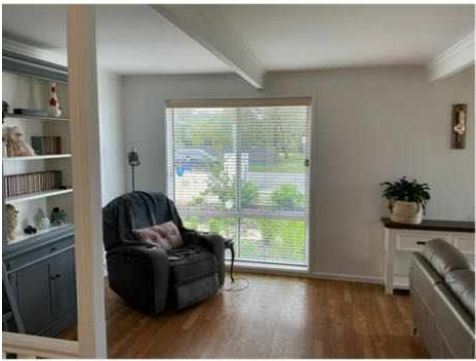
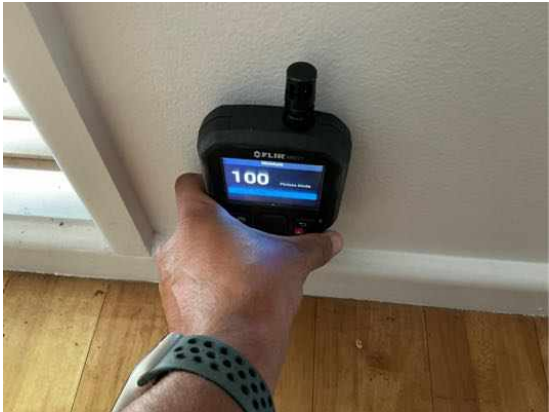
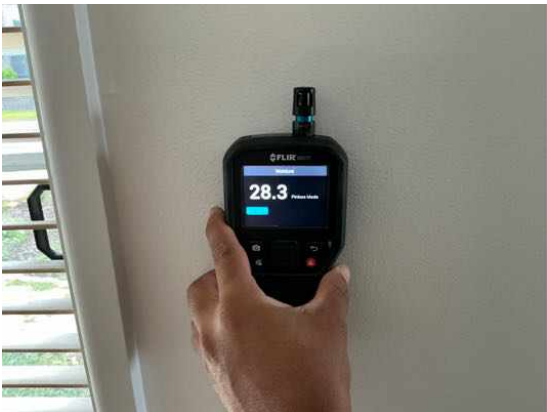
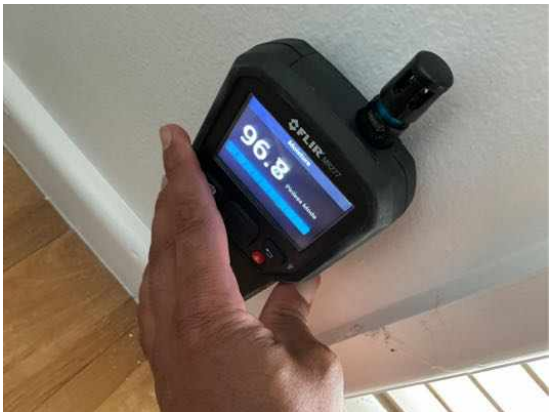
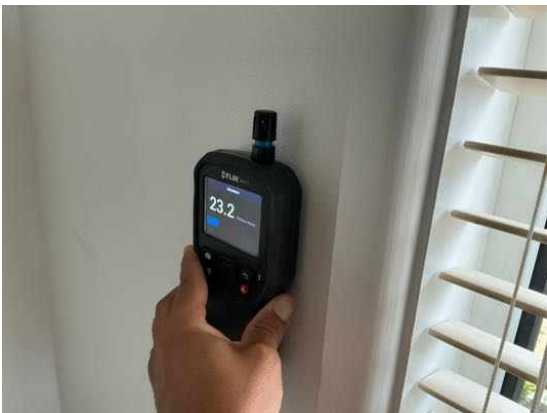
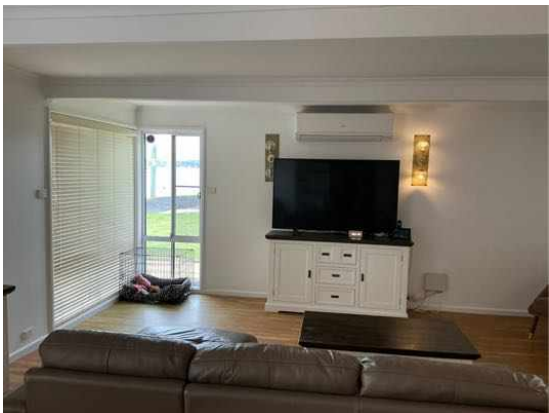
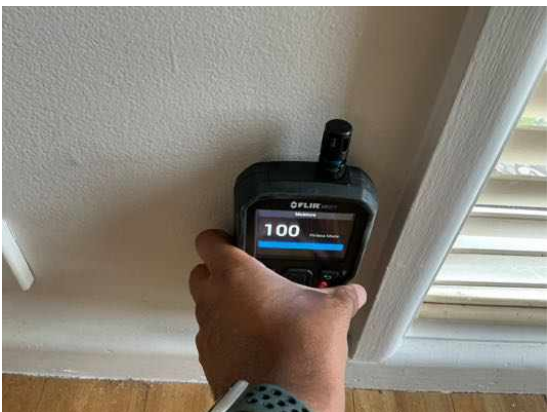
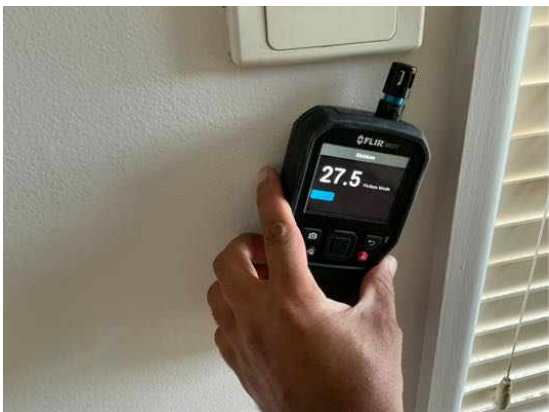
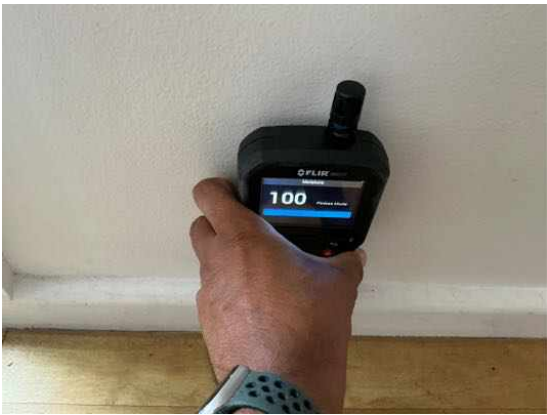
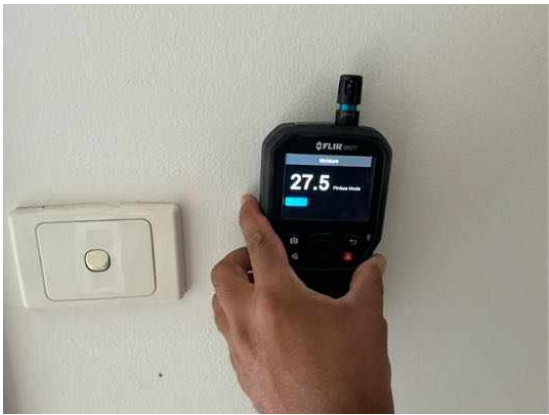
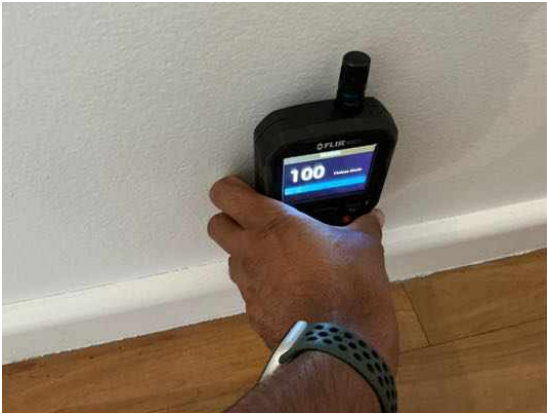
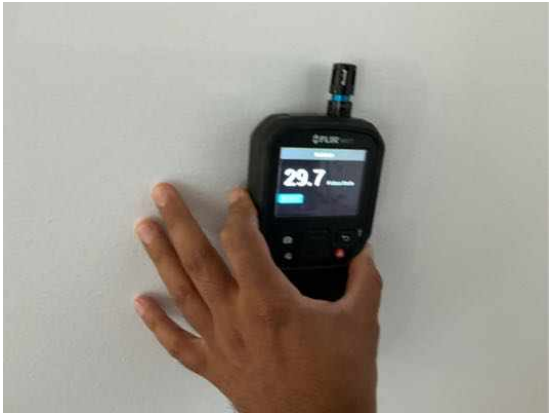
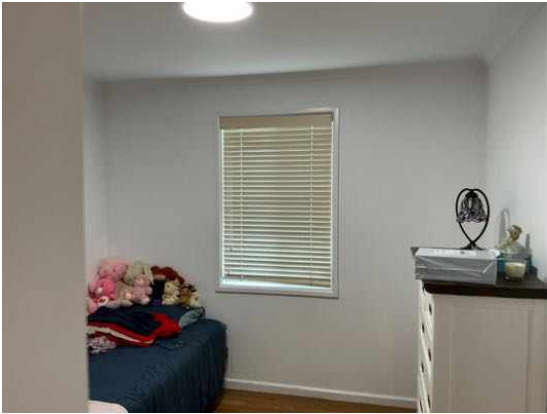
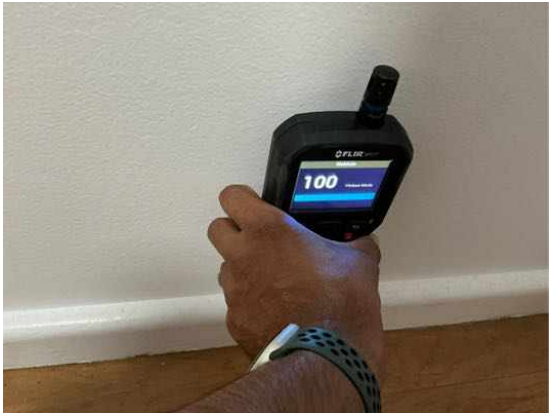
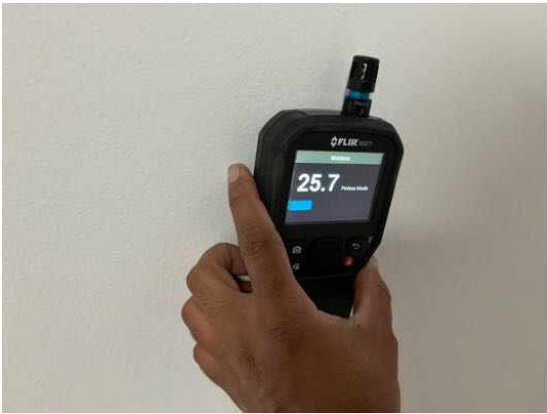
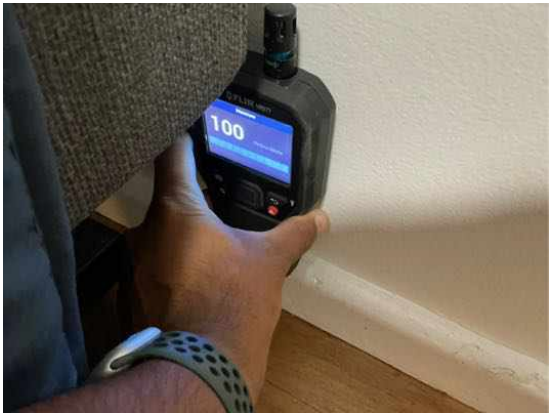
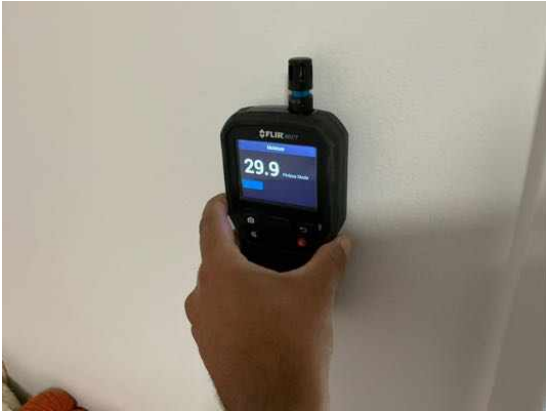
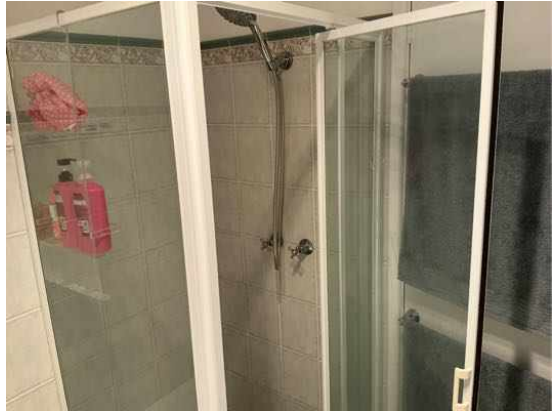
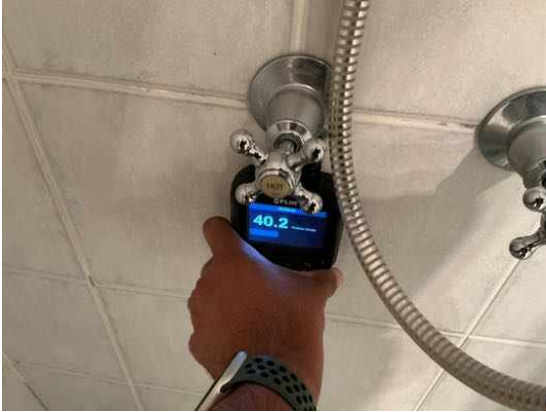
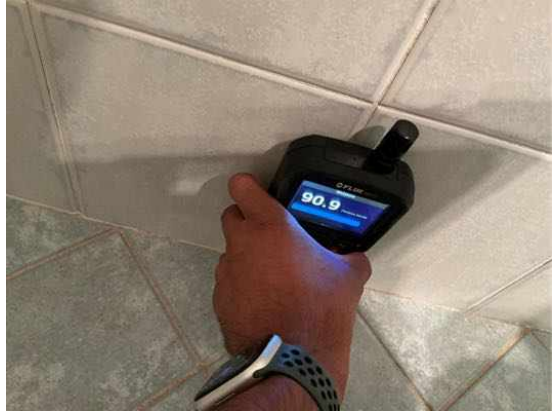
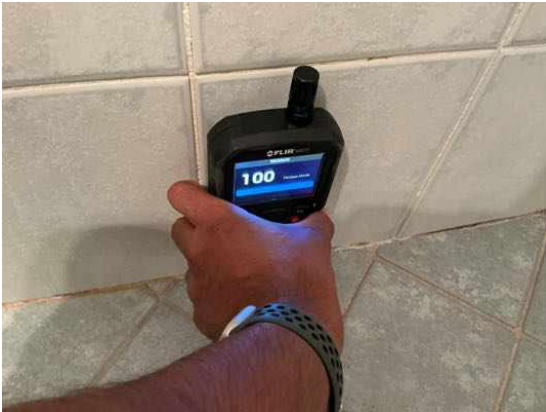
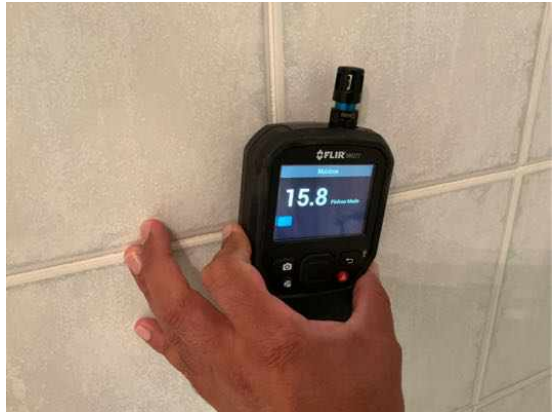
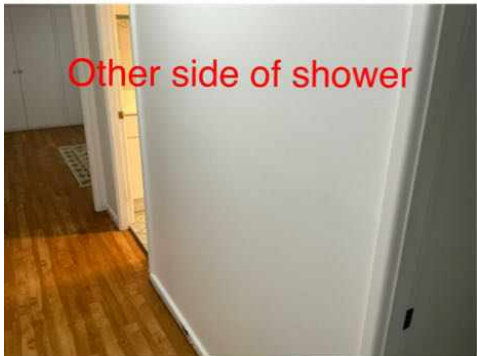
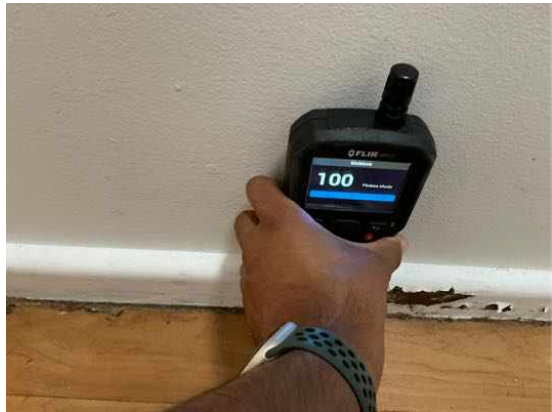
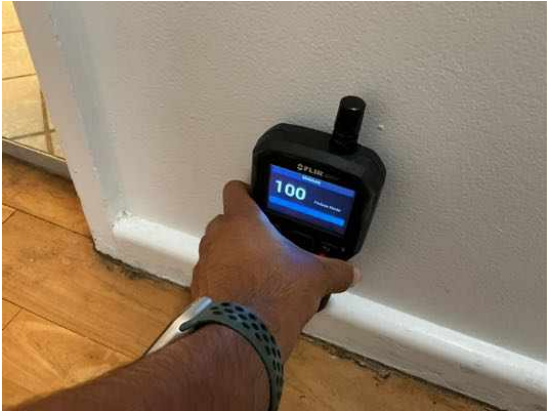
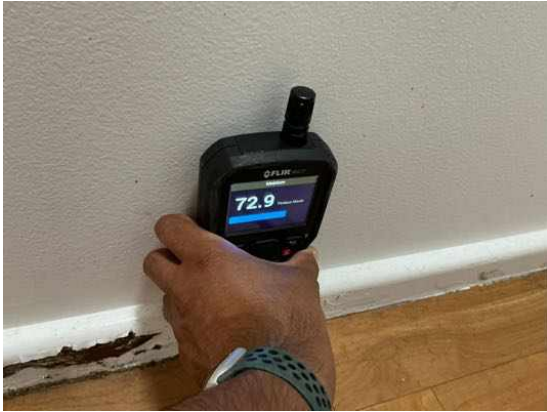
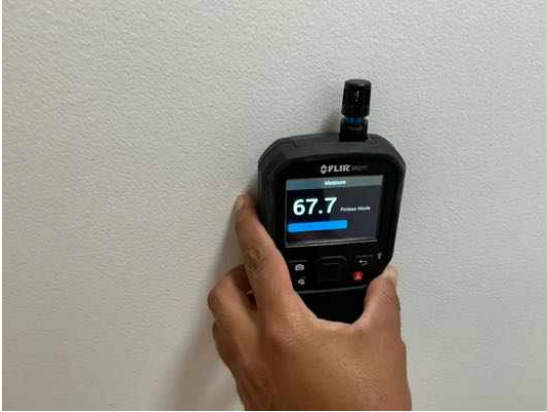
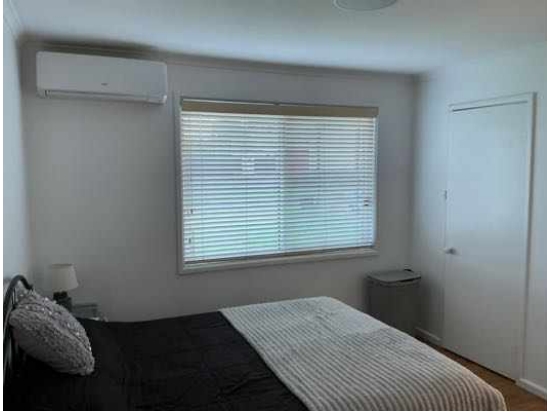
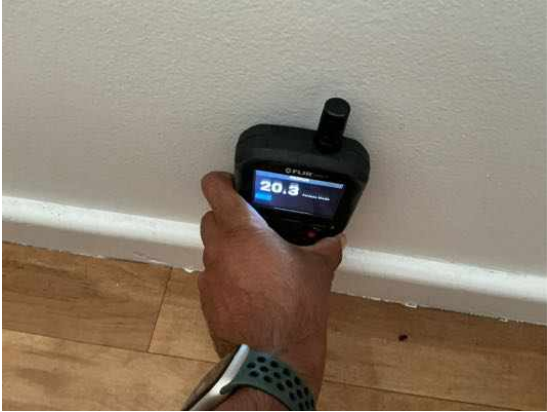
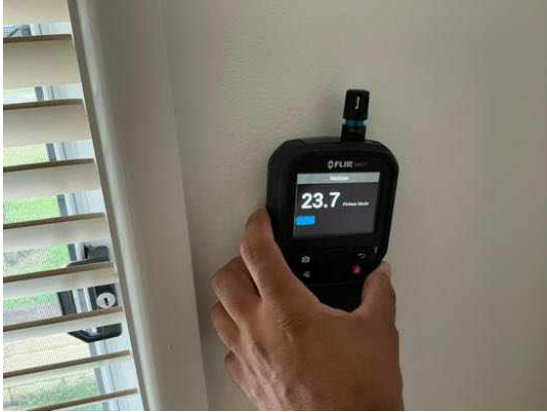
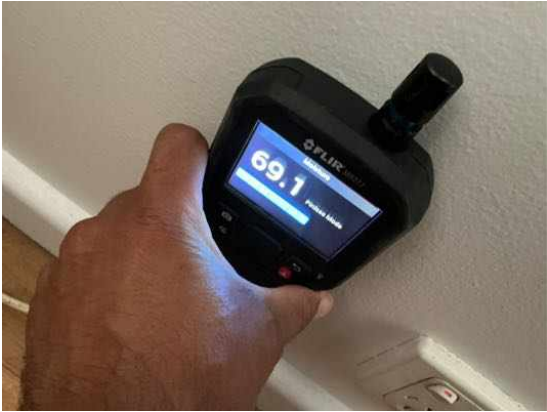
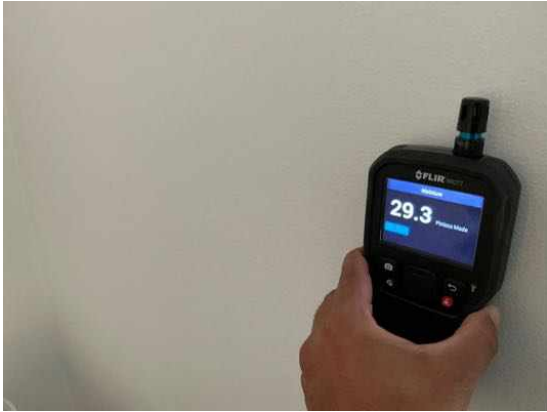
Noted Item

Building:	Main Building
Location:	All Areas
Finding:	Additional Photos - Moisture Meter Readings
Information:	Additional moisture meter reading photos have been provided for the property to offer further clarity on areas tested during the inspection. These photos are intended to give a visual reference for the specific locations where moisture levels were measured. These readings were taken at the time of the inspection to assess any potential moisture-related issues within the property. Any defects related to moisture that were identified during the inspection have been separately mentioned in the defect statements within the report.

It is important for the client to understand that moisture levels can fluctuate over time due to various factors, including changes in weather, humidity, and environmental conditions. While the readings reflect the property's moisture levels during the inspection, they may not represent future conditions, and increased moisture could lead to issues such as dampness, mould growth, or deterioration of building materials if left unmonitored.

For further clarification or additional information regarding the moisture readings, the client is encouraged to contact the building inspector directly. Regular monitoring of moisture-prone areas is recommended to ensure any emerging concerns are addressed promptly, particularly during wetter seasons or in high-humidity conditions.

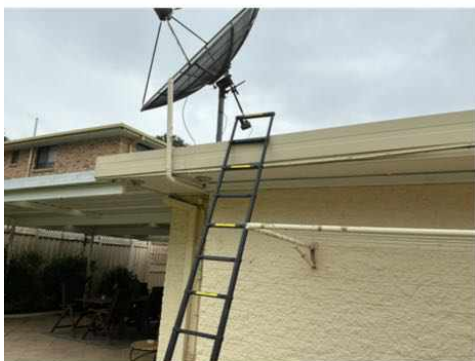
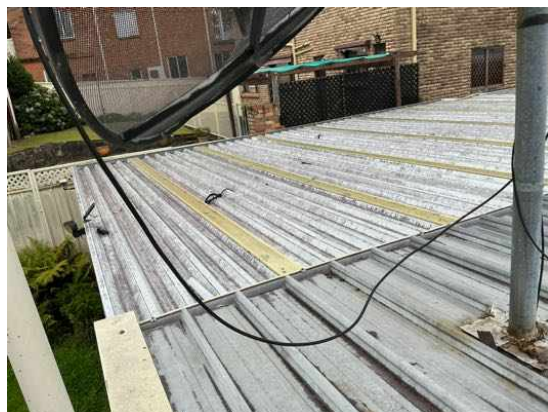
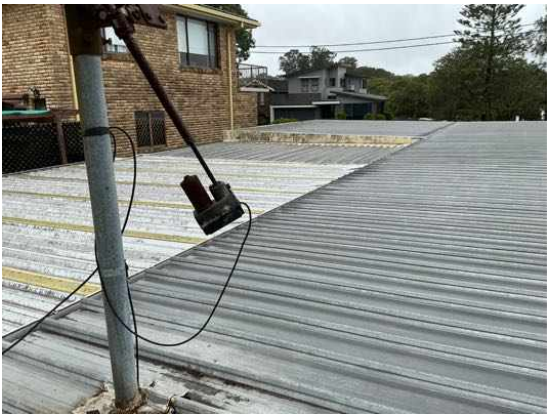
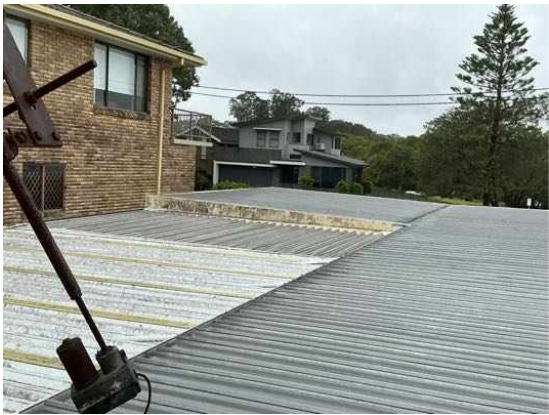
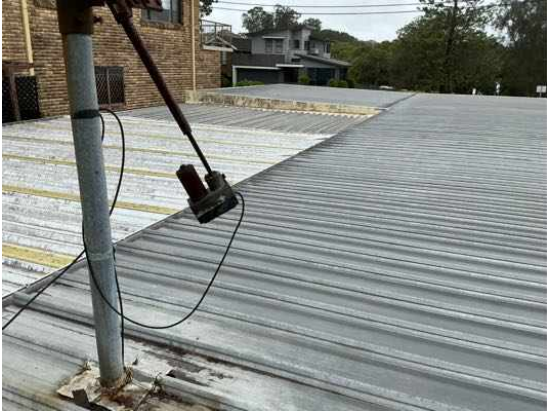
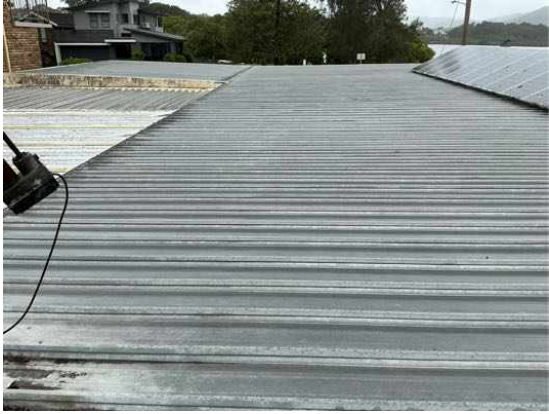
Information: As part of the information provided, please note that the attached roof photos represent the condition of the roof at the time of inspection. These photos are for visual reference only and do not constitute a detailed roofing assessment. Any defects or issues identified with the roof are mentioned separately in the defect statements. It is strongly recommended that the client engage a qualified roofer to conduct a thorough inspection of the roof, ensuring that any potential issues, such as leaks, structural integrity, or wear and tear, are properly identified and addressed.

Additionally, the condition of the roof may change over time due to weather, natural wear, or other unforeseen factors. Regular maintenance and inspections by a licensed professional are advised to ensure the roof remains in good condition and to avoid costly repairs in the future. The information provided in these photos should be considered a snapshot of the roof's condition during the time of inspection and not a guarantee of its future performance.

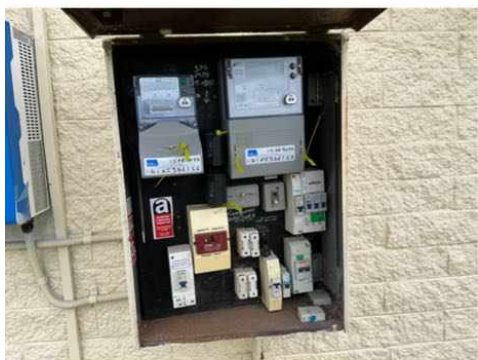
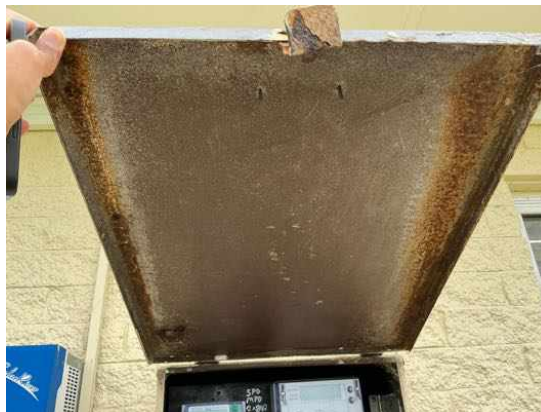
Noted Item

Building: Main Building

Finding: Termite Management Recommendation – No Evidence of Chemical Installation

In accordance with standard requirements, a durable notice should be located within the electrical switchboard to detail any termite protection systems applied, including chemical treatments. No such notice was observed during the inspection.

It is recommended that the client engage a licensed pest controller to assess the suitability of installing a chemical barrier, and to provide advice on associated costs and procedures. This should be considered a short-term priority, particularly if the property has any history of termite activity or is located in a high-risk area.

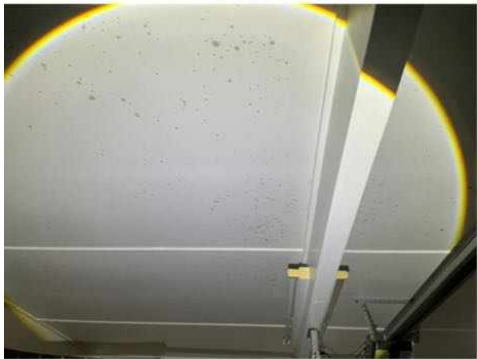
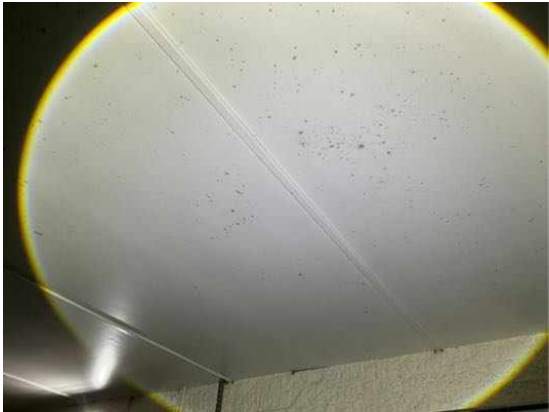
Noted Item

Building:	Main Building
Location:	Garage
Finding:	Suspected Mould - Present
Information:	Where evidence of suspected mould growth was identified during the inspection, there may be associated environmental, biological, or health concerns. In cases where the suspected mould is extensive or where questions regarding air quality, spores, or other related issues arise, it is recommended to engage a suitably qualified mould inspector. The inspector can take samples of the suspected mould, send them to a laboratory for analysis, and confirm whether it is mould and its type, allowing for a more accurate assessment and appropriate remediation.

To prevent further mould growth, the client is advised to maintain a dry and well-ventilated environment by addressing moisture and humidity levels within the property. Any suspected mould observed during the inspection should be cleaned promptly by the homeowner or a professional cleaning contractor, depending on the extent of the growth.

For building elements severely affected by suspected mould and beyond repair, replacement by a registered builder or qualified carpenter may be required to ensure the structural integrity of the property. Timely action is essential to mitigate potential health risks and prevent further deterioration.

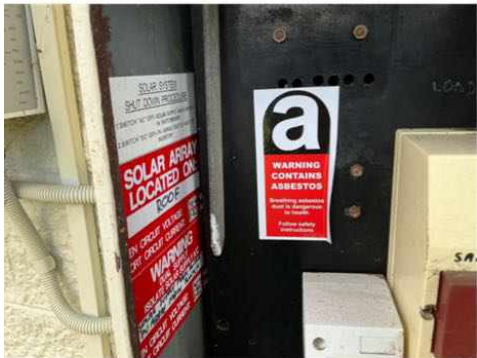
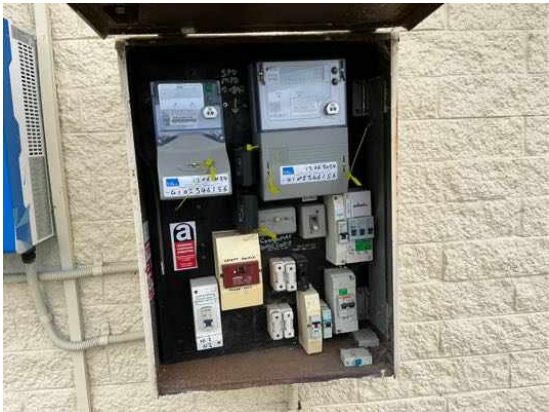
Noted Item

Building: Main Building
 Location: Meter Box
 Finding: Asbestos - Suspected ACM Identified on Site
 Information: Reporting on Asbestos is outside the Scope of this Report. This suspected defect is highlighted as a caution only. We suspect, based on our experience in the building industry, that there is a higher risk of the identified building element containing asbestos.

As Asbestos Reporting is outside the scope of this report, we advise that you consider a separate Asbestos Inspection and Condition Audit, which can include the taking of samples for definitive confirmation of the presence of Asbestos.

In the interim, the client is advised to act with caution, especially when considering any damage to building materials general wear and tear renovations extensions demolition and general maintenance activities due to the suspected presence of Asbestos.
