Building and Timber Pest Inspection Report

Inspection Date: Tue, 6 Jan 2026

Property Address: 17 Sharyn St, Cranbourne West VIC 3977,
Australia

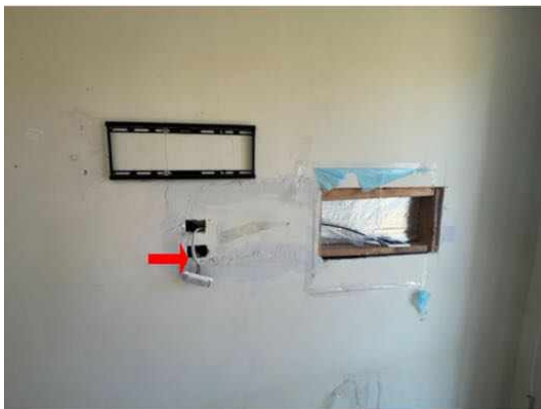
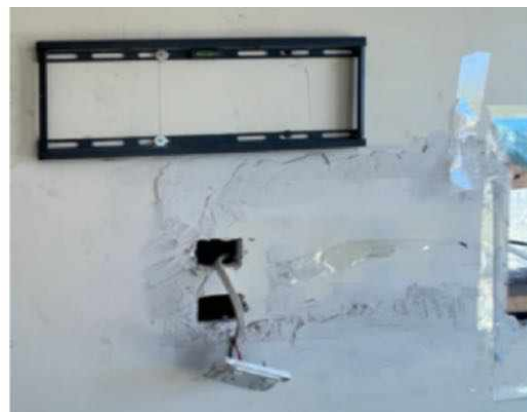
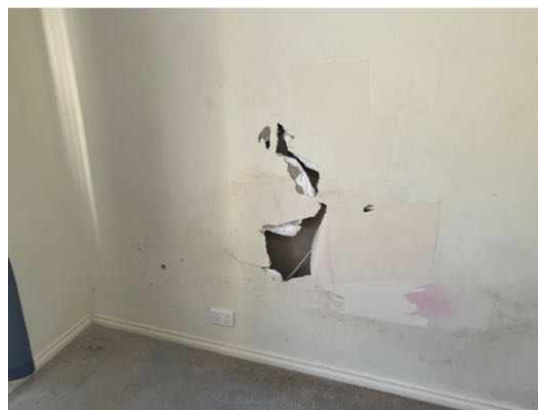
Building: Main Building
Location: Master Bedroom and Bedroom 4
Finding: Electrical TPS Cable - Unprotected
Information: Whilst inspection of electrical services and installation is outside the scope of the report, at the time of inspection an exposed TPS electrical cable was observed, due to damaged plaster including a GPO that was not fixed leaving terminals exposed, which is considered a significant safety hazard.

The likely causes appear to be due to physical damage to the wall linings which was observed in numerous locations throughout the property.

The implications of this defect include increased risk of electrical shock, cable deterioration from exposure, and potential non-compliance with relevant electrical standards..

A licensed electrician should be engaged to install suitable mechanical protection, such as conduit, and/or wall surfaces should be repaired to ensure the wiring is compliant and safe. Rectification should be undertaken as a matter of urgency due to the heightened electrical risks associated with exposed cabling and GPO terminals.

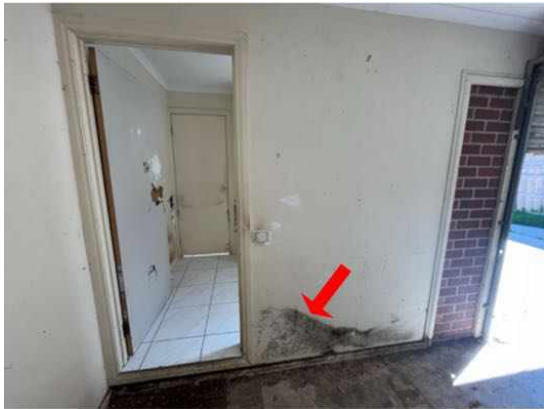
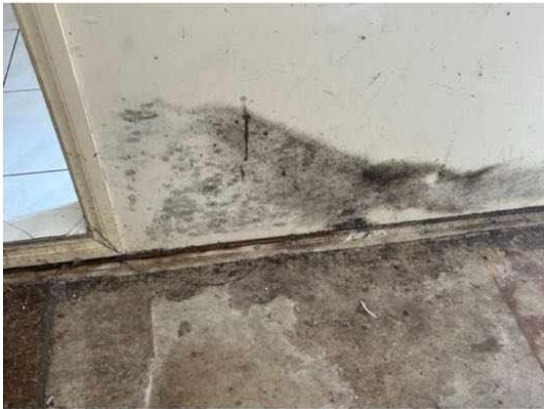
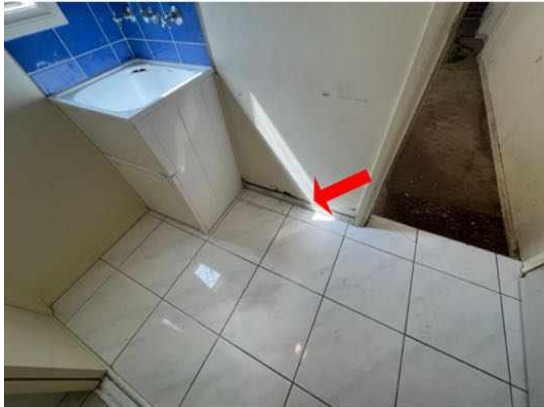
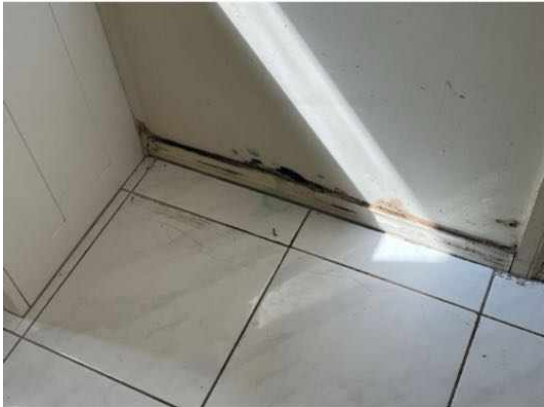
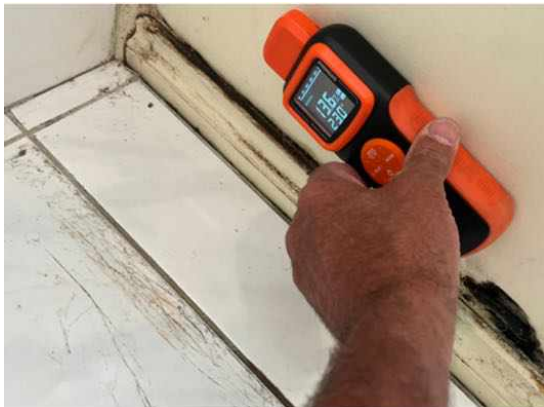
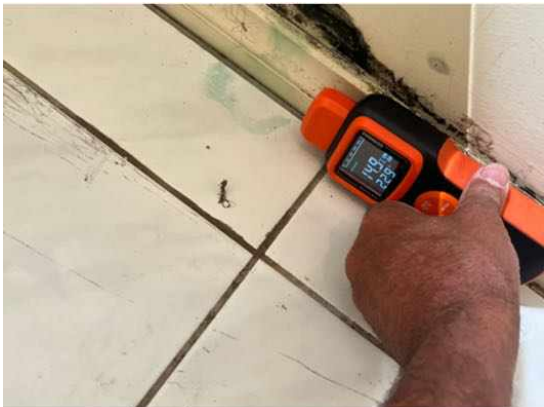
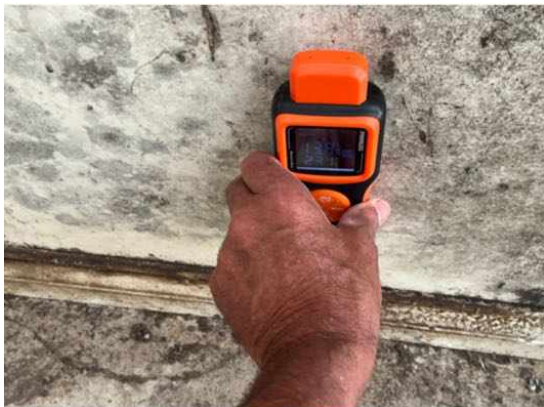
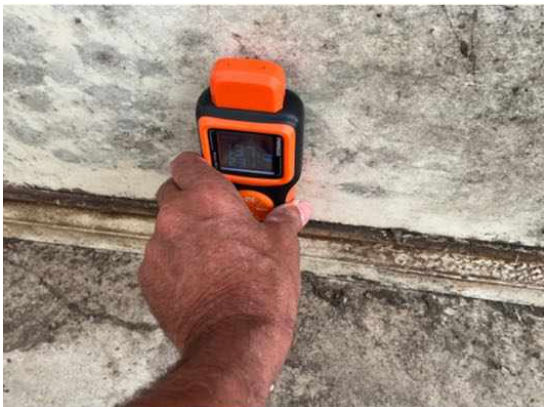
Finding 2.01

Building:	Main Building
Location:	Laundry & Garage
Finding:	Building Elements - Moisture damage and suspected mould.
Information:	Moisture damage and suspected mould were observed in the highlighted locations.

Whilst the moisture readings were relatively low, visual indications suggest that the issue has been ongoing for some time.

Moisture issues in building elements such as walls create areas conducive to timber pest activity that may be concealed in the wall and roof cavity that will require an invasive investigation to determine to what extent.

Where moisture issues have been ongoing over a period of time it is likely that concealed structural elements have been compromised and this is considered in the opinion of the inspector as a major defect and should be treated as such until proven otherwise by further and invasive investigations of the area.

Likely causes are leaking plumbing pipes, fixtures or washing machine connections.

Recommend an invasive inspection of the wall by a registered builder to determine the extent of any concealed structural damage and a plumber to locate moisture sources and rectify prior to engaging a mould remediation specialist where affected materials are being retained. This issue should be managed and rectified as a priority.

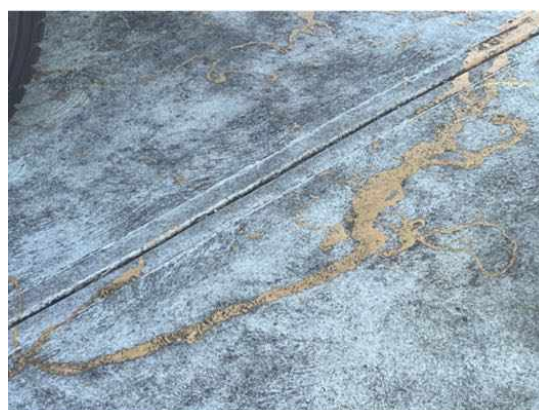
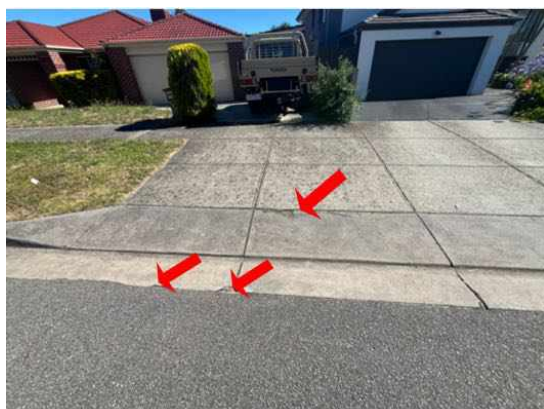
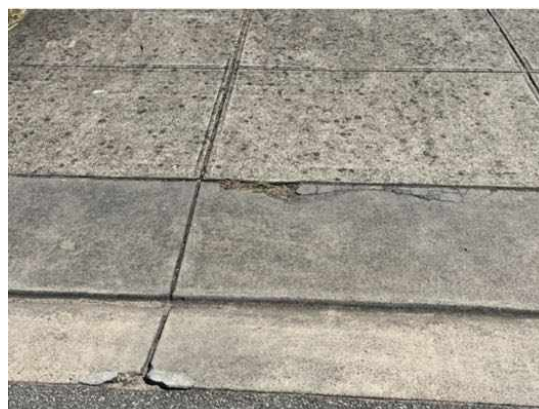
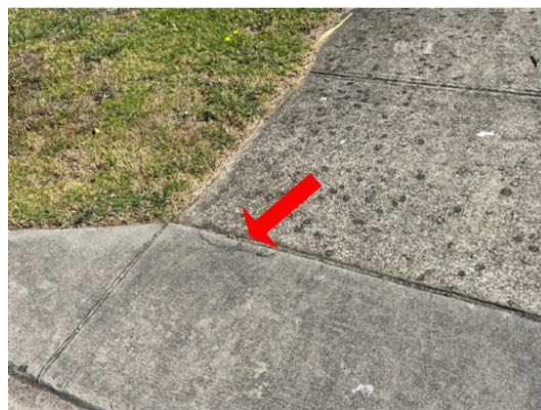
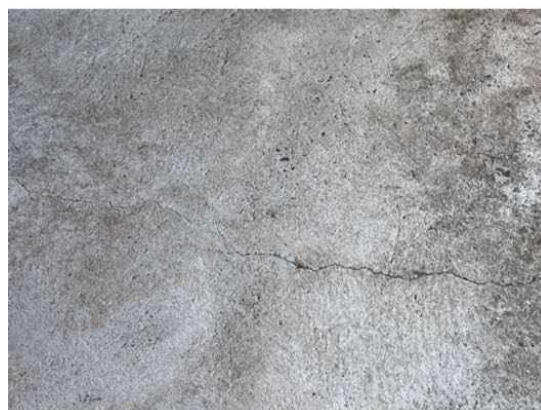
Finding 3.01

Building:	Yard
Location:	External Front & Rear
Finding:	External Concrete Paving Damage - Cracking, chipped and spilt paint
Information:	Various cracks and damage were identified in the external concrete including hairline cracks, chips and spilt paint was evident in the highlighted locations. Cracks and chips are generally found in older concrete paving, and may also present as a trip hazard where there is uneven, stepped or curved surfaces.

General age and expected deterioration of the paved areas is a common cause of this type of cracking. However, poor ground preparation, poor installation, expansion and contraction of the slab may also have occurred due to environmental factors. Such factors include variable moisture and weather conditions, the presence of trees and their roots having a settling or lifting affect on the soil, or the effect of load bearing, e.g. heavy vehicles over a sustained period of time.

Monitoring of all cracking should be conducted frequently. Always contact a building inspector should cracks inexplicably widen, lengthen, or become more numerous.

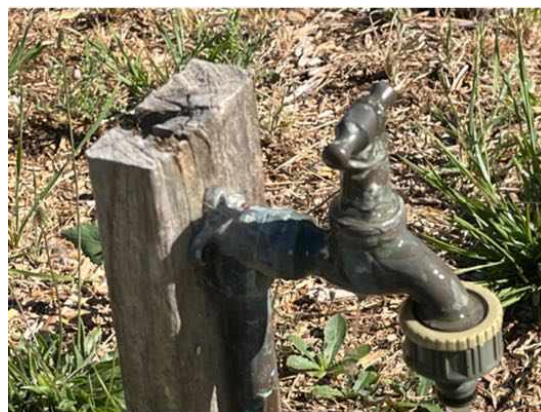
Finding 3.02

Building:	Yard
Location:	External Front
Finding:	Front Tap - Unable to control water flow
Information:	The front garden tap was observed to be unable to be fully turned off, with water control ineffective. Based on the condition and operation of the tap, the defect is suspected to be due to a missing or deteriorated internal tap washer or worn valve components or possibly the complete removal of the washer to discourage turning on of water to the property. At the time of inspection, the water supply to the property had been turned off, which prevented confirmation of active leakage at other plumbing fixtures throughout the property.

The likely causes of this defect include general wear and tear of the tap washer, age-related deterioration of internal components, removal of the washer by the vendor or poor-quality fittings. Prolonged exposure to weather and frequent use can also contribute to premature failure of external taps.

If left unrectified, this defect may result in uncontrolled water loss if the supply is turned on, increased water charges, potential water damage to surrounding structures or landscaping, and an inability to isolate water at the fixture. The inability to test the plumbing system also means any existing leaks or faults elsewhere in the property may remain undetected.

A licensed plumber should be engaged to replace the tap washer or tap assembly as required and to restore water supply so that all plumbing fixtures and pipework can be properly tested for leaks and correct operation.

Rectification should be carried out promptly and prior to occupation or normal use of the property, as the defect affects water control and prevents adequate assessment of the plumbing system.

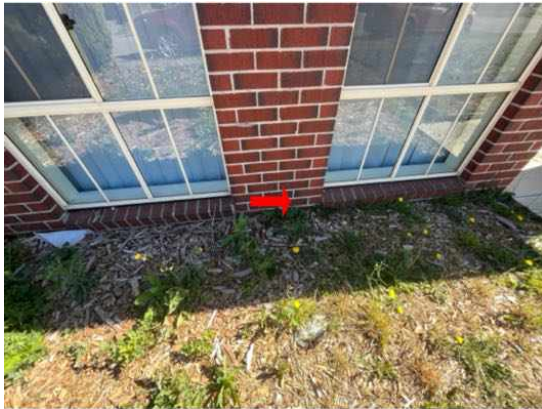
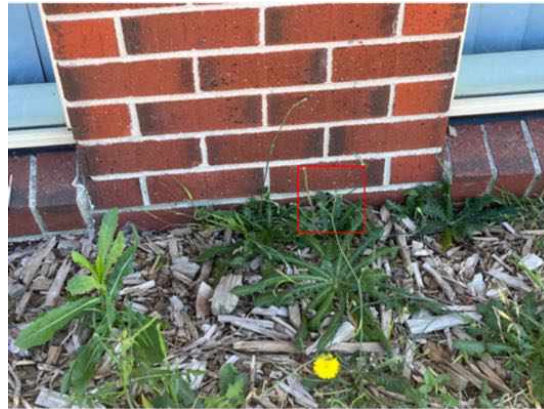
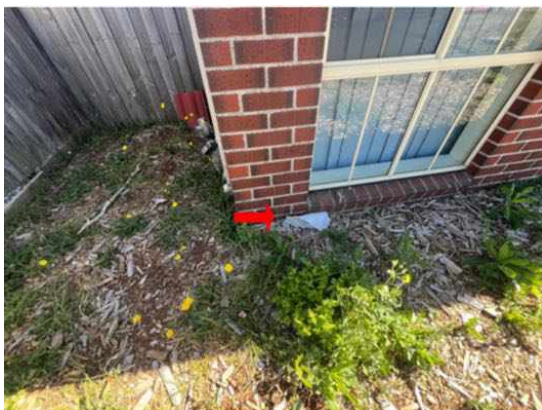
Finding 3.03

Building:	Main Building
Location:	External Front
Finding:	Weep holes blocked - Landscaping levels established at an unsuitable height
Information:	The weep holes to the brickwork are blocked due to the landscaping levels in the highlighted areas.

Weep holes are designed to allow water to escape the cavity from leaks or seepages in brickwork before the water enters in or damages the wall cavity and in particular to windows and doorways. Weep holes should be kept clean and free of debris or blockages and landscaping and paving should be installed below the bottom of the weep holes in compliance with the NCC.

The landscaping to the areas highlighted will require re-establishing in compliance with the NCC. A landscaper, builder or handy-person should be engaged to perform these works immediately to prevent any possible further damage.

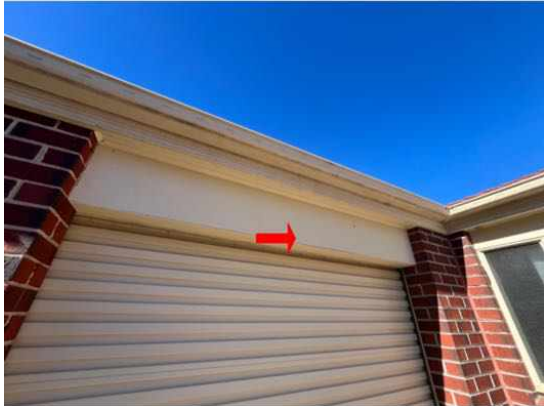
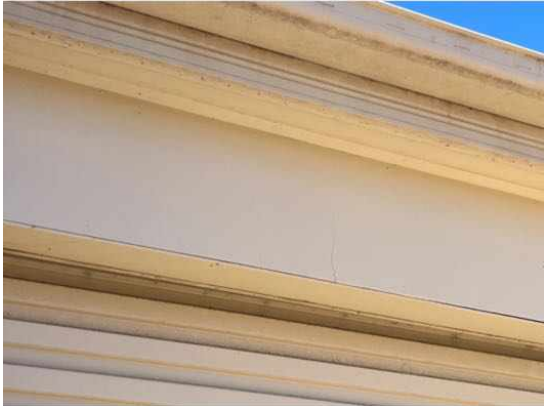
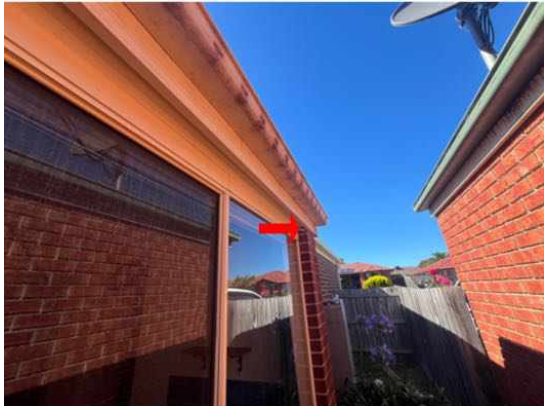
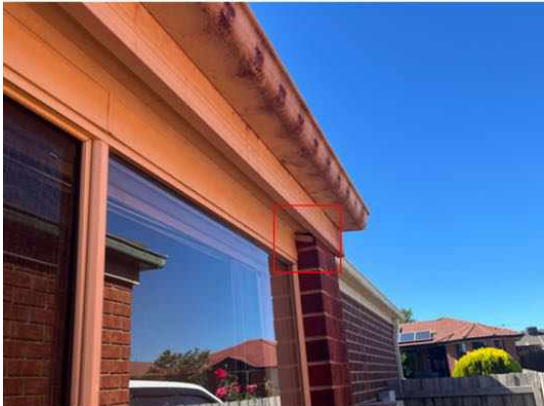
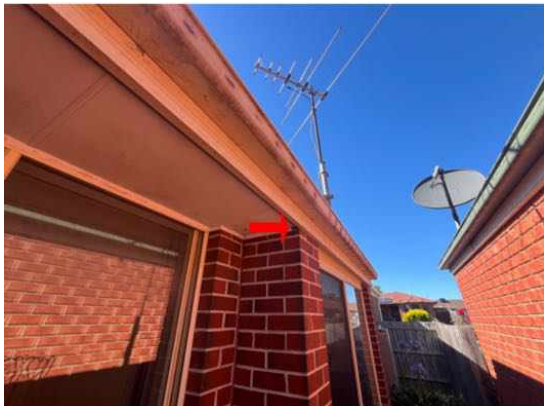
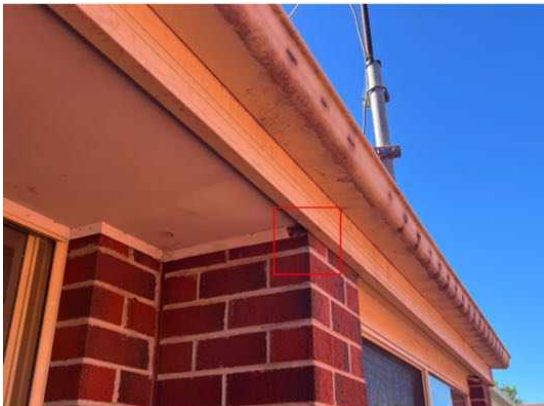
Finding 3.04

Building:	Main Building
Location:	External LHS & Rear
Finding:	Eaves/Soffits - General Defects
Information:	The eaves/soffits were observed to have a couple of various types of minor defects in the areas highlighted.

Common defects include missing trims and cracking and/or installation damage. These issues reduce the durability and weatherproofing of the building and affect its overall appearance.

Likely causes include poor installation and maintenance.

Implications include ongoing deterioration and aesthetic degradation. If left unaddressed, these issues can lead to further structural or internal water damage.

A qualified carpenter or handy-person should be engaged to assess and repair defects at the clients discretion.

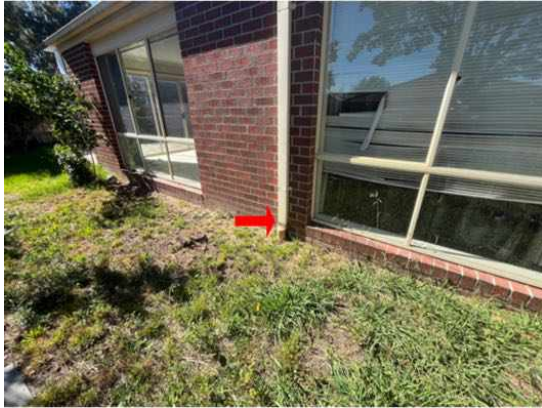
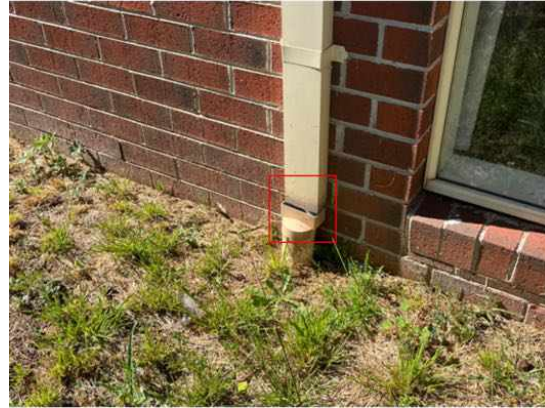
Finding 3.05

Building:	Main Building
Location:	External LHS
Finding:	Downpipe - Not properly connected to stormwater drain.
Information:	The downpipe has not been connected properly to the stormwater drains.

A gap is evident between the downpipe and stormwater drain adaptor, this may allow stormwater to inundate the area and create an environment conducive to timber pest activity.

Recommend engaging a plumber to rectify as a matter of urgency.

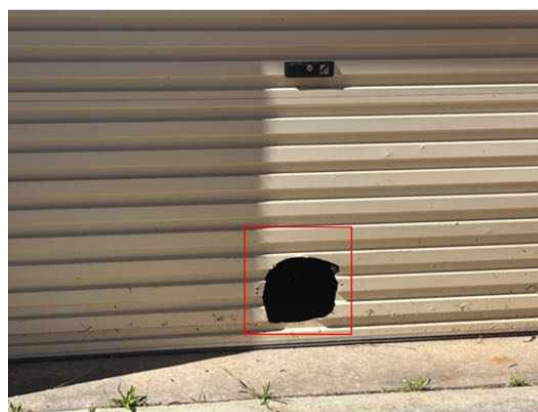
Finding: Garage Door - Hole
Information: The garage roller shutter door was observed to have a hole cut through the door curtain. The opening appears to have been deliberately created and is suspected to have been for pet access into the garage, resulting in damage to the door and loss of its original form and function.

The likely causes of this defect include unauthorised modification of the roller shutter door after installation, with the panel being cut to allow animal access without consideration for the door's design or structural integrity.

This defect compromises the security of the garage, reduces weatherproofing, and may allow vermin, pests, or unauthorised access into the garage space. The modification may also affect the operation, strength, and longevity of the roller shutter door and detract from the overall presentation of the property.

A qualified garage door contractor or suitably licensed tradesperson should be engaged to assess the damage and either repair the affected panel or replace the roller shutter door as necessary to reinstate security and proper operation.

Rectification should be undertaken in the short term, particularly if the garage forms part of the home's security envelope or provides internal access to the dwelling.

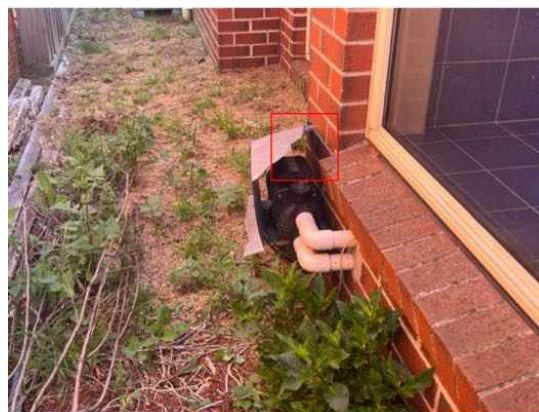
Finding 3.08

Building: Main Building
Location: External LHS
Finding: Spa Pump - Cover Detached
Information: The external spa pump motor cover was observed to have detached from the adjacent brickwork and is no longer securely fixed in place. This has left the pump motor and associated components partially exposed to the elements and potential physical damage.

The likely causes of this defect include failure or corrosion of fixings, inadequate original installation, vibration from the operating pump, or general deterioration due to prolonged exposure to weather conditions.

If left unrectified, the detached cover may allow water ingress, debris accumulation, and increased risk of electrical or mechanical damage to the spa pump motor. There is also a potential safety hazard if the loose cover falls or allows unintended access to moving or electrical components, and it may shorten the service life of the equipment.

A handy-person or qualified carpenter should be engaged to refix or replace the motor cover and ensure it is securely and appropriately mounted to the brickwork.

Rectification should be carried out in the short term to protect the equipment, maintain safe operation, and prevent further damage.

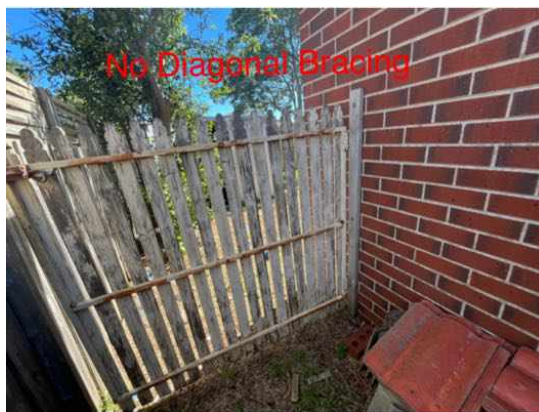
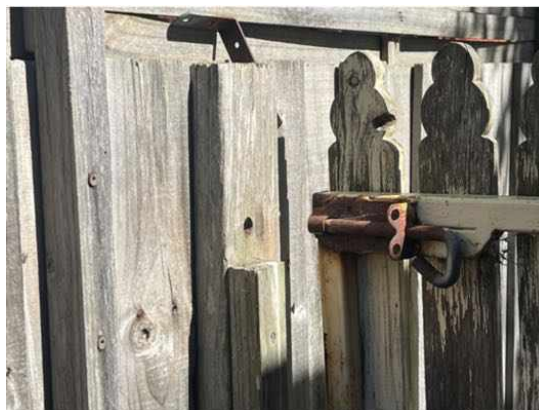
Finding 3.09

Building:	Yard
Location:	External Rear LHS
Finding:	Gates - Non-Professional construction and require repair
Information:	The gates as observed were of poor construction, were binding and not closing properly at the time of inspection.

Poor construction methodology generally indicates non-professional construction and installation that can attribute to the poor functionality and subsequent damage to fittings. Binding gates can also be attributed to seasonal variations, ground movement, poor construction & installation, and/or lack of maintenance.

Gates that do not function correctly can impact the adjoining fencing and cause nuisance and inconvenience for the occupants.

Recommend engaging a qualified fencing contractor to rectify and provide further advice at the clients discretion.

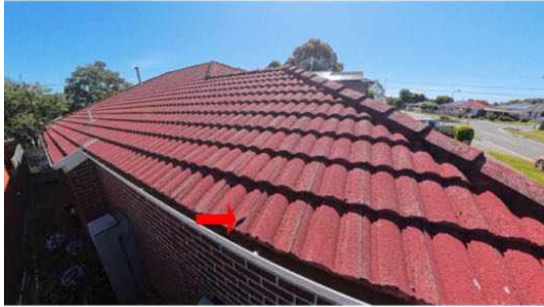
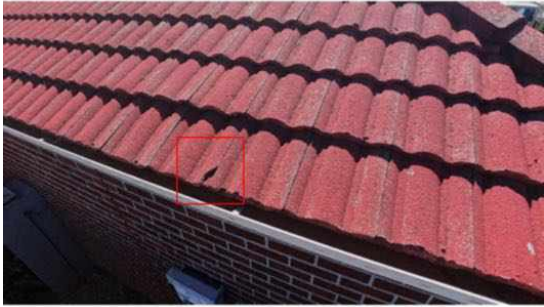
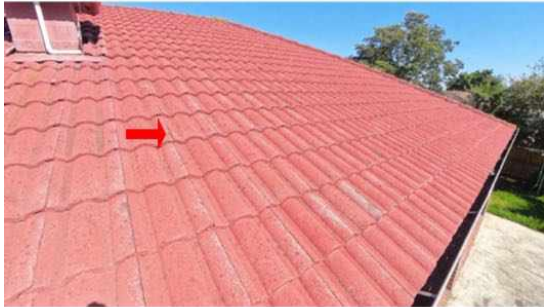
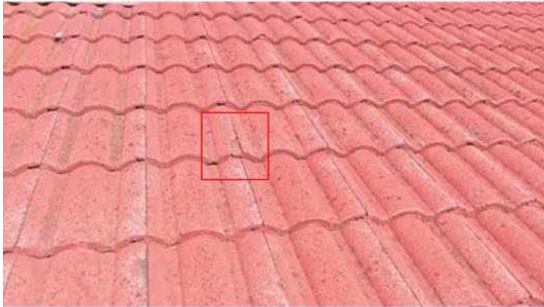
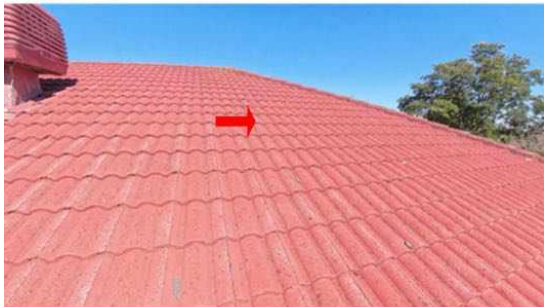
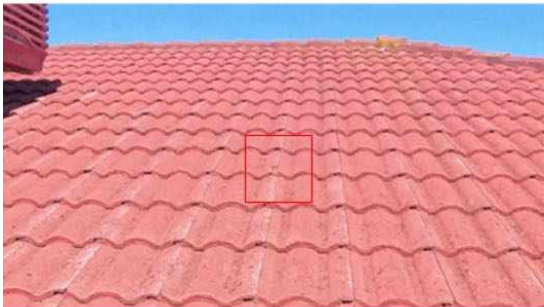
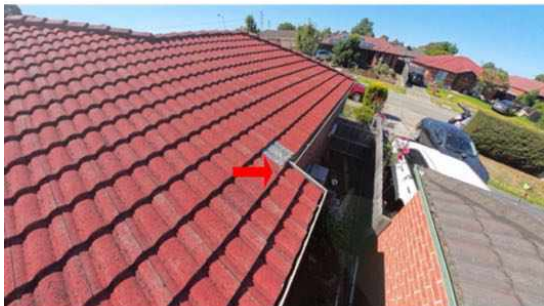
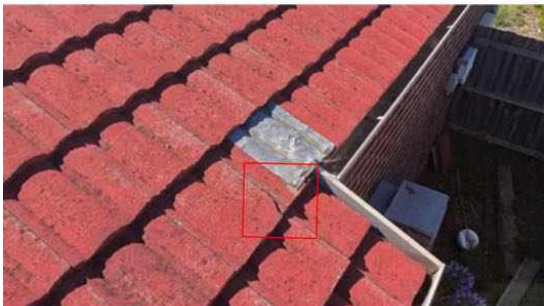
Building: Main Building
 Location: Roof Exterior
 Finding: Roof tiles - Broken
 Information: Upon inspection of the exterior roof covering, broken roofing tiles were identified in the areas highlighted. Broken roof tiles are generally the result of foot traffic during works in the vicinity (Often by follow up trades such as plumbers, electricians and antenna installers) these are sometimes inadequately repaired by silicone which can break down with UV exposure and allow moisture ingress into the roof cavity.

If left unmanaged, broken and/or silicone repaired roof tiles are likely to lead to water penetration via the roof into the ceiling space, causing secondary damage to ceiling linings, insulation and roof structures. Broken roof tiles are also likely to detract from the effectiveness of the roof drainage system, creating potential for secondary damage to the exterior roof covering and roof plumbing.

Replacement of broken tiles is required and should be performed by a roof tiling contractor as soon as possible as well as following up with cleaning of gutters, downpipes and stormwater drains to remove any broken tiles and debris that may affect the drainage system.

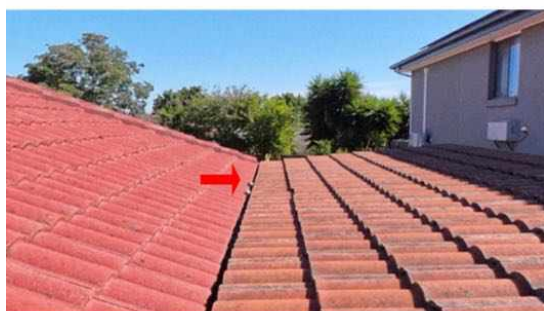
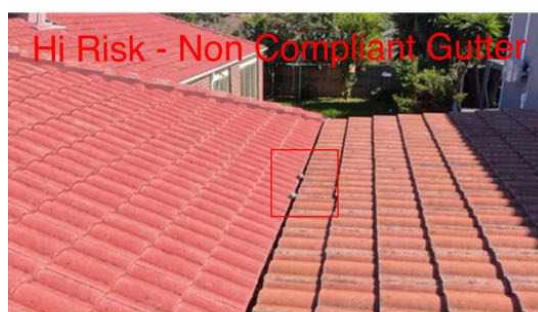
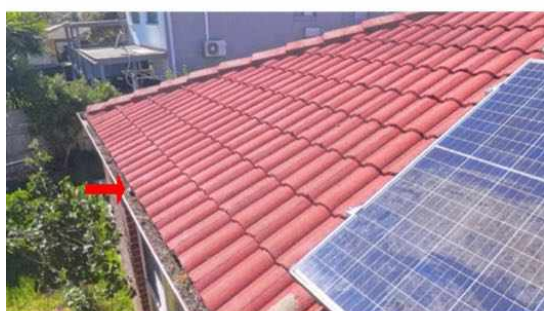
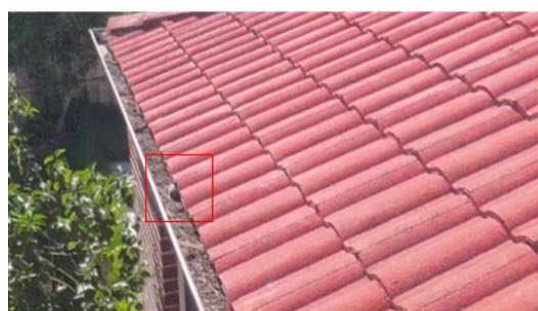
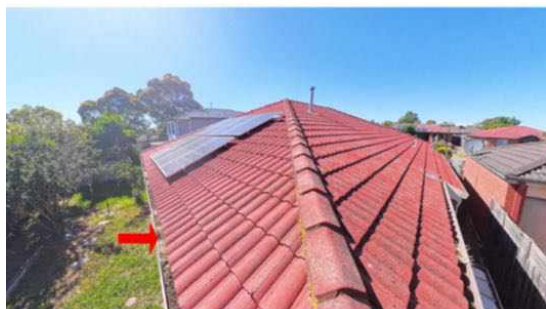
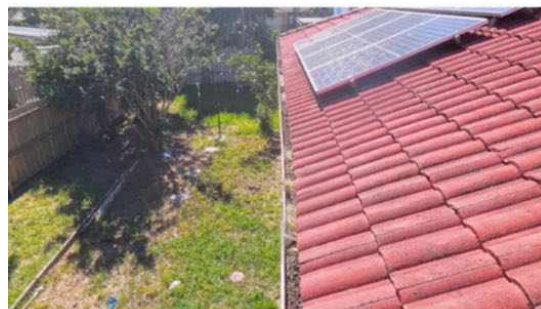
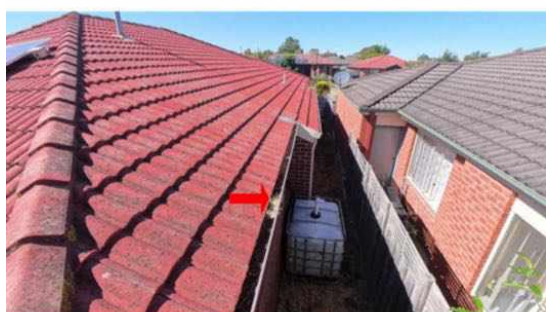
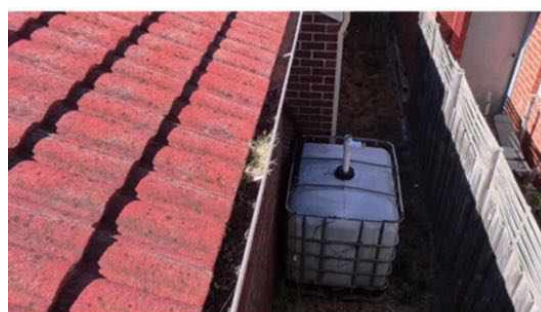
Finding 3.11

Building:	Main Building
Location:	Roof Exterior
Finding:	Gutters - Blocked
Information:	The gutters were observed to be blocked with debris in the highlighted locations.

Blocked gutters are likely to lead to high levels of moisture in the affected areas. Such moisture will not only cause rust and decay of the associated building materials, but can also provide conditions that are conducive to termite and timber pest activity. Blockages in gutters should therefore be removed immediately to maintain dry conditions.

Consult a Licensed Roof Plumber for further specific advice on remedial works that may be required. In the interim, it is highly advised that blocked gutters be cleared by the homeowner or a general handyperson as a matter of urgency.

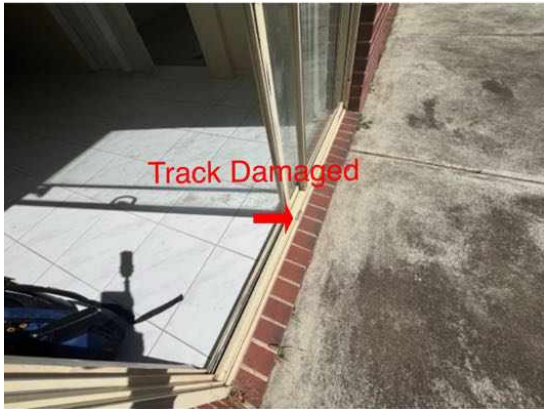
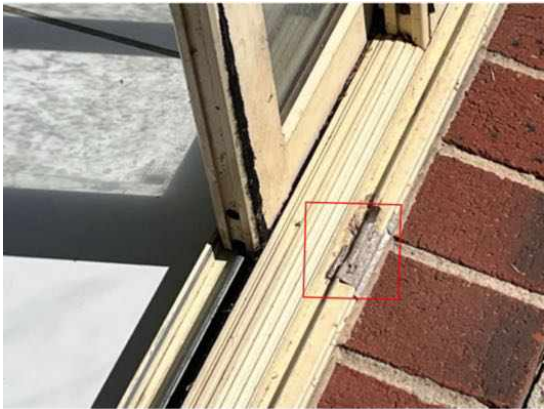
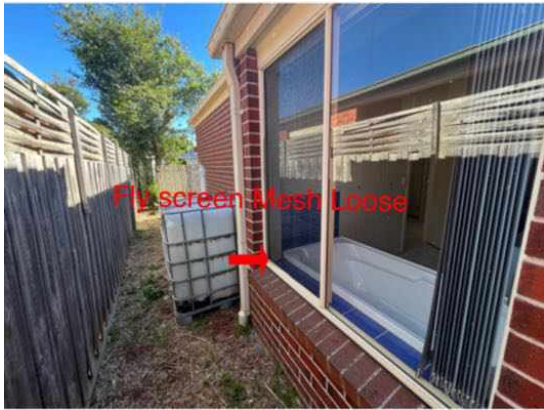
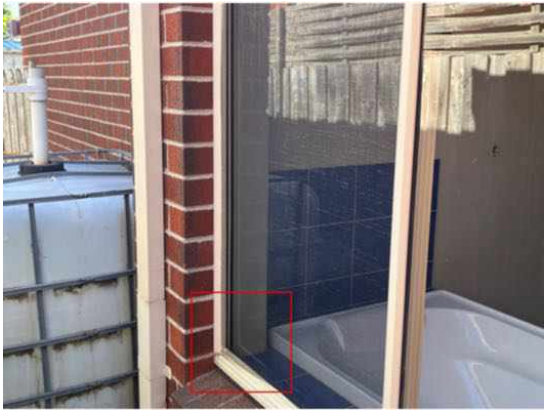
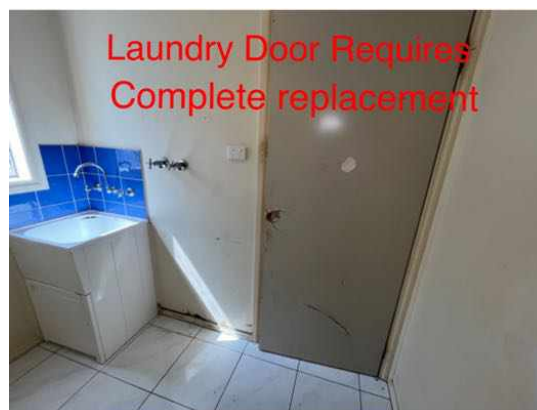
Finding 3.12

Building:	Main Building
Location:	All Internal Areas
Finding:	Doors & Flyscreen - Require general maintenance, replacement and repairs
Information:	Several doors throughout the property and a flyscreen to the bathroom were identified as requiring maintenance due to poor operation, damage and reduced functionality. Issues observed include loose hardware, misalignment, degraded seals, damaged flyscreens, moisture damage, physical damage and difficulty opening, closing, or locking.

These conditions reduce the building's energy efficiency, security, and ventilation, and may worsen and cause damage to adjoining building elements over time if not managed promptly.

We recommend that a qualified maintenance carpenter or handy-person is engaged to assess and carry out necessary repairs, replacement or maintenance to ensure all windows and doors operate smoothly, seal correctly, and meet relevant performance and safety standards.

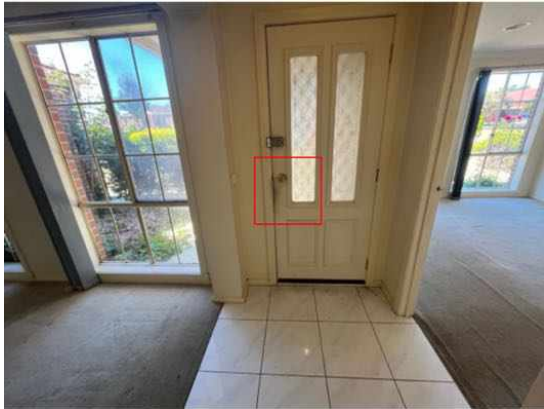
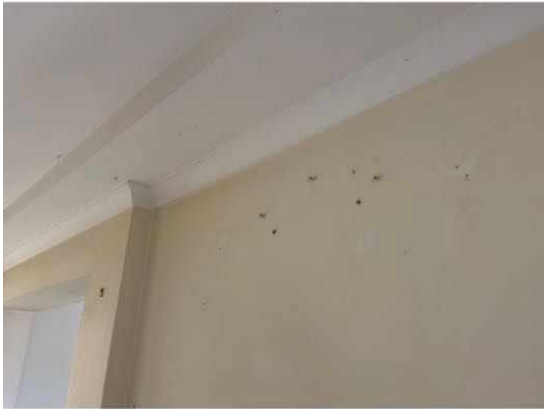
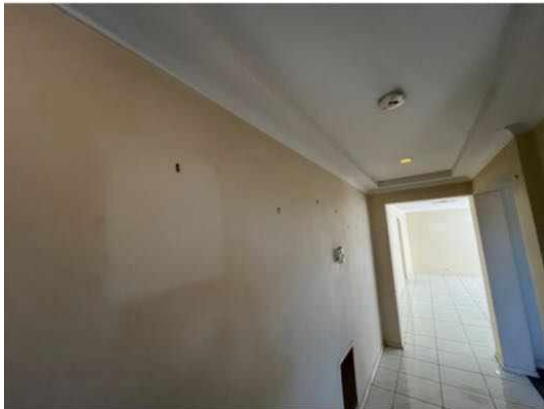
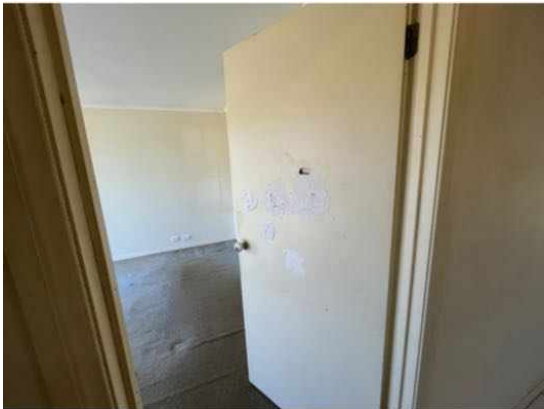
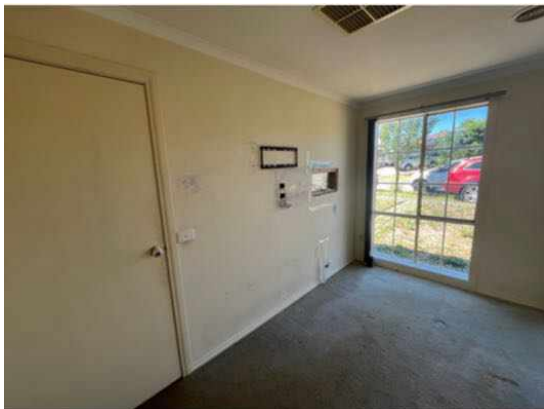
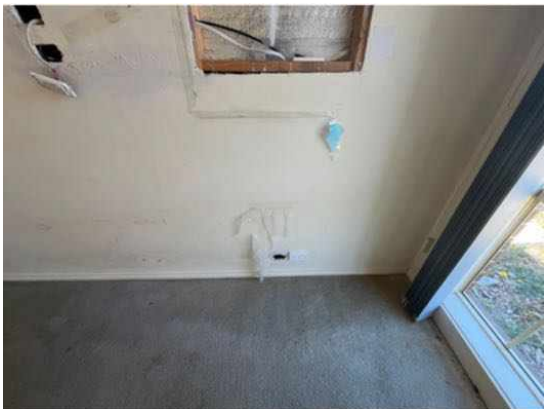
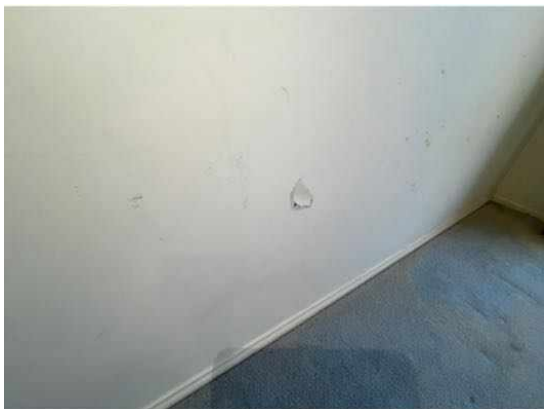
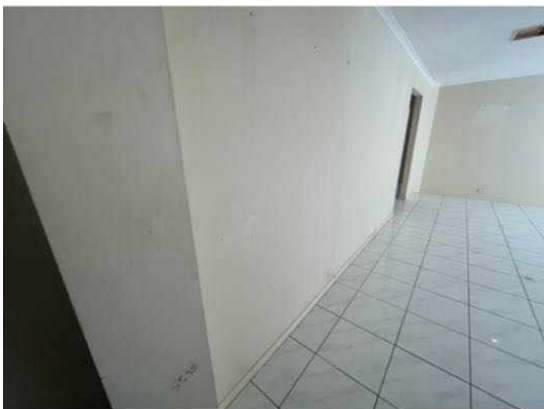
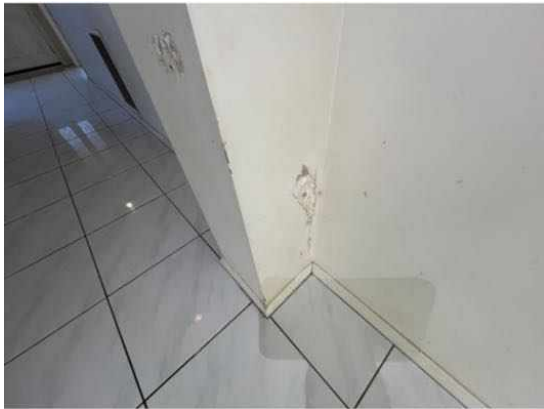
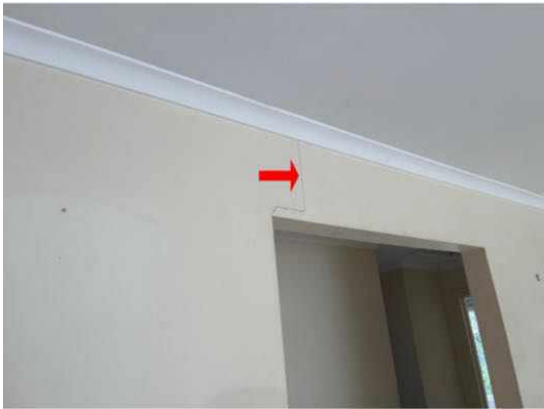
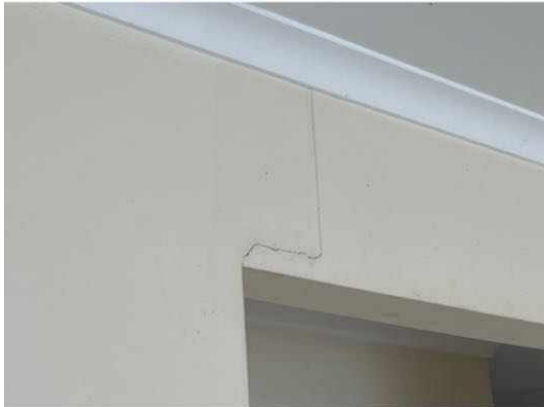
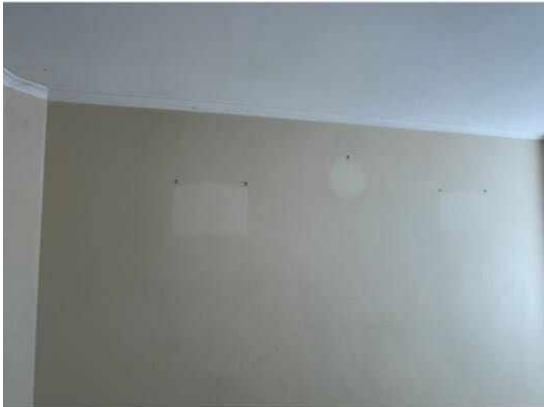
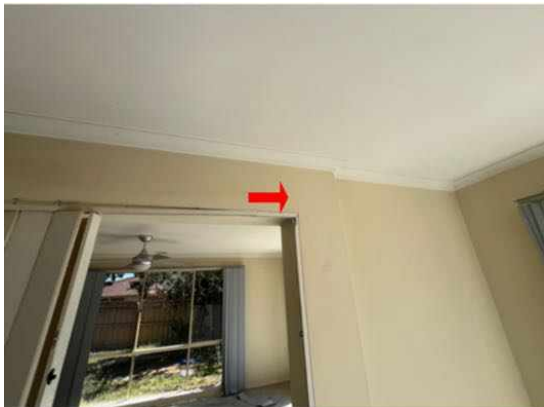
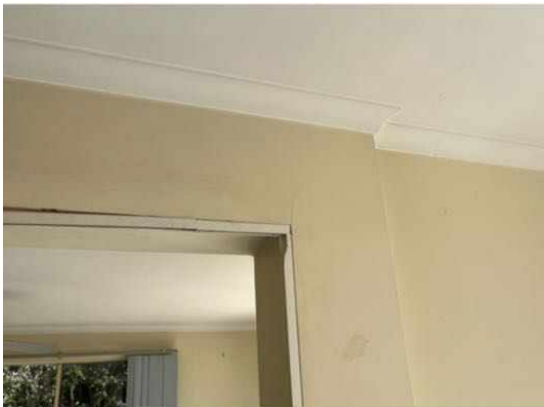
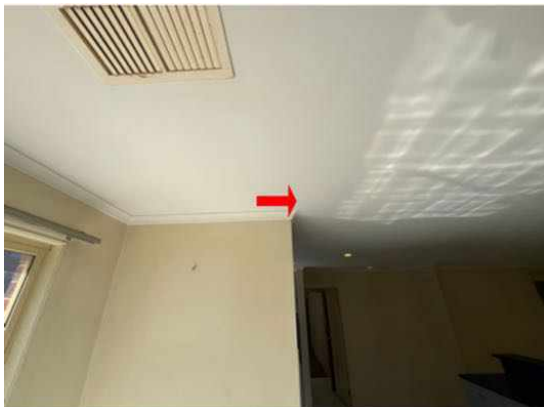
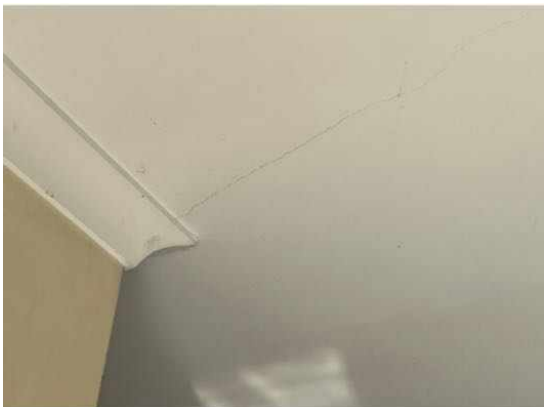
Finding 3.13

Building:	Main Building
Location:	All Internal Areas
Finding:	Interior Finishes - Extensive defects throughout.
Information:	Scuff marks, popped nails, dents, cracks, mitre gaps, poor and unfinished patches, picture hook holes, nail holes, pet damage, physical damage, and defective and poor quality paintwork were observed in and on the internal linings, doors and woodwork in multiple locations.

Whilst some of these defects are attributed to normal wear and tear, poor workmanship, replacement of fixtures, and/or seasonal variations and settlement some are attributed to extensive and deliberate physical damage as well as suspected pet damage. These defects were observed throughout the property and a sample of those observed are provided as an example for your information and are by no means exhaustive of this type of defect.

If left unmanaged, however unlikely, these defects can lead to further deterioration of the associated elements or could lead to safety hazards where electrical services are exposed.

Maintenance of the interior finishes is recommended and a qualified plasterer, painter, handy-person and/or carpenter should be engaged prior to occupation.
