Building and Timber Pest Inspection Report

Inspection Date: Tue, 6 Jan 2026

Property Address: 17 Sharyn St, Cranbourne West VIC 3977,
Australia

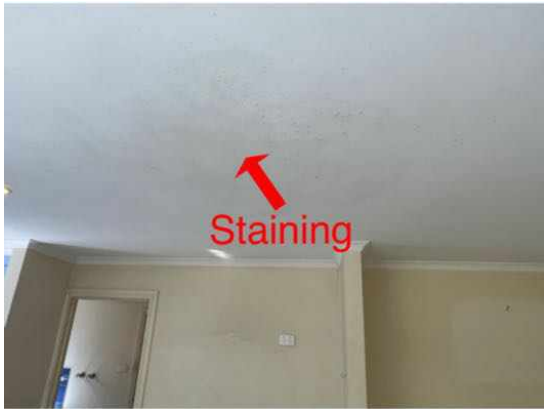
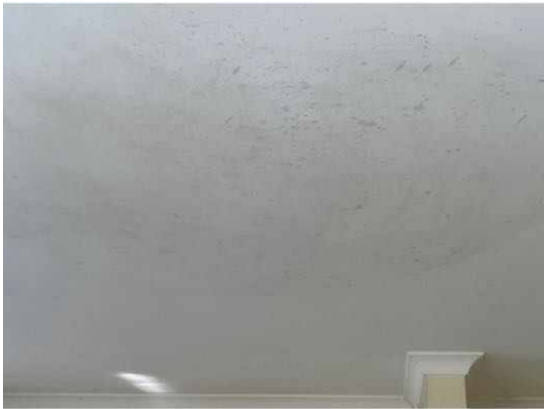
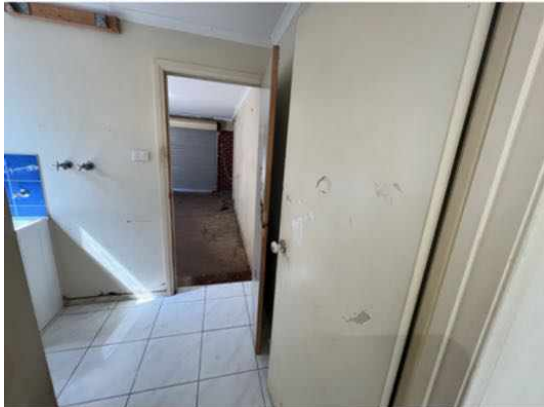
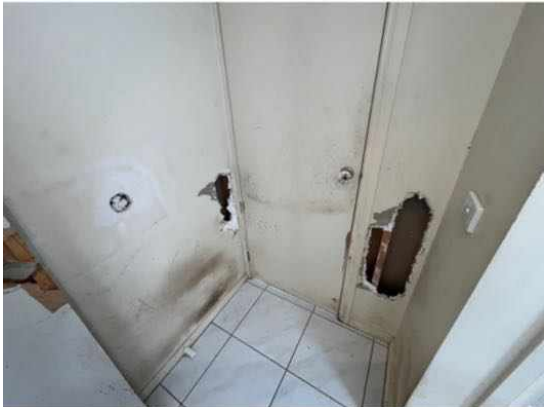
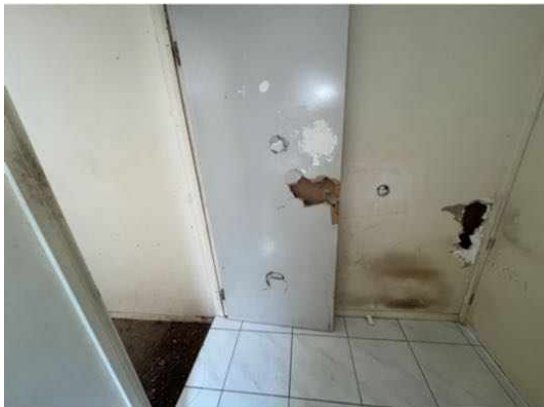
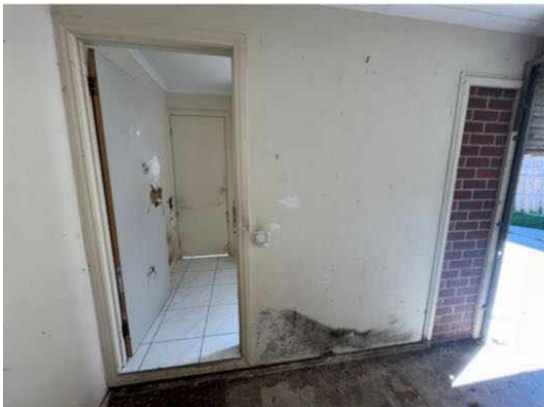
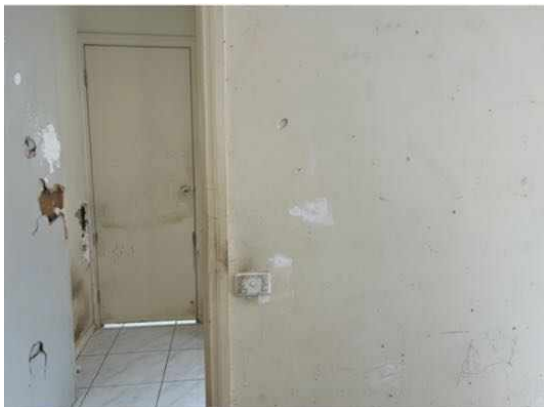
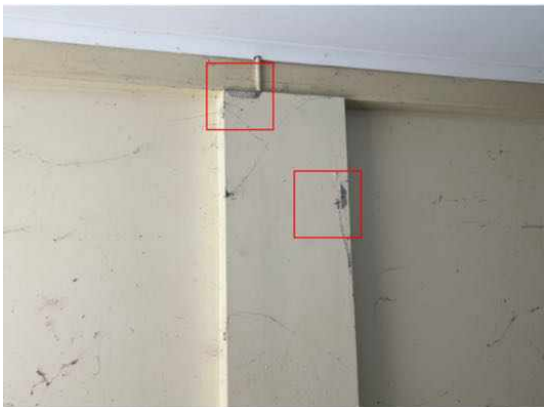
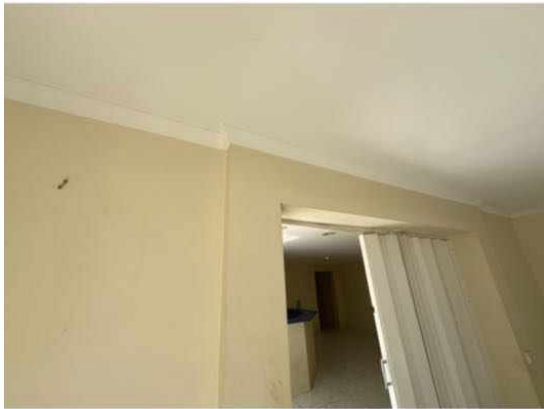
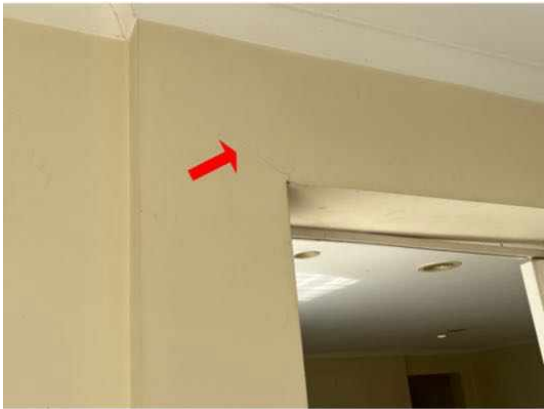
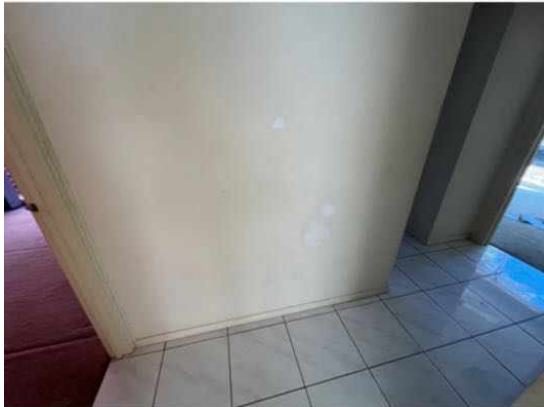
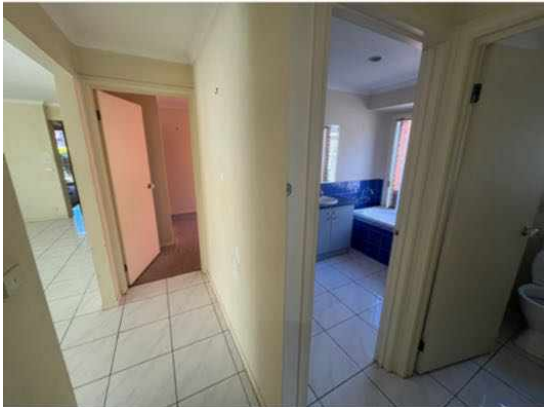
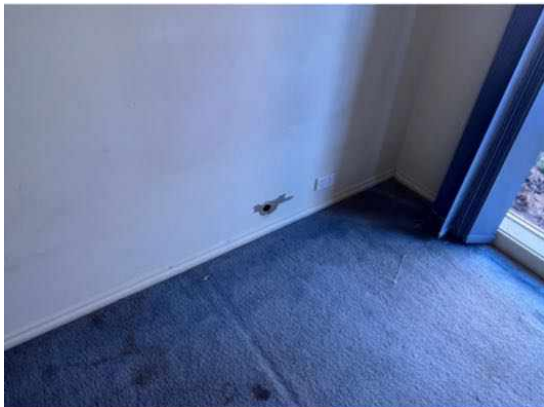
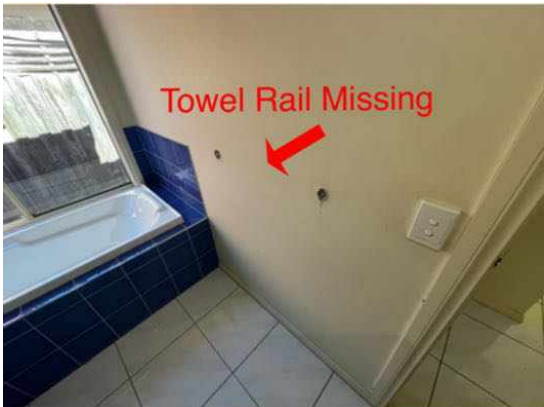
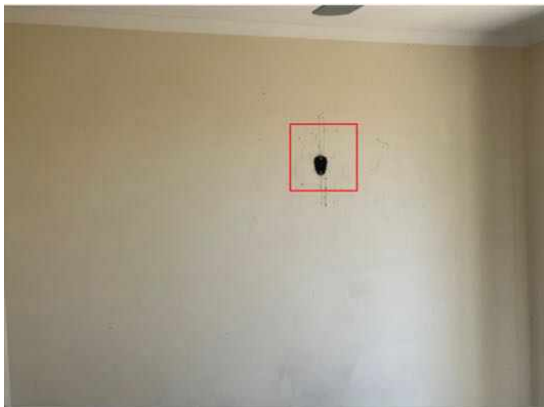
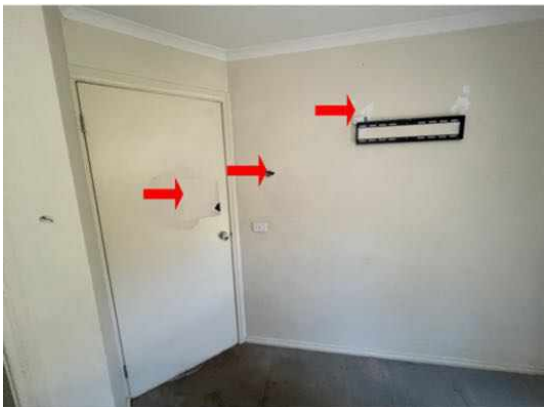
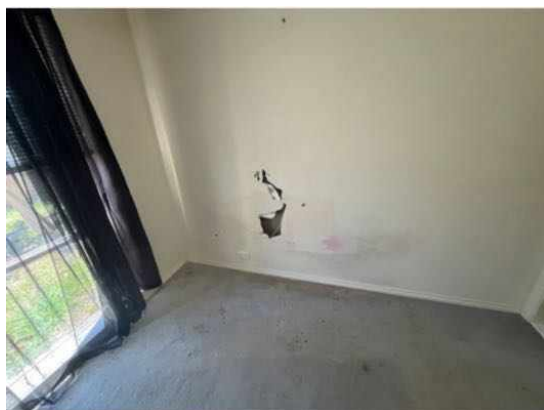
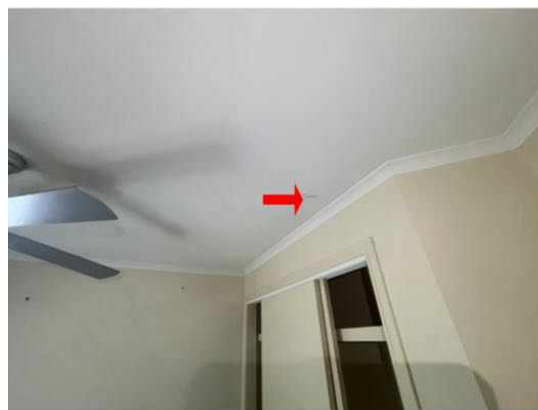
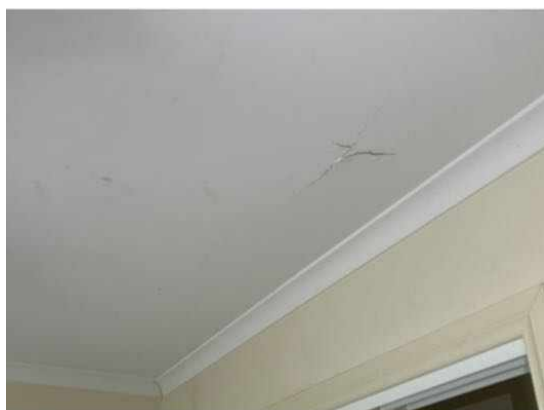
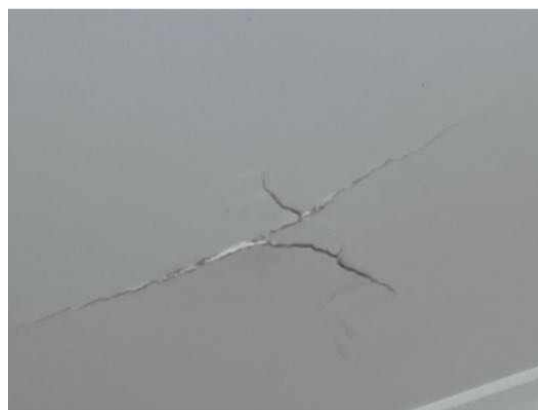
Building:	Main Building
Location:	All Internal Areas
Finding:	Interior Finishes - Extensive defects throughout.
Information:	Scuff marks, popped nails, dents, cracks, mitre gaps, poor and unfinished patches, picture hook holes, nail holes, pet damage, physical damage, and defective and poor quality paintwork were observed in and on the internal linings, doors and woodwork in multiple locations.

Whilst some of these defects are attributed to normal wear and tear, poor workmanship, replacement of fixtures, and/or seasonal variations and settlement some are attributed to extensive and deliberate physical damage as well as suspected pet damage. These defects were observed throughout the property and a sample of those observed are provided as an example for your information and are by no means exhaustive of this type of defect.

If left unmanaged, however unlikely, these defects can lead to further deterioration of the associated elements or could lead to safety hazards where electrical services are exposed.

Maintenance of the interior finishes is recommended and a qualified plasterer, painter, handy-person and/or carpenter should be engaged prior to occupation.

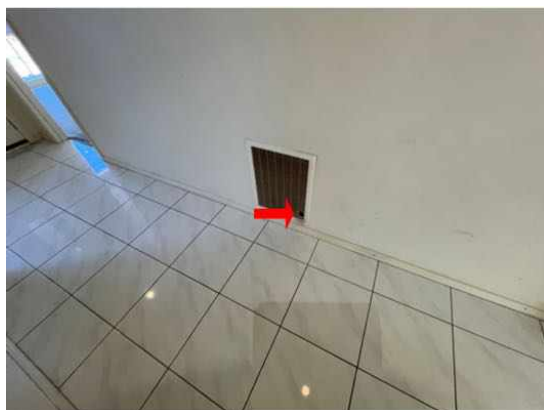
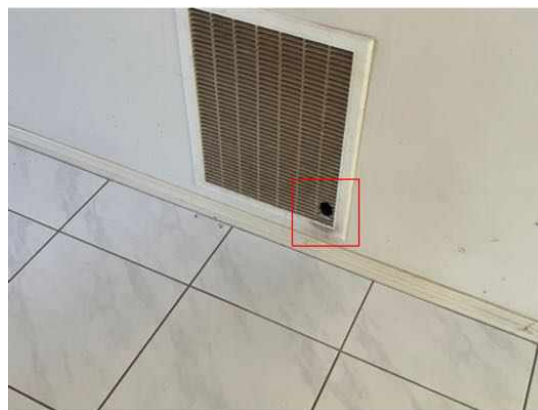
Finding 3.14

Building:	Main Building
Location:	Entry
Finding:	HVAC - Damaged RA Grill
Information:	The return air grille was observed to be damaged and not in its intended condition. This affects its ability to operate as designed and detracts from the overall finish.

The likely causes include impact damage, poor handling during maintenance, or general wear and tear.

If left unrectified, the damage may restrict airflow, reduce HVAC efficiency, and place additional strain on the system. There is also a minor aesthetic concern.

A suitably qualified mechanical services plumber should be engaged to repair or replace the grille.

Rectification should be carried out at the clients discretion.

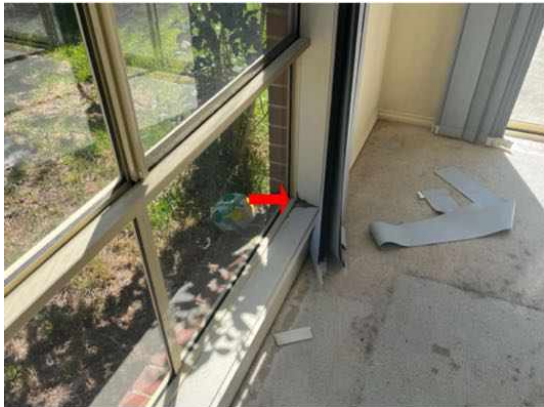
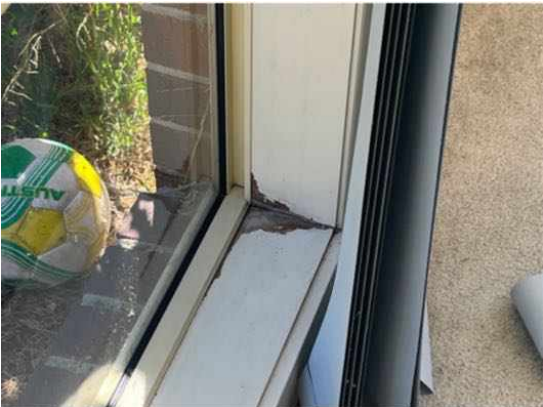
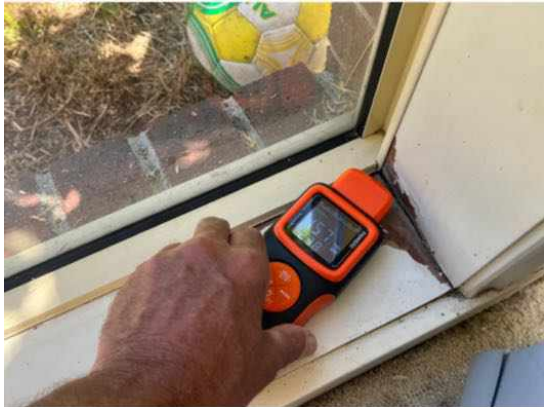
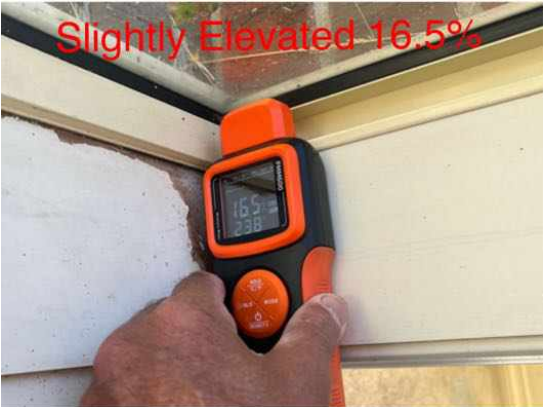
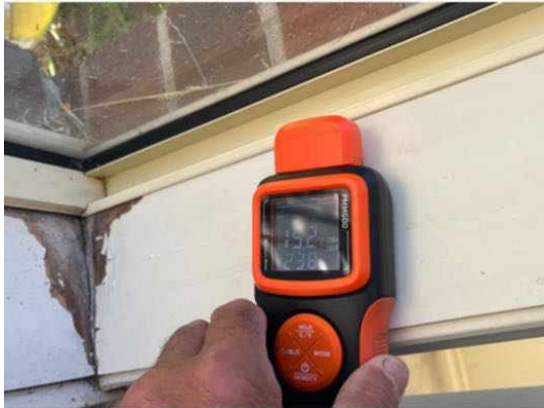
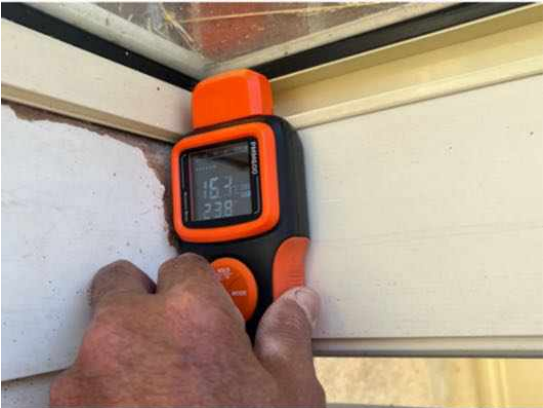
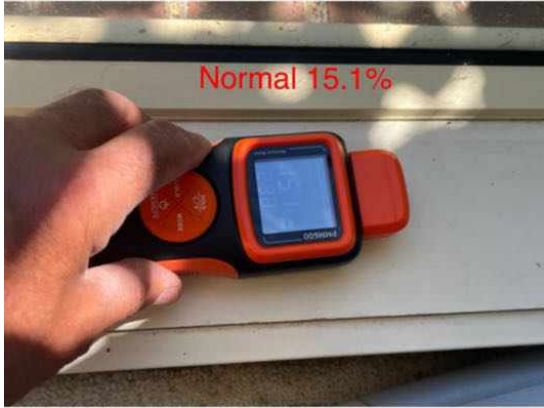
Finding 3.15

Building:	Main Building
Location:	All Internal Areas
Finding:	Window Reveals - Water Damage
Information:	The timber window reveals show evidence of water damage, with swelling, surface deterioration, and elevated moisture readings detected in the highlighted locations. The affected areas indicate that moisture has penetrated the timber, compromising its integrity and finish.

The likely causes of this defect include water ingress from poorly sealed window frames, inadequate flashing or caulking, inadequate overflow provisions in the guttering above the windows, or condensation accumulating within the window assembly.

The implications of this defect include ongoing moisture retention, potential fungal growth or decay within the timber, and further swelling or distortion that may affect the operation of the window and the overall appearance of the joinery. If left unrectified, the damage may worsen, leading to costly repairs or replacement of affected components.

A qualified carpenter or window repair specialist should be engaged to investigate the extent of the damage, identify and correct the source of moisture ingress, and repair or replace the affected reveals as required.

The defect should be rectified as soon as practicable to prevent further deterioration, minimise the risk of structural or mould-related issues, and restore the durability of the window assembly.

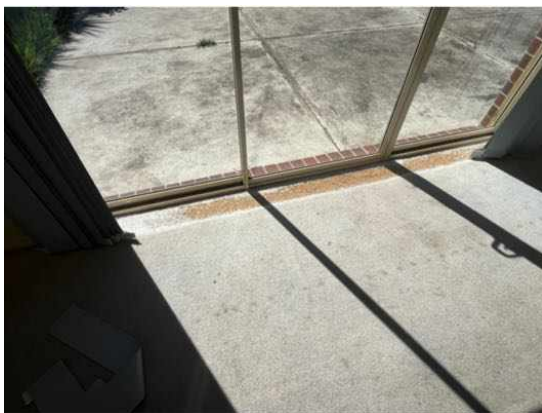
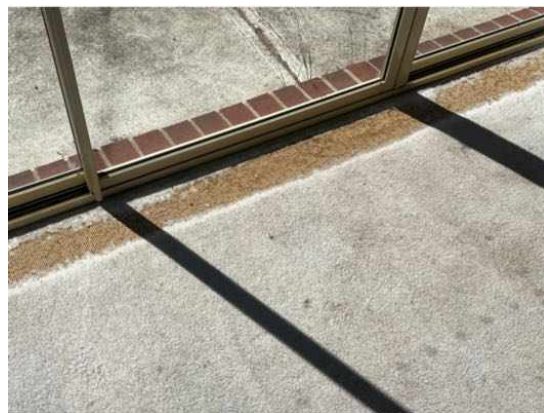
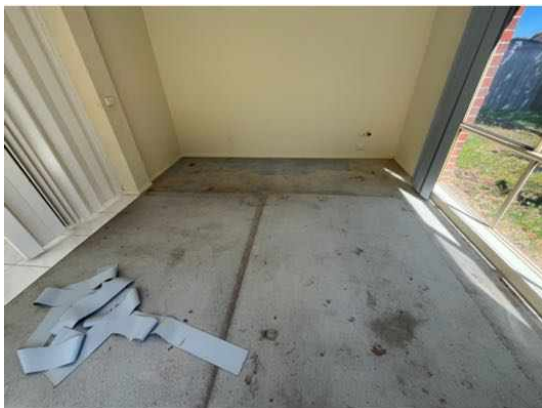
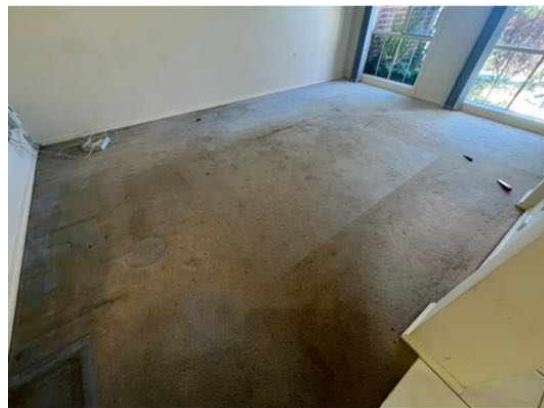
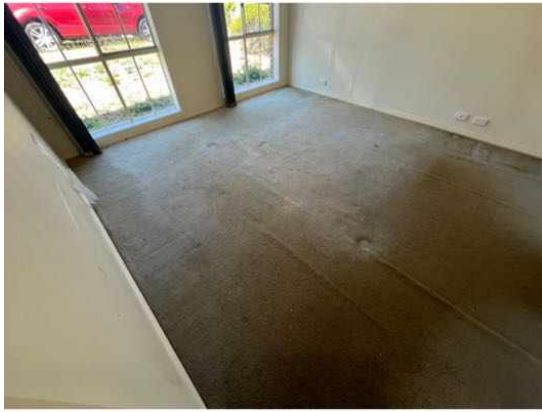
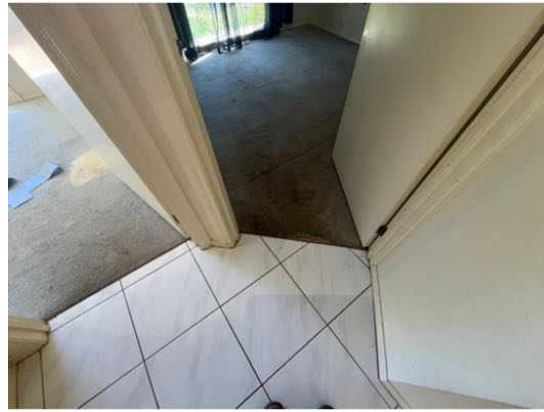
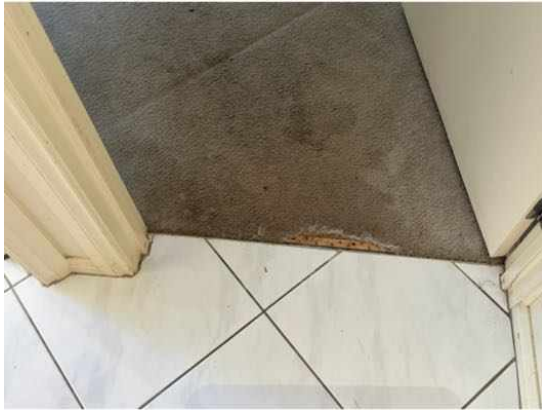
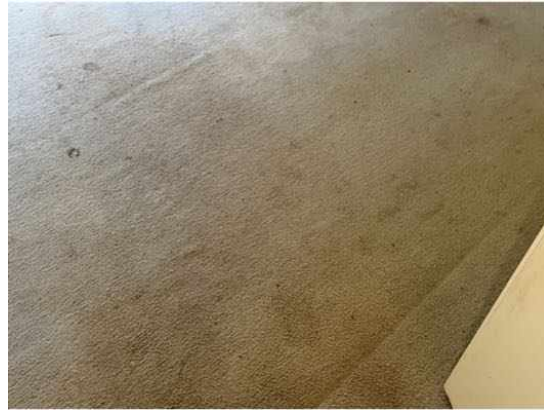
Finding 3.16

Building:	Main Building
Location:	All Internal Carpeted Areas
Finding:	Carpets - Deteriorated Throughout
Information:	Badly worn and stained carpets were observed throughout the property, with noticeable deterioration to the pile and visible discolouration. The condition of the carpets indicates they are at or beyond the end of their useful service life and no longer present in a serviceable or hygienic condition.

The likely causes of this defect include long-term use, age-related wear, UV exposure, inadequate maintenance, and repeated soiling or spillage over time. High foot traffic areas and pets appear to have contributed significantly to the level of wear observed.

If left unrectified, the carpets may continue to degrade, detract from the overall presentation of the property, and may harbour dirt, allergens, or odours. Worn carpets can also present a minor trip hazard where the edges or backing have deteriorated.

A suitably qualified flooring contractor should be engaged to remove and replace the carpets. Replacement is recommended to restore amenity, hygiene, and appearance throughout the property.

Rectification should be undertaken in the short term, particularly prior to ongoing occupation, sale, or leasing of the property.

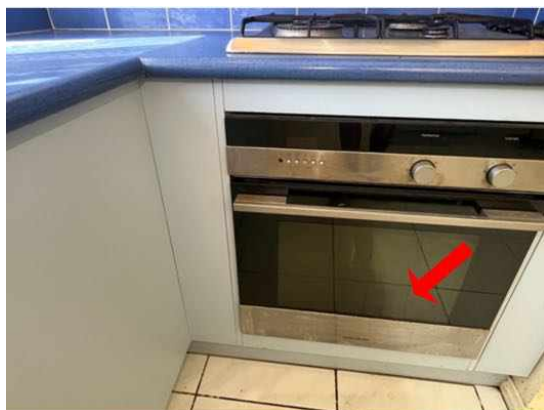
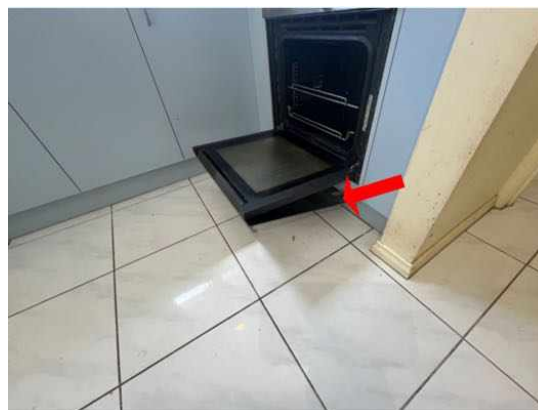
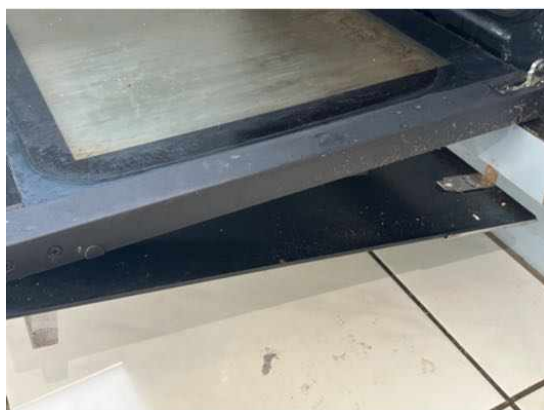
Finding 3.17

Building:	Main Building
Location:	Kitchen
Finding:	Oven - Door Panel Detached
Information:	The oven door was observed to have the glass front panel partially detached from the door frame.

The likely causes include impact, wear and tear, or failure of the fixing clips or adhesive holding the glass in place.

If left unrectified, the glass may fully detach, creating a safety hazard and affecting the oven's operation.

A qualified appliance technician or qualified tradesperson should be engaged to repair or replace the oven door.

Rectification should be carried out promptly to ensure safe use of the appliance.

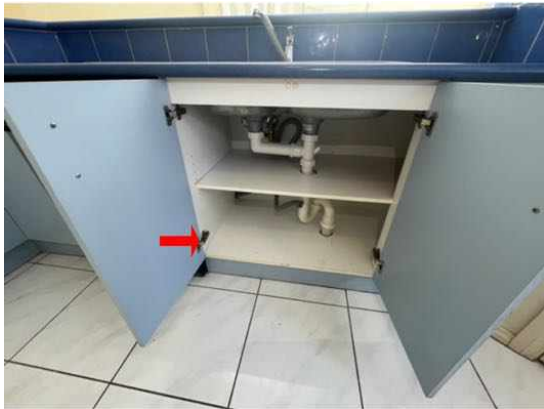
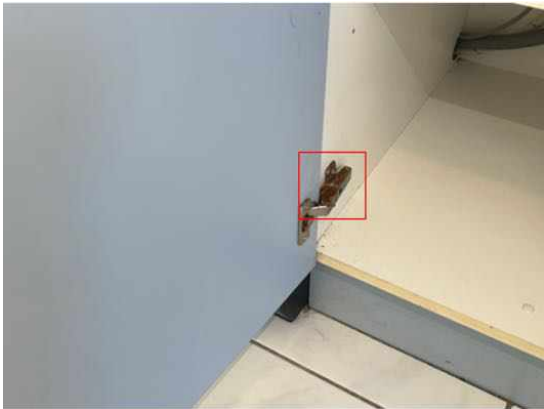
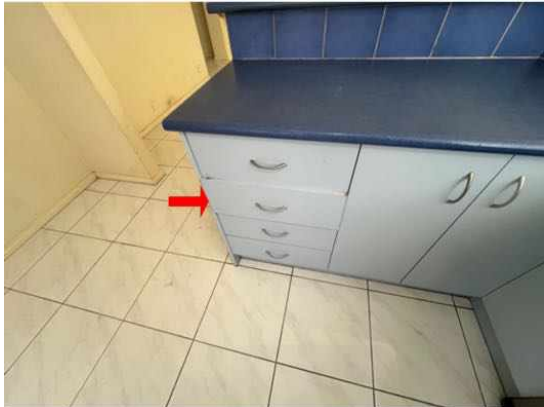
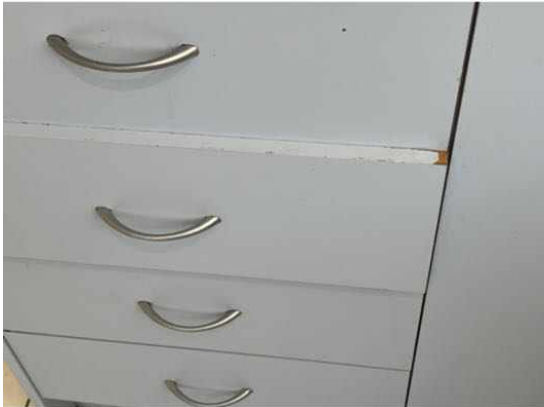
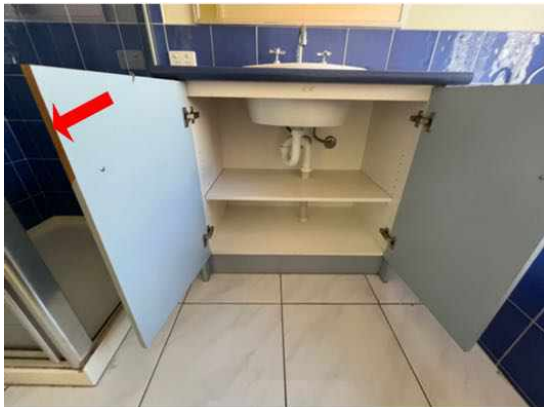
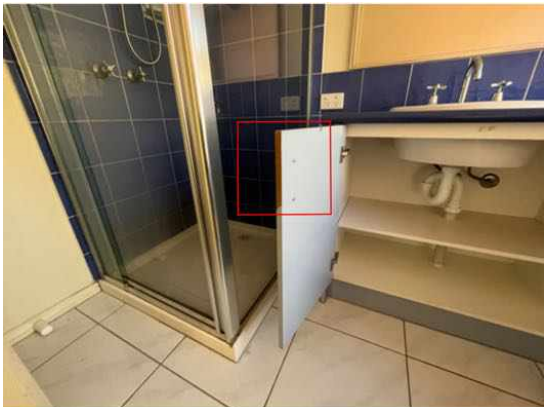
Building:	Main Building
Location:	Kitchen
Finding:	Cabinetry - General maintenance items and defects
Information:	Cabinetry was observed to have chipped laminate surfaces, loose handles, rusting hardware and misaligned doors and drawers requiring adjustment to ensure correct operation.

This condition was noted in various locations in the kitchen and bathroom cabinetry.

These defects commonly occur as a result of wear and tear coupled with a lack of maintenance and affect the functionality, appearance, and durability of the cabinetry. If left unrectified, they may worsen over time, leading to further damage and reduced usability.

A qualified cabinetmaker or joiner should be engaged to repair or replace damaged components, refit hardware, and adjust doors and drawers. Where moisture damage is evident, the source of the moisture should be identified and rectified as a priority.

Rectification should be carried out in the near term to restore proper function and prevent further deterioration.

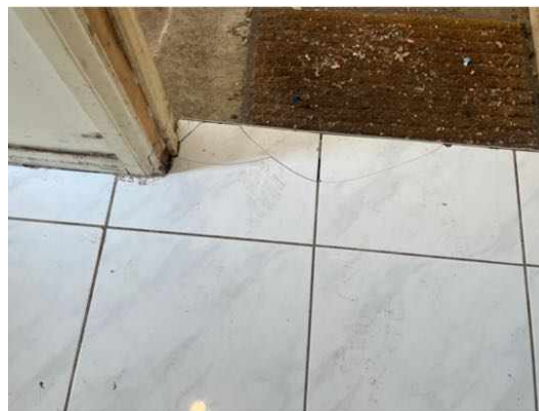
Finding 3.19

Building: Main Building
Location: All Internal Areas
Finding: Floor Tiles - Cracked or damaged
Information: Cracking was evident to the floor tiling in this area at the time of inspection. While the cracking appears to be minor, this area is frequently exposed to water trafficked by occupants, allowing potential for water penetration into adjoining sections of walls and door jambs.

If left unmanaged, water penetration to this area may lead to subsequent further water damage.

A tiling contractor should be appointed in a timely manner to ensure that no further water damage occurs. The re-application of silicone and grouting throughout remaining tile work and around the fixtures is also advised, to further protect the area against water penetration.

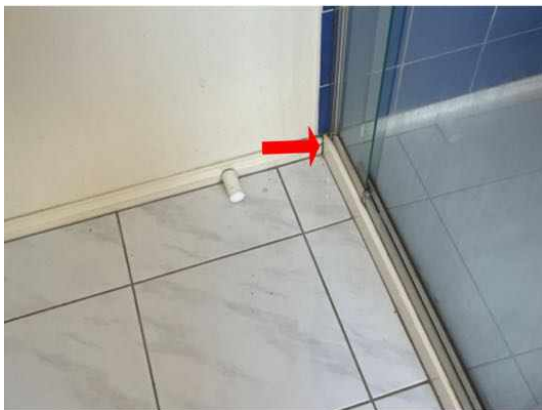
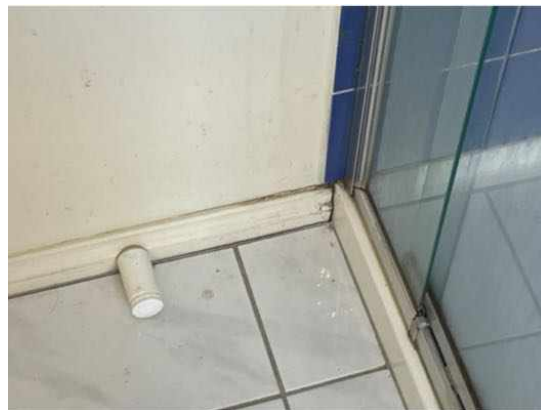
Finding 3.20

Building:	Main Building
Location:	All Internal Areas
Finding:	Woodwork and Trims - Water Damage Evident (Shower Area Skirting)
Information:	Water damage was observed in the skirting adjoining the shower base in the areas highlighted, with visible signs of swelling, delamination, and surface deterioration consistent with prolonged moisture exposure.

This may indicate inadequate waterproofing, past leaks or flooding, or ongoing leaks in that area or adjoining areas.

Whilst there was no evidence of unexpected elevated moisture readings in the vicinity at the time of inspection the area highlighted is a common area for leaks around a shower enclosure and it is advised that timber skirting when used in a wet area should not be embedded in the tiles in the manner observed.

Rectification and further advice is recommended to be sought by a qualified carpenter and/or tiler to prevent further damage and maintain the functionality and hygiene of the areas affected as a priority.

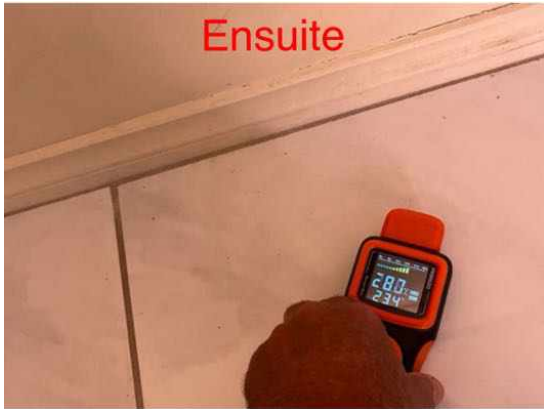
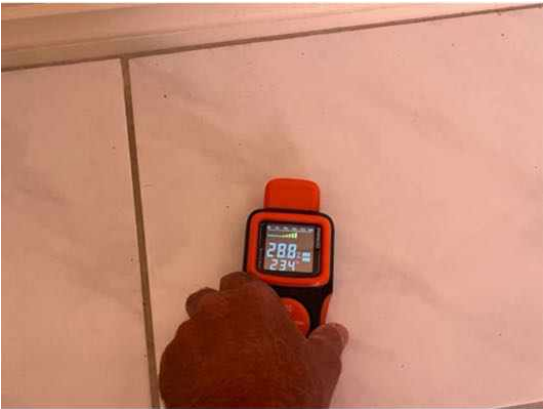
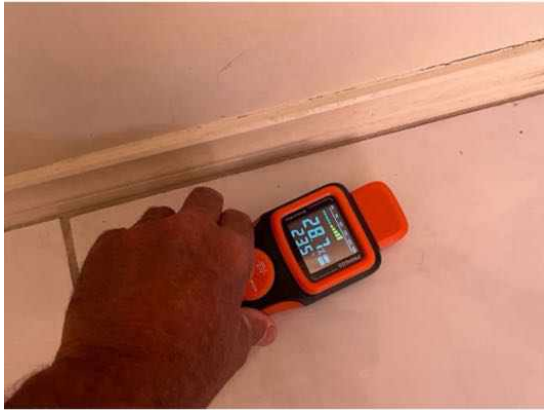
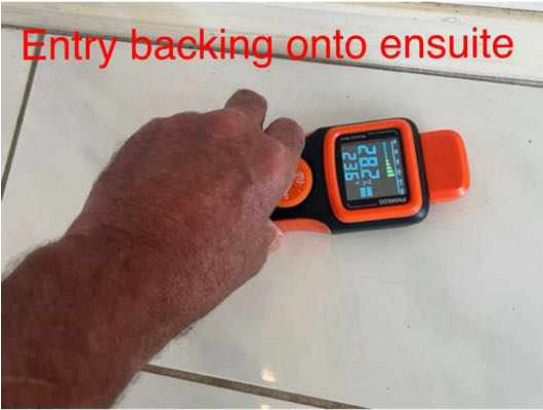
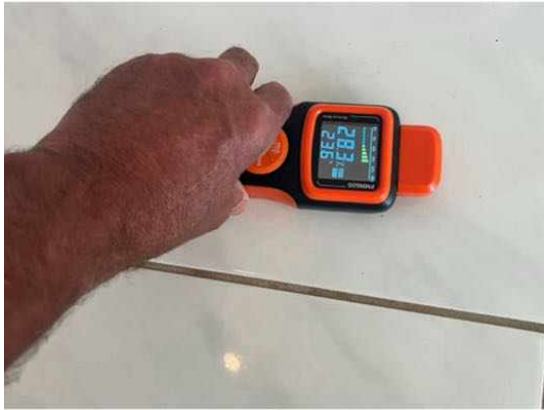
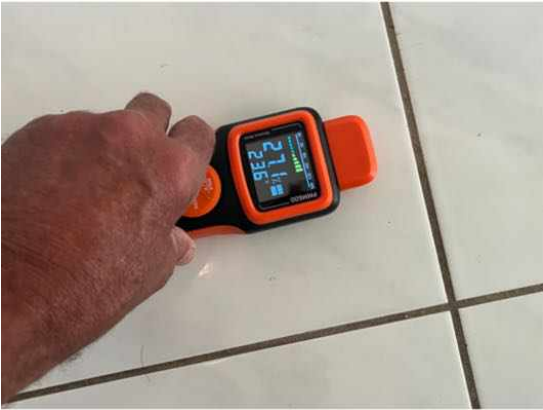
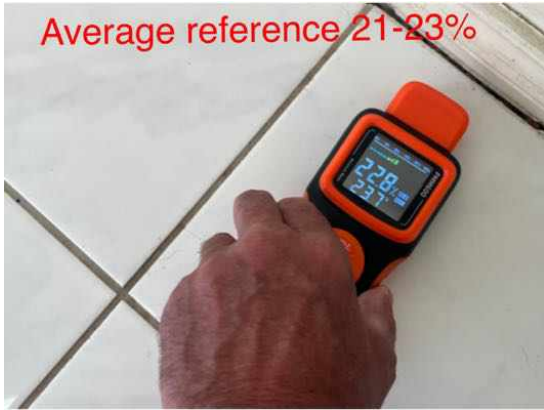
Finding 3.21

Building:	Main Building
Location:	Ensuite & Entry
Finding:	Elevated relative moisture readings - Wet area (Vacant)
Information:	Slightly elevated relative moisture readings were observed both sides of the wall adjoining the shower enclosure in the areas highlighted.

Elevated relative moisture readings in a wet area such as a bathroom or shower, indicates an area that is conducive to termite attack and susceptible to fungal growth, mould and wood decay.

Elevated moisture readings may be caused by recent occupant usage, roof drainage and moisture ingress issues, leaking plumbing pipes or fixtures, or failure of the waterproofing in the area. As this is a vacant property and has been for a period of time it may indicate a concealed leak in the plumbing in this area.

Prior to any remedial works being performed a qualified plumber should be appointed to further inspect the property and to identify the cause of the elevated moisture readings. Works to remove affected building elements may then be necessary and should be performed by an appropriate tradesperson.

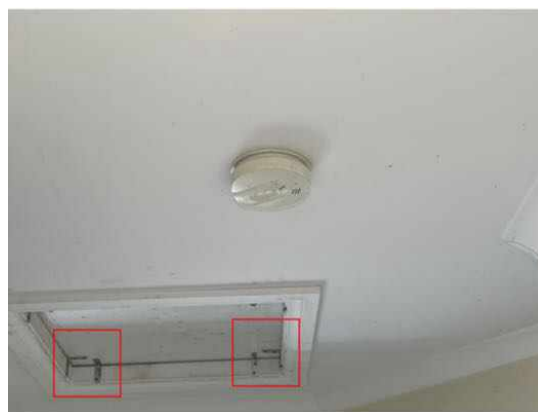
Finding 3.22

Building: Main Building
 Location: Passage
 Finding: Manhole - Fixed shut
 Information: The roof void manhole was observed to be fixed shut, preventing access and inspection of the roof space at the time of inspection.

The likely cause is intentional fixing of the manhole following previous works or to restrict access.

This prevented assessment of roof framing, insulation, services, and potential concealed defects, which may remain undetected.

A suitably qualified tradesperson or building contractor should be engaged to reinstate removable access and allow inspection.

Rectification should be carried out as soon as practicable to enable proper assessment of the roof void and a follow-up inspection arranged prior to further financial commitment.

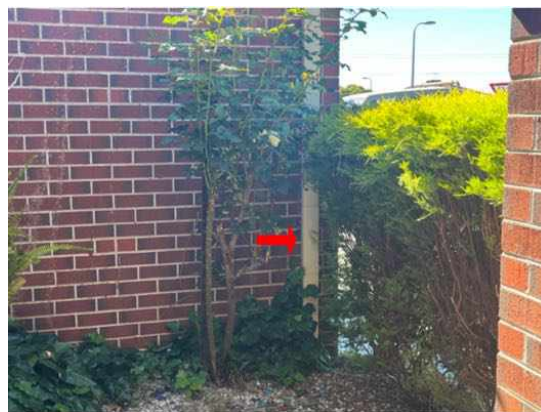
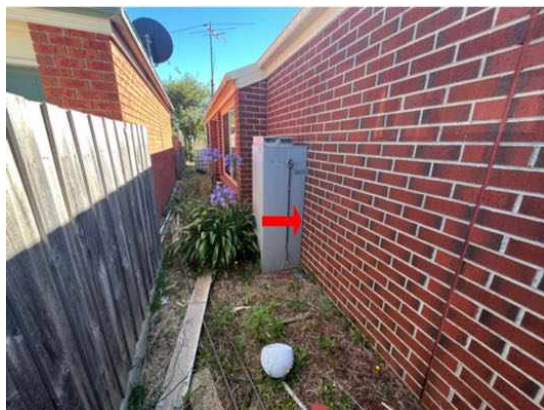
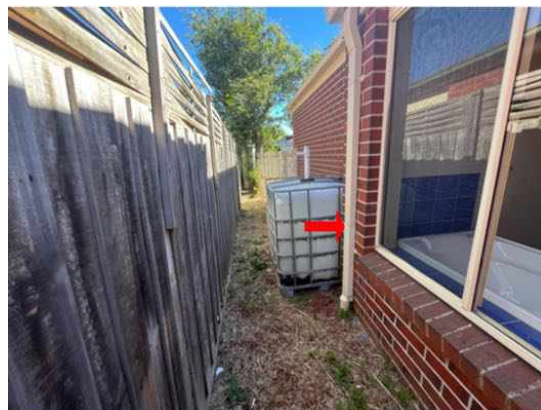
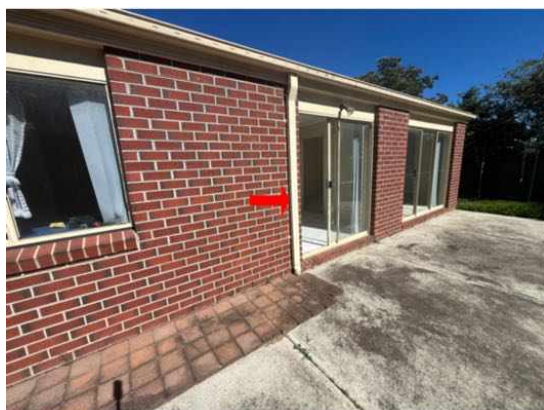
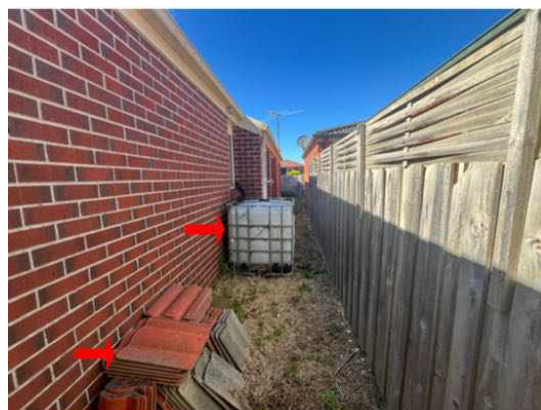
Where any part of an attachment to a building is not isolated and is not provided with a clear gap of not less than 25mm from the building, bridging occurs. Attachments to buildings such as hot water services, downpipes, verandahs, decks, steps, fences, service conduits and the like provide the opportunity for concealed entry.

Building attachments of this nature need to be frequently inspected for termite activity by a qualified inspector.

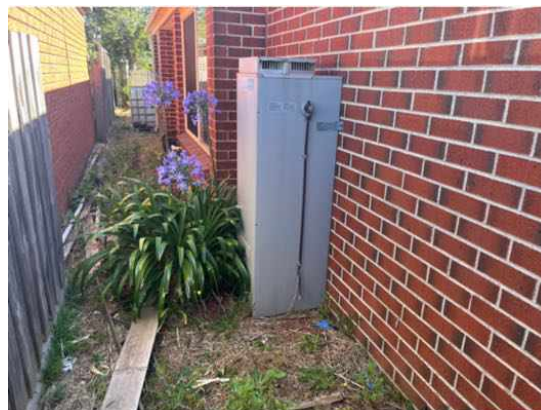
Finding 6.03

Building:	Main Building
Location:	External LHS
Finding:	Hot Water Service TPRV Drain - Discharging against the building
Information:	The hot water service temperature and pressure relief valve (TPRV) drain was found to be installed in a manner that will discharge against the building and may create excessive moisture in the surrounding area.

Damp conditions arising from the discharge can lead to secondary defects such as rot, rising damp, rust or corrosion of associated building elements, the formation of fungal decay, differential foundation movement or the creation of potential slip hazards. When coupled with poor site drainage, pooling of water may also attract

termite activity to this area.

It is highly recommended that a licensed plumber be appointed to connect the TPRV drain to stormwater in order to prevent such an environment from being created. These works should be carried out as soon as possible.

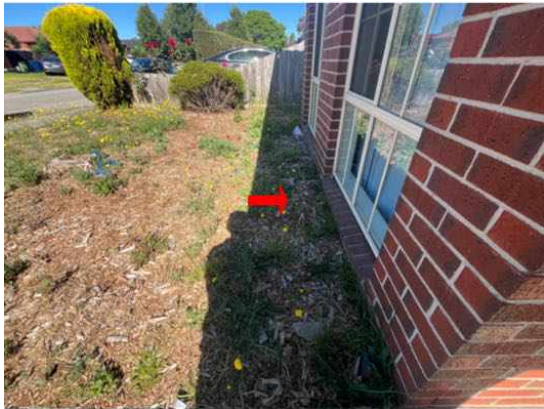
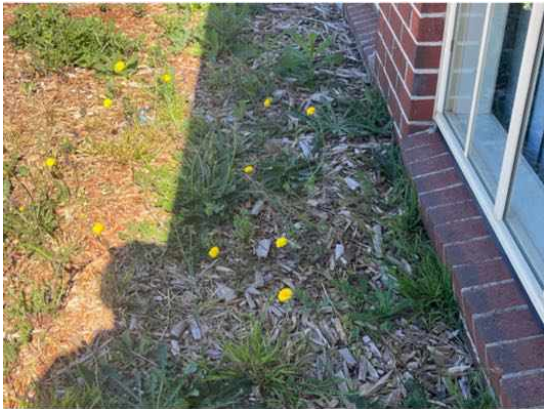
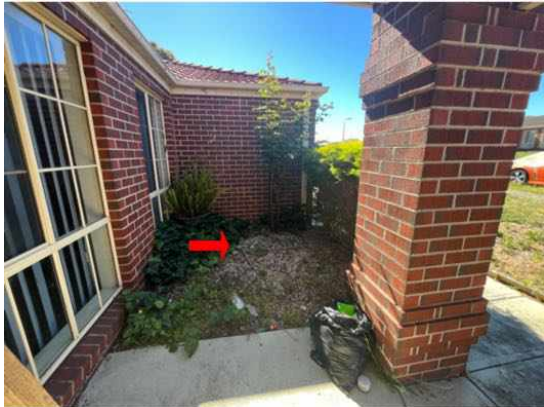
Finding 6.04

Building:	Yard
Location:	External Front
Finding:	Garden Beds Adjacent Building - Conditions conducive to termite attack and differential foundation movement.
Information:	Garden beds containing timber mulch were found to be evident in close proximity to the building.

Where there are raised garden beds, termites can easily access, weep holes, vents, penetrations and cracks and voids in the front facade.

Where garden beds have base soils below surrounding surface levels without adequate drainage, they are susceptible to moisture accumulation which can lead to differential foundation movement and rising damp.

Where garden beds have untreated timber and organic debris the combination of accumulated stormwater, moisture from watering and any of the conditions described above create conditions conducive to termite activity.

Further advice from a Timber Pest Technician is required to ensure an appropriate Termite Management System is implemented to mitigate the risk.

Recommend engaging a licensed plumber to provide further advice on incorporating suitable drainage if subsoil drainage appears inadequate.

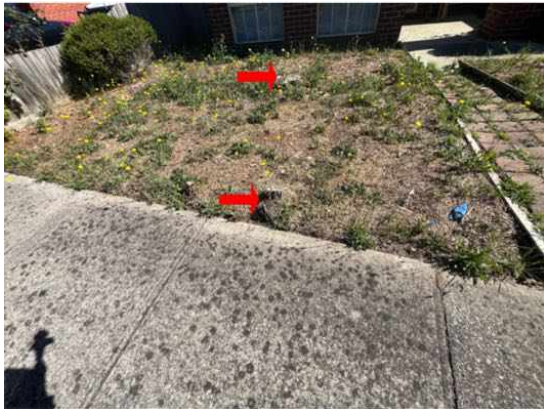
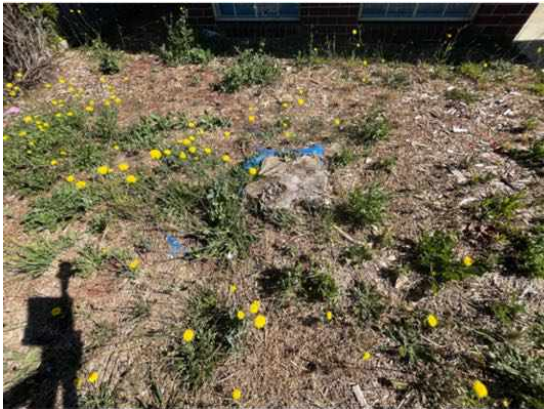
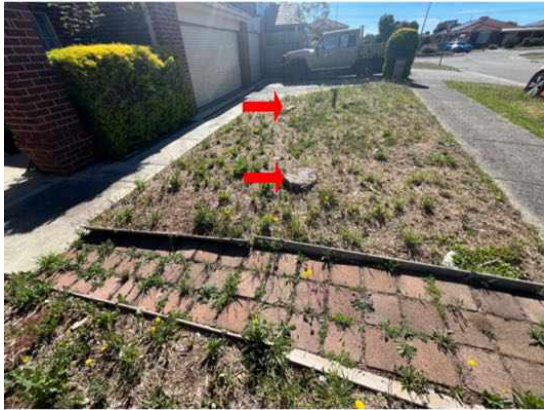
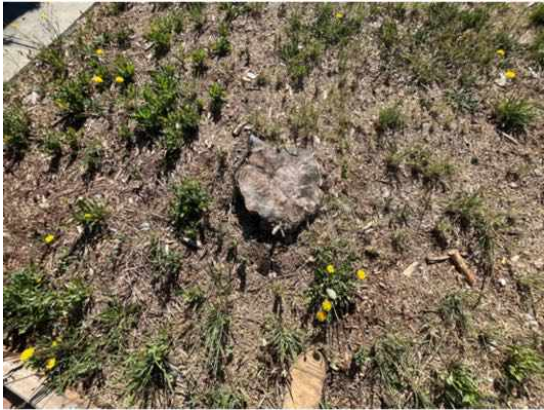
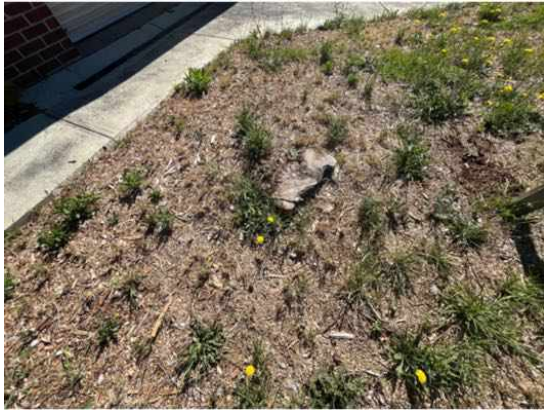
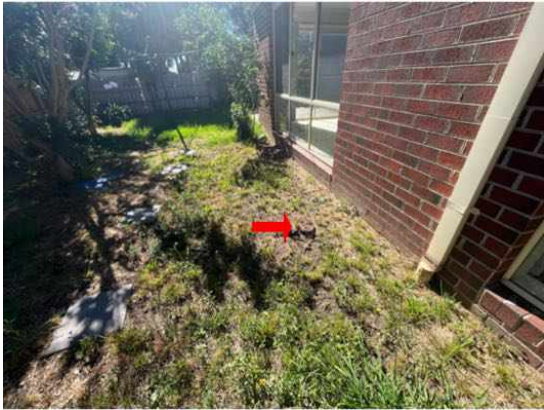
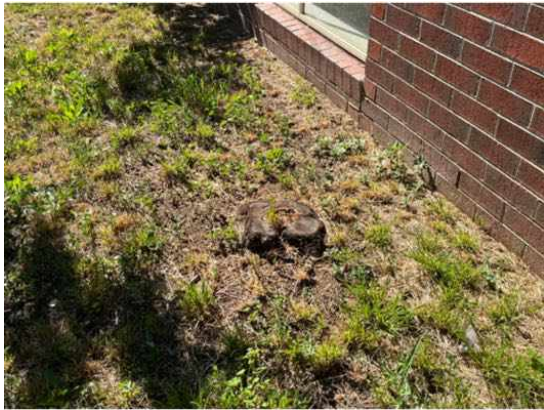
Finding 6.05

Building: Yard
Location: External Front & Rear
Finding: Tree stumps
Information: Tree stumps were observed in various locations around the property at the time of inspection.

Where tree stumps are present and exposed to moisture and in close proximity to the building they create areas conducive to termite pest activity.

Recommend clearing all timber away from the building and removing dead tree's and stumps around the property.

If active termites are encountered it is recommended to stop further disturbance and engage a licensed Pest Technician to treat the area prior to resumption of clearing activities.

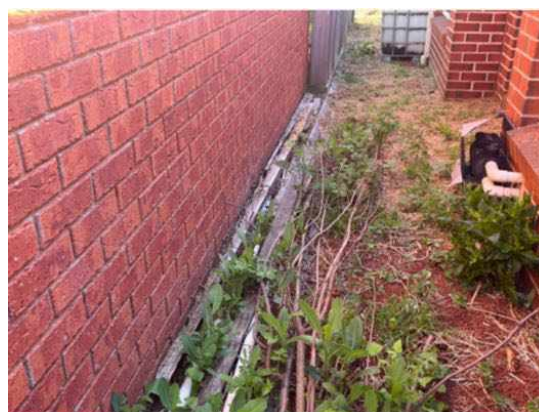
Finding 6.06

Building:	Yard
Location:	External LHS
Finding:	Stored timbers
Information:	The storing of timbers around the external property increases the risk of termite activity being present. As they are likely to come into contact with weather conditions or excessive moisture, wood rot is likely to develop creating conditions conducive to termite activity.

It is highly recommended that any stored timbers be immediately removed from areas in which they may attract any termite / timber pest attack and be kept clear of the ground and any building elements to enable regular visual inspection for termite activity.

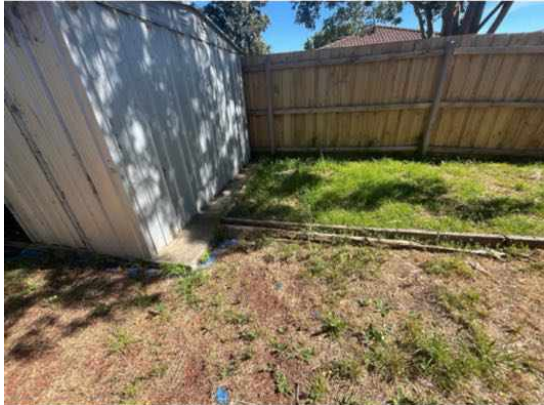
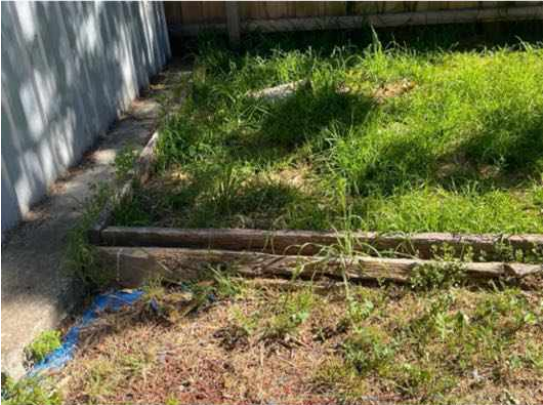
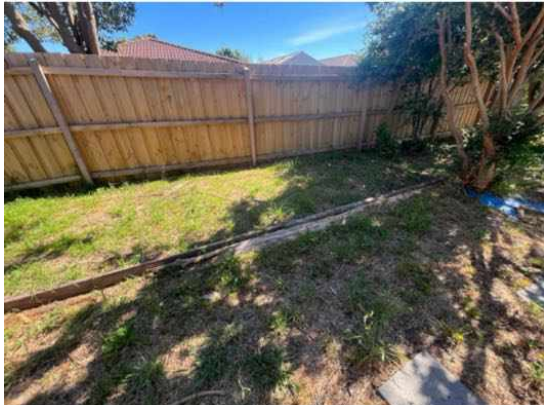
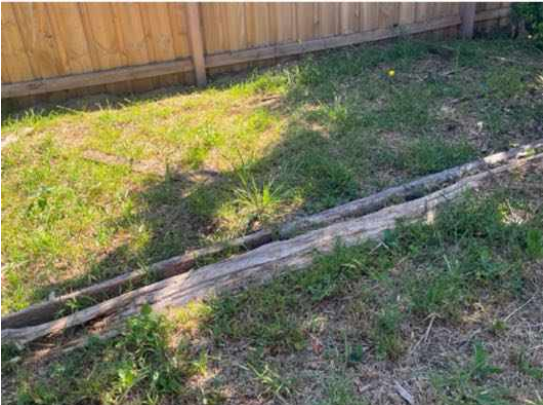
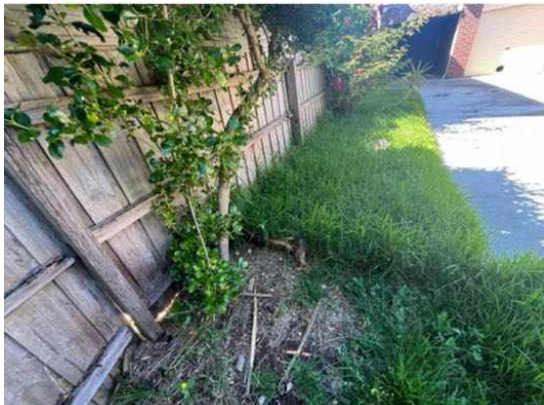
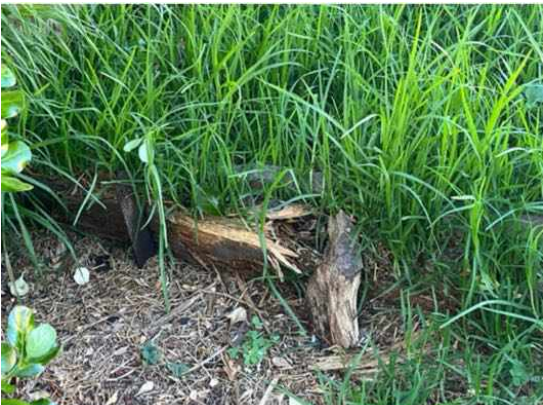
Finding 7.01

Building:	Main Building
Location:	All External Areas
Finding:	Wood Rot - Retaining walls
Information:	The highlighted timber retaining walls were observed to have wood rot at the time of inspection.

Wood rot, also known as Fungal Decay, occurs when timber is exposed to damp conditions on an ongoing basis. This could be the result of any combination of exposure to weathering over a prolonged period of time, material selection, inadequate maintenance, installation or the attraction of excessive moisture from other abutting building materials.

Timber elements that contain wood rot as well as being structurally compromised

create areas conducive to termite attack and if left unmanaged can lead to further decay of adjoining timber elements and/or structural failure.

A licensed builder, landscaper and/or qualified carpenter should be engaged to replace affected timber elements as soon as possible to prevent further issues arising.
