Building and Timber Pest Inspection Report

Inspection Date: Tue, 6 Jan 2026

Property Address: 17 Sharyn St, Cranbourne West VIC 3977,
Australia

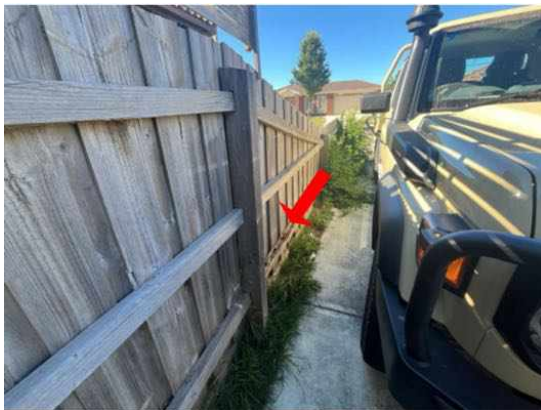
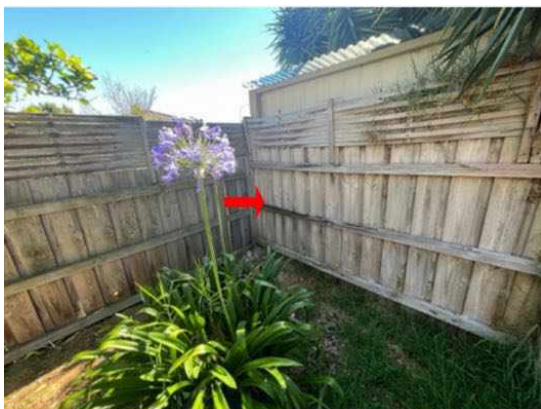
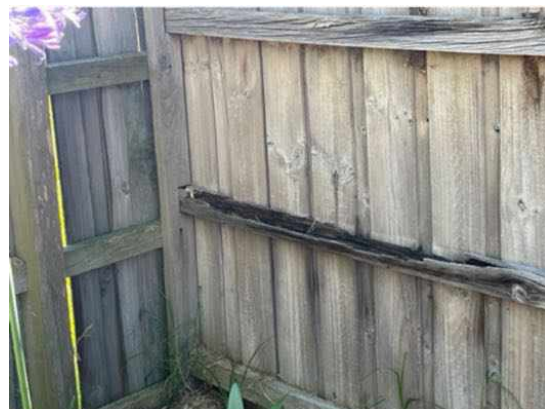
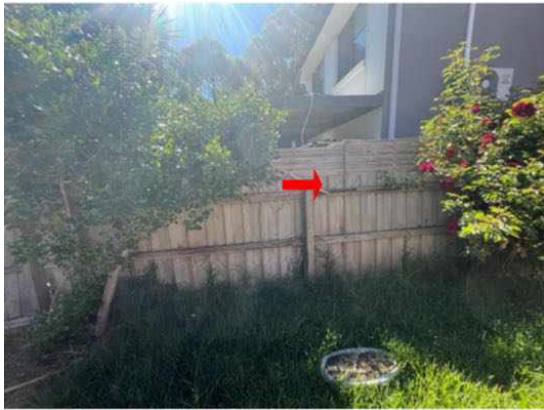
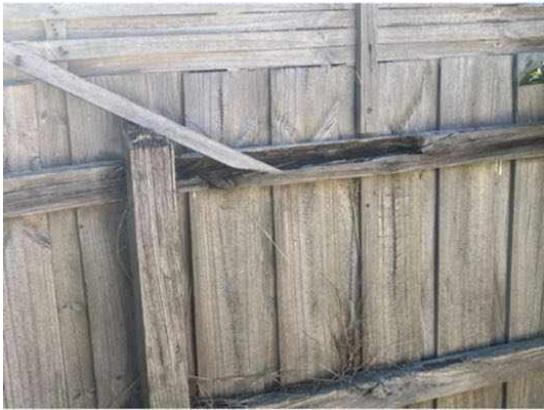
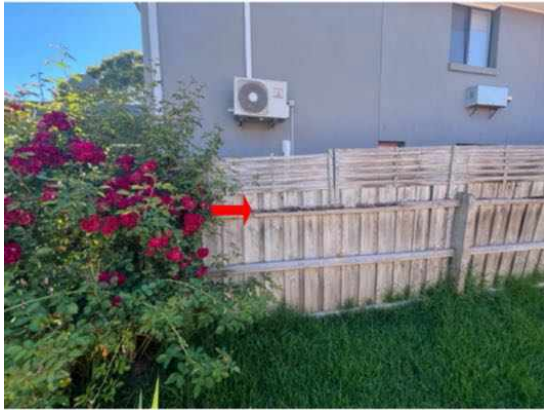
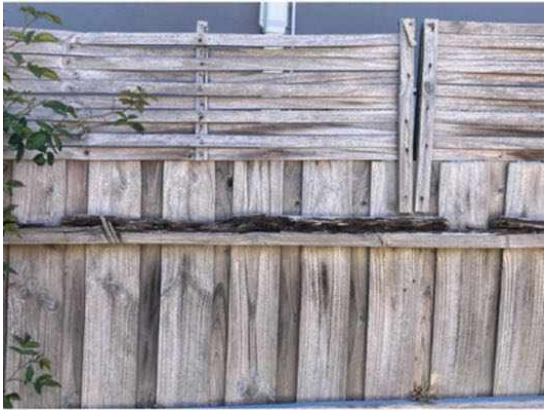
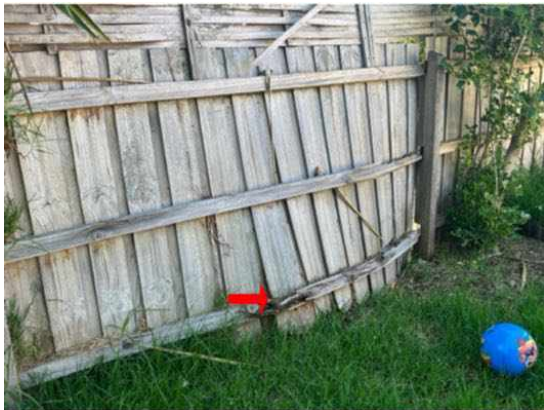
Note that consideration should be given to the fences total replacement along the RHS boundary as in the inspectors opinion it is not practical to repair.

A fencer, carpenter or handyperson should be engaged to replace the affected building materials at the clients discretion. A licensed pest technician should be engaged to install a termite management system for this site.

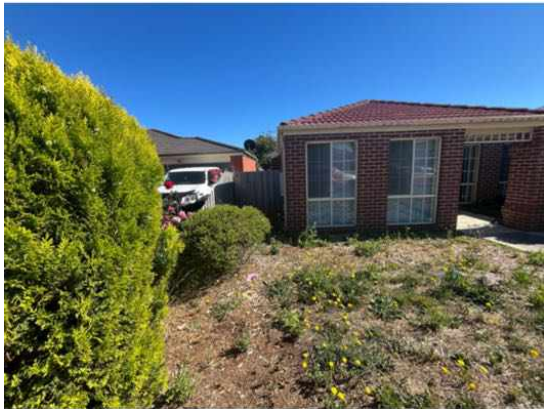
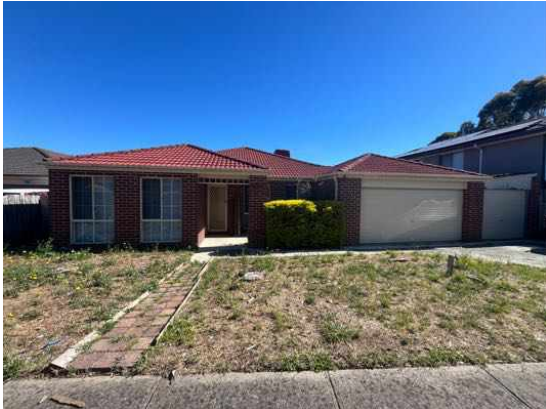
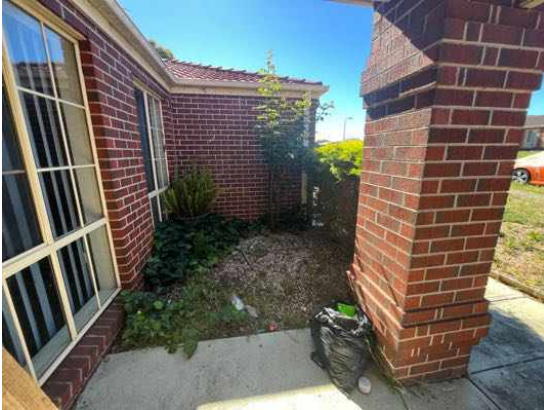
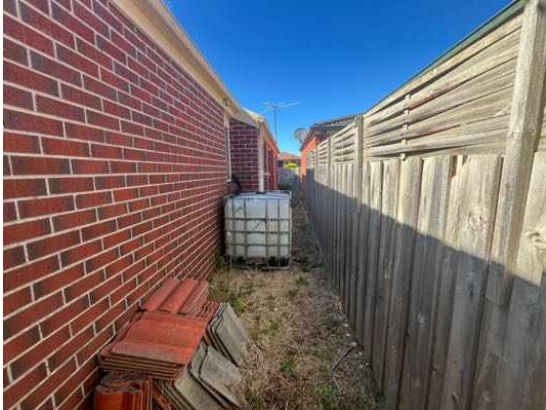
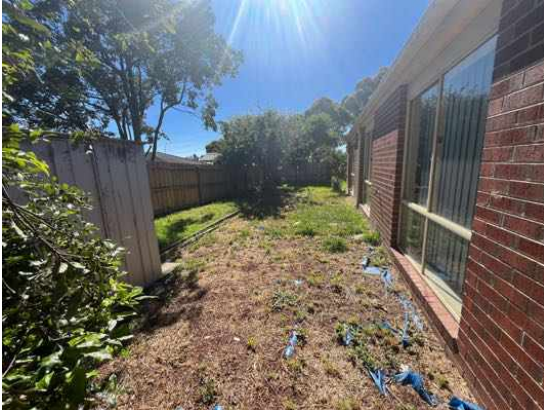
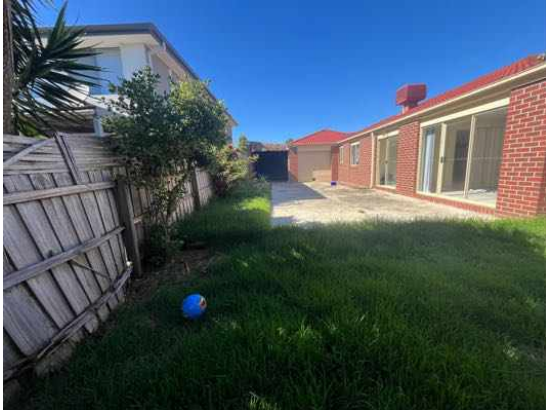
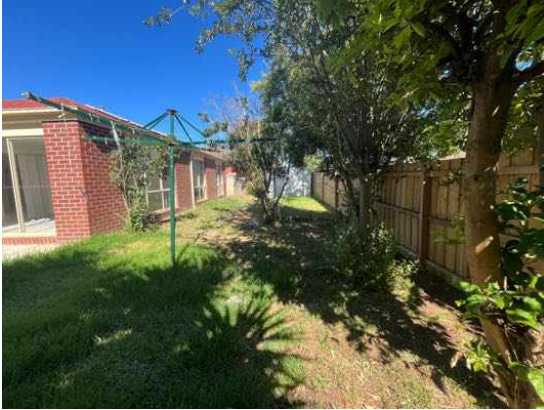
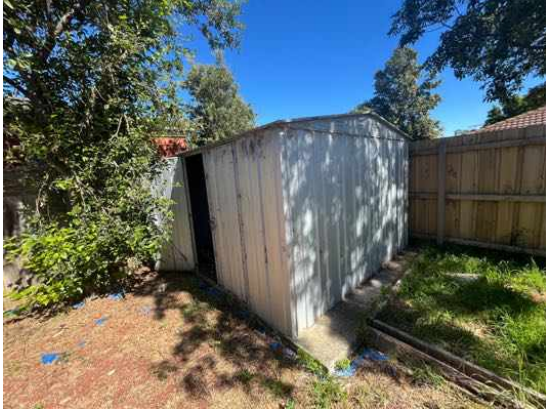
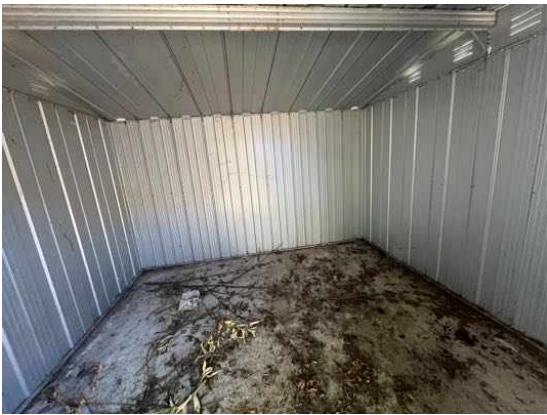
Building: Main Building
Location: All External Areas
Finding: Additional Photos - External Obstructions and Limitations
Information: These photographs are an indication of the external obstructions and limitations which impeded full inspection of the property at the time of inspection. Any obstructions can hide an array of defects and should be removed where practical to allow full inspection to be carried out. A re-inspection is recommended once hidden areas are made accessible.

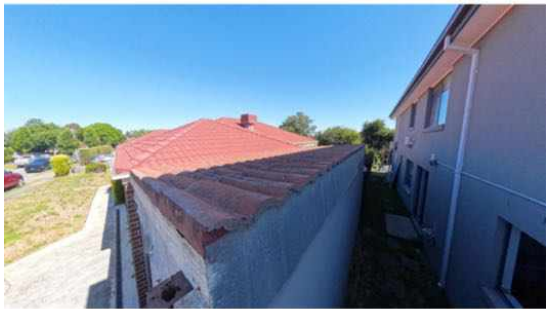
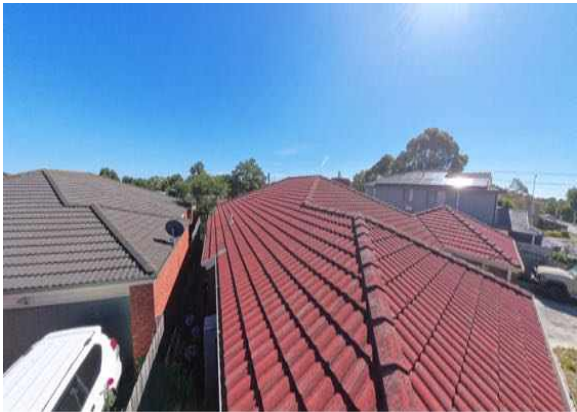
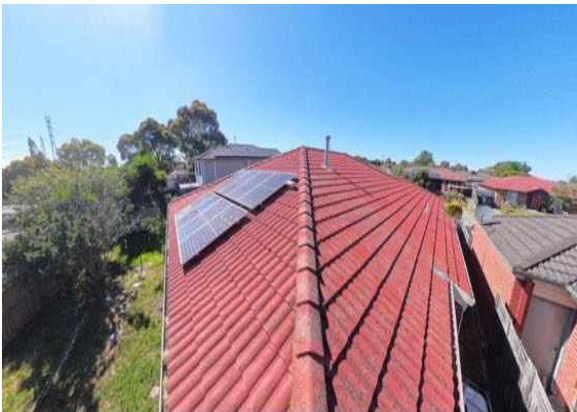
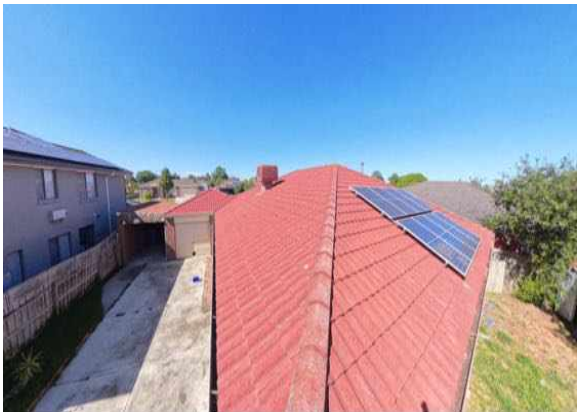
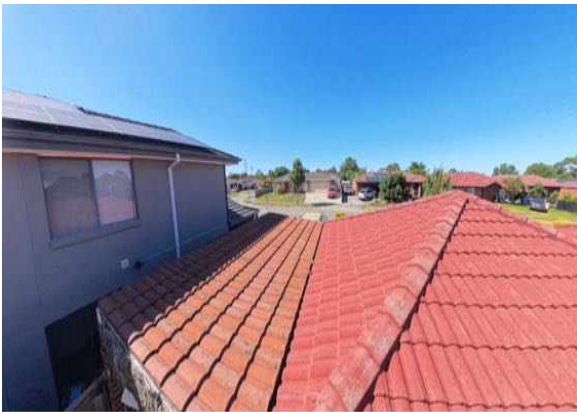
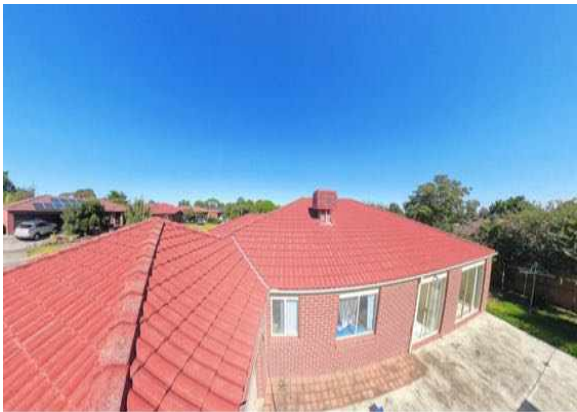
Building: Main Building
Location: Roof Exterior
Finding: Additional Photos - Roof Obstructions and Limitations
Information: These photographs are an indication of the obstructions and limitations which impeded full inspection of the roof at the time of inspection. These obstructions can hide an array of defects and should be inspected by other means. It is recommended that safe roof access is provided and a re-inspection is recommended once the areas are made safely accessible. Contact us for further recommendations.

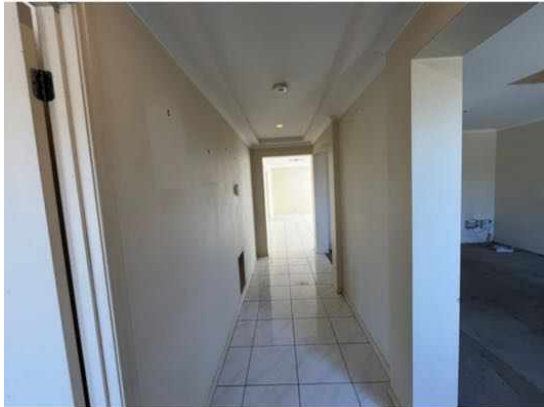
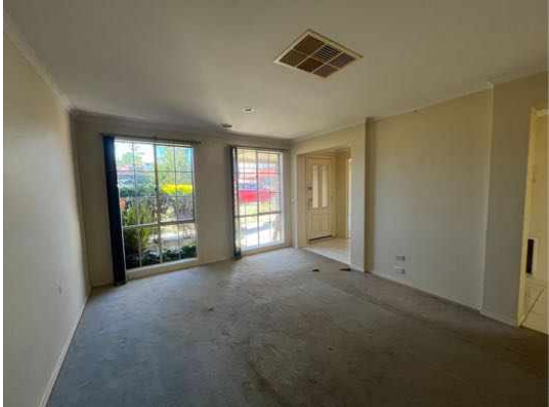
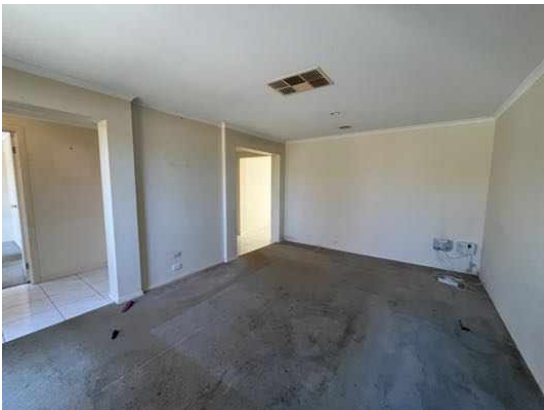
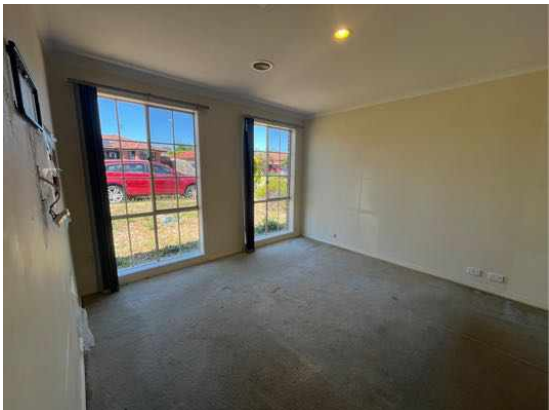
Building: Main Building
Location: All Internal Areas
Finding: Additional Photos - Internal Obstructions and Limitations
Information: These photographs are an indication of the internal obstructions and limitations which impeded full inspection of the property at the time of inspection. Obstructions can hide an array of defects and should be removed where practical to allow full inspection to be carried out. A re-inspection is recommended once any obstructions are removed and areas are made accessible.
