Building and Timber Pest Inspection Report

Inspection Date: Mon, 16 Feb 2026

Property Address: 113 Douglas McInnes Dr, Laidley QLD 4341,
Australia

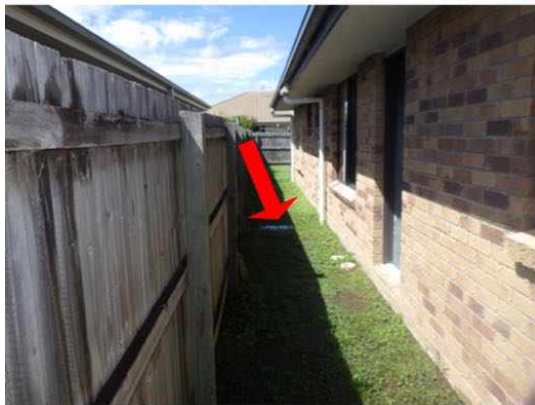
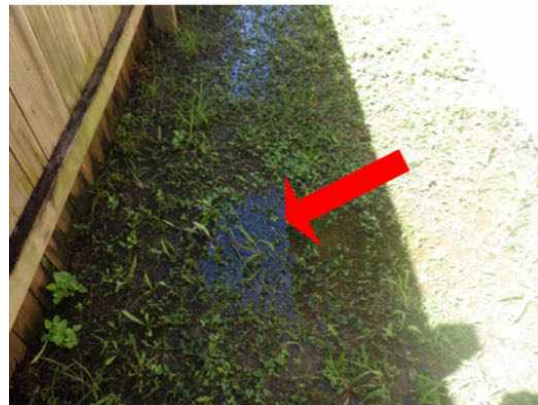
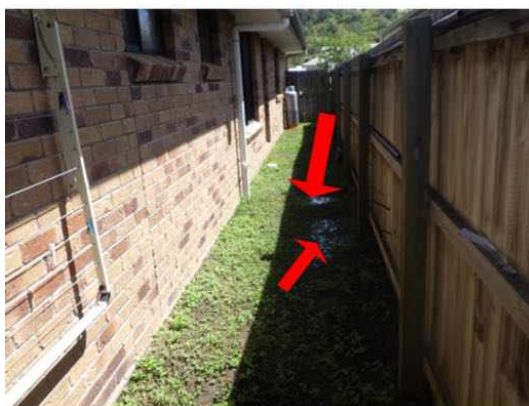
Information: At the time of inspection it was noted there was water ponding to ground areas on the left side of the property. Water pooling near foundations and footings is a serious concern with the potential to adversely impact on the longevity of the dwelling.

If left unattended damp or wet conditions may have many consequences including the development of fungal decay and/or wood rot as well as providing an environment that may be conducive to termite or timber pest attack.

Raising ground levels in areas where ponding occurs may rectify the issue.

Additionally a licensed plumber should be consulted regarding drainage options for the area.

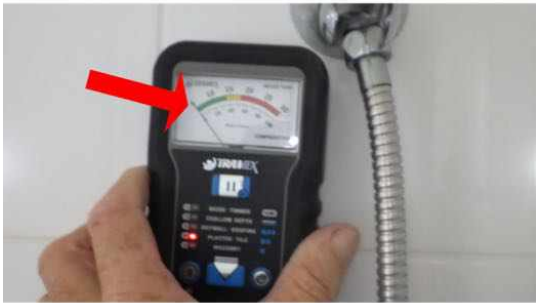
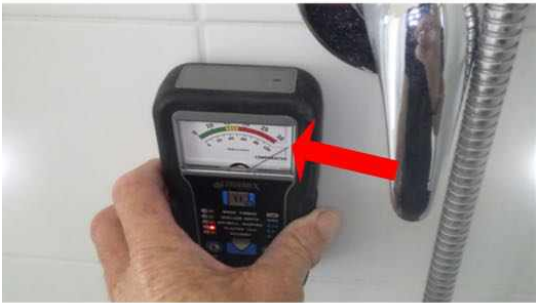
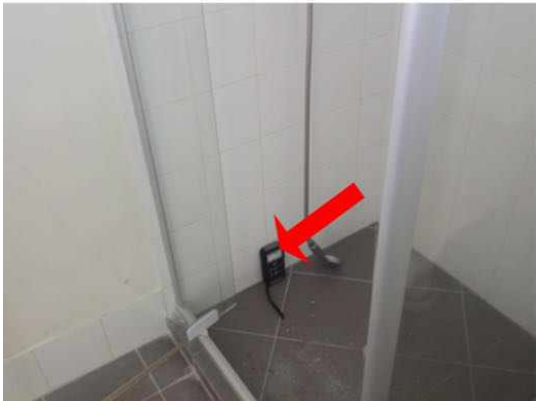
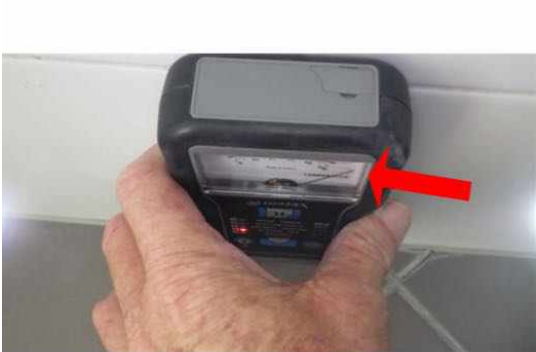
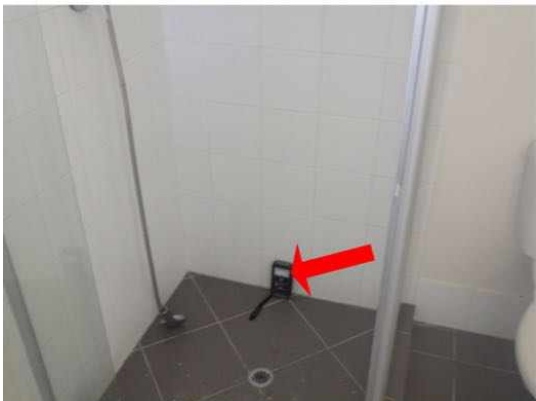
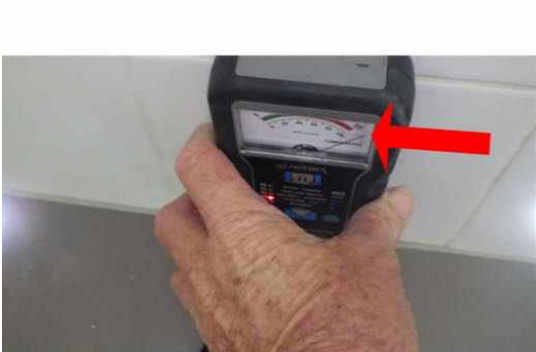
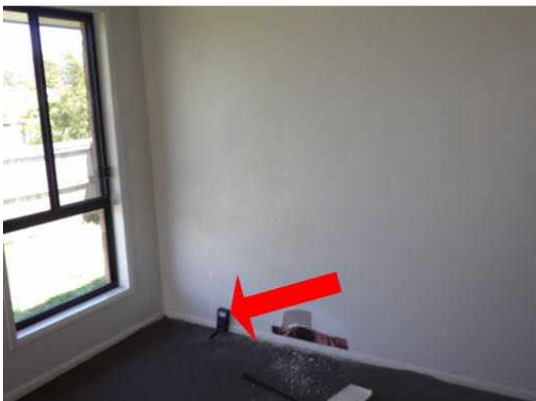
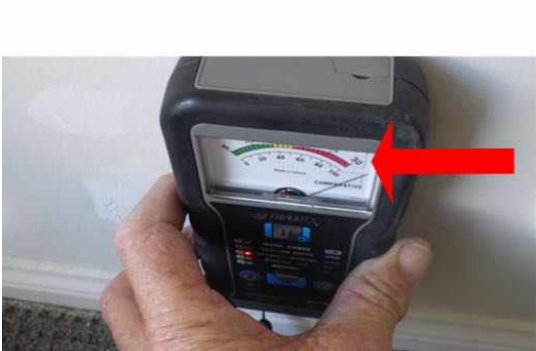
Finding 2.02

Building:	Main Building
Location:	Ensuite > Rear Left
Finding:	Shower - Leaking
Information:	The ensuite shower area registered elevated moisture level readings around the flick mixer tap and to the lower wall areas of the shower cubicle at the time of inspection, with the elevated moisture level readings transferring to the opposite side of the wall which would indicate the shower is leaking.

It is suspected that the leaking has occurred as a result of a possible faulty plumbing fixture or fitting, and/or general ageing of the building elements and deterioration of sealants and grout.

Leaking from the shower area, where left unattended, is likely to lead to water damage to adjoining flooring and walls. Such damage can lead to extensive remedial works being required. Active water leaks may also create an environment that is susceptible to the formation and development of mould and /or timber termite activity.

Appointment of a licensed plumber to undertake a pressure test on the plumbing pipework and/or shower base is advised. Additionally a licensed builder or shower area specialist may be required to repair or replace the shower cubicle area. Such works should be performed as soon as possible to ensure that no further damage occurs.

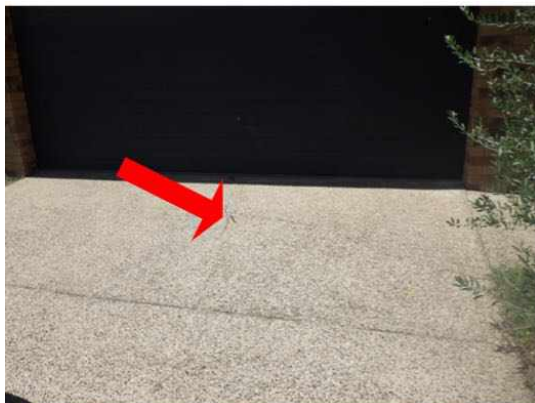
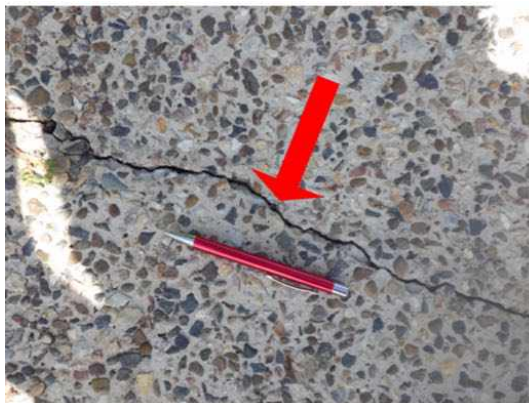
Finding 3.01

Building:	Main Building
Location:	Driveway > Ground Level
Finding:	Cracking in concrete slab - Category 1 - 2
Information:	Cracking coded as Category 1 -2 was identified in the driveway concrete slab. A Category 1 crack is described as a fine but noticeable crack, with the slab at an otherwise reasonable level.

To be considered Category 1, the approximate width of the crack is less than 1.0mm, or a less than 10mm change in offset when a 3m straight edge is placed over the defect.

Category 1 cracks should be monitored for a period of 12 months. At the end of the monitoring period, identified cracks that are rated greater than Category 2 are considered defects, and require rectification.

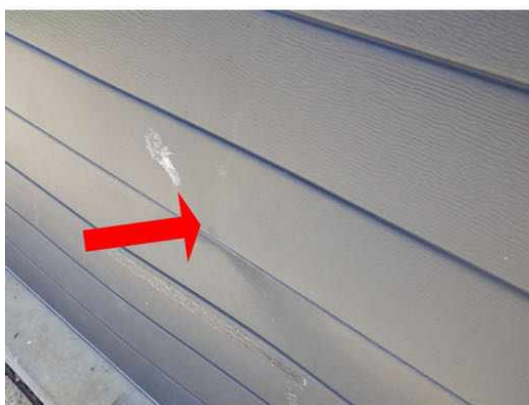
Finding 3.02

Building:	Main Building
Location:	Garage > Front
Finding:	Garage door - dent
Information:	The garage door has a dent likely to have resulted from impact damage be it accidental or deliberate impact at sometime.

Repair and/or replacement of the garage door would improve the condition of the garage but certainly not an urgent item

A qualified sectional door installer or supplier could be engaged to check out the operation and overall condition of the door to determine if repair is an option otherwise replacement may need to be considered.

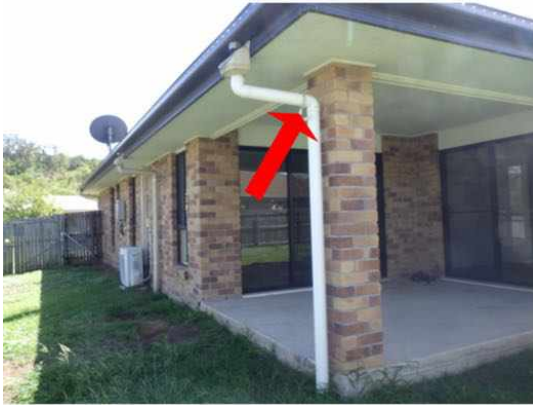
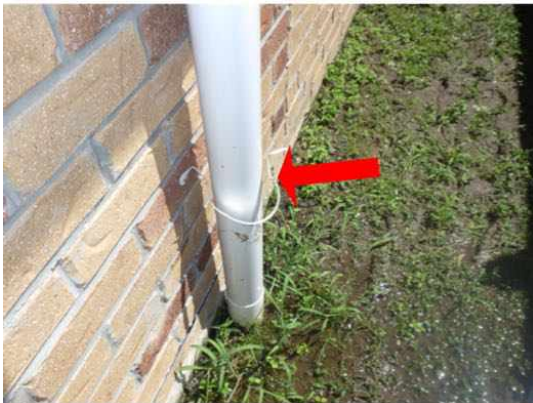
Finding 3.03

Building:	Main Building
Location:	Exterior walls - sides > Existing
Finding:	Downpipes fixing - defective
Information:	It was observed that a number of downpipes to the exterior walls are not securely

fixed.

A general handyman could be engaged to undertake rectification work.

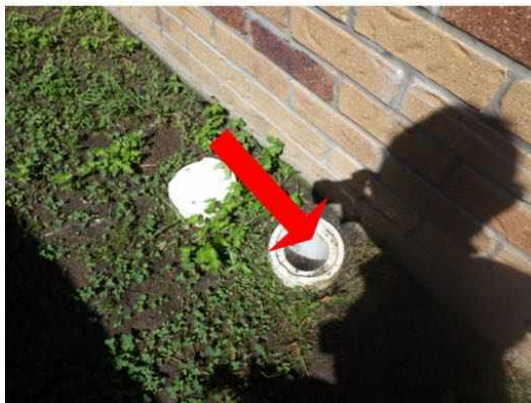
Finding 3.04

Building:	Main Building
Location:	Yard - Side > Ground Level
Finding:	Sewer line - Caps Missing
Information:	At the time of inspection it was noted the sewer line inspection cap on the left side of the property was missing.

It is assumed the cap has been previously removed (reason unknown). The missing sewer line cap creates potential for sewer line blockages.

A licensed plumber or general handyman could be engaged to replace the sewer line cap..

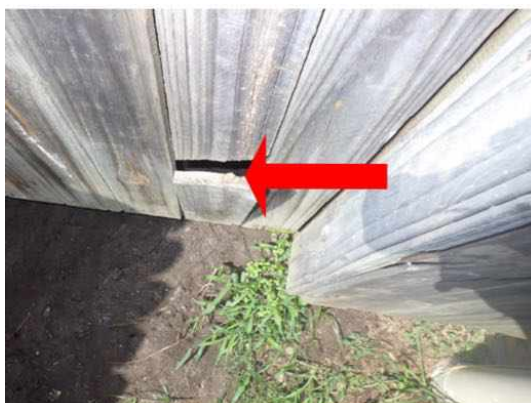
Finding 3.05

Building: Main Building
 Location: Yard > All Areas
 Finding: Fencing - Deteriorated
 Information: It was noted at the time of inspection that sections of the fencing and gates throughout the property have deteriorated. Typically fencing deteriorates due to age and or wear, rot and or rust which is generally expected for a structure of this age, due to prolonged exposure to weather conditions. Sometimes inadequate installation or maintenance can be to blame.

If left unattended, it is likely that further damage will occur. It is suspected that repair of several elements of the fencing may be required however replacement may be a consideration of the client also.

A licensed fencing contractor should be appointed to provide further advice and perform rectification works as necessary.

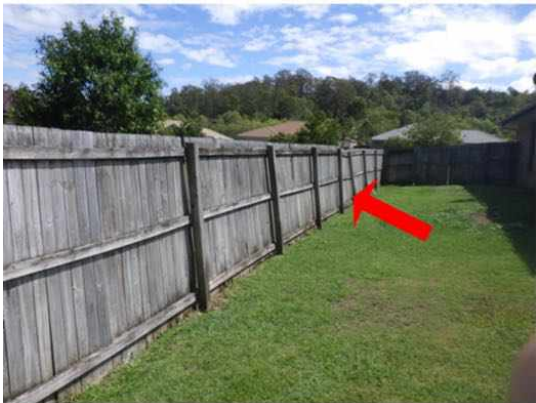
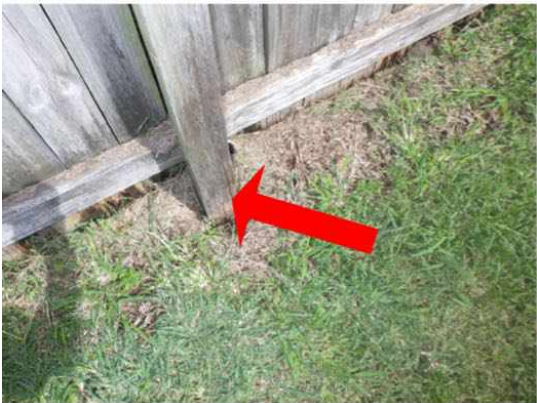
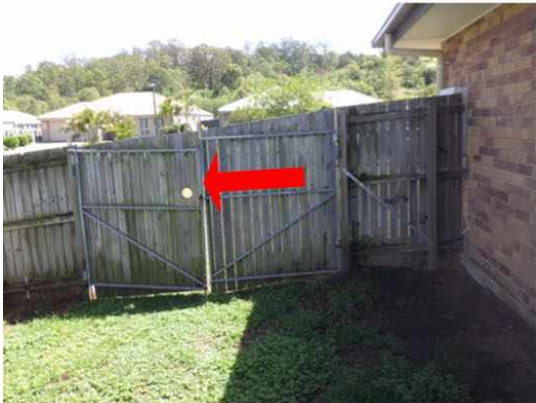
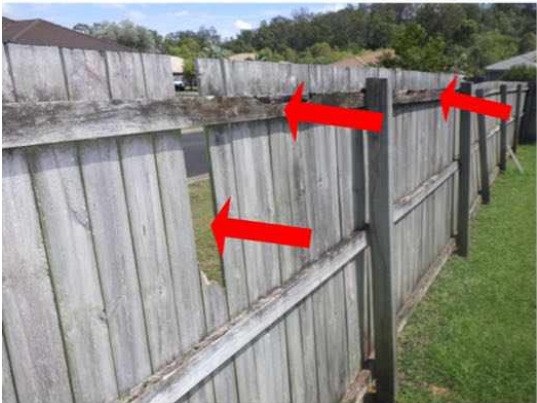
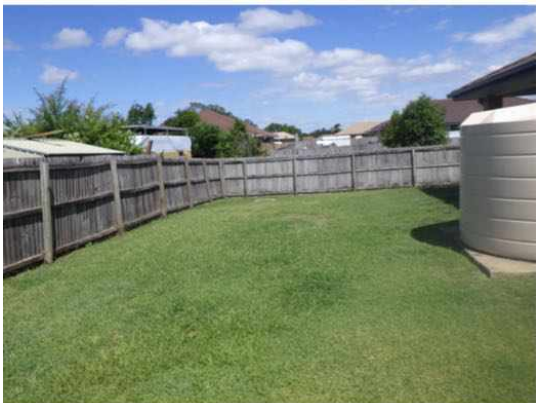
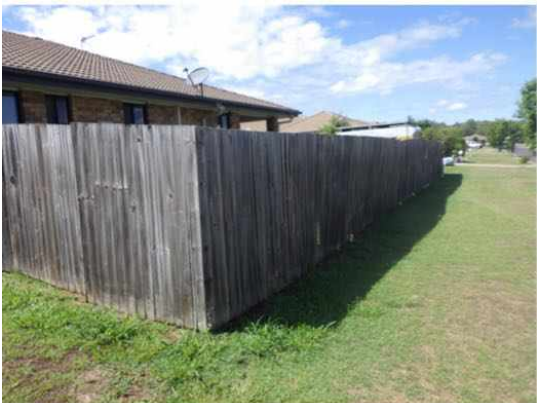
Finding 3.06

Building: Main Building
Location: Yard > Ground Level
Finding: Ground Subsidence
Information:

At the time of inspection it was noted there is ground subsidence to areas around the perimeter of the building. The erosion appears to be the result of water coursing or ponding. The continued ground erosion may in turn compromise the structural integrity of the concrete footings.

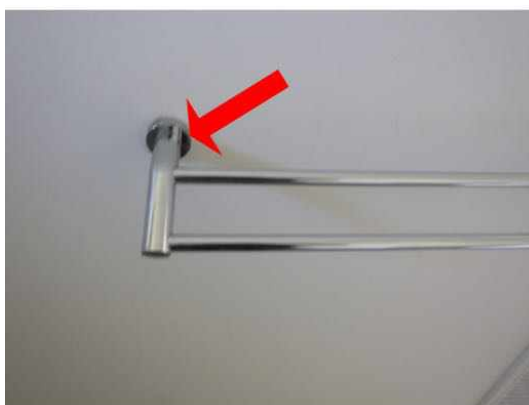
Building:	Main Building
Location:	Ensuite > Front Right
Finding:	Fitting or fixture - Loose towel rail
Information:	The ensuite towel rail is loose and requires adjustment to tighten.

If left unmanaged, the fitting may further deteriorate, causing potential for the development of other minor secondary defects.

A general handyman could be appointed to perform these rectification works at discretion of the client.

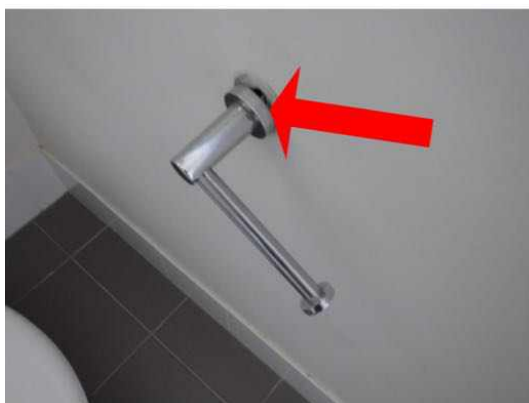
Finding 3.10

Building:	Main Building
Location:	Ensuite > Centre Right
Finding:	Toilet roll holder - Loose
Information:	The ensuite area toilet roll holder was found to be loose at the time of inspection. While not a major operational defect, function can deteriorate if the problem is left unmanaged.

It is advised that the homeowner performs remedial works to re-attach the toilet roll holder to its original fixing. A general handyperson may be required to perform these works.

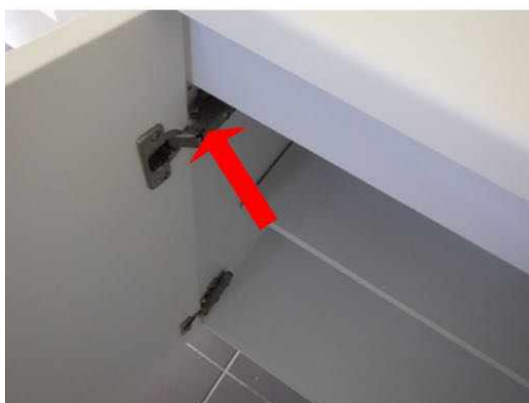
Finding 3.11

Building:	Main Building
Location:	Ensuite > Centre Left
Finding:	Cabinetry - Loose hinges
Information:	At the time of inspection, it was noted that the top hinge to the ensuite vanity cupboard door has deteriorated over time and, as a result, has come loose from it's original fixing. To improve operation of the affected cupboard doors, a general handyman may be appointed to replace the faulty hinges. Such works should be completed at discretion of the client.

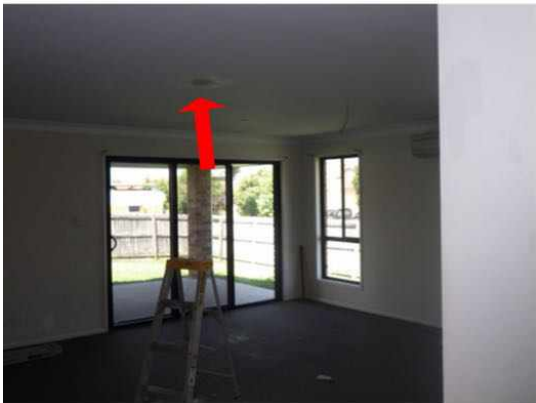
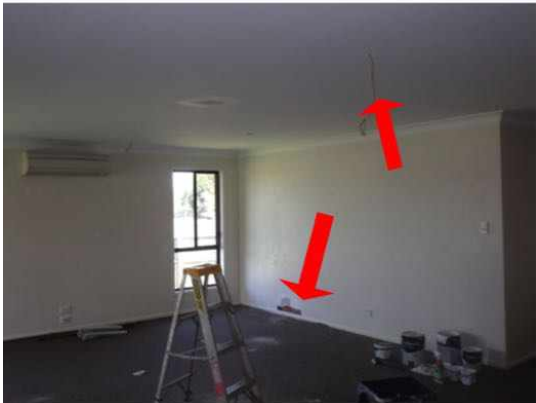
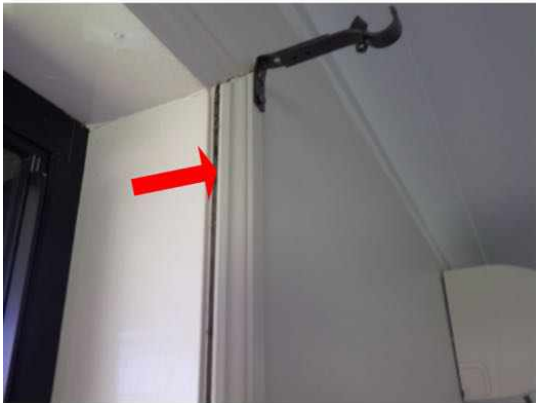
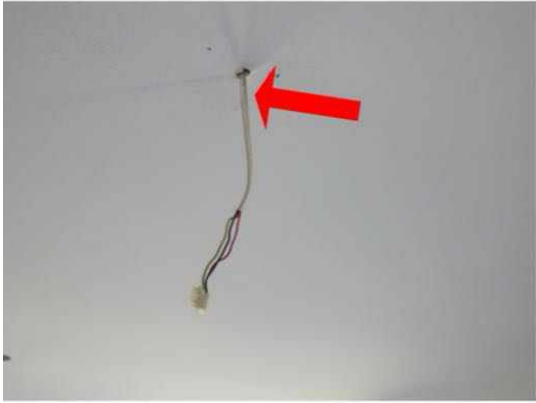
Finding 3.12

Building:	Main Building
Location:	Living/Dining Room > Existing
Finding:	Wear and Tear
Information:	At the time of inspection the living/dining room interior showed signs of existing repair/renovation work, and/or scuffing or cracking to internal wall & ceiling linings and timber trims. The level of damage appears consistent with general deterioration and/or wear and tear.

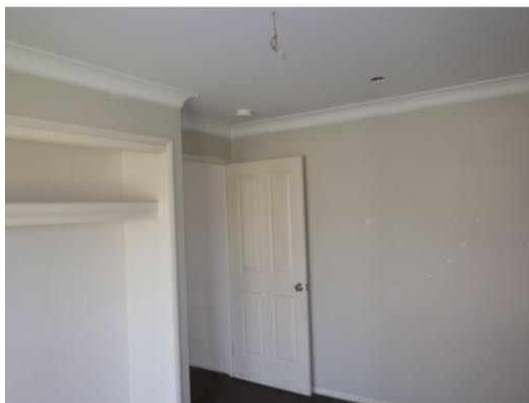
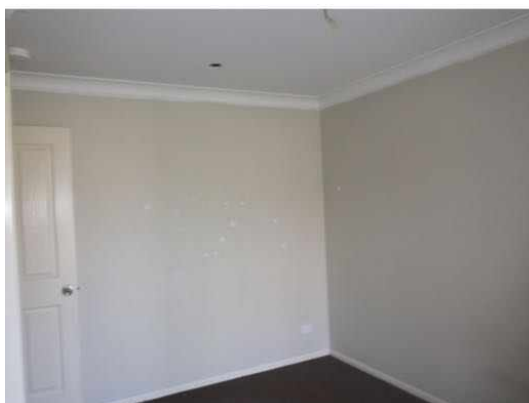
Finding 3.13

Building: Main Building
 Location: Bedroom 2 > Existing
 Finding: Wear and Tear
 Information: At the time of inspection the bedroom 2 interior showed signs of existing repair/renovation work, and/or scuffing to internal wall & ceiling linings and timber trims.

The level of damage appears consistent with general deterioration and/or wear and tear.

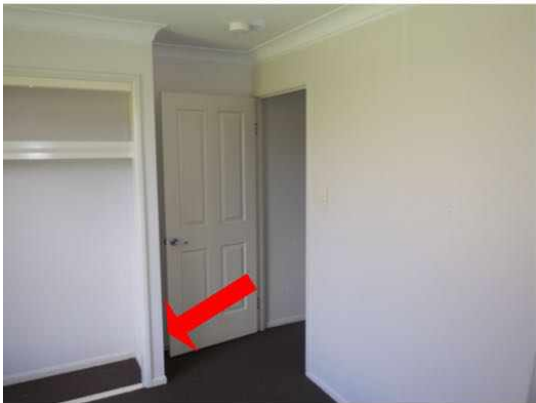
Finding 3.14

Building: Main Building
 Location: Bedroom 3 > Front
 Finding: Door stop - Missing
 Information: The door stop is missing or is inadequate to stop the door handle from damaging the wall.

Re-installation or replacement of the door stop is advised to prevent any subsequent damage to the wall linings or associated structures.

A general handyman may be appointed to perform these works at client discretion.

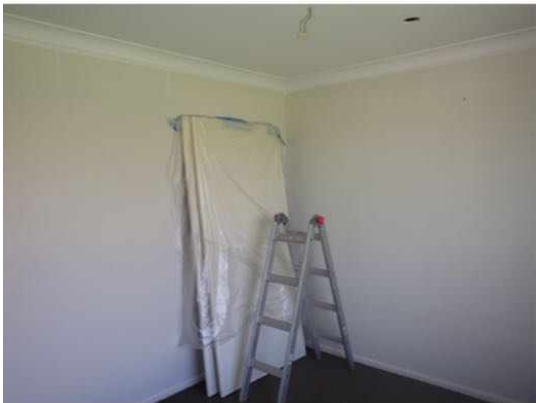
Finding 3.15

Building: Main Building
Location: Bedroom 3 > Existing
Finding: Wear and Tear
Information: At the time of inspection the bedroom 3 interior showed signs of existing repair/renovation work, and/or scuffing to internal wall & ceiling linings and timber trims.

The level of damage appears consistent with general deterioration and/or wear and tear.

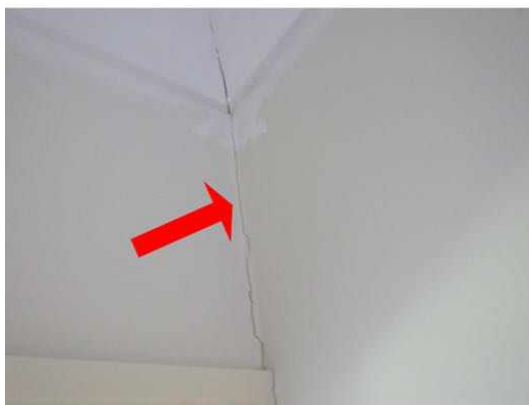
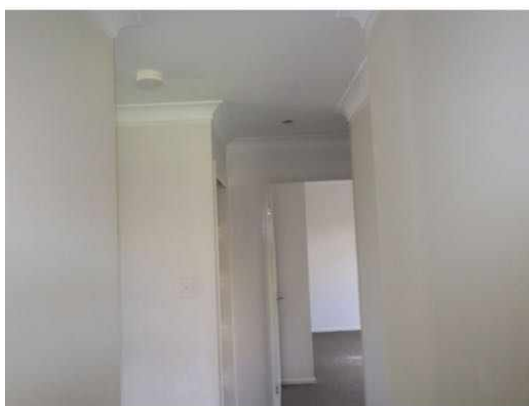
Finding 3.16

Building:	Main Building
Location:	Hallway 2 > Existing
Finding:	Wear and Tear
Information:	At the time of inspection the hallway 2 interior showed signs of existing repair/renovation work, and/or scuffing to internal wall & ceiling linings and timber trims.
	The level of damage appears consistent with general deterioration and/or wear and tear.

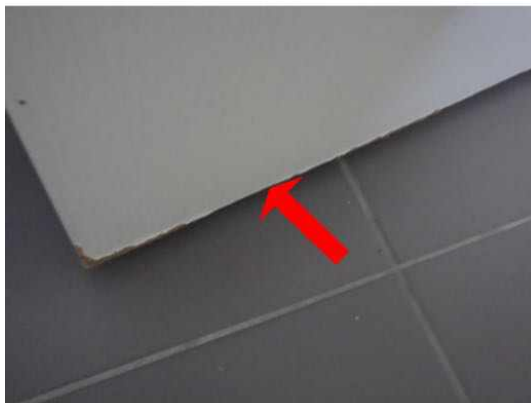
Finding 3.17

Building:	Main Building
Location:	Bathroom > Front
Finding:	Damaged Door
Information:	The door leading into the bathroom has suffered damage to the bottom edge.

Damage occurs generally when the building materials have aged and decayed, but in this instance the damage appears to be the result of exposure to moisture, possibly from the bottom and/or top edges of the door not being sealed with a suitable paint or sealant at the time of construction.

A qualified carpenter or general handyman could be appointed to repair/replace the door at the clients discretion.

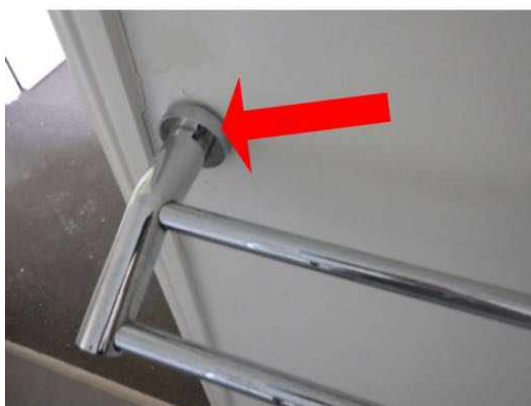
Building: Main Building
 Location: Bathroom > Centre Left
 Finding: Fitting or fixture - Loose towel rail
 Information: The bathroom towel rail is loose and requires adjustment to tighten.

If left unmanaged, the fitting may further deteriorate, causing potential for the development of other minor secondary defects.

A general handyman could be appointed to perform these rectification works at discretion of the client.

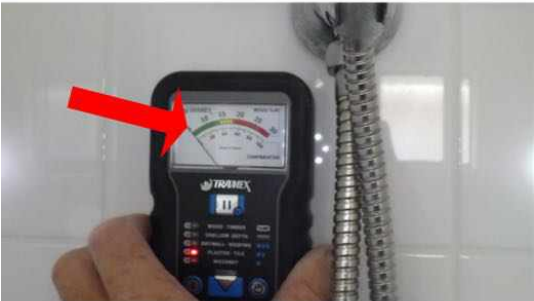
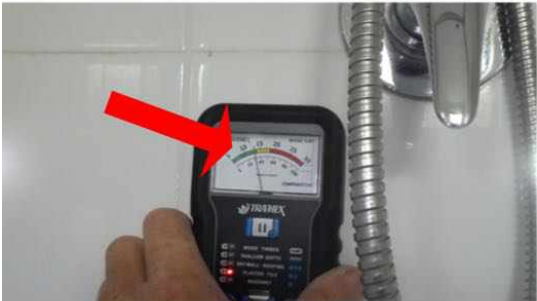
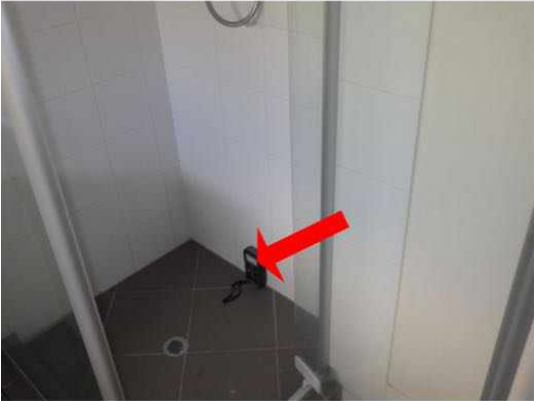
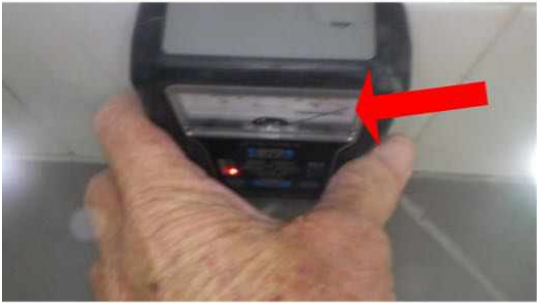
Finding 3.19

Building: Main Building
 Location: Bathroom > Rear Right
 Finding: Shower - Monitor
 Information: Elevated moisture level readings were recorded to the lower 200mm of wall to the bathroom shower alcove at the time of inspection. There was no elevated moisture

level readings around the tap area, and no elevated readings transferring to the other side of the wall in the areas where moisture readings were able to be obtained. Both sealant and grout appear in good condition at present.

This defect is quite common, and is suspected to have been caused by moisture permeating or leaching through the grouting and perhaps gaps in the sealant.

Monitoring the area is advised and if any visual signs of excessive moisture appear (peeling paint, mould) then consultation with a qualified plumber or bathroom specialist would be advised to identify the cause of damp and to perform remedial works as required.

Always ensure that sealant and grout is in good condition to prevent any moisture issues occurring in the future.

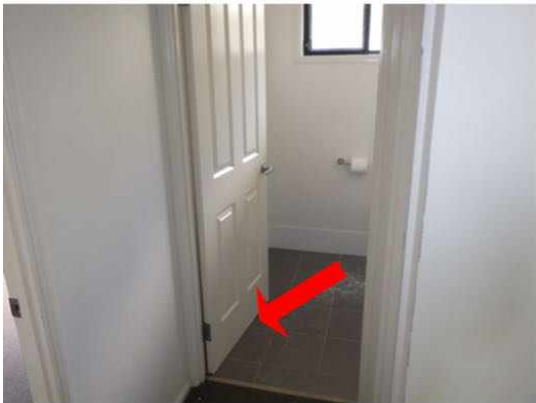
Finding 3.20

Building:	Main Building
Location:	Toilet (WC) > Front
Finding:	Damaged Door
Information:	The door leading into the WC area has suffered damage to the bottom edge.

Damage occurs generally when the building materials have aged and decayed, but in this instance the damage appears to be the result of exposure to moisture, possibly from the bottom and/or top edges of the door not being sealed with a suitable paint or sealant at the time of construction.

A qualified carpenter or general handyman could be appointed to repair/replace the

door at the clients discretion.

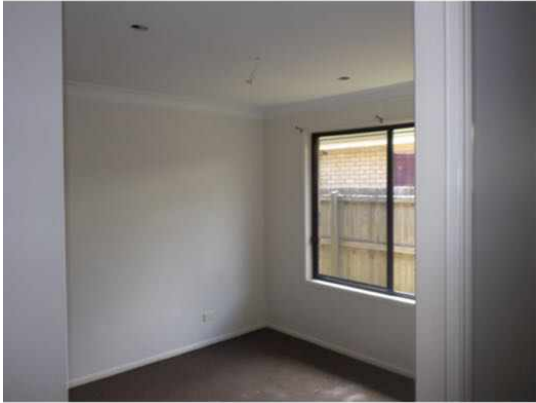
Finding 3.21

Building: Main Building
Location: Bedroom 4 > Existing
Finding: Wear and Tear
Information: At the time of inspection the bedroom 4 interior showed signs of existing repair/renovation work, and/or scuffing to internal wall & ceiling linings and timber trims.

The level of damage appears consistent with general deterioration and/or wear and tear.

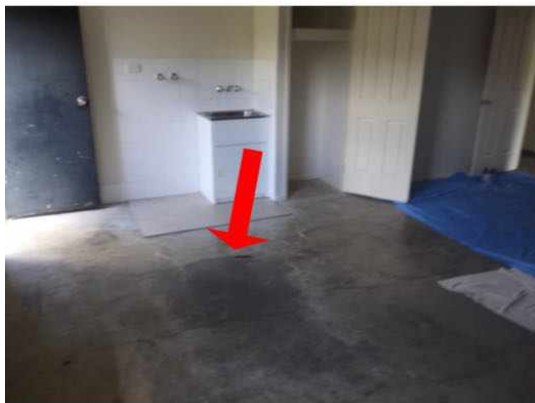
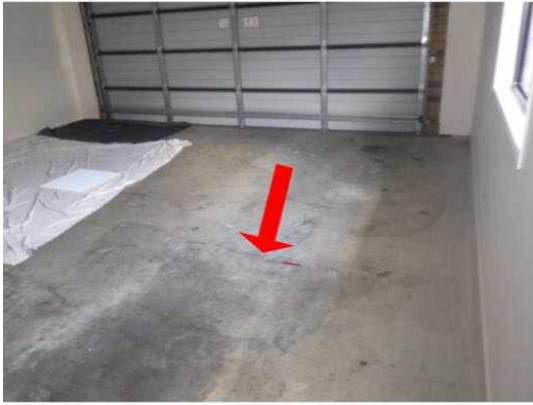
Finding 3.22

Building: Main Building
 Location: Garage > Ground Level
 Finding: Cracking in concrete slab - Category 1
 Information: Cracking coded as Category 1 was identified in the garage floor concrete slab (as per example photos). A Category 1 crack is described as a fine but noticeable crack, with the slab at an otherwise reasonable level.

To be considered Category 1, the approximate width of the crack is less than 1.0mm, or a less than 10mm change in offset when a 3m straight edge is placed over the defect.

Category 1 cracks should be monitored for a period of 12 months. At the end of the monitoring period, identified cracks that are rated greater than Category 2 are considered defects, and require rectification.

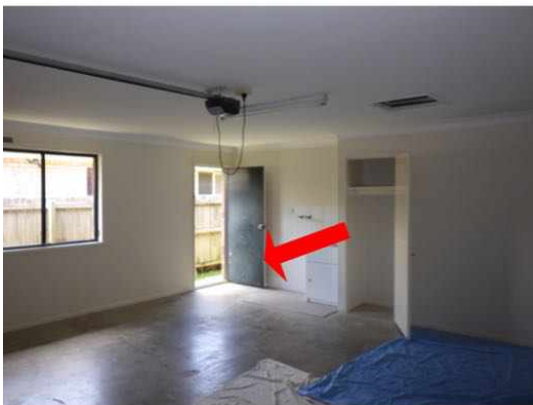
Finding 3.23

Building: Main Building
Location: Garage > Rear Left
Finding: Damaged Door
Information: The garage area exterior door has suffered damage to the front and back panels or surface.

Damage occurs generally when the building materials have aged and decayed, but appears to be indicative of exposure to moisture or impact damage.

A qualified carpenter or general handyman could be appointed to repair/replace the door at the clients discretion.

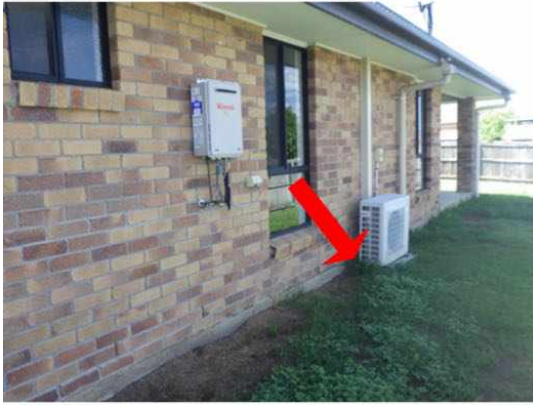
Finding 6.01

Building:	Main Building
Location:	Exterior walls - right side > Centre Right
Finding:	Overflow - Not plumbed for drainage
Information:	The air conditioning unit overflow is not plumbed or connected to suitable drainage, which can result in the surrounding area becoming excessively damp. These damp conditions can lead to secondary defects such as rot, rust or corrosion of associated building elements, the formation of fungal decay, or even the creation of potential slip hazards. When coupled with poor site drainage, pooling of water may also attract termite activity to this area. It is highly recommended that a qualified plumber be appointed to install adequate drainage to the overflow. These works will ensure that the area remains dry and free of any secondary defects.

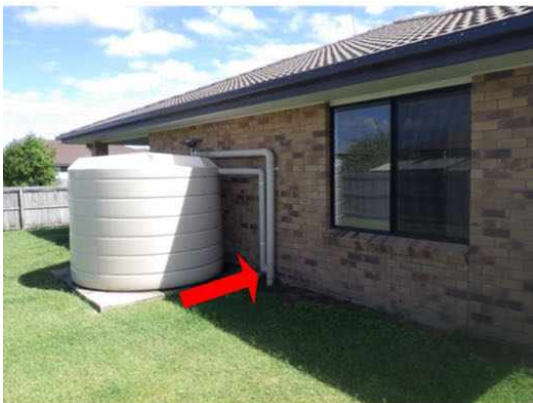
Finding 6.02

Building:	Main Building
Location:	Exterior walls - rear > Centre,Rear
Finding:	Stormwater pipe
Information:	The overflow down pipe to the water tank at the rear of the building finishes short of the stormwater drainage on the site. This disconnection negatively impacts the functional capacity of the down pipe.

Where roof plumbing doesn't drain adequately, the area at the base perimeter can become excessively damp, potentially creating an environment that is susceptible to rust and corrosion of surrounding building elements, as well as attracting termites and other pests.

It is recommended that a plumber or handyman be appointed to further inspect and to extend the down pipe as necessary.

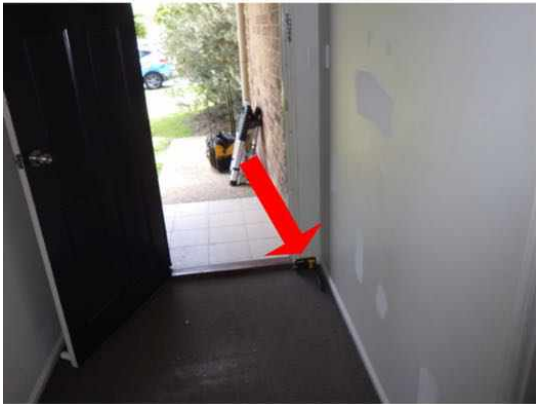
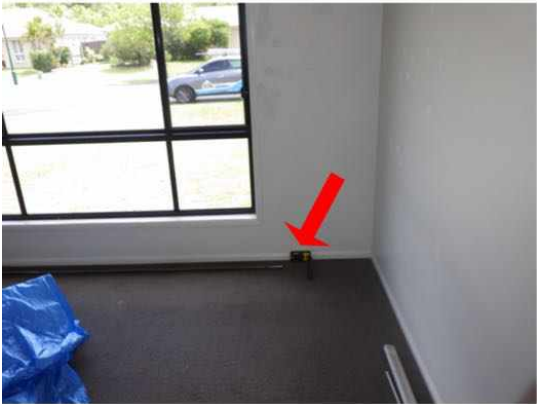
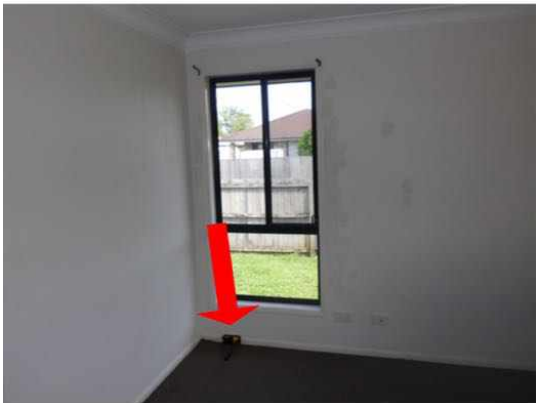
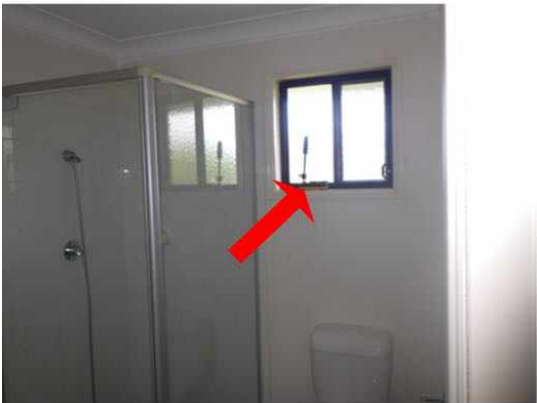
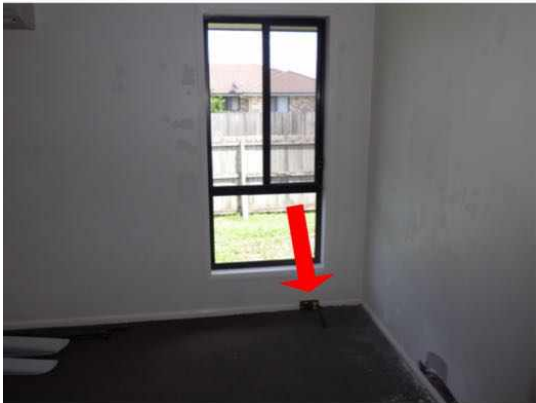
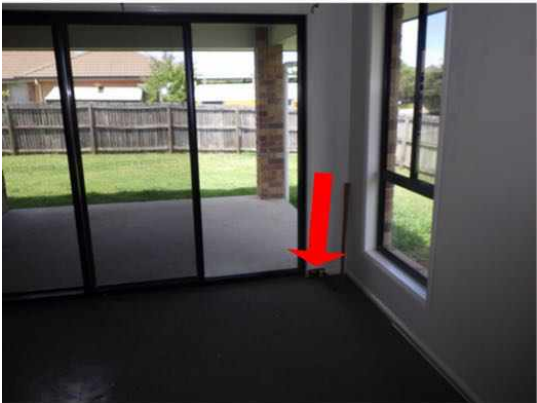
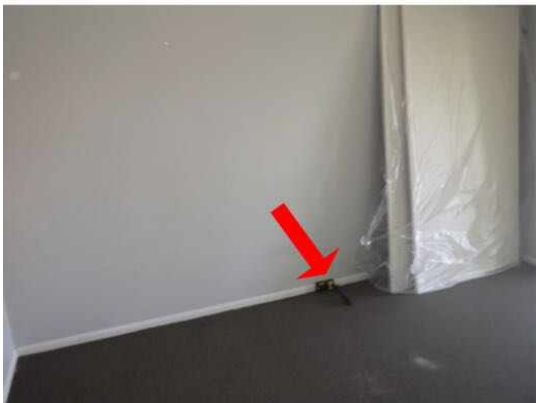
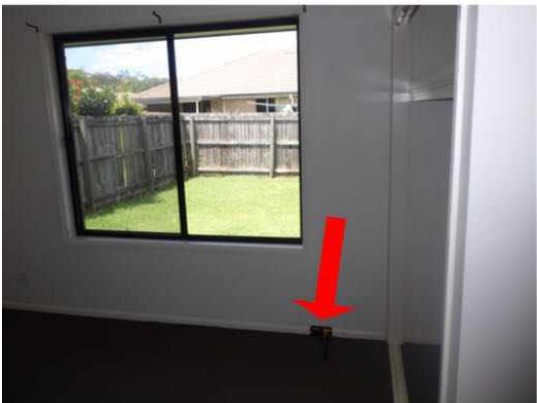
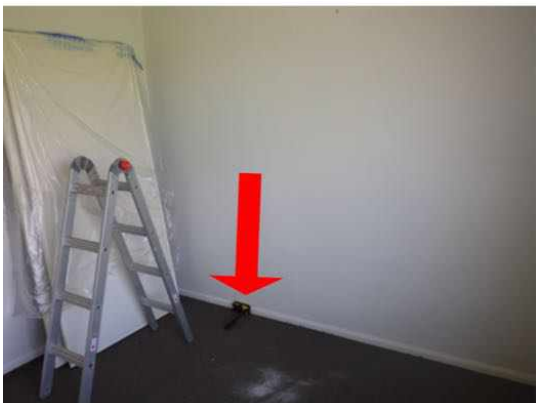
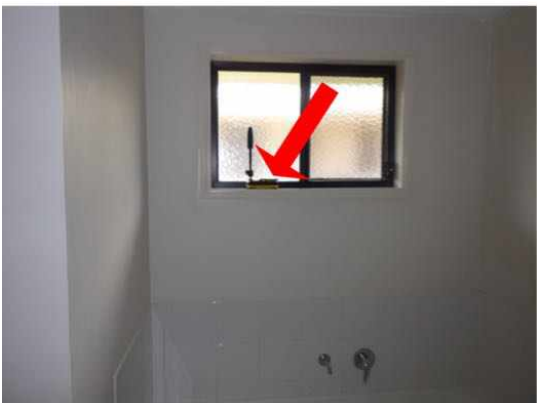
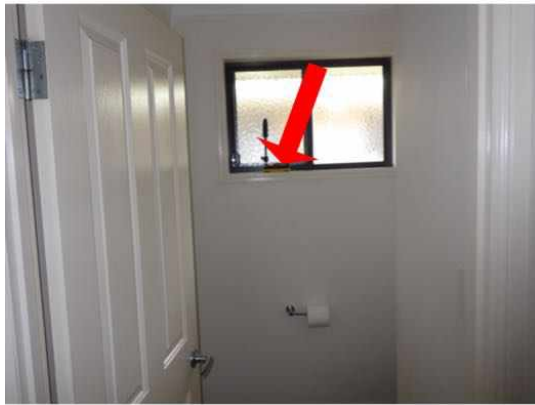
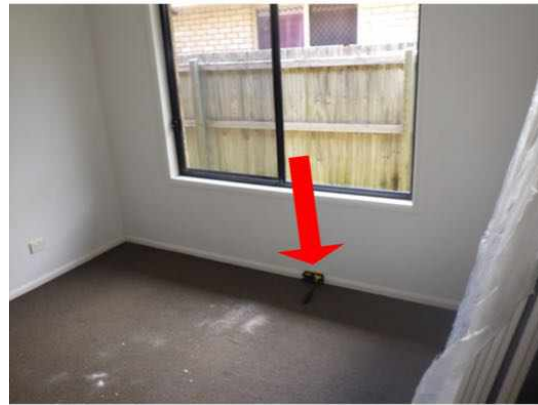
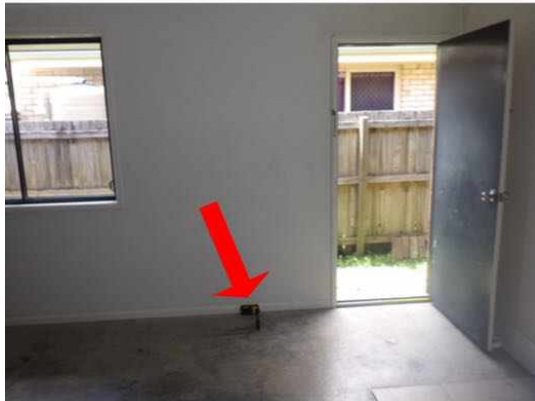
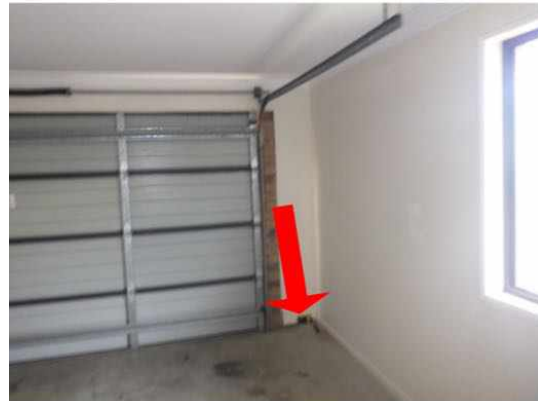
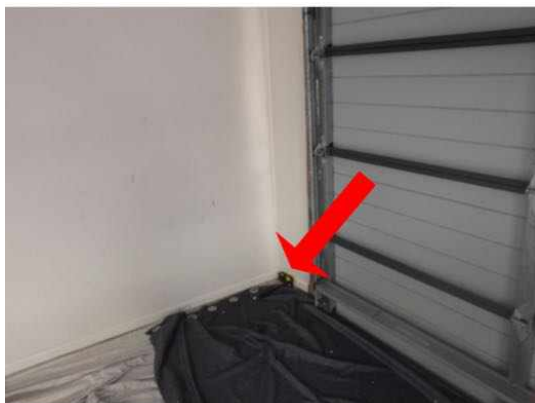
Building: Main Building
Location: Internal Areas > Existing
Finding: Termitracker
Information: The termitracker itracker was positioned randomly to internal wall, timber skirting and window frame areas checking for signs of termite activity.

No activity was recorded at the time of inspection.

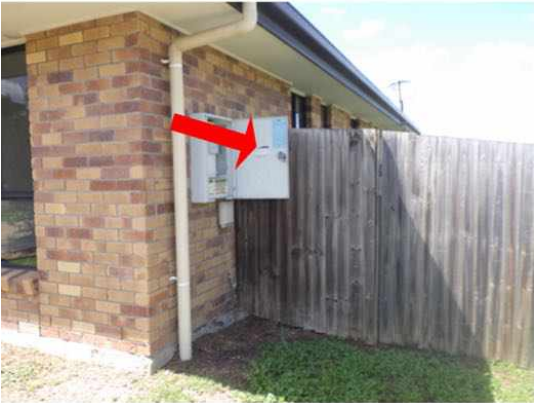
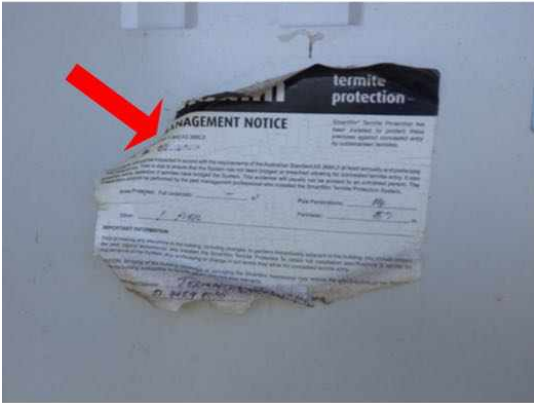
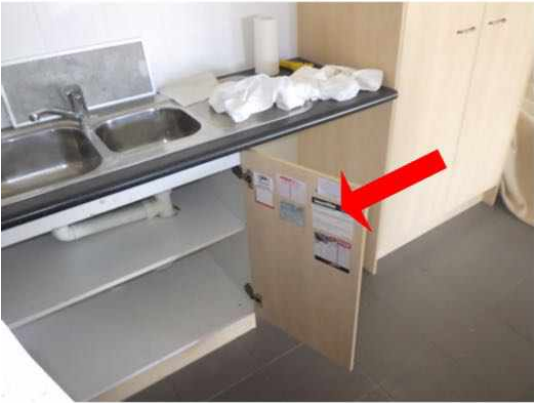
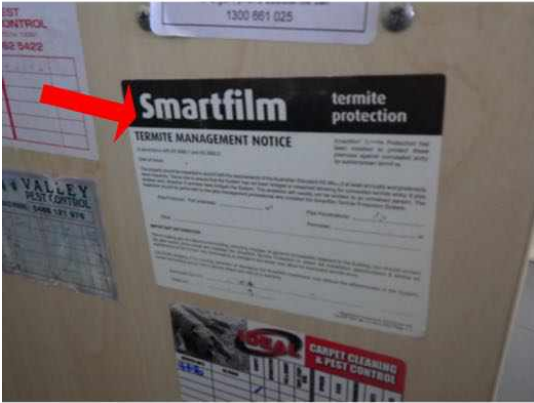
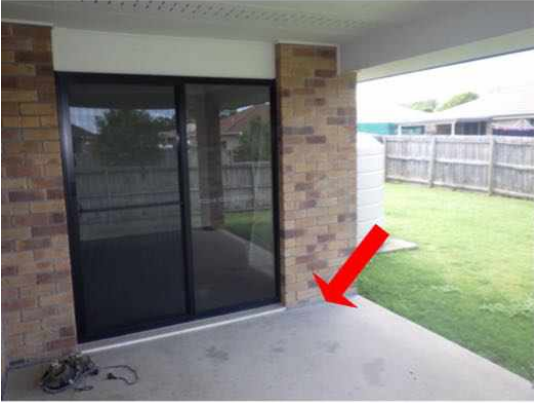
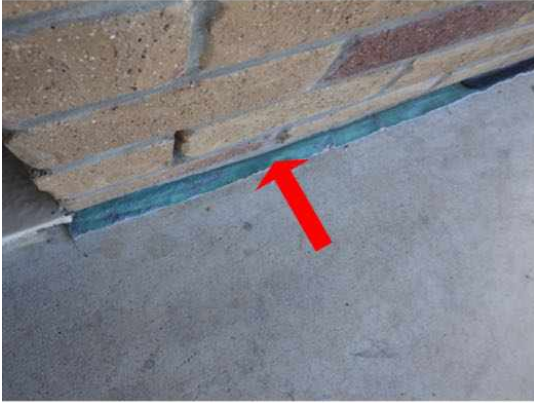
In this instance evidence of a previously installed physical barrier was observed, along with a durable notice inside the electrical meter box and kitchen area under sink cabinetry. This system requires regular annual inspections.

No evidence of regular or annual inspections was found.

Where a Termite Management System has been identified you should refer to the type of barrier date of installation warranty conditions and any documentation provided by the termite barrier installation company or past owner.
