# Building and Timber Pest Inspection Report

Inspection Date: Thu, 8 Jan 2026

Property Address: 29 Scott St, Euroa VIC 3666, Australia

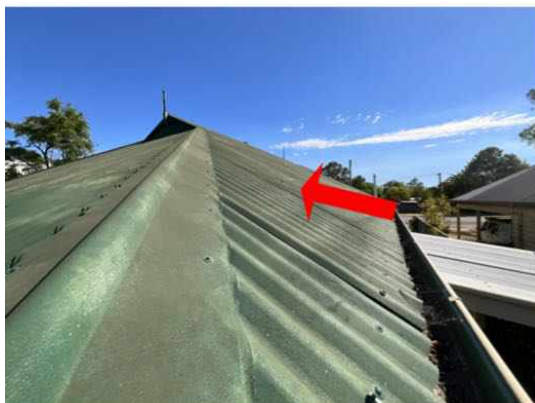
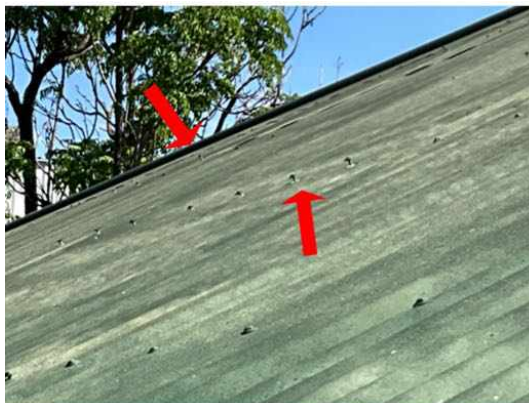
Building: Building 1  
Location: Roof Exterior  
Finding: Roof sheets - Loose  
Information: Upon inspection of the exterior roof covering, it was noted that numerous roof sheets have become loose from their original fixings. It is suspected that this defect has developed as a result of a lack of adequate maintenance, but may also have been caused by inappropriate fixings being used in the construction process.

Loose roof sheeting detracts from the weather tightness of the roof covering, making the internal roofing structure susceptible to water penetration and subsequent damage. If left unaddressed, it is likely that secondary damage to associated building elements will develop, potentially necessitating remedial works to these structures.

A roofing restoration contractor should be appointed to advise on rectification options and on the cost of repair. It is advised that remedial works be performed as soon as possible to prevent any further damage.

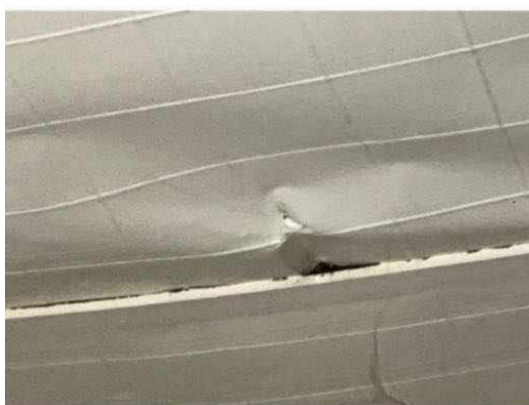
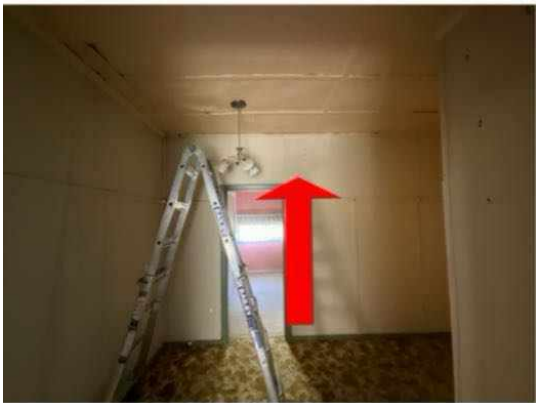
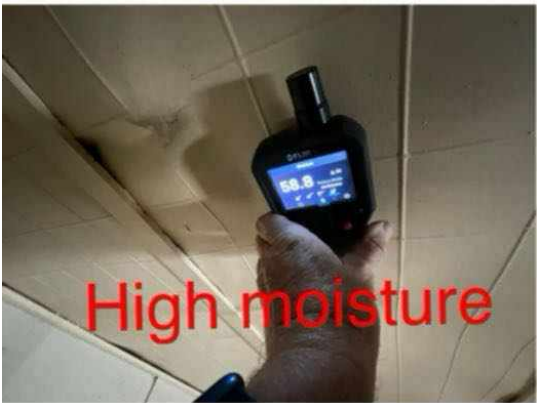
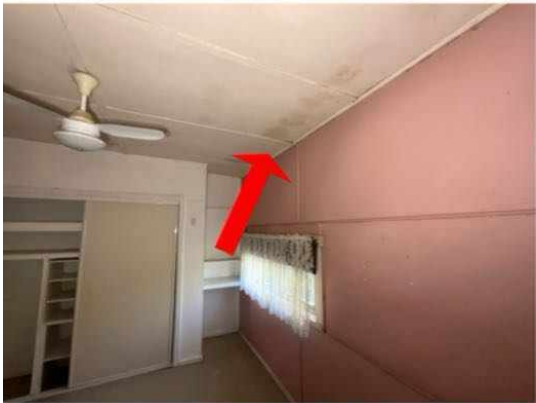
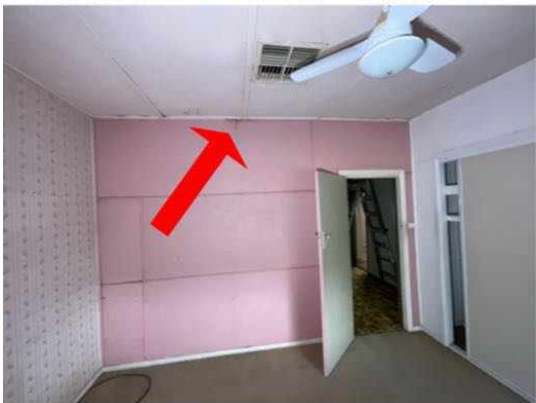
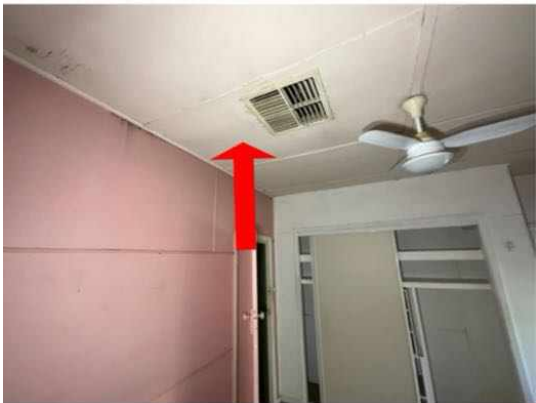
### Finding 3.02

Building:	Building 1
Location:	Hall, bed 2, dining, laundry area,
Finding:	Ceiling - Water damaged
Information:	Water damage to the ceiling lining is generally an indication of excessive moisture being present in the roof void, usually via a leak to the roof covering.

Where water damage is evident to the ceiling, the primary requirement is to identify and rectify the source of the leak. A roofing plumber should be appointed as soon as possible to identify the leak and perform rectification works as necessary, ensuring the water damage is restricted.

Once the leak is repaired, consultation with relevant tradespeople, including plasterers and painters, is advised. Rectification works may include replacement of ceiling lining or minor repainting, depending on the extent of the damage.

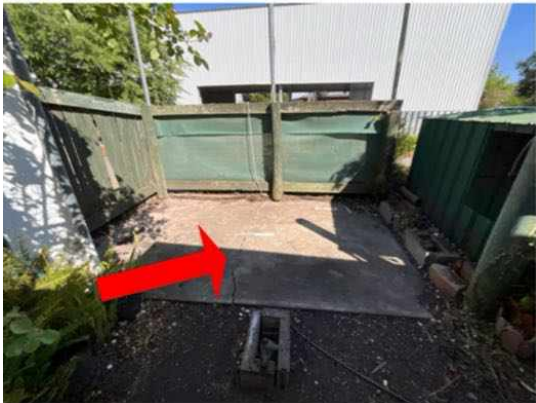
Building:	Building 1
Location:	Yard - Front, side
Finding:	Cracking - External Concrete Paving Damage Category 4 - Gaps in Slab (4mm - 10mm +)
Information:	Gaps in the slab were identified in external concrete paving. Gaps in the slab are significant and are likely to lead to the development of safety hazards and secondary defects if left unmanaged, such as the creation of a trip hazard.

Cracking to this degree may also be due to poor original installation of the concrete. Factors such as poor compaction of the sub surface and/or inadequate reinforcing of the slab may create cracking and other secondary defects. Gaps in the concrete paving may also have a more significant structural cause, such as subsidence of soils.

Where gaps in the concrete paving are adjacent to structural elements of the building, the advice of a Structural Engineer is advisable before undertaking repairs. Significant repair and likely replacement of the concrete paving is probable.

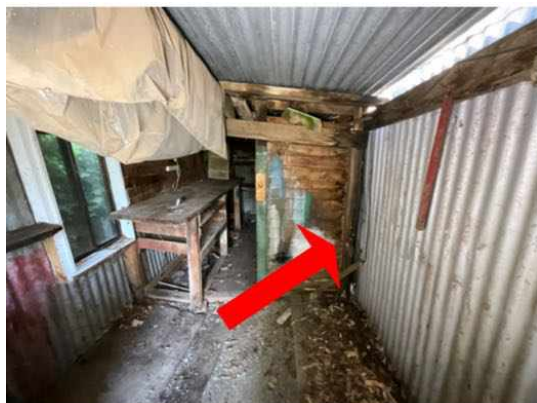
Building: Building 1  
Location: Shed  
Finding: Evidence of termite damage - minor

It is advised that the area be visually inspected frequently to ensure that the condition of affected building materials does not worsen. At the time of inspection, damage is not structural and is only considered to be superficial.

A building contractor may be appointed to provide a further invasive inspection if further damage is evident.

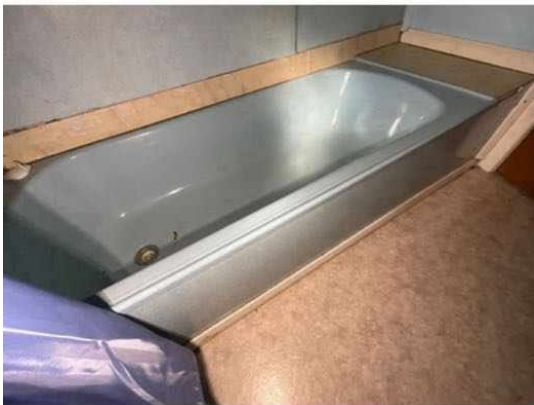
Finding: Additional Photos - Obstructions and Limitations

Information: These photographs are an indication of the obstructions and limitations which impeded full inspection of the property at the time of inspection. These obstructions can hide an array of defects and should be removed to allow full inspection to be carried out. A re-inspection is recommended once the areas are made accessible.
