Building and Timber Pest Inspection Report

Inspection Date: Wed, 4 Mar 2026

Property Address: 45 Francis St, Rochester VIC 3561, Australia

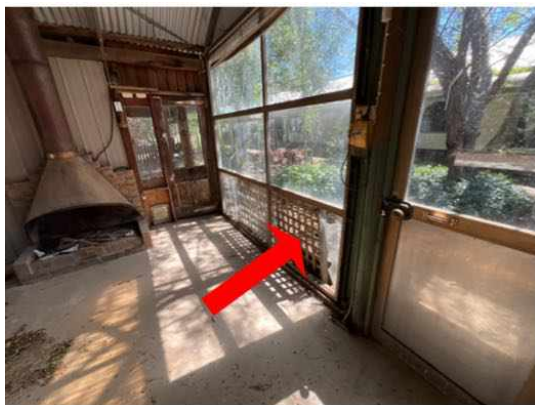
Building: Building 1
Location: Carport
Finding: Window - Cracked
Information: Cracks were identified in the window in this area. Cracking in windows is generally the result of impact damage, and is likely to develop further when left unmanaged.

The likelihood of this windowpane further cracking and shattering is increased exponentially, providing a safety hazard in the area. The cracked window also impairs the weather tightness of the building, creating potential for minor water leaks.

A qualified glazier is required to repair the window as soon as possible. Depending on the extent of the cracking, replacement of the window may be required. Please be advised that any persons coming into contact with the cracked window should do so with due caution to avoid any personal injury that may ensue.

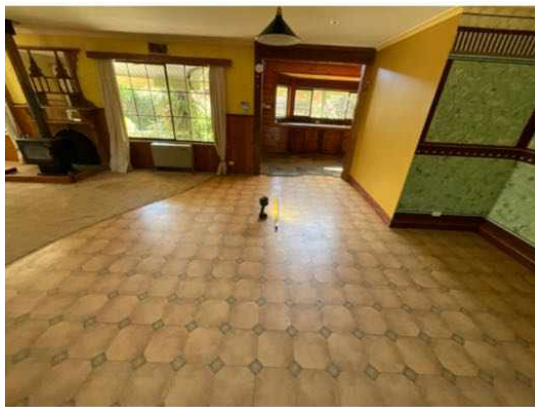
Information: The internal flooring in this area is out of level and uneven. Uneven flooring is likely to indicate minor defects such as expected movement of the foundations of the property, but may also indicate subsidence of the associated subfloor stumps.

It is advised that the flooring be closely monitored to identify any further movement. Where flooring remains relatively unchanged for an extended period of time (i.e. several months), it is likely that this defect has been caused by expected movement of the foundations of the property.

However, where flooring is uneven further, potentially invasive inspection of the subfloor structures and stumps in this area is required. In this case, works to repair are likely to be required, and would be carried out by a registered builder specialising in re-stumping.

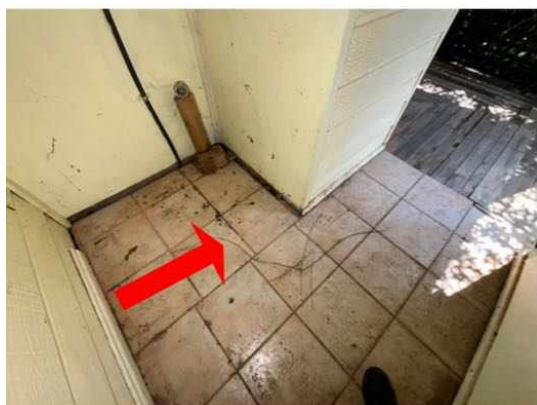
Building:	Building 1
Location:	Verandah
Finding:	Cracked floor tiles
Information:	Cracking in the floor tiles was evident in this area at the time of inspection. It is suspected that this cracking has occurred as a result of minor settlement or impact damage.

Cracked tiles throughout the household detract from the overall appearance of the affected areas however it is unlikely to create or lead to any secondary defects.

While not considered a matter of urgency, replacement of cracked floor tiles is

recommended at the clients discretion. A tiling contractor may be appointed to perform these works. Where cracks become more numerous, contact a licensed building inspector for further investigation.

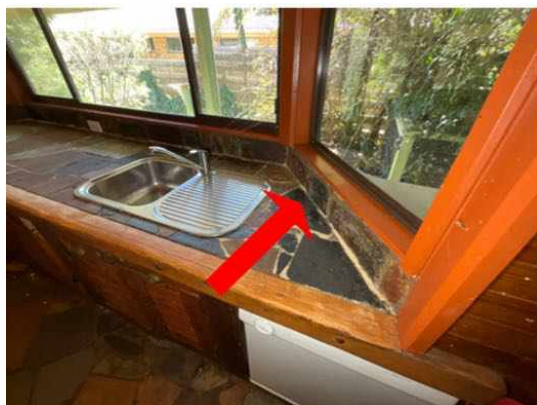
Information: Drummy tiled areas were identified at the time of inspection. The term 'drummy' refers to tiles that have become detached from their fixing, despite otherwise being in relatively good condition. Such defects are generally caused by physical or moisture damage to the area. Drummy tiled areas may also be a direct result of poor workmanship during the construction process.

Tiled areas may swell and shrink with changes in air humidity if the area has sustained moisture damage. Any exposure to moisture is capable of causing tiled areas to become drummy and/or cracked over a prolonged period of time. Drummy tiled areas generally require removal and replacement of affected tiles, with adequate sealant and grouting.

Specialist trades are available for these types of services. A registered builder may be required to undertake works if damage is extensive or if secondary building defects have resulted. Otherwise, it is advised that a tiling contractor be appointed to perform works as necessary. Immediate action is recommended to ensure that no further damage is sustained in the affected area.

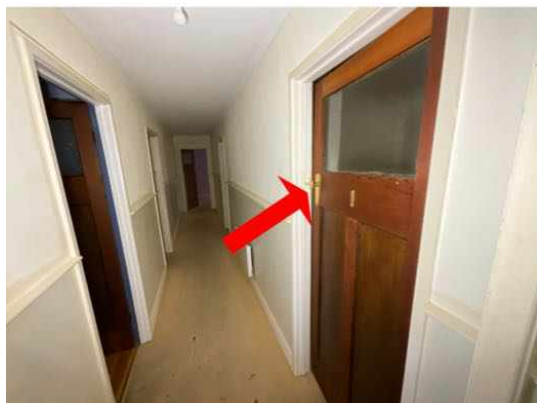
Finding 3.06

Building: Building 1
 Location: Bedroom 1, 2
 Finding: Door - Striker plate misaligned
 Information: The striker plate to this door appears to have become misaligned and has consequently resulted in the door's operation being compromised.

This is a common defect and is expected in a property of this age, whether being due to substandard installation or general deterioration of the door hardware.

Readjustment of the striker plate is recommended at client discretion. Works such as these can be completed by a general handyman or qualified carpenter.

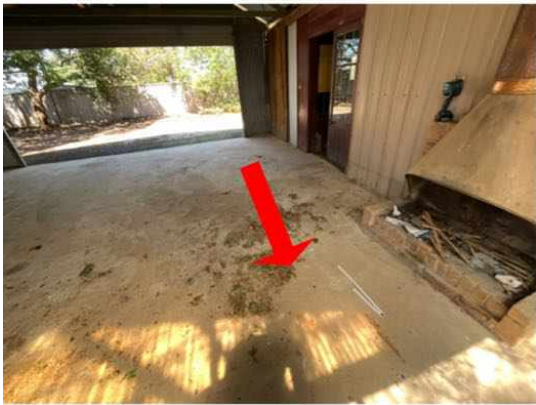
Finding 3.07

Building: Building 1
 Location: Carport
 Finding: Crack in concrete slab - Category 1
 Information: A crack coded as Category 1 was identified in the slab. A Category 1 crack is described as a fine but noticeable crack, with the slab at an otherwise reasonable level.

To be considered Category 1, the approximate width of the crack is less than 1.0mm, or a less than 10mm change in offset when a 3m straight edge is placed over the defect.

Category 1 cracks should be monitored for a period of 12 months. At the end of the monitoring period, identified cracks that are rated greater than Category 2 are considered defects, and require rectification.

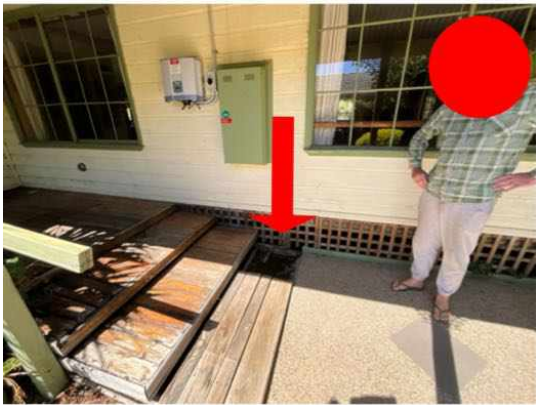
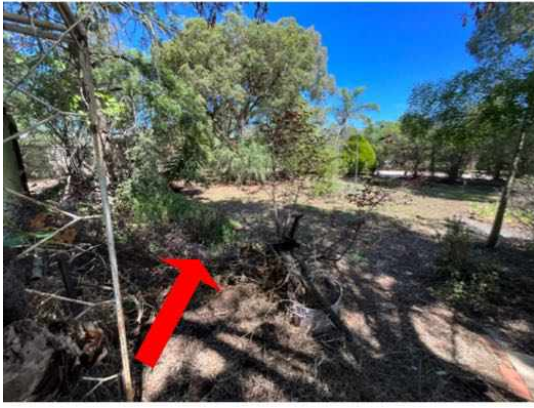
Building: Building 1
 Location: Yard - Side
 Finding: Evidence of termite damage- minor
 Information: Despite no live termite or timber pest activity being indicated, previous termite damage was found to have affected this area. This damage is considered to be inactive and is minor in nature.

It is advised that the area be visually inspected frequently to ensure that the condition of affected building materials does not worsen. At the time of inspection, damage is not structural and is only considered to be superficial.

A building contractor may be appointed to provide a further invasive inspection if further damage is evident.

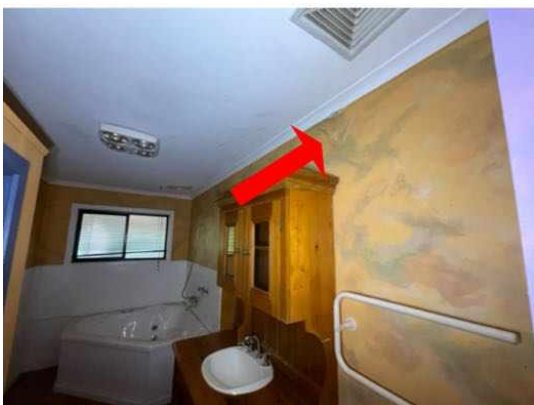
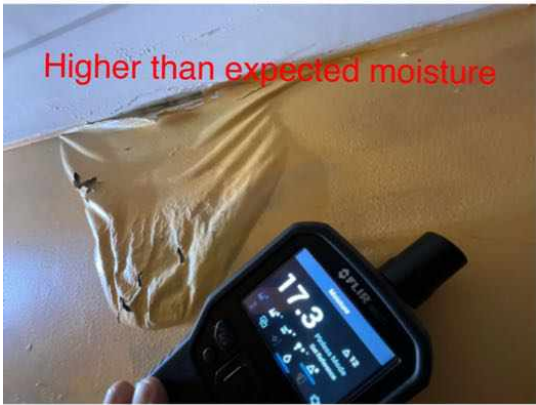
Finding: Water leak - Inactive

Information: Water leaks generally occur when a particular area of the property is not weather- or water-tight. While the damage in this area appears to be from an old inactive water leak, the area should be monitored frequently for the recurrence of any dampness.

Repair and / or replacement of previously affected building elements is at client discretion. Consider a further invasive inspection: removal of obstructions around the damaged area may reveal further damage which has been concealed. A more significant or major defect may be identified at this time.

Where recurrence of an active water leak is identified, a qualified plumber should be appointed immediately to rectify the leak and advise on any further preventative works as necessary.

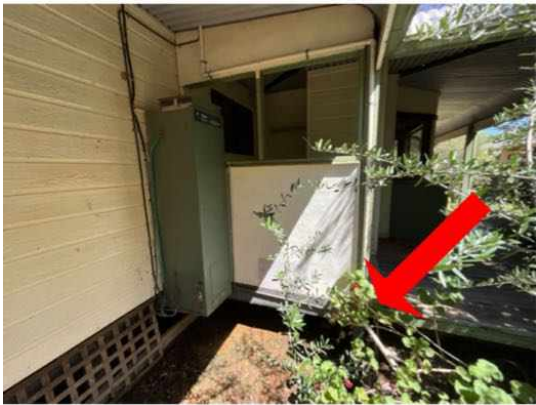
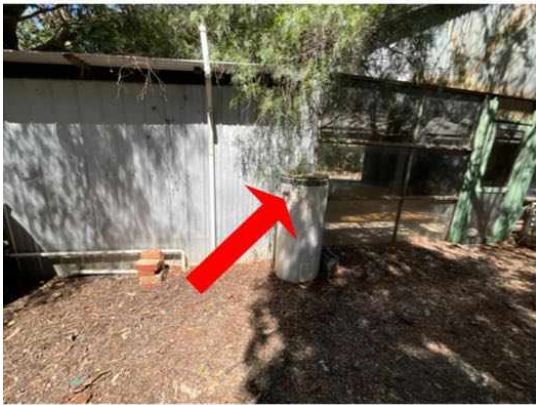
Finding 6.02

Building: Building 1
Location: Yard - Side, back
Finding: HWS Overflow - Not Connected
Information: The Hot Water System (HWS) overflow was found to be disconnected from storm water drainage and is creating excessive moisture in the surrounding area.

These damp conditions can lead to secondary defects such as rot, rust or corrosion of associated building elements, the formation of fungal decay, or even the creation of potential slip hazards. When coupled with poor site drainage, pooling of water may also attract termite activity to this area.

It is highly recommended that a licensed plumber be appointed to connect the HWS overflow in order to prevent such an environment from being created. These minor works should be carried out as soon as possible.

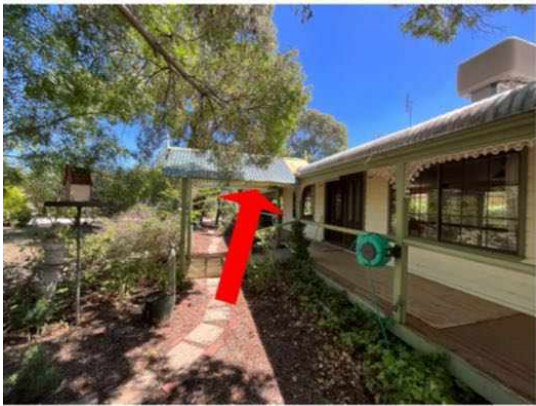
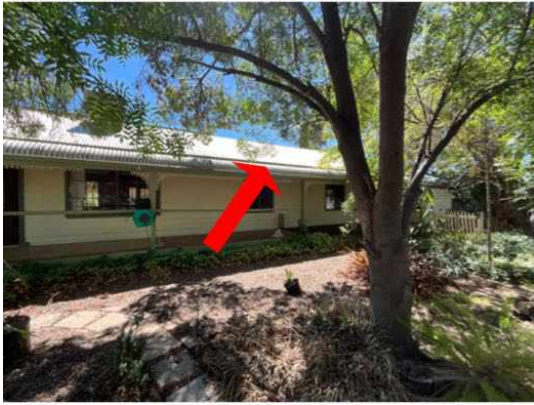
Finding 6.03

Building: Building 1
 Location: Verandah, upper roof >
 Finding: Guttering Missing
 Information: The Guttering in this area was missing at the time of inspection. Guttering, Downpipes and Stormwater drainage are vital to protect the integrity of the structure and to prevent an environment conducive to Timber Pest attack.

A Plumber should be contacted as soon as possible to replace and connect to drainage the missing Guttering.

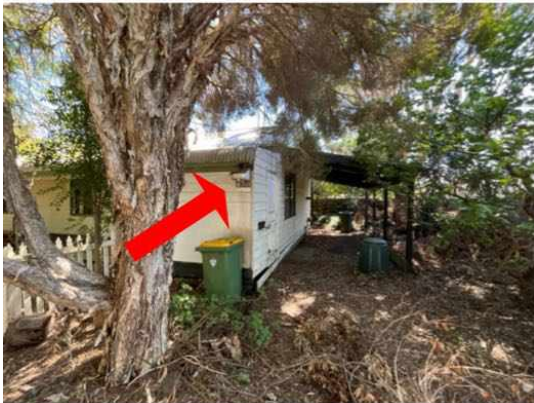
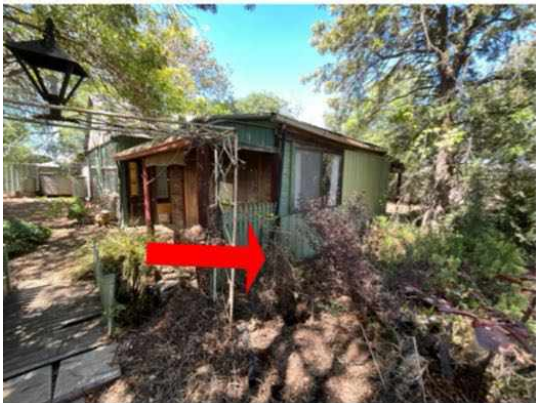
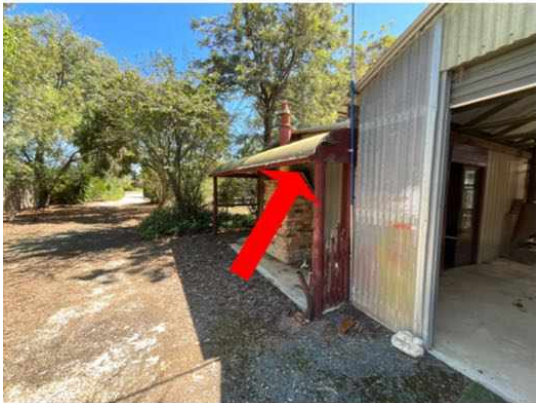
Finding 6.04

Building:	Building 1
Location:	Yard - Side, carport
Finding:	Stormwater drain - Not connected
Information:	The roof plumbing is not adequately connected to stormwater drainage on the site. This disconnection negatively impacts the functional capacity of the roof plumbing.

Where roof plumbing doesn't drain adequately, the area at the base perimeter can become excessively damp, potentially creating an environment that is susceptible to rust and corrosion of surrounding building elements, as well as attracting termites and other pests.

It is highly recommended that a plumber be appointed to further inspect the area and to install adequate drainage equipment where necessary.

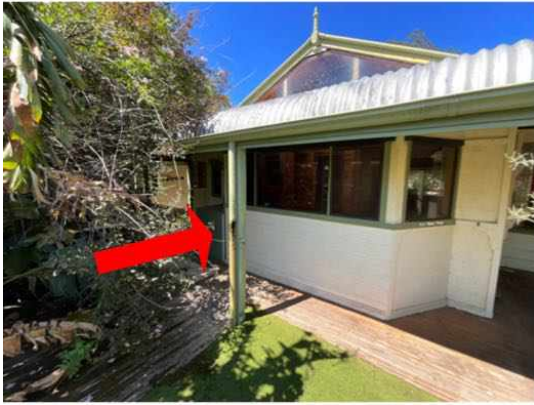
Finding 6.05

Building: Building 1
Location: Yard - Side
Finding: Downpipe/ Stormwater pipe Damaged
Information: The Stormwater element was found to be damaged at the time of inspection.

Downpipes ensure excess water is directed away from the structure to prevent damage. This damage includes Fungal timber decay, Termite attack and sinking of the stumps that support the floor. All of this type of damage may lead to costly repairs.

A Plumber should be contacted to make repairs as soon as possible to prevent deterioration of the Structure.

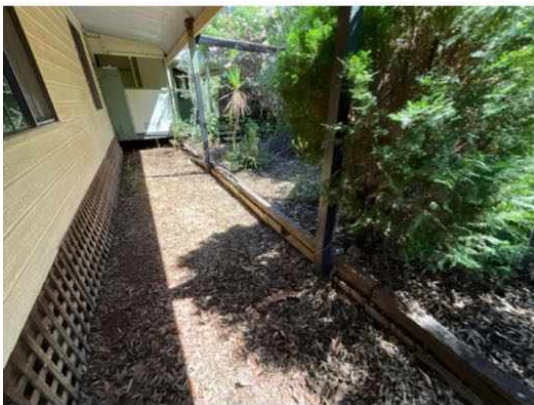
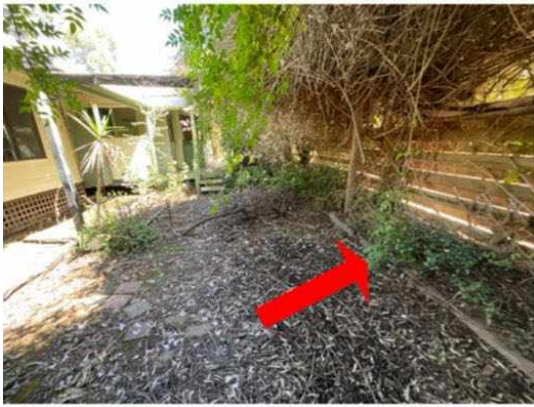
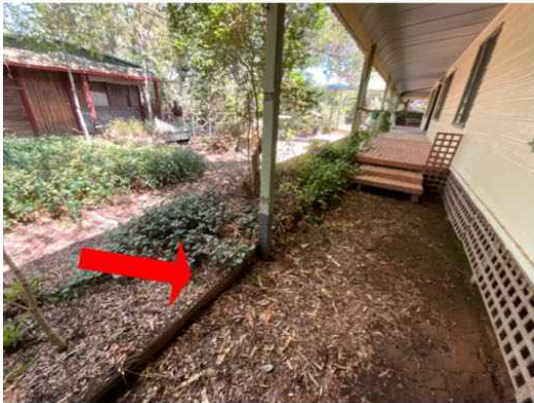
Finding 6.06

Building:	Building 1
Location:	Yard - Side, verandah
Finding:	Untreated or non-durable timbers in a hazardous environment
Information:	To reduce the risk of timber pest attack it is essential that timber used in a hazardous environment (e.g. in direct contact with the ground or frequently exposed to damp conditions) is of sufficient durability and/or is adequately preservative treated.

Untreated timbers in direct contact with the ground are likely to develop severe wood rot and/or fungal decay if left unattended creating attraction for subterranean termites to infest the timbers from surrounding areas.

If untreated or non-durable timbers are found to be in a hazardous environment it is highly advised that replacement of these building elements be performed as soon as possible to aid the protection of the property against termite / timber pest attack.

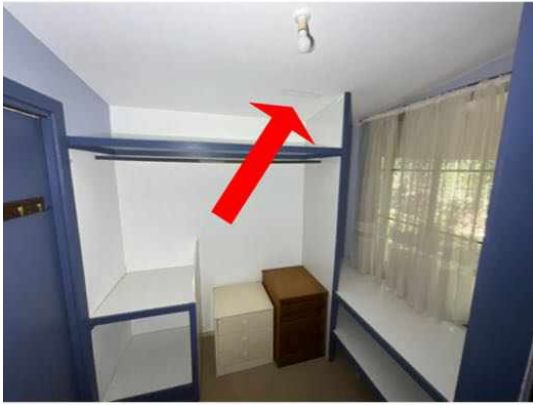
Finding 6.07

Building:	Building 1
Location:	Walk in robe
Finding:	Ceiling - Water stained
Information:	Water staining to ceiling linings in this area was evident at the time of inspection. Water staining indicates that surfaces have been exposed to excessive moisture over time. The minerals and other elements in the water lead to staining, which may graduate to corrosion and deterioration if left unmanaged.

While mostly an appearance defect, water staining can be indicative of more serious defects, which may be currently concealed by interior ceilings.

Where water staining is active, a licensed plumber must be consulted to identify the cause of the staining and to provide advice on any reparation works that may be required. Replacement of any damaged structures is advised.

Conversely, where water staining is old and inactive, affected building materials may be repaired or replaced at client discretion.

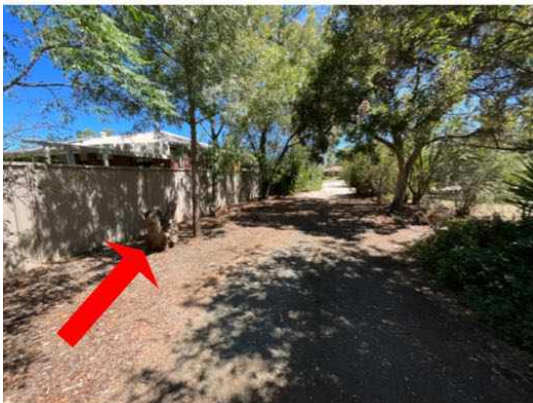
Finding 6.08

Building:	Building 1
Location:	Yard - Back
Finding:	Tree Stump in Ground
Information:	Any tree stumps in the yard not removed during the tree removal process provides the opportunity for Termite infestation and is likely to be subject to decay from damp conditions against the stump.

All tree stumps should be removed by professional tree removal services where possible. Meanwhile regular inspections are advised to identify any termite activity in the areas identified.

Services for tree stump removal should be contacted as soon as possible to reduce the risk of timber pest attack.

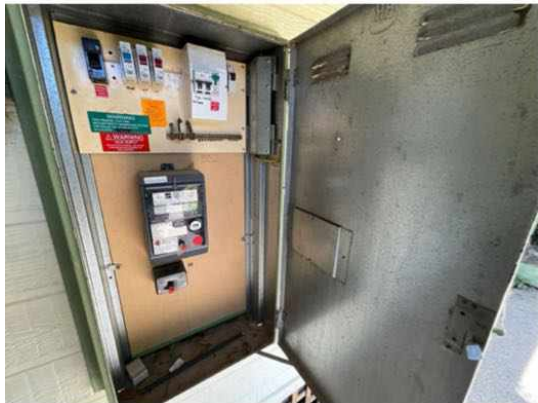
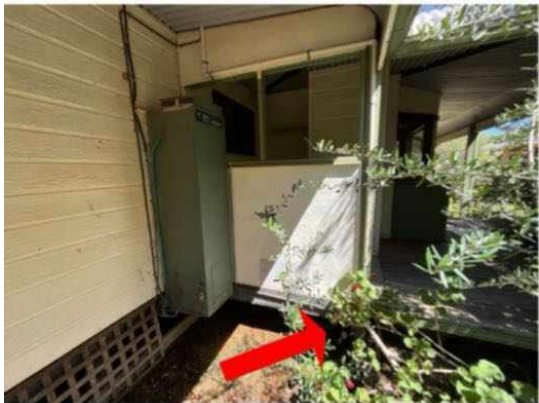
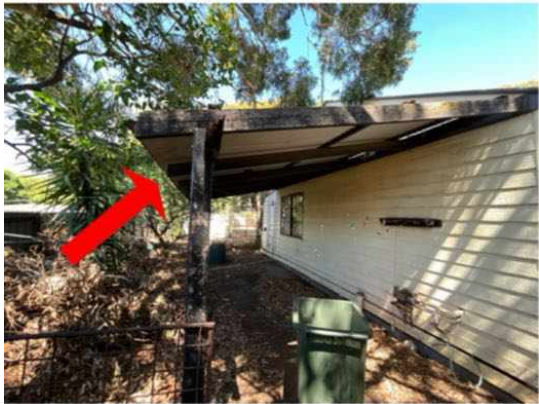
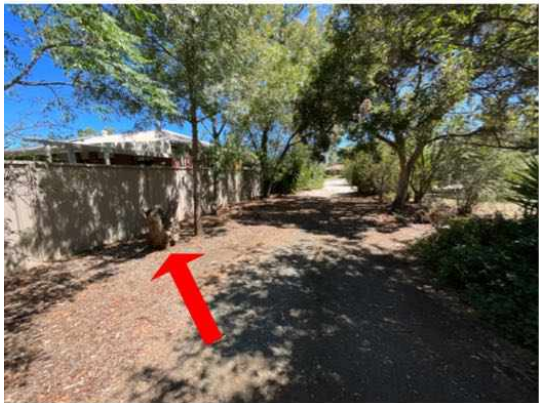
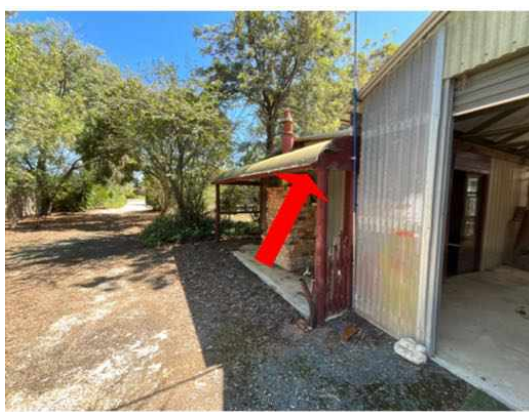
Finding 6.09

Building:	Building 1
Location:	All External Areas
Finding:	Termite Management System - no evidence of a chemical installation
Information:	The application of a post-construction chemical termite barrier is highly recommended for all properties, particularly if live termite activity has been found on the site

A durable notice should be placed in the switchboard unit to indicate current termite barriers. At the time of inspection, it appeared as though no termite management system has been installed, with no evidence to suggest preventative works taking place.

The client may consider gaining further advice from a pest controller as to the costs and procedures involved with this application. It is recommended that obtaining such advice be a short-term priority.

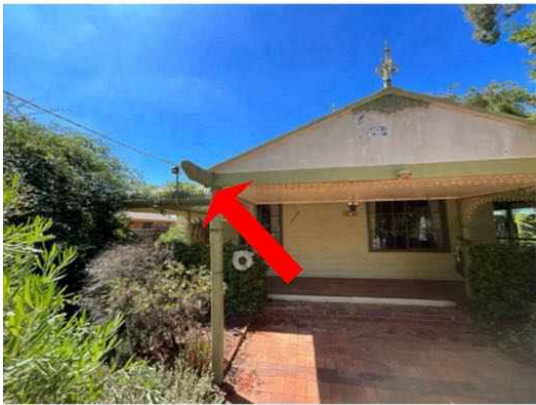
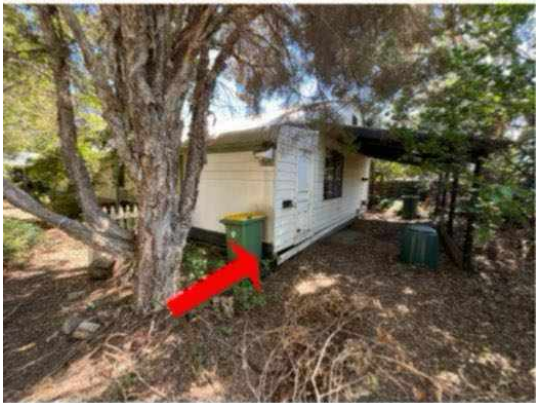
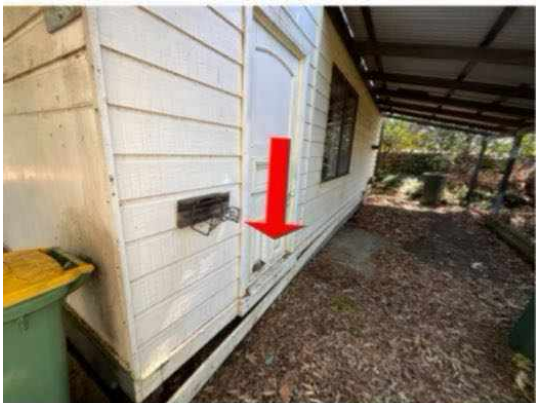
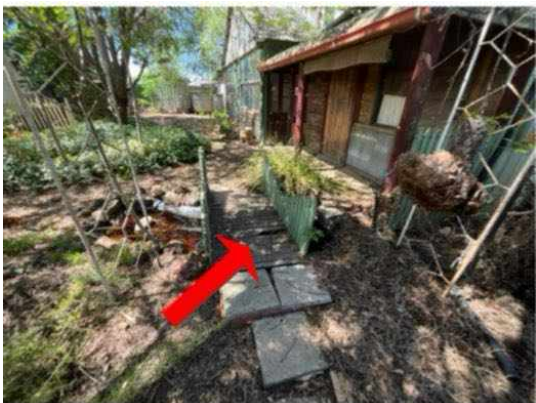
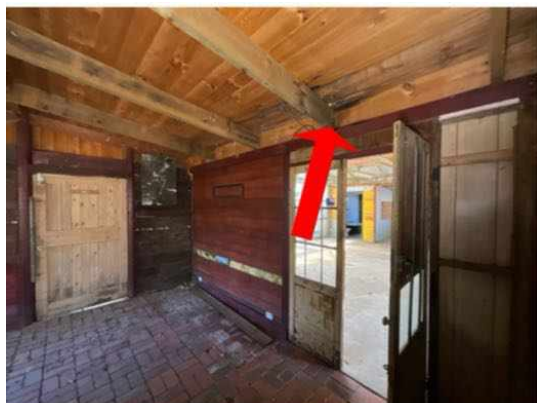
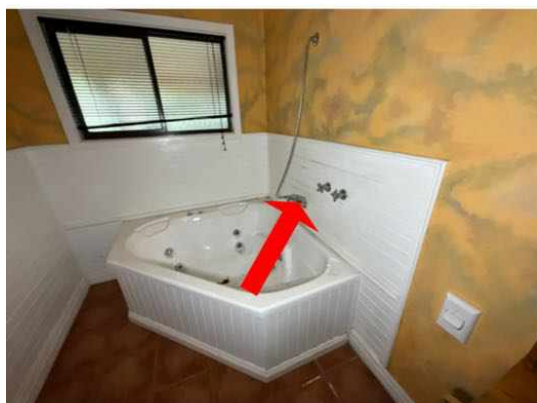
Finding 7.01

Building:	Building 1
Location:	Entry, back yard, carport, spa
Finding:	Fungal decay - present (localised)
Information:	Fungal decay also known as wood decay or wood rot generally refers to the deterioration of timber elements when in contact with excessive levels of moisture for a prolonged period of time.

In this case although the affected timber element is in a decaying state the extent of any visible damage appears to be localised to a specific area and is yet to spread to other parts of the building element or affect adjoining structures. The fungal decay is therefore likely to be of a relatively superficial nature with minimal impact on the structural integrity or tensile strength of the timber element.

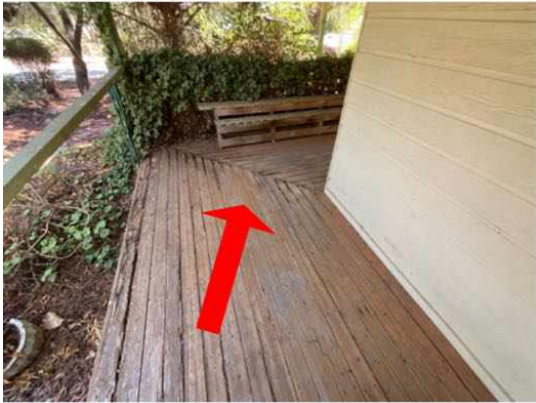
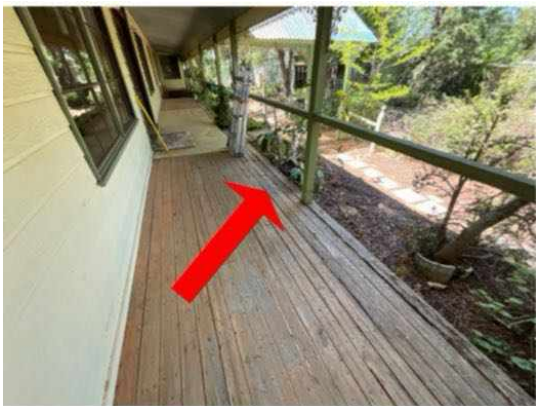
Finding 7.02

Building:	Building 1
Location:	Verandah
Finding:	Fungal decay - present (widespread)
Information:	Fungal decay is also known as wood decay or wood rot generally refers to the deterioration of timber elements when in contact with excessive levels of moisture for a prolonged period of time.

In this case, fungal decay appears to have become widespread and is likely to have affected any adjoining timber elements/structures. The widespread development of fungal decay is likely to have heavily impacted the structural integrity and tensile strength of the affected timber elements and the associated structure.

Timbers affected by widespread fungal decay should be replaced immediately. The cause of the moisture that has led to the development of such decay should also be identified and dealt with in an appropriate manner.

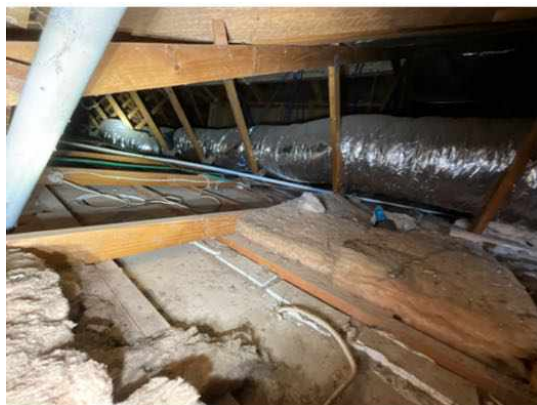
Building: Building 1
 Location: Roof Void
 Finding: Insulation - Inadequate
 Information: Upon inspection of the roof void it was noted that there is a lack of adequate insulation.

Installation of adequate insulation is required and should be conducted as soon as possible.

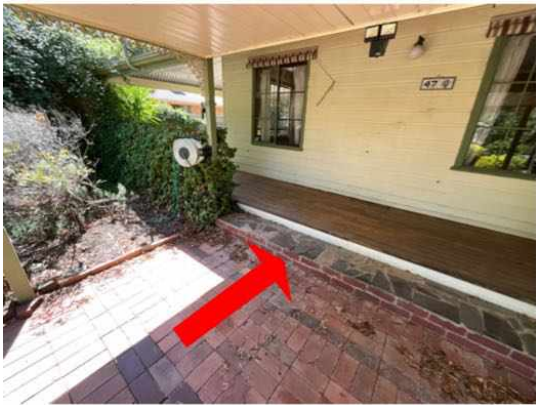
Building: Building 1
 Location: Verandah entry
 Finding: Tiles - Cracked or damaged
 Information: Cracking and removal was evident to the tiling in this area at the time of inspection. This area is frequently exposed to water, allowing potential for water penetration into adjoining sections of walls or flooring.

If left unmanaged, water penetration to these areas may lead to subsequent water damage, which is likely necessitate repair work to affected building elements.

A tiling contractor should be appointed to ensure that no further water damage occurs. The re-application of silicone and grouting throughout remaining tile work is also advised, to further protect the area against water penetration.

Where water penetration has led to water damage, appointment of a relevant tradesperson may be required to repair damaged building elements.

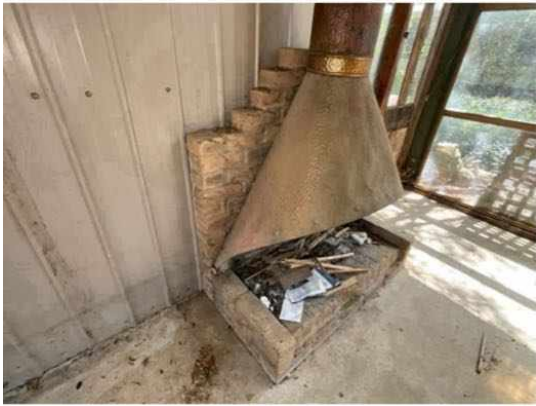
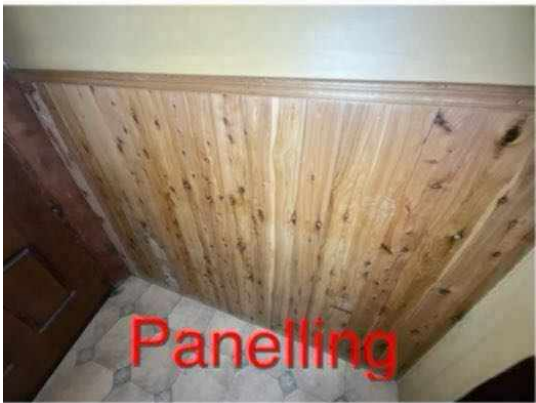
Building: Building 1
 Location: All Areas
 Finding: Additional Photos - Obstructions and Limitations
 Information: These photographs are an indication of the obstructions and limitations which impeded full inspection of the property at the time of inspection. These obstructions can hide an array of defects and should be removed to allow full inspection to be carried out. A re-inspection is recommended once the areas are made accessible.
