Building and Timber Pest Inspection Report

Inspection Date: Thu, 5 Feb 2026

Property Address: 25 merrigum crescent , Clarinda ,3169

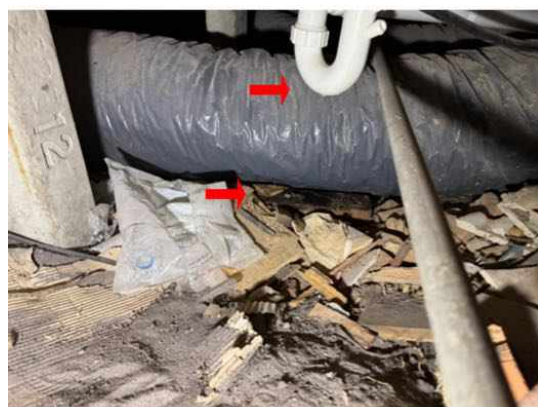
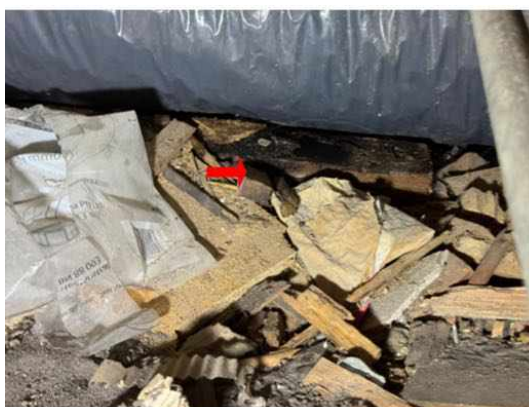
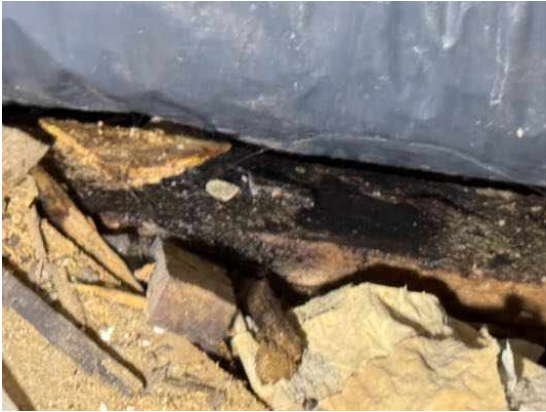
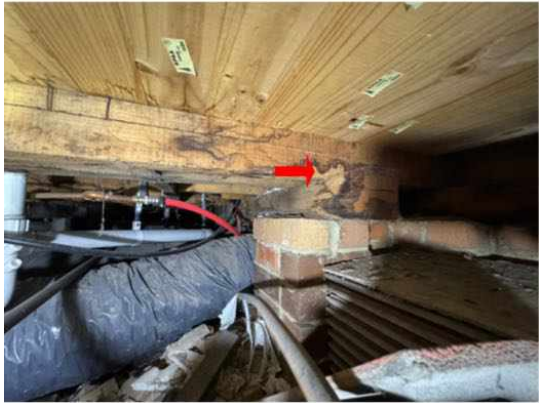
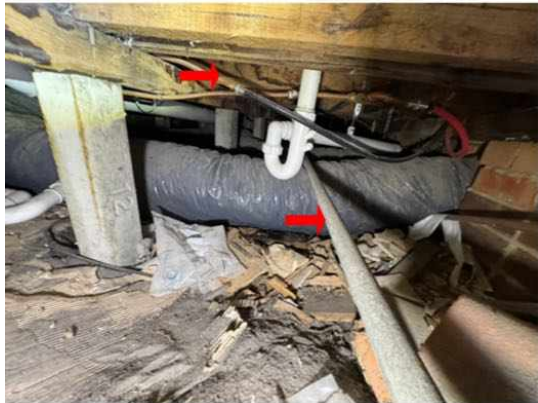
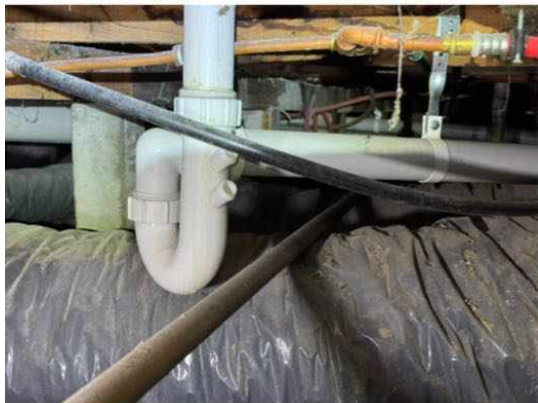
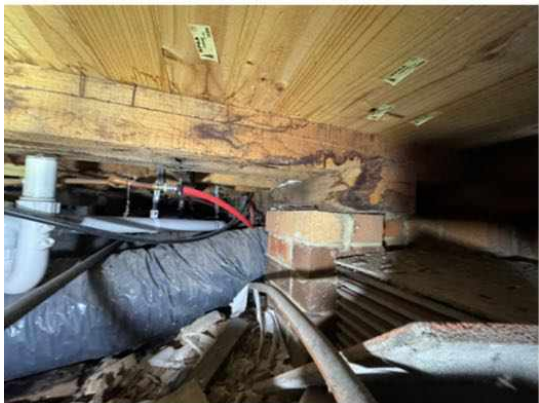
Building: Main Building
Location: Subfloor
Finding: Subfloor (Below Bathroom) – Water Leakage & Moisture Damage to Bearer (Potential Major Defect)

Information: Evidence of water leakage was observed within the subfloor area located beneath the bathroom, with visible moisture staining and dampness noted to a section of a structural bearer. This condition is consistent with ongoing or previous water escape from bathroom plumbing or waterproofing-related components.

Prolonged moisture exposure to structural timber beneath wet areas may result in timber deterioration, reduced bearing capacity, and progressive structural movement if not addressed. Moist conditions in this location are conducive to timber deterioration and create conditions conducive to termite activity. If the source of water ingress remains unresolved, this condition may develop into a major structural defect over time.

This issue should be investigated and assessed as soon as practicable (ASAP) by a suitably qualified structural engineer, in conjunction with an appropriately licensed plumber to identify and rectify the source of water leakage. Further investigation may be required to determine the extent of timber impact and any necessary remedial works.

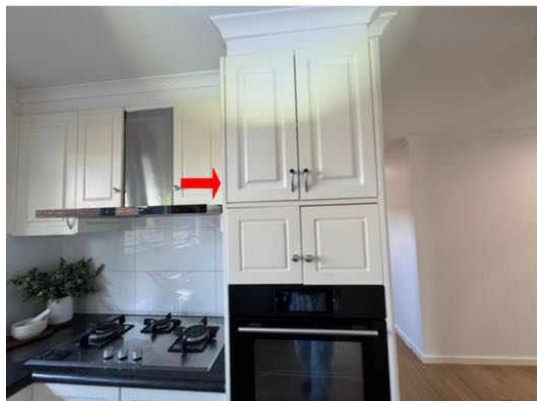
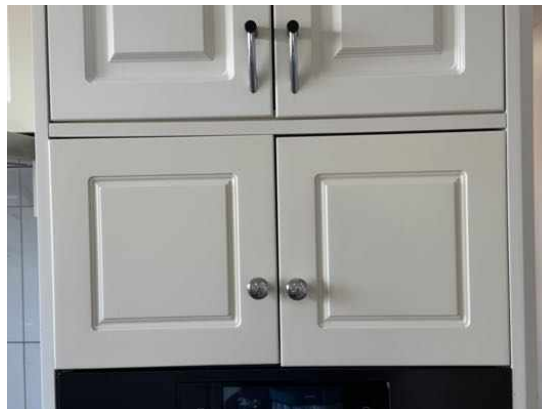
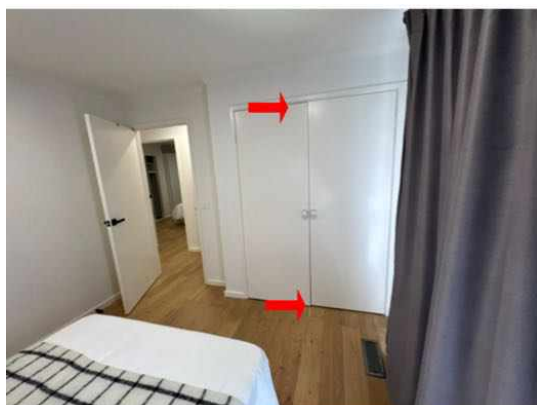
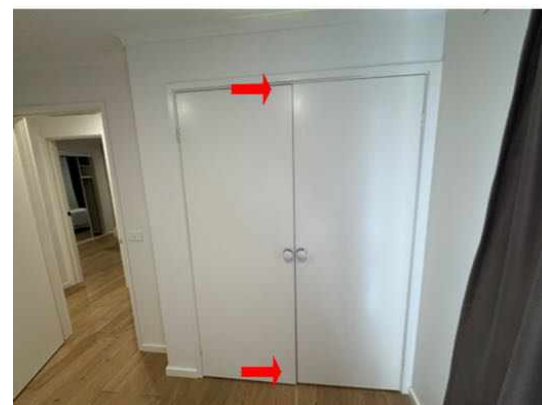
Finding 3.01

Building: Main Building
Location: All Internal Areas
Finding: Cabinetry – Misalignment
Information: Sections of the cabinetry were noted to be out of alignment, with doors or panels not sitting evenly or closing correctly. This condition may be due to hinge movement, installation tolerances, or normal building movement over time.

If left unrectified, the continued misalignment may lead to wear on hinges, rubbing on adjacent panels, or reduced functionality of the cabinetry.

Rectification should be carried out as soon as practicable by a qualified cabinetmaker or carpenter to adjust the fittings and restore proper alignment.

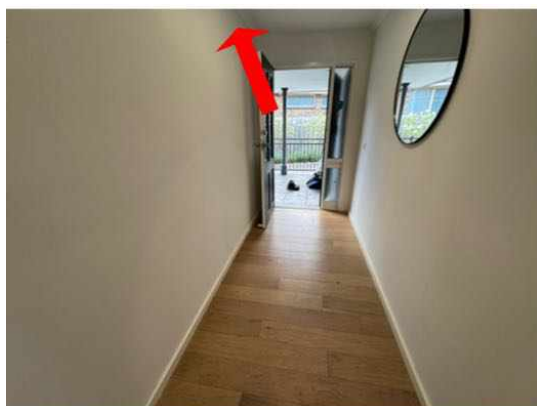
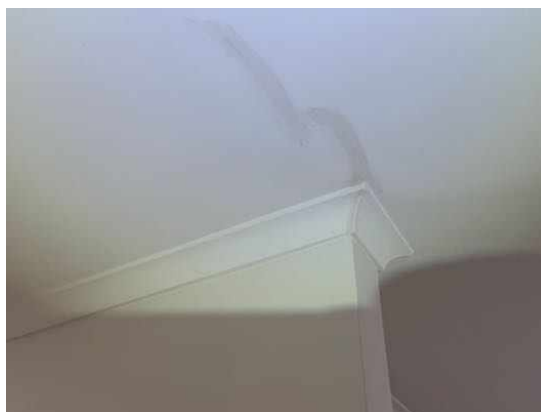
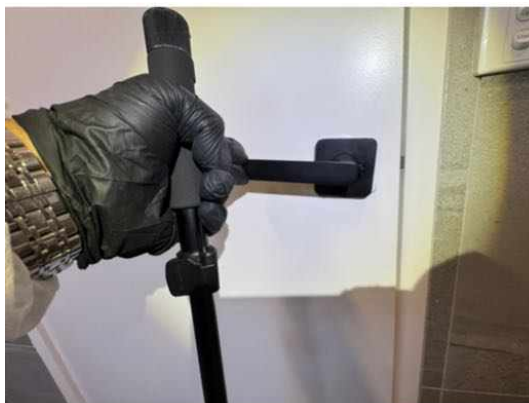
Finding 3.02

Building:	Main Building
Location:	All Areas
Finding:	Internal Walls – Surface Imperfections
Information:	Sections of the internal walls show visible dents and surface imperfections. These marks are consistent with general wear, minor impact, or previous patching that was not finished to a high standard.

If left unrectified, the imperfections may remain visible through new paintwork and affect the overall presentation of the interior surfaces.

Rectification should be carried out as soon as practicable by a qualified painter or plasterer to properly sand, patch, and repaint the affected areas for a smooth and consistent finish.

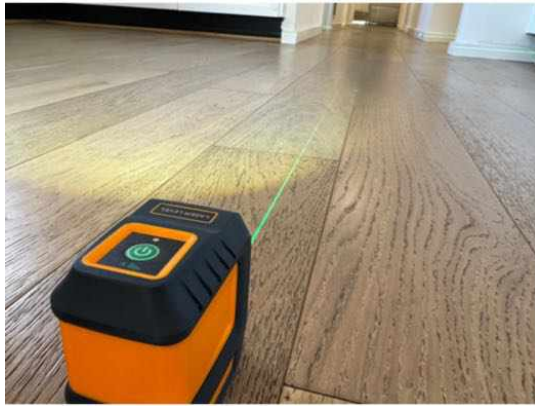
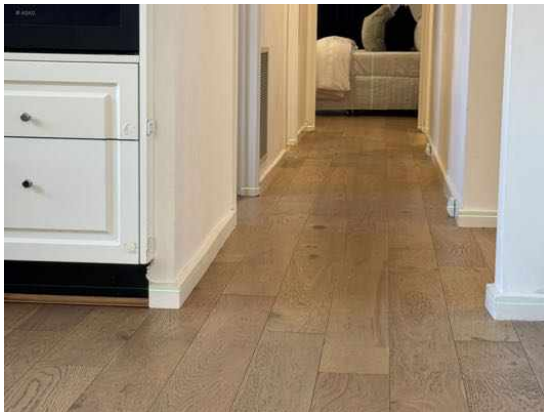
Finding 3.03

Building:	Main Building
Location:	All Areas
Finding:	Timber Flooring – Suspected Unevenness & Movement (Potential Major Defect)
Information:

A section of the timber flooring was observed to exhibit unevenness and possible movement when traversed. Laser levelling checks indicate variations that may exceed normal expectations for floor performance, suggesting potential issues within the underlying support system.

Due to limited access to the subfloor at the time of inspection, the condition of bearers, joists, and supporting elements could not be fully assessed. Possible contributing factors may include subfloor movement, inadequate support, settlement, or moisture-related effects. If left unaddressed, this condition may worsen and develop into a major structural issue. Any moisture affecting timber is conducive to deterioration and creates conditions conducive to termite activity where timber elements may be present.

This matter should be assessed as soon as practicable (ASAP) by a suitably qualified structural engineer. Further access to the subfloor is likely required to determine the cause, extent, and appropriate remedial action to prevent progressive structural damage.

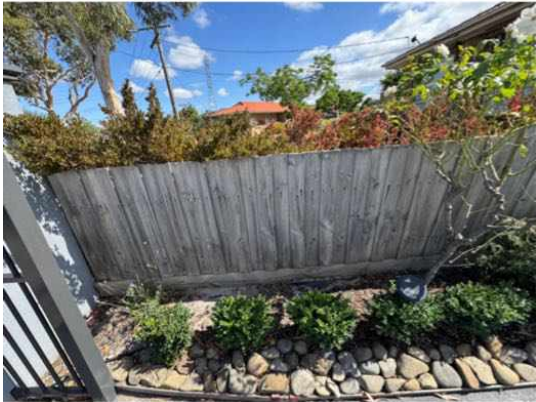
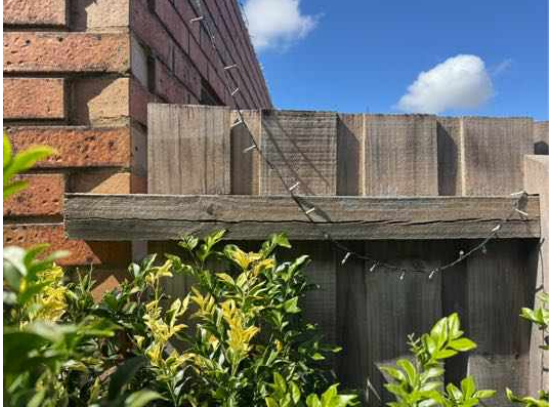
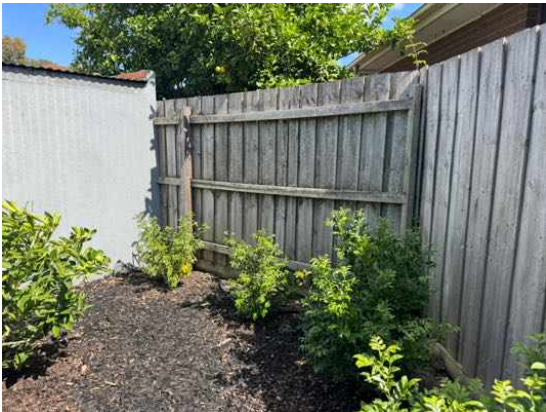
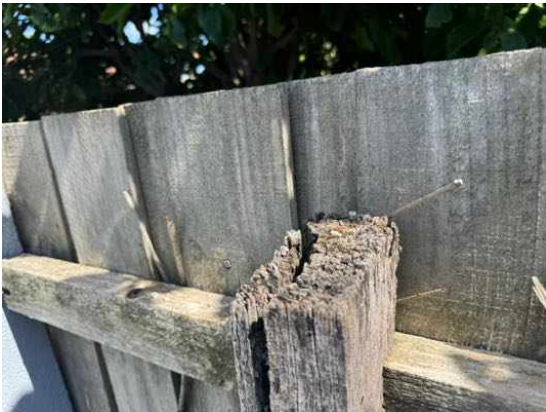
Finding 3.04

Building: Main Building
 Location: All Areas
 Finding: Timber Fence – Deterioration and Weathering
 Information:

A section of the timber fencing shows visible signs of deterioration and weathering. This may be due to age, exposure to moisture, or reduced structural support affecting the stability and condition of the fence.

If not addressed, the deterioration may worsen and lead to further weakening of the

fence structure. Any moisture in contact with timber is conducive to termite activity, so this condition should be attended to as soon as practicable to reduce the risk of further damage.

Assessment and rectification should be carried out by a licensed carpenter or builder to repair or replace affected sections and ensure the fence is structurally sound.

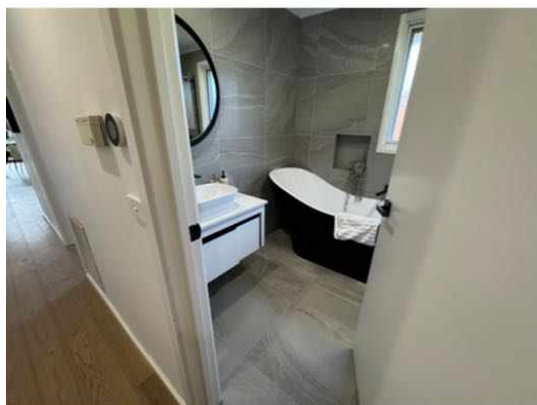
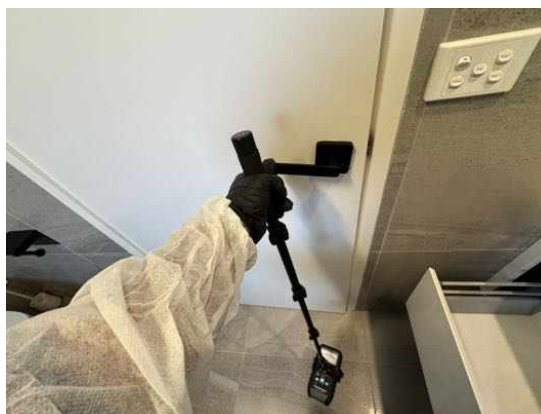
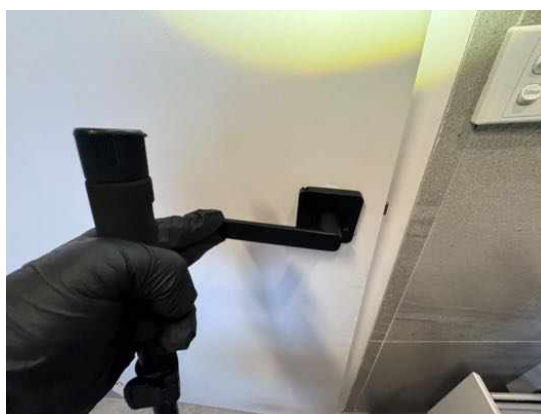
Finding 3.05

Building: Main Building
Location: All Areas
Finding: Door Hardware – Loose Handle Mechanisms

Information: A section of the internal door hardware shows loose handle mechanisms during normal operation. This condition may be due to worn fixings or general use over time.

If left unattended, the looseness may worsen and affect the correct operation of the door hardware. To prevent further deterioration, this minor issue should be addressed as soon as practicable.

Rectification should be carried out by a qualified handyman or licensed carpenter, who can tighten or replace the affected hardware as required.

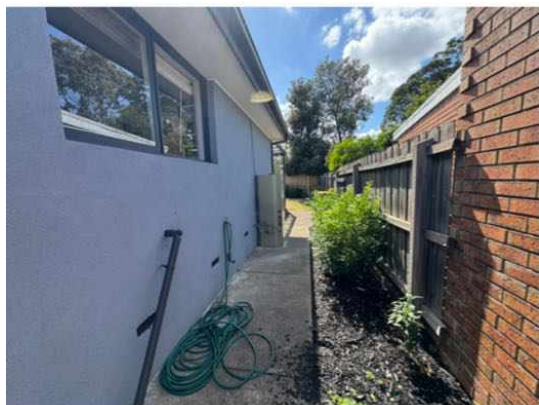
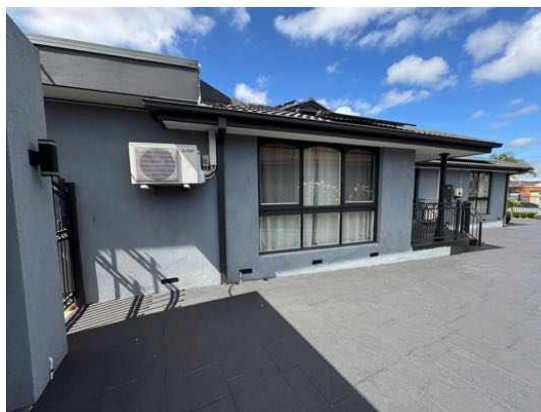
Finding 3.06

Building: Main Building
 Location: All Areas
 Finding: Rendered Wall Finish – No Expansion Joint Observed (Cracking Risk)
 Information:

The rendered external wall finish was observed without visible expansion or control joints along the wall length. This configuration may not adequately allow for normal building movement, thermal expansion, or substrate movement.

In the absence of expansion joints, rendered surfaces are more prone to cracking over time due to thermal changes, minor structural movement, or settlement. Once cracking occurs, moisture may penetrate behind the render, leading to deterioration of underlying materials. Moisture in this area is conducive to deterioration and creates

conditions conducive to termite activity where timber elements may be present.

This condition should be addressed as soon as practicable. Assessment and installation of appropriate expansion or control joints should be carried out by a suitably qualified renderer or licensed builder to reduce the likelihood of future cracking and moisture-related damage.

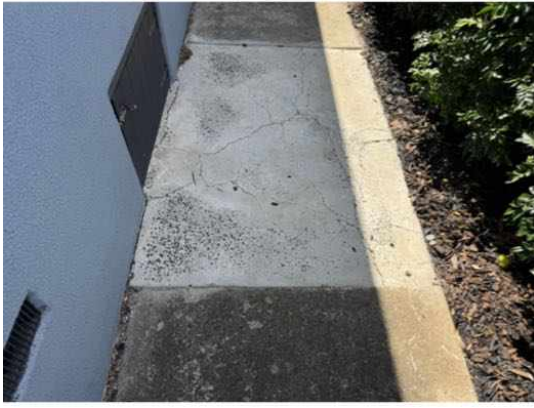
Finding 3.07

Building: Main Building
 Location: All Areas
 Finding: Concrete Elements – Fine Cracking Observed
 Information:

Fine cracking was observed across sections of the concrete elements around the property. These cracks may be related to normal shrinkage, thermal movement, or minor settlement of the substrate beneath the concrete.

Although minor at this stage, if left unattended the cracks may widen and allow moisture to penetrate the concrete, potentially leading to deterioration of reinforcement or surrounding building elements. This condition should be addressed as soon as practicable to prevent further progression.

Rectification should be carried out by a licensed builder or concreter, who can seal and repair the affected areas. A structural engineer may be required if any signs of ongoing movement or structural impact are suspected.

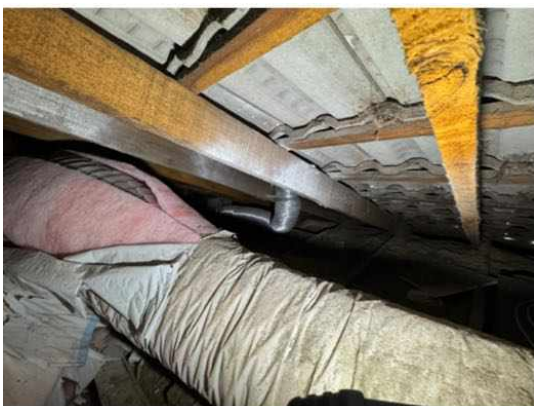
Finding 3.08

Building: Main Building
 Location: Roof Void
 Finding: Bathroom Exhaust Fan Ducting – Deteriorated / Venting into Roof Void
 Information:

The bathroom exhaust fan ducting within the roof void was observed to be in poor condition, with signs of deterioration and wear. The duct appears to discharge moist air into the roof space rather than being fully sealed and vented to the external atmosphere.

This condition allows warm, moisture-laden air to accumulate within the roof void, increasing the risk of condensation, mould growth, and deterioration of roof timbers, insulation, and other building elements. Ongoing moisture within the roof space is conducive to deterioration and creates conditions conducive to termite activity where timber elements are present.

This issue should be rectified as soon as practicable. Replacement of the deteriorated ducting and proper connection to an external vent should be carried out by a licensed electrician or suitably qualified contractor to ensure compliant and effective ventilation.

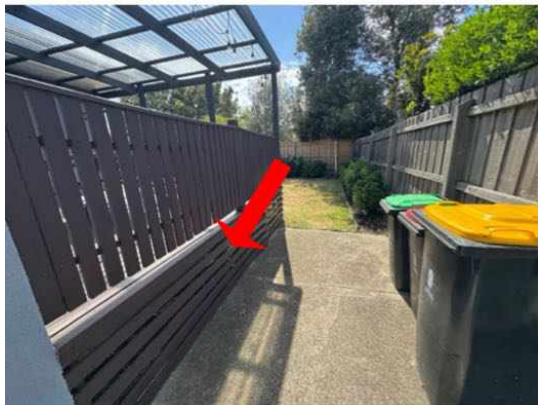
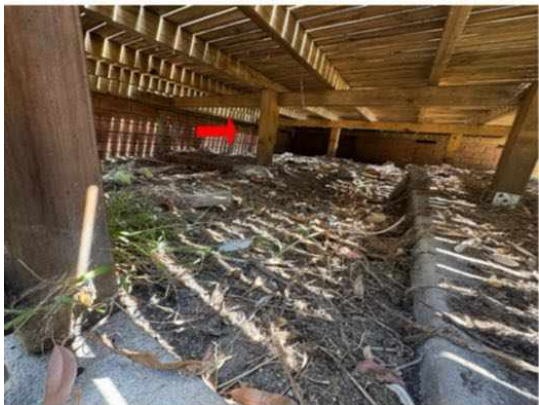
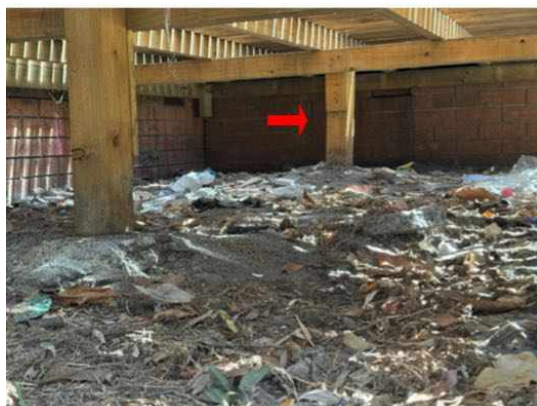
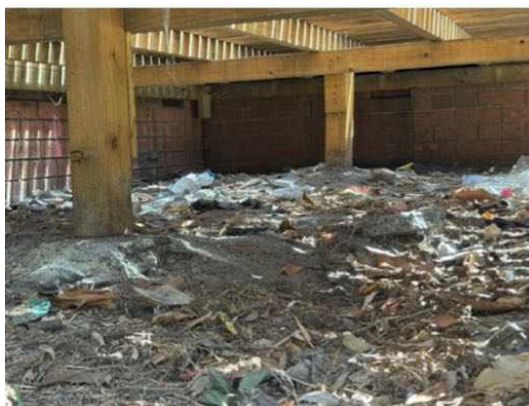
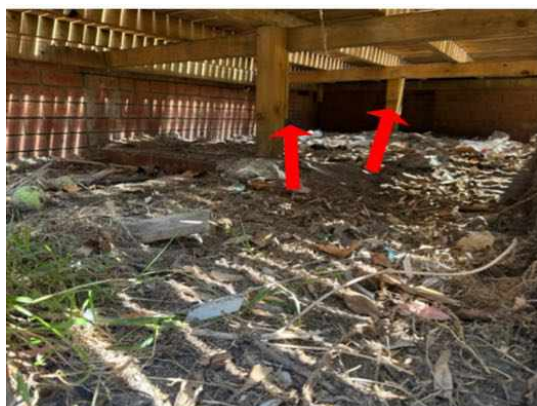
Finding 3.09

Building: Main Building
 Location: Alfresco
 Finding: Deck / Verandah Substructure – Suspected Non-Compliant Support & Ground Conditions (Potential Major Defect)

Information: The deck/verandah substructure was observed with uneven ground conditions, debris accumulation, and irregular support arrangements beneath the framing. The configuration, bearing conditions, and apparent support spacing raise concerns regarding structural adequacy and possible non-compliance with accepted construction practices.

If this condition is not addressed, ongoing settlement or movement may occur, potentially leading to loss of support, uneven loading, or structural instability of the deck/verandah over time. Poor ground conditions and potential moisture exposure are conducive to deterioration of structural timbers and create conditions conducive to termite activity. If left unrectified, this issue may develop into a major structural defect.

This matter should be assessed as soon as practicable (ASAP) by a suitably qualified structural engineer. Further investigation is required to confirm compliance, assess structural capacity, and specify any necessary remedial works to ensure the deck/verandah is structurally sound and safe.

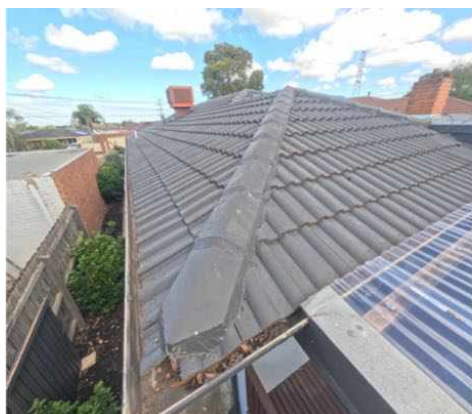
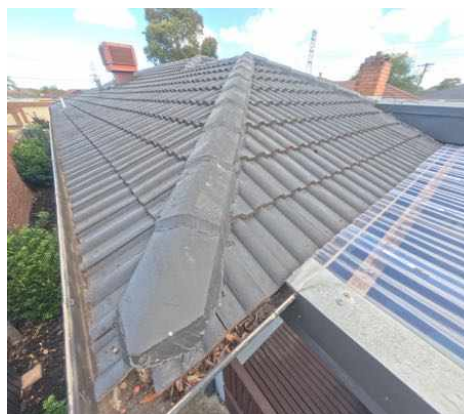
Finding 3.10

Building:	Main Building
Location:	All Areas
Finding:	Gutter Blockage – Suspected Restricted Water Flow
Information:	Sections of the guttering appear to show suspected blockage or restricted water flow, consistent with debris buildup or inadequate maintenance. This may cause water to overflow during rainfall instead of draining correctly through the downpipe system.

Blocked gutters can lead to moisture spilling onto fascia boards, eaves, and wall surfaces, which is conducive to termite activity and may contribute to deterioration of timber, staining, or possible water ingress into concealed building elements. Prolonged overflow may also affect foundation areas and increase the risk of damp conditions.

As this is a potential moisture-related issue, it should be addressed as soon as possible (ASAP) to prevent escalation.

Cleaning and assessment should be carried out as soon as practicable by a qualified guttering specialist or licensed roof plumber to restore proper drainage and check for any resulting damage.

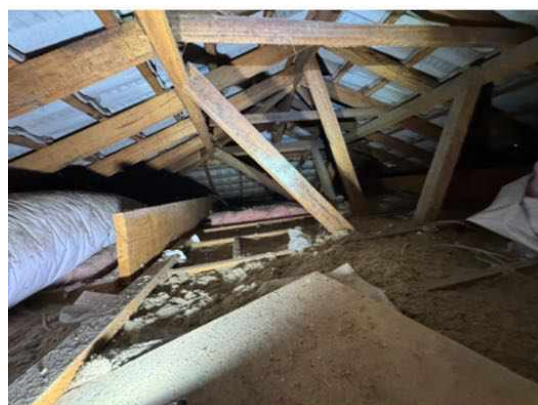
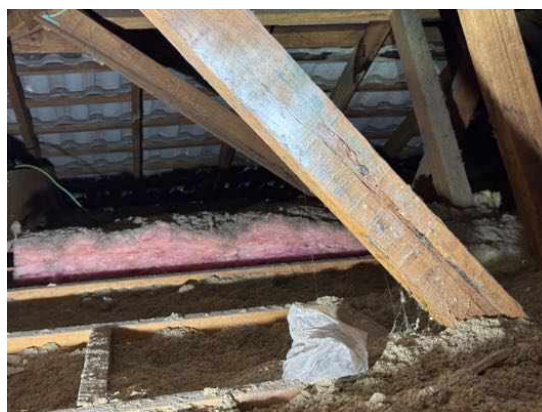
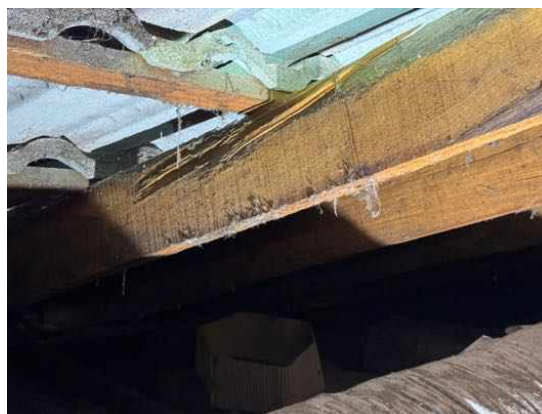
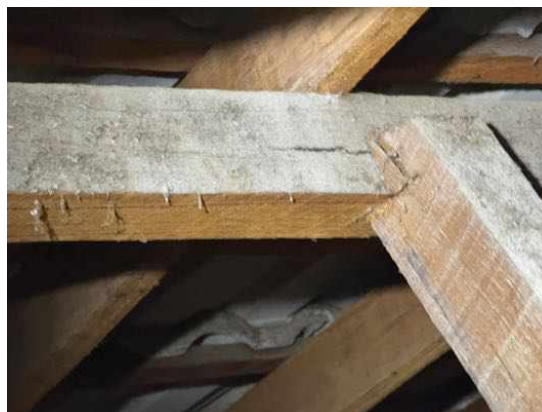
Finding 3.11

Building: Main Building
 Location: Roof Exterior
 Finding: Roof Structure – Cracked Hip & Rafter (Structural Concern)
 Information:

Cracking was observed to a section of the roof hip and associated rafter within the roof structure. This condition indicates possible structural stress, movement, or overloading affecting the roof framing members.

If left unaddressed, cracking to primary roof elements may progress and adversely affect the structural performance and load distribution of the roof system over time.

This issue should be assessed as soon as practicable (ASAP) by a suitably qualified structural engineer. Further access and investigation are likely required to determine the cause, extent, and structural significance of the cracking and to specify appropriate remedial works.

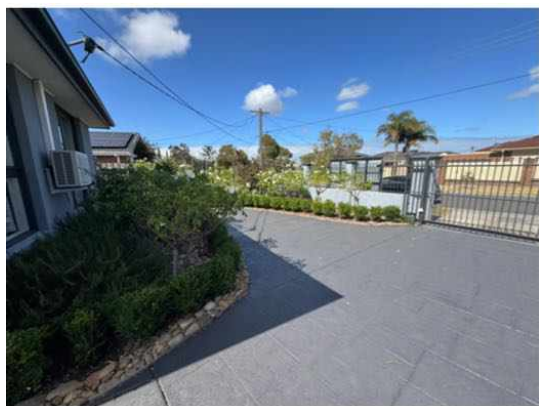
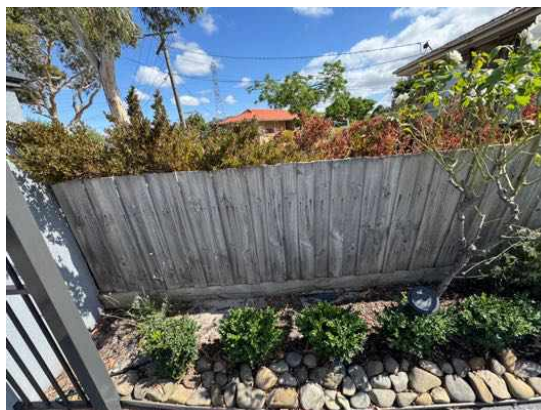
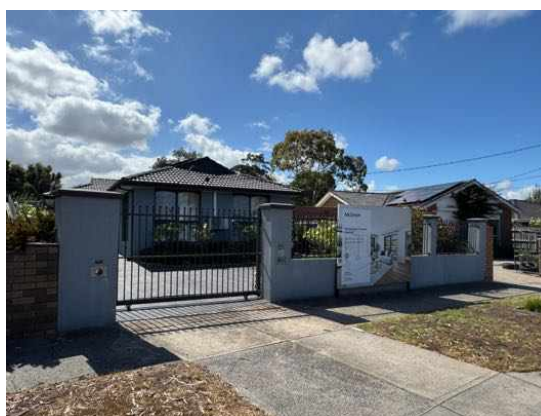
Building: Main Building
 Location: All External Areas
 Finding: Trees Around Property – Conducive Conditions
 Information: Vegetation and trees positioned close to the property were observed around sections of the external areas. The proximity of foliage, roots, and organic debris creates conditions that are conducive to timber decay and termite activity. Moisture retention around walls and footings is also increased in these areas.

These conditions may lead to deterioration of external elements, encourage fungal growth, and provide concealed pathways for termites. Any moisture in contact with

timber is considered highly conducive, and if not addressed, this issue may escalate into a more significant concern.

Rectification should be carried out as soon as practicable by a qualified gardener or arborist to trim vegetation away from the structure and improve airflow. A pest technician may also be needed to reassess conducive conditions once vegetation is cleared.

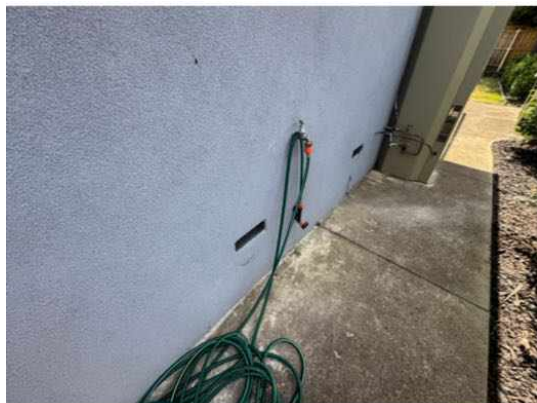
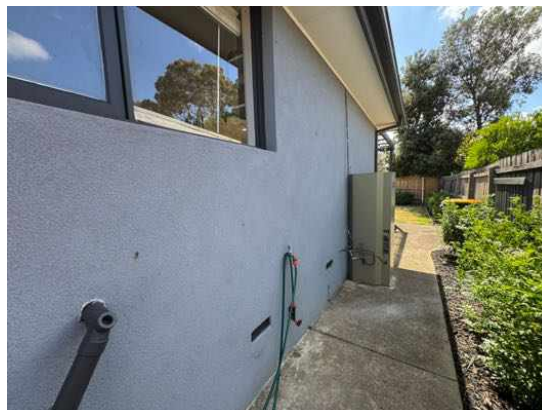
Finding 6.02

Building:	Main Building
Location:	All External Areas
Finding:	Tap No Drainage
Information:	A tap in the external area shows inadequate drainage, with water pooling around the base instead of dispersing effectively. Standing water in this area creates conditions that are conducive to timber decay, fungal growth, and termite activity if nearby building elements are exposed to moisture.

Poor drainage can also lead to deterioration of surrounding materials and may increase moisture levels around footings or adjacent structural components. Any moisture in contact with timber is highly conducive and may escalate into a more significant issue if not addressed.

Rectification should be carried out as soon as practicable by a licensed plumber to

improve drainage and ensure water is directed away from the property. A pest technician may also be required to reassess after drainage improvements are completed.

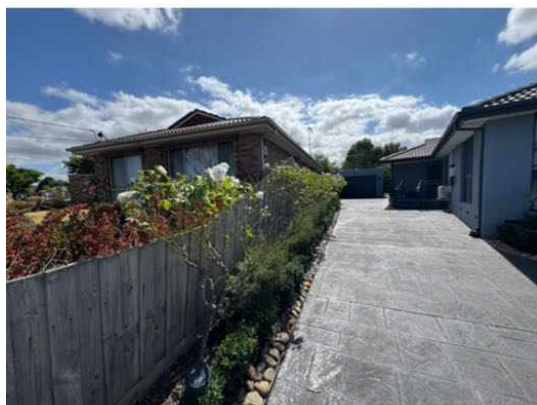
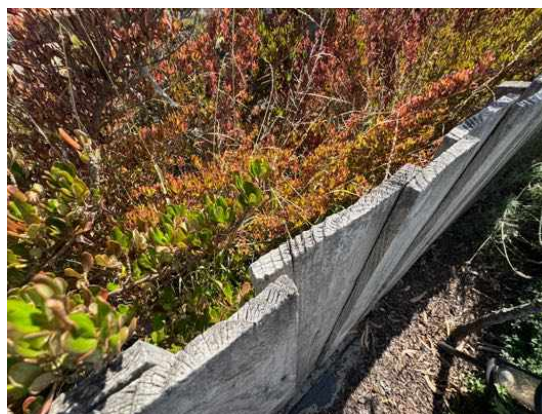
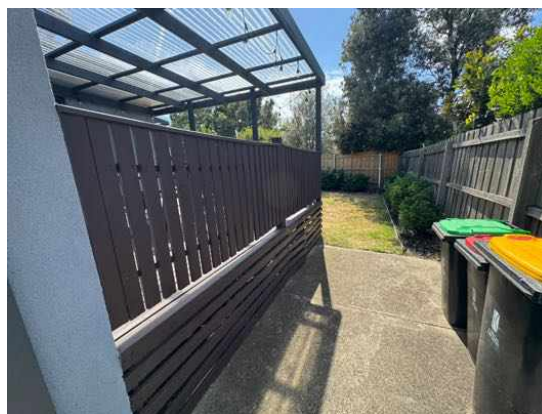
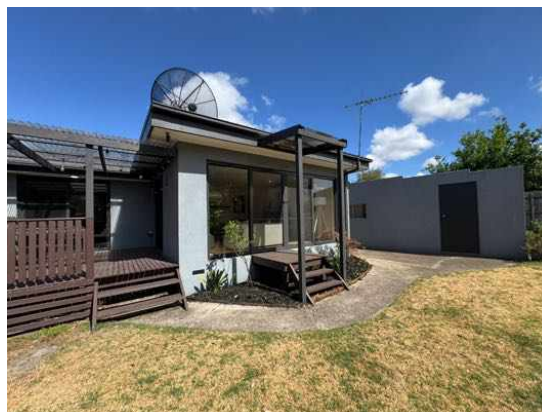
Finding 6.03

Building:	Main Building
Location:	All External Areas
Finding:	Timber No Protective Sealer – Moisture-Related Deterioration (Conductive Conditions)
Information:	Timber elements in the inspected area were noted to have no protective sealer or coating applied. Exposed raw timber is more vulnerable to moisture absorption, surface deterioration, and fungal growth. Moisture in contact with timber is conducive to termite activity, and unsealed surfaces increase this risk.

If left unprotected, the timber may warp, deteriorate, or weaken over time, especially in areas exposed to humidity, water splashes, or outdoor weathering. Continued exposure may escalate the condition into a more significant maintenance or structural concern.

Rectification should be carried out as soon as practicable by a qualified carpenter or painter to apply an appropriate timber sealer or protective coating. A pest technician may also be required if signs of moisture-related conducive conditions persist.

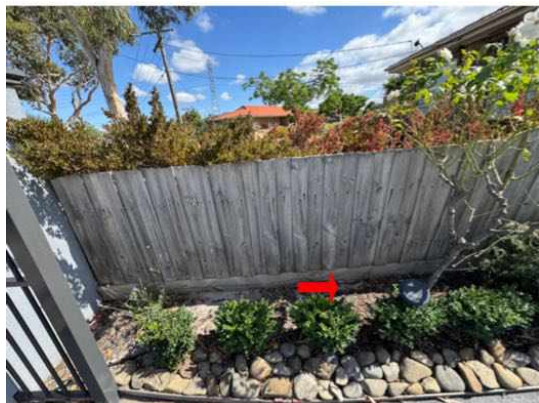
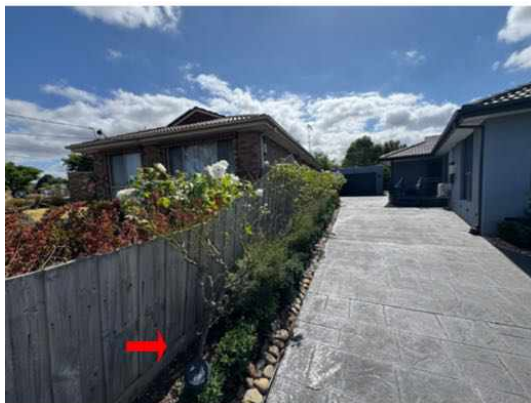
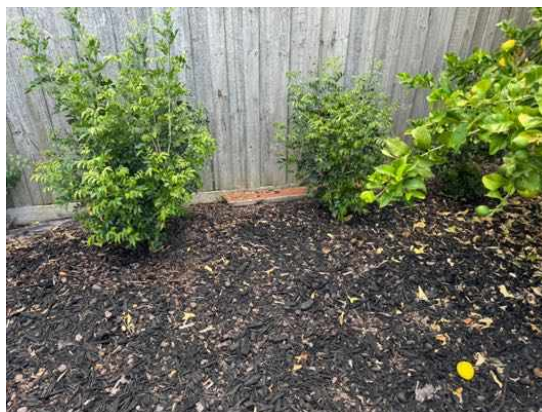
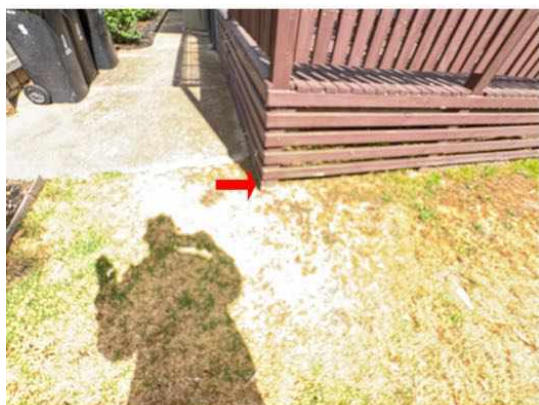
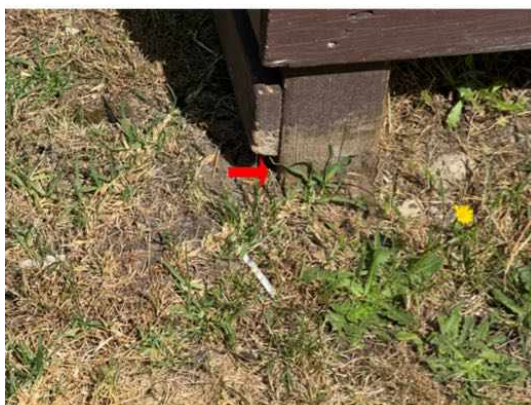
Finding 6.04

Building:	Main Building
Location:	All External Areas
Finding:	Timber in Contact With Soil – Conductive Conditions
Information:	Timber elements were observed in direct contact with soil around the property. This condition is conducive to termite activity and moisture absorption, as soil contact keeps the timber damp and provides concealed access points for termites.

If left unrectified, the timber may deteriorate, absorb moisture, and increase the risk of concealed pest entry or deterioration of connected components. This area should also be kept under observation, particularly after rain or changes in ground moisture levels.

Rectification should be carried out as soon as practicable by a qualified carpenter or builder to separate the timber from soil and install an appropriate barrier.

A licensed termite management technician is also recommended to inspect the area and advise on suitable termite management system options once conducive conditions are reduced.

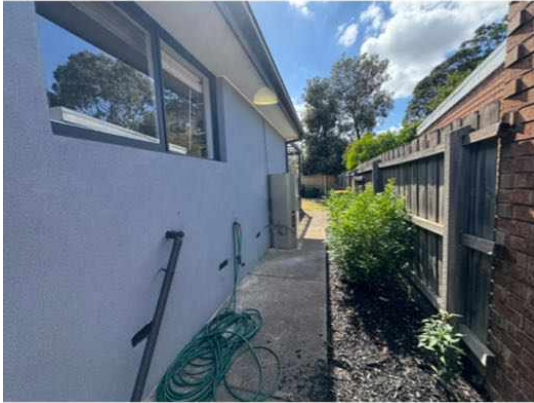
Finding 6.05

Building: Main Building
 Location: All Areas
 Finding: Air Conditioner Overflow – Disconnected
 Information: The air conditioner overflow pipe was found disconnected from the stormwater drainage system, resulting in excess moisture around the external wall.

This moisture can create conditions conducive to timber decay and termite activity if not managed.

A licensed plumber should reconnect the overflow to prevent ongoing dampness as soon as practicable.

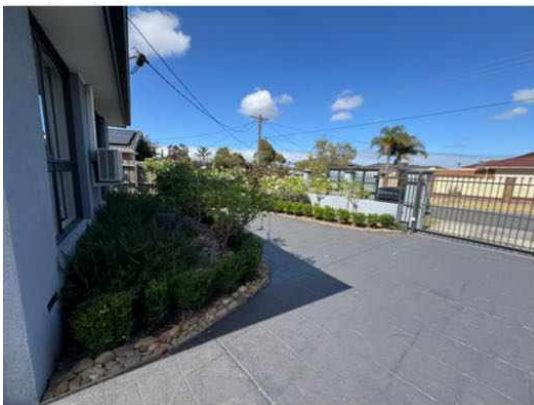
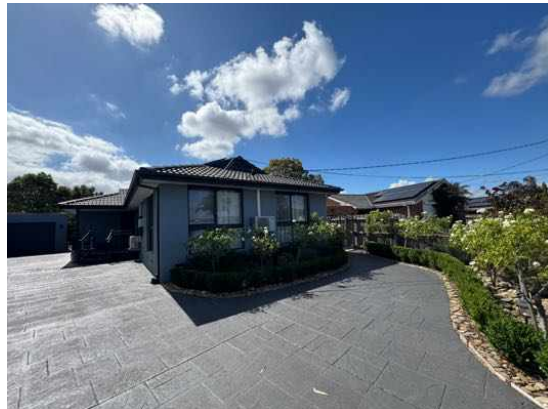
Finding 6.06

Building:	Main Building
Location:	All External Areas
Finding:	Vegetation, Soil and Mulch Against Property – Conductive Conditions
Information:

Trees, vegetation, mulch, and soil were noted in direct contact with sections of the external walls. This condition retains moisture against the structure, can conceal deterioration, and reduces visibility for timber pest inspection. A clear physical separation or barrier is required to protect the building.

Moisture retained against external walls is conducive to termite activity, and this should be addressed as soon as practicable to prevent potential deterioration of nearby building materials.

Rectification should include lowering soil or mulch levels, trimming vegetation away from walls, and creating an adequate barrier or clearance line around the perimeter. A licensed gardener, landscaper, or pest technician can assist depending on the required works.

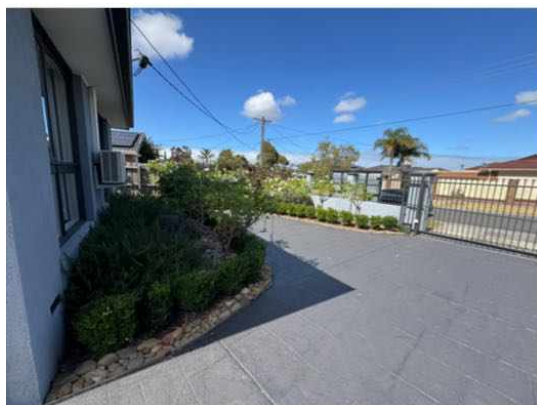
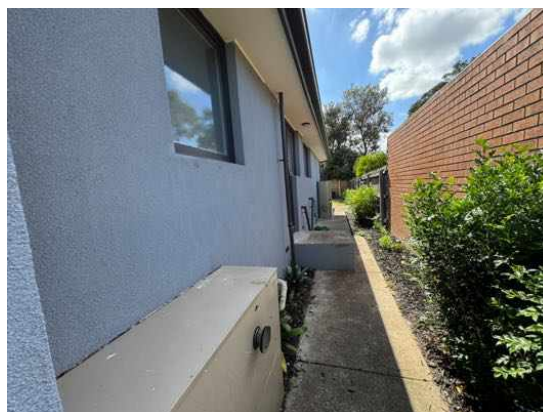
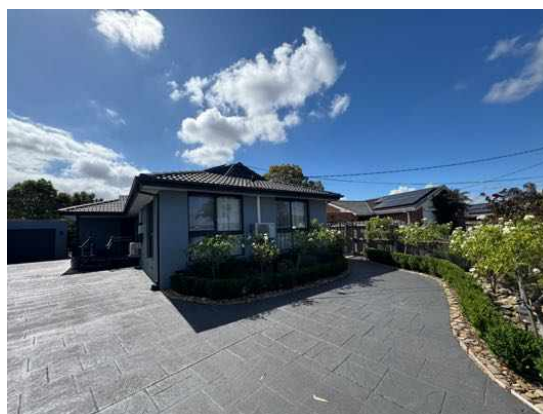
Finding 6.07

Building:	Main Building
Location:	All External Areas
Finding:	Bridging – Attachment in Contact with Building
Information:	An attachment was observed in direct contact with the external wall, creating a potential concealed entry point for termites. This condition bypasses any termite management system or inspection zone and restricts visibility for inspection.

Bridging occurs when fixtures such as posts, downpipes, decks, or steps are not separated from the structure and do not maintain a minimum 25mm inspection gap. These conditions increase the risk of undetected termite activity.

This area should be regularly monitored for signs of termite activity by a licensed termite management technician, and steps should be taken to maintain clear access for future inspections.

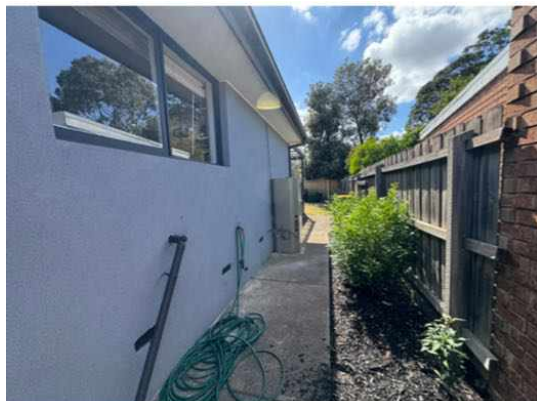
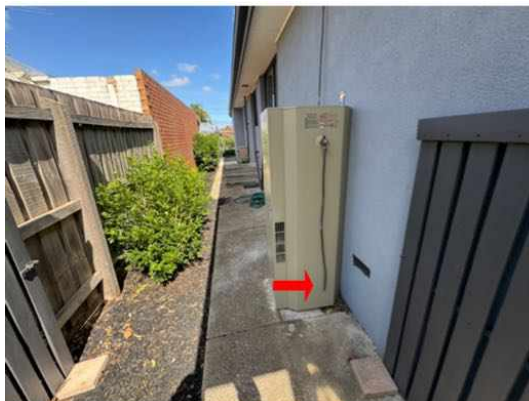
Finding 6.08

Building:	Main Building
Location:	All External Areas
Finding:	Air Conditioner Overflow – Disconnected
Information:	The air conditioner overflow pipe was found disconnected from the stormwater drainage system, resulting in excess moisture around the external wall.

This moisture can create conditions conducive to timber decay and termite activity if not managed.

A licensed plumber should reconnect the overflow to prevent ongoing dampness as soon as practicable.

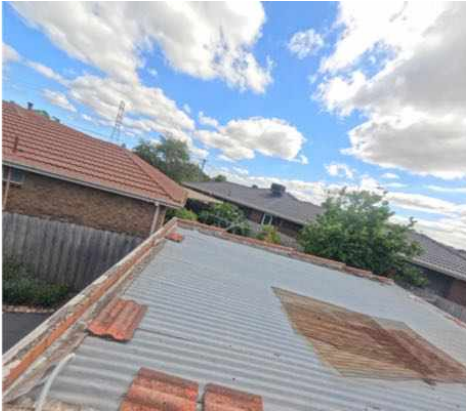
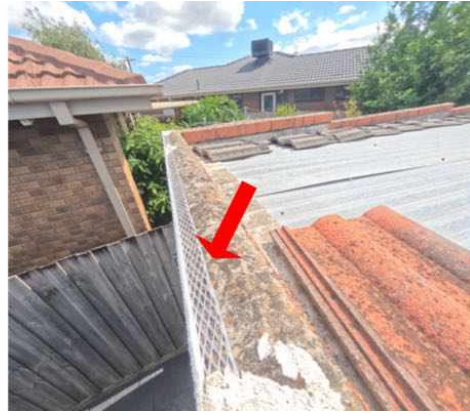
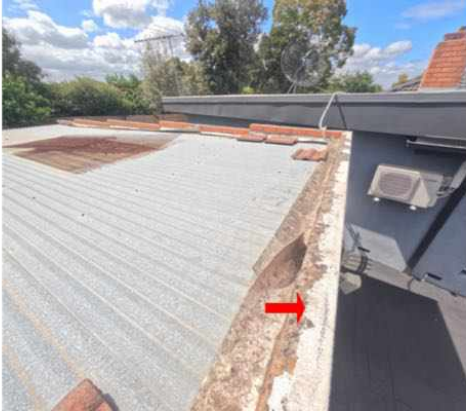
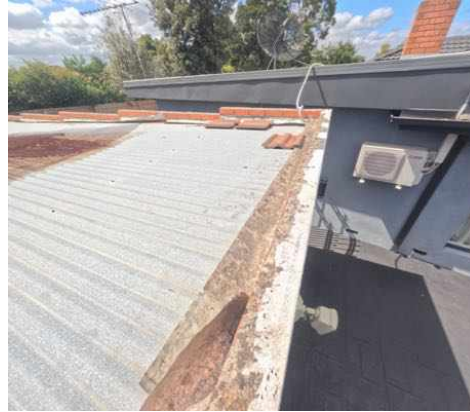
Finding 6.09

Building: Main Building
 Location: Roof Exterior
 Finding: Parapet / Roof Junction – Unfinished Render & Missing Flashing (Water Ingress Risk)
 Information:

The parapet wall and adjoining roof junction were observed with unfinished or deteriorated render and no visible flashing installed at the interface between the parapet and roof sheeting. This detailing does not provide adequate weatherproofing to prevent water penetration at this junction.

In the absence of proper flashing and with exposed or unfinished render, rainwater may enter behind the wall and roof junction, leading to moisture ingress and progressive deterioration of adjacent building materials. Ongoing moisture at this location is conducive to deterioration and creates conditions conducive to termite activity where timber elements may be present.

This issue should be rectified as soon as practicable. Installation of appropriate flashing and completion or repair of the rendered finish should be carried out by a licensed roof plumber or suitably qualified builder to reduce the risk of ongoing water ingress and associated damage.

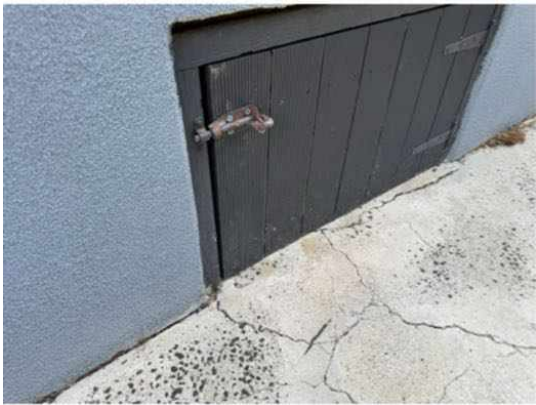
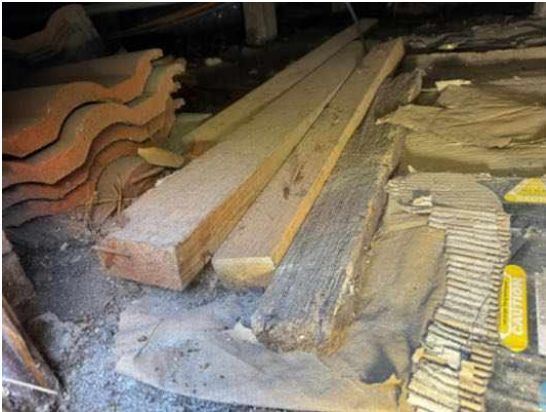
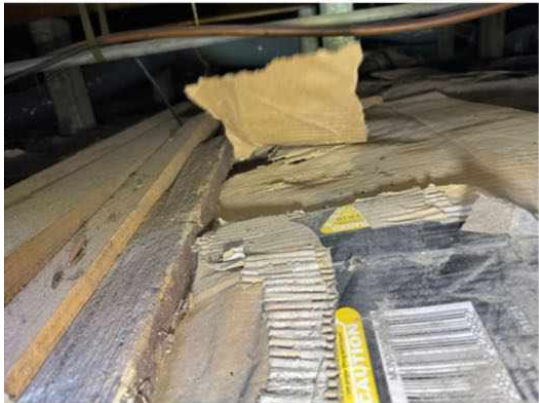
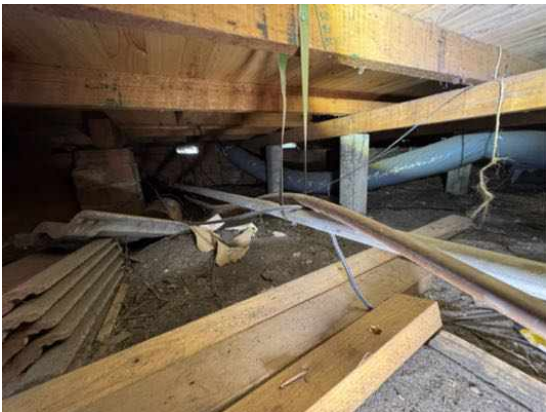
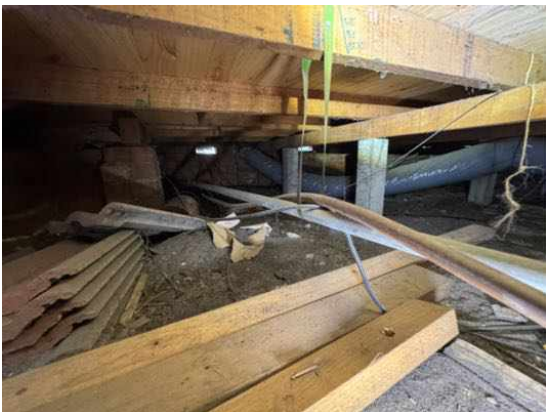
Finding 6.10

Building:	Main Building
Location:	Subfloor
Finding:	Subfloor – Loose Timber and Cardboard
Information:	Loose timber and cardboard were found in the subfloor. These materials were in contact with the ground and close to structural parts of the building.

Timber and cardboard can hold moisture and attract termites. They also make it harder to see parts of the subfloor clearly during inspection.

These materials must be removed by a qualified person, and the area must be kept under regular monitoring by a licensed termite management technician as soon as practicable.

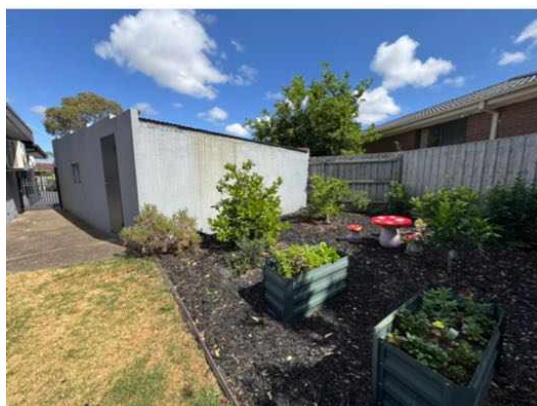
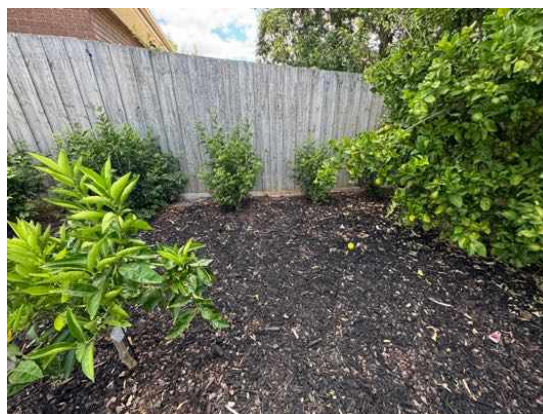
Finding 7.01

Building:	Main Building
Location:	All Areas
Finding:	Timber Elements – Suspected Decay and Deterioration
Information:	A section of the external timber elements shows signs of possible decay and deterioration. This condition may be related to weathering, inadequate sealing, or moisture exposure affecting the integrity of the timber surfaces.

If not attended to, deterioration may progress and affect the performance of the surrounding building materials. Any moisture in contact with timber is conducive to termite activity, so this matter should be addressed as soon as practicable to avoid further damage.

Rectification should be carried out by a licensed carpenter or builder, who can repair or replace affected sections and ensure all exposed timber is properly sealed and protected. A licensed structural engineer may be required if any structural impact is suspected.

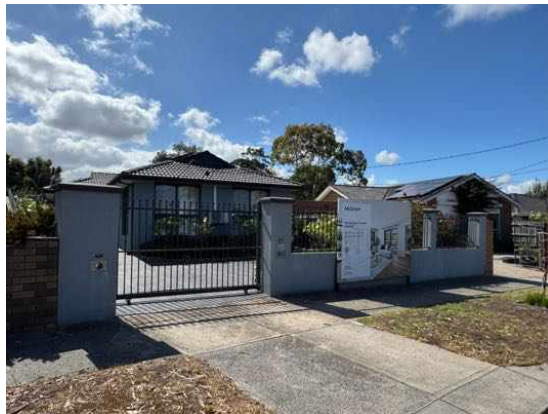
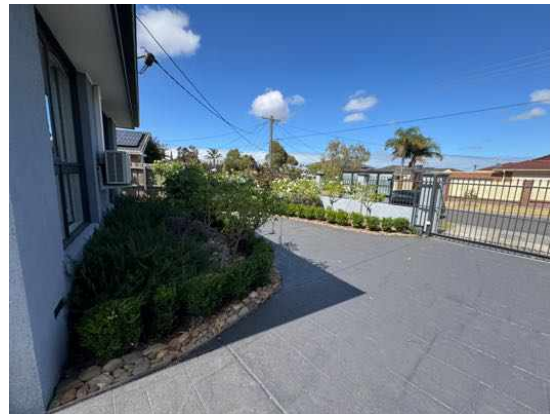
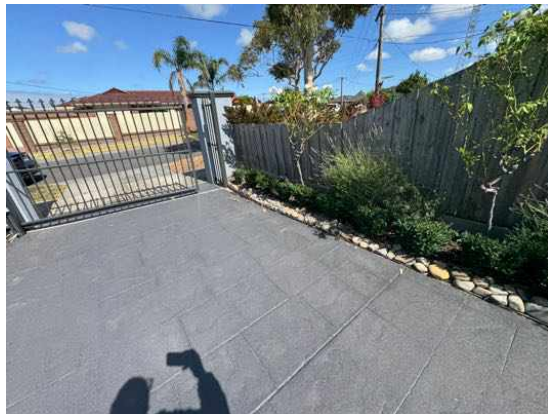
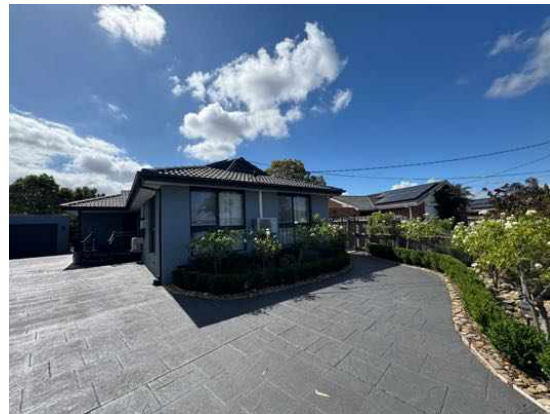
Noted Item

Building: Main Building
Location: All Areas
Finding: Additional Photos - Obstructions and Limitations
Information: These photographs are an indication of the obstructions and limitations which impeded full inspection of the property at the time of inspection. These obstructions can hide an array of defects and should be removed to allow full inspection to be carried out. A re-inspection is recommended once the areas are made accessible.
