Building and Timber Pest Inspection Report

Inspection Date: Thu, 5 Feb 2026

Property Address: 25 merrigum crescent , Clarinda ,3169

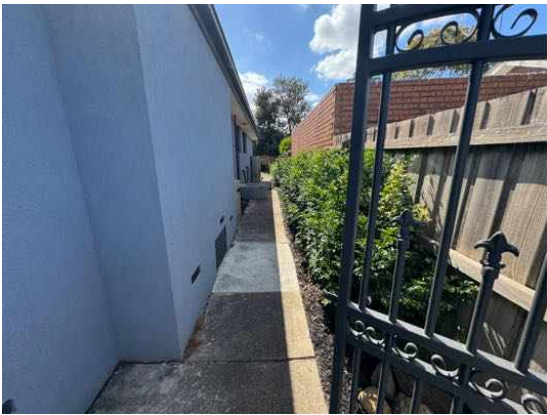
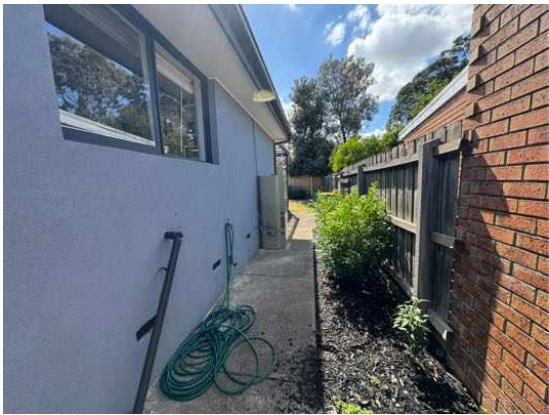
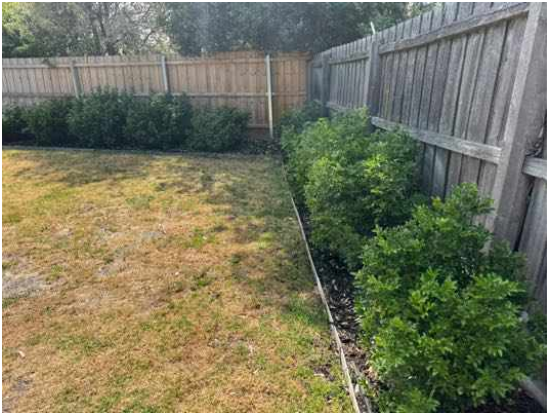
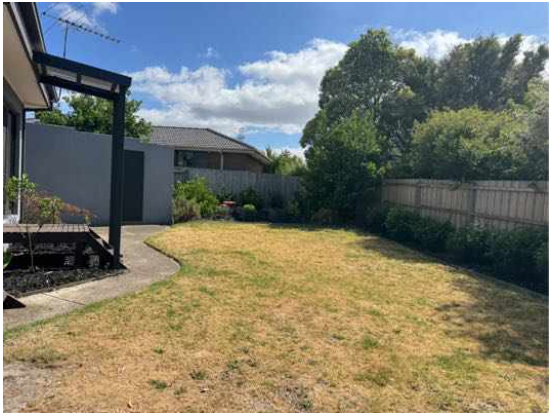
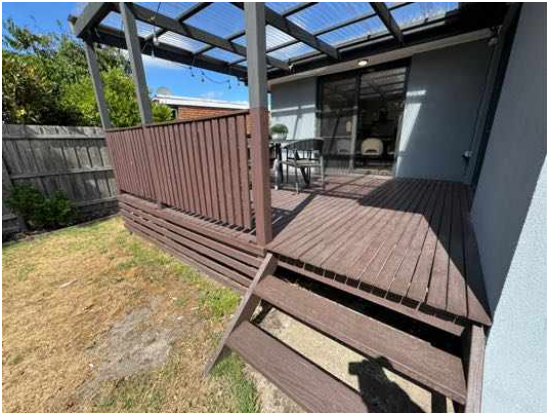
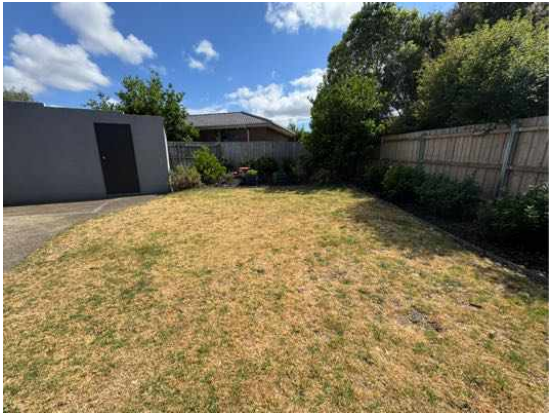
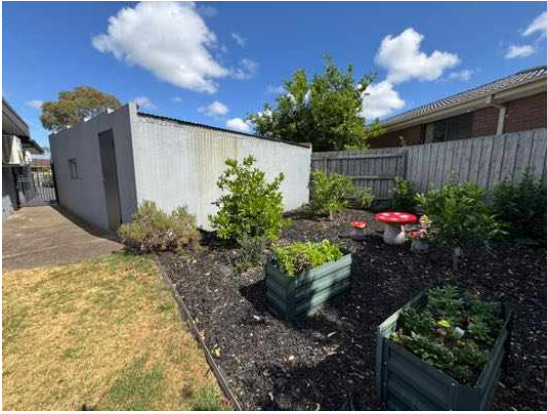
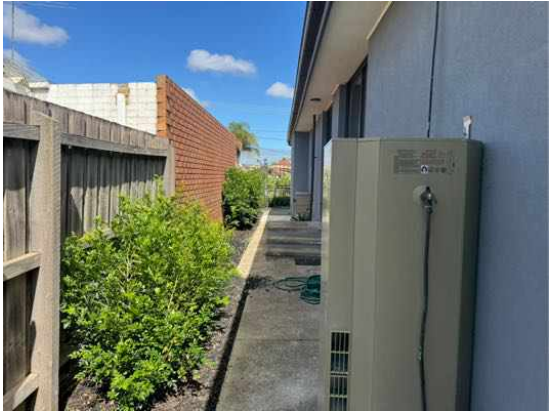
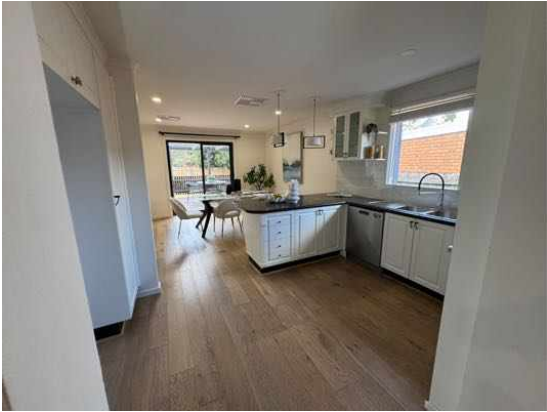
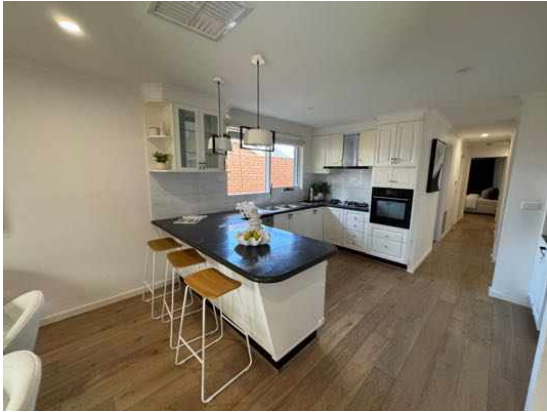
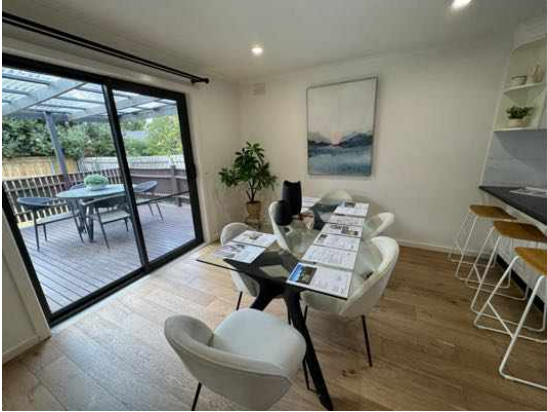
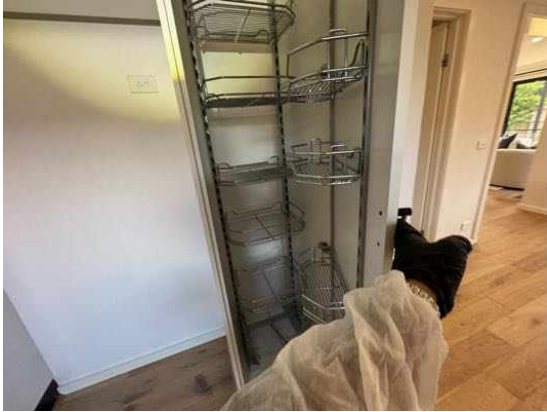
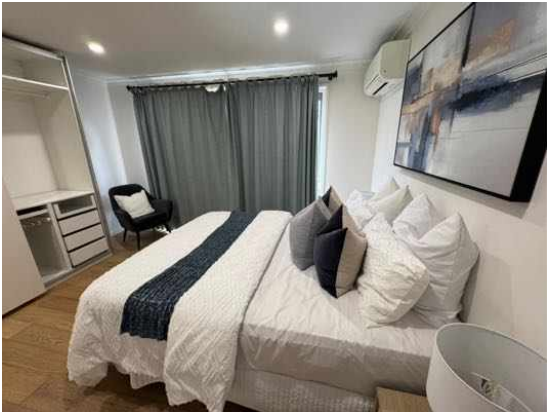
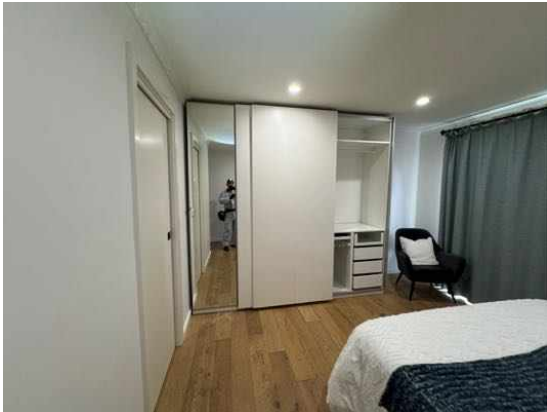
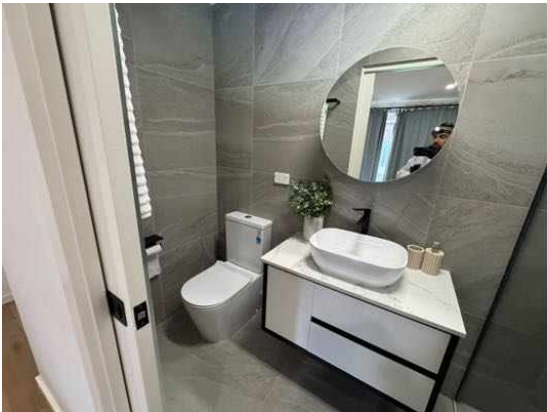
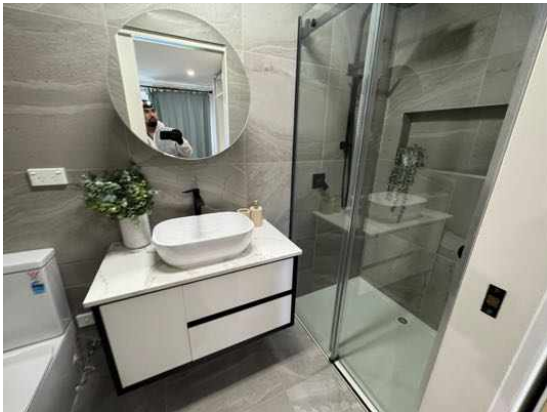
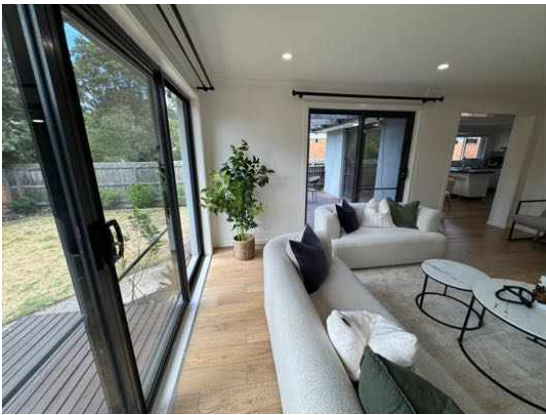
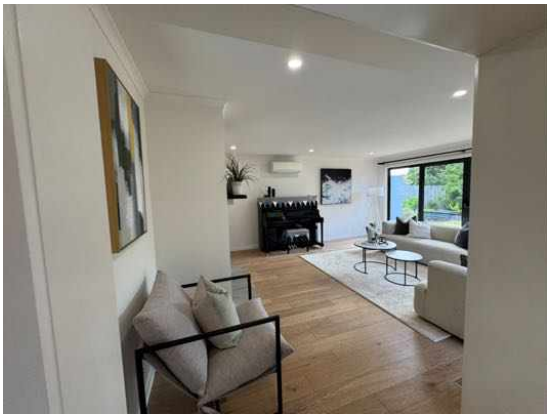
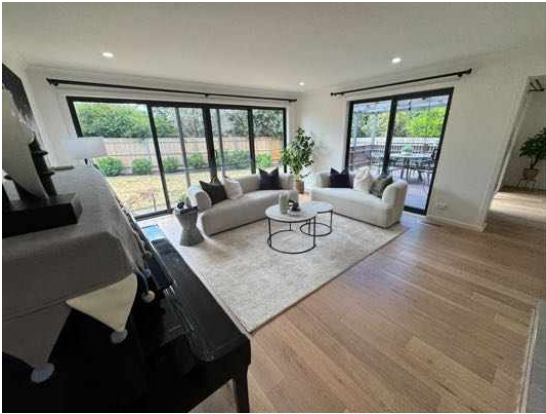
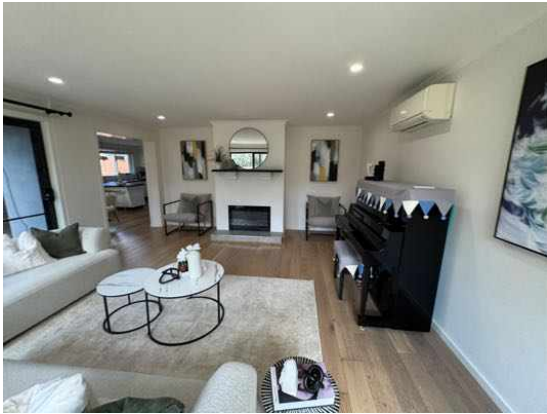
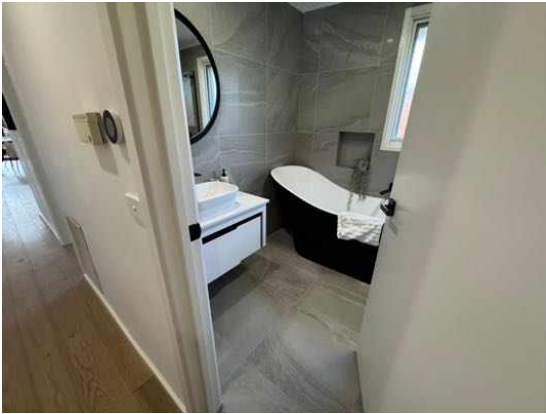
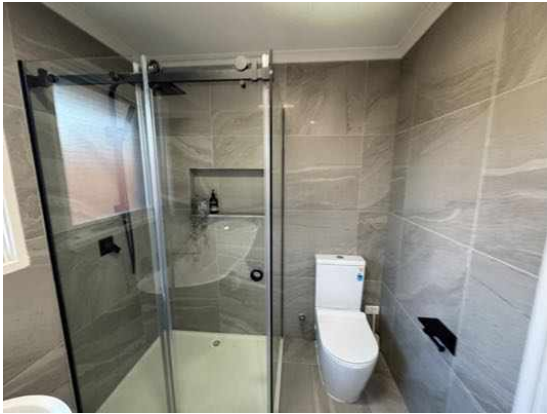
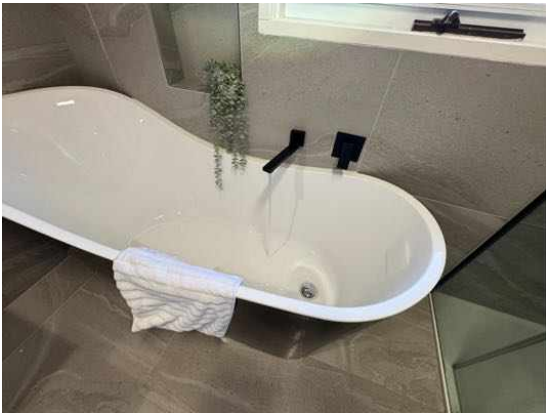
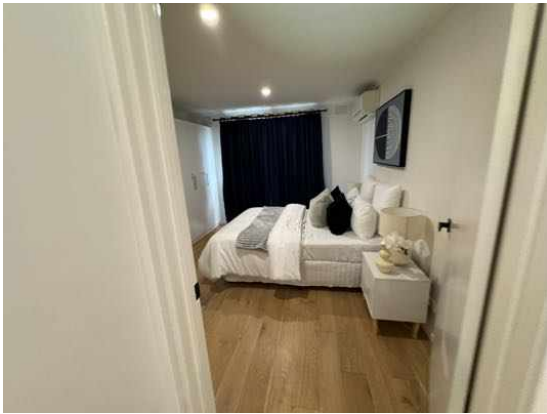
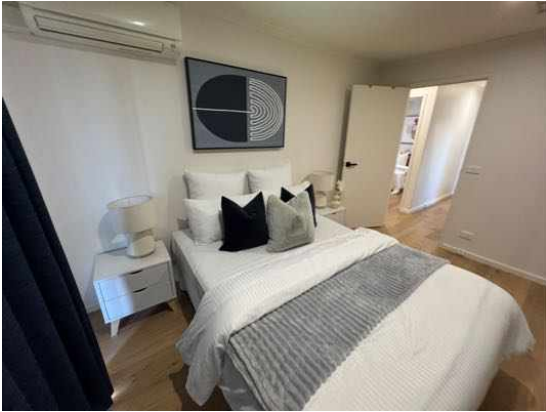
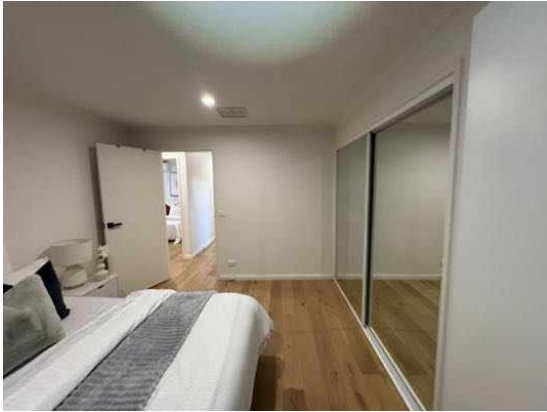
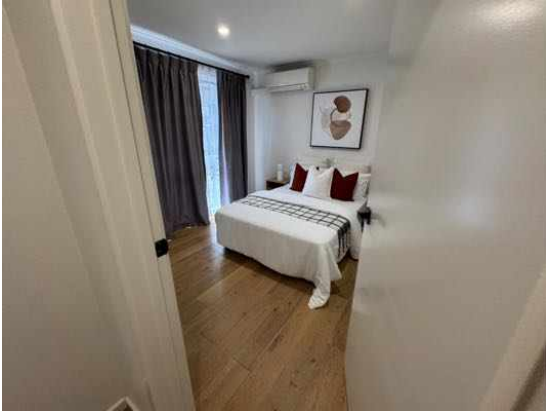
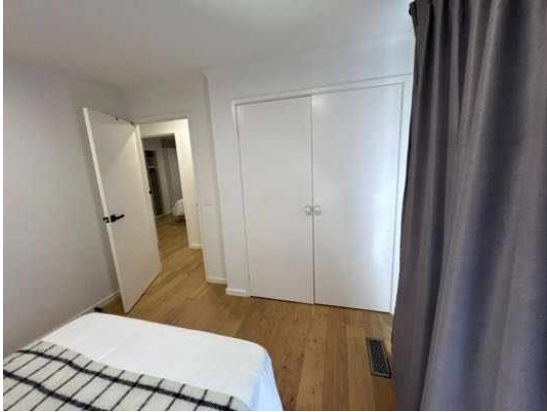
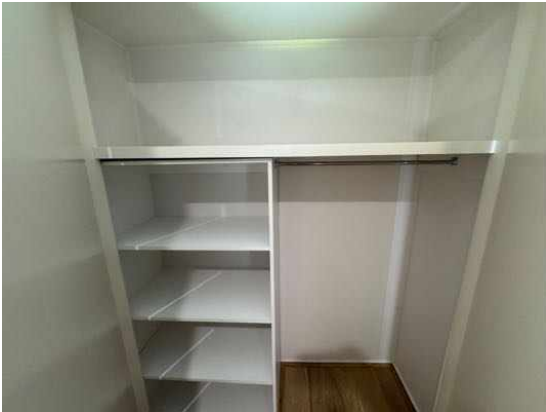
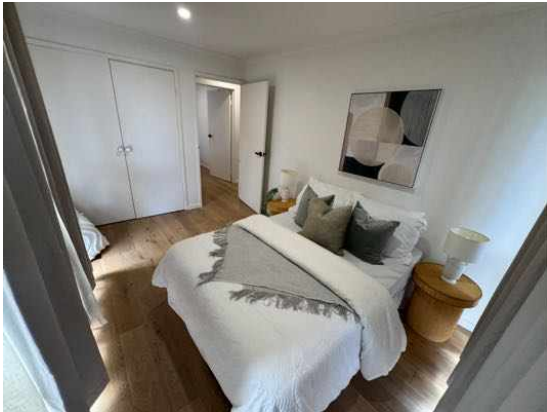
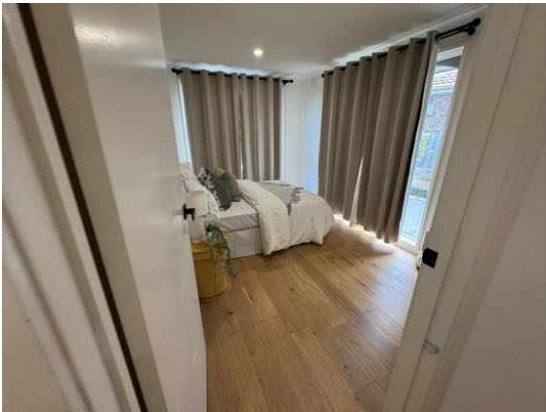
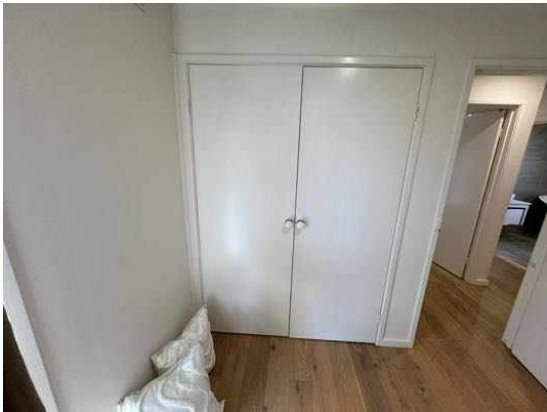
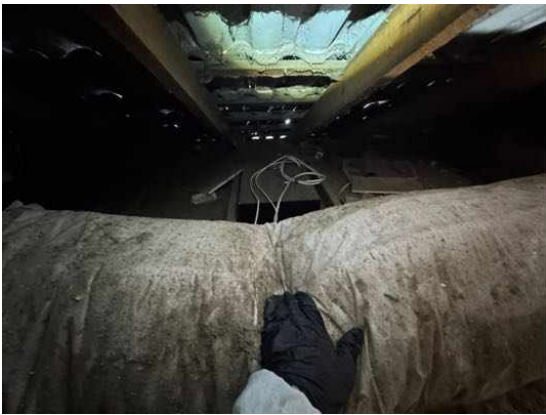
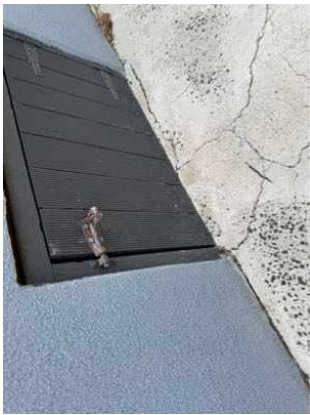
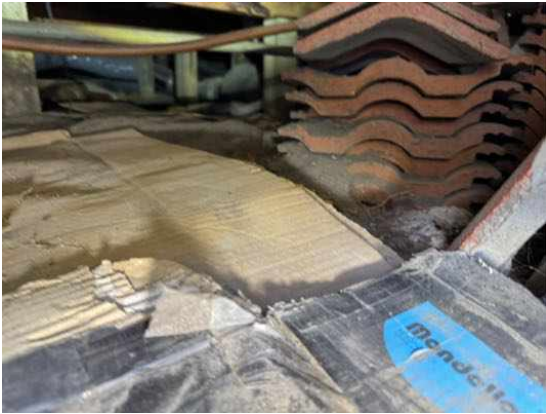
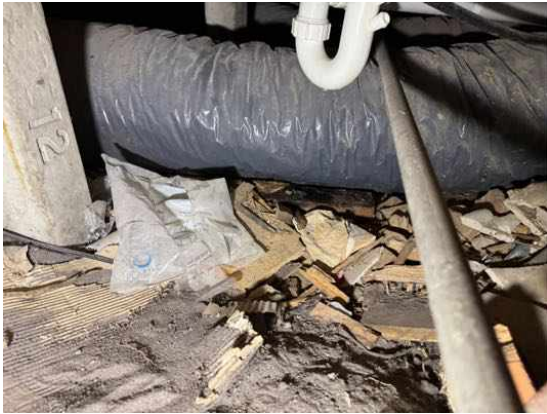
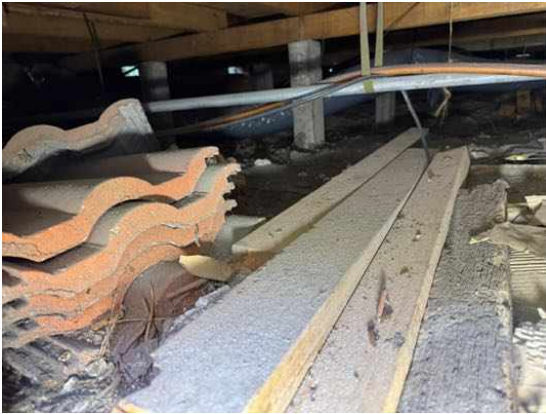
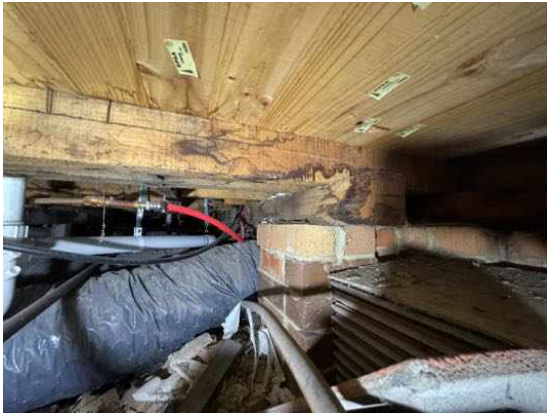
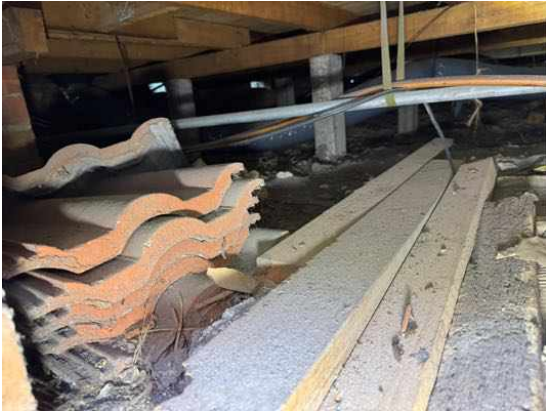
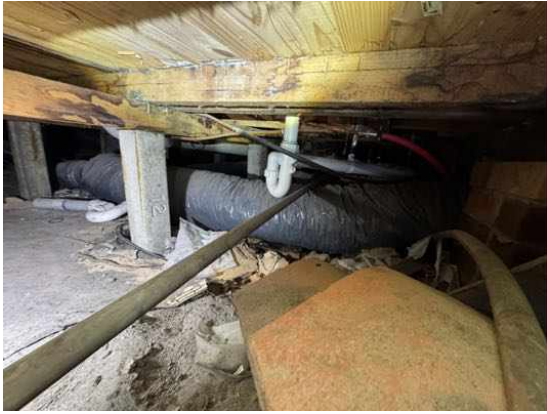
Building: Main Building
Location: All Areas
Finding: Additional Photos - Obstructions and Limitations
Information: These photographs are an indication of the obstructions and limitations which impeded full inspection of the property at the time of inspection. These obstructions can hide an array of defects and should be removed to allow full inspection to be carried out. A re-inspection is recommended once the areas are made accessible.

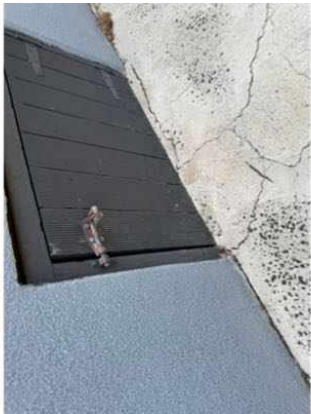
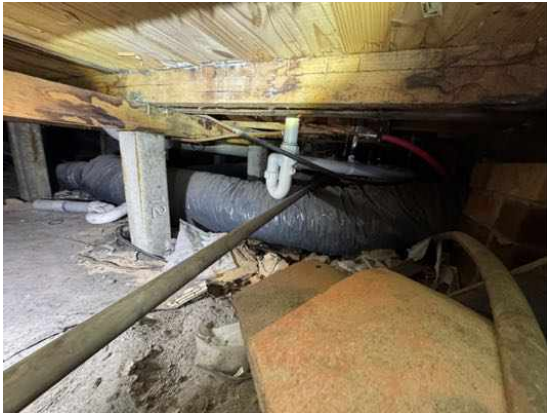
Building: Main Building
Location: All Areas
Finding: Subfloor – Limited Access for Termite Inspection
Information: Access to the subfloor area was restricted due to inadequate clearance and physical obstructions, preventing full visual assessment of the internal timbers and perimeter areas.

This condition increases the risk of concealed termite activity or damage, as these areas cannot be fully inspected.

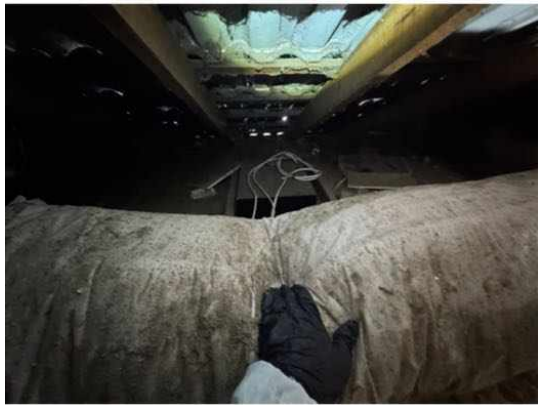
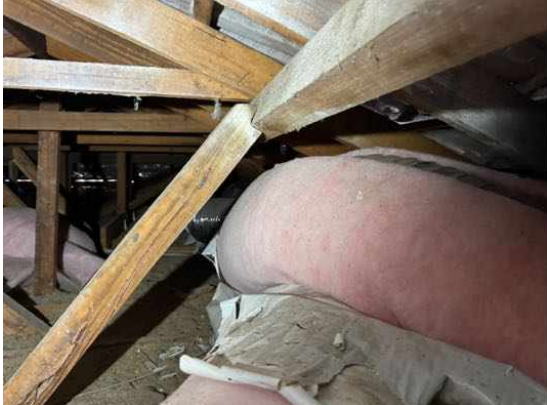
Building: Main Building
Location: Roof Void
Finding: Roof Void – Limited Access
Information: Access to the roof void was limited due to restricted clearance, structural obstructions, or safety constraints. This reduced visibility may prevent a full assessment of roof framing, insulation, services, and potential moisture-related conditions within the space.

Limited access can result in sections of the roof void remaining uninspected, meaning concealed defects such as leaks, timber deterioration, or conducive moisture conditions may not be fully identifiable during the inspection.

Further assessment should be carried out as soon as practicable by a licensed builder, roofer, or pest technician if safe access becomes available, or if any signs of moisture or structural concerns appear elsewhere in the property.
