Building and Timber Pest Inspection Report

Inspection Date: Mon, 19 Jan 2026

Property Address: 25 Wattle St, Rydalmere NSW 2116,
Australia

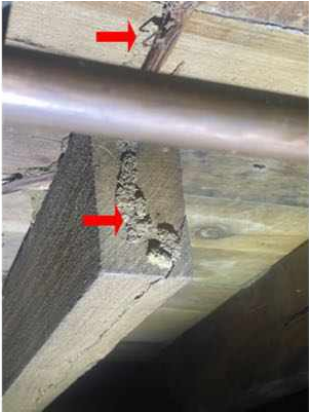
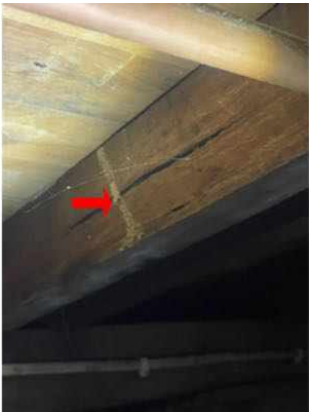
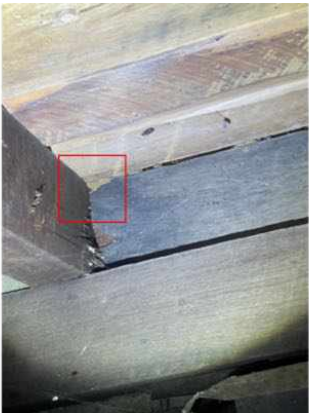
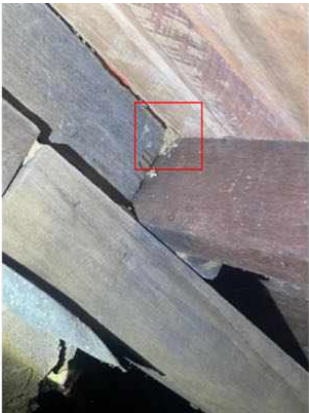
It is advised that the area be visually inspected frequently and also invasive inspection is required to determine the extent of damage if there is an in the walls .

A building contractor may be appointed to provide a further invasive inspection if further damage is evident.

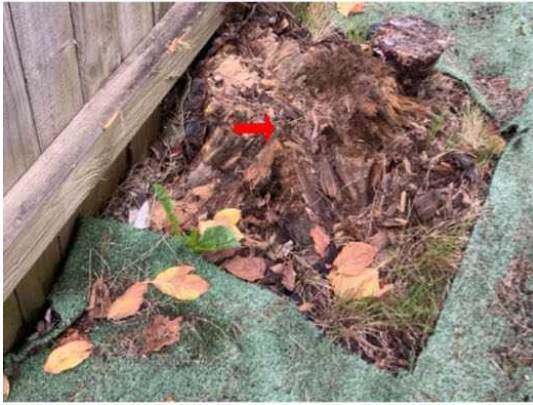
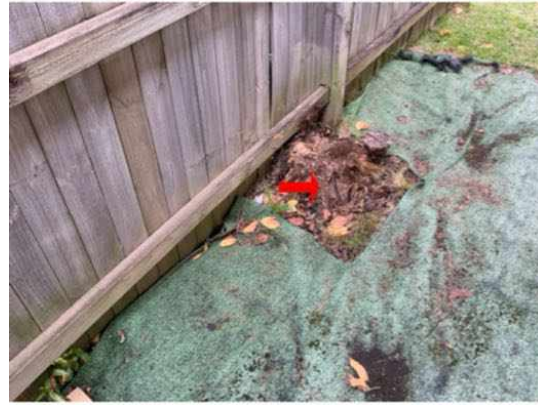
Finding 6.01

Any tree stumps that are in direct contact with external grounds provide ingress for subterranean termites into that particular element.

The removal of any tree stumps that may be conducive to termite activity should be removed as soon as possible to minimise the risk of termite attack or alternatively drill and testing all tree stumps will be required to determine the presence of termite activity

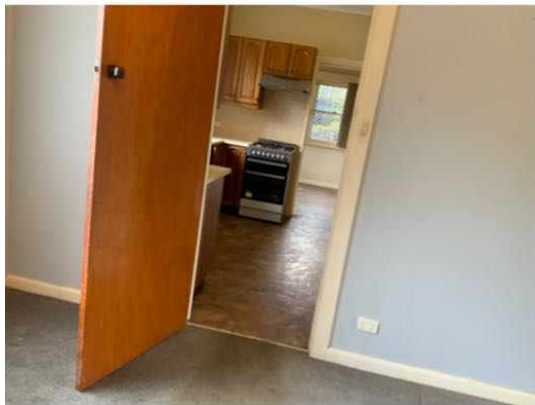
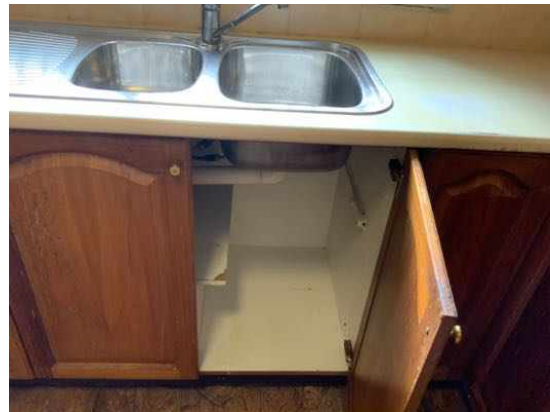
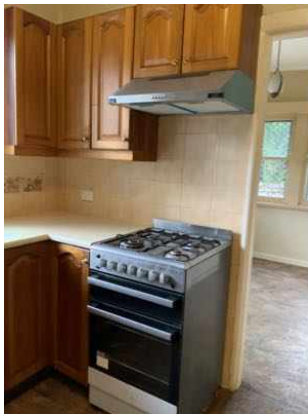
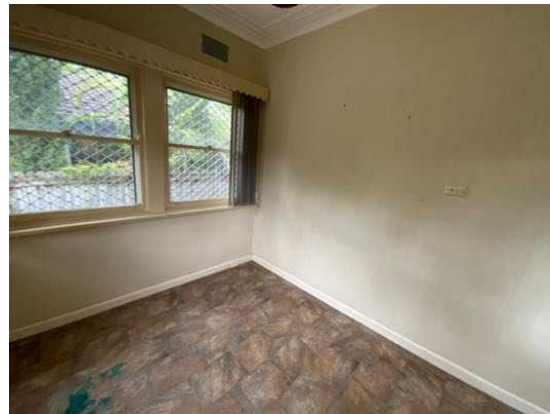
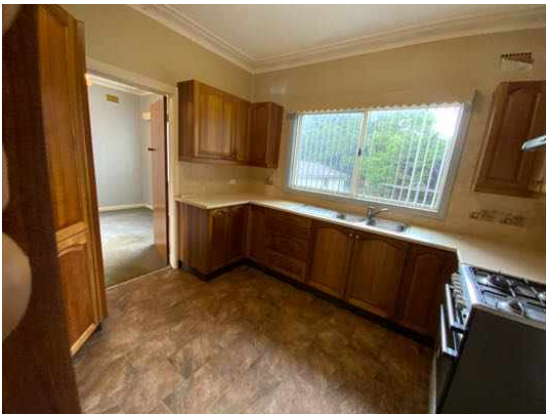
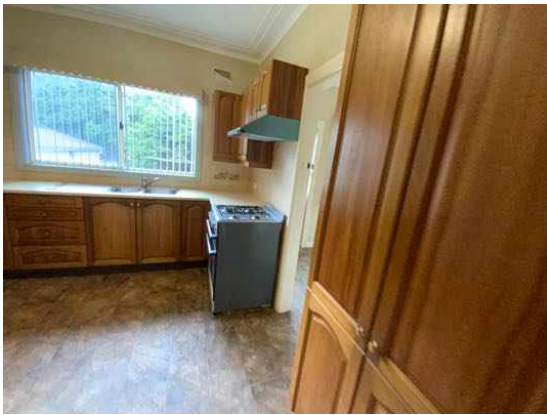
Building: Main Building
Location: All Areas
Finding: Additional Photos - Obstructions and Limitations
Information: These photographs are an indication of the obstructions and limitations which impeded full inspection of the property at the time of inspection. These obstructions can hide an array of defects and should be removed to allow full inspection to be carried out. A re-inspection is recommended once the areas are made accessible.
