Building and Timber Pest Inspection Report

Inspection Date: Mon, 2 Mar 2026

Property Address: 1 Clydesdale Ct, Mooroopna VIC 3629,
Australia

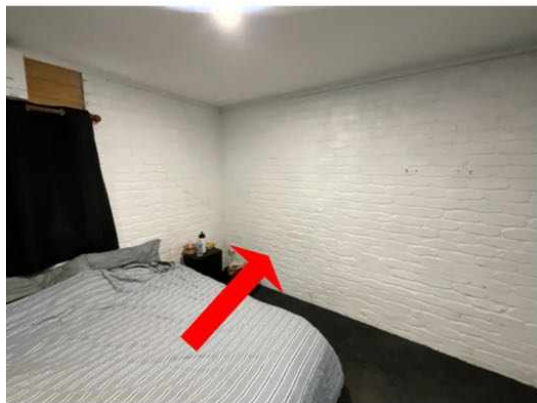
Building: Building 1
Location: Bed 1
Finding: Brickwork- Step cracking
Information: Step cracking was identified to the brickwork in this area at the time of inspection. Step cracking, which is similar to other forms of cracking, has a variety of possible causes. However, the most common is the subsidence of adjacent footings.

Step cracking is a relatively common defect, and is most likely to occur adjacent to windows, doors and other openings. Mortar failure in the gaps between affected bricks indicates the stresses and tensions affecting the wall.

Minor step cracking can be used as a warning sign to address factors causing stress to the wall, which can include the effect of surrounding trees, water leaks, soil erosion, or even the presence of reactive soils in the surrounding area.

If cracks increase in size or number contact a Licensed builder immediately to make all needed repairs.

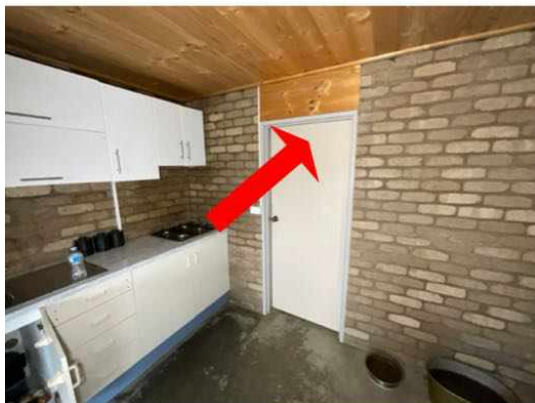
Building:	Building 1
Location:	Laundry, Wc
Finding:	Door- Binding/jamming
Information:	Binding and/or jamming of this door is evident during standard operation. This defect inhibits the functionality of the affected door as well as creating potential for secondary defects to associated building elements, such as damage to the floor covering.

A door that binds to flooring or to the associated door frame may have several causes, ranging from minor defects, such as poor installation of the door or deteriorated hinges, through to major structural issues, such as damage to subfloor structures.

A qualified carpenter or general handyperson should be appointed to perform minor rectification works at client discretion.

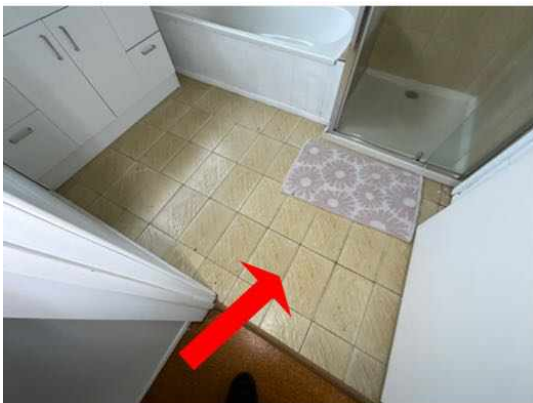
Finding 3.04

Building:	Building 1
Location:	Bathroom > Level 1
Finding:	Cracked floor tiles
Information:	Cracking in the floor tiles was evident in this area at the time of inspection. It is suspected that this cracking has occurred as a result of minor settlement or impact damage.

Cracked tiles throughout the household detract from the overall appearance of the affected areas however it is unlikely to create or lead to any secondary defects.

While not considered a matter of urgency, replacement of cracked floor tiles is recommended at the clients discretion. A tiling contractor may be appointed to perform these works. Where cracks become more numerous, contact a licensed building inspector for further investigation.

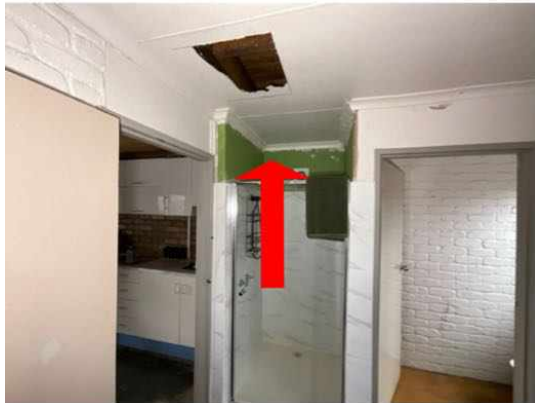
Building:	Building 1
Location:	Laundry
Finding:	Water leak - Inactive
Information:	Water leaks generally occur when a particular area of the property is not weather- or water-tight. While the damage in this area appears to be from an old inactive water

leak, the area should be monitored frequently for the recurrence of any dampness.

Repair and / or replacement of previously affected building elements is at client discretion. Consider a further invasive inspection: removal of obstructions around the damaged area may reveal further damage which has been concealed. A more significant or major defect may be identified at this time.

Where recurrence of an active water leak is identified, a qualified plumber should be appointed immediately to rectify the leak and advise on any further preventative works as necessary.

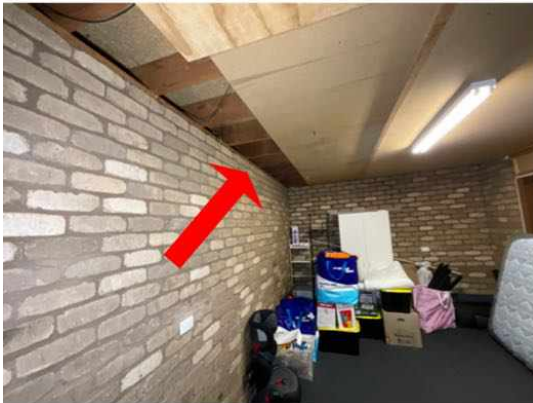
Building: Building 1
 Location: Ground floor
 Finding: Installation - substandard or incomplete
 Information: The installation of this building element appears to have been completed to a substandard level of workmanship or is incomplete. Generally substandard repairs or installation are related to poor workmanship, the use of inappropriate materials, or a failure to complete installation to a suitable standard.

Where installation is substandard and/or incomplete, the client should contact the responsible trade to undertake rectification. Unfinished and substandard building works are likely to degrade more quickly and may create potential for secondary defects to associated building elements.

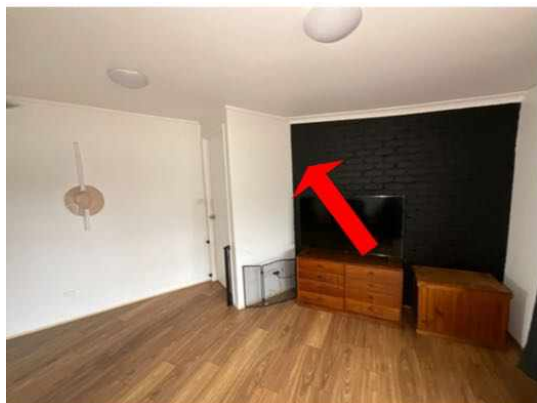
Finding 3.09

Building: Building 1
 Location: Living > Level 1
 Finding: Cracking - Damage Category 2 - Noticeable (up to 5mm)
 Information: Noticeable cracks are a common occurrence as a result of many primary defects. Such causes may include age, general wear and tear, expected building movement, general expansion/contraction of building materials in different weather conditions, and/or minor failings in the installation or application of building materials.

Noticeable cracks may result in minor sticking or jamming of associated doors and windows, which require easement. However, noticeable cracks are easily filled and repaired. A plasterer can be consulted to install an expansion joint at this point to allow

for this movement during different weather conditions.

Monitoring of all cracking should be conducted frequently. Always contact a building inspector should cracks widen, lengthen, or become more numerous. Additionally, your building inspector should also be contacted if associated building elements such as doors and windows become more difficult to operate over time.

Relevant tradespeople, such as carpenters, painters and plasterers, should be appointed to perform remedial works, as deemed necessary.

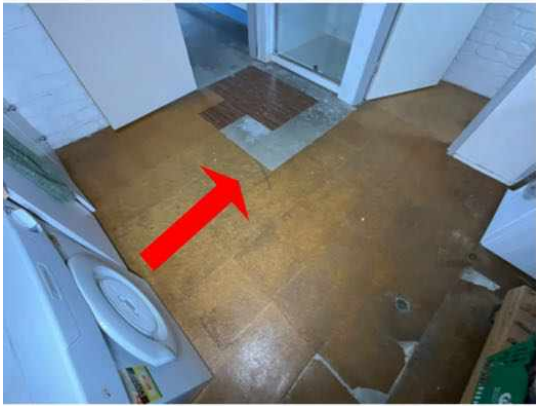
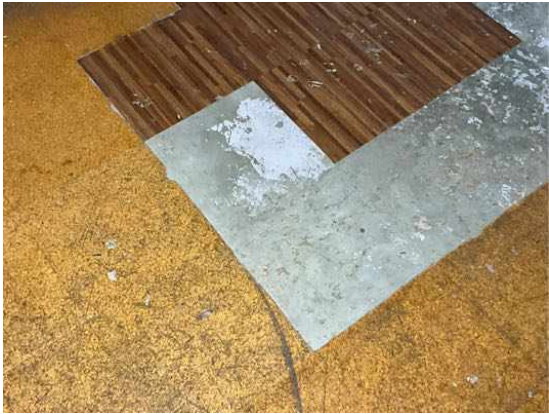
Finding 3.12

Building: Building 1
Location: Laundry
Finding: Cork floor lifting
Information:

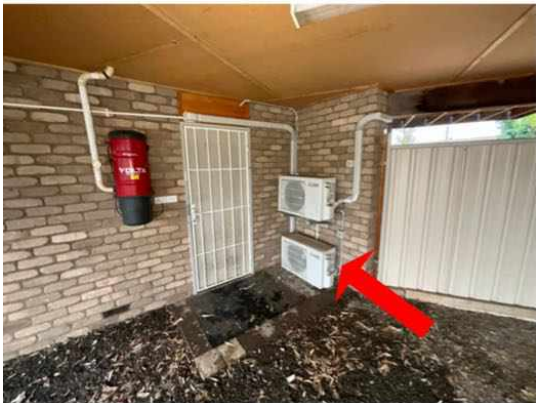
Such leaking creates an environment which is conducive to an array of defects, including water damage to associated building elements and the attraction of termite or timber pest infestation.

It is highly recommended that a licensed plumber be appointed to connect the A/C overflow in order to prevent such an environment from being created. These minor works should be carried out as soon as possible.

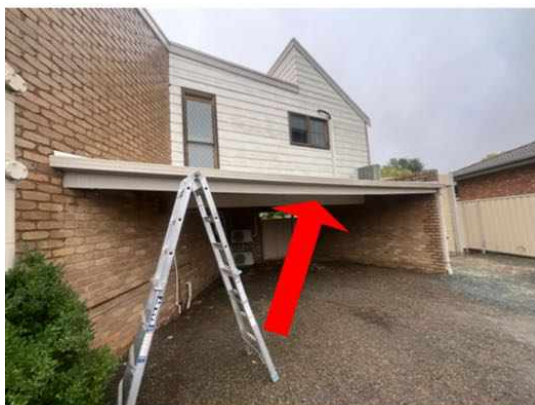
Blocked gutters are likely to lead to high levels of moisture in the affected areas. Such moisture will not only cause rust and decay of the associated building materials, but can also provide conditions that are conducive to termite and timber pest activity. Blockages in gutters should therefore be removed immediately to ensure dry conditions are maintained.

Consult a Licensed Plumber for further specific advice on remedial works that may be required. In the interim, it is highly advised that blocked gutters be removed by the homeowner or a general handyperson as a matter of urgency.

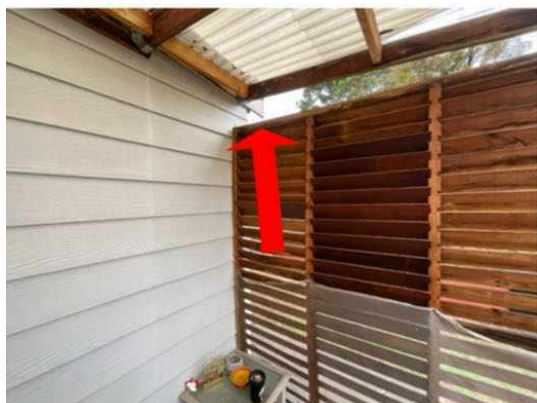
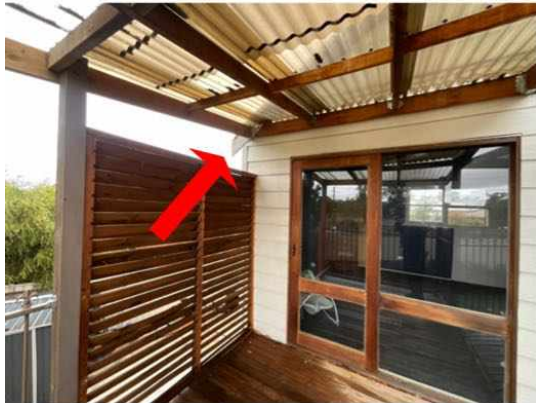
The development of fungal decay is accelerated by temperatures in the range of 5degreeC to 40degreeC as well as the presence of oxygen. Generally fungal decay develops on timber elements that are in use in an external environment which are exposed to rain penetration.

In this case although the affected timber element is in a decaying state the extent of any visible damage appears to be localised to a specific area and is yet to spread to other parts of the building element or affect adjoining structures. The fungal decay is therefore likely to be of a relatively superficial nature with minimal impact on the structural integrity or tensile strength of the timber element.
