Building and Timber Pest Inspection Report

Inspection Date: Tue, 17 Mar 2026

Property Address: 58 Faulconbridge St, The Ponds NSW 2769, Australia

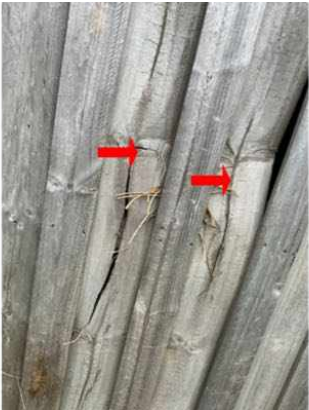
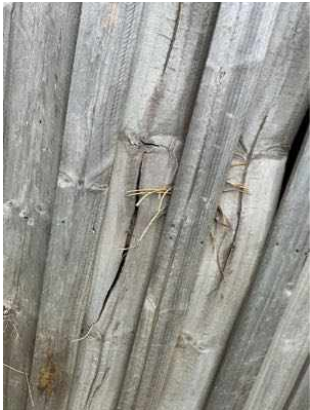
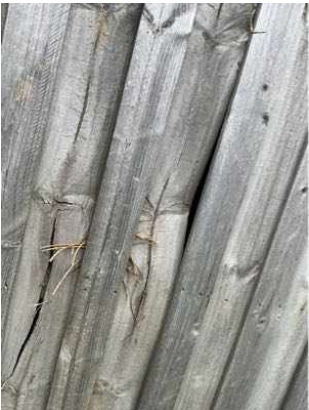
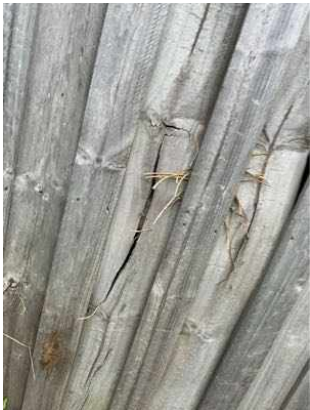
Finding 3.02

Building:	Main Building
Location:	All Areas
Finding:	Deteriorated fence
Information:	The fence along the property boundary has deteriorated significantly, showing signs of rot, rust, and structural weakness. Several sections are leaning or have become detached, compromising the integrity of the fence and its ability to perform its intended function.

The deteriorated fence poses multiple risks:

1. ****Safety Hazard:**** The unstable fence may collapse, posing a risk of injury to residents, visitors, and passersby.
2. ****Security Concern:**** The compromised fence may allow unauthorized access to the property, increasing the risk of theft, vandalism, or trespassing.
3. ****Property Damage:**** Falling sections of the fence could damage nearby structures, plants, or other property features.

- ****Licensed Fencing Contractor:**** A professional fencing contractor should be hired to assess the extent of the damage and either repair or replace the deteriorated sections.
- ****Handyman Services:**** For minor repairs, a qualified handyman could be engaged to reinforce or repair specific sections of the fence.
- ****Landscaper (if the fence is part of a larger garden feature):**** If the fence is integrated into the landscape design, a landscaper with experience in fencing could be involved in the repair or replacement process.

It's important to ensure that whoever is hired is experienced and qualified to ensure the fence is restored to a safe and functional condition, compliant with local regulations.

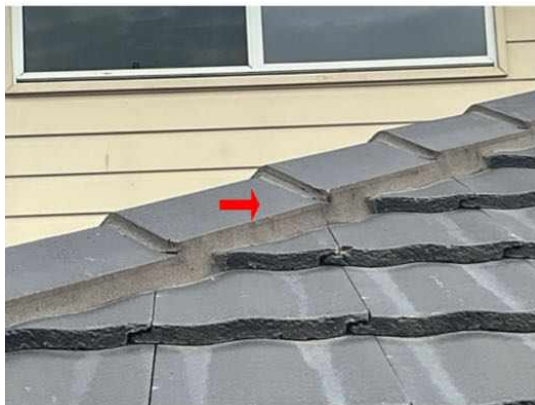
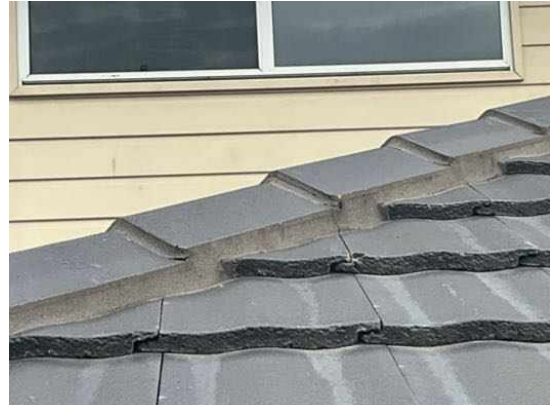
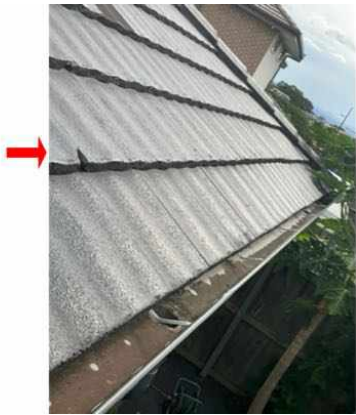
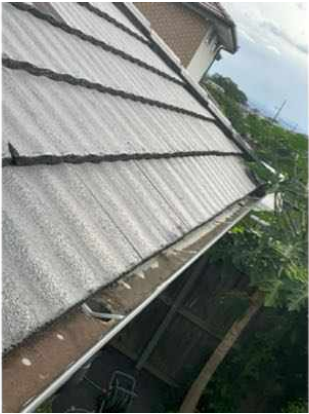
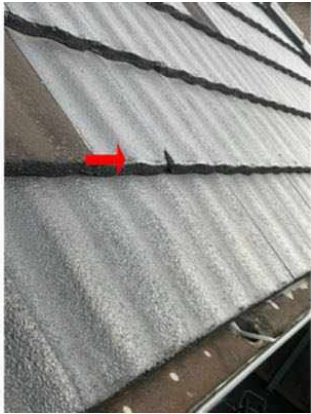
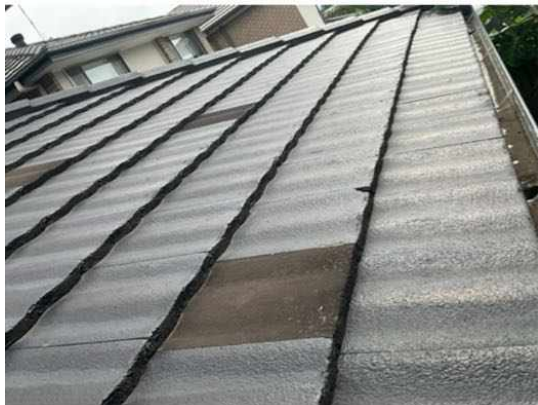
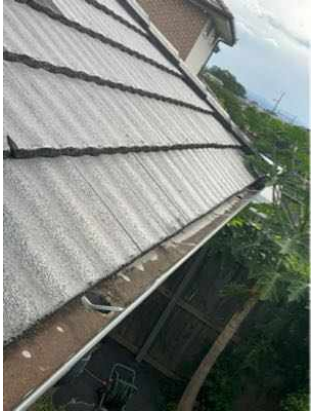
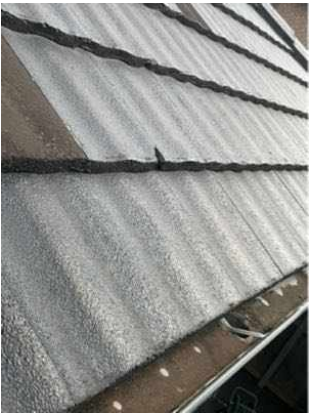
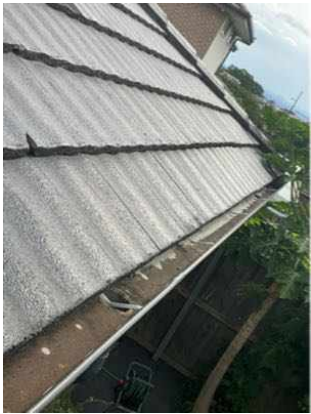
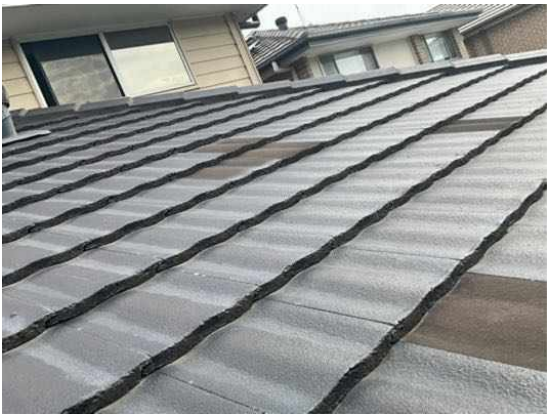
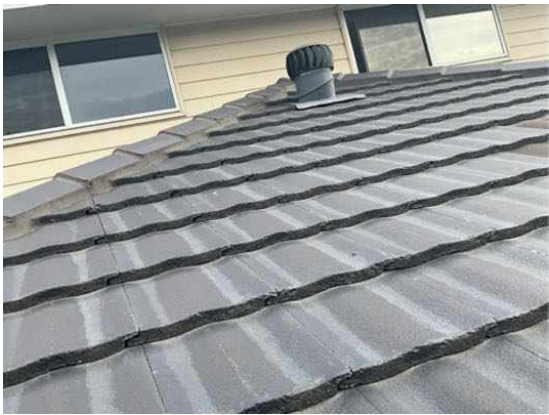
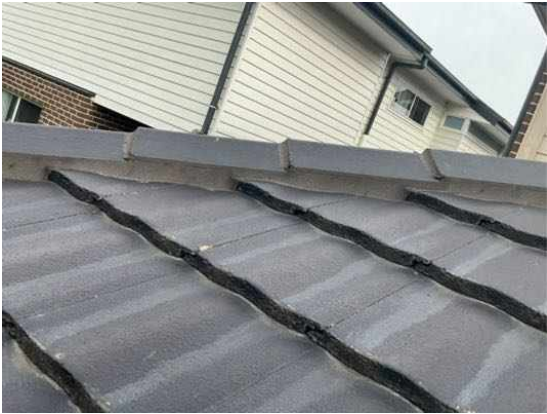
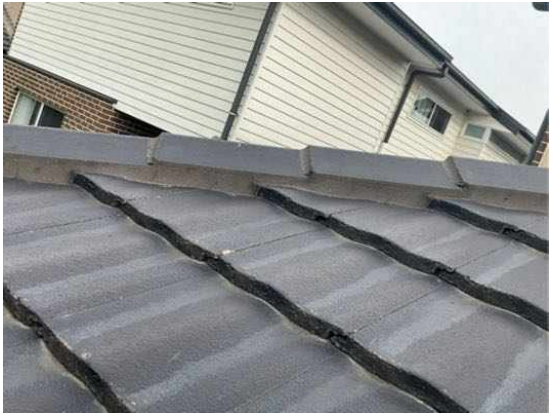
Finding 3.03

Information: Inspection of the roof revealed widespread weathering to the tiled roof surface. The tiles show loss of surface finish, colour fading, and age-related deterioration typical of older roof coverings. Although no significant cracking was noted, weathering can lead to increased porosity, reduced water-shedding capability, and a higher risk of future cracking or displacement during adverse weather conditions.

A licensed roofer should be engaged to undertake a closer inspection, carry out routine maintenance, and replace any tiles that may be compromised. Ongoing monitoring is recommended due to the age and condition of the roof covering.

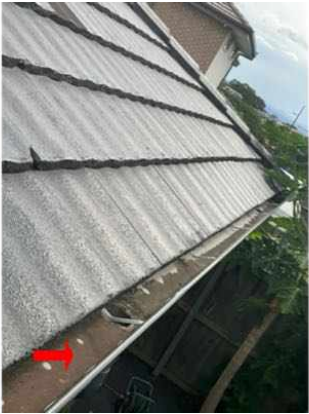
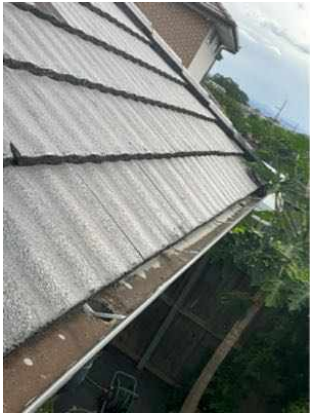
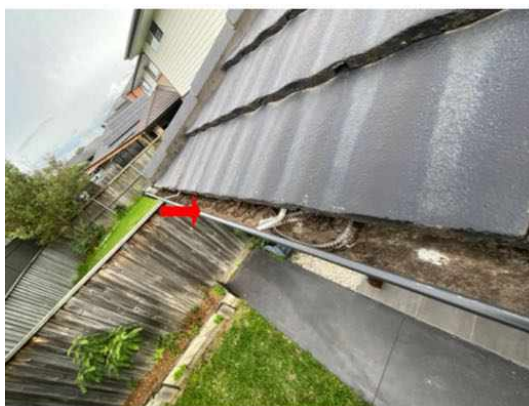
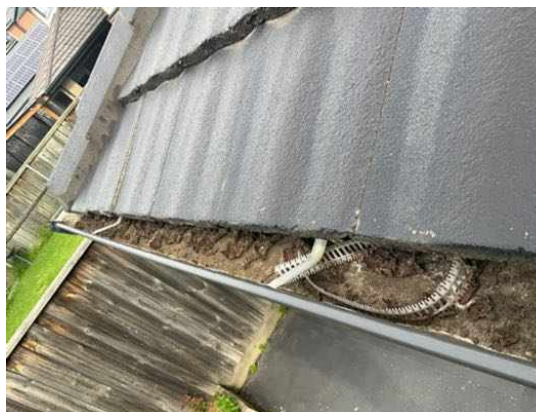
Finding 3.04

Building: Main Building
Location: Roof Exterior
Finding: Blocked Gutters
Information: Blocked gutters , advised gutter to be cleaned.

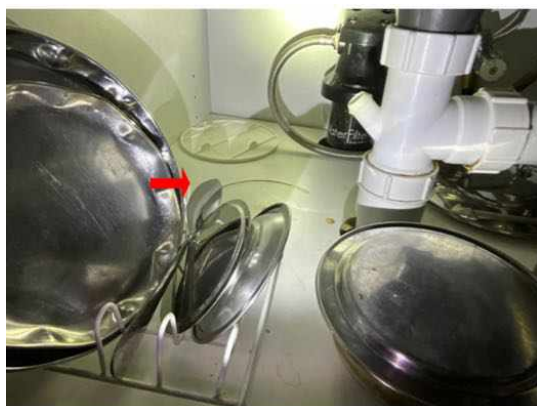
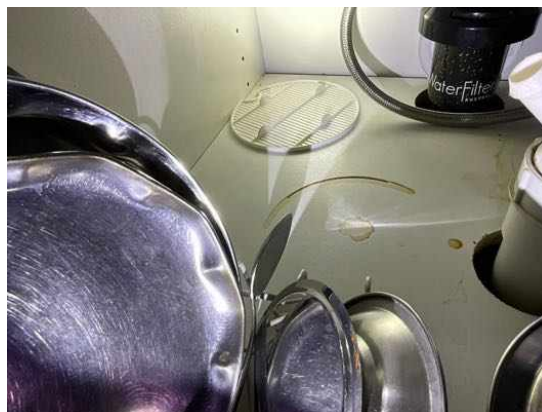
Finding 3.05

Building:	Main Building
Location:	Kitchen
Finding:	Water damage / Vanity
Information:	"The vanity in the shower area has sustained water damage, resulting in swelling and discoloration of the wood, as well as potential structural issues. This damage compromises both the aesthetic and functional aspects of the vanity."

1. **Carpenter or Woodworker:** They can assess and repair the damage to the vanity, potentially replacing any irreparable parts.
2. **Plumber:** If the water damage is due to plumbing issues, a plumber can fix leaks and ensure there are no further water-related problems.
3. **General Contractor:** If the damage is extensive and affects the surrounding area, a general contractor can coordinate the repair work, including both the vanity and any related structural or cosmetic repairs.

Make sure to obtain quotes from these professionals to determine the most cost-effective and efficient solution for your specific situation.

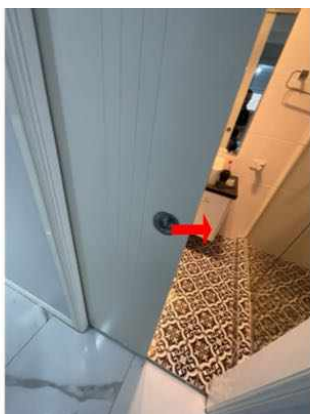
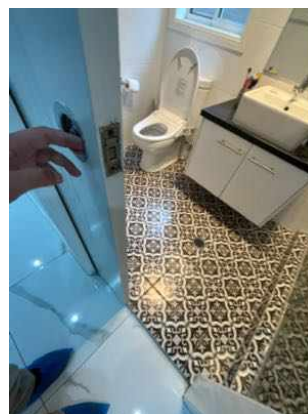
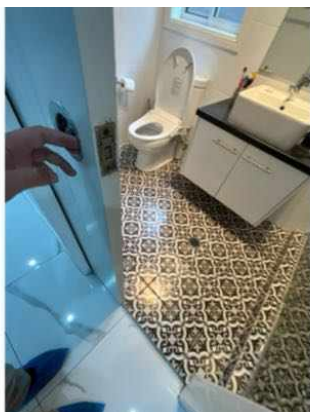
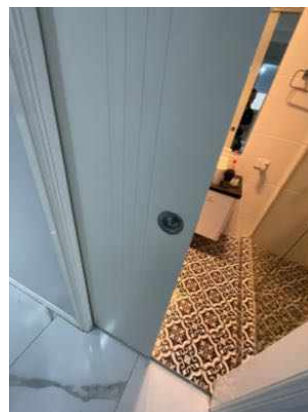
Finding 3.06

Building:	Main Building
Location:	Bathroom downstairs
Finding:	Door - stiff to slide
Information:	The door to this area was difficult to operate at the time of inspection. This is likely due to damaged wheels which help the door to operate in a smooth fashion.

Doors provide ventilation and exits to the adjoining area and should be at a fully operational level to ensure user comfort and safety. Restricted function of the door may also pose as a potential safety hazard if required for emergency egress from the building.

Generally, factors such as general age of the building element and a lack of maintenance are the usual causes for this type of defect.

Replacement of door running hardware may be required, as well as minor repairs and cleaning. A registered builder or general handy person will be required to repair the sliding door.

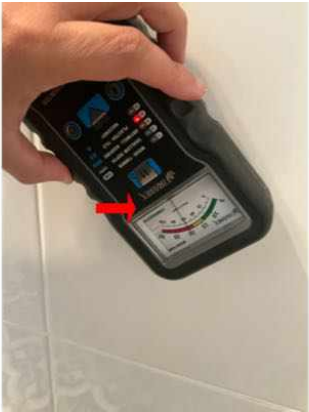
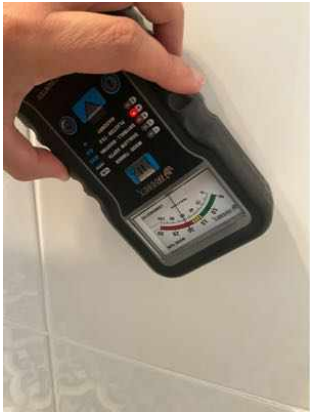
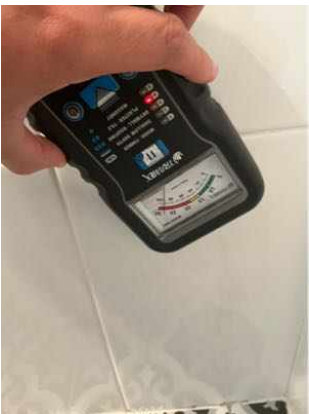
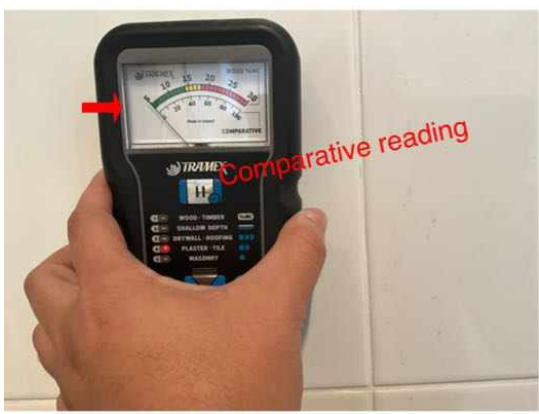
Finding 3.07

Building:	Main Building
Location:	Bathroom downstairs
Finding:	Shower - Damp
Information:	Damp is evident to the lower 300mm of wall to the shower alcove. This defect is quite common, and is suspected to have been caused by moisture permeating through the grouting in this area, which shows evidence of deterioration. Leaking pipes within the adjoining wall is also a possible cause.

Damp (or structural damp) refers to the presence of unwanted moisture in the structure of a building, either as the result of intrusion from outside, or condensation from within the structure. In the shower area, internal water leaks or other sources of excessive moisture are generally the cause of damp.

Unmanaged damp in the shower recess is likely to facilitate the formation and development of mould and fungi growth, decaying associated building materials and compromising their structural integrity. It is important to address damp conditions, as the World Health Organisation notes that excess moisture leads - on almost all indoor materials - to growth of microbes such as moulds, fungi and bacteria, which subsequently emit spores and other matter into the indoor air. Exposure to these contaminants is associated with a wide range of respiratory and other health-related problems.

Consultation with a qualified plumber or bathroom specialist is advised immediately to identify the cause of damp and to perform remedial works as required. Where excessive mould growth is present, further inspection by a specialist environmental health inspector should also be considered.

Always ensure that sealant and grout is in good condition to prevent any moisture issues occurring in the future.

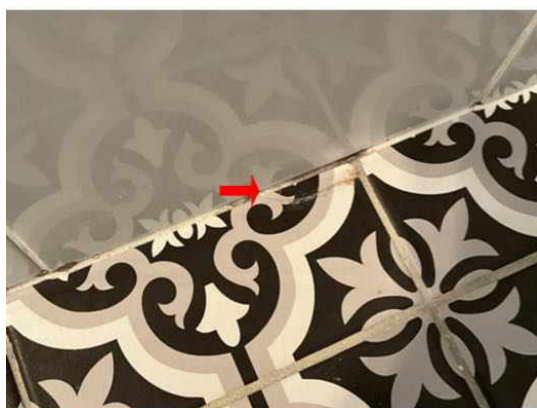
Finding 3.08

Building: Main Building
Location: Bathroom downstairs

Finding:	Tiles - Cracked or damaged
Information:	Cracking was evident to the tiling in this area at the time of inspection. While the cracking appears to be minor, this area is frequently exposed to water, allowing potential for water penetration into adjoining sections of walls or flooring. If left unmanaged, water penetration to these areas may lead to subsequent water damage, which is likely necessitate repair work to affected building elements. A tiling contractor should be appointed to ensure that no further water damage occurs. The re-application of silicone and grouting throughout remaining tile work is also advised, to further protect the area against water penetration. Where water penetration has led to water damage, appointment of a relevant tradesperson may be required to repair damaged building elements.

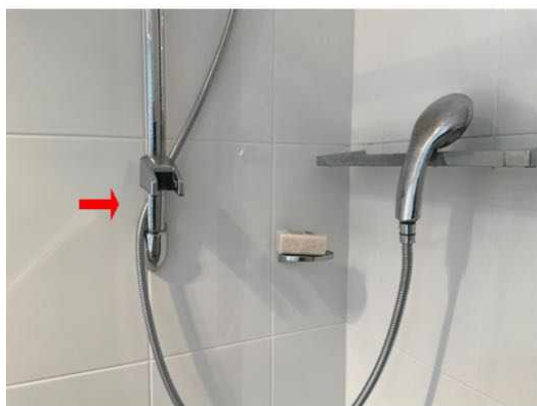
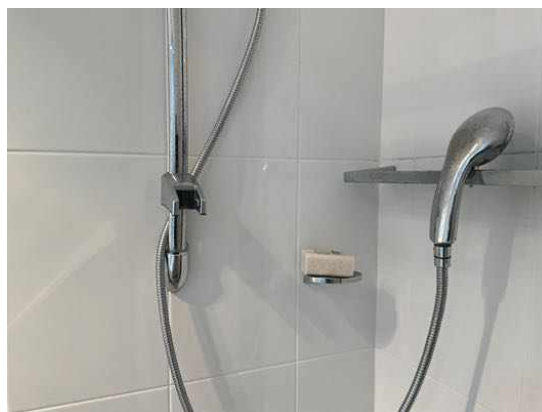
Finding 3.09

Building:	Main Building
Location:	Bathroom downstairs
Finding:	Shower head / holder loose
Information:	The showerhead holder is loose from the installed unit.

Without a proper holder, the showerhead may not be securely positioned, posing a risk of falling during use, potentially causing injury or damage.

A qualified plumber or maintenance personnel should install a new showerhead holder to ensure proper functionality and safety.

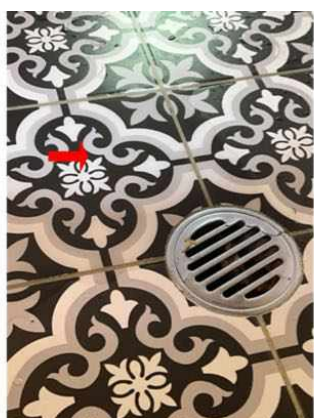
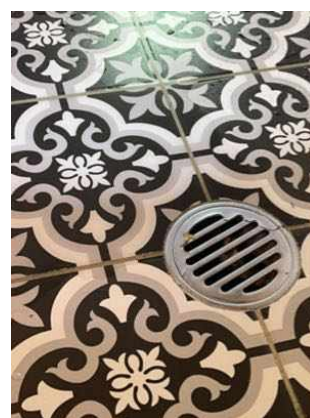
Finding 3.10

Building:	Main Building
Location:	Bathroom downstairs
Finding:	Shower base - Water pooling
Information:	Evidence of water pooling around the floor waste in the shower recess was noticed at the time of inspection. It is suspected that this excessive moisture is attributed to insufficient fall in the shower floor tiles.

This pooling is minor overall but is still considered unsatisfactory, as standard tiling practices would not permit this situation to occur. Pooling water around floor wastes can create a slip hazard in extreme cases and create conditions that are conducive to mould growth over time. Where left unmanaged, the degradation of sealant and grouting is also likely to occur, possibly necessitating further repair works.

Remedial works may involve some sections of tiling and flooring repair and replacement. A tiling contractor or bathroom specialist should be appointed to provide further advice on reparation options and to perform works as necessary.

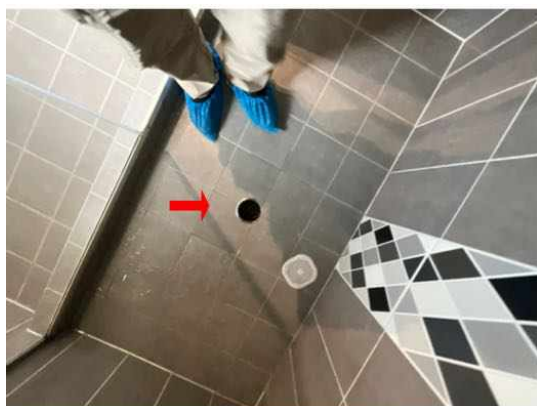
Finding 3.11

Building:	Main Building
Location:	Ensuite
Finding:	Floor waste drain cover missing
Information:	The floor waste drain cover in the bathroom is missing, exposing the open pipe and surrounding debris. Accumulated hair and organic matter are visible, indicating poor maintenance and posing hygiene concerns.

- **Injury Hazard:** The open drain presents a risk of foot injury, especially in a wet environment.
- **Health & Hygiene:** Unsealed drains can emit foul odours and allow pests or gases to enter from the sewer system.
- **Drainage Issues:** Loose debris or hair may obstruct water flow, leading to blockages or slow drainage.

- **Licensed Plumber:** To clean and clear the drain and install a compliant, sealed floor waste cover to prevent recurrence.
- **Handyman (for minor cleaning and cover replacement only):** If no deeper plumbing or sealing issues exist.

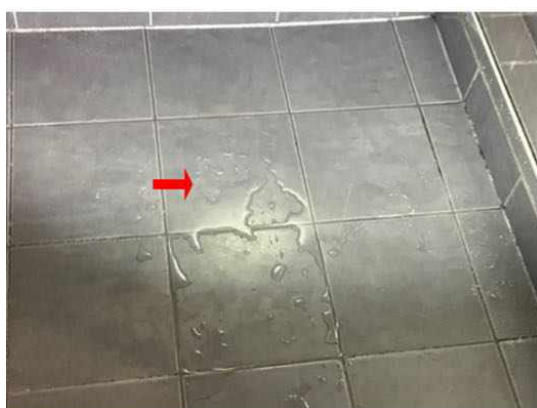
Finding 3.12

Building:	Main Building
Location:	Ensuite
Finding:	Shower base - Water pooling
Information:	Evidence of water pooling around the floor waste in the shower recess was noticed at the time of inspection. It is suspected that this excessive moisture is attributed to insufficient fall in the shower floor tiles.

This pooling is minor overall but is still considered unsatisfactory, as standard tiling practices would not permit this situation to occur. Pooling water around floor wastes can create a slip hazard in extreme cases and create conditions that are conducive to mould growth over time. Where left unmanaged, the degradation of sealant and grouting is also likely to occur, possibly necessitating further repair works.

Remedial works may involve some sections of tiling and flooring repair and replacement. A tiling contractor or bathroom specialist should be appointed to provide further advice on reparation options and to perform works as necessary.

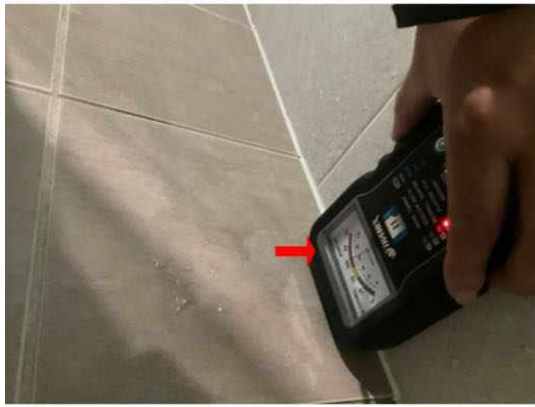
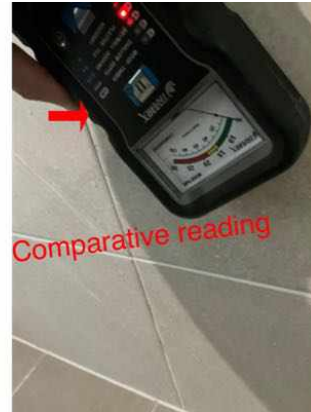
Finding 3.13

Building:	Main Building
Location:	Bathroom upstairs
Finding:	Shower - Damp
Information:	Damp is evident to the lower 300mm of wall to the shower alcove. This defect is quite common, and is suspected to have been caused by moisture permeating through the grouting in this area, which shows evidence of deterioration. Leaking pipes within the adjoining wall is also a possible cause.

Unmanaged damp in the shower recess is likely to facilitate the formation and development of mould and fungi growth, decaying associated building materials and compromising their structural integrity. It is important to address damp conditions, as the World Health Organisation notes that excess moisture leads - on almost all indoor materials - to growth of microbes such as moulds, fungi and bacteria, which subsequently emit spores and other matter into the indoor air. Exposure to these contaminants is associated with a wide range of respiratory and other health-related problems.

Consultation with a qualified plumber or bathroom specialist is advised immediately to identify the cause of damp and to perform remedial works as required. Where excessive mould growth is present, further inspection by a specialist environmental health inspector should also be considered.

Always ensure that sealant and grout is in good condition to prevent any moisture issues occurring in the future.

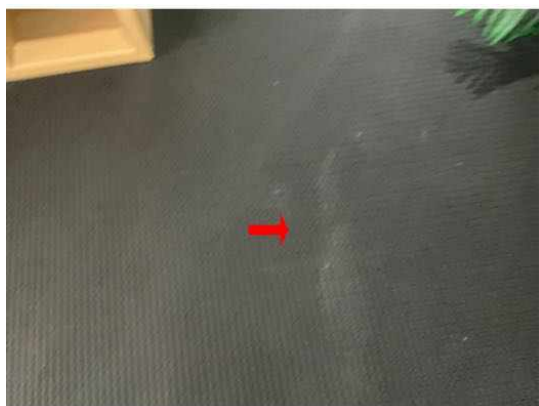
Finding 3.14

Building:	Main Building
Location:	All Areas
Finding:	carpet exhibits visible signs of aging
Information:	Carpets are exhibiting visible signs of aging, including fraying edges, faded colors, and flattened fibers, diminishing their aesthetic appeal and functional quality.

The risk associated with aging carpets includes diminished appearance, decreased comfort, potential tripping hazards due to frayed edges, and a negative impact on indoor air quality if fibers begin to degrade and release particles into the air.

Professional carpet cleaning and restoration services can address issues such as deep cleaning to rejuvenate colors, repairing frayed edges, and restoring fibers. Additionally, replacing the carpets entirely may be necessary in severe cases of aging or damage beyond repair.

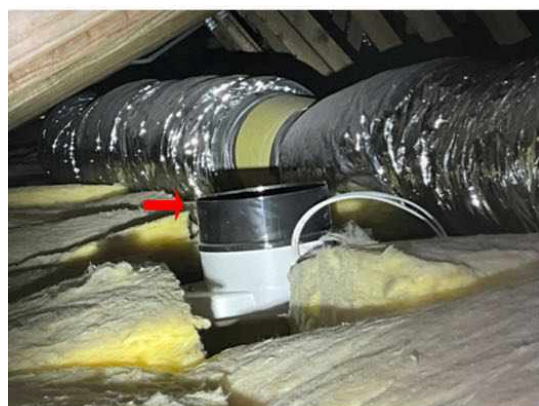
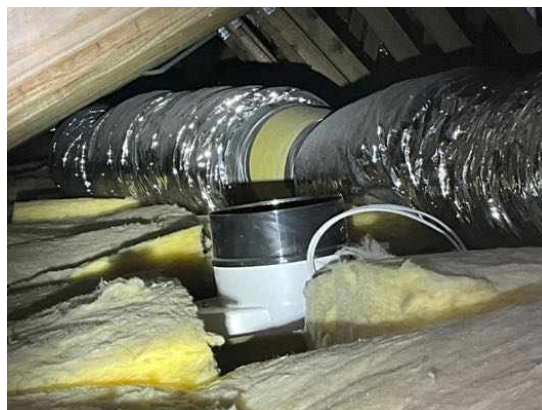
Finding 3.15

Information: The exhaust fan located within the roof void is not appropriately ducted to the external atmosphere and is currently discharging moist air directly into the roof space. This is considered a defect under AS 4349.1, as it does not meet the minimum standard of residential building performance expected under normal residential building practices.

This condition may lead to excessive condensation within the roof void, increasing the

risk of mould growth, deterioration of insulation, timber decay, and overall reduced durability of building elements. It may also result in poor indoor air quality, potentially affecting occupant health.

It is recommended that the exhaust fan be modified by a licensed HVAC contractor or qualified builder, ensuring it is properly ducted to discharge externally in accordance with manufacturer specifications, the National Construction Code (NCC), and applicable Australian Standards.

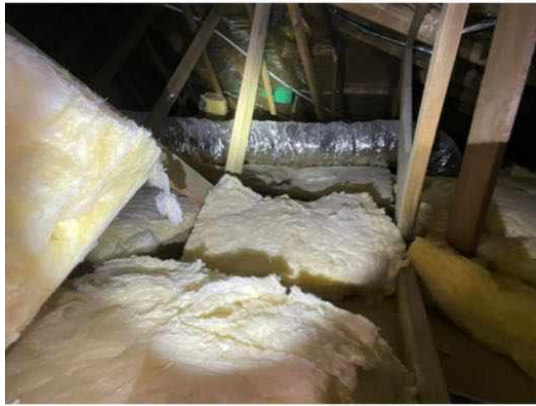
Finding 3.16

Building:	Main Building
Location:	Roof Void
Finding:	Insulation - Covering downlights
Information:	Sections of insulation in the roof void have been poorly installed or moved from their original position and are covering down light fittings. While the down lights have been fitted with appropriate protective covers, the presence of this insulation creates a potential fire hazard.

Any insulation within the vicinity of down light fixtures should be moved and re-applied to more appropriate sections of the roof void, thus ensuring the area is fire-safe. An insulation contractor should be appointed as soon as possible to perform any

necessary works as required.

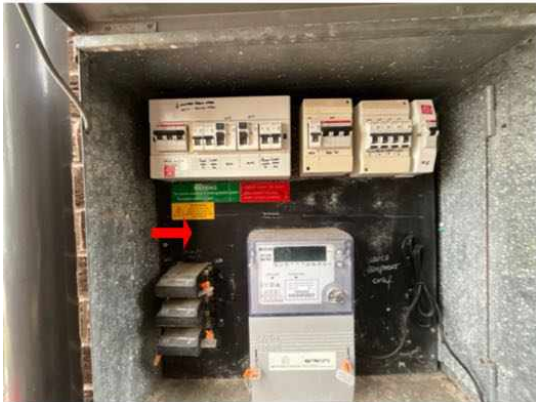
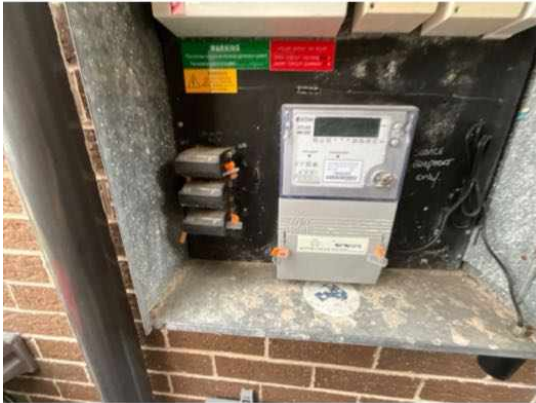
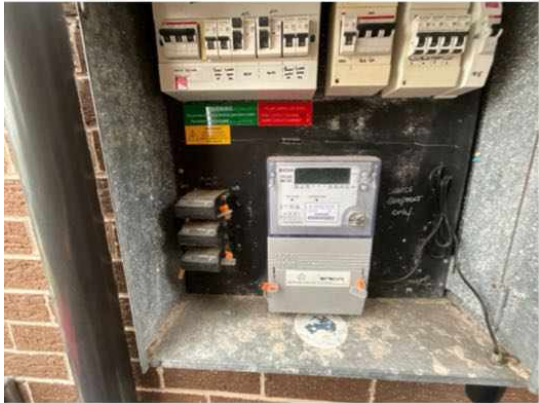
Building: Main Building
Location: Exterior walls - right side
Finding: No Evidence of Termite Management System - Durable notice / Legible Sticker
Information: The application of a pre & post-construction chemical termite barrier is highly recommended for all properties. Such barriers are highly effective in preventing termite attack on any timber building elements throughout the property.

A durable notice was not placed in the switchboard unit to indicate current termite barriers is legible at the time of inspection.

Client must seek further information from the vendor or real estate agent if the conditions of termite management systems were maintained.

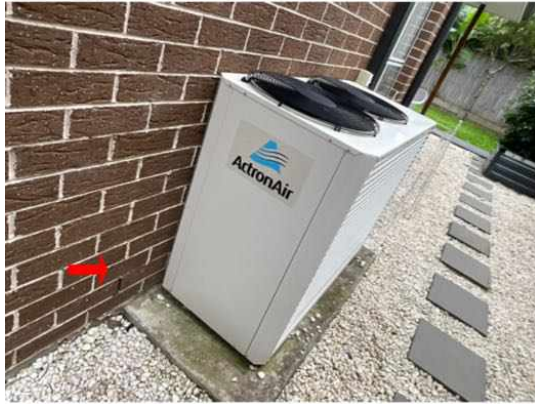
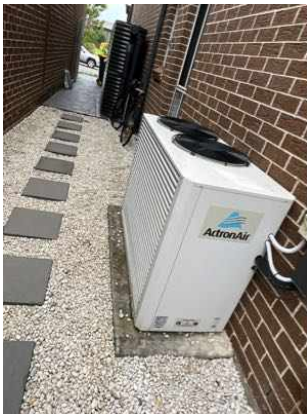
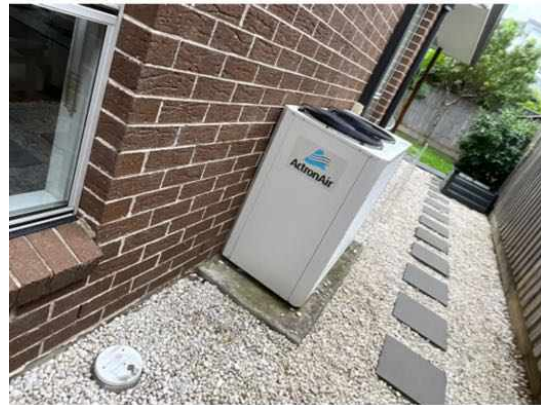
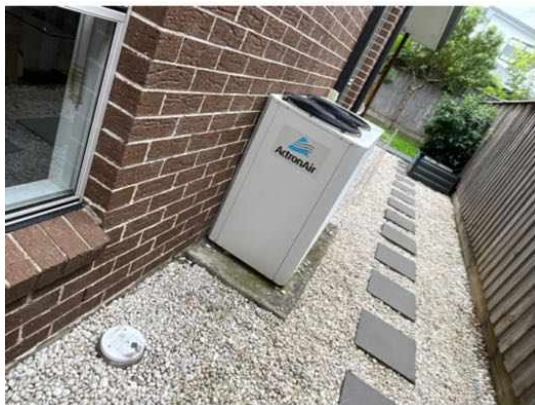
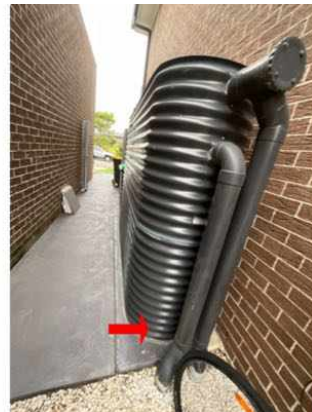
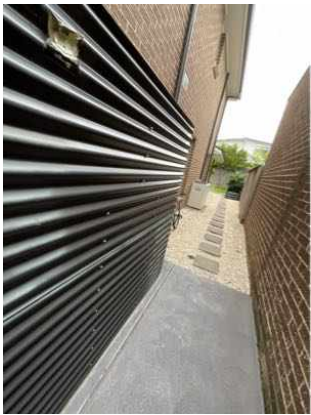
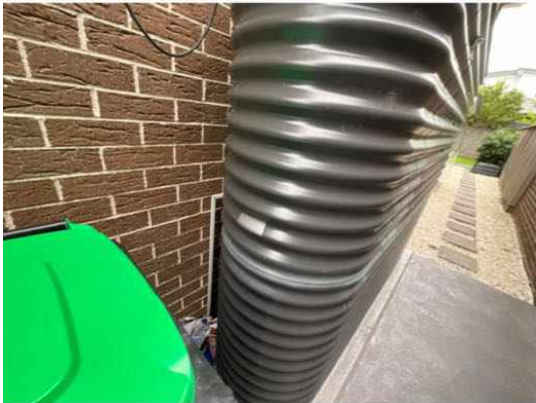
Finding 6.03

Building: Main Building
 Location: All Areas
 Finding: Bridging or Obstruction Conducive environment for Termites
 Information: Bridging of termite barriers occurs when termites bridge (usually by building a mud tunnel) a termite barrier or inspection zone or where termites have a passage, allowing them to bridge the barrier.

Recommended moving obstructions away from the external walls for further and future inspections.

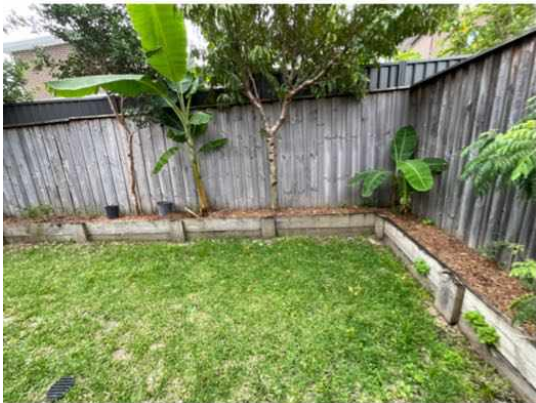
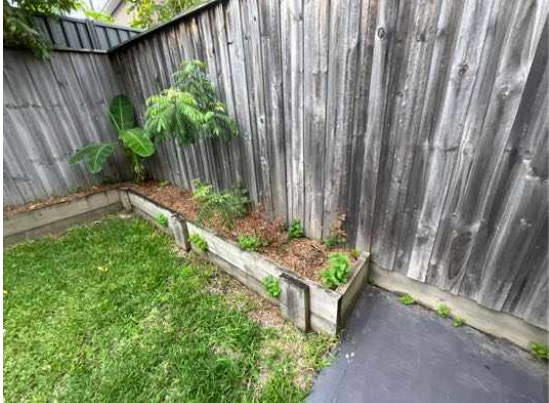
Finding 6.04

Building: Main Building
 Location: All Areas
 Finding: Timber on ground / conducive conditions to termite damage
 Information: Timber on the ground is indeed conducive to termite damage. Termites are known to thrive in moist environments, and wood in contact with soil or moisture is more susceptible to infestation.

To prevent this, it's important to keep timber elevated and away from direct ground contact. Regular inspections and proper termite control measures are also essential to protect your wooden structures from termite damage.

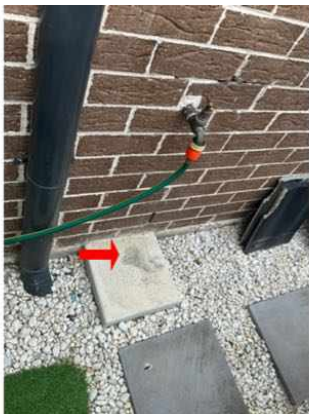
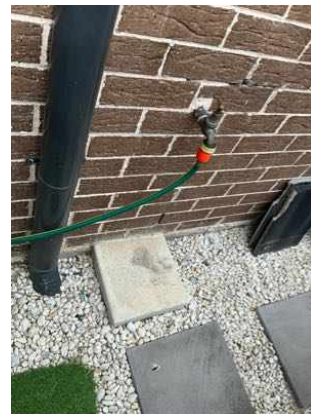
Finding 6.05

Building:	Main Building
Location:	Exterior walls - left side
Finding:	No Drain under tap
Information:	There is no drain installed under the tap, leading to water accumulation and creating conducive conditions for timber pests. This defect needs immediate attention to prevent potential damage and pest infestation.

1. Water Accumulation: Without proper drainage, water can accumulate around the base of the tap, leading to persistent dampness in the surrounding area.
2. Timber Pest Infestation: The damp environment created by standing water is highly conducive to timber pests, such as termites and wood borers, which thrive in moist conditions and can cause significant damage to wooden structures.
3. Structural Damage: Prolonged exposure to moisture can lead to wood rot and deterioration of structural timber, compromising the integrity of the building.
4. Health Hazards: Persistent dampness can also promote mold and mildew growth, posing health risks to occupants.

5. Aesthetic Damage: Water stains and damage to finishes and materials around the tap area can detract from the appearance of the building and lead to costly repairs.

A licensed plumber or a qualified building contractor can address this defect by:

1. Assessment: Evaluating the area to determine the best approach for installing a proper drainage system under the tap.
2. Installation: Installing a drain that effectively channels water away from the base of the tap, preventing water accumulation and dampness.
3. Repair and Prevention: Inspecting and repairing any existing water damage and implementing measures to prevent future water accumulation and pest infestations.

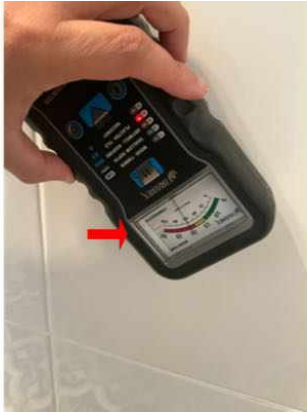
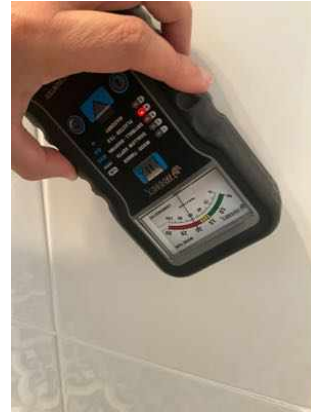
Finding 6.06

Building:	Main Building
Location:	Bathroom downstairs
Finding:	Excessive moisture - Conducive to Timber pest
Information:	Excessive moisture can attract termites and produce conditions that promote fungal growth and wood decay.

Excessive moisture is generally caused by deteriorated inadequate or missing roof drainage leaking plumbing pipes or fixtures poorly plumbed HWS overflows or condenser units and poor site drainage.

Prior to any remedial works being performed a qualified plumber should be appointed to further inspect the property and to identify the cause of the excessive moisture. Works to remove affected building elements may then be necessary and should be performed by an appropriate tradesperson.

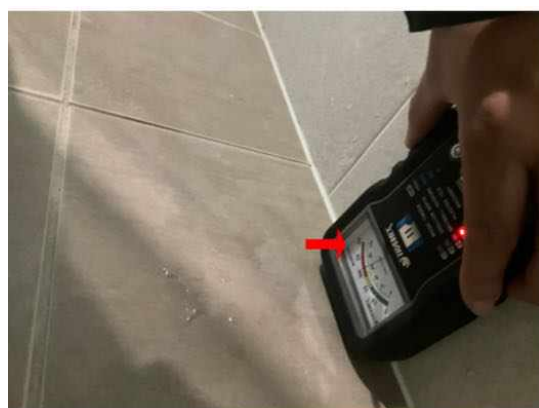
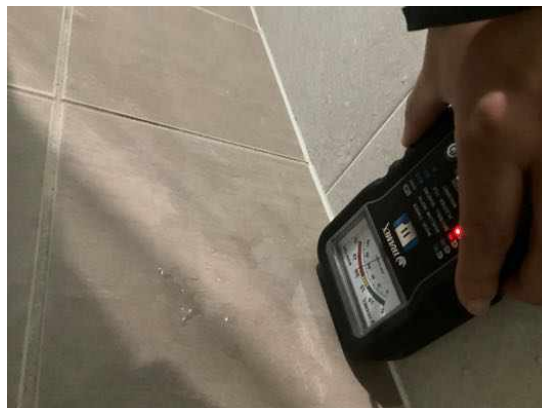
Finding 6.07

Building:	Main Building
Location:	Bathroom upstairs
Finding:	Excessive moisture - Conducive to Timber pest
Information:	Excessive moisture can attract termites and produce conditions that promote fungal growth and wood decay.

Excessive moisture is generally caused by deteriorated inadequate or missing roof drainage leaking plumbing pipes or fixtures poorly plumbed HWS overflows or condenser units and poor site drainage.

Prior to any remedial works being performed a qualified plumber should be appointed to further inspect the property and to identify the cause of the excessive moisture. Works to remove affected building elements may then be necessary and should be performed by an appropriate tradesperson.
