Building and Timber Pest Inspection Report

Inspection Date: Tue, 17 Mar 2026

Property Address: 58 Faulconbridge St, The Ponds NSW 2769, Australia

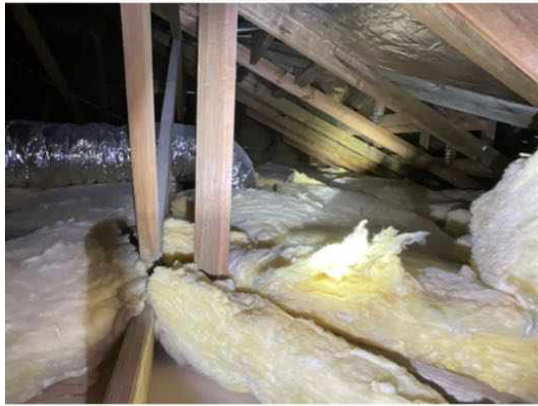
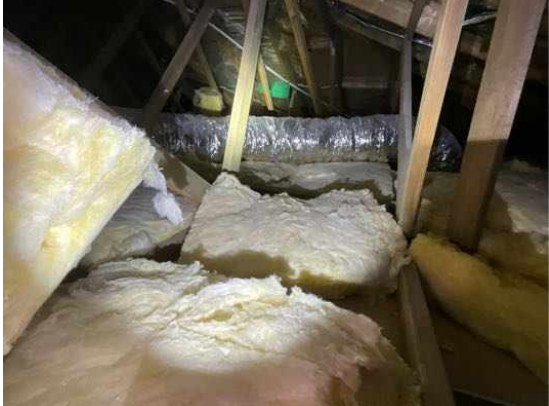
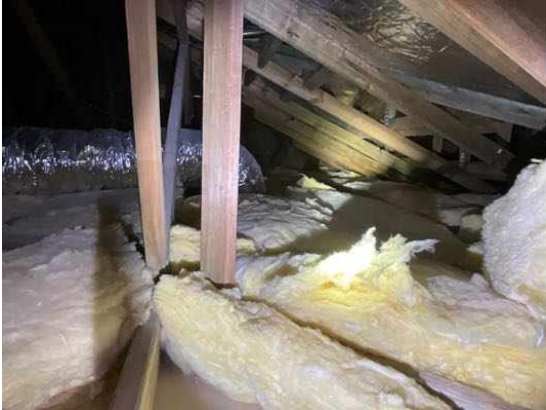
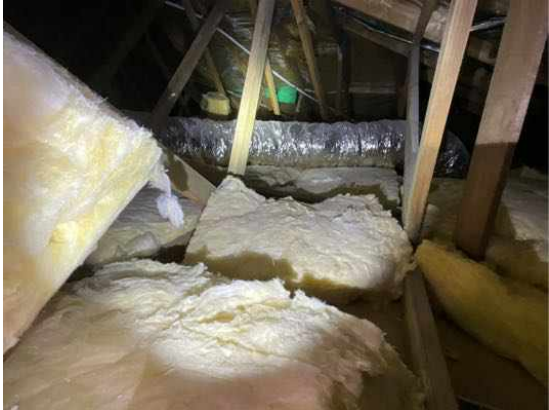
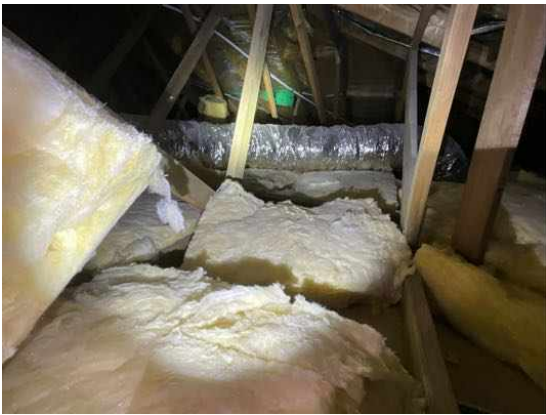
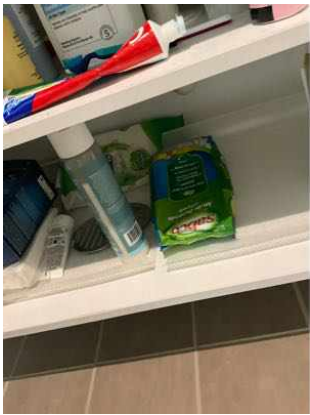
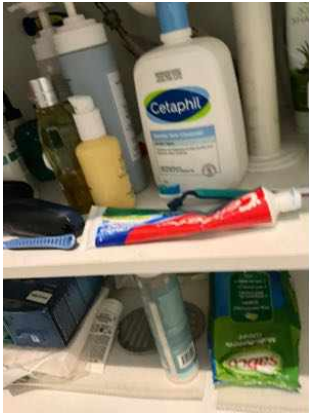
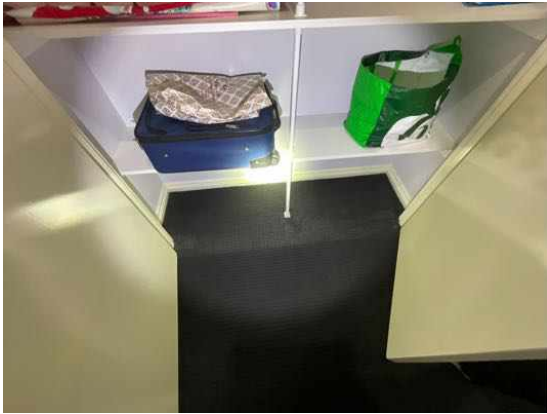
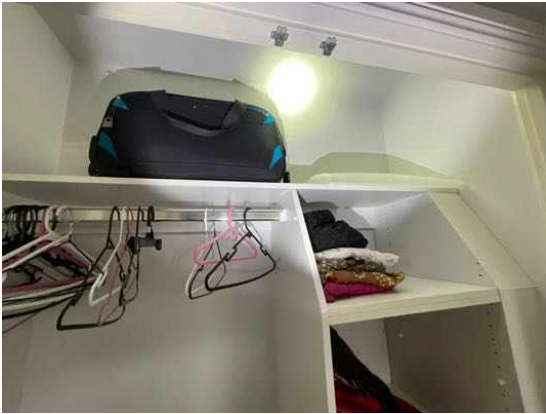
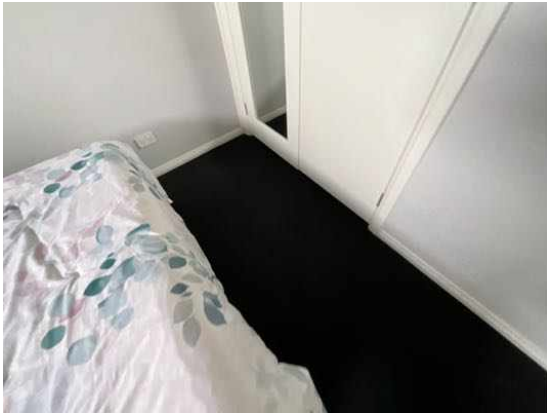
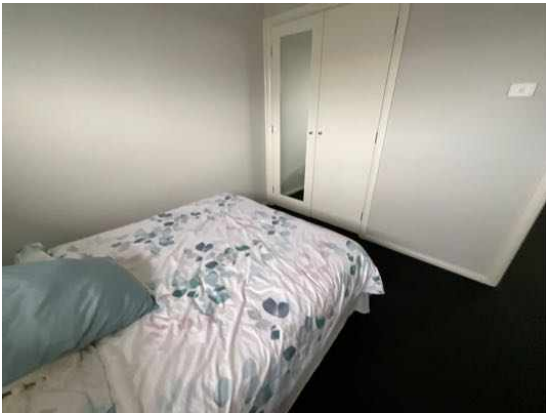
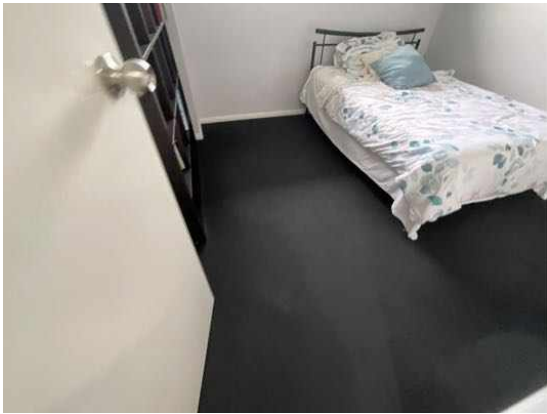
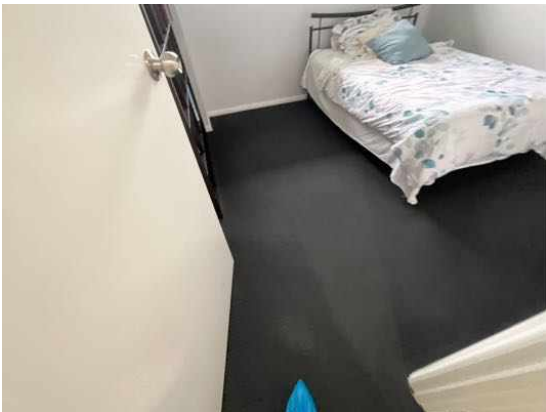
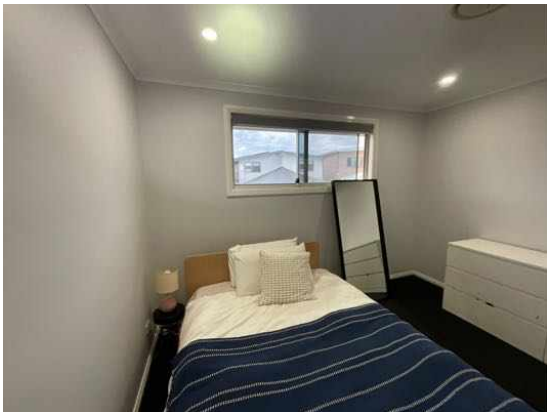
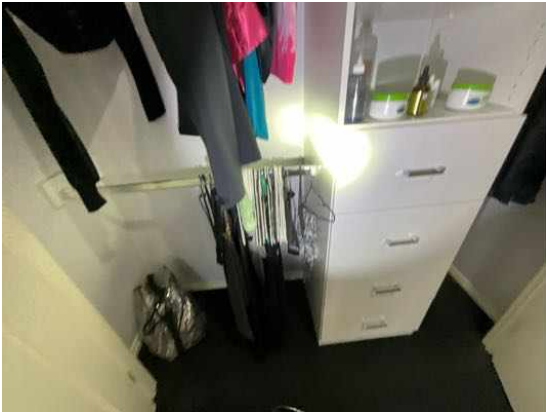
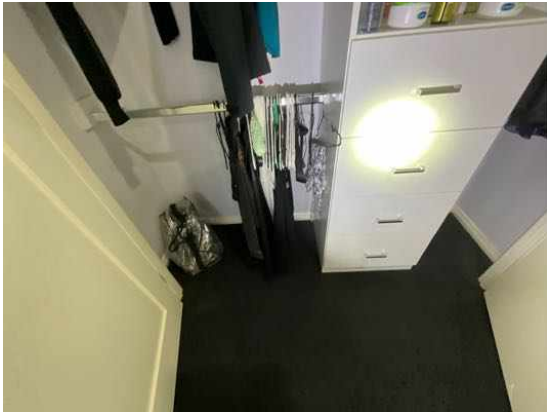
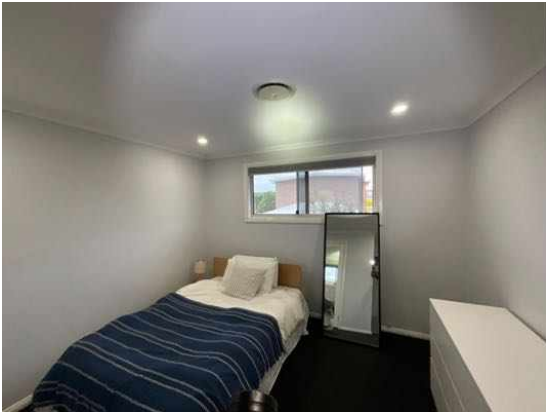
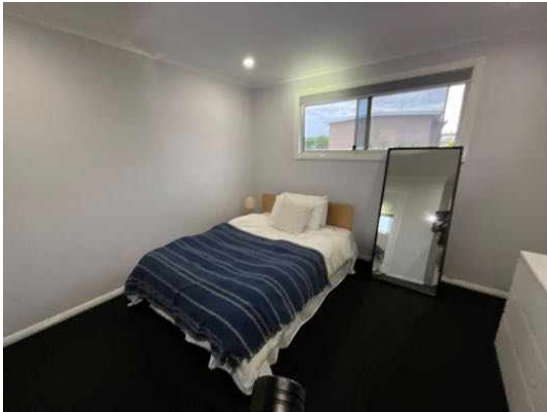
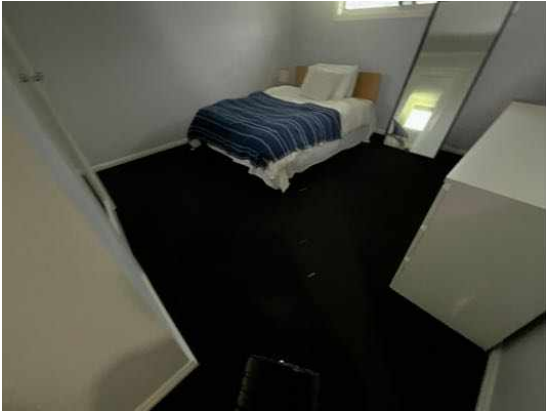
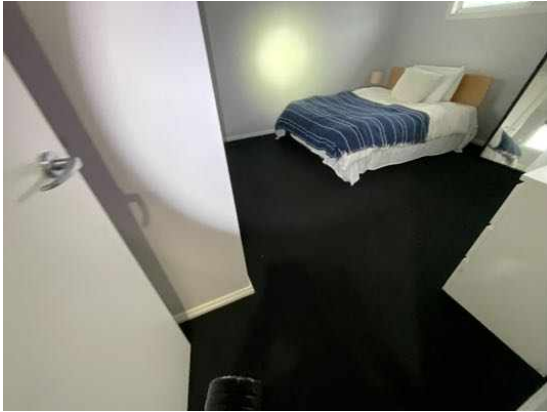
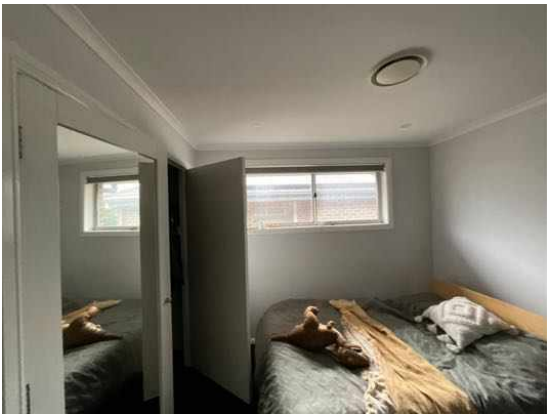
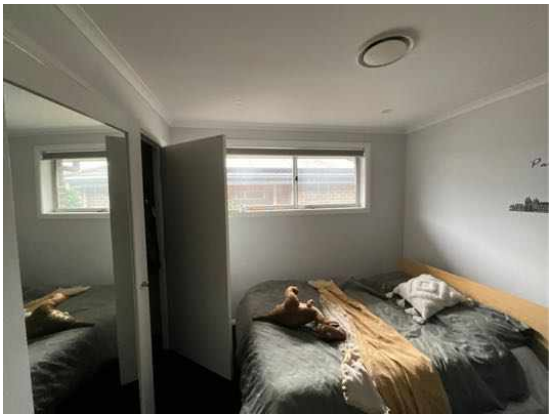
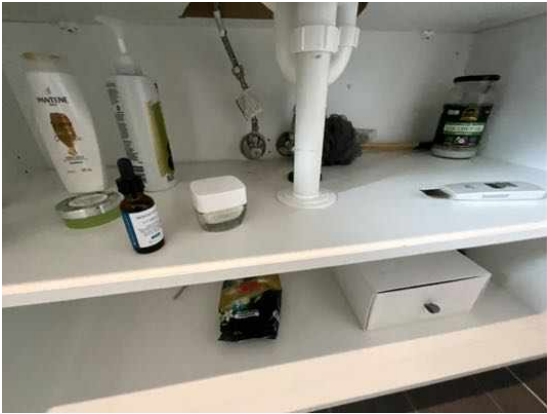
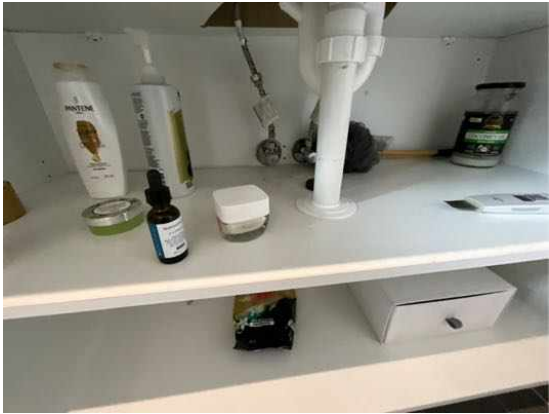
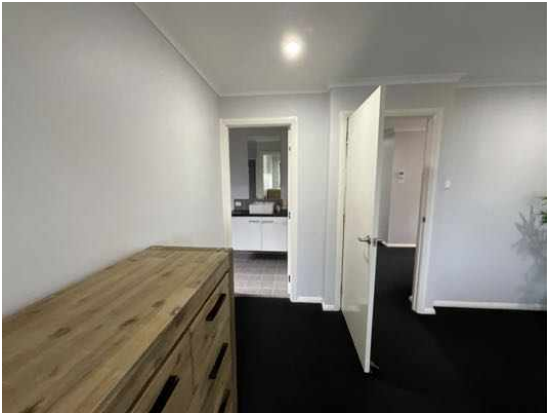
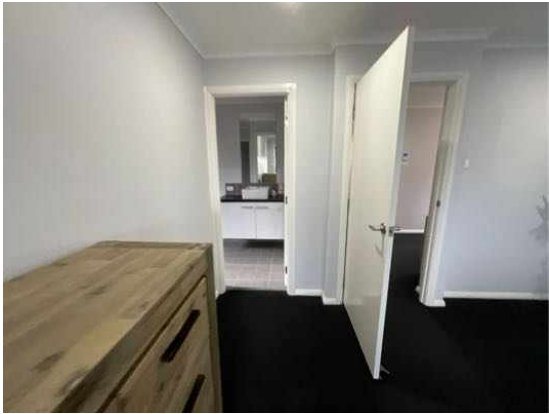
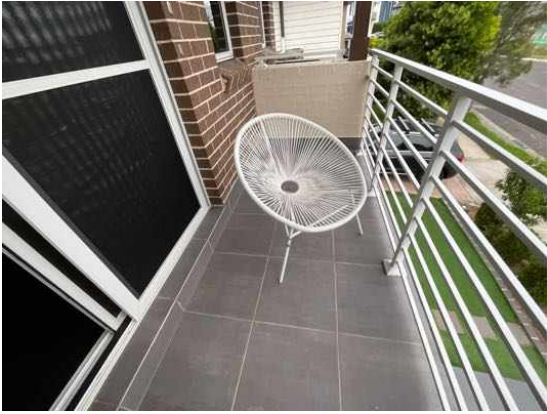
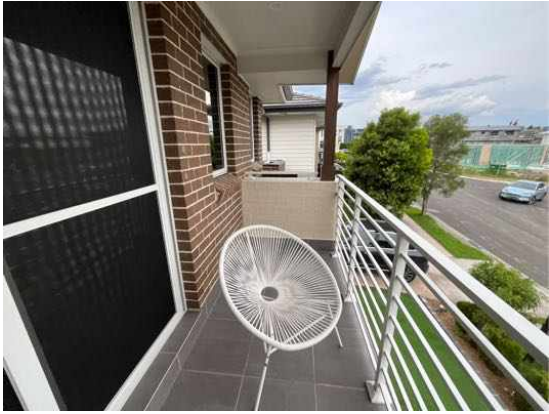
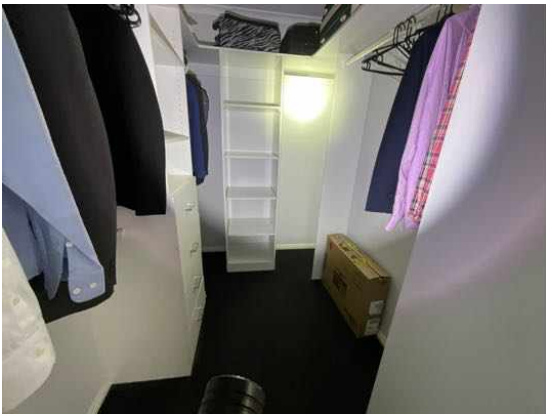
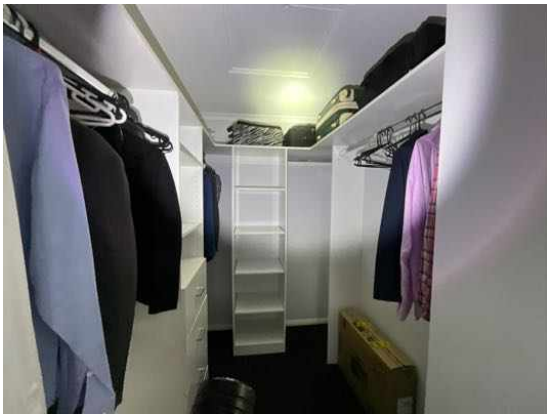
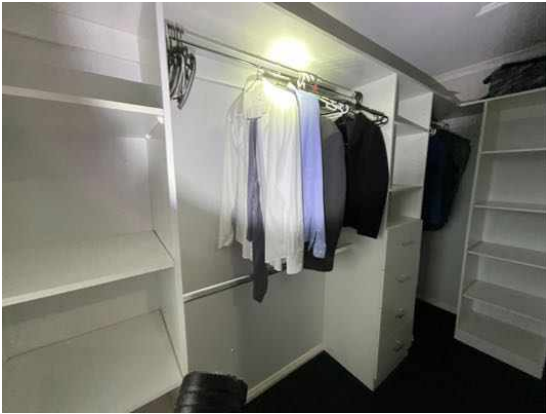
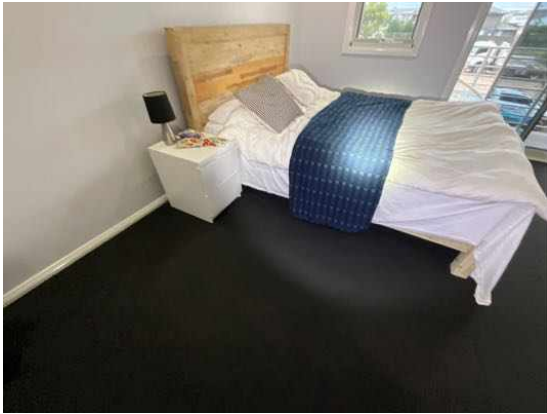
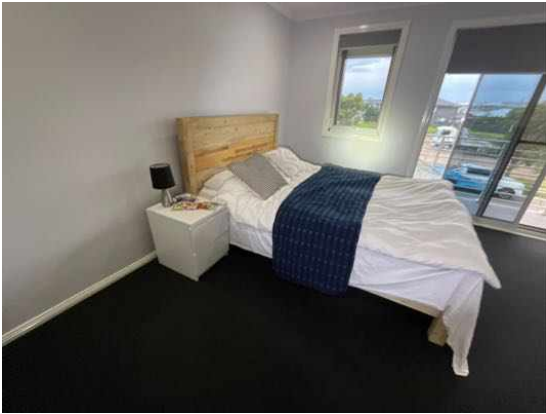
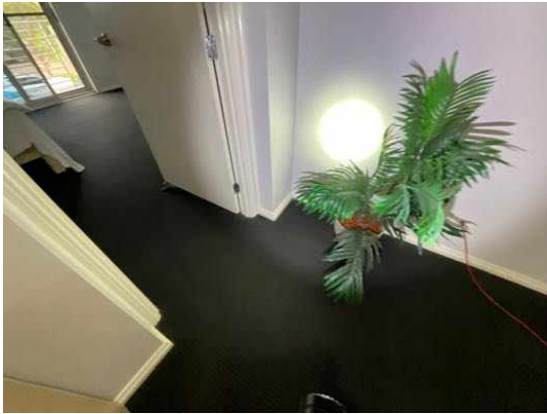
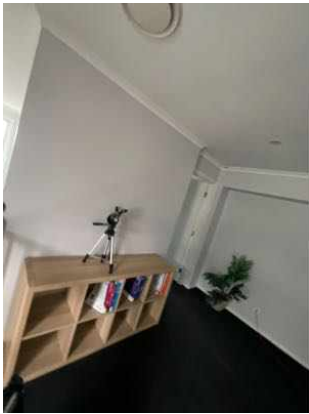
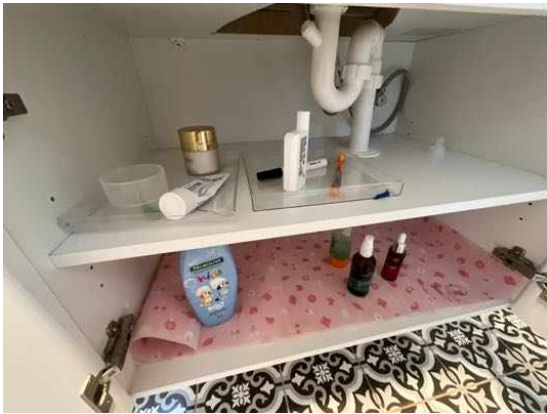
Building: Main Building
Location: All Areas
Finding: Additional Photos - Obstructions and Limitations
Information: These photographs are an indication of the obstructions and limitations which impeded full inspection of the property at the time of inspection. These obstructions can hide an array of defects and should be removed to allow full inspection to be carried out. A re-inspection is recommended once the areas are made accessible.
